## Flood Control Project Maintenance Levee Inspections

### Fall 2020 Levee Maintenance Deficiency Summary Report

#### San Joaquin River Basin

**Merced Streams Group**

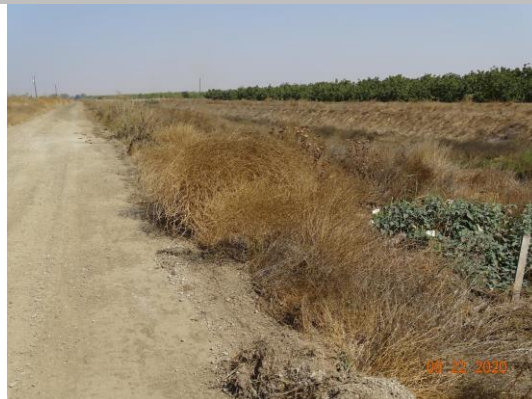
Photo 1 of 1 : FA\_2020\_NA0013\_331\_2\_20200928\_00010.jpg

LM Start	0.01	Rating **	U	Issue No.	2
LM End	1.59	Issue Type +	Ma	Location *	WS
Category	Earthen Levee			GPS Latitude/Longitude	
				Start	End
Item	Vegetation			37.314849 °	37.336860 °
				-120.396375 °	-120.396523 °
DWR ID	DWR_NA0013_01_f_2020_2				
Comment Code					
V1 : Control annual grass and weeds on the levee slopes and easements.					
Inspector Comment

View of vegetation on the waterside slope. (Fall 2020)

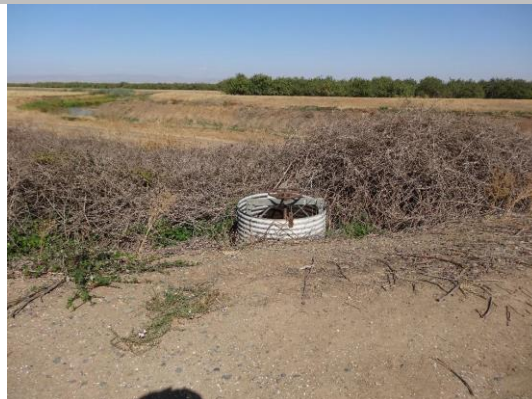
Photo 2 of 3 : UCIP\_FA\_2020\_41672\_35210.jpg

LS view: overview of CM pipe riser with slide gate. Dense vegetation on landside.

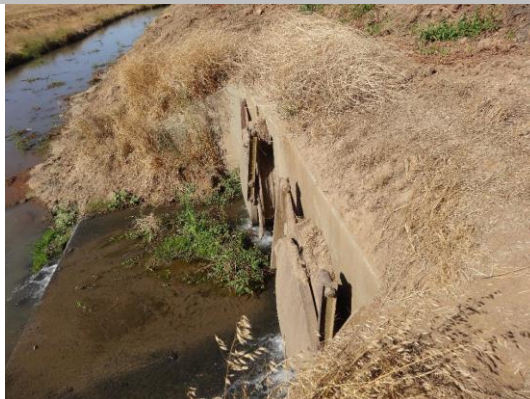
Photo 1 of 3 : UCIP\_FA\_2020\_20965\_35292.jpg

Comment Code						
Inspector Comment						
DS_ID:23056 FS_ID:20965 EP_NO: N/A Repair Type: No Action Needed EVAL Issue: Crossing Status: Found UCIP Comments: 09/17/2013 - working during field inspection. - vegetation on drainage ditch/channel (DWR UCIP - P. Amatya) FIELD_STRUCT_DESC: 1 of 2: 60-inch corrugated metal gravity drainage pipe through the levee, 10 feet below the crown. Concrete headwall and flap gate on the waterside (WS) berm, 5 feet from the levee toe. Concrete headwall on the landside (LS) toe. [Additional Reference(s): DWR Levee Log, 2005. USACE San Joaquin O&M Manual 607, June 1962, (HLM 0.91)]. FS Date: 9/17/2013

WS view: two 60" CMPs, flap gates, and headwall on channel bank.

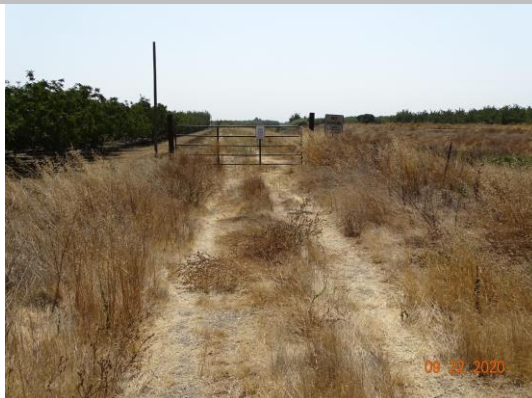
Photo 1 of 1 : FA\_2020\_NA0013\_332\_31\_20200928\_00039.jpg

LM Start	1.62	Rating **	U	Issue No.	31
LM End	1.66	Issue Type +	Ma	Location *	CR
Category	Earthen Levee			GPS Latitude/Longitude	
				Start	End
Item	Vegetation			37.317992 °	37.317396 °
				-120.395735 °	-120.395744 °
DWR ID	DWR_NA0013_02_s_2020_31				
Comment Code					
V9 : Keep the crown roadway free of vegetation.					
Inspector Comment

Looking downstream along the levee crown. (Fall 2020)

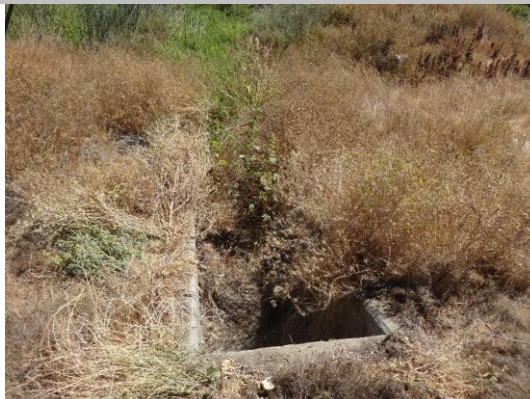
Photo 1 of 3 : UCIP\_FA\_2020\_50149\_35535.jpg

WS view: cobble spillway and channel on waterside. Dense vegetation on levee slope.

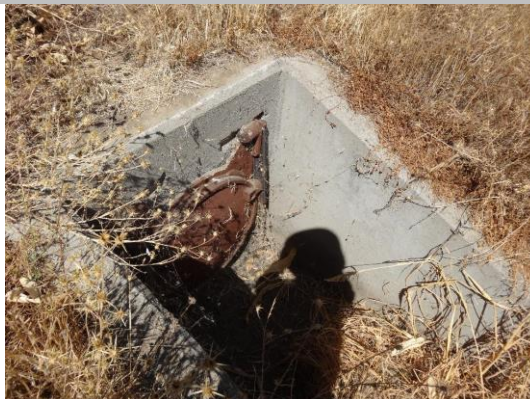
Photo 2 of 3 : UCIP\_FA\_2020\_50151\_35538.jpg

WS view: U typed concrete headwall, CM pipe, and flap gate. Vegetation needs to be cleared.

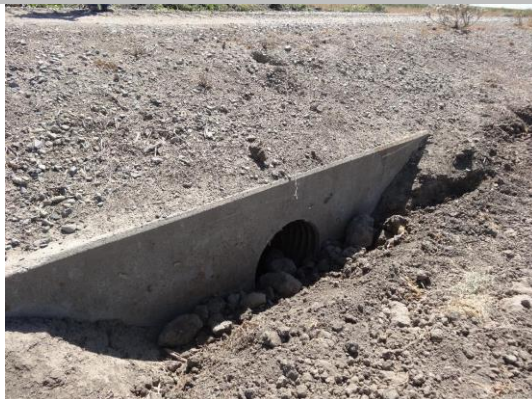
Photo 2 of 3 : UCIP\_FA\_2020\_21063\_35501.jpg

LS view: concrete headwall and CM pipe. Inlet needs clearing.

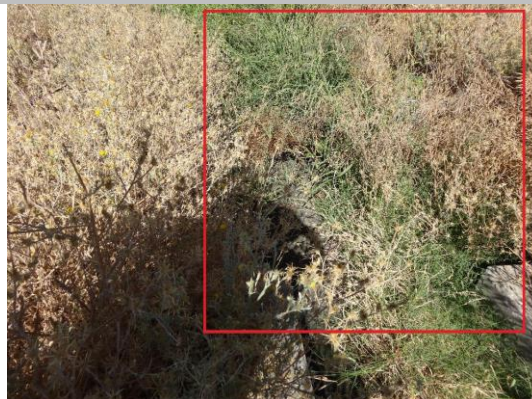
Photo 1 of 3 : UCIP\_FA\_2020\_50148\_35613.jpg

WS view: Dense vegetation on levee slope and spillway.

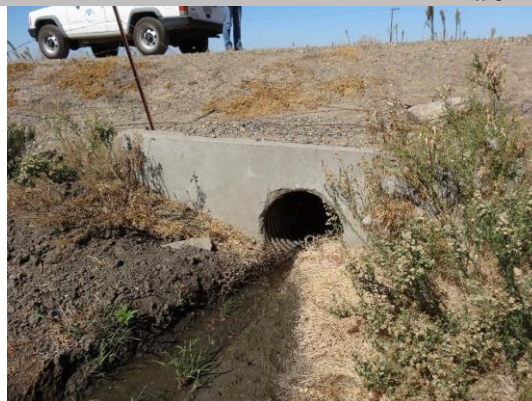
Photo 3 of 3 : UCIP\_FA\_2020\_21126\_35654.jpg

LS view: concrete headwall and CM pipe. Drain pipe was working during field survey.

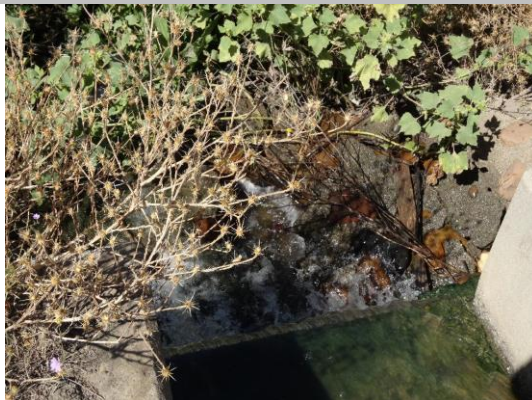
Photo 2 of 3 : UCIP\_FA\_2020\_21127\_35656.jpg

WS view: concrete headwall and concrete spillway on waterside.

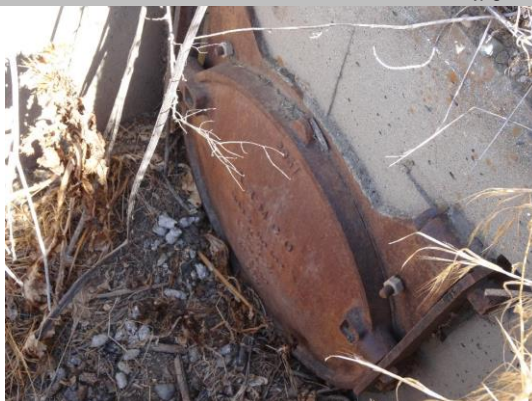
Photo 2 of 3 : UCIP\_FA\_2020\_52888\_35708.jpg

WS view: U typed concrete headwall, CM pipe, and flap gate. Spillway needs to be cleared.

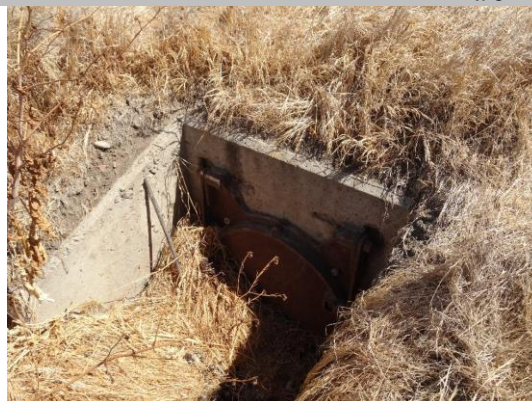
Photo 1 of 3 : UCIP\_FA\_2020\_50153\_35745.jpg

WS view: U typed concrete headwall, CM pipe, and flap gate. Dirt and vegetations need to be removed and cleared.
