Flood Control Project Maintenance Levee Inspections

Fall 2021 Levee Maintenance Deficiency Summary Report

San Joaquin River Basin

Merced Streams Group

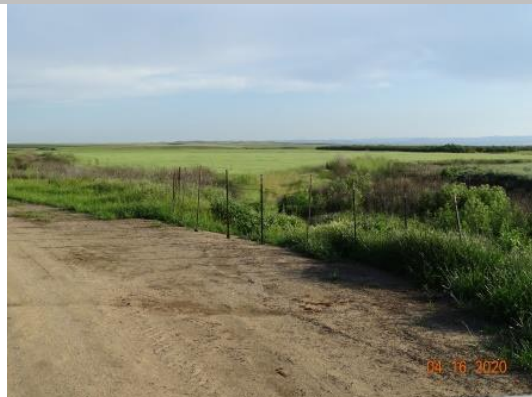
Photo 1 of 1 : FA_2021_NA0013_331_18_20210830_00006.jpg

LM Start	1.27	Rating **	M	Issue No.	18
LM End	1.27	Issue Type +	En	Location *	WS
Category	Earthen Levee			GPS Latitude/Longitude	
				Start	End
Item	Encroachments			37.332554 °	37.332554 °
				-120.394767 °	-120.394767 °
DWR ID	DWR_NA0013_01_s_ 2019_18				
Comment Code					
RA : Ramp					
Inspector Comment					
Ramp has been fenced off at waterside shoulder.

View of ramp on waterside slope looking Northeast. (Spring 2020)

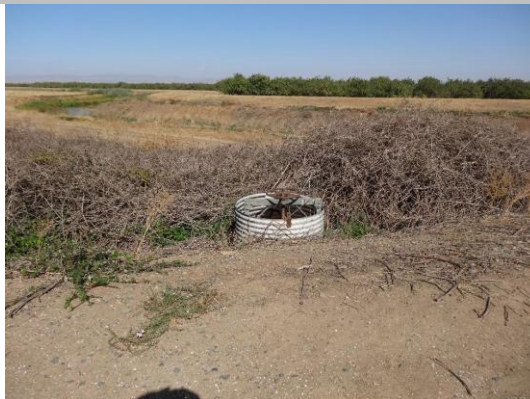
Photo 2 of 3 : UCIP_FA_2021_41672_35210.jpg

LS view: overview of CM pipe riser with slide gate. Dense vegetation on landside.

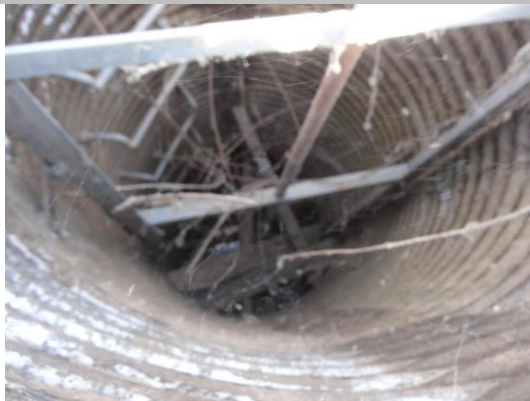
Photo 3 of 3 : UCIP_FA_2021_41672_35209.jpg

LS view: inside view of CM pipe riser with slide gate.

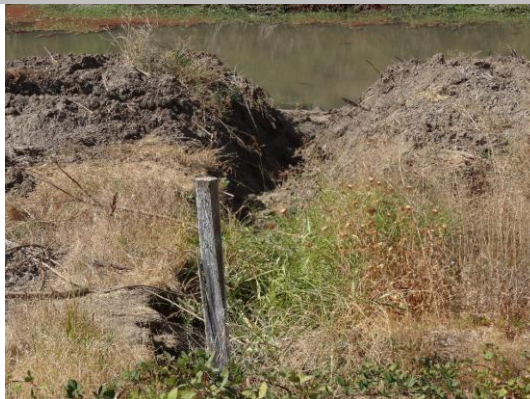
Photo 1 of 3 : UCIP_FA_2021_50156_35245.jpg

WS view: cobble spillway and channel on waterside.

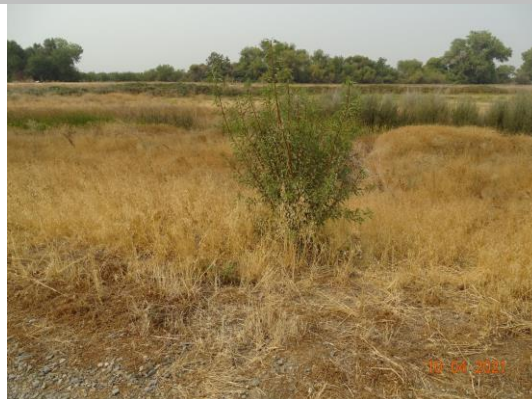
Photo 1 of 1 : FA_2021_NA0013_332_12_20211012_00033.jpg

LM Start	0.53	Rating **	M	Issue No.	12
LM End	0.53	Issue Type +	Ma	Location *	WS
Category	Earthen Levee			GPS Latitude/Longitude	
				Start	End
Item	Trim / Thin Trees			37.333210 °	37.333210 °
				-120.394036 °	-120.394036 °
DWR ID	DWR_NA0013_02_f _ 2021_12				
Comment Code					
T2 : Thin trees to allow visibility of the ground and room to flood fight.					
Inspector Comment					
Sapling should be removed before it can establish.

Sapling growing in the waterside shoulder. (Fall 2021)

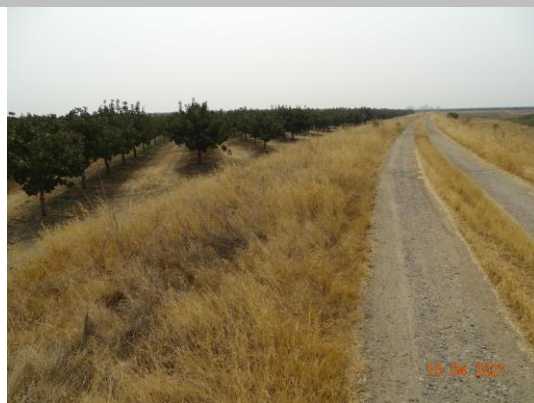
Photo 1 of 1 : FA_2021_NA0013_332_13_20211012_00034.jpg

LM Start	0.63	Rating **	U	Issue No.	13
LM End	0.84	Issue Type +	Ma	Location *	LS
Category	Earthen Levee			GPS Latitude/Longitude	
				Start	End
Item	Vegetation			37.331788 °	37.329227 °
				-120.394198 °	-120.396019 °
DWR ID	DWR_NA0013_02_f_2021_13				
Comment Code					
V1 : Control annual grass and weeds on the levee slopes and easements.					
Inspector Comment

Looking downstream along the landside slope. (Fall 2021)

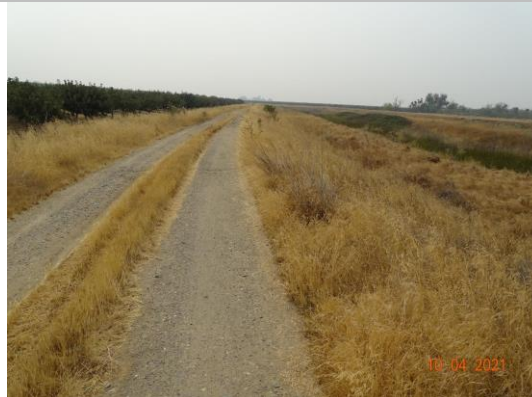
Photo 1 of 1 : FA_2021_NA0013_332_14_20211012_00035.jpg

LM Start	0.63	Rating **	U	Issue No.	14
LM End	0.93	Issue Type +	Ma	Location *	WS
Category	Earthen Levee			GPS Latitude/Longitude	
				Start	End
Item	Vegetation			37.331788 °	37.327876 °
				-120.394198 °	-120.396091 °
DWR ID	DWR_NA0013_02_f _ 2021_14				
Comment Code					
V1 : Control annual grass and weeds on the levee slopes and easements.					
Inspector Comment

View of vegetation growing along the waterside slope. (Fall 2021)

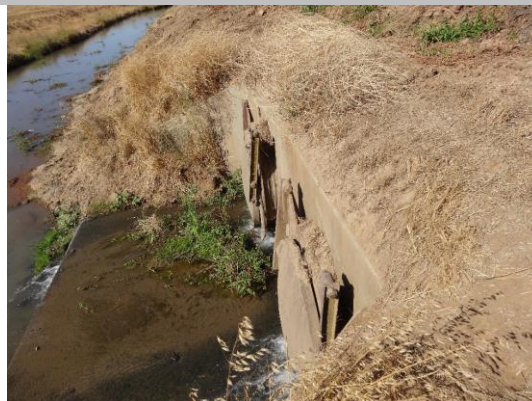
Photo 1 of 3 : UCIP_FA_2021_20965_35292.jpg

WS view: two 60" CMPs, flap gates, and headwall on channel bank.

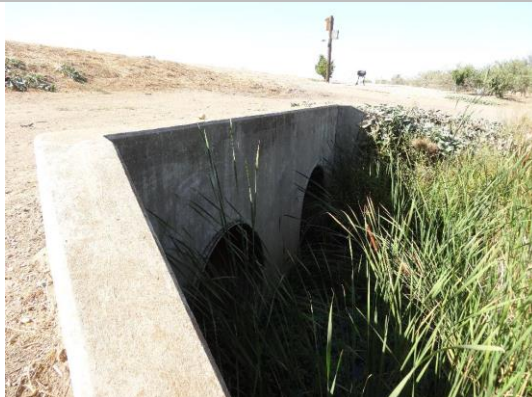
Photo 3 of 3 : UCIP_FA_2021_20965_35290.jpg

LS view: two CM pipes and U typed headwall on levee toe. Green vegetation in drainage channel.

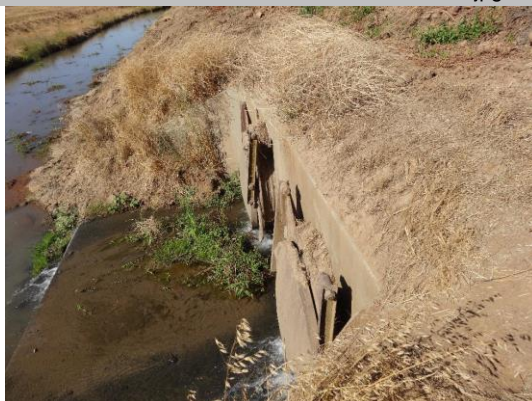
Photo 1 of 3 : UCIP_FA_2021_20983_35302.jpg

DS_ID:23080
FS_ID:20983
EP_NO: N/A
Repair Type: No Action Needed
EVAL Issue:
Crossing Status: Found
UCIP Comments: 09/17/2013 It was working during field inspection.

WS view: two CMPs with flap gate, concrete spillway and channel on waterside.

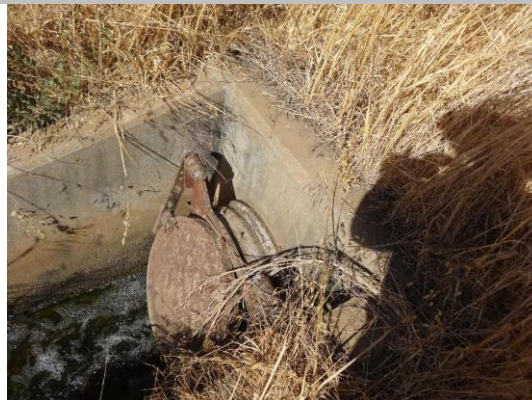
Photo 2 of 3 : UCIP_FA_2021_20984_35304.jpg

WS view: U typed concrete headwall, CM pipe, and flap gate. It was working during field inspection.

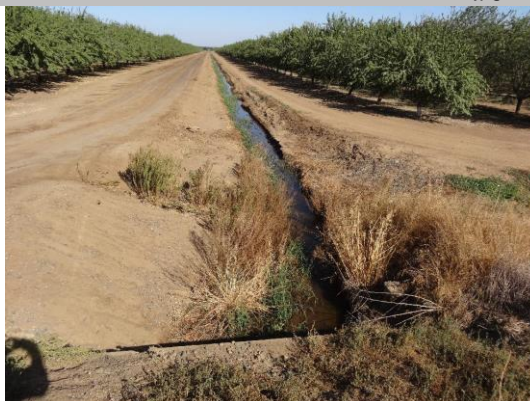
Photo 3 of 3 : UCIP_FA_2021_20984_35303.jpg

LS view: concrete headwall on levee toe and drainage ditch.

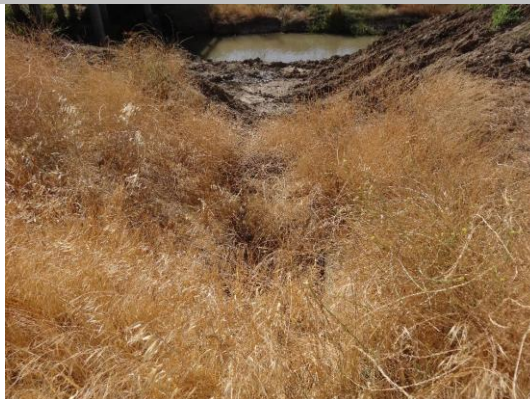
Photo 1 of 3 : UCIP_FA_2021_42993_35310.jpg

WS view: overview of outlet area and channel. Debris and vegetations on spillway.

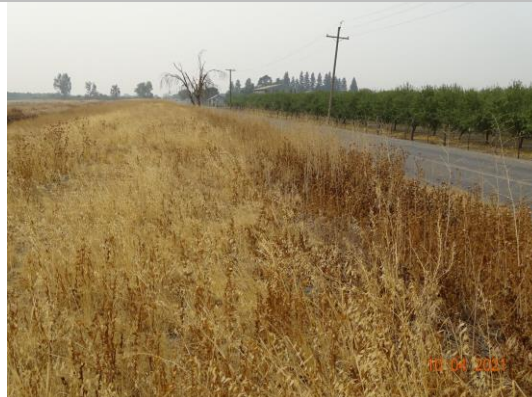
Photo 1 of 1 : FA_2021_NA0013_333_8_20211012_00025.jpg

LM Start	0.00	Rating **	U	Issue No.	8
LM End	0.33	Issue Type +	Ma	Location *	LS
Category	Earthen Levee			GPS Latitude/Longitude	
				Start	End
Item	Vegetation			37.257654 °	37.262365 °
				-120.288501 °	-120.288240 °
DWR ID	DWR_NA0013_03_f_2021_8				
Comment Code					
V1 : Control annual grass and weeds on the levee slopes and easements.					
Inspector Comment

View of the landside slope looking downstream. (Fall 2021)

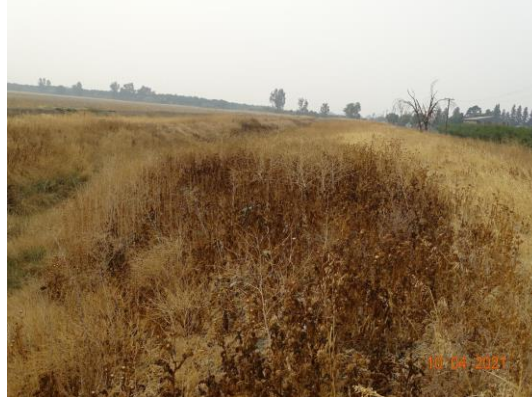
Photo 1 of 1 : FA_2021_NA0013_333_10_20211012_00024.jpg

LM Start	0.00	Rating **	U	Issue No.	10
LM End	0.33	Issue Type +	Ma	Location *	WS
Category	Earthen Levee			GPS Latitude/Longitude	
				Start	End
Item	Vegetation			37.257654 °	37.262365 °
				-120.288501 °	-120.288240 °
DWR ID	DWR_NA0013_03_f _ 2021_10				
Comment Code					
V1 : Control annual grass and weeds on the levee slopes and easements.					
Inspector Comment

View of vegetation growing on the waterside slope. (Fall 2021)

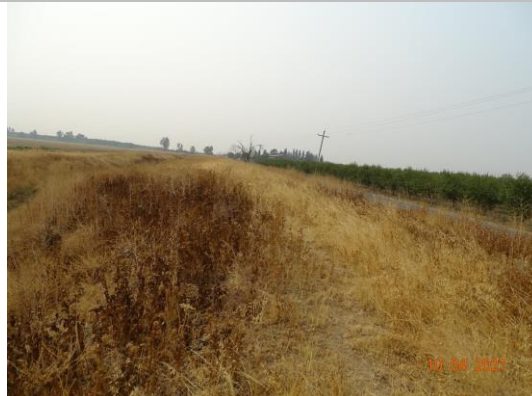
Photo 1 of 1 : FA_2021_NA0013_333_11_20211012_00026.jpg

LM Start	0.00	Rating **	U	Issue No.	11
LM End	0.34	Issue Type +	Ma	Location *	CR
Category	Earthen Levee			GPS Latitude/Longitude	
				Start	End
Item	Vegetation			37.257654 °	37.262435 °
				-120.288501 °	-120.288340 °
DWR ID	DWR_NA0013_03_s_2021_11				
Comment Code					
V9 : Keep the crown roadway free of vegetation.					
Inspector Comment

View of the levee crown looking downstream. (Fall 2021)

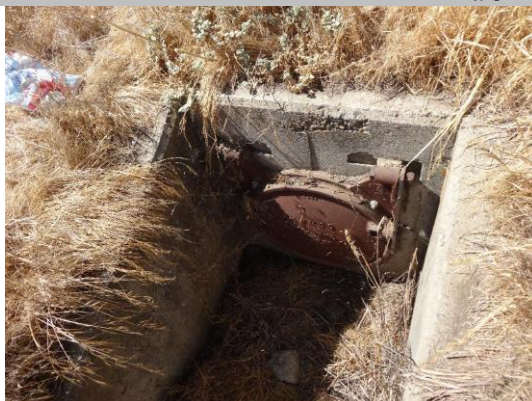
Photo 1 of 3 : UCIP_FA_2021_41815_35533.jpg

WS view: U typed concrete headwall, CM pipe, and flap gate.

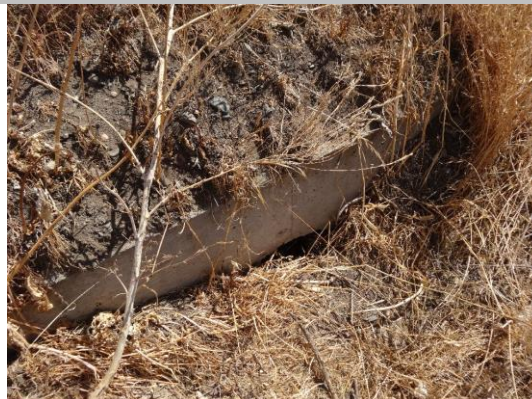
Photo 3 of 3 : UCIP_FA_2021_41815_35531.jpg

LS view: concrete headwall and CM pipe. Inlet needs cleaning and silt removed.

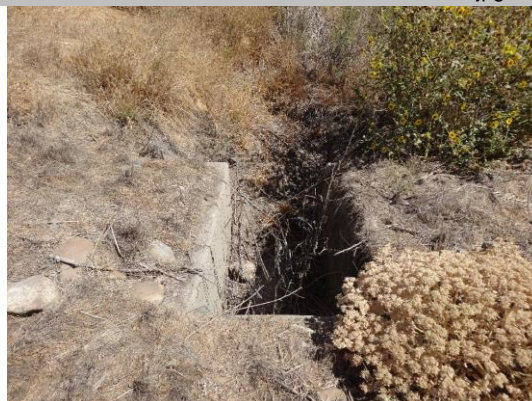
Photo 1 of 3 : UCIP_FA_2021_50144_35422.jpg

WS view: U typed concrete headwall, cobble spillway, and channel on waterside.

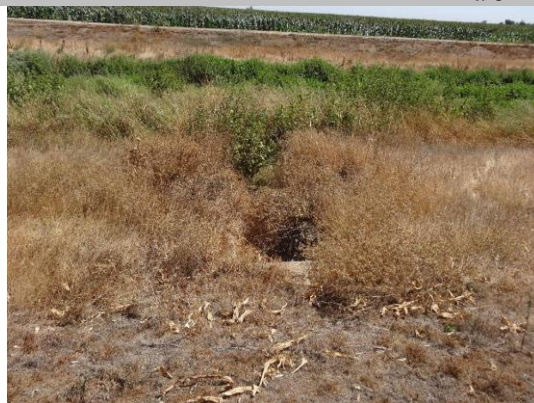
Photo 1 of 3 : UCIP_FA_2021_50151_35539.jpg

DS_ID:23063
 FS_ID:50151
 EP_NO: N/A
 Repair Type: No Action Needed
 EVAL Issue:
 Crossing Status: Found
 UCIP Comments: 09/2016: LS and WS ends have been cleared by NA0013 and crossing has been downgraded to No Action Needed. (K. Fazel - UCIP)09/2013: Needs vegetation clearing on WS. (P. Amatya - UCIP)
 FIELD_STRUCT_DESC: 24-inch corrugated metal gravity drainage pipe through the levee, 6.5 feet below the crown. Concrete headwall, flap gate, and concrete grouted cobble spillway on the waterside (WS) toe. Concrete headwall on the landside (LS) toe. [Additional Reference(s): DWR Levee Log, 2005. USACE San Joaquin O&M Manual 607, June 1962, (HLM 0.80), referenced as 10 feet below the crown].
 FS Date: 9/7/2016

WS view: overview of spillway/outlet area on waterside.

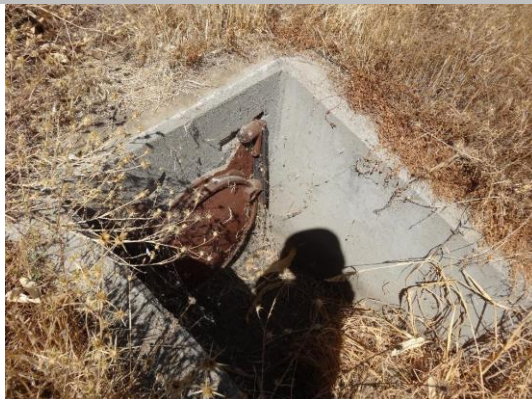
Photo 2 of 3 : UCIP_FA_2021_50151_35538.jpg

WS view: U typed concrete headwall, CM pipe, and flap gate. Vegetation needs to be cleared.

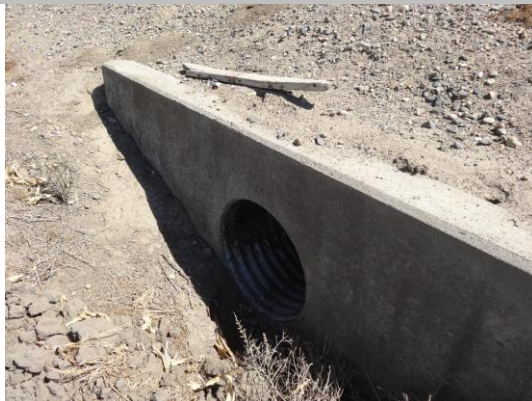
Photo 3 of 3 : UCIP_FA_2021_50151_35541.jpg

LS view: concrete headwall and CM pipe.

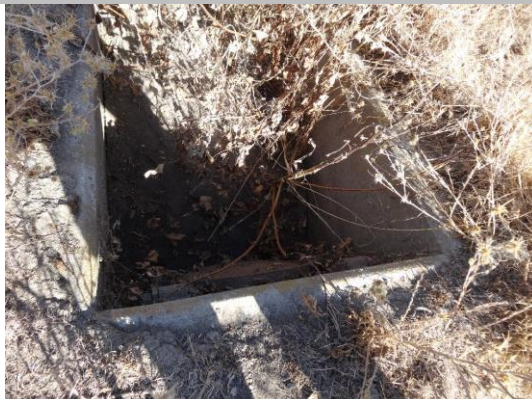
Photo 1 of 3 : UCIP_FA_2021_50146_35748.jpg

DS_ID:23069
FS_ID:50146
EP_NO: N/A
Repair Type: Non-Urgent
EVAL Issue:
Crossing Status: Found
UCIP Comments: 09/29/2016: WS and LS ends have been cleared. Crossing will be downgraded from Non-Urgent to No Action Needed upon receipt of photo showing cleared LS inlet. (K. Fazel - UCIP)09/2013:- needs vegetation clearing on both sides. Flapgate blocked on WS. - inlet pipe needs clearing on landside. (P. Amaty - UCIP)
FIELD_STRUCT_DESC: 24-inch corrugated metal gravity drainage pipe through the levee, 6 feet below the crown. Concrete headwall, flap gate, and concrete grouted cobble spillway on the waterside (WS) toe. Concrete headwall on the landside (LS) toe. [Additional Reference(s): DWR Levee Log, 2005. USACE San Joaquin O&M Manual 607, June 1962, (HLM 0.17)].
FS Date: 9/7/2016

WS view: U typed concrete headwall, CM pipe, and flap gate. Vegetation needs to be cleared.

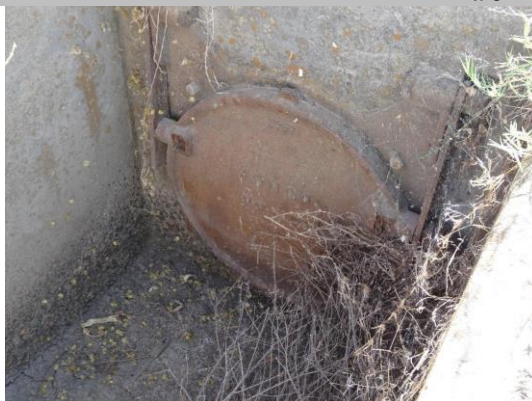
Photo 3 of 3 : UCIP_FA_2021_50154_35606.jpg

DS_ID:23070
 FS_ID:50154
 EP_NO: N/A
 Repair Type: Non-Urgent
 EVAL Issue:
 Crossing Status: Found
 UCIP Comments: 09/29/2016: WS and LS ends have been cleared by Mike Walejko of NA0013. Crossing will be downgraded from Non-Urgent to No Action Needed upon receipt of photo showing cleared LS inlet. (K. Fazel - UCIP)09/2013:- needs vegetation clearing on waterside.- inlet on landside needs clearing. (P. Amaty - UCIP)
 FIELD_STRUCT_DESC: 24-inch corrugated metal gravity drainage pipe through the levee, 6 feet below the crown. Concrete headwall, flap gate, and concrete grouted cobble spillway on the waterside (WS) toe. Concrete headwall on the landside (LS) toe. [Additional Reference(s): DWR Levee Log, 2005. USACE San Joaquin O&M Manual 607, June 1962, (HLM 0.31)].
 FS Date: 9/7/2016

WS view: CM pipe and flap gate. Vegetation needs to be cleared.

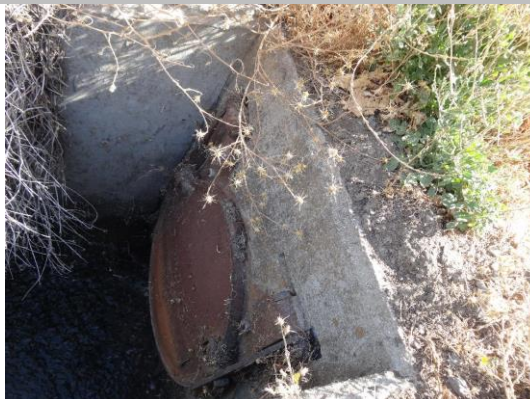
Photo 2 of 3 : UCIP_FA_2021_21126_35651.jpg

WS view: U typed concrete headwall, CM pipe, and flap gate. Vegetation needs to be cleared on spillway.

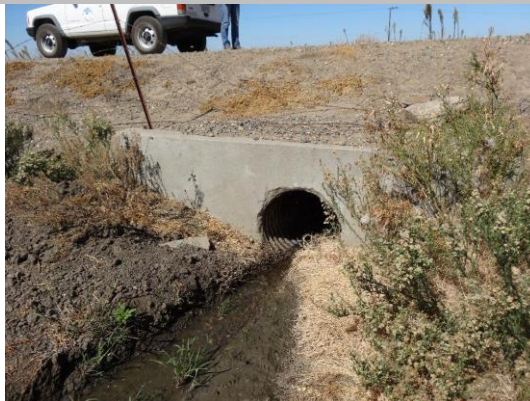
Photo 3 of 3 : UCIP_FA_2021_21126_35654.jpg

LS view: concrete headwall and CM pipe. Drain pipe was working during field survey.

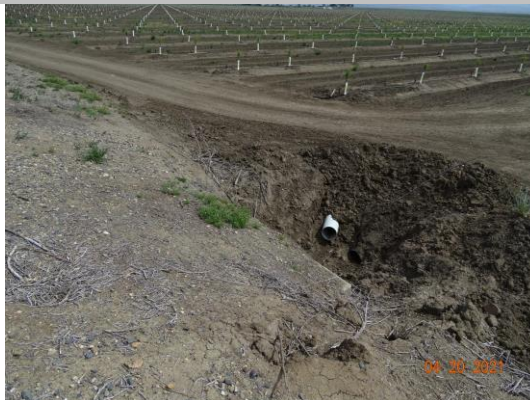
Photo 1 of 1 : FA_2021_NA0013_334_13_20210830_00002.jpg

LM Start	1.01	Rating **	M	Issue No.	13
LM End	1.01	Issue Type +	En	Location *	LS
Category	Earthen Levee			GPS Latitude/Longitude	
				Start	End
Item	Encroachments			37.263139 °	37.263139 °
				-120.287799 °	-120.287799 °
DWR ID	DWR_NA0013_04_s_2021_13				
Comment Code					
PI : Pipe					
Inspector Comment					
Appears to be newly installed drainage pipes feeding to the existing pipe crossing. No known permit related to these pipes.

Drainage pipes feeding to existing pipe crossing. (Spring 2021)

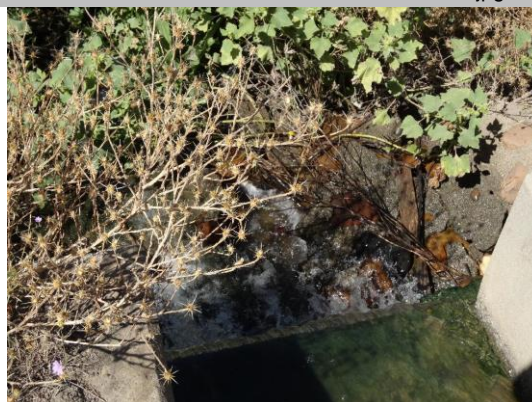
Photo 2 of 3 : UCIP_FA_2021_21127_35656.jpg

WS view: concrete headwall and concrete spillway on waterside.

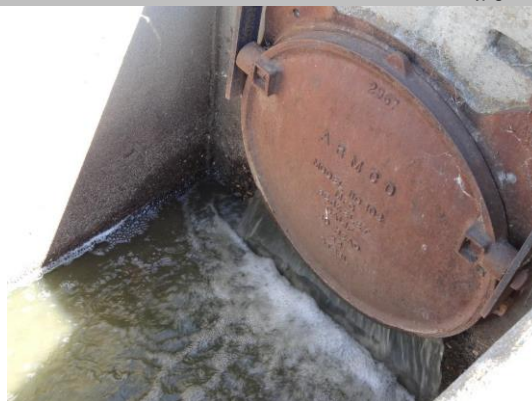
Photo 3 of 3 : UCIP_FA_2021_21127_35655.jpg

WS view: U typed concrete headwall, CM pipe, and flap gate. Drainage was working during survey.

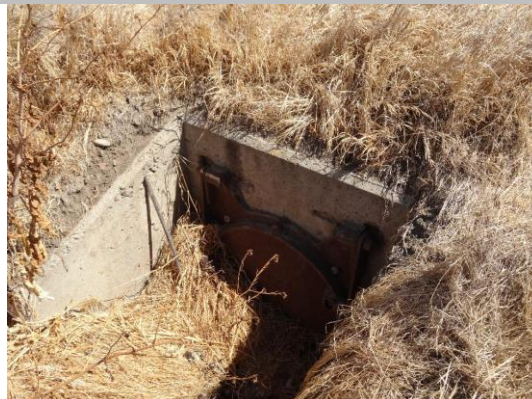
Photo 1 of 3 : UCIP_FA_2021_50153_35745.jpg

WS view: U typed concrete headwall, CM pipe, and flap gate. Dirt and vegetations need to be removed and cleared.
