**Flood Control Project Maintenance  
Levee Inspections**  
**LMA District Cover Sheet**  
**Spring 2016 Levee Inspection Results**  
**Merced Streams Group**

**Spring 2016 Levee Inspection Results**

**Merced Streams Group**

Waterway		Bank	Unit Miles	
Unit No. 01 Black Rascal Diversion		Right	1.61	
	Spring (March - May)	Summer (June - August)	(September - November) Fall	Winter (December - February)
Unit Maintenance Rating (Fall Only)				
Date of Inspection	4/12/2016 - 4/12/2016			
DWR Inspector	Herman Phillips			
Accompanied By

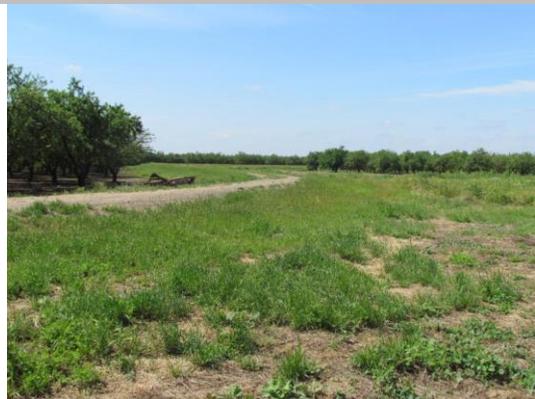
Photo 1 of 1 : SP\_2016\_NA0013\_332\_10\_20160506\_00021.jpg

LM Start	<b>0.01</b>	Rating **	M	Issue No.	<b>10</b>
LM End	<b>0.61</b>	Issue Type +	Ma	Location *	WS
Category	Earthen Levee		GPS Latitude/Longitude		
			Start	End	
Item	Vegetation		37.337008 °	37.332155 °	
			-120.387457 °	-120.394130 °	
DWR ID	DWR_NA0013_02_s_2016_10				
Comment Code					
V1 : Control annual grass and weeds on the levee slopes and easements.					
Inspector Comment

Looking downstream from levee miles 0.01-0.61 waterside slope.

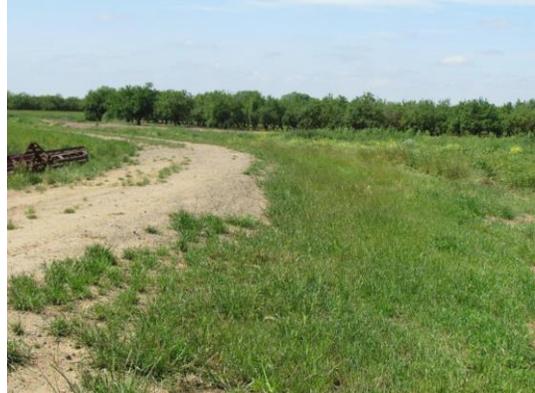
Photo 1 of 1 : SP\_2016\_NA0013\_332\_8\_20160506\_00020.jpg

LM Start	<b>0.01</b>	Rating **	M	Issue No.	<b>8</b>
LM End	<b>0.61</b>	Issue Type +	Ma	Location *	CR
Category	Earthen Levee		GPS Latitude/Longitude		
			Start	End	
Item	Vegetation		37.337008 °	37.332155 °	
			-120.387457 °	-120.394130 °	
DWR ID	DWR_NA0013_02_s_2016_8				
Comment Code					
V9 : Keep the crown roadway free of vegetation.					
Inspector Comment					
Crown roadway should be free of vegetation.

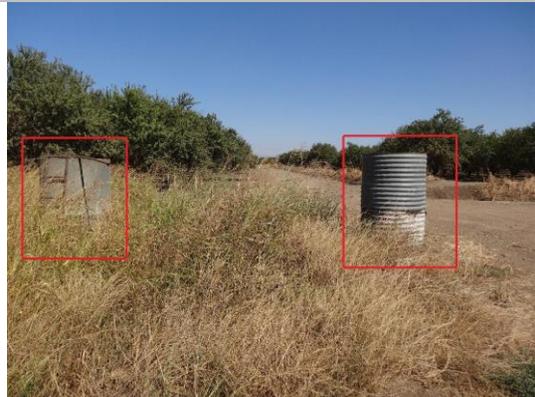
Photo 1 of 2 : UCIP\_SP\_2016\_21263\_35761.jpg

LM Start	<b>0.01</b>	Rating **	M	Issue No.	<b>25</b>
LM End	<b>0.01</b>	Issue Type +	En	Location *	CR
Category	Supplemental		GPS Latitude/Longitude		
			Start	End	
Item	DWR UCIP Field Study		37.337019 °	37.337019 °	
			-120.387539 °	-120.387539 °	
DWR ID					
Comment Code					
Inspector Comment					
FS_ID:21263 DS_ID:23052 EP_NO: N/A Repair Type: Non-Urgent Crossing Status: Found UCIP Comments: - needs more investigations on this crossing. - new water filtration plant on LS with pump and concrete vault.- a concrete standpipe and CM pipe riser on WS. FIELD_STRUCT_DESC: 10-inch steel pipe through the levee, 5.0 feet below the crown, riser on the landward side, screw gate in a 36-inch pipe well on the waterward slope (O&M Unit No. 607, 1962) FS Date: 9/17/2013

WS view: concrete standpipe (left) and CMP standpipe (right).

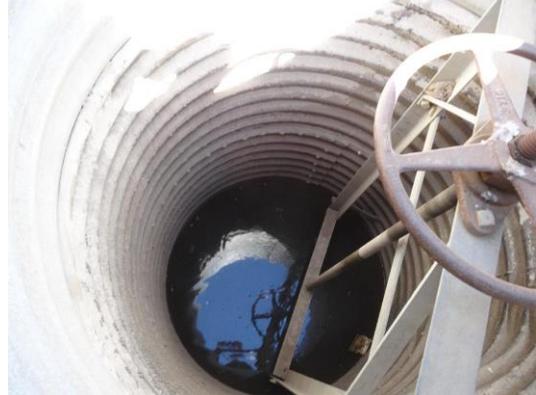
Photo 2 of 2 : UCIP\_SP\_2016\_21263\_35760.jpg

LM Start	<b>0.01</b>	Rating **	M	Issue No.	<b>25 (cont)</b>
LM End	<b>0.01</b>	Issue Type +	En	Location *	CR
Category	Supplemental			GPS Latitude/Longitude	
				Start	End
Item	DWR UCIP Field Study			37.337019 °	37.337019 °
				-120.387539 °	-120.387539 °
DWR ID					
Comment Code					
Inspector Comment					
FS_ID:21263 DS_ID:23052 EP_NO: N/A Repair Type: Non-Urgent Crossing Status: Found UCIP Comments: - needs more investigations on this crossing. - new water filtration plant on LS with pump and concrete vault. - a concrete standpipe and CM pipe riser on WS. FIELD_STRUCT_DESC: 10-inch steel pipe through the levee, 5.0 feet below the crown, riser on the landward side, screw gate in a 36-inch pipe well on the waterward slope (O&M Unit No. 607, 1962) FS Date: 9/17/2013

WS view: inside view of CMP standpipe with slide gate.

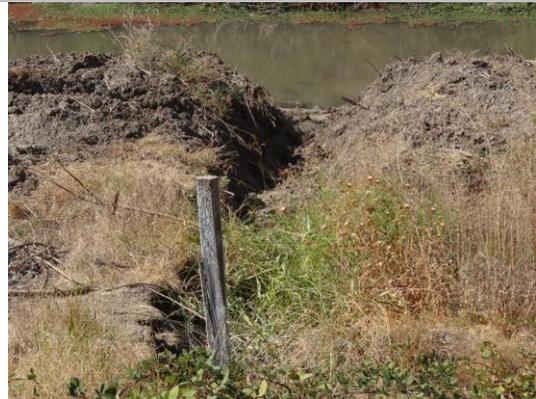
Photo 1 of 2 : UCIP\_SP\_2016\_41261\_35245.jpg

LM Start	<b>0.29</b>	Rating **	U	Issue No.	<b>28</b>
LM End	<b>0.29</b>	Issue Type +	En	Location *	LS
Category	Supplemental			GPS Latitude/Longitude	
				Start	End
Item	DWR UCIP Field Study			37.336006°	37.336006°
				-120.392011°	-120.392011°
DWR ID					
Comment Code					
Inspector Comment					
FS_ID:41261 DS_ID:23053 EP_NO: N/A Repair Type: Urgent Crossing Status: Found UCIP Comments: - needs vegetation cleaning on both sides.- flap gate was not closed during field survey.- inlet needs cleaning. FIELD_STRUCT_DESC: 24-inch corrugated metal drainage pipe through the levee, 8.0 feet below the crown, concrete headwall, flap gate, and concrete grouted cobble spillway on the waterward toe, concrete headwall on the landward toe (O&M Unit No. 607, 1962) FS Date: 9/17/2013

WS view: cobble spillway and channel on waterside.

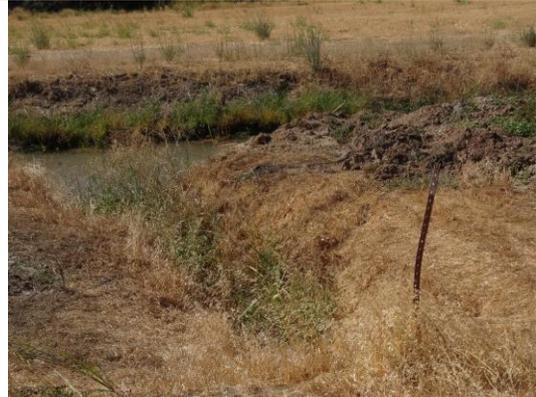
Photo 1 of 2 : UCIP\_SP\_2016\_20946\_35266.jpg

LM Start	<b>0.54</b>	Rating **	M	Issue No.	<b>26</b>
LM End	<b>0.54</b>	Issue Type +	En	Location *	LS
Category	Supplemental			GPS Latitude/Longitude	
				Start	End
Item	DWR UCIP Field Study			37.333180°	37.333180°
				-120.394069°	-120.394069°
DWR ID					
Comment Code					
Inspector Comment					
FS_ID:20946 DS_ID:23054 EP_NO: N/A Repair Type: Non-Urgent Crossing Status: Found UCIP Comments: - needs vegetation cleaning on both sides.- flap gate was not properly closed during field survey.- inlet needs cleaning. FIELD_STRUCT_DESC: 24-inch corrugated metal drainage pipe through the levee, 12.0 feet below the crown, concrete headwall, flap gate, and concrete grouted cobble spillway on the waterward toe, concrete headwall on the landward toe (O&M Unit No. 607, 1962) FS Date: 9/17/2013

WS view: cobble spillway and channel on waterside.

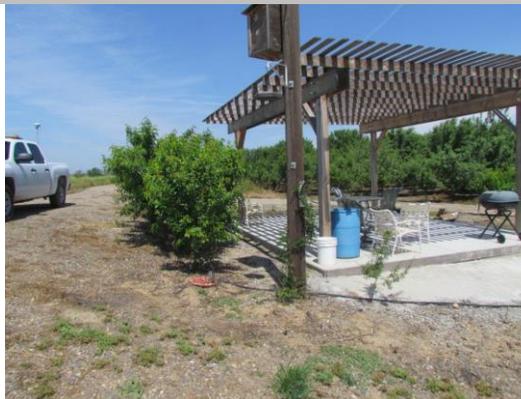
Photo 1 of 2 : SP\_2016\_NA0013\_332\_24\_20160506\_00024.jpg

LM Start	<b>0.88</b>	Rating **	U	Issue No.	<b>24</b>
LM End	<b>0.88</b>	Issue Type +	En	Location *	LS
Category	Earthen Levee		GPS Latitude/Longitude		
			Start	End	
Item	Encroachments		37.328567 °	37.328567 °	
			-120.396062 °	-120.396062 °	
DWR ID	DWR_NA0013_02_s_2014_24				
Comment Code					
BU : Building					
Inspector Comment					
This structure placed on the landside toe doesn't have a CFVPB Permit. Landowner is in process of getting a permit.

View looking upstream.

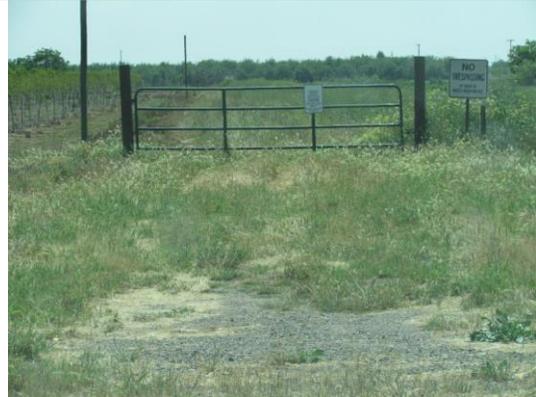
Photo 1 of 1 : SP\_2016\_NA0013\_332\_22\_20160506\_00028.jpg

LM Start	<b>1.63</b>	Rating **	U	Issue No.	<b>22</b>
LM End	<b>1.85</b>	Issue Type +	Ma	Location *	CR
Category	Earthen Levee		GPS Latitude/Longitude		
			Start	End	
Item	Vegetation		37.317798 °	37.314609 °	
			-120.395720 °	-120.395807 °	
DWR ID	DWR_NA0013_02_s_2016_22				
Comment Code					
V9 : Keep the crown roadway free of vegetation.					
Inspector Comment					
Keep the crown roadway free of all vegetation.

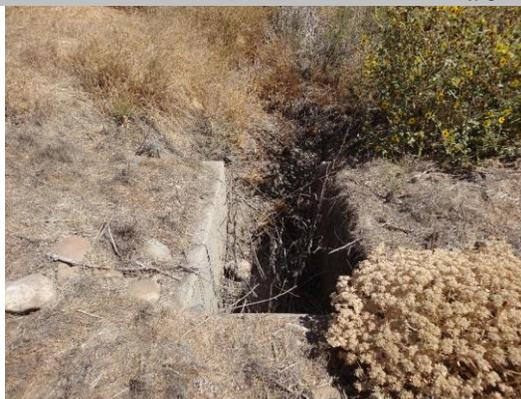
Photo 1 of 2 : UCIP\_SP\_2016\_42989\_35422.jpg

LM Start	<b>0.39</b>	Rating **	U	Issue No.	<b>27</b>
LM End	<b>0.39</b>	Issue Type +	En	Location *	CR
Category	Supplemental			GPS Latitude/Longitude	
				Start	End
Item	DWR UCIP Field Study			37.263182 °	37.263182 °
				-120.288239 °	-120.288239 °
DWR ID					
Comment Code					
Inspector Comment					
FS_ID:42989 DS_ID:23061 EP_NO: N/A Repair Type: Urgent Crossing Status: Found UCIP Comments: Appears to be abandoned. Flapgate blocked by debris.- debris blocked inlet pipe on LS.- Needs to be cleared on both sides or it needs to abandoned properly. FIELD_STRUCT_DESC: 24-inch corrugated metal drainage pipe through the levee, 10.0 feet below the crown, concrete headwall, flap gate, and concrete grouted cobble spillway on the waterward toe, concrete headwall on the landward toe (O&M Unit No. 607, 1962) FS Date: 9/17/2013

WS view: U typed concrete headwall, cobble spillway, and channel on waterside.

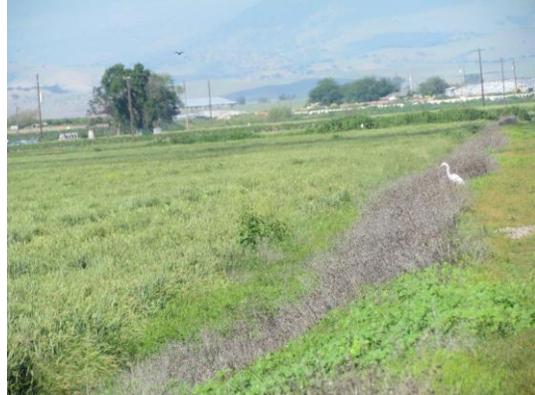
Photo 1 of 1 : SP\_2016\_NA0013\_333\_16\_20160506\_00027.jpg

LM Start	<b>0.60</b>	Rating **	U	Issue No.	<b>16</b>
LM End	<b>1.25</b>	Issue Type +	Ma	Location *	LS
Category	Earthen Levee		GPS Latitude/Longitude		
			Start	End	
Item	Vegetation		37.266193 °	37.272905 °	
			-120.288037 °	-120.280283 °	
DWR ID	DWR_NA0013_03_s_2016_16				
Comment Code					
V1 : Control annual grass and weeds on the levee slopes and easements.					
Inspector Comment					
Control the weed growth on the landside slope.

Looking upstream from levee mile 0.60- 1.25 landside slope.

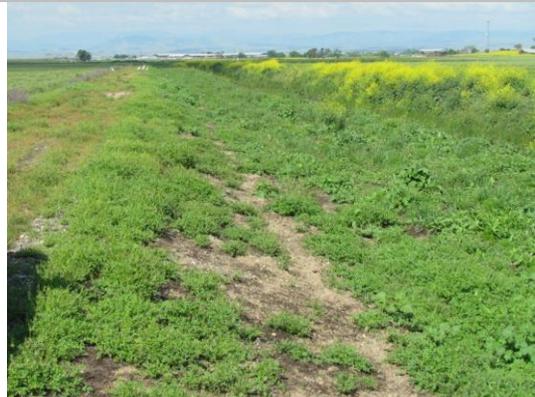
Photo 1 of 1 : SP\_2016\_NA0013\_333\_17\_20160506\_00028.jpg

LM Start	<b>0.60</b>	Rating **	U	Issue No.	<b>17</b>
LM End	<b>1.41</b>	Issue Type +	Ma	Location *	WS
Category	Earthen Levee		GPS Latitude/Longitude		
			Start	End	
Item	Vegetation		37.266193 °	37.273638 °	
			-120.288037 °	-120.277840 °	
DWR ID	DWR_NA0013_03_s_2016_17				
Comment Code					
V1 : Control annual grass and weeds on the levee slopes and easements.					
Inspector Comment					
Control the weed growth on the waterside slope.

Looking upstream from the waterside slope levee mile 0.60- 1.41.

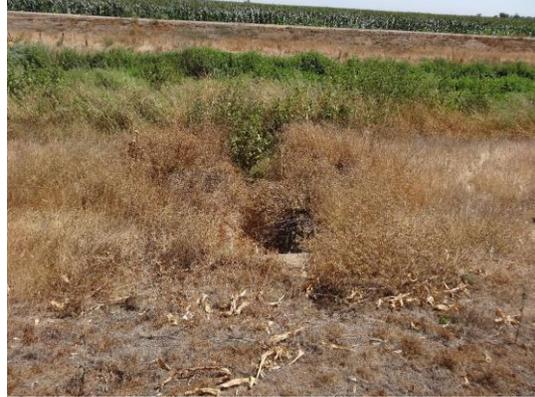
Photo 1 of 2 : UCIP\_SP\_2016\_21069\_35539.jpg

LM Start	<b>0.79</b>	Rating **	M	Issue No.	<b>25</b>
LM End	<b>0.79</b>	Issue Type +	En	Location *	WS
Category	Supplemental			GPS Latitude/Longitude	
				Start	End
Item	DWR UCIP Field Study			37.268420 °	37.268420 °
				-120.286231 °	-120.286231 °
DWR ID					
Comment Code					
Inspector Comment					
FS_ID:21069 DS_ID:23063 EP_NO: N/A Repair Type: Non-Urgent Crossing Status: Found UCIP Comments: - needs vegetation clearing on WS. FIELD_STRUCT_DESC: 24-inch corrugated metal drainage pipe through the levee, 6.5 feet below the crown, concrete headwall, flap gate, and concrete grouted cobble spillway on the waterward toe, concrete headwall on the landward toe (O&M Unit No. 607, 1962) FS Date: 9/17/2013

WS view: overview of spillway/outlet area on waterside.

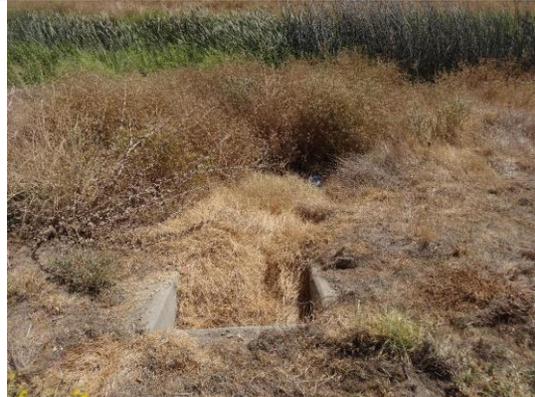
Photo 1 of 2 : UCIP\_SP\_2016\_42992\_35544.jpg

LM Start	<b>1.02</b>	Rating **	M	Issue No.	<b>28</b>
LM End	<b>1.02</b>	Issue Type +	En	Location *	WS
Category	Supplemental			GPS Latitude/Longitude	
				Start	End
Item	DWR UCIP Field Study			37.271111 °	37.271111 °
				-120.283786 °	-120.283786 °
DWR ID					
Comment Code					
Inspector Comment					
FS_ID:42992 DS_ID:23064 EP_NO: N/A Repair Type: Non-Urgent Crossing Status: Found UCIP Comments: - vegetations need to be removed from spillway and outlet at flaggate (blocked). It needs clearing.- more than half of inet pipe was burried in inlet. It needs cleaning & clearing. FIELD_STRUCT_DESC: 24-inch corrugated metal drainage pipe through the levee, 5.0 feet below the crown, concrete headwall, flap gate, and concrete grouted cobble spillway on the waterward toe, concrete headwall on the landward toe (O&M Unit No. 607, 1962) FS Date: 9/17/2013

WS view: cobble spillway and channel on waterside.

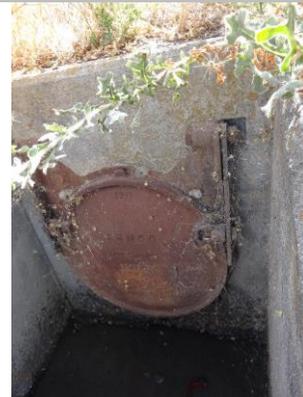
Photo 2 of 2 : UCIP\_SP\_2016\_21106\_35612.jpg

LM Start	<b>0.45</b>	Rating **	M	Issue No.	<b>21 (cont)</b>
LM End	<b>0.45</b>	Issue Type +	En	Location *	CR

WS view: U typed concrete headwall, CM pipe, and flap gate.
