**Flood Control Project Maintenance
Levee Inspections
2012 Channel Summary Report
Overall Unit and Item Ratings**

San Joaquin County Flood Control and Water Conservation District

Flood Control Project Maintenance**Unit Cover Sheet****2012 Channel Inspection Results****San Joaquin County Flood Control and Water Conservation District**

Channel Inspection Report By Check Point and View Direction - 2012

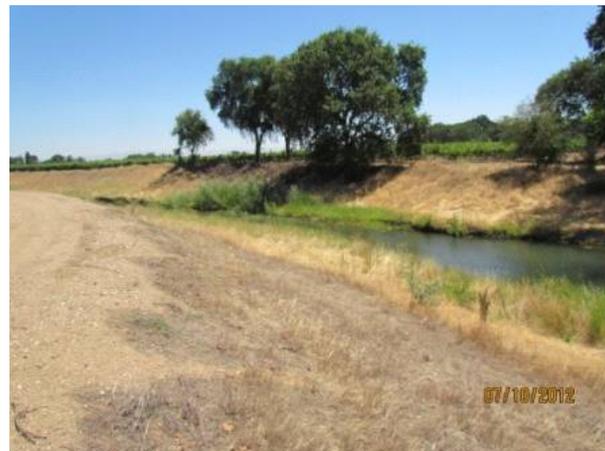
Levee Mile Report Line	16
Start Levee Mile	0.00
End Levee Mile	0.00
Location	
Category	Channels
Item	Vegetation & Obstructions
View of the channel looking upstream.	
pkazi_c_20120720_138.jpg

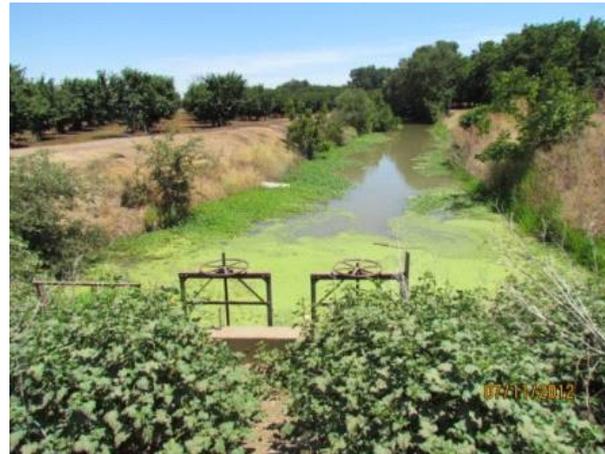
Levee Mile Report Line	6
Start Levee Mile	0.00
End Levee Mile	0.00
Location	
Category	Channels
Item	Vegetation & Obstructions
View of the channel looking upstream.	
pkazi_c_20120718_103.jpg

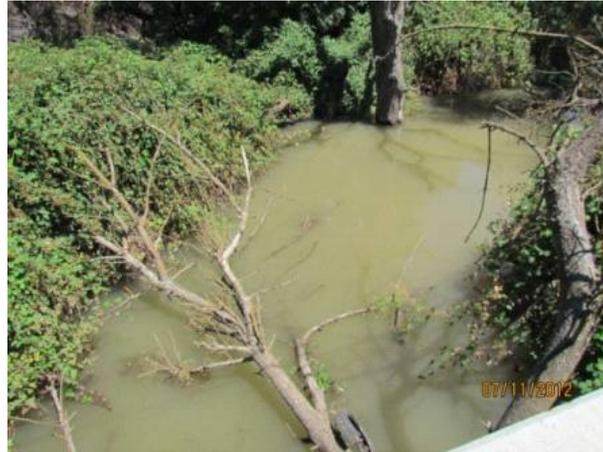
View of the channel looking upstream.

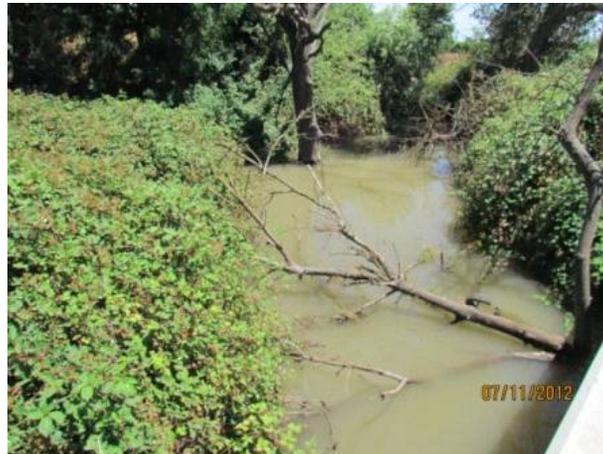
Levee Mile Report Line	21
Start Levee Mile	0.00
End Levee Mile	0.00
Location	
Category	Channels
Item	Encroachments

21		Up	Encroachments		M	Inspector Comments: Old tire and debris were present during inspection.	37.918960 ° -121.056260 °	Y	25
22		Down	Vegetation & Obstructions		M	Inspector Comments: Various lengths of logs, and vegetation growth appeared to impede the flow of the channel.	37.918960 ° -121.056260 °	Y	26
23		Down	Shoaling / Sedimentation		A	Inspector Comments: No sedimentation is present at this location.	37.918960 ° -121.056260 °		27
24		Down	Erosion / Bank Caving		A	Inspector Comments: No erosion is present at this location during inspection.	37.918960 ° -121.056260 °		28
25		Down	Revetments		N	Inspector Comments: No revetments are present at this location.	37.918960 ° -121.056260 °		29
26		Down	Encroachments		M	Inspector Comments: A broken pipe was found on the bank of the channel during inspection.	37.918960 ° -121.056260 °	Y	30

View of encroachment at the upstream end of the channel.

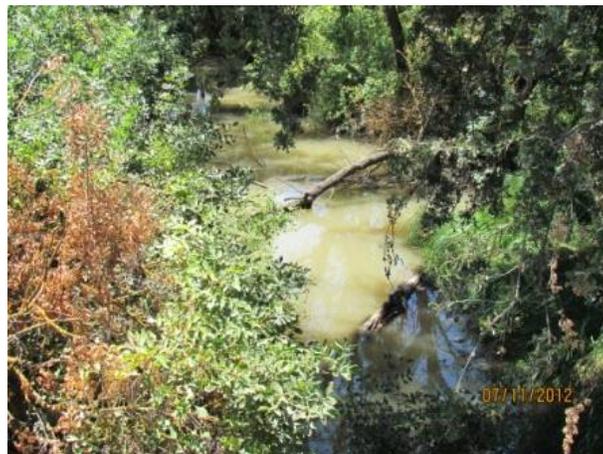
Levee Mile Report Line	22
Start Levee Mile	0.00
End Levee Mile	0.00
Location	
Category	Channels
Item	Vegetation & Obstructions

View of the vegetation and tree logs in the channel looking downstream.

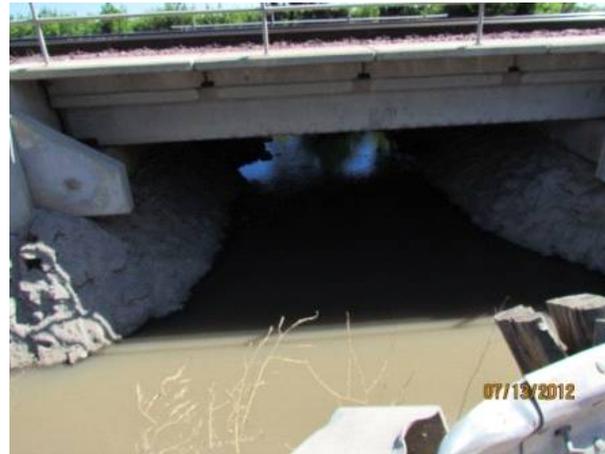
Levee Mile Report Line	37
Start Levee Mile	0.00
End Levee Mile	0.00
Location	
Category	Channels
Item	Vegetation & Obstructions
The picture shows the upstream of the channel.	
pkazi_c_20120718_112.jpg

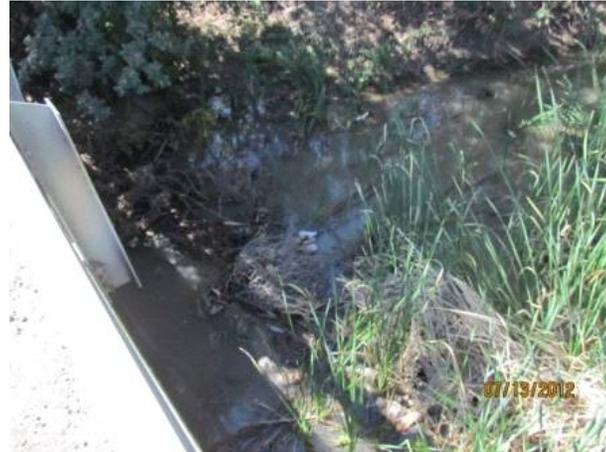
Levee Mile Report Line	46
Start Levee Mile	0.00
End Levee Mile	0.00
Location	
Category	Channels
Item	Encroachments
View of the encroachments on the downstream end of the channel.	
pkazi_c_20120718_115.jpg

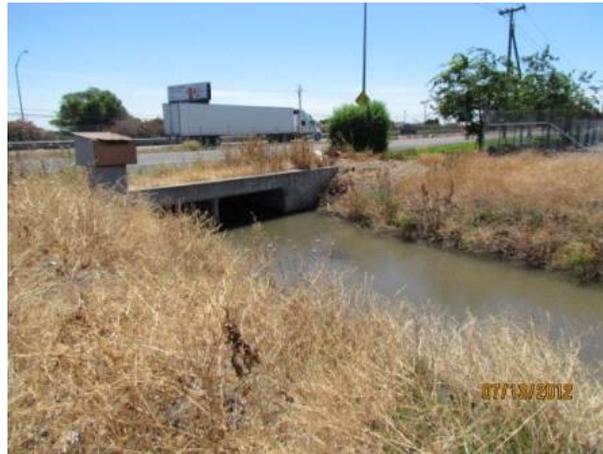
Levee Mile Report Line	52
Start Levee Mile	0.00
End Levee Mile	0.00
Location	
Category	Channels
Item	Vegetation & Obstructions
View of the downstream end of the channel.	
pkazi_c_20120720_118.jpg

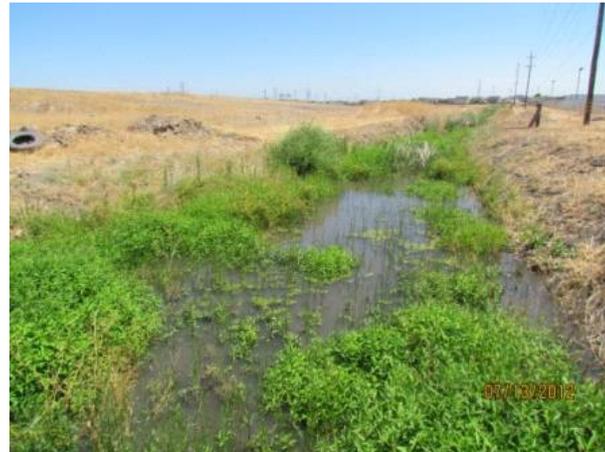
View of the channel looking upstream.

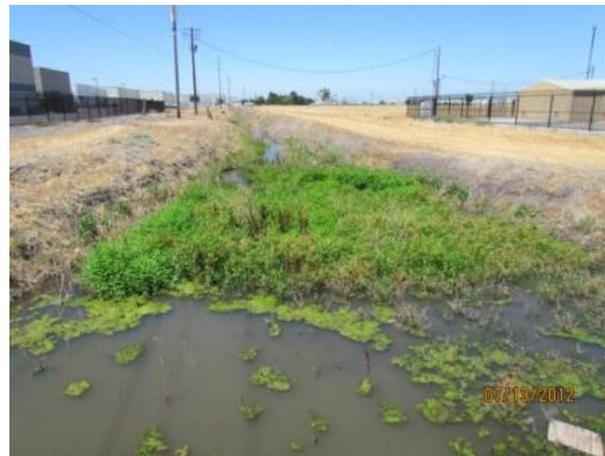
Levee Mile Report Line	72
Start Levee Mile	0.00
End Levee Mile	0.00
Location	
Category	Channels
Item	Vegetation & Obstructions

View of the channel looking downstream.

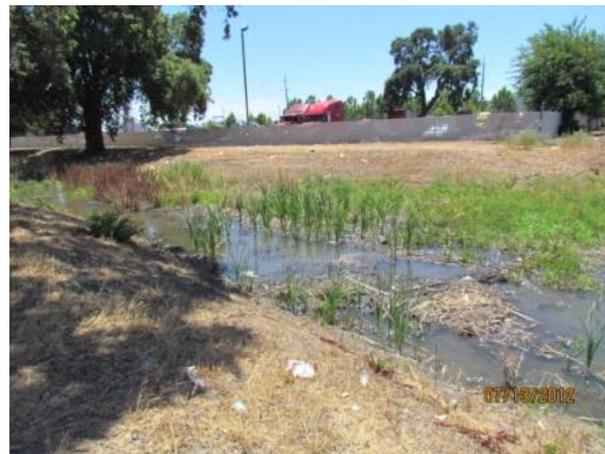
Levee Mile Report Line	77
Start Levee Mile	0.00
End Levee Mile	0.00
Location	
Category	Channels
Item	Vegetation & Obstructions

76		Down	Encroachments		A		37.913940 ° -121.247810 °		80
77	Airport Way	Up	Vegetation & Obstructions		M	Inspector Comments: Vegetation and tree branches may impede the flow of the channel.	37.911910 ° -121.258690 °	Y	81
78		Up	Shoaling / Sedimentation		A		37.911910 ° -121.258690 °		82
79		Up	Erosion / Bank Caving		A	Inspector Comments: No erosion is present at this location.	37.911910 ° -121.258690 °		83
80		Up	Revetments		N	Inspector Comments: No revetments are present at this location.	37.911910 ° -121.258690 °		84
81		Up	Encroachments		M	Inspector Comments: Trash and debris are present in the channel.	37.911910 ° -121.258690 °	Y	85
82		Down	Vegetation & Obstructions		M	Inspector Comments: Vegetation obstructions including tree branches and debris are impeding the flow of the channel.	37.911910 ° -121.258690 °	Y	86
83		Down	Shoaling / Sedimentation		A		37.911910 ° -121.258690 °		87

View of the channel looking upstream.

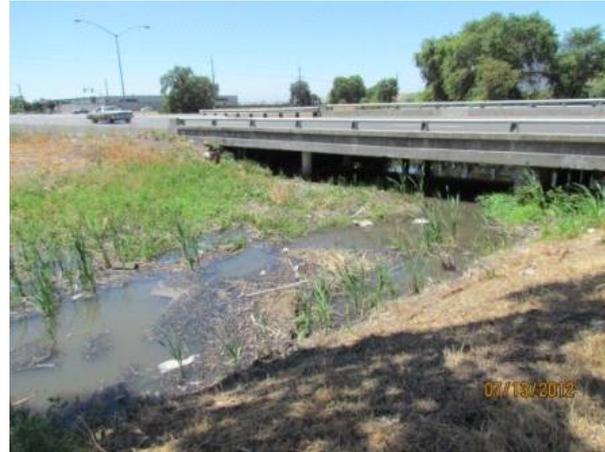
Levee Mile Report Line	81
Start Levee Mile	0.00
End Levee Mile	0.00
Location	
Category	Channels
Item	Encroachments
View of encroachments on the upstream end of the channel..	
pkazi_c_20120720_124.jpg

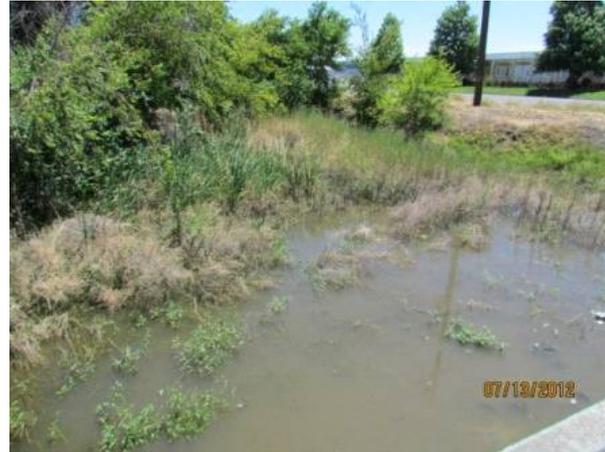
This picture was taken looking upstream of the channel.

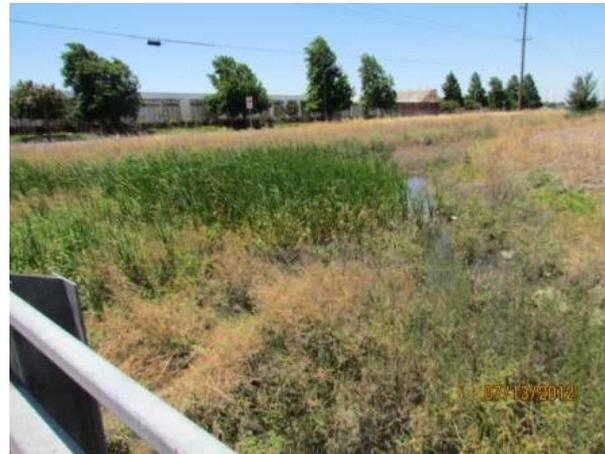
Levee Mile Report Line	92
Start Levee Mile	0.00
End Levee Mile	0.00
Location	
Category	Channels
Item	Vegetation & Obstructions

View of the vegetation growth on the downstream end of the channel.

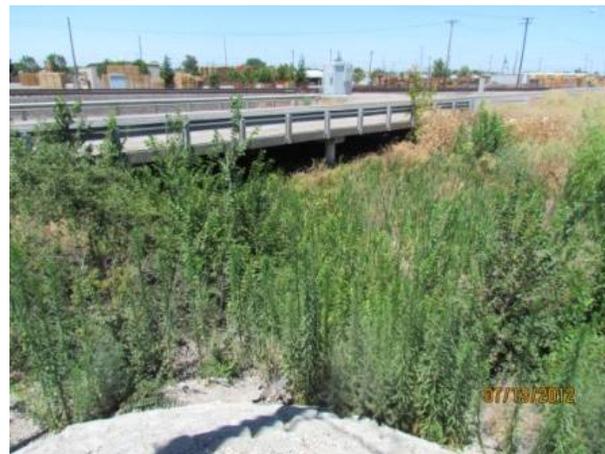
Levee Mile Report Line	97
Start Levee Mile	0.00
End Levee Mile	0.00
Location	
Category	Channels
Item	Vegetation & Obstructions

View of the vegetation growth at upstream end of the channel.

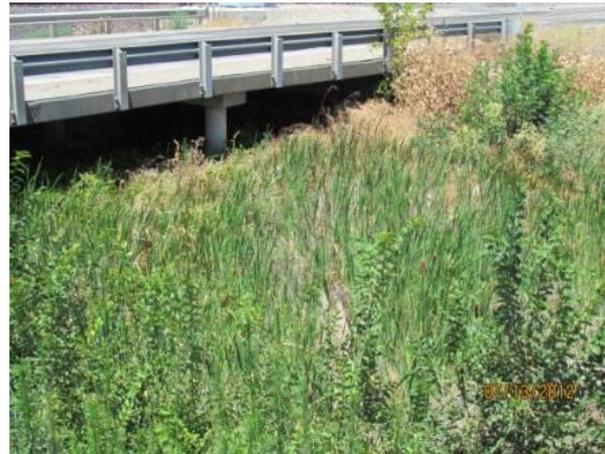
Levee Mile Report Line	101
Start Levee Mile	0.00
End Levee Mile	0.00
Location	
Category	Channels
Item	Encroachments
View of encroachments on the upstream end of the channel.	
pkazi_c_20120720_130.jpg

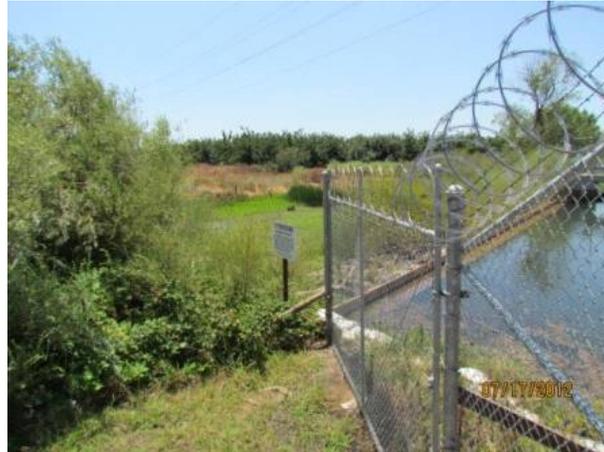
Levee Mile Report Line	1
Start Levee Mile	0.00
End Levee Mile	0.00
Location	
Category	Channels
Item	Vegetation & Obstructions
View of the vegetation growth and tree branches on the channel looking downstream.	
pkazi_c_20120718_077.jpg

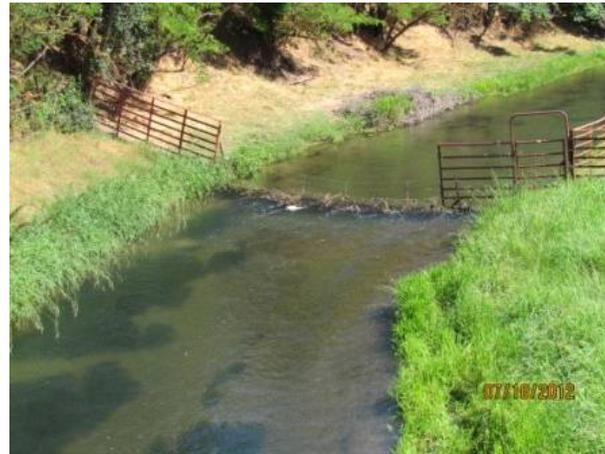
This picture shows debris on the fence which could impede the flow of the channel. The picture was taken looking upstream.

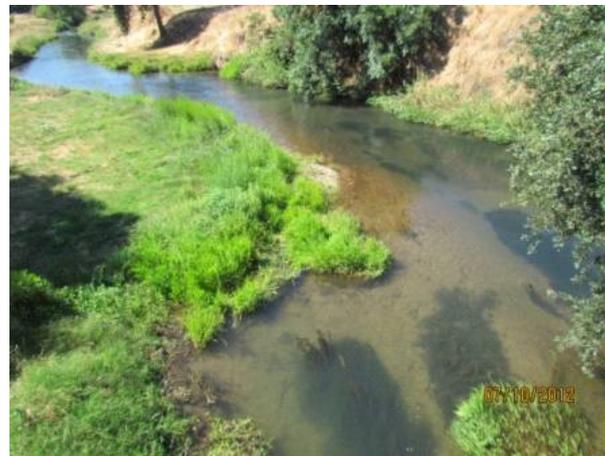
Levee Mile Report Line	11
Start Levee Mile	0.00
End Levee Mile	0.00
Location	
Category	Channels
Item	Vegetation & Obstructions

This photo shows the vegetation growth on the downstream of the channel.

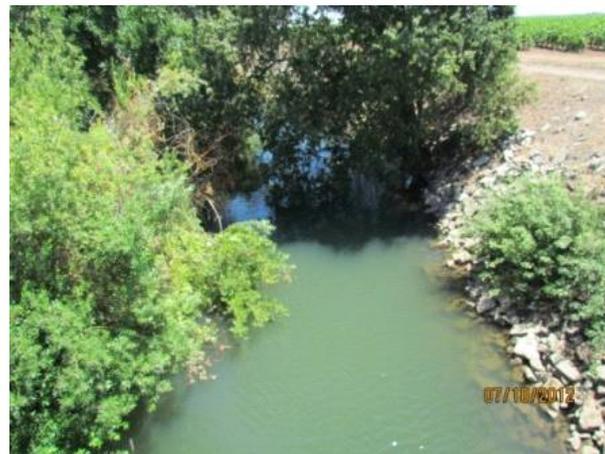
Levee Mile Report Line	16
Start Levee Mile	0.00
End Levee Mile	0.00
Location	
Category	Channels
Item	Vegetation & Obstructions

Vegetation growth and tree branches were impeding the flow of the channel looking upstream.

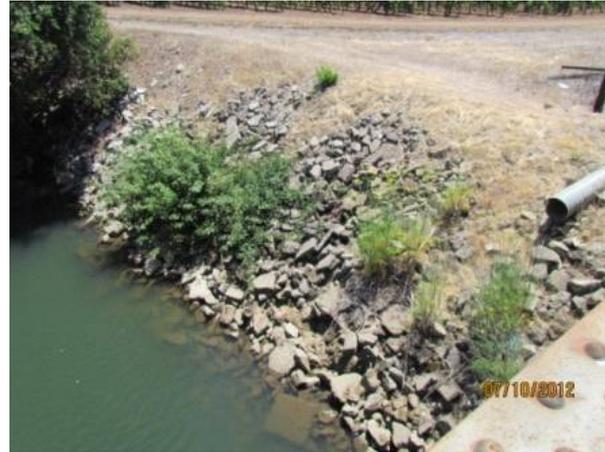
Levee Mile Report Line	19
Start Levee Mile	0.00
End Levee Mile	0.00
Location	
Category	Channels
Item	Revetments
Existing revetments are properly maintained. The picture was taken looking upstream of the channel.	
pkazi_c_20120716_071.jpg

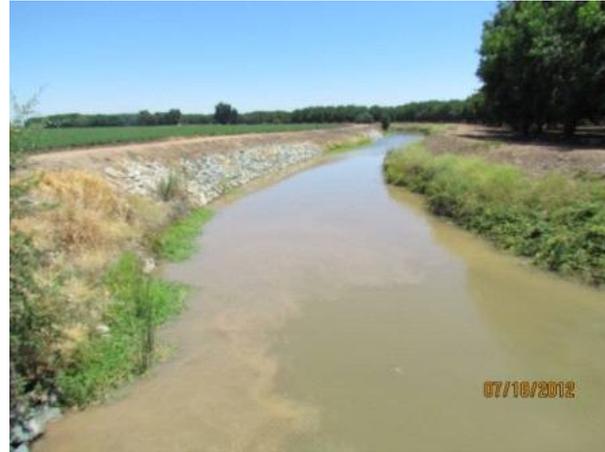
Levee Mile Report Line	26
Start Levee Mile	0.00
End Levee Mile	0.00
Location	
Category	Channels
Item	Vegetation & Obstructions
<p>This picture shows the minimal vegetation growth which doesn't impede the flow in the upstream of the channel.</p>	
<p>pkazi_c_20120716_074.jpg</p>

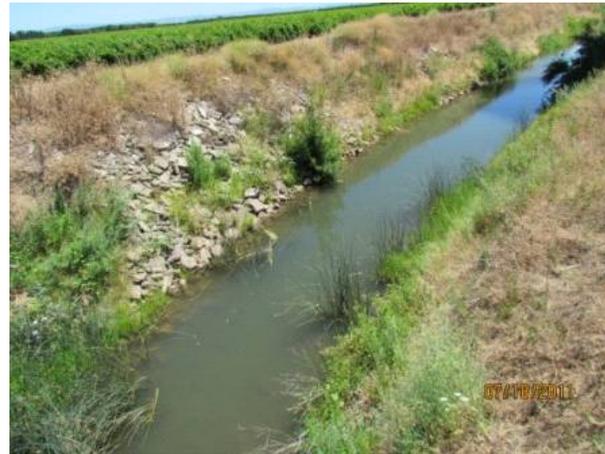
Levee Mile Report Line	39
Start Levee Mile	0.00
End Levee Mile	0.00
Location	
Category	Channels
Item	Revetments
The picture shows the revetements looking upstream of the channel.	
pkazi_c_20120611_045.jpg

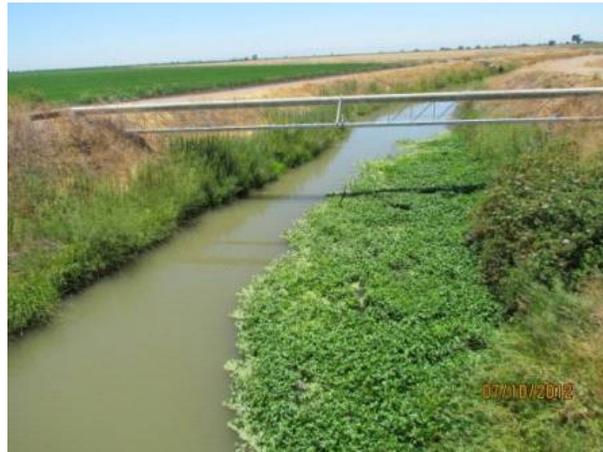
View of the channel looking downstream.

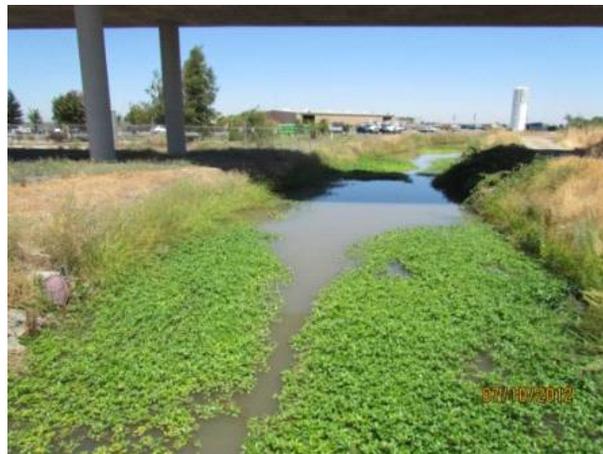
Levee Mile Report Line	56
Start Levee Mile	0.00
End Levee Mile	0.00
Location	
Category	Channels
Item	Vegetation & Obstructions

View of the channel looking upstream.

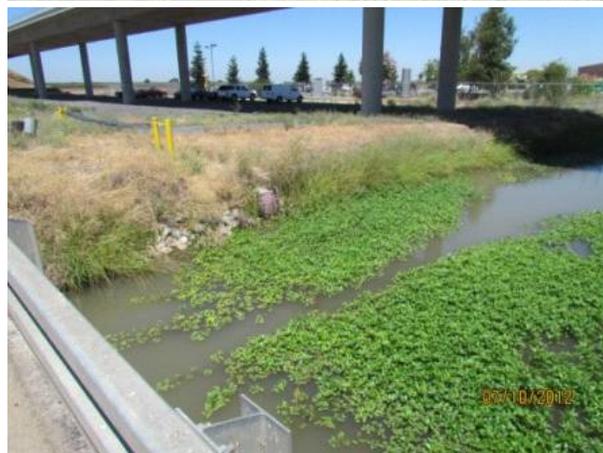
Levee Mile Report Line	59
Start Levee Mile	0.00
End Levee Mile	0.00
Location	
Category	Channels
Item	Revetments

View of existing revetments on the channel bank looking upstream.

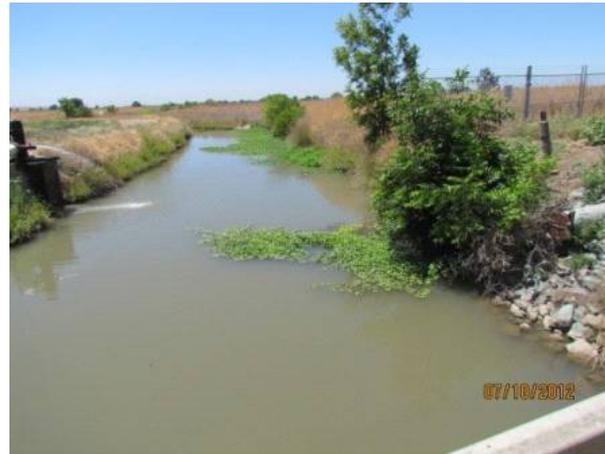
Levee Mile Report Line	61
Start Levee Mile	0.00
End Levee Mile	0.00
Location	
Category	Channels
Item	Vegetation & Obstructions
View of the channel looking downstream.	
pkazi_c_20120718_083.jpg

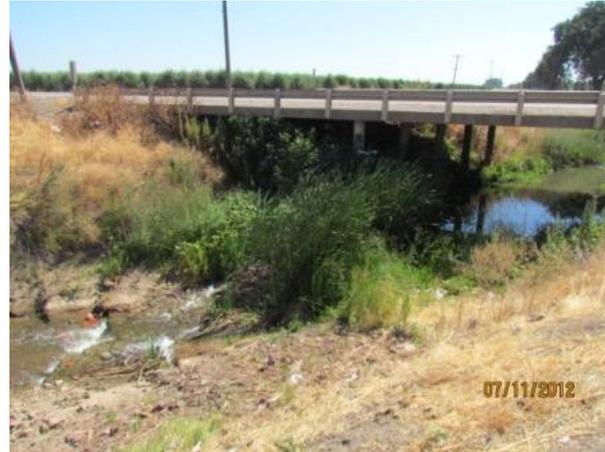
This picture shows the vegetation grown on the downstream of the channel.

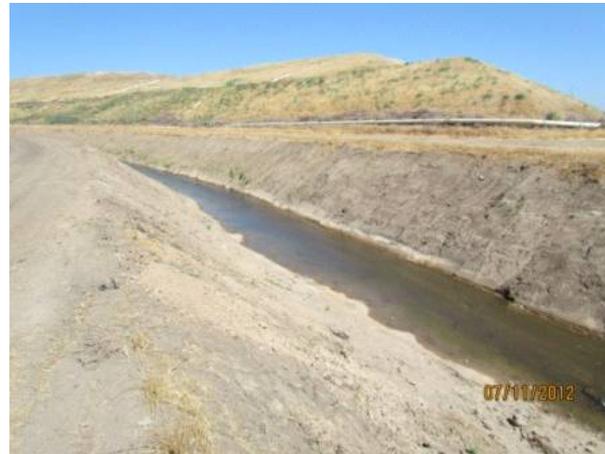
Levee Mile Report Line	73
Start Levee Mile	0.00
End Levee Mile	0.00
Location	
Category	Channels
Item	Erosion / Bank Caving

View of the channel bank looking downstream.

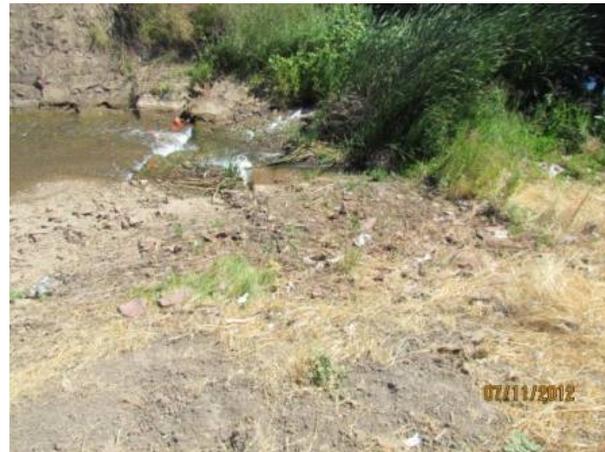
Levee Mile Report Line	75
Start Levee Mile	0.00
End Levee Mile	0.00
Location	
Category	Channels
Item	Encroachments

View of the debris on the downstream of the channel.

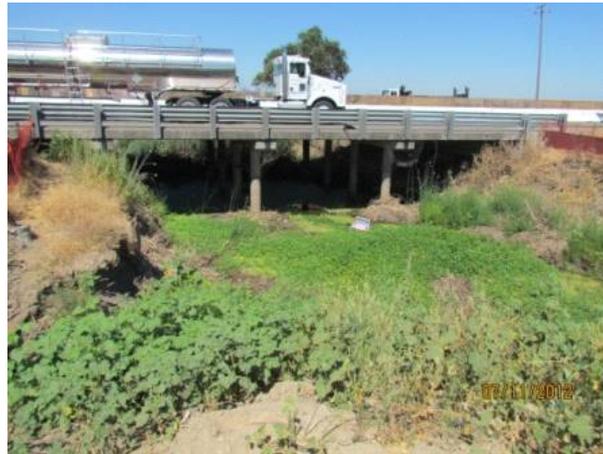
Levee Mile Report Line	76
Start Levee Mile	0.00
End Levee Mile	0.00
Location	
Category	Channels
Item	Vegetation & Obstructions
View of vegetation growth on the upstream end of channel	
pkazi_c_20120718_089.jpg

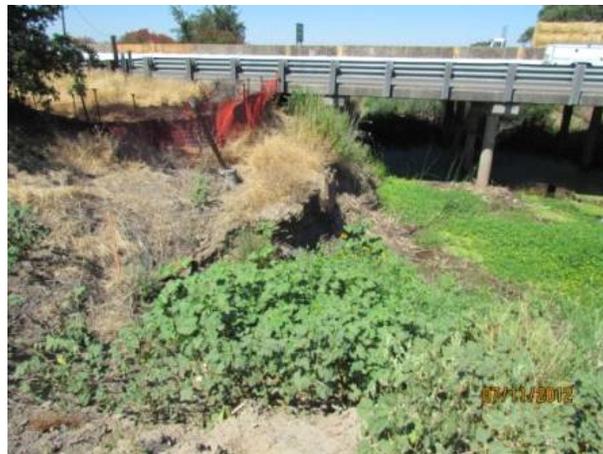
Levee Mile Report Line	78
Start Levee Mile	0.00
End Levee Mile	0.00
Location	
Category	Channels
Item	Erosion / Bank Caving
View of the erosion on the channel bank looking upstream.	
pkazi_c_20120718_090.jpg

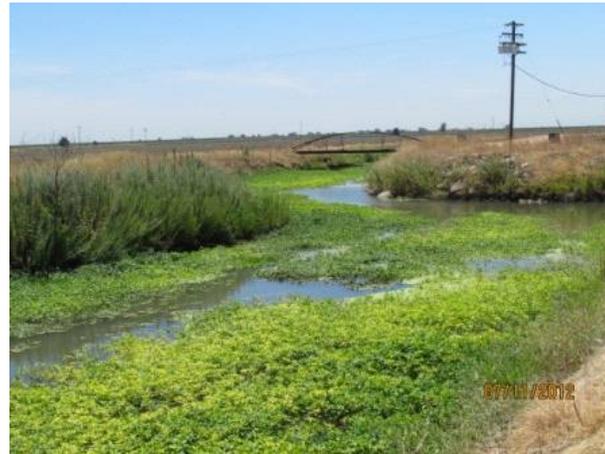
pkazi_c_20120718_102.jpg

View of the downstream of the channel.

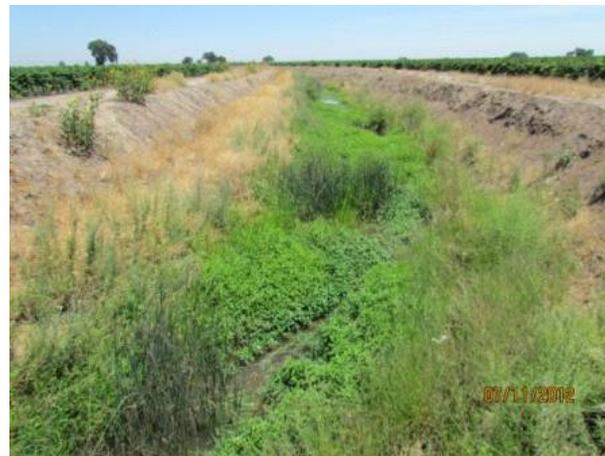
pkazi_c_20120718_098.jpg

Levee Mile Report Line	6
Start Levee Mile	0.00
End Levee Mile	0.00
Location	
Category	Channels
Item	Vegetation & Obstructions

This picture shows the vegetation growth at the upstream end of the channel.

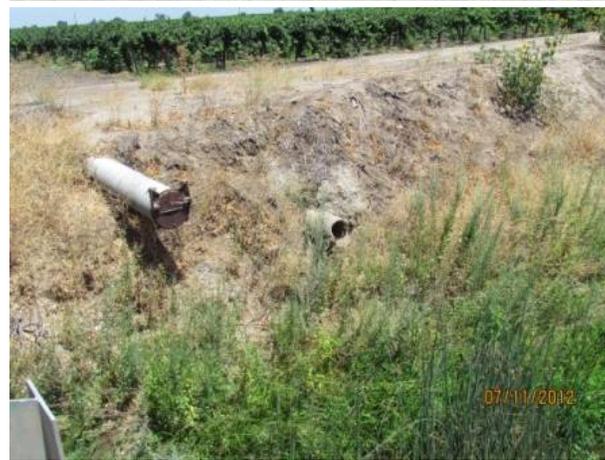
pkazi_c_20120718_099.jpg

Levee Mile Report Line	10
Start Levee Mile	0.00
End Levee Mile	0.00
Location	
Category	Channels
Item	Encroachments

View of the encroachments at the upstream of the channel.

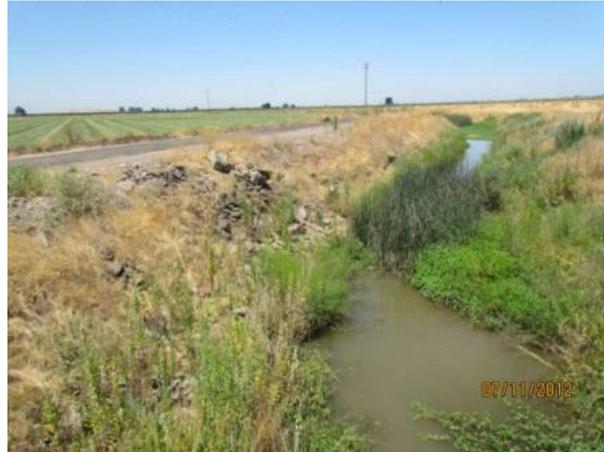
Levee Mile Report Line	11
Start Levee Mile	0.00
End Levee Mile	0.00
Location	
Category	Channels
Item	Vegetation & Obstructions
View of the channel looking downstream.	
pkazi_c_20120718_100.jpg

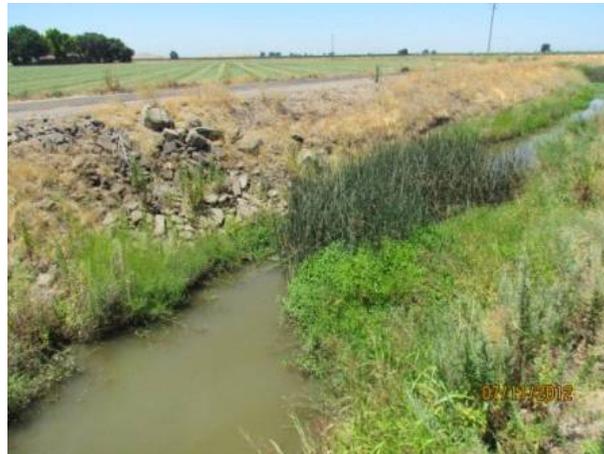
Levee Mile Report Line	14
Start Levee Mile	0.00
End Levee Mile	0.00
Location	
Category	Channels
Item	Revetments
View of the revetments at the downstream of the channel.	
pkazi_c_20120718_101.jpg

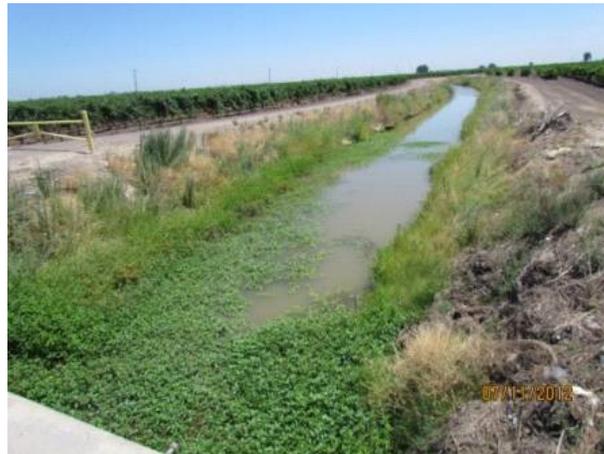
Levee Mile Report Line	16
Start Levee Mile	0.00
End Levee Mile	0.00
Location	
Category	Channels
Item	Vegetation & Obstructions
This picture shows the vegetation appears to obstructing the flow at the upstream of the channel.	
pkazi_c_20120718_094.jpg

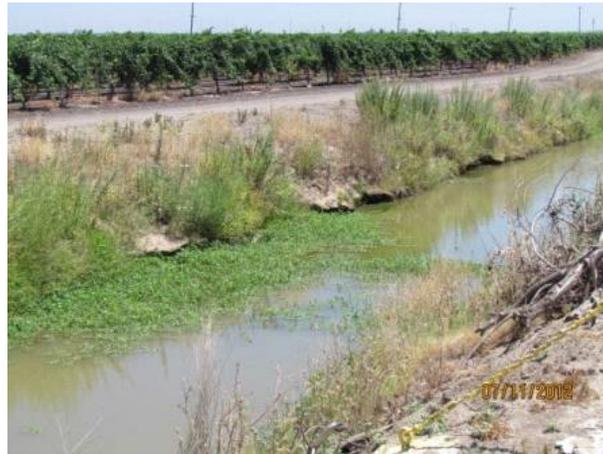
Levee Mile Report Line	18
Start Levee Mile	0.00
End Levee Mile	0.00
Location	
Category	Channels
Item	Erosion / Bank Caving
The picture shows the occurrence of erosion at the upstream of the channel.	
pkazi_c_20120718_095.jpg

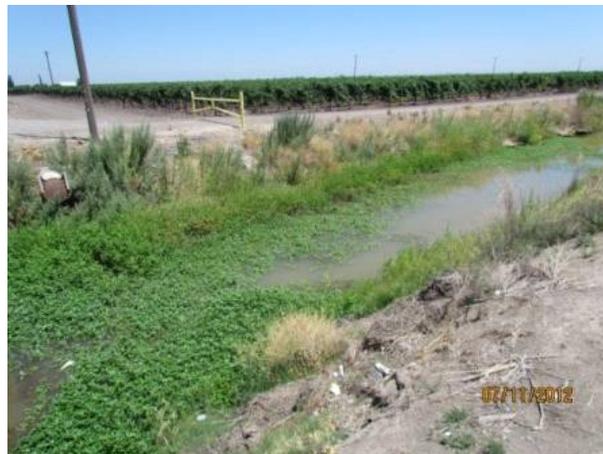
Levee Mile Report Line	20
Start Levee Mile	0.00
End Levee Mile	0.00
Location	
Category	Channels
Item	Encroachments
This picture shows the encroachment at the upstream of the channel.	
pkazi_c_20120718_096.jpg

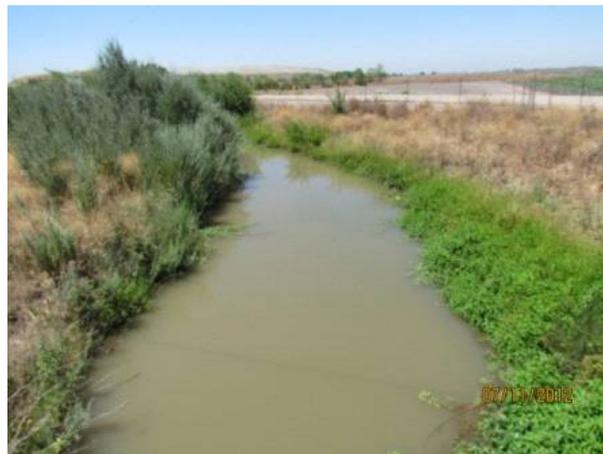
Levee Mile Report Line	21
Start Levee Mile	0.00
End Levee Mile	0.00
Location	
Category	Channels
Item	Vegetation & Obstructions
View of the downstream of the channel.	
pkazi_c_20120718_097.jpg

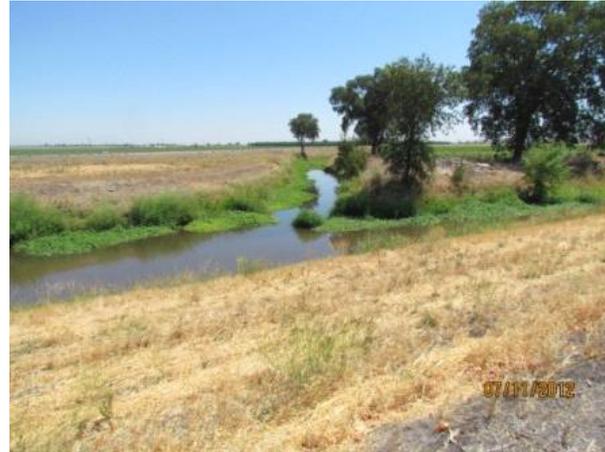
pkazi_c_20120718_092.jpg

Levee Mile Report Line	26
Start Levee Mile	0.00
End Levee Mile	0.00
Location	
Category	Channels
Item	Vegetation & Obstructions

View of upstream of the channel.

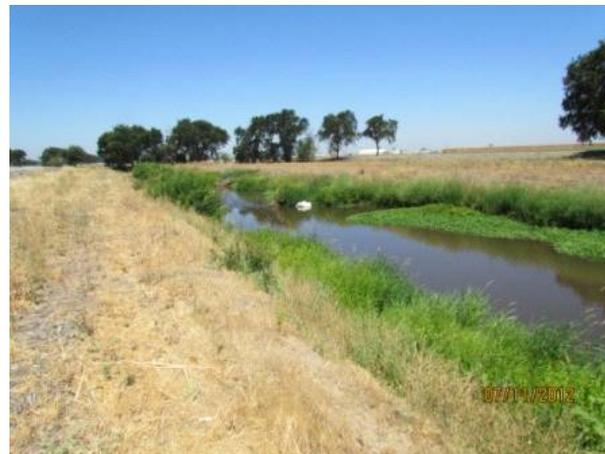
pkazi_c_20120718_093.jpg

Levee Mile Report Line	31
Start Levee Mile	0.00
End Levee Mile	0.00
Location	
Category	Channels
Item	Vegetation & Obstructions

View of the downstream of the channel.
