**Flood Control Project Maintenance
Levee Inspections
2014 Channel Summary Report
Overall Unit and Item Ratings**

San Joaquin County Flood Control and Water Conservation District

Flood Control Project Maintenance**Unit Cover Sheet****2014 Channel Inspection Results****San Joaquin County Flood Control and Water Conservation District**

Levee Inspection Report By Mile - Channel 2014

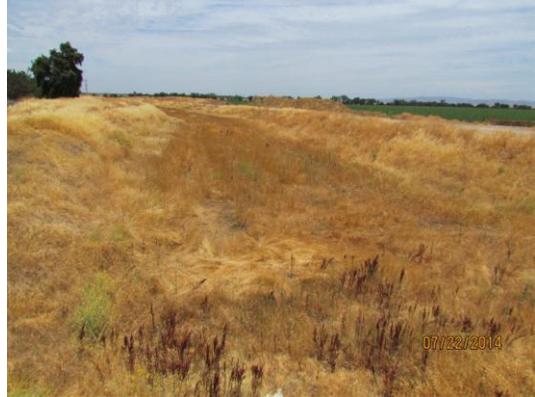
Photo 1 of 2 : CH_2014_NA0017_43_11_20140805_00010.jpg

Check Point / View				
Farmington Rd/ Hwy 4 / Up				
Rating **	A	Issue No.	11	GPS Lat/Long
Issue Type +	Ma	Location *		37.930250 °
Category	Rivers, Channels & Designated Flood			-120.991220 °
Item	Vegetation & Obstructions			
DWR ID	DWR_NA0017_43_c_2012_11			
Action/Comments				
Inspector Comments: Minimal vegetation is present in the channel but doesn't appear to obstruct the flow of the channel.

View of the vegetation on the channel looking upstream during 2014 inspection.

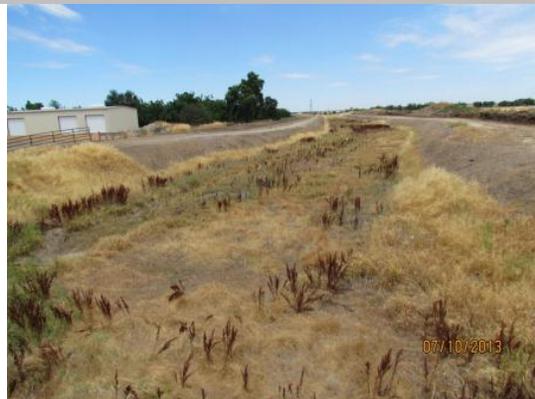
Photo 2 of 2 : CH_2014_NA0017_43_11_20140709_00001.jpg

View of the vegetation on the channel looking upstream.

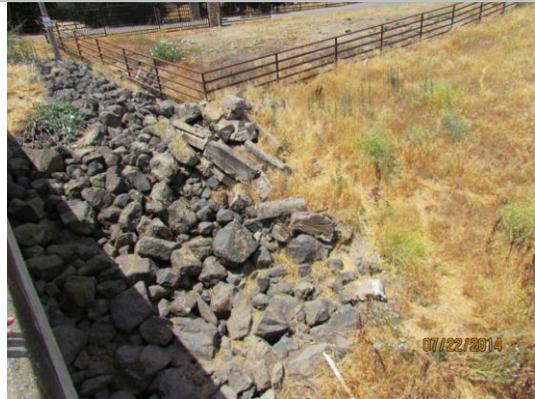
Photo 1 of 2 : CH_2014_NA0017_43_14_20140805_00011.jpg

Rating **	A	Issue No.	14	GPS Lat/Long
Issue Type +	Ma	Location *		37.930250 °
Category	Rivers, Channels & Designated Flood			-120.991220 °
Item	Revetments			
DWR ID	DWR_NA0017_43_c_2012_14			
Action/Comments				
Inspector Comments: Existing riprap appears to be properly maintained.

View of the revetments on the right bank of the channel looking upstream.

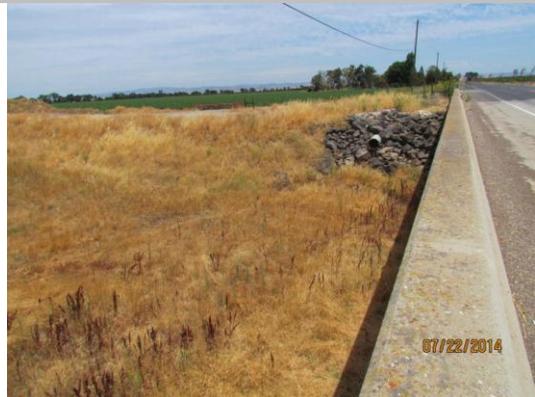
Photo 2 of 2 : CH_2014_NA0017_43_14_20140805_00012.jpg

View of the revetments on the left bank of the channel looking upstream.

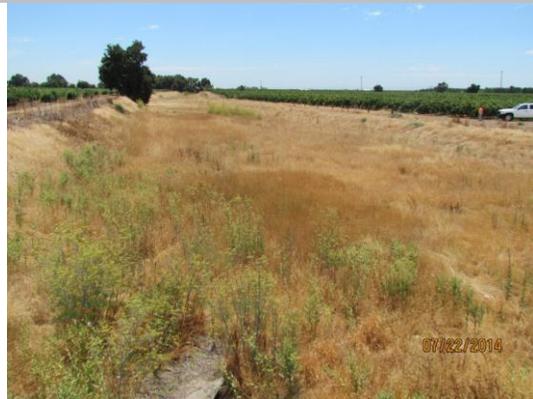
Photo 1 of 2 : CH_2014_NA0017_43_16_20140805_00013.jpg

Check Point / View			
Farmington Rd/ Hwy 4 / Down			
Rating **	A	Issue No.	16
Issue Type +	Ma	Location *	GPS Lat/Long
Category	Rivers, Channels & Designated Flood		37.929802 °
Item	Vegetation & Obstructions		-120.991160 °
DWR ID	DWR_NA0017_43_c_2012_16		
Action/Comments			
Inspector Comments: Minimal vegetation is present in the channel but doesn't appear to obstruct the flow of the channel.

Vegetation growth on the looking downstream during 2014 inspection.

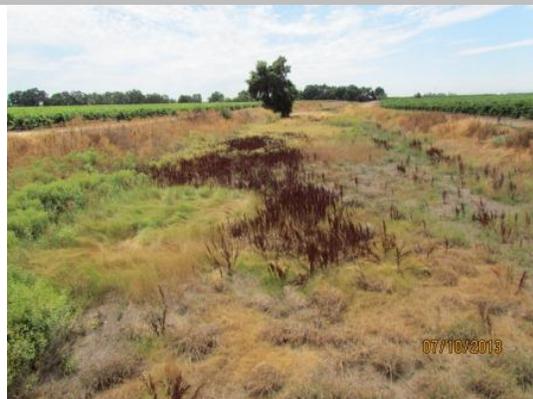
Photo 2 of 2 : CH_2014_NA0017_43_16_20140709_00004.jpg

View of the vegetation growth on downstream of the channel.

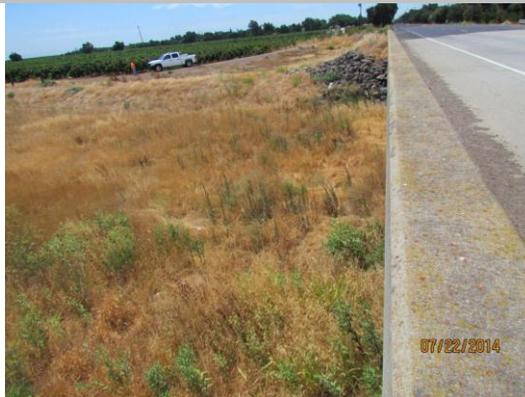
Photo 1 of 2 : CH_2014_NA0017_43_19_20140805_00014.jpg

Rating **	A	Issue No.	19	GPS Lat/Long
Issue Type +	Ma	Location *		37.929807 °
Category	Rivers, Channels & Designated Flood			-120.991183 °
Item	Revetments			
DWR ID	DWR_NA0017_43_c_2012_19			
Action/Comments				
Inspector Comments: Existing riprap appears to be properly maintained.

View of the revetments on the right bank of the channel looking downstream.

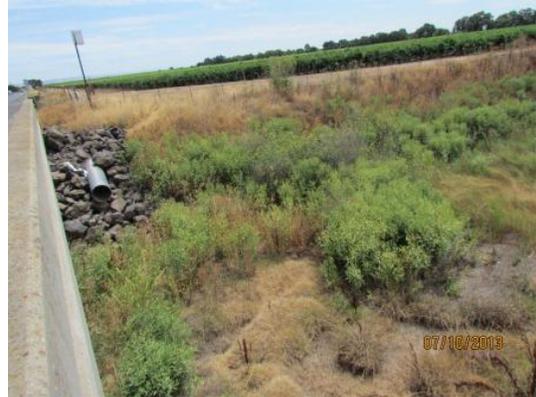
Photo 2 of 2 : CH_2014_NA0017_43_19_20140709_00005.jpg

Check Point / View				
Farmington Rd/ Hwy 4 / Down (cont)				
Rating **	A	Issue No.	19 (cont)	GPS Lat/Long
Issue Type +	Ma	Location *		37.929807 °
Category	Rivers, Channels & Designated Flood			-120.991183 °
Item	Revetments			
DWR ID	DWR_NA0017_43_c_2012_19			
Action/Comments				
Inspector Comments: Existing riprap appears to be properly maintained.

View of the revetments on the left bank of the channel looking downstream.

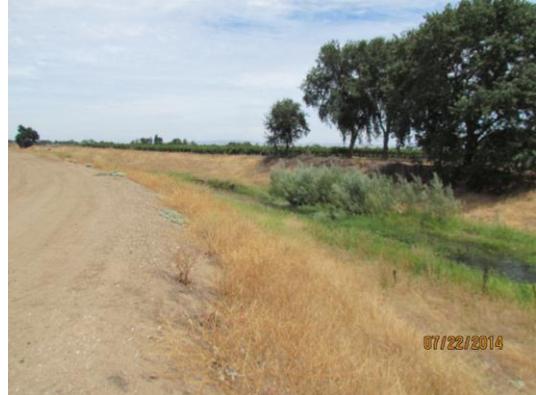
Photo 1 of 3 : CH_2014_NA0017_43_21_20140805_00015.jpg

Check Point / View				
Confluence with South Littlejohn Creek / Up				
Rating **	A	Issue No.	21	GPS Lat/Long
Issue Type +	Ma	Location *		37.925730 °
Category	Rivers, Channels & Designated Flood			-120.992290 °
Item	Vegetation & Obstructions			
DWR ID	DWR_NA0017_43_c_2012_21			
Action/Comments				
Inspector Comments: Vegetation growth in the channel doesn't appeared to impede the flow.

View of the channel looking upstream during 2014 inspection.

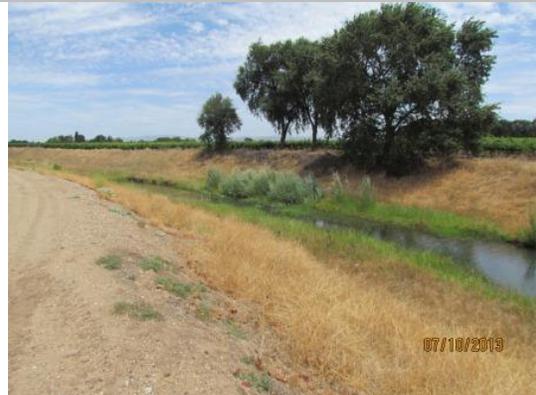
Photo 2 of 3 : CH_2014_NA0017_43_21_20140709_00007.jpg

View of the channel looking upstream.

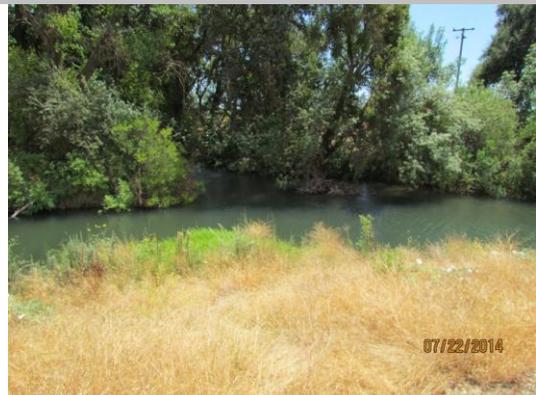
Photo 3 of 3 : CH_2014_NA0017_43_21_20140805_00016.jpg

View of the confluence.

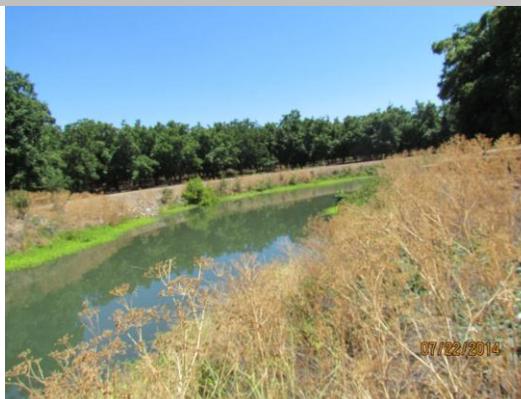
Photo 1 of 3 : CH_2014_NA0017_42_6_20140808_00031.jpg

Check Point / View			
Upstream Limit / Down			
Rating **	A	Issue No.	6
Issue Type +	Ma	Location *	37.919430 °
Category	Rivers, Channels & Designated Flood		-121.034800 °
Item	Vegetation & Obstructions		
DWR ID	DWR_NA0017_42_c_2012_6		
Action/Comments			
Inspector Comments: No vegetation is obstructing the flow of the channel.

View of the vegetation looking upstream of North Little John during 2014 inspection.

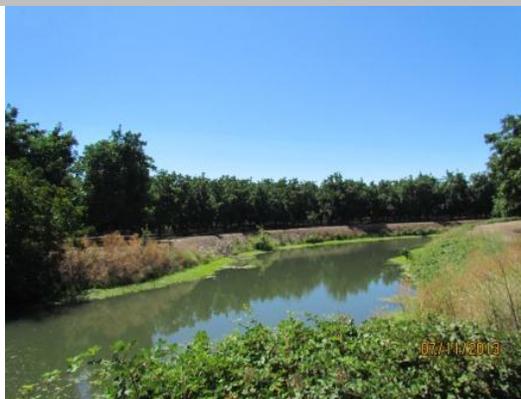
Photo 2 of 3 : CH_2014_NA0017_42_6_20140709_00001.jpg

View of vegetation on the upstream limit of North Little John.

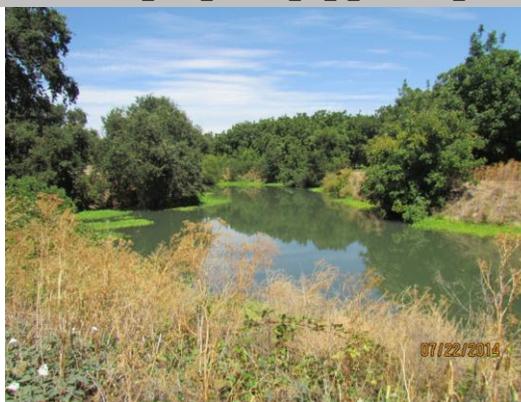
Photo 3 of 3 : CH_2014_NA0017_42_6_20140808_00032.jpg

View of the confluence at that location.

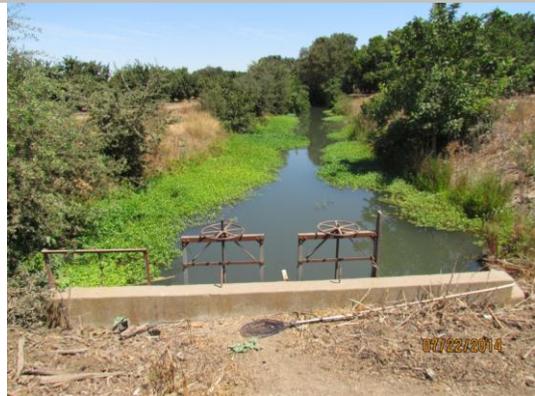
Photo 1 of 2 : CH_2014_NA0017_42_11_20140808_00033.jpg

Check Point / View				
Hewit Lane / Up				
Rating **	M	Issue No.	11	GPS Lat/Long
Issue Type +	Ma	Location *		37.920600 °
Category	Rivers, Channels & Designated Flood			-121.037920 °
Item	Vegetation & Obstructions			
DWR ID	DWR_NA0017_42_c_2012_11			
Action/Comments				
Inspector Comments: Minimal vegetation may obstruct the flow of the channel.

View of vegetation looking upstream during 2014 inspection.

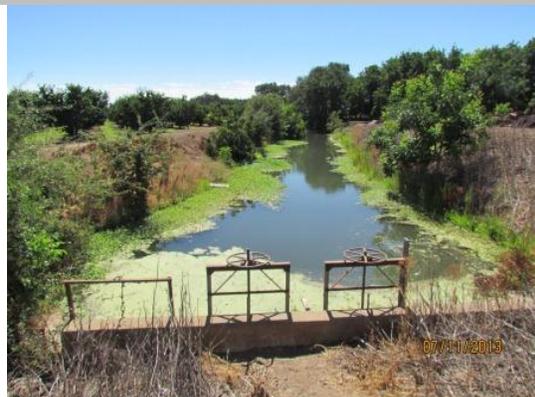
Photo 2 of 2 : CH_2014_NA0017_42_11_20140709_00002.jpg

View of vegetation looking upstream of the channel.

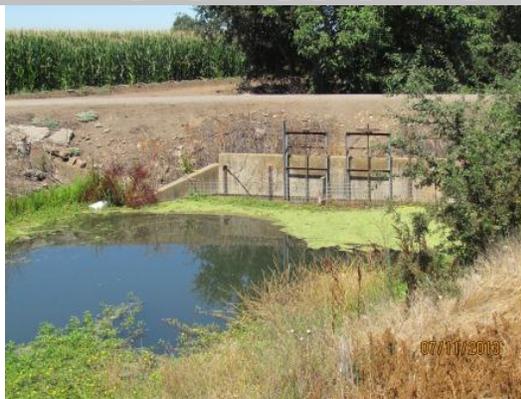
Photo 2 of 2 : CH_2014_NA0017_42_113_20140709_00030.jpg

Rating **	A	Issue No.	113	GPS Lat/Long
Issue Type +	Ma	Location *		37.920600 °
Category	Rivers, Channels & Designated Flood			-121.037920 °
Item	Gates			
DWR ID	DWR_NA0017_42_c_2012_113			
Action/Comments				
Inspector Comments: Slide gates appeared to be in good operational condition.

View of the gates on the upstream of the channel.

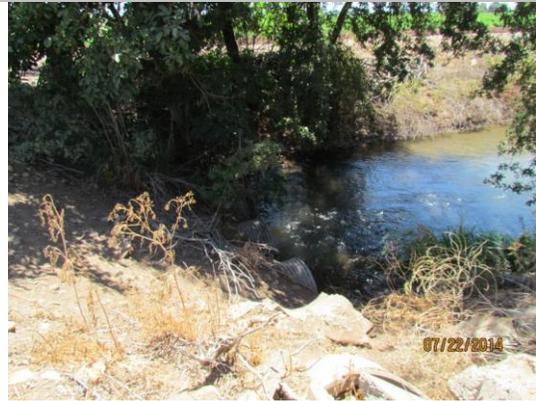
Photo 1 of 2 : CH_2014_NA0017_42_16_20140808_00036.jpg

Check Point / View				
Hewit Lane / Down				
Rating **	A	Issue No.	16	GPS Lat/Long
Issue Type +	Ma	Location *		37.920584 °
Category	Rivers, Channels & Designated Flood			-121.037914 °
Item	Vegetation & Obstructions			
DWR ID	DWR_NA0017_42_c_2012_16			
Action/Comments				
Inspector Comments: Walnut tree exists on left side of the shoulder. It doesn't obstructed the flow, but it could fall down in the creek.

View of minimal vegetation on the channel looking downstream during 2014 inspection.

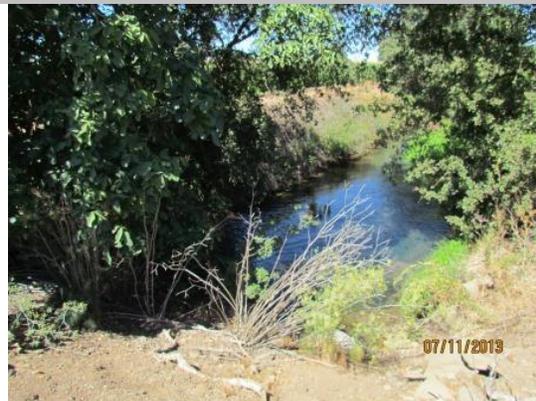
Photo 2 of 2 : CH_2014_NA0017_42_16_20140709_00003.jpg

View of the vegetation on the downstream of the channel.

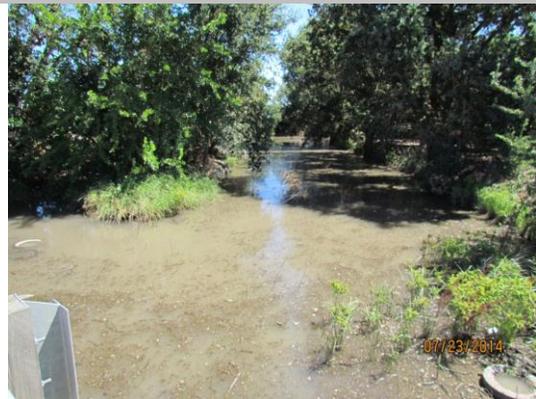
Photo 1 of 1 : CH_2014_NA0017_42_31_20140808_00040.jpg

Check Point / View			
Jack Tone Rd / Up			
Rating **	A	Issue No.	31
Issue Type +	Ma	Location *	GPS Lat/Long
Category	Rivers, Channels & Designated Flood		-121.147570 °
Item	Vegetation & Obstructions		
DWR ID	DWR_NA0017_42_c_2012_31		
Action/Comments			
Inspector Comments: Minimal vegetation exists on the channel.

View of upstream of the channel.

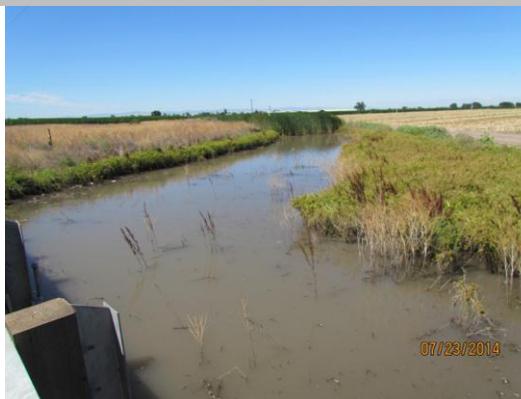
Photo 1 of 1 : CH_2014_NA0017_42_36_20140808_00042.jpg

Rating **	A	Issue No.	36	GPS Lat/Long
Issue Type +	Ma	Location *		37.921460 °
Category	Rivers, Channels & Designated Flood			-121.147570 °
Item	Vegetation & Obstructions			
DWR ID	DWR_NA0017_42_c_2012_36			
Action/Comments				
Inspector Comments: Minimal vegetation on the channel should not obstruct the flow.

View of the channel looking downstream.

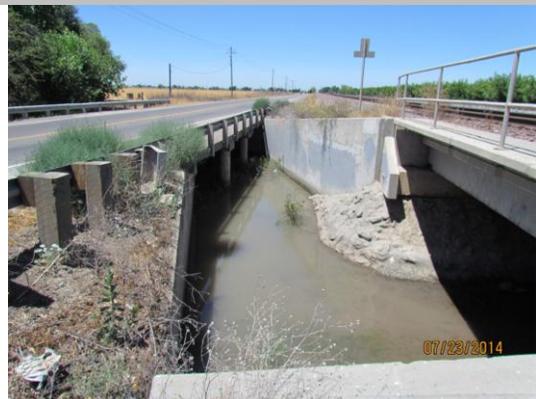
Photo 1 of 1 : CH_2014_NA0017_42_41_20140811_00044.jpg

Check Point / View			
Mariposa Rd / Up			
Rating **	A	Issue No.	41
Issue Type +	Ma	Location *	GPS Lat/Long
Category	Rivers, Channels & Designated Flood		37.915600 °
Item	Vegetation & Obstructions		-121.189270 °
DWR ID	DWR_NA0017_42_c_2012_41		
Action/Comments			
Inspector Comments: Minimal vegetation on the channel should not impede the flow.

View of upstream of the channel.

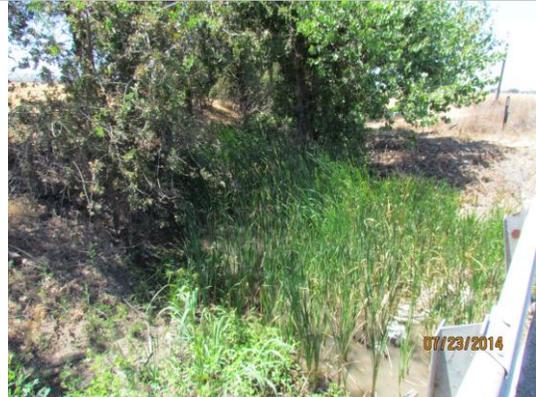
Photo 1 of 2 : CH_2014_NA0017_42_46_20140811_00043.jpg

Check Point / View			
Mariposa Rd / Down			
Rating **	M	Issue No.	46
Issue Type +	Ma	Location *	37.915600 °
Category	Rivers, Channels & Designated Flood		-121.189270 °
Item	Vegetation & Obstructions		
DWR ID	DWR_NA0017_42_c_2012_46		
Action/Comments			
Inspector Comments: Vegetation growth may obstruct the flow of the channel.

View of vegetation on the downstream of the channel during 2014 inspection.

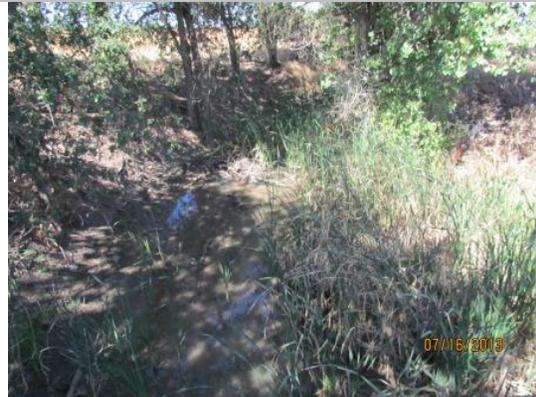
Photo 2 of 2 : CH_2014_NA0017_42_46_20140709_00011.jpg

Check Point / View			
Mariposa Rd / Down (cont)			
Rating **	M	Issue No. 46 (cont)	GPS Lat/Long
Issue Type +	Ma	Location *	37.915600 °
Category	Rivers, Channels & Designated Flood		-121.189270 °
Item	Vegetation & Obstructions		
DWR ID	DWR_NA0017_42_c_2012_46		
Action/Comments			
Inspector Comments: Vegetation growth may obstruct the flow of the channel.

View of the vegetation growth on the downstream end of the channel.

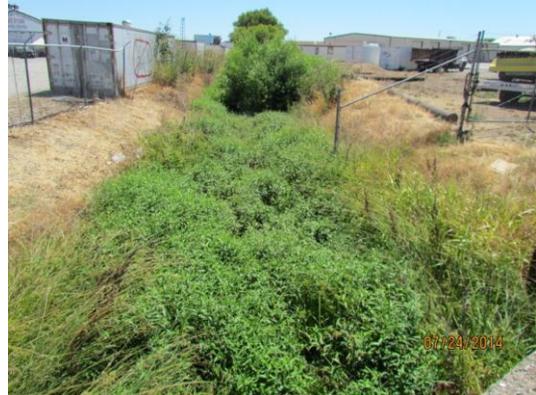
Photo 1 of 2 : CH_2014_NA0017_42_51_20140811_00045.jpg

Check Point / View				
Highway 99 / Up				
Rating **	M	Issue No.	51	GPS Lat/Long
Issue Type +	Ma	Location *		37.913340 °
Category	Rivers, Channels & Designated Flood			-121.225940 °
Item	Vegetation & Obstructions			
DWR ID	DWR_NA0017_42_c_2012_51			
Action/Comments				
Inspector Comments: Vegetation on the channel may impede the flow of the channel.

View of the vegetation on the channel looking upstream during 2014 inspection.

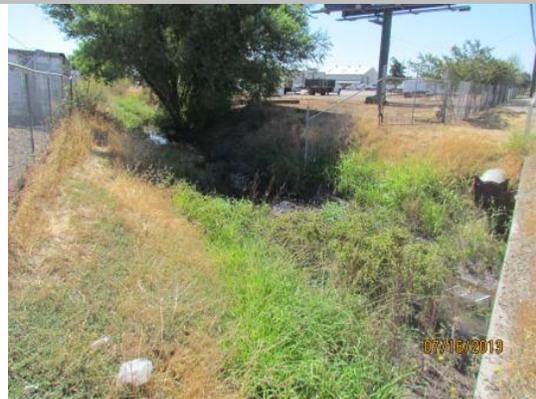
Photo 2 of 2 : CH_2014_NA0017_42_51_20140709_00013.jpg

Rating **	M	Issue No.	51 (cont)	GPS Lat/Long
Issue Type +	Ma	Location *		37.913340 °
Category	Rivers, Channels & Designated Flood			-121.225940 °
Item	Vegetation & Obstructions			
DWR ID	DWR_NA0017_42_c_2012_51

View of the vegetation on the channel looking upstream.

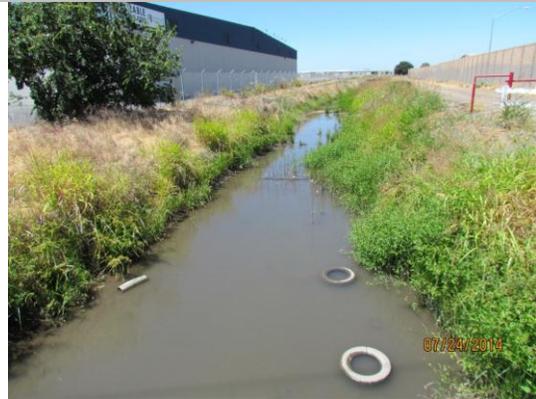
Photo 1 of 1 : CH_2014_NA0017_42_56_20140811_00046.jpg

Check Point / View				
Highway 99 / Down				
Rating **	A	Issue No.	56	GPS Lat/Long
Issue Type +	Ma	Location *		37.913340 °
Category	Rivers, Channels & Designated Flood			-121.225940 °
Item	Vegetation & Obstructions			
DWR ID	DWR_NA0017_42_c_2012_56			
Action/Comments				
Inspector Comments: Minimal vegetation does not impede the flow on the channel.

View of the downstream end of the channel.

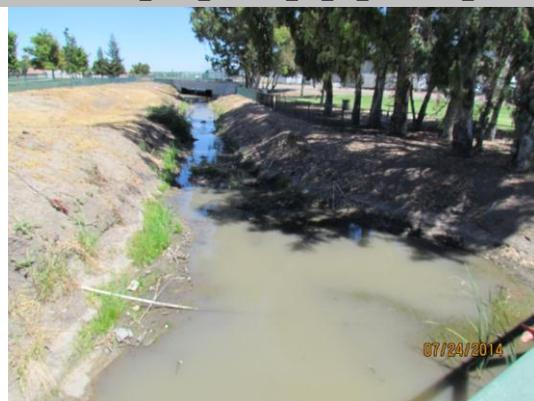
Photo 1 of 2 : CH_2014_NA0017_42_61_20140811_00047.jpg

Check Point / View			
Pock Lane / Up			
Rating **	A	Issue No.	61
Issue Type +	Ma	Location *	GPS Lat/Long
Category	Rivers, Channels & Designated Flood		37.914290 °
Item	Vegetation & Obstructions		
DWR ID	DWR_NA0017_42_c_2012_61		
Action/Comments			
Inspector Comments: Minimal vegetation may not impede the flow of the channel.

View of the channel looking upstream during 2014 inspection.

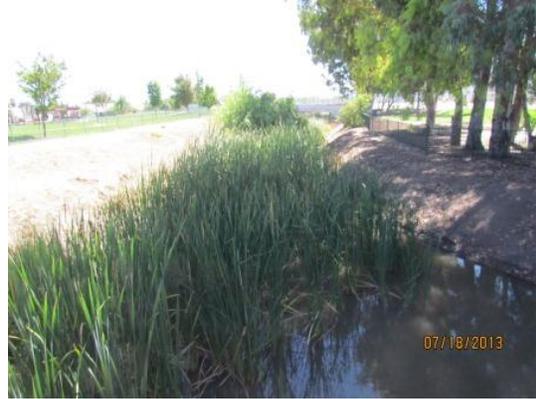
Photo 2 of 2 : CH_2014_NA0017_42_61_20140709_00017.jpg

Check Point / View				
Pock Lane / Up (cont)				
Rating **	A	Issue No.	61 (cont)	GPS Lat/Long
Issue Type +	Ma	Location *		37.914290 °
Category	Rivers, Channels & Designated Flood			-121.238800 °
Item	Vegetation & Obstructions			
DWR ID	DWR_NA0017_42_c_2012_61			
Action/Comments				
Inspector Comments: Minimal vegetation may not impede the flow of the channel.

View of the vegetation in the channel looking upstream.

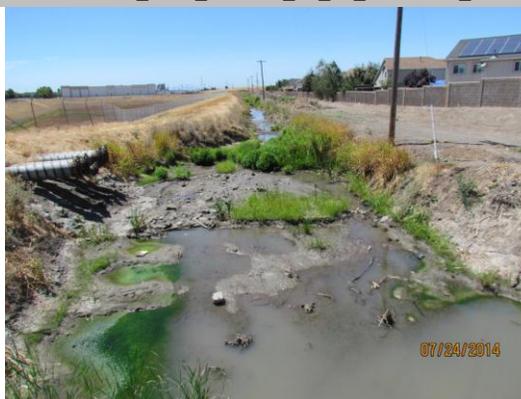
Photo 1 of 2 : CH_2014_NA0017_42_66_20140811_00048.jpg

Check Point / View			
Pock Lane / Down			
Rating **	A	Issue No. 66	GPS Lat/Long
Issue Type +	Ma	Location *	37.914290 °
Category	Rivers, Channels & Designated Flood		-121.238800 °
Item	Vegetation & Obstructions		
DWR ID	DWR_NA0017_42_c_2012_66		
Action/Comments			
Inspector Comments: Minimal vegetation may not impede the flow of the channel.

View of the channel looking downstream during 2014 inspection.

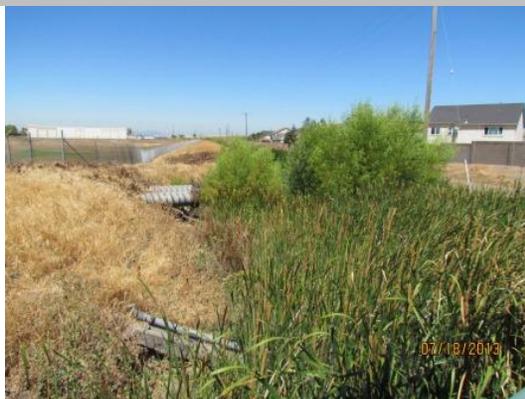
Photo 2 of 2 : CH_2014_NA0017_42_66_20140709_00018.jpg

Check Point / View			
Pock Lane / Down (cont)			
Rating **	A	Issue No.	66 (cont)
Issue Type +	Ma	Location *	GPS Lat/Long
Category	Rivers, Channels & Designated Flood		37.914290 °
Item	Vegetation & Obstructions		-121.238800 °
DWR ID	DWR_NA0017_42_c_2012_66		
Action/Comments			
Inspector Comments: Minimal vegetation may not impede the flow of the channel.

View of the heavy vegetation on the downstream of the channel.

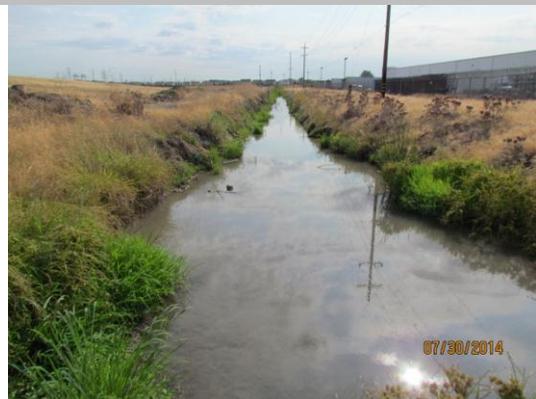
Photo 1 of 2 : CH_2014_NA0017_42_71_20140811_00049.jpg

Check Point / View			
South B Street / Up			
Rating **	A	Issue No. 71	GPS Lat/Long
Issue Type +	Ma	Location *	37.913940 °
Category	Rivers, Channels & Designated Flood		-121.247810 °
Item	Vegetation & Obstructions		
DWR ID	DWR_NA0017_42_c_2012_71		
Action/Comments			
Inspector Comments: Minimal vegetation is present in the channel.

View of the channel looking upstream during 2014 inspection.

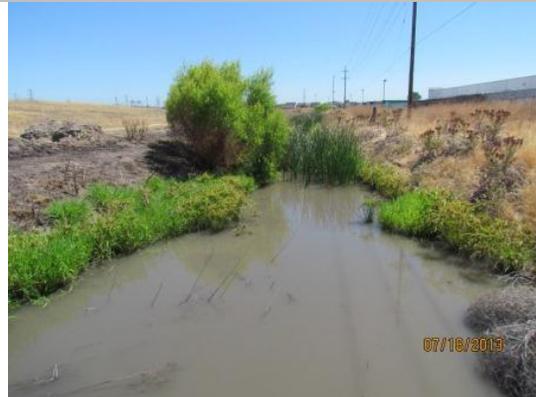
Photo 2 of 2 : CH_2014_NA0017_42_71_20140709_00019.jpg

Check Point / View			
South B Street / Up (cont)			
Rating **	A	Issue No. 71 (cont)	GPS Lat/Long
Issue Type +	Ma	Location *	37.913940 °
Category	Rivers, Channels & Designated Flood		-121.247810 °
Item	Vegetation & Obstructions		
DWR ID	DWR_NA0017_42_c_2012_71		
Action/Comments			
Inspector Comments: Minimal vegetation is present in the channel.

View of the channel looking upstream.

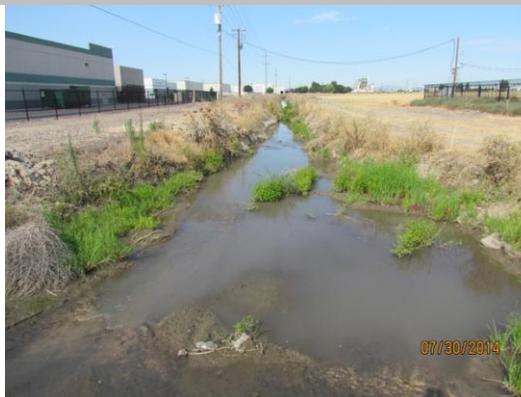
Photo 1 of 2 : CH_2014_NA0017_42_76_20140811_00050.jpg

Check Point / View			
South B Street / Down			
Rating **	A	Issue No. 76	GPS Lat/Long
Issue Type +	Ma	Location *	37.913940 °
Category	Rivers, Channels & Designated Flood		-121.247810 °
Item	Vegetation & Obstructions		
DWR ID	DWR_NA0017_42_c_2012_76		
Action/Comments			
Inspector Comments: Minimal vegetation on the channel should not impede the flow.

View of the channel looking downstream on 2014 inspection.

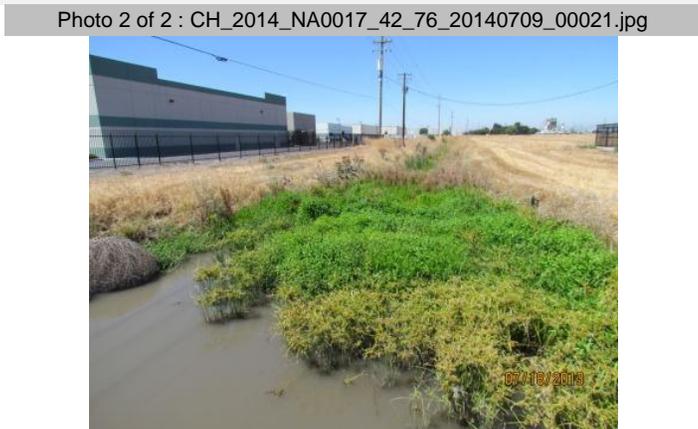
Check Point / View				
South B Street / Down (cont)				
Rating **	A	Issue No.	76 (cont)	GPS Lat/Long
Issue Type +	Ma	Location *		37.913940 °
Category	Rivers, Channels & Designated Flood			-121.247810 °
Item	Vegetation & Obstructions			
DWR ID	DWR_NA0017_42_c_2012_76			
Action/Comments				
Inspector Comments: Minimal vegetation on the channel should not impede the flow.

View of the channel looking downstream.

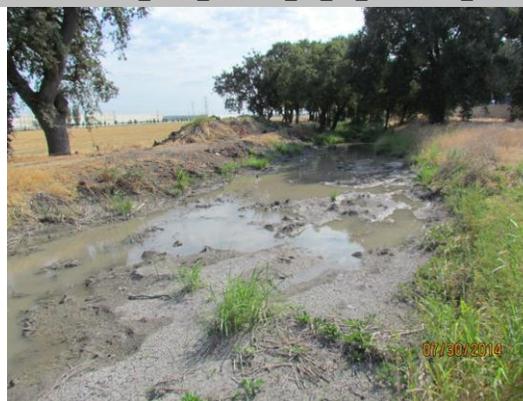
Photo 1 of 2 : CH_2014_NA0017_42_81_20140811_00051.jpg

Check Point / View			
Airport Way / Up			
Rating **	A	Issue No. 81	GPS Lat/Long
Issue Type +	Ma	Location *	37.911910 °
Category	Rivers, Channels & Designated Flood		-121.258690 °
Item	Vegetation & Obstructions		
DWR ID	DWR_NA0017_42_c_2012_81		
Action/Comments			
Inspector Comments: Minimal vegetation will not impede the flow of the channel.

View of the channel looking upstream on 2014 inspection.

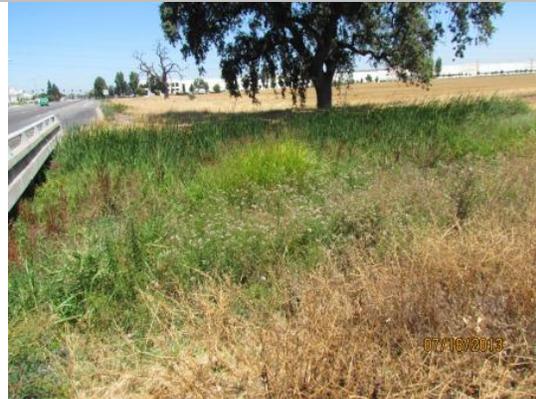
Photo 2 of 2 : CH_2014_NA0017_42_81_20140709_00022.jpg

Check Point / View			
Airport Way / Up (cont)			
Rating **	A	Issue No. 81 (cont)	GPS Lat/Long
Issue Type +	Ma	Location *	37.911910 °
Category	Rivers, Channels & Designated Flood		-121.258690 °
Item	Vegetation & Obstructions		
DWR ID	DWR_NA0017_42_c_2012_81		
Action/Comments			
Inspector Comments: Minimal vegetation will not impede the flow of the channel.

View of the channel looking upstream.

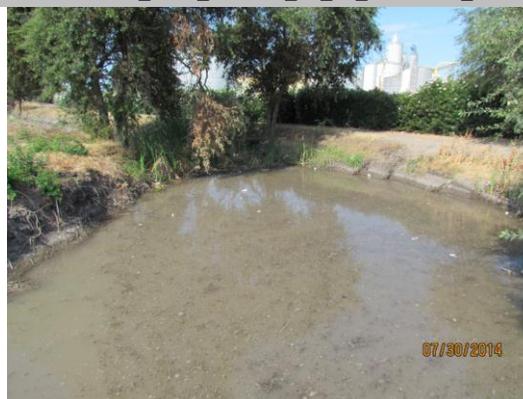
Photo 1 of 2 : CH_2014_NA0017_42_86_20140811_00052.jpg

Check Point / View			
Airport Way / Down			
Rating **	A	Issue No. 86	GPS Lat/Long
Issue Type +	Ma	Location *	37.911910 °
Category	Rivers, Channels & Designated Flood		-121.258690 °
Item	Vegetation & Obstructions		
DWR ID	DWR_NA0017_42_c_2012_86		
Action/Comments			
Inspector Comments: The flow of the channel doesn't appear to be impeded.

View of the channel looking downstream during 2014 inspection.

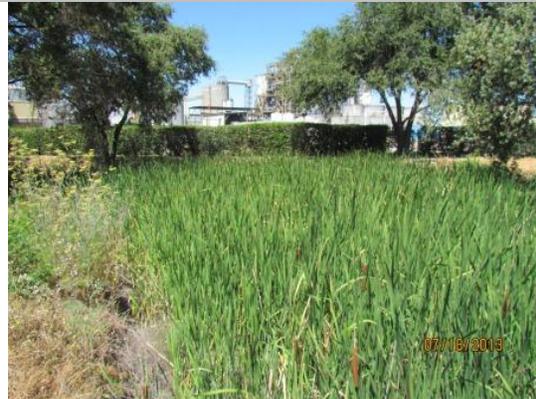
Photo 2 of 2 : CH_2014_NA0017_42_86_20140709_00023.jpg

Check Point / View			
Airport Way / Down (cont)			
Rating **	A	Issue No.	86 (cont)
Issue Type +	Ma	Location *	GPS Lat/Long
Category	Rivers, Channels & Designated Flood		37.911910 °
Item	Vegetation & Obstructions		-121.258690 °
DWR ID	DWR_NA0017_42_c_2012_86		
Action/Comments			
Inspector Comments: The flow of the channel doesn't appear to be impeded.

View of the vegetation growth on the channel looking downstream.

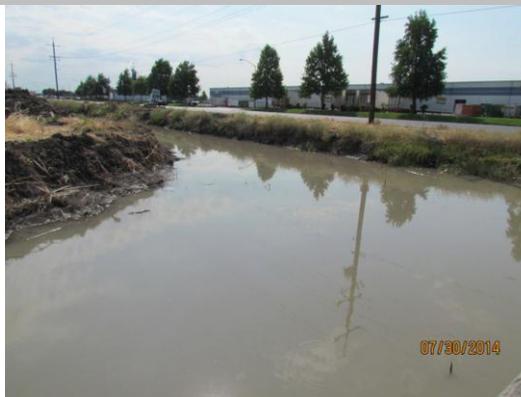
Photo 1 of 2 : CH_2014_NA0017_42_91_20140811_00053.jpg

Check Point / View			
Producers Drive / Up			
Rating **	A	Issue No.	91
Issue Type +	Ma	Location *	GPS Lat/Long
Category	Rivers, Channels & Designated Flood		37.908550 °
Item	Vegetation & Obstructions		-121.269150 °
DWR ID	DWR_NA0017_42_c_2012_91		
Action/Comments			
Inspector Comments: The flow of the channel doesn't appear to be impeded.

View of the channel looking upstream during 2014 inspection.

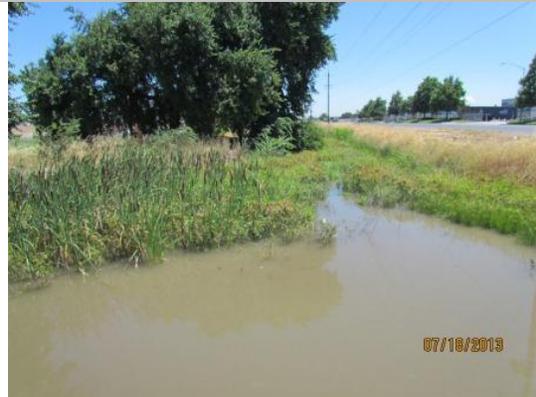
Photo 2 of 2 : CH_2014_NA0017_42_91_20140709_00025.jpg

Check Point / View			
Producers Drive / Up (cont)			
Rating **	A	Issue No.	91 (cont)
Issue Type +	Ma	Location *	GPS Lat/Long
Category	Rivers, Channels & Designated Flood		37.908550 °
Item	Vegetation & Obstructions		-121.269150 °
DWR ID	DWR_NA0017_42_c_2012_91		
Action/Comments			
Inspector Comments: The flow of the channel doesn't appear to be impeded.

This picture was taken looking upstream of the channel.

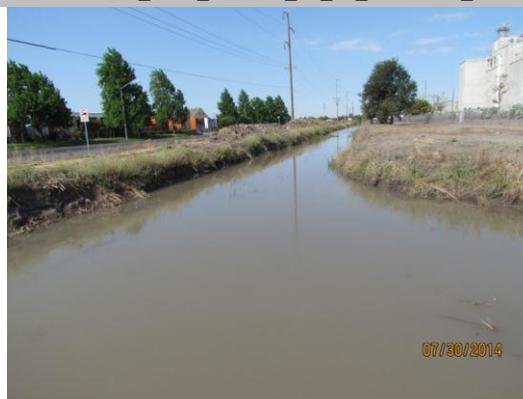
Photo 1 of 2 : CH_2014_NA0017_42_96_20140811_00054.jpg

Check Point / View			
Producers Drive / Down			
Rating **	A	Issue No. 96	GPS Lat/Long
Issue Type +	Ma	Location *	37.908550 °
Category	Rivers, Channels & Designated Flood		-121.269150 °
Item	Vegetation & Obstructions		
DWR ID	DWR_NA0017_42_c_2012_96		
Action/Comments			
Inspector Comments: The flow is not impeded.

View of the channel looking downstream during 2014 inspection.

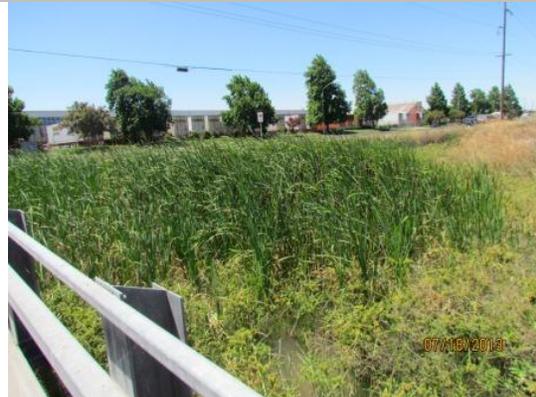
Photo 2 of 2 : CH_2014_NA0017_42_96_20140709_00026.jpg

Check Point / View			
Producers Drive / Down (cont)			
Rating **	A	Issue No. 96 (cont)	GPS Lat/Long
Issue Type +	Ma	Location *	37.908550 °
Category	Rivers, Channels & Designated Flood		-121.269150 °
Item	Vegetation & Obstructions		
DWR ID	DWR_NA0017_42_c_2012_96		
Action/Comments			
Inspector Comments: The flow is not impeded.

View of the vegetation growth on the downstream end of the channel.

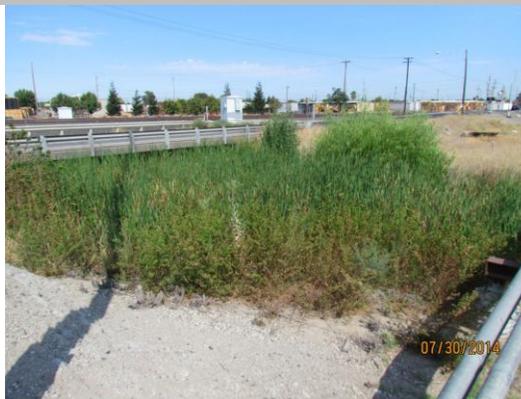
Photo 1 of 1 : CH_2014_NA0017_42_101_20140811_00055.jpg

Check Point / View			
McKinley Avenue / Up			
Rating **	U	Issue No. 101	GPS Lat/Long
Issue Type +	Ma	Location *	37.906950 °
Category	Rivers, Channels & Designated Flood		-121.273860 °
Item	Vegetation & Obstructions		
DWR ID	DWR_NA0017_42_c_2012_101		
Action/Comments			
Inspector Comments: Vegetation, logs and other debris could impede the flow of the channel.

View of the vegetation growth at upstream end of the channel.

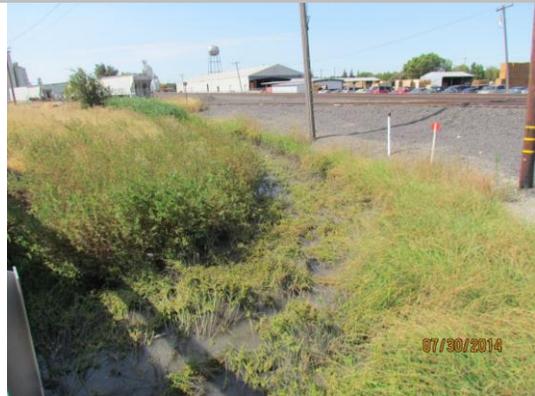
Photo 1 of 1 : CH_2014_NA0017_42_106_20140811_00056.jpg

Check Point / View				
McKinley Avenue / Down				
Rating **	M	Issue No.	106	GPS Lat/Long
Issue Type +	Ma	Location *		37.906950 °
Category	Rivers, Channels & Designated Flood			-121.273860 °
Item	Vegetation & Obstructions			
DWR ID	DWR_NA0017_42_c_2012_106			
Action/Comments				
Inspector Comments: Vegetation and debris may impede the flow of the channel.

View of the vegetation looking downstream of the channel.

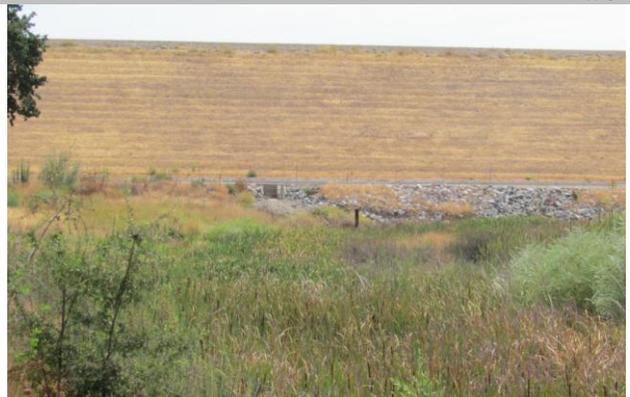
Photo 1 of 1 : CH_2014_NA0017_44_119_20140806_00033.jpg

Rating **	A	Issue No.	119	GPS Lat/Long
Issue Type +	Ma	Location *		37.900580 °
Category	Rivers, Channels & Designated Flood			-120.936018 °
Item	Gates			
DWR ID	DWR_NA0017_44_c_2014_119			
Action/Comments				
Inspector Comments: The gate appears to be functional.

View of the release gate from Farmington Dam. The picture was taken looking upstream of the creek.

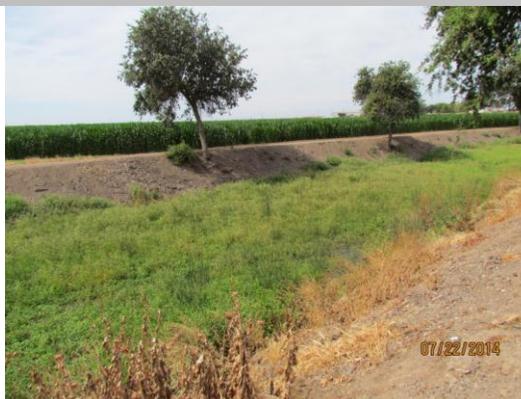
Photo 1 of 2 : CH_2014_NA0017_44_6_20140806_00034.jpg

Check Point / View			
Farmington Dam / Down			
Rating **	A	Issue No.	6
Issue Type +	Ma	Location *	
Category	Rivers, Channels & Designated Flood		GPS Lat/Long
Item	Vegetation & Obstructions		
DWR ID	DWR_NA0017_44_c_2012_6		
Action/Comments			
Inspector Comments: Minimal vegetation was present on the channel. The flow is not impeded.

View of the vegetation on the channel looking downstream during 2014 inspection.

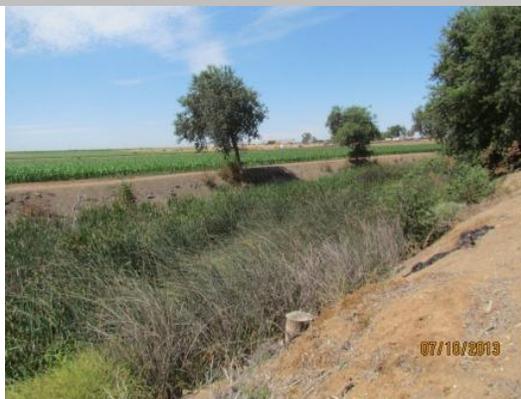
Photo 2 of 2 : CH_2014_NA0017_44_6_20140709_00001.jpg

View of the vegetation which could impede the flow of the channel looking downstream.

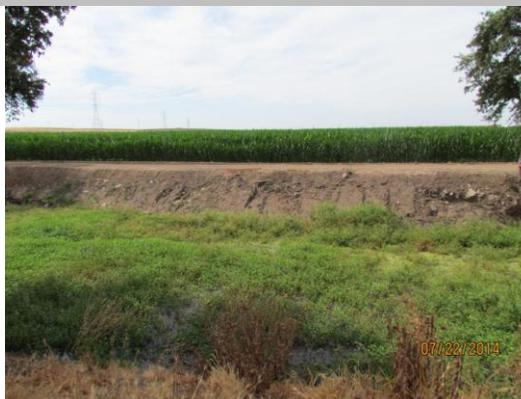
Photo 1 of 2 : CH_2014_NA0017_44_9_20140806_00036.jpg

Check Point / View				
Farmington Dam / Down (cont)				
Rating **	A	Issue No.	9	GPS Lat/Long
Issue Type +	Ma	Location *		37.900914 °
Category	Rivers, Channels & Designated Flood			-120.934604 °
Item	Revetments			
DWR ID	DWR_NA0017_44_c_2012_9			
Action/Comments				
Inspector Comments: Existing riprap appeared to be maintained.

Existing revetments were covered by soil and appeared to be holding in place. The picture was taken looking upstream of the channel during 2014 inspection.

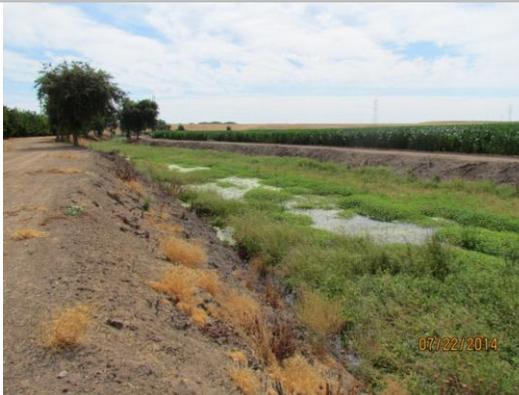
Photo 1 of 2 : CH_2014_NA0017_44_99_20140806_00037.jpg

Inspector Comments: Minimal vegetation may not impede the flow of the channel.

View of the vegetation on the channel looking upstream during 2014 inspection.

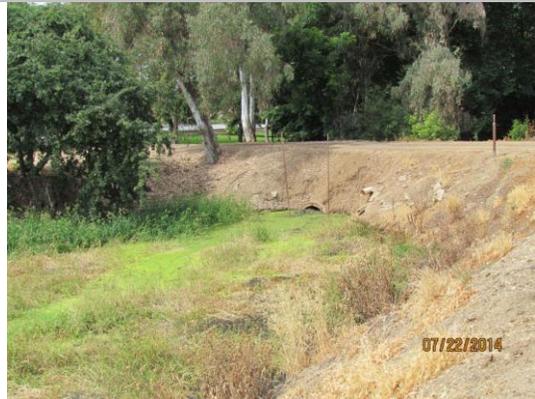
Photo 1 of 2 : CH_2014_NA0017_44_108_20140806_00038.jpg

Rating **	M	Issue No. 108	GPS Lat/Long
Issue Type +	Ma	Location *	37.900040 °
Category	Rivers, Channels & Designated Flood		-120.938949 °
Item	Gates		
DWR ID	DWR_NA0017_44_c_2013_108		
Action/Comments			
Inspector Comments: The gate appeared to be in good condition, but accumulated debris may block the flow inside the gate.

View of the gate looking upstream of the channel during 2014 inspection.

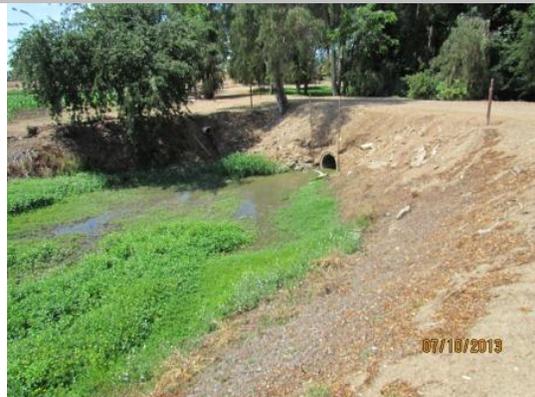
Photo 2 of 2 : CH_2014_NA0017_44_108_20140709_00031.jpg

View of the pipe gate on the upstream of the checkpoint.

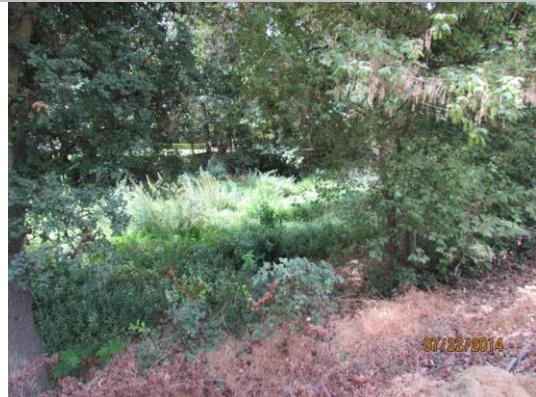
Photo 1 of 2 : CH_2014_NA0017_44_104_20140806_00039.jpg

Check Point / View			
Wedding Chappel Crossing / Down			
Rating **	U	Issue No. 104	GPS Lat/Long
Issue Type +	Ma	Location *	37.900332 °
Category	Rivers, Channels & Designated Flood		-120.939298 °
Item	Vegetation & Obstructions		
DWR ID	DWR_NA0017_44_c_2013_104		
Action/Comments			
Inspector Comments: Heavy vegetation growth will impede the flow and may block approximately 50% capacity of the channel.

Heavy vegetation was present on the downstream of the channel during 2014 inspection.

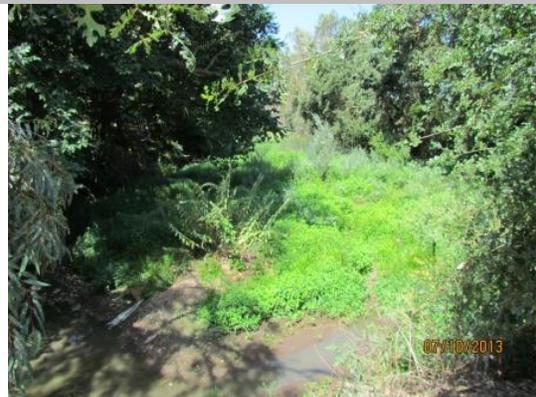
Photo 2 of 2 : CH_2014_NA0017_44_104_20140709_00029.jpg

View of heavy vegetation on the downstream of the channel.

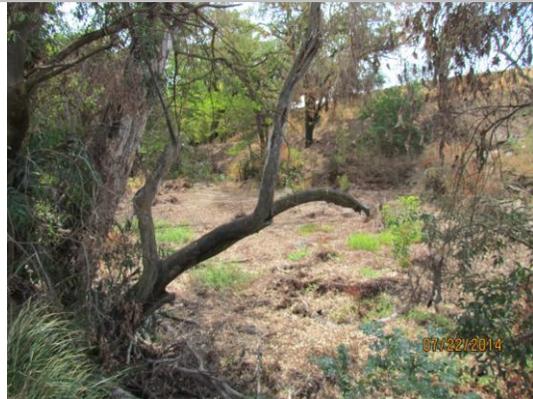
Photo 1 of 2 : CH_2014_NA0017_44_107_20140806_00040.jpg

Rating **	U	Issue No.	107	GPS Lat/Long
Issue Type +	Ma	Location *		37.900040 °
Category	Rivers, Channels & Designated Flood			-120.938949 °
Item	Encroachments			
DWR ID	DWR_NA0017_44_c_2013_107			
Action/Comments				
Inspector Comments: Various debris and tree trunks were present on the channel during the inspection.

View of obstructions on the channel looking upstream during 2014 inspection.

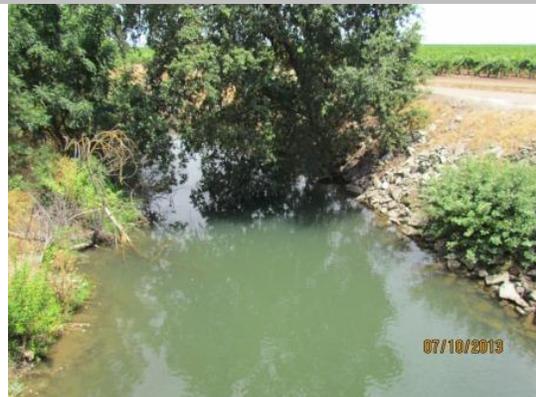
Photo 2 of 2 : CH_2014_NA0017_44_21_20140709_00004.jpg

Tree branches may impede the flow of the channel looking upstream.

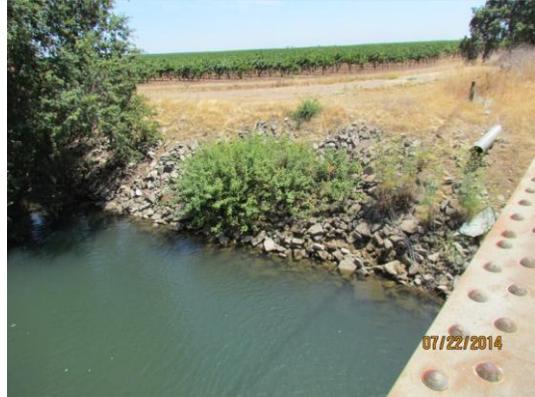
Photo 1 of 1 : CH_2014_NA0017_44_24_20140807_00042.jpg

Rating **	A	Issue No. 24	GPS Lat/Long
Issue Type +	Ma	Location *	37.925330 °
Category	Rivers, Channels & Designated Flood		-121.000120 °
Item	Revetments		
DWR ID	DWR_NA0017_44_c_2012_24		
Action/Comments			
Inspector Comments: Existing riprap is properly maintained.

Existing revetments are properly maintained looking upstream of the channel.

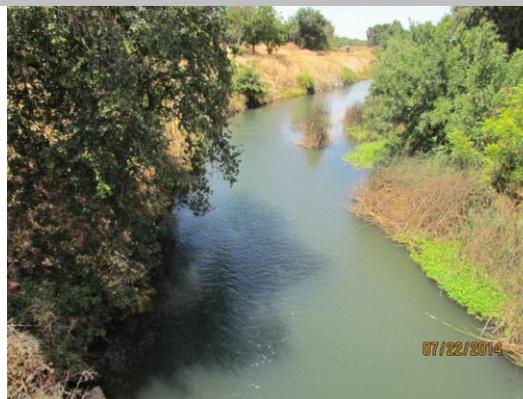
Photo 1 of 1 : CH_2014_NA0017_44_26_20140807_00043.jpg

Check Point / View			
Escalon Bellota Rd / Down			
Rating **	A	Issue No. 26	GPS Lat/Long
Issue Type +	Ma	Location *	37.925330 °
Category	Rivers, Channels & Designated Flood		-121.000120 °
Item	Vegetation & Obstructions		
DWR ID	DWR_NA0017_44_c_2012_26		
Action/Comments			
Inspector Comments: Minimal vegetation was found on the channel.

View of the channel looking downstream.

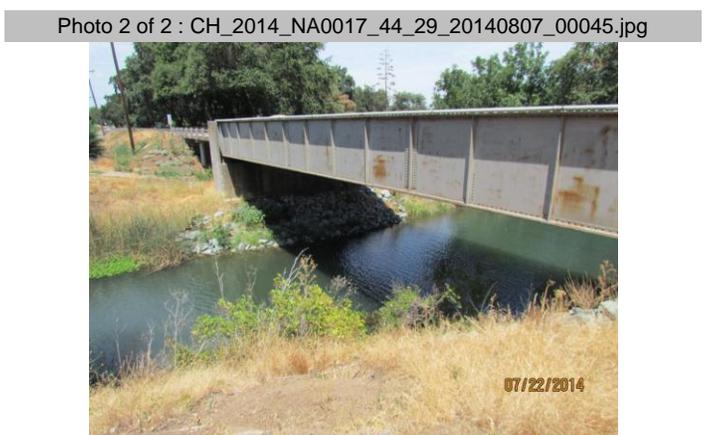
View of the revetments under the bridge. The picture was taken looking upstream of the creek.

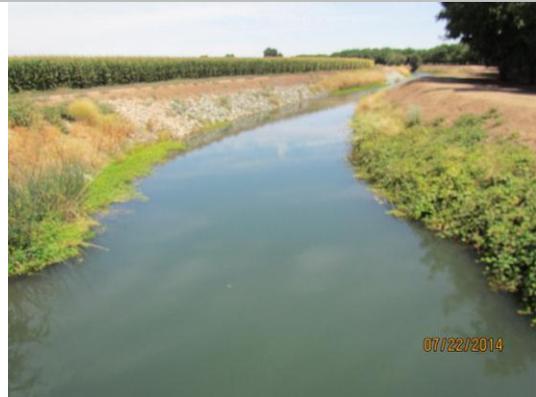
Photo 1 of 2 : CH_2014_NA0017_44_31_20140807_00046.jpg

Check Point / View				
Stanley Rd / Up				
Rating **	A	Issue No.	31	GPS Lat/Long
Issue Type +	Ma	Location *		37.919960 °
Category	Rivers, Channels & Designated Flood			-121.027867 °
Item	Vegetation & Obstructions			
DWR ID	DWR_NA0017_44_c_2012_31			
Action/Comments				
Inspector Comments: Minimal vegetation will not impede the flow of the channel.

View of the channel looking upstream during 2014 inspection.

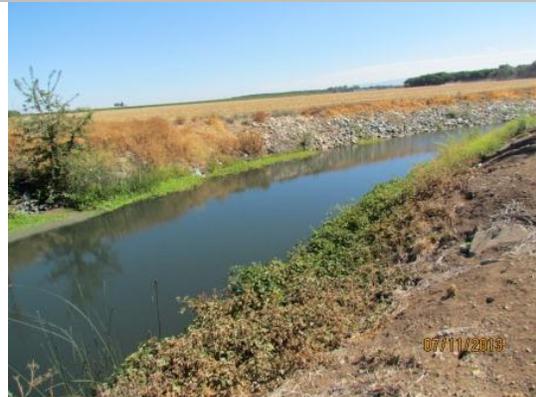
Photo 2 of 2 : CH_2014_NA0017_44_31_20140709_00008.jpg

View of the channel looking upstream.

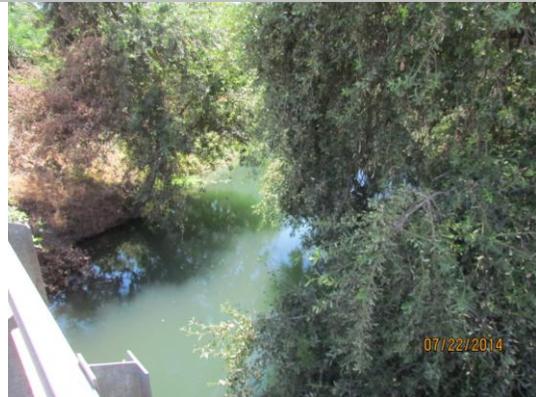
Photo 1 of 1 : CH_2014_NA0017_44_36_20140807_00048.jpg

Check Point / View				
Stanley Rd / Down				
Rating **	M	Issue No.	36	GPS Lat/Long
Issue Type +	Ma	Location *		37.920008 °
Category	Rivers, Channels & Designated Flood			-121.027842 °
Item	Vegetation & Obstructions			
DWR ID	DWR_NA0017_44_c_2012_36			
Action/Comments				
Inspector Comments: Tree branches might obstruct the downstream flow of the channel.

Tree branches might obstruct the flow of the channel looking downstream.

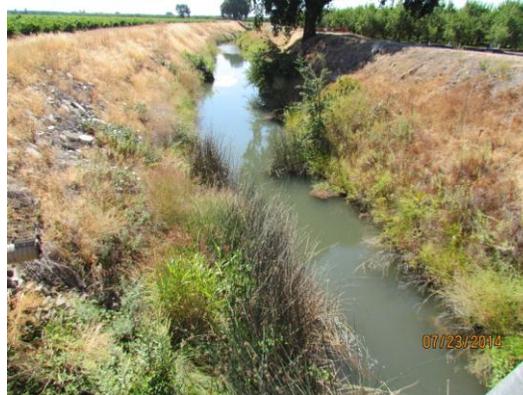
Photo 1 of 1 : CH_2014_NA0017_44_41_20140808_00049.jpg

Check Point / View			
Van Allen Rd / Up			
Rating **	A	Issue No. 41	GPS Lat/Long
Issue Type +	Ma	Location *	37.913060 °
Category	Rivers, Channels & Designated Flood		-121.056230 °
Item	Vegetation & Obstructions		
DWR ID	DWR_NA0017_44_c_2012_41		
Action/Comments			
Inspector Comments: Minimal vegetation growth is present on the channel.

View of the vegetation on the channel looking upstream.

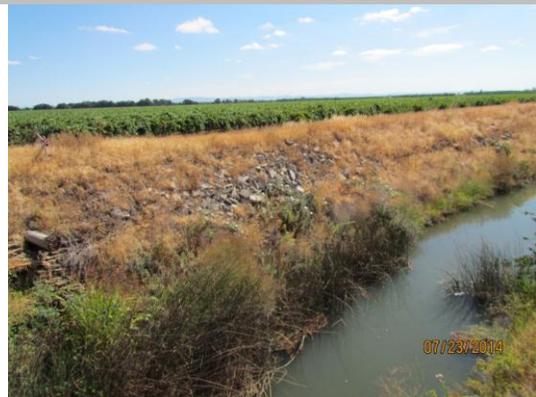
Photo 1 of 2 : CH_2014_NA0017_44_44_20140808_00050.jpg

Rating **	A	Issue No. 44	GPS Lat/Long
Issue Type +	Ma	Location *	37.913060 °
Category	Rivers, Channels & Designated Flood		-121.056230 °
Item	Revetments		
DWR ID	DWR_NA0017_44_c_2012_44		
Action/Comments			
Inspector Comments: Existing riprap protection is properly maintained.

View of the revetments on the channel bank looking upstream during 2014 inspection.

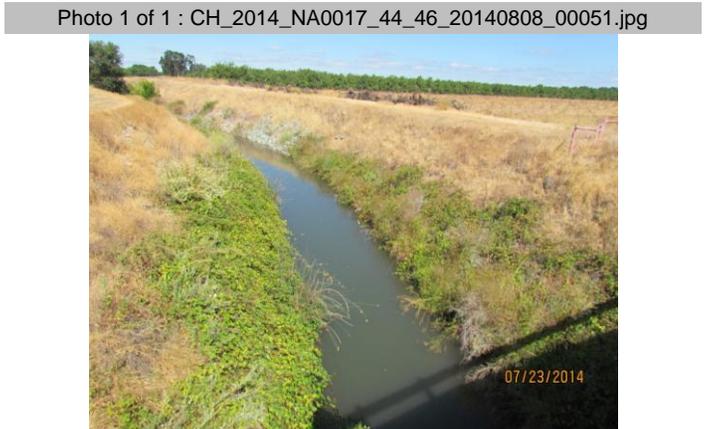
Check Point / View			
Van Allen Rd / Down			
Rating **	A	Issue No.	46
Issue Type +	Ma	Location *	GPS Lat/Long
Category	Rivers, Channels & Designated Flood		37.913060 °
Item	Vegetation & Obstructions		-121.056230 °
DWR ID	DWR_NA0017_44_c_2012_46		
Action/Comments			
Inspector Comments: The vegetation growth around the channel is not impeding the flow.

View of the channel looking downstream.

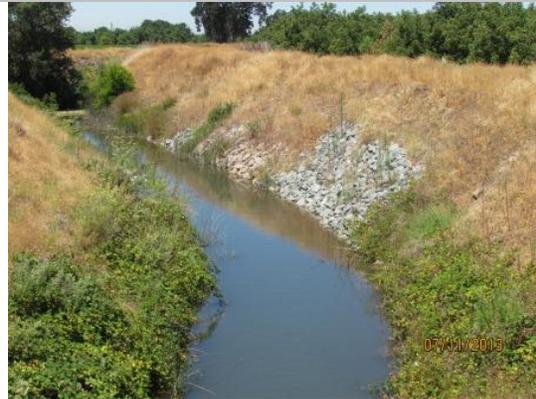
Photo 1 of 1 : CH_2014_NA0017_44_49_20140709_00014.jpg

Check Point / View			
Van Allen Rd / Down (cont)			
Rating **	A	Issue No.	49
Issue Type +	Ma	Location *	GPS Lat/Long
Category	Rivers, Channels & Designated Flood		37.913060 °
Item	Revetments		-121.056230 °
DWR ID	DWR_NA0017_44_c_2012_49		
Action/Comments			
Inspector Comments: Existing riprap protection is properly maintained.

View of the existing revetments looking downstream.

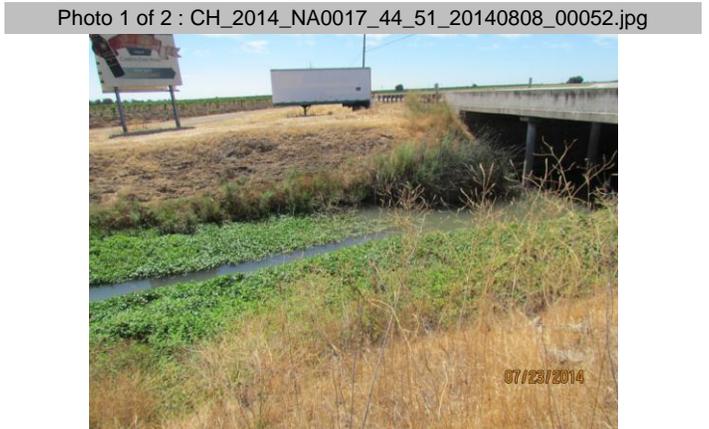
Check Point / View				
Mariposa Rd / Up				
Rating **	A	Issue No.	51	GPS Lat/Long
Issue Type +	Ma	Location *		37.895050 °
Category	Rivers, Channels & Designated Flood			-121.118200 °
Item	Vegetation & Obstructions			
DWR ID	DWR_NA0017_44_c_2012_51			
Action/Comments				
Inspector Comments: Minimal vegetation is present in the channel.

View of the channel bank under the bridge.

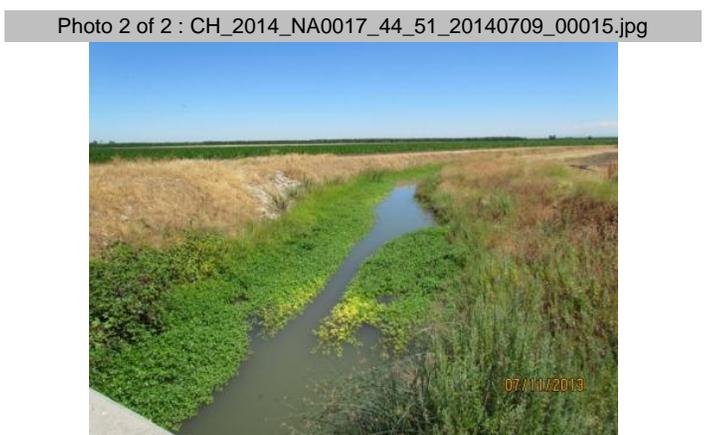
View of the channel looking upstream.

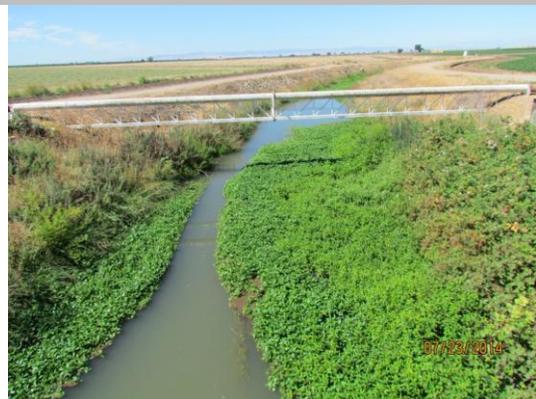
Photo 1 of 1 : CH_2014_NA0017_44_56_20140808_00053.jpg

Check Point / View			
Mariposa Rd / Down			
Rating **	A	Issue No. 56	GPS Lat/Long
Issue Type +	Ma	Location *	37.895050 °
Category	Rivers, Channels & Designated Flood		-121.118200 °
Item	Vegetation & Obstructions		
DWR ID	DWR_NA0017_44_c_2012_56		
Action/Comments			
Inspector Comments: Minimal vegetation is not obstructing the flow of the channel.

View of the vegetation on the channel looking downstream.
