**Flood Control Project Maintenance
Levee Inspections
2014 Channel Summary Report
Overall Unit and Item Ratings**

San Joaquin County Flood Control and Water Conservation District

Flood Control Project Maintenance**Unit Cover Sheet****2014 Channel Inspection Results****San Joaquin County Flood Control and Water Conservation District**

Levee Inspection Report By Mile - Channel 2014

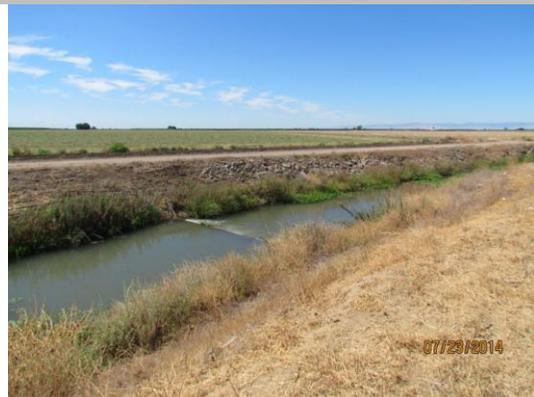
Photo 1 of 1 : CH_2014_NA0017_44_59_20140808_00054.jpg

Rating **	A	Issue No.	59
			GPS Lat/Long
Issue Type +	Ma	Location *	37.895050 °
Category	Rivers, Channels & Designated Flood		-121.118200 °
Item	Revetments		
DWR ID	DWR_NA0017_44_c_2012_59		
Action/Comments			
Inspector Comments: Existing revetments appears to be undamaged.

View of existing revetments on the channel banks looking downstream.

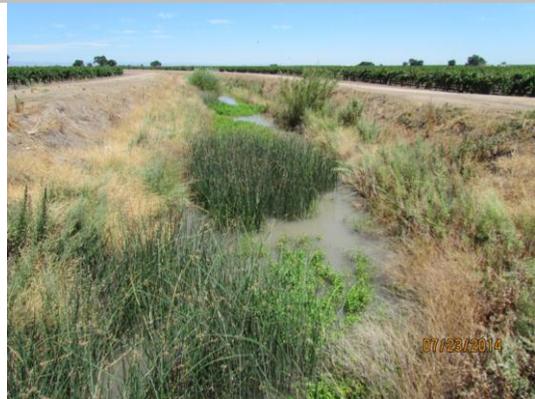
Photo 1 of 1 : CH_2014_NA0017_44_61_20140811_00055.jpg

Check Point / View				
Jack Tone Rd / Up				
Rating **	M	Issue No.	61	GPS Lat/Long
Issue Type +	Ma	Location *		37.880726 °
Category	Rivers, Channels & Designated Flood			-121.146929 °
Item	Vegetation & Obstructions			
DWR ID	DWR_NA0017_44_c_2012_61			
Action/Comments				
Inspector Comments: Minimal vegetation is obstructing the flow of the channel.

View of the vegetation on the upstream of the channel.

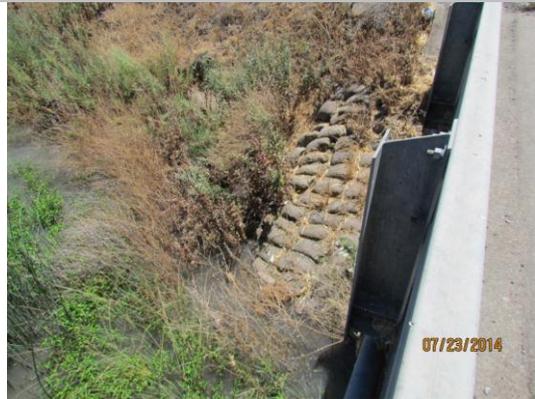
Photo 1 of 1 : CH_2014_NA0017_44_64_20140811_00056.jpg

Rating **	A	Issue No. 64	GPS Lat/Long
Issue Type +	Ma	Location *	37.880726 °
Category	Rivers, Channels & Designated Flood		-121.146929 °
Item	Revetments		
DWR ID	DWR_NA0017_44_c_2012_64		
Action/Comments			
Inspector Comments: Existing riprap protection is properly maintained.

View of existing riprap on the upstream of the channel.

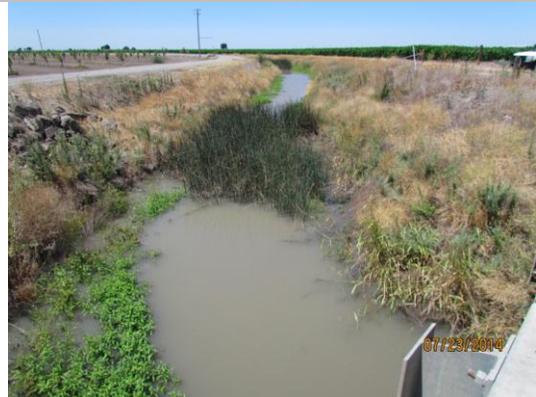
Photo 1 of 1 : CH_2014_NA0017_44_66_20140811_00057.jpg

Check Point / View			
Jack Tone Rd / Down			
Rating **	M	Issue No. 66	GPS Lat/Long
Issue Type +	Ma	Location *	37.880726 °
Category	Rivers, Channels & Designated Flood		-121.146929 °
Item	Vegetation & Obstructions		
DWR ID	DWR_NA0017_44_c_2012_66		
Action/Comments			
Inspector Comments: Vegetation may obstruct the flow of the channel.

View of the vegetation in the channel looking downstream.

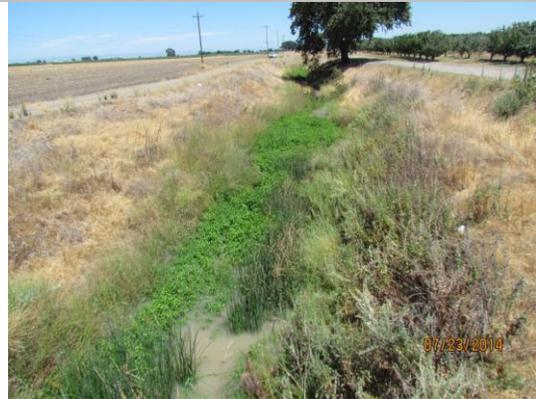
Photo 1 of 1 : CH_2014_NA0017_44_71_20140811_00059.jpg

Check Point / View			
Austin Rd / Up			
Rating **	A	Issue No.	71
Issue Type +	Ma	Location *	GPS Lat/Long
Category	Rivers, Channels & Designated Flood		37.872720 °
Item	Vegetation & Obstructions		-121.183100 °
DWR ID	DWR_NA0017_44_c_2012_71		
Action/Comments			
Inspector Comments: Minimal vegetation is present in the channel, but the flow is not impeded.

View of vegetation in the upstream end of the channel.

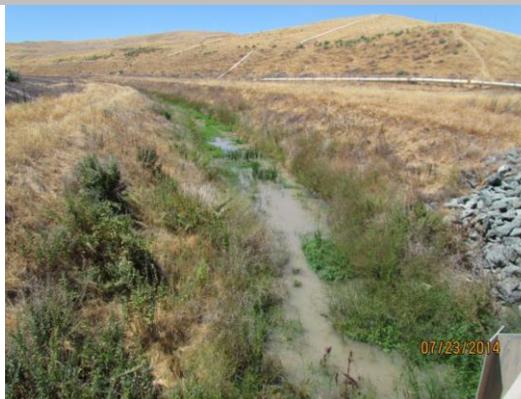
Photo 1 of 1 : CH_2014_NA0017_44_76_20140811_00060.jpg

Check Point / View			
Austin Rd / Down			
Rating **	A	Issue No.	76
Issue Type +	Ma	Location *	GPS Lat/Long
Category	Rivers, Channels & Designated Flood		37.872720 °
Item	Vegetation & Obstructions		-121.183100 °
DWR ID	DWR_NA0017_44_c_2012_76		
Action/Comments			
Inspector Comments: Minimal vegetation growth is found, but it doesn't appear to impede the flow of the channel.

View of the vegetation on the downstream end of the channel.

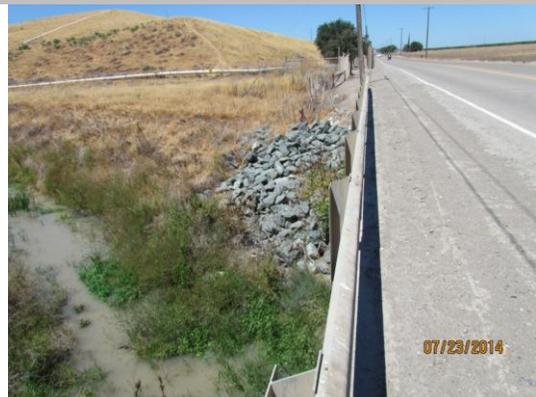
Photo 1 of 1 : CH_2014_NA0017_44_79_20140811_00061.jpg

Rating **	A	Issue No. 79	GPS Lat/Long
Issue Type +	Ma	Location *	37.872720 °
Category	Rivers, Channels & Designated Flood		-121.183100 °
Item	Revetments		
DWR ID	DWR_NA0017_44_c_2012_79		
Action/Comments			
Inspector Comments: Existing revetments are properly maintained.

View of the revetments on the downstream of the channel.

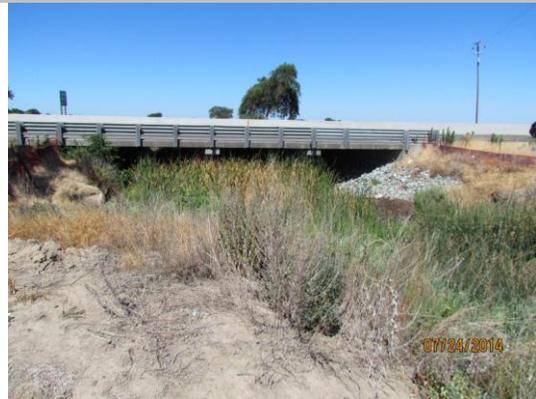
Photo 1 of 2 : CH_2014_NA0017_44_81_20140811_00062.jpg

Check Point / View				
Highway 99 / Up				
Rating **	M	Issue No.	81	GPS Lat/Long
Issue Type +	Ma	Location *		37.872432 °
Category	Rivers, Channels & Designated Flood			-121.219059 °
Item	Vegetation & Obstructions			
DWR ID	DWR_NA0017_44_c_2012_81			
Action/Comments				
Inspector Comments: Vegetation growth may impede the flow of the channel.

View of vegetation on the upstream end of the channel during 2014 inspection.

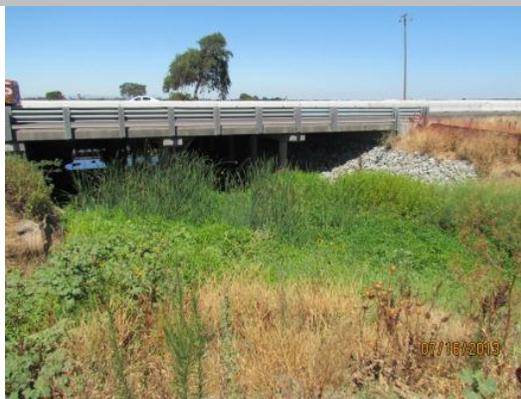
Photo 2 of 2 : CH_2014_NA0017_44_81_20140709_00023.jpg

Check Point / View				
Highway 99 / Up (cont)				
Rating **	M	Issue No.	81 (cont)	GPS Lat/Long
Issue Type +	Ma	Location *		37.872432 °
Category	Rivers, Channels & Designated Flood			-121.219059 °
Item	Vegetation & Obstructions			
DWR ID	DWR_NA0017_44_c_2012_81			
Action/Comments				
Inspector Comments: Vegetation growth may impede the flow of the channel.

View of vegetation growth on the upstream end of channel.

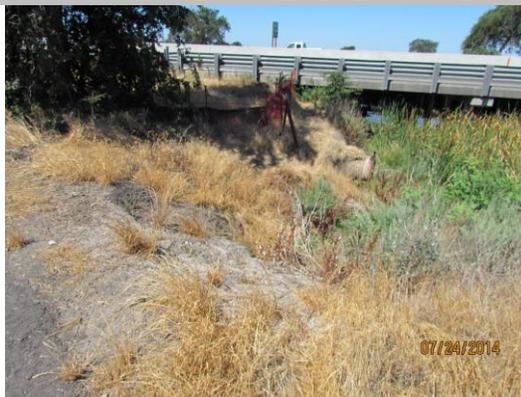
Photo 1 of 1 : CH_2014_NA0017_44_83_20140811_00063.jpg

Rating **	M	Issue No.	83	GPS Lat/Long
Issue Type +	Ma	Location *		37.872432 °
Category	Rivers, Channels & Designated Flood			-121.219059 °
Item	Erosion / Bank Caving			
DWR ID	DWR_NA0017_44_c_2012_83			
Action/Comments				
Inspector Comments: Erosion is present on the bank of the channel.

View of the erosion on the channel bank looking upstream.

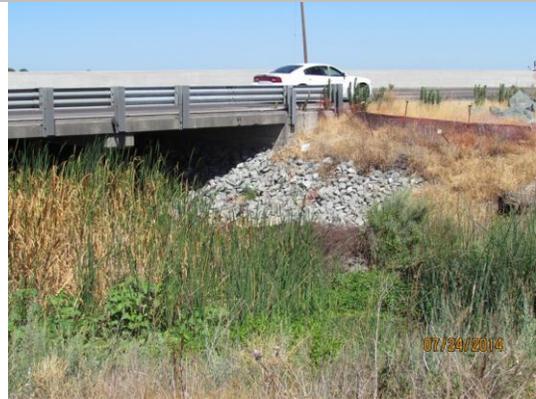
Photo 1 of 1 : CH_2014_NA0017_44_84_20140811_00064.jpg

Check Point / View			
Highway 99 / Up (cont)			
Rating **	A	Issue No. 84	GPS Lat/Long
Issue Type +	Ma	Location *	37.872432 °
Category	Rivers, Channels & Designated Flood		-121.219059 °
Item	Revetments		
DWR ID	DWR_NA0017_44_c_2012_84		
Action/Comments			
Inspector Comments: Existing revetments were properly maintained at this location.

View of the existing revetments on the upstream end of the channel.

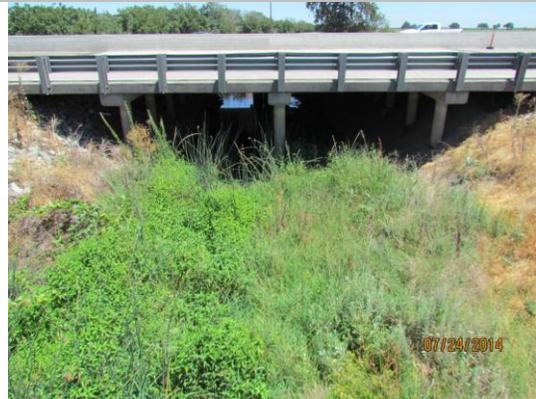
Photo 1 of 1 : CH_2014_NA0017_44_86_20140811_00065.jpg

Check Point / View			
Highway 99 / Down			
Rating **	M	Issue No. 86	GPS Lat/Long
Issue Type +	Ma	Location *	37.872432 °
Category	Rivers, Channels & Designated Flood		-121.219059 °
Item	Vegetation & Obstructions		
DWR ID	DWR_NA0017_44_c_2012_86		
Action/Comments			
Inspector Comments: Minimal vegetation may impede the flow of the channel.

View of the vegetation looking downstream of the channel.

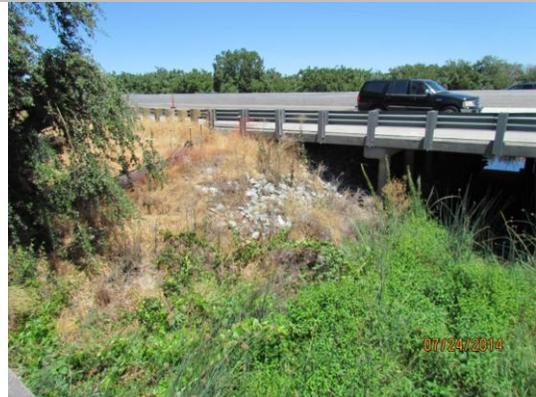
Photo 1 of 1 : CH_2014_NA0017_44_89_20140811_00066.jpg

Check Point / View			
Highway 99 / Down (cont)			
Rating **	A	Issue No.	89
Issue Type +	Ma	Location *	GPS Lat/Long
Category	Rivers, Channels & Designated Flood		37.872432 °
Item	Revetments		-121.219059 °
DWR ID	DWR_NA0017_44_c_2012_89		
Action/Comments			
Inspector Comments: Existing riprap was properly maintained at this location.

View of the existing revetments on the downstream end of the channel.

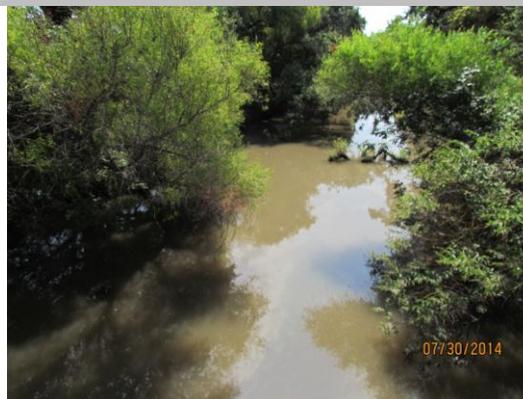
Photo 1 of 1 : CH_2014_NA0017_44_120_20140811_00067.jpg

Check Point / View			
El Dorado Rd. / Up			
Rating **	A	Issue No.	120
			GPS Lat/Long
Issue Type +	Ma	Location *	37.894422 °
Category	Rivers, Channels & Designated Flood		-121.275907 °
Item	Vegetation & Obstructions		
DWR ID	DWR_NA0017_44_c_2014_120		
Action/Comments			
Inspector Comments: Minimal vegetation may not impede the flow of the channel.

View of the channel looking upstream.

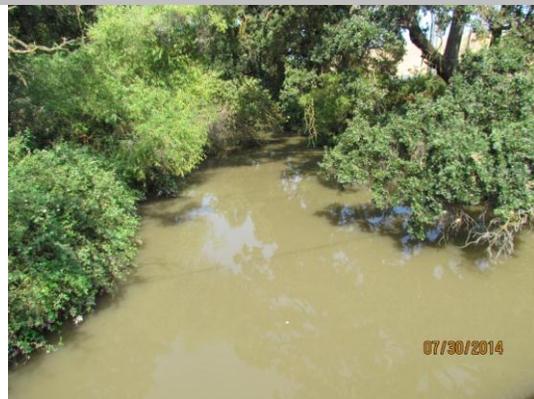
Photo 1 of 1 : CH_2014_NA0017_44_125_20140811_00068.jpg

Check Point / View			
El Dorado Rd. / Down			
Rating **	M	Issue No. 125	GPS Lat/Long
Issue Type +	Ma	Location *	37.894628 °
Category	Rivers, Channels & Designated Flood		-121.276048 °
Item	Vegetation & Obstructions		
DWR ID	DWR_NA0017_44_c_2014_125		
Action/Comments			
Inspector Comments: Tree branches may fall into the channel and obstruct the flow.

View of the vegetation on the downstream of the channel.

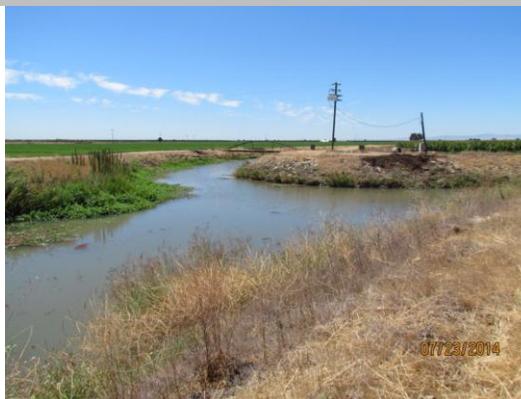
Photo 1 of 2 : CH_2014_NA0017_45_6_20140811_00018.jpg

Check Point / View				
Diversion / Down				
Rating **	A	Issue No.	6	GPS Lat/Long
Issue Type +	Ma	Location *		37.888860 °
Category	Rivers, Channels & Designated Flood			-121.130320 °
Item	Vegetation & Obstructions			
DWR ID	DWR_NA0017_45_c_2012_6			
Action/Comments				
Inspector Comments: Minimal vegetation was present in the channel but it may not impede the flow.

View of the confluence looking downstream of the channel during 2014 inspection.

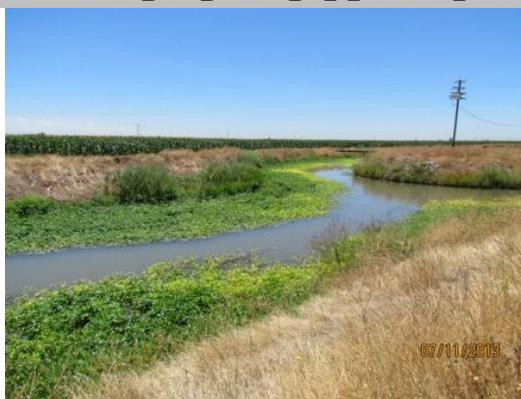
Photo 2 of 2 : CH_2014_NA0017_45_6_20140709_00001.jpg

View of the downstream of the channel.

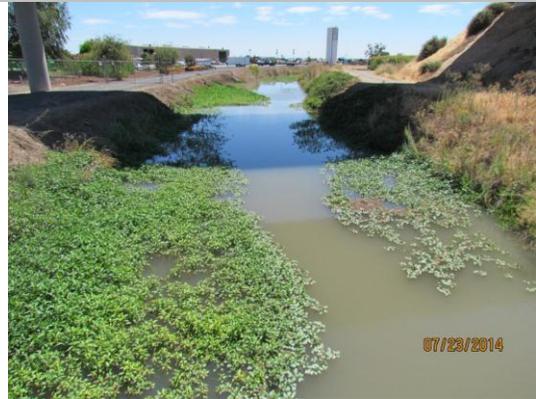
Photo 1 of 1 : CH_2014_NA0017_45_11_20140808_00014.jpg

Check Point / View				
Jack Tone Rd / Up				
Rating **	A	Issue No.	11	GPS Lat/Long
Issue Type +	Ma	Location *		37.889520 °
Category	Rivers, Channels & Designated Flood			-121.146980 °
Item	Vegetation & Obstructions			
DWR ID	DWR_NA0017_45_c_2012_11			
Action/Comments				
Inspector Comments: Vegetation growth was found on the channel, but it is not going to impede the flow of the channel.

View of the vegetation upstream end of the channel.

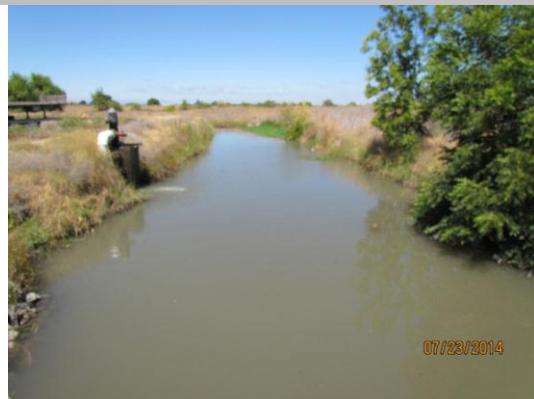
Photo 1 of 1 : CH_2014_NA0017_45_16_20140808_00015.jpg

Check Point / View			
Jack Tone Rd / Down			
Rating **	A	Issue No. 16	GPS Lat/Long
Issue Type +	Ma	Location *	37.889520 °
Category	Rivers, Channels & Designated Flood		-121.146980 °
Item	Vegetation & Obstructions		
DWR ID	DWR_NA0017_45_c_2012_16		
Action/Comments			
Inspector Comments: No vegetation was obstructing the flow of the channel.

View of the channel looking downstream.

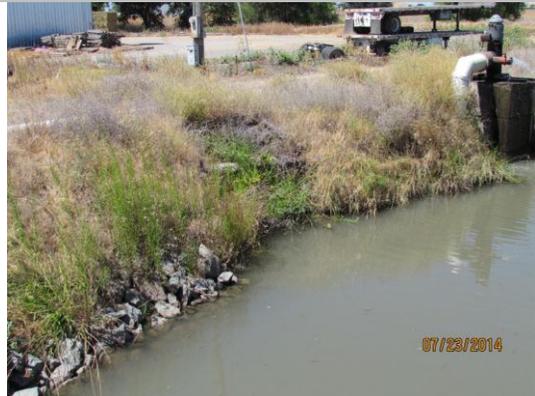
Photo 1 of 1 : CH_2014_NA0017_45_18_20140808_00016.jpg

Rating **	M	Issue No.	18
Issue Type +	Ma	Location *	37.889520 °
Category	Rivers, Channels & Designated Flood		-121.146980 °
Item	Erosion / Bank Caving		
DWR ID	DWR_NA0017_45_c_2012_18		
Action/Comments			
Inspector Comments: Minor erosion or bank caving is present.

View of bank erosion on the downstream of the channel.

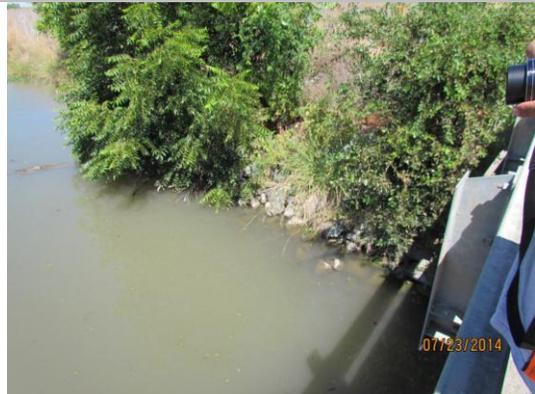
Photo 1 of 1 : CH_2014_NA0017_45_19_20140808_00017.jpg

Rating **	A	Issue No.	19
Issue Type +	Ma	Location *	37.889520 °
Category	Rivers, Channels & Designated Flood		-121.146980 °
Item	Revetments		
DWR ID	DWR_NA0017_45_c_2012_19		
Action/Comments			
Inspector Comments: Existing revetments appeared to be properly maintained.

View of the existing revetments on the channel bank looking downstream.

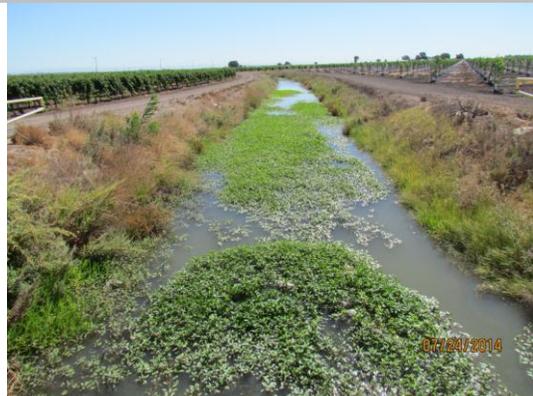
Photo 1 of 1 : CH_2014_NA0017_45_21_20140811_00019.jpg

Check Point / View				
Austin Rd / Up				
Rating **	A	Issue No.	21	GPS Lat/Long
Issue Type +	Ma	Location *		37.886060 °
Category	Rivers, Channels & Designated Flood			-121.183760 °
Item	Vegetation & Obstructions			
DWR ID	DWR_NA0017_45_c_2012_21			
Action/Comments				
Inspector Comments: Minimal vegetation exist but it doesn't appear to obstruct the flow of the channel.

View of the vegetation on the upstream of the channel.

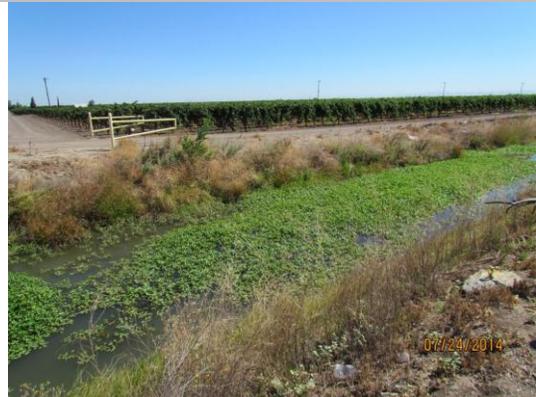
Photo 1 of 1 : CH_2014_NA0017_45_23_20140811_00020.jpg

Check Point / View			
Austin Rd / Up (cont)			
Rating **	M	Issue No. 23	GPS Lat/Long
Issue Type +	Ma	Location *	37.886060 °
Category	Rivers, Channels & Designated Flood		-121.183760 °
Item	Erosion / Bank Caving		
DWR ID	DWR_NA0017_45_c_2012_23		
Action/Comments			
Inspector Comments: Sign of erosion was discovered on the bank of the channel.

View of the erosion on the channel bank looking upstream.

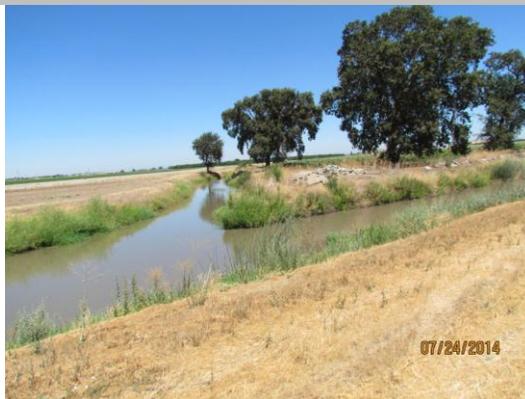
Photo 1 of 1 : CH_2014_NA0017_45_31_20140811_00026.jpg

Check Point / View			
Confluence at Airport Way / Up			
Rating **	A	Issue No. 31	GPS Lat/Long
Issue Type +	Ma	Location *	37.876360 °
Category	Rivers, Channels & Designated Flood		-121.236360 °
Item	Vegetation & Obstructions		
DWR ID	DWR_NA0017_45_c_2012_31		
Action/Comments			
Inspector Comments: Minimal scattered vegetation didn't impede the flow of the channel.

View of the confluence looking upstream.

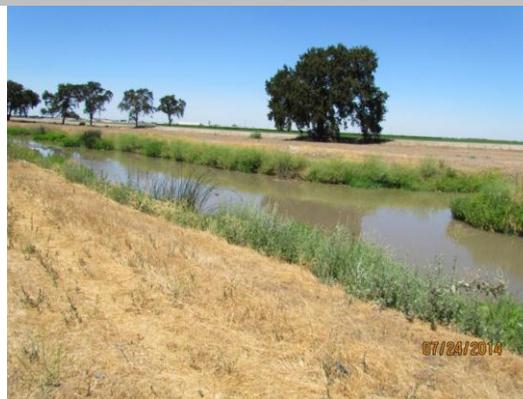
Photo 1 of 1 : CH_2014_NA0017_45_36_20140811_00027.jpg

Check Point / View			
Confluence at Airport Way / Down			
Rating **	A	Issue No. 36	GPS Lat/Long
Issue Type +	Ma	Location *	37.876360 °
Category	Rivers, Channels & Designated Flood		-121.236360 °
Item	Vegetation & Obstructions		
DWR ID	DWR_NA0017_45_c_2012_36		
Action/Comments			
Inspector Comments: Minimal scattered vegetation didn't impede the flow of the channel.

View of the downstream of the channel.

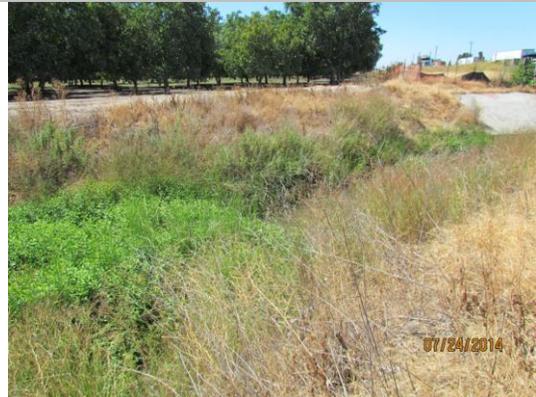
Photo 1 of 1 : CH_2014_NA0017_45_41_20140811_00022.jpg

Check Point / View				
Highway 99 / Up				
Rating **	M	Issue No.	41	GPS Lat/Long
Issue Type +	Ma	Location *		37.875127 °
Category	Rivers, Channels & Designated Flood			-121.219201 °
Item	Vegetation & Obstructions			
DWR ID	DWR_NA0017_45_c_2013_41			
Action/Comments				
Inspector Comments: Vegetation may impede the flow of the channel.

View of the vegetation on the upstream end of the channel.

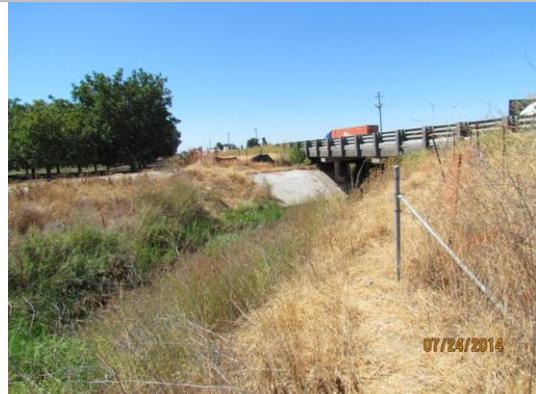
Photo 1 of 1 : CH_2014_NA0017_45_43_20140811_00023.jpg

Rating **	A	Issue No.	43	GPS Lat/Long
Issue Type +	Ma	Location *		37.875127 °
Category	Rivers, Channels & Designated Flood			-121.219201 °
Item	Revetments			
DWR ID	DWR_NA0017_45_c_2013_43			
Action/Comments				
Inspector Comments: Existing revetments were properly maintained.

View of the existing revetment looking upstream.

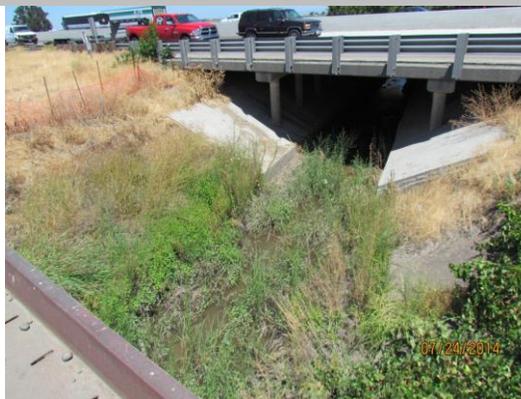
Photo 1 of 1 : CH_2014_NA0017_45_45_20140811_00024.jpg

Check Point / View			
Highway 99 / Down			
Rating **	A	Issue No. 45	GPS Lat/Long
Issue Type +	Ma	Location *	37.875127 °
Category	Rivers, Channels & Designated Flood		-121.219201 °
Item	Vegetation & Obstructions		
DWR ID	DWR_NA0017_45_c_2013_45		
Action/Comments			
Inspector Comments: Vegetation was not impeding the flow of the channel.

View of the channel looking downstream.

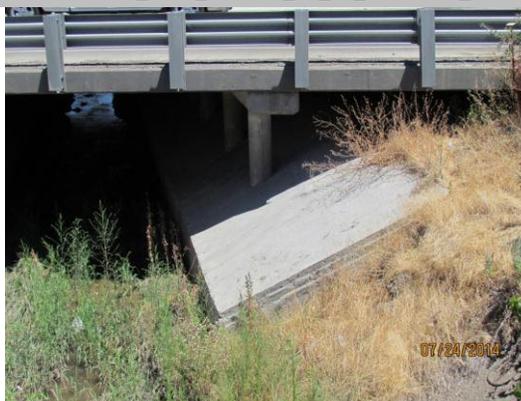
Photo 1 of 1 : CH_2014_NA0017_45_48_20140811_00025.jpg

Rating **	A	Issue No.	48
Issue Type +	Ma	Location *	GPS Lat/Long
Category	Rivers, Channels & Designated Flood		37.875127 °
Item	Revetments		-121.219201 °
DWR ID	DWR_NA0017_45_c_2013_48		
Action/Comments			
Inspector Comments: Existing revetments were properly maintained.

View of the revetments on the downstream end of the channel.
