**Flood Control Project Maintenance
Levee Inspections**

Fall 2008 Levee Maintenance Deficiency Summary Report

San Joaquin River Basin

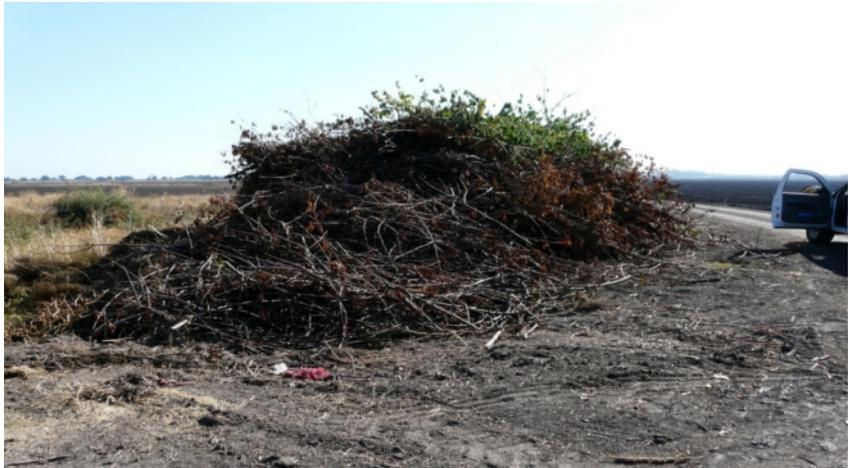
Levee Mile Report Line	2
Start Levee Mile	0.30
End Levee Mile	0.30
Location	
Category	Earthen Levee
Item	Encroachments
Remove prunings pile from within 10 feet of landside toe of levee at LM 0.30.

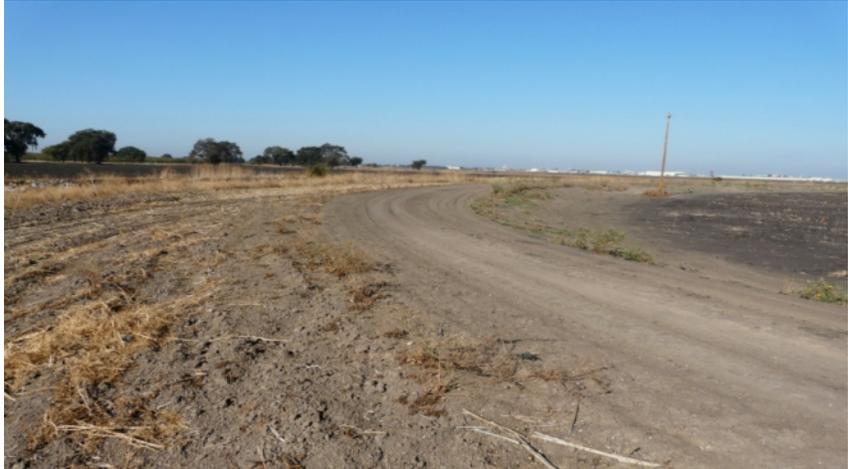
Levee Mile Report Line	1
Start Levee Mile	0.00
End Levee Mile	0.00
Location	
Category	Earthen Levee
Item	Vegetation
Example of good vegetation control on this unit.

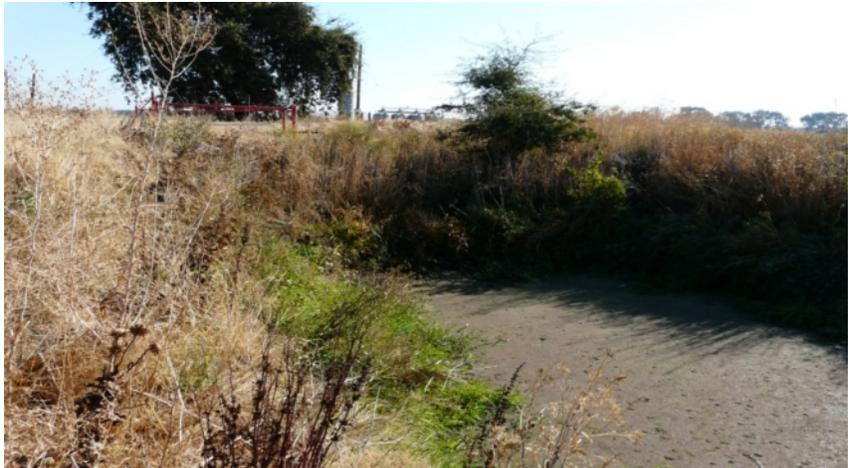
Levee Mile Report Line	2
Start Levee Mile	1.20
End Levee Mile	1.20
Location	
Category	Interior Drainage & Piping Systems
Item	Flap Gates
Unable to see waterside end of culvert at LM 1.20- Cannot confirm if it has a flapgate.

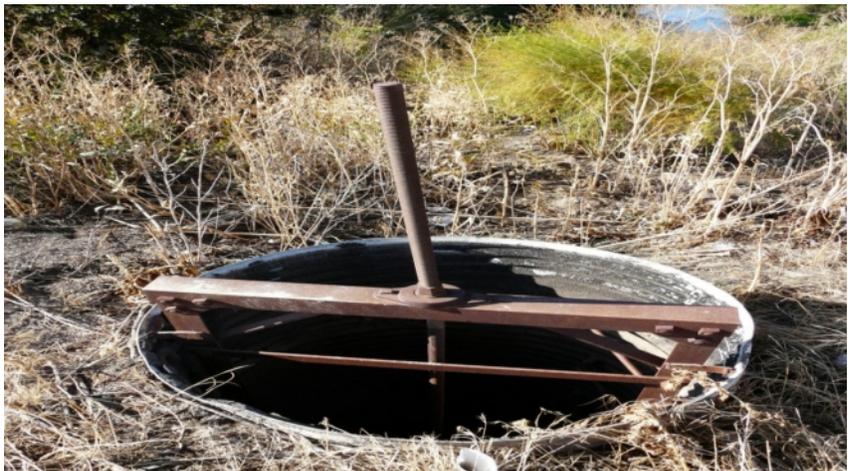
Levee Mile Report Line	2
Start Levee Mile	1.20
End Levee Mile	1.20
Location	
Category	Interior Drainage & Piping Systems
Item	Flap Gates
Screwgate located at waterward shoulder at LM 1.20. Close gate to ensure that the culvert cannot carry drainage.

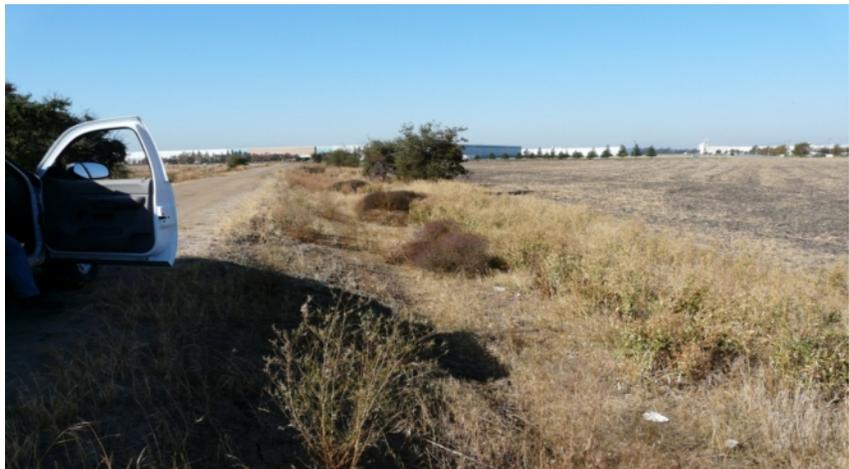
Levee Mile Report Line	4
Start Levee Mile	2.50
End Levee Mile	2.70
Location	
Category	Earthen Levee
Item	Vegetation
Remove/mow wild growth within 10 feet of landside toe from LM 2.50 to LM 2.70.

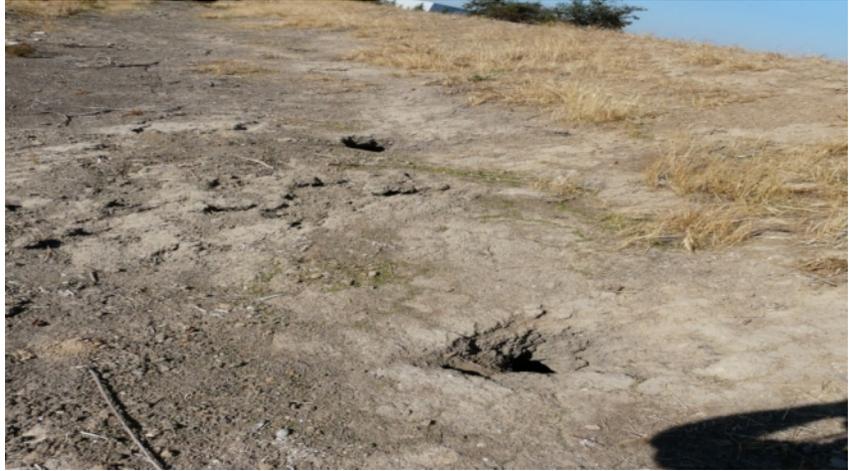
Levee Mile Report Line	5
Start Levee Mile	2.60
End Levee Mile	2.60
Location	
Category	Earthen Levee
Item	Animal Control
Exterminate rodents and backfill/grout along waterward slope at LM 2.60.

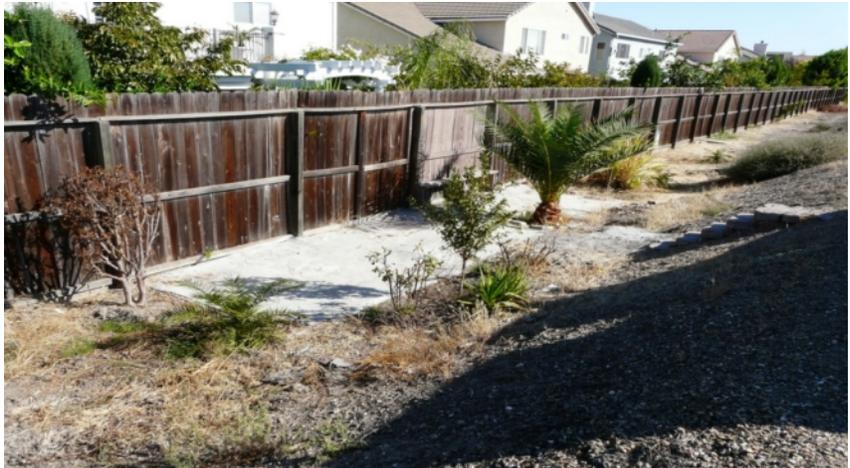
Levee Mile Report Line	3
Start Levee Mile	1.45
End Levee Mile	1.45
Location	
Category	Earthen Levee
Item	Encroachments
<p>Landscaping located within 10' from landside toe of levee at LM 1.45.</p>

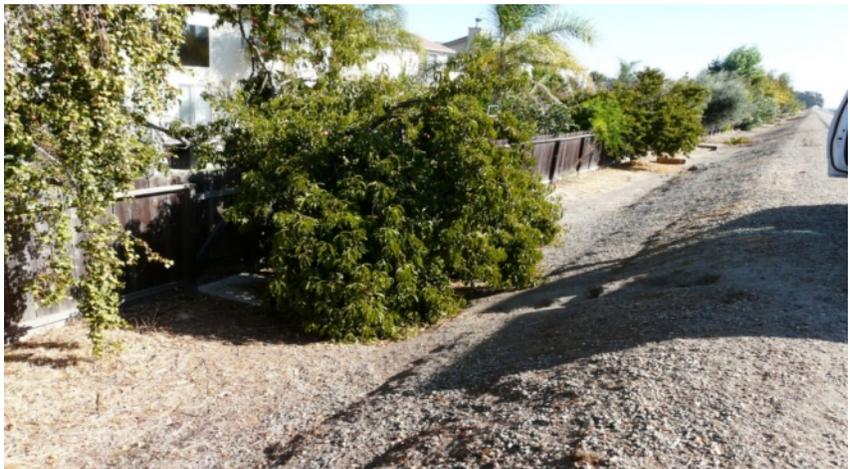
Levee Mile Report Line	4
Start Levee Mile	2.15
End Levee Mile	2.15
Location	
Category	Earthen Levee
Item	Trim / Thin Trees
<p>Fruit trees planted within 10' from landside toe of levee at LM 2.15. Remove or prune to 5' from levee surface to allow for visibility and ability to flood fight.</p>

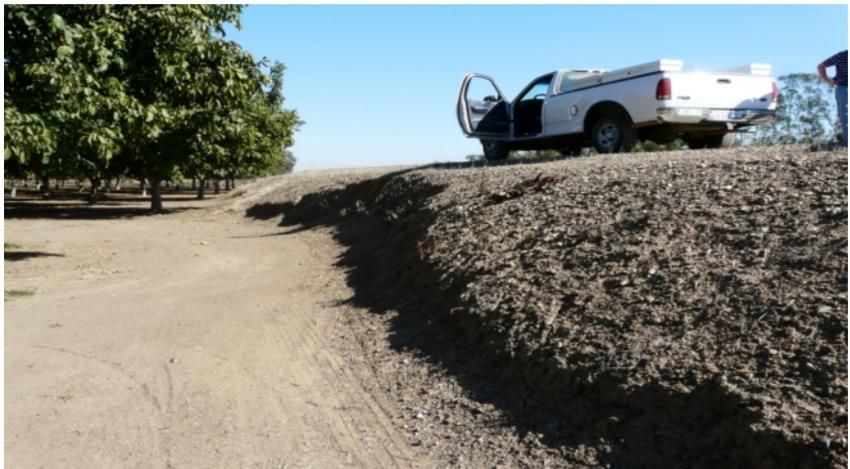
Levee Mile Report Line	14
Start Levee Mile	9.95
End Levee Mile	9.95
Location	
Category	Earthen Levee
Item	Slope Stability
Significant amount of landside levee slope removed and damaged by farm equipment at LM 9.95. Repair levee and attempt to prevent future damage.

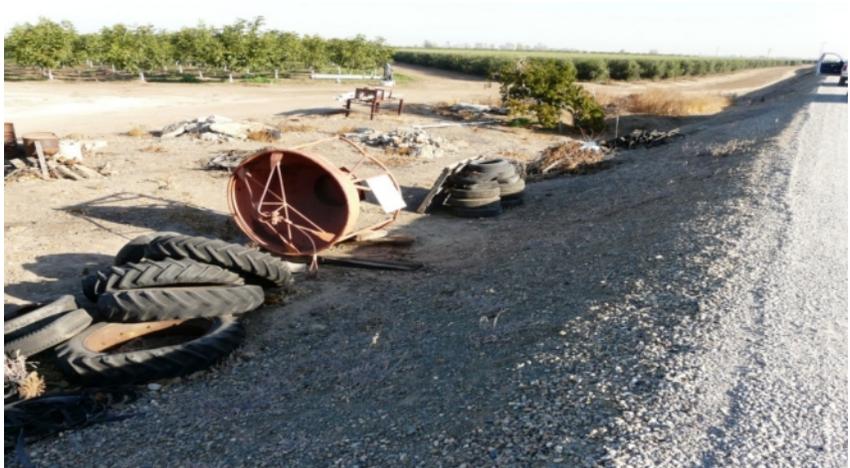
Levee Mile Report Line	18
Start Levee Mile	10.95
End Levee Mile	10.96
Location	
Category	Earthen Levee
Item	Encroachments
Debris located along landside toe of levee from LM 10.95 to LM 10.96.

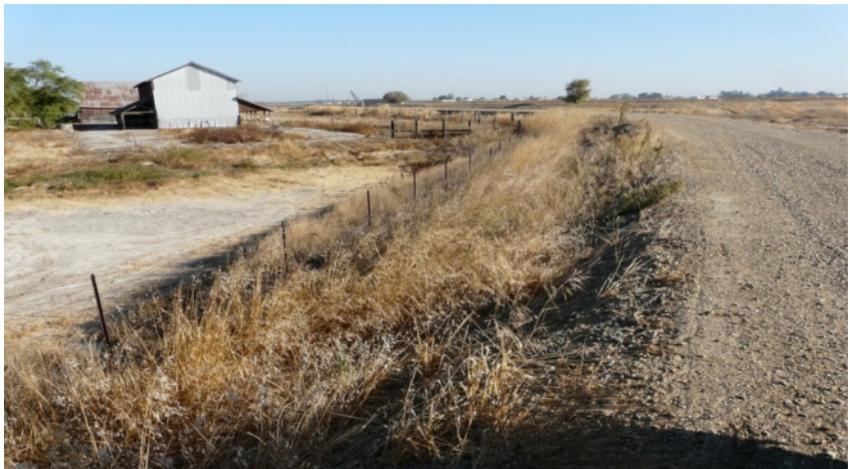
Levee Mile Report Line	19
Start Levee Mile	12.65
End Levee Mile	12.74
Location	
Category	Earthen Levee
Item	Vegetation
Remove/mow vegetation along landside slope of levee to 10' from toe from LM 12.65 to 12.74.

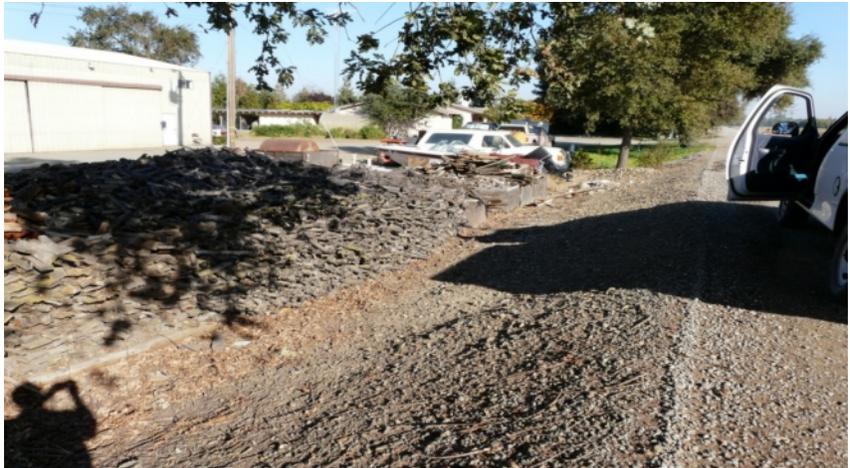
Levee Mile Report Line	24
Start Levee Mile	14.08
End Levee Mile	14.08
Location	
Category	Earthen Levee
Item	Encroachments
Move firewood to outside of 10' from landside toe of levee at LM 14.08.

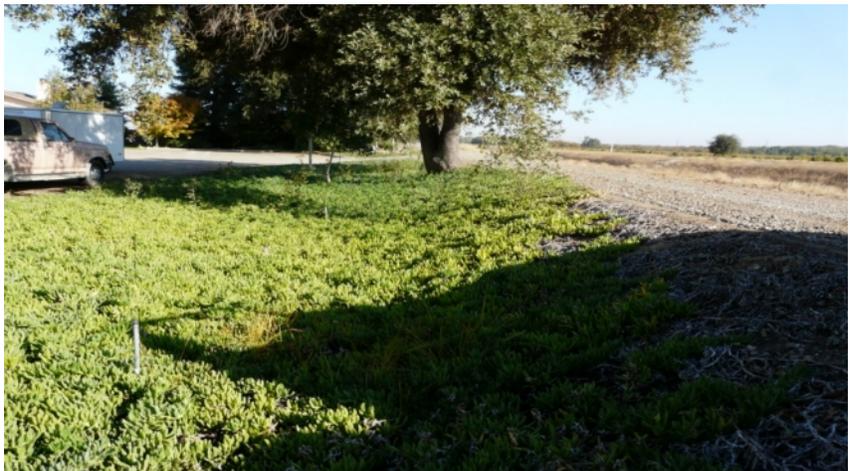
Levee Mile Report Line	25
Start Levee Mile	14.09
End Levee Mile	14.13
Location	
Category	Earthen Levee
Item	Encroachments
Landscaping on landside of levee from LM 14.09 to LM 14.13.

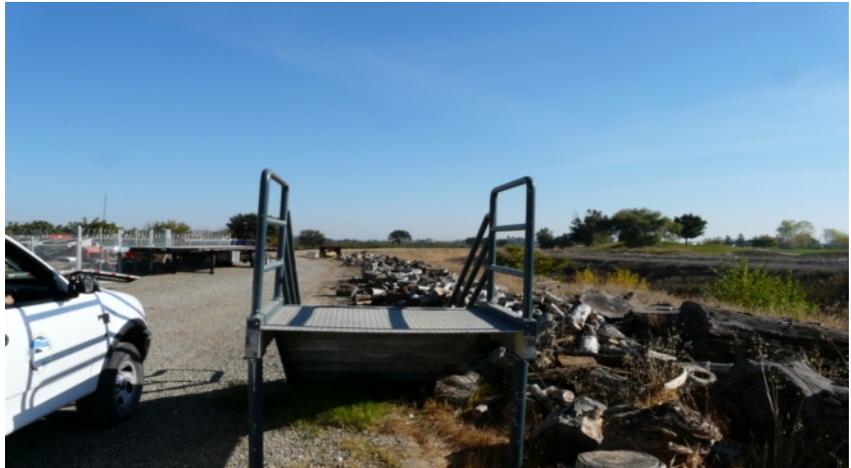
Levee Mile Report Line	27
Start Levee Mile	15.58
End Levee Mile	15.63
Location	
Category	Earthen Levee
Item	Encroachments
Debris located on waterside shoulder of access road next to golf course maintenance yard from LM 15.58 to 15.63. Debris should be moved to allow for patrolling next to channel and for visibility.

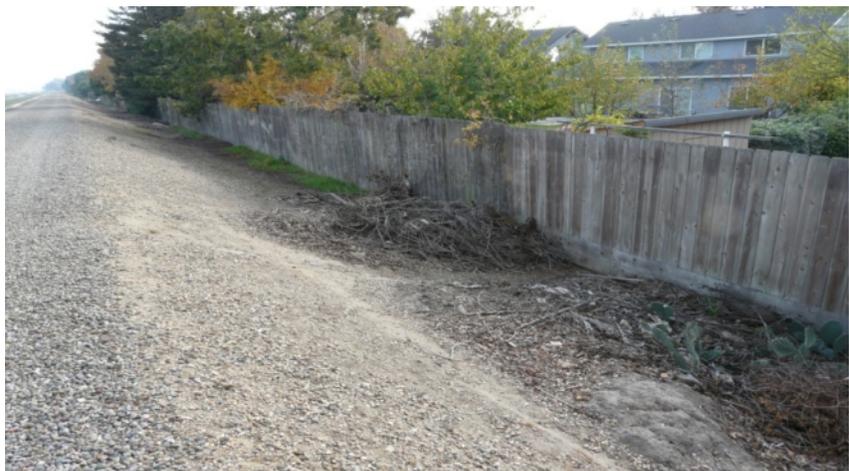
Levee Mile Report Line	3
Start Levee Mile	1.34
End Levee Mile	1.34
Location	
Category	Earthen Levee
Item	Encroachments
Remove prunings along toe of landside of levee at LM 1.34

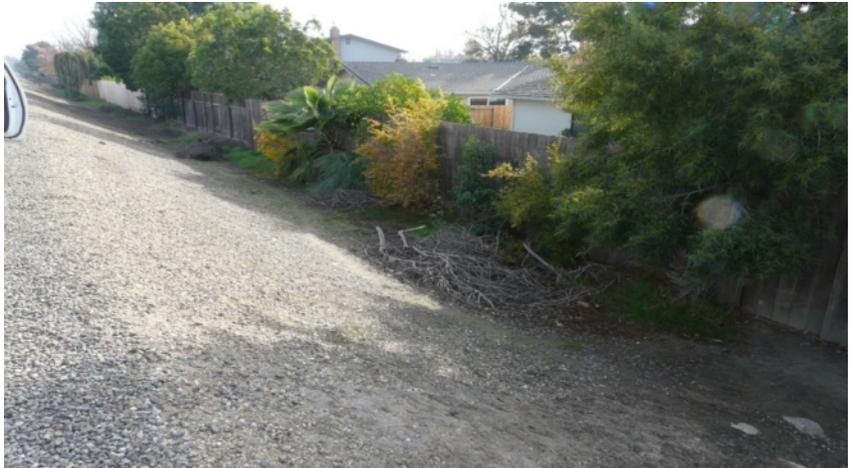
Levee Mile Report Line	5
Start Levee Mile	1.48
End Levee Mile	1.48
Location	
Category	Earthen Levee
Item	Encroachments
Landscaping along toe of landside of levee at LM 1.48

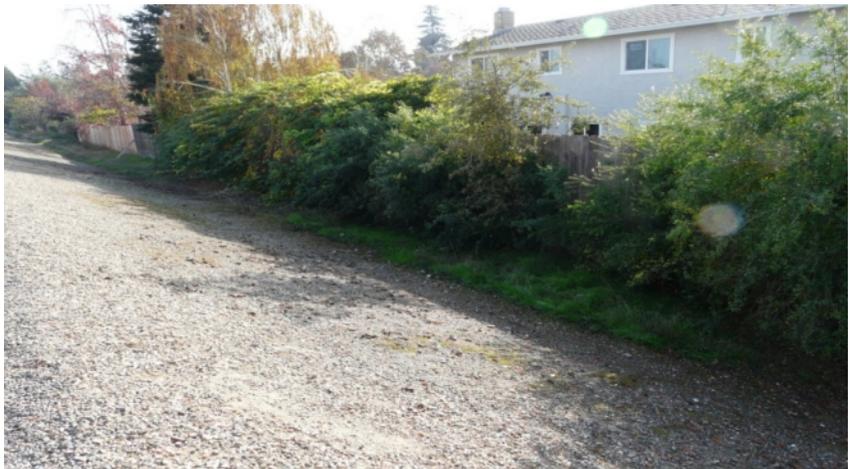
Levee Mile Report Line	6
Start Levee Mile	1.67
End Levee Mile	1.67
Location	
Category	Earthen Levee
Item	Encroachments
Landscaping along toe of landside of levee at LM 1.67

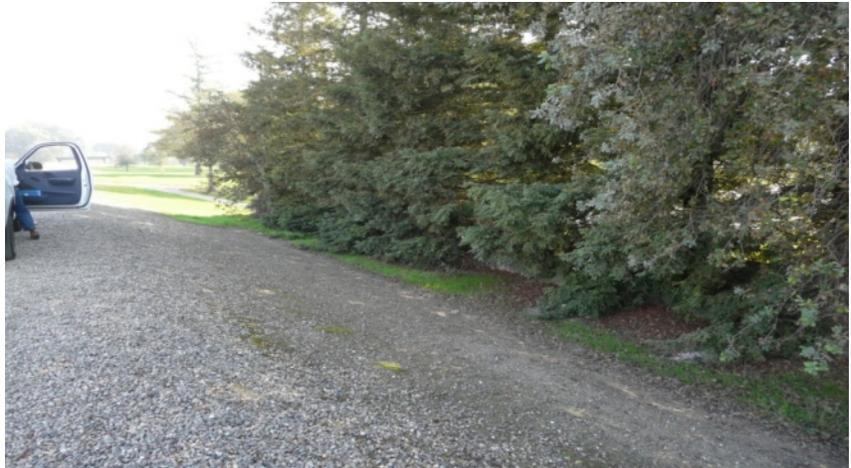
Levee Mile Report Line	8
Start Levee Mile	1.77
End Levee Mile	1.77
Location	
Category	Earthen Levee
Item	Encroachments
Landscaping along landside toe of levee at LM 1.77

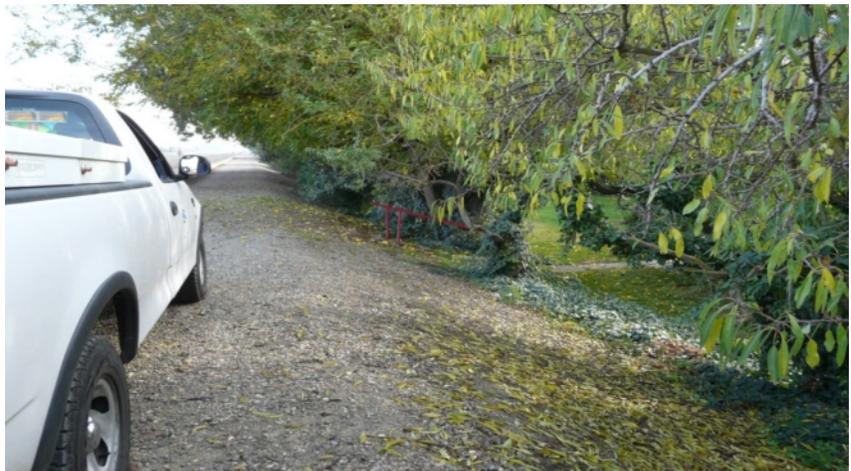
Levee Mile Report Line	9
Start Levee Mile	2.06
End Levee Mile	2.17
Location	
Category	Earthen Levee
Item	Encroachments
Landscaping along landside of levee from LM 2.06 to LM 2.17

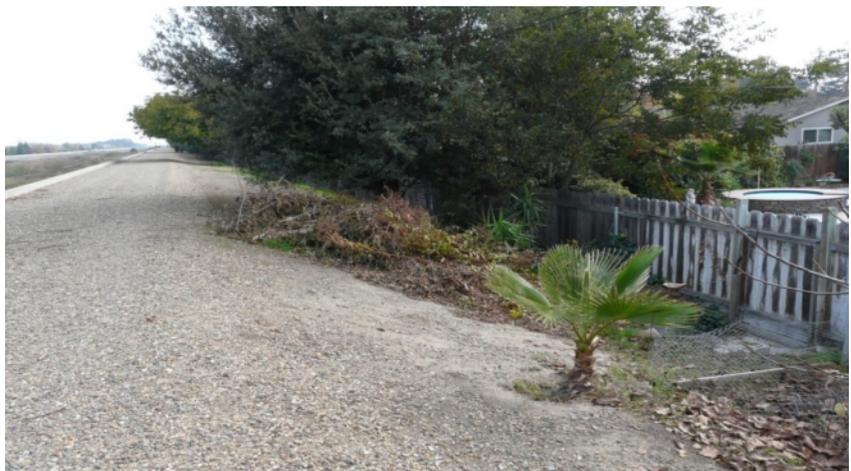
Levee Mile Report Line	12
Start Levee Mile	2.22
End Levee Mile	2.22
Location	
Category	Earthen Levee
Item	Encroachments
Remove prunings from landside of levee at LM 2.22

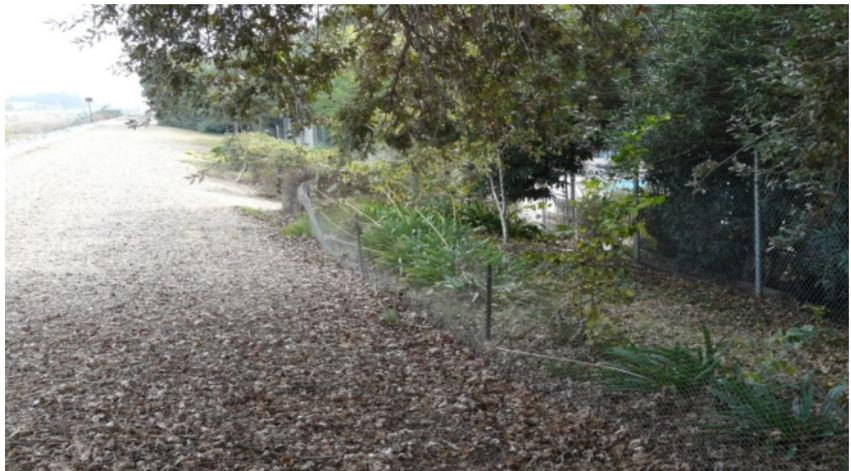
Levee Mile Report Line	15
Start Levee Mile	2.32
End Levee Mile	2.35
Location	
Category	Earthen Levee
Item	Encroachments
Garden located on landside slope of levee from LM 2.32 to LM 2.35

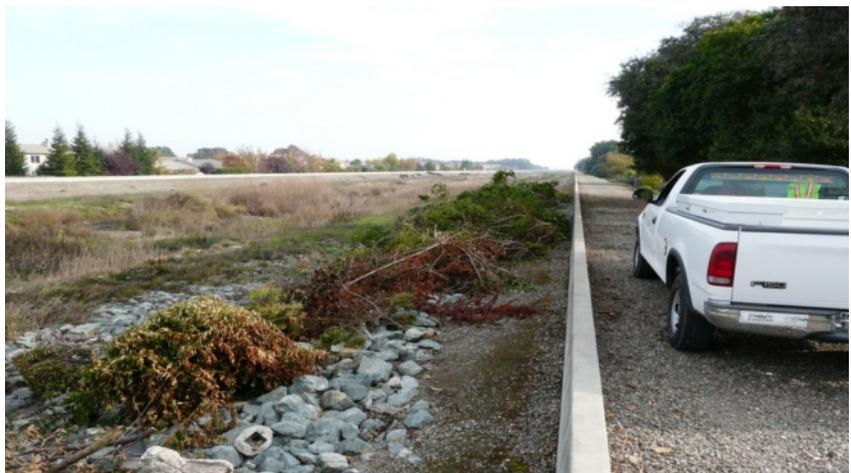
Levee Mile Report Line	18
Start Levee Mile	2.40
End Levee Mile	2.42
Location	
Category	Earthen Levee
Item	Encroachments
Remove prunings from waterside of levee from LM 2.40 to LM 2.42

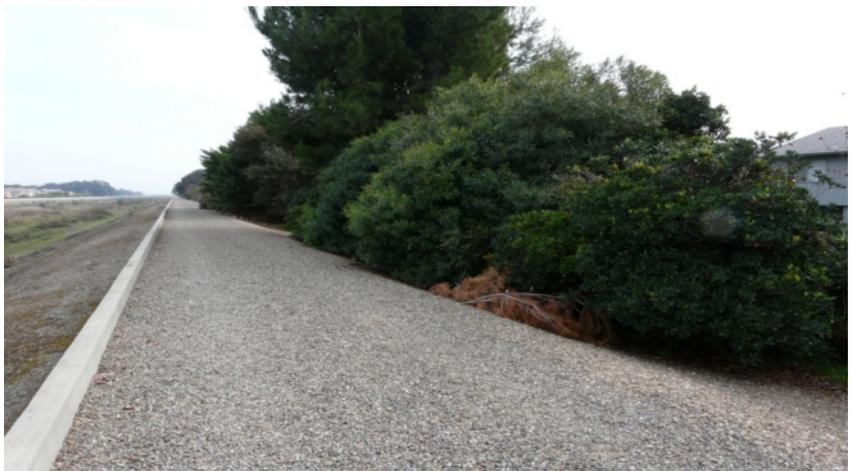
Levee Mile Report Line	21
Start Levee Mile	2.48
End Levee Mile	2.52
Location	
Category	Earthen Levee
Item	Trim / Thin Trees
Trim trees along landside of levee to allow for visibility from LM 2.48 to LM 2.52

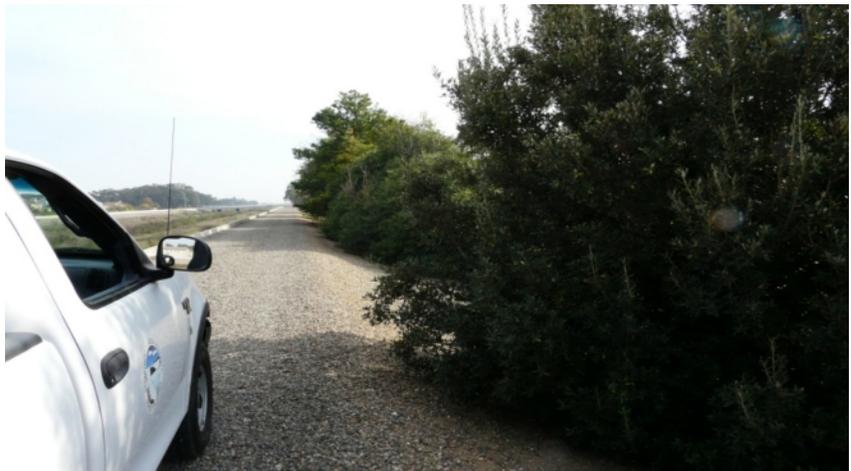
Levee Mile Report Line	24
Start Levee Mile	2.67
End Levee Mile	2.71
Location	
Category	Earthen Levee
Item	Trim / Thin Trees
Trim trees along landside of levee slope from LM 2.67 to LM 2.71

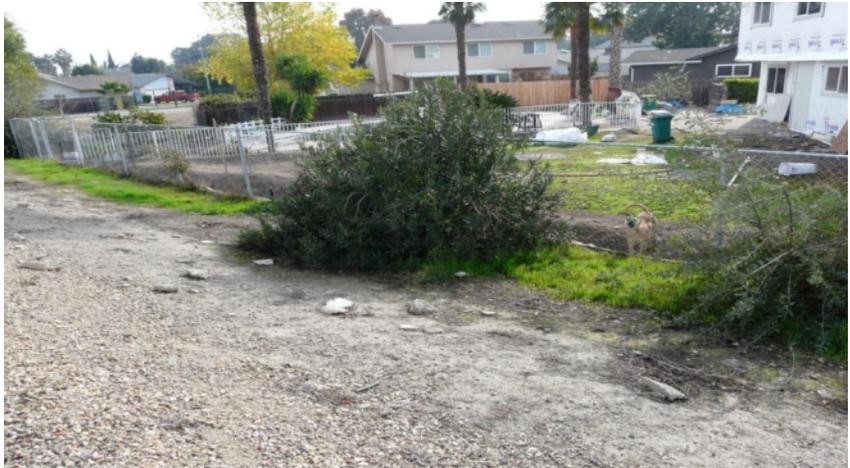
Levee Mile Report Line	26
Start Levee Mile	2.78
End Levee Mile	2.78
Location	
Category	Earthen Levee
Item	Encroachments
Landscaping along landside toe of levee at LM 2.78

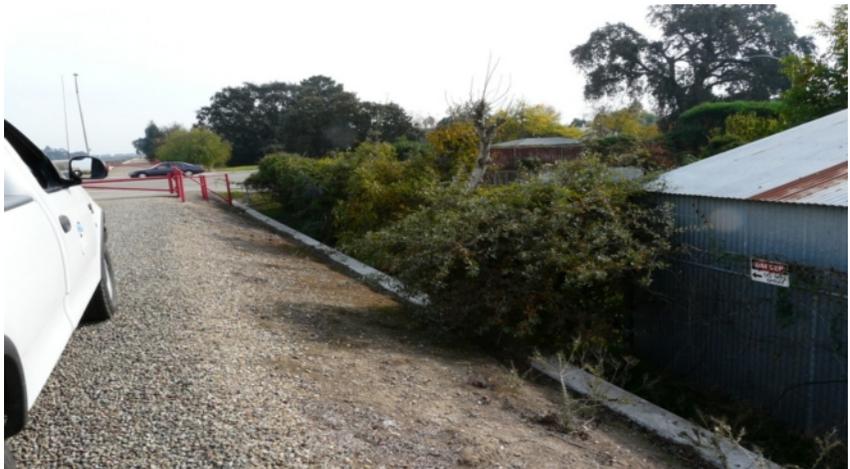
Levee Mile Report Line	27
Start Levee Mile	2.87
End Levee Mile	2.89
Location	
Category	Earthen Levee
Item	Encroachments
Landscaping along landside toe of levee from LM 2.87 to LM 2.89

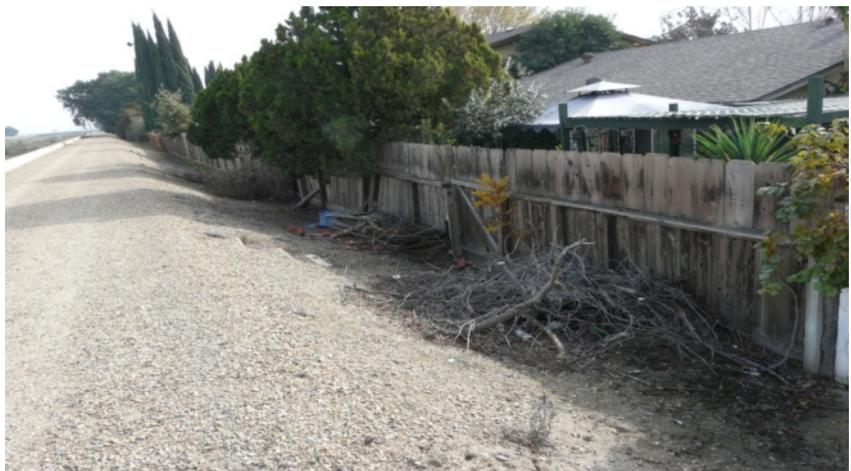
Levee Mile Report Line	30
Start Levee Mile	3.01
End Levee Mile	3.01
Location	
Category	Earthen Levee
Item	Encroachments
Remove prunings from landside of levee at LM 3.01

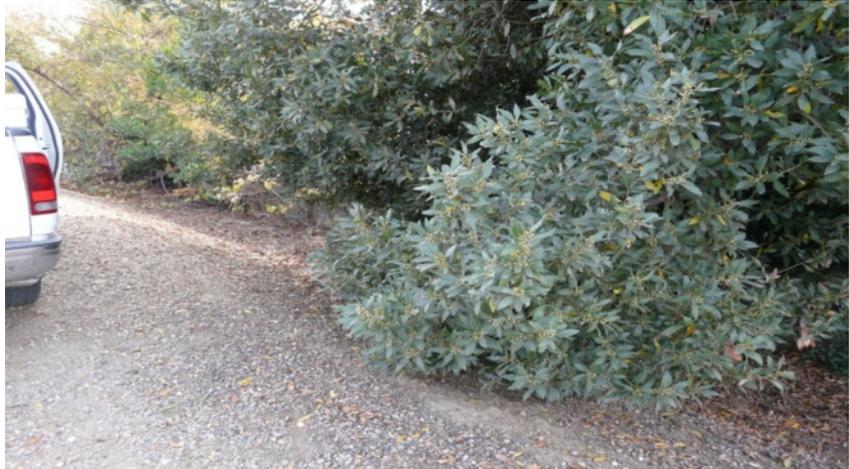
Levee Mile Report Line	31
Start Levee Mile	3.12
End Levee Mile	3.12
Location	
Category	Earthen Levee
Item	Trim / Thin Trees
Trim trees along landside slope of levee to allow for visibility at LM 3.12

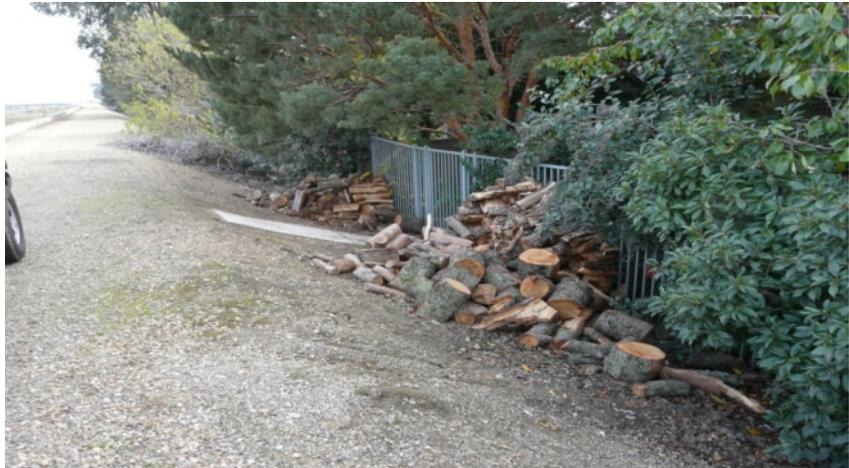
Levee Mile Report Line	32
Start Levee Mile	3.18
End Levee Mile	3.18
Location	
Category	Earthen Levee
Item	Encroachments
Remove firewood from landside of levee at LM 3.18

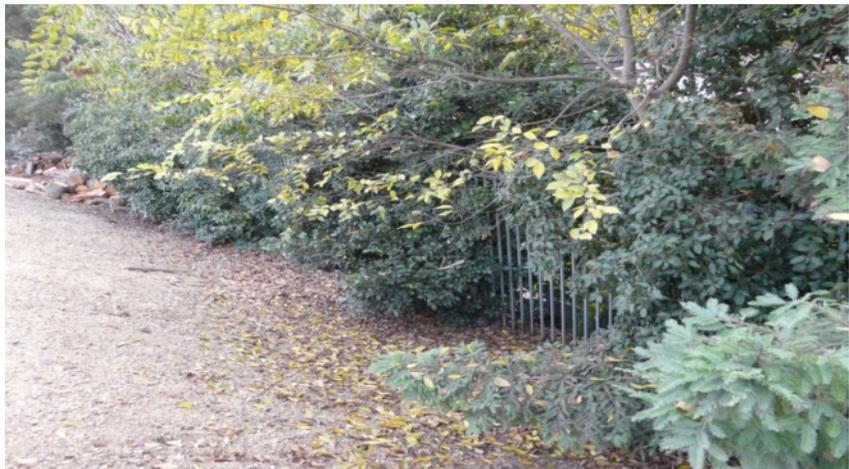
Levee Mile Report Line	33
Start Levee Mile	3.18
End Levee Mile	3.18
Location	
Category	Earthen Levee
Item	Trim / Thin Trees
Trim trees along landside toe of levee at LM 3.18

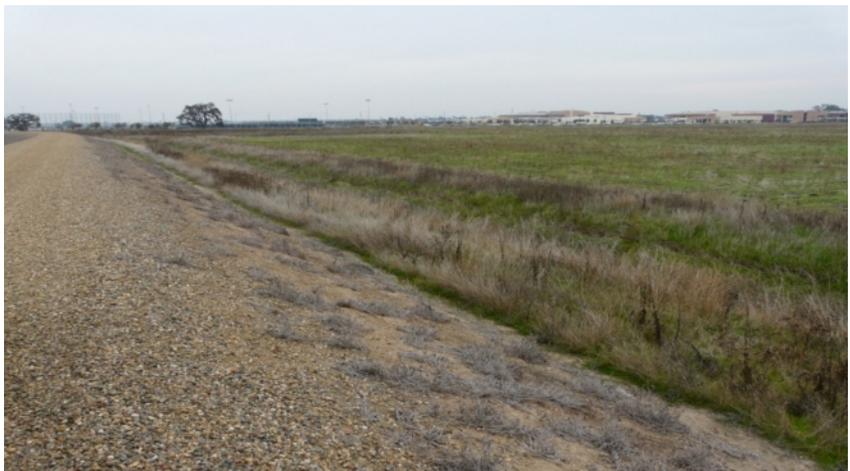
Levee Mile Report Line	36
Start Levee Mile	4.50
End Levee Mile	4.66
Location	
Category	Earthen Levee
Item	Vegetation
Remove/mow vegetation within 10' of landside toe of levee from LM 4.50 to LM 4.66

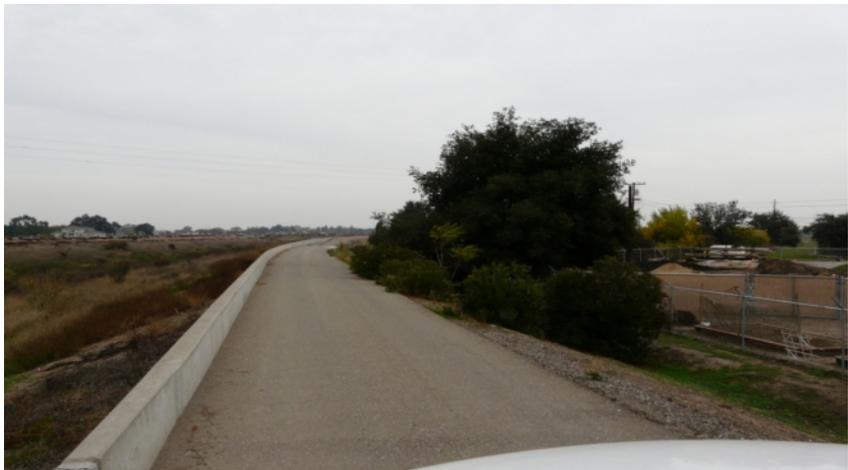
Levee Mile Report Line	38
Start Levee Mile	7.57
End Levee Mile	7.62
Location	
Category	Earthen Levee
Item	Encroachments
Landscaping along landside slope of levee at from LM 7.57 to 7.62

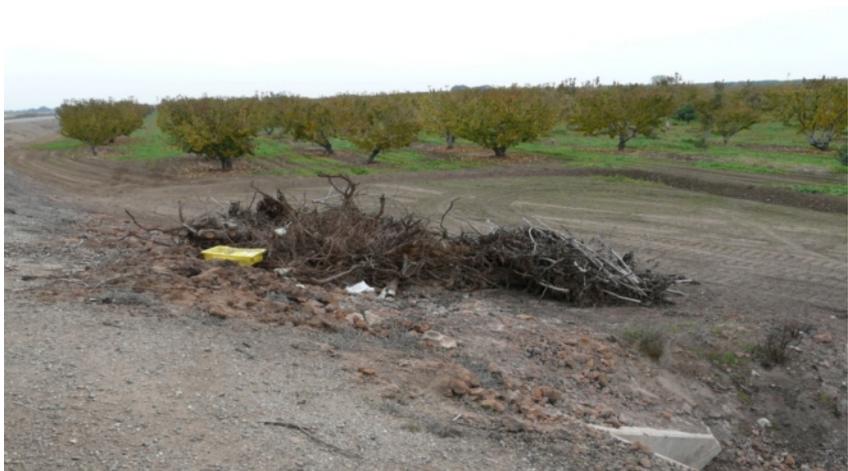
Levee Mile Report Line	39
Start Levee Mile	9.52
End Levee Mile	9.52
Location	
Category	Earthen Levee
Item	Encroachments
Remove prunings from landside of levee at LM 9.52

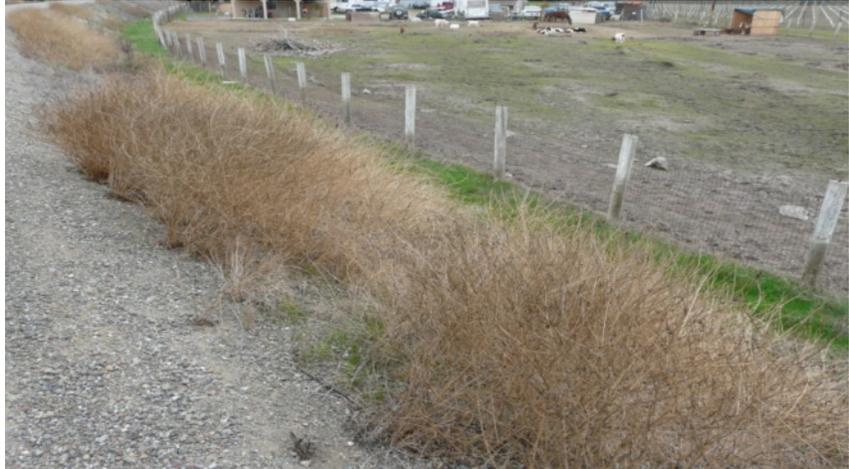
Levee Mile Report Line	40
Start Levee Mile	12.62
End Levee Mile	12.62
Location	
Category	Earthen Levee
Item	Vegetation
Remove/mow vegetation along landside of levee at LM 12.62

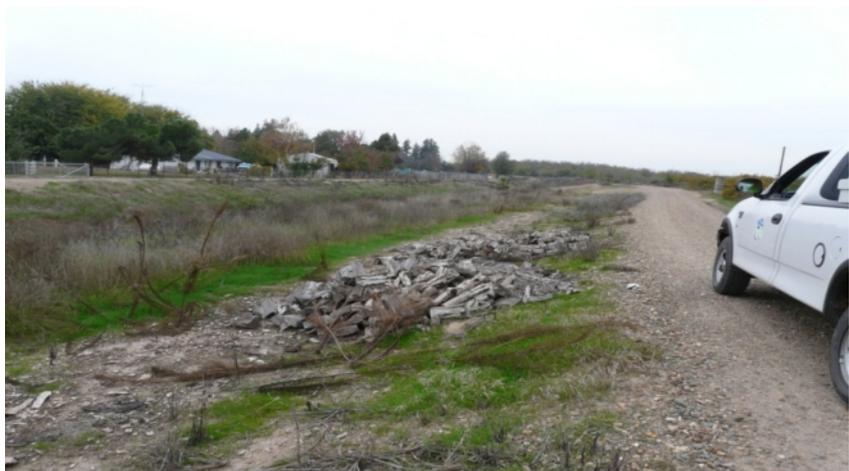
Levee Mile Report Line	44
Start Levee Mile	14.90
End Levee Mile	14.90
Location	
Category	Earthen Levee
Item	Encroachments
Remove prunings from waterside of levee at LM 14.90

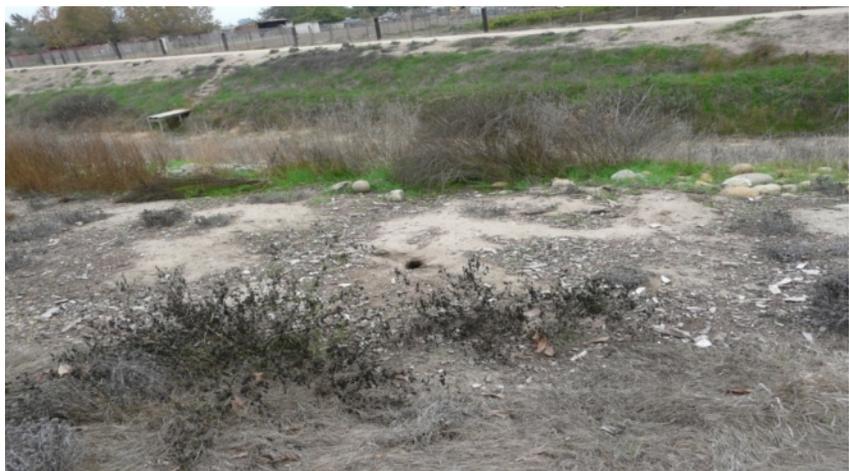
Levee Mile Report Line	47
Start Levee Mile	15.14
End Levee Mile	15.15
Location	
Category	Earthen Levee
Item	Animal Control
Example of rodent hole needing to be repaired along waterside of levee from LM 15.14 to LM 15.15

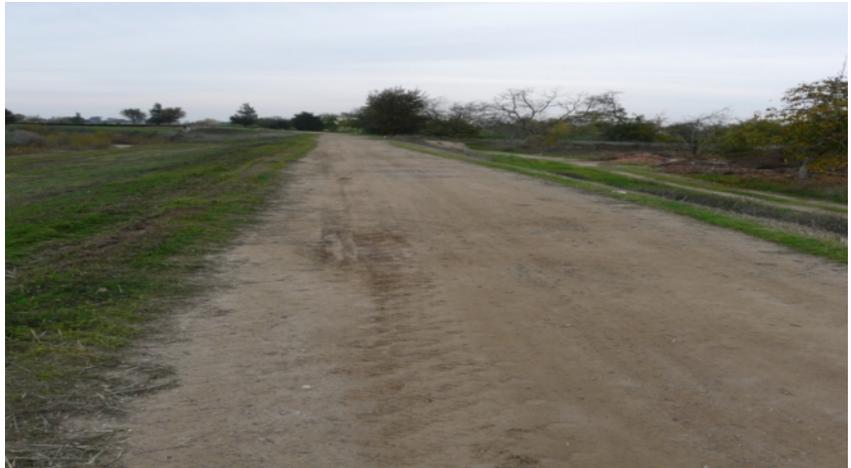
Levee Mile Report Line	49
Start Levee Mile	15.64
End Levee Mile	15.74
Location	
Category	Earthen Levee
Item	Crown Surface / Depressions / Rutting
Regrade crown of levee to provide proper drainage and prevent ponding from LM 15.64 to LM 15.74

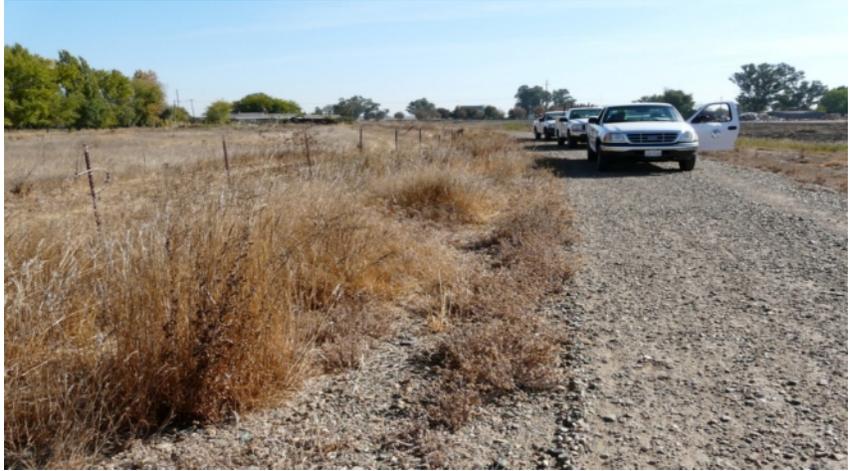
Levee Mile Report Line	3
Start Levee Mile	1.11
End Levee Mile	1.26
Location	
Category	Earthen Levee
Item	Vegetation
Remove/mow vegetation on landside slope to allow for visibility and ability to flood fight from LM 1.11 to 1.26.

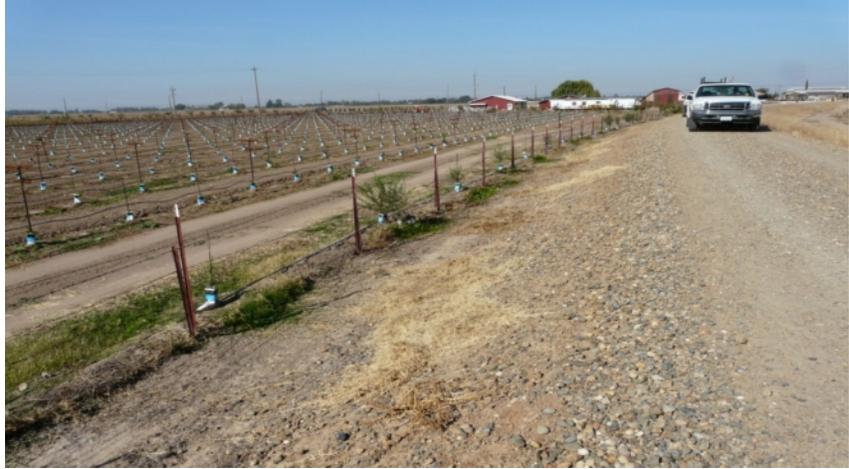
Levee Mile Report Line	2
Start Levee Mile	0.17
End Levee Mile	0.49
Location	
Category	Earthen Levee
Item	Encroachments
Fence located from LM 0.17 to LM 0.49 and crops located from LM 0.17 to LM 0.41 within 10' from landside toe of levee.

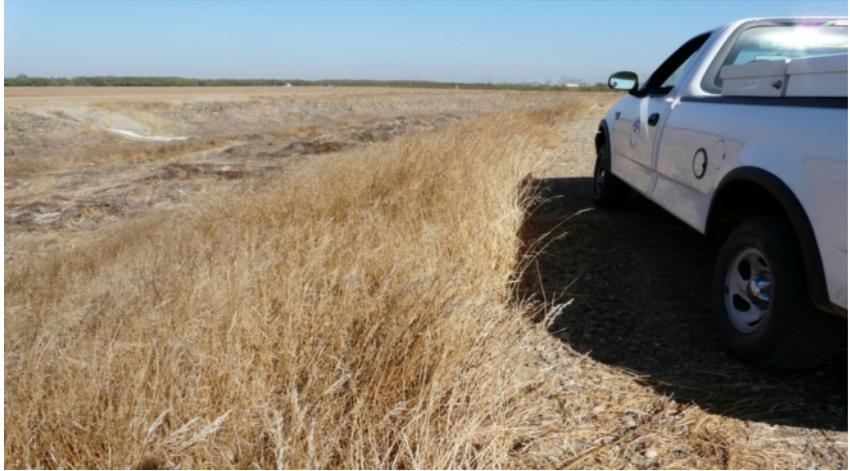
Levee Mile Report Line	1
Start Levee Mile	1.01
End Levee Mile	1.05
Location	
Category	Earthen Levee
Item	Vegetation
Remove/mow vegetation on waterside of levee to 20' from shoulder from LM 1.01 to LM 1.05.

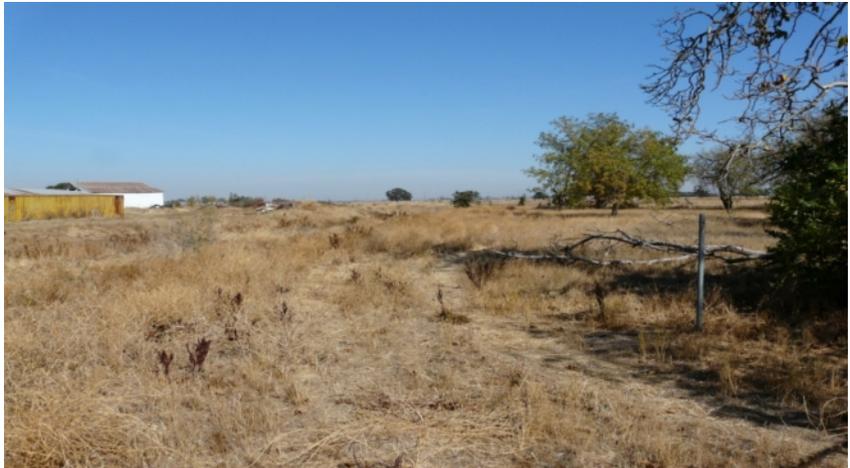
Levee Mile Report Line	3
Start Levee Mile	3.53
End Levee Mile	3.92
Location	
Category	Earthen Levee
Item	Vegetation
Remove/mow vegetation from access road to allow for access to upper portion of unit from LM 3.53 to LM 3.92.

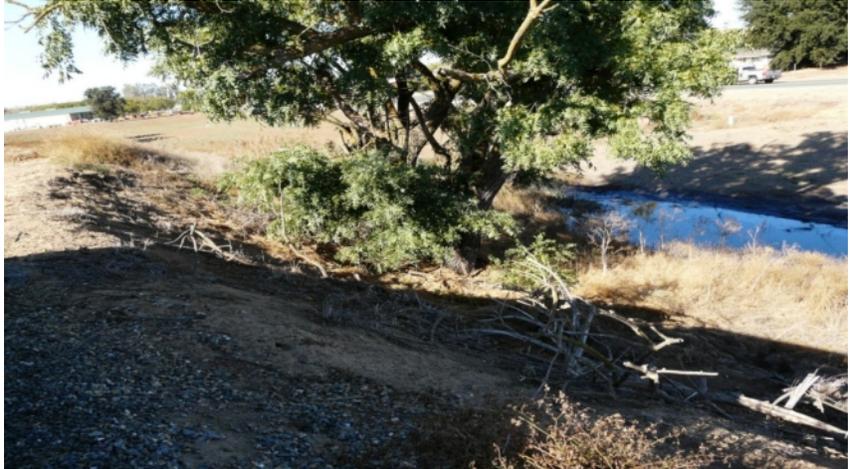
Levee Mile Report Line	3
Start Levee Mile	2.41
End Levee Mile	2.41
Location	
Category	Earthen Levee
Item	Trim / Thin Trees
Trim trees to provide visibility of landside of levee at LM 2.41.

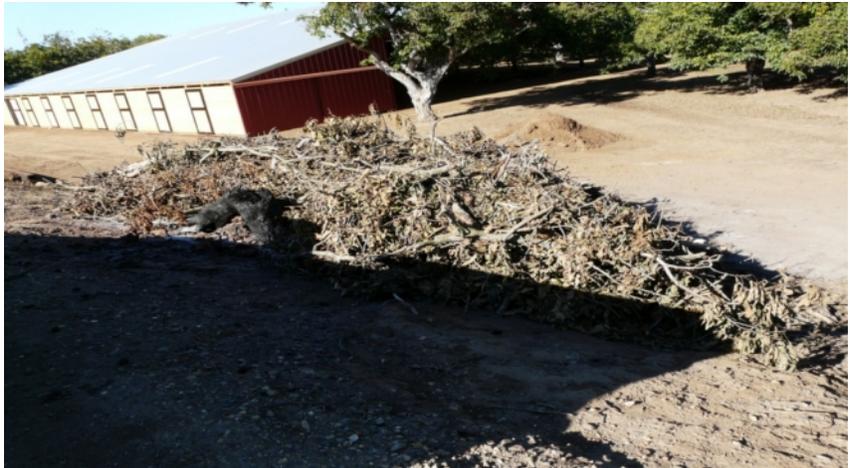
Levee Mile Report Line	6
Start Levee Mile	2.68
End Levee Mile	2.68
Location	
Category	Earthen Levee
Item	Encroachments
Remove prunings pile from landside of levee at LM 2.68.

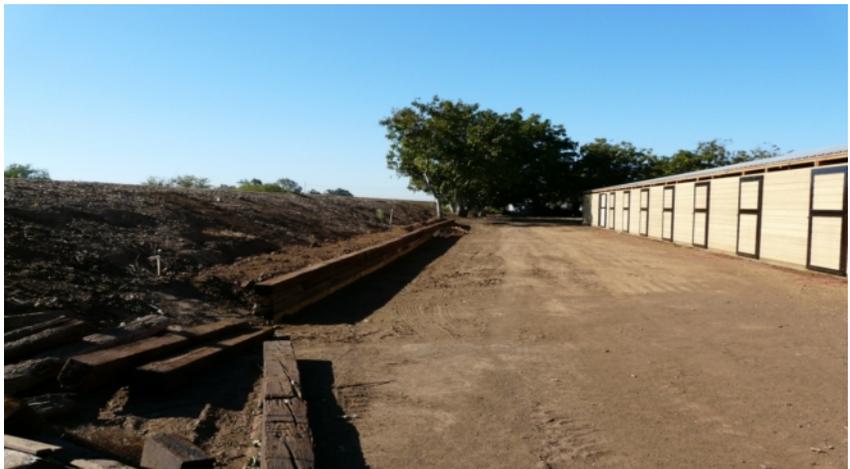
Levee Mile Report Line	7
Start Levee Mile	2.68
End Levee Mile	2.71
Location	
Category	Earthen Levee
Item	Encroachments
Recently built retaining wall at toe of landside levee at LM 2.68.

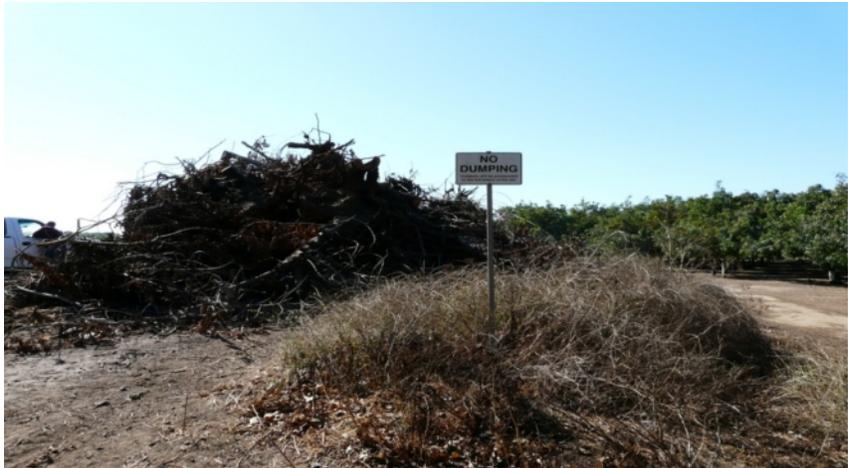
Levee Mile Report Line	27
Start Levee Mile	4.29
End Levee Mile	4.29
Location	
Category	Earthen Levee
Item	Encroachments
Example of a prunings pile immediately adjacent to access road at LM 4.29. Evidence of habitual burnings at this site.

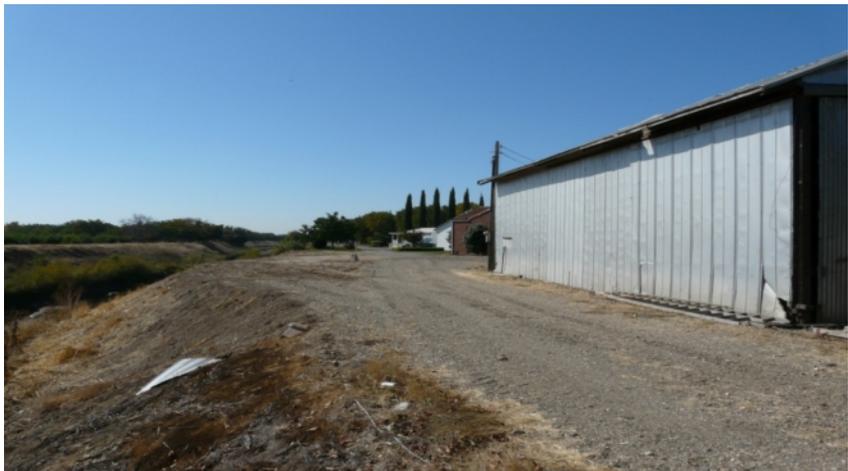
Levee Mile Report Line	37
Start Levee Mile	5.38
End Levee Mile	5.45
Location	
Category	Earthen Levee
Item	Encroachments
Building located immediately adjacent to access road approximately from LM 5.38 to 5.45

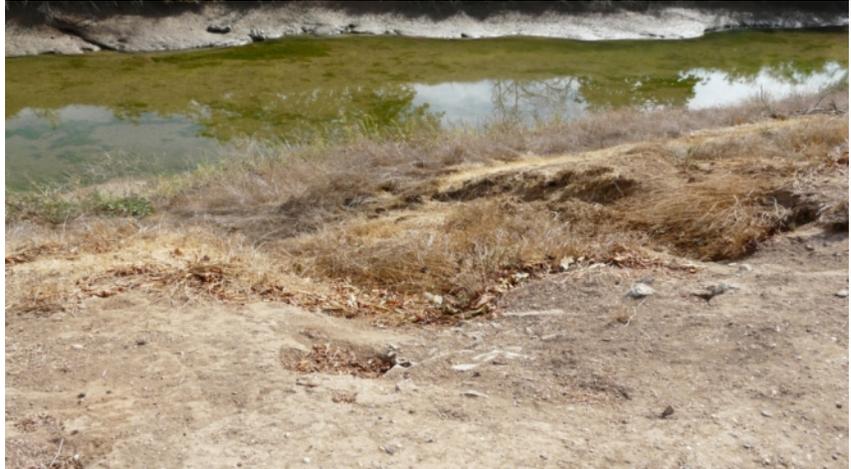
Levee Mile Report Line	40
Start Levee Mile	6.37
End Levee Mile	6.37
Location	
Category	Earthen Levee
Item	Erosion / Bank Caving
<p>Minor erosion occurring locate at LM 6.37. Evidence present that is facilitated by rodent holes in the area. This site should be monitored and repaired</p>

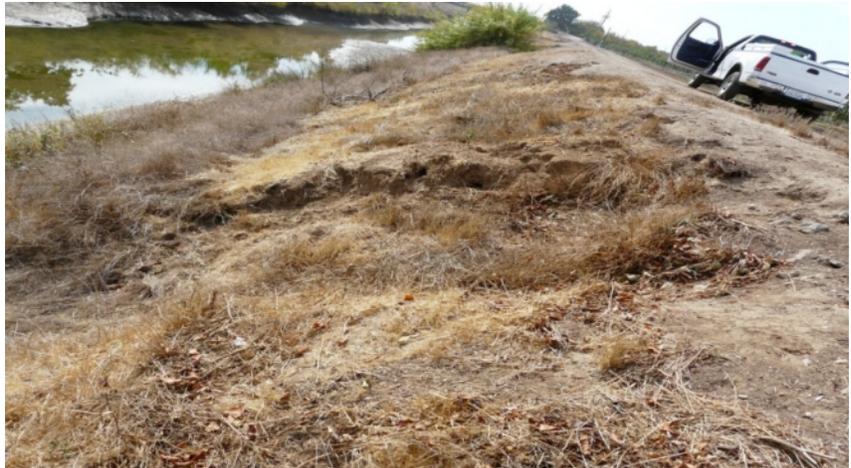
Levee Mile Report Line	40
Start Levee Mile	6.37
End Levee Mile	6.37
Location	
Category	Earthen Levee
Item	Erosion / Bank Caving
<p>Additional view of erosion facilitated by rodent holes located at LM 6.37.</p>

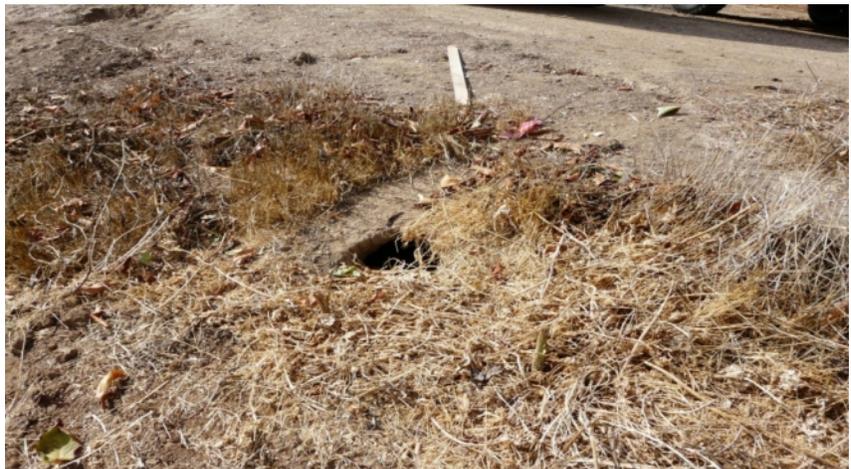
Levee Mile Report Line	41
Start Levee Mile	6.38
End Levee Mile	6.43
Location	
Category	Earthen Levee
Item	Animal Control
<p>Rodent holes located from LM 6.38 to 6.43. Backfill and compact or grout the hole.</p>

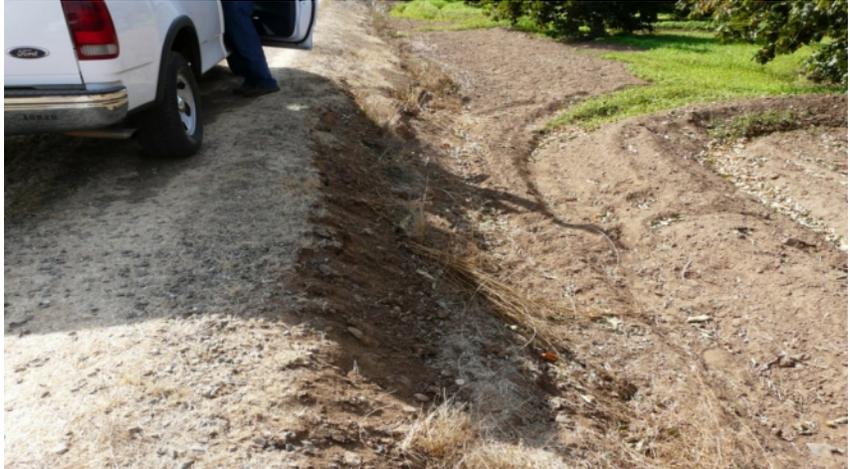
Levee Mile Report Line	43
Start Levee Mile	6.90
End Levee Mile	6.90
Location	
Category	Earthen Levee
Item	Erosion / Bank Caving
<p>Farming equipment grading into the landside toe of the levee located at LM 6.90. Backfill and compact to design shape and attempt to prevent future damage.</p>
