**Flood Control Project Maintenance
Levee Inspections**

Fall 2008 Levee Maintenance Deficiency Summary Report

San Joaquin River Basin

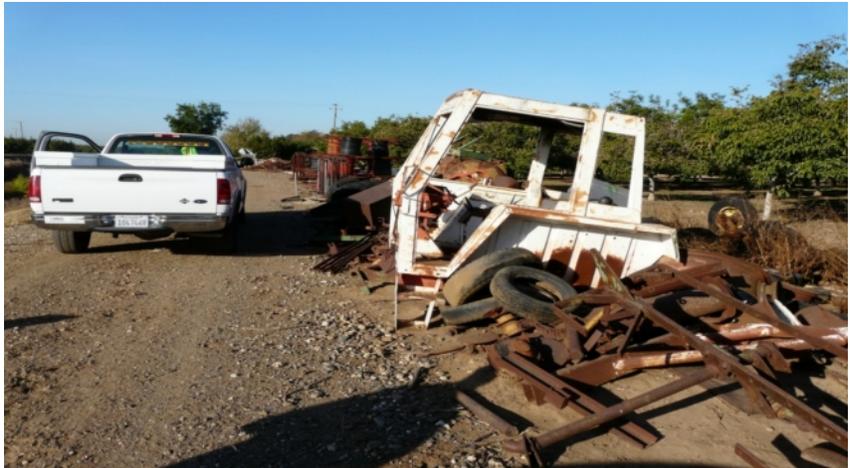
Levee Mile Report Line	52
Start Levee Mile	8.68
End Levee Mile	8.70
Location	
Category	Earthen Levee
Item	Encroachments
<p>Remove equipment from landside slope of levee at from LM 8.68 to LM 8.70.</p>

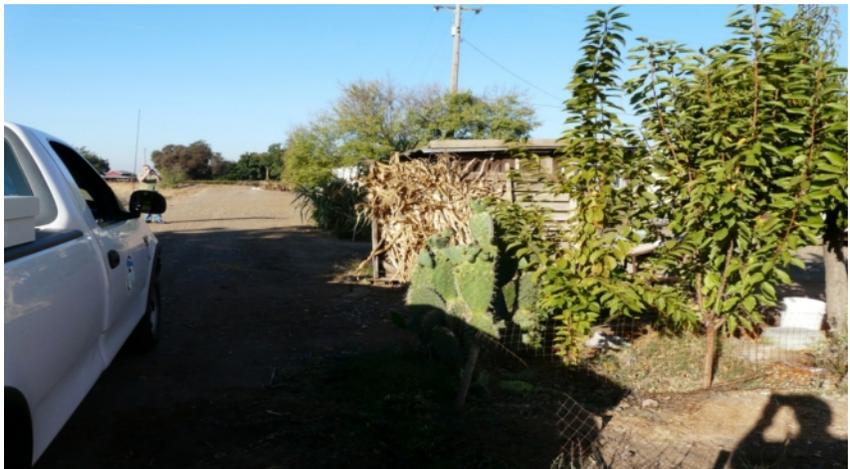
Levee Mile Report Line	53
Start Levee Mile	8.72
End Levee Mile	8.72
Location	
Category	Earthen Levee
Item	Encroachments
<p>Building, fence and landscaping immediately adjacent to the access road at LM 8.72.</p>

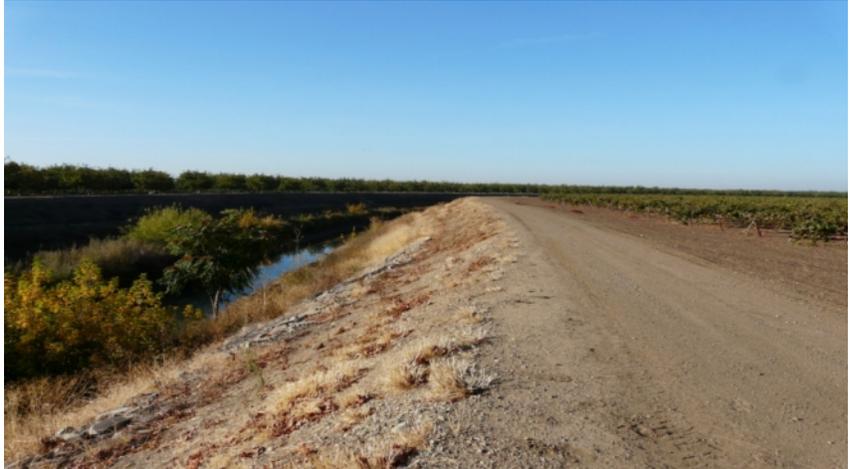
Levee Mile Report Line	57
Start Levee Mile	9.03
End Levee Mile	9.13
Location	
Category	Earthen Levee
Item	Vegetation
<p>Good control of vegetation on waterside of levee. Proper visibility maintained within 20' of waterside shoulder from LM 9.03 to LM 9.13.</p>

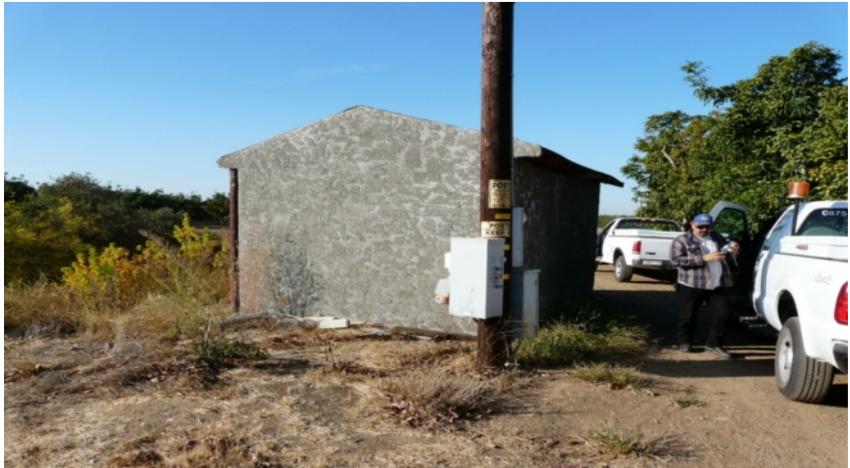
Levee Mile Report Line	58
Start Levee Mile	9.63
End Levee Mile	9.63
Location	
Category	Earthen Levee
Item	Encroachments
<p>Building located at LM 9.63 on waterside of access road. This building appears to be recently constructed and does not currently contain anything.</p>

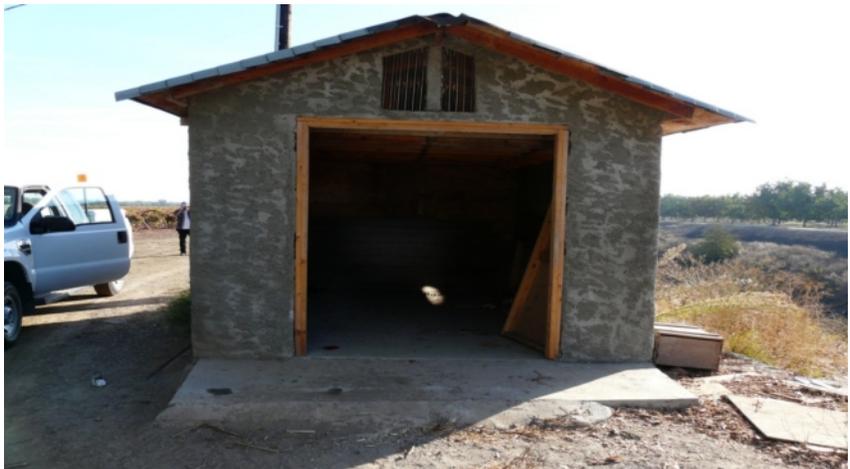
Levee Mile Report Line	58
Start Levee Mile	9.63
End Levee Mile	9.63
Location	
Category	Earthen Levee
Item	Encroachments
<p>Additional view of building at LM 9.63.</p>

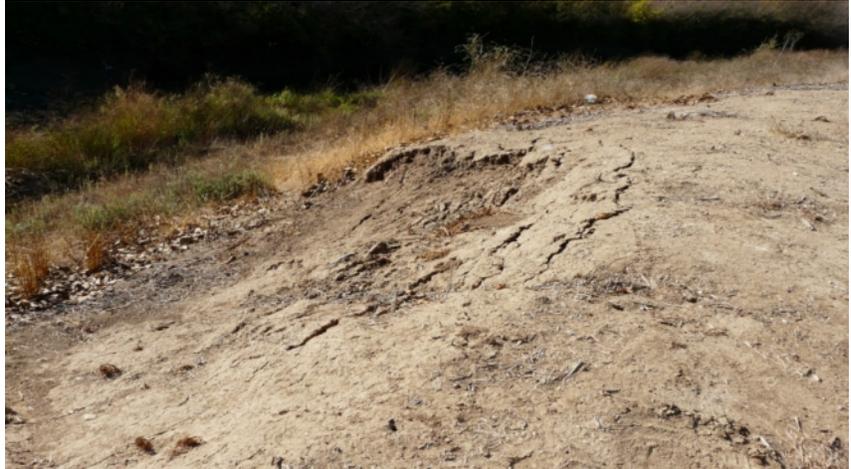
Levee Mile Report Line	60
Start Levee Mile	9.80
End Levee Mile	9.80
Location	
Category	Earthen Levee
Item	Erosion / Bank Caving
<p>Minor erosion occurring at LM 9.80. This erosion appears to be active as evidenced by cracking. Monitor and repair to prevent larger erosion.</p>

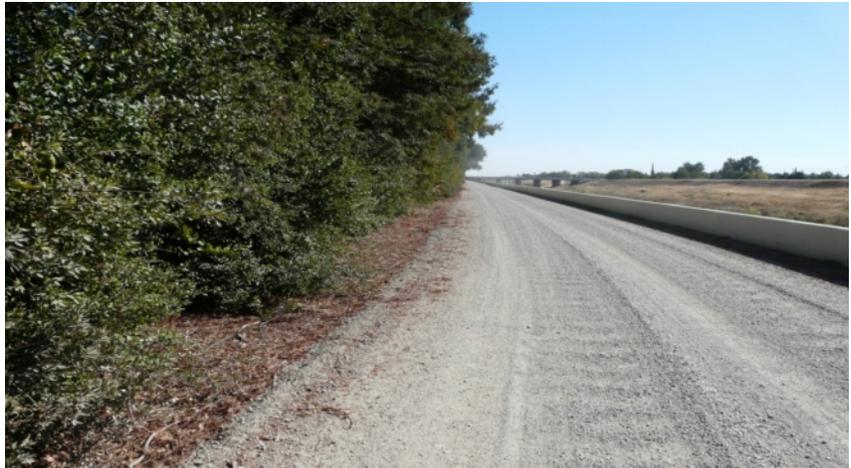
Levee Mile Report Line	75
Start Levee Mile	17.83
End Levee Mile	18.04
Location	
Category	Earthen Levee
Item	Trim / Thin Trees
<p>Trim trees from LM 17.83 to LM 18.04 to at least 5 feet from levee surface to allow visibility and ability to conduct flood fight.</p>

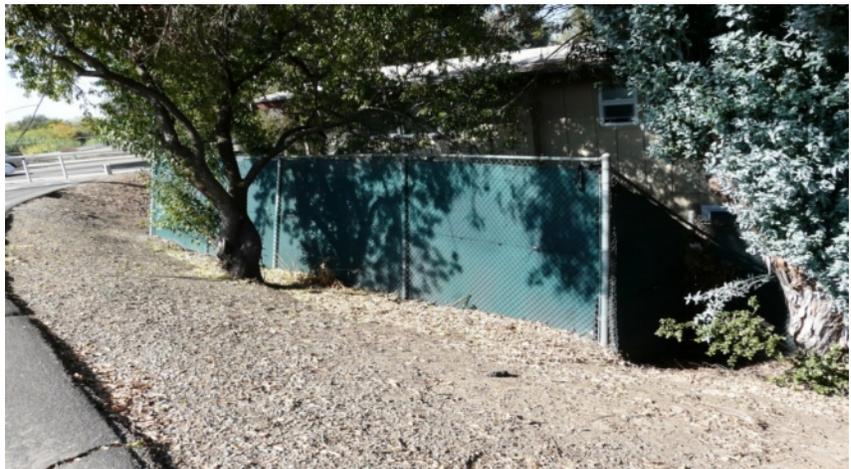
Levee Mile Report Line	83
Start Levee Mile	22.36
End Levee Mile	22.37
Location	
Category	Earthen Levee
Item	Encroachments
<p>Fence located from LM 22.36 to LM 22.37 significantly encroaches onto landside levee slope.</p>

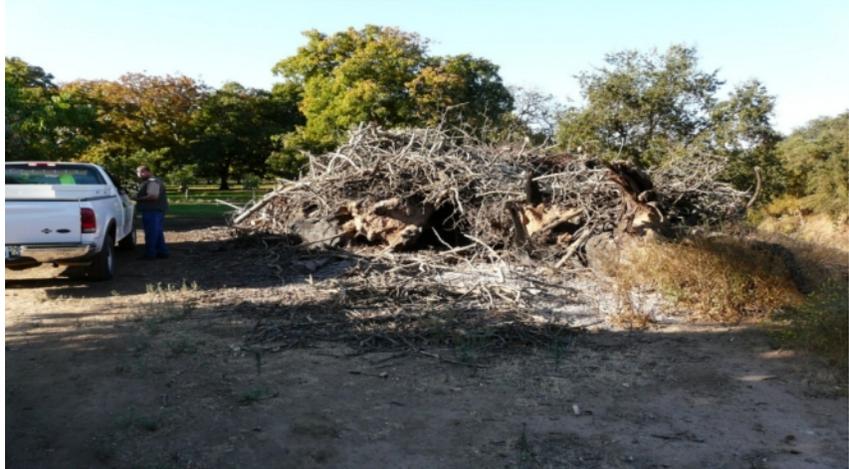
Levee Mile Report Line	1
Start Levee Mile	0.32
End Levee Mile	0.32
Location	
Category	Earthen Levee
Item	Encroachments
<p>Prunings pile located at LM 0.32 on waterside shoulder of access road. The pile impedes access and forces vehicles to drive through orchard.</p>

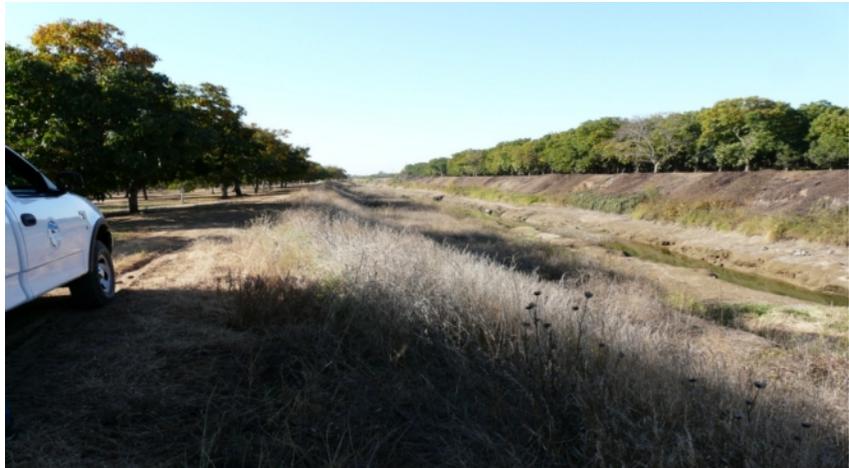
Levee Mile Report Line	7
Start Levee Mile	5.55
End Levee Mile	5.84
Location	
Category	Earthen Levee
Item	Vegetation
<p>Remove/mow vegetation 20' from waterside shoulder to allow visibility of waterside slope from LM 5.55 to LM 5.84.</p>

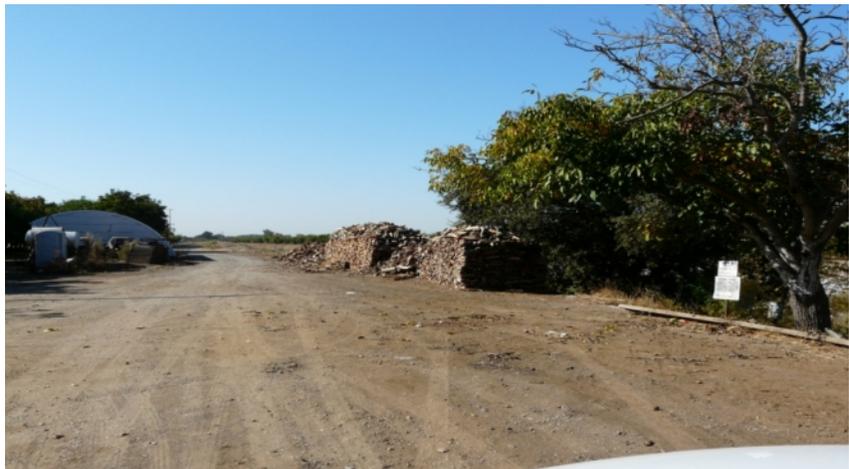
Levee Mile Report Line	10
Start Levee Mile	5.95
End Levee Mile	5.95
Location	
Category	Earthen Levee
Item	Encroachments
<p>Firewood piles located on waterside of shoulder at LM 5.95. These piles should be moved away from landside of access road.</p>

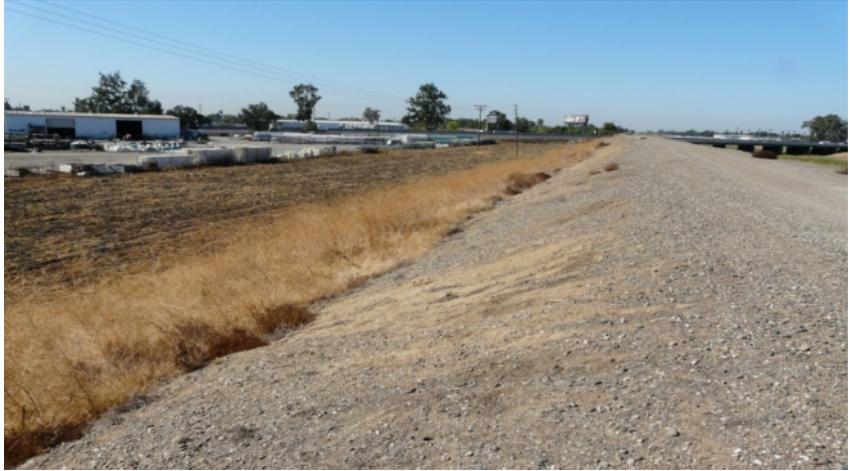
Levee Mile Report Line	21
Start Levee Mile	16.38
End Levee Mile	16.41
Location	
Category	Earthen Levee
Item	Vegetation
Remove/mow vegetation to 10' from landside toe to maintain visibility from LM 16.38 to LM 16.41 and LM 16.46 to LM 16.65.

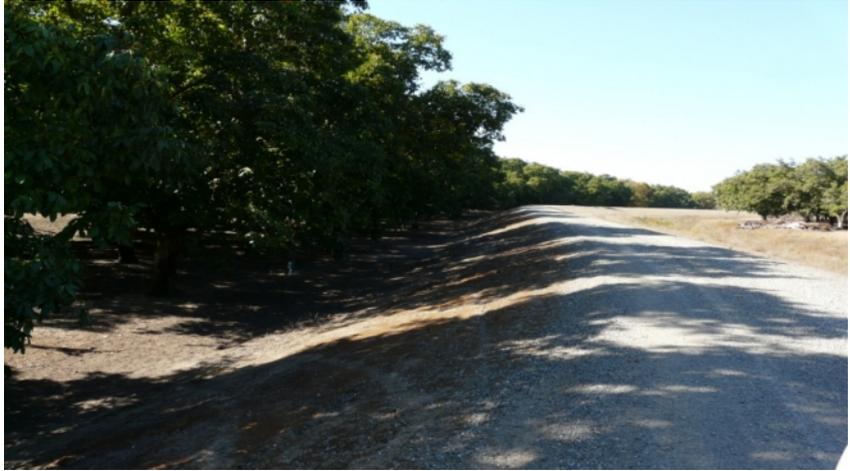
Waterway	Bank	Unit Miles	Inspection Date	Inspector
Unit No. 18 Potter Creek	Left	0.90	10/22/2008	David Pesavento

Levee Mile Report Line	1
Start Levee Mile	0.00
End Levee Mile	0.10
Location	
Category	Earthen Levee
Item	Vegetation
Good vegetation maintenance on Unit 18 of Potter Creek.
