**Flood Control Project Maintenance
Levee Inspections**

Fall 2011 Levee Maintenance Deficiency Summary Report

San Joaquin River Basin

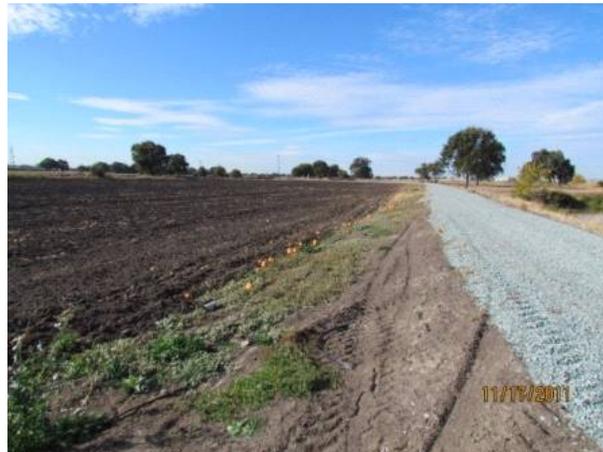
Levee Mile Report Line	6
Start Levee Mile	0.88
End Levee Mile	1.04
Location	Land Side
Category	Earthen Levee
Item	Encroachments
Tilling was repaired by the LMA on the landside of the levee looking downstream.	
pkazi_f_20111201_323.jpg

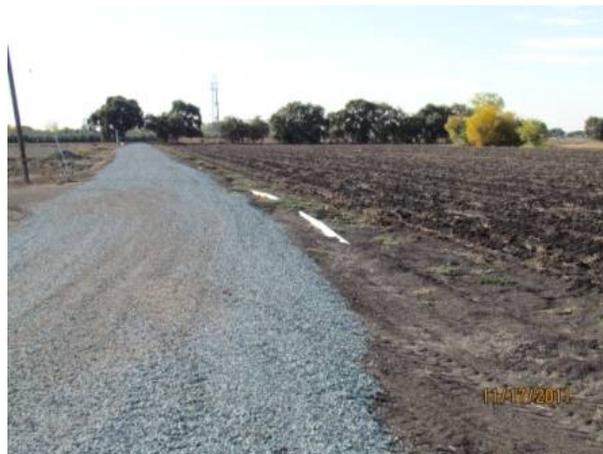
pkazi_f_20111201_326.jpg

PVC Pipe was found on the waterside of the levee looking downstream.

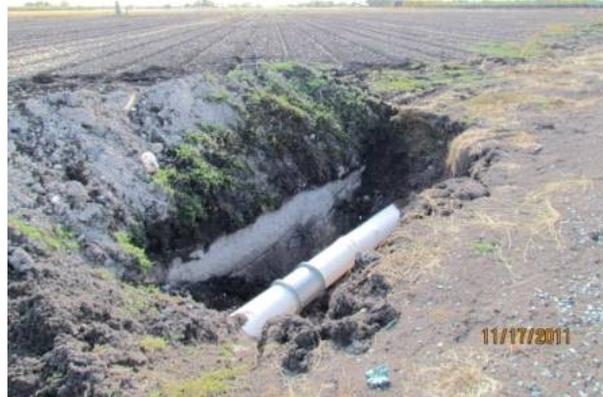
Levee Mile Report Line	12
Start Levee Mile	1.14
End Levee Mile	1.14
Location	Land Side
Category	Earthen Levee
Item	Encroachments
A ditch was found on the landside of the levee looking downstream.	
pkazi_f_20111201_327.jpg

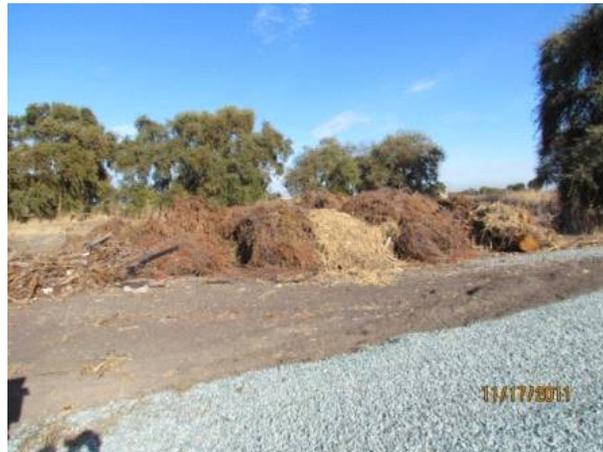
Levee Mile Report Line	16
Start Levee Mile	1.32
End Levee Mile	1.32
Location	Water Side
Category	Earthen Levee
Item	Encroachments
Prunings were found on the waterside of the levee looking upstream.	
pkazi_f_20111201_329.jpg

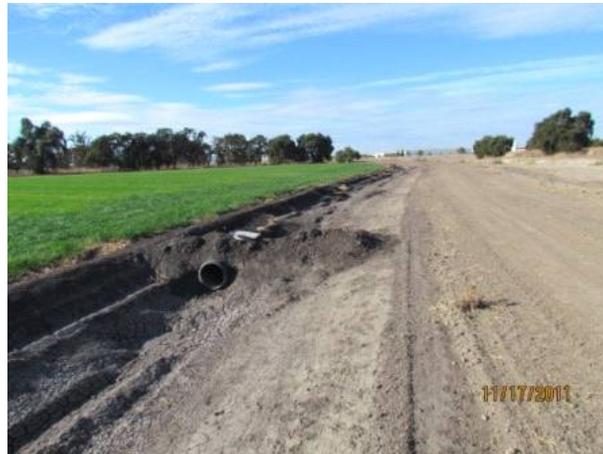
pkazi_f_20111201_332.jpg

An agricultural ditch was found on the landside of the levee looking downstream.

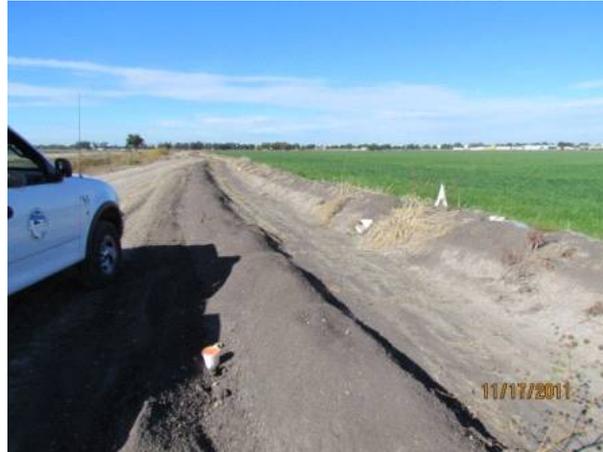
Levee Mile Report Line	1
Start Levee Mile	1.49
End Levee Mile	1.86
Location	Land Side
Category	Earthen Levee
Item	Encroachments
Agricultural ditch was found on the landside of the levee looking downstream.	
pkazi_f_20111128_303.jpg

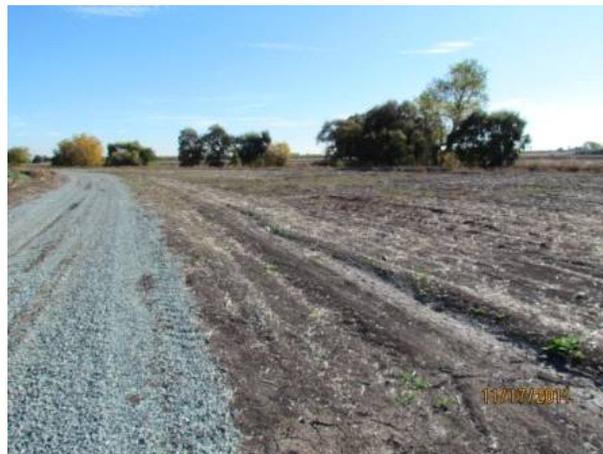
Levee Mile Report Line	4
Start Levee Mile	1.70
End Levee Mile	1.70
Location	Water Side
Category	Earthen Levee
Item	Encroachments
Tilling on the waterside of the levee has been fixed by the LMA. The picture was taken from the crown looking upstream.	
pkazi_f_20111128_320.jpg

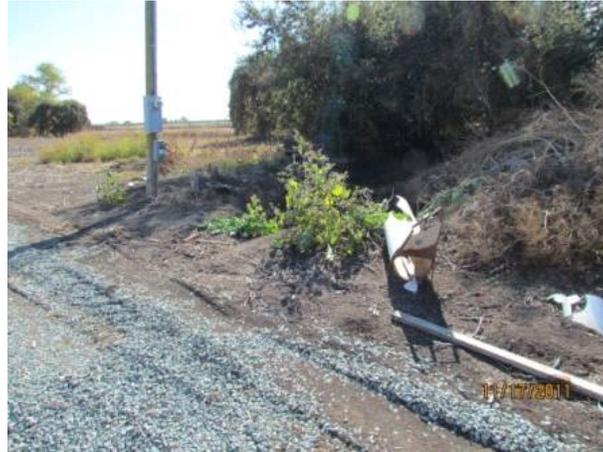
Levee Mile Report Line	5
Start Levee Mile	1.74
End Levee Mile	1.74
Location	Water Side
Category	Earthen Levee
Item	Encroachments
Debris was found on the waterside of the levee looking upstream.	
pkazi_f_20111128_319.jpg

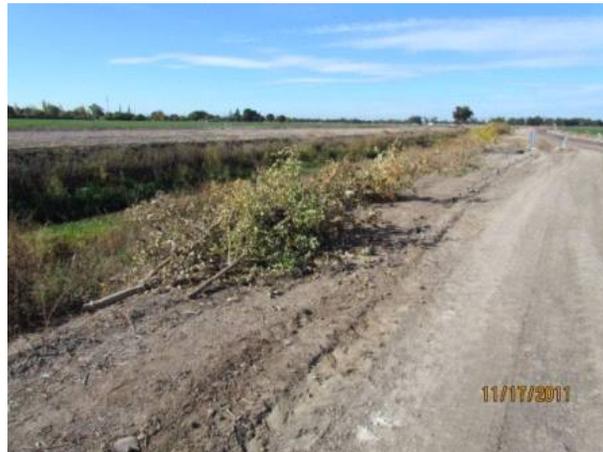
Levee Mile Report Line	8
Start Levee Mile	1.95
End Levee Mile	1.95
Location	Water Side
Category	Earthen Levee
Item	Encroachments
Pruning was found on the waterside shoulder of the levee looking downstream.	
pkazi_f_20111128_305.jpg

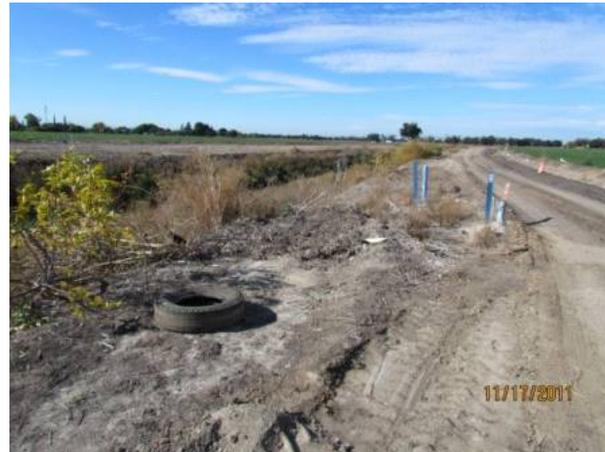
Levee Mile Report Line	9
Start Levee Mile	1.97
End Levee Mile	1.97
Location	Water Side
Category	Earthen Levee
Item	Encroachments
Debris was located on the waterside shoulder of the levee looking downstream.	
pkazi_f_20111128_306.jpg

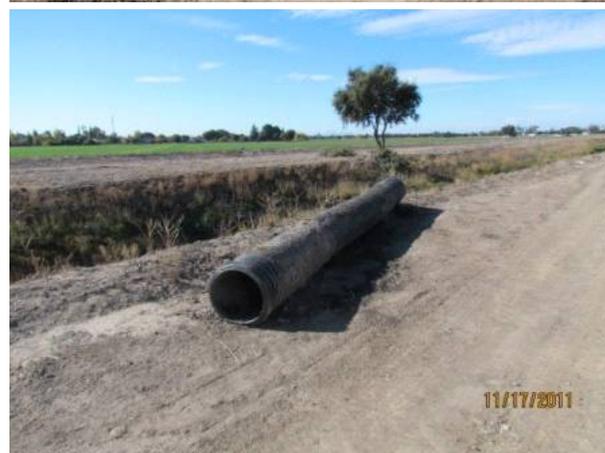
Levee Mile Report Line	11
Start Levee Mile	2.06
End Levee Mile	2.06
Location	Water Side
Category	Earthen Levee
Item	Encroachments
An abandoned pipe was found on the waterside of the levee looking downstream.	
pkazi_f_20111128_308.jpg

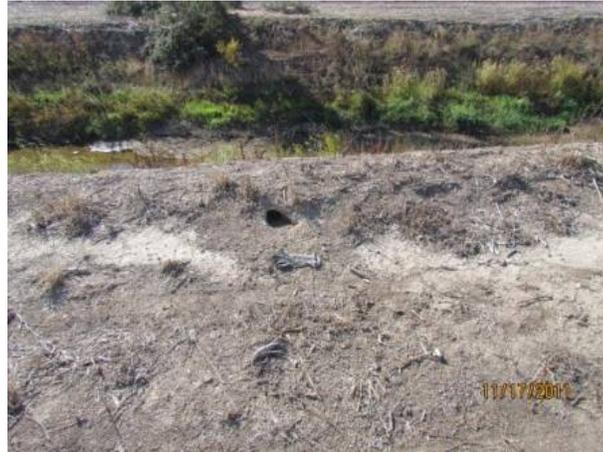
Levee Mile Report Line	12
Start Levee Mile	2.08
End Levee Mile	2.08
Location	Water Side
Category	Earthen Levee
Item	Animal Control
<p>A rodent hole was found on the waterside of the levee looking downstream.</p>	
<p>pkazi_f_20111128_309.jpg</p>

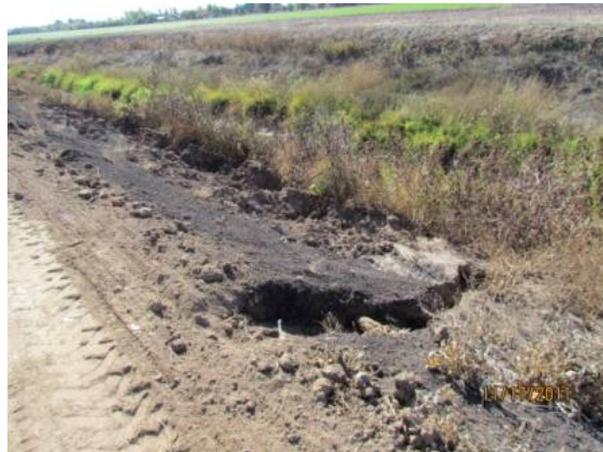
Levee Mile Report Line	14
Start Levee Mile	2.27
End Levee Mile	2.27
Location	Water Side
Category	Earthen Levee
Item	Erosion / Bank Caving
<p>Erosion was found on the waterside of the levee looking upstream.</p>	
<p>pkazi_f_20111128_311.jpg</p>

14	2.27	2.27	Earthen Levee	Erosion / Bank Caving	WS	M	Schedule repair of erosion site prior to the next inspection.	37.885182 ° -121.253971 °	37.885182 ° -121.253971 °	13 Y
15	2.27	2.27	Earthen Levee	Animal Control	WS	M	No rodents visible, but rodent burrows visible; need to backfill and compact or grout burrows.	37.885183 ° -121.253971 °	37.885183 ° -121.253971 °	14 Y
16	2.54	2.54	Earthen Levee	Erosion / Bank Caving	WS	M	Schedule repair of erosion site prior to the next inspection.	37.888239 ° -121.256586 °	37.888239 ° -121.256586 °	15 Y
17	2.65	2.65	Earthen Levee	Animal Control	CR	M	Exterminate rodents and backfill and compact or grout burrows.	37.888847 ° -121.258344 °	37.888847 ° -121.258344 °	10 Y
18	2.66	3.17	Earthen Levee	Encroachments	LS	PO	Agricultural Ditch	37.888885 ° -121.258519 °	37.888573 ° -121.267475 °	17 Y

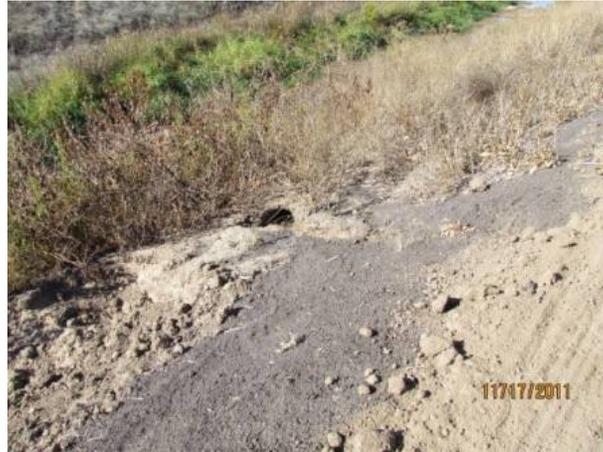
Levee Mile Report Line	15
Start Levee Mile	2.27
End Levee Mile	2.27
Location	Water Side
Category	Earthen Levee
Item	Animal Control
Rodent hole was found on the waterside of the levee looking downstream.	
pkazi_f_20111128_312.jpg

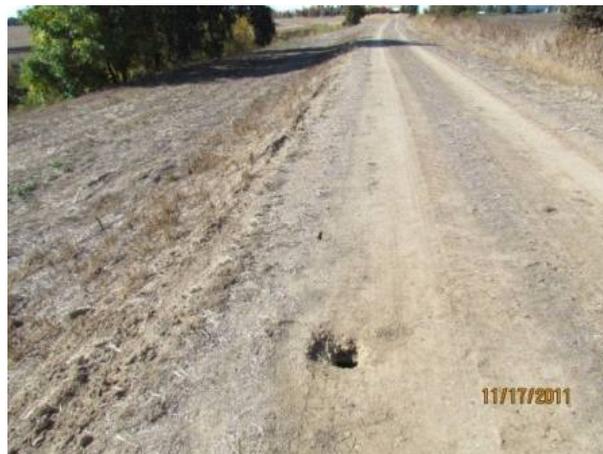
Levee Mile Report Line	17
Start Levee Mile	2.65
End Levee Mile	2.65
Location	Crown
Category	Earthen Levee
Item	Animal Control
Rodent hole was found on the crown of the levee looking downstream.	
pkazi_f_20111128_314.jpg

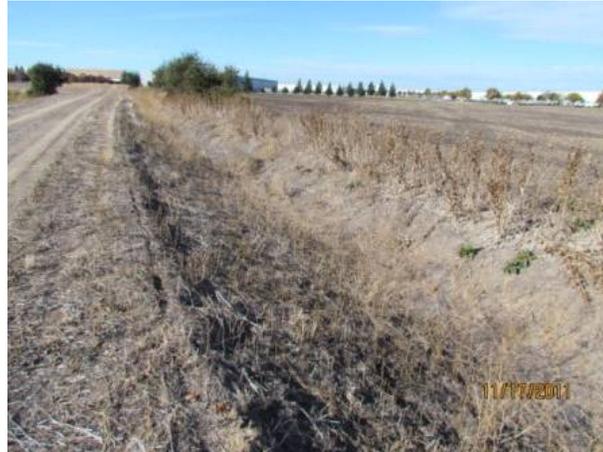
Levee Mile Report Line	18
Start Levee Mile	2.66
End Levee Mile	3.17
Location	Land Side
Category	Earthen Levee
Item	Encroachments
A ditch was found on the landside of the levee looking downstream.	
pkazi_f_20111128_315.jpg

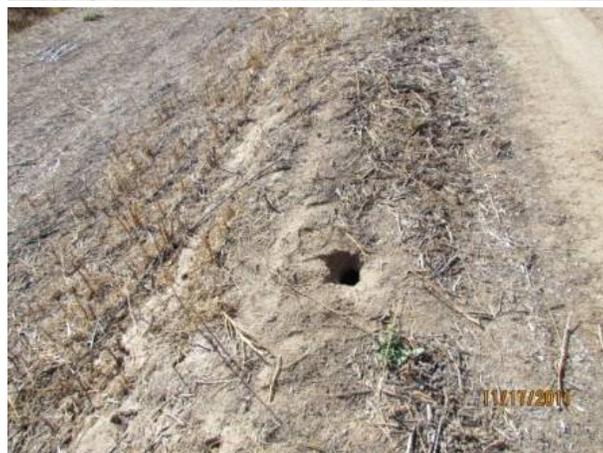
Levee Mile Report Line	21
Start Levee Mile	2.89
End Levee Mile	2.89
Location	Water Side
Category	Earthen Levee
Item	Animal Control
A rodent hole was found on the waterside slope of the levee looking downstream.	
pkazi_f_20111128_317.jpg

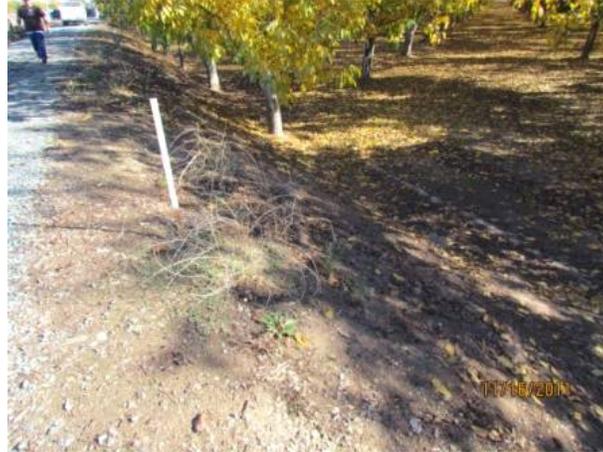
Levee Mile Report Line	1
Start Levee Mile	0.30
End Levee Mile	0.30
Location	Land Side
Category	Earthen Levee
Item	Erosion / Bank Caving
Erosion was repaired by the LMA on the landside of the levee looking upstream.	
pkazi_f_20111207_403.jpg

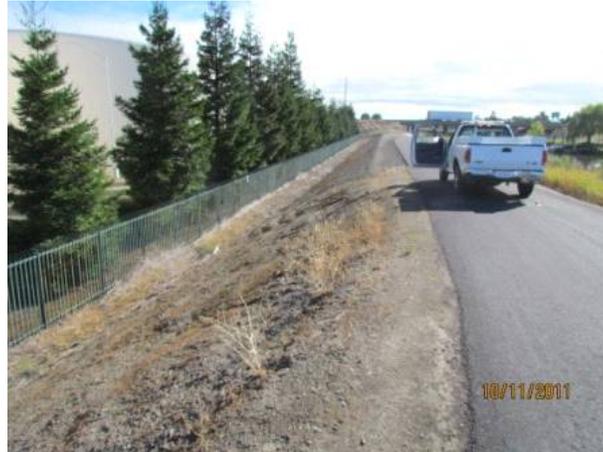
Levee Mile Report Line	2
Start Levee Mile	0.39
End Levee Mile	0.50
Location	Land Side
Category	Earthen Levee
Item	Encroachments
View of the fence along landside toe of the levee looking upstream.	
pkazi_f_20111117_196.jpg

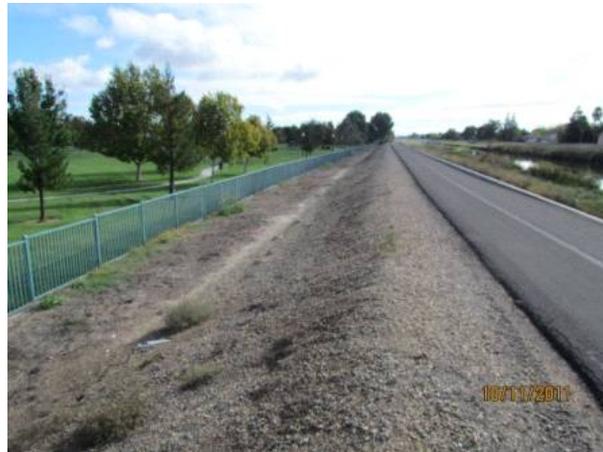
Levee Mile Report Line	3
Start Levee Mile	0.58
End Levee Mile	1.72
Location	Land Side
Category	Earthen Levee
Item	Vegetation
No vegetation was found on the landside slope of the levee looking upstream.	
pkazi_f_20111117_197.jpg

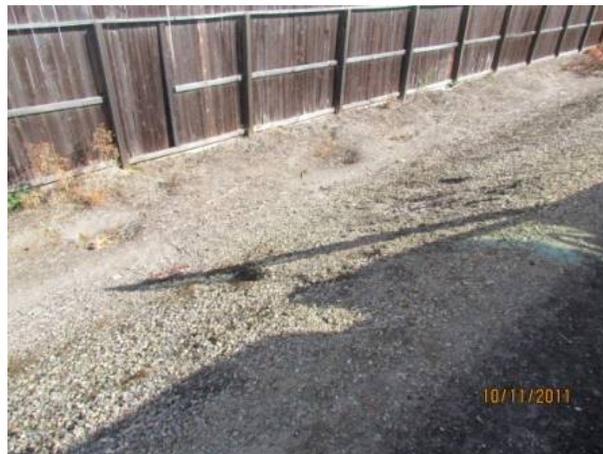
Levee Mile Report Line	5
Start Levee Mile	1.22
End Levee Mile	1.22
Location	Land Side
Category	Earthen Levee
Item	Slope Stability
Landside slope was damaged by foot traffic looking upstream.	
pkazi_f_20111117_198.jpg

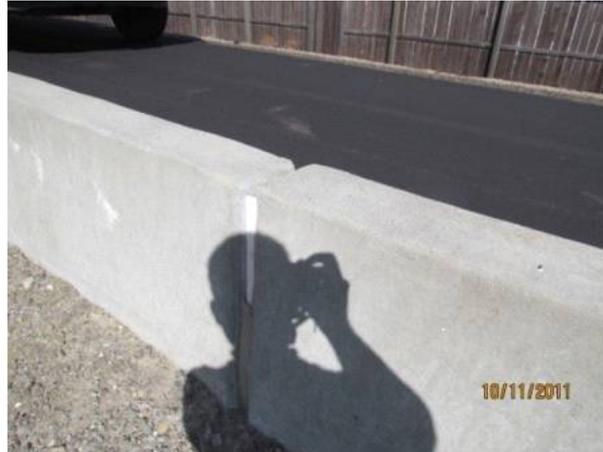
Levee Mile Report Line	7
Start Levee Mile	1.47
End Levee Mile	1.47
Location	Water Side
Category	Concrete Floodwalls
Item	Monolith Joints
<p>Monolith joint material appeared to be deteriorating at the joint. The picture was taken from waterside of the levee looking downstream.</p>	
<p>pkazi_f_20111117_199.jpg</p>

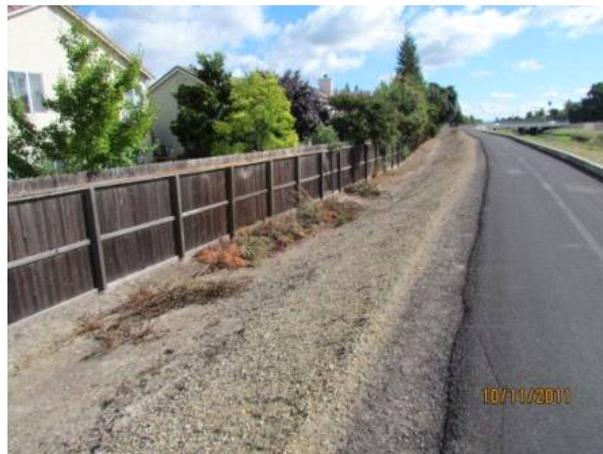
Levee Mile Report Line	9
Start Levee Mile	1.47
End Levee Mile	1.47
Location	Land Side
Category	Earthen Levee
Item	Encroachments
<p>Debris was found on the landside of the levee looking upstream.</p>	
<p>pkazi_f_20111117_200.jpg</p>

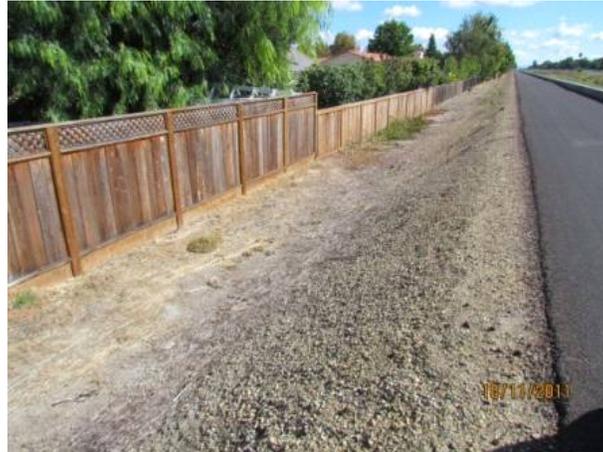
Levee Mile Report Line	11
Start Levee Mile	1.68
End Levee Mile	1.68
Location	Land Side
Category	Earthen Levee
Item	Encroachments
<p>The stairway was removed and the site was graded with new material. The picture was taken from the crown looking towards the landside toe of the levee facing upstream.</p>	
<p>pkazi_f_20111117_202.jpg</p>

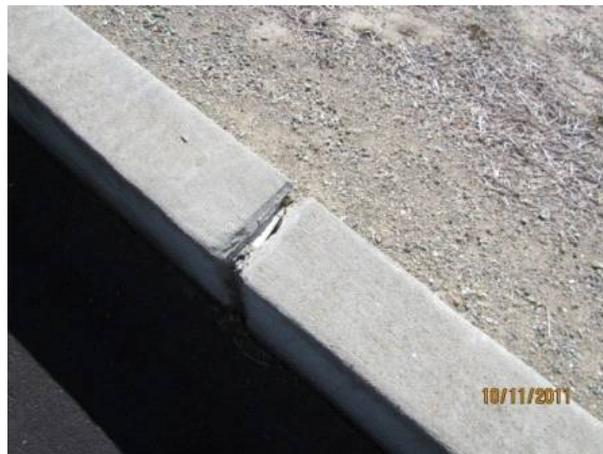
Levee Mile Report Line	15
Start Levee Mile	1.80
End Levee Mile	1.80
Location	Water Side
Category	Concrete Floodwalls
Item	Monolith Joints
<p>Monolith joint material appeared to be deteriorating at the joint. The picture was taken from the crown of the levee looking upstream.</p>	
<p>pkazi_f_20111117_204.jpg</p>

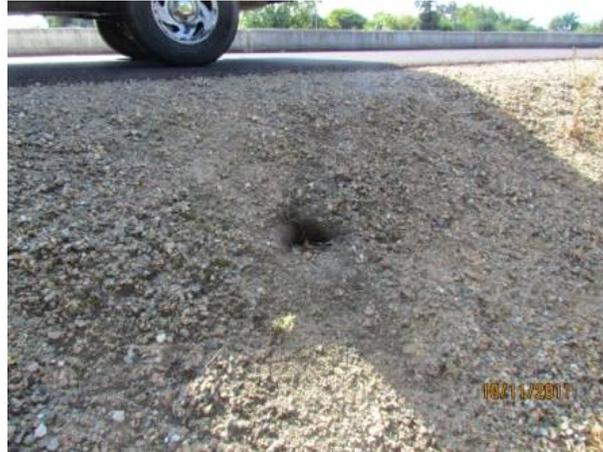
Levee Mile Report Line	16
Start Levee Mile	1.88
End Levee Mile	1.88
Location	Land Side
Category	Earthen Levee
Item	Animal Control
<p>A rodent hole was found on the landside of the levee looking downstream.</p>	
<p>pkazi_f_20111117_205.jpg</p>

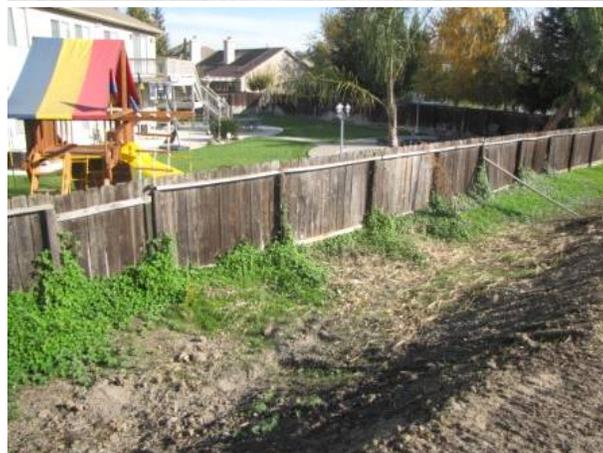
Levee Mile Report Line	19
Start Levee Mile	2.30
End Levee Mile	2.30
Location	Land Side
Category	Earthen Levee
Item	Encroachments
<p>View of landscaping coming through the fence and blocking visibility within 10' of the landward toe looking upstream.</p>	
<p>pkazi_f_20110923_585.jpg</p>

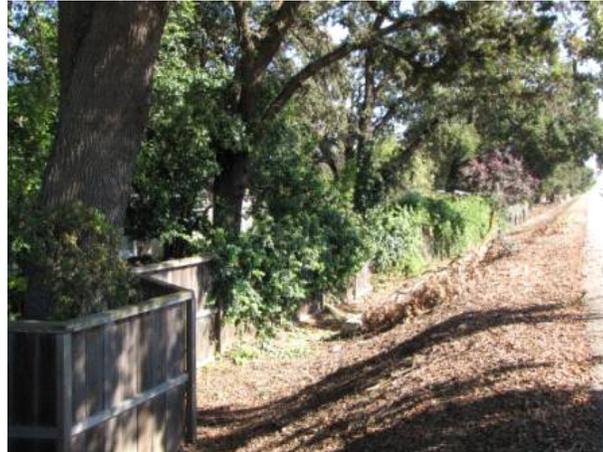
Levee Mile Report Line	20
Start Levee Mile	2.57
End Levee Mile	2.65
Location	Land Side
Category	Earthen Levee
Item	Encroachments
View of a wood fence adjacent to the landward toe looking upstream.	
pkazi_f_20110923_604.jpg

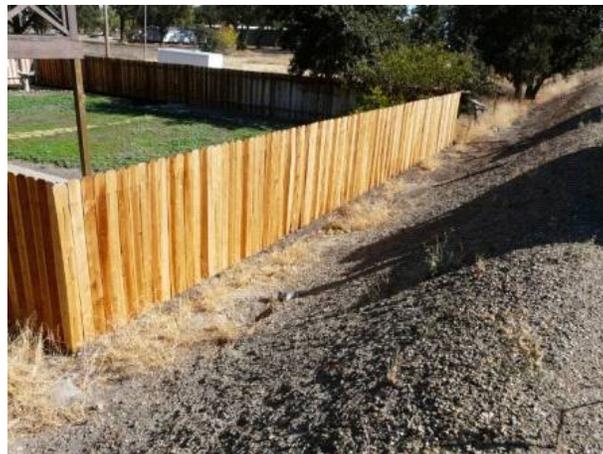
Levee Mile Report Line	21
Start Levee Mile	2.66
End Levee Mile	2.67
Location	Land Side
Category	Earthen Levee
Item	Encroachments
Newer fence built within landside toe of levee at from LM 2.66 to LM 2.67.	
pkazi_f_20110923_582.JPG

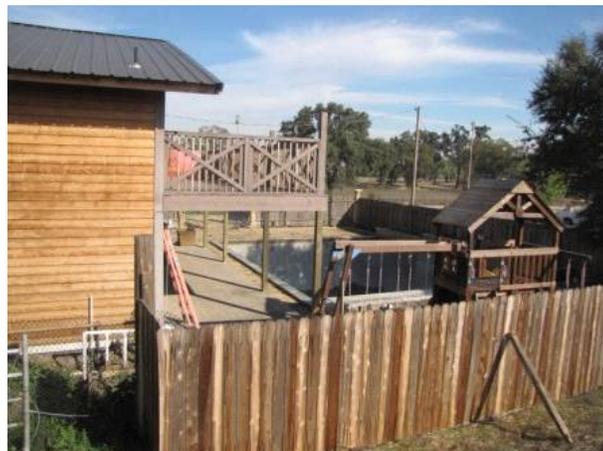
Levee Mile Report Line	22
Start Levee Mile	2.67
End Levee Mile	2.67
Location	Land Side
Category	Earthen Levee
Item	Encroachments
View of a recently constructed pool looking landward.	
pkazi_f_20110923_590.jpg

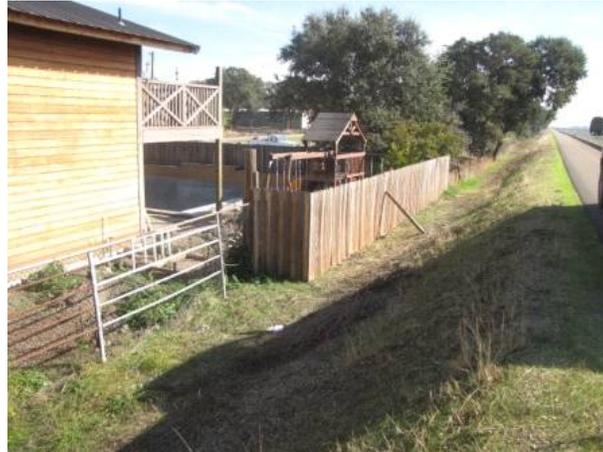
Levee Mile Report Line	22
Start Levee Mile	2.67
End Levee Mile	2.67
Location	Land Side
Category	Earthen Levee
Item	Encroachments
View of a recently constructed pool looking upstream.	
pkazi_f_20110923_591.jpg

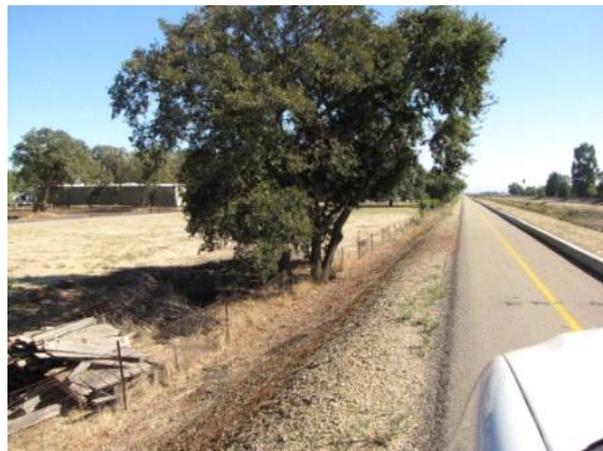
Levee Mile Report Line	24
Start Levee Mile	2.68
End Levee Mile	3.04
Location	Land Side
Category	Earthen Levee
Item	Encroachments
View of a metal fence adjacent to the landward toe looking upstream.	
pkazi_f_20110923_605.jpg

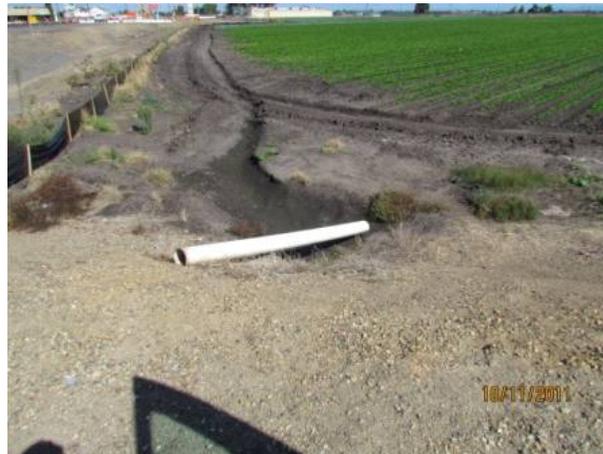
Levee Mile Report Line	27
Start Levee Mile	3.12
End Levee Mile	3.12
Location	Land Side
Category	Earthen Levee
Item	Encroachments
<p>An abandoned PVC pipe was found on the landside slope of the levee. The picture was taken from the crown looking towards the toe.</p>	
<p>pkazi_f_20111117_210.jpg</p>

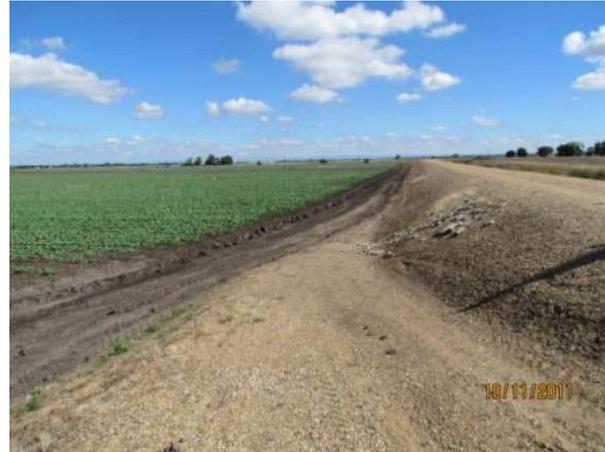
Levee Mile Report Line	28
Start Levee Mile	3.16
End Levee Mile	3.35
Location	Land Side
Category	Earthen Levee
Item	Encroachments
Farmer discing the toe of the landside of the levee looking upstream.	
pkazi_f_20111117_211.jpg

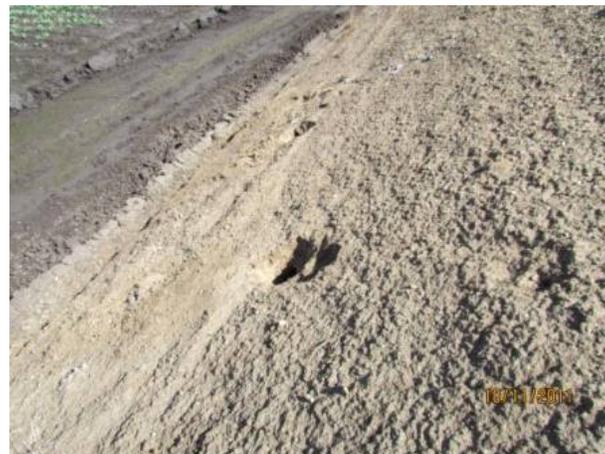
Levee Mile Report Line	31
Start Levee Mile	3.44
End Levee Mile	3.44
Location	Land Side
Category	Earthen Levee
Item	Animal Control
A rodent hole was found on the landside of the levee looking upstream.	
pkazi_f_20111117_213.jpg

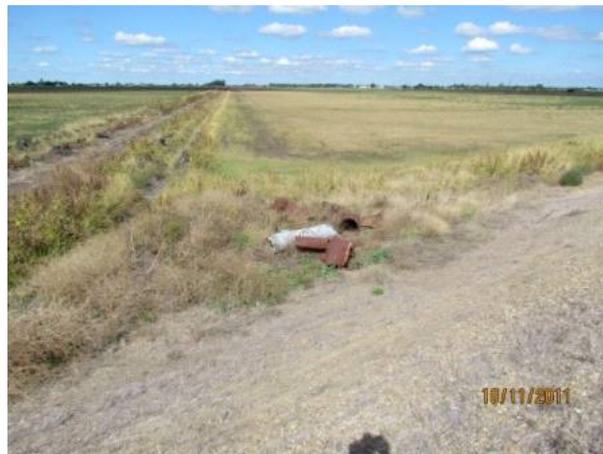
Levee Mile Report Line	35
Start Levee Mile	4.37
End Levee Mile	4.37
Location	Land Side
Category	Earthen Levee
Item	Encroachments
Metal pipes were found on the landside of the levee looking upstream.	
pkazi_f_20111117_216.jpg

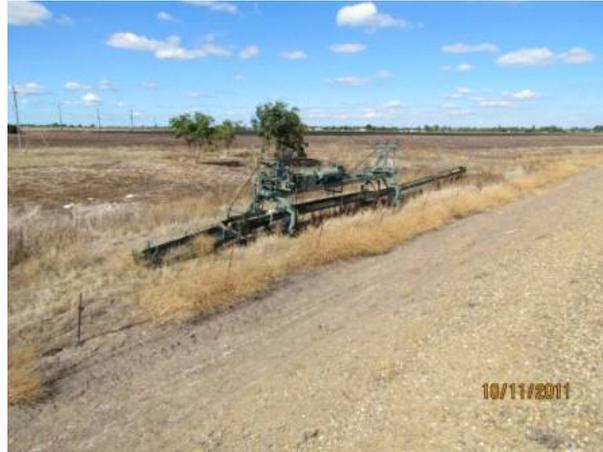
Levee Mile Report Line	37
Start Levee Mile	4.83
End Levee Mile	4.83
Location	Land Side
Category	Earthen Levee
Item	Encroachments
Abandoned equipment was found on the landside of the levee looking upstream.	
pkazi_f_20111117_217.jpg

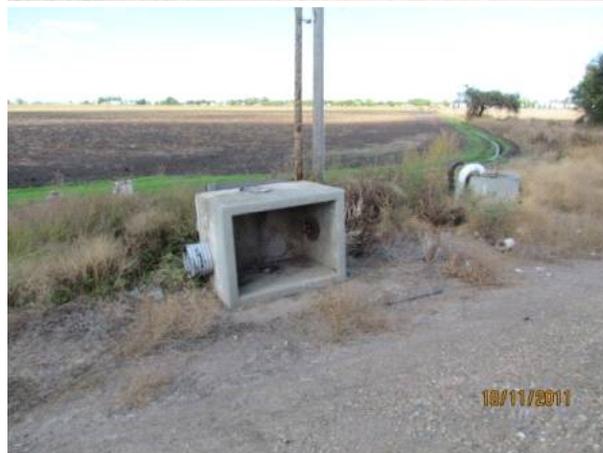
Levee Mile Report Line	40
Start Levee Mile	5.28
End Levee Mile	5.28
Location	Land Side
Category	Earthen Levee
Item	Encroachments
Abandoned culvert joint was found on the landside toe of the levee looking upstream.	
pkazi_f_20111117_219.jpg

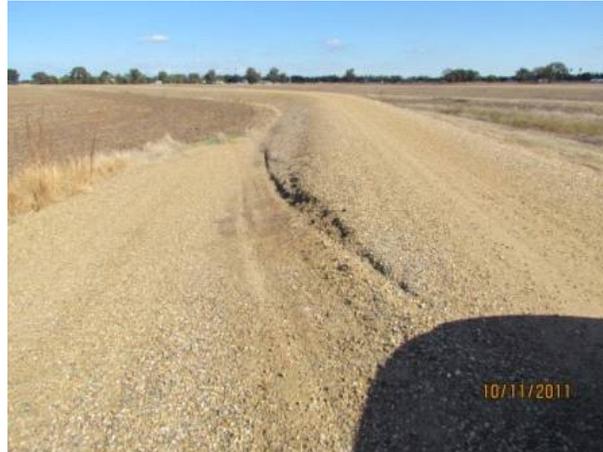
Levee Mile Report Line	43
Start Levee Mile	6.52
End Levee Mile	6.52
Location	Land Side
Category	Earthen Levee
Item	Slope Stability
Slope instability was caused by vehicular traffic on the landside of the levee looking upstream.	
pkazi_f_20111117_220.jpg

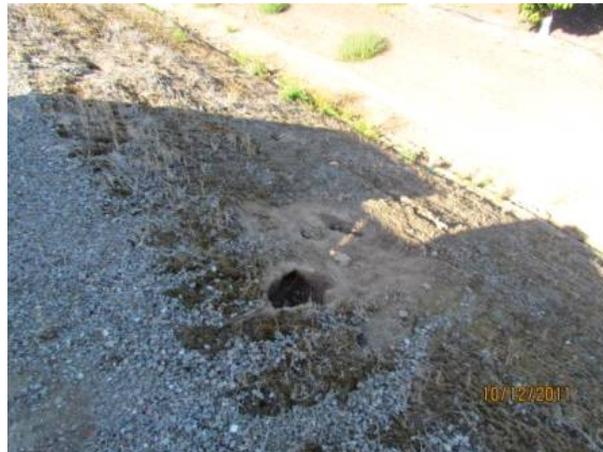
Levee Mile Report Line	45
Start Levee Mile	7.36
End Levee Mile	7.36
Location	Land Side
Category	Earthen Levee
Item	Animal Control
Rodent hole was found on the landside of the levee looking downstream.	
pkazi_f_20111117_222.jpg

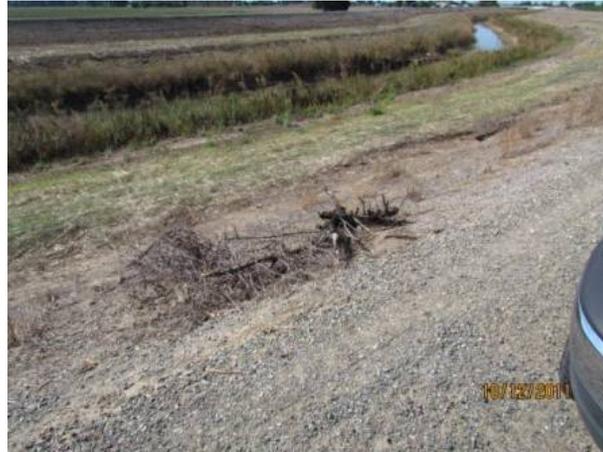
Levee Mile Report Line	47
Start Levee Mile	7.62
End Levee Mile	7.62
Location	Water Side
Category	Earthen Levee
Item	Encroachments
Pruning was found on the waterside of the levee looking downstream.	
pkazi_f_20111117_224.jpg

46	7.50	7.50	Earthen Levee	Slope Stability	LS	M	Repair the levee slope damaged by vehicle traffic and prevent access where possible.	° °	° °	12
47	7.62	7.62	Earthen Levee	Encroachments	WS	M	Prunings	38.064970 ° -121.252926 °	38.064970 ° -121.252926 °	791 Y
48	7.62	7.62	Earthen Levee	Animal Control	LS	M	No rodents visible, but rodent burrows visible; need to backfill and compact or grout burrows.	38.064969 ° -121.252923 °	38.064969 ° -121.252923 °	792 Y
49	7.73	7.73	Earthen Levee	Encroachments	WS	M	Prunings	38.064989 ° -121.250959 °	38.064989 ° -121.250959 °	794 Y
50	7.73	7.73	Earthen Levee	Slope Stability	LS	M	Repair the levee slope damaged by vehicle traffic and prevent access where possible.	38.064989 ° -121.250958 °	38.064989 ° -121.250958 °	793 Y
51	7.78	7.90	Earthen Levee	Vegetation	LS	C	Remove the wild growth other than native grasses from the levee slopes.	38.065182 ° -121.250205 °	38.066167 ° -121.248520 °	60

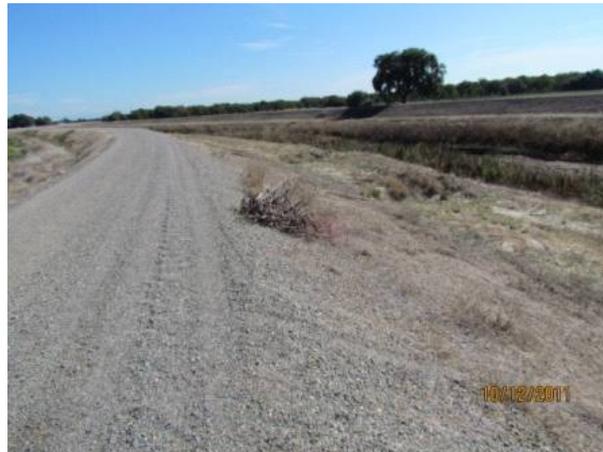
Levee Mile Report Line	49
Start Levee Mile	7.73
End Levee Mile	7.73
Location	Water Side
Category	Earthen Levee
Item	Encroachments
Pruning was found on the waterside of the levee looking upstream.	
pkazi_f_20111117_226.jpg

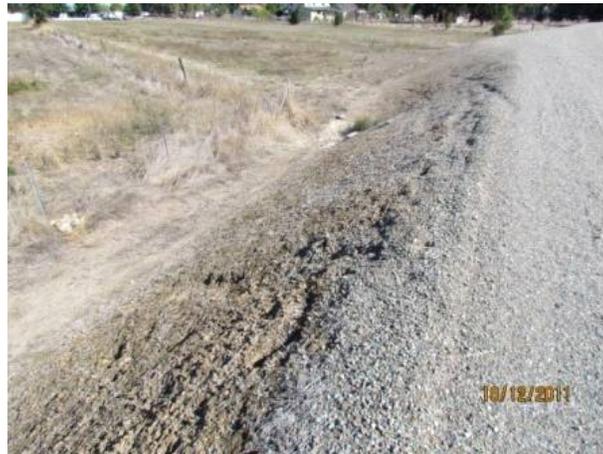
Levee Mile Report Line	53
Start Levee Mile	7.98
End Levee Mile	7.98
Location	Land Side
Category	Earthen Levee
Item	Slope Stability
Slope instability was found on the landside of the levee looking upstream.	
pkazi_f_20111117_228.jpg

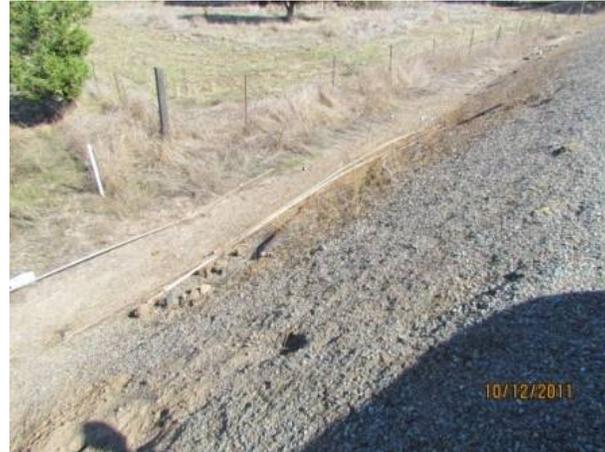
Levee Mile Report Line	54
Start Levee Mile	8.03
End Levee Mile	8.03
Location	Land Side
Category	Earthen Levee
Item	Encroachments
Abandoned irrigation pipe was found on the landside of the levee looking upstream.	
pkazi_f_20111117_229.jpg

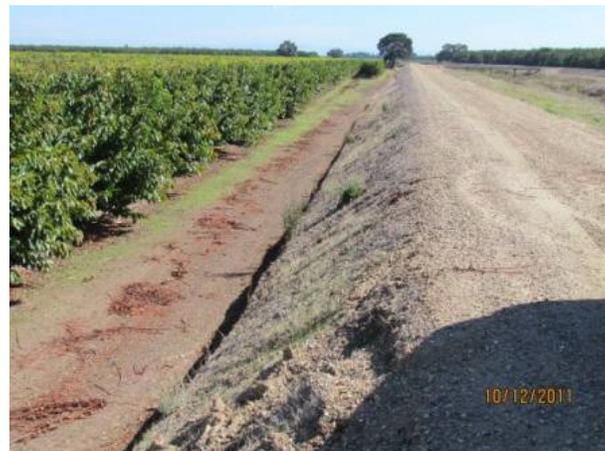
Levee Mile Report Line	56
Start Levee Mile	8.29
End Levee Mile	8.51
Location	Land Side
Category	Earthen Levee
Item	Slope Stability
Farmer is cutting at the toe of landside of the levee and in addition a slope instability issue exists on the slope. The picture was taken from the crown looking upstream.	
pkazi_f_20111117_232.jpg

56	8.29	8.51	Earthen Levee	Slope Stability	LS	M	Repair slope instability. Inspector Comments: Farmer is cutting at the toe of the levee.	38.067459 ° -121.241939 °	38.067475 ° -121.237975 °	800 Y
57	8.29	8.29	Earthen Levee	Encroachments	LS	M	Firewood	38.067457 ° -121.241937 °	38.067457 ° -121.241937 °	799 Y
58	8.87	8.87	Earthen Levee	Encroachments	LS	M	Prunings Inspector Comments: Burn pile has been burned but new material has been placed.	38.068319 ° -121.231559 °	38.068319 ° -121.231559 °	29 Y
59	9.06	9.06	Earthen Levee	Encroachments	LS	M	Prunings Inspector Comments: Burn pile has been burned but new material has been placed.	38.069536 ° -121.228662 °	38.069536 ° -121.228662 °	987 Y
60	9.15	9.15	Earthen Levee	Encroachments	LS	M	Debris Inspector Comments: Ash pile & debris on waterward side of levee.	38.070104 ° -121.227281 °	38.070104 ° -121.227281 °	25 Y
61	9.18	9.18	Earthen Levee	Encroachments	LS	M	Prunings Inspector Comments: Burn pile has been burned but new material has been placed.	38.070231 ° -121.226677 °	38.070231 ° -121.226677 °	31 Y

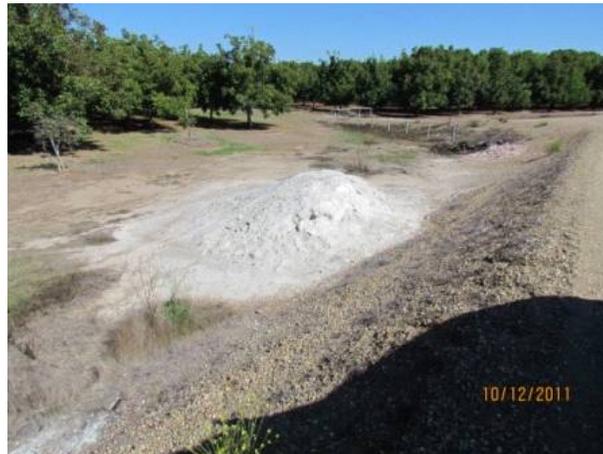
Levee Mile Report Line	60
Start Levee Mile	9.15
End Levee Mile	9.15
Location	Land Side
Category	Earthen Levee
Item	Encroachments
Ash pile was found on the landside of the levee looking upstream.	
pkazi_f_20111117_234.jpg

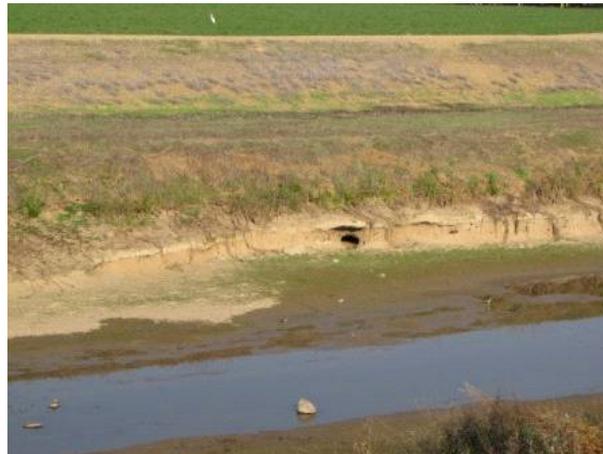
Levee Mile Report Line	66
Start Levee Mile	9.65
End Levee Mile	9.65
Location	Water Side
Category	Earthen Levee
Item	Animal Control
<p>View of a large hole and several smaller holes from across the channel.</p>	
<p>pkazi_f_20110923_602.jpg</p>

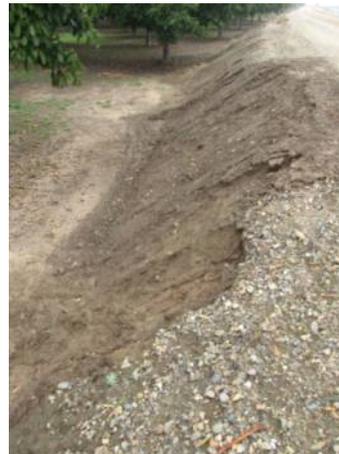
Levee Mile Report Line	71
Start Levee Mile	9.95
End Levee Mile	9.95
Location	Land Side
Category	Earthen Levee
Item	Erosion / Bank Caving
View of erosion occurring on a recent slope repair on the landward slope looking upstream.	
pkazi_f_20110923_606.jpg

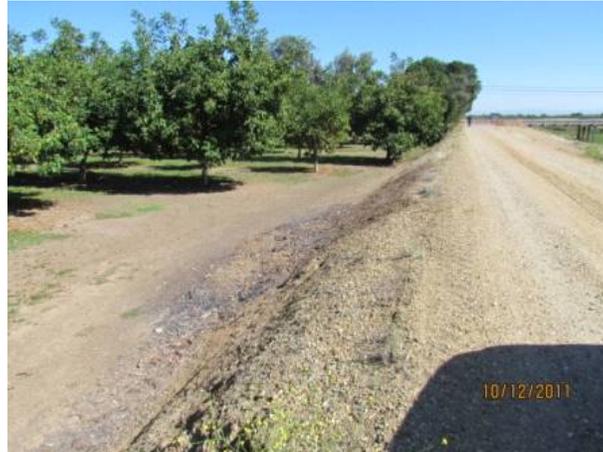
Levee Mile Report Line	72
Start Levee Mile	10.05
End Levee Mile	10.05
Location	Land Side
Category	Earthen Levee
Item	Slope Stability
Slope instability was found on the landside of the levee looking upstream.	
pkazi_f_20111117_238.jpg

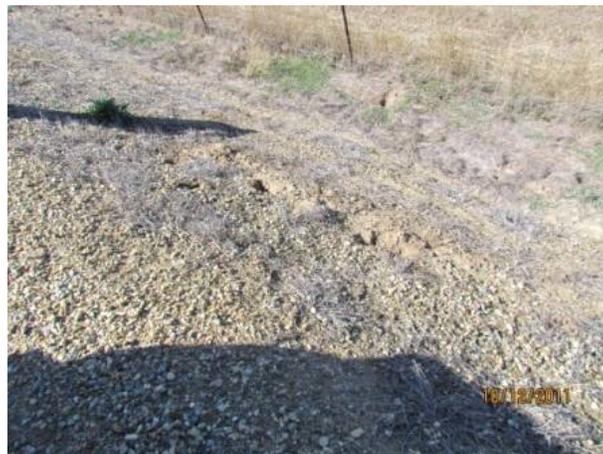
Levee Mile Report Line	78
Start Levee Mile	10.51
End Levee Mile	10.51
Location	Land Side
Category	Earthen Levee
Item	Animal Control
Rodent holes were found on the landside of the levee looking downstream.	
pkazi_f_20111117_240.jpg

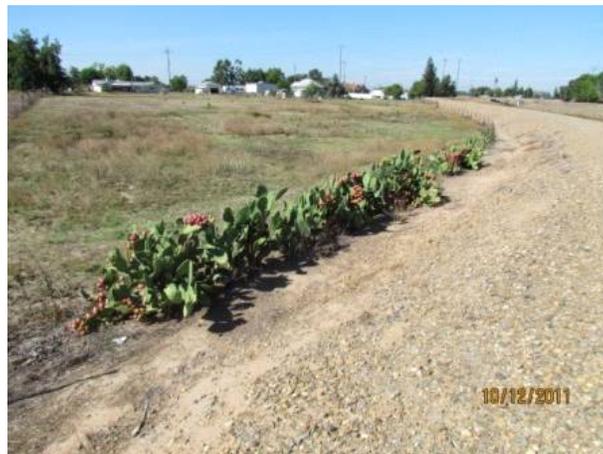
Levee Mile Report Line	83
Start Levee Mile	13.06
End Levee Mile	13.06
Location	Land Side
Category	Earthen Levee
Item	Encroachments
Cacti were found on the toe of landside of the levee looking upstream.	
pkazi_f_20111117_243.jpg

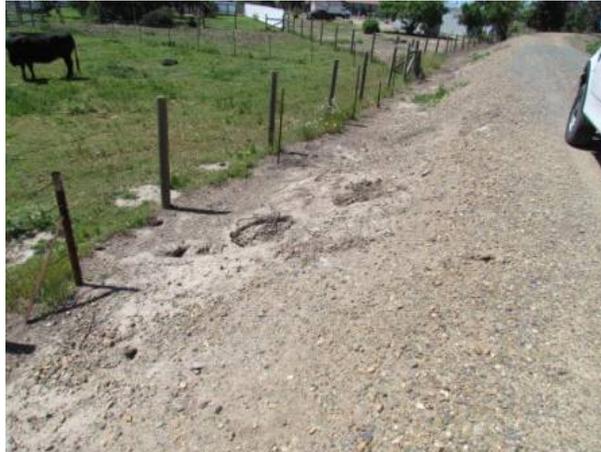
Levee Mile Report Line	84
Start Levee Mile	13.14
End Levee Mile	13.14
Location	Land Side
Category	Earthen Levee
Item	Animal Control
<p>Rodent hole was found on the toe of the landside of the levee during Spring 2011 inspection. The picture was taken from the crown of the levee looking upstream.</p>	
<p>pkazi_f_20110923_597.jpg</p>

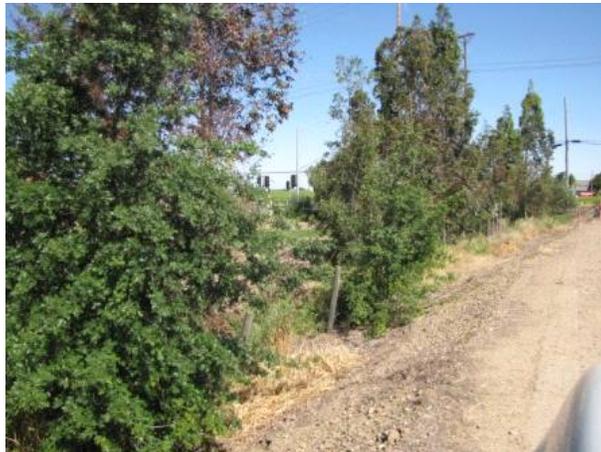
Levee Mile Report Line	85
Start Levee Mile	13.22
End Levee Mile	13.22
Location	Land Side
Category	Earthen Levee
Item	Trim / Thin Trees
<p>View of trees blocking visibility along the landward toe looking upstream.</p>	
<p>pkazi_f_20110923_589.jpg</p>

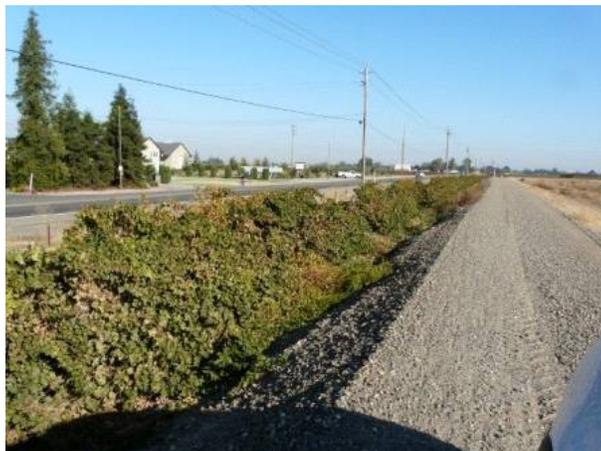
Levee Mile Report Line	86
Start Levee Mile	13.39
End Levee Mile	13.51
Location	Land Side
Category	Earthen Levee
Item	Encroachments
<p>Grape vines within 10' from landside toe of levee from LM 13.39 to 13.51.</p>	
<p>pkazi_f_20110923_586.JPG</p>

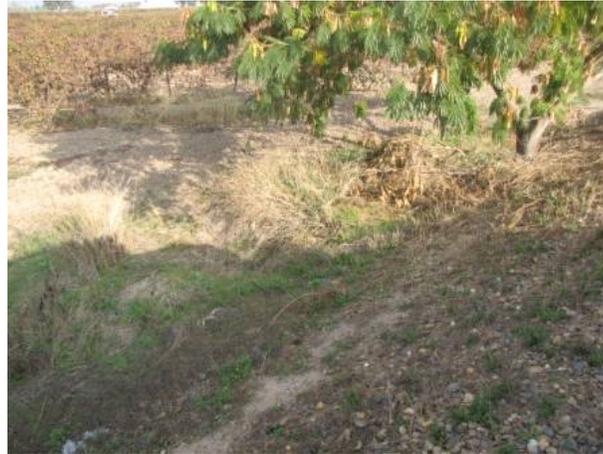
pkazi_f_20110923_598.jpg

View of a pit along the landward levee toe looking upstream.

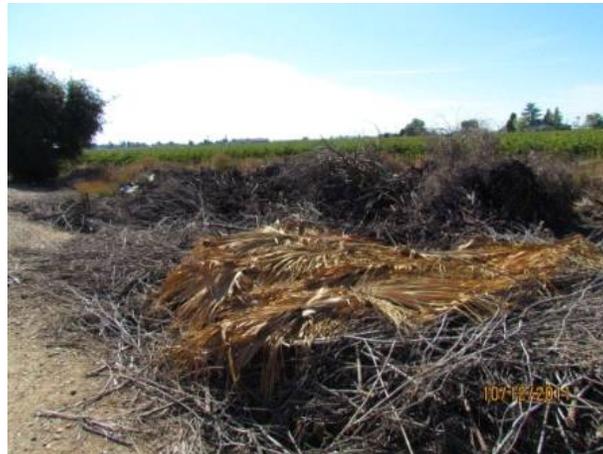
pkazi_f_20111117_244.jpg

Pruning and debris were found on the landside of the levee looking downstream.

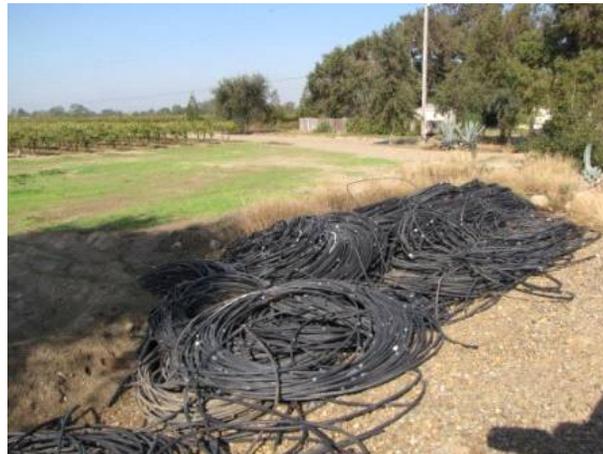
pkazi_f_20110923_607.jpg

View of irrigation pipe on the landward slope.

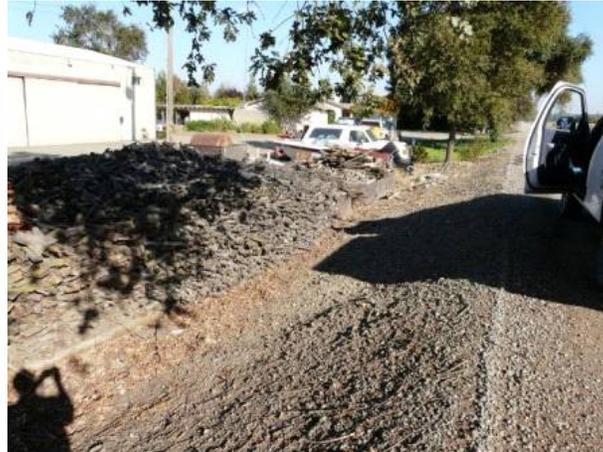
Levee Mile Report Line	91
Start Levee Mile	14.08
End Levee Mile	14.08
Location	Land Side
Category	Earthen Levee
Item	Encroachments
Move firewood to outside of 10' from landside toe of levee at LM 14.08.	
pkazi_f_20110923_587.JPG

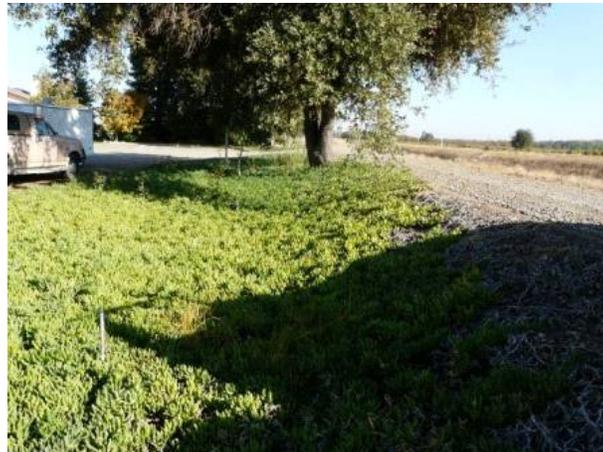
Levee Mile Report Line	92
Start Levee Mile	14.09
End Levee Mile	14.13
Location	Land Side
Category	Earthen Levee
Item	Encroachments
Landscaping on landside of levee from LM 14.09 to LM 14.13.	
pkazi_f_20110923_588.JPG

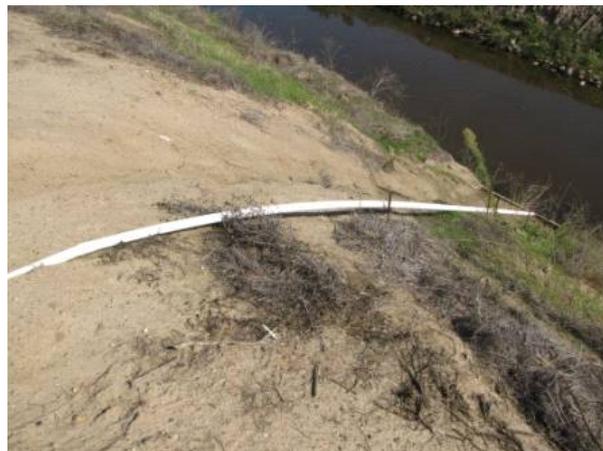
Levee Mile Report Line	95
Start Levee Mile	14.77
End Levee Mile	14.77
Location	Water Side
Category	Earthen Levee
Item	Encroachments
View of a pipe a landowner placed in the access road and waterward slope to pump water from the channel to irrigate their garden.	
pkazi_f_20110923_608.jpg

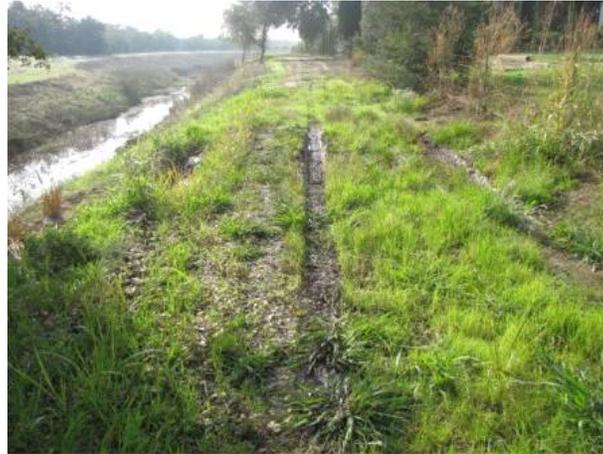
Levee Mile Report Line	96
Start Levee Mile	14.89
End Levee Mile	14.89
Location	Water Side
Category	Earthen Levee
Item	Crown Surface / Depressions / Rutting
View of a saturated portion of the access road with rutting, especially at the waterward hinge looking downstream.	
pkazi_f_20110923_599.jpg

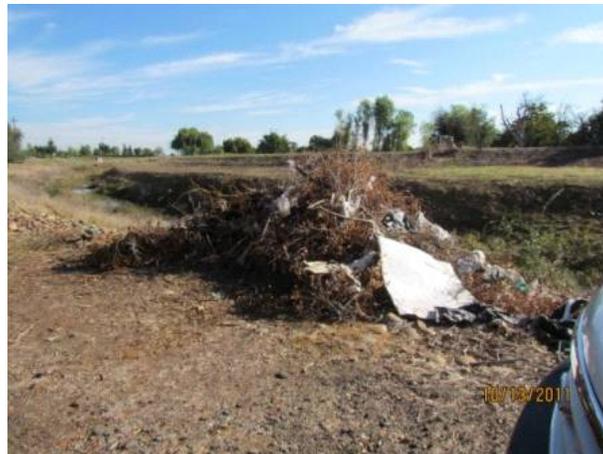
Levee Mile Report Line	97
Start Levee Mile	14.90
End Levee Mile	14.90
Location	Water Side
Category	Earthen Levee
Item	Encroachments
Pruning was found on the waterside of the levee looking upstream.	
pkazi_f_20111117_245.jpg

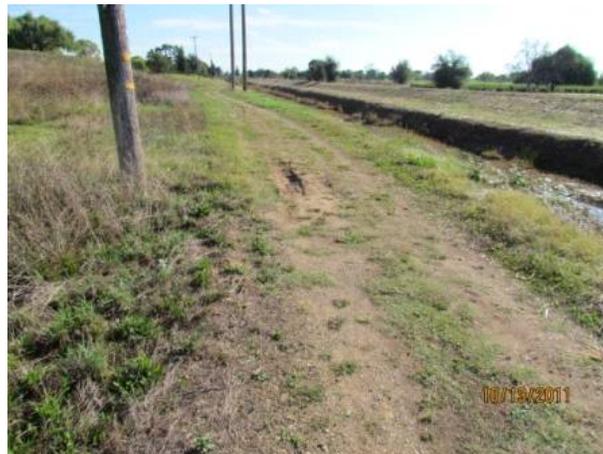
Levee Mile Report Line	99
Start Levee Mile	15.16
End Levee Mile	15.16
Location	Crown
Category	Earthen Levee
Item	Crown Surface / Depressions / Rutting
Depression was found on the crown of the levee looking upstream.	
pkazi_f_20111117_246.jpg

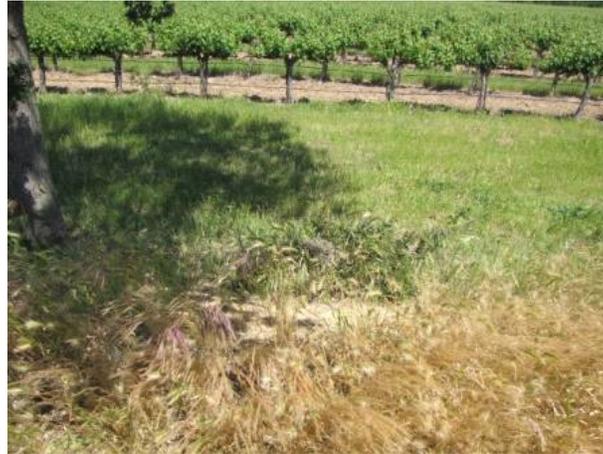
pkazi_f_20110923_592.jpg

View of a stump in the landward slope.

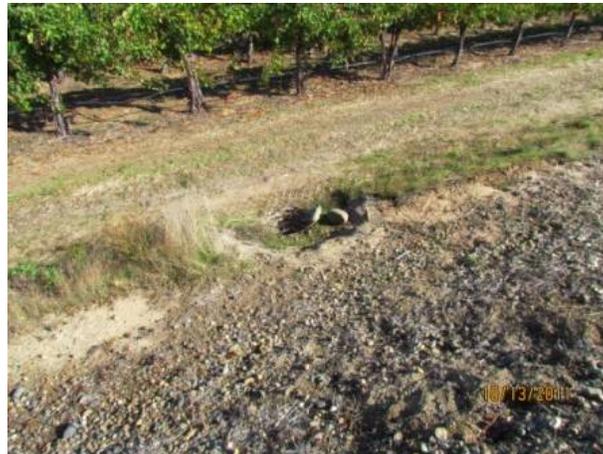
pkazi_f_20111117_247.jpg

Drain was found at the toe of landside of the levee. The picture was taken from the crown looking towards the toe.

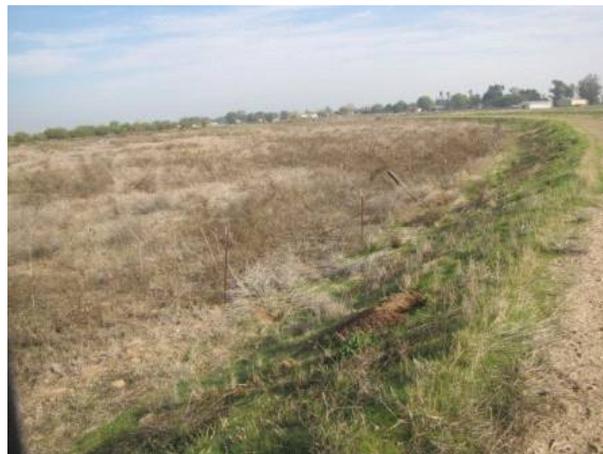
pkazi_f_20110923_600.jpg

View of rodent activity along the landward slope looking upstream.
