**Flood Control Project Maintenance
Levee Inspections**

Fall 2011 Levee Maintenance Deficiency Summary Report

San Joaquin River Basin

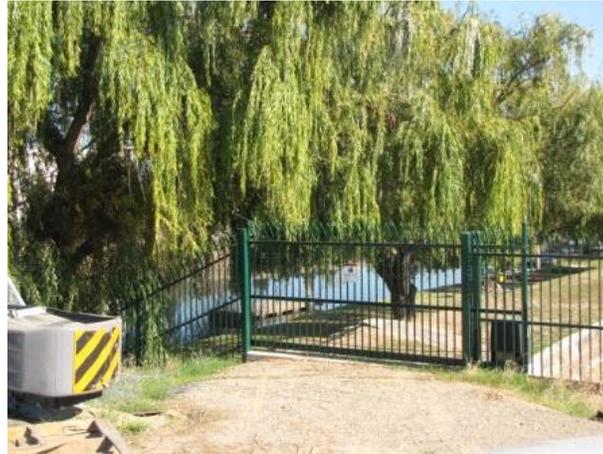
pkazi_f_20110923_546.jpg

View of a open fence and gate across the crown at the current start of the unit looking upstream. Limited access has been provided.

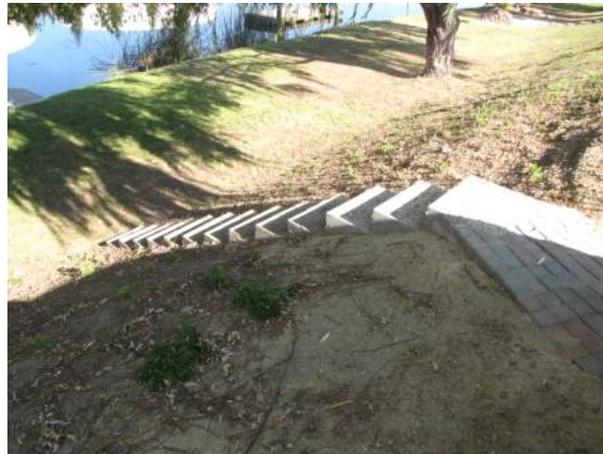
pkazi_f_20110923_547.jpg

View of steps on the waterward slope of the levee looking upstream.

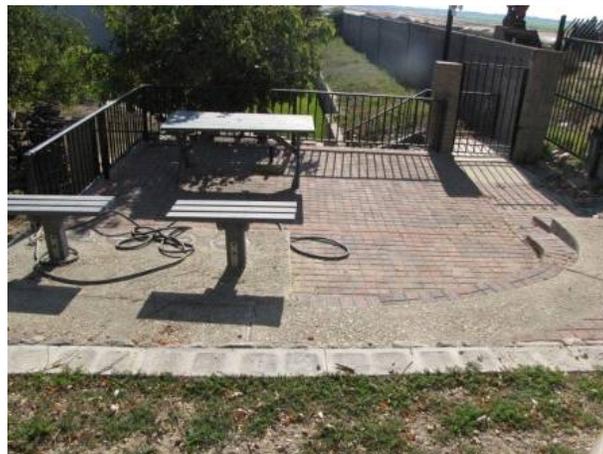
pkazi_f_20110923_548.jpg

View of a patio with table, benches, and irrigation on the landward side of the levee.

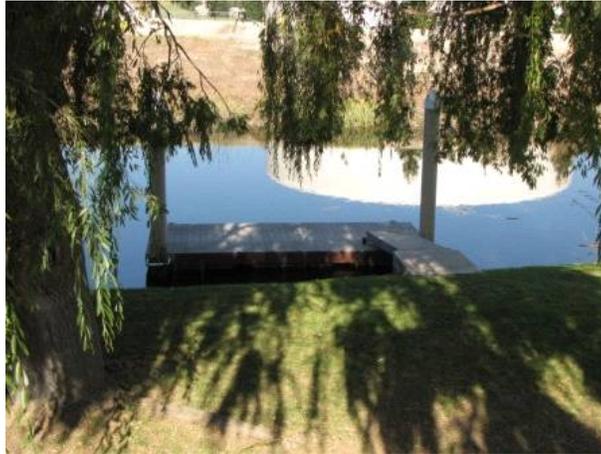
pkazi_f_20110923_549.jpg

View of a dock off the waterward berm.

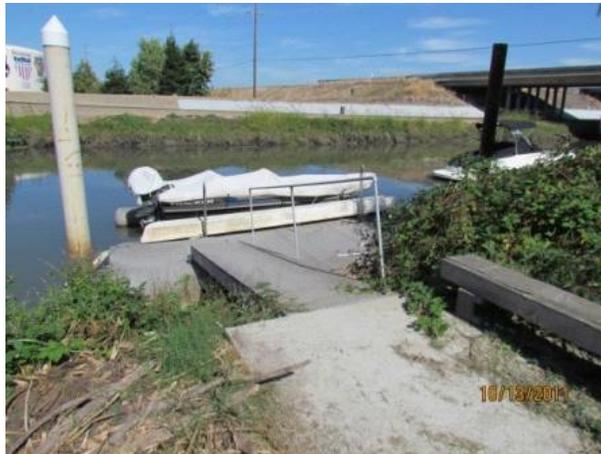
pkazi_f_20111120_237.jpg

View of the dock at the waterside of the levee during fall 2011 inspection. The picture was taken from the crown looking upstream.

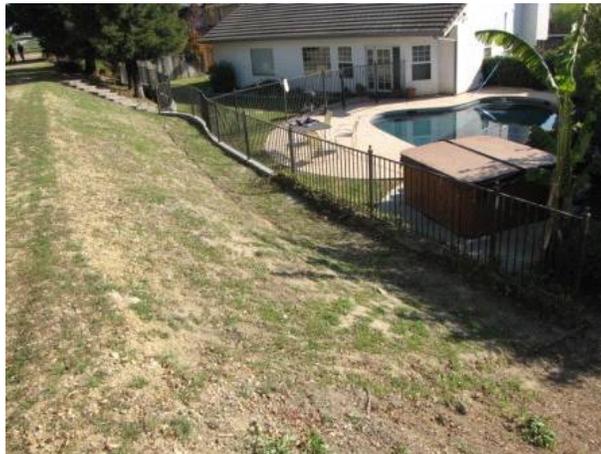
pkazi_f_20110923_550.jpg

View of a fence on top of a retaining wall in the landward toe of the levee. Some landscaping and irrigation are also present.

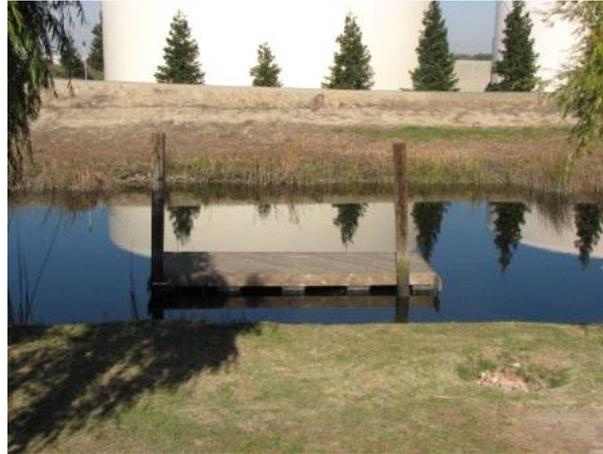
pkazi_f_20110923_551.jpg

View of a dock off the waterward side of the berm.

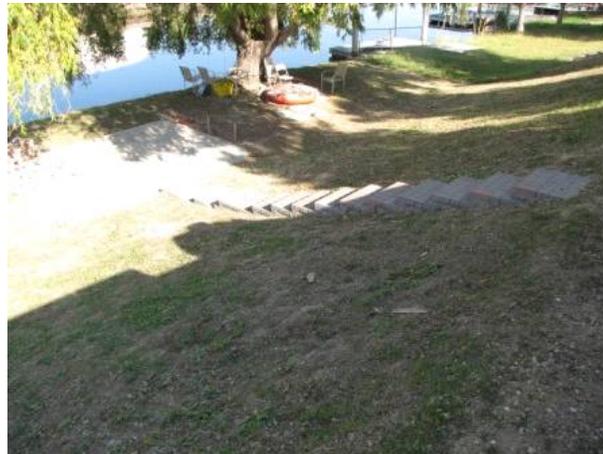
pkazi_f_20110923_552.jpg

View of stairs and patio on the waterward slope and berm looking upstream.

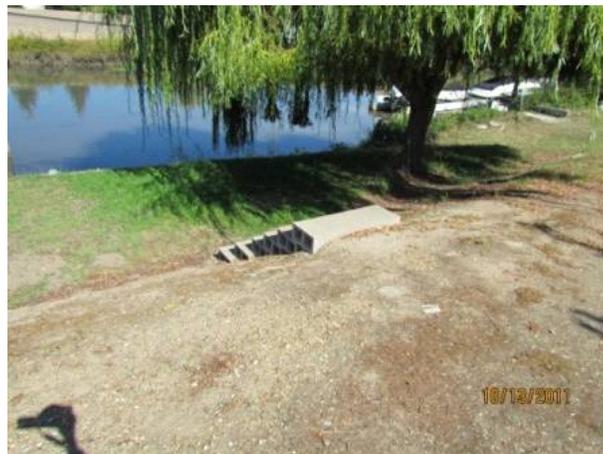
pkazi_f_20111120_238.jpg

Stairway on the waterside slope of the levee during fall 2011 inspection.

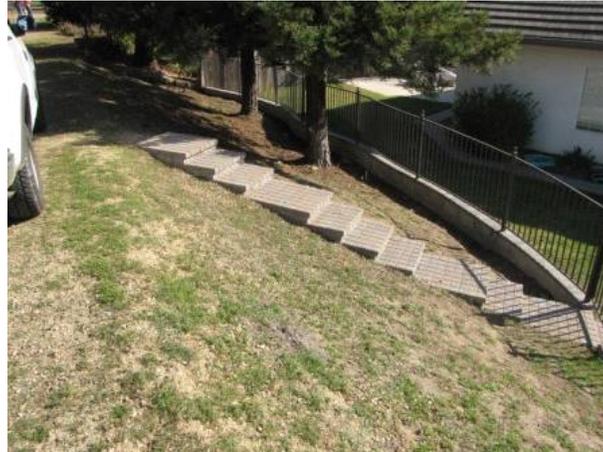
Levee Mile Report Line	8
Start Levee Mile	0.80
End Levee Mile	0.80
Location	Land Side
Category	Earthen Levee
Item	Encroachments
View of steps on the landward slope looking upstream.	
pkazi_f_20110923_561.jpg

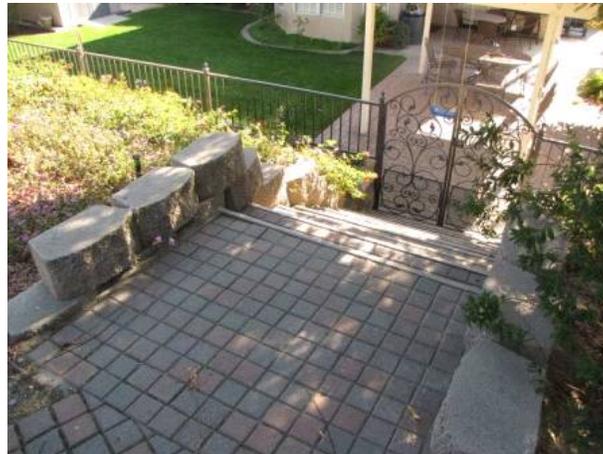
Levee Mile Report Line	9
Start Levee Mile	0.81
End Levee Mile	0.81
Location	Land Side
Category	Earthen Levee
Item	Encroachments
View of steps on the landward slope.	
pkazi_f_20110923_555.jpg

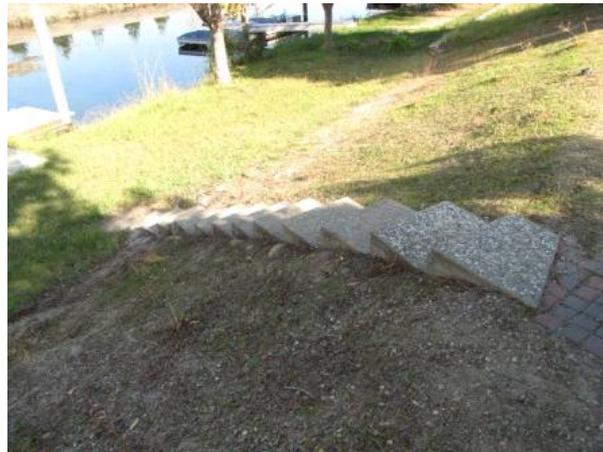
Levee Mile Report Line	10
Start Levee Mile	0.81
End Levee Mile	0.81
Location	Water Side
Category	Earthen Levee
Item	Encroachments
View of steps on the waterward slope looking upstream.	
pkazi_f_20110923_556.jpg

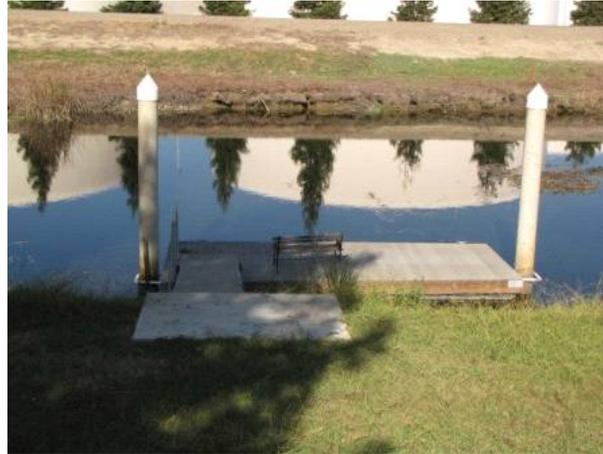
pkazi_f_20110923_557.jpg

View of a dock on the waterward side of the berm.

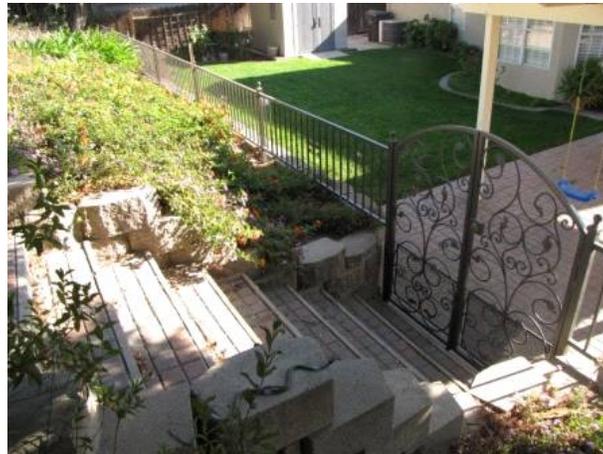
pkazi_f_20110923_553.jpg

View of a open fence on a retaining wall in the landward toe of the levee looking upstream.

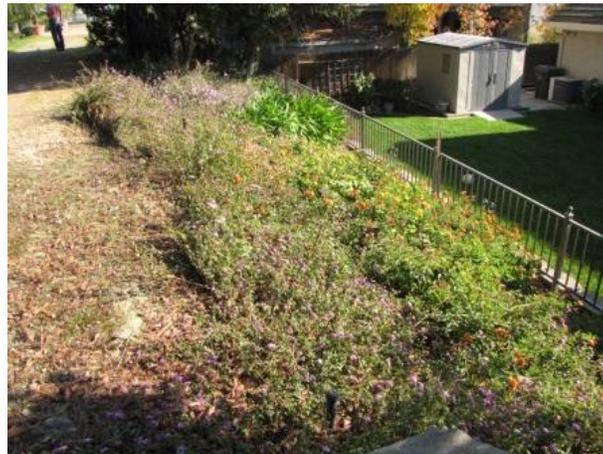
pkazi_f_20110923_554.jpg

View of landscaping obstructing visibility and access and irrigation along the landward slope looking upstream.

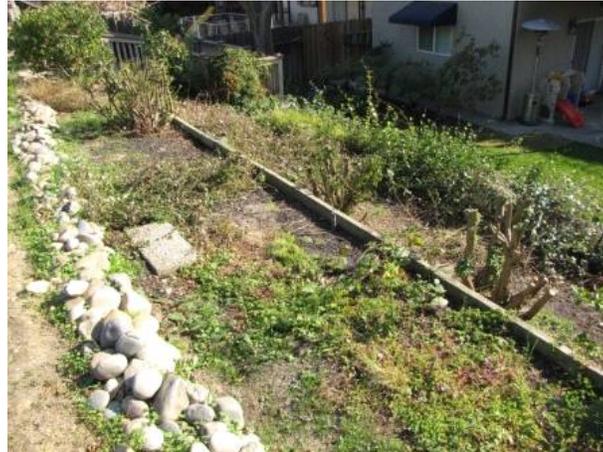
pkazi_f_20110923_558.jpg

View of landscaping and irrigation along the landward slope looking upstream.

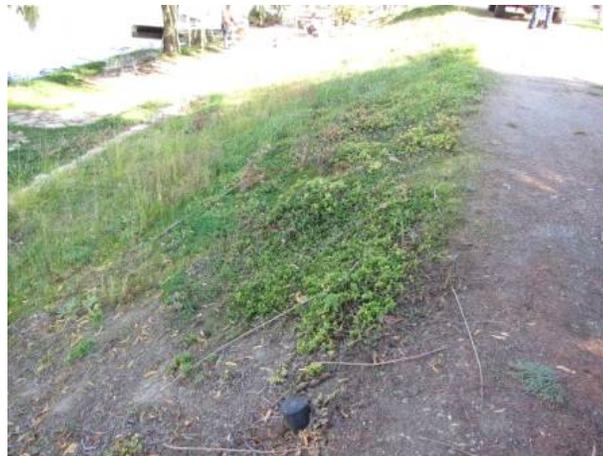
pkazi_f_20110923_559.jpg

View of landscaping and irrigation on the waterward slope looking upstream.

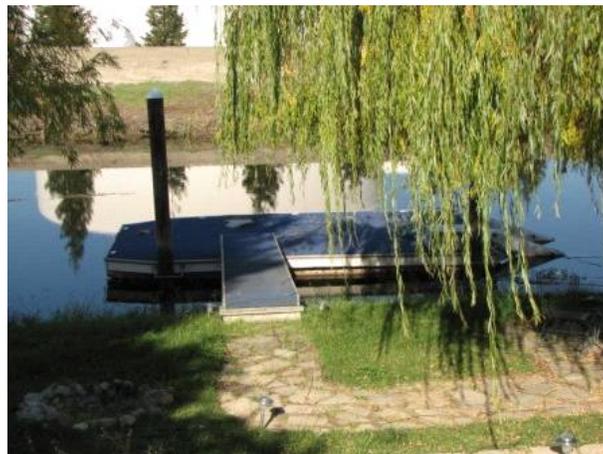
pkazi_f_20110923_560.jpg

View of a dock and pathway on the waterward side of the berm.

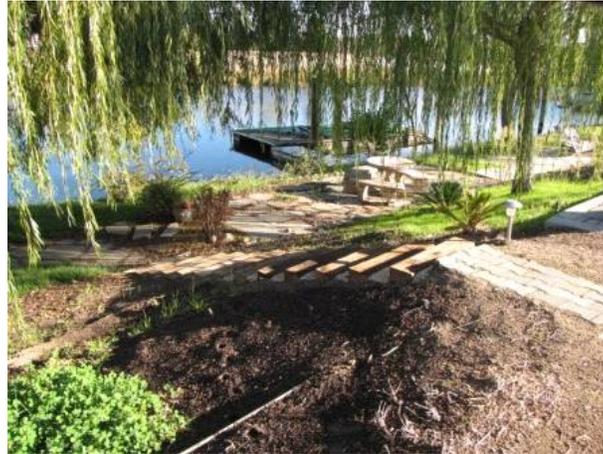
Levee Mile Report Line	18
Start Levee Mile	0.83
End Levee Mile	0.83
Location	Land Side
Category	Earthen Levee
Item	Encroachments
View of recently modified steps on the waterward slope of the levee looking upstream.	
pkazi_f_20110923_488.jpg

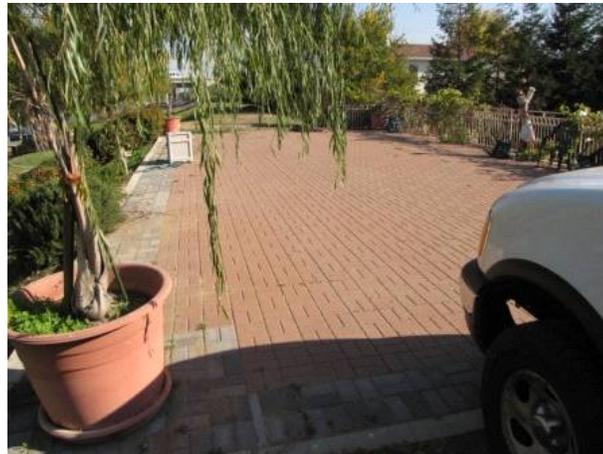
Levee Mile Report Line	19
Start Levee Mile	0.83
End Levee Mile	0.84
Location	Crown
Category	Earthen Levee
Item	Encroachments
View of pavers placed on the crown of the levee looking upstream. Potted landscaping and irrigation can also be seen.	
pkazi_f_20110923_562.jpg

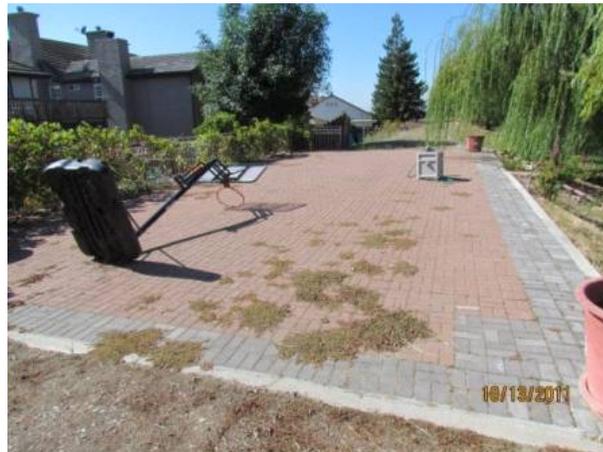
Levee Mile Report Line	19
Start Levee Mile	0.83
End Levee Mile	0.84
Location	Crown
Category	Earthen Levee
Item	Encroachments
View of a paved placed on the crown looking downstream. This picture was taken during fall 2011 inspection.	
pkazi_f_20111120_239.jpg

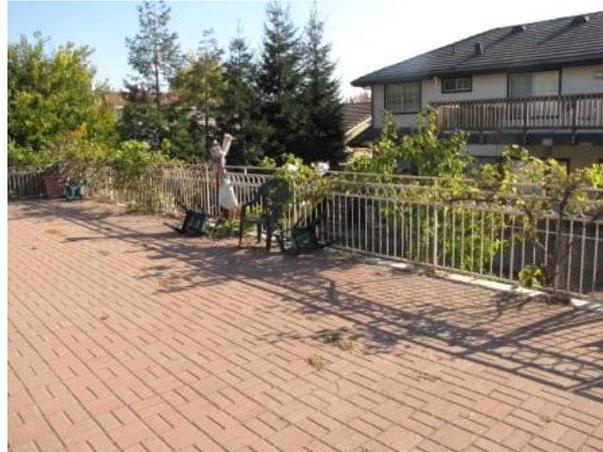
Levee Mile Report Line	20
Start Levee Mile	0.83
End Levee Mile	0.84
Location	Land Side
Category	Earthen Levee
Item	Encroachments
View of a fence on top of a large retaining wall in the landward slope looking upstream. Landscaping is growing along the fence.	
pkazi_f_20110923_563.jpg

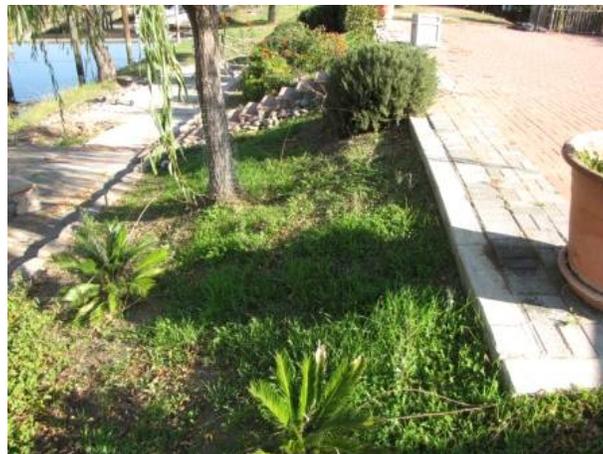
Levee Mile Report Line	21
Start Levee Mile	0.83
End Levee Mile	0.84
Location	Water Side
Category	Earthen Levee
Item	Encroachments
View of landscaping and irrigation on the waterward slope looking upstream.	
pkazi_f_20110923_565.jpg

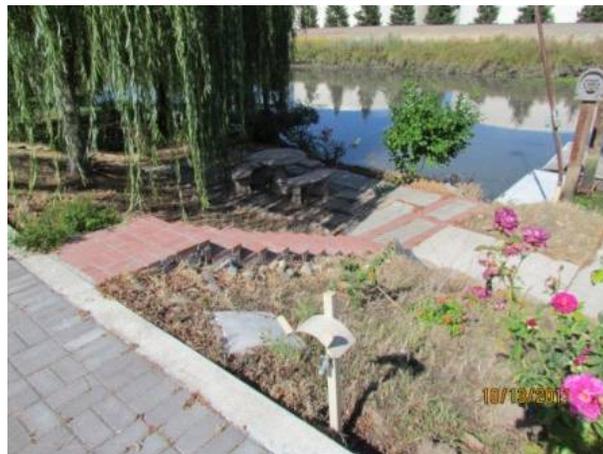
Levee Mile Report Line	21
Start Levee Mile	0.83
End Levee Mile	0.84
Location	Water Side
Category	Earthen Levee
Item	Encroachments
View of the landscaping on the waterside of the levee looking downstream. This picture was taken during fall 2011 inspection.	
pkazi_f_20111120_240.jpg

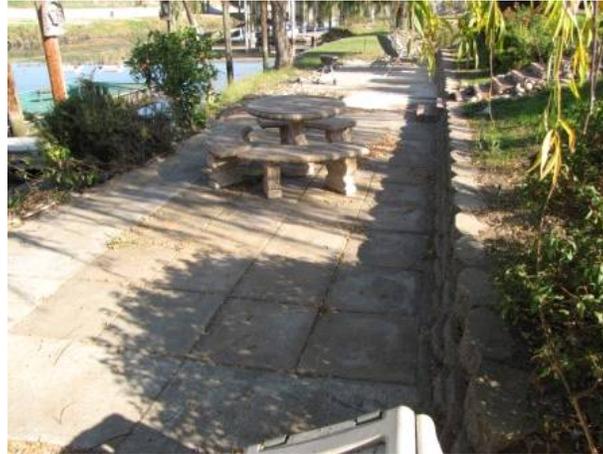
pkazi_f_20110923_566.jpg

View of a retaining wall and patio with furniture in the waterward toe and berm looking upstream.

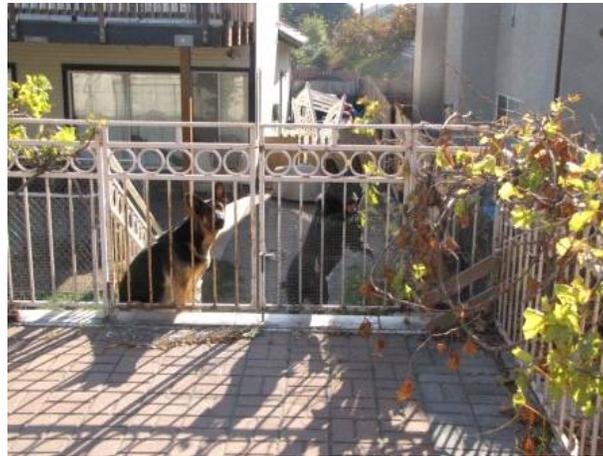
pkazi_f_20110923_564.jpg

View of steps on the landward slope and dogs preventing a closer inspection.

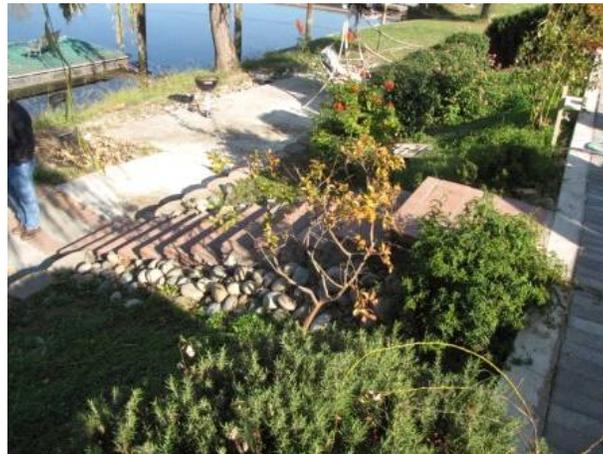
pkazi_f_20110923_567.jpg

View of steps on the waterward slope of the levee looking upstream.

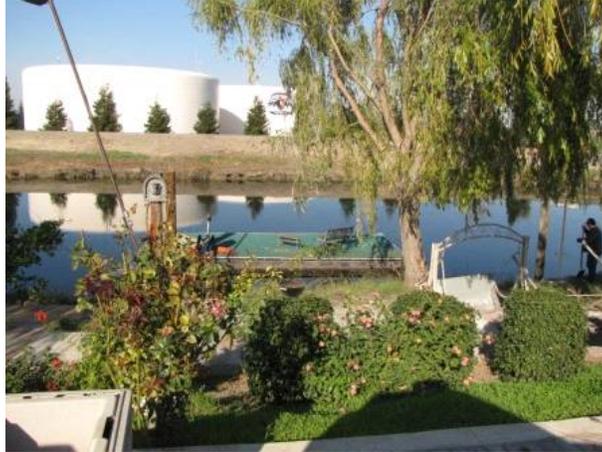
pkazi_f_20110923_568.jpg

View of a dock on the waterward side of the berm.

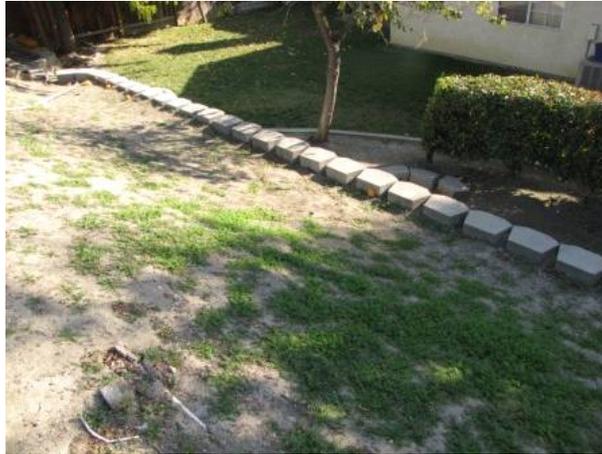
pkazi_f_20110923_569.jpg

View of a retaining wall in the landward slope.

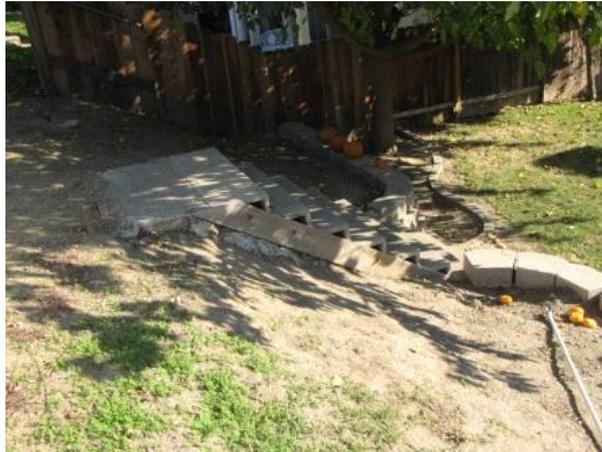
pkazi_f_20110923_570.jpg

View of steps on the landward slope looking upstream.

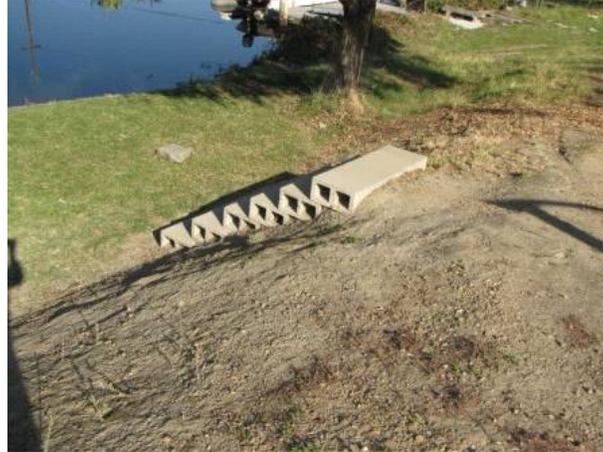
Levee Mile Report Line	28
Start Levee Mile	0.85
End Levee Mile	0.85
Location	Water Side
Category	Earthen Levee
Item	Encroachments
View of steps on the waterward slope looking upstream.	
pkazi_f_20110923_571.jpg

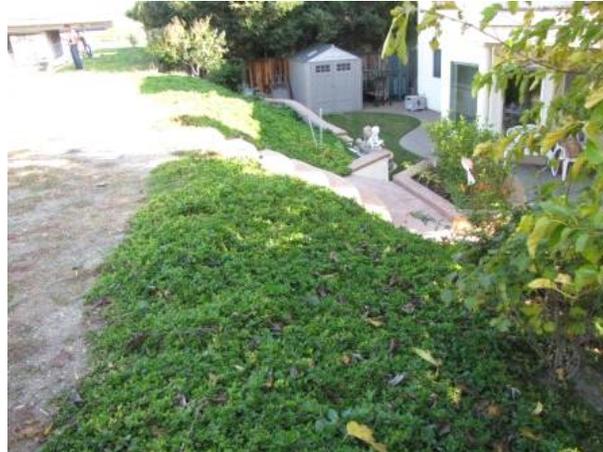
Levee Mile Report Line	29
Start Levee Mile	0.85
End Levee Mile	0.87
Location	Land Side
Category	Earthen Levee
Item	Encroachments
View of landscaping and irrigation on the landward slope looking upstream.	
pkazi_f_20110923_572.jpg

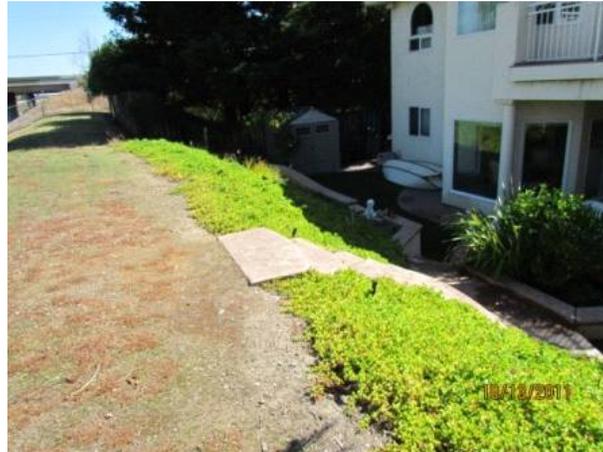
Levee Mile Report Line	29
Start Levee Mile	0.85
End Levee Mile	0.87
Location	Land Side
Category	Earthen Levee
Item	Encroachments
View of landscaping on the landside of the levee looking upstream. This picture was taken during fall 2011 inspection.	
pkazi_f_20111120_241.jpg

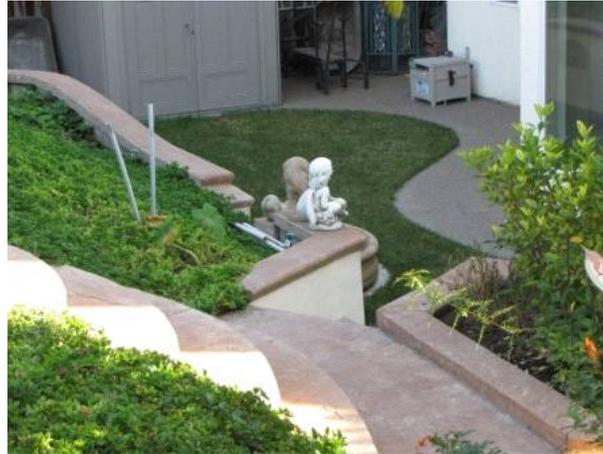
pkazi_f_20110923_573.jpg

View of a retaining wall and patio in the landward slope.

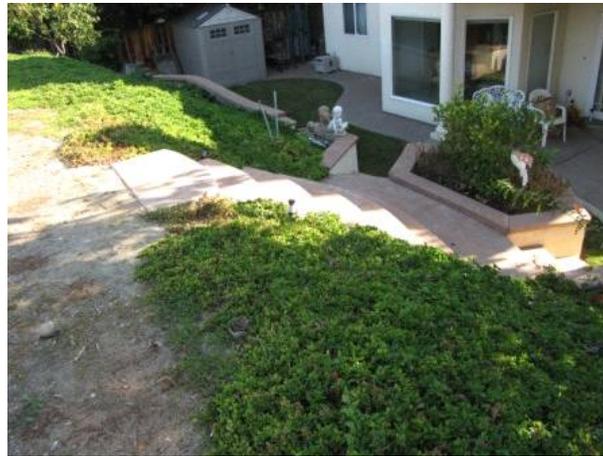
pkazi_f_20110923_574.jpg

View of steps on the landward slope looking upstream.

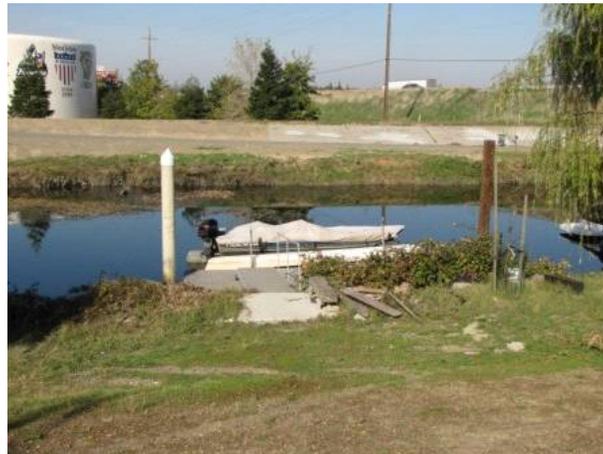
pkazi_f_20110923_575.jpg

View of a dock and concrete pad on the waterward side of the berm.

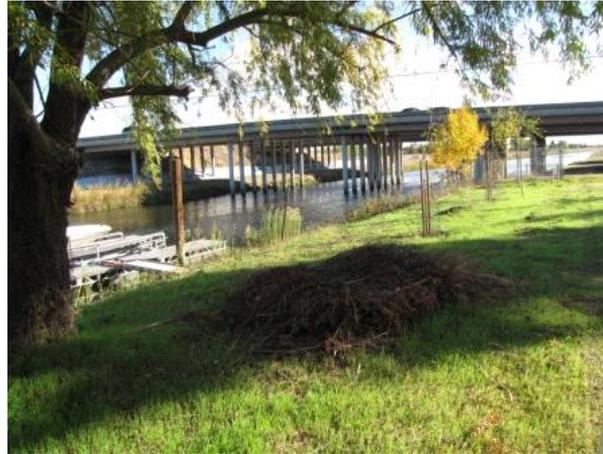
Levee Mile Report Line	33
Start Levee Mile	0.87
End Levee Mile	0.87
Location	Water Side
Category	Earthen Levee
Item	Encroachments
View of a prunings pile on the waterward berm looking upstream.	
pkazi_f_20110923_489.jpg

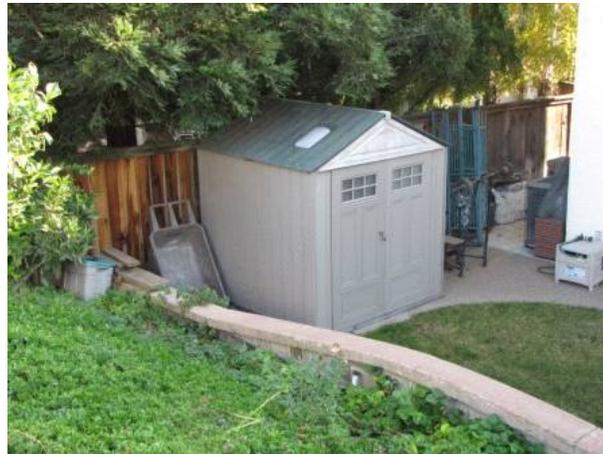
Levee Mile Report Line	34
Start Levee Mile	0.87
End Levee Mile	0.87
Location	Land Side
Category	Earthen Levee
Item	Encroachments
View of a shed located at the landward toe looking upstream.	
pkazi_f_20110923_576.jpg

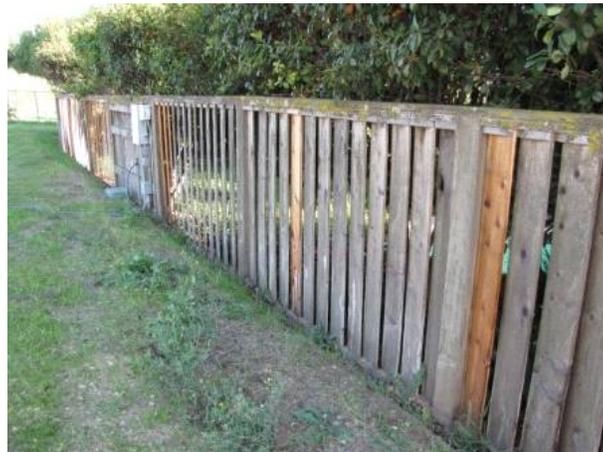
Levee Mile Report Line	35
Start Levee Mile	0.87
End Levee Mile	0.88
Location	Land Side
Category	Earthen Levee
Item	Encroachments
View of a fence at the landward shoulder blocking visibility and access looking upstream. Some encroachments can be seen through the fence but not with any detail. Also visible is an electrical panel and hose bib.	
pkazi_f_20110923_577.jpg

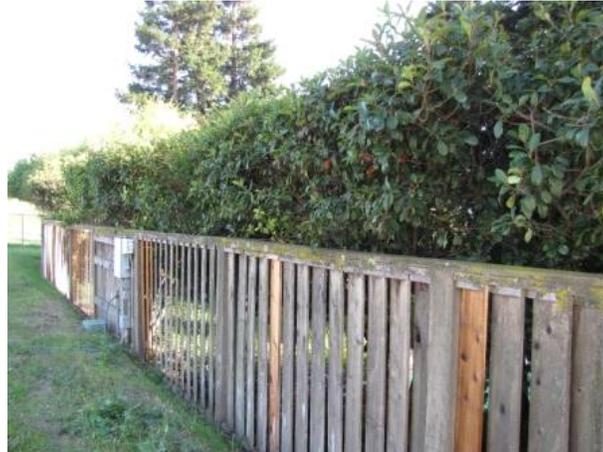
Levee Mile Report Line	36
Start Levee Mile	0.87
End Levee Mile	0.88
Location	Land Side
Category	Earthen Levee
Item	Encroachments
View of bushes above the fence at the landward shoulder further obstructing visibility looking upstream.	
pkazi_f_20110923_578.jpg

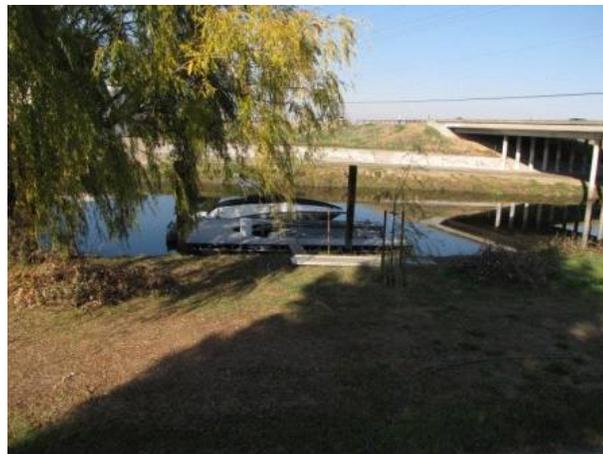
Levee Mile Report Line	37
Start Levee Mile	0.88
End Levee Mile	0.88
Location	Water Side
Category	Earthen Levee
Item	Encroachments
View of a dock on the waterward side of the berm.	
pkazi_f_20110923_579.jpg

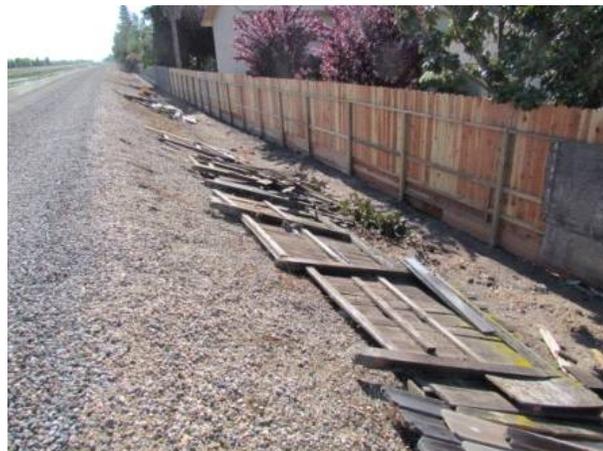
Levee Mile Report Line	38
Start Levee Mile	1.05
End Levee Mile	1.07
Location	Land Side
Category	Earthen Levee
Item	Encroachments
Picture of the old wood fences along with some debris on the landside of the levee. The picture was taken from the crown of the levee looking upstream.	
pkazi_f_20110923_491.jpg

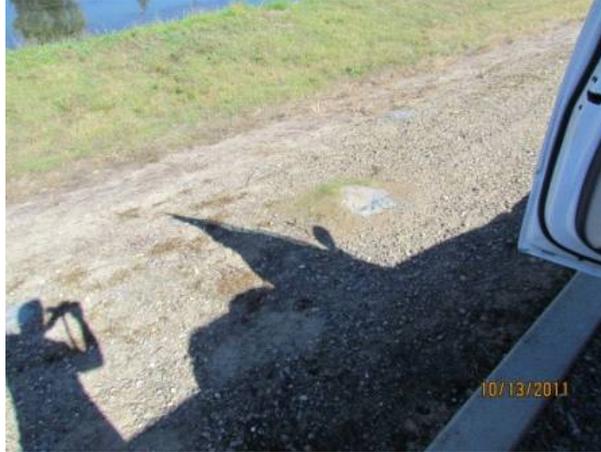
Levee Mile Report Line	40
Start Levee Mile	1.41
End Levee Mile	1.41
Location	Water Side
Category	Earthen Levee
Item	Animal Control
View of fixed rodent holes on the waterside of the levee looking upstream.	
pkazi_f_20111120_242.jpg

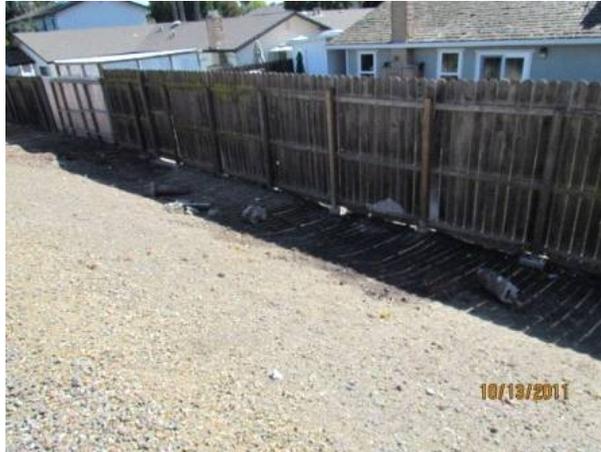
Levee Mile Report Line	41
Start Levee Mile	1.43
End Levee Mile	1.43
Location	Land Side
Category	Earthen Levee
Item	Encroachments
View of broken concrete debris on the landside of the levee looking upstream.	
pkazi_f_20111120_243.jpg

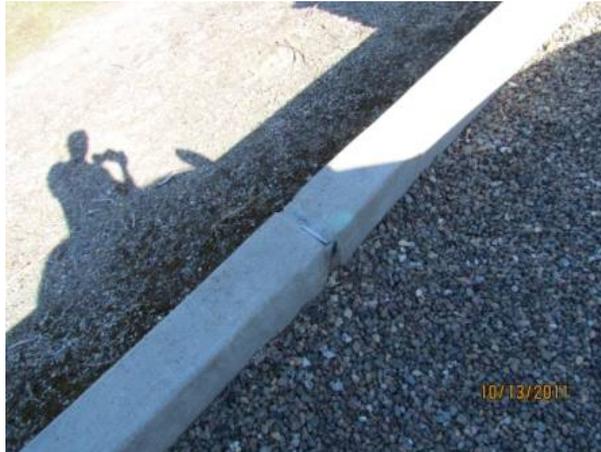
Levee Mile Report Line	45
Start Levee Mile	1.73
End Levee Mile	1.73
Location	Water Side
Category	Concrete Floodwalls
Item	Monolith Joints
Monolith joint material is deteriorating at the joint of the flood wall. The picture was taken from the crown looking upstream.	
pkazi_f_20111120_244.jpg

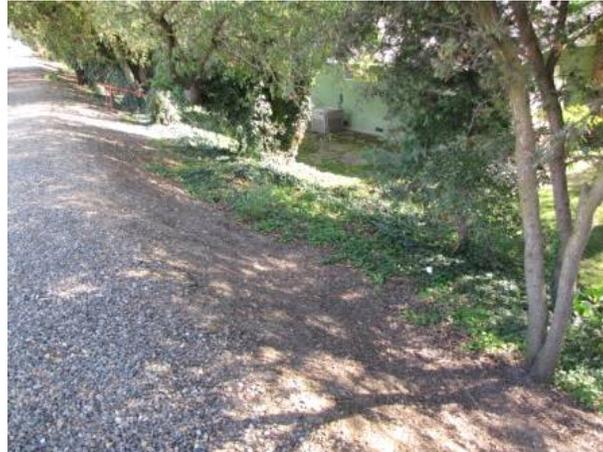
Levee Mile Report Line	47
Start Levee Mile	2.04
End Levee Mile	2.07
Location	Land Side
Category	Earthen Levee
Item	Encroachments
View of landscaping along the landward slope looking upstream. County crews have greatly reduced the amount of material and increased visibility and access.	
pkazi_f_20110923_535.jpg

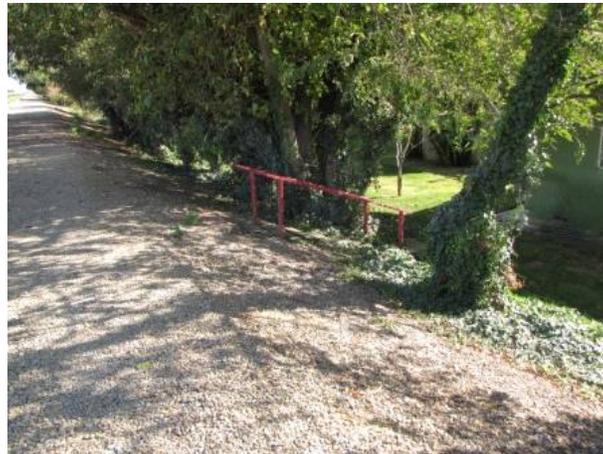
Levee Mile Report Line	48
Start Levee Mile	2.06
End Levee Mile	2.06
Location	Land Side
Category	Earthen Levee
Item	Encroachments
View of steps dug into the landward slope looking upstream.	
pkazi_f_20110923_536.jpg

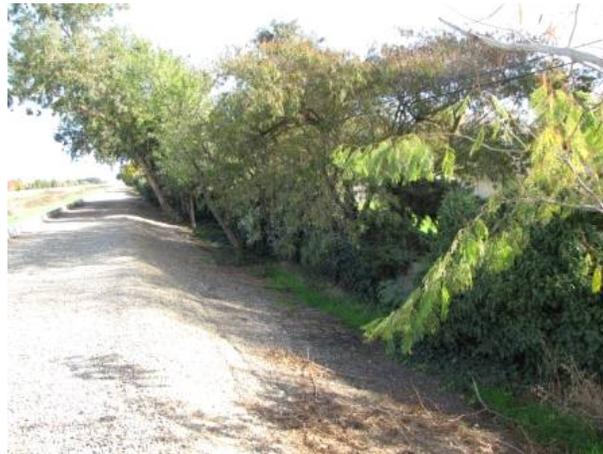
Levee Mile Report Line	49
Start Levee Mile	2.11
End Levee Mile	2.14
Location	Land Side
Category	Earthen Levee
Item	Encroachments
View of a fence with landscaping growing on it at the landward toe looking upstream.	
pkazi_f_20110923_537.jpg

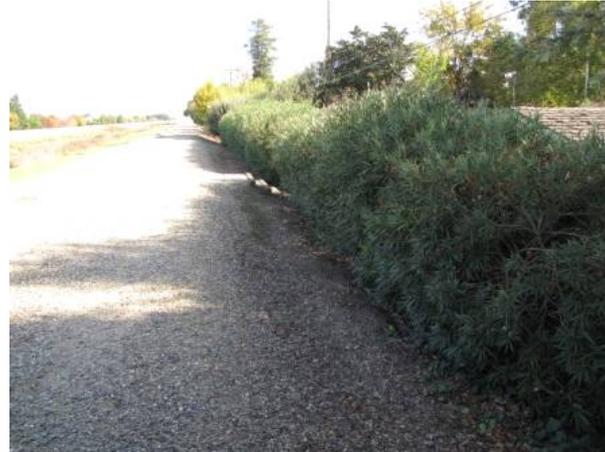
pkazi_f_20110923_538.jpg

51	2.17	2.19	Earthen Levee	Encroachments	LS	CO	Fences Inspector Comments: Wood fence on landward toe.	38.042779 ° -121.345119 °	38.042775 ° -121.344777 °	1011 Y
52	2.19	2.19	Earthen Levee	Slope Stability	LS	M	Repair the levee slope damaged by foot traffic and prevent access where possible.	38.042760 ° -121.344784 °	38.042760 ° -121.344784 °	38 Y
53	2.19	2.25	Earthen Levee	Encroachments	LS	CO	Fences Inspector Comments: Wood fence on landward toe.	38.042775 ° -121.344777 °	38.042773 ° -121.343691 °	1012 Y
54	2.25	2.30	Earthen Levee	Encroachments	LS	CO	Fences Inspector Comments: Wood fence on the landward slope.	38.042764 ° -121.343690 °	38.042765 ° -121.342620 °	1018 Y
55	2.30	2.38	Earthen Levee	Encroachments	LS	PO	Fences Inspector Comments: Chain link fence on landward slope.	38.042765 ° -121.342620 °	38.042760 ° -121.341167 °	1021 Y
56	2.38	2.38	Earthen Levee	Encroachments	LS	PO	Buildings Inspector Comments: Handrails on the landward slope.	38.042758 ° -121.341210 °	38.042758 ° -121.341210 °	10 Y

View of landscaping along the landward slope looking upstream.

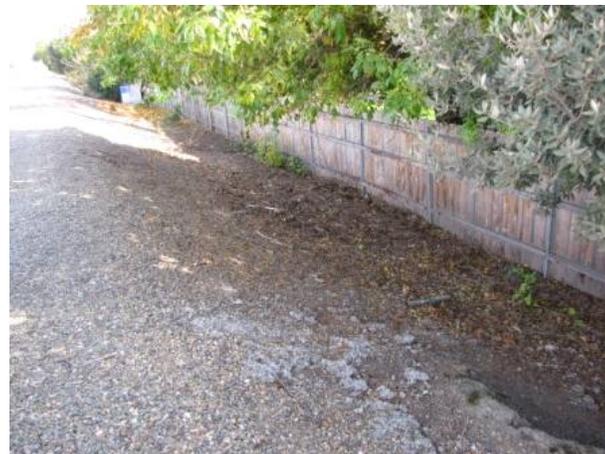
pkazi_f_20110923_539.jpg

View of a fence along the landward toe looking upstream.

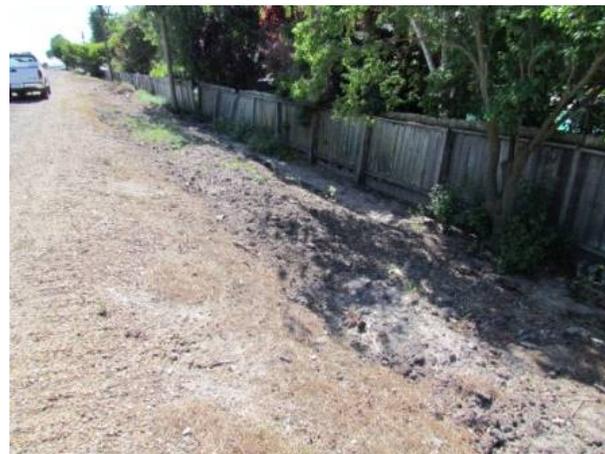
pkazi_f_20110923_502.jpg

Additional soil was placed by the owner of the property on the landside of the levee. The picture was taken from the crown of the levee looking upstream.

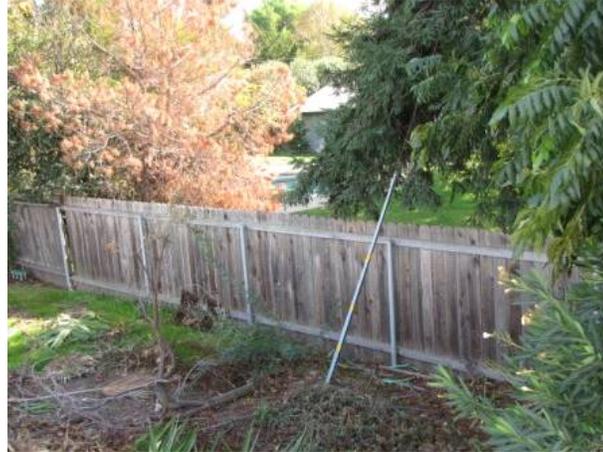
Levee Mile Report Line	53
Start Levee Mile	2.19
End Levee Mile	2.25
Location	Land Side
Category	Earthen Levee
Item	Encroachments
View of a fence along the landward toe looking upstream.	
pkazi_f_20110923_540.jpg

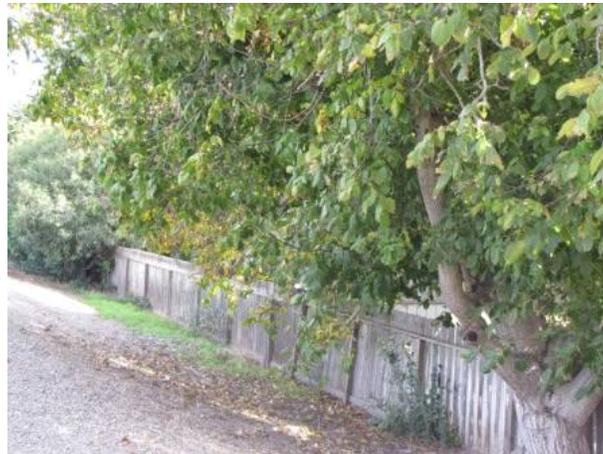
Levee Mile Report Line	54
Start Levee Mile	2.25
End Levee Mile	2.30
Location	Land Side
Category	Earthen Levee
Item	Encroachments
View of a wood fence at the landward toe.	
pkazi_f_20110923_541.jpg

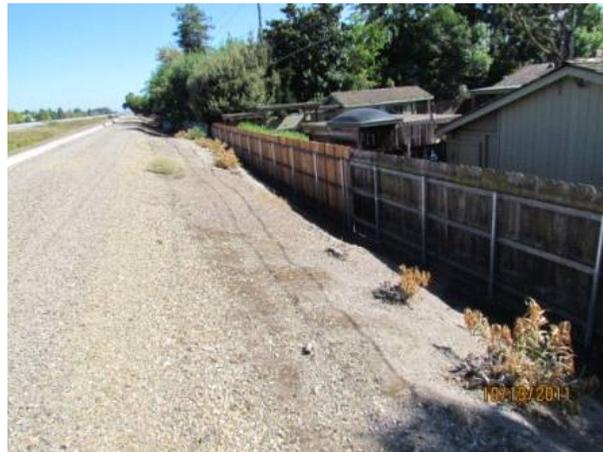
Levee Mile Report Line	54
Start Levee Mile	2.25
End Levee Mile	2.30
Location	Land Side
Category	Earthen Levee
Item	Encroachments
View of the fence on the landside toe of the levee looking upstream. This picture was taken during fall 2011 inspection.	
pkazi_f_20111120_245.jpg

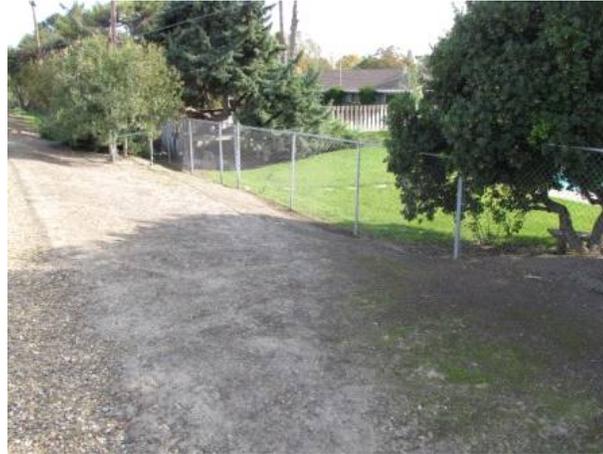
pkazi_f_20110923_542.jpg

View of a fence on the landward slope looking upstream.

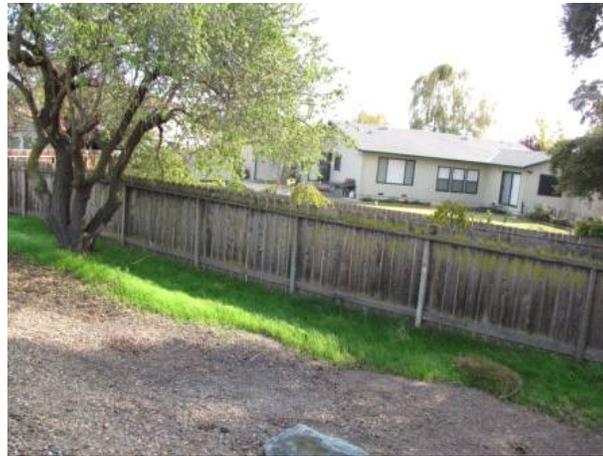
pkazi_f_20110923_543.jpg

Levee Mile Report Line	57
Start Levee Mile	2.38
End Levee Mile	2.40
Location	Land Side
Category	Earthen Levee
Item	Encroachments

View of a fence at the landward toe.

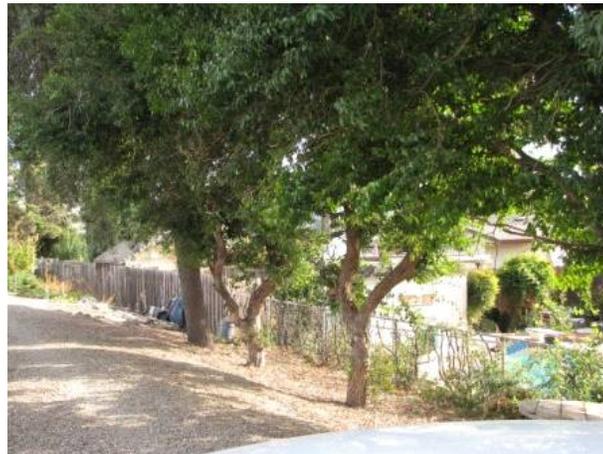
pkazi_f_20110923_544.jpg

Levee Mile Report Line	58
Start Levee Mile	2.40
End Levee Mile	2.43
Location	Land Side
Category	Earthen Levee
Item	Encroachments

View of a fence at the landward toe.

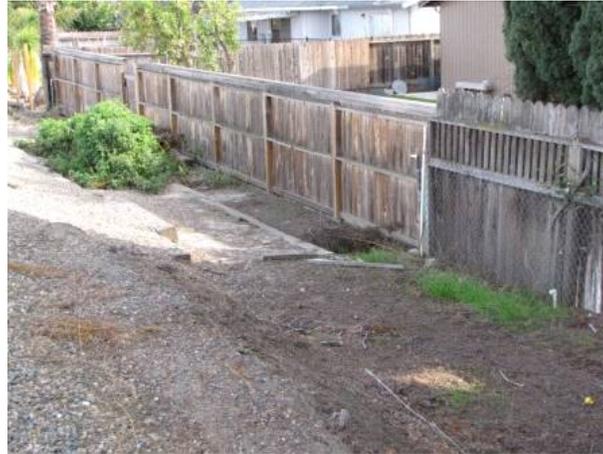
pkazi_f_20110923_545.jpg

View of a fence at the landward toe looking upstream.

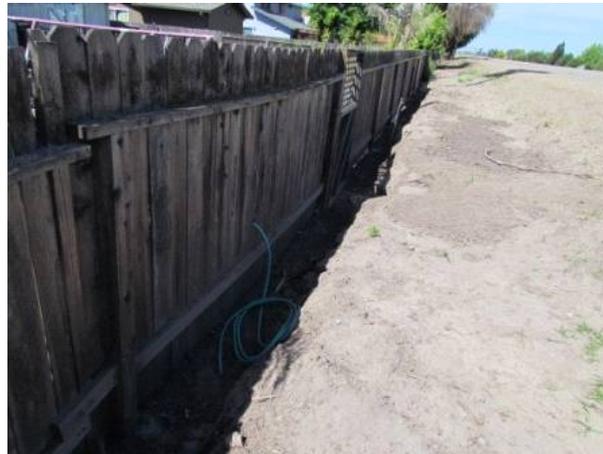
pkazi_f_20110923_504.jpg

Levee Mile Report Line	61
Start Levee Mile	2.48
End Levee Mile	2.48
Location	Land Side
Category	Earthen Levee
Item	Encroachments

The owner excavated a ditch on the toe at the landside of the levee, The picture was taken from the landside of the levee looking downstream.

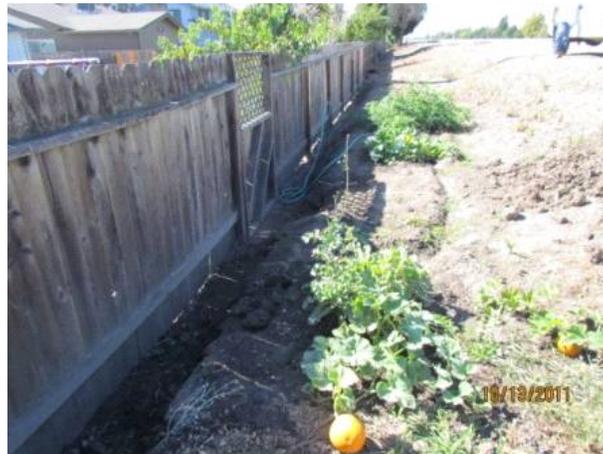
pkazi_f_20111120_246.jpg

Levee Mile Report Line	61
Start Levee Mile	2.48
End Levee Mile	2.48
Location	Land Side
Category	Earthen Levee
Item	Encroachments

View of a ditch at the landside toe of the levee looking downstream.

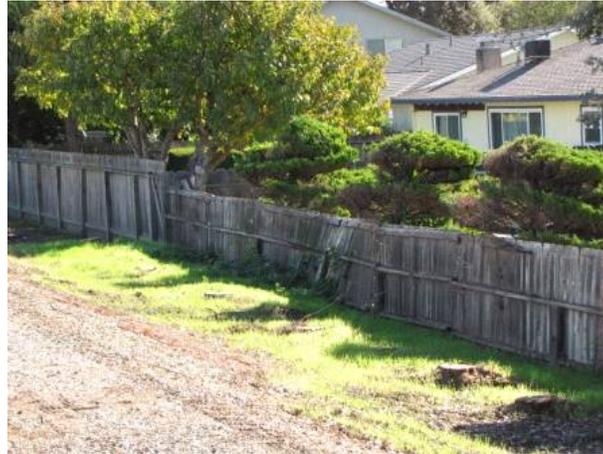
Levee Mile Report Line	64
Start Levee Mile	2.55
End Levee Mile	2.55
Location	Land Side
Category	Earthen Levee
Item	Trim / Thin Trees
View of stumps along the landward toe looking upstream.	
pkazi_f_20110923_492.jpg

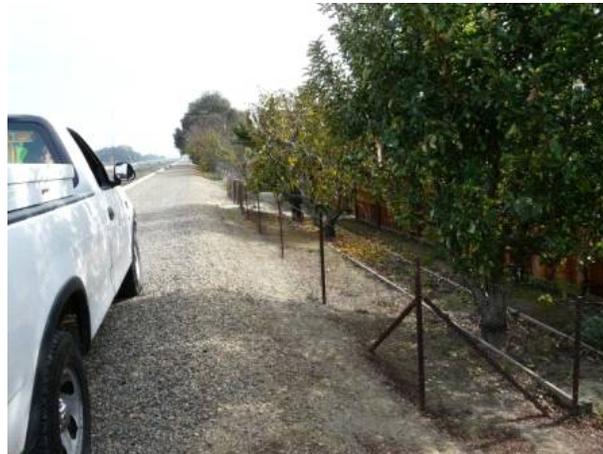
Levee Mile Report Line	65
Start Levee Mile	2.58
End Levee Mile	2.61
Location	Land Side
Category	Earthen Levee
Item	Encroachments
Fence located on sholder of landside of levee from LM 2.58 to LM 2.61	
pkazi_f_20110923_503.JPG

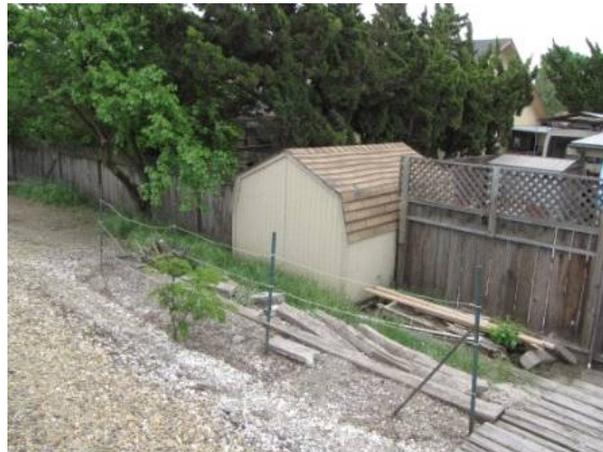
Levee Mile Report Line	66
Start Levee Mile	2.61
End Levee Mile	2.61
Location	Land Side
Category	Earthen Levee
Item	Encroachments
Landscaping and shed placed on landward levee slope and within 10' of the toe.	
pkazi_f_20110923_534.jpg

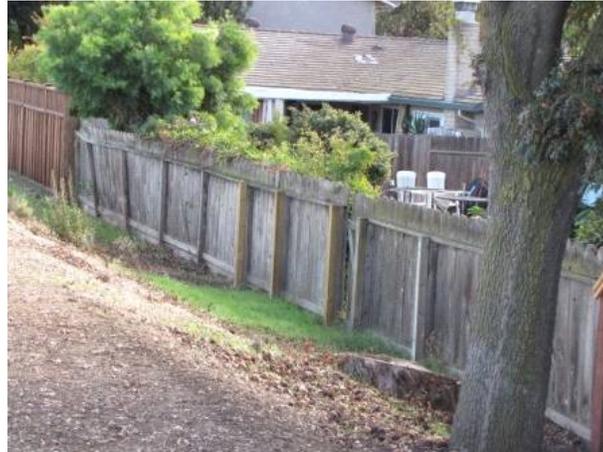
Levee Mile Report Line	74
Start Levee Mile	3.08
End Levee Mile	3.08
Location	Land Side
Category	Earthen Levee
Item	Trim / Thin Trees
View of a stump on the landward slope looking upstream.	
pkazi_f_20110923_493.jpg

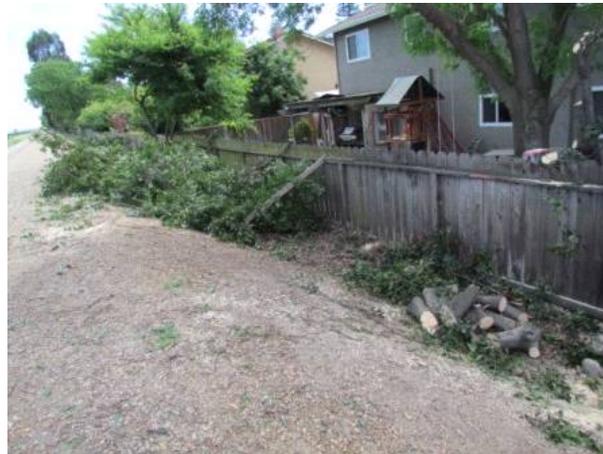
Levee Mile Report Line	75
Start Levee Mile	3.11
End Levee Mile	3.11
Location	Land Side
Category	Earthen Levee
Item	Encroachments
Tree branches along with other debris were places on the landside of the levee. The picture was taken from the crown of the levee looking upstream.	
pkazi_f_20110923_514.jpg

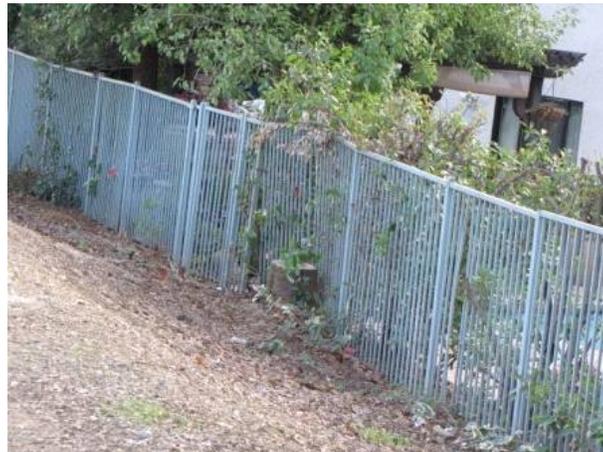
Levee Mile Report Line	76
Start Levee Mile	3.15
End Levee Mile	3.15
Location	Land Side
Category	Earthen Levee
Item	Trim / Thin Trees
View of a stump on the landward slope looking upstream.	
pkazi_f_20110923_494.jpg

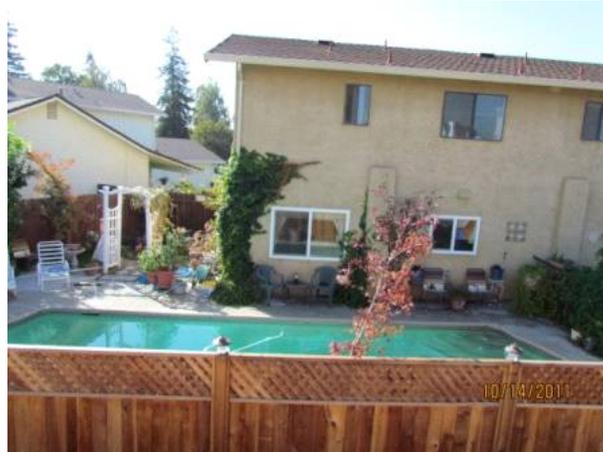
Levee Mile Report Line	77
Start Levee Mile	3.15
End Levee Mile	3.15
Location	Land Side
Category	Earthen Levee
Item	Encroachments
View of the pool located within 10 feet from the toe of the landside of the levee. The picture was taken from the crown looking towards the toe.	
pkazi_f_20111120_247.jpg

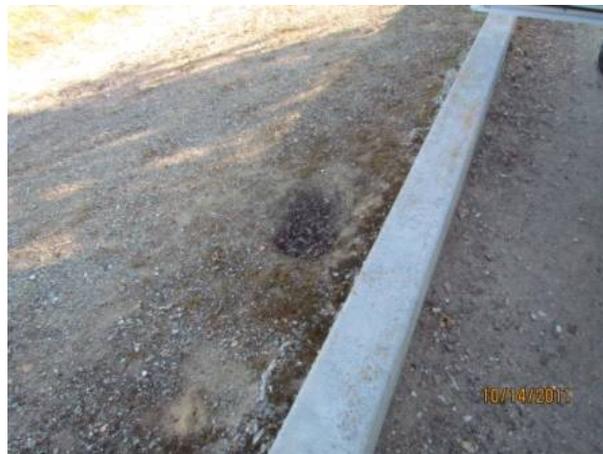
Levee Mile Report Line	78
Start Levee Mile	3.15
End Levee Mile	3.15
Location	Water Side
Category	Earthen Levee
Item	Crown Surface / Depressions / Rutting
View of a depression caused by an animal hole located on waterside slope of the levee looking upstream.	
pkazi_f_20111120_248.jpg

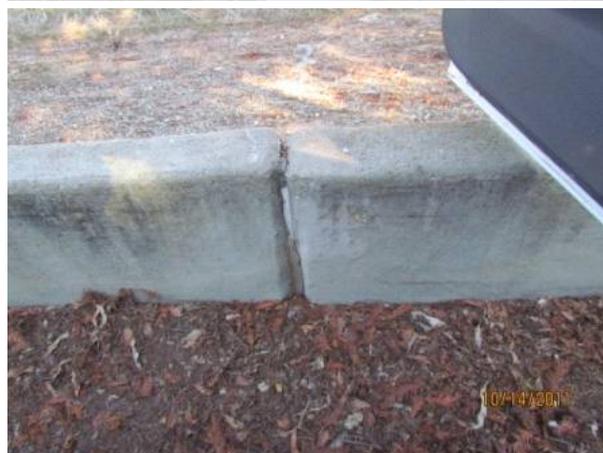
Levee Mile Report Line	81
Start Levee Mile	3.26
End Levee Mile	3.26
Location	Land Side
Category	Concrete Floodwalls
Item	Monolith Joints
Monolith joint material is deteriorating at the joint of the flood wall. The picture was taken from the crown looking upstream.	
pkazi_f_20111120_249.jpg
