**Flood Control Project Maintenance
Levee Inspections**

Fall 2011 Levee Maintenance Deficiency Summary Report

San Joaquin River Basin

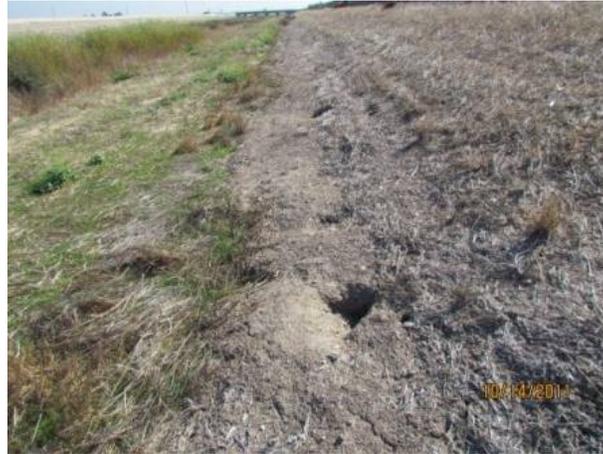
Levee Mile Report Line	84
Start Levee Mile	3.53
End Levee Mile	3.53
Location	Water Side
Category	Earthen Levee
Item	Animal Control
Rodent holes were found on the landside of the levee looking upstream.	
pkazi_f_20111120_250.jpg

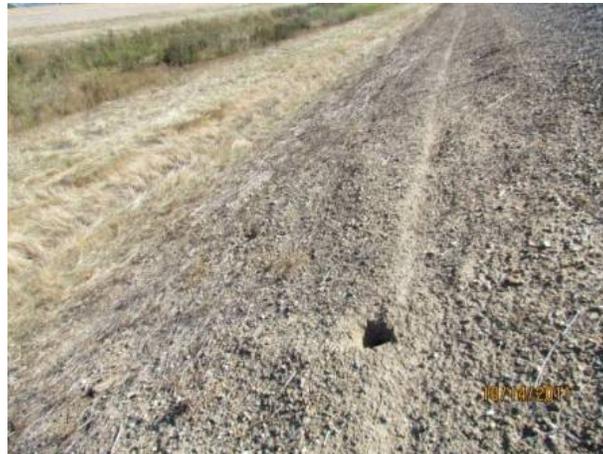
Levee Mile Report Line	87
Start Levee Mile	4.06
End Levee Mile	4.06
Location	Water Side
Category	Earthen Levee
Item	Animal Control
Rodent hole was found on the landside of the levee looking upstream.	
pkazi_f_20111120_251.jpg

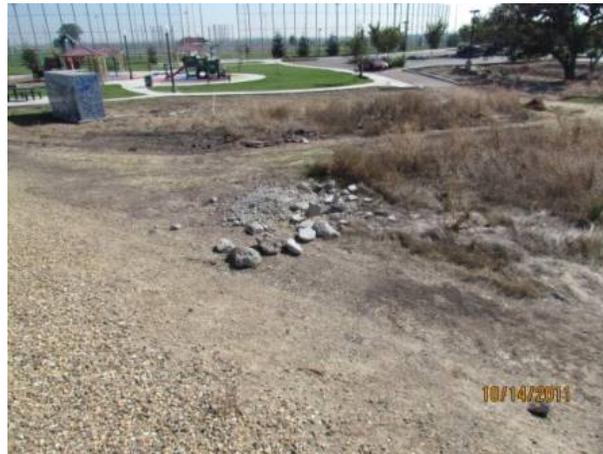
Levee Mile Report Line	89
Start Levee Mile	4.68
End Levee Mile	4.68
Location	Land Side
Category	Earthen Levee
Item	Encroachments
Debris was found on the landside of the levee looking upstream.	
pkazi_f_20111120_252.jpg

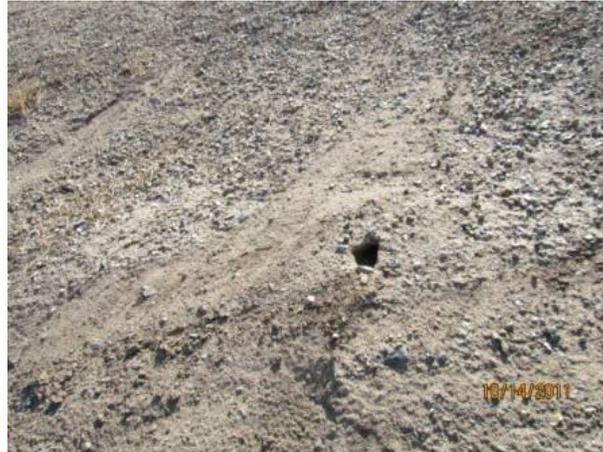
Levee Mile Report Line	94
Start Levee Mile	6.23
End Levee Mile	6.23
Location	Water Side
Category	Earthen Levee
Item	Animal Control
Rodent hole was found on the waterside of the levee looking upstream.	
pkazi_f_20111120_253.jpg

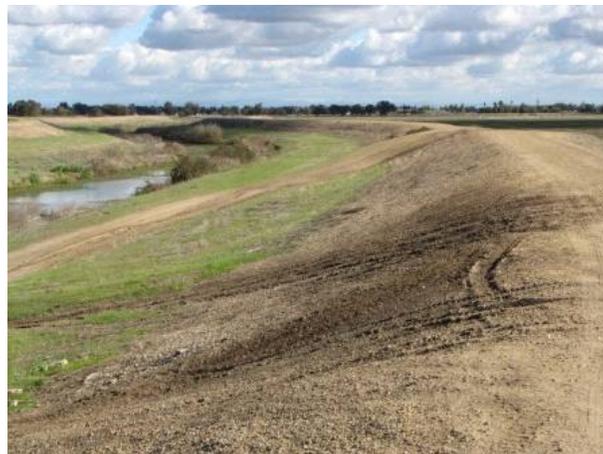
Levee Mile Report Line	95
Start Levee Mile	6.24
End Levee Mile	6.24
Location	Water Side
Category	Earthen Levee
Item	Slope Stability
View of damage to the waterward slope of the levee due to vehicle traffic looking upstream.	
pkazi_f_20110923_500.jpg

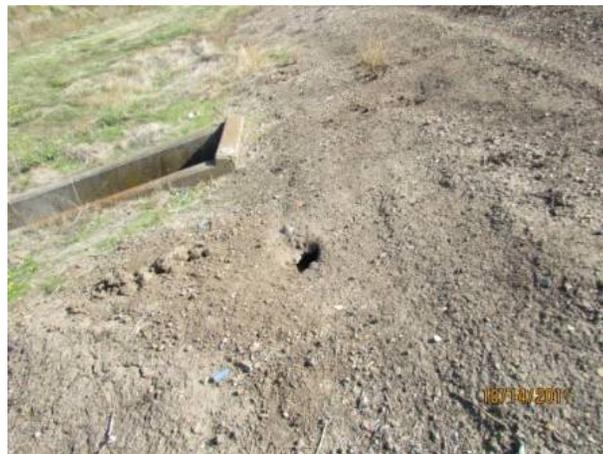
Levee Mile Report Line	97
Start Levee Mile	6.55
End Levee Mile	6.55
Location	Land Side
Category	Earthen Levee
Item	Animal Control
Rodent hole was found on the waterside of the levee looking upstream.	
pkazi_f_20111120_254.jpg

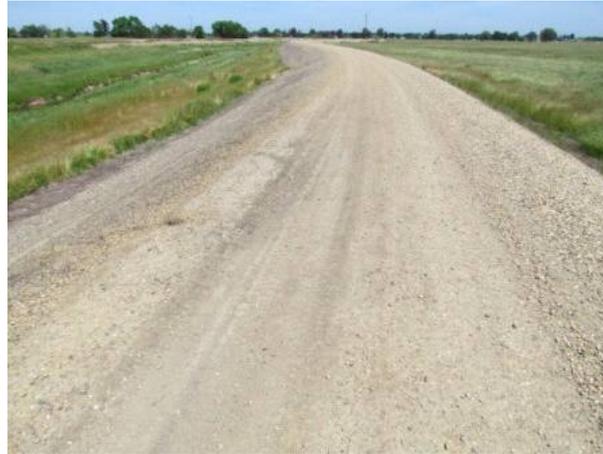
Levee Mile Report Line	98
Start Levee Mile	6.68
End Levee Mile	6.68
Location	Crown
Category	Earthen Levee
Item	Crown Surface / Depressions / Rutting
<p>The depression on the crown has been regraded. The picture was taken from the crown of the levee looking upstream.</p>	
<p>pkazi_f_20110923_529.jpg</p>

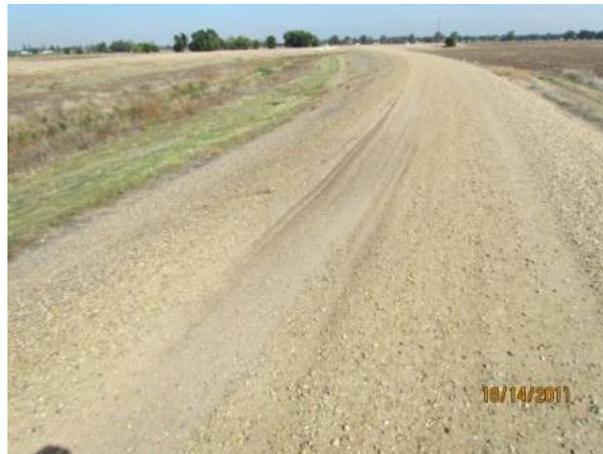
Levee Mile Report Line	98
Start Levee Mile	6.68
End Levee Mile	6.68
Location	Crown
Category	Earthen Levee
Item	Crown Surface / Depressions / Rutting
<p>View of a crown depression looking upstream. This picture was taken during fall 2011 inspection.</p>	
<p>pkazi_f_20111120_255.jpg</p>

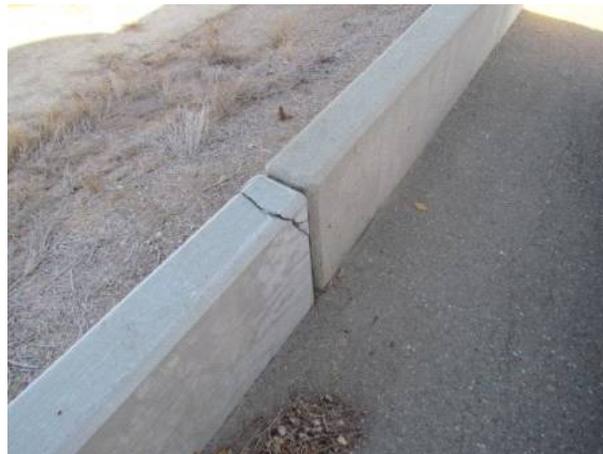
Levee Mile Report Line	99
Start Levee Mile	7.57
End Levee Mile	7.57
Location	Water Side
Category	Concrete Floodwalls
Item	Concrete Surfaces
<p>View of a crack near the monolith joint of the flood wall. The picture was taken from the crown looking upstream.</p>	
<p>pkazi_f_20111120_256.jpg</p>

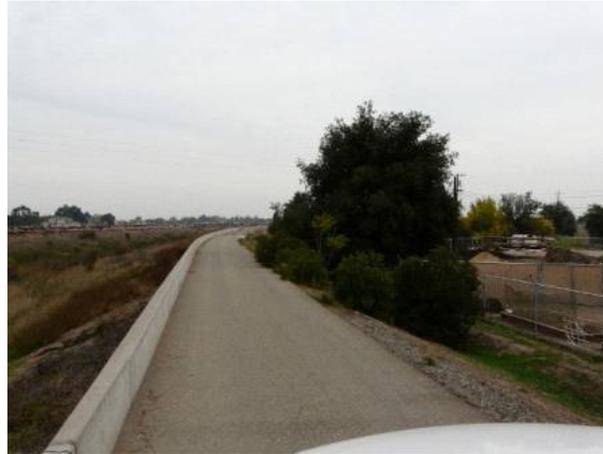
Levee Mile Report Line	100
Start Levee Mile	7.57
End Levee Mile	7.62
Location	Land Side
Category	Earthen Levee
Item	Encroachments
Landscaping along landside slope of levee from LM 7.57 to 7.62	
pkazi_f_20110923_508.JPG

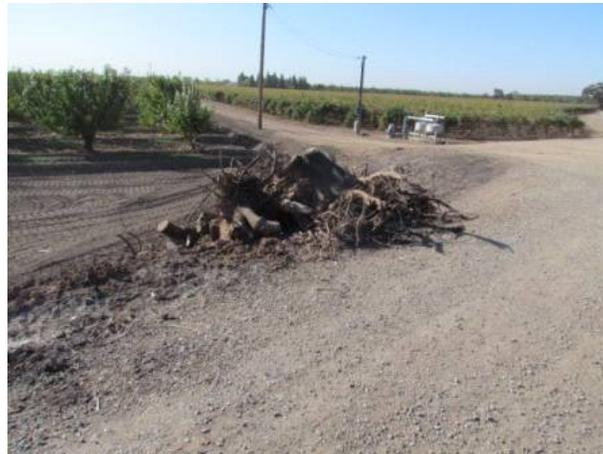
Levee Mile Report Line	114
Start Levee Mile	9.52
End Levee Mile	9.52
Location	Land Side
Category	Earthen Levee
Item	Encroachments
Pruning was found on the landside of the levee looking upstream.	
pkazi_f_20111120_257.jpg

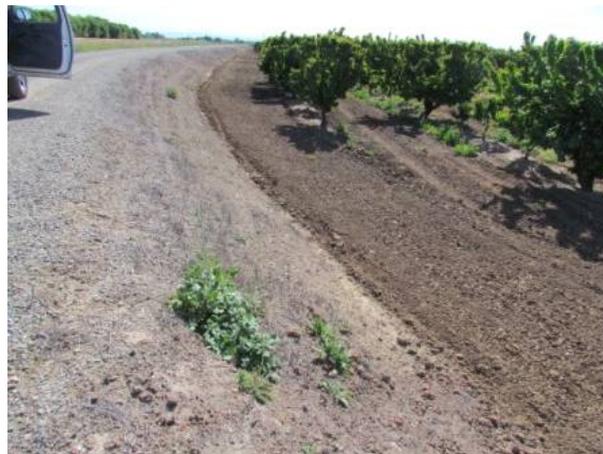
Levee Mile Report Line	115
Start Levee Mile	9.54
End Levee Mile	9.60
Location	Land Side
Category	Earthen Levee
Item	Encroachments
Tilling was done by the farmers at the landside toe of the levee. The picture was taken from the crown of the levee looking upstream.	
pkazi_f_20110923_520.jpg

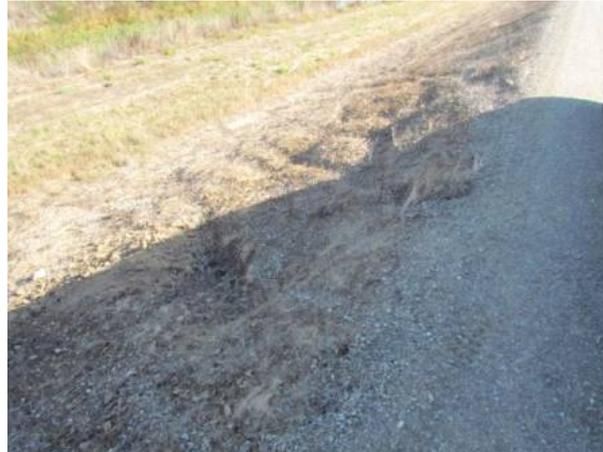
Levee Mile Report Line	117
Start Levee Mile	9.67
End Levee Mile	9.67
Location	Water Side
Category	Earthen Levee
Item	Slope Stability
Slope instability was found due to vehicular traffic on the waterside slope of the levee looking upstream.	
pkazi_f_20111120_258.jpg

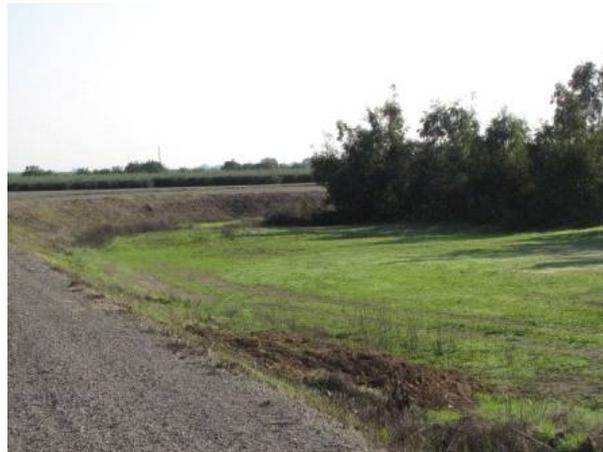
Levee Mile Report Line	123
Start Levee Mile	10.53
End Levee Mile	10.53
Location	Land Side
Category	Earthen Levee
Item	Encroachments
View of soil placed on the landward slope looking upstream.	
pkazi_f_20110923_506.jpg

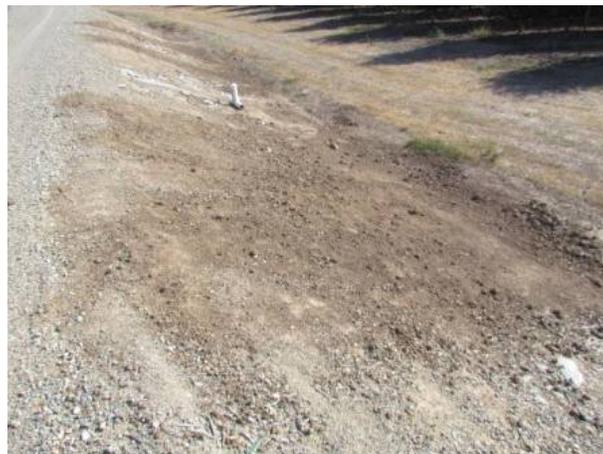
Levee Mile Report Line	125
Start Levee Mile	10.62
End Levee Mile	10.62
Location	Land Side
Category	Earthen Levee
Item	Slope Stability
Slope stability was repaired by the LMA on landside of the levee looking upstream.	
pkazi_f_20111120_259.jpg

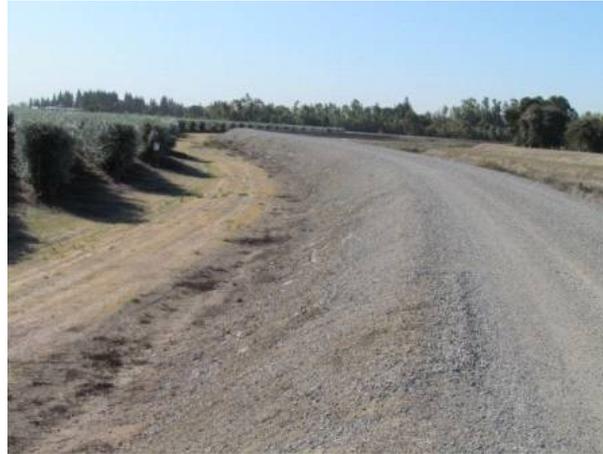
Levee Mile Report Line	130
Start Levee Mile	10.81
End Levee Mile	10.81
Location	Water Side
Category	Earthen Levee
Item	Animal Control
All the rodent holes were grouted on the landside of the levee looking downstream.	
pkazi_f_20111120_260.jpg

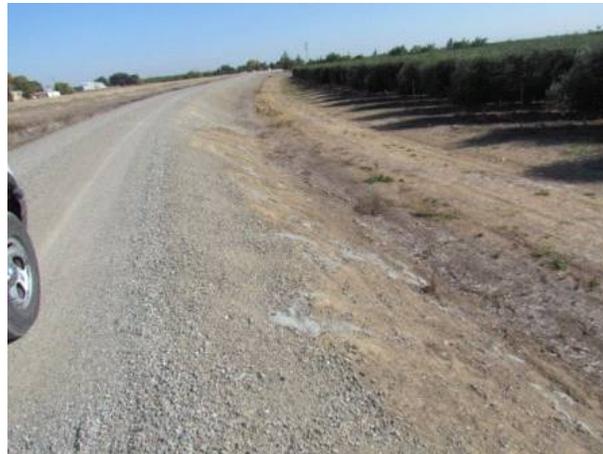
Levee Mile Report Line	132
Start Levee Mile	10.84
End Levee Mile	10.84
Location	Land Side
Category	Earthen Levee
Item	Slope Stability
Slope stability was fixed on the landside of the levee looking upstream.	
pkazi_f_20111120_261.jpg

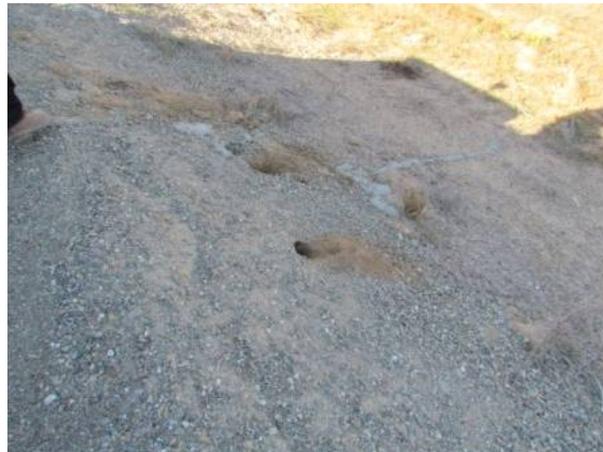
Levee Mile Report Line	133
Start Levee Mile	10.87
End Levee Mile	10.87
Location	Water Side
Category	Earthen Levee
Item	Animal Control
Rodent hole was found on the waterside of the levee looking downstream.	
pkazi_f_20111120_262.jpg

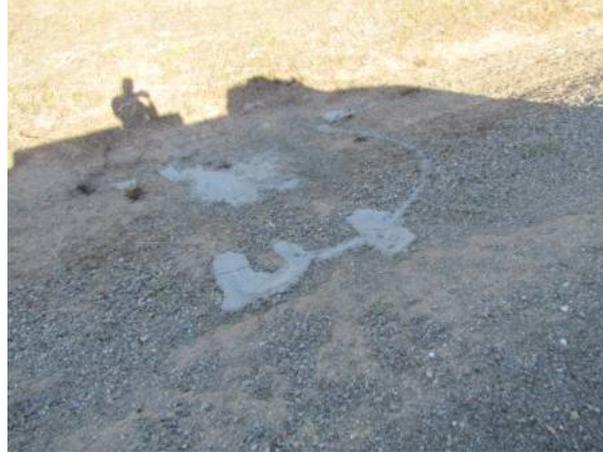
pkazi_f_20111120_263.jpg

Rodent holes were grouted by the LMA on the waterside of the levee looking upstream.

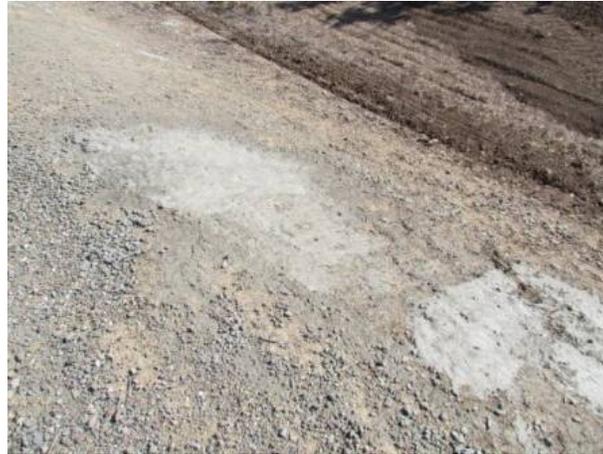
pkazi_f_20111120_264.jpg

Levee Mile Report Line	138
Start Levee Mile	11.44
End Levee Mile	11.44
Location	Land Side
Category	Earthen Levee
Item	Animal Control

Rodent holes were grouted by the LMA on the landside of the levee looking upstream.

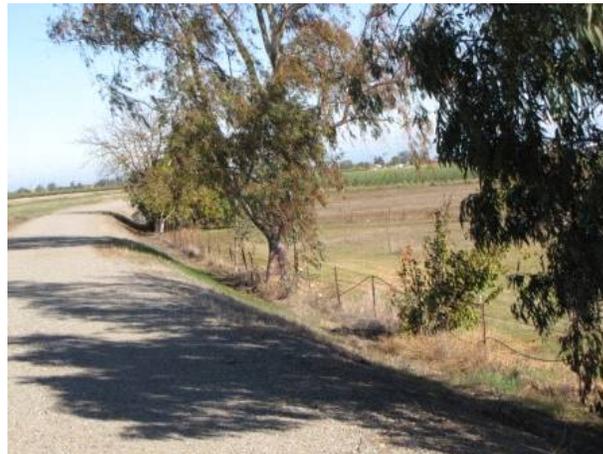
pkazi_f_20110923_580.jpg

Levee Mile Report Line	140
Start Levee Mile	11.47
End Levee Mile	11.64
Location	Land Side
Category	Earthen Levee
Item	Encroachments

View of a fence at the landward toe looking upstream.

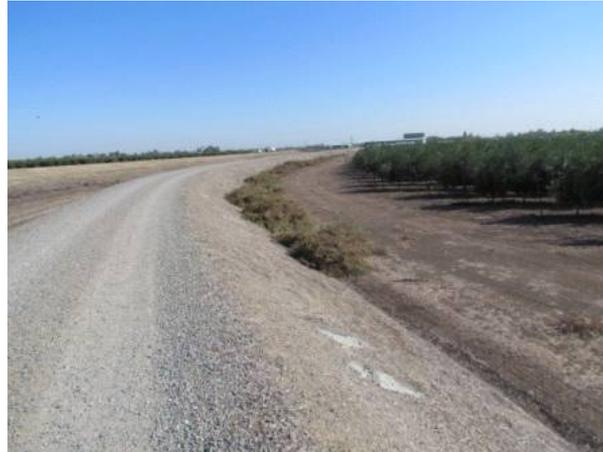
Levee Mile Report Line	142
Start Levee Mile	11.86
End Levee Mile	11.96
Location	Land Side
Category	Earthen Levee
Item	Encroachments
Pruning was found on the landside toe of the levee looking upstream.	
pkazi_f_20111120_265.jpg

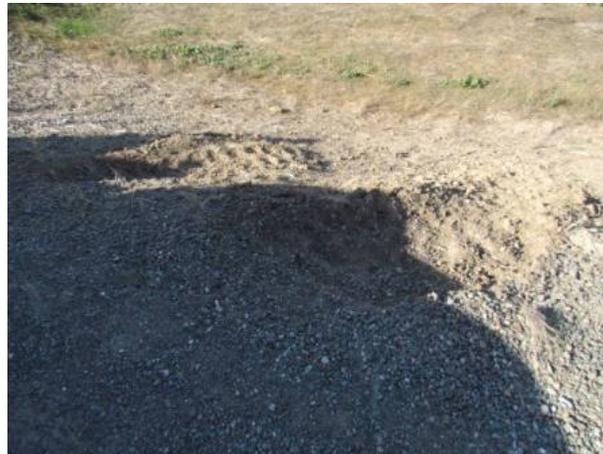
Levee Mile Report Line	144
Start Levee Mile	12.17
End Levee Mile	12.17
Location	Water Side
Category	Earthen Levee
Item	Slope Stability
Slope stability was found on the waterside of the levee looking downstream.	
pkazi_f_20111120_266.jpg

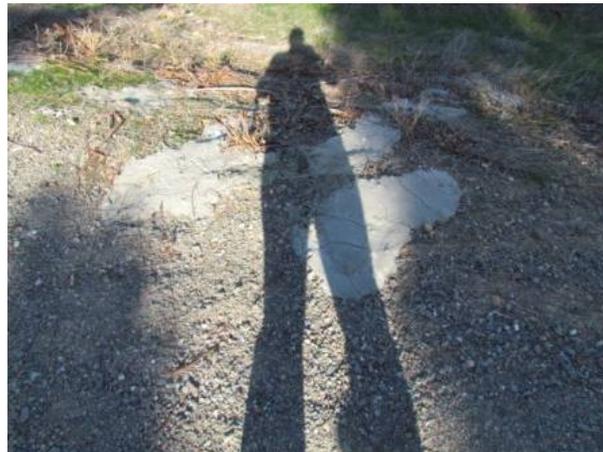
Levee Mile Report Line	147
Start Levee Mile	12.75
End Levee Mile	12.75
Location	Land Side
Category	Earthen Levee
Item	Animal Control
Rodent holes were grouted on the landside of the levee looking upstream.	
pkazi_f_20111120_267.jpg

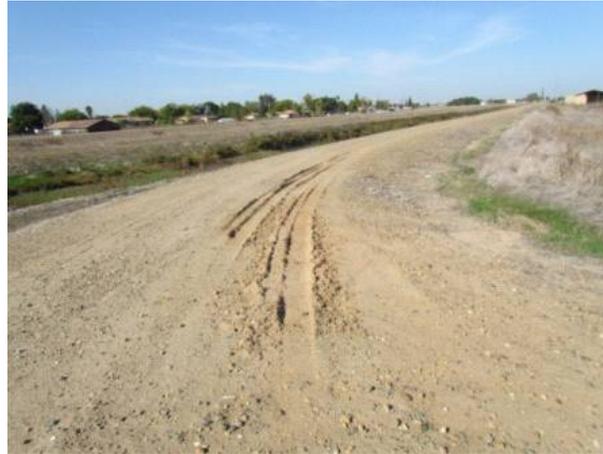
Levee Mile Report Line	151
Start Levee Mile	13.05
End Levee Mile	13.05
Location	Land Side
Category	Earthen Levee
Item	Crown Surface / Depressions / Rutting
Depression was found on the crown of the levee looking upstream.	
pkazi_f_20111120_269.jpg

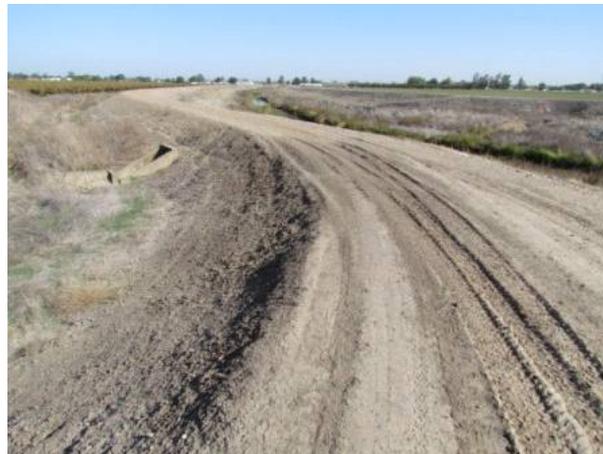
Levee Mile Report Line	152
Start Levee Mile	13.08
End Levee Mile	13.08
Location	Crown
Category	Earthen Levee
Item	Crown Surface / Depressions / Rutting
Depression and rutting was found on the crown of the levee looking downstream.	
pkazi_f_20111120_268.jpg

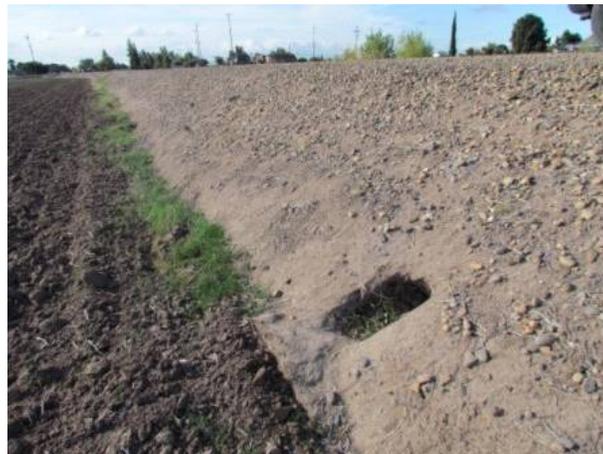
Levee Mile Report Line	159
Start Levee Mile	13.75
End Levee Mile	13.75
Location	Land Side
Category	Earthen Levee
Item	Animal Control
Rodent hole was found on the landside of the levee looking downstream.	
pkazi_f_20111120_270.jpg

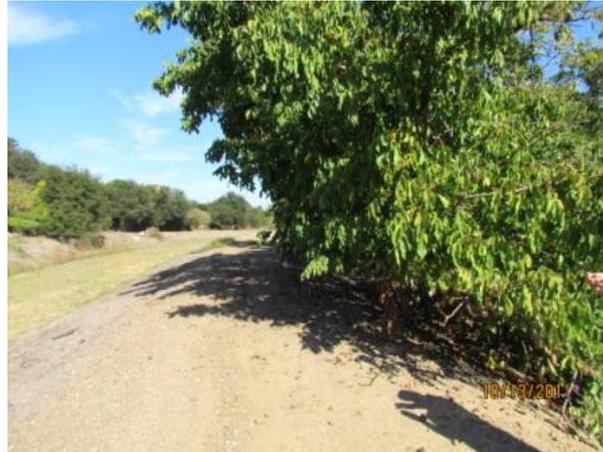
Levee Mile Report Line	166
Start Levee Mile	15.16
End Levee Mile	15.16
Location	Land Side
Category	Earthen Levee
Item	Trim / Thin Trees
<p>Trees on the landside of the levee needs to be trimmed for visibility. The picture was taken from the crown looking upstream.</p>	
<p>pkazi_f_20111120_236.jpg</p>

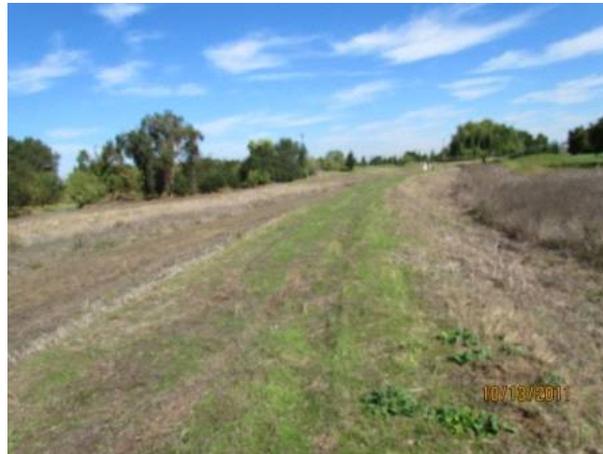
Levee Mile Report Line	167
Start Levee Mile	15.23
End Levee Mile	15.23
Location	Crown
Category	Earthen Levee
Item	Vegetation
<p>Good grass cover was maintained on both crown and waterside of the levee. The picture was taken from the crown looking upstream.</p>	
<p>pkazi_f_20111120_235.jpg</p>

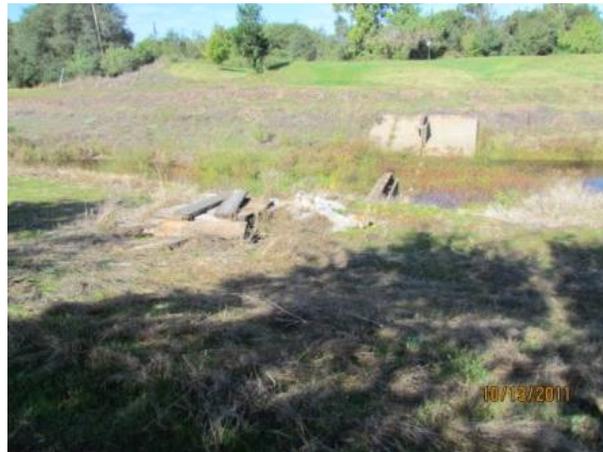
Levee Mile Report Line	171
Start Levee Mile	15.31
End Levee Mile	15.31
Location	Water Side
Category	Earthen Levee
Item	Encroachments
<p>Materials from the flap board dam was found on the waterside of the levee looking downstream.</p>	
<p>pkazi_f_20111120_234.jpg</p>

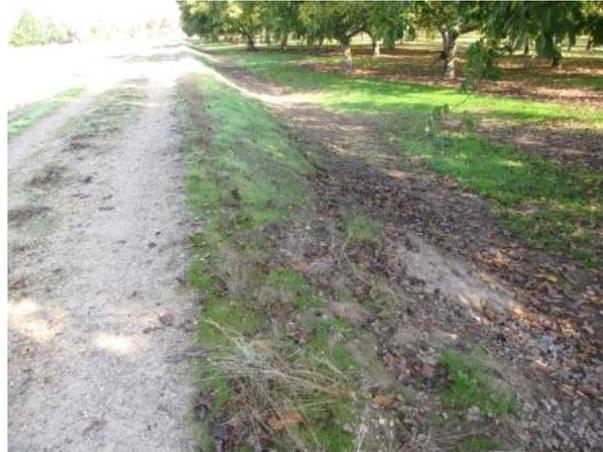
Levee Mile Report Line	176
Start Levee Mile	15.41
End Levee Mile	15.41
Location	Land Side
Category	Earthen Levee
Item	Animal Control
View of rodent activity on the landward slope looking upstream.	
pkazi_f_20110923_512.jpg

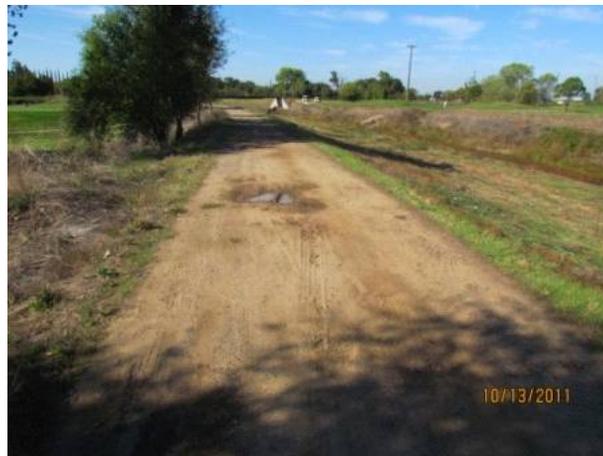
Levee Mile Report Line	177
Start Levee Mile	15.44
End Levee Mile	15.44
Location	Crown
Category	Earthen Levee
Item	Crown Surface / Depressions / Rutting
Depression was found on the crown of the levee looking downstream.	
pkazi_f_20111120_233.jpg

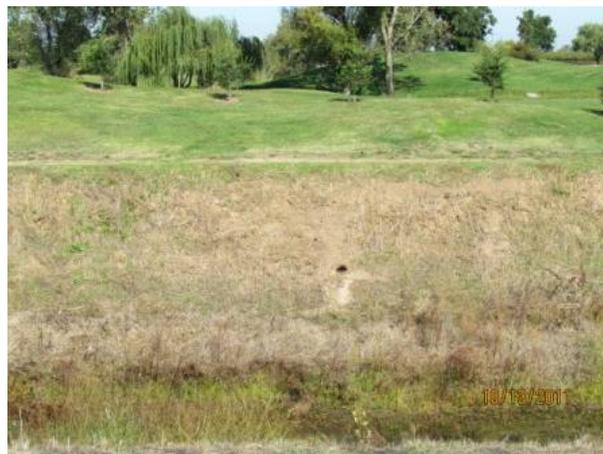
Levee Mile Report Line	179
Start Levee Mile	15.60
End Levee Mile	15.60
Location	Water Side
Category	Earthen Levee
Item	Animal Control
Rodent hole was located on right bank of Bear Creek on the waterside of the levee, levee mile 14.96. The picture was taken from crown looking towards the right bank of Bear Creek.	
pkazi_f_20111120_232.jpg

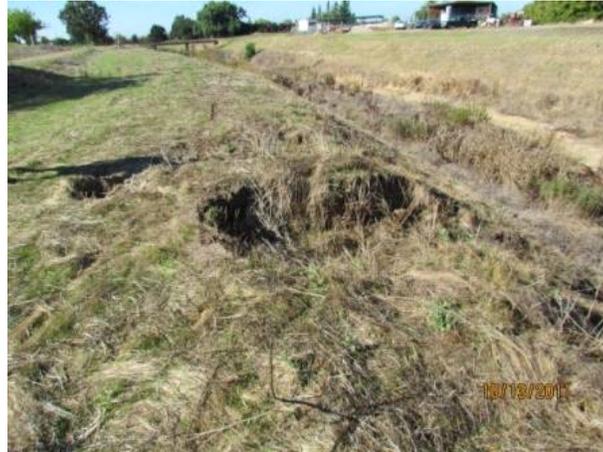
Levee Mile Report Line	182
Start Levee Mile	15.94
End Levee Mile	15.94
Location	Water Side
Category	Earthen Levee
Item	Erosion / Bank Caving
Erosion was found on the waterside slope of the levee looking downstream.	
pkazi_f_20111120_230.jpg

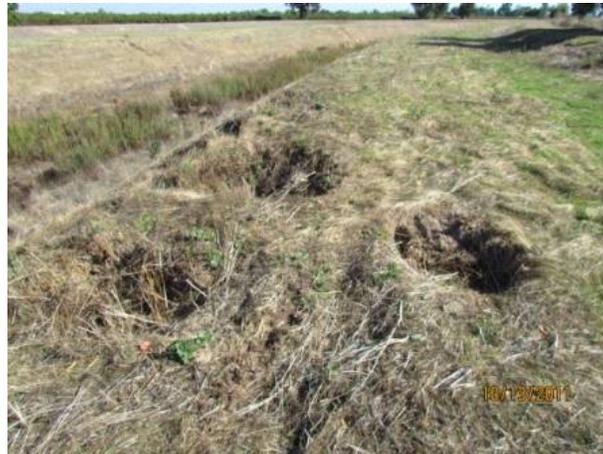
Levee Mile Report Line	182
Start Levee Mile	15.94
End Levee Mile	15.94
Location	Water Side
Category	Earthen Levee
Item	Erosion / Bank Caving
Erosion was found on the waterside slope of the levee looking downstream.	
pkazi_f_20111120_231.jpg

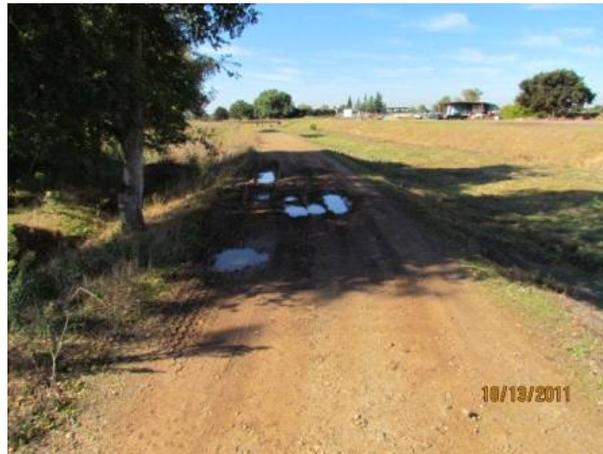
Levee Mile Report Line	183
Start Levee Mile	15.98
End Levee Mile	15.98
Location	Crown
Category	Earthen Levee
Item	Crown Surface / Depressions / Rutting
Depression was found on the crown of the levee looking downstream.	
pkazi_f_20111120_229.jpg

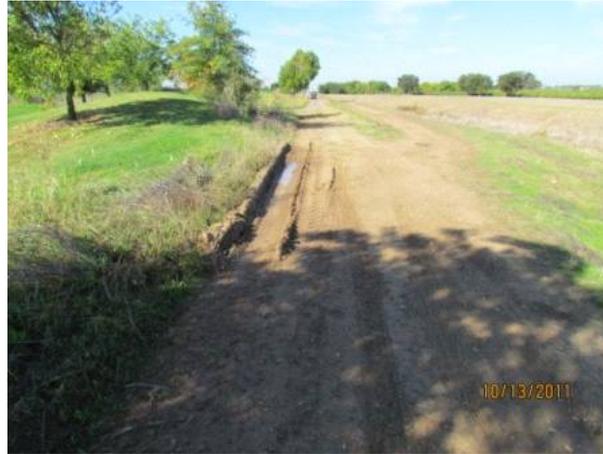
Levee Mile Report Line	184
Start Levee Mile	16.13
End Levee Mile	16.13
Location	Crown
Category	Earthen Levee
Item	Crown Surface / Depressions / Rutting
Depression was found on the crown of the levee looking downstream.	
pkazi_f_20111120_228.jpg

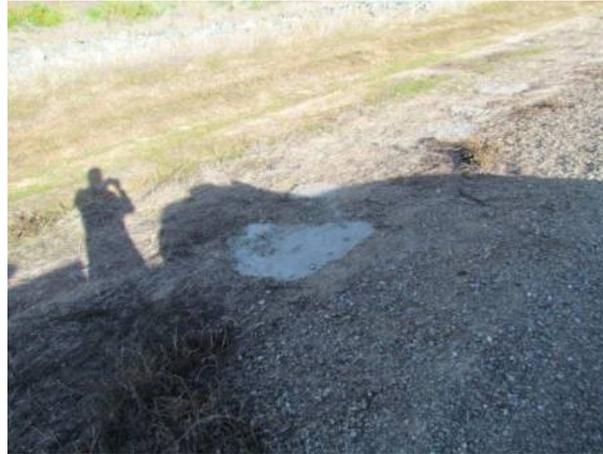
Levee Mile Report Line	2
Start Levee Mile	0.04
End Levee Mile	0.04
Location	Land Side
Category	Earthen Levee
Item	Animal Control
Rodent hole is grouted on the landside of the levee looking upstream.	
pkazi_f_20111121_271.jpg

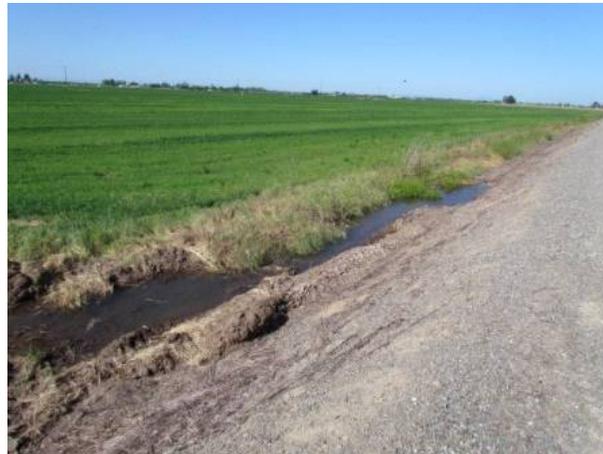
Levee Mile Report Line	4
Start Levee Mile	0.42
End Levee Mile	0.42
Location	Land Side
Category	Earthen Levee
Item	Encroachments
Agriculture ditch with running water at the toe of the landside of the levee. The picture was taken from the crown looking downstream.	
pkazi_f_20110923_788.jpg

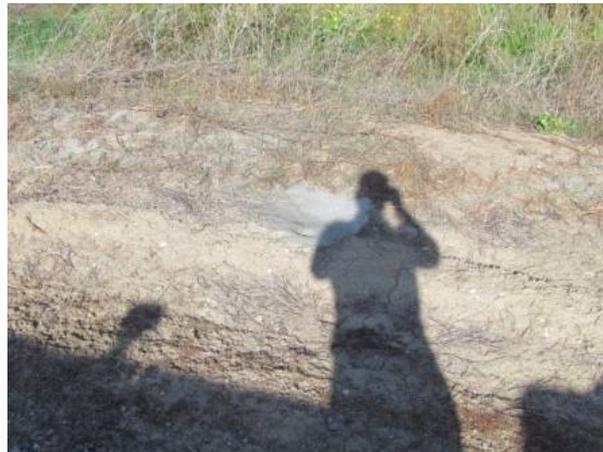
Levee Mile Report Line	5
Start Levee Mile	1.45
End Levee Mile	1.45
Location	Land Side
Category	Earthen Levee
Item	Animal Control
Rodent hole is grouted on the landside of the levee looking upstream.	
pkazi_f_20111121_272.jpg

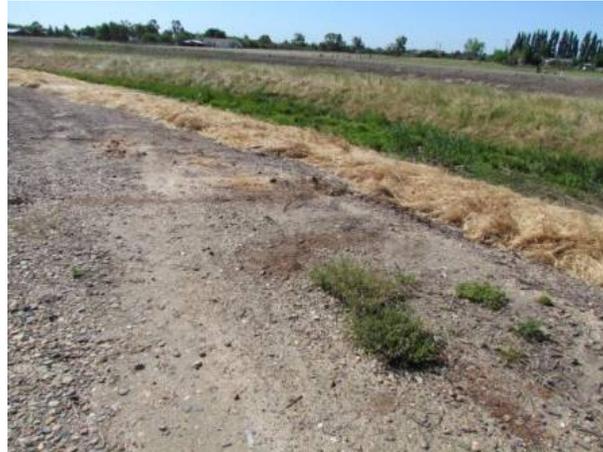
Levee Mile Report Line	2
Start Levee Mile	0.59
End Levee Mile	0.59
Location	Land Side
Category	Earthen Levee
Item	Encroachments
Abandoned pipe was removed from the waterside of the levee. The picture was taken from the crown looking downstream.	
pkazi_f_20110923_847.jpg

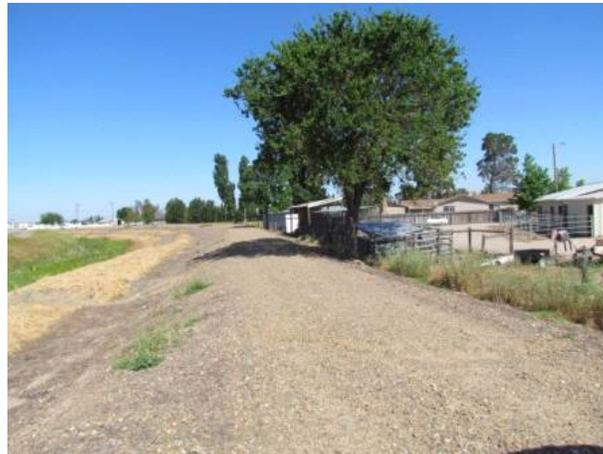
Levee Mile Report Line	2
Start Levee Mile	0.59
End Levee Mile	0.59
Location	Land Side
Category	Earthen Levee
Item	Encroachments
Tree was trimmed for visibility of the landside of the levee. The picture was taken from the crown looking upstream.	
pkazi_f_20110923_848.jpg

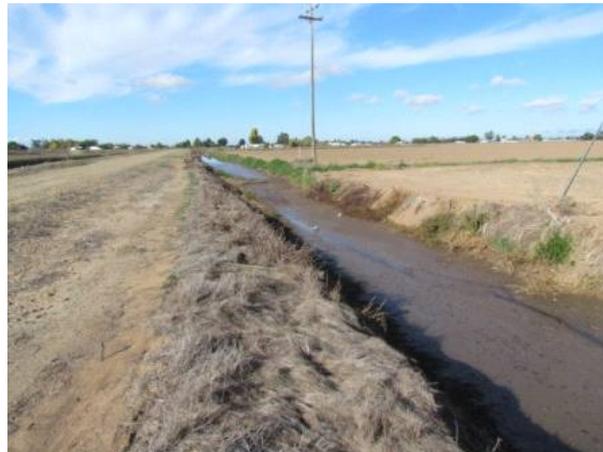
Levee Mile Report Line	3
Start Levee Mile	0.71
End Levee Mile	0.97
Location	Land Side
Category	Earthen Levee
Item	Encroachments
An agricultural ditch was found on the landside of the levee looking downstream.	
pkazi_f_20111122_285.jpg

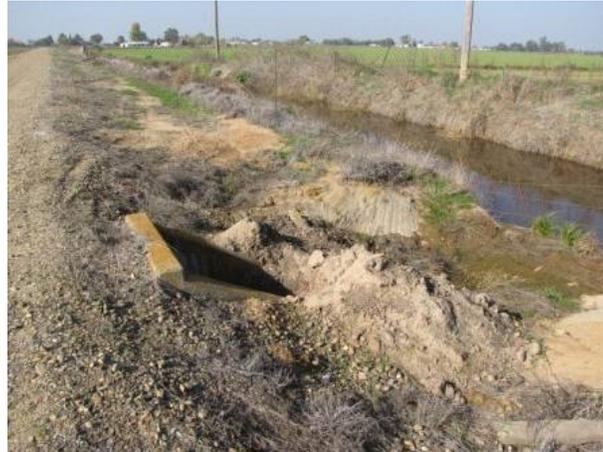
pkazi_f_20110923_846.jpg

View of the entrance to the project drainage culvert blocked by soil placed by the landowner on the landward side looking downstream.

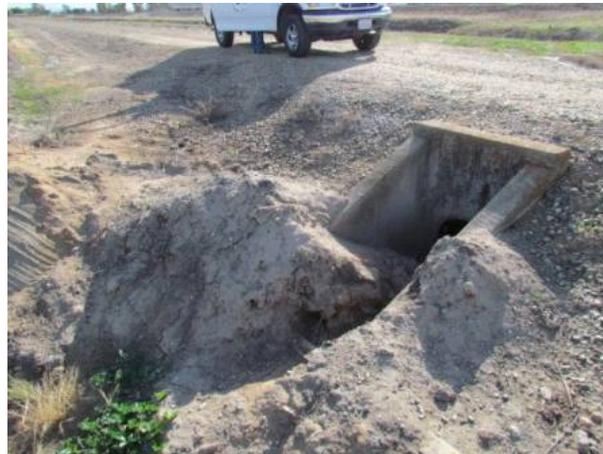
pkazi_f_20111122_284.jpg

Levee Mile Report Line	4
Start Levee Mile	0.87
End Levee Mile	0.87
Location	Land Side
Category	Interior Drainage & Piping Systems
Item	Culverts: Inlets / Outlets

Soil is blocking the culvert on the landside of the levee looking upstream. This picture was taken during fall 2011 inspection.

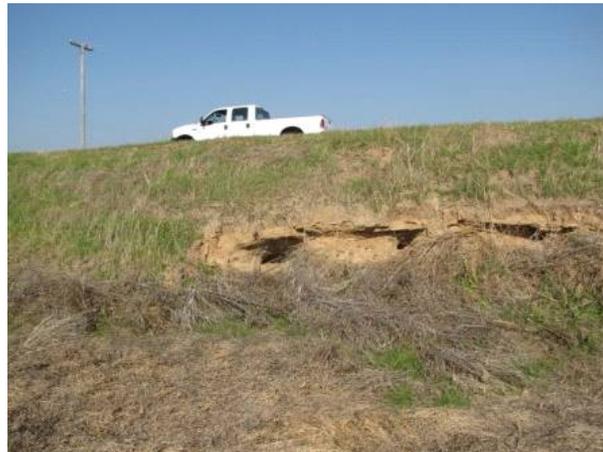
pkazi_f_20110923_844.jpg

Levee Mile Report Line	5
Start Levee Mile	0.87
End Levee Mile	0.87
Location	Water Side
Category	Earthen Levee
Item	Animal Control

View of rodent holes in the waterward berm from the channel.

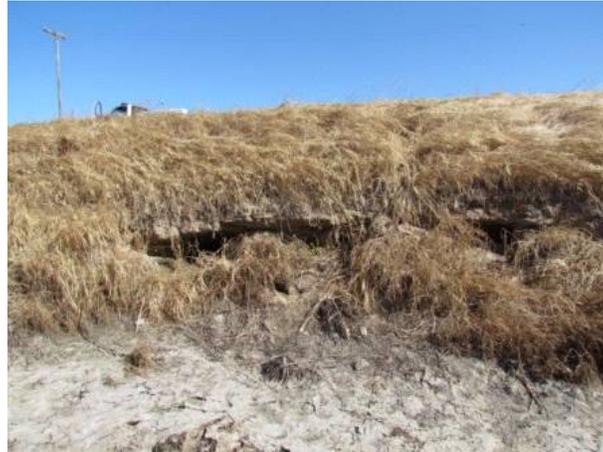
pkazi_f_20110923_845.jpg

Erosion above the pilot channel was located but it didn't look like rodent holes. The picture was taken from the toe at the waterside of the levee looking towards the crown.

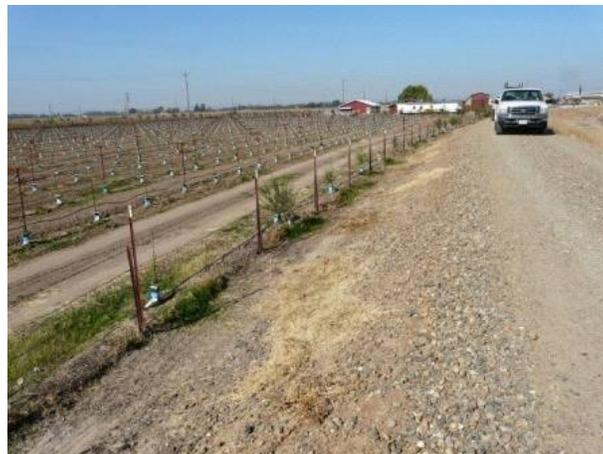
Levee Mile Report Line	3
Start Levee Mile	0.17
End Levee Mile	0.49
Location	Land Side
Category	Earthen Levee
Item	Encroachments
Fence located from LM 0.17 to LM 0.49 and crops located from LM 0.17 to LM 0.41 within 10' from landside toe of levee.	
pkazi_f_20110923_904.JPG

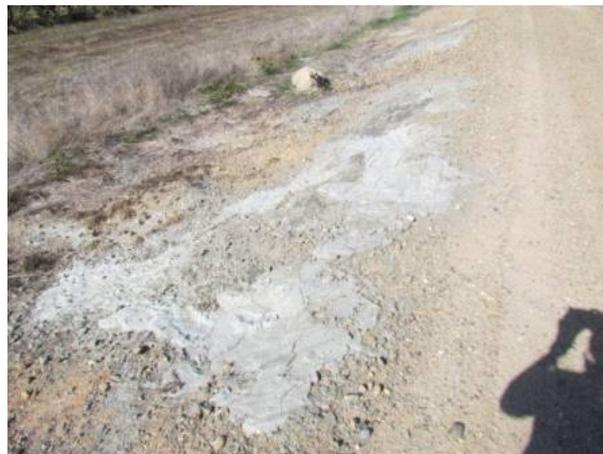
Levee Mile Report Line	5
Start Levee Mile	0.17
End Levee Mile	0.17
Location	Water Side
Category	Earthen Levee
Item	Animal Control
Rodent holes were grouted on the landside slope of the levee looking upstream.	
pkazi_f_20111122_283.jpg

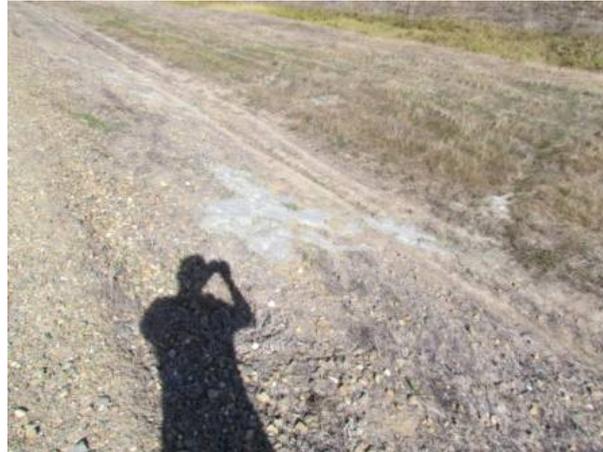
Levee Mile Report Line	8
Start Levee Mile	0.27
End Levee Mile	0.27
Location	Water Side
Category	Earthen Levee
Item	Animal Control
Rodent holes were grouted on the waterside of the levee looking upstream.	
pkazi_f_20111122_281.jpg

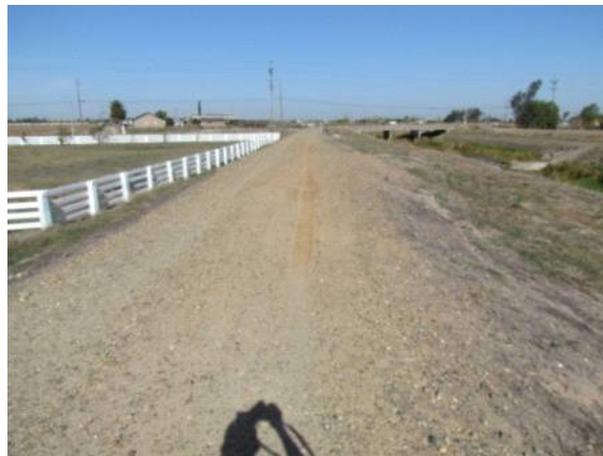
Levee Mile Report Line	10
Start Levee Mile	0.42
End Levee Mile	0.42
Location	Crown
Category	Earthen Levee
Item	Crown Surface / Depressions / Rutting
Depression was found on the crown caused by vehicle traffic looking upstream.	
pkazi_f_20111122_280.jpg

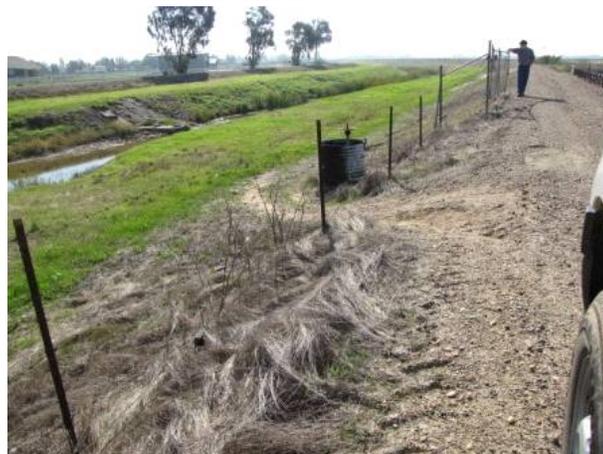
Levee Mile Report Line	11
Start Levee Mile	0.47
End Levee Mile	0.47
Location	Land Side
Category	Earthen Levee
Item	Slope Stability
View of damage to the waterward slope caused by pedestrian traffic looking downstream.	
pkazi_f_20110923_910.jpg

11	0.47	0.47	Earthen Levee	Slope Stability	LS	M	Repair the levee slope damaged by foot traffic and prevent access where possible.	38.101527 ° -121.168606 °	38.101527 ° -121.168606 °	15 Y
12	1.07	1.14	Earthen Levee	Slope Stability	LS	U	Repair slope instability. Inspector Comments: A notice of violation was issued to the owner for this ditch during fall 2011 inspection.	38.109070 ° -121.165992 °	38.109595 ° -121.164954 °	206 Y
13	1.07	1.15	Earthen Levee	Encroachments	LS	PO	Agricultural Ditch	38.109162 ° -121.165890 °	38.109625 ° -121.164659 °	17
14	1.58	1.58	Earthen Levee	Animal Control	WS	C	Exterminate rodents and backfill and compact or grout burrows.	38.112269 ° -121.158930 °	38.112269 ° -121.158930 °	11
15	1.88	1.88	Earthen Levee	Animal Control	WS	C	No rodents visible, but rodent burrows visible; need to backfill and compact or grout burrows.	38.115089 ° -121.155547 °	38.115089 ° -121.155547 °	10

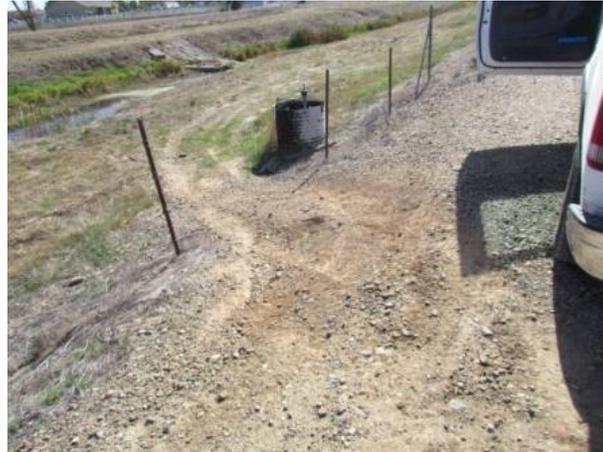
Levee Mile Report Line	11
Start Levee Mile	0.47
End Levee Mile	0.47
Location	Land Side
Category	Earthen Levee
Item	Slope Stability
<p>Rutting caused by foot traffic on the waterside slope of the levee looking downstream. This picture was taken during fall 2011 inspection.</p>	
<p>pkazi_f_20111122_279.jpg</p>

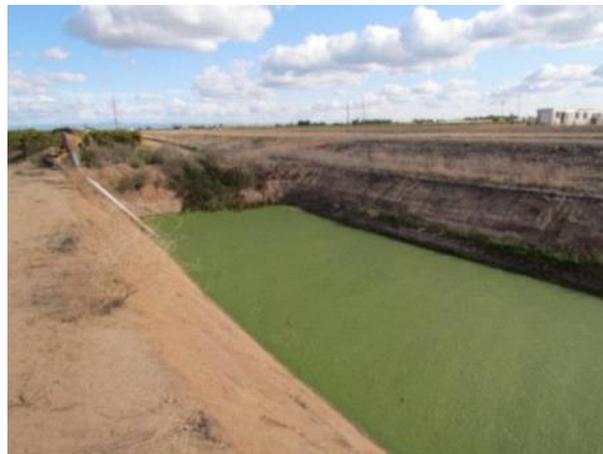
Levee Mile Report Line	12
Start Levee Mile	1.07
End Levee Mile	1.14
Location	Land Side
Category	Earthen Levee
Item	Slope Stability
<p>View of the ditch on the landside of the levee looking upstream. The picture was taken during fall 2011 inspection.</p>	
<p>pkazi_f_20111122_291.jpg</p>

REQUESTED CORRECTION: Repair the ditch at the landside toe of the levee. The ditch is approximately 10 feet in width from the toe of the levee. likely to cause significant levee stability issue.

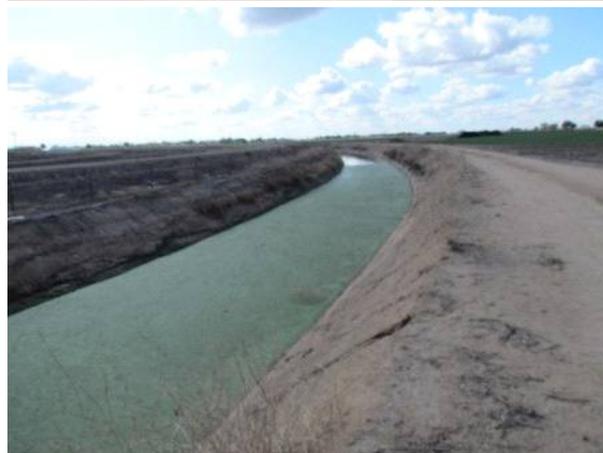
Levee Mile Report Line	12
Start Levee Mile	1.07
End Levee Mile	1.14
Location	Land Side
Category	Earthen Levee
Item	Slope Stability
<p>View of the ditch on the landside of the levee looking downstream. The picture was taken during fall 2011 inspection.</p>	
<p>pkazi_f_20111122_292.jpg</p>

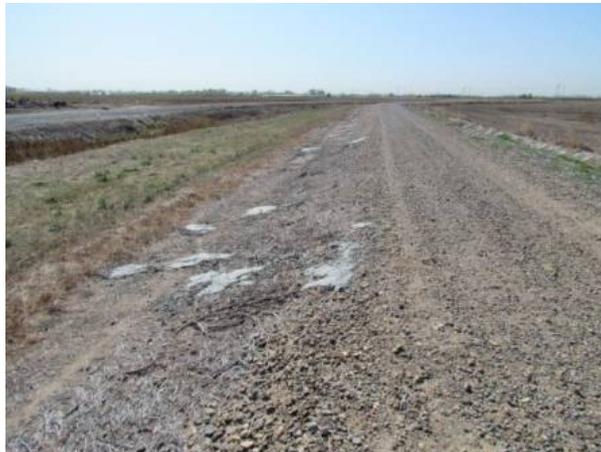
Levee Mile Report Line	16
Start Levee Mile	1.89
End Levee Mile	1.89
Location	Water Side
Category	Earthen Levee
Item	Animal Control
Rodent holes were grouted on the waterside of the levee looking downstream.	
pkazi_f_20111122_278.jpg

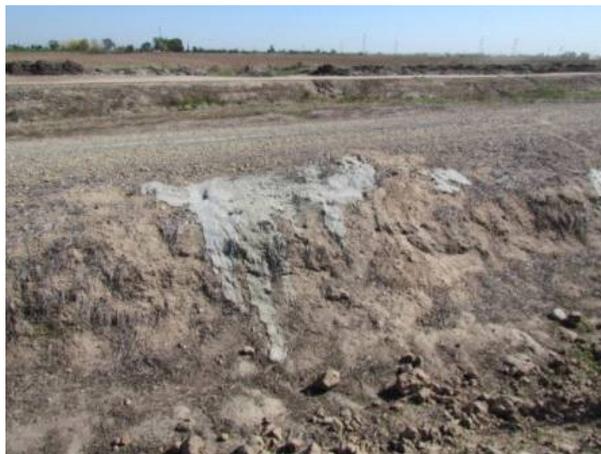
Levee Mile Report Line	19
Start Levee Mile	2.89
End Levee Mile	2.89
Location	Land Side
Category	Earthen Levee
Item	Animal Control
Rodent holes were grouted on the landside shoulder of the levee looking downstream.	
pkazi_f_20111122_277.jpg

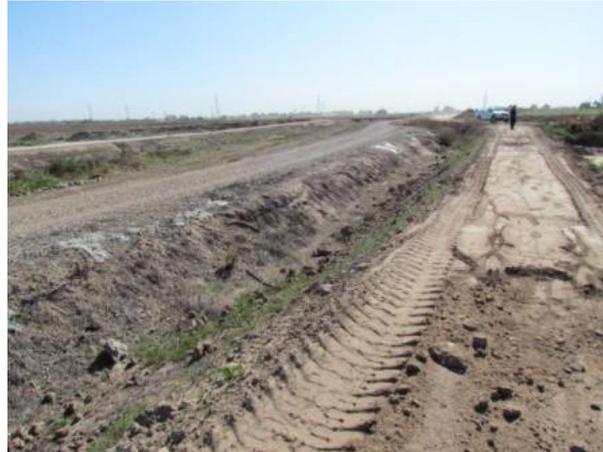
Levee Mile Report Line	20
Start Levee Mile	2.90
End Levee Mile	3.14
Location	Land Side
Category	Earthen Levee
Item	Encroachments
A ditch was found on the landside of the levee looking downstream.	
pkazi_f_20111121_276.jpg

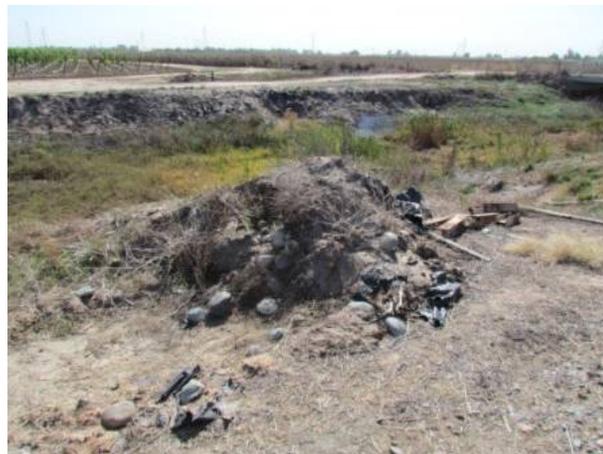
Levee Mile Report Line	23
Start Levee Mile	3.16
End Levee Mile	3.16
Location	Water Side
Category	Earthen Levee
Item	Encroachments
Debris was found on the waterside of the levee looking downstream.	
pkazi_f_20111121_275.jpg

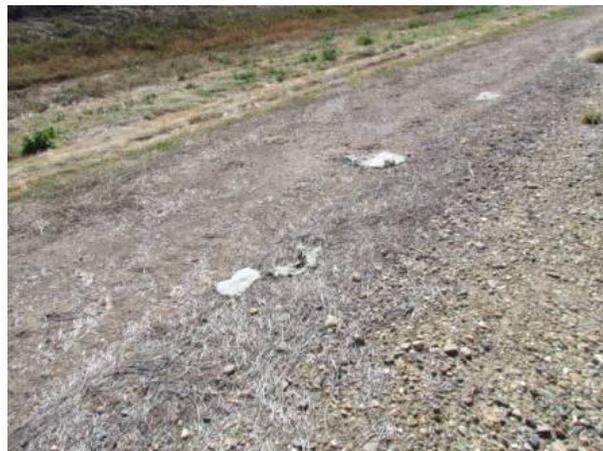
Levee Mile Report Line	25
Start Levee Mile	3.23
End Levee Mile	3.23
Location	Water Side
Category	Earthen Levee
Item	Animal Control
Rodent holes are grouted by the LMA on the waterside of the levee looking downstream.	
pkazi_f_20111121_274.jpg

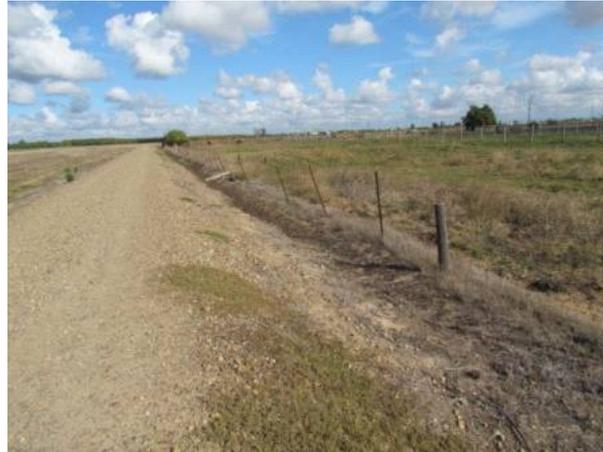
Levee Mile Report Line	3
Start Levee Mile	0.78
End Levee Mile	1.30
Location	Land Side
Category	Earthen Levee
Item	Encroachments
Fence was located on the landside toe of the levee looking upstream.	
pkazi_f_20111122_286.jpg

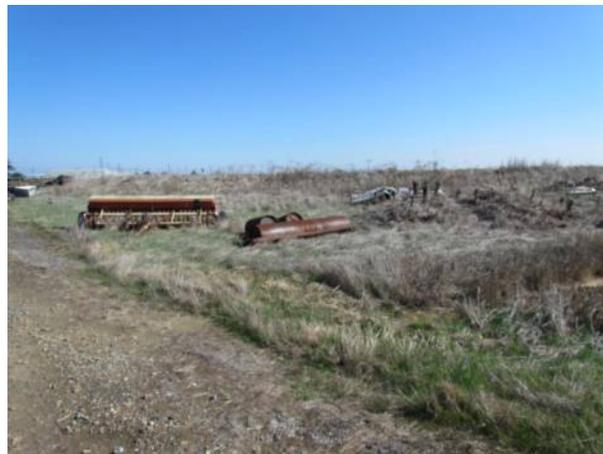
Levee Mile Report Line	5
Start Levee Mile	1.81
End Levee Mile	1.81
Location	Land Side
Category	Earthen Levee
Item	Encroachments
Equipment was found on the landside of the levee looking upstream.	
pkazi_f_20111122_296.jpg

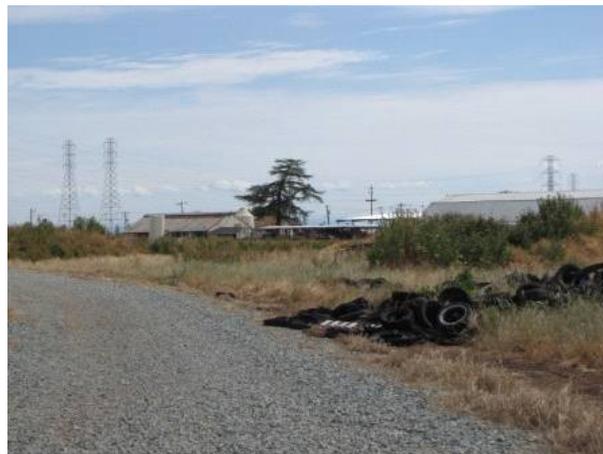
Levee Mile Report Line	6
Start Levee Mile	1.85
End Levee Mile	1.85
Location	Land Side
Category	Earthen Levee
Item	Encroachments
View of tires on the landward portion of the levee looking upstream.	
pkazi_f_20110923_098.jpg

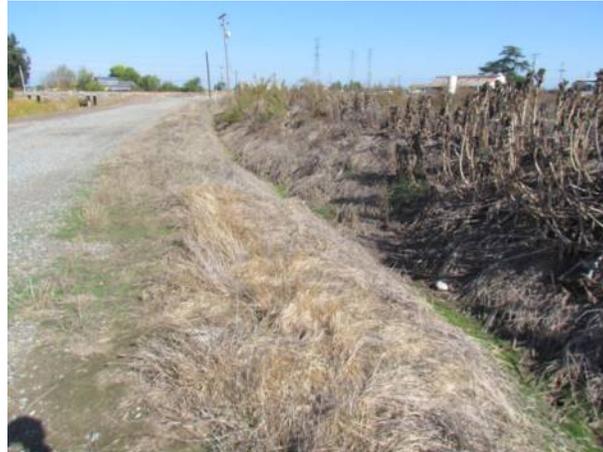
Levee Mile Report Line	7
Start Levee Mile	1.91
End Levee Mile	1.91
Location	Land Side
Category	Earthen Levee
Item	Encroachments
<p>A ditch was located on the landside toe of the levee looking upstream.</p>	
<p>pkazi_f_20111122_297.jpg</p>

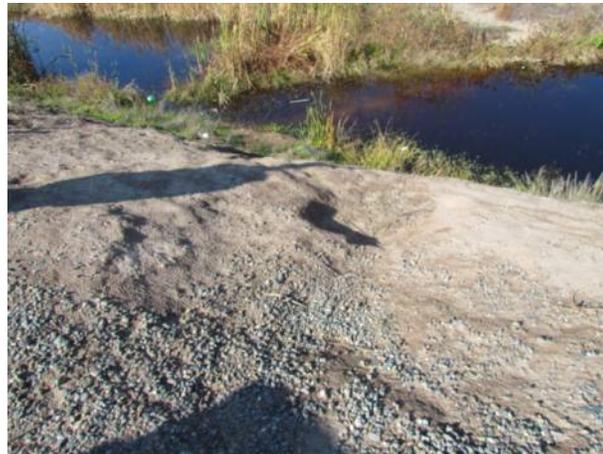
Levee Mile Report Line	8
Start Levee Mile	2.08
End Levee Mile	2.08
Location	Water Side
Category	Earthen Levee
Item	Slope Stability
<p>Slope stability was found on the waterside slope of the levee looking upstream.</p>	
<p>pkazi_f_20111122_298.jpg</p>

8	2.08	2.08	Earthen Levee	Slope Stability	WS	M	Repair slope instability.	38.117311 ° -121.152330 °	38.117311 ° -121.152330 °	110 Y
9	2.22	2.22	Earthen Levee	Trim / Thin Trees	LS	C	Trim trees to at least five feet above ground level.	38.117773 ° -121.149879 °	38.117773 ° -121.149879 °	23
10	2.37	2.43	Earthen Levee	Encroachments	LS	PO	Landscaping	38.118957 ° -121.147865 °	38.119761 ° -121.147461 °	8 Y
11	2.74	2.74	Earthen Levee	Crown Surface / Depressions / Rutting	CR	M	Regrade the crown roadway for proper drainage.	38.122841 ° -121.144365 °	38.122841 ° -121.144365 °	111 Y
12	2.93	2.93	Earthen Levee	Slope Stability	WS	M	Repair the levee slope damaged by foot traffic and prevent access where possible.	38.125605 ° -121.143951 °	38.125605 ° -121.143951 °	112 Y
13	2.95	2.95	Interior Drainage & Piping Systems	Flap Gates	WS	U	Inspector Comments: The flap gate is broken and not able to close.	38.125896 ° -121.144001 °	38.125896 ° -121.144001 °	15 Y
