**Flood Control Project Maintenance
Levee Inspections**

Fall 2011 Levee Maintenance Deficiency Summary Report

San Joaquin River Basin

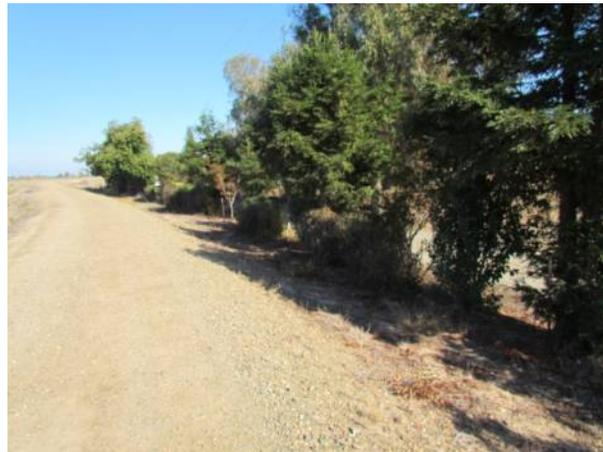
Levee Mile Report Line	10
Start Levee Mile	2.37
End Levee Mile	2.43
Location	Land Side
Category	Earthen Levee
Item	Encroachments
<p>Trees and landscaping was found on the landside of the levee looking upstream.</p>	
<p>pkazi_f_20111122_299.jpg</p>

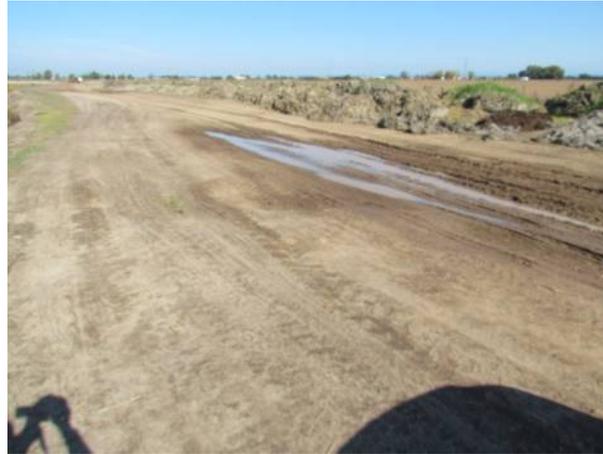
Levee Mile Report Line	11
Start Levee Mile	2.74
End Levee Mile	2.74
Location	Crown
Category	Earthen Levee
Item	Crown Surface / Depressions / Rutting
Depression was found on the crown of the levee looking upstream.	
pkazi_f_20111122_300.jpg

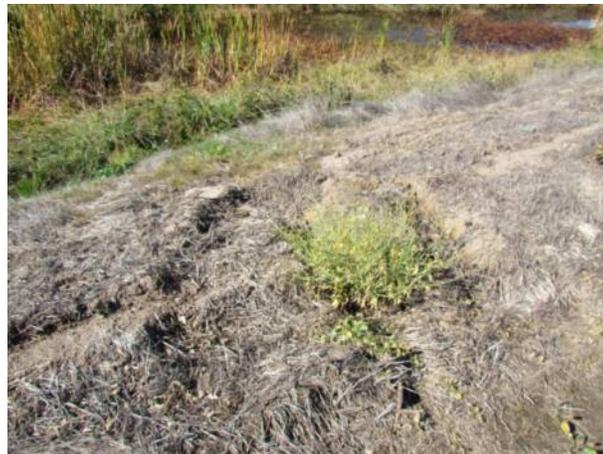
Levee Mile Report Line	12
Start Levee Mile	2.93
End Levee Mile	2.93
Location	Water Side
Category	Earthen Levee
Item	Slope Stability
Slope stability was found on the waterside of the levee looking upstream.	
pkazi_f_20111122_301.jpg

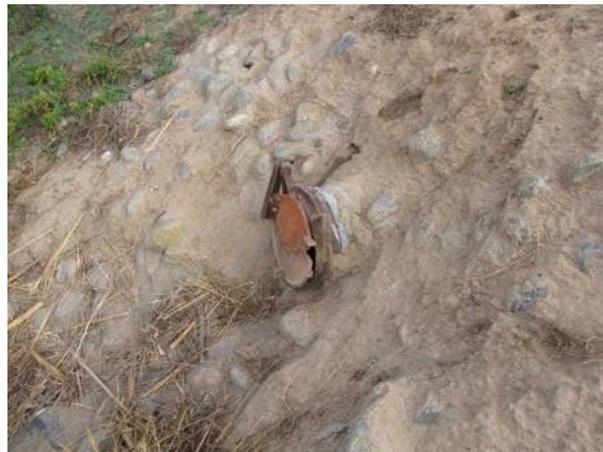
Levee Mile Report Line	13
Start Levee Mile	2.95
End Levee Mile	2.95
Location	Water Side
Category	Interior Drainage & Piping Systems
Item	Flap Gates
View of a flap gate that has been damaged and is unable to completely close.	
pkazi_f_20110923_097.jpg

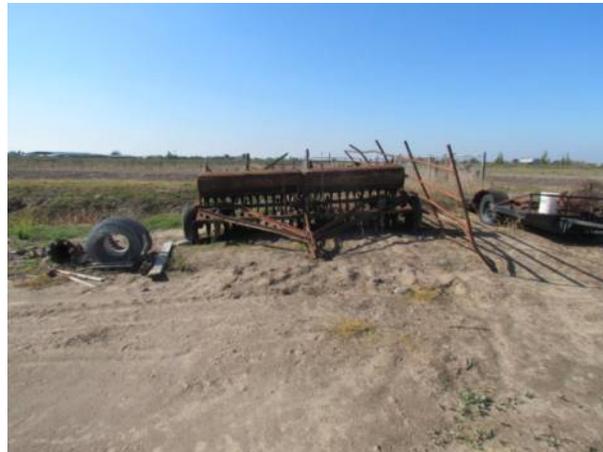
Levee Mile Report Line	15
Start Levee Mile	3.39
End Levee Mile	3.39
Location	Water Side
Category	Earthen Levee
Item	Encroachments
<p>Farming equipment was found on the waterside of the levee looking upstream.</p>	
<p>pkazi_f_20111122_302.jpg</p>

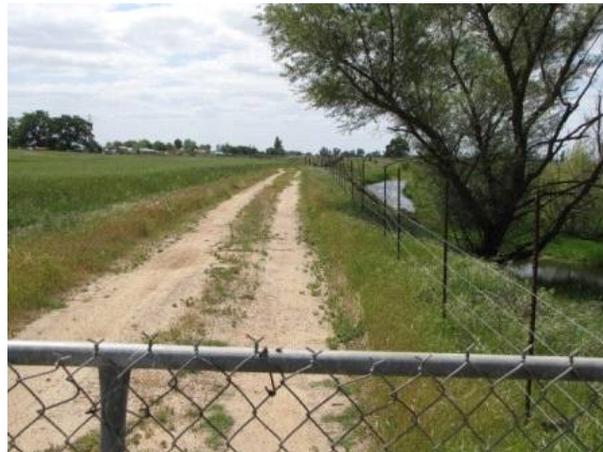
Levee Mile Report Line	16
Start Levee Mile	3.53
End Levee Mile	3.92
Location	Crown
Category	Earthen Levee
Item	Encroachments
<p>Fence along waterward sholder and crown of access road. The road cannot be driven through as the fence blocks access. The gate does not have a county key on the gate.</p>	
<p>pkazi_f_20110923_096.jpg</p>

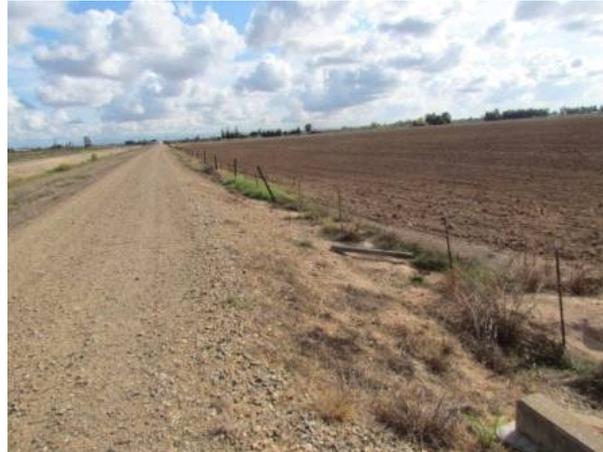
Levee Mile Report Line	1
Start Levee Mile	0.00
End Levee Mile	1.38
Location	Land Side
Category	Earthen Levee
Item	Encroachments
Fence was located on the landside of the levee looking upstream.	
pkazi_f_20111122_287.jpg

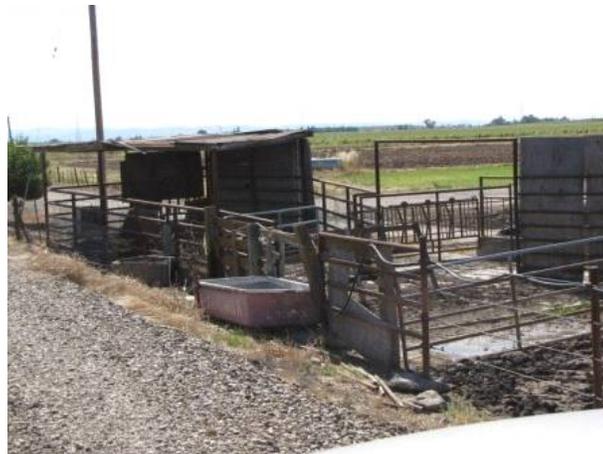
Levee Mile Report Line	2
Start Levee Mile	0.39
End Levee Mile	0.39
Location	Land Side
Category	Earthen Levee
Item	Encroachments
View of a tub/tank on the landward slope blocking access and visibility looking upstream.	
pkazi_f_20110923_195.jpg

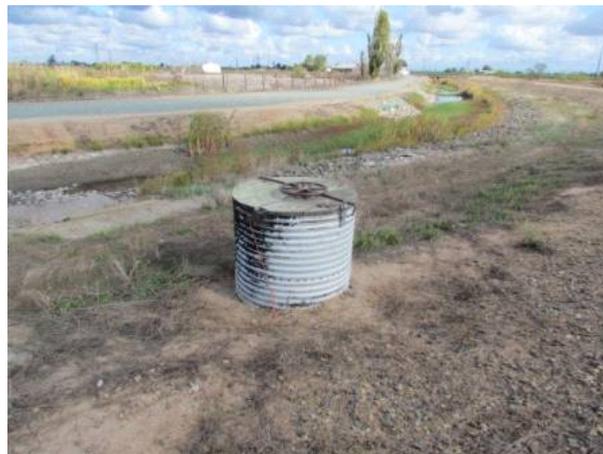
Levee Mile Report Line	3
Start Levee Mile	0.40
End Levee Mile	0.40
Location	Water Side
Category	Interior Drainage & Piping Systems
Item	Sluice / Slide Gates
The slide gate was closed during fall 2011 inspection, therefore no water was flowing through the culvert. The picture was taken from the crown looking upstream.	
pkazi_f_20111122_288.jpg

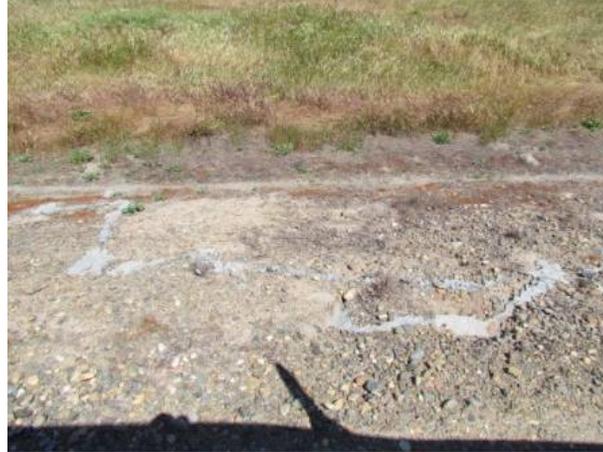
Levee Mile Report Line	5
Start Levee Mile	0.96
End Levee Mile	0.96
Location	Water Side
Category	Earthen Levee
Item	Animal Control
<p>Rodent holes were grouted by the LMA at the waterside of the levee. The picture was taken from the crown looking towards the toe.</p>	
<p>pkazi_f_20110923_194.jpg</p>

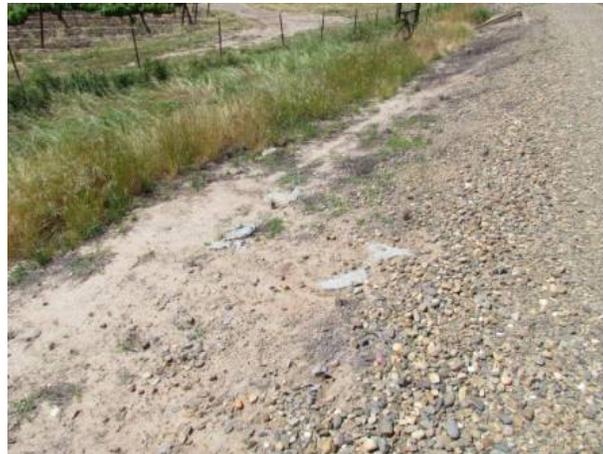
Levee Mile Report Line	6
Start Levee Mile	1.11
End Levee Mile	1.11
Location	Land Side
Category	Earthen Levee
Item	Animal Control
<p>Rodent holes were grouted by the LMA on the landside of the levee. The picture was taken from the crown looking upstream.</p>	
<p>pkazi_f_20110923_196.jpg</p>

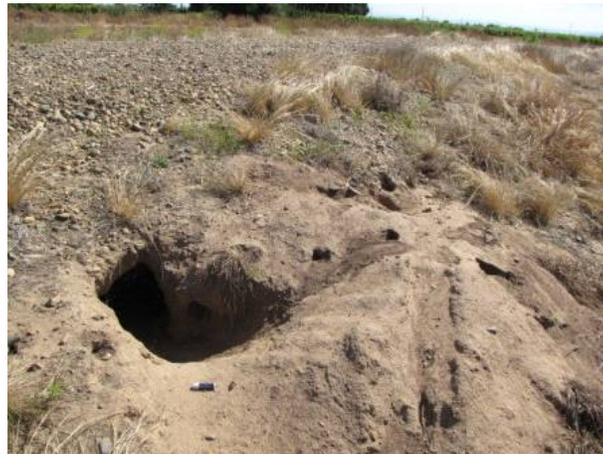
Levee Mile Report Line	8
Start Levee Mile	1.16
End Levee Mile	1.16
Location	Land Side
Category	Earthen Levee
Item	Animal Control
<p>View of a large hole in the landward slope of the levee looking upstream.</p>	
<p>pkazi_f_20110923_197.jpg</p>

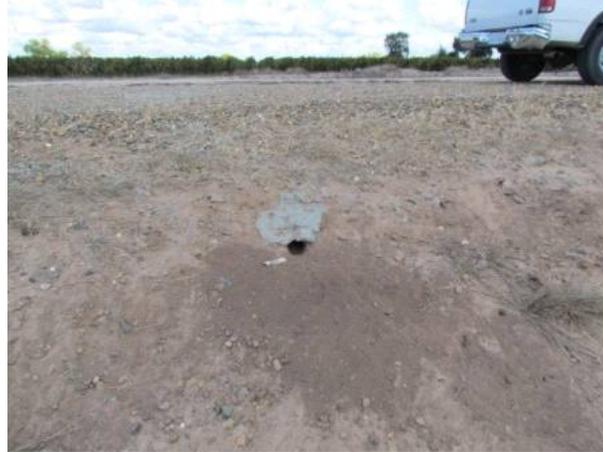
Levee Mile Report Line	8
Start Levee Mile	1.16
End Levee Mile	1.16
Location	Land Side
Category	Earthen Levee
Item	Animal Control
<p>The rodent hole was grouted on the landside of the levee looking upstream, but the fellow rodent didn't give up his home. The picture was taken during fall 2011 inspection.</p>	
<p>pkazi_f_20111122_290.jpg</p>

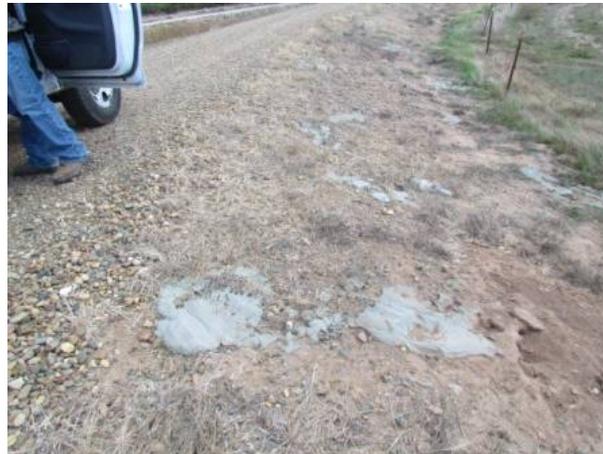
Levee Mile Report Line	9
Start Levee Mile	1.16
End Levee Mile	1.16
Location	Land Side
Category	Earthen Levee
Item	Animal Control
<p>Rodent holes were grouted on the landside of the levee looking upstream.</p>	
<p>pkazi_f_20111122_289.jpg</p>

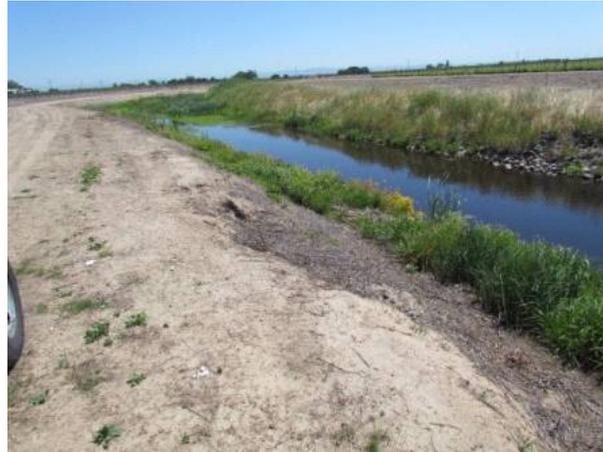
Levee Mile Report Line	1
Start Levee Mile	0.61
End Levee Mile	0.61
Location	Water Side
Category	Earthen Levee
Item	Erosion / Bank Caving
Erosion was found on the waterside of the levee.	
pkazi_f_20110923_254.jpg

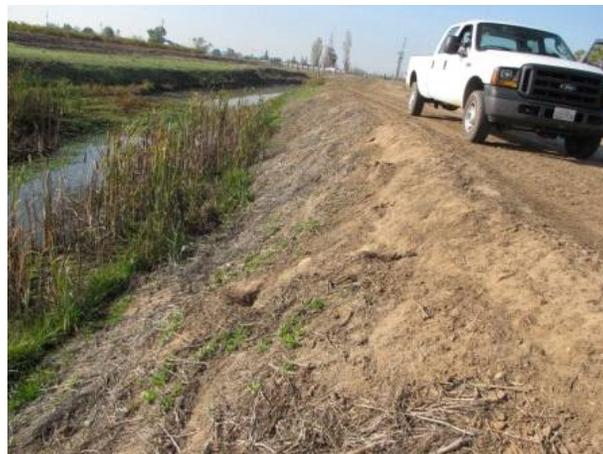
Levee Mile Report Line	2
Start Levee Mile	0.65
End Levee Mile	0.65
Location	Water Side
Category	Earthen Levee
Item	Animal Control
View of rodent holes in the waterward berm looking downstream.	
pkazi_f_20110923_252.jpg

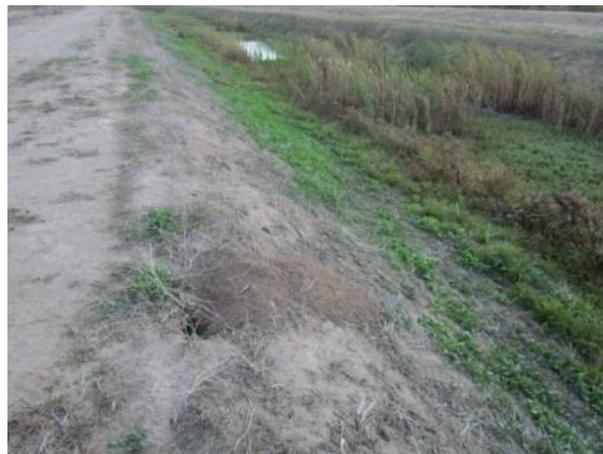
Levee Mile Report Line	3
Start Levee Mile	0.73
End Levee Mile	0.73
Location	Water Side
Category	Earthen Levee
Item	Animal Control
Rodent hole was found on the waterside shoulder of the levee looking upstream.	
pkazi_f_20111122_294.jpg

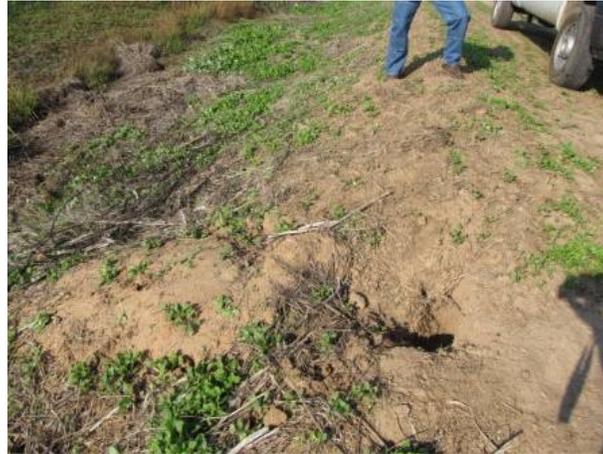
pkazi_f_20110923_253.jpg

View of a large diameter rodent hole in the waterward berm looking downstream.

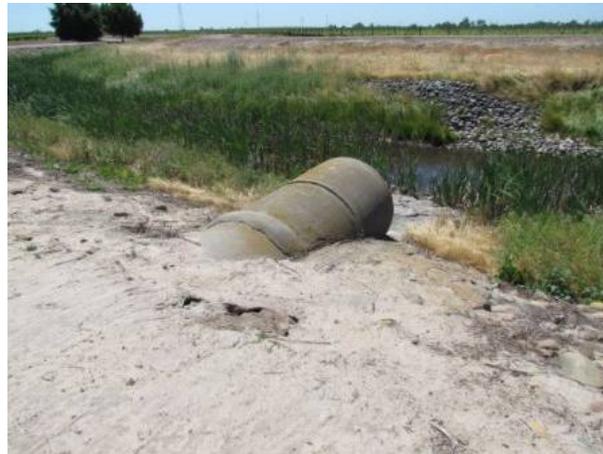
Levee Mile Report Line	5
Start Levee Mile	1.17
End Levee Mile	1.17
Location	Water Side
Category	Earthen Levee
Item	Erosion / Bank Caving

Erosion existed on top of the pipe was repaired. The picture was taken from the crown looking upstream.

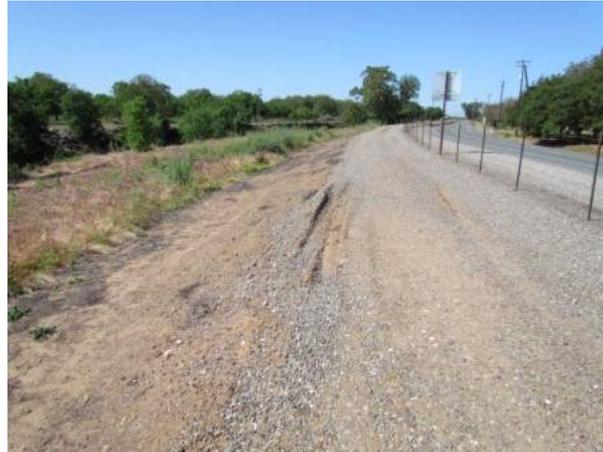
Levee Mile Report Line	2
Start Levee Mile	0.29
End Levee Mile	0.29
Location	Land Side
Category	Earthen Levee
Item	Slope Stability
<p>Rutting and depression was found on the shoulder of landside of the levee. The picture was taken from the crown looking downstream.</p>	
<p>pkazi_f_20111118_171.jpg</p>

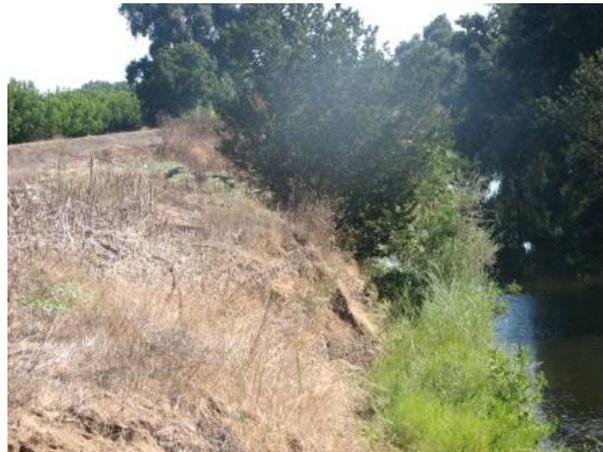
Levee Mile Report Line	3
Start Levee Mile	0.41
End Levee Mile	1.32
Location	Water Side
Category	Supplemental
Item	DWR Erosion Survey
<p>Close view of the erosion. Note the dense vegetation and tree on site.</p>	
<p>SJR2011_NA0017U15RM0.86_2.jpg</p>

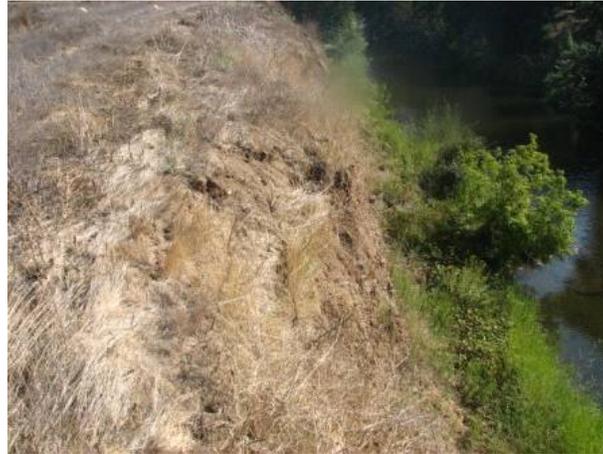
SJR2011_NA0017U15RM0.86_3.jpg

Close view of erosion site. Note the exposed soil at the top might be caused by animal activities.

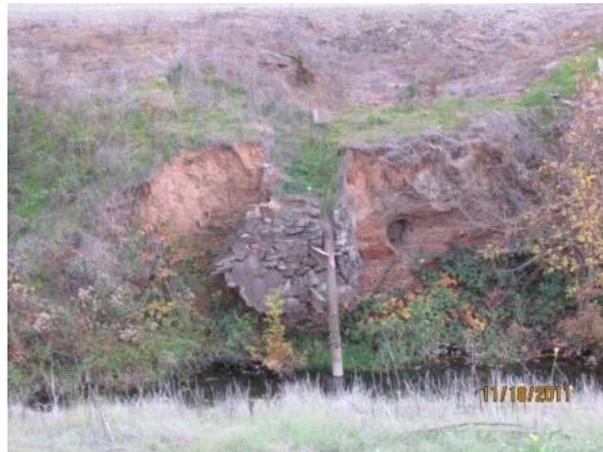
Levee Mile Report Line	4
Start Levee Mile	1.08
End Levee Mile	1.08
Location	Water Side
Category	Earthen Levee
Item	Erosion / Bank Caving

Erosion was found on the waterside slope of the levee. The picture was taken from crown of left of the levee.

4	1.08	1.08	Earthen Levee	Erosion / Bank Caving	WS	M	Note and monitor erosion site.	° °	° °	1157 Y
5	1.47	1.47	Earthen Levee	Trim / Thin Trees	LS	N	Tree stumps.	38.040188 ° -121.031854 °	38.040188 ° -121.031854 °	1128 Y
6	1.52	1.52	Earthen Levee	Erosion / Bank Caving	WS	M	Schedule repair of erosion site prior to the next inspection. Inspector Comments: The LMA was working on fixing the erosion site using an excavator during the inspection.	38.040202 ° -121.032659 °	38.040202 ° -121.032659 °	995 Y
7	1.55	1.62	Supplemental Levee	DWR Erosion Survey	WS	W	Inspector Comments: 09/02/2011: Site was repaired in 2011 summer by the district. Needs to monitor during the next flood season for performance. The site was previously rated "U". 11/02/2010: No significant changes observed on site. Bank erosion extends approximately 100 feet downstream and 250 feet upstream of the drop structure. 8/12/2009: No major change observed; erosion is upstream and downstream of drop structure; bank erosion is associated with high velocities; it is recommended for annual assessment and monitoring of critical erosion site per CLRO CES Evaluation 2008 Report; it was previously rated "U". 2007: Visited site 02/06/2007. [2011 Site ID:NA0017U15RM1.58]	38.040170 ° -121.033800 °	38.040170 ° -121.033800 °	11 Y

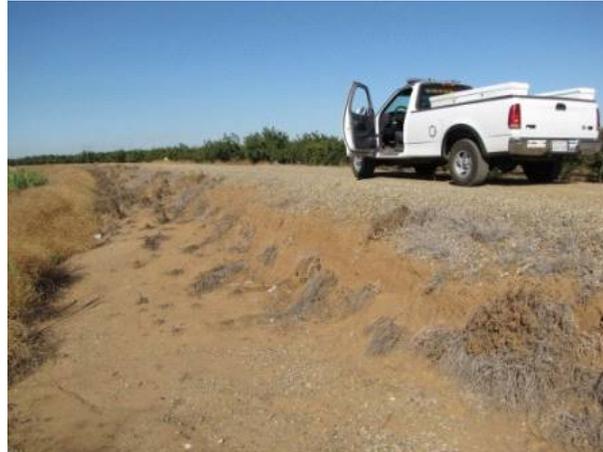
Levee Mile Report Line	6
Start Levee Mile	1.52
End Levee Mile	1.52
Location	Water Side
Category	Earthen Levee
Item	Erosion / Bank Caving
View of erosion of waterward levee slope looking upstream.	
pkazi_f_20111118_251.jpg

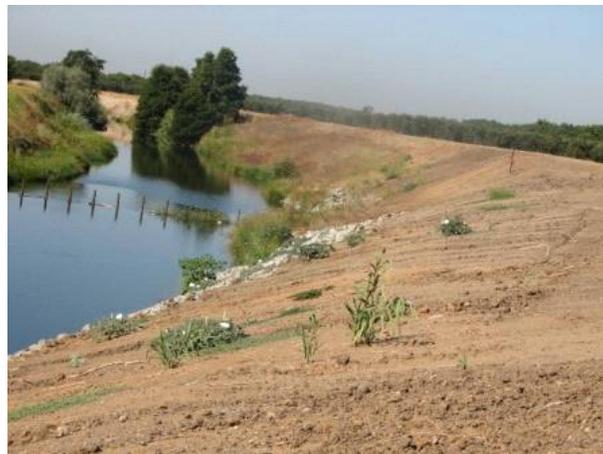
Levee Mile Report Line	7
Start Levee Mile	1.55
End Levee Mile	1.62
Location	Water Side
Category	Supplemental
Item	DWR Erosion Survey
Looking at the repaired site upstream of the drop structure.	
SJR2011_NA0017U15RM1.58_1.jpg

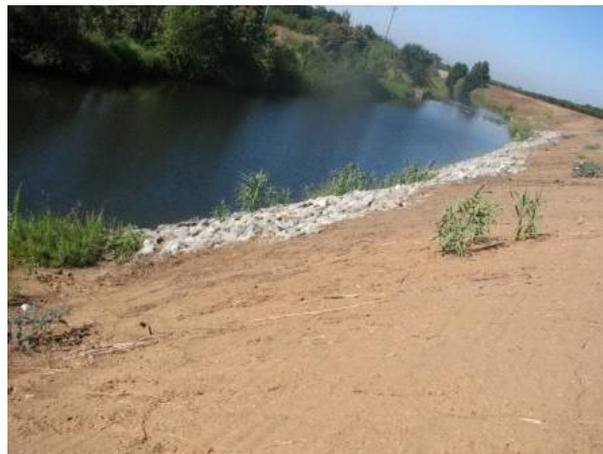
Levee Mile Report Line	7
Start Levee Mile	1.55
End Levee Mile	1.62
Location	Water Side
Category	Supplemental
Item	DWR Erosion Survey
Close look of the repaired site	
SJR2011_NA0017U15RM1.58_2.jpg

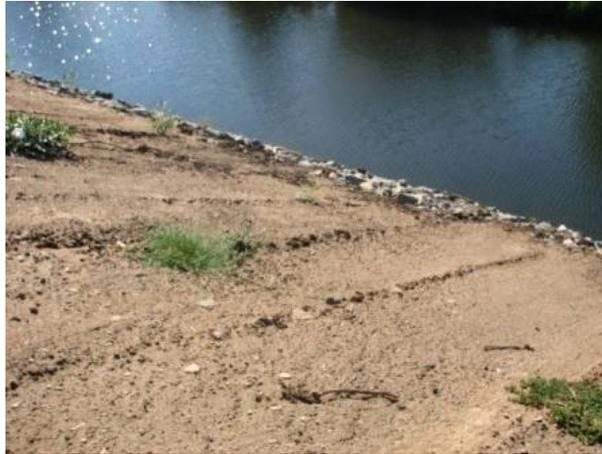
Levee Mile Report Line	7
Start Levee Mile	1.55
End Levee Mile	1.62
Location	Water Side
Category	Supplemental
Item	DWR Erosion Survey

Close view of the repaired site. Note the riprap at the toe

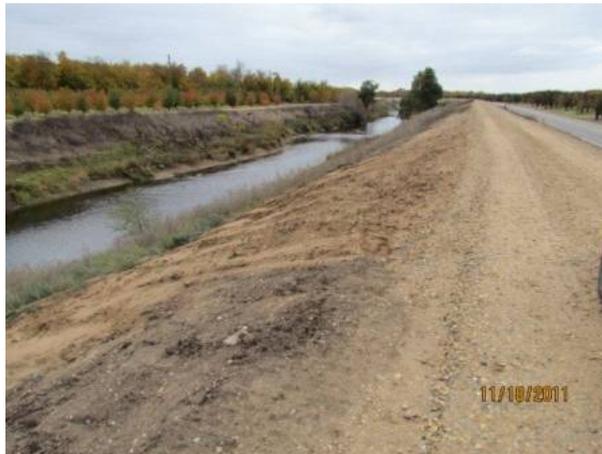
Levee Mile Report Line	8
Start Levee Mile	1.66
End Levee Mile	1.66
Location	Water Side
Category	Earthen Levee
Item	Slope Stability

Slope instability on the waterside of the levee looking downstream.

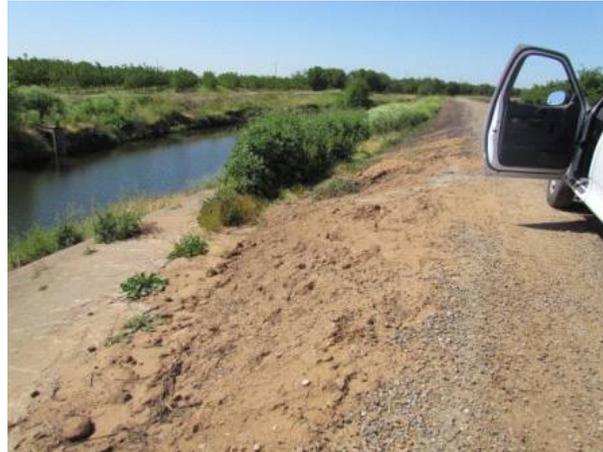
pkazi_f_20111118_188.jpg

Slope stability was discovered on the waterside of the levee. The picture was taken from the crown looking downstream.

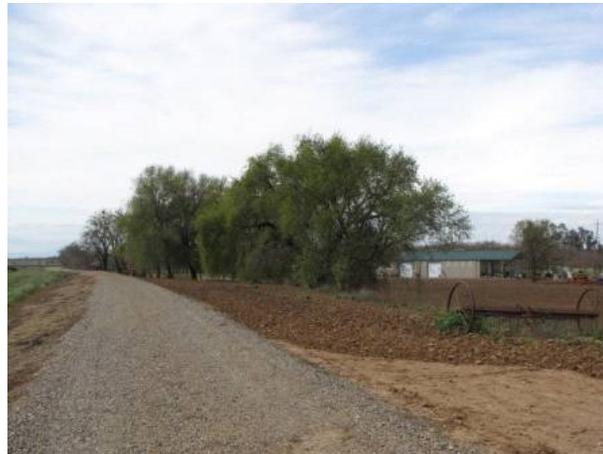
Levee Mile Report Line	10
Start Levee Mile	2.42
End Levee Mile	2.57
Location	Land Side
Category	Earthen Levee
Item	Erosion / Bank Caving

View of the landward shoulder where a landowner has disced the levee looking downstream.

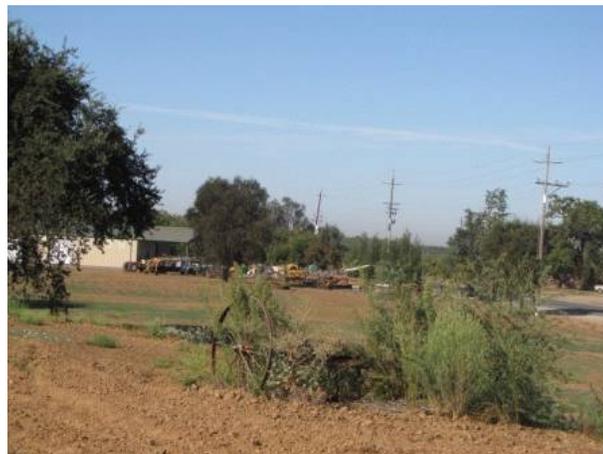
Levee Mile Report Line	11
Start Levee Mile	2.43
End Levee Mile	2.43
Location	Land Side
Category	Earthen Levee
Item	Encroachments

View of equipment on the landward slope of the levee looking downstream.

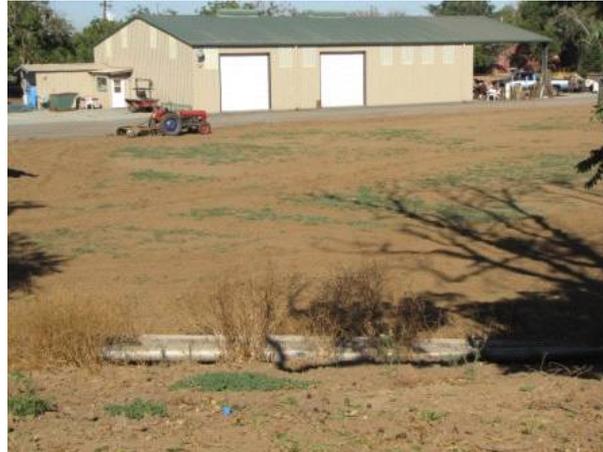
Levee Mile Report Line	13
Start Levee Mile	2.54
End Levee Mile	2.54
Location	Land Side
Category	Earthen Levee
Item	Encroachments
View of debris at the landward toe looking landward.	
pkazi_f_20111118_199.jpg

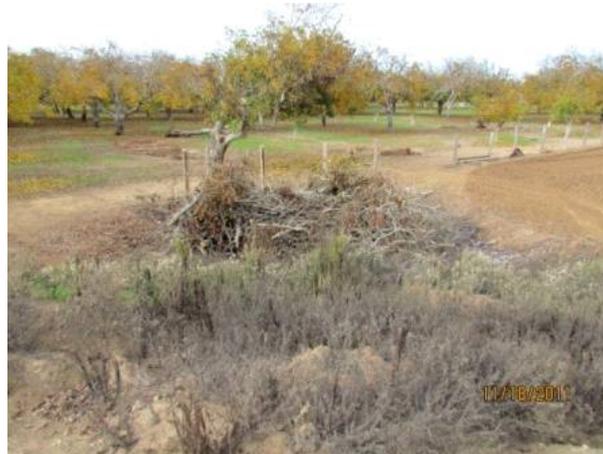
Levee Mile Report Line	14
Start Levee Mile	2.61
End Levee Mile	2.61
Location	Land Side
Category	Earthen Levee
Item	Encroachments
Prunings were found on the landside of the levee looking downstream.	
pkazi_f_20111208_451.jpg

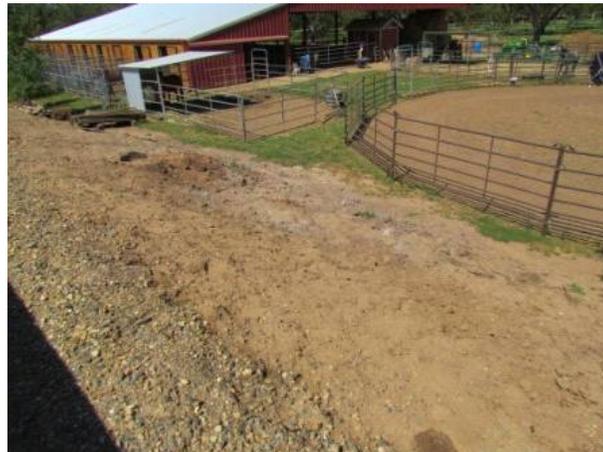
Levee Mile Report Line	15
Start Levee Mile	2.68
End Levee Mile	2.68
Location	Land Side
Category	Earthen Levee
Item	Slope Stability
Slope stability was found on the landside of the levee. The picture was taken from the crown looking downstream.	
pkazi_f_20111118_189.jpg

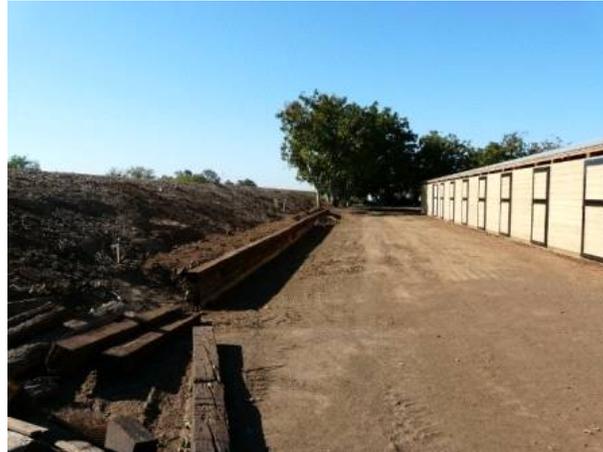
Levee Mile Report Line	16
Start Levee Mile	2.68
End Levee Mile	2.71
Location	Land Side
Category	Earthen Levee
Item	Encroachments
Recently built retaining wall at toe of landside levee at LM 2.68.	
pkazi_f_20111118_209.JPG

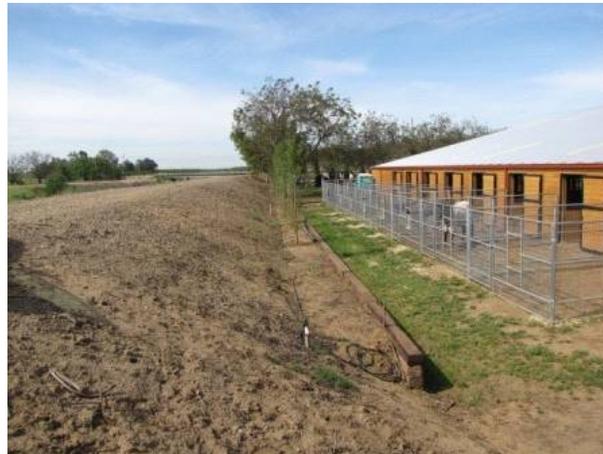
Levee Mile Report Line	16
Start Levee Mile	2.68
End Levee Mile	2.71
Location	Land Side
Category	Earthen Levee
Item	Encroachments
Updated view as of spring 2009. Landscaping and irrigation have been added at the toe of the levee.	
pkazi_f_20111118_210.jpg

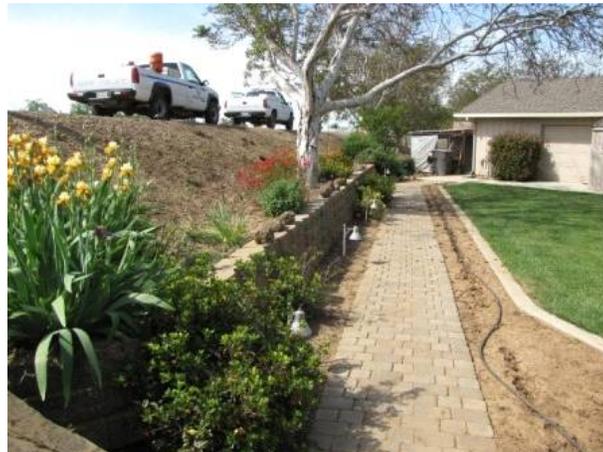
Levee Mile Report Line	18
Start Levee Mile	2.74
End Levee Mile	2.75
Location	Land Side
Category	Earthen Levee
Item	Encroachments
View of retaining wall and landscaping along the landward toe of the levee.	
pkazi_f_20111118_248.jpg

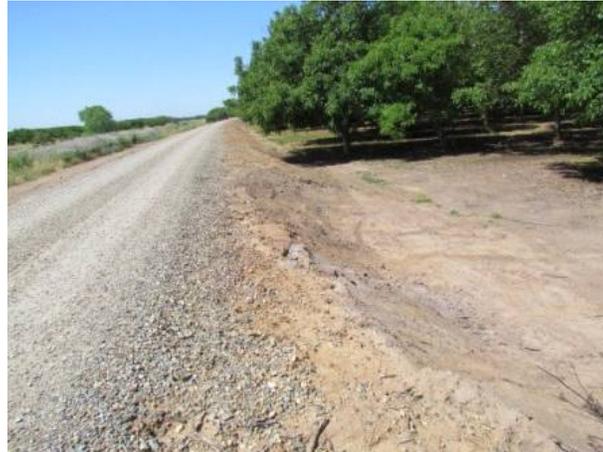
Levee Mile Report Line	19
Start Levee Mile	2.86
End Levee Mile	2.86
Location	Land Side
Category	Earthen Levee
Item	Slope Stability
Slope stability was found on the landside of the levee. The picture was taken from the crown looking downstream.	
pkazi_f_20111118_190.jpg

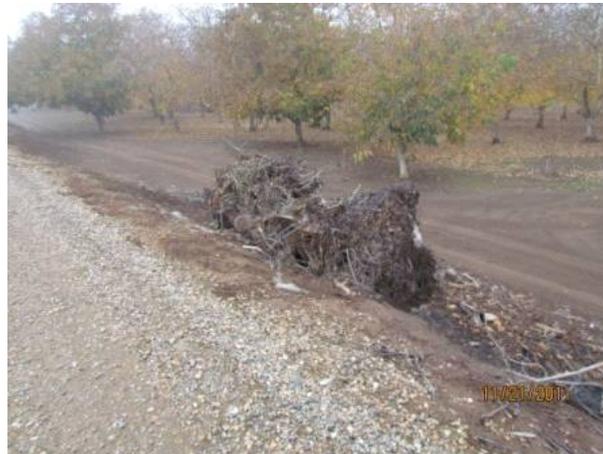
Levee Mile Report Line	20
Start Levee Mile	2.87
End Levee Mile	2.87
Location	Land Side
Category	Earthen Levee
Item	Encroachments
Prunings were found on the waterside of the levee looking downstream.	
pkazi_f_20111208_453.jpg

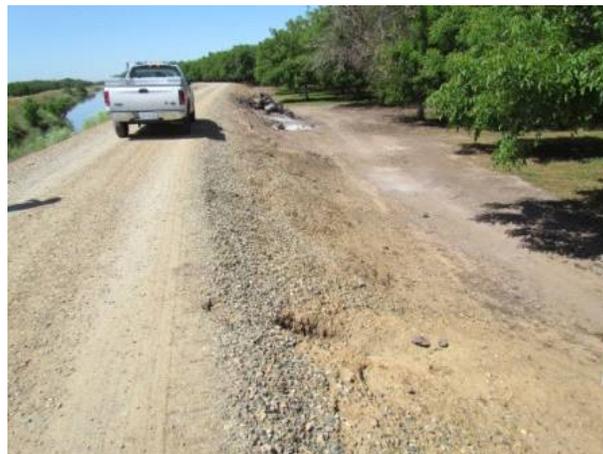
Levee Mile Report Line	22
Start Levee Mile	2.98
End Levee Mile	2.98
Location	Land Side
Category	Earthen Levee
Item	Slope Stability
Slope stability was found on the landside of the levee. The picture was taken from the crown looking downstream.	
pkazi_f_20111118_191.jpg

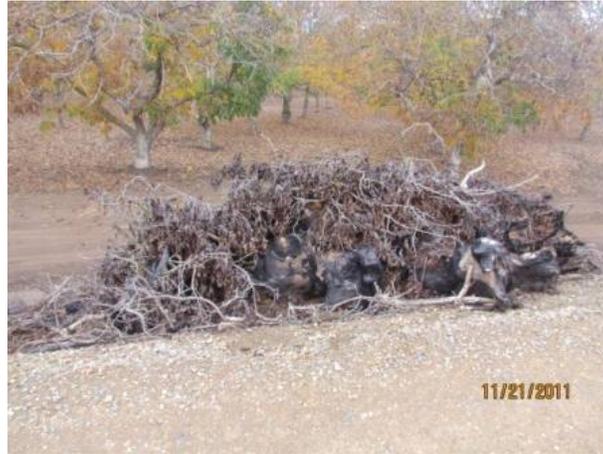
Levee Mile Report Line	23
Start Levee Mile	3.04
End Levee Mile	3.04
Location	Land Side
Category	Earthen Levee
Item	Encroachments
Prunings were found on the landside of the levee looking downstream.	
pkazi_f_20111208_454.jpg

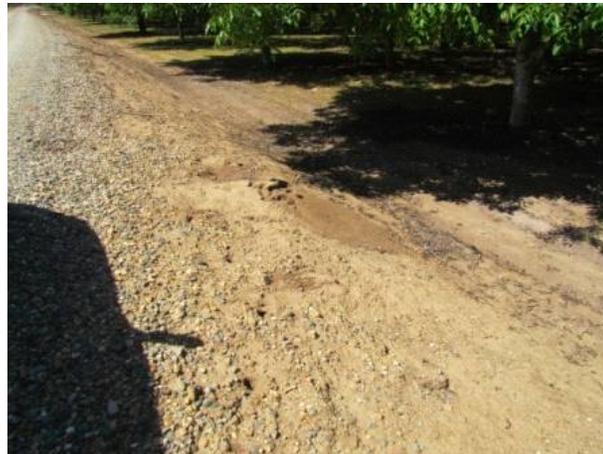
Levee Mile Report Line	24
Start Levee Mile	3.05
End Levee Mile	3.05
Location	Land Side
Category	Earthen Levee
Item	Animal Control
Animal burrow was found on the landside of the levee. The picture was taken from the crown looking downstream.	
pkazi_f_20111118_192.jpg

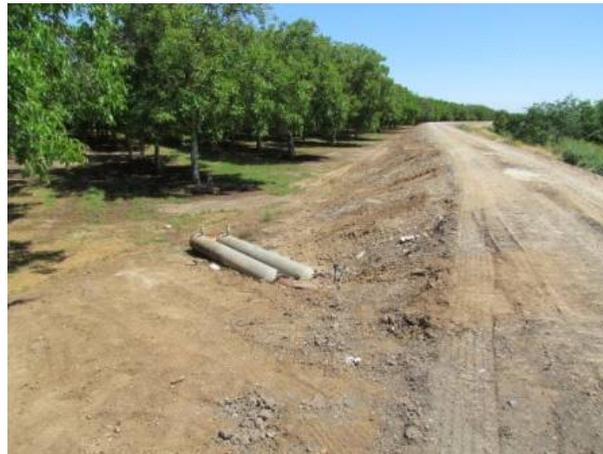
Levee Mile Report Line	25
Start Levee Mile	3.10
End Levee Mile	3.14
Location	Land Side
Category	Earthen Levee
Item	Slope Stability
Slope stability was found on the landside of the levee. The picture was taken from the crown looking upstream.	
pkazi_f_20111118_200.jpg

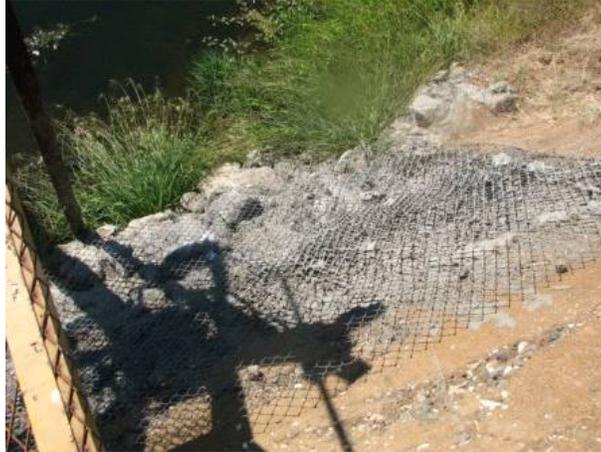
SJR2011_NA0017U15RM3.14_1.jpg

Looking down at the repaired site.

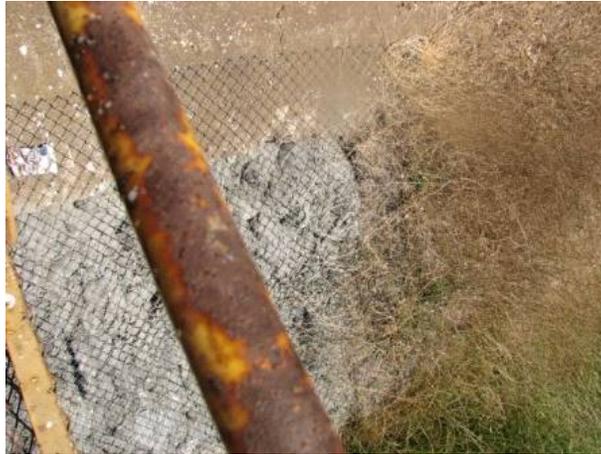
SJR2011_NA0017U15RM3.14_2.jpg

Looking down at the repaired site.

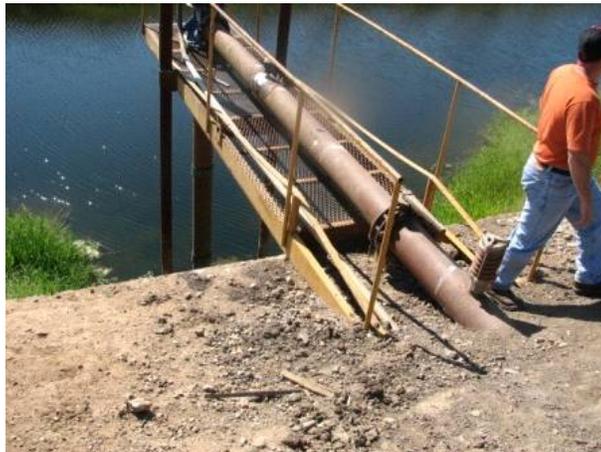
SJR2011_NA0017U15RM3.14_3.jpg

Levee Mile Report Line	26
Start Levee Mile	3.14
End Levee Mile	3.15
Location	Water Side
Category	Supplemental
Item	DWR Erosion Survey

View from levee top

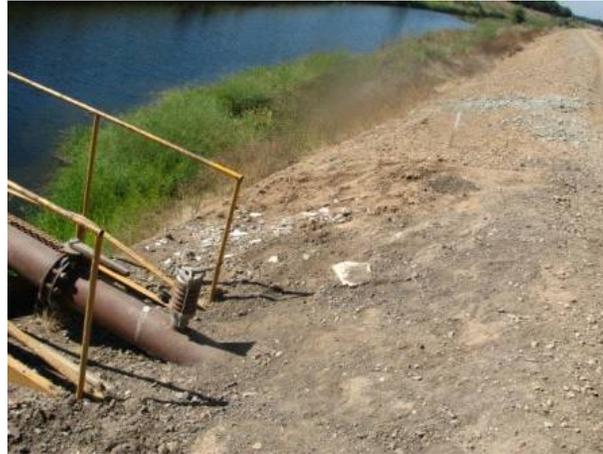
SJR2011_NA0017U15RM3.14_4.jpg

Looking at the levee shoulder

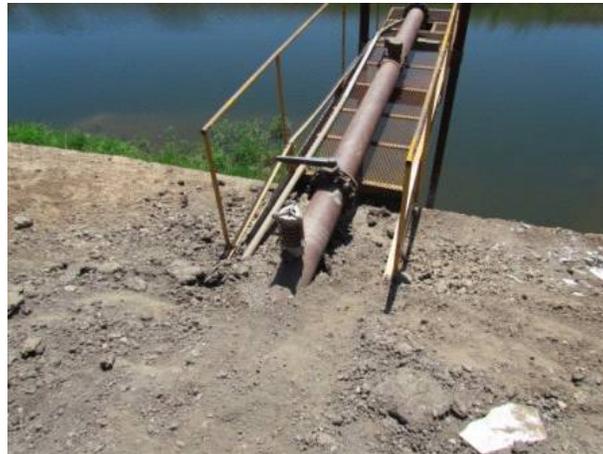
pkazi_f_20111118_245.jpg

Levee Mile Report Line	27
Start Levee Mile	3.14
End Levee Mile	3.14
Location	Water Side
Category	Earthen Levee
Item	Erosion / Bank Caving

Erosion around and under the pipe has been fixed. The picture was taken from the crown looking toward the waterside.

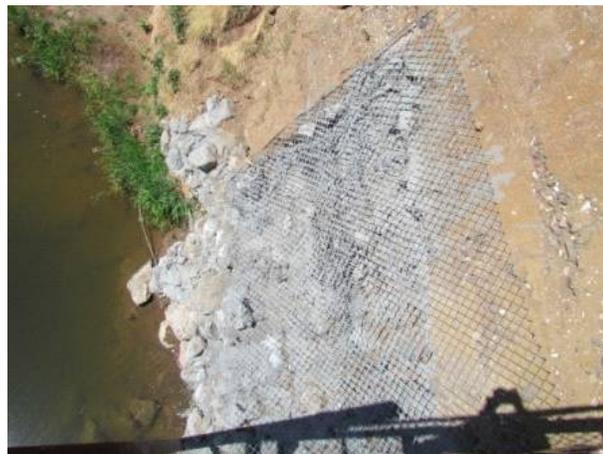
pkazi_f_20111118_246.jpg

Levee Mile Report Line	27
Start Levee Mile	3.14
End Levee Mile	3.14
Location	Water Side
Category	Earthen Levee
Item	Erosion / Bank Caving

Rocks have been placed to control the erosion on the waterside slope of the levee. The picture was taken at the location of the pipe looking waterside of the levee.

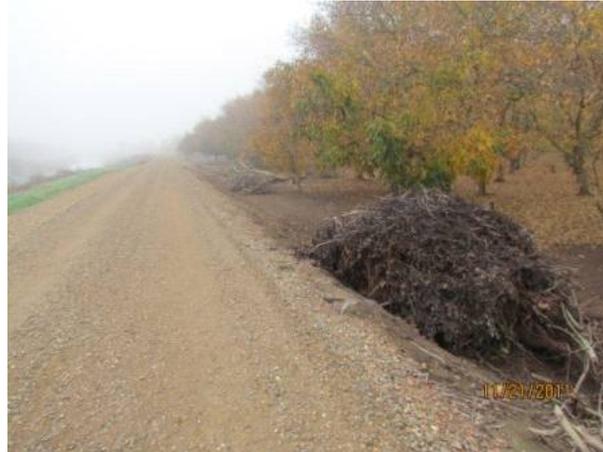
Levee Mile Report Line	29
Start Levee Mile	3.26
End Levee Mile	3.26
Location	Land Side
Category	Earthen Levee
Item	Encroachments
Prunings were found on the landside of the levee looking downstream.	
pkazi_f_20111208_455.jpg

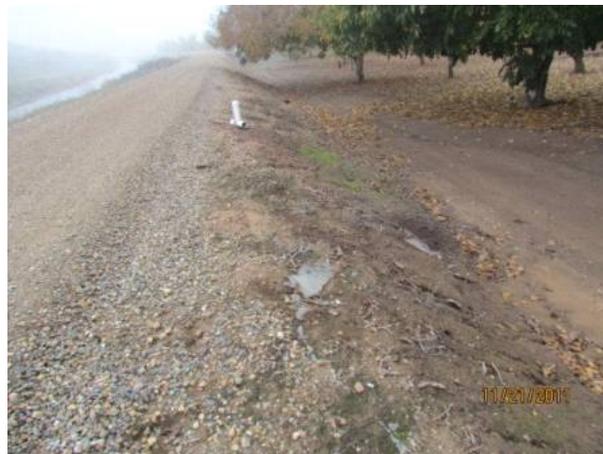
Levee Mile Report Line	31
Start Levee Mile	3.33
End Levee Mile	3.33
Location	Land Side
Category	Earthen Levee
Item	Animal Control
Rodent holes were grouted by the LMA on the landside of the levee looking downstream.	
pkazi_f_20111208_456.jpg

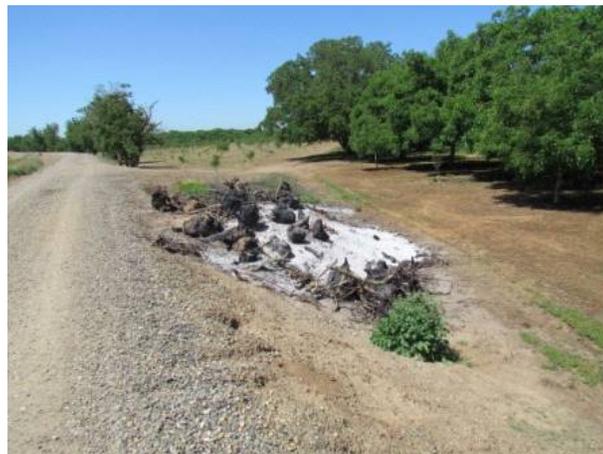
Levee Mile Report Line	36
Start Levee Mile	3.40
End Levee Mile	3.40
Location	Land Side
Category	Earthen Levee
Item	Encroachments
Burn pile and new material was placed at the toe of the landside of the levee. The picture was taken from the crown looking downstream.	
pkazi_f_20111118_170.jpg

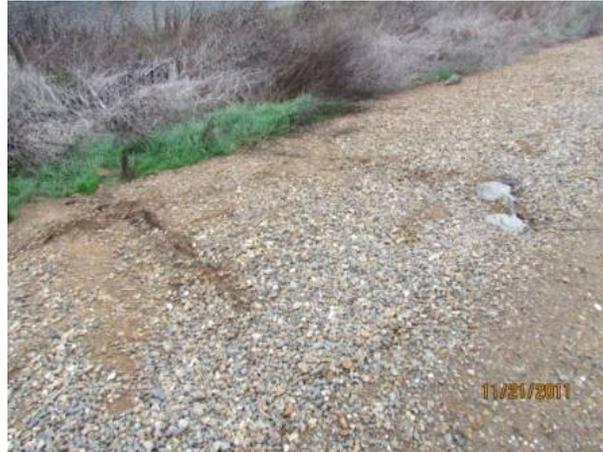
Levee Mile Report Line	37
Start Levee Mile	3.41
End Levee Mile	3.41
Location	Water Side
Category	Earthen Levee
Item	Slope Stability
Slope instability was found on the landside of the levee looking upstream.	
pkazi_f_20111208_457.jpg

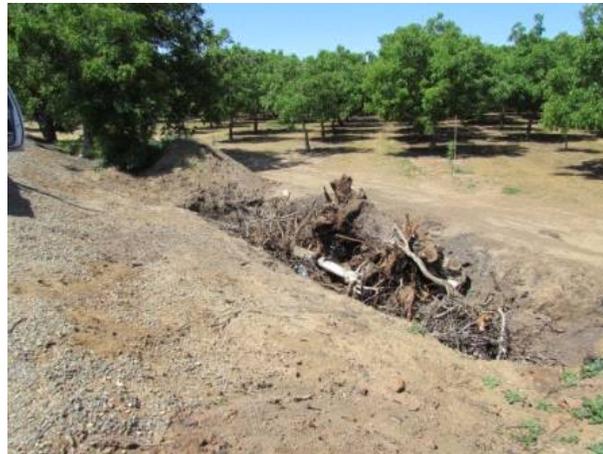
Levee Mile Report Line	40
Start Levee Mile	3.61
End Levee Mile	3.61
Location	Land Side
Category	Earthen Levee
Item	Slope Stability
A pit was dug out by the farmers at the toe of landside of the levee. The picture was taken from the crown looking downstream.	
pkazi_f_20111118_211.jpg

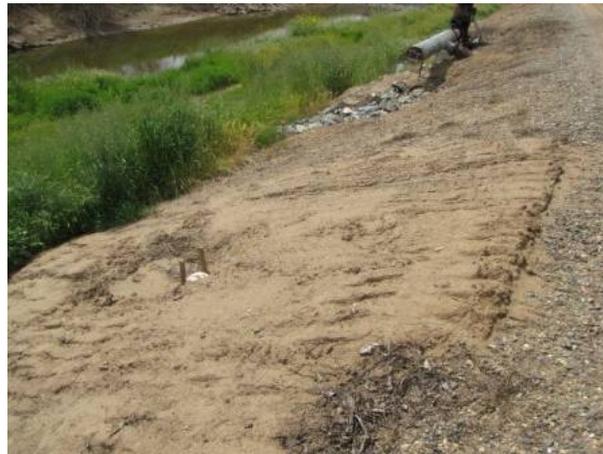
Levee Mile Report Line	41
Start Levee Mile	3.62
End Levee Mile	3.62
Location	Water Side
Category	Earthen Levee
Item	Encroachments
View of a recently place pipe in the waterward slope looking downstream.	
pkazi_f_20111118_202.jpg

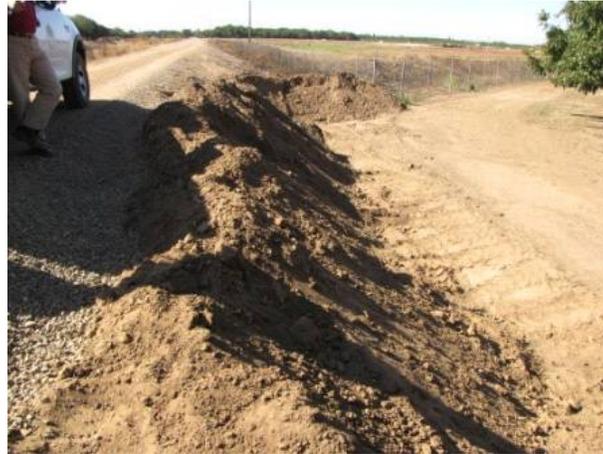
Levee Mile Report Line	43
Start Levee Mile	3.64
End Levee Mile	3.66
Location	Land Side
Category	Earthen Levee
Item	Slope Stability
View of excavations and embankments created by landowner along the landward slope looking downstream.	
pkazi_f_20111118_253.jpg

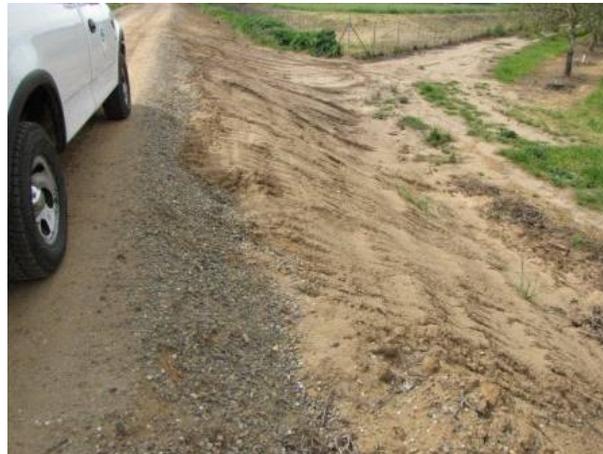
Levee Mile Report Line	43
Start Levee Mile	3.64
End Levee Mile	3.66
Location	Land Side
Category	Earthen Levee
Item	Slope Stability
Updated view of the location with a partially completed repair looking downstream.	
pkazi_f_20111118_254.jpg

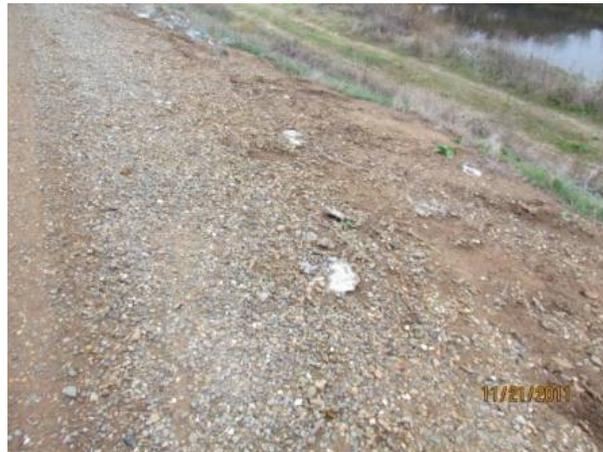
Levee Mile Report Line	44
Start Levee Mile	3.65
End Levee Mile	3.65
Location	Water Side
Category	Earthen Levee
Item	Animal Control
Rodent holes were grouted by the LMA on the waterside of the levee looking upstream.	
pkazi_f_20111209_458.jpg

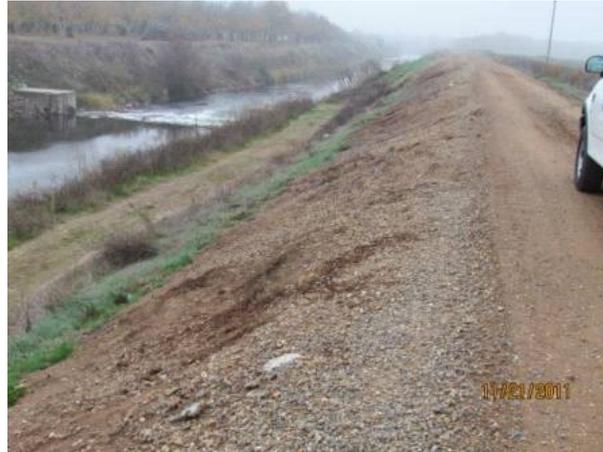
pkazi_f_20111209_459.jpg

Slope instability was found on the waterside of the levee looking downstream.

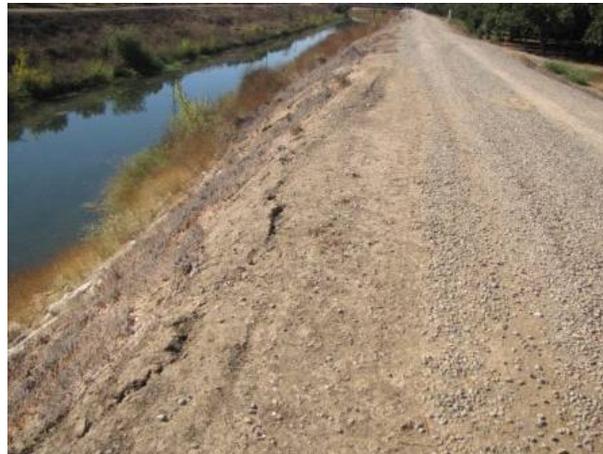
pkazi_f_20111118_213.jpg

Levee Mile Report Line	49
Start Levee Mile	3.92
End Levee Mile	3.92
Location	Land Side
Category	Earthen Levee
Item	Cracking

View of cracking on the waterward shoulder occurring at an erosion repair looking downstream.

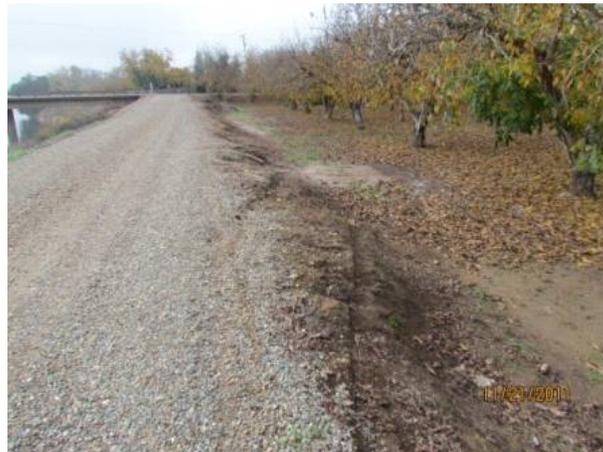
pkazi_f_20111209_460.jpg

Levee Mile Report Line	50
Start Levee Mile	4.06
End Levee Mile	4.06
Location	Land Side
Category	Earthen Levee
Item	Slope Stability

Slope instability was found on the landside of the levee looking downstream.

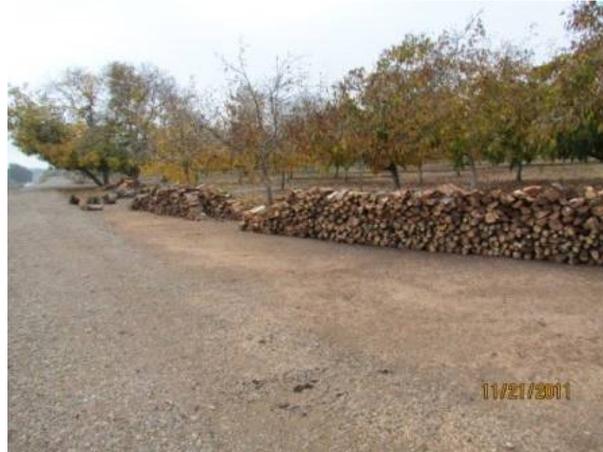
Levee Mile Report Line	53
Start Levee Mile	4.16
End Levee Mile	4.16
Location	Land Side
Category	Earthen Levee
Item	Encroachments
Firewood was found on the landside of the levee looking downstream.	
pkazi_f_20111209_461.jpg

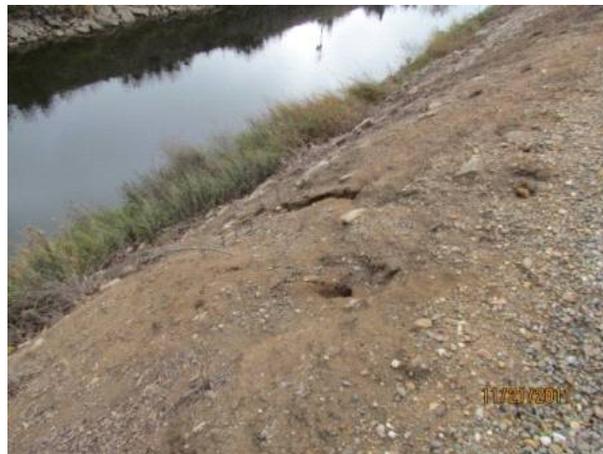
Levee Mile Report Line	55
Start Levee Mile	4.25
End Levee Mile	4.25
Location	Water Side
Category	Earthen Levee
Item	Erosion / Bank Caving
Erosion caused by rodent holes on the waterside of the levee looking downstream.	
pkazi_f_20111209_462.jpg

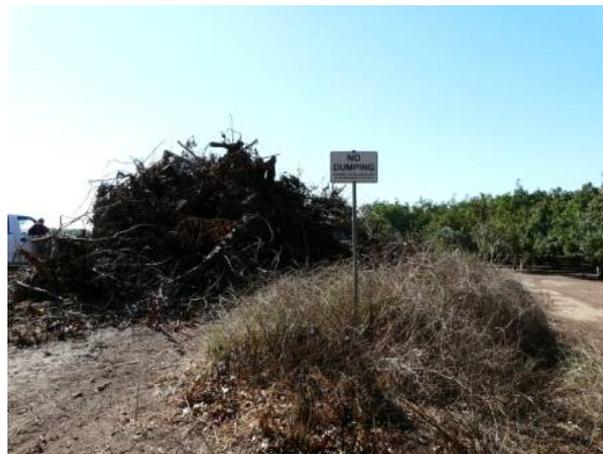
Levee Mile Report Line	56
Start Levee Mile	4.29
End Levee Mile	4.29
Location	Land Side
Category	Earthen Levee
Item	Encroachments
Example of a prunings pile immediately adjacent to access road at LM 4.29. Evidence of habitual burnings at this site.	
pkazi_f_20111118_183.JPG

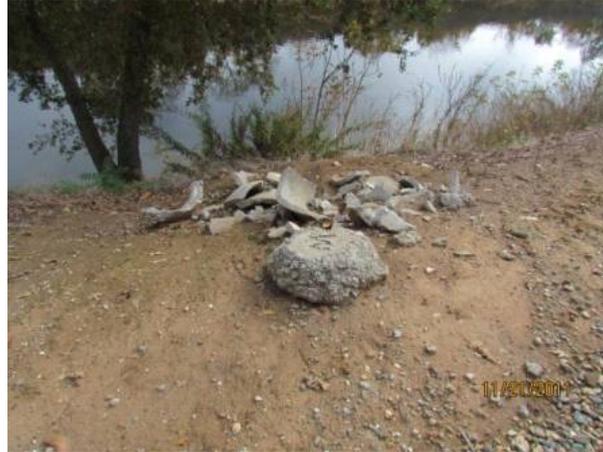
Levee Mile Report Line	58
Start Levee Mile	4.66
End Levee Mile	4.66
Location	Water Side
Category	Earthen Levee
Item	Encroachments
Debris was found on the waterside of the levee looking downstream.	
pkazi_f_20111209_463.jpg

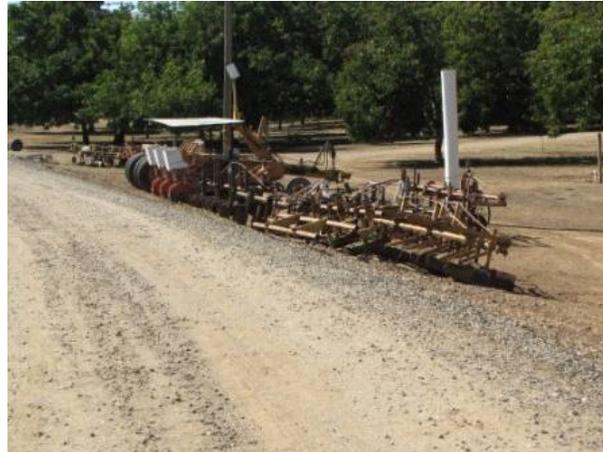
Levee Mile Report Line	60
Start Levee Mile	4.96
End Levee Mile	4.96
Location	Land Side
Category	Earthen Levee
Item	Encroachments
View of equipment along the landward slope looking downstream.	
pkazi_f_20111118_184.jpg
