**Flood Control Project Maintenance
Levee Inspections**

Fall 2011 Levee Maintenance Deficiency Summary Report

San Joaquin River Basin

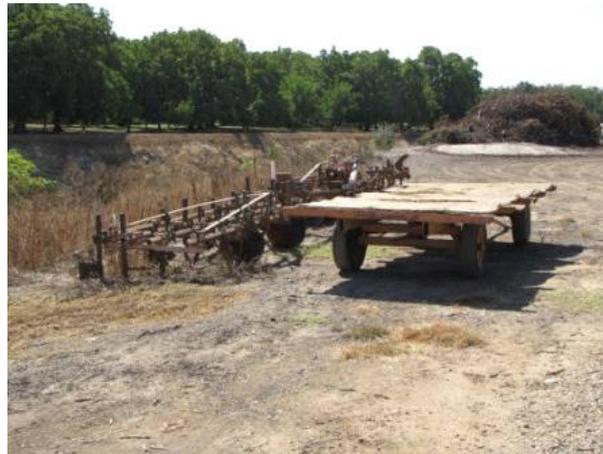
Levee Mile Report Line	61
Start Levee Mile	4.96
End Levee Mile	4.96
Location	Water Side
Category	Earthen Levee
Item	Encroachments
View of equipment along the waterward side of the levee crown looking downstream.	
pkazi_f_20111118_185.jpg

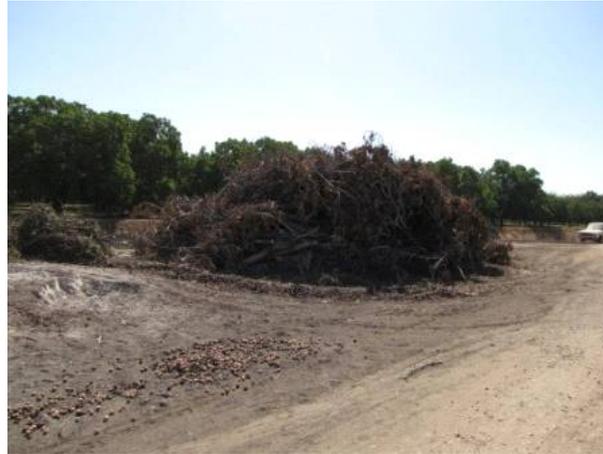
pkazi_f_20111118_214.jpg

View of prunings pile along the waterward side of the crown looking downstream.

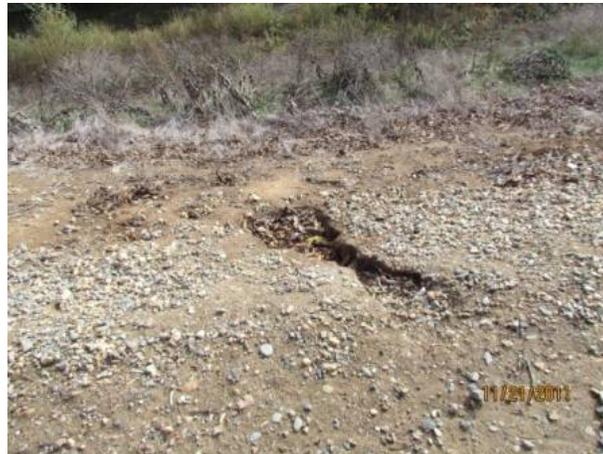
pkazi_f_20111209_464.jpg

Levee Mile Report Line	63
Start Levee Mile	5.00
End Levee Mile	5.00
Location	Water Side
Category	Earthen Levee
Item	Erosion / Bank Caving

Erosion was found on the waterside of the levee looking downstream.

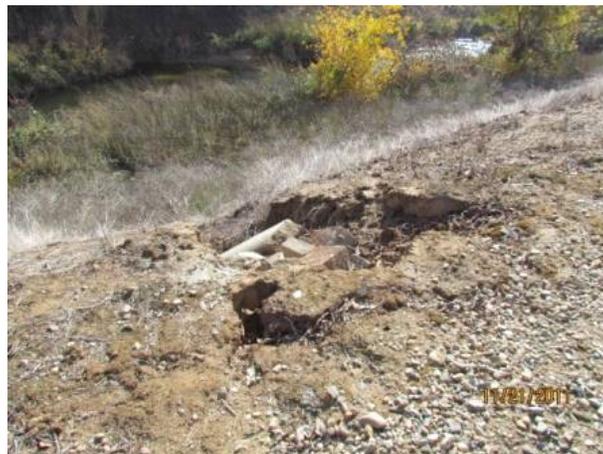
pkazi_f_20111209_465.jpg

Levee Mile Report Line	64
Start Levee Mile	5.07
End Levee Mile	5.07
Location	Water Side
Category	Earthen Levee
Item	Slope Stability

Slope instability was found on the waterside of the levee looking downstream.

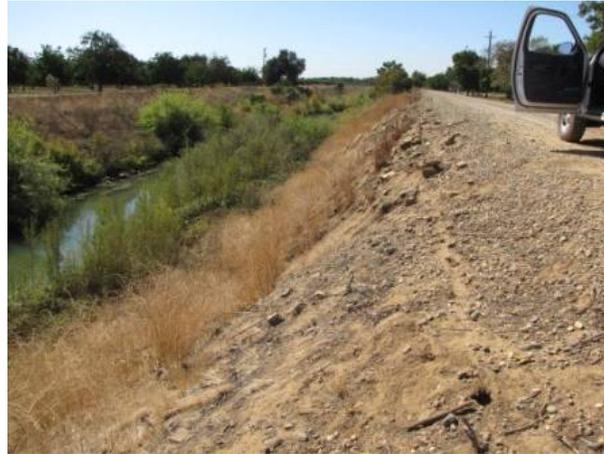
Levee Mile Report Line	65
Start Levee Mile	5.14
End Levee Mile	5.14
Location	Water Side
Category	Earthen Levee
Item	Slope Stability
View of a slip in the waterward levee slope looking downstream.	
pkazi_f_20111118_255.jpg

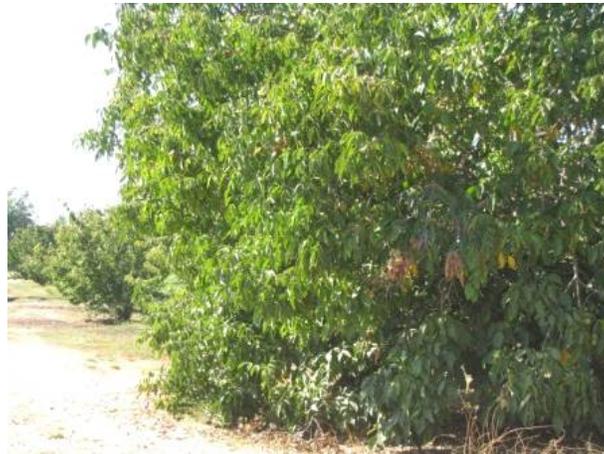
Levee Mile Report Line	67
Start Levee Mile	5.26
End Levee Mile	5.26
Location	Land Side
Category	Earthen Levee
Item	Trim / Thin Trees
View of trees on the landward slope blocking visibility and access looking downstream.	
pkazi_f_20111118_217.jpg

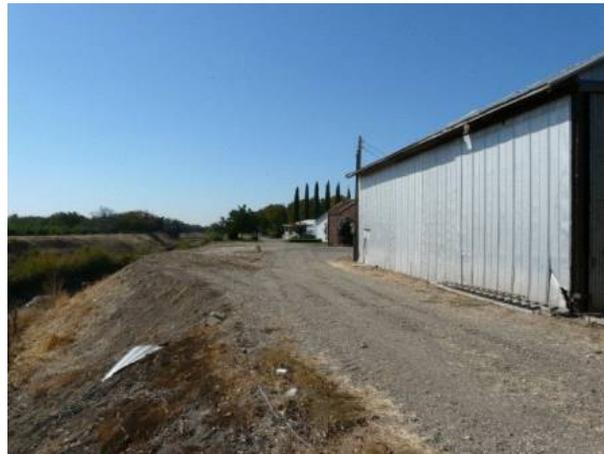
Levee Mile Report Line	70
Start Levee Mile	5.38
End Levee Mile	5.45
Location	Land Side
Category	Earthen Levee
Item	Encroachments
Building located immediately adjacent to access road approximately from LM 5.38 to 5.45	
pkazi_f_20111118_186.JPG

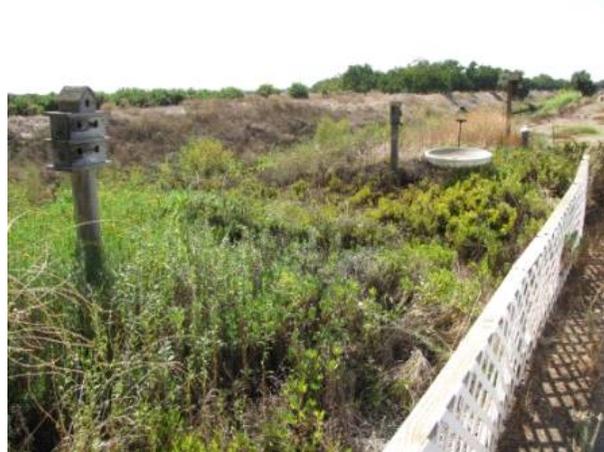
Levee Mile Report Line	71
Start Levee Mile	5.42
End Levee Mile	5.42
Location	Water Side
Category	Earthen Levee
Item	Encroachments
View of landscaping planted along the waterward side of the access road impacting visibility and the ability to floodfight looking downstream.	
pkazi_f_20111118_256.jpg

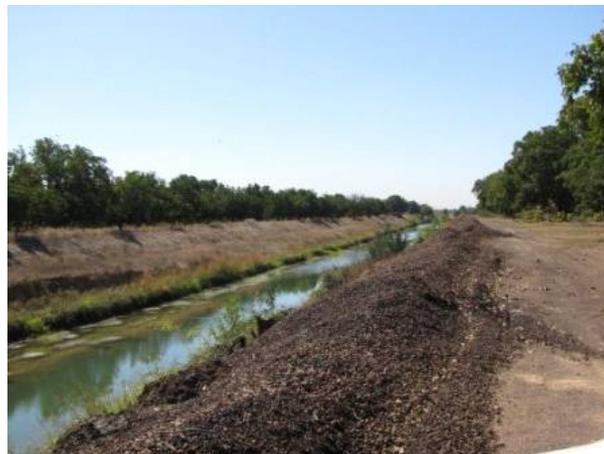
Levee Mile Report Line	72
Start Levee Mile	5.60
End Levee Mile	5.65
Location	Water Side
Category	Earthen Levee
Item	Encroachments
View of discarded nut shells placed along the waterward slope to be burned looking downstream.	
pkazi_f_20111118_257.jpg

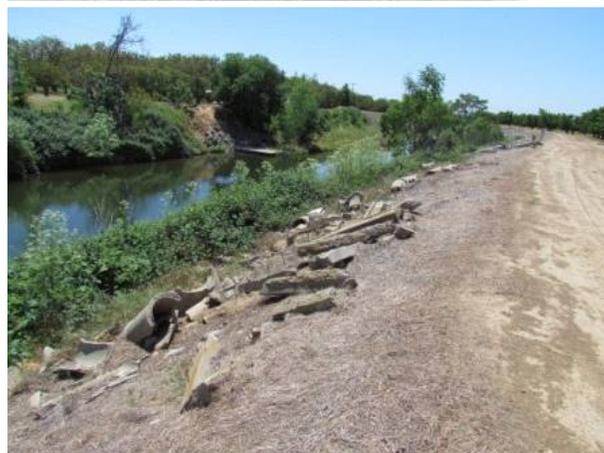
Levee Mile Report Line	74
Start Levee Mile	5.76
End Levee Mile	5.86
Location	Water Side
Category	Earthen Levee
Item	Encroachments
Broken concrete pipes and other debris was found on the waterside of the levee. The picture was taken from the crown looking downstream.	
pkazi_f_20111118_187.jpg

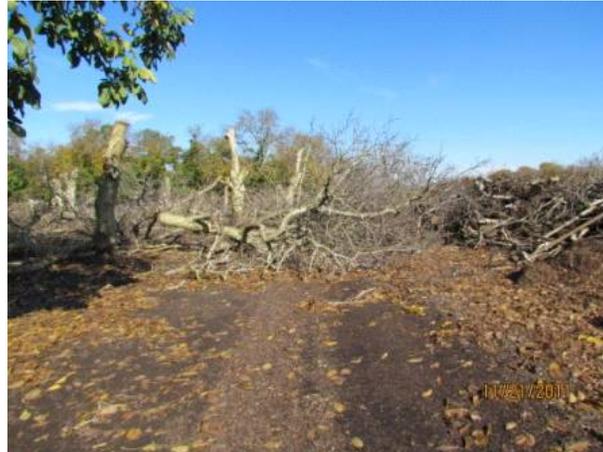
Levee Mile Report Line	75
Start Levee Mile	5.85
End Levee Mile	5.85
Location	Crown
Category	Earthen Levee
Item	Encroachments
<p>Prunings was found on the crown of the levee blocking the pathway. The picture was taken from the crown looking downstream.</p>	
<p>pkazi_f_20111209_466.jpg</p>

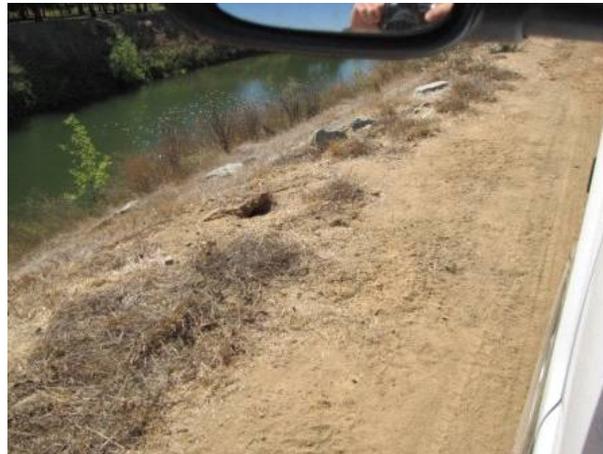
Levee Mile Report Line	76
Start Levee Mile	5.92
End Levee Mile	5.92
Location	Water Side
Category	Earthen Levee
Item	Animal Control
<p>View of rodent activity in the waterward slope looking downstream.</p>	
<p>pkazi_f_20111118_218.jpg</p>

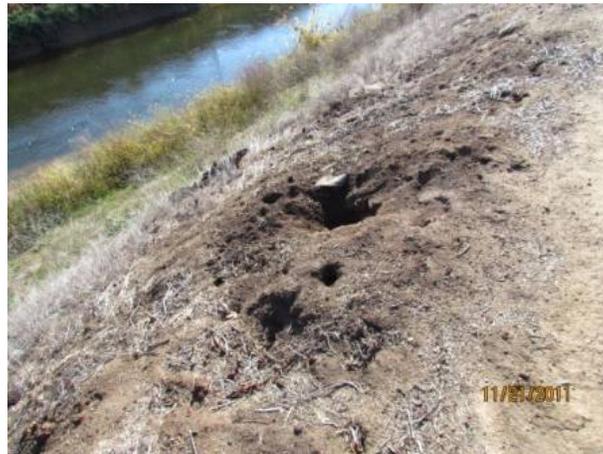
Levee Mile Report Line	78
Start Levee Mile	6.14
End Levee Mile	6.14
Location	Water Side
Category	Earthen Levee
Item	Animal Control
<p>Rodent holes were found on the waterside of the levee looking downstream.</p>	
<p>pkazi_f_20111209_467.jpg</p>

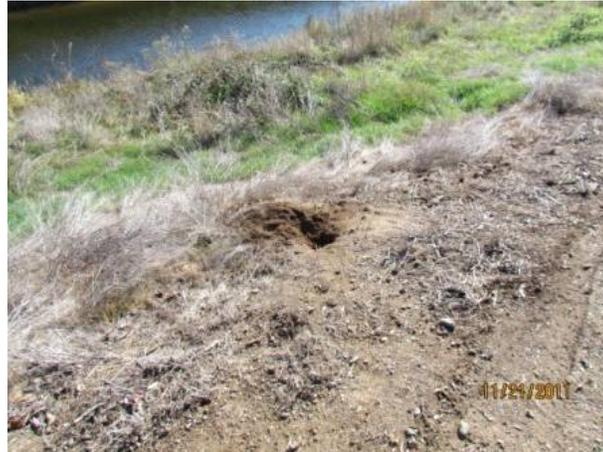
Levee Mile Report Line	79
Start Levee Mile	6.43
End Levee Mile	6.43
Location	Water Side
Category	Earthen Levee
Item	Animal Control
Rodent hole was found on the waterside of the levee looking downstream.	
pkazi_f_20111209_468.jpg

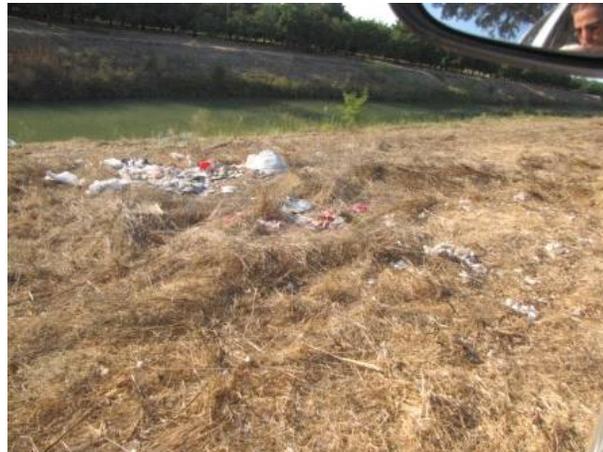
Levee Mile Report Line	82
Start Levee Mile	6.55
End Levee Mile	6.55
Location	Water Side
Category	Earthen Levee
Item	Encroachments
View of garbage on the waterward slope and berm looking downstream.	
pkazi_f_20111118_221.jpg

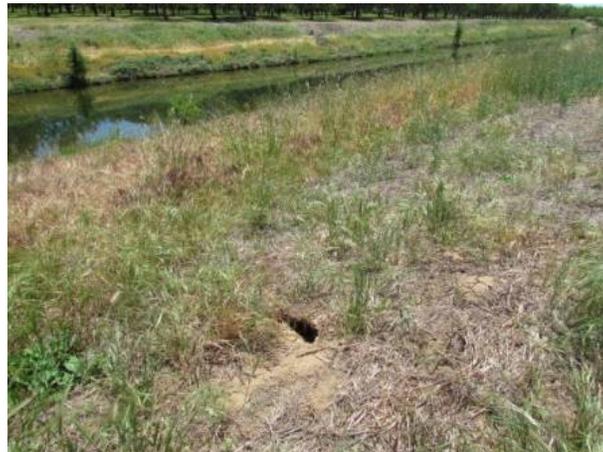
Levee Mile Report Line	83
Start Levee Mile	6.58
End Levee Mile	6.58
Location	Water Side
Category	Earthen Levee
Item	Animal Control
A rodent hole was found on the waterside of the levee. The picture was taken from the crown looking downstream.	
pkazi_f_20111118_227.jpg

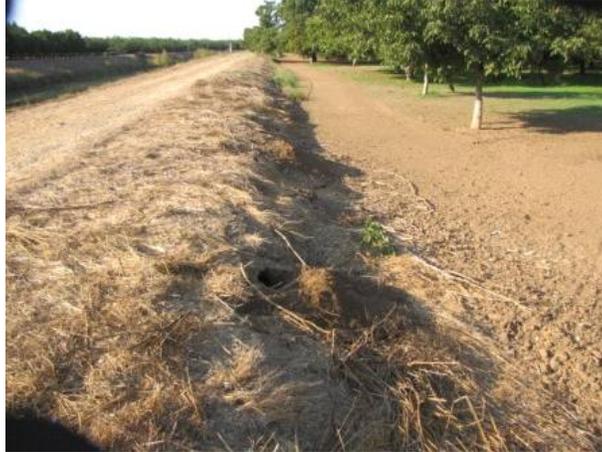
Levee Mile Report Line	84
Start Levee Mile	6.61
End Levee Mile	6.61
Location	Land Side
Category	Earthen Levee
Item	Animal Control
View of rodent activity in the landward slope looking downstream.	
pkazi_f_20111118_222.jpg

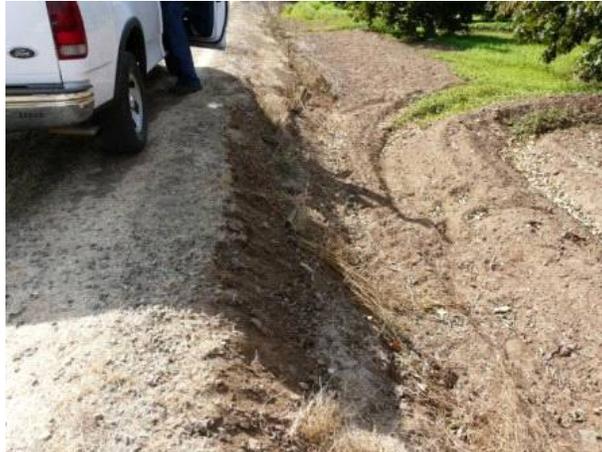
Levee Mile Report Line	88
Start Levee Mile	6.75
End Levee Mile	6.88
Location	Land Side
Category	Earthen Levee
Item	Erosion / Bank Caving
Farming equipment grading into the landside toe of the levee located at LM 6.90. Backfill and compact to design shape and attempt to prevent future damage.	
pkazi_f_20111118_216.JPG

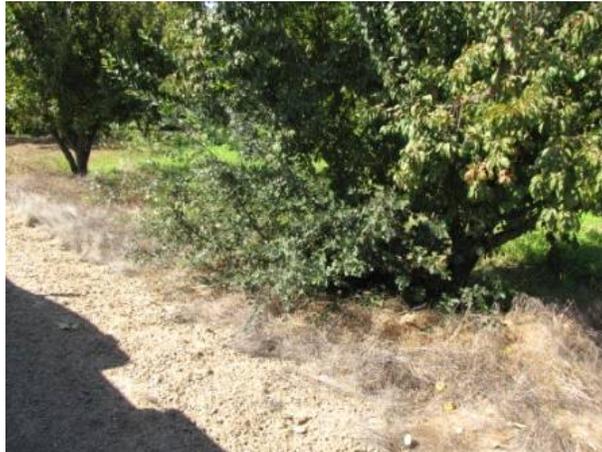
Levee Mile Report Line	90
Start Levee Mile	6.91
End Levee Mile	6.91
Location	Land Side
Category	Earthen Levee
Item	Trim / Thin Trees
View of trees obstructing visibility and the ability to floodfight along the landward slope.	
pkazi_f_20111118_258.jpg

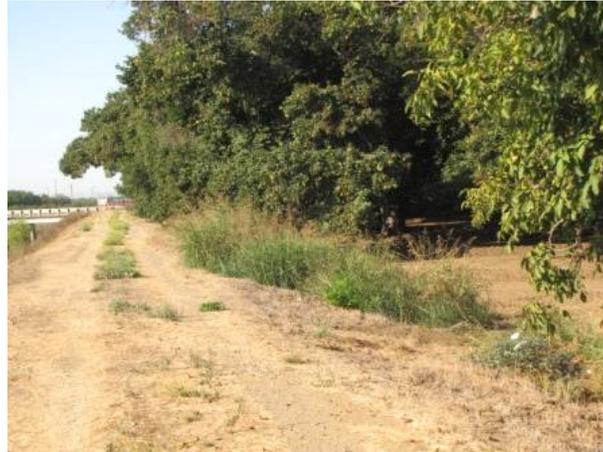
Levee Mile Report Line	91
Start Levee Mile	6.94
End Levee Mile	6.94
Location	Land Side
Category	Earthen Levee
Item	Vegetation
View of vegetation on the landward slope blocking visibility looking downstream.	
pkazi_f_20111118_223.jpg

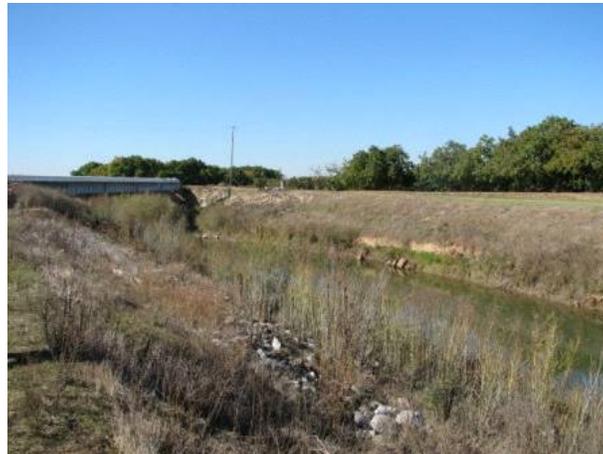
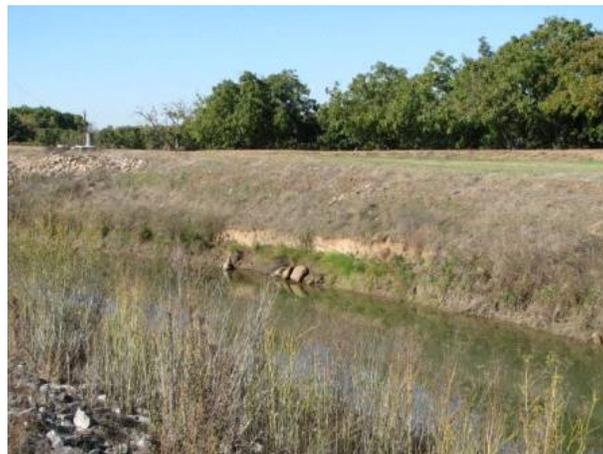
Levee Mile Report Line	94
Start Levee Mile	7.23
End Levee Mile	7.23
Location	Water Side
Category	Supplemental
Item	DWR Erosion Survey
Looking downstream at the site.	
SJR2011_NA0017U15RM7.23_1.jpg

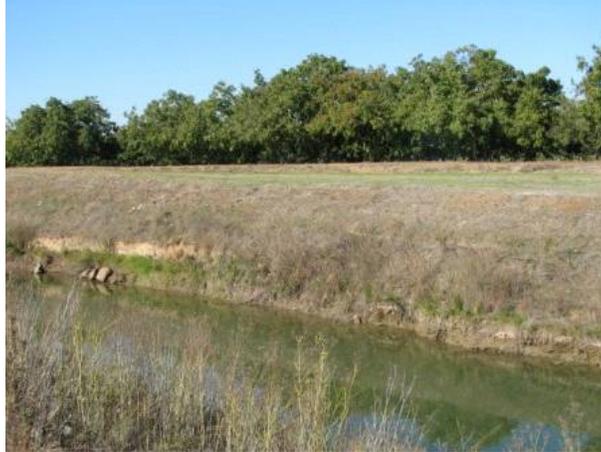
Levee Mile Report Line	94
Start Levee Mile	7.23
End Levee Mile	7.23
Location	Water Side
Category	Supplemental
Item	DWR Erosion Survey
Looking downstream at the bank scarp. Minor erosion is not affecting the levee due to a wide berm.	
SJR2011_NA0017U15RM7.23_3.jpg

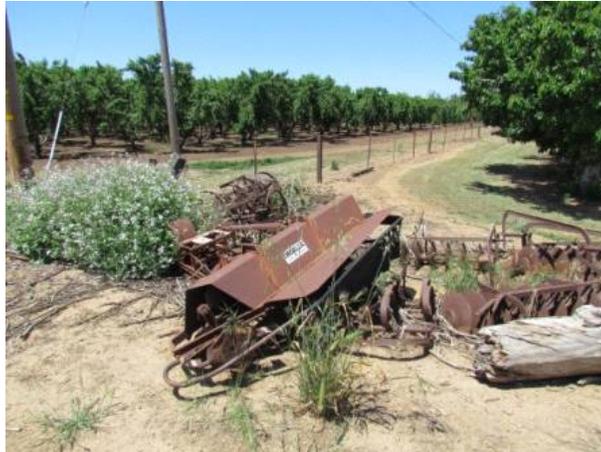
Levee Mile Report Line	100
Start Levee Mile	7.98
End Levee Mile	7.98
Location	Land Side
Category	Earthen Levee
Item	Encroachments
Equipments were left out by the farmers on the landside of the levee. The picture was taken from crown looking toward the landside of the levee.	
pkazi_f_20111118_236.jpg

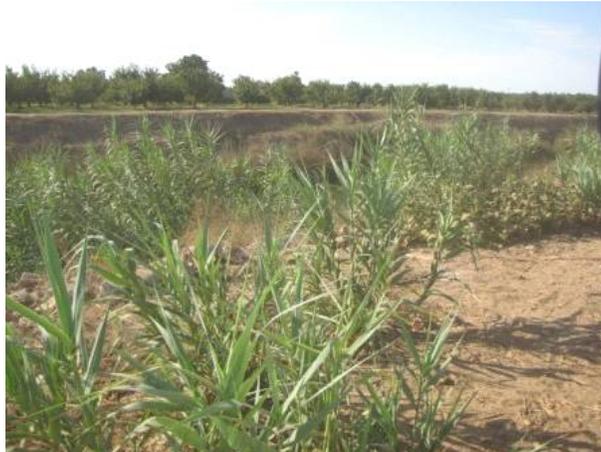
Levee Mile Report Line	101
Start Levee Mile	8.06
End Levee Mile	8.06
Location	Water Side
Category	Earthen Levee
Item	Vegetation
View of arrundo on the waterward shoulder and slope blocking visibility looking downstream.	
pkazi_f_20111118_228.jpg

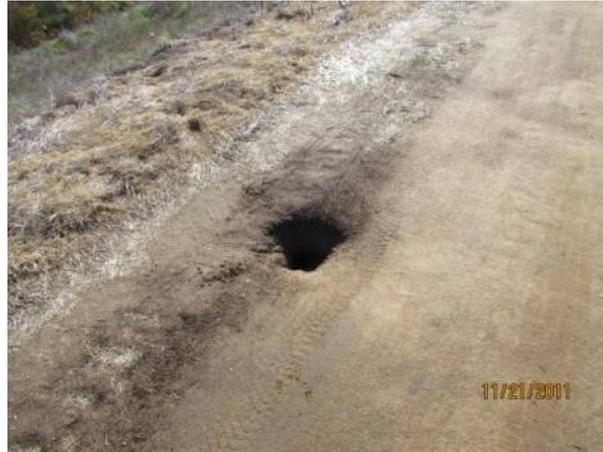
Levee Mile Report Line	103
Start Levee Mile	8.44
End Levee Mile	8.44
Location	Crown
Category	Earthen Levee
Item	Animal Control
Rodent hole was found on the crown of the levee looking downstream.	
pkazi_f_20111209_469.jpg

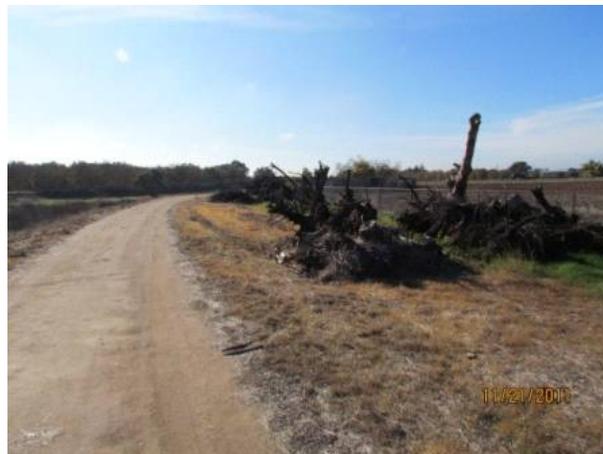
Levee Mile Report Line	104
Start Levee Mile	8.47
End Levee Mile	8.50
Location	Land Side
Category	Earthen Levee
Item	Encroachments
Prunings were found on the landside of the levee looking downstream.	
pkazi_f_20111209_470.jpg

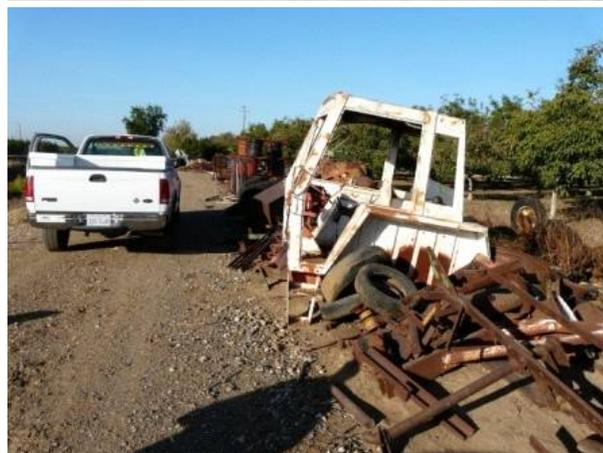
Levee Mile Report Line	107
Start Levee Mile	8.68
End Levee Mile	8.70
Location	Land Side
Category	Earthen Levee
Item	Encroachments
Remove equipment from landside slope of levee at from LM 8.68 to LM 8.70.	
pkazi_f_20111118_195.JPG

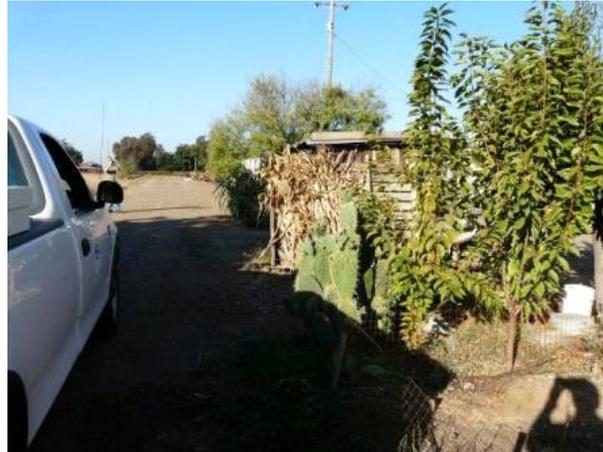
Levee Mile Report Line	108
Start Levee Mile	8.72
End Levee Mile	8.72
Location	Land Side
Category	Earthen Levee
Item	Encroachments
Building, fence and landscaping immediately adjacent to the access road at LM 8.72.	
pkazi_f_20111118_219.JPG

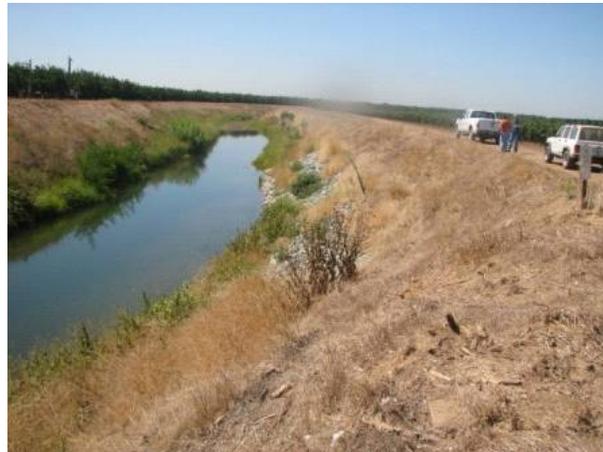
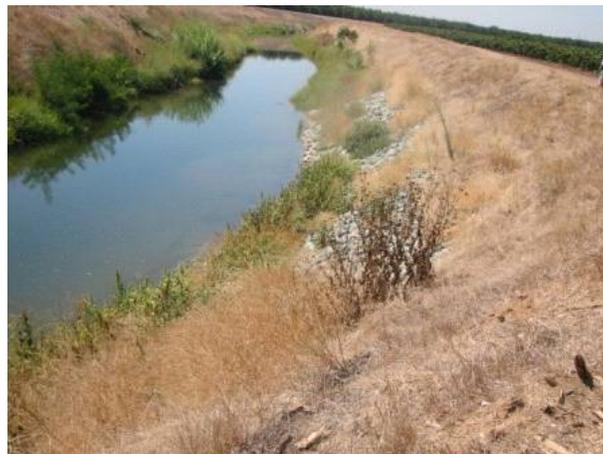
Levee Mile Report Line	110
Start Levee Mile	9.10
End Levee Mile	9.12
Location	Water Side
Category	Supplemental
Item	DWR Erosion Survey
Upstream view of repaired site.	
SJR2011_NA0017U15RM9.11_1.jpg

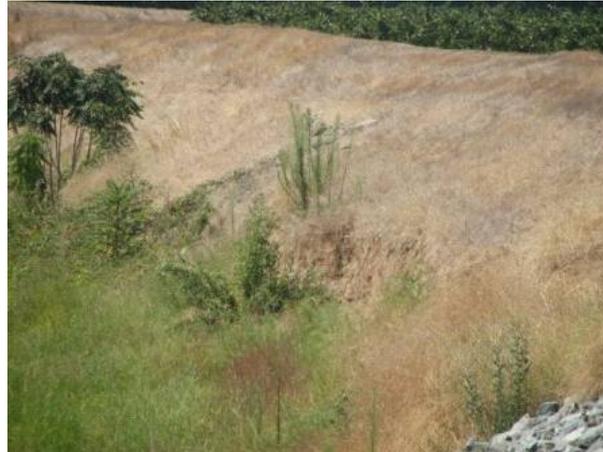
Levee Mile Report Line	110
Start Levee Mile	9.10
End Levee Mile	9.12
Location	Water Side
Category	Supplemental
Item	DWR Erosion Survey
Downstream view of repaired site. Note the pocket erosion downstream of the riparian protection.	
SJR2011_NA0017U15RM9.11_3.jpg

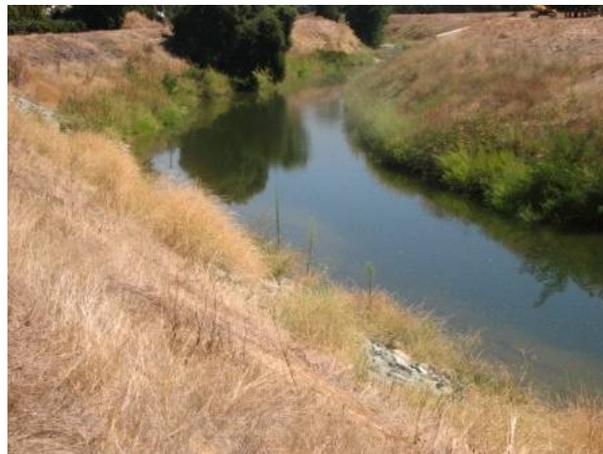
Levee Mile Report Line	110
Start Levee Mile	9.10
End Levee Mile	9.12
Location	Water Side
Category	Supplemental
Item	DWR Erosion Survey
Downstream view of repaired site.	
SJR2011_NA0017U15RM9.11_4.jpg

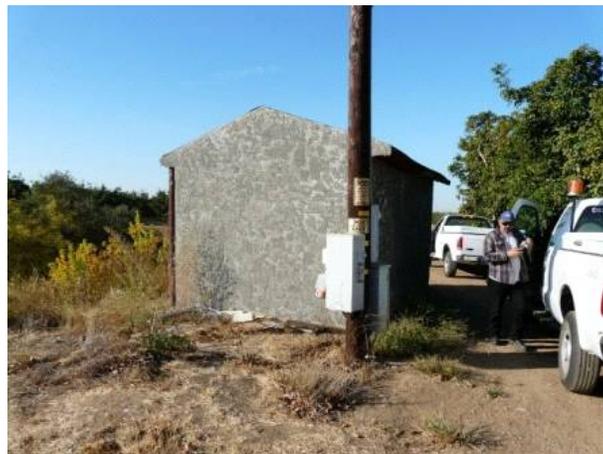
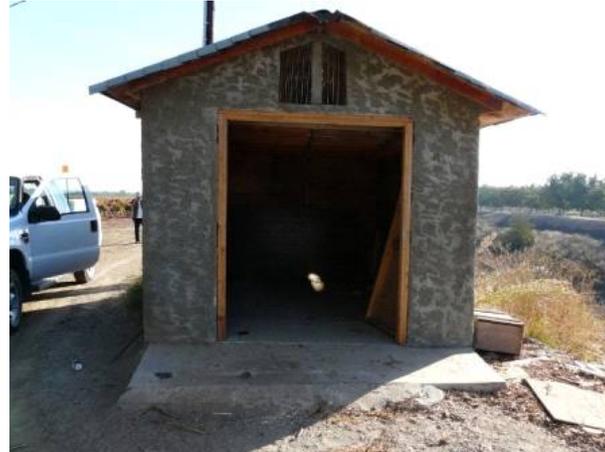
Levee Mile Report Line	113
Start Levee Mile	9.63
End Levee Mile	9.63
Location	Water Side
Category	Earthen Levee
Item	Encroachments
Building located at LM 9.63 on waterside of access road. This building appears to be recently constructed and does not currently contain anything.	
pkazi_f_20111118_197.JPG

Levee Mile Report Line	113
Start Levee Mile	9.63
End Levee Mile	9.63
Location	Water Side
Category	Earthen Levee
Item	Encroachments
Additional view of building at LM 9.63.	
pkazi_f_20111118_198.JPG

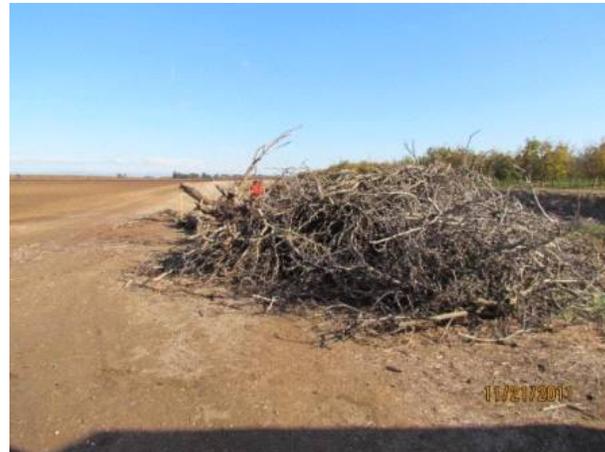
Levee Mile Report Line	114
Start Levee Mile	9.63
End Levee Mile	9.75
Location	Water Side
Category	Earthen Levee
Item	Encroachments
Prunings were found on the waterside of the levee looking upstream.	
pkazi_f_20111209_471.jpg

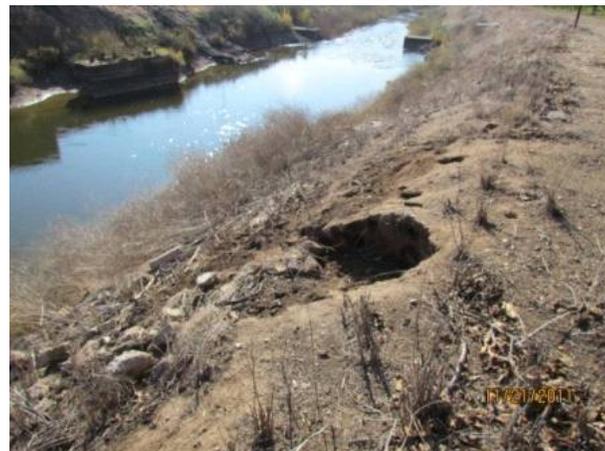
Levee Mile Report Line	115
Start Levee Mile	9.73
End Levee Mile	9.73
Location	Water Side
Category	Earthen Levee
Item	Slope Stability
Slope instability was found on the waterside of the levee looking downstream.	
pkazi_f_20111209_472.jpg

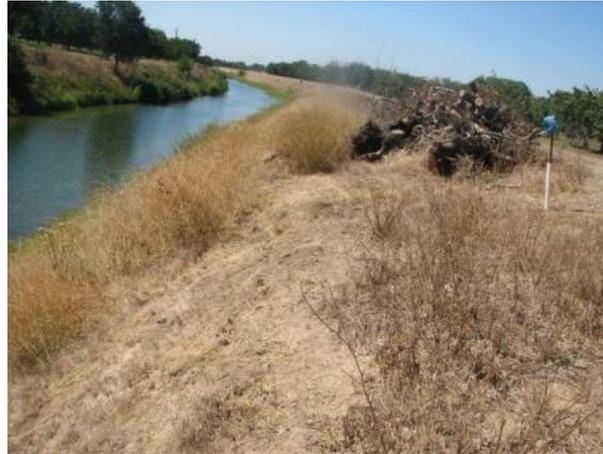
SJR2011_NA0017U15RM10.62_1.jpg

Looking downstream at the repaired site.

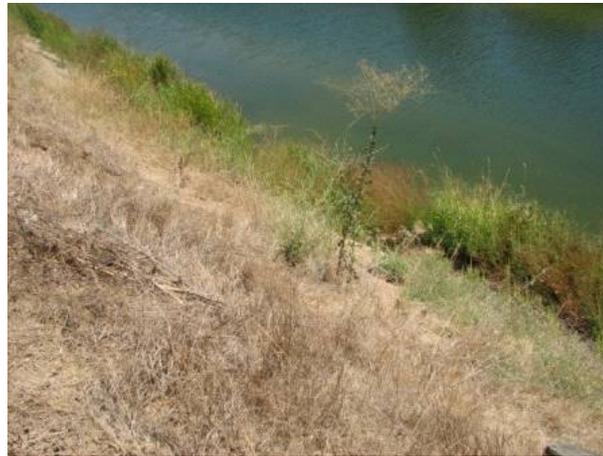
SJR2011_NA0017U15RM10.62_2.jpg

Looking at the upstream of the repaired site. Note the pocket erosion at the toe.

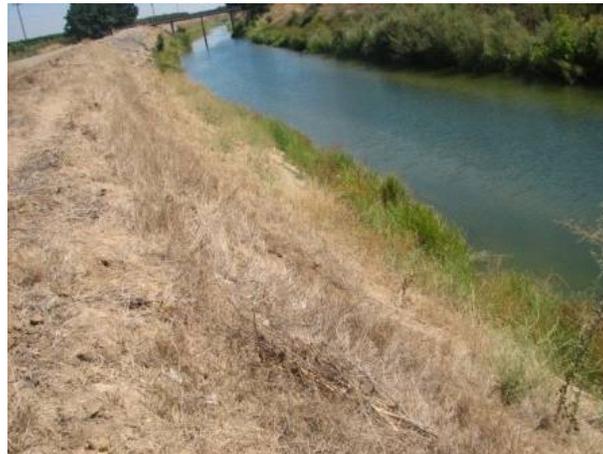
SJR2011_NA0017U15RM10.62_3.jpg

Looking downstream at the repaired site

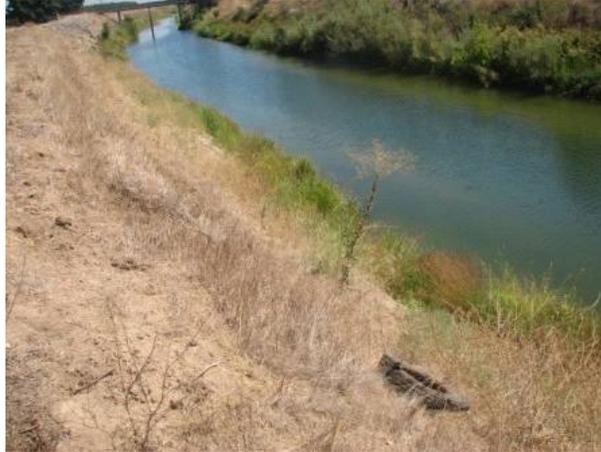
SJR2011_NA0017U15RM10.62_4.jpg

Looking upstream of the repaired site. The burning wood pile still on site.

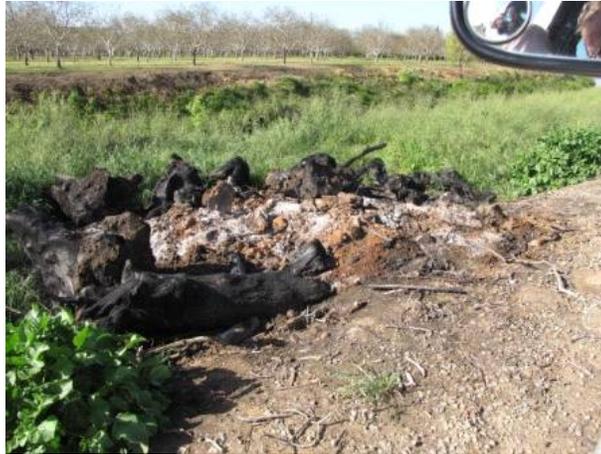
pkazi_f_20111118_215.jpg

View of the prunings pile on the waterward slope looking downstream.

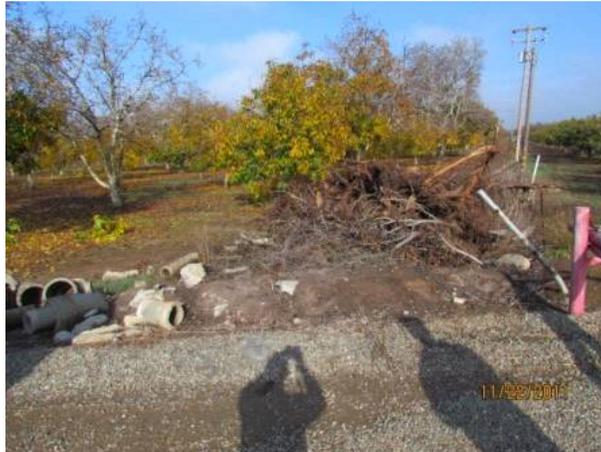
pkazi_f_20111209_473.jpg

Prunings were found on the landside of the levee looking downstream.

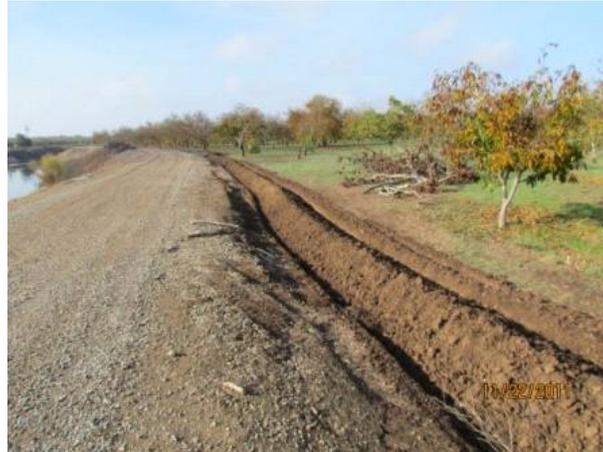
pkazi_f_20111209_474.jpg

An agricultural tilling was found on the landside of the levee looking downstream.

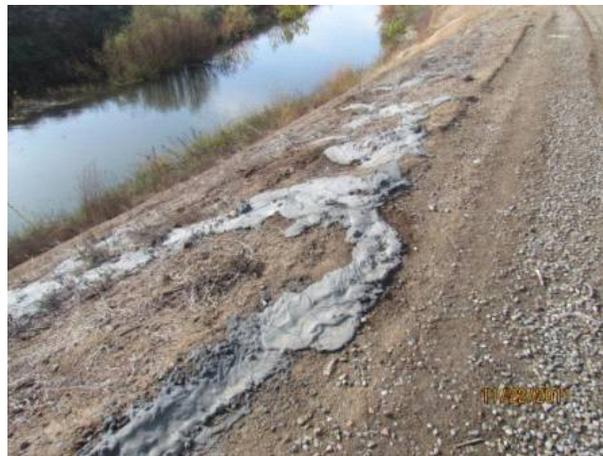
pkazi_f_20111209_475.jpg

Rodent holes were grouted by the LMA on the waterside of the levee looking downstream.

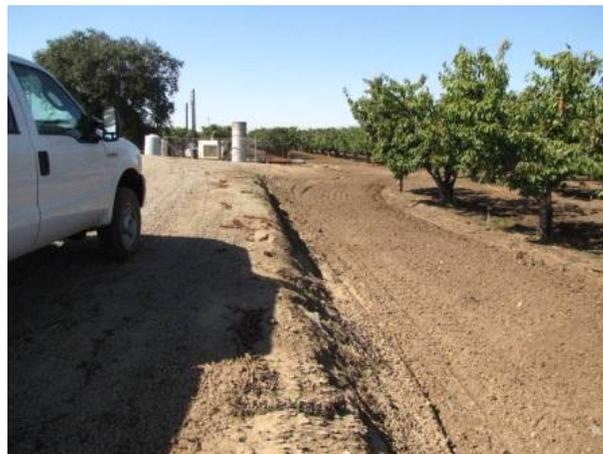
pkazi_f_20111118_230.jpg

View of the damage caused to the levee by a farmer's tilling activity looking downstream.

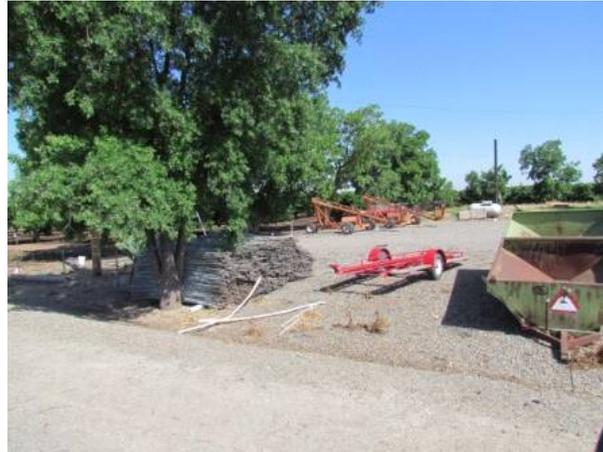
Levee Mile Report Line	130
Start Levee Mile	11.58
End Levee Mile	11.58
Location	Land Side
Category	Earthen Levee
Item	Encroachments
Equipments on the landside of the levee. The picture was taken from the crown looking downstream.	
pkazi_f_20111118_239.jpg

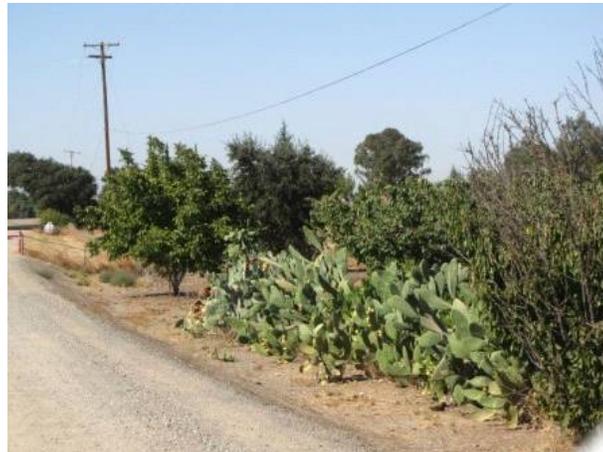
Levee Mile Report Line	131
Start Levee Mile	11.61
End Levee Mile	11.61
Location	Land Side
Category	Earthen Levee
Item	Encroachments
View of cactus within 10 feet of the landward toe blocking visibility and access.	
pkazi_f_20111118_231.jpg

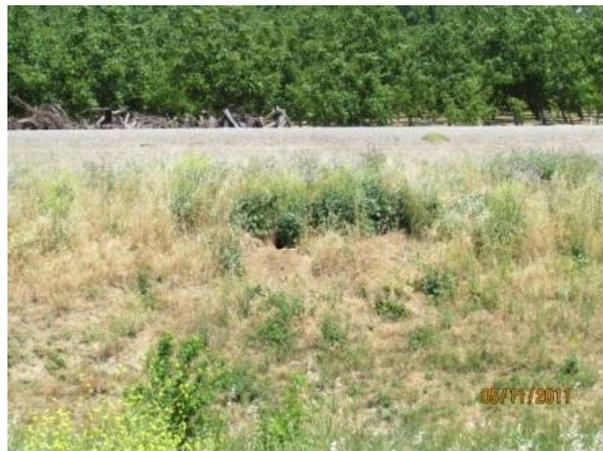
Levee Mile Report Line	132
Start Levee Mile	12.08
End Levee Mile	12.08
Location	Water Side
Category	Earthen Levee
Item	Animal Control
A rodent hole was discovered on the waterside slope of the levee. The picture was taken from the opposite side of the channel.	
pkazi_f_20111118_247.jpg

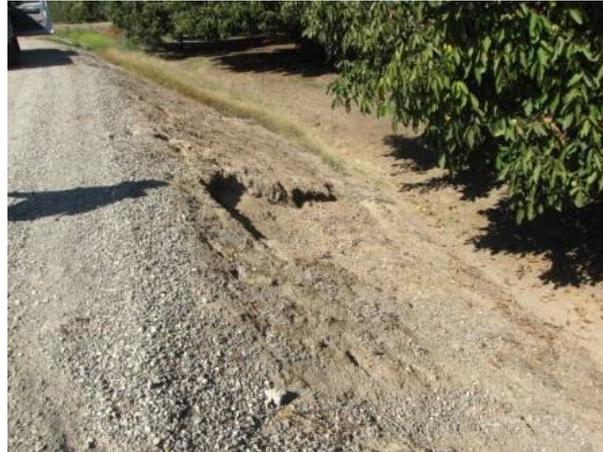
Levee Mile Report Line	137
Start Levee Mile	12.80
End Levee Mile	12.80
Location	Water Side
Category	Earthen Levee
Item	Erosion / Bank Caving
View of erosion occurring on the landward slope looking downstream.	
pkazi_f_20111118_232.jpg

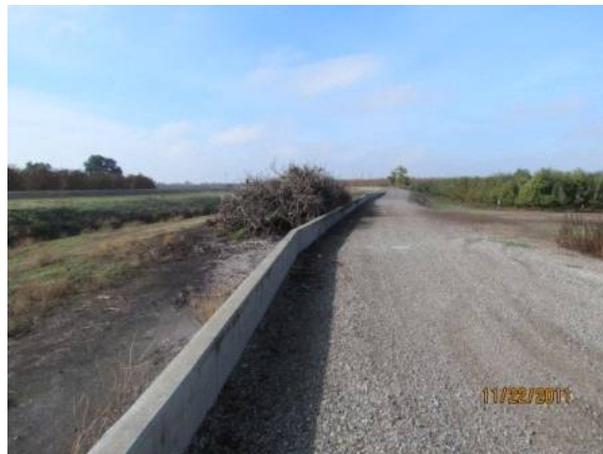
Levee Mile Report Line	138
Start Levee Mile	12.82
End Levee Mile	12.82
Location	Water Side
Category	Earthen Levee
Item	Encroachments
Prunings were found on the waterside of the levee looking downstream.	
pkazi_f_20111209_476.jpg

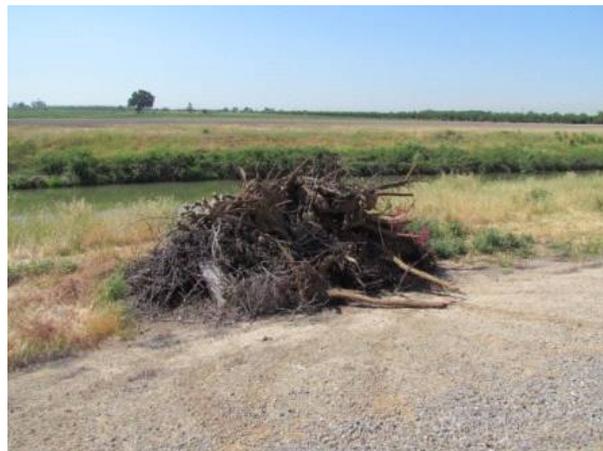
Levee Mile Report Line	141
Start Levee Mile	13.08
End Levee Mile	13.08
Location	Water Side
Category	Earthen Levee
Item	Encroachments
Pruning on the waterside of the levee looking downstream.	
pkazi_f_20111118_240.jpg

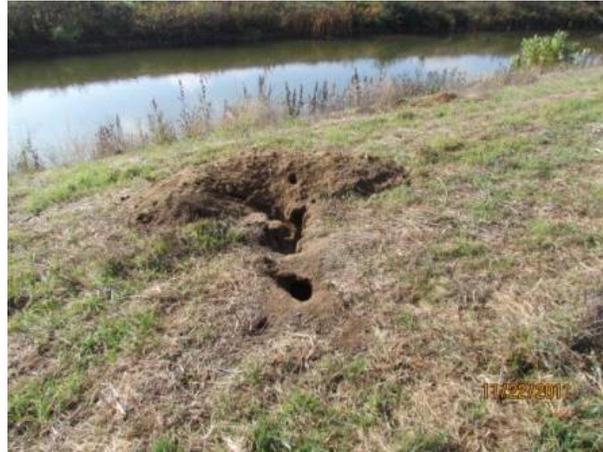
Levee Mile Report Line	142
Start Levee Mile	13.11
End Levee Mile	13.11
Location	Water Side
Category	Earthen Levee
Item	Animal Control
Rodent holes were found on the waterside of the levee looking downstream.	
pkazi_f_20111209_477.jpg

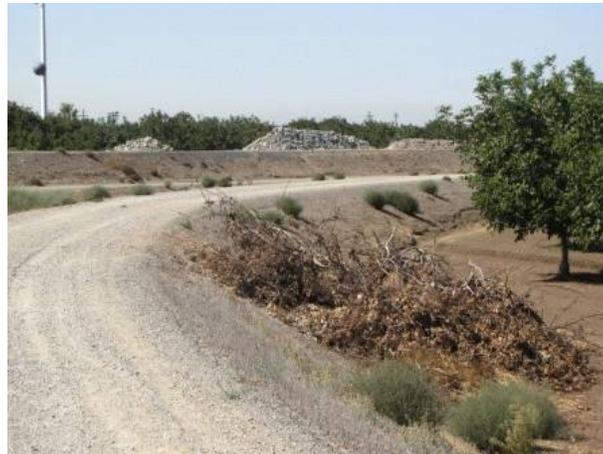
Levee Mile Report Line	145
Start Levee Mile	13.58
End Levee Mile	13.58
Location	Land Side
Category	Earthen Levee
Item	Encroachments
View of a prunings pile on the landward slope looking downstream. The resident stated it would be moved in a few weeks.	
pkazi_f_20111118_233.jpg

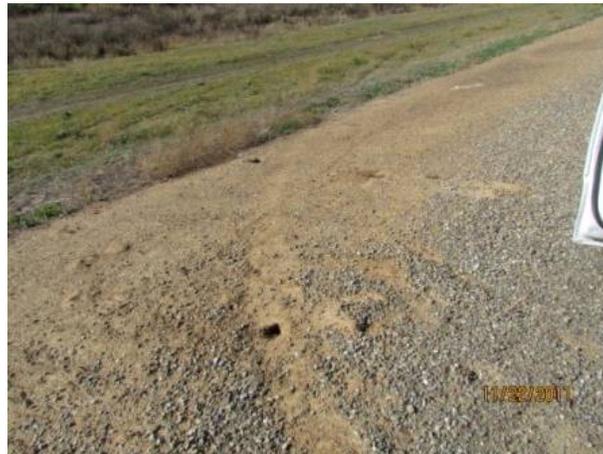
Levee Mile Report Line	146
Start Levee Mile	14.74
End Levee Mile	14.74
Location	Water Side
Category	Earthen Levee
Item	Animal Control
Rodent hole was found on the waterside of the levee looking downstream.	
pkazi_f_20111209_478.jpg

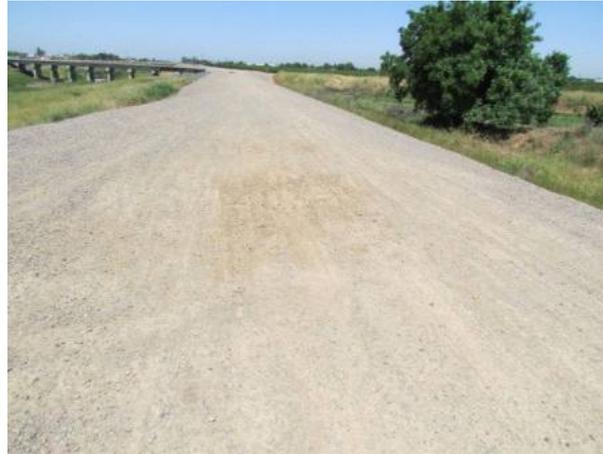
Levee Mile Report Line	147
Start Levee Mile	14.85
End Levee Mile	14.85
Location	Crown
Category	Earthen Levee
Item	Crown Surface / Depressions / Rutting
<p>Crown depression was discovered possibly caused by vehicular traffic. The picture was taken from the crown looking downstream.</p>	
<p>pkazi_f_20111118_241.jpg</p>

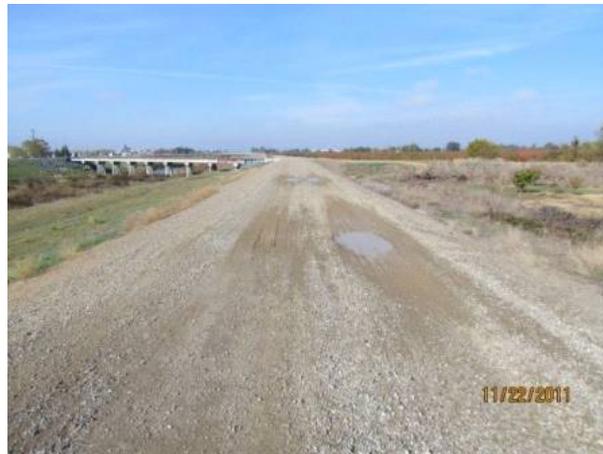
Levee Mile Report Line	147
Start Levee Mile	14.85
End Levee Mile	14.85
Location	Crown
Category	Earthen Levee
Item	Crown Surface / Depressions / Rutting
<p>Depression was found on the crown of the levee looking downstream. This picture was taken during fall 2011 inspection.</p>	
<p>pkazi_f_20111209_479.jpg</p>

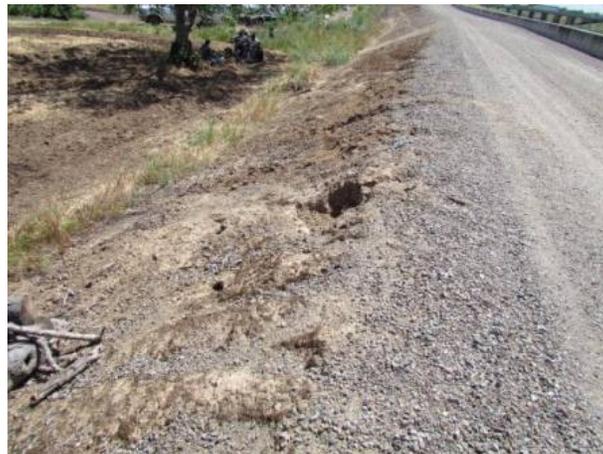
Levee Mile Report Line	150
Start Levee Mile	15.70
End Levee Mile	15.74
Location	Land Side
Category	Earthen Levee
Item	Animal Control
<p>Multiple rodent holes was found on the landside of the levee. The picture was taken from the crown looking upstream.</p>	
<p>pkazi_f_20111118_243.jpg</p>

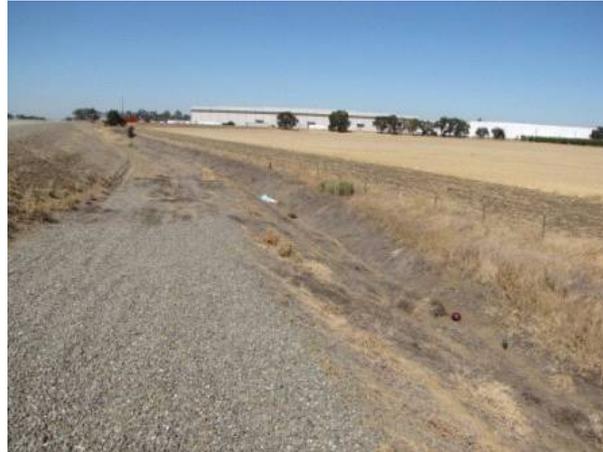
pkazi_f_20111118_261.jpg

View of a ditch adjacent to the landward toe looking downstream.

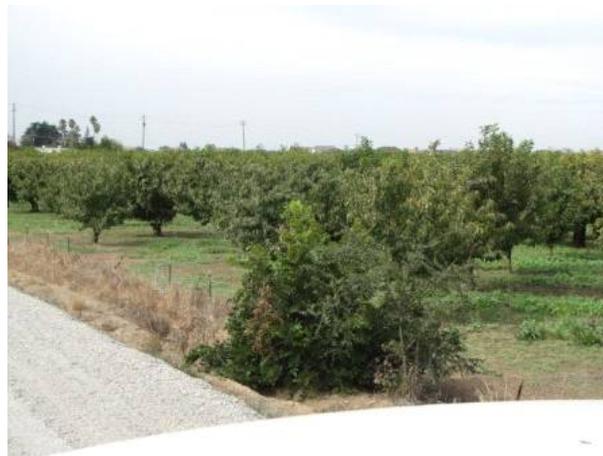
Levee Mile Report Line	159
Start Levee Mile	18.10
End Levee Mile	18.10
Location	Land Side
Category	Earthen Levee
Item	Trim / Thin Trees

View of a small clump of trees on the landward slope blocking visibility and access looking downstream.

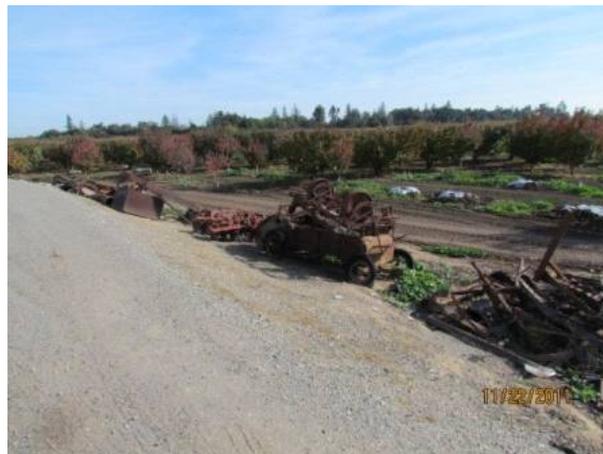
Levee Mile Report Line	160
Start Levee Mile	18.44
End Levee Mile	18.44
Location	Land Side
Category	Earthen Levee
Item	Encroachments

Equipment was found on the landside of the levee looking downstream.

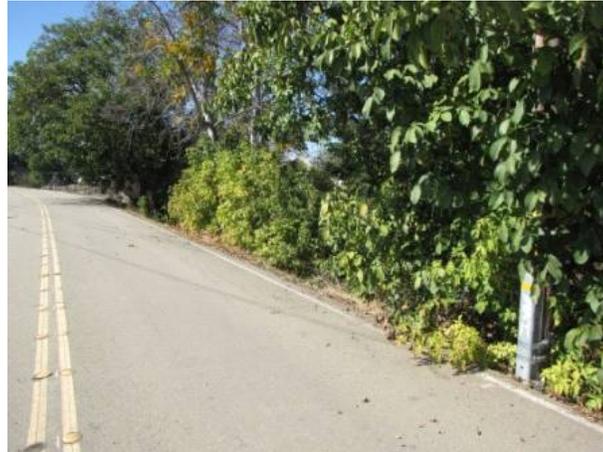
Levee Mile Report Line	161
Start Levee Mile	18.54
End Levee Mile	18.55
Location	Land Side
Category	Earthen Levee
Item	Encroachments
View of landowner planted and maintained vegetation along the landward slope looking downstream.	
pkazi_f_20111118_264.jpg

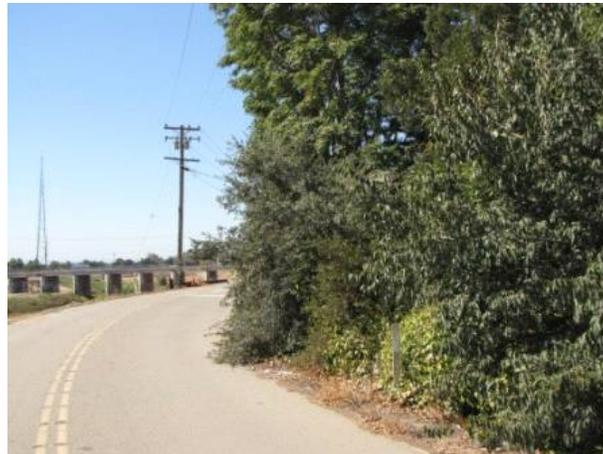
Levee Mile Report Line	164
Start Levee Mile	19.80
End Levee Mile	19.86
Location	Land Side
Category	Earthen Levee
Item	Encroachments
View of landowner planted and maintained vegetation along the landward slope looking downstream.	
pkazi_f_20111118_265.jpg

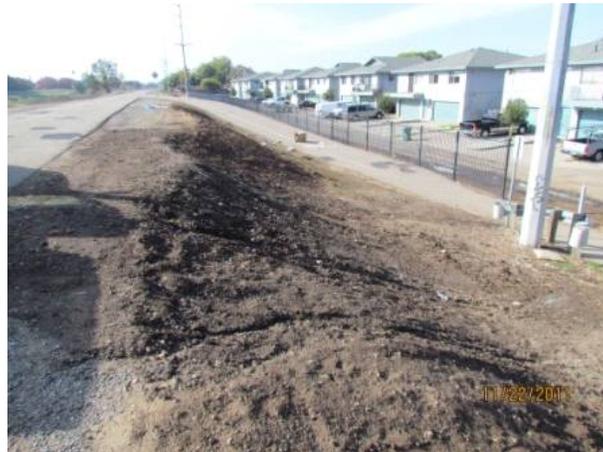
Levee Mile Report Line	166
Start Levee Mile	20.64
End Levee Mile	20.64
Location	Land Side
Category	Earthen Levee
Item	Slope Stability
Erosion was found on the landside of the levee looking downstream.	
pkazi_f_20111209_481.jpg

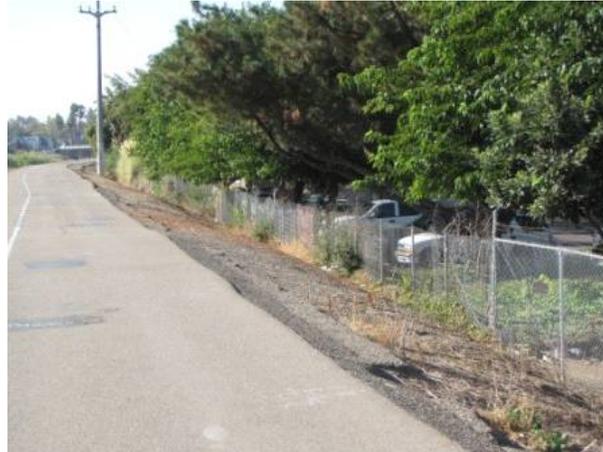
Levee Mile Report Line	172
Start Levee Mile	21.46
End Levee Mile	21.61
Location	Land Side
Category	Earthen Levee
Item	Encroachments
View of fence along the landward toe looking downstream.	
pkazi_f_20111118_266.jpg

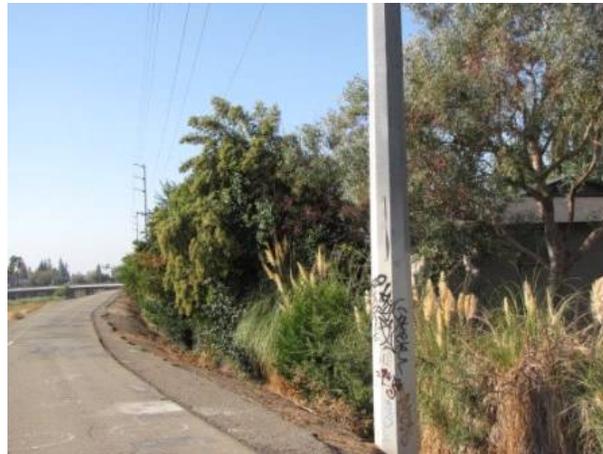
Levee Mile Report Line	173
Start Levee Mile	21.52
End Levee Mile	21.73
Location	Land Side
Category	Earthen Levee
Item	Encroachments
View of landscaping along the landward slope and toe looking downstream.	
pkazi_f_20111118_203.jpg

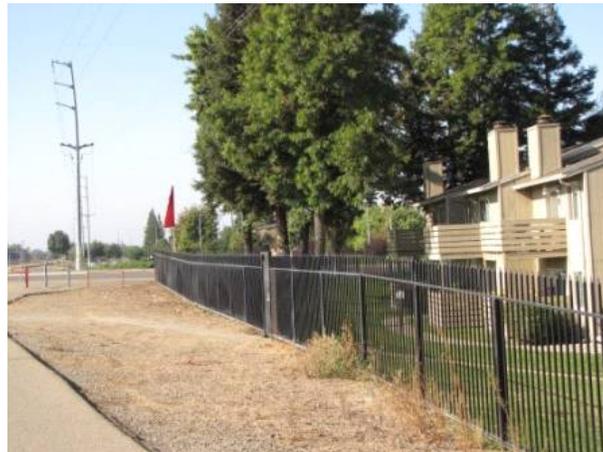
Levee Mile Report Line	174
Start Levee Mile	21.73
End Levee Mile	21.77
Location	Land Side
Category	Earthen Levee
Item	Encroachments
View of fence along the landward shoulder looking downstream.	
pkazi_f_20111118_267.jpg

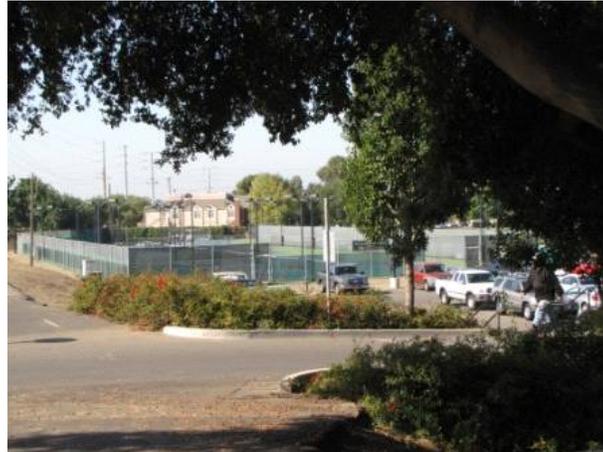
Levee Mile Report Line	175
Start Levee Mile	22.11
End Levee Mile	22.11
Location	Land Side
Category	Earthen Levee
Item	Encroachments
View of landscaping maintained by UOP along the landward slope looking downstream.	
pkazi_f_20111118_268.jpg
