**Flood Control Project Maintenance
Levee Inspections**

Fall 2011 Levee Maintenance Deficiency Summary Report

San Joaquin River Basin

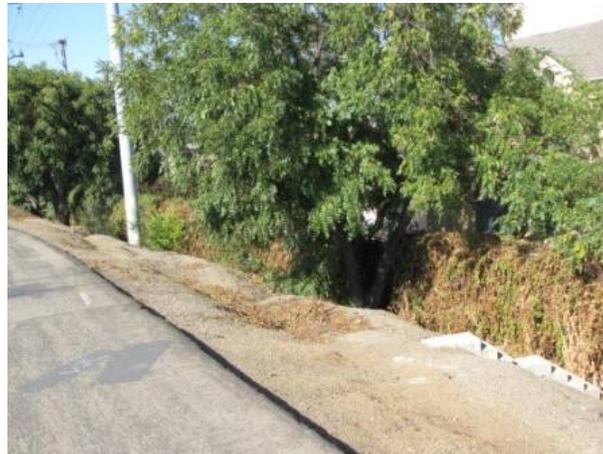
Levee Mile Report Line	176
Start Levee Mile	22.27
End Levee Mile	22.32
Location	Land Side
Category	Earthen Levee
Item	Encroachments
View of landscaping along the landward toe of the levee looking downstream.	
pkazi_f_20111118_204.jpg

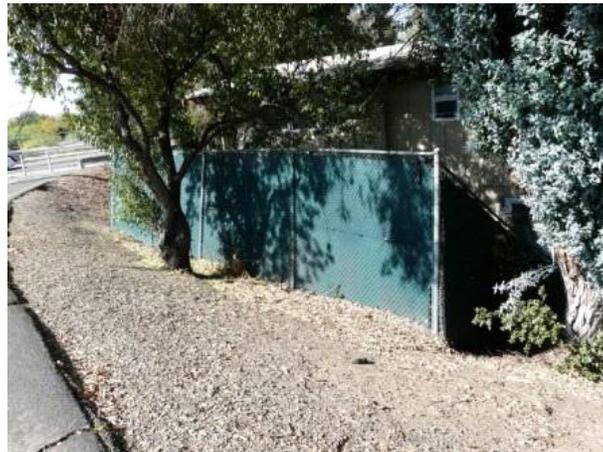
Levee Mile Report Line	177
Start Levee Mile	22.36
End Levee Mile	22.37
Location	Land Side
Category	Earthen Levee
Item	Encroachments
Fence located from LM 22.36 to LM 22.37 significantly encroaches onto landside levee slope.	
pkazi_f_20111118_225.JPG

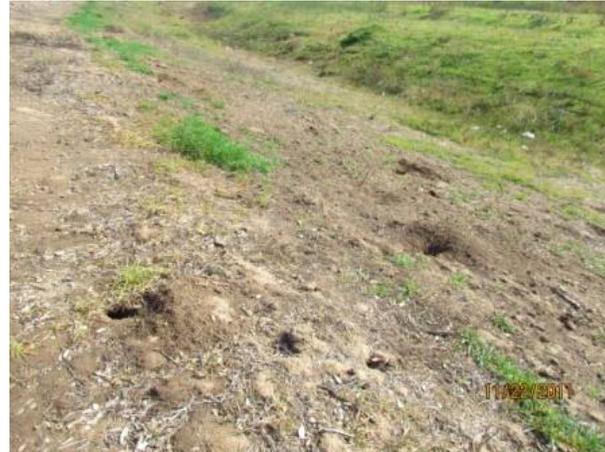
Levee Mile Report Line	178
Start Levee Mile	22.53
End Levee Mile	22.53
Location	Water Side
Category	Earthen Levee
Item	Animal Control
Rodent holes were found on the waterside of the levee looking upstream.	
pkazi_f_20111209_482.jpg

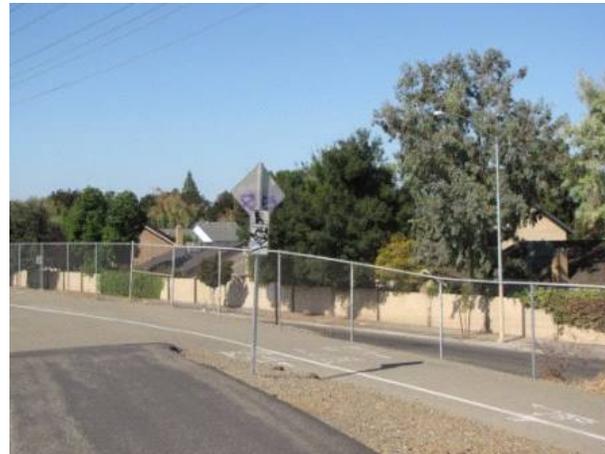
Levee Mile Report Line	179
Start Levee Mile	22.88
End Levee Mile	22.90
Location	Land Side
Category	Earthen Levee
Item	Encroachments
View of fence along the landward shoulder looking downstream.	
pkazi_f_20111118_269.jpg

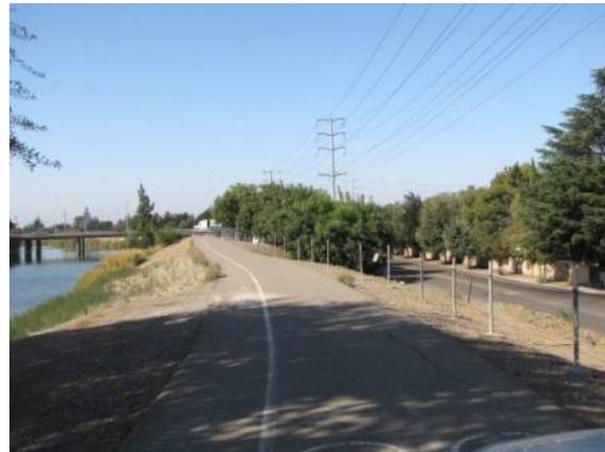
Levee Mile Report Line	180
Start Levee Mile	23.54
End Levee Mile	23.69
Location	Land Side
Category	Earthen Levee
Item	Encroachments
View of fence along landward shoulder looking downstream.	
pkazi_f_20111118_270.jpg

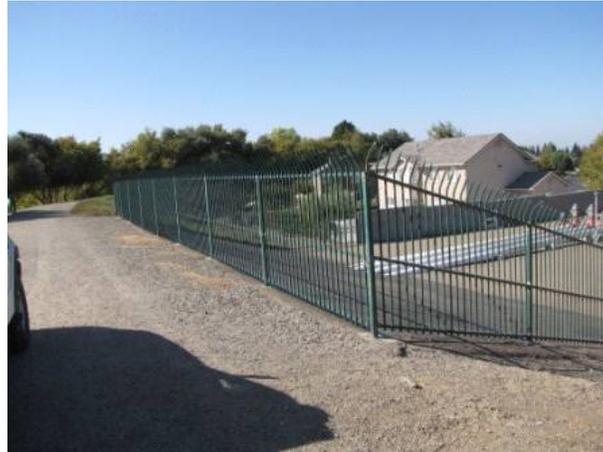
Levee Mile Report Line	181
Start Levee Mile	24.20
End Levee Mile	24.21
Location	Land Side
Category	Earthen Levee
Item	Encroachments
View of fence along the landward shoulder looking downstream.	
pkazi_f_20111118_271.jpg

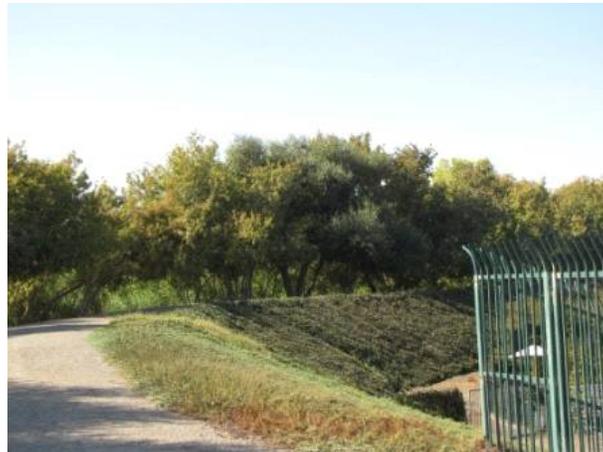
Levee Mile Report Line	182
Start Levee Mile	24.21
End Levee Mile	25.62
Location	Land Side
Category	Earthen Levee
Item	Encroachments
View of typical landowner planted and maintained landscaping and irrigation along the landward shoulder, slope, and toe looking downstream.	
pkazi_f_20111118_205.jpg

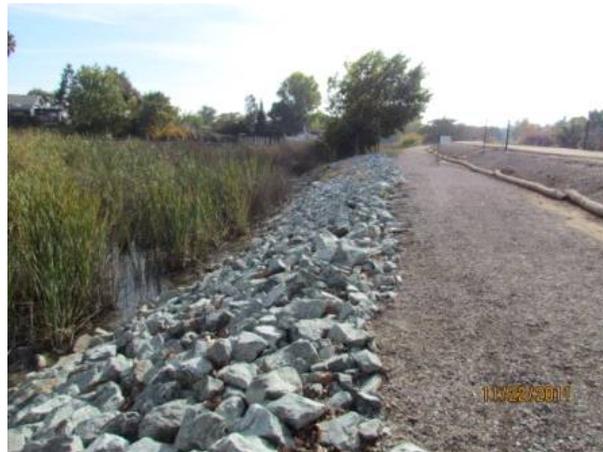
Levee Mile Report Line	183
Start Levee Mile	24.48
End Levee Mile	24.48
Location	Water Side
Category	Earthen Levee
Item	Erosion / Bank Caving
Erosion site was fixed by the LMA on the waterside of the levee looking downstream.	
pkazi_f_20111209_483.jpg

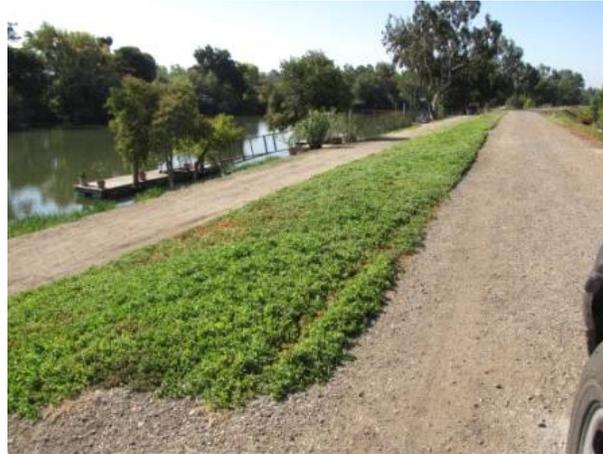
pkazi_f_20111118_272.jpg

View of typical landowner planted and maintained landscaping and irrigation along the waterward shoulder and slope looking downstream.

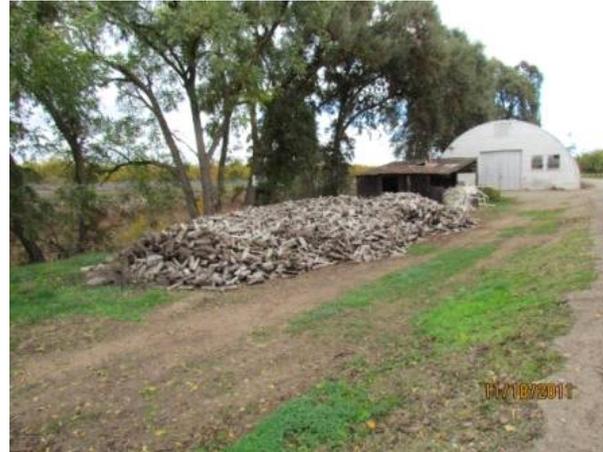
Levee Mile Report Line	4
Start Levee Mile	0.57
End Levee Mile	0.57
Location	Crown
Category	Earthen Levee
Item	Encroachments
Firewood was found on the waterside of the levee looking upstream.	
pkazi_f_20111208_417.jpg

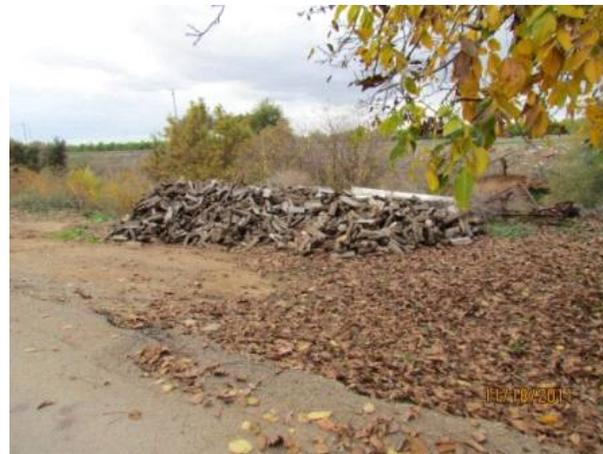
Levee Mile Report Line	5
Start Levee Mile	0.79
End Levee Mile	0.79
Location	Water Side
Category	Earthen Levee
Item	Encroachments
Firewood was found on the waterside of the levee looking downstream.	
pkazi_f_20111208_416.jpg

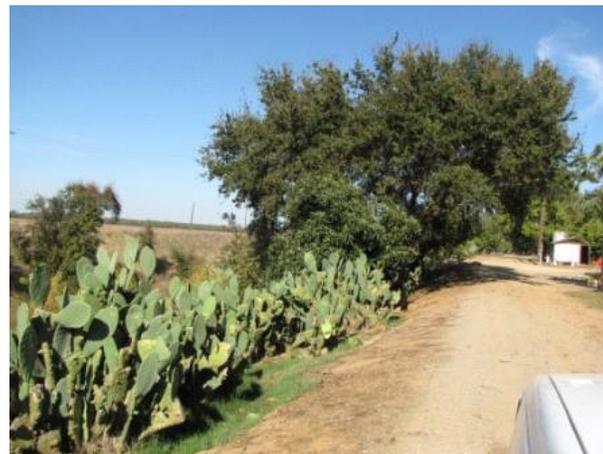
Levee Mile Report Line	8
Start Levee Mile	0.83
End Levee Mile	0.89
Location	Water Side
Category	Earthen Levee
Item	Encroachments
View of landowner maintained landscaping on waterward side looking upstream.	
pkazi_f_20111118_318.jpg

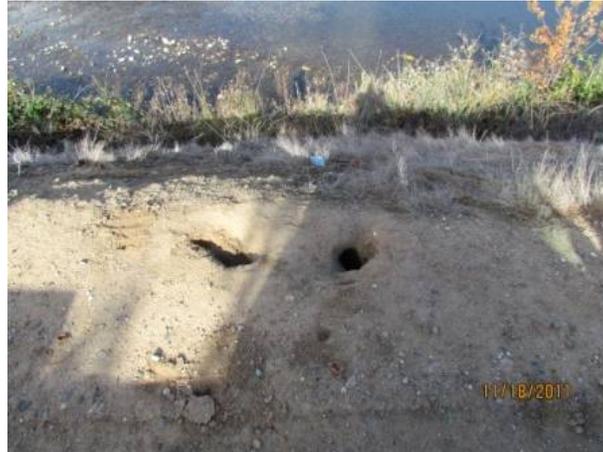
Levee Mile Report Line	13
Start Levee Mile	1.65
End Levee Mile	1.65
Location	Water Side
Category	Earthen Levee
Item	Animal Control
Rodent holes were found on the waterside of the levee looking upstream.	
pkazi_f_20111208_415.jpg

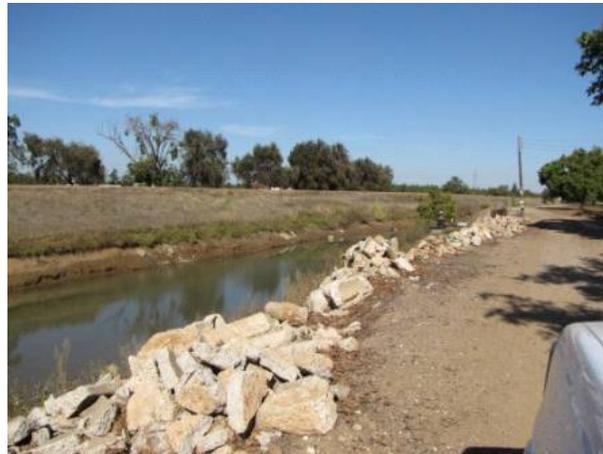
Levee Mile Report Line	17
Start Levee Mile	2.47
End Levee Mile	2.50
Location	Water Side
Category	Earthen Levee
Item	Encroachments
View of concrete debris on waterward side looking upstream.	
pkazi_f_20111118_317.jpg

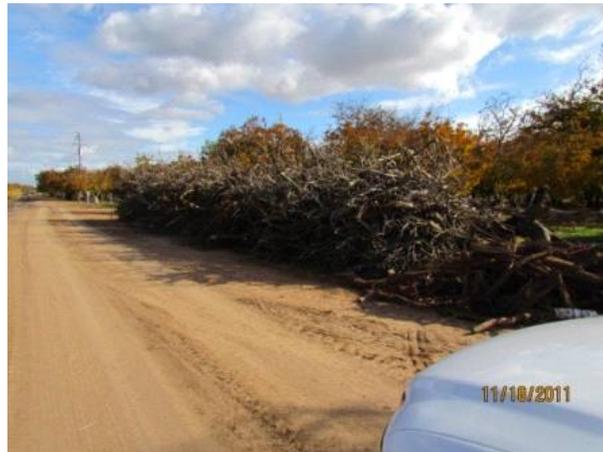
Levee Mile Report Line	21
Start Levee Mile	3.66
End Levee Mile	3.66
Location	Land Side
Category	Earthen Levee
Item	Encroachments
Prunings were found on the landside of the levee looking upstream.	
pkazi_f_20111208_414.jpg

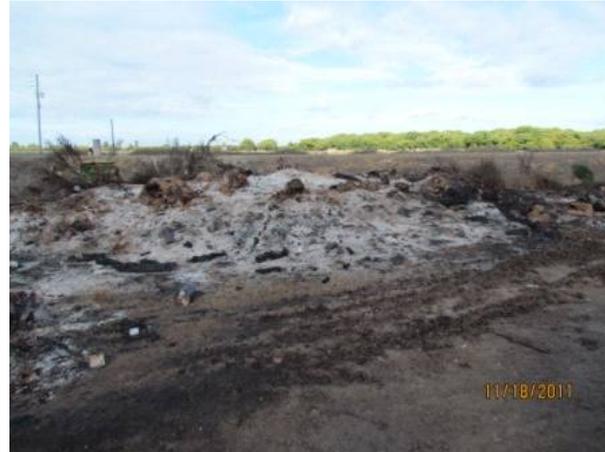
Levee Mile Report Line	22
Start Levee Mile	3.78
End Levee Mile	3.78
Location	Water Side
Category	Earthen Levee
Item	Encroachments
Prunings were found on the waterside of the levee looking upstream.	
pkazi_f_20111208_413.jpg

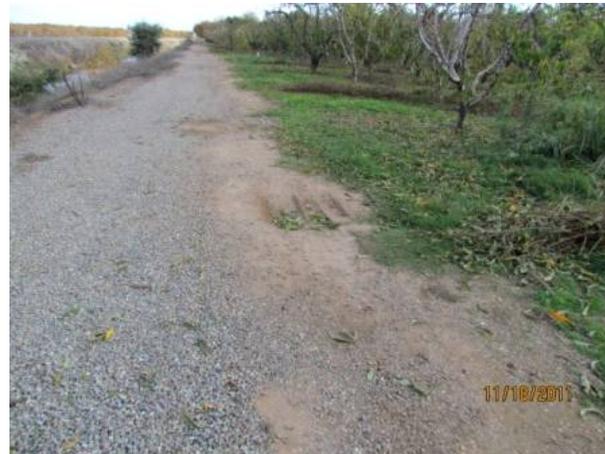
Levee Mile Report Line	23
Start Levee Mile	3.91
End Levee Mile	3.91
Location	Crown
Category	Earthen Levee
Item	Crown Surface / Depressions / Rutting
Depression was found on the crown of the levee looking upstream.	
pkazi_f_20111208_412.jpg

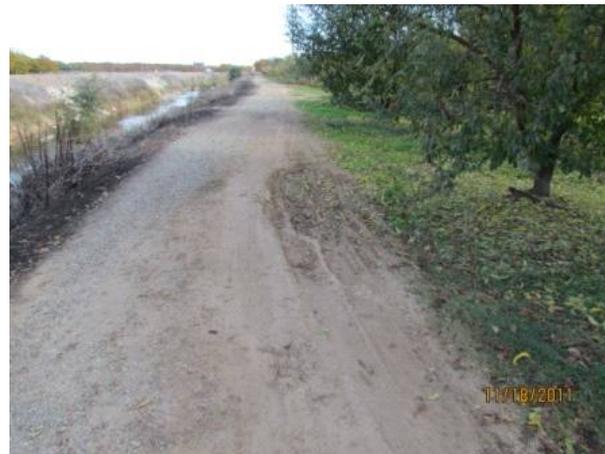
Levee Mile Report Line	24
Start Levee Mile	3.96
End Levee Mile	3.96
Location	Crown
Category	Earthen Levee
Item	Crown Surface / Depressions / Rutting
Depression was found on the crown of the levee looking upstream.	
pkazi_f_20111208_411.jpg

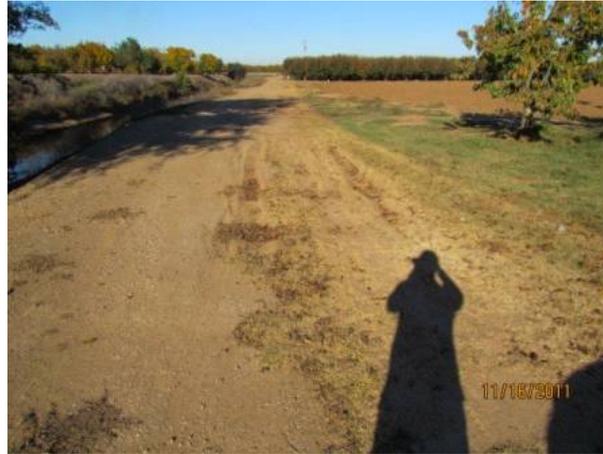
Levee Mile Report Line	25
Start Levee Mile	4.31
End Levee Mile	4.31
Location	Crown
Category	Earthen Levee
Item	Crown Surface / Depressions / Rutting
Depression was found on the crown of the levee looking upstream.	
pkazi_f_20111208_410.jpg

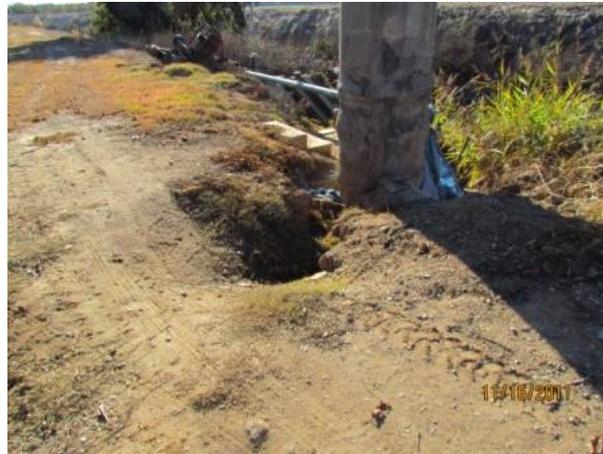
Levee Mile Report Line	26
Start Levee Mile	4.32
End Levee Mile	4.32
Location	Water Side
Category	Earthen Levee
Item	Slope Stability
Slope instability was found on the waterside of the levee looking downstream.	
pkazi_f_20111208_409.jpg

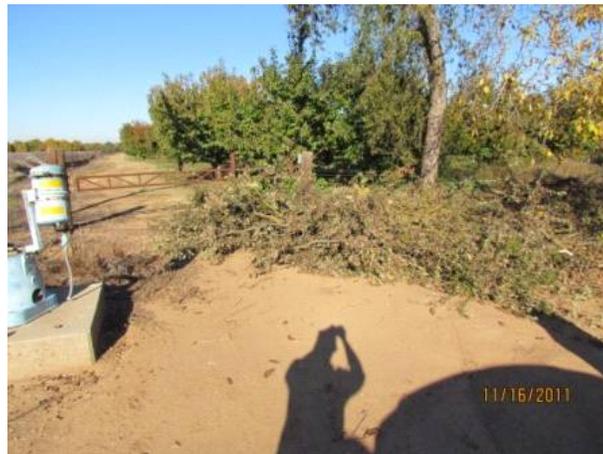
Levee Mile Report Line	30
Start Levee Mile	4.60
End Levee Mile	4.60
Location	Crown
Category	Earthen Levee
Item	Encroachments
Prunings were found crown of the levee obstructing the gate. The picture was taken from the crown looking upstream.	
pkazi_f_20111208_408.jpg

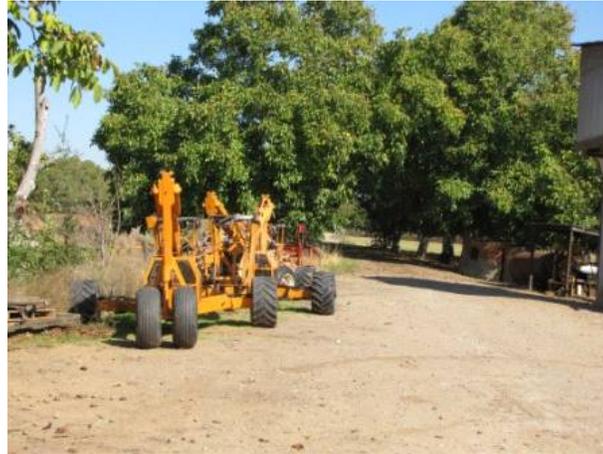
pkazi_f_20111118_313.jpg

View of equipment located on the waterward side looking upstream.

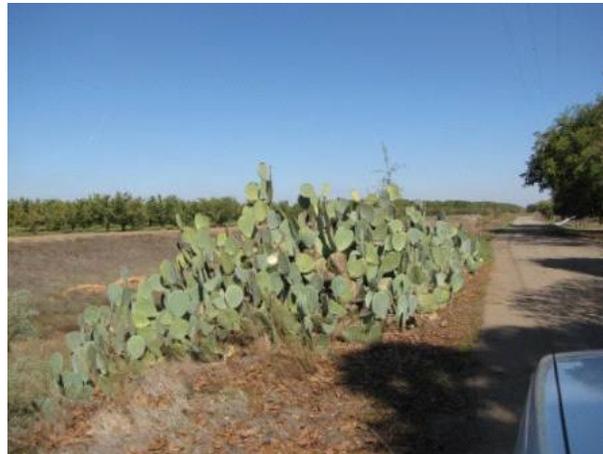
pkazi_f_20111118_311.jpg

View of cacti located on waterward side looking upstream.

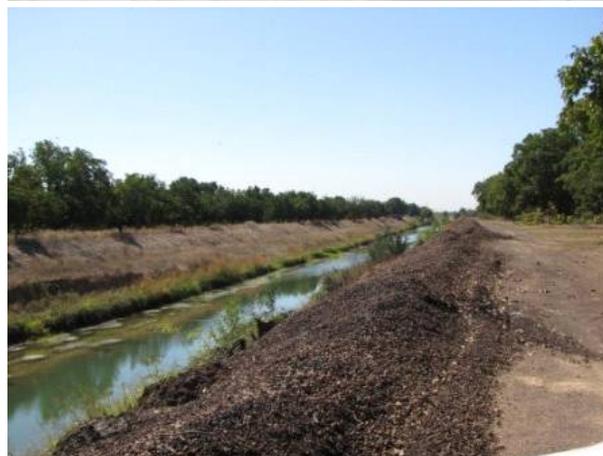
pkazi_f_20111118_257.jpg

View of a large prunings pile on waterward side and access road blocking visibility and access looking upstream.

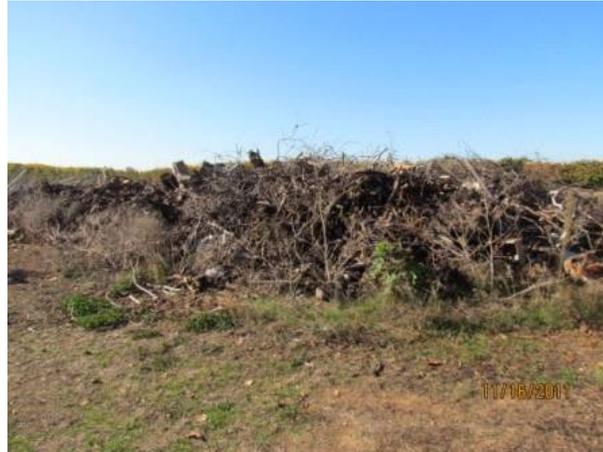
Levee Mile Report Line	42
Start Levee Mile	6.32
End Levee Mile	6.32
Location	Water Side
Category	Earthen Levee
Item	Encroachments
<p>Prunings were found on the waterside of the levee looking upstream. This picture was taken during fall 2011 inspection.</p>	
<p>pkazi_f_20111208_407.jpg</p>

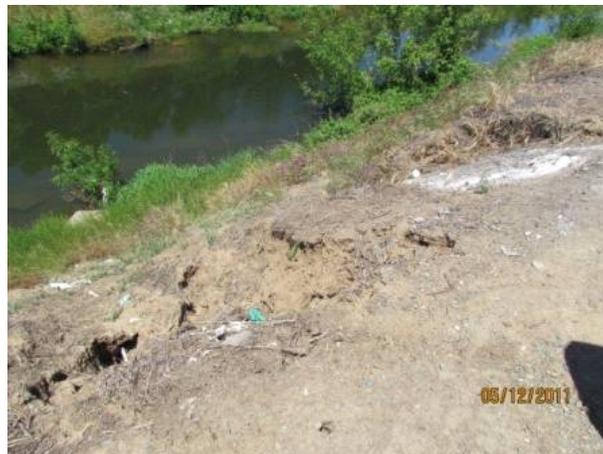
Levee Mile Report Line	44
Start Levee Mile	6.97
End Levee Mile	6.97
Location	Water Side
Category	Earthen Levee
Item	Slope Stability
<p>Slope stability was found on the shoulder of waterside of the levee. The picture was taken from the crown looking upstream.</p>	
<p>pkazi_f_20111118_325.jpg</p>

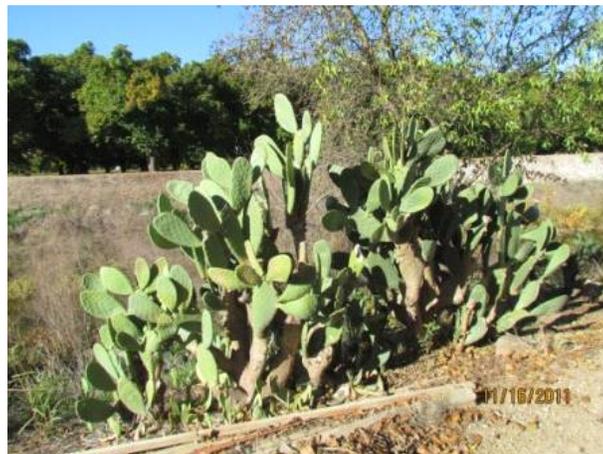
Levee Mile Report Line	45
Start Levee Mile	7.01
End Levee Mile	7.01
Location	Water Side
Category	Earthen Levee
Item	Encroachments
<p>Cacti were found on the waterside of the levee looking upstream.</p>	
<p>pkazi_f_20111208_406.jpg</p>

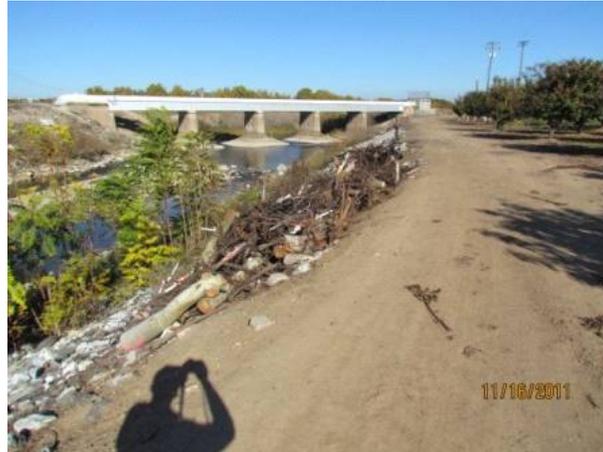
Levee Mile Report Line	48
Start Levee Mile	7.37
End Levee Mile	7.37
Location	Water Side
Category	Earthen Levee
Item	Encroachments
Debris and prunings were found on the waterside of the levee looking upstream.	
pkazi_f_20111207_401.jpg

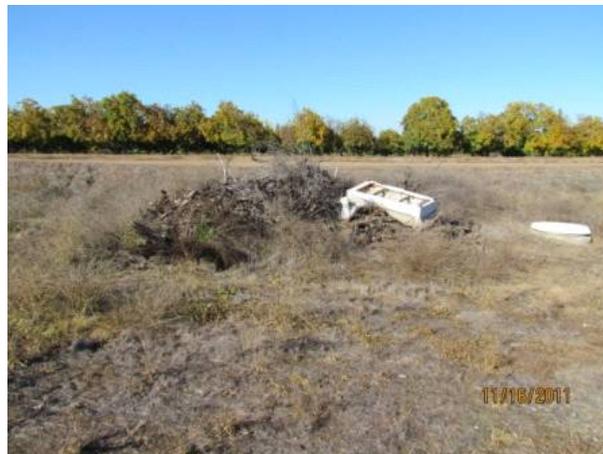
Levee Mile Report Line	49
Start Levee Mile	7.39
End Levee Mile	7.39
Location	Water Side
Category	Earthen Levee
Item	Encroachments
Debris was found on the waterside of the levee looking upstream.	
pkazi_f_20111207_404.jpg

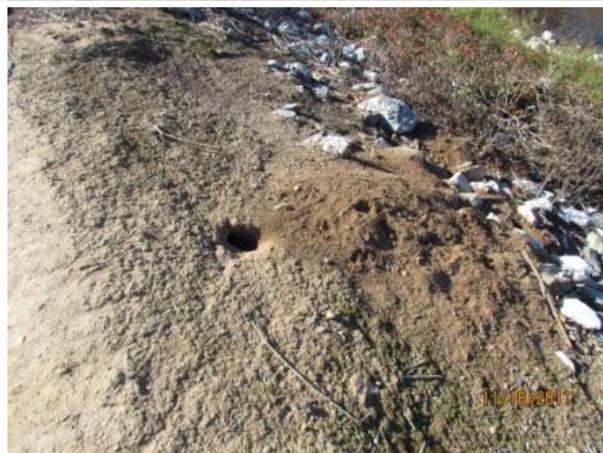
Levee Mile Report Line	50
Start Levee Mile	7.40
End Levee Mile	7.40
Location	Water Side
Category	Earthen Levee
Item	Animal Control
Rodent hole was found on the waterside of the levee looking downstream.	
pkazi_f_20111207_402.jpg

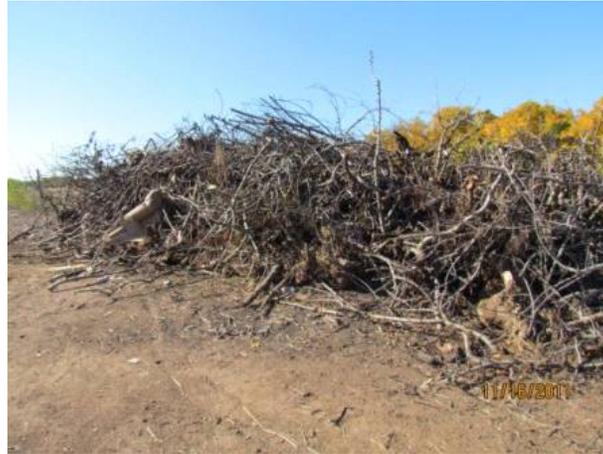
Levee Mile Report Line	51
Start Levee Mile	7.83
End Levee Mile	7.83
Location	Water Side
Category	Earthen Levee
Item	Encroachments
<p>Prunings were found on the waterside of the levee looking downstream.</p>	
<p>pkazi_f_20111207_400.jpg</p>

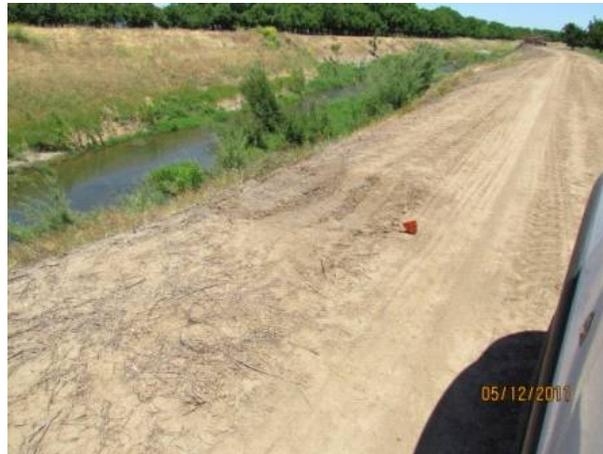
Levee Mile Report Line	52
Start Levee Mile	7.92
End Levee Mile	7.92
Location	Crown
Category	Earthen Levee
Item	Crown Surface / Depressions / Rutting
<p>Depression on the crown of the levee near waterside shoulder. The picture was taken from the crown looking upstream.</p>	
<p>pkazi_f_20111118_324.jpg</p>

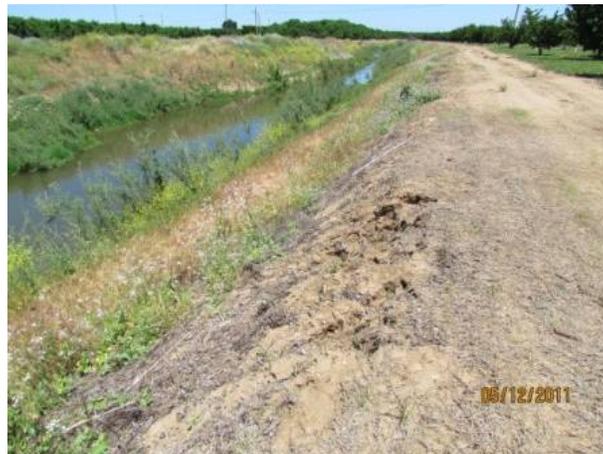
Levee Mile Report Line	53
Start Levee Mile	8.05
End Levee Mile	8.05
Location	Water Side
Category	Earthen Levee
Item	Slope Stability
<p>Slope stability on the shoulder of the waterside of the levee. The picture was taken from the crown looking upstream.</p>	
<p>pkazi_f_20111118_323.jpg</p>

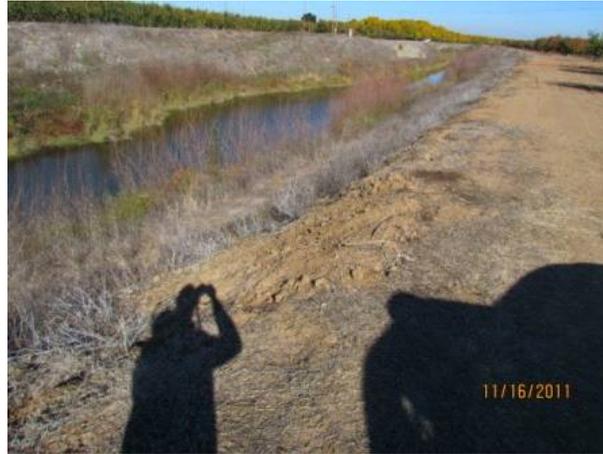
pkazi_f_20111207_399.jpg

Slope instability was found on the waterside of the levee looking upstream. This picture was taken during fall 2011 inspection.

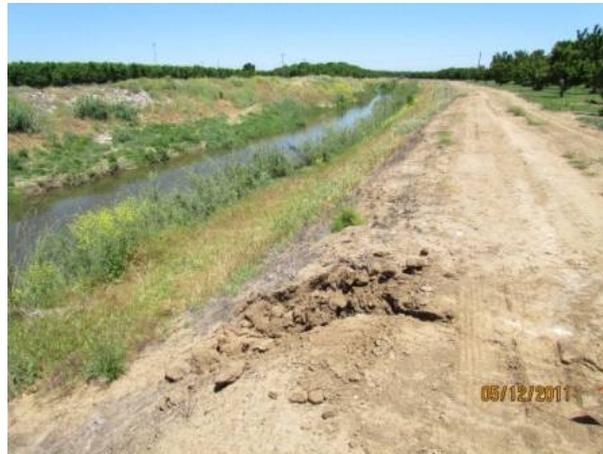
pkazi_f_20111118_322.jpg

Levee Mile Report Line	54
Start Levee Mile	8.08
End Levee Mile	8.08
Location	Water Side
Category	Earthen Levee
Item	Slope Stability

Slope stability was found on the shoulder of the waterside of the levee. The picture was taken from the crown looking upstream.

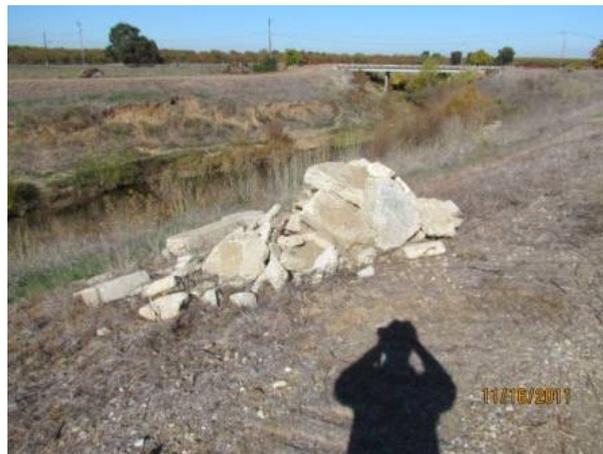
pkazi_f_20111207_398.jpg

Levee Mile Report Line	56
Start Levee Mile	8.41
End Levee Mile	8.41
Location	Water Side
Category	Earthen Levee
Item	Encroachments

Concrete debris was found on the waterside of the levee looking upstream.

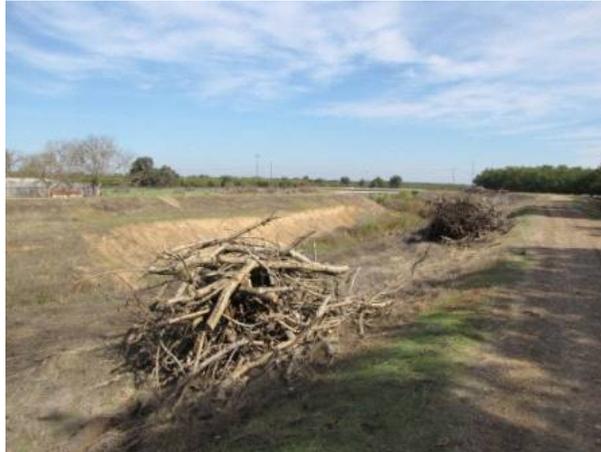
Levee Mile Report Line	57
Start Levee Mile	8.46
End Levee Mile	8.46
Location	Water Side
Category	Earthen Levee
Item	Encroachments
View of pruning piles located on waterward side looking upstream.	
pkazi_f_20111118_310.jpg

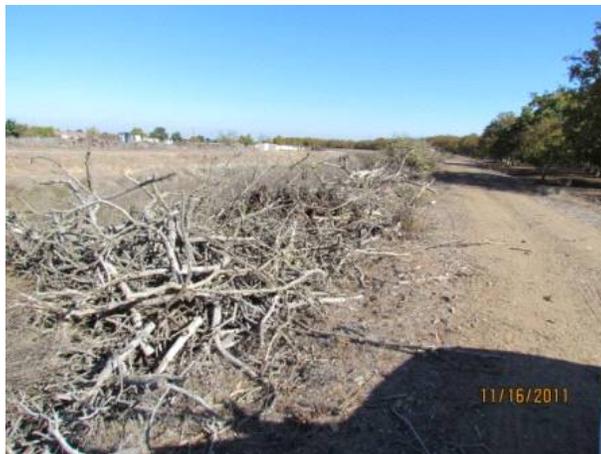
Levee Mile Report Line	58
Start Levee Mile	8.54
End Levee Mile	8.66
Location	Water Side
Category	Earthen Levee
Item	Encroachments
Prunings were found on the waterside of the levee looking upstream.	
pkazi_f_20111207_397.jpg

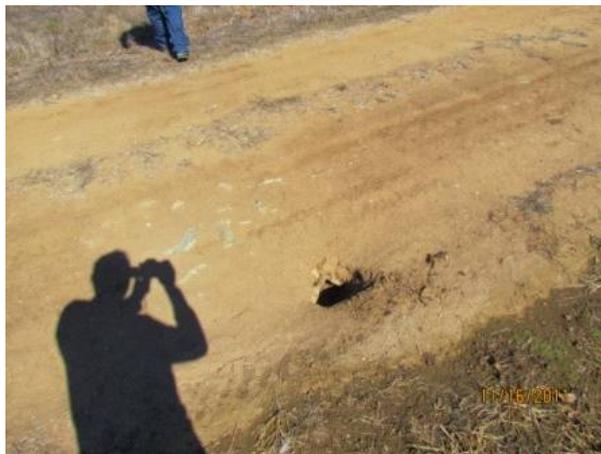
Levee Mile Report Line	60
Start Levee Mile	9.77
End Levee Mile	9.77
Location	Land Side
Category	Earthen Levee
Item	Animal Control
Rodent hole was found on the landside of the levee looking upstream.	
pkazi_f_20111207_396.jpg

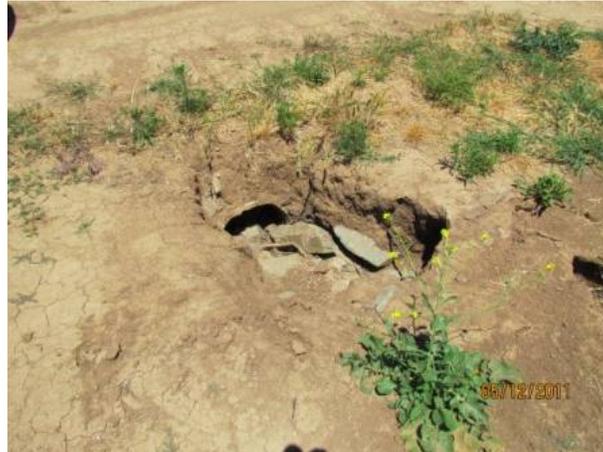
Levee Mile Report Line	61
Start Levee Mile	9.77
End Levee Mile	9.77
Location	Land Side
Category	Earthen Levee
Item	Encroachments
<p>An abandon pipe was left by the farmer. The picture was taken from the toe of the landside of the levee looking upstream.</p>	
<p>pkazi_f_20111118_321.jpg</p>

LMIR No.	Levee Mile		Category	Item	Location	Rating	Action/Comment	GPS Latitude/Longitude		Issue No. Photo
	Start	End						Start	End	
61	9.77	9.77	Earthen Levee	Encroachments	LS	W	Pipe Inspector Comments: Drain pipe from the farmer needs repair.	37.965854 ° -121.135960 °	37.965854 ° -121.135960 °	194 Y
62	10.26	10.26	Earthen Levee	Encroachments	LS	W	Prunings	37.964697 ° -121.144216 °	37.964697 ° -121.144216 °	171 Y
63	10.77	10.77	Earthen Levee	Encroachments	WS	M	Prunings	37.964159 ° -121.153094 °	37.964159 ° -121.153094 °	91
64	10.80	10.80	Earthen Levee	Vegetation	WS	M	Remove the wild growth other than native grasses from the levee slopes.	37.964053 ° -121.153671 °	37.964053 ° -121.153671 °	80
65	10.83	10.83	Earthen Levee	Encroachments	WS	PO	Poles	37.963807 ° -121.154087 °	37.963807 ° -121.154087 °	81
66	10.84	10.88	Earthen Levee	Encroachments	WS	PO	Landscaping	37.963704 ° -121.154321 °	37.963524 ° -121.155045 °	159 Y

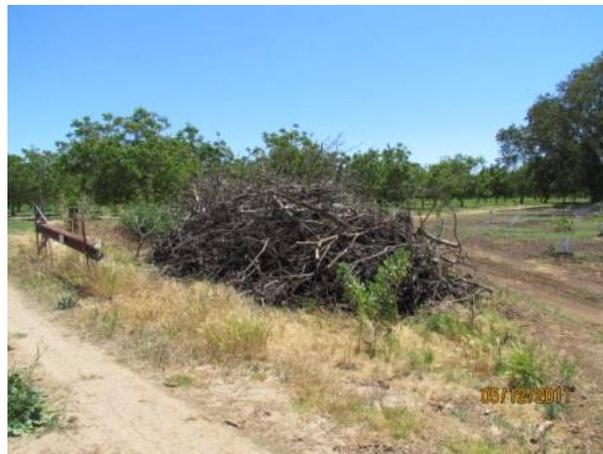
Levee Mile Report Line	62
Start Levee Mile	10.26
End Levee Mile	10.26
Location	Land Side
Category	Earthen Levee
Item	Encroachments
<p>Prunings were found landside of the levee. The picture was taken from the crown looking upstream.</p>	
<p>pkazi_f_20111118_312.jpg</p>

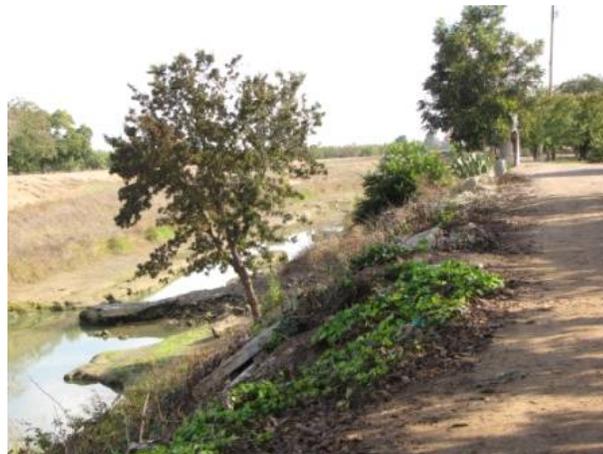
Levee Mile Report Line	66
Start Levee Mile	10.84
End Levee Mile	10.88
Location	Water Side
Category	Earthen Levee
Item	Encroachments
<p>View of landscaping on waterward side looking upstream.</p>	
<p>pkazi_f_20111118_306.jpg</p>

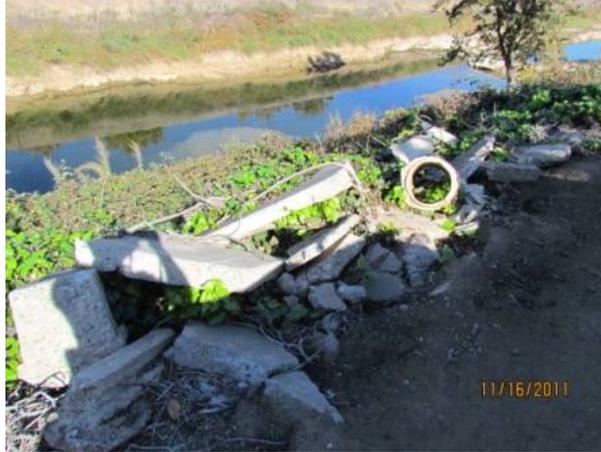
Levee Mile Report Line	67
Start Levee Mile	10.87
End Levee Mile	10.87
Location	Water Side
Category	Earthen Levee
Item	Encroachments
Concrete debris was found on the waterside of the levee looking upstream.	
pkazi_f_20111207_395.jpg

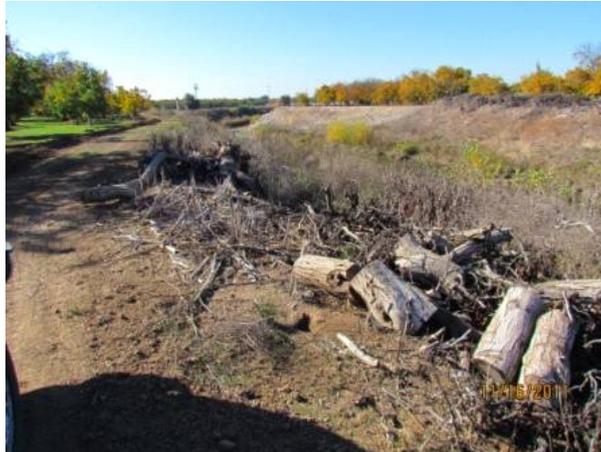
Levee Mile Report Line	68
Start Levee Mile	11.07
End Levee Mile	11.07
Location	Water Side
Category	Earthen Levee
Item	Encroachments
Prunings were found on the waterside of the levee looking downstream.	
pkazi_f_20111207_394.jpg

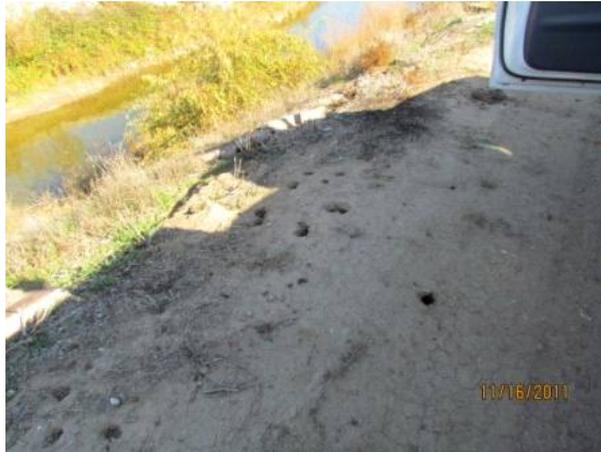
Levee Mile Report Line	69
Start Levee Mile	11.19
End Levee Mile	11.19
Location	Water Side
Category	Earthen Levee
Item	Animal Control
Rodent holes were found on the waterside of the levee looking upstream.	
pkazi_f_20111207_393.jpg

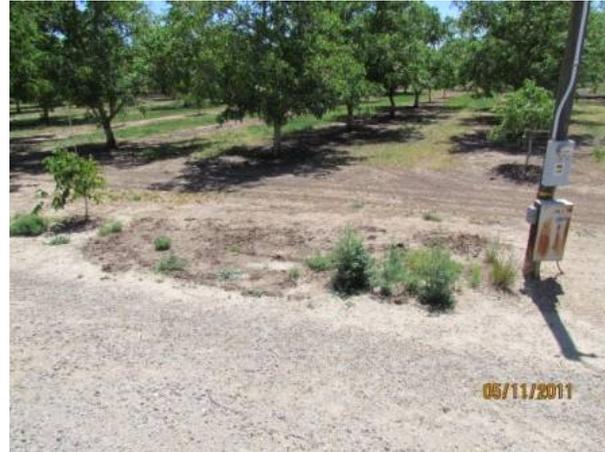
Levee Mile Report Line	71
Start Levee Mile	11.51
End Levee Mile	11.51
Location	Land Side
Category	Earthen Levee
Item	Erosion / Bank Caving
<p>The pit dug on previous inspection was filled and compacted. The picture was taken from the crown looking upstream.</p>	
<p>pkazi_f_20111118_305.jpg</p>

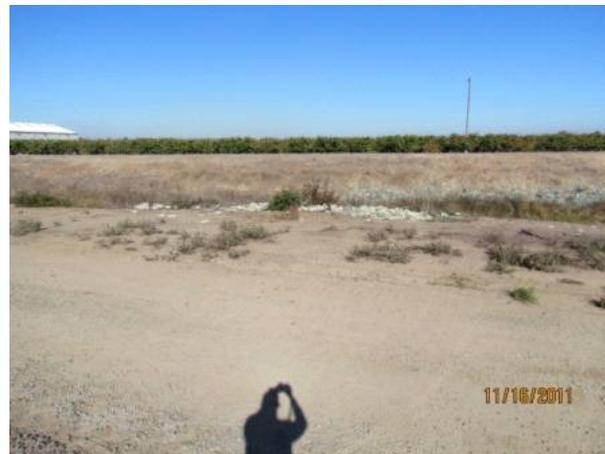
Levee Mile Report Line	72
Start Levee Mile	11.51
End Levee Mile	11.51
Location	Water Side
Category	Earthen Levee
Item	Encroachments
<p>Concrete debris was found on the waterside of the levee looking downstream.</p>	
<p>pkazi_f_20111207_387.jpg</p>

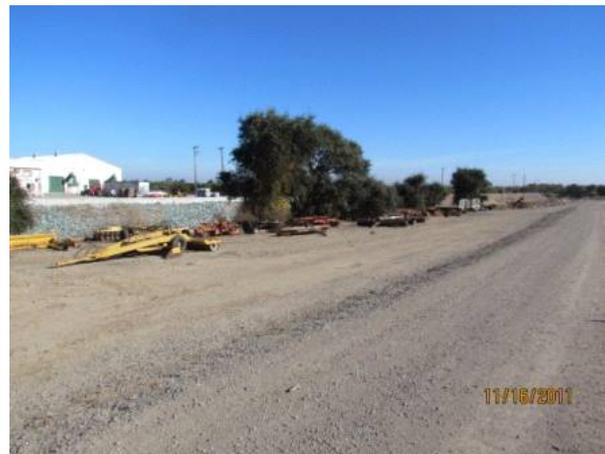
Levee Mile Report Line	73
Start Levee Mile	11.52
End Levee Mile	11.59
Location	Water Side
Category	Earthen Levee
Item	Encroachments
<p>Equipment was found on the waterside of the levee looking upstream.</p>	
<p>pkazi_f_20111207_386.jpg</p>

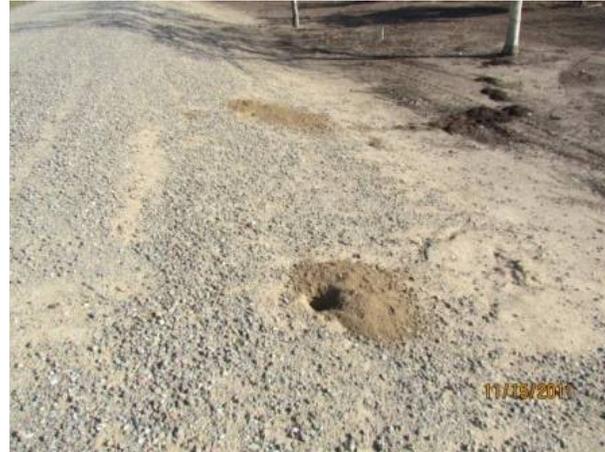
Levee Mile Report Line	75
Start Levee Mile	11.85
End Levee Mile	11.85
Location	Land Side
Category	Earthen Levee
Item	Animal Control
<p>Rodent hole was found on the landside of the levee looking upstream.</p>	
<p>pkazi_f_20111207_385.jpg</p>

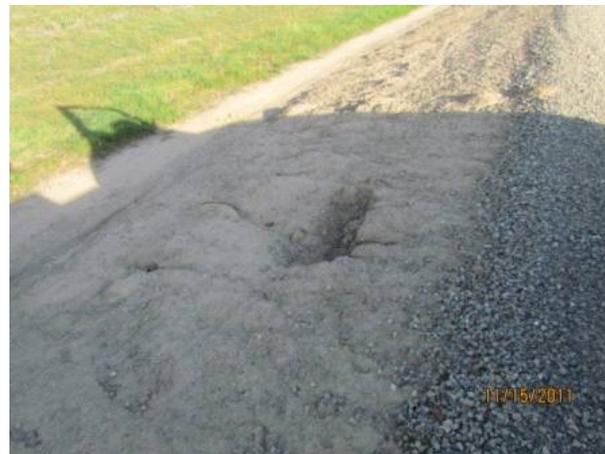
Levee Mile Report Line	77
Start Levee Mile	11.95
End Levee Mile	11.95
Location	Water Side
Category	Earthen Levee
Item	Slope Stability
<p>Slope instability was possible created by rodent holes on the waterside of the levee looking upstream.</p>	
<p>pkazi_f_20111207_384.jpg</p>

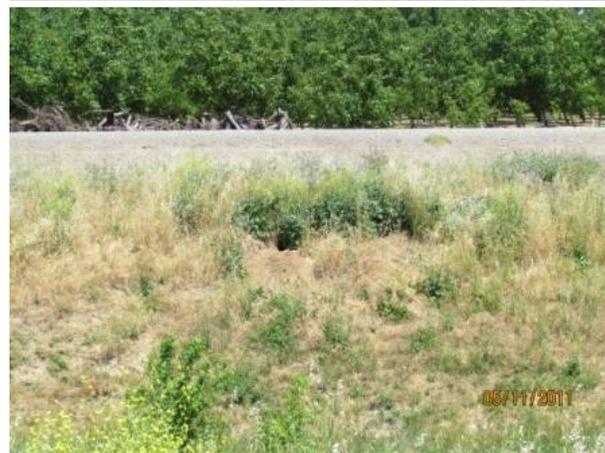
Levee Mile Report Line	78
Start Levee Mile	12.09
End Levee Mile	12.09
Location	Water Side
Category	Earthen Levee
Item	Animal Control
<p>Rodent hole was found on the waterside of the levee. The picture was taken from left bank of Mormon Slough looking towards right bank of the levee.</p>	
<p>pkazi_f_20111118_327.jpg</p>

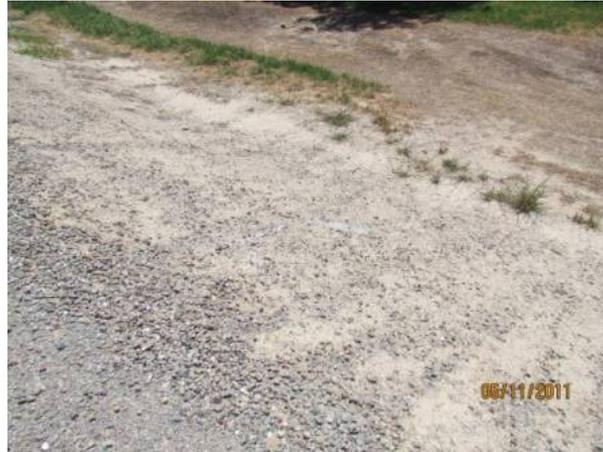
Levee Mile Report Line	79
Start Levee Mile	12.13
End Levee Mile	12.13
Location	Land Side
Category	Earthen Levee
Item	Animal Control
<p>Rodent hole was grouted by the LMA. The picture was taken from the crown looking upstream.</p>	
<p>pkazi_f_20111118_308.jpg</p>

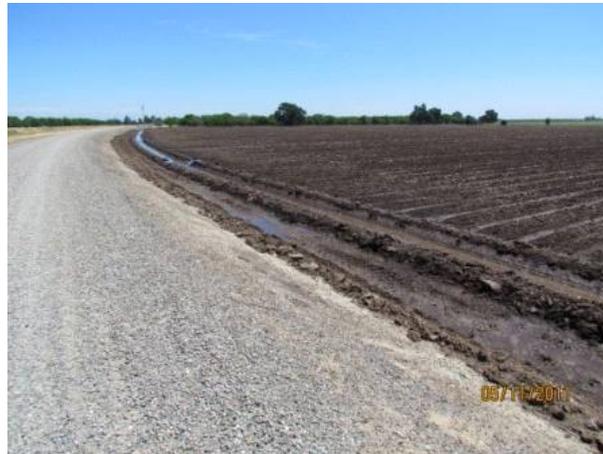
Levee Mile Report Line	80
Start Levee Mile	12.27
End Levee Mile	12.47
Location	Land Side
Category	Earthen Levee
Item	Encroachments
<p>An agricultural ditch was found on the landside of the levee. The picture was taken from crown looking upstream.</p>	
<p>pkazi_f_20111118_307.jpg</p>

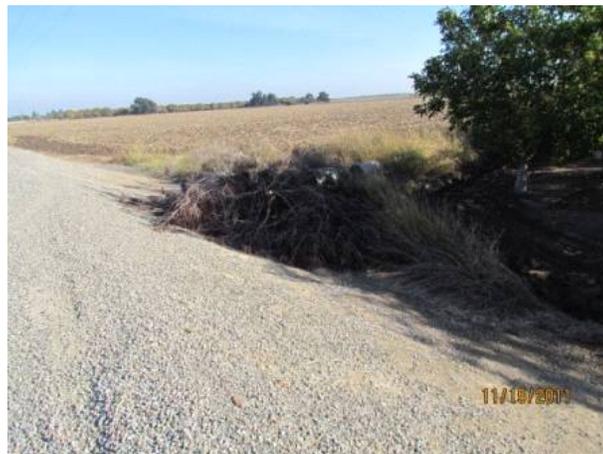
Levee Mile Report Line	81
Start Levee Mile	12.59
End Levee Mile	12.59
Location	Land Side
Category	Earthen Levee
Item	Encroachments
<p>Prunings were found on the landside of the levee looking upstream.</p>	
<p>pkazi_f_20111207_383.jpg</p>

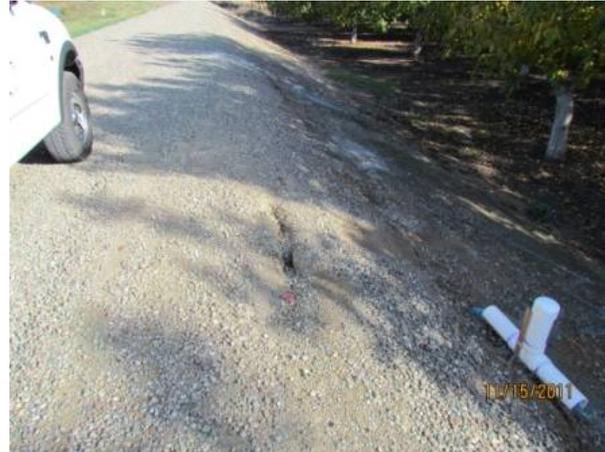
Levee Mile Report Line	83
Start Levee Mile	12.65
End Levee Mile	12.65
Location	Land Side
Category	Earthen Levee
Item	Cracking
Cracking was found on the landside shoulder of the levee looking upstream.	
pkazi_f_20111207_382.jpg

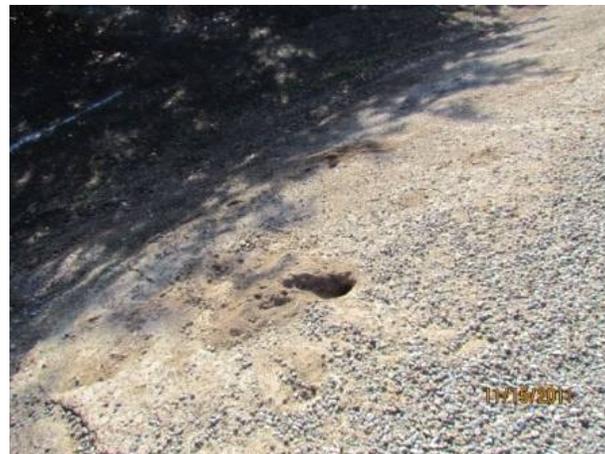
Levee Mile Report Line	84
Start Levee Mile	12.71
End Levee Mile	12.71
Location	Land Side
Category	Earthen Levee
Item	Animal Control
Rodent hole was found on the landside of the levee looking downstream.	
pkazi_f_20111207_381.jpg

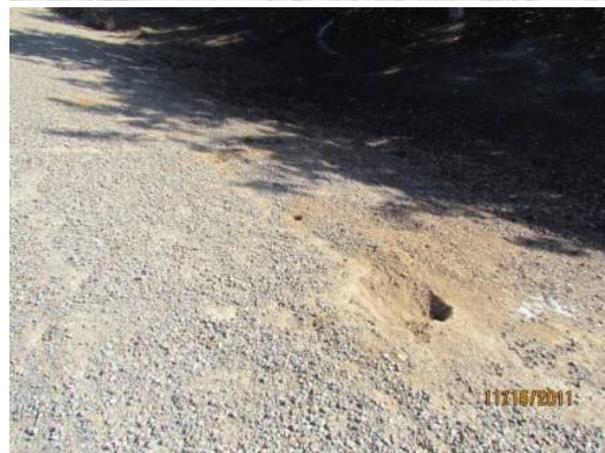
Levee Mile Report Line	85
Start Levee Mile	12.87
End Levee Mile	12.87
Location	Land Side
Category	Earthen Levee
Item	Animal Control
Rodent hole was found on the landside of the levee looking upstream.	
pkazi_f_20111207_380.jpg

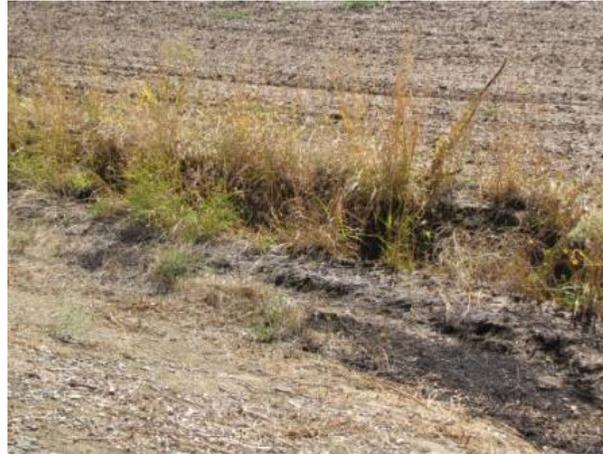
pkazi_f_20111118_303.jpg

View of an irrigation/drainage ditch along the landward toe.

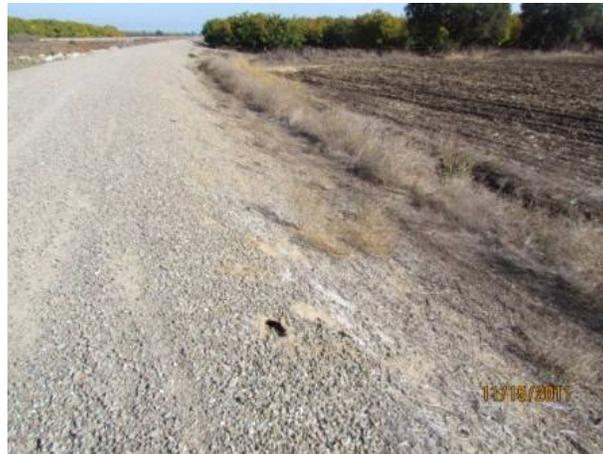
pkazi_f_20111207_379.jpg

Levee Mile Report Line	87
Start Levee Mile	13.00
End Levee Mile	13.00
Location	Land Side
Category	Earthen Levee
Item	Animal Control

Rodent hole was found on the landside of the levee looking upstream.

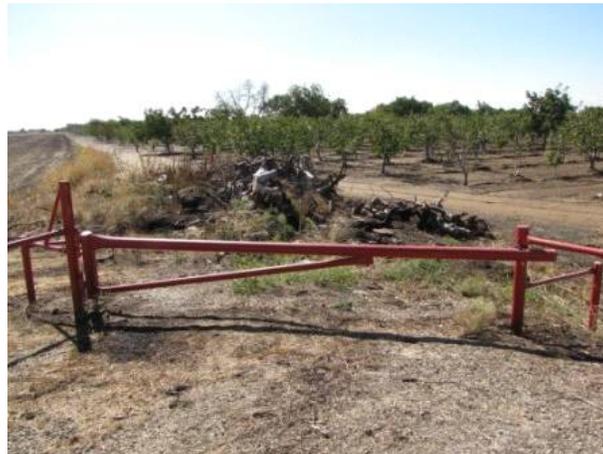
pkazi_f_20111118_302.jpg

Levee Mile Report Line	88
Start Levee Mile	13.17
End Levee Mile	13.17
Location	Land Side
Category	Earthen Levee
Item	Encroachments

View of a prunings pile along the landward toe of an access ramp. Pile is blocking access through this gate.

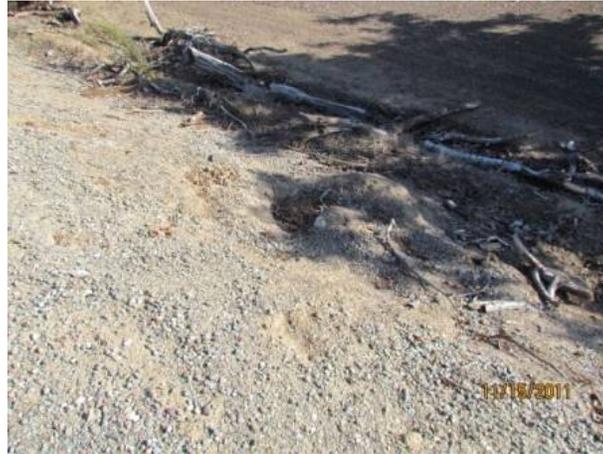
Levee Mile Report Line	90
Start Levee Mile	13.59
End Levee Mile	13.59
Location	Land Side
Category	Earthen Levee
Item	Encroachments
Debris was found on the toe of the landside of the levee looking upstream.	
pkazi_f_20111207_378.jpg

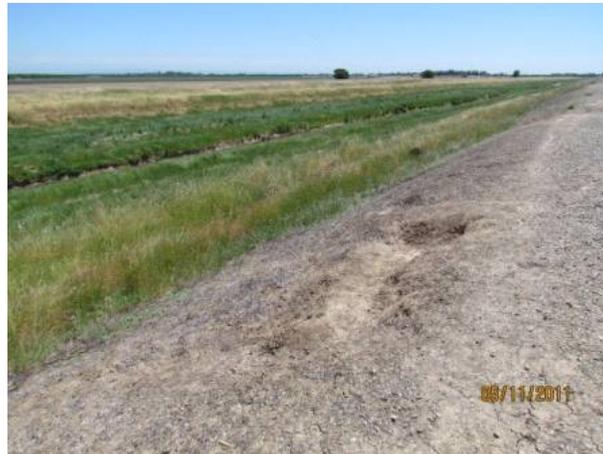
Levee Mile Report Line	92
Start Levee Mile	14.85
End Levee Mile	14.85
Location	Water Side
Category	Earthen Levee
Item	Erosion / Bank Caving
Slope stability on the waterside of the levee. The picture was taken from the crown looking upstream.	
pkazi_f_20111118_295.jpg

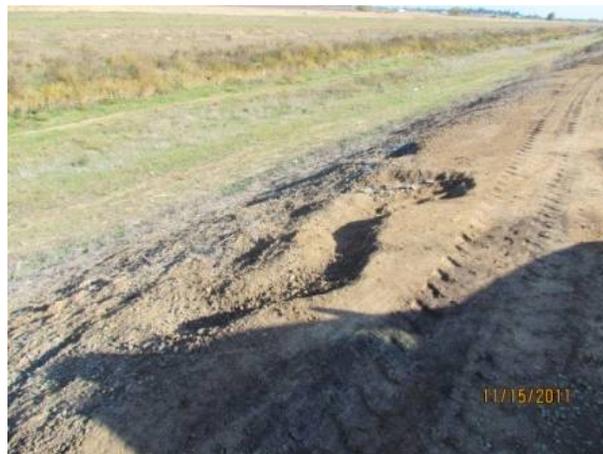
Levee Mile Report Line	92
Start Levee Mile	14.85
End Levee Mile	14.85
Location	Water Side
Category	Earthen Levee
Item	Erosion / Bank Caving
Slope instability was found on the waterside of the levee looking upstream. This picture was taken during Fall 2011 Inspection.	
pkazi_f_20111207_377.jpg

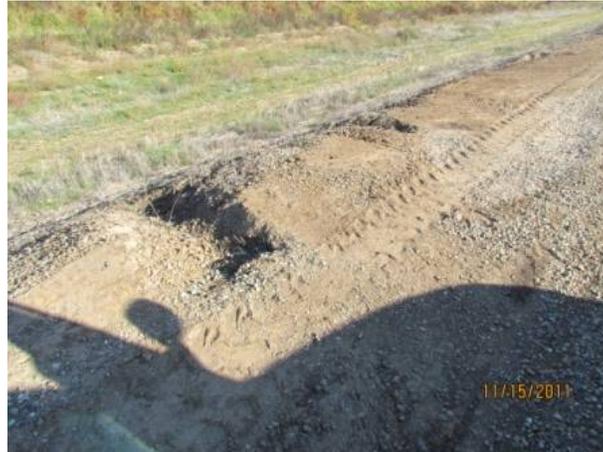
Levee Mile Report Line	93
Start Levee Mile	14.95
End Levee Mile	14.95
Location	Water Side
Category	Earthen Levee
Item	Slope Stability
Slope instability was found on the waterside of the levee looking upstream.	
pkazi_f_20111207_376.jpg

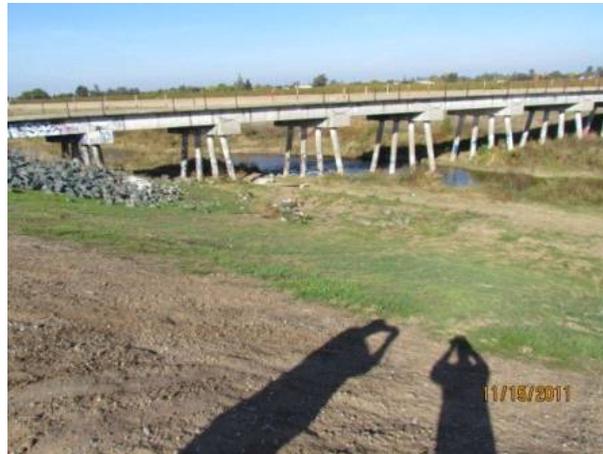
Levee Mile Report Line	94
Start Levee Mile	15.01
End Levee Mile	15.01
Location	Water Side
Category	Earthen Levee
Item	Encroachments
Debris was found on the waterside of the levee looking downstream.	
pkazi_f_20111207_374.jpg

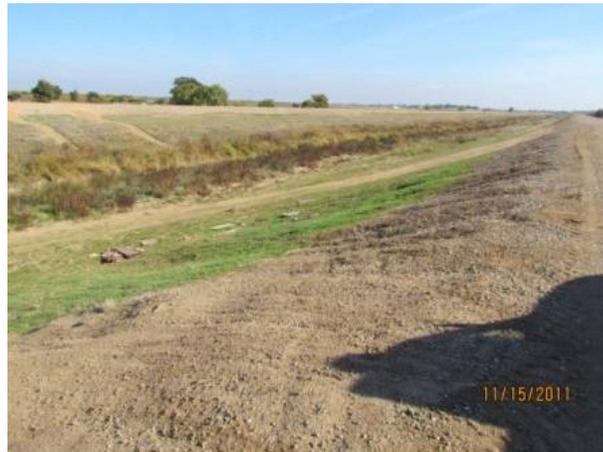
Levee Mile Report Line	95
Start Levee Mile	15.01
End Levee Mile	15.01
Location	Water Side
Category	Earthen Levee
Item	Slope Stability
Slope instability was found on the waterside of the levee looking upstream.	
pkazi_f_20111207_375.jpg
