**Flood Control Project Maintenance
Levee Inspections**

Fall 2011 Levee Maintenance Deficiency Summary Report

San Joaquin River Basin

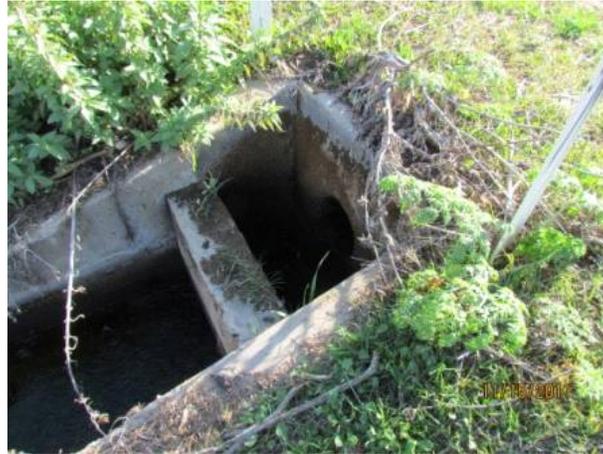
Levee Mile Report Line	96
Start Levee Mile	15.42
End Levee Mile	15.42
Location	Water Side
Category	Interior Drainage & Piping Systems
Item	Culverts: Inlets / Outlets
<p>Debris was found on the outlet of the culvert. The picture was taken from waterside of the levee looking upstream.</p>	
<p>pkazi_f_20111207_373.jpg</p>

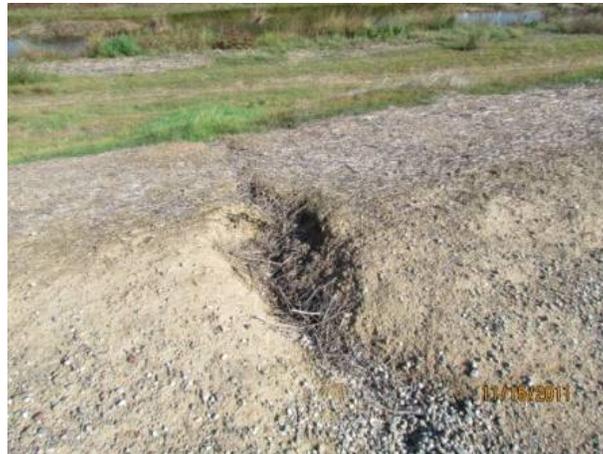
Levee Mile Report Line	97
Start Levee Mile	15.91
End Levee Mile	15.91
Location	Water Side
Category	Earthen Levee
Item	Slope Stability
<p>Slope instability was found on the waterside of the levee looking upstream.</p>	
<p>pkazi_f_20111207_368.jpg</p>

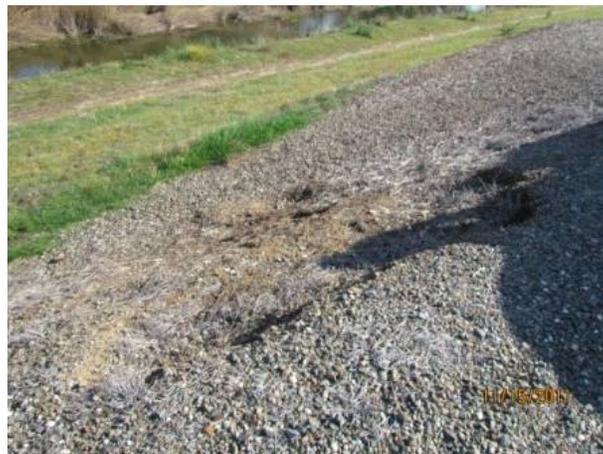
Levee Mile Report Line	98
Start Levee Mile	15.98
End Levee Mile	15.98
Location	Water Side
Category	Earthen Levee
Item	Slope Stability
<p>Slope instability was found on the waterside of the levee looking upstream.</p>	
<p>pkazi_f_20111207_369.jpg</p>

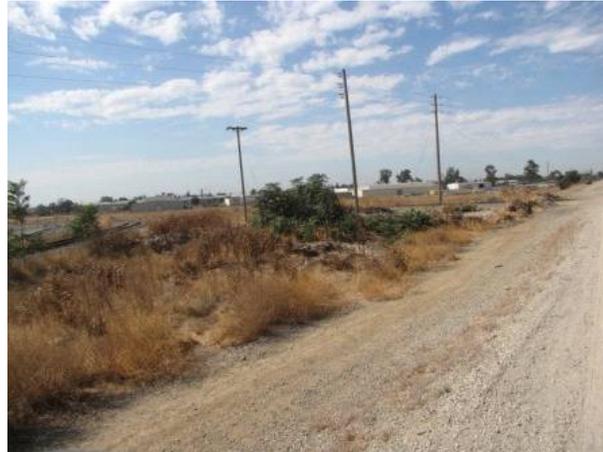
Levee Mile Report Line	99
Start Levee Mile	16.34
End Levee Mile	16.34
Location	Crown
Category	Earthen Levee
Item	Vegetation
View of vegetation within 10 feet of the landward slope looking downstream.	
pkazi_f_20111118_288.jpg

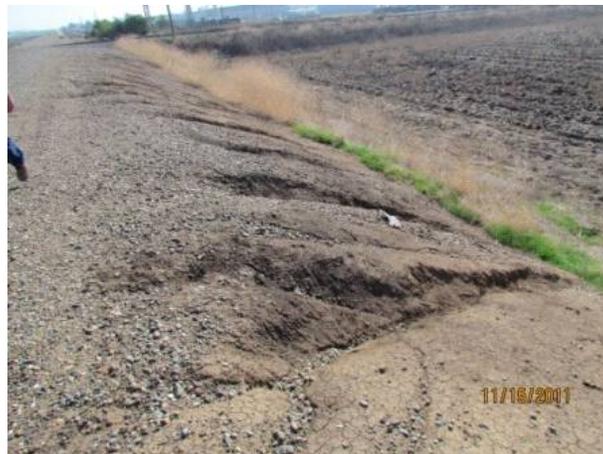
Levee Mile Report Line	102
Start Levee Mile	16.42
End Levee Mile	16.42
Location	Land Side
Category	Earthen Levee
Item	Slope Stability
Slope instability was found on the landside of the levee looking upstream.	
pkazi_f_20111207_370.jpg

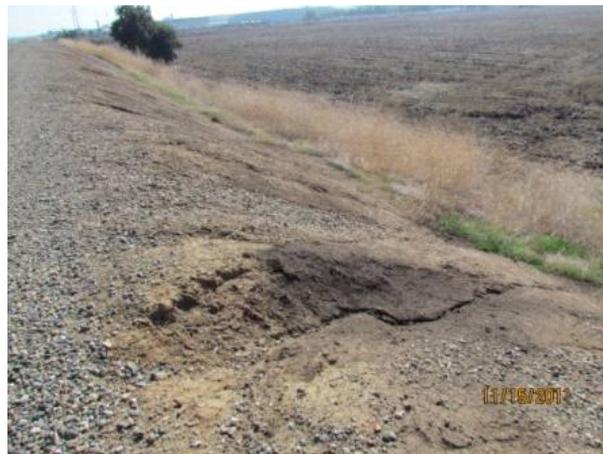
Levee Mile Report Line	103
Start Levee Mile	16.51
End Levee Mile	16.51
Location	Land Side
Category	Earthen Levee
Item	Slope Stability
Slope instability was found on the landside of the levee looking upstream.	
pkazi_f_20111207_371.jpg

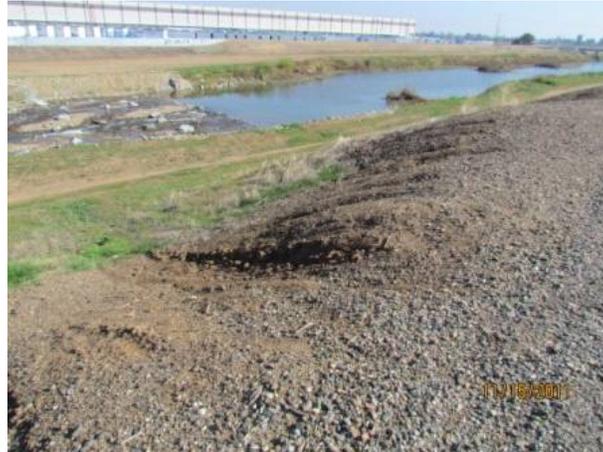
Levee Mile Report Line	104
Start Levee Mile	16.53
End Levee Mile	16.53
Location	Water Side
Category	Earthen Levee
Item	Slope Stability
Slope instability was found on the landside of the levee looking upstream.	
pkazi_f_20111207_372.jpg

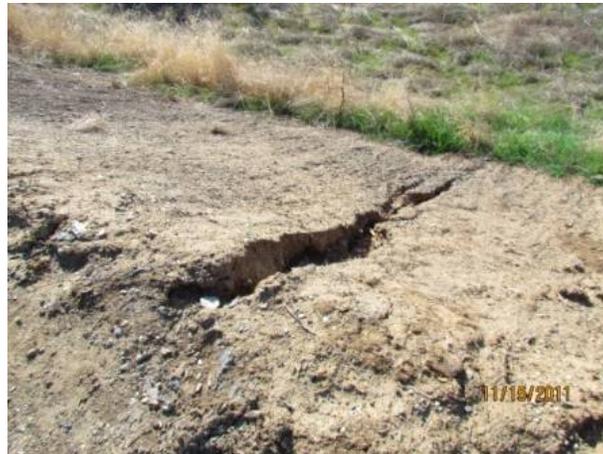
Levee Mile Report Line	106
Start Levee Mile	16.86
End Levee Mile	16.86
Location	Land Side
Category	Earthen Levee
Item	Slope Stability
Slope instability was found on the landside of the levee looking upstream.	
pkazi_f_20111207_367.jpg

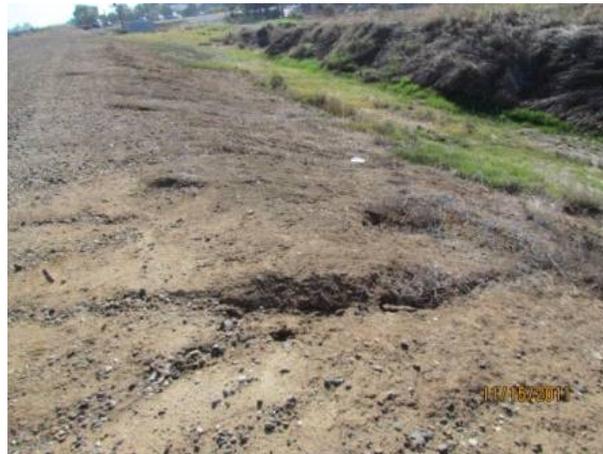
Levee Mile Report Line	107
Start Levee Mile	16.98
End Levee Mile	16.98
Location	Land Side
Category	Earthen Levee
Item	Slope Stability
Slope instability was found on the landside of the levee looking upstream.	
pkazi_f_20111207_366.jpg

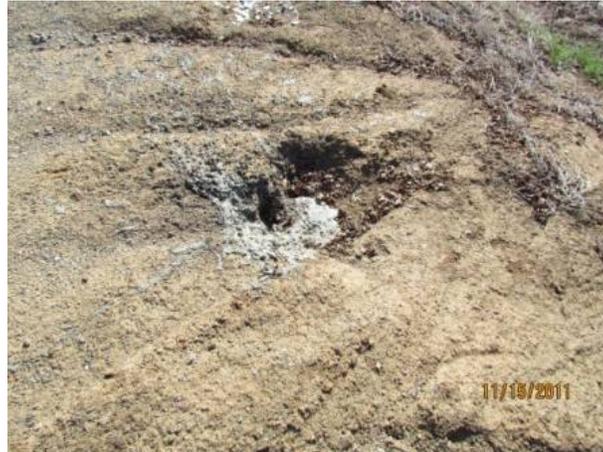
Levee Mile Report Line	108
Start Levee Mile	17.04
End Levee Mile	17.04
Location	Land Side
Category	Earthen Levee
Item	Animal Control
Rodent hole was found on the landside of the levee looking upstream.	
pkazi_f_20111207_365.jpg

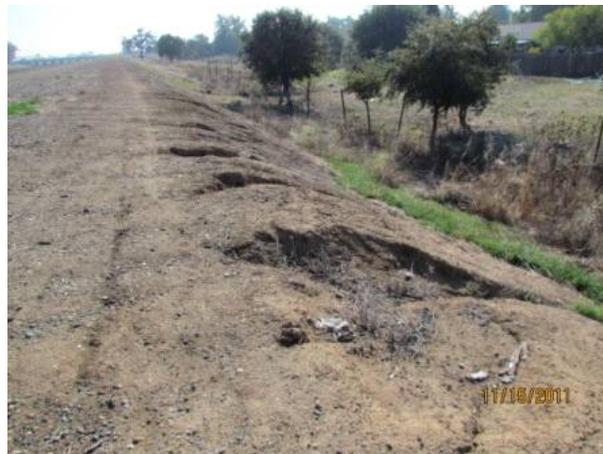
Levee Mile Report Line	110
Start Levee Mile	17.21
End Levee Mile	17.21
Location	Land Side
Category	Earthen Levee
Item	Slope Stability
Slope instability was found on the landside of the levee looking upstream.	
pkazi_f_20111207_363.jpg

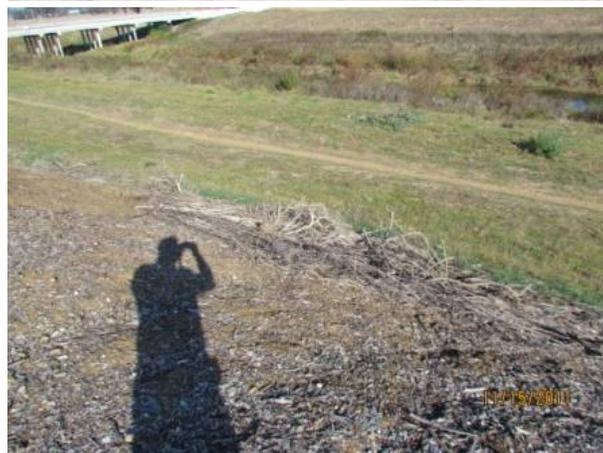
Levee Mile Report Line	111
Start Levee Mile	17.21
End Levee Mile	17.21
Location	Water Side
Category	Earthen Levee
Item	Encroachments
Pruning were found on the waterside of the levee looking downstream.	
pkazi_f_20111207_364.jpg

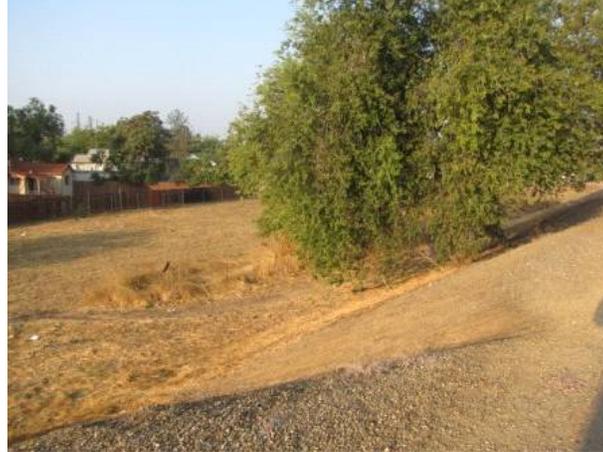
pkazi_f_20111118_296.jpg

View of damage to the landward slope caused by vehicular traffic looking downstream.

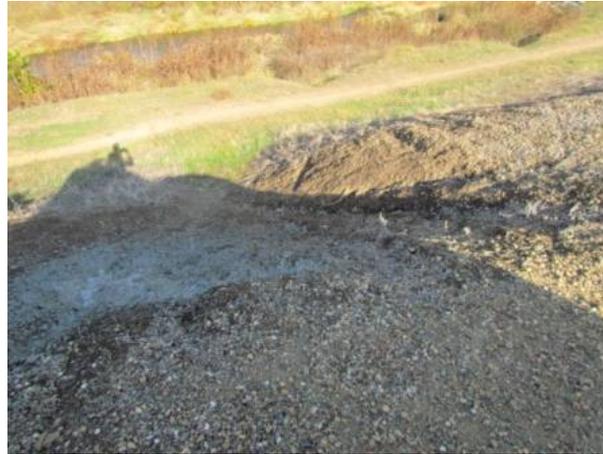
Levee Mile Report Line	114
Start Levee Mile	17.64
End Levee Mile	17.64
Location	Water Side
Category	Earthen Levee
Item	Erosion / Bank Caving

Slope stability caused by washout rodent holes on the waterside shoulder of the levee. The picture was taken from the crown looking upstream.

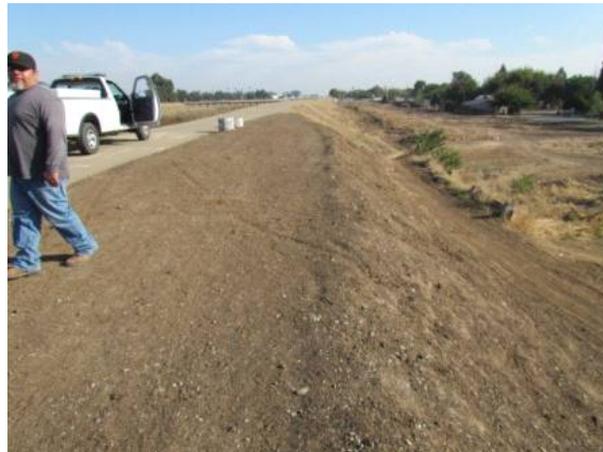
Levee Mile Report Line	117
Start Levee Mile	17.77
End Levee Mile	17.77
Location	Land Side
Category	Earthen Levee
Item	Slope Stability

Slope instability was repaired by the LMA on the landside of the levee looking upstream.

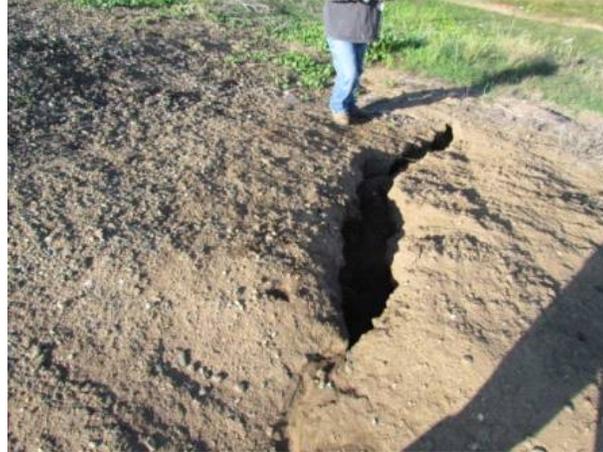
Levee Mile Report Line	119
Start Levee Mile	18.55
End Levee Mile	18.55
Location	Land Side
Category	Earthen Levee
Item	Slope Stability
Slope stability was found on the waterside of the levee looking downstream.	
pkazi_f_20111206_358.jpg

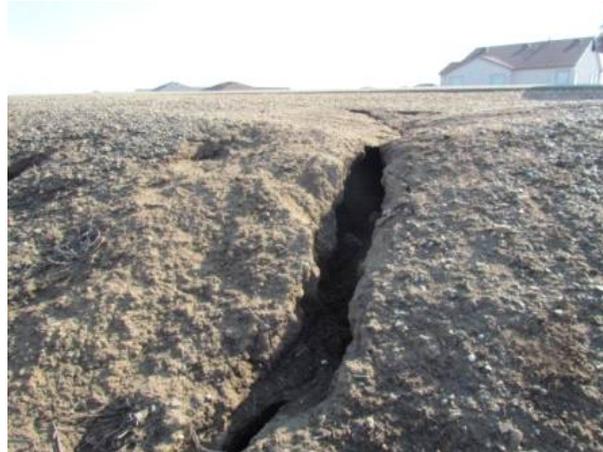
Levee Mile Report Line	119
Start Levee Mile	18.55
End Levee Mile	18.55
Location	Land Side
Category	Earthen Levee
Item	Slope Stability
Slope instability was found on the waterside of the levee. The picture was taken from the toe of the levee looking towards the crown.	
pkazi_f_20111206_359.jpg

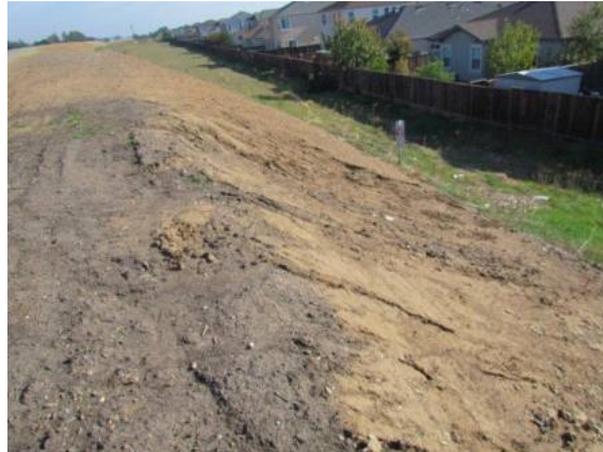
Levee Mile Report Line	120
Start Levee Mile	18.56
End Levee Mile	18.56
Location	Land Side
Category	Earthen Levee
Item	Slope Stability
Slope instability possibly created by run off on the landside of the levee. The picture was taken from the crown looking upstream.	
pkazi_f_20111207_360.jpg

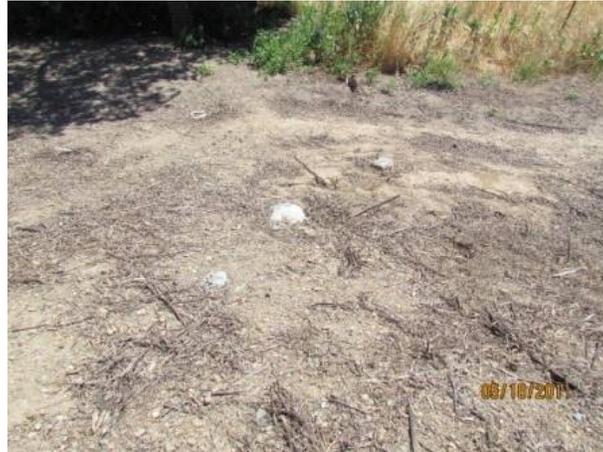
Levee Mile Report Line	122
Start Levee Mile	18.83
End Levee Mile	18.83
Location	Land Side
Category	Earthen Levee
Item	Animal Control
<p>Rodent holes were grouted by the LMA. The picture was taken from the crown looking downstream.</p>	
<p>pkazi_f_20111118_329.jpg</p>

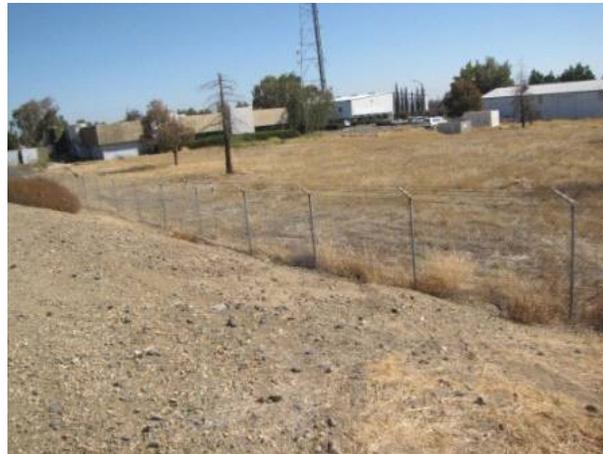
Levee Mile Report Line	123
Start Levee Mile	19.00
End Levee Mile	19.20
Location	Land Side
Category	Earthen Levee
Item	Encroachments
<p>View of a fence along the landward toe looking upstream.</p>	
<p>pkazi_f_20111118_299.jpg</p>

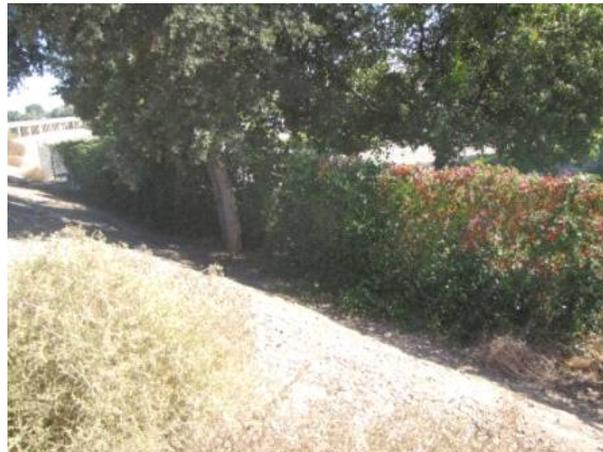
Levee Mile Report Line	124
Start Levee Mile	19.12
End Levee Mile	19.14
Location	Land Side
Category	Earthen Levee
Item	Encroachments
<p>View of landscaping along the landward toe.</p>	
<p>pkazi_f_20111118_300.jpg</p>

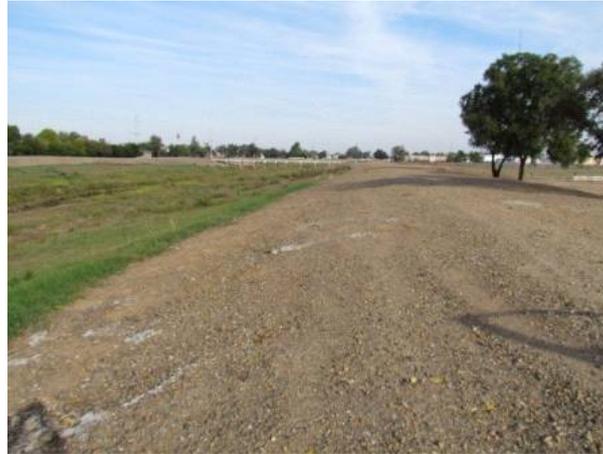
Levee Mile Report Line	126
Start Levee Mile	19.33
End Levee Mile	19.33
Location	Water Side
Category	Earthen Levee
Item	Vegetation
Vegetation was fixed by the LMA on the waterside of the levee looking upstream.	
pkazi_f_20111206_357.jpg

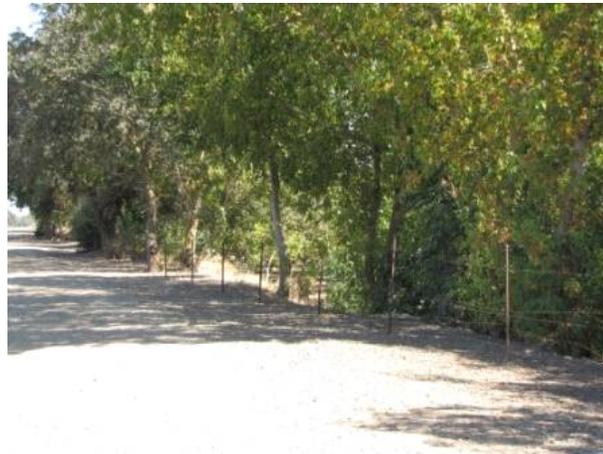
Levee Mile Report Line	128
Start Levee Mile	19.47
End Levee Mile	19.60
Location	Land Side
Category	Earthen Levee
Item	Encroachments
View of a barbed wire fence and landscaping along the landward shoulder and slope looking upstream.	
pkazi_f_20111118_294.jpg

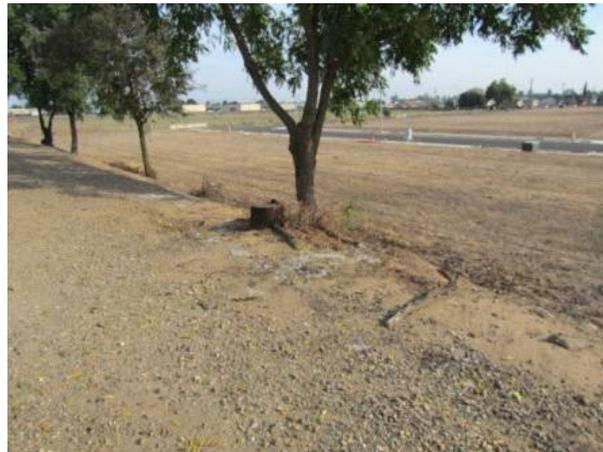
Levee Mile Report Line	129
Start Levee Mile	19.48
End Levee Mile	19.48
Location	Land Side
Category	Earthen Levee
Item	Trim / Thin Trees
Tree stump was found on the landside of the levee looking upstream.	
pkazi_f_20111206_356.jpg

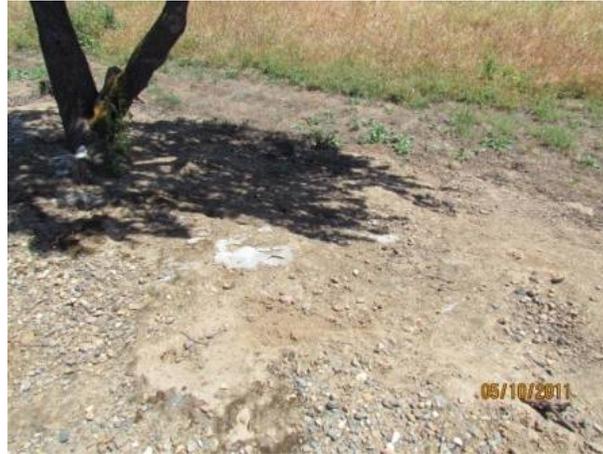
Levee Mile Report Line	130
Start Levee Mile	19.48
End Levee Mile	19.48
Location	Land Side
Category	Earthen Levee
Item	Animal Control
<p>The rodent holes were grouted by the LMA. The picture was taken from the crown looking upstream.</p>	
<p>pkazi_f_20111118_328.jpg</p>

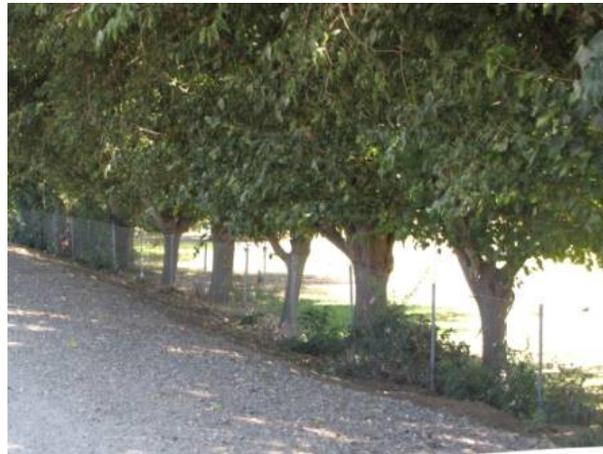
Levee Mile Report Line	132
Start Levee Mile	19.60
End Levee Mile	19.69
Location	Land Side
Category	Earthen Levee
Item	Encroachments
<p>View of a fence along the landward slope looking upstream.</p>	
<p>pkazi_f_20111118_293.jpg</p>

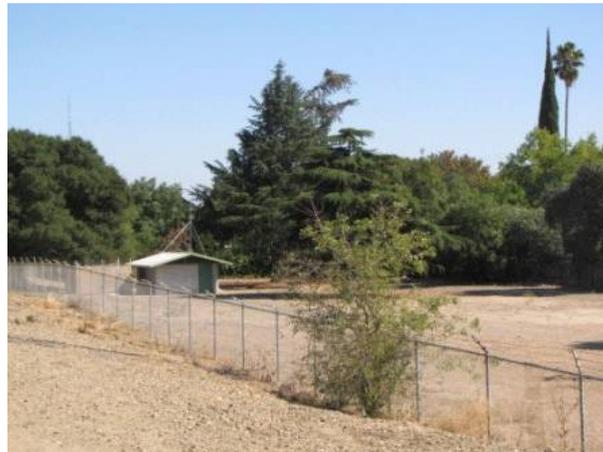
Levee Mile Report Line	136
Start Levee Mile	19.82
End Levee Mile	19.90
Location	Land Side
Category	Earthen Levee
Item	Encroachments
<p>View of a fence along the landward toe looking upstream.</p>	
<p>pkazi_f_20111118_292.jpg</p>

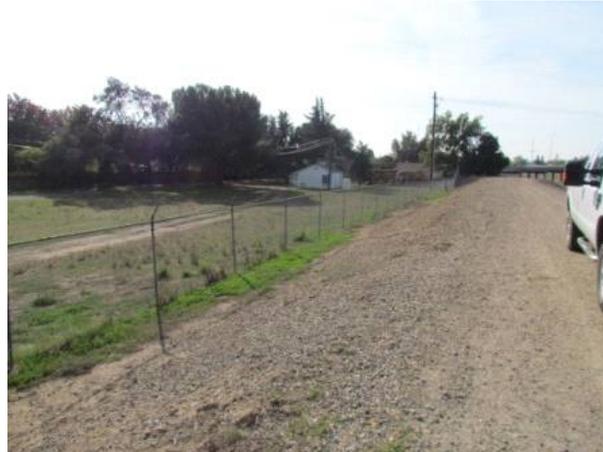
Levee Mile Report Line	137
Start Levee Mile	19.90
End Levee Mile	19.91
Location	Land Side
Category	Earthen Levee
Item	Encroachments
Wire fence was found on the toe of landside of the levee looking downstream.	
pkazi_f_20111206_355.jpg

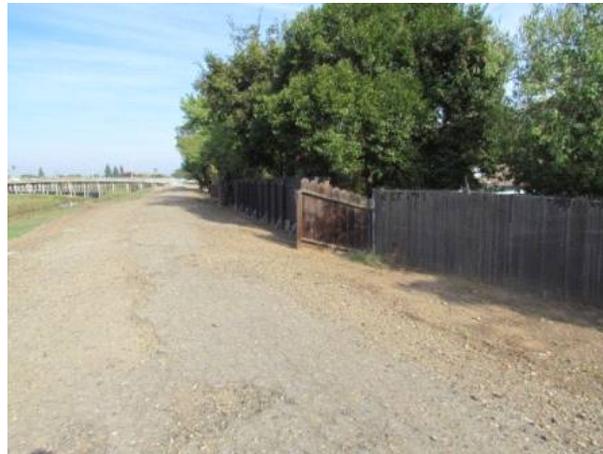
Levee Mile Report Line	141
Start Levee Mile	20.05
End Levee Mile	20.05
Location	Land Side
Category	Earthen Levee
Item	Encroachments
Wooden fence on the landside of the levee looking upstream.	
pkazi_f_20111206_354.jpg

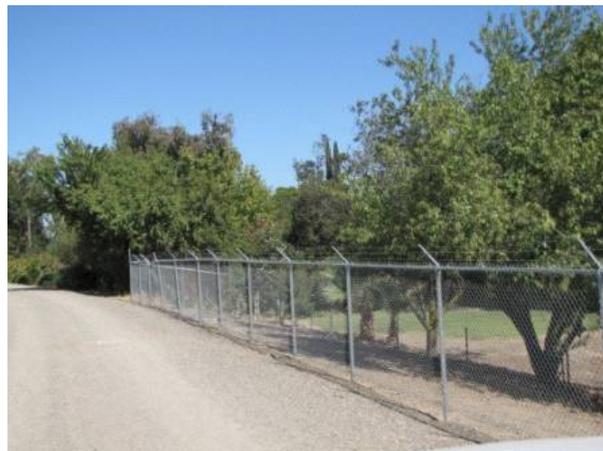
Levee Mile Report Line	153
Start Levee Mile	20.26
End Levee Mile	20.28
Location	Land Side
Category	Earthen Levee
Item	Encroachments
View of a fence along the landward slope looking upstream.	
pkazi_f_20111118_291.jpg

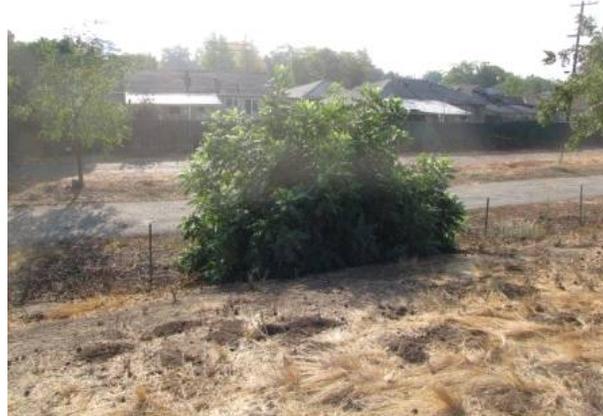
pkazi_f_20111118_314.jpg

View of a tree blocking visibility and access along the landward slope looking landward and downstream.

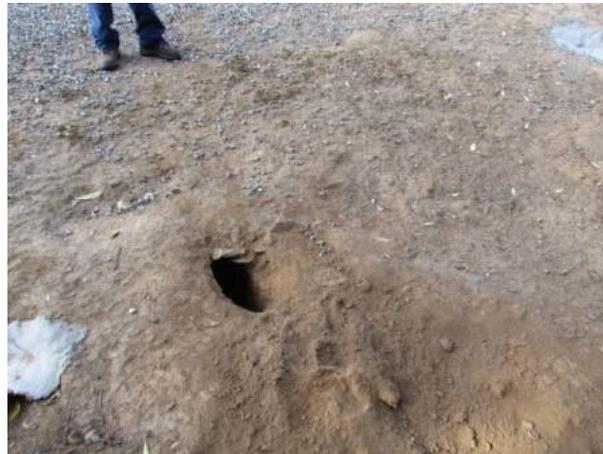
Levee Mile Report Line	155
Start Levee Mile	20.39
End Levee Mile	20.39
Location	Land Side
Category	Earthen Levee
Item	Animal Control

Rodent hole was found on the landside of the levee looking upstream. The picture was taken during fall 2011 inspection.

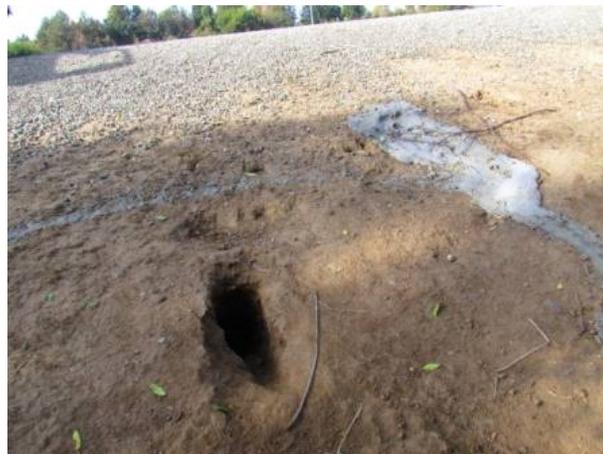
Levee Mile Report Line	155
Start Levee Mile	20.39
End Levee Mile	20.39
Location	Land Side
Category	Earthen Levee
Item	Animal Control

Rodent hole was found on the landside of the levee looking upstream. The picture was taken during fall 2011 inspection.

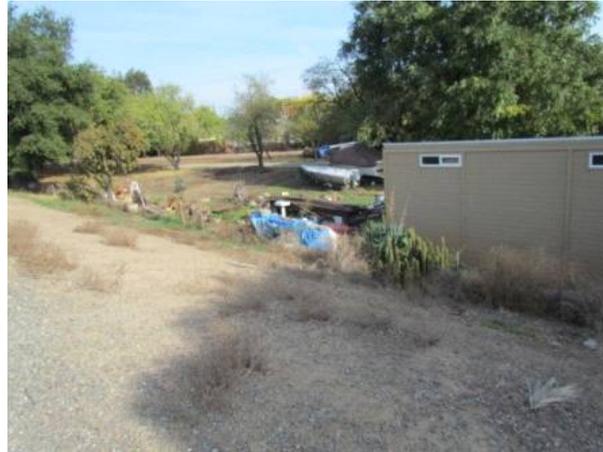
Levee Mile Report Line	156
Start Levee Mile	20.45
End Levee Mile	20.48
Location	Land Side
Category	Earthen Levee
Item	Encroachments
Landscape was found on the toe of landside of the levee looking upstream.	
pkazi_f_20111206_351.jpg

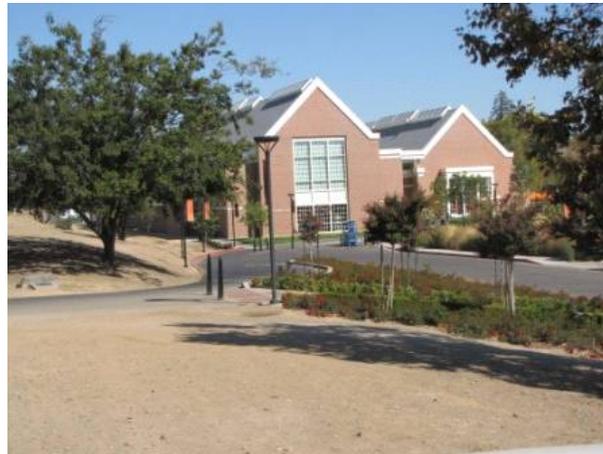
Levee Mile Report Line	157
Start Levee Mile	20.83
End Levee Mile	20.83
Location	Land Side
Category	Earthen Levee
Item	Encroachments
View of landscaping planted and maintained by UOP along the landward slope and toe looking upstream.	
pkazi_f_20111118_289.jpg

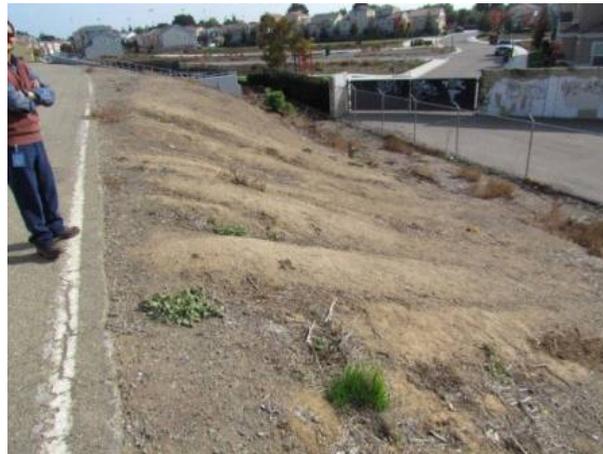
Levee Mile Report Line	161
Start Levee Mile	21.49
End Levee Mile	21.49
Location	Water Side
Category	Earthen Levee
Item	Erosion / Bank Caving
Erosion was found on the landside of the levee possible due to run off. The picture was taken from the crown looking upstream.	
pkazi_f_20111206_350.jpg

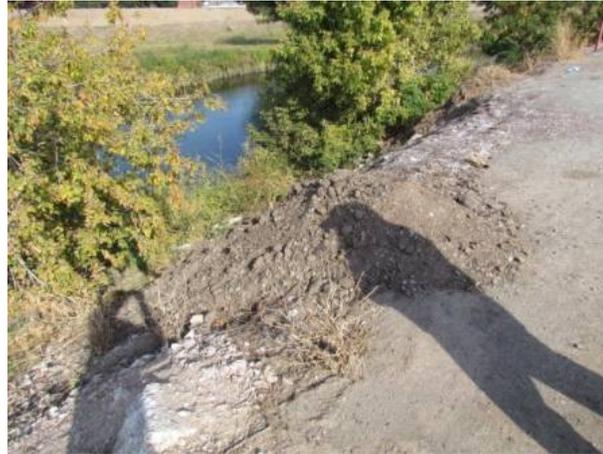
Levee Mile Report Line	162
Start Levee Mile	21.54
End Levee Mile	21.54
Location	Water Side
Category	Earthen Levee
Item	Encroachments
<p>Loose material was found on the waterside shoulder of the levee looking upstream.</p>	
<p>pkazi_f_20111206_346.jpg</p>

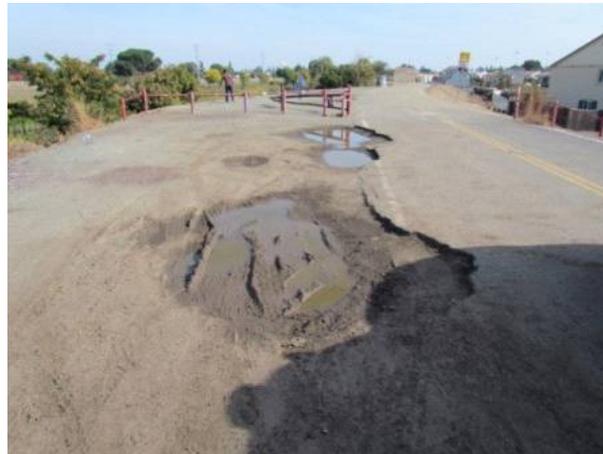
Levee Mile Report Line	163
Start Levee Mile	21.54
End Levee Mile	21.54
Location	Crown
Category	Earthen Levee
Item	Crown Surface / Depressions / Rutting
<p>Depression was found on the crown of the levee looking upstream.</p>	
<p>pkazi_f_20111206_347.jpg</p>

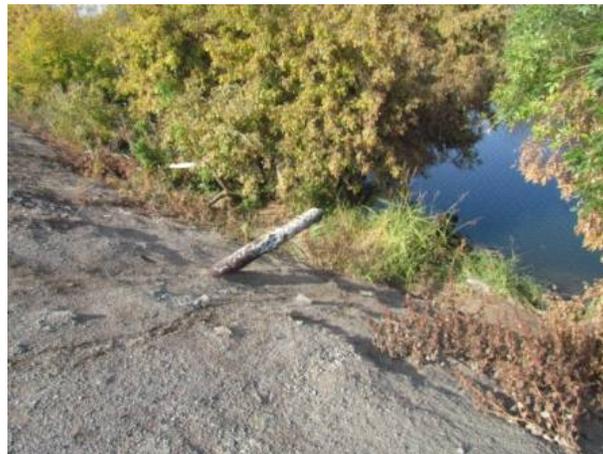
Levee Mile Report Line	164
Start Levee Mile	21.54
End Levee Mile	21.54
Location	Water Side
Category	Earthen Levee
Item	Encroachments
<p>An abandoned pipe was found on the waterside of the levee looking downstream.</p>	
<p>pkazi_f_20111206_348.jpg</p>

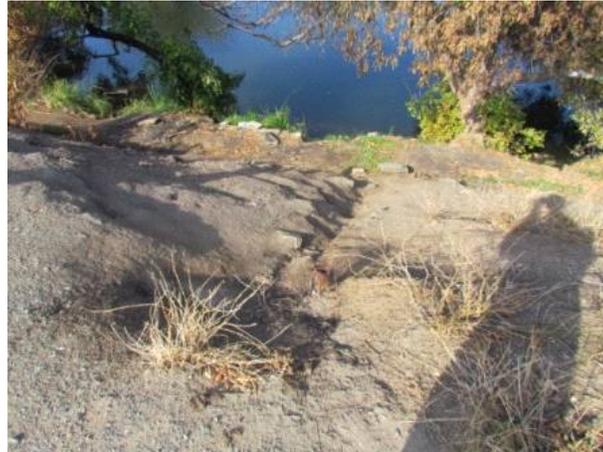
Levee Mile Report Line	165
Start Levee Mile	21.54
End Levee Mile	21.54
Location	Water Side
Category	Earthen Levee
Item	Erosion / Bank Caving
Erosion was found on the waterside of the levee looking upstream.	
pkazi_f_20111206_349.jpg

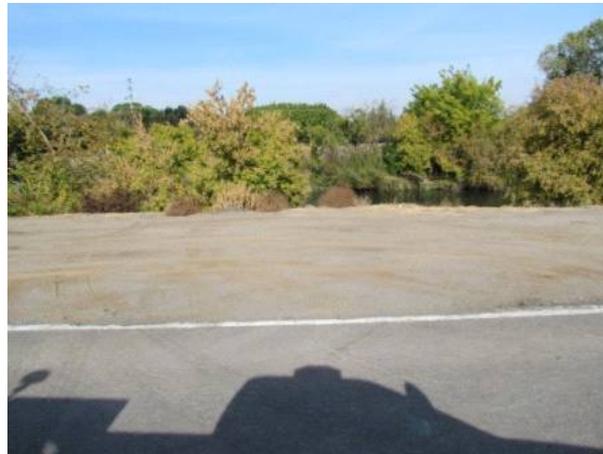
Levee Mile Report Line	167
Start Levee Mile	21.63
End Levee Mile	21.63
Location	Water Side
Category	Earthen Levee
Item	Encroachments
Debris on the landside of the levee have been picked up by the LMA looking upstream.	
pkazi_f_20111206_345.jpg

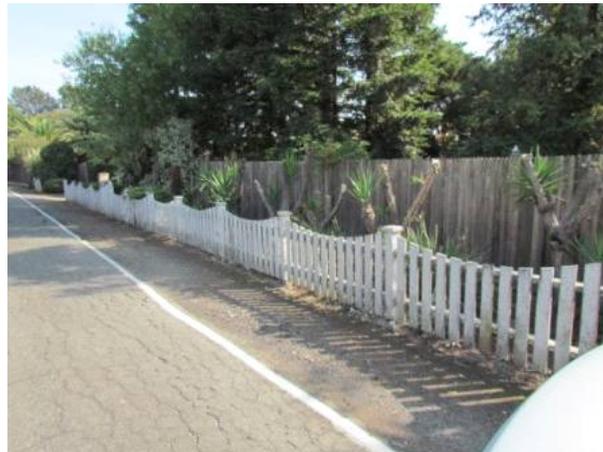
Levee Mile Report Line	174
Start Levee Mile	21.90
End Levee Mile	21.90
Location	Land Side
Category	Earthen Levee
Item	Encroachments
View of the fence on the landside of the levee looking upstream.	
pkazi_f_20111206_344.jpg

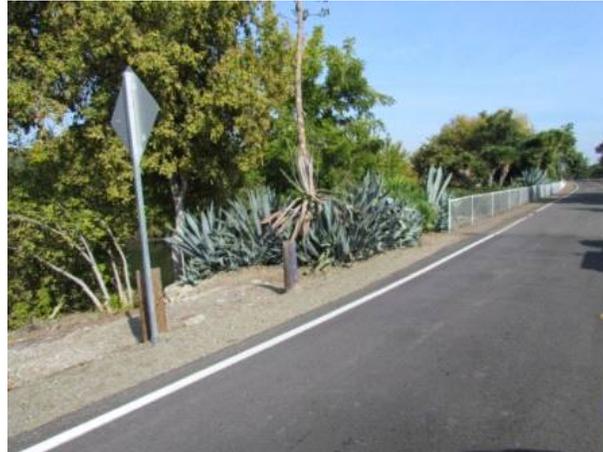
Levee Mile Report Line	177
Start Levee Mile	21.97
End Levee Mile	21.97
Location	Land Side
Category	Earthen Levee
Item	Encroachments
View of landscaping on the waterside of the levee looking upstream.	
pkazi_f_20111206_343.jpg

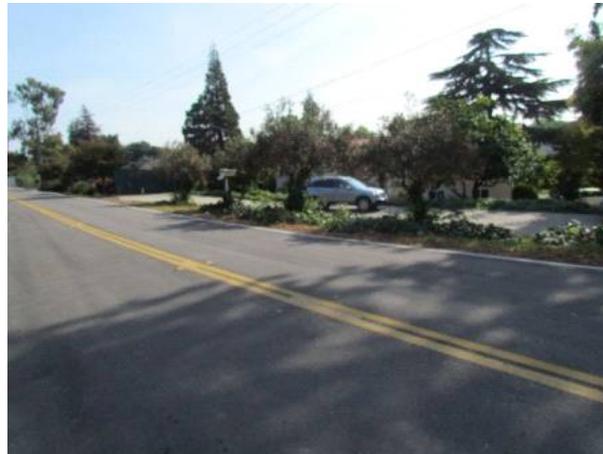
Levee Mile Report Line	180
Start Levee Mile	22.08
End Levee Mile	22.08
Location	Land Side
Category	Earthen Levee
Item	Encroachments
View of the landscape on the landside of the levee looking upstream.	
pkazi_f_20111206_342.jpg

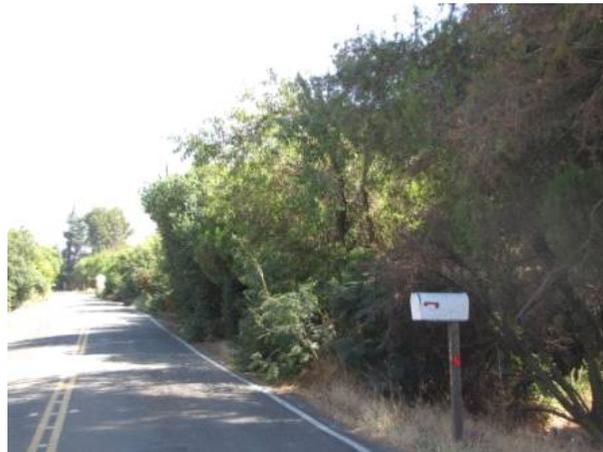
Levee Mile Report Line	183
Start Levee Mile	22.17
End Levee Mile	22.37
Location	Land Side
Category	Earthen Levee
Item	Encroachments
View of landscaping along landward slope looking upstream.	
pkazi_f_20111118_282.jpg

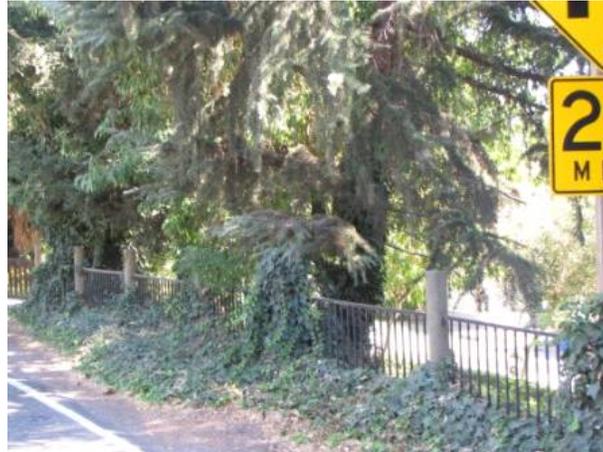
Levee Mile Report Line	184
Start Levee Mile	22.17
End Levee Mile	22.18
Location	Land Side
Category	Earthen Levee
Item	Encroachments
View of a fence and landscaping along the landward shoulder and slope looking upstream.	
pkazi_f_20111118_286.jpg

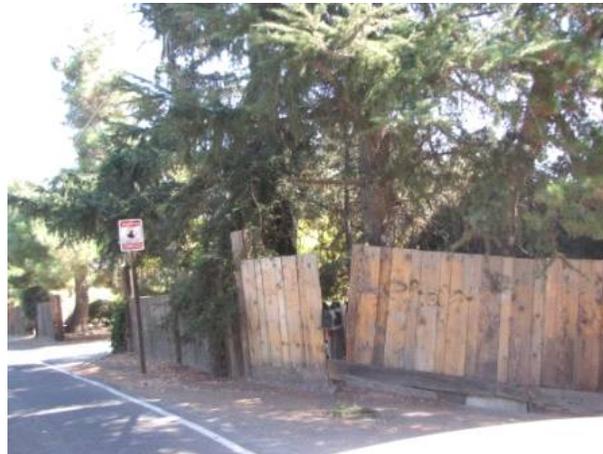
Levee Mile Report Line	186
Start Levee Mile	22.19
End Levee Mile	22.21
Location	Land Side
Category	Earthen Levee
Item	Encroachments
View of a fence along the landward shoulder and slope looking upstream.	
pkazi_f_20111118_285.jpg

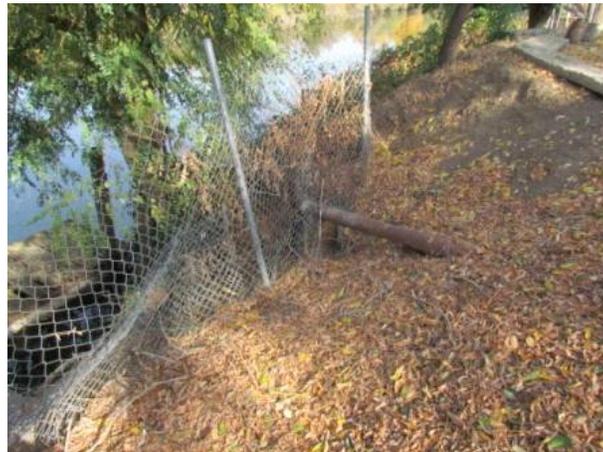
Levee Mile Report Line	188
Start Levee Mile	22.21
End Levee Mile	22.21
Location	Water Side
Category	Earthen Levee
Item	Encroachments
An unpermitted abandoned pipe was found with electrical wires running through it on the waterside shoulder of the levee looking upstream.	
pkazi_f_20111206_340.jpg

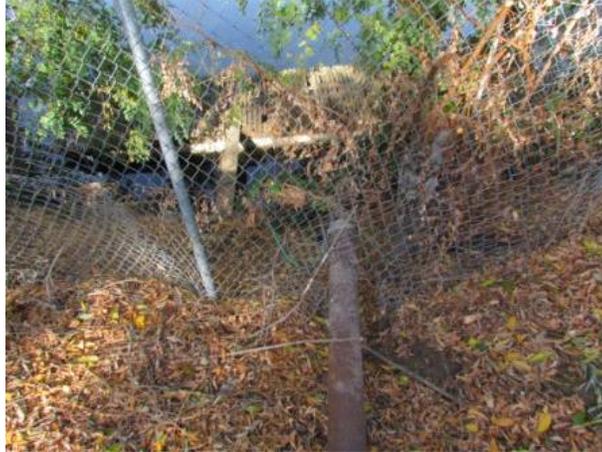
Levee Mile Report Line	188
Start Levee Mile	22.21
End Levee Mile	22.21
Location	Water Side
Category	Earthen Levee
Item	Encroachments
View of the electrical wires through the pipe is found on the waterside of the levee. The picture was taken from the crown looking towards the toe of the levee.	
pkazi_f_20111206_341.jpg

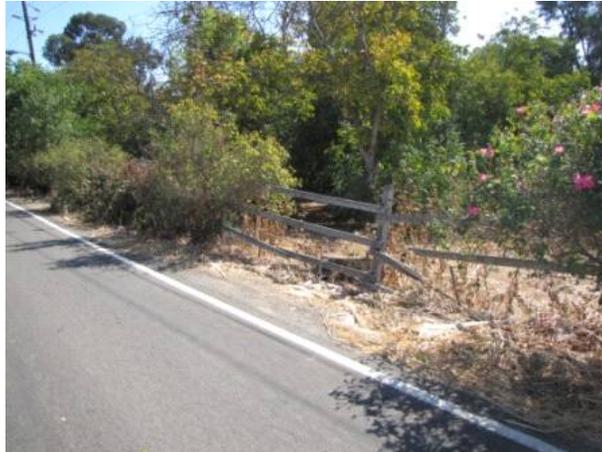
Levee Mile Report Line	189
Start Levee Mile	22.26
End Levee Mile	22.30
Location	Land Side
Category	Earthen Levee
Item	Encroachments
View of a fence along the landward shoulder looking upstream.	
pkazi_f_20111118_283.jpg

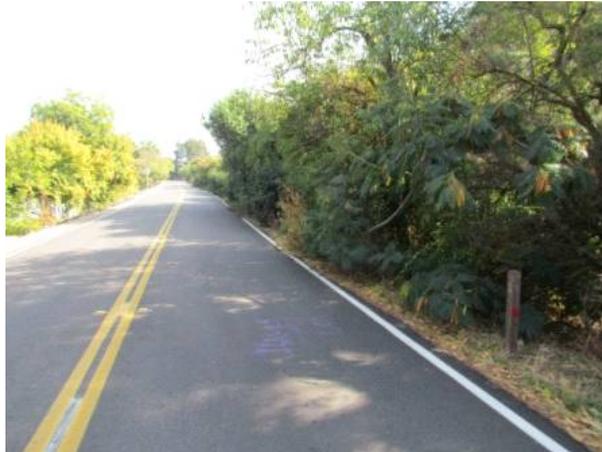
Levee Mile Report Line	190
Start Levee Mile	22.27
End Levee Mile	22.28
Location	Land Side
Category	Earthen Levee
Item	Encroachments
Landscaping was found on the landside of the levee looking upstream.	
pkazi_f_20111202_339.jpg

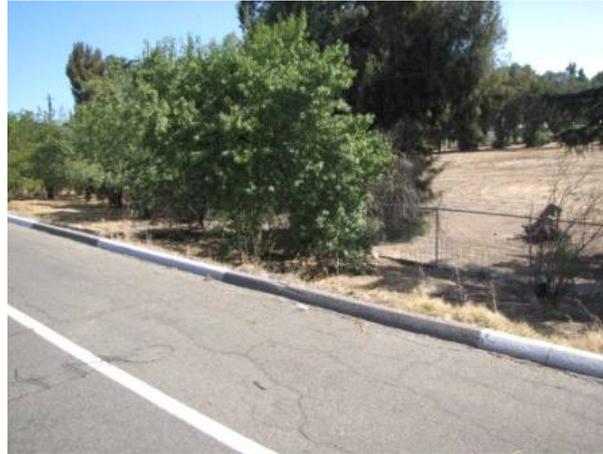
Levee Mile Report Line	191
Start Levee Mile	22.37
End Levee Mile	22.43
Location	Land Side
Category	Earthen Levee
Item	Encroachments
View of fence and landscaping along landward slope looking upstream.	
pkazi_f_20111118_281.jpg

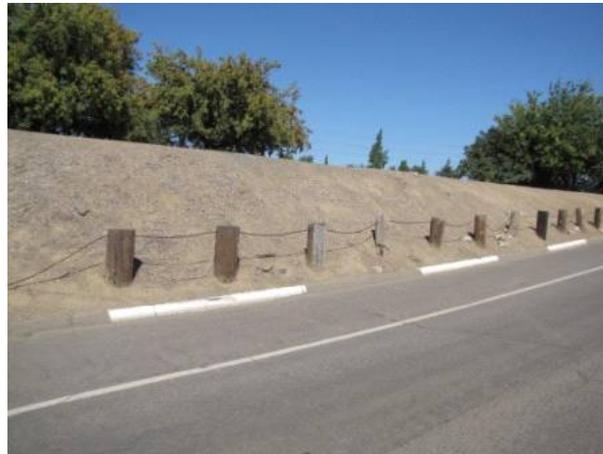
Levee Mile Report Line	192
Start Levee Mile	22.43
End Levee Mile	22.46
Location	Land Side
Category	Earthen Levee
Item	Encroachments
View of a post and cable fence along the landward slope looking upstream.	
pkazi_f_20111118_280.jpg

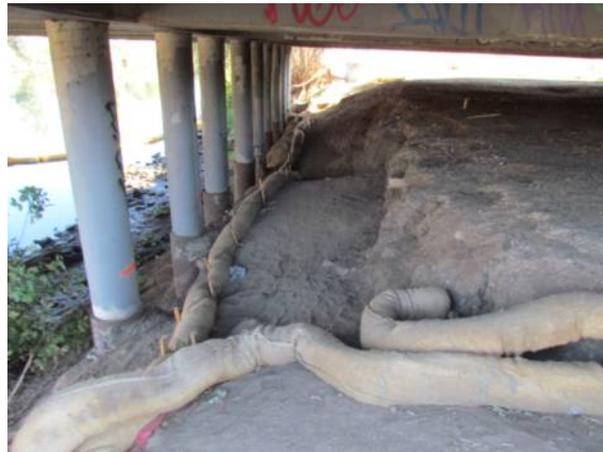
Levee Mile Report Line	193
Start Levee Mile	22.52
End Levee Mile	22.52
Location	Water Side
Category	Earthen Levee
Item	Slope Stability
View of the erosion under the I-5 bridge looking upstream.	
pkazi_f_20111202_338.jpg

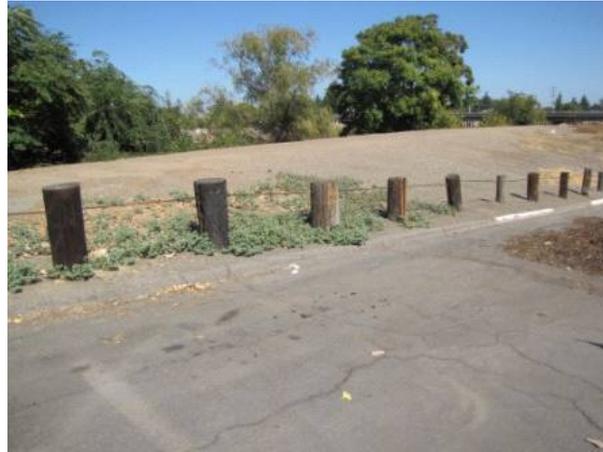
pkazi_f_20111118_278.jpg

View of post and cable fence along the landward levee slope looking upstream.

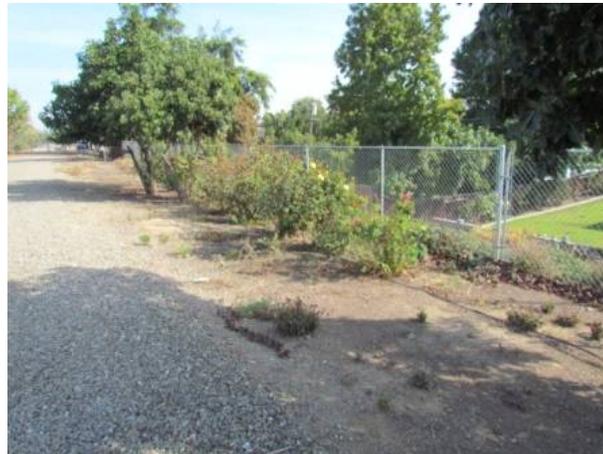
pkazi_f_20111202_337.jpg

Landscape was found on the landside of the levee looking upstream.

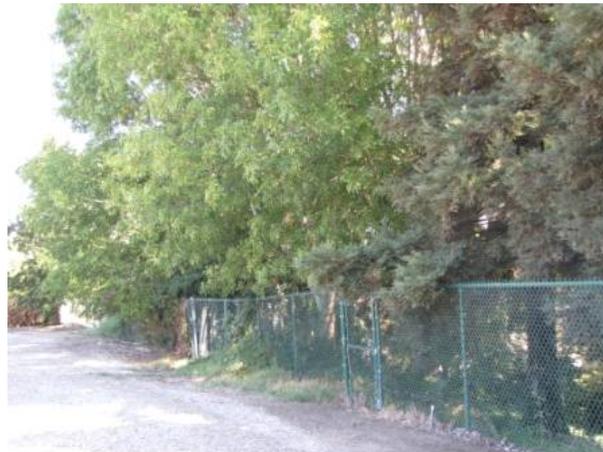
pkazi_f_20111118_277.jpg

View of fence and landscaping along the landward shoulder and slope looking upstream.

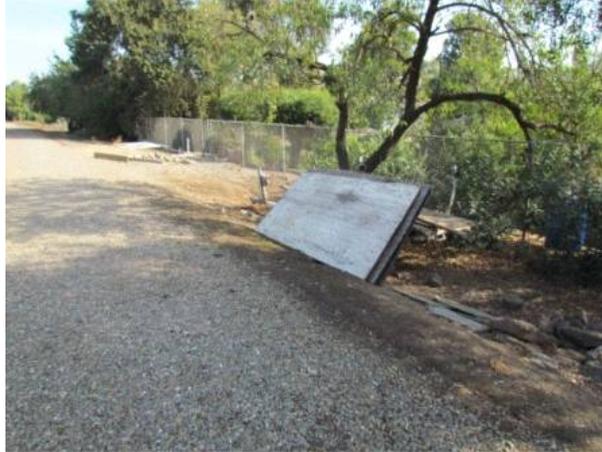
Levee Mile Report Line	197
Start Levee Mile	22.78
End Levee Mile	22.78
Location	Land Side
Category	Earthen Levee
Item	Encroachments
Debris was found on the landside of the levee looking upstream.	
pkazi_f_20111202_336.jpg

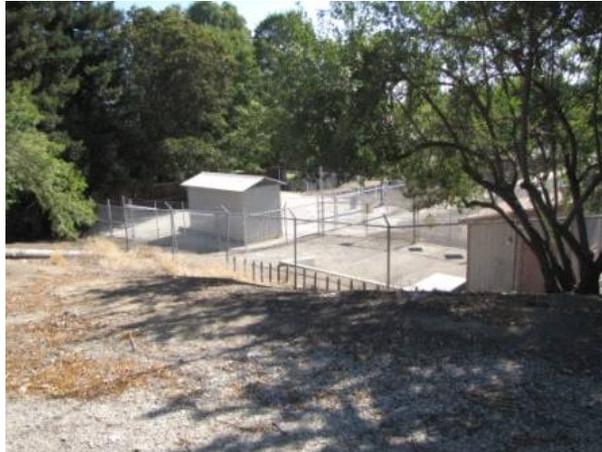
Levee Mile Report Line	198
Start Levee Mile	22.87
End Levee Mile	22.89
Location	Land Side
Category	Earthen Levee
Item	Encroachments
View of fence along the landward slope.	
pkazi_f_20111118_276.jpg

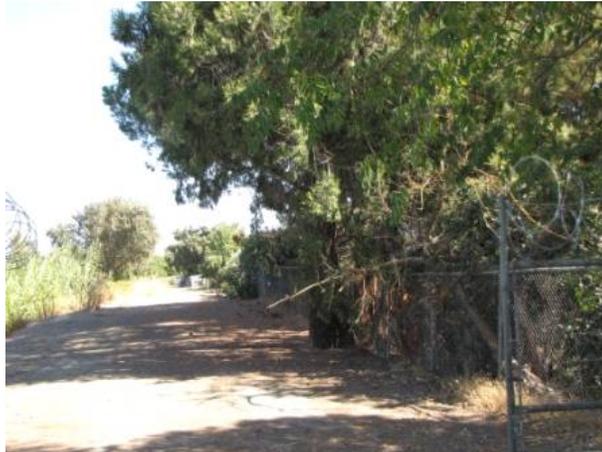
Levee Mile Report Line	201
Start Levee Mile	22.90
End Levee Mile	23.08
Location	Land Side
Category	Earthen Levee
Item	Encroachments
View of fence and landscaping along the landward shoulder looking upstream.	
pkazi_f_20111118_275.jpg

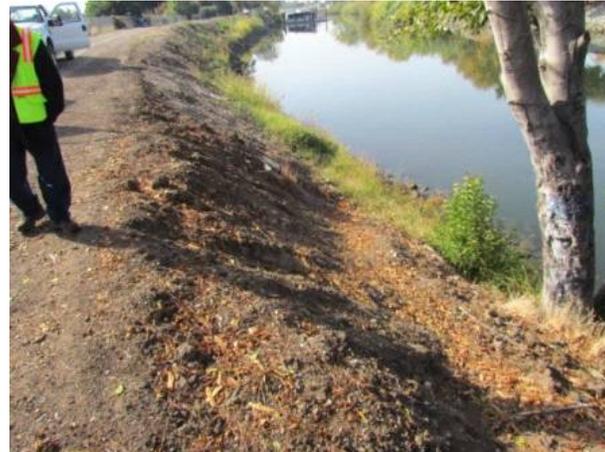
Levee Mile Report Line	202
Start Levee Mile	22.96
End Levee Mile	22.96
Location	Water Side
Category	Earthen Levee
Item	Slope Stability
Slope instability was found on the waterside of the levee looking downstream.	
pkazi_f_20111202_335.jpg

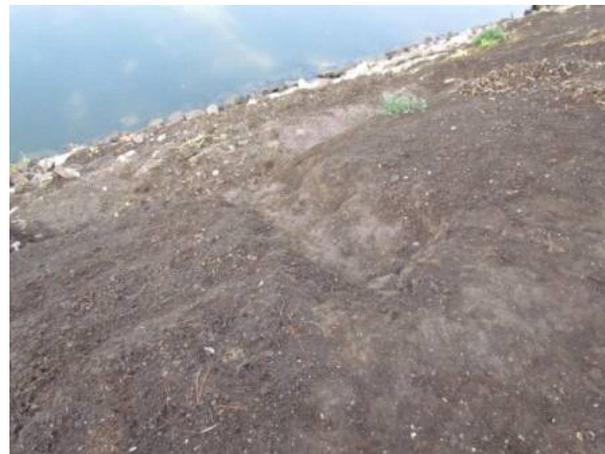
Levee Mile Report Line	203
Start Levee Mile	23.07
End Levee Mile	23.07
Location	Water Side
Category	Earthen Levee
Item	Slope Stability
Slope instability was found on the waterside of the levee looking upstream.	
pkazi_f_20111202_333.jpg

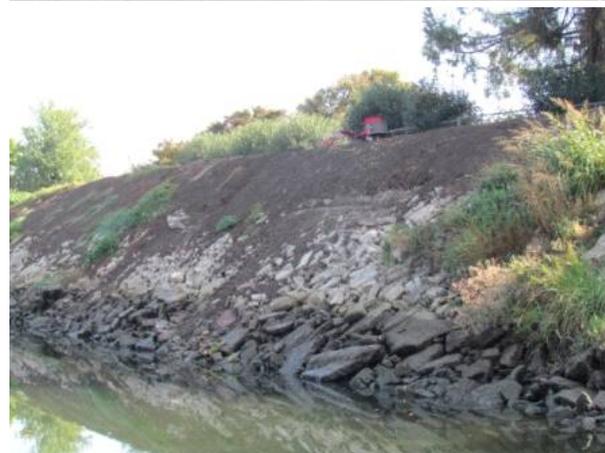
Levee Mile Report Line	203
Start Levee Mile	23.07
End Levee Mile	23.07
Location	Water Side
Category	Earthen Levee
Item	Slope Stability
A bench was cut on the water ward slope of the levee. The picture was taken from toe looking upstream.	
pkazi_f_20111202_334.jpg

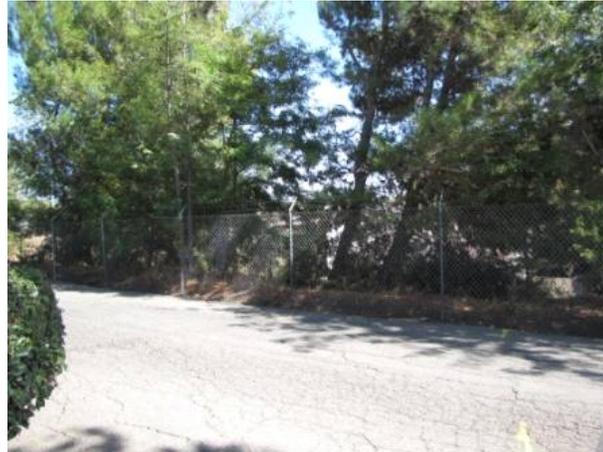
Levee Mile Report Line	204
Start Levee Mile	23.08
End Levee Mile	23.22
Location	Land Side
Category	Earthen Levee
Item	Encroachments
View of fence along the landward shoulder looking upstream.	
pkazi_f_20111118_274.jpg

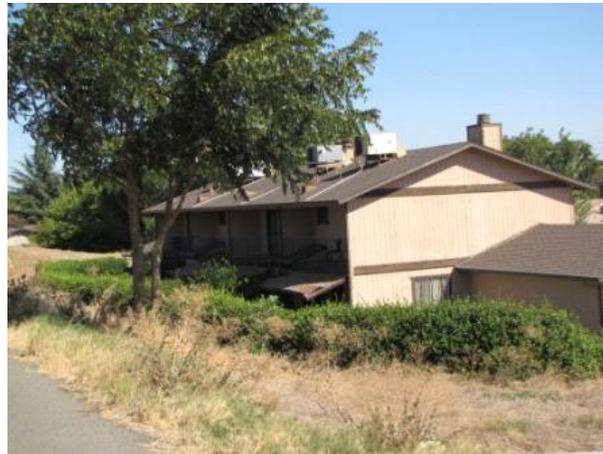
Levee Mile Report Line	205
Start Levee Mile	23.24
End Levee Mile	23.27
Location	Land Side
Category	Earthen Levee
Item	Encroachments
View of landscaping along the landward slope looking upstream.	
pkazi_f_20111118_273.jpg

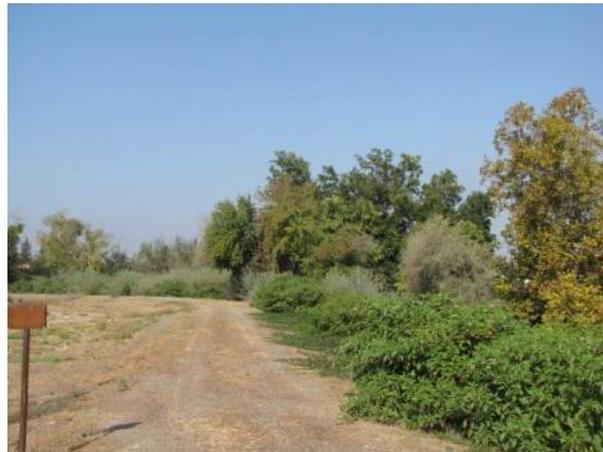
Levee Mile Report Line	208
Start Levee Mile	23.70
End Levee Mile	23.70
Location	Water Side
Category	Earthen Levee
Item	Encroachments
View of vegetation along the waterward slope looking downstream.	
pkazi_f_20111118_320.jpg

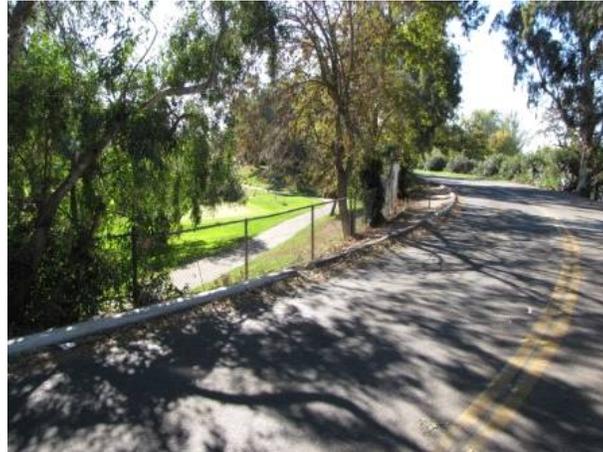
Levee Mile Report Line	210
Start Levee Mile	23.70
End Levee Mile	24.00
Location	Land Side
Category	Earthen Levee
Item	Encroachments
View of the fence along the landward slope looking downstream.	
pkazi_f_20111118_319.jpg
