**Flood Control Project Maintenance
Levee Inspections**

Fall 2011 Levee Maintenance Deficiency Summary Report

San Joaquin River Basin

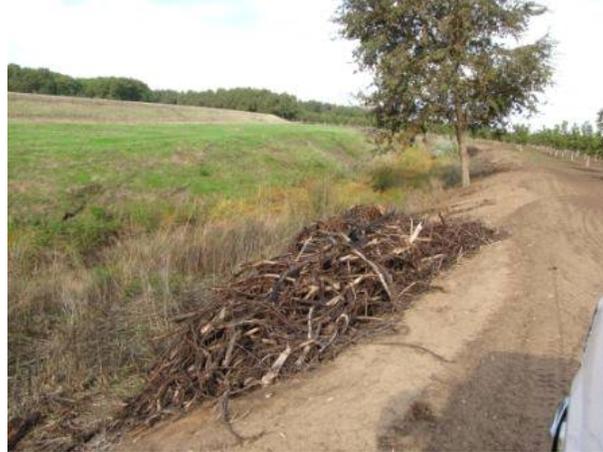
Levee Mile Report Line	1
Start Levee Mile	0.13
End Levee Mile	0.13
Location	Water Side
Category	Earthen Levee
Item	Encroachments
View of a prunings pile along the waterward bank looking downstream.	
pkazi_f_20110923_237.jpg

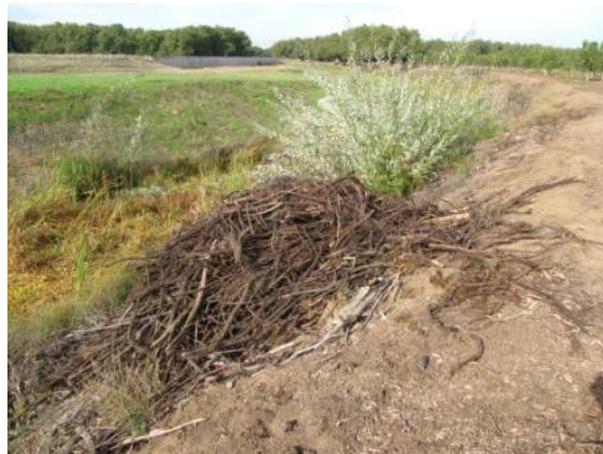
Levee Mile Report Line	2
Start Levee Mile	0.17
End Levee Mile	0.17
Location	Water Side
Category	Earthen Levee
Item	Encroachments
View of a prunings pile along the waterward bank looking downstream.	
pkazi_f_20110923_238.jpg

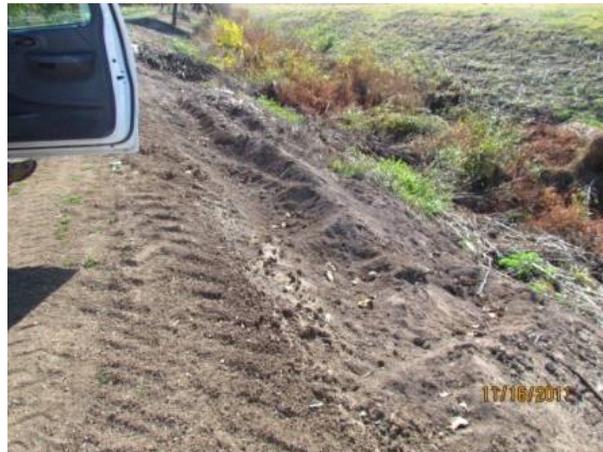
Levee Mile Report Line	3
Start Levee Mile	0.19
End Levee Mile	0.19
Location	Water Side
Category	Earthen Levee
Item	Slope Stability
Slope instability was found on the waterside of the levee looking upstream.	
pkazi_f_20111207_391.jpg

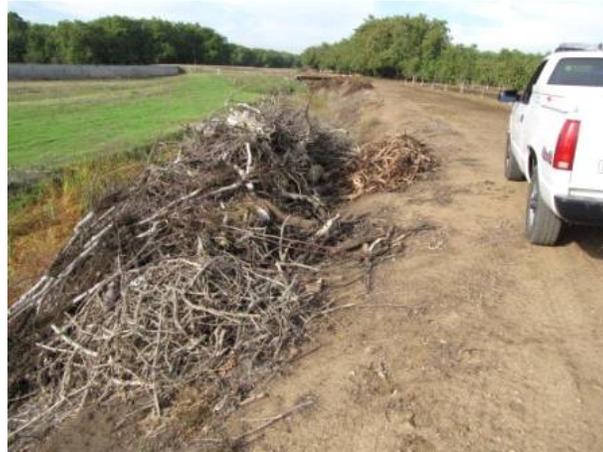
pkazi_f_20110923_239.jpg

View of a prunings pile along the waterward bank looking downstream.

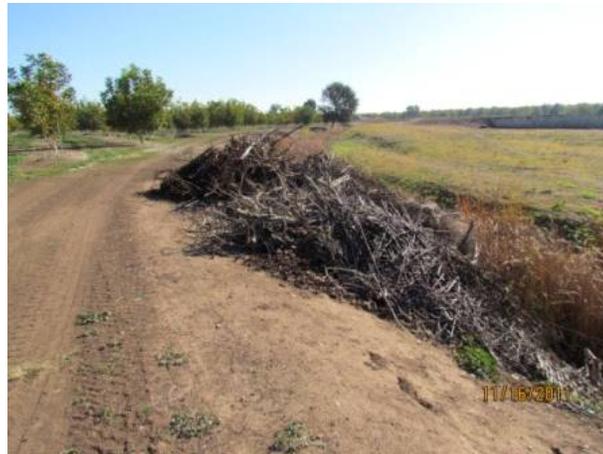
pkazi_f_20111207_390.jpg

Prunings were found on the waterside of the levee looking upstream.

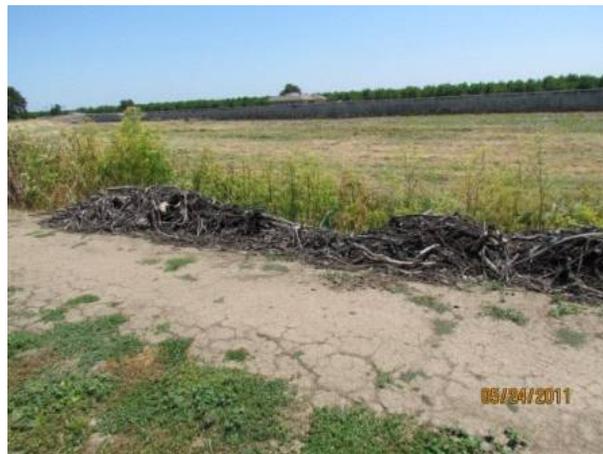
pkazi_f_20110923_240.jpg

Prunings was found on the waterside of the levee. The picture was taken from the crown looking upstream.

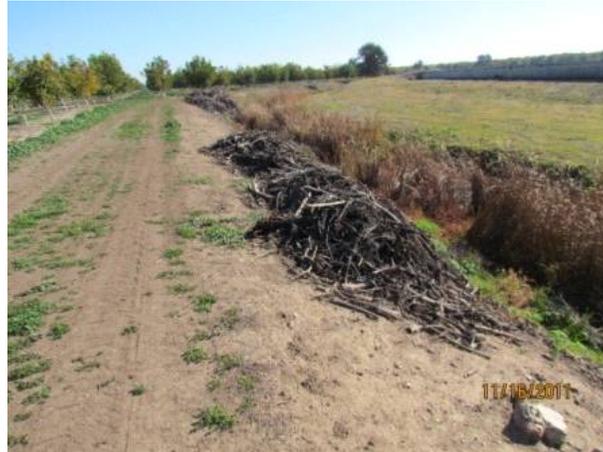
Levee Mile Report Line	7
Start Levee Mile	0.27
End Levee Mile	0.27
Location	Water Side
Category	Earthen Levee
Item	Encroachments
Pruning were found on the waterside of the levee looking upstream. This picture was taken during fall 2011 inspection.	
pkazi_f_20111207_389.jpg

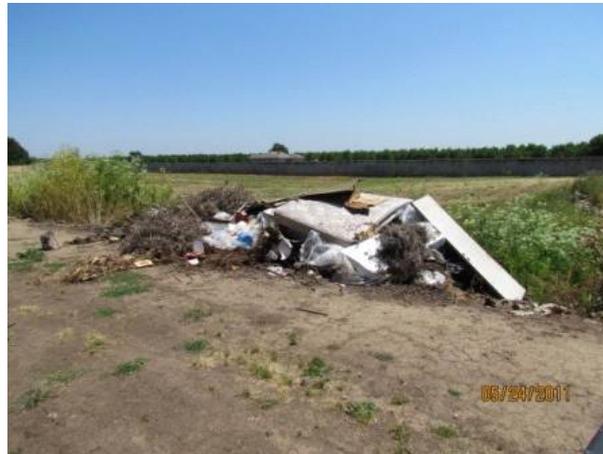
8	0.28	0.28	Earthen Levee	Encroachments	WS	M	Garbage	37.959013 ° -121.153087 °	37.959013 ° -121.153087 °	8 Y
9	0.28	0.28	Earthen Levee	Animal Control	CR	M	No rodents visible, but rodent burrows visible; need to backfill and compact or grout burrows.	37.959013 ° -121.153089 °	37.959013 ° -121.153089 °	7 Y
10	0.37	0.37	Earthen Levee	Encroachments	WS	M	Debris Inspector Comments: Pile appears to be the same pile as last year and has not been burned.	37.958565 ° -121.154819 °	37.958565 ° -121.154819 °	1 Y

Levee Mile Report Line	8
Start Levee Mile	0.28
End Levee Mile	0.28
Location	Water Side
Category	Earthen Levee
Item	Encroachments
Garbage on the waterside of the levee looking upstream.	
pkazi_f_20110923_242.jpg

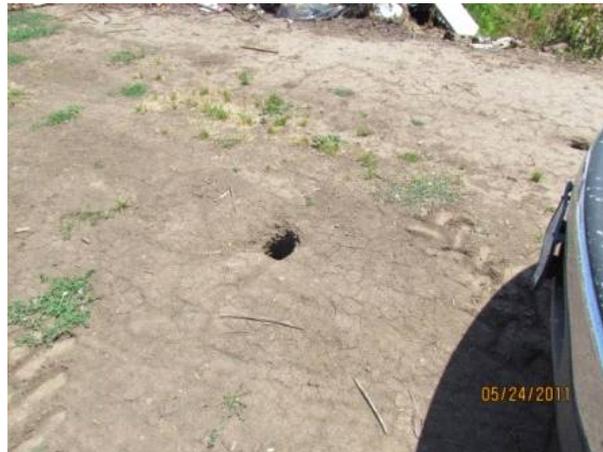
Levee Mile Report Line	9
Start Levee Mile	0.28
End Levee Mile	0.28
Location	Crown
Category	Earthen Levee
Item	Animal Control
A rodent hole was found on the crown of the levee. The picture was taken from the crown looking upstream.	
pkazi_f_20110923_241.jpg

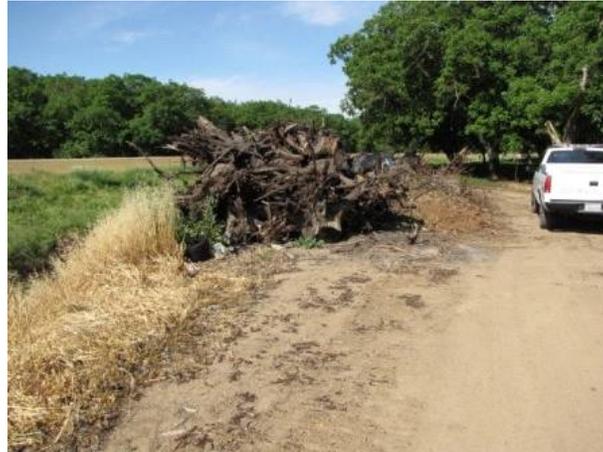
Levee Mile Report Line	10
Start Levee Mile	0.37
End Levee Mile	0.37
Location	Water Side
Category	Earthen Levee
Item	Encroachments
Debris pile located on waterside of levee at LM 0.50.	
pkazi_f_20110923_236.jpg

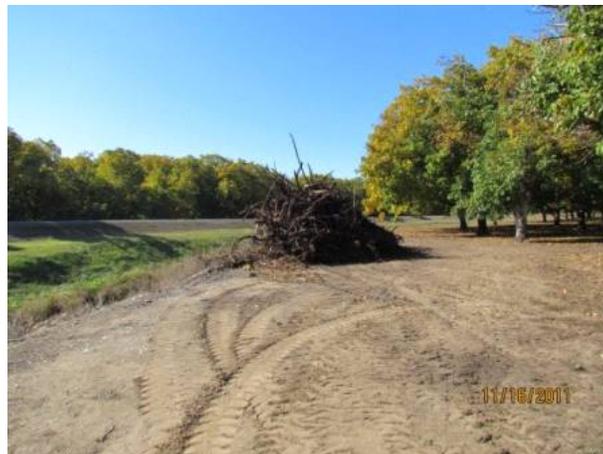
Levee Mile Report Line	10
Start Levee Mile	0.37
End Levee Mile	0.37
Location	Water Side
Category	Earthen Levee
Item	Encroachments
Prunings were found on the waterside of the levee looking downstream. This picture was taken during fall 2011 inspection.	
pkazi_f_20111207_392.jpg

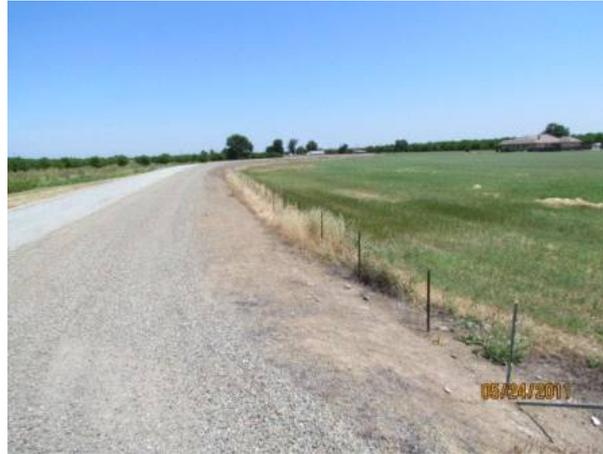
Levee Mile Report Line	1
Start Levee Mile	0.08
End Levee Mile	0.29
Location	Land Side
Category	Earthen Levee
Item	Encroachments
<p>Fences along the landside toe of the levee. The picture was taken from the crown looking upstream.</p>	
<p>pkazi_f_20110923_243.jpg</p>

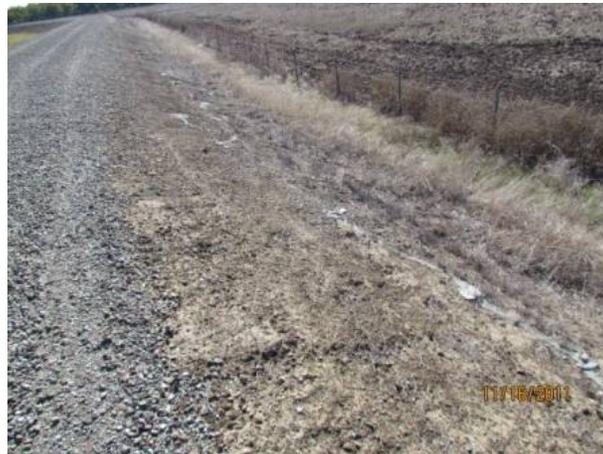
Levee Mile Report Line	2
Start Levee Mile	0.18
End Levee Mile	0.18
Location	Land Side
Category	Earthen Levee
Item	Animal Control
<p>Rodent holes were grouted by the LMA on the landside of the levee looking upstream.</p>	
<p>pkazi_f_20111207_388.jpg</p>
