**Flood Control Project Maintenance  
Levee Inspections**

**Fall 2015 Levee Maintenance Deficiency Summary Report**

**San Joaquin River Basin**

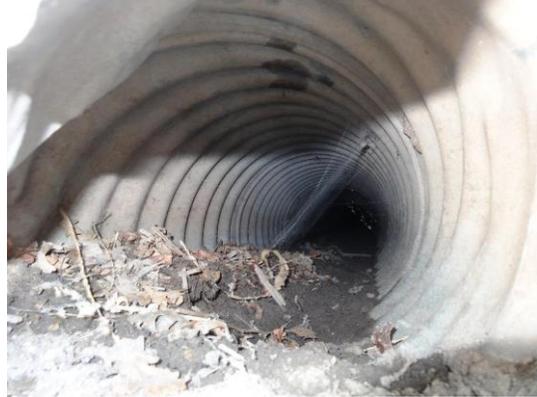
Photo 1 of 3 : UCIP\_FA\_2015\_4011.jpg

LM Start	<b>0.17</b>	Rating **	M	Issue No.	<b>199</b>
LM End	<b>0.17</b>	Issue Type +	En	Location *	CR
Category	Supplemental			GPS Latitude/Longitude	
				Start	End
Item	DWR UCIP Field Study			37.873926 °	37.873926 °
				-121.233588 °	-121.233588 °
DWR ID					
Action/Comments					
Inspector Comments: FS_ID:32743 DS_ID:17965 EP_NO: N/A FS_HLM: 0.425 Repair Type: Non-Urgent Crossing Status: Found UCIP Comments: May need cleaning of the pipe. Reshaping the pipe end on landside. FIELD_STRUCT_DESC: 18-inch pipe through the levee, 6.0 feet below the crown; flap gate on the waterward end. Open end at inlet on landside. FS Date: 03/25/2014

LS view: inside view of the CM pipe. Needs cleaning and clearing the pipe.

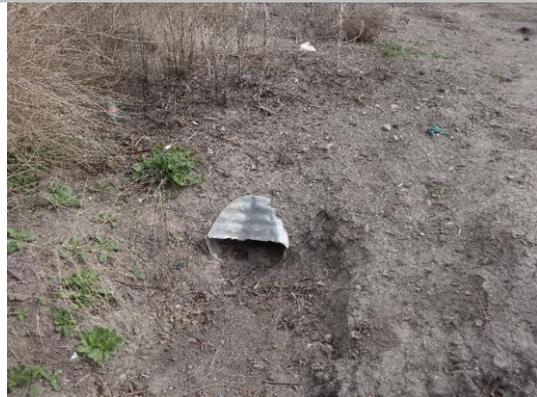
Photo 2 of 3 : UCIP\_FA\_2015\_4012.jpg

LS view: deformed CM inlet pipe on levee slope. Vegetation debris and mud on inlet ditch.

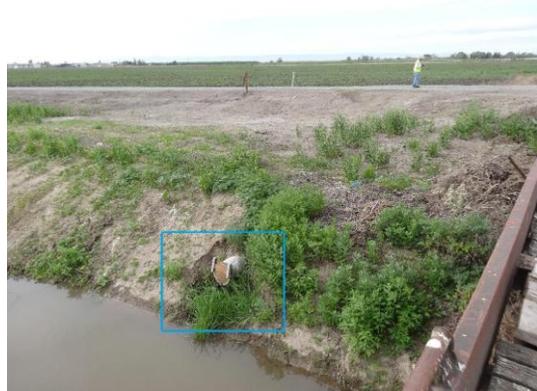
Photo 3 of 3 : UCIP\_FA\_2015\_4013.jpg

WS view: CM drain outfall pipe with flap gate on creek bank.

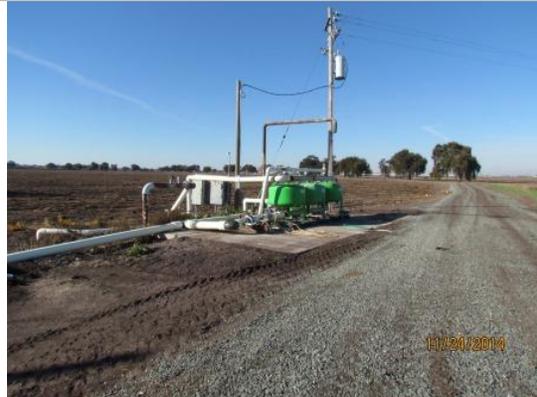
Photo 1 of 1 : FA\_2015\_NA0017\_148\_105\_20150911\_00005.jpg

LM Start	<b>0.18</b>	Rating **	M	Issue No.	<b>105</b>
LM End	<b>0.18</b>	Issue Type +	En	Location *	LS
Category	Earthen Levee			GPS Latitude/Longitude	
				Start	End
Item	Encroachments			37.873997 °	37.873997 °
				-121.233640 °	-121.233640 °
DWR ID	DWR_NA0017_01_f_2014_105				
Action/Comments					
Equipment

Farming equipment were found on the landside of the levee looking downstream.

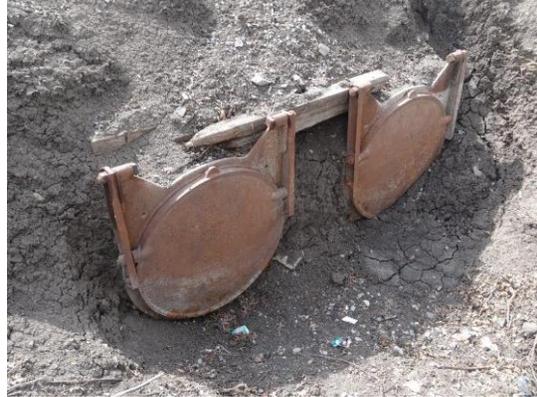
Photo 1 of 3 : UCIP\_FA\_2015\_3907.jpg

LM Start	<b>0.79</b>	Rating **	M	Issue No.	<b>198</b>
LM End	<b>0.79</b>	Issue Type +	En	Location *	LS
Category	Supplemental			GPS Latitude/Longitude	
				Start	End
Item	DWR UCIP Field Study			37.878502 °	37.878502 °
				-121.242377 °	-121.242377 °
DWR ID	DWR_NA0017_01_f_2015_198				
Action/Comments					
Inspector Comments: FS_ID:46809 DS_ID:17972 EP_NO: N/A FS_HLM: 1.053 Repair Type: Non-Urgent Crossing Status: Found UCIP Comments: LS: vegetation debris and mud on inlet ditch and inside the pipe. FIELD_STRUCT_DESC: 1 of 2. Two 36-inch CM drain pipes through the levee, 6.6 feet below the crown. Flap gate on the waterward end. O&M Manual May 1963 (SJR 613C Vol 15) FS Date: 03/25/2014

WS view: closer view of CMP drain pipes with flap gates on ditch. Right flap gate was blocked by soil/mud.

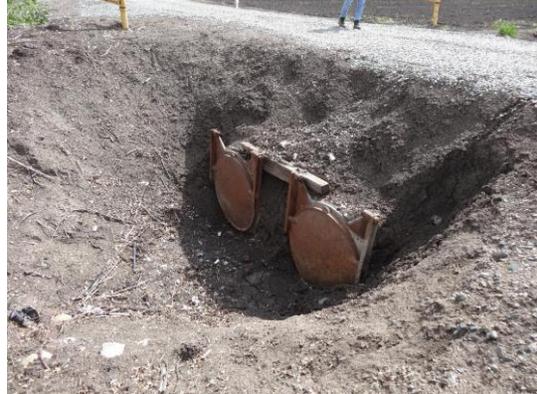
Photo 2 of 3 : UCIP\_FA\_2015\_3908.jpg

WS view: CMP drain pipes with flap gates on ditch.

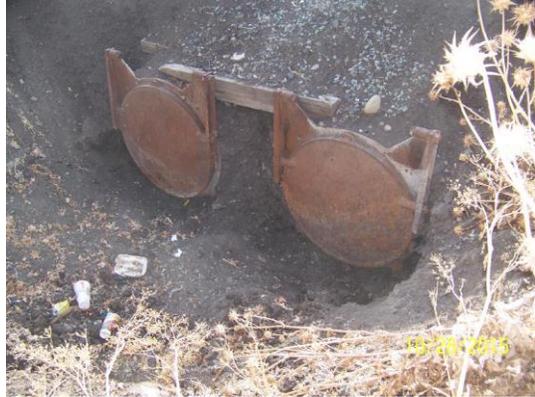
Photo 3 of 3 : UCIP\_FA\_2015\_4410.jpg

WS: Debris blocking flap gate has been cleared per FPIIB Inspector email 11/16/2015

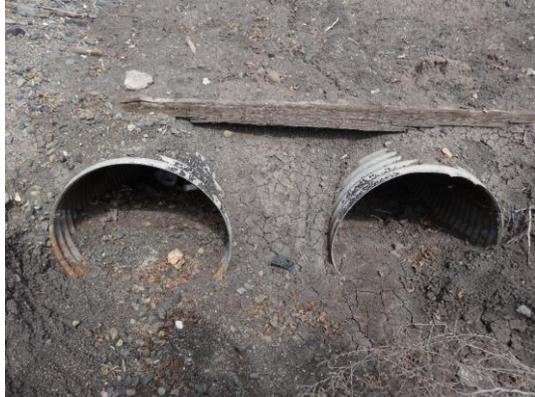
Photo 1 of 3 : UCIP\_FA\_2015\_3909.jpg

LM Start	<b>0.79</b>	Rating **	M	Issue No.	<b>201</b>
LM End	<b>0.79</b>	Issue Type +	En	Location *	LS
Category	Supplemental			GPS Latitude/Longitude	
				Start	End
Item	DWR UCIP Field Study			37.878494 °	37.878494 °
				-121.242392 °	-121.242392 °
DWR ID					
Action/Comments					
Inspector Comments: FS_ID:32704 DS_ID:23995 EP_NO: N/A FS_HLM: 1.054 Repair Type: Non-Urgent Crossing Status: Found UCIP Comments: Needs cleaning and clearing the culvert. FIELD_STRUCT_DESC: 2 of 2. Two 36-inch CM drain pipes through the levee, 6.6 feet below the crown. Flap gate on the waterward end. O&M Manual May 1963 (SJR 613C Vol 15) FS Date: 03/25/2014

LS view: CMP inlet pipes on levee slope. Debris and mud on inlet ditch and inside the pipe.

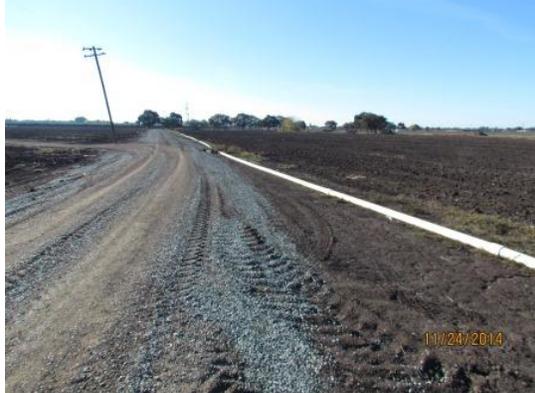
Photo 1 of 2 : FA\_2015\_NA0017\_148\_12\_20150911\_00002.jpg

LM Start	<b>0.80</b>	Rating **	M	Issue No.	<b>12</b>
LM End	<b>1.01</b>	Issue Type +	En	Location *	WS
Category	Earthen Levee		GPS Latitude/Longitude		
			Start	End	
Item	Encroachments		37.878425 °	37.877636 °	
			-121.242593 °	-121.246147 °	
DWR ID	DWR_NA0017_01_s_2012_12				
Action/Comments					
Pipe

Updated picture of the PVC pipe on the waterside shoulder of the levee looking downstream.

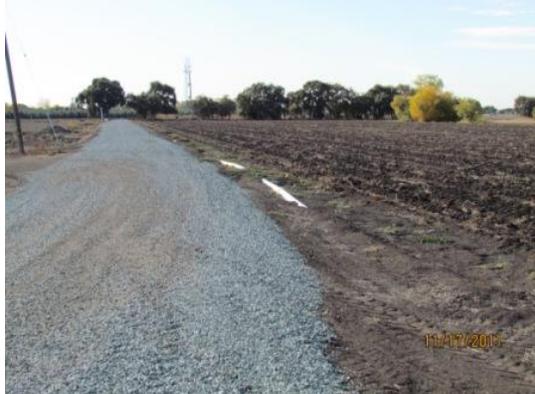
Photo 2 of 2 : FA\_2015\_NA0017\_148\_12\_20150911\_00003.jpg

PVC Pipe was found on the waterside of the levee looking downstream.

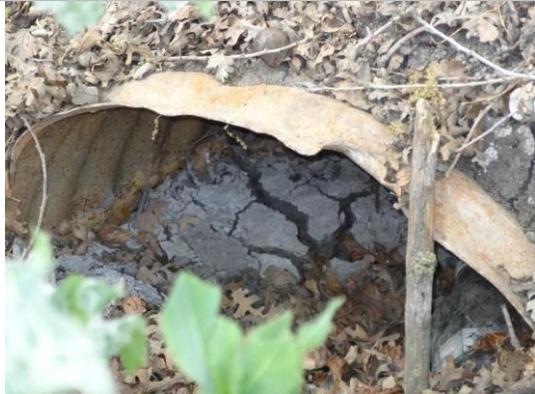
Photo 1 of 3 : UCIP\_FA\_2015\_4037.jpg

LM Start	<b>1.02</b>	Rating **	M	Issue No.	<b>202</b>
LM End	<b>1.02</b>	Issue Type +	En	Location *	WS
Category	Supplemental		GPS Latitude/Longitude		
			Start	End	
Item	DWR UCIP Field Study		37.877566 °	37.877566 °	
			-121.246391 °	-121.246391 °	
DWR ID					
Action/Comments					
Inspector Comments: FS_ID:32746 DS_ID:23985 EP_NO: N/A FS_HLM: 1.284 Repair Type: Non-Urgent Crossing Status: Found

LS view: inside view of CM inlet pipe. Needs cleaning and clearing the culvert.

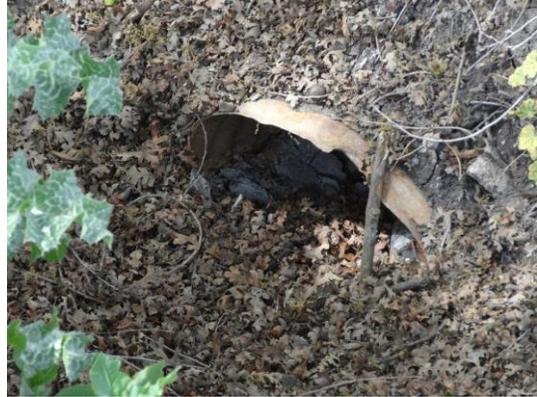
Photo 2 of 3 : UCIP\_FA\_2015\_4038.jpg

LS view: CMP inlet pipe on levee slope. Vegetation debris and mud on inlet ditch.

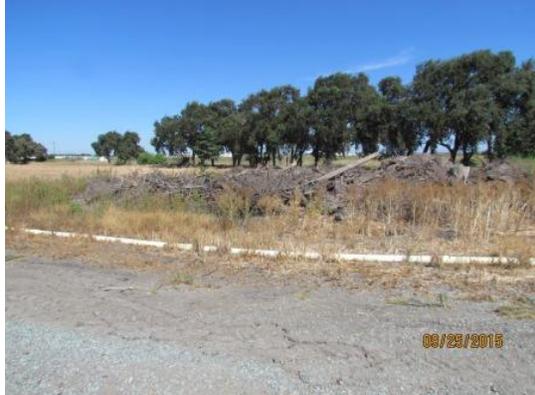
Photo 1 of 2 : FA\_2015\_NA0017\_148\_14\_20150928\_00007.jpg

LM Start	<b>1.06</b>	Rating **	M	Issue No.	<b>14</b>
LM End	<b>1.06</b>	Issue Type +	En	Location *	WS
Category	Earthen Levee		GPS Latitude/Longitude		
			Start	End	
Item	Encroachments		37.877724 °	37.877724 °	
			-121.247054 °	-121.247054 °	
DWR ID	DWR_NA0017_01_s_2012_14				
Action/Comments					
Prunings

Updated picture of the prunings on the waterside of the levee looking downstream during fall 2015 inspection.

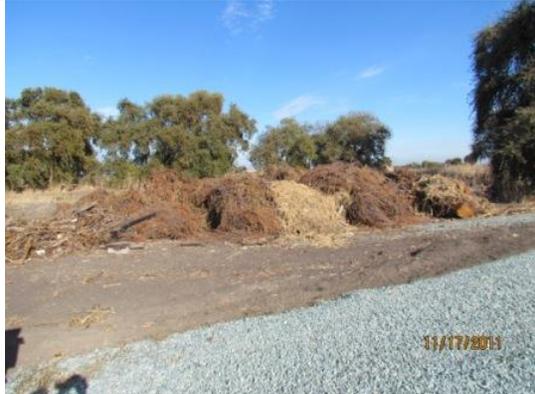
Photo 2 of 2 : FA\_2015\_NA0017\_148\_14\_20150911\_00004.jpg

Prunings were found on the waterside of the levee looking upstream.

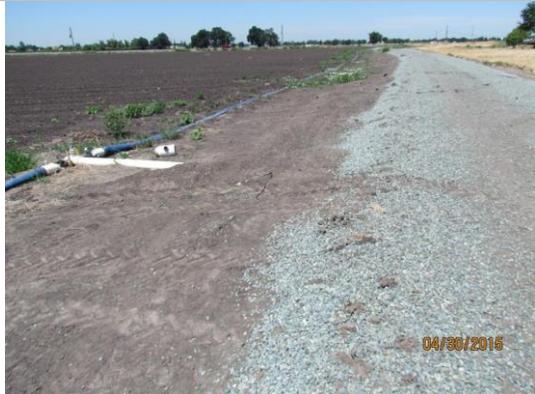
Photo 1 of 1 : FA\_2015\_NA0017\_148\_197\_20150911\_00006.jpg

LM Start	<b>1.12</b>	Rating **	U	Issue No.	<b>197</b>
LM End	<b>1.12</b>	Issue Type +	En	Location *	CR
Category	Earthen Levee		GPS Latitude/Longitude		
			Start	End	
Item	Encroachments		37.878448 °	37.878448 °	
			-121.247723 °	-121.247723 °	
DWR ID	DWR_NA0017_01_s_2015_197				
Action/Comments					
Pipe					
Inspector Comments: PVC pipe going through the levee.

View of a PVC pipe penetrating through the levee looking downstream.

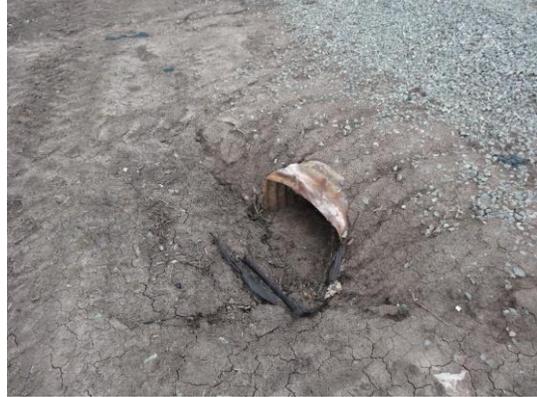
Photo 1 of 3 : UCIP\_FA\_2015\_4040.jpg

LM Start	<b>1.18</b>	Rating **	M	Issue No.	<b>203</b>
LM End	<b>1.18</b>	Issue Type +	En	Location *	CR
Category	Supplemental			GPS Latitude/Longitude	
				Start	End
Item	DWR UCIP Field Study			37.879076 °	37.879076 °
				-121.248304 °	-121.248304 °
DWR ID					
Action/Comments					
Inspector Comments: FS_ID:32747 DS_ID:17970 EP_NO: N/A FS_HLM: 1.44 Repair Type: Non-Urgent Crossing Status: Found UCIP Comments: Needs cleaning and clearing the culvert. FIELD_STRUCT_DESC: 24-inch CM pipe through the levee, 4.1 feet, below the crown; flap gate on the waterside end. O&M Manual May 1963 (SJR 613C Vol 15). FS Date: 03/25/2014

LS view: deformed CM inlet pipe on levee slope. Debris and mud on inlet ditch.

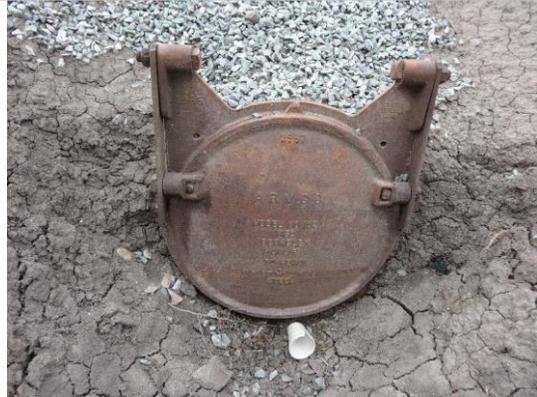
Photo 2 of 3 : UCIP\_FA\_2015\_4041.jpg

WS view: closer view of CM drain pipe with flap gate on levee slope.

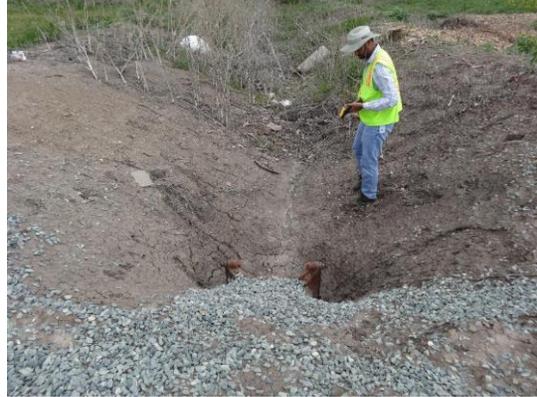
Photo 3 of 3 : UCIP\_FA\_2015\_4042.jpg

WS view: CM drain pipe with flap gate on levee slope. Dirt spillway to the creek.

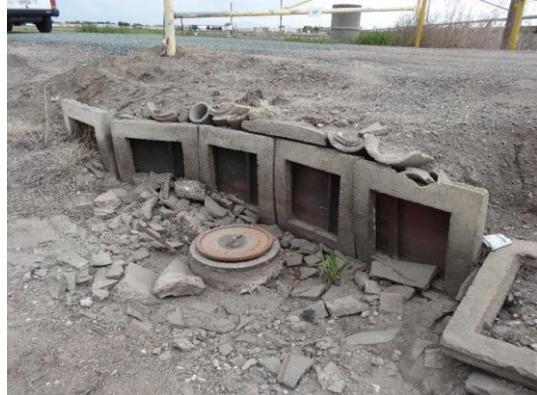
Photo 1 of 3 : UCIP\_FA\_2015\_4008.jpg

LM Start	<b>1.33</b>	Rating **	M	Issue No.	<b>204</b>
LM End	<b>1.33</b>	Issue Type +	En	Location *	CR
Category	Supplemental			GPS Latitude/Longitude	
				Start	End
Item	DWR UCIP Field Study			37.881077 °	37.881077 °
				-121.249368 °	-121.249368 °
DWR ID					
Action/Comments					
Inspector Comments: FS_ID:41788 DS_ID:17969 EP_NO: N/A FS_HLM: 1.595 Repair Type: Non-Urgent Crossing Status: Indicator Found UCIP Comments: Appears abandoned and should be verified as having been done so properly. Concrete standpipe on waterside. Abandoned gate valve on waterside. Steel pipe disconnected with the standpipe. Inlet structure with steel gates and 18-inch alfalfa valve on landside. FIELD_STRUCT_DESC: 18-inch concrete pipe through the levee, 6.2 feet below the crown. O&M Manual May 1963 (SJR 613C Vol 15). FS Date: 03/25/2014

LS view: inlet structure with steel gates and 18-inch alfalfa valve. Pipe not visible.

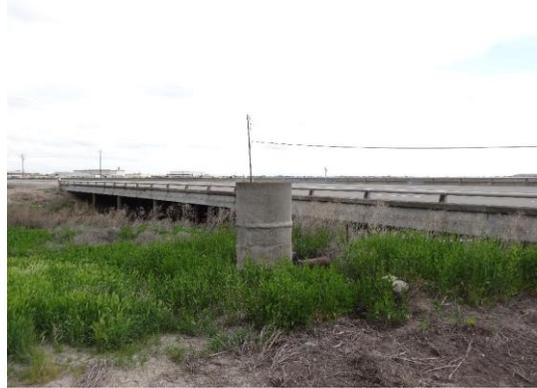
Photo 2 of 3 : UCIP\_FA\_2015\_4009.jpg

Inspector Comments: FS\_ID:41788  
 DS\_ID:17969  
 EP\_NO: N/A  
 FS\_HLM: 1.595  
 Repair Type: Non-Urgent  
 Crossing Status: Indicator Found  
 UCIP Comments: Appears abandoned and should be verified as having been done so properly. Concrete standpipe on waterside. Abandoned gate valve on waterside. Steel pipe disconnected with the standpipe. Inlet structure with steel gates and 18-inch alfalfa valve on landside.  
 FIELD\_STRUCT\_DESC: 18-inch concrete pipe through the levee, 6.2 feet below the crown. O&M Manual May 1963 (SJR 613C Vol 15).  
 FS Date: 03/25/2014

WS view: a concrete standpipe on levee slope.

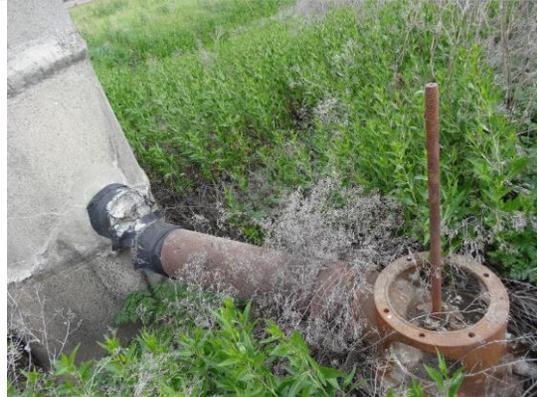
Photo 3 of 3 : UCIP\_FA\_2015\_4010.jpg

WS view: a concrete standpipe and pipe with appurtenance.

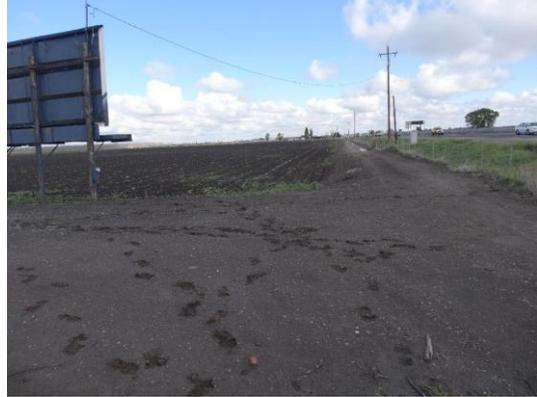
Photo 1 of 3 : UCIP\_FA\_2015\_3802.jpg

LM Start	<b>0.00</b>	Rating **	M	Issue No.	<b>129</b>
LM End	<b>0.00</b>	Issue Type +	En	Location *	WS
Category	Supplemental			GPS Latitude/Longitude	
				Start	End
Item	DWR UCIP Field Study			37.875087 °	37.875087 °
				-121.220019 °	-121.220019 °
DWR ID					
Action/Comments					
Inspector Comments: FS_ID:33123 DS_ID:23987 EP_NO: N/A FS_HLM: 0.001 Repair Type: Non-Urgent Crossing Status: Found UCIP Comments: Not found: 24-inch CM pipe with flap gate on waterside of the levee. O&M Manual May 1963 (SJR 613C Vol 15). Probably, the pipe mentioned in desk study is one across the channel on other bank of the creek. Needs confirmation from DWR inspector or LMA. FIELD_STRUCT_DESC: A 14-inch steel pipe attached to steel deck bridge and crossing the creek. Air vent on the pipe across the channel. No pipe or other structure found on landside. FS Date: 04/02/2014

LS view: no pipe or appurtenances found on landside.

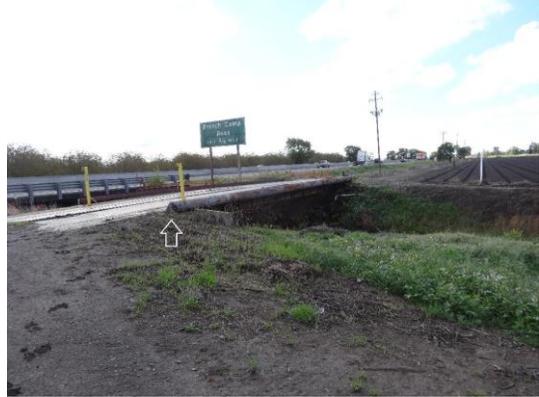
Photo 3 of 3 : UCIP\_FA\_2015\_3804.jpg

WS view: 14-inch steel pipe attached to the steel bridge.

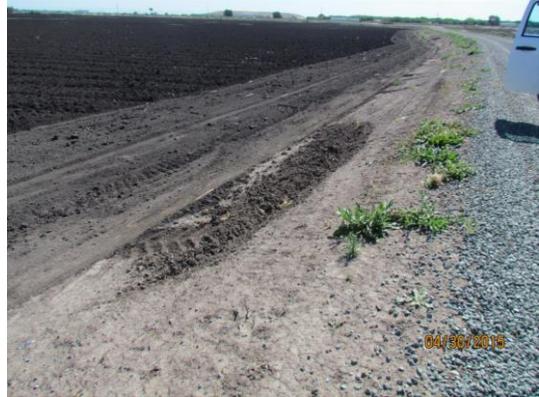
Photo 1 of 1 : FA\_2015\_NA0017\_149\_125\_20150911\_00006.jpg

LM Start	<b>0.29</b>	Rating **	M	Issue No.	<b>125</b>
LM End	<b>0.29</b>	Issue Type +	Ma	Location *	LS
Category	Earthen Levee			GPS Latitude/Longitude	
				Start	End
Item	Slope Stability			37.875189 °	37.875189 °
				-121.225048 °	-121.225048 °
DWR ID	DWR_NA0017_02_s_2015_125				
Action/Comments					
Repair the levee slope damaged by vehicle traffic and prevent access where possible.

A slope instability was found on the landside of the levee looking upstream.

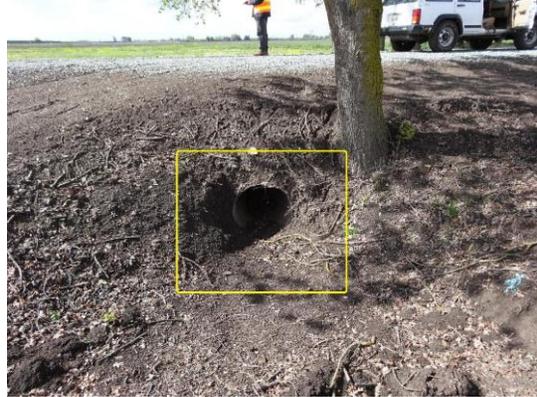
Photo 3 of 3 : UCIP\_FA\_2015\_3807.jpg

LM Start	<b>1.06</b>	Rating **	M	Issue No.	<b>130 (cont)</b>
LM End	<b>1.06</b>	Issue Type +	En	Location *	LS
Category	Supplemental			GPS Latitude/Longitude	
				Start	End
Item	DWR UCIP Field Study			37.877386 °	37.877386 °
				-121.237044 °	-121.237044 °
DWR ID					
Action/Comments					
Inspector Comments: FS_ID:33125 DS_ID:17983 EP_NO: N/A FS_HLM: 1.07 Repair Type: Non-Urgent Crossing Status: Found

LS view: CM inlet pipe on levee slope.

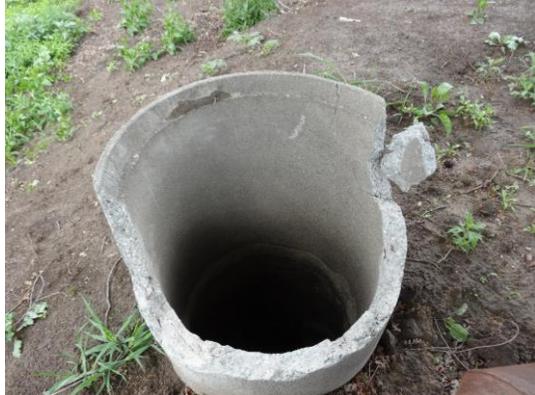
Photo 1 of 2 : UCIP\_FA\_2015\_3918.jpg

LM Start	<b>1.72</b>	Rating **	M	Issue No.	<b>134</b>
LM End	<b>1.72</b>	Issue Type +	En	Location *	LS
Category	Supplemental		GPS Latitude/Longitude		
			Start	End	
Item	DWR UCIP Field Study		37.879670 °	37.879670 °	
			-121.247572 °	-121.247572 °	
DWR ID					
Action/Comments					
Inspector Comments: FS_ID:40344 DS_ID:17979 EP_NO: N/A FS_HLM: 1.736 Repair Type: Non-Urgent Crossing Status: Indicator Found UCIP Comments: No pipe found. Need an accurate locationA vertical pump on the creek bank. Another pump found on landside field. A concrete riser on waterside berm. A steel pipe crosses the channel. FIELD_STRUCT_DESC: 30-inch steel pipe through the levee, 2.5 feet below the crown; open on both ends. FS Date: 04/02/2014

WS view: a concrete riser on levee berm. concrete pipe visible inside the riser.

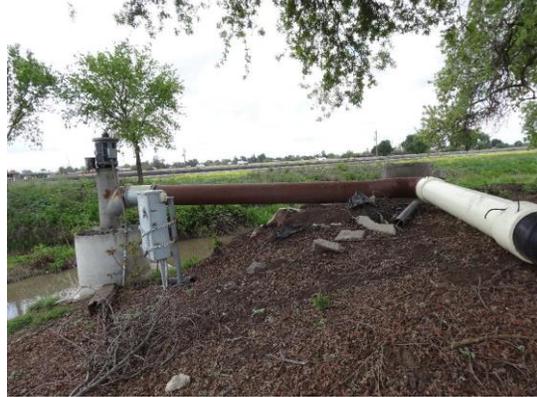
Photo 2 of 2 : UCIP\_FA\_2015\_3919.jpg

LM Start	<b>1.72</b>	Rating **	M	Issue No.	<b>134 (cont)</b>
LM End	<b>1.72</b>	Issue Type +	En	Location *	LS
Category	Supplemental			GPS Latitude/Longitude	
				Start	End
Item	DWR UCIP Field Study			37.879670 °	37.879670 °
				-121.247572 °	-121.247572 °
DWR ID					
Action/Comments					
Inspector Comments: FS_ID:40344 DS_ID:17979 EP_NO: N/A FS_HLM: 1.736 Repair Type: Non-Urgent Crossing Status: Indicator Found UCIP Comments: No pipe found. Need an accurate locationA vertical pump on the creek bank. Another pump found on landside field. A concrete riser on waterside berm. A steel pipe crosses the channel. FIELD_STRUCT_DESC: 30-inch steel pipe through the levee, 2.5 feet below the crown; open on both ends. FS Date: 04/02/2014

WS view: a vertical pump on end of levee berm. The pump discharges water into irrigation ditch on the berm.

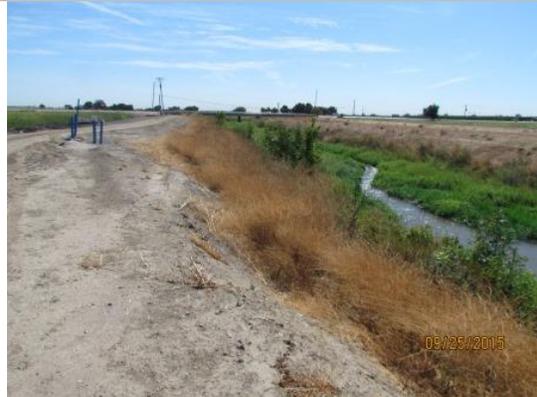
Photo 1 of 1 : FA\_2015\_NA0017\_149\_14\_20150928\_00011.jpg

LM Start	<b>1.91</b>	Rating **	M	Issue No.	<b>14</b>
LM End	<b>1.97</b>	Issue Type +	Ma	Location *	WS
Category	Earthen Levee			GPS Latitude/Longitude	
				Start	End
Item	Vegetation			37.881857 °	37.882421 °
				-121.249441 °	-121.250336 °
DWR ID	DWR_NA0017_02_f_2015_14				
Action/Comments					
Control annual grass and weeds on the levee slopes and easements.

View of the vegetation on the waterside of the levee looking upstream.

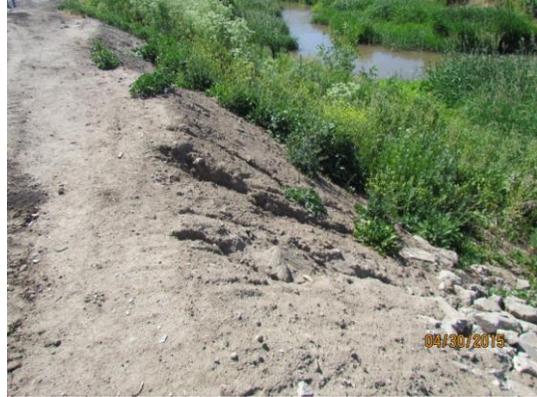
Photo 1 of 1 : FA\_2015\_NA0017\_149\_127\_20150911\_00007.jpg

LM Start	<b>1.97</b>	Rating **	M	Issue No.	<b>127</b>
LM End	<b>1.97</b>	Issue Type +	Ma	Location *	WS
Category	Earthen Levee		GPS Latitude/Longitude		
			Start	End	
Item	Erosion / Bank Caving		37.882404 °	37.882404 °	
			-121.250359 °	-121.250359 °	
DWR ID	DWR_NA0017_02_s_2015_127				
Action/Comments					
Note and monitor erosion site.

Erosion was found on the waterside slope of the levee looking upstream.

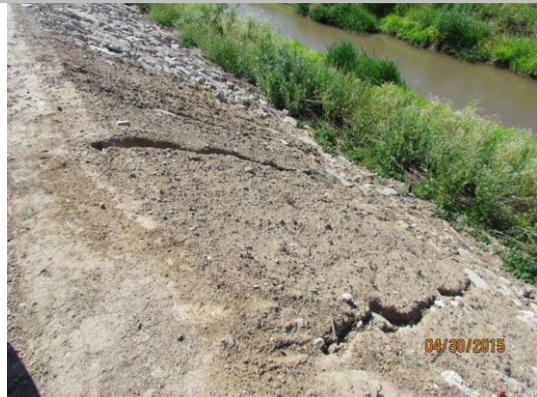
Photo 1 of 1 : FA\_2015\_NA0017\_149\_128\_20150911\_00008.jpg

LM Start	<b>2.11</b>	Rating **	M	Issue No.	<b>128</b>
LM End	<b>2.11</b>	Issue Type +	Ma	Location *	WS
Category	Earthen Levee		GPS Latitude/Longitude		
			Start	End	
Item	Erosion / Bank Caving		37.883599 °	37.883599 °	
			-121.252355 °	-121.252355 °	
DWR ID	DWR_NA0017_02_s_2015_128				
Action/Comments					
Schedule repair of erosion site prior to the next inspection. Inspector Comments: Runoff

Erosion caused by runoff on the waterside looking upstream.

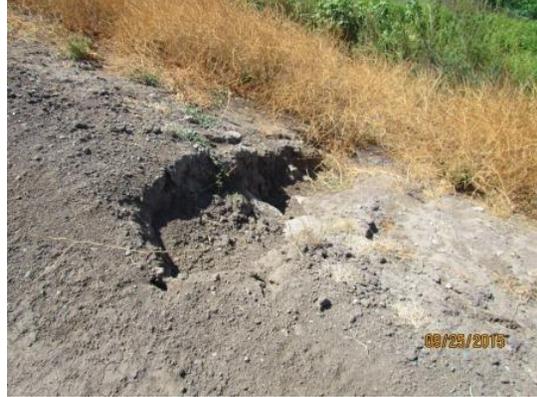
Photo 1 of 2 : FA\_2015\_NA0017\_149\_4\_20150928\_00010.jpg

LM Start	<b>2.22</b>	Rating **	M	Issue No.	<b>4</b>
LM End	<b>2.22</b>	Issue Type +	Ma	Location *	WS
Category	Earthen Levee			GPS Latitude/Longitude	
				Start	End
Item	Erosion / Bank Caving			37.884741 °	37.884741 °
				-121.253808 °	-121.253808 °
DWR ID	DWR_NA0017_02_s_2014_4				
Action/Comments					
Schedule repair of erosion site prior to the next inspection.

Updated picture of the erosion on the waterside of the levee during fall 2015 inspection.

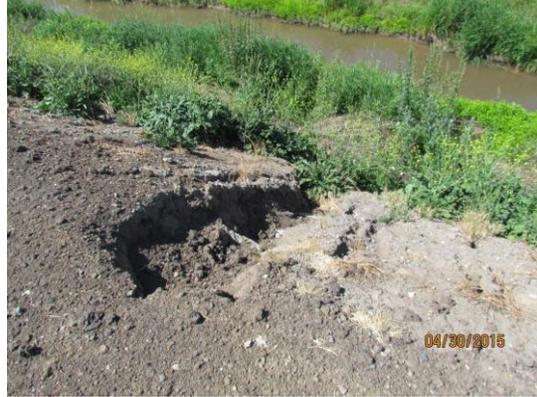
Photo 2 of 2 : FA\_2015\_NA0017\_149\_4\_20150911\_00002.jpg

View of the erosion on the waterside shoulder looking upstream during spring 2015 inspection.

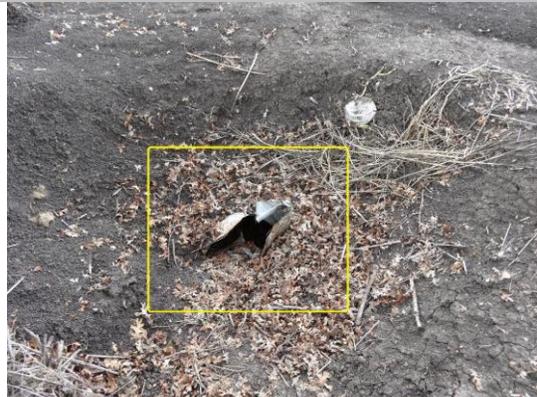
Photo 1 of 3 : UCIP\_FA\_2015\_3920.jpg

LM Start	<b>2.46</b>	Rating **	M	Issue No.	<b>135</b>
LM End	<b>2.46</b>	Issue Type +	En	Location *	WS
Category	Supplemental			GPS Latitude/Longitude	
				Start	End
Item	DWR UCIP Field Study			37.887657 °	37.887657 °
				-121.255670 °	-121.255670 °
DWR ID					
Action/Comments					
Inspector Comments: FS_ID:40345 DS_ID:17977 EP_NO: N/A FS_HLM: 2.473 Repair Type: Non-Urgent Crossing Status: Found

LS view: distorted CM inlet pipe on levee slope.

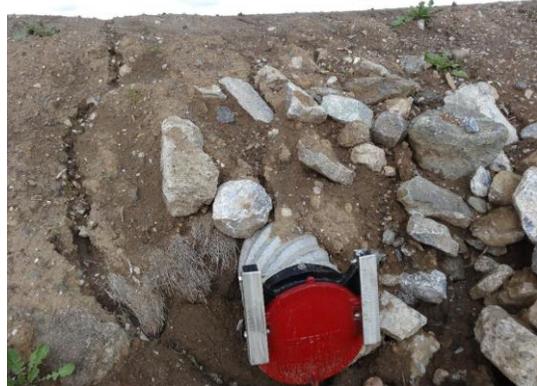
Photo 2 of 3 : UCIP\_FA\_2015\_3921.jpg

LM Start	2.46	Rating **	M	Issue No.	135 (cont)
LM End	2.46	Issue Type +	En	Location *	WS
Category	Supplemental			GPS Latitude/Longitude	
				Start	End
Item	DWR UCIP Field Study			37.887657 °	37.887657 °
				-121.255670 °	-121.255670 °
DWR ID					
Action/Comments					
Inspector Comments: FS_ID:40345 DS_ID:17977 EP_NO: N/A FS_HLM: 2.473 Repair Type: Non-Urgent Crossing Status: Found UCIP Comments: Distorted inlet end on landside. Flap gate and pipe looks very new. FIELD_STRUCT_DESC: 12-inch CM drain pipe, 3.0 feet below the crown; flap gate on waterside and pipe open on landside end. Permit No. 11896, 1973. FS Date: 04/07/2014

WS view: closer view of CM drain pipe and flap gate on levee slope.

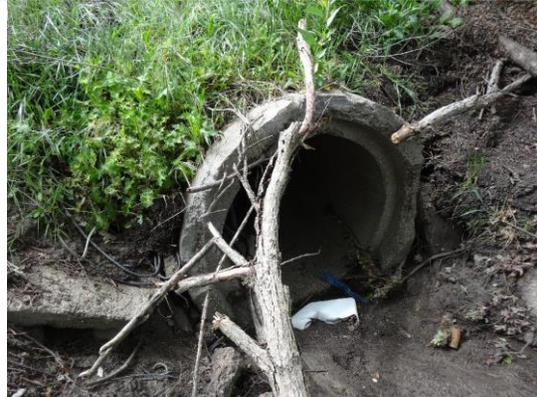
Photo 1 of 3 : UCIP\_FA\_2015\_4034.jpg

LM Start	<b>2.54</b>	Rating **	M	Issue No.	<b>136</b>
LM End	<b>2.54</b>	Issue Type +	En	Location *	WS
Category	Supplemental			GPS Latitude/Longitude	
				Start	End
Item	DWR UCIP Field Study			37.888389 °	37.888389 °
				-121.256771 °	-121.256771 °
DWR ID					
Action/Comments					
Inspector Comments: FS_ID:41373 DS_ID:24849 EP_NO: N/A FS_HLM: 2.553 Repair Type: Non-Urgent Crossing Status: Found

LS view: concrete inlet pipe on drainage ditch. Vegetation debris and mud in the pipe.

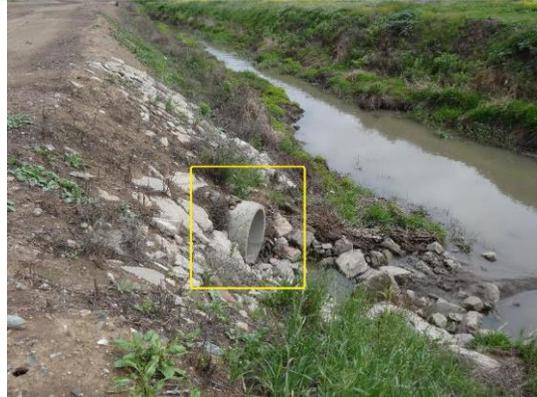
Photo 3 of 3 : UCIP\_FA\_2015\_4036.jpg

LM Start	<b>2.54</b>	Rating **	M	Issue No.	<b>136 (cont)</b>
LM End	<b>2.54</b>	Issue Type +	En	Location *	WS
Category	Supplemental			GPS Latitude/Longitude	
				Start	End
Item	DWR UCIP Field Study			37.888389 °	37.888389 °
				-121.256771 °	-121.256771 °
DWR ID					
Action/Comments					
Inspector Comments: FS_ID:41373 DS_ID:24849 EP_NO: N/A FS_HLM: 2.553 Repair Type: Non-Urgent Crossing Status: Found

WS view: concrete drain pipe on levee slope.

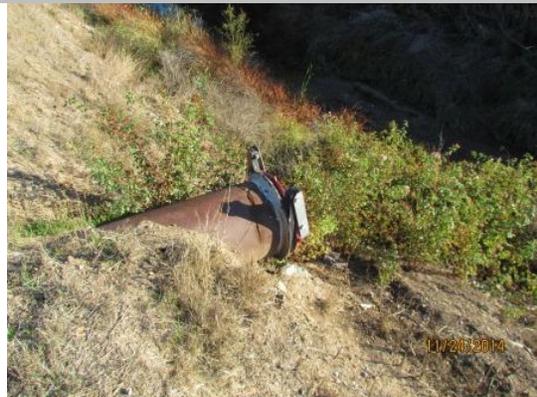
Photo 1 of 2 : FA\_2015\_NA0017\_149\_8\_20150911\_00004.jpg

LM Start	<b>2.65</b>	Rating **	A/W	Issue No.	<b>8</b>
LM End	<b>2.65</b>	Issue Type +	Ma	Location *	WS
Category	Earthen Levee			GPS Latitude/Longitude	
				Start	End
Item	Encroachments			37.888853 °	37.888853 °
				-121.258640 °	-121.258640 °
DWR ID	DWR_NA0017_02_s_2012_8				
Action/Comments					
Pipe Inspector Comments: Pipe crossing the channel has corroded and can carry water to/from the channel. A flap gate was installed by the LMA, but the pipe appeared to be damaged.

A flap gate was installed at the end of the pipe, but the pipe appeared to have cracks. The picture was taken from the crown looking upstream during fall 2014 inspection.

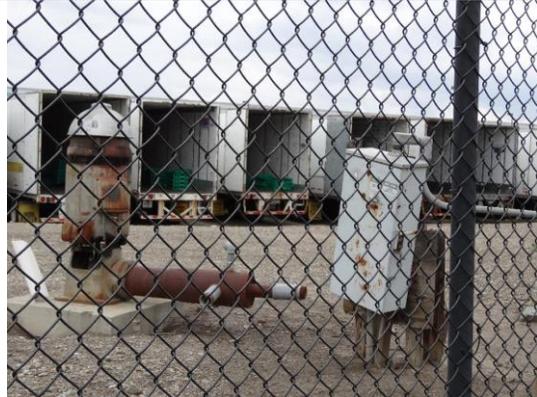
Photo 1 of 1 : UCIP\_FA\_2015\_4033.jpg

LM Start	<b>3.16</b>	Rating **	M	Issue No.	<b>137</b>
LM End	<b>3.16</b>	Issue Type +	En	Location *	WS
Category	Supplemental			GPS Latitude/Longitude	
				Start	End
Item	DWR UCIP Field Study			37.888582 °	37.888582 °
				-121.267511 °	-121.267511 °
DWR ID					
Action/Comments					
Inspector Comments: FS_ID:40346 DS_ID:17974 EP_NO: N/A FS_HLM: 3.178 Repair Type: Non-Urgent Crossing Status: Indicator Found

LS view: an abandoned pump and appurtenances off the levee inside fenced private property.

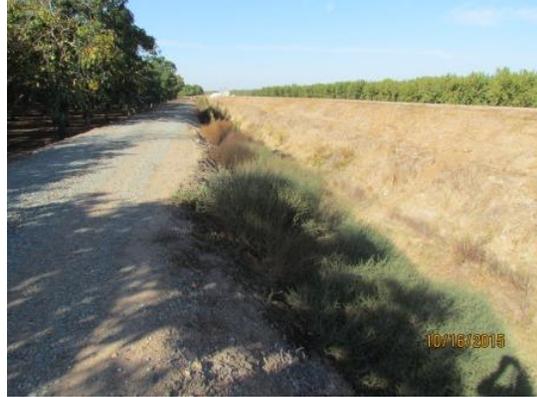
Photo 1 of 1 : FA\_2015\_NA0017\_150\_3\_20151023\_00001.jpg

LM Start	<b>0.06</b>	Rating **	M	Issue No.	<b>3</b>
LM End	<b>0.16</b>	Issue Type +	Ma	Location *	WS
Category	Earthen Levee		GPS Latitude/Longitude		
			Start	End	
Item	Vegetation		37.979193 °	37.979229 °	
			-121.097709 °	-121.095906 °	
DWR ID	DWR_NA0017_06_f_2015_3				
Action/Comments					
Control annual grass and weeds on the levee slopes and easements.

View of the vegetation on the waterside of the levee.

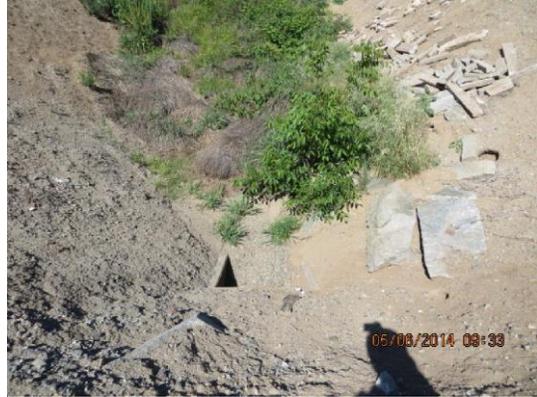
Photo 1 of 2 : UCIP\_FA\_2015\_5942.jpg

LM Start	<b>0.49</b>	Rating **	M	Issue No.	<b>1</b>
LM End	<b>0.49</b>	Issue Type +	En	Location *	WS
Category	Supplemental			GPS Latitude/Longitude	
				Start	End
Item	DWR UCIP Field Study			37.979495 °	37.979495 °
				-121.089996 °	-121.089996 °
DWR ID	DWR_NA0017_06_f_2015_1				
Action/Comments					
Inspector Comments: FS_ID:39403 DS_ID:17988 EP_NO:N/A >>> This site is 162 feet past the .457 LM end point of the levee. <<<< Repair Type:Non-Urgent Crossing Status:Found UCIP Comments:Flap gate won't close as pipe is filled with debris that blocks its operation. FIELD_STRUCT_DESC:30-inch pipe through plug across drain ditch 7.0 feet below the crown. Concrete "U" headwall on WS toe with a flap gate. FS_DATE:05/06/2014

Headwall and flapgate on WS toe.

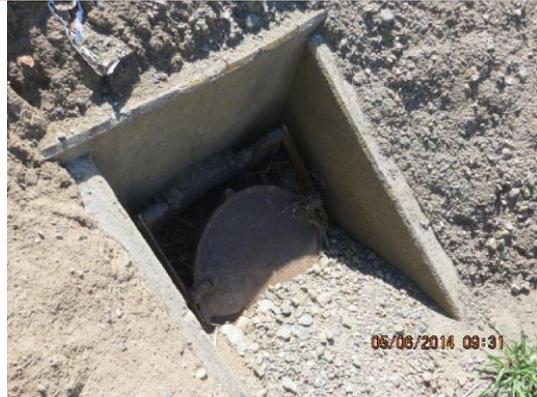
Photo 2 of 2 : UCIP\_FA\_2015\_5943.jpg

Headwall and flapgate on WS toe. Note gravel that fills pipe is preventing the gate from closing.

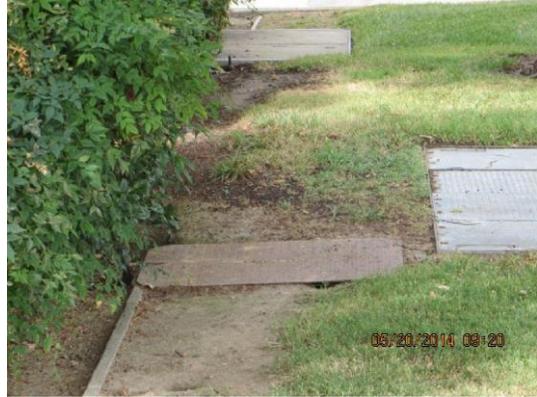
Photo 1 of 1 : UCIP\_FA\_2015\_6596.jpg

LM Start	<b>1.36</b>	Rating **	M	Issue No.	<b>1055</b>
LM End	<b>1.36</b>	Issue Type +	En	Location *	LS
Category	Supplemental			GPS Latitude/Longitude	
				Start	End
Item	DWR UCIP Field Study			38.043302 °	38.043302 °
				-121.348728 °	-121.348728 °
DWR ID					
Action/Comments					
Inspector Comments: FS_ID:41957 DS_ID:25002 EP_NO: N/A FS_HLM: 1.606 Repair Type: Non-Urgent Crossing Status: Indicator Found UCIP Comments: No permit identified for this crossing. FIELD_STRUCT_DESC: Communication line of unknown size through the levee at unknown depth below the crown. 2'X3' concrete vault off LS shoulder. FS Date: 05/20/2014

Possible communications vault off LS shoulder.

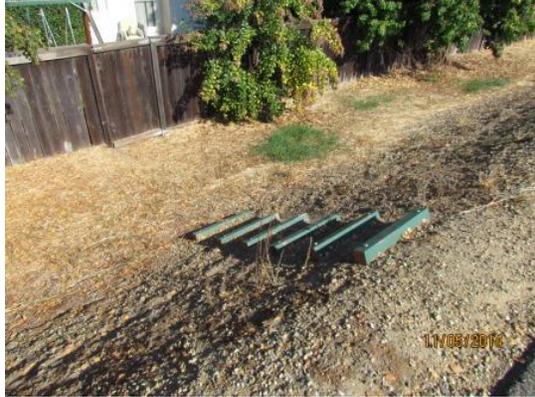
Photo 1 of 1 : FA\_2015\_NA0017\_151\_76\_20150911\_00034.jpg

LM Start	<b>1.54</b>	Rating **	M	Issue No.	<b>76</b>
LM End	<b>1.54</b>	Issue Type +	Ma	Location *	LS
Category	Earthen Levee		GPS Latitude/Longitude		
			Start	End	
Item	Encroachments		38.043304 °	38.043304 °	
			-121.345485 °	-121.345485 °	
DWR ID	DWR_NA0017_07_f_2014_76				
Action/Comments					
Stairway

A stairway was found on the landside of the levee looking upstream.

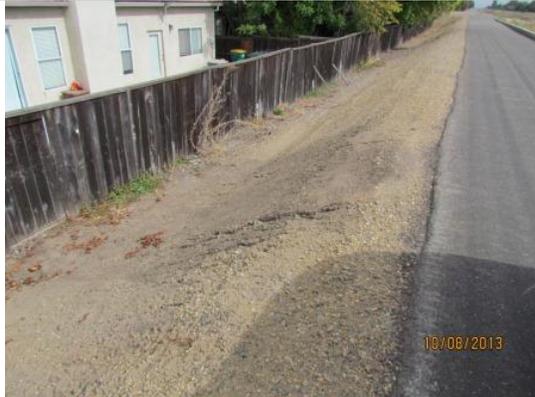
Photo 1 of 1 : FA\_2015\_NA0017\_151\_11\_20150911\_00004.jpg

LM Start	<b>1.68</b>	Rating **	M	Issue No.	<b>11</b>
LM End	<b>1.68</b>	Issue Type +	Ma	Location *	LS
Category	Earthen Levee		GPS Latitude/Longitude		
			Start	End	
Item	Erosion / Bank Caving		38.043276 °	38.043276 °	
			-121.342812 °	-121.342812 °	
DWR ID	DWR_NA0017_07_f_2013_11				
Action/Comments					
Schedule repair of erosion site prior to the next inspection. Inspector Comments: Runoff on the landside slope.

Runoff was discovered on the landside slope of the levee looking upstream.

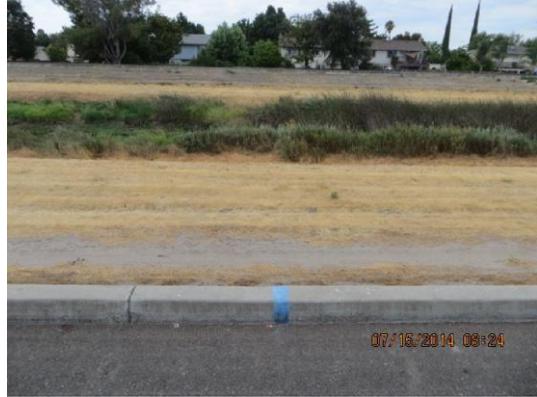
Photo 1 of 2 : UCIP\_FA\_2015\_6636.jpg

LM Start	<b>1.90</b>	Rating **	M	Issue No.	<b>1057</b>
LM End	<b>1.90</b>	Issue Type +	En	Location *	LS
Category	Supplemental			GPS Latitude/Longitude	
				Start	End
Item	DWR UCIP Field Study			38.043238 °	38.043238 °
				-121.338902 °	-121.338902 °
DWR ID					
<b>Action/Comments</b>					
Inspector Comments: FS_ID:39712 DS_ID:23622 EP_NO: 15447 FS_HLM: 2.156 Repair Type: Non-Urgent Crossing Status: Indicator Found UCIP Comments: Waterline needs to be marked at crossing through levee. FIELD_STRUCT_DESC: 12-inch steel water pipe through the levee, 11.0-feet below the crown. Shutoff valve on landward side. Valve in street next to intersection of Chaparral and Bowie Way south of Bear Creek. Pipe crosses through levee then runs parallel to toe to West. Permit No. 15447, 1991. FS Date: 05/20/2014

USAA paint on flood wall at WS shoulder.

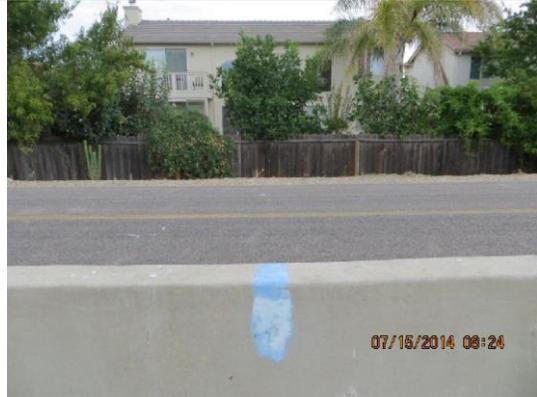
Photo 2 of 2 : UCIP\_FA\_2015\_6638.jpg

USAA paint on flood wall at WS shoulder.

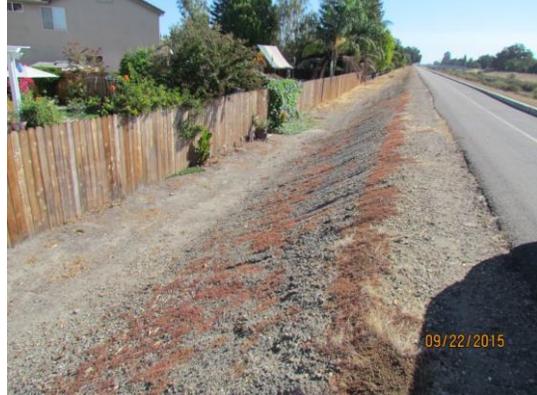
Photo 1 of 2 : FA\_2015\_NA0017\_151\_35\_20150928\_00062.jpg

LM Start	<b>2.01</b>	Rating **	M	Issue No.	<b>35</b>
LM End	<b>2.01</b>	Issue Type +	Ma	Location *	LS
Category	Earthen Levee			GPS Latitude/Longitude	
				Start	End
Item	Erosion / Bank Caving			38.043243 °	38.043243 °
				-121.336780 °	-121.336780 °
DWR ID	DWR_NA0017_07_s_2015_35				
Action/Comments					
Schedule repair of erosion site prior to the next inspection. Inspector Comments: Runoff

Updated picture of the erosion on the landside of the levee during fall 2015 inspection.

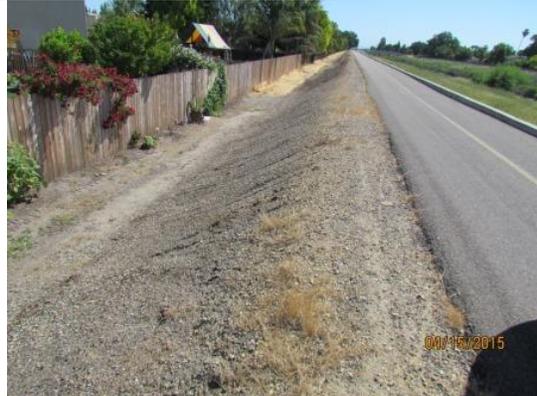
Photo 2 of 2 : FA\_2015\_NA0017\_151\_35\_20150911\_00012.jpg

Erosion caused by runoff on the landside of the levee looking upstream.

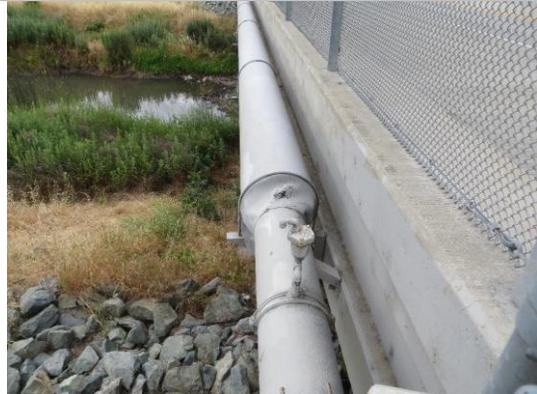
Photo 1 of 2 : UCIP\_FA\_2015\_6593.jpg

LM Start	<b>2.28</b>	Rating **	M	Issue No.	<b>1058</b>
LM End	<b>2.28</b>	Issue Type +	En	Location *	LS
Category	Supplemental			GPS Latitude/Longitude	
				Start	End
Item	DWR UCIP Field Study			38.043191 °	38.043191 °
				-121.331860 °	-121.331860 °
DWR ID					
Action/Comments					
Inspector Comments: FS_ID:41969 DS_ID:25000 EP_NO: N/A FS_HLM: 2.551 Repair Type: Non-Urgent Crossing Status: Found

Waterline and vent visible on upstream side of bridge.

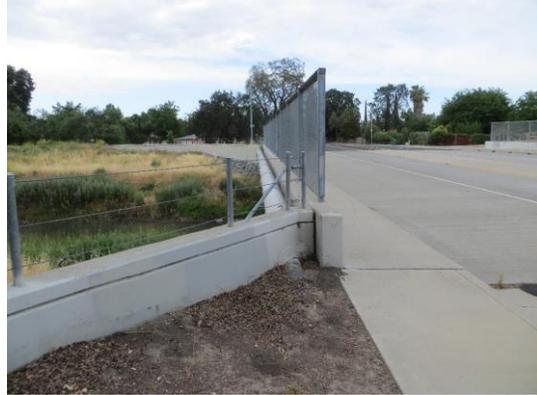
Photo 2 of 2 : UCIP\_FA\_2015\_6594.jpg

LM Start	2.28	Rating **	M	Issue No.	1058 (cont)
LM End	2.28	Issue Type +	En	Location *	LS
Category	Supplemental			GPS Latitude/Longitude	
			Start	End	
Item	DWR UCIP Field Study			38.043191 °	38.043191 °
				-121.331860 °	-121.331860 °
DWR ID					
Action/Comments					
Inspector Comments: FS_ID:41969 DS_ID:25000 EP_NO: N/A FS_HLM: 2.551 Repair Type: Non-Urgent Crossing Status: Found UCIP Comments: No permit identified for this crossing. FIELD_STRUCT_DESC: 12-inch steel domestic water pipe through the levee, 2.0-feet below the crown. Pipe visible on upstream side of bridge. Vent on pipe at WS slope. FS Date: 05/20/2014

Waterline and vent visible on upstream side of bridge.

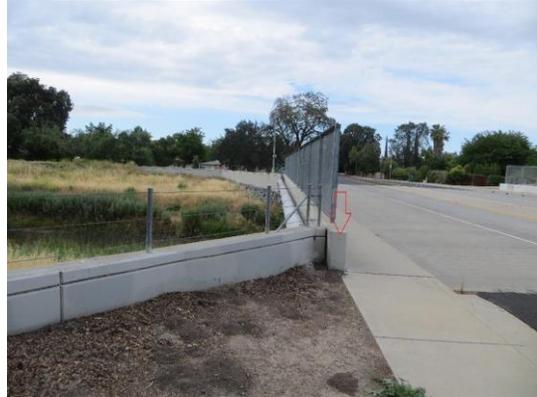
Photo 1 of 2 : UCIP\_FA\_2015\_2428.jpg

LM Start	2.28	Rating **	U	Issue No.	1059
LM End	2.28	Issue Type +	En	Location *	LS
Category	Supplemental			GPS Latitude/Longitude	
			Start	End	
Item	DWR UCIP Field Study			38.043154 °	38.043154 °
				-121.331793 °	-121.331793 °
DWR ID					
Action/Comments					
Inspector Comments: FS_ID:40144 DS_ID:23627 EP_NO: 14745 FS_HLM: 2.555 Repair Type: Urgent Crossing Status: Indicator Found UCIP Comments: Need to install markers for gasoline. Circular marker on bridge has been painted over (see pic). FIELD_STRUCT_DESC: 4-inch steel high pressure gas main through the levee, 3.0 feet below the crown. Cutoff wall around pipe under center of levee. Rock revetment on waterward slope. Permit No. 14745, 1987. FS Date: 05/20/2014

There is a circular marker on the bridge abutment that is typical of this type of crossing. However, it has been painted over.

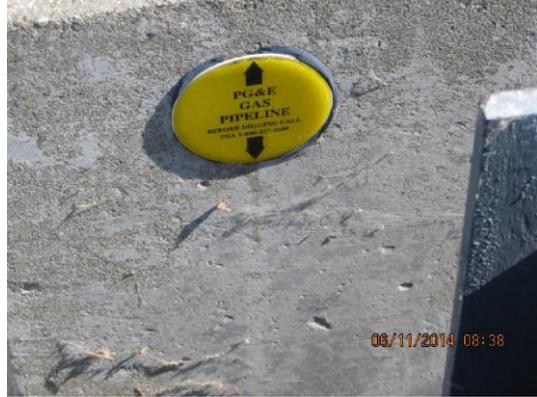
Photo 2 of 2 : UCIP\_FA\_2015\_2429.jpg

LM Start	<b>2.28</b>	Rating **	U	Issue No.	<b>1059 (cont)</b>
LM End	<b>2.28</b>	Issue Type +	En	Location *	LS
Category	Supplemental			GPS Latitude/Longitude	
				Start	End
Item	DWR UCIP Field Study			38.043154 °	38.043154 °
				-121.331793 °	-121.331793 °
DWR ID					
Action/Comments					
Inspector Comments: FS_ID:40144 DS_ID:23627 EP_NO: 14745 FS_HLM: 2.555 Repair Type: Urgent Crossing Status: Indicator Found UCIP Comments: Need to install markers for gasoline. Circular marker on bridge has been painted over (see pic). FIELD_STRUCT_DESC: 4-inch steel high pressure gas main through the levee, 3.0 feet below the crown. Cutoff wall around pipe under center of levee. Rock revetment on waterward slope. Permit No. 14745, 1987. FS Date: 05/20/2014

A marker installed on opposite bank at this alignment that is typical of a gasoline crossing in this area.

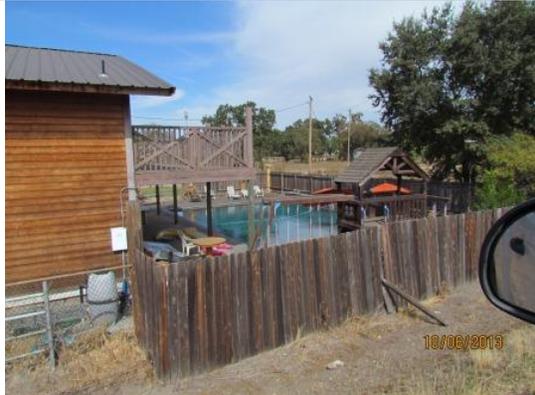
Photo 1 of 2 : FA\_2015\_NA0017\_151\_50\_20150911\_00022.jpg

LM Start	<b>2.39</b>	Rating **	M	Issue No.	<b>50</b>
LM End	<b>2.39</b>	Issue Type +	En	Location *	LS
Category	Earthen Levee			GPS Latitude/Longitude	
				Start	End
Item	Encroachments			38.043189 °	38.043189 °
				-121.329810 °	-121.329810 °
DWR ID	DWR_NA0017_07_s_2012_50				
Action/Comments					
Pool Inspector Comments: New pool being built without a permit. The top of the pool is outside of the assumed easement, but it is deep enough that it may need some attention.

View of the pool on the landside toe of the levee looking upstream during fall 2013 inspection.

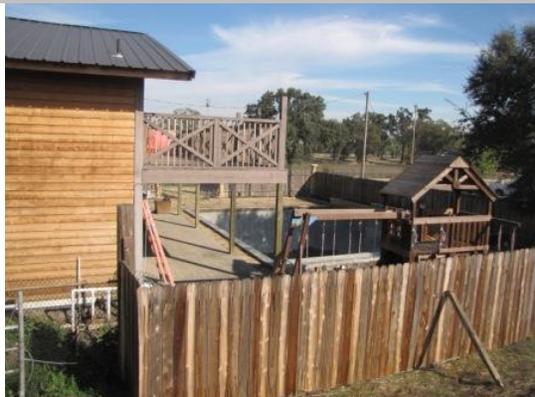
Photo 2 of 2 : FA\_2015\_NA0017\_151\_50\_20150911\_00023.jpg

View of a recently constructed pool looking landward.

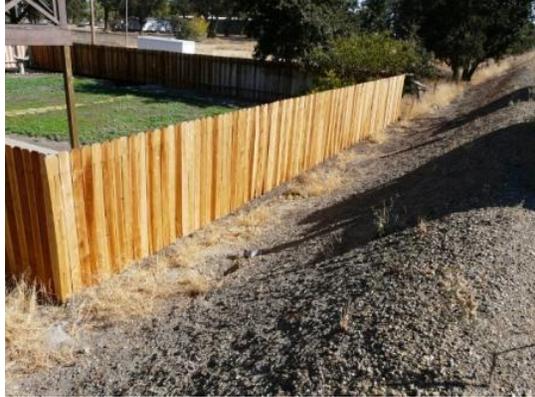
Photo 1 of 1 : FA\_2015\_NA0017\_151\_26\_20150911\_00008.jpg

LM Start	<b>2.39</b>	Rating **	U	Issue No.	<b>26</b>
LM End	<b>2.40</b>	Issue Type +	En	Location *	LS
Category	Earthen Levee		GPS Latitude/Longitude		
			Start	End	
Item	Encroachments		38.043182 °	38.043179 °	
			-121.329790 °	-121.329613 °	
DWR ID	DWR_NA0017_07_s_2012_26				
Action/Comments					
Fence

A new fence was found on the landside toe of the levee looking upstream.

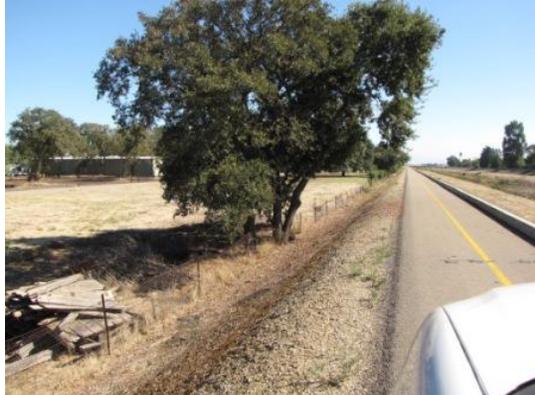
Photo 1 of 1 : FA\_2015\_NA0017\_151\_1034\_20150911\_00059.jpg

LM Start	<b>2.40</b>	Rating **	M	Issue No.	<b>1034</b>
LM End	<b>2.76</b>	Issue Type +	En	Location *	LS
Category	Earthen Levee		GPS Latitude/Longitude		
			Start	End	
Item	Encroachments		38.043160 °	38.043166 °	
			-121.329618 °	-121.323143 °	
DWR ID	DWR_NA0017_07_s_2012_1034				
Action/Comments					
Fence Inspector Comments: Metal fence

View of a metal fence adjacent to the landward toe looking upstream.

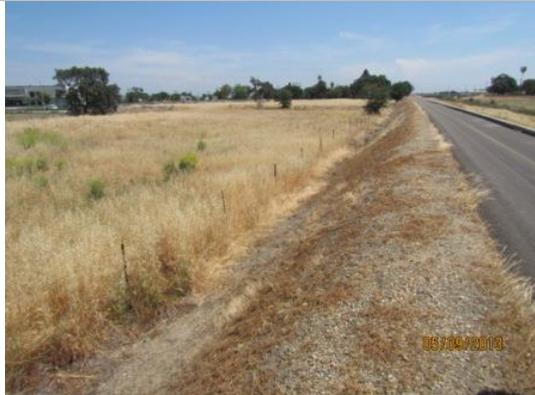
Photo 1 of 1 : FA\_2015\_NA0017\_151\_8\_20150911\_00003.jpg

LM Start	<b>2.56</b>	Rating **	M	Issue No.	<b>8</b>
LM End	<b>2.84</b>	Issue Type +	En	Location *	LS
Category	Earthen Levee		GPS Latitude/Longitude		
			Start	End	
Item	Encroachments		38.043156 °	38.043167 °	
			-121.326670 °	-121.321592 °	
DWR ID	DWR_NA0017_07_s_2013_8				
Action/Comments					
Fence

Fences were found on the landside toe of the levee looking upstream.

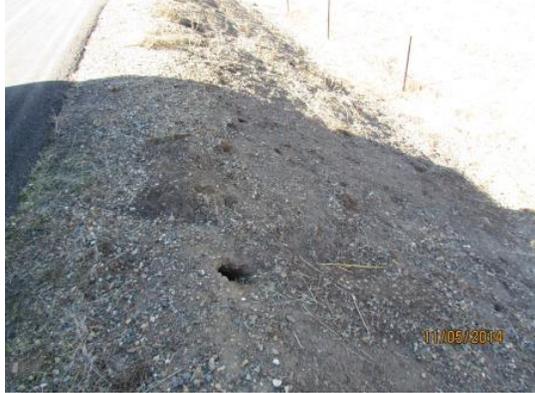
Photo 1 of 1 : FA\_2015\_NA0017\_151\_83\_20150911\_00037.jpg

LM Start	<b>2.71</b>	Rating **	M	Issue No.	<b>83</b>
LM End	<b>2.71</b>	Issue Type +	Ma	Location *	LS
Category	Earthen Levee		GPS Latitude/Longitude		
			Start	End	
Item	Animal Control		38.043189 °	38.043189 °	
			-121.323881 °	-121.323881 °	
DWR ID	DWR_NA0017_07_f_2014_83				
Action/Comments					
No rodents visible, but rodent burrows visible; need to backfill and compact or grout burrows.

Rodent holes were found on the landside of the levee looking downstream.

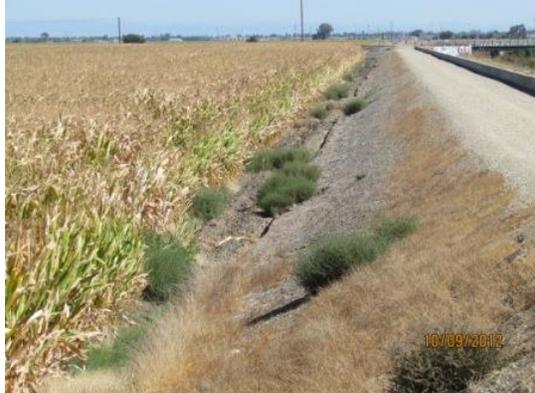
Photo 1 of 2 : FA\_2015\_NA0017\_151\_778\_20150911\_00053.jpg

LM Start	<b>2.88</b>	Rating **	M	Issue No.	<b>778</b>
LM End	<b>3.06</b>	Issue Type +	En	Location *	LS
Category	Earthen Levee		GPS Latitude/Longitude		
			Start	End	
Item	Encroachments		38.043164 °	38.043160 °	
			-121.320946 °	-121.317532 °	
DWR ID	DWR_NA0017_07_s_2012_778				
Action/Comments					
Ditch Inspector Comments: Farmer discing the toe of the levee.

Updated picture of the toe cutting on the landside toe of the levee looking upstream.

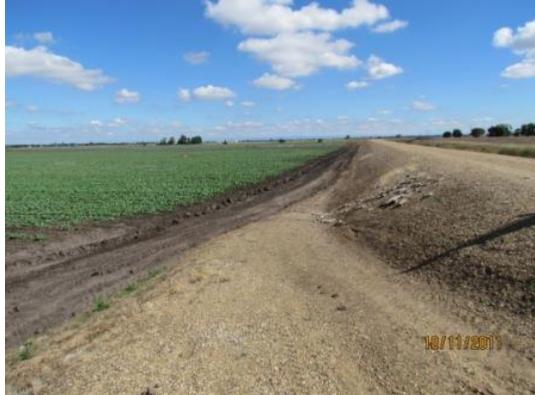
Photo 2 of 2 : FA\_2015\_NA0017\_151\_778\_20150911\_00054.jpg

Farmer discing the toe of the landside of the levee looking upstream.

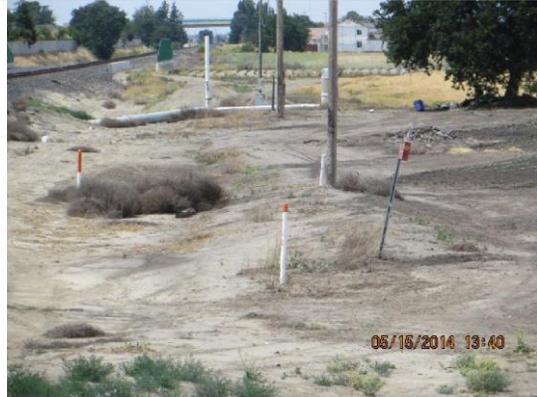
Photo 1 of 1 : UCIP\_FA\_2015\_6572.jpg

LM Start	<b>3.08</b>	Rating **	M	Issue No.	<b>1060</b>
LM End	<b>3.08</b>	Issue Type +	En	Location *	LS
Category	Supplemental			GPS Latitude/Longitude	
				Start	End
Item	DWR UCIP Field Study			38.043209 °	38.043209 °
				-121.317107 °	-121.317107 °
DWR ID					
Action/Comments					
Inspector Comments: FS_ID:37995 DS_ID:23530 EP_NO: N/A FS_HLM: 3.38 Repair Type: Non-Urgent Crossing Status: Indicator Found

Gasline marker off LS toe.

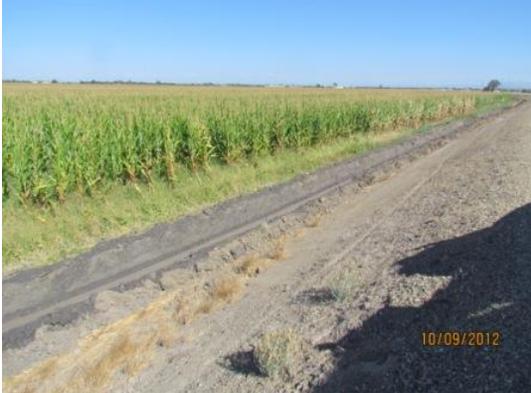
Photo 1 of 1 : FA\_2015\_NA0017\_151\_70\_20150911\_00031.jpg

LM Start	<b>3.79</b>	Rating **	M	Issue No.	<b>70</b>
LM End	<b>3.89</b>	Issue Type +	En	Location *	LS
Category	Earthen Levee		GPS Latitude/Longitude		
			Start	End	
Item	Encroachments		38.042963 °	38.042990 °	
			-121.304235 °	-121.302329 °	
DWR ID	DWR_NA0017_07_f_2012_70				
Action/Comments					
Ditch

A ditch was found on the landside toe of the levee looking upstream.

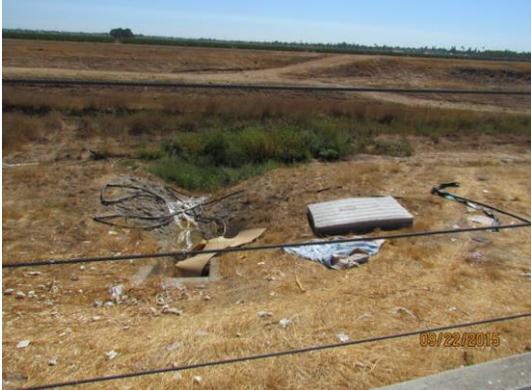
Photo 1 of 1 : FA\_2015\_NA0017\_151\_37\_20150928\_00063.jpg

LM Start	<b>4.32</b>	Rating **	M	Issue No.	<b>37</b>
LM End	<b>4.32</b>	Issue Type +	Ma	Location *	WS
Category	Earthen Levee		GPS Latitude/Longitude		
			Start	End	
Item	Encroachments		38.044853 °	38.044853 °	
			-121.295143 °	-121.295143 °	
DWR ID	DWR_NA0017_07_f_2015_37				
Action/Comments					
Debris

Debris was found on the waterside toe of the levee looking downstream.

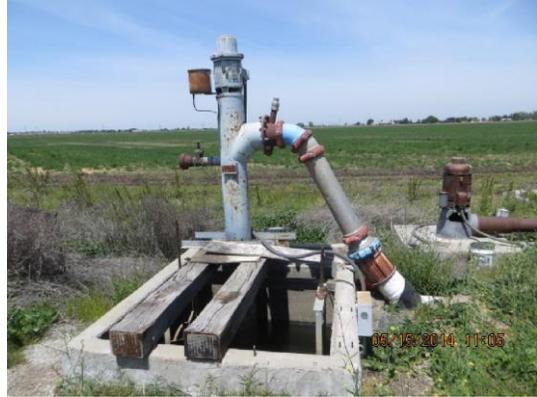
Photo 1 of 3 : UCIP\_FA\_2015\_4758.jpg

Inspector Comments: FS\_ID:39716  
 DS\_ID:23542  
 EP\_NO: N/A  
 FS\_HLM: 5.286  
 Repair Type: Non-Urgent  
 Crossing Status: Indicator Found  
 UCIP Comments: Crossing through levee appears abandoned and if so should be done so properly. Unclear exactly where pipe crosses.  
 FIELD\_STRUCT\_DESC: 10-inch steel irrigation pipe through the levee, 2.5-feet below the crown. Pump mounted on the concrete base on landward side. Irrigation well and concrete distribution box on landward side 10.0 feet from the toe. 60-inch concrete standpipe on LS toe.  
 O&M Manual Bear Creek Part 1, June 1965.  
 FS Date: 05/15/2014

2 pumps on LS toe over concrete bases. Unclear exactly where pipe crosses.
