**Flood Control Project Maintenance  
Levee Inspections**

**Fall 2015 Levee Maintenance Deficiency Summary Report**

**San Joaquin River Basin**

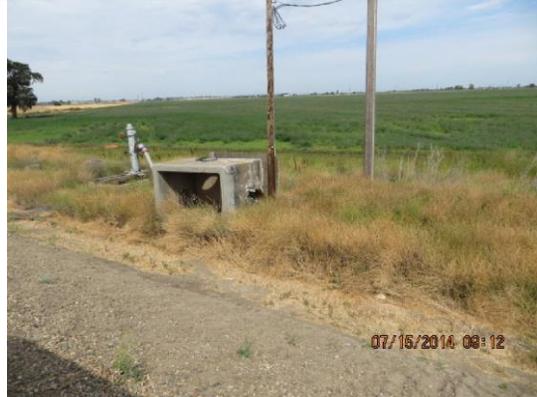
Photo 2 of 3 : UCIP\_FA\_2015\_6667.jpg

Abandoned distribution box on LS toe.

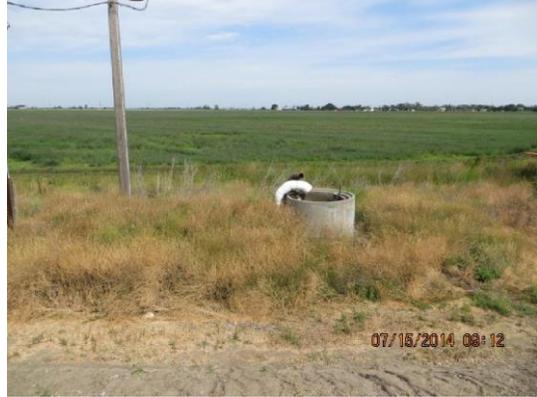
Photo 3 of 3 : UCIP\_FA\_2015\_6668.jpg

60-inch concrete standpipe on LS toe.

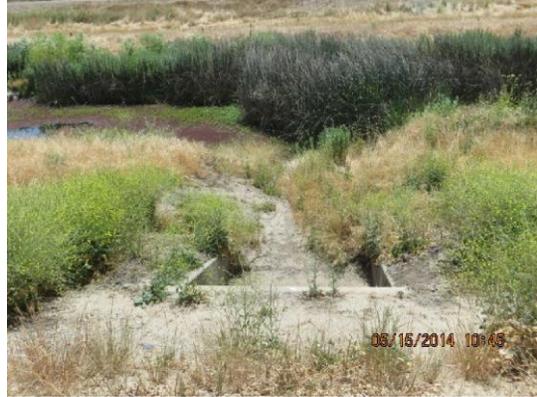
Photo 2 of 3 : UCIP\_FA\_2015\_4756.jpg

Headwall and flapgate on WS toe.

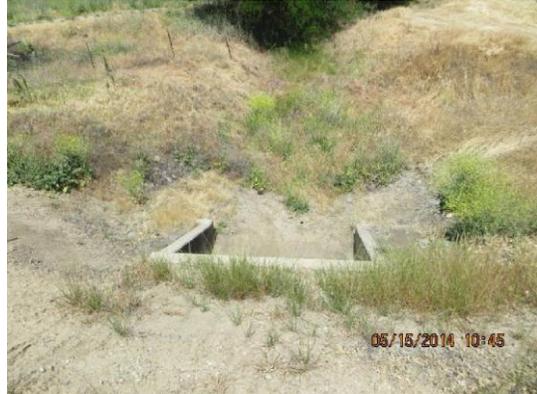
Photo 3 of 3 : UCIP\_FA\_2015\_4757.jpg

Concrete headwall on LS toe.

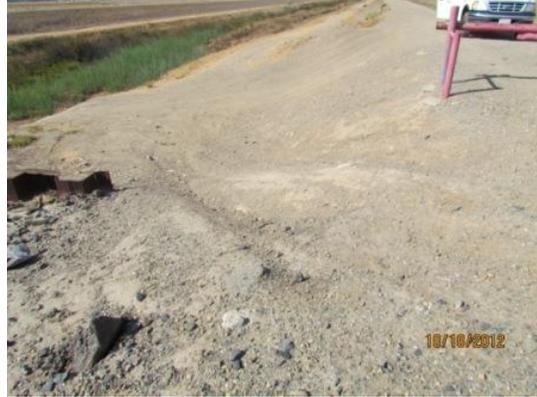
Photo 1 of 1 : FA\_2015\_NA0017\_151\_73\_20150911\_00033.jpg

LM Start	<b>5.50</b>	Rating **	M	Issue No.	<b>73</b>
LM End	<b>5.50</b>	Issue Type +	Ma	Location *	WS
Category	Earthen Levee			GPS Latitude/Longitude	
				Start	End
Item	Erosion / Bank Caving			38.052753 °	38.052753 °
				-121.277680 °	-121.277680 °
DWR ID	DWR_NA0017_07_f_2012_73				
Action/Comments					
Schedule repair of erosion site prior to the next inspection. Inspector Comments: Erosion caused by vehicle, and the slopes are stable.

Slope instability was found on the landside of the levee looking upstream.

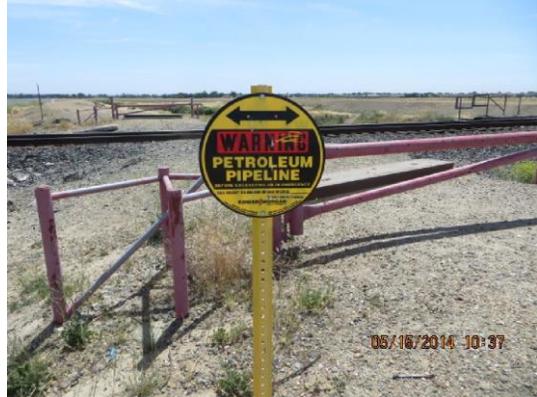
Photo 1 of 3 : UCIP\_FA\_2015\_6591.jpg

Petroleum pipeline markers on west side of railroad tracks.

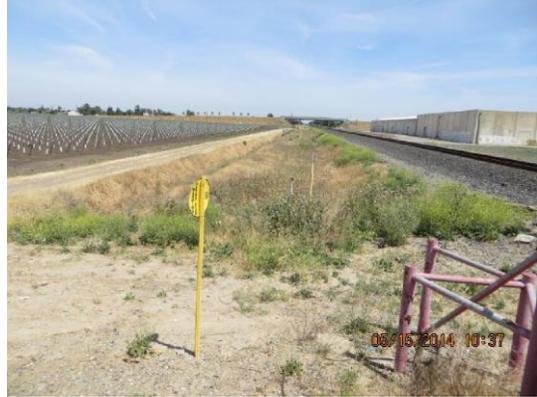
Photo 2 of 3 : UCIP\_FA\_2015\_6592.jpg

Petroleum pipeline markers on west side of railroad tracks.

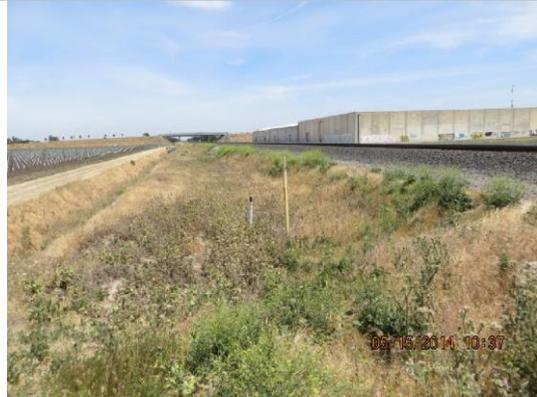
Photo 3 of 3 : UCIP\_FA\_2015\_6595.jpg

Petroleum pipeline markers on west side of railroad tracks on LS of levee.

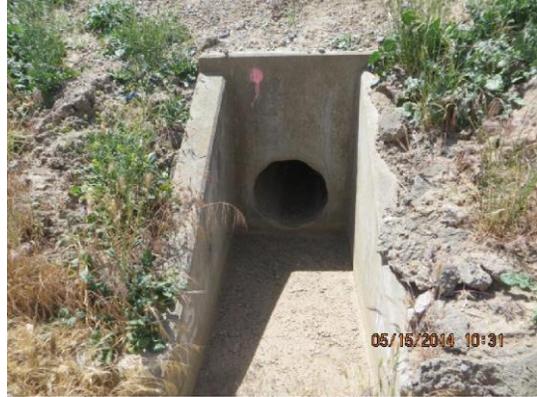
Photo 1 of 3 : UCIP\_FA\_2015\_6716.jpg

Headwall on LS toe.

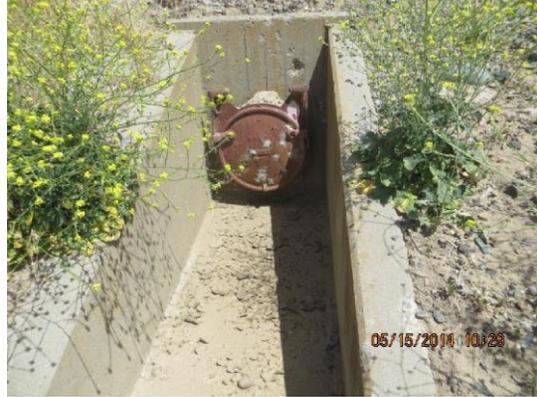
Photo 3 of 3 : UCIP\_FA\_2015\_6718.jpg

Headwall and flaggate on WS toe.

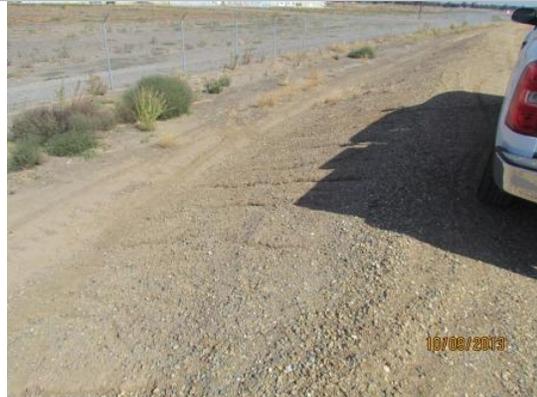
Photo 1 of 1 : FA\_2015\_NA0017\_151\_43\_20150911\_00017.jpg

LM Start	<b>5.53</b>	Rating **	M	Issue No.	<b>43</b>
LM End	<b>5.53</b>	Issue Type +	Ma	Location *	LS
Category	Earthen Levee			GPS Latitude/Longitude	
				Start	End
Item	Erosion / Bank Caving			38.052794 °	38.052794 °
				-121.277035 °	-121.277035 °
DWR ID	DWR_NA0017_07_f_2013_43				
Action/Comments					
Schedule repair of erosion site prior to the next inspection. Inspector Comments: Runoff on the landside.

Runoff was found on the landside slope of the levee looking upstream.

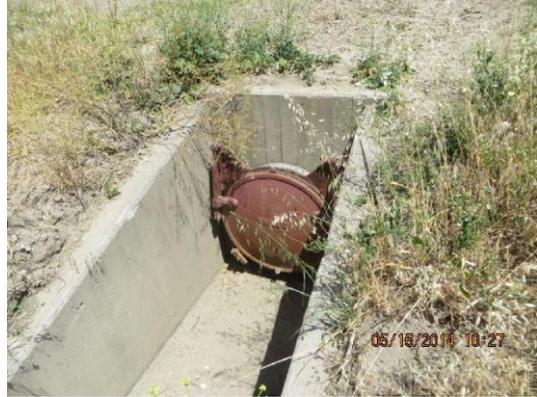
Photo 1 of 2 : UCIP\_FA\_2015\_6714.jpg

Headwall and flapgate at WS toe.

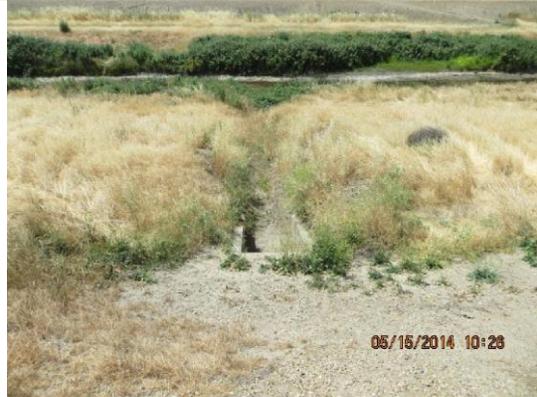
Photo 2 of 2 : UCIP\_FA\_2015\_6715.jpg

Headwall and flapgate at WS toe.

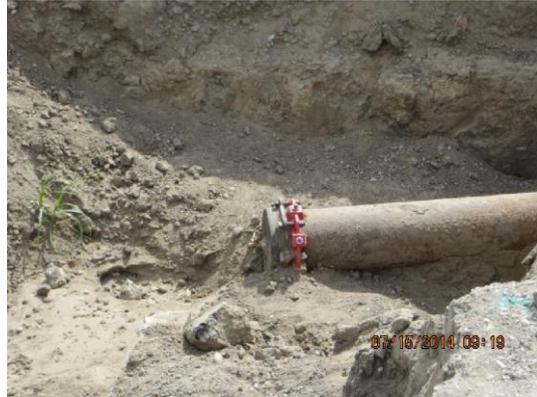
Photo 1 of 2 : UCIP\_FA\_2015\_2430.jpg

Pipe with temporary pressure seal installed at LS toe. WS not visible.

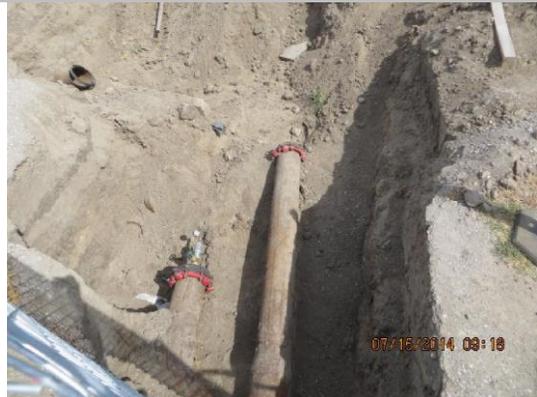
Photo 2 of 2 : UCIP\_FA\_2015\_2431.jpg

Two pipes connected at Y on LS before entering levee.

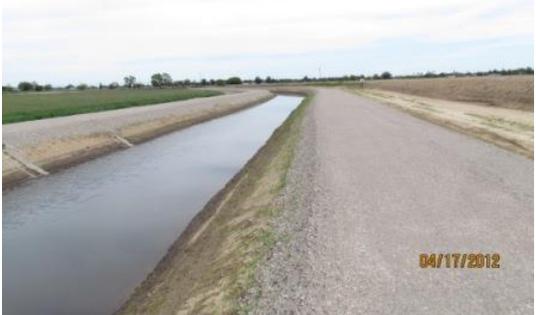
Photo 2 of 2 : FA\_2015\_NA0017\_151\_22\_20150911\_00006.jpg

LM Start	<b>5.88</b>	Rating **	A/W	Issue No.	<b>22 (cont)</b>
LM End	<b>5.88</b>	Issue Type +	En	Location *	LS
Category	Earthen Levee			GPS Latitude/Longitude	
				Start	End
Item	Encroachments			38.053609 °	38.053609 °
				-121.270838 °	-121.270838 °
DWR ID	DWR_NA0017_07_s_2012_22				
Action/Comments					
Ditch Inspector Comments: Woodbridge irrigation dug 20 feet wide channel 20 feet away from the toe of the levee. For details, please see Field Investigation Report #4581. According to their calculations, the ditch is away from the levee prism.

A 20 feet wide channel was dug on the landside of the levee looking upstream.

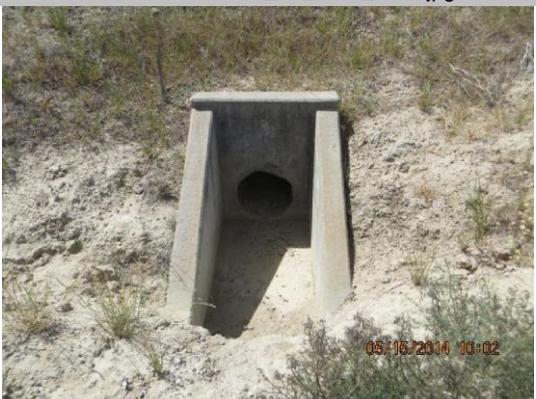
Photo 1 of 3 : UCIP\_FA\_2015\_6711.jpg

Headwall on LS toe.

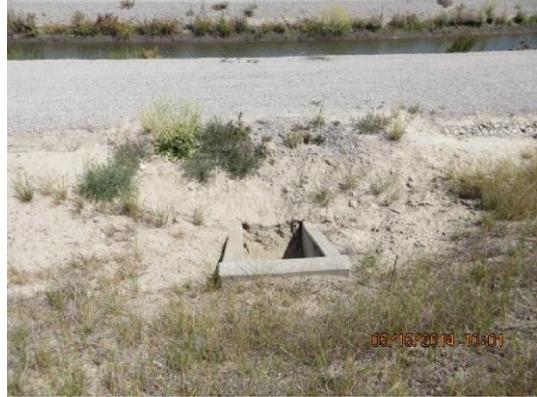
Photo 2 of 3 : UCIP\_FA\_2015\_6712.jpg

Headwall on LS toe.

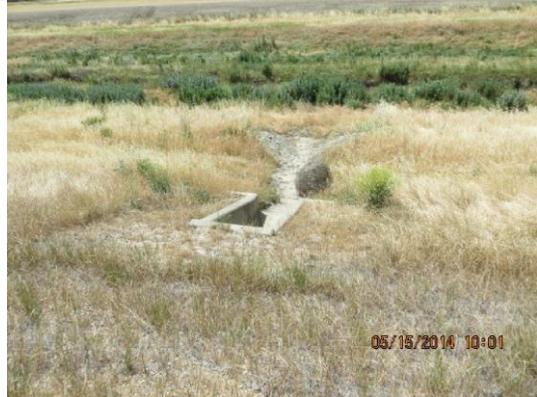
Photo 3 of 3 : UCIP\_FA\_2015\_6713.jpg

Headwall and flapgate on WS toe.

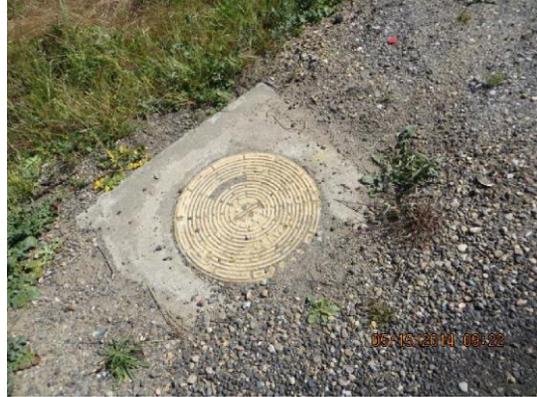
Photo 2 of 3 : UCIP\_FA\_2015\_2457.jpg

Access lid between vault and levee crown.

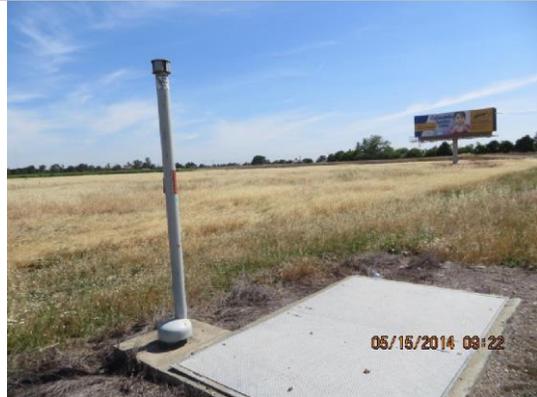
Photo 3 of 3 : UCIP\_FA\_2015\_2458.jpg

Vault, 400-feet west of levee crown.

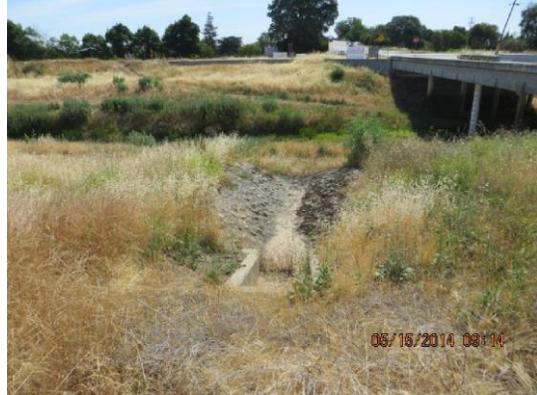
Photo 1 of 3 : UCIP\_FA\_2015\_6573.jpg

Headwall, pipe, flapgates, and grouted spillway on WS toe.

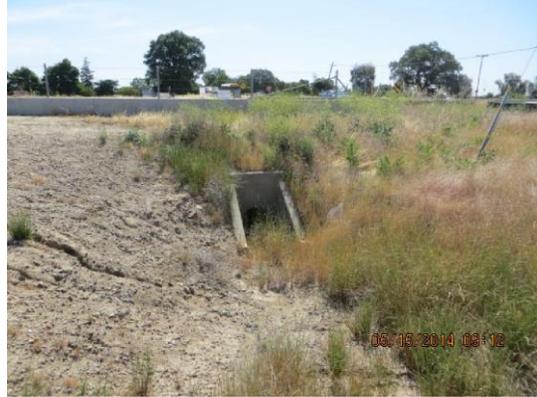
Photo 3 of 3 : UCIP\_FA\_2015\_6575.jpg

Pipe and headwall on LS toe.

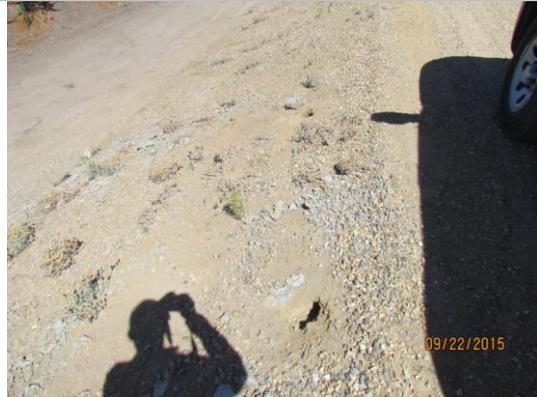
Photo 1 of 1 : FA\_2015\_NA0017\_151\_40\_20150928\_00064.jpg

LM Start	<b>6.60</b>	Rating **	M	Issue No.	<b>40</b>
LM End	<b>6.60</b>	Issue Type +	Ma	Location *	LS
Category	Earthen Levee			GPS Latitude/Longitude	
				Start	End
Item	Animal Control			38.059303 °	38.059303 °
				-121.261736 °	-121.261736 °
DWR ID	DWR_NA0017_07_f_2015_40				
Action/Comments					
No rodents visible, but rodent burrows visible; need to backfill and compact or grout burrows.

Rodent holes were found on the landside slope of the levee looking upstream.

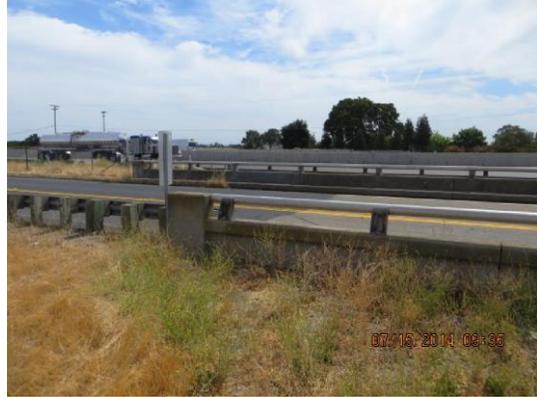
Photo 1 of 2 : UCIP\_FA\_2015\_6220.jpg

LM Start	<b>6.74</b>	Rating **	U	Issue No.	<b>1074</b>
LM End	<b>6.74</b>	Issue Type +	En	Location *	LS
Category	Supplemental			GPS Latitude/Longitude	
				Start	End
Item	DWR UCIP Field Study			38.060903 °	38.060903 °
				-121.260002 °	-121.260002 °
DWR ID					
Action/Comments					
Inspector Comments: FS_ID:39743 DS_ID:23558 EP_NO: 4286A FS_HLM: 7.129 Repair Type: Urgent Crossing Status: Not Found UCIP Comments: Need to have PG&E locate and permanently mark gasoline crossing. FIELD_STRUCT_DESC: 8-inch high pressure gas main through the levee, 3.7 feet below the crown. No marker visible. Application No. 4286, 1963. Included in O&M Manual Bear Creek Part 1, June 1965. FS Date: 05/22/2014

No signs or markers found on either levee.

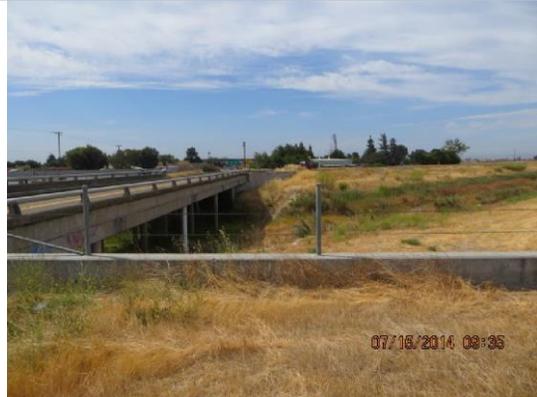
Photo 2 of 2 : UCIP\_FA\_2015\_6266.jpg

No signs or markers found on either levee.

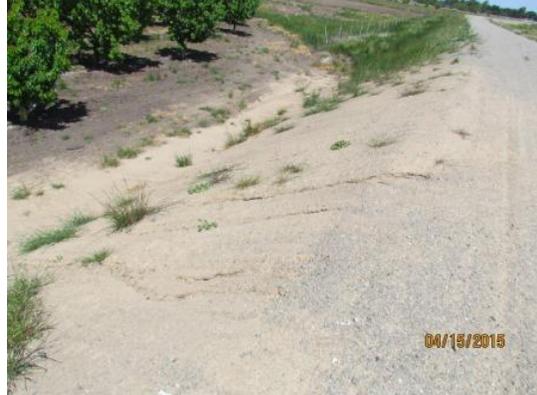
Photo 1 of 1 : FA\_2015\_NA0017\_151\_63\_20150911\_00030.jpg

LM Start	<b>7.09</b>	Rating **	M	Issue No.	<b>63</b>
LM End	<b>7.09</b>	Issue Type +	Ma	Location *	LS
Category	Earthen Levee		GPS Latitude/Longitude		
			Start	End	
Item	Slope Stability		38.063929 °	38.063929 °	
			-121.254950 °	-121.254950 °	
DWR ID	DWR_NA0017_07_s_2015_63				
Action/Comments					
Repair slope instability. Inspector Comments: Runoff

Slope instability was found on the landside of the levee looking upstream.

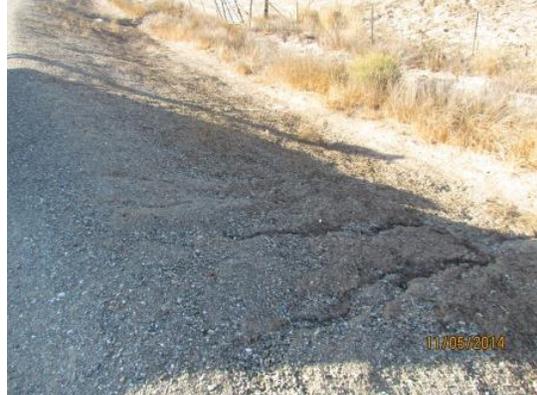
Photo 1 of 1 : FA\_2015\_NA0017\_151\_102\_20150911\_00048.jpg

LM Start	<b>7.33</b>	Rating **	M	Issue No.	<b>102</b>
LM End	<b>7.33</b>	Issue Type +	Ma	Location *	LS
Category	Earthen Levee		GPS Latitude/Longitude		
			Start	End	
Item	Erosion / Bank Caving		38.064983 °	38.064983 °	
			-121.251043 °	-121.251043 °	
DWR ID	DWR_NA0017_07_f_2014_102				
Action/Comments					
Schedule repair of erosion site prior to the next inspection. Inspector Comments: Runoff

View of erosion caused by runoff found on the landside of the levee looking downstream.

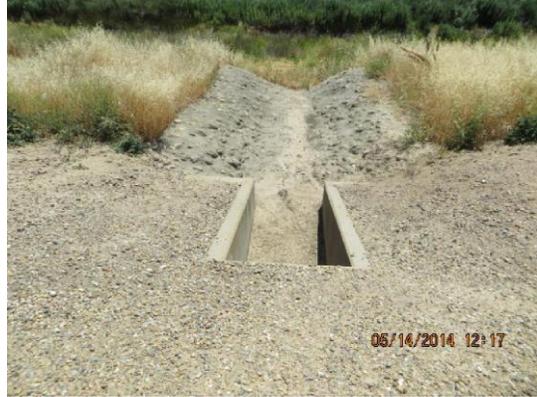
Photo 1 of 3 : UCIP\_FA\_2015\_6408.jpg

LM Start	<b>8.34</b>	Rating **	M	Issue No.	<b>1075</b>
LM End	<b>8.34</b>	Issue Type +	En	Location *	LS
Category	Supplemental			GPS Latitude/Longitude	
				Start	End
Item	DWR UCIP Field Study			38.067959 °	38.067959 °
				-121.233443 °	-121.233443 °
DWR ID					
Action/Comments					
Inspector Comments: FS_ID:37826 DS_ID:23572 EP_NO: N/A FS_HLM: 8.767 Repair Type: Non-Urgent Crossing Status: Found UCIP Comments: A gap at the joint between pipe sections was noted inside pipe at LS toe. This may indicate a need for further maintenance. FIELD_STRUCT_DESC: 36-inch CM stormdrain pipe through the levee, 7.0-feet below the crown. Flap gate on the waterward end. Concrete "U" headwalls on both ends. Cobble grouted spillway across the berm. Cobble grouted apron on the landward end. O&M Manual Bear Creek Part 2, 1967. FS Date: 05/14/2014

Headwall, pipe, flapgate, and grouted spillway on WS toe.

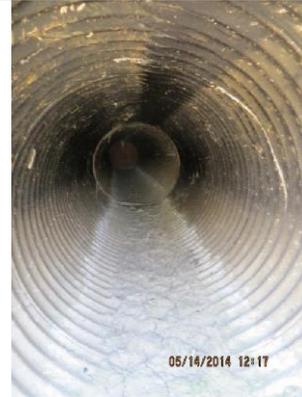
Photo 2 of 3 : UCIP\_FA\_2015\_6409.jpg

Inside pipe at LS toe. Note gap at joint between pipes.

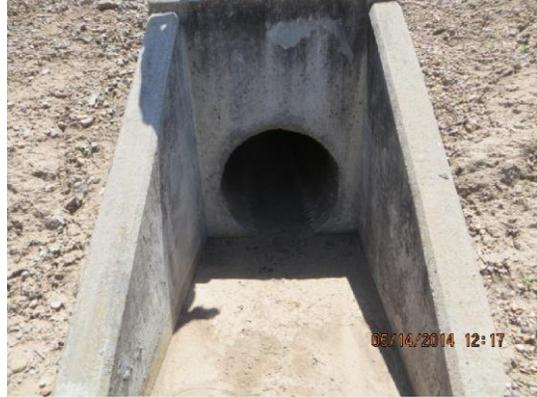
Photo 3 of 3 : UCIP\_FA\_2015\_6410.jpg

Pipe and headwall on LS toe.

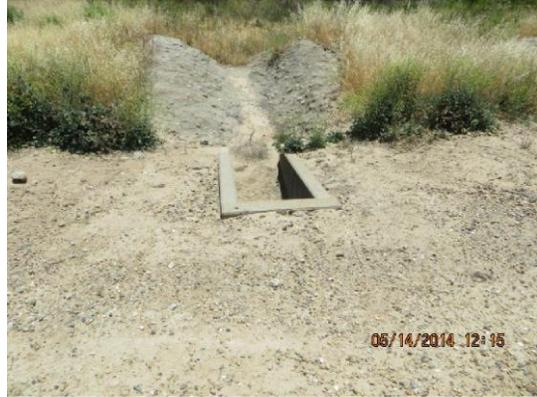
Photo 2 of 3 : UCIP\_FA\_2015\_6244.jpg

Pipe, headwall, flapgate, and grouted spillway on WS toe.

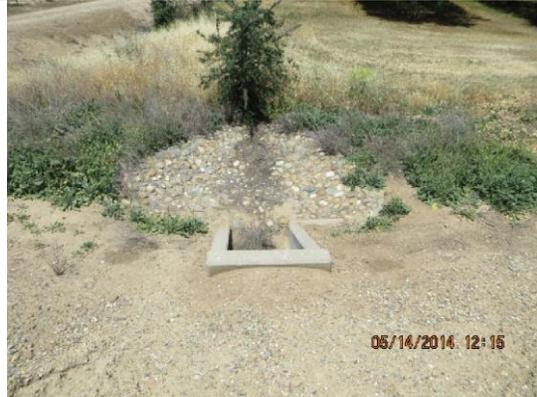
Photo 3 of 3 : UCIP\_FA\_2015\_6407.jpg

Pipe and headwall on LS toe.

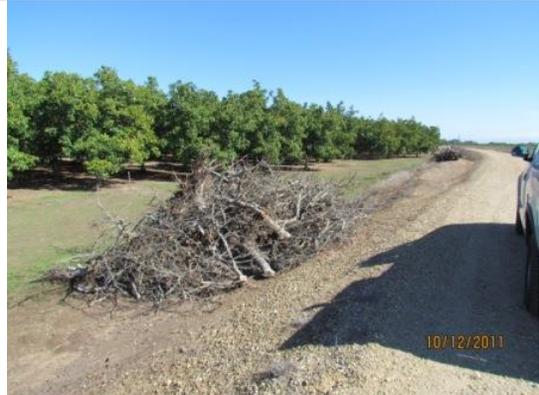
Photo 1 of 1 : FA\_2015\_NA0017\_151\_29\_20150911\_00009.jpg

LM Start	<b>8.44</b>	Rating **	M	Issue No.	<b>29</b>
LM End	<b>8.44</b>	Issue Type +	Ma	Location *	LS
Category	Earthen Levee		GPS Latitude/Longitude		
			Start	End	
Item	Encroachments		38.068319 °	38.068319 °	
			-121.231559 °	-121.231559 °	
DWR ID	DWR_NA0017_07_s_2012_29				
Action/Comments					
Prunings Inspector Comments: Burn pile has been burned but new material has been placed.

View of prunings found on the landside of the levee looking upstream.

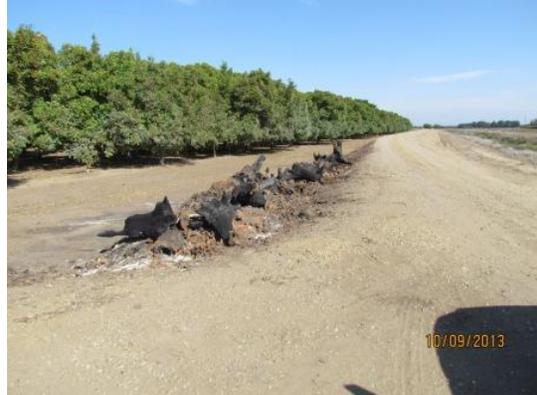
Photo 1 of 2 : FA\_2015\_NA0017\_151\_31\_20150911\_00010.jpg

LM Start	<b>8.74</b>	Rating **	M	Issue No.	<b>31</b>
LM End	<b>8.74</b>	Issue Type +	En	Location *	LS
Category	Earthen Levee		GPS Latitude/Longitude		
			Start	End	
Item	Encroachments		38.070231 °	38.070231 °	
			-121.226677 °	-121.226677 °	
DWR ID	DWR_NA0017_07_s_2012_31				
Action/Comments					
Prunings Inspector Comments: Burn pile has been burned but new material has been placed.

Updated picture of the burning piles on the landside of the levee looking upstream.

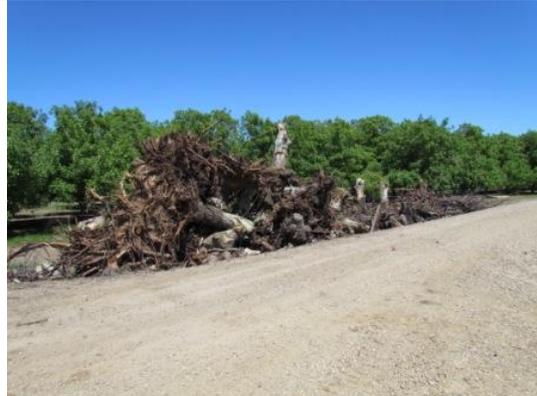
Photo 2 of 2 : FA\_2015\_NA0017\_151\_31\_20150911\_00011.jpg

Burn piles on the landside of the levee. The picture was taken from the crown of the levee looking upstream.

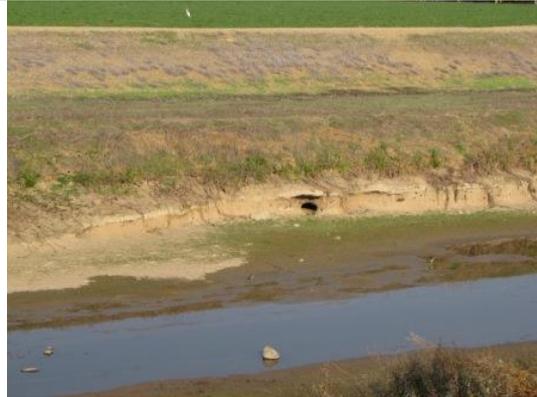
Photo 1 of 1 : FA\_2015\_NA0017\_151\_80\_20150911\_00035.jpg

LM Start	<b>9.65</b>	Rating **	U	Issue No.	<b>80</b>
LM End	<b>9.65</b>	Issue Type +	Ma	Location *	WS
Category	Earthen Levee			GPS Latitude/Longitude	
				Start	End
Item	Animal Control			38.070458 °	38.070458 °
				-121.218596 °	-121.218596 °
DWR ID	DWR_NA0017_07_s_2012_80				
Action/Comments					
No rodents visible, but rodent burrows visible; need to backfill and compact or grout burrows. Inspector Comments: Beaver den in the waterward berm visible from the opposite bank.

View of a large hole and several smaller holes from across the channel.

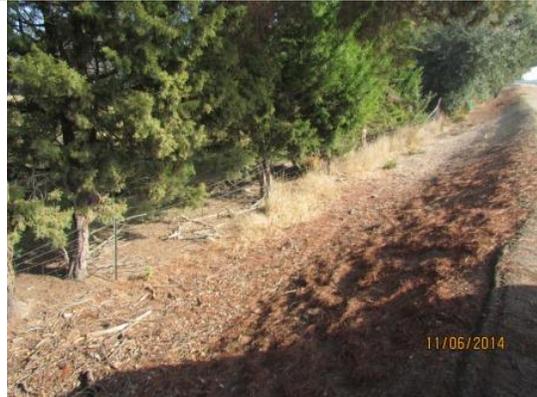
Photo 1 of 1 : FA\_2015\_NA0017\_151\_48\_20150911\_00020.jpg

LM Start	<b>9.68</b>	Rating **	M	Issue No.	<b>48</b>
LM End	<b>10.15</b>	Issue Type +	En	Location *	LS
Category	Earthen Levee			GPS Latitude/Longitude	
				Start	End
Item	Encroachments			38.074323 °	38.078813 °
				-121.211309 °	-121.205763 °
DWR ID	DWR_NA0017_07_s_2012_48				
Action/Comments					
Fence

View of fences found on the landside toe of the levee looking upstream.

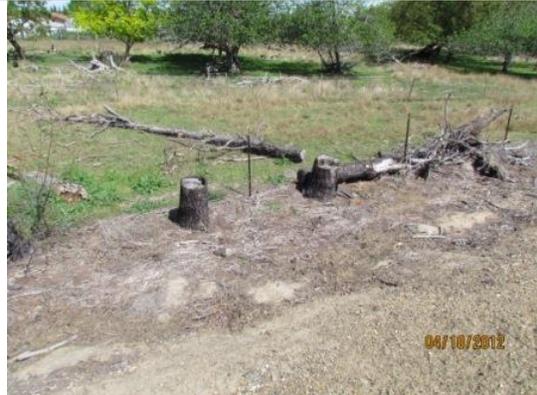
Photo 1 of 1 : FA\_2015\_NA0017\_151\_46\_20150911\_00019.jpg

LM Start	<b>9.76</b>	Rating **	N	Issue No.	<b>46</b>
LM End	<b>9.76</b>	Issue Type +	Ma	Location *	LS
Category	Earthen Levee			GPS Latitude/Longitude	
				Start	End
Item	Trim / Thin Trees			38.074613 °	38.074613 °
				-121.209882 °	-121.209882 °
DWR ID	DWR_NA0017_07_s_2012_46				
Action/Comments					
Tree stumps.

View of tree stumps found on the landside of the levee looking upstream.

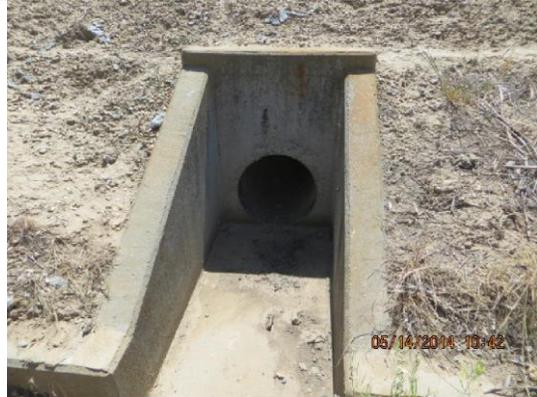
Photo 1 of 3 : UCIP\_FA\_2015\_6653.jpg

Inspector Comments: FS\_ID:41804  
 DS\_ID:23585  
 EP\_NO: N/A  
 FS\_HLM: 10.446  
 Repair Type: Non-Urgent  
 Crossing Status: Found  
 UCIP Comments: Some silt buildup in pipe.  
 FIELD\_STRUCT\_DESC: 24-inch CM stormdrain pipe through the levee, 7.5-feet below the crown. Flap gate on the waterward end. Concrete "U" headwalls on both ends. Cobble grouted spillway across the berm. O&M Manual Bear Creek Part 2, 1967. Included in O&M Manual Bear Creek Addendum, February 1999.  
 FS Date: 05/14/2014

Pipe and headwall on LS toe.

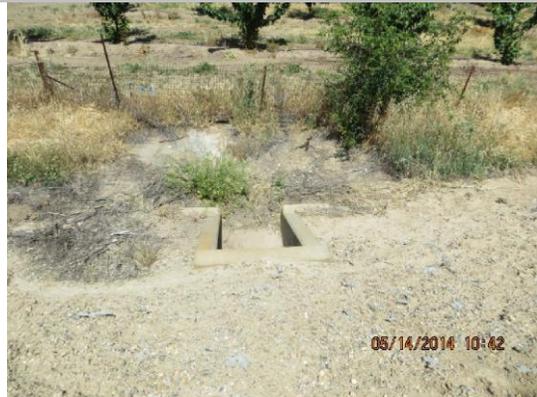
Photo 2 of 3 : UCIP\_FA\_2015\_6654.jpg

Pipe and headwall on LS toe.

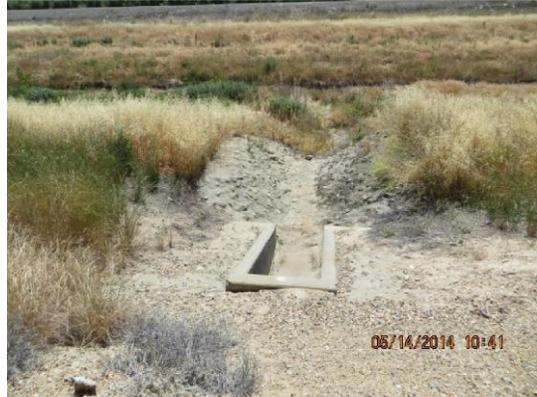
Photo 3 of 3 : UCIP\_FA\_2015\_6655.jpg

Headwall, pipe, flapgate, and grouted spillway on WS toe.

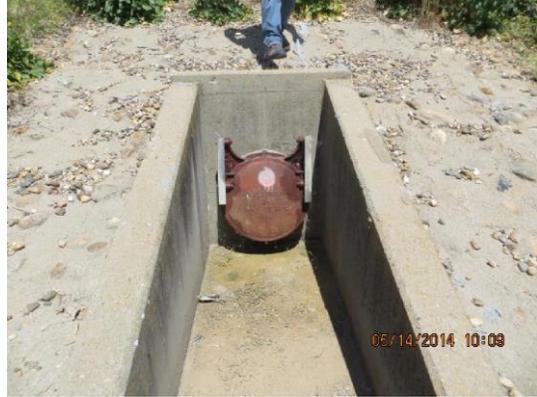
Photo 1 of 3 : UCIP\_FA\_2015\_6547.jpg

Inspector Comments: FS\_ID:41805  
 DS\_ID:23587  
 EP\_NO: N/A  
 FS\_HLM: 11.136  
 Repair Type: Non-Urgent  
 Crossing Status: Found  
 UCIP Comments: Silt buildup in pipe at LS toe.  
 FIELD\_STRUCT\_DESC: 24-inch CM stormdrain pipe through the levee, 6.5-feet below the crown. Flap gate on the waterward end. Concrete "U" headwall on both ends. Cobble grouted spillway across the berm. Cobble grouted apron on the waterward end. O&M Manual Bear Creek Part 2, 1967.  
 FS Date: 05/14/2014

Pipe, flapgate, and headwall on WS toe.

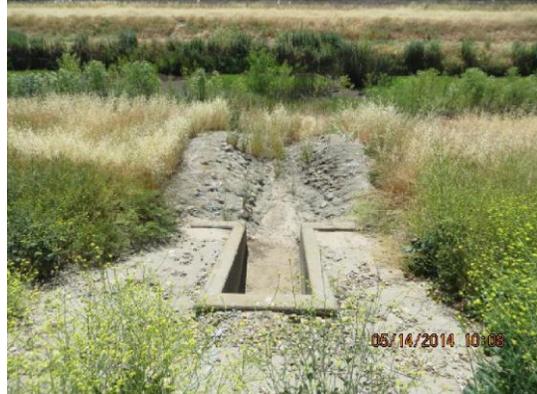
Photo 2 of 3 : UCIP\_FA\_2015\_6548.jpg

Pipe, flapgate, headwall, and grouted spillway on WS toe.

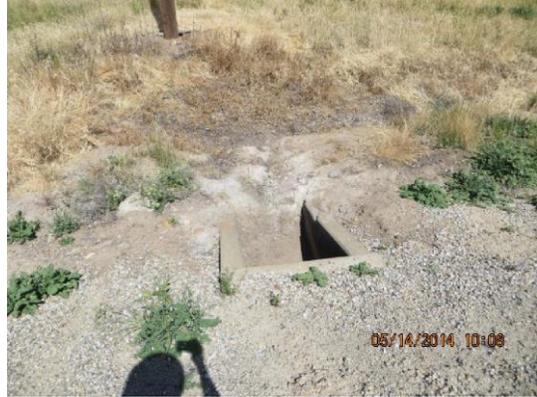
Photo 3 of 3 : UCIP\_FA\_2015\_6549.jpg

Pipe and headwall on LS toe.

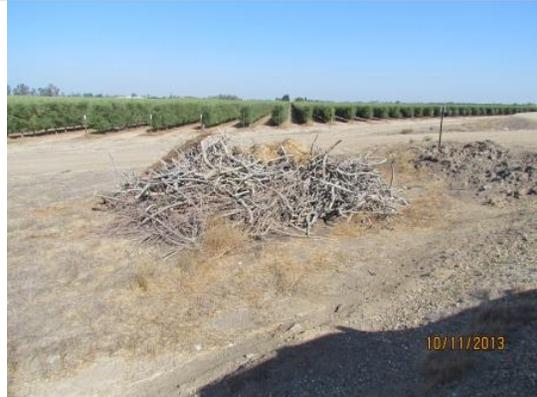
Photo 1 of 1 : FA\_2015\_NA0017\_151\_44\_20150911\_00018.jpg

LM Start	<b>11.24</b>	Rating **	M	Issue No.	<b>44</b>
LM End	<b>11.24</b>	Issue Type +	En	Location *	LS
Category	Earthen Levee			GPS Latitude/Longitude	
				Start	End
Item	Encroachments			38.086900 °	38.086900 °
				-121.189617 °	-121.189617 °
DWR ID	DWR_NA0017_07_f_2013_44				
Action/Comments					
Prunings

Prunings were found on the landside of the levee looking upstream.

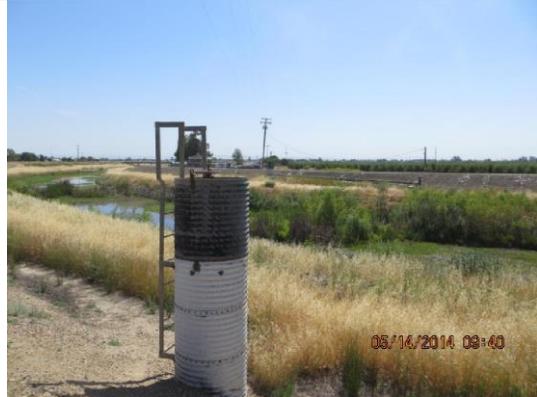
Photo 1 of 3 : UCIP\_FA\_2015\_6525.jpg

LM Start	11.65	Rating **	M	Issue No.	1079
LM End	11.65	Issue Type +	En	Location *	LS
Category	Supplemental		GPS Latitude/Longitude		
			Start	End	
Item	DWR UCIP Field Study		38.091106 °	38.091106 °	
			-121.185094 °	-121.185094 °	
DWR ID					
Action/Comments					
Inspector Comments: FS_ID:40205 DS_ID:23591 EP_NO: N/A FS_HLM: 12.153 Repair Type: Non-Urgent Crossing Status: Found UCIP Comments: Pipe rusted through at connection to slide gate inside standpipe (see picture). FIELD_STRUCT_DESC: 12-inch steel siphon pipe through the levee, 8.0 feet below the crown. Slide gate in CMP riser on the waterward slope. Concrete standpipe on the landward side. Siphon cleanout in center of channel. O&M Manual Bear Creek Part 2, 1967. FS Date: 05/14/2014

Slide gate in CMP riser on WS slope.

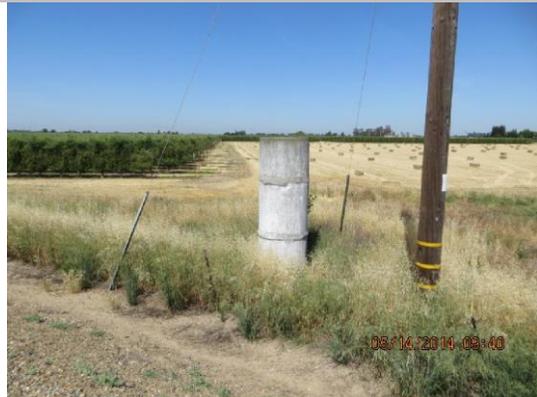
Photo 2 of 3 : UCIP\_FA\_2015\_6526.jpg

Concrete standpipe off LS toe.

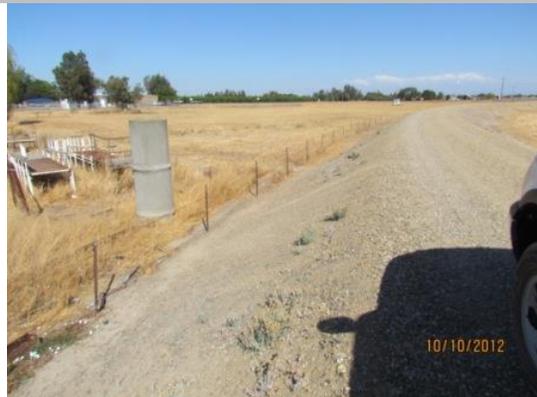
Photo 1 of 1 : FA\_2015\_NA0017\_151\_49\_20150911\_00021.jpg

LM Start	<b>11.71</b>	Rating **	M	Issue No.	<b>49</b>
LM End	<b>12.72</b>	Issue Type +	En	Location *	LS
Category	Earthen Levee			GPS Latitude/Longitude	
				Start	End
Item	Encroachments			38.091665 °	38.101502 °
				-121.184428 °	-121.177753 °
DWR ID	DWR_NA0017_07_f_2012_49				
Action/Comments					
Fence

Fence was found on the landside toe of the levee looking upstream.

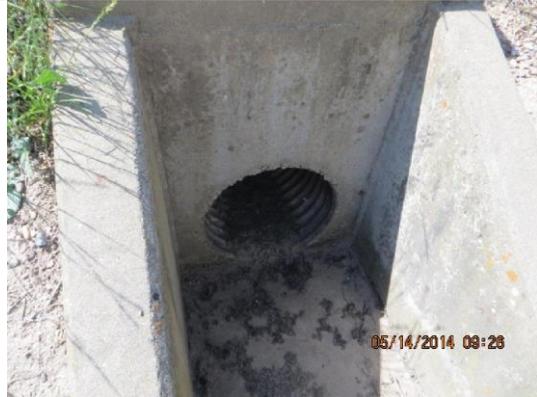
Photo 1 of 3 : UCIP\_FA\_2015\_6522.jpg

LM Start	11.78	Rating **	M	Issue No.	1080
LM End	11.78	Issue Type +	En	Location *	LS
Category	Supplemental			GPS Latitude/Longitude	
				Start	End
Item	DWR UCIP Field Study			38.092076 °	38.092076 °
				-121.183118 °	-121.183118 °
DWR ID					
<b>Action/Comments</b>					
Inspector Comments: FS_ID:37753 DS_ID:23593 EP_NO: N/A FS_HLM: 12.286 Repair Type: Non-Urgent Crossing Status: Found UCIP Comments: Some rocky debris buildup inside pipe on LS toe. FIELD_STRUCT_DESC: 24-inch CM pipe through the levee, 8.5-feet below the crown. Flap gate on the waterward end. Concrete "U" headwalls on both ends. Cobble grouted spillway across the berm. Cobble grouted apron on the landward end. O&M Manual Bear Creek Part 2, 1967. FS Date: 05/14/2014

Pipe and headwall on LS toe.

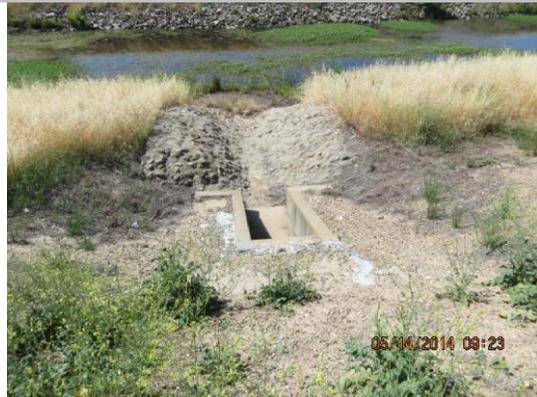
Photo 2 of 3 : UCIP\_FA\_2015\_6523.jpg

Pipe, flapgate, headwall, and grouted spillway on WS toe.

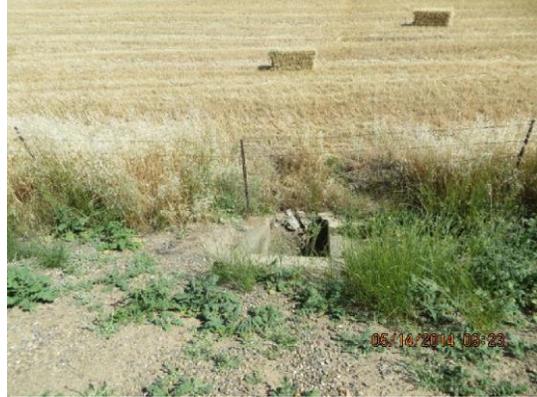
Photo 3 of 3 : UCIP\_FA\_2015\_6524.jpg

Pipe and headwall on LS toe.

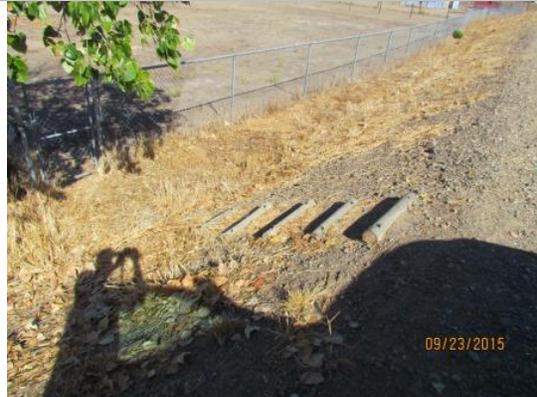
Photo 1 of 1 : FA\_2015\_NA0017\_151\_47\_20150928\_00065.jpg

LM Start	<b>12.31</b>	Rating **	M	Issue No.	<b>47</b>
LM End	<b>12.31</b>	Issue Type +	En	Location *	LS
Category	Earthen Levee			GPS Latitude/Longitude	
				Start	End
Item	Encroachments			38.095915 °	38.095915 °
				-121.176657 °	-121.176657 °
DWR ID	DWR_NA0017_07_f_2015_47				
Action/Comments					
Stairway

Stairway was found on the landside of the levee looking upstream.

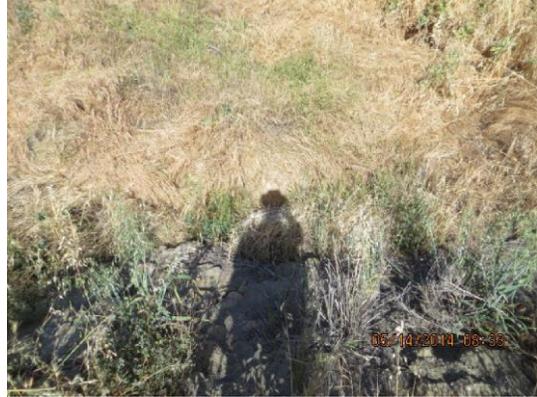
Photo 1 of 3 : UCIP\_FA\_2015\_6361.jpg

LM Start	<b>12.53</b>	Rating **	M	Issue No.	<b>1081</b>
LM End	<b>12.53</b>	Issue Type +	En	Location *	LS
Category	Supplemental			GPS Latitude/Longitude	
				Start	End
Item	DWR UCIP Field Study			38.099065 °	38.099065 °
				-121.176315 °	-121.176315 °
DWR ID					
<b>Action/Comments</b>					
Inspector Comments: FS_ID:37726 DS_ID:23511 EP_NO: N/A FS_HLM: 13.046 Repair Type: Non-Urgent Crossing Status: Found UCIP Comments: Pipe appears abandoned and if so should be done so properly. No actuator for slide gate and no cover for standpipe = attractive nuisance/hazard. FIELD_STRUCT_DESC: 36-inch CM irrigation outlet pipe through the levee, 8.0-feet below the crown. Pipe open on both ends. Slide gate in CM riser on the waterward slope. Concrete "U" headwall on the waterward end. Cobble grouted around headwall. O&M Manual Bear Creek Part 2, 1967. FS Date: 05/14/2014

Pipe at inlet off LS toe.

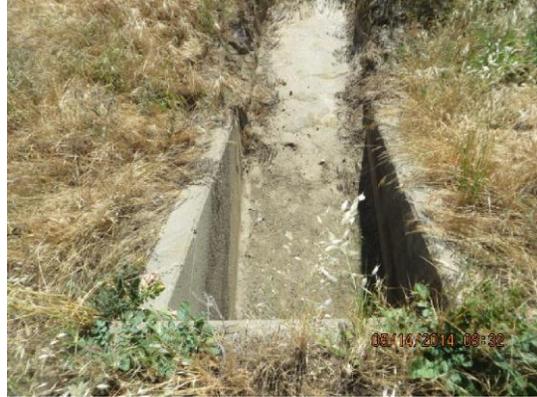
Photo 3 of 3 : UCIP\_FA\_2015\_6363.jpg

Pipe and headwall on WS slope.

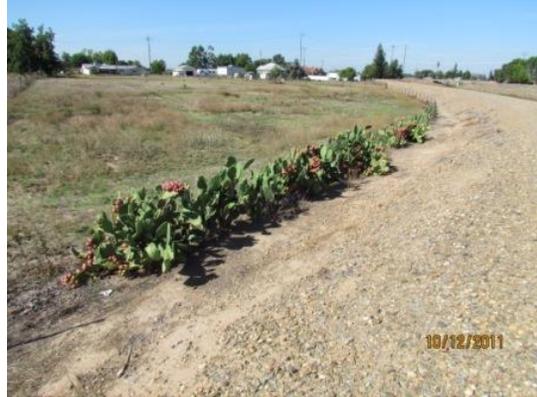
Photo 1 of 1 : FA\_2015\_NA0017\_151\_42\_20150911\_00016.jpg

LM Start	<b>12.54</b>	Rating **	M	Issue No.	<b>42</b>
LM End	<b>12.54</b>	Issue Type +	En	Location *	LS
Category	Earthen Levee			GPS Latitude/Longitude	
				Start	End
Item	Vegetation			38.099206 °	38.099206 °
				-121.176350 °	-121.176350 °
DWR ID	DWR_NA0017_07_s_2012_42				
Action/Comments					
Landscaping Inspector Comments: Cacti on landward toe and through fence.

Cacti were found on the toe of landside of the levee looking upstream.

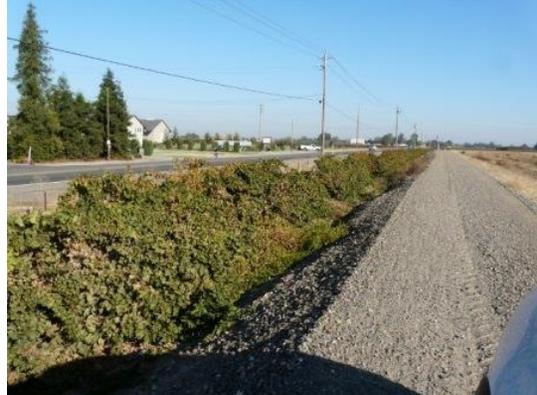
Photo 1 of 1 : FA\_2015\_NA0017\_151\_38\_20150911\_00014.jpg

LM Start	<b>12.84</b>	Rating **	M	Issue No.	<b>38</b>
LM End	<b>12.96</b>	Issue Type +	En	Location *	LS
Category	Earthen Levee			GPS Latitude/Longitude	
				Start	End
Item	Encroachments			38.103297 °	38.104991 °
				-121.177588 °	-121.177134 °
DWR ID	DWR_NA0017_07_s_2012_38				
Action/Comments					
Crops Inspector Comments: Grape vines on the levee toe.

Grape vines within 10' from landside toe of levee.

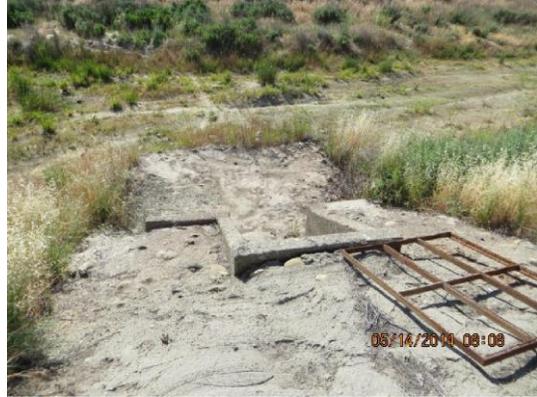
Photo 1 of 3 : UCIP\_FA\_2015\_6358.jpg

Item	DWR UCIP Field Study			38.105190 °	38.105190 °
				-121.177050 °	-121.177050 °
DWR ID					
Action/Comments					
Inspector Comments: FS_ID:37700 DS_ID:23595 EP_NO: N/A FS_HLM: 13.499 Repair Type: Non-Urgent Crossing Status: Found UCIP Comments: Facility appears abandoned and if so should be done so properly. FIELD_STRUCT_DESC: 1 of 3: 12-inch steel irrigation pipe through the levee 3.0-feet below the crown. Concrete cutoff wall on waterward end. 6-foot diameter concrete sump on the waterward berm. Pump mounted on top of sump. 36-inch C.M. intake pipe from channel to sump. 36-inch concrete standpipe on the landward slope. Switch panel on the landward side. Concrete "U" headwall with trash rack on the waterward end. O&M Manual Bear Creek Part 2, 1967. Pumping plant and sump installed under Permit No. 4854 (1967). FS Date: 05/14/2014

Headwall on WS toe.

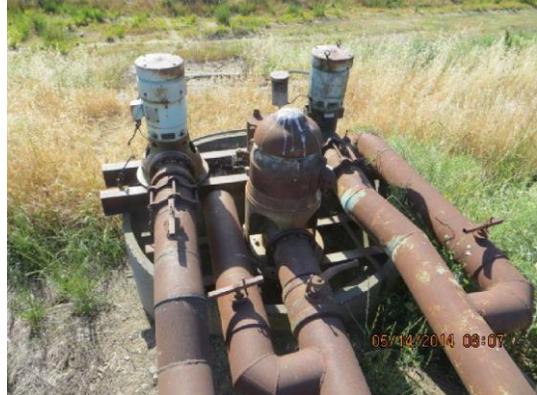
Photo 2 of 3 : UCIP\_FA\_2015\_6359.jpg

Pump and pipe with butterfly valve at right.

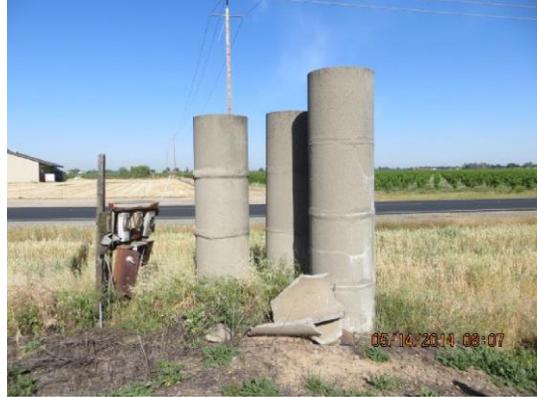
Photo 3 of 3 : UCIP\_FA\_2015\_6360.jpg

Concrete standpipe at left.

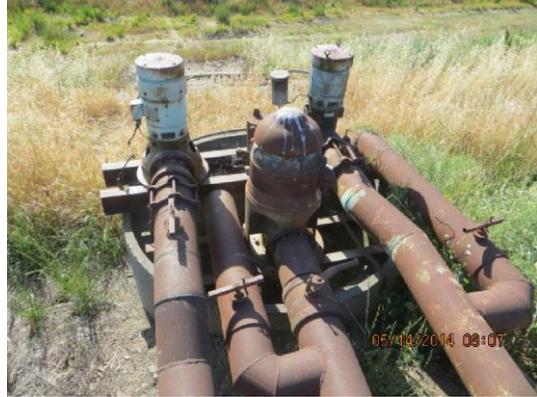
Photo 2 of 3 : UCIP\_FA\_2015\_6356.jpg

LM Start	12.98	Rating **	M	Issue No.	1084 (cont)
LM End	12.98	Issue Type +	En	Location *	LS
Category	Supplemental			GPS Latitude/Longitude	
				Start	End
Item	DWR UCIP Field Study			38.105198 °	38.105198 °
				-121.177040 °	-121.177040 °
DWR ID					
Action/Comments					
Inspector Comments: FS_ID:37699 DS_ID:23687 EP_NO: N/A FS_HLM: 13.5 Repair Type: Non-Urgent Crossing Status: Found UCIP Comments: Facility appears abandoned and if so should be done so properly. FIELD_STRUCT_DESC: 2 of 3: 12-inch steel irrigation pipe through the levee 3.0-feet below the crown. Concrete cutoff wall on waterward end. 6-foot diameter concrete sump on the waterward berm. Pump mounted on top of sump. 36-inch C.M. intake pipe from channel to sump. 36-inch concrete standpipe on the landward slope. Switch panel on the landward side. Concrete "U" headwall with trash rack on the waterward end. O&M Manual Bear Creek Part 2, 1967. Pumping plant and sump installed under Permit No. 4854 (1967). FS Date: 05/14/2014

Pump and butterfly valve on WS berm.

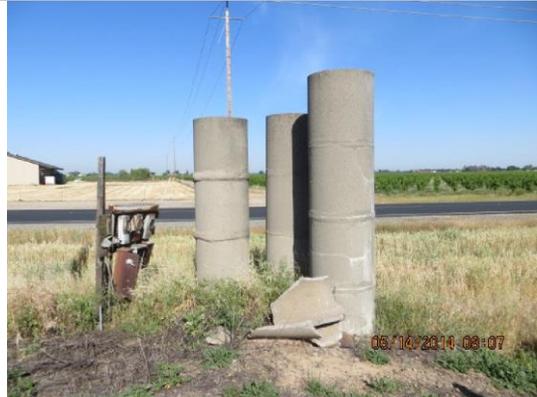
Photo 3 of 3 : UCIP\_FA\_2015\_6357.jpg

Concrete standpipe on LS shoulder.

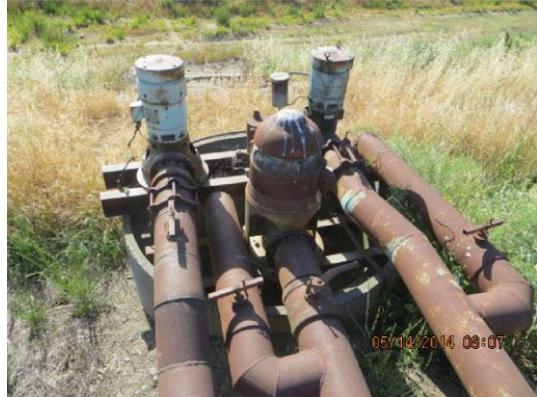
Photo 1 of 3 : UCIP\_FA\_2015\_6352.jpg

LM Start	<b>12.98</b>	Rating **	M	Issue No.	<b>1085</b>
LM End	<b>12.98</b>	Issue Type +	En	Location *	LS
Category	Supplemental			GPS Latitude/Longitude	
				Start	End
Item	DWR UCIP Field Study			38.105200 °	38.105200 °
				-121.177036 °	-121.177036 °
DWR ID					
Action/Comments					
Inspector Comments: FS_ID:37698 DS_ID:23688 EP_NO: N/A FS_HLM: 13.501 Repair Type: Non-Urgent Crossing Status: Found

Pipe and pump visible on WS berm over sump.

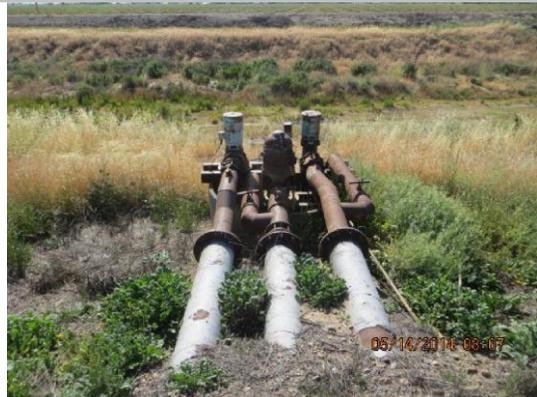
Photo 2 of 3 : UCIP\_FA\_2015\_6353.jpg

Pipe and pump visible on WS berm over sump.

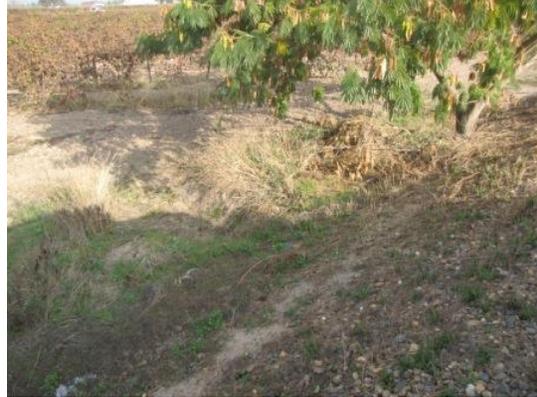
Photo 1 of 1 : FA\_2015\_NA0017\_151\_72\_20150911\_00032.jpg

LM Start	<b>13.03</b>	Rating **	M	Issue No.	<b>72</b>
LM End	<b>13.03</b>	Issue Type +	Ma	Location *	LS
Category	Earthen Levee			GPS Latitude/Longitude	
				Start	End
Item	Slope Stability			38.105846 °	38.105846 °
				-121.176552 °	-121.176552 °
DWR ID	DWR_NA0017_07_s_2012_72				
Action/Comments					
Repair slope instability. Inspector Comments: Shallow pit at the landward toe with nearby prunings.

View of a pit along the landward levee toe looking upstream.

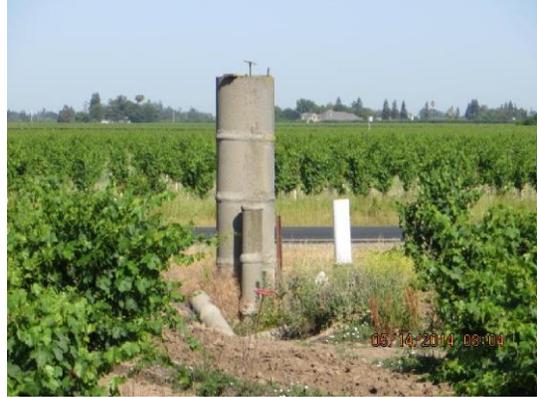
Photo 1 of 3 : UCIP\_FA\_2015\_6187.jpg

LM Start	13.04	Rating **	M	Issue No.	1086
LM End	13.04	Issue Type +	En	Location *	WS
Category	Supplemental			GPS Latitude/Longitude	
				Start	End
Item	DWR UCIP Field Study			38.105874 °	38.105874 °
				-121.176441 °	-121.176441 °
DWR ID					
Action/Comments					
Inspector Comments: FS_ID:37692 DS_ID:23596 EP_NO: N/A FS_HLM: 13.558 Repair Type: Non-Urgent Crossing Status: Found UCIP Comments: Possible evidence of leak on LS toe as there is a hole dug over the pipe, see pic. FIELD_STRUCT_DESC: 12-inch steel irrigation siphon pipe through the levee, 3.0 feet below crown. 3-inch vent pipe on the waterward slope. 36-inch concrete standpipe 120-feet off LS toe. O&M Manual Bear Creek Part 2, 1967. FS Date: 05/14/2014

Concrete standpipe 120-feet off LS toe.

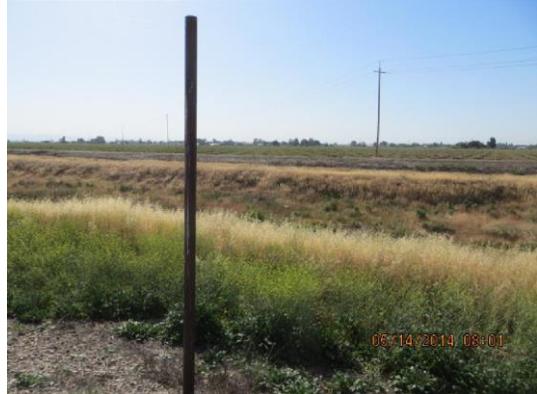
Photo 2 of 3 : UCIP\_FA\_2015\_6188.jpg

Vent pipe on WS slope.

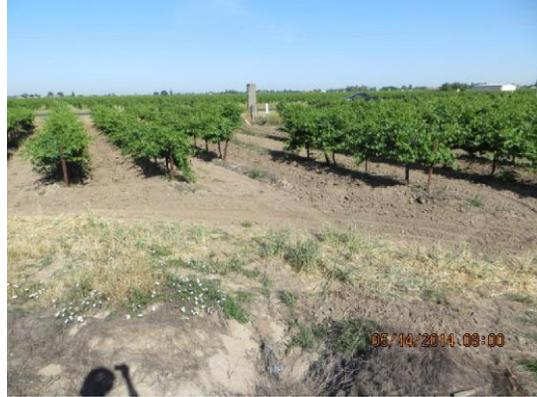
Photo 3 of 3 : UCIP\_FA\_2015\_6189.jpg

Large hole over pipe in foreground with concrete standpipe 120-feet off LS toe.

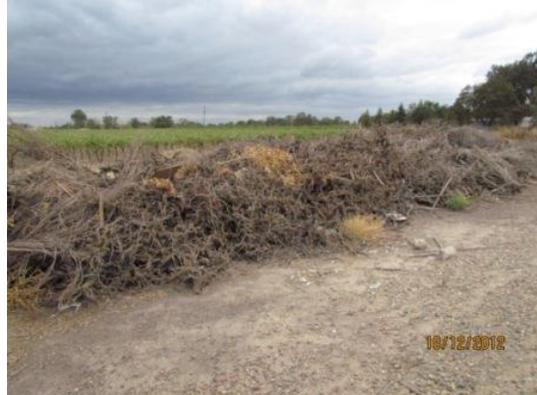
Photo 1 of 1 : FA\_2015\_NA0017\_151\_57\_20150911\_00026.jpg

LM Start	<b>13.43</b>	Rating **	M	Issue No.	<b>57</b>
LM End	<b>13.43</b>	Issue Type +	En	Location *	LS
Category	Earthen Levee			GPS Latitude/Longitude	
				Start	End
Item	Encroachments			38.110491 °	38.110491 °
				-121.172863 °	-121.172863 °
DWR ID	DWR_NA0017_07_f_2012_57				
Action/Comments					
Prunings

Prunings were found on the landside of the levee. The picture was taken from the crown looking towards the toe of the levee.

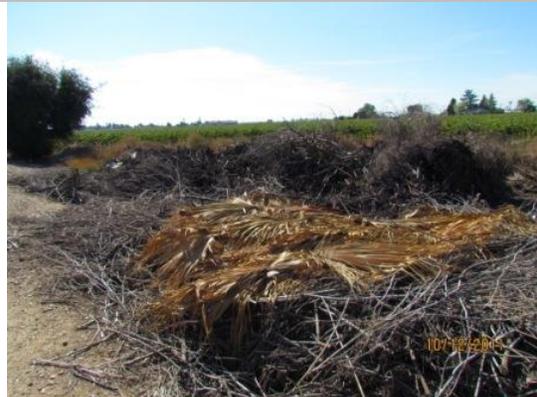
Photo 1 of 1 : FA\_2015\_NA0017\_151\_807\_20150911\_00056.jpg

LM Start	<b>13.45</b>	Rating **	M	Issue No.	<b>807</b>
LM End	<b>13.45</b>	Issue Type +	En	Location *	LS
Category	Earthen Levee			GPS Latitude/Longitude	
				Start	End
Item	Encroachments			38.110753 °	38.110753 °
				-121.172829 °	-121.172829 °
DWR ID	DWR_NA0017_07_s_2012_807				
Action/Comments					
Debris

Pruning and debris were found on the landside of the levee looking downstream.

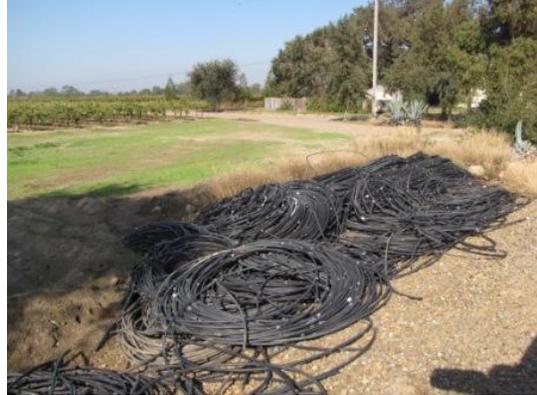
Photo 1 of 1 : FA\_2015\_NA0017\_151\_1053\_20150911\_00060.jpg

LM Start	<b>13.46</b>	Rating **	M	Issue No.	<b>1053</b>
LM End	<b>13.46</b>	Issue Type +	En	Location *	LS
Category	Earthen Levee		GPS Latitude/Longitude		
			Start	End	
Item	Encroachments		38.111026 °	38.111026 °	
			-121.172823 °	-121.172823 °	
DWR ID	DWR_NA0017_07_s_2012_1053				
Action/Comments					
Material

View of irrigation pipe on the landward slope.

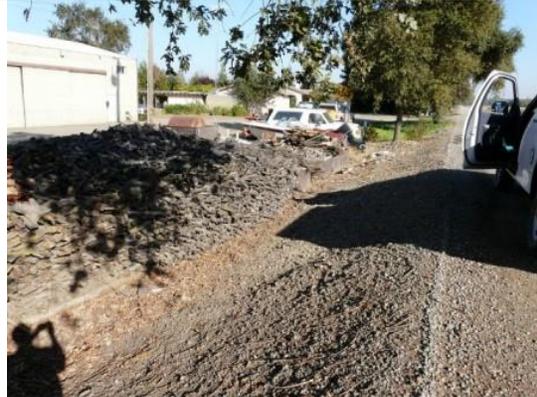
Photo 1 of 1 : FA\_2015\_NA0017\_151\_39\_20150911\_00015.jpg

LM Start	<b>13.52</b>	Rating **	M	Issue No.	<b>39</b>
LM End	<b>13.52</b>	Issue Type +	Ma	Location *	LS
Category	Earthen Levee		GPS Latitude/Longitude		
			Start	End	
Item	Encroachments		38.111902 °	38.111902 °	
			-121.172685 °	-121.172685 °	
DWR ID	DWR_NA0017_07_s_2012_39				
Action/Comments					
Firewood

Firewood was found on the landside toe of the levee.

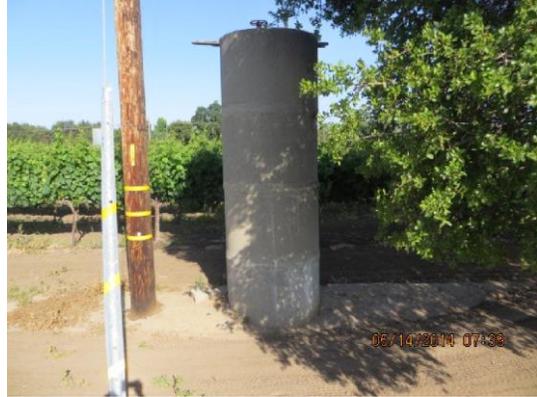
Photo 1 of 3 : UCIP\_FA\_2015\_6139.jpg

Inspector Comments: FS\_ID:37688  
 DS\_ID:23599  
 EP\_NO: N/A  
 FS\_HLM: 14.185  
 Repair Type: Non-Urgent  
 Crossing Status: Found  
 UCIP Comments: Pump and pipe appear abandoned and if so should be done so properly.  
 FIELD\_STRUCT\_DESC: 1 of 2: 8-inch steel irrigation pipe through the levee, 3.0 feet below the crown. Gate valve on the waterward slope. Pump mounted over 36-inch CMP sump on the waterward berm. 42-inch concrete standpipe on the landside. 1.5-inch galvanized iron electrical conduit at same location. O&M Manual Bear Creek Part 2, 1967.  
 FS Date: 05/14/2014

Concrete standpipe on LS toe.

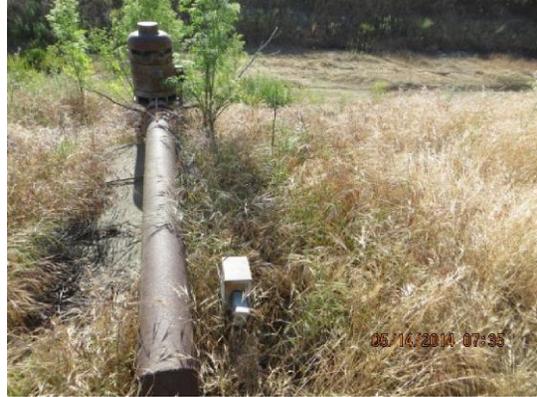
Photo 3 of 3 : UCIP\_FA\_2015\_6141.jpg

LM Start	<b>13.65</b>	Rating **	M	Issue No.	<b>1087 (cont)</b>
LM End	<b>13.65</b>	Issue Type +	En	Location *	WS
Category	Supplemental			GPS Latitude/Longitude	
				Start	End
Item	DWR UCIP Field Study			38.113731 °	38.113731 °
				-121.172456 °	-121.172456 °
DWR ID					
Action/Comments					
Inspector Comments: FS_ID:37688 DS_ID:23599 EP_NO: N/A FS_HLM: 14.185 Repair Type: Non-Urgent Crossing Status: Found

Pump, and pipe on WS berm.
