**Flood Control Project Maintenance  
Levee Inspections**

**Fall 2015 Levee Maintenance Deficiency Summary Report**

**San Joaquin River Basin**

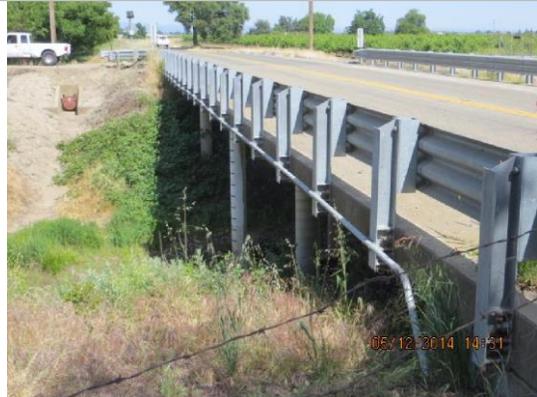
Photo 1 of 1 : UCIP\_FA\_2015\_5885.jpg

LM Start	<b>13.83</b>	Rating **	M	Issue No.	<b>1088</b>
LM End	<b>13.83</b>	Issue Type +	En	Location *	WS
Category	Supplemental			GPS Latitude/Longitude	
				Start	End
Item	DWR UCIP Field Study			38.116365 °	38.116365 °
				-121.172202 °	-121.172202 °
DWR ID					
Action/Comments					
Inspector Comments: FS_ID:41525 DS_ID:24994 EP_NO: N/A FS_HLM: 14.371 Repair Type: Non-Urgent Crossing Status: Found UCIP Comments: No permit identified for this crossing. FIELD_STRUCT_DESC: 2-inch galvanized iron electrical conduit through the levee at an unknown depth below the crown. Attached to upstream side of bridge. FS Date: 05/12/2014

Conduit visible on upstream side of bridge.

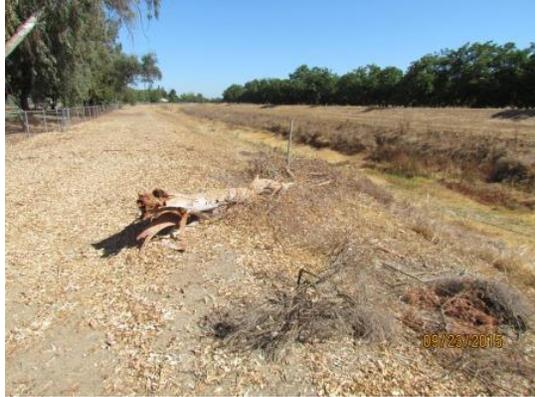
Photo 1 of 1 : FA\_2015\_NA0017\_151\_52\_20150928\_00066.jpg

LM Start	<b>13.88</b>	Rating **	M	Issue No.	<b>52</b>
LM End	<b>13.88</b>	Issue Type +	Ma	Location *	CR
Category	Earthen Levee		GPS Latitude/Longitude		
			Start	End	
Item	Encroachments		38.116971 °	38.116971 °	
			-121.172043 °	-121.172043 °	
DWR ID	DWR_NA0017_07_f_2015_52				
Action/Comments					
Prunings

Prunings were found on the crown of the levee looking upstream.

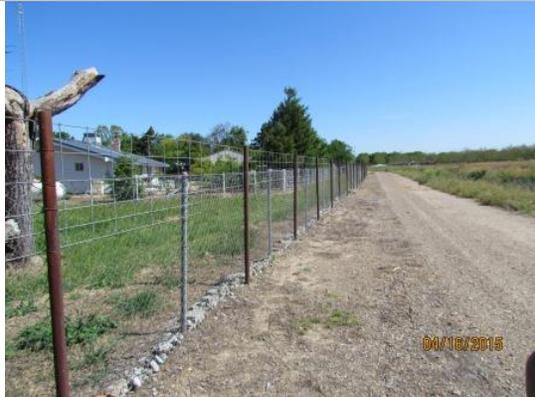
Photo 1 of 1 : FA\_2015\_NA0017\_151\_88\_20150911\_00041.jpg

LM Start	<b>14.07</b>	Rating **	M	Issue No.	<b>88</b>
LM End	<b>14.14</b>	Issue Type +	En	Location *	LS
Category	Earthen Levee		GPS Latitude/Longitude		
			Start	End	
Item	Encroachments		38.119583 °	38.120393 °	
			-121.170861 °	-121.170111 °	
DWR ID	DWR_NA0017_07_s_2015_88				
Action/Comments					
Fence Inspector Comments: Unpermitted fence

A fence was found on the landside of the levee looking upstream.

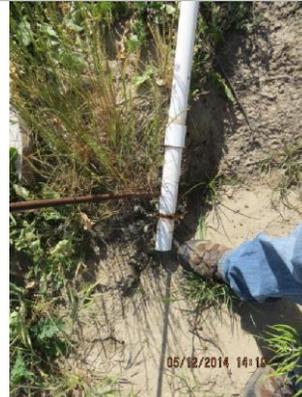
Photo 1 of 3 : UCIP\_FA\_2015\_5882.jpg

LM Start	<b>14.22</b>	Rating **	M	Issue No.	<b>1089</b>
LM End	<b>14.22</b>	Issue Type +	En	Location *	LS
Category	Supplemental		GPS Latitude/Longitude		
			Start	End	
Item	DWR UCIP Field Study		38.121573 °	38.121573 °	
			-121.169566 °	-121.169566 °	
DWR ID					
Action/Comments					
Inspector Comments: FS_ID:41823 DS_ID:24993 EP_NO: N/A FS_HLM: 14.768 Repair Type: Non-Urgent Crossing Status: Found UCIP Comments: No permit identified for this crossing. FIELD_STRUCT_DESC: 1.5-inch PVC drain pipe through the levee 0.5-feet below the crown. Possible irrigation pipe. FS Date: 05/12/2014

Pipe visible on WS toe.

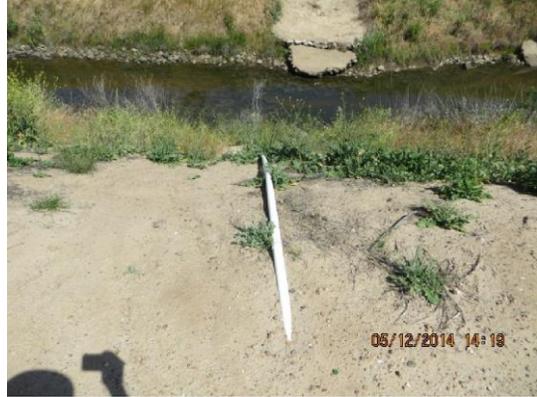
Photo 2 of 3 : UCIP\_FA\_2015\_5883.jpg

LM Start	<b>14.22</b>	Rating **	M	Issue No.	<b>1089 (cont)</b>
LM End	<b>14.22</b>	Issue Type +	En	Location *	LS
Category	Supplemental			GPS Latitude/Longitude	
				Start	End
Item	DWR UCIP Field Study			38.121573 °	38.121573 °
				-121.169566 °	-121.169566 °
DWR ID					
Action/Comments					
Inspector Comments: FS_ID:41823 DS_ID:24993 EP_NO: N/A FS_HLM: 14.768 Repair Type: Non-Urgent Crossing Status: Found UCIP Comments: No permit identified for this crossing. FIELD_STRUCT_DESC: 1.5-inch PVC drain pipe through the levee 0.5-feet below the crown. Possible irrigation pipe. FS Date: 05/12/2014

Pipe visible on WS shoulder and slope.

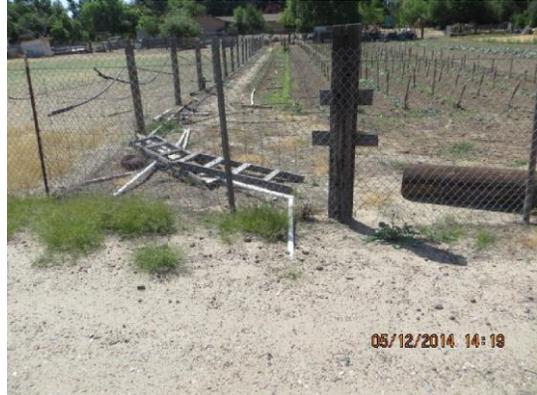
Photo 3 of 3 : UCIP\_FA\_2015\_5884.jpg

Pipe visible on LS shoulder.

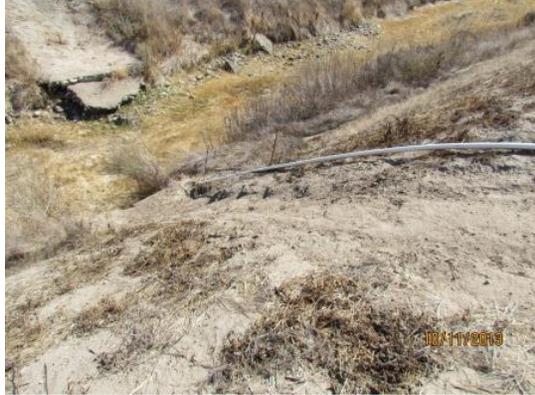
Photo 1 of 1 : FA\_2015\_NA0017\_151\_61\_20150911\_00029.jpg

LM Start	<b>14.23</b>	Rating **	M	Issue No.	<b>61</b>
LM End	<b>14.23</b>	Issue Type +	Ma	Location *	WS
Category	Earthen Levee		GPS Latitude/Longitude		
			Start	End	
Item	Encroachments		38.121625 °	38.121625 °	
			-121.169563 °	-121.169563 °	
DWR ID	DWR_NA0017_07_f_2013_61				
Action/Comments					
Stairway

Steps were found on the waterside slope of the levee looking downstream.

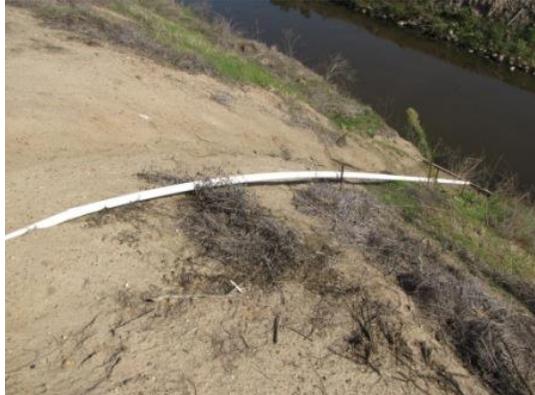
Photo 1 of 1 : FA\_2015\_NA0017\_151\_1054\_20150911\_00061.jpg

LM Start	<b>14.23</b>	Rating **	M	Issue No.	<b>1054</b>
LM End	<b>14.23</b>	Issue Type +	En	Location *	WS
Category	Earthen Levee		GPS Latitude/Longitude		
			Start	End	
Item	Encroachments		38.121661 °	38.121661 °	
			-121.169548 °	-121.169548 °	
DWR ID	DWR_NA0017_07_s_2012_1054				
Action/Comments					
Pipe Inspector Comments: Landowner has installed a pipe in the access road to take water from the channel for irrigation. Steps have also been dug into the side of the channel.

View of a pipe a landowner placed in the access road and waterward slope to pump water from the channel to irrigate their garden.

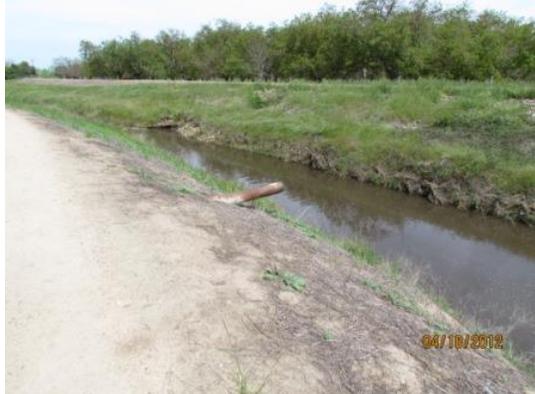
Photo 1 of 1 : FA\_2015\_NA0017\_151\_59\_20150911\_00027.jpg

LM Start	<b>14.25</b>	Rating **	M	Issue No.	<b>59</b>
LM End	<b>14.25</b>	Issue Type +	En	Location *	WS
Category	Earthen Levee		GPS Latitude/Longitude		
			Start	End	
Item	Encroachments		38.121912 °	38.121912 °	
			-121.169421 °	-121.169421 °	
DWR ID	DWR_NA0017_07_s_2012_59				
Action/Comments					
Pipe

A corroded pipe was found on the waterside of the levee looking upstream.

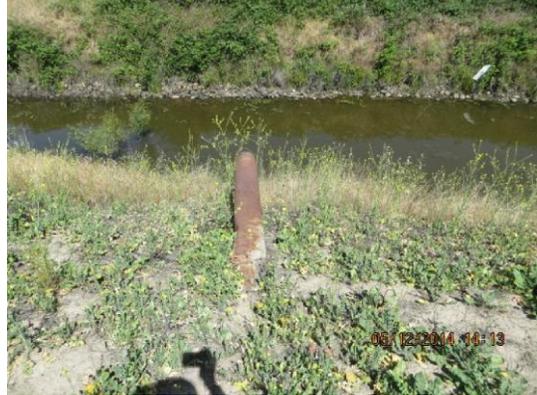
Photo 1 of 1 : UCIP\_FA\_2015\_6693.jpg

LM Start	<b>14.25</b>	Rating **	M	Issue No.	<b>1090</b>
LM End	<b>14.25</b>	Issue Type +	En	Location *	WS
Category	Supplemental			GPS Latitude/Longitude	
				Start	End
Item	DWR UCIP Field Study			38.121993 °	38.121993 °
				-121.169423 °	-121.169423 °
DWR ID					
Action/Comments					
Inspector Comments: FS_ID:37662 DS_ID:23603 EP_NO: N/A FS_HLM: 14.8 Repair Type: Non-Urgent Crossing Status: Found UCIP Comments: Pipe appears abandoned and if so should be done so properly. FIELD_STRUCT_DESC: 8-inch steel stormdrain pipe through the levee 1.5-feet below the crown. Not visible on LS. FS Date: 05/12/2014

Pipe on WS slope.

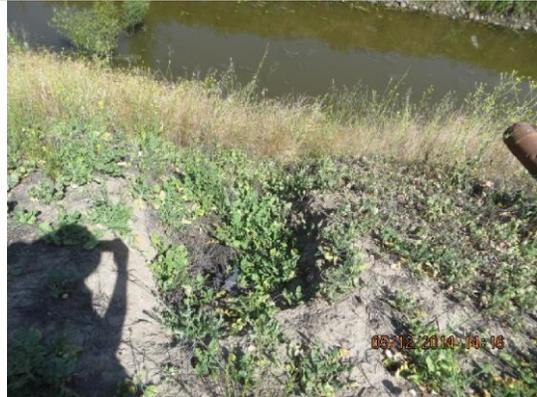
Photo 1 of 2 : UCIP\_FA\_2015\_5880.jpg

LM Start	<b>14.26</b>	Rating **	M	Issue No.	<b>1091</b>
LM End	<b>14.26</b>	Issue Type +	En	Location *	WS
Category	Supplemental			GPS Latitude/Longitude	
				Start	End
Item	DWR UCIP Field Study			38.122029 °	38.122029 °
				-121.169428 °	-121.169428 °
DWR ID					
Action/Comments					
Inspector Comments: FS_ID:41370 DS_ID:24992 EP_NO: N/A FS_HLM: 14.801 Repair Type: Non-Urgent Crossing Status: Found UCIP Comments: Some erosion at outlet on WS slope. No permit identified for this crossing. FIELD_STRUCT_DESC: 4-inch PVC stormdrain pipe through the levee 3.5-feet below the crown. Inlet on LS not visible. FS Date: 05/12/2014

Pipe on WS shoulder.

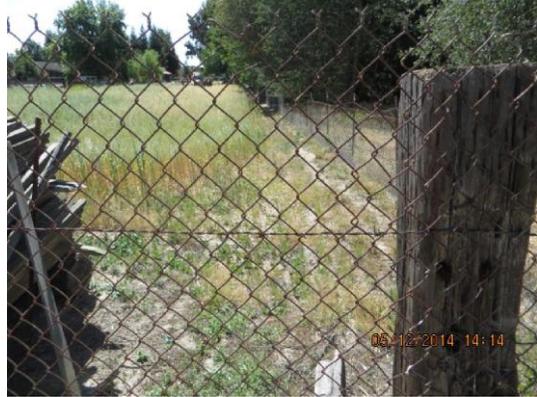
Photo 2 of 2 : UCIP\_FA\_2015\_5881.jpg

LM Start	<b>14.26</b>	Rating **	M	Issue No.	<b>1091 (cont)</b>
LM End	<b>14.26</b>	Issue Type +	En	Location *	WS
Category	Supplemental			GPS Latitude/Longitude	
				Start	End
Item	DWR UCIP Field Study			38.122029 °	38.122029 °
				-121.169428 °	-121.169428 °
DWR ID					
Action/Comments					
Inspector Comments: FS_ID:41370 DS_ID:24992 EP_NO: N/A FS_HLM: 14.801 Repair Type: Non-Urgent Crossing Status: Found UCIP Comments: Some erosion at outlet on WS slope. No permit identified for this crossing. FIELD_STRUCT_DESC: 4-inch PVC stormdrain pipe through the levee 3.5-feet below the crown. Inlet on LS not visible. FS Date: 05/12/2014

Pipe not visible on LS shoulder.

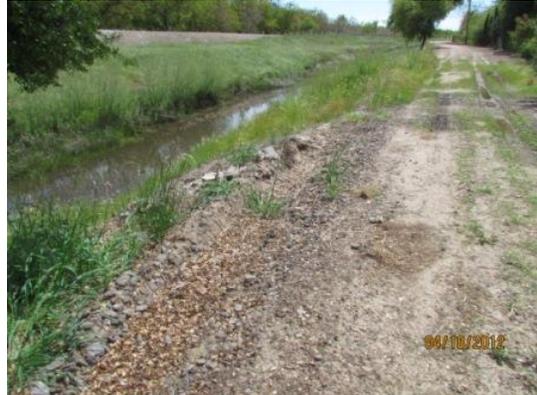
Photo 1 of 1 : FA\_2015\_NA0017\_151\_60\_20150911\_00028.jpg

LM Start	<b>14.35</b>	Rating **	M	Issue No.	<b>60</b>
LM End	<b>14.35</b>	Issue Type +	Ma	Location *	CR
Category	Earthen Levee			GPS Latitude/Longitude	
				Start	End
Item	Crown Surface / Depressions / Rutting			38.123286 °	38.123286 °
				-121.169609 °	-121.169609 °
DWR ID	DWR_NA0017_07_s_2012_60				
Action/Comments					
Repair depressions or ruts in the crown or slope.

Crown depression was found on the waterside shoulder of the levee looking downstream.

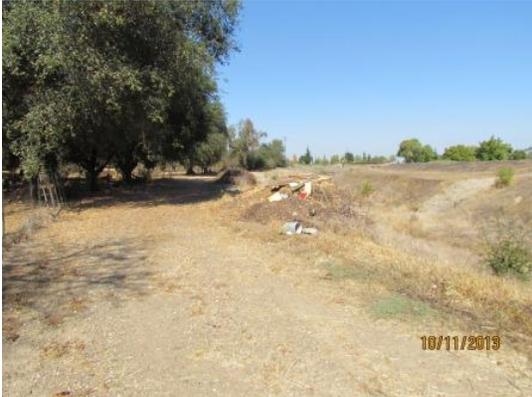
Photo 1 of 2 : FA\_2015\_NA0017\_151\_95\_20150911\_00045.jpg

LM Start	<b>14.35</b>	Rating **	M	Issue No.	<b>95</b>
LM End	<b>14.35</b>	Issue Type +	En	Location *	WS
Category	Earthen Levee		GPS Latitude/Longitude		
			Start	End	
Item	Encroachments		38.123415 °	38.123415 °	
			-121.169666 °	-121.169666 °	
DWR ID	DWR_NA0017_07_f_2012_95				
Action/Comments					
Prunings

Updated picture of the prunings on the waterside shoulder of the levee looking upstream.

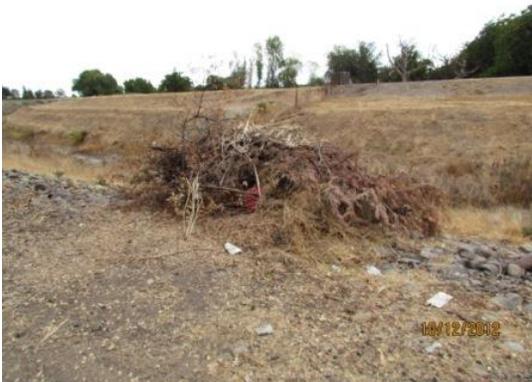
Photo 2 of 2 : FA\_2015\_NA0017\_151\_95\_20150911\_00046.jpg

Prunings were found on the waterside of the levee looking upstream.

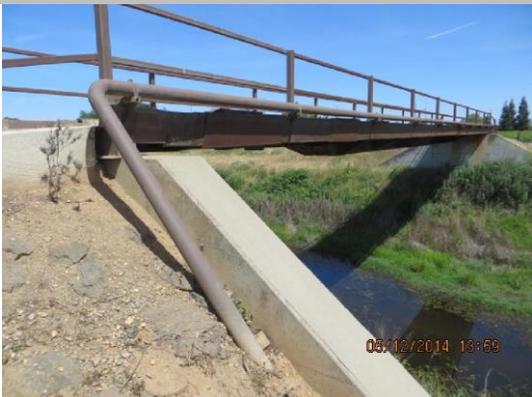
Photo 1 of 1 : UCIP\_FA\_2015\_5941.jpg

LM Start	<b>14.50</b>	Rating **	M	Issue No.	<b>1092</b>
LM End	<b>14.50</b>	Issue Type +	En	Location *	WS
Category	Supplemental		GPS Latitude/Longitude		
			Start	End	
Item	DWR UCIP Field Study		38.125325 °	38.125325 °	
			-121.168441 °	-121.168441 °	
DWR ID					
Action/Comments					
Inspector Comments: FS_ID:41704 DS_ID:25014 EP_NO: N/A FS_HLM: 15.051 Repair Type: Non-Urgent Crossing Status: Found

Pipe visible on downstream side of bridge on WS shoulder.

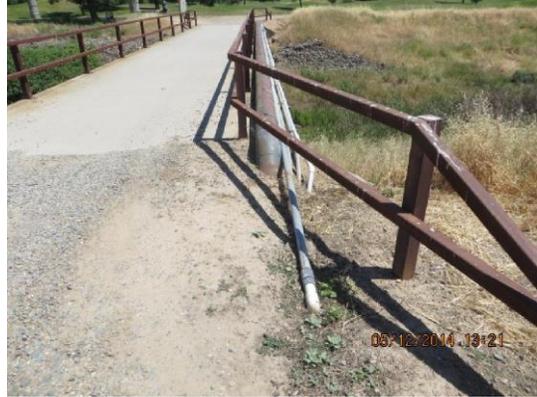
Photo 1 of 1 : UCIP\_FA\_2015\_5879.jpg

LM Start	<b>15.00</b>	Rating **	M	Issue No.	<b>1093</b>
LM End	<b>15.00</b>	Issue Type +	En	Location *	WS
Category	Supplemental			GPS Latitude/Longitude	
				Start	End
Item	DWR UCIP Field Study			38.128792 °	38.128792 °
				-121.160650 °	-121.160650 °
DWR ID					
Action/Comments					
Inspector Comments: FS_ID:41685 DS_ID:24989 EP_NO: N/A FS_HLM: 15.559 Repair Type: Non-Urgent Crossing Status: Found UCIP Comments: No permit identified for this crossing. FIELD_STRUCT_DESC: 2-inch galvanized iron waterline over bridge on upstream side. FS Date: 05/12/2014

Galvanized iron waterline visible next to larger irrigation pipe on downstream side of bridge.

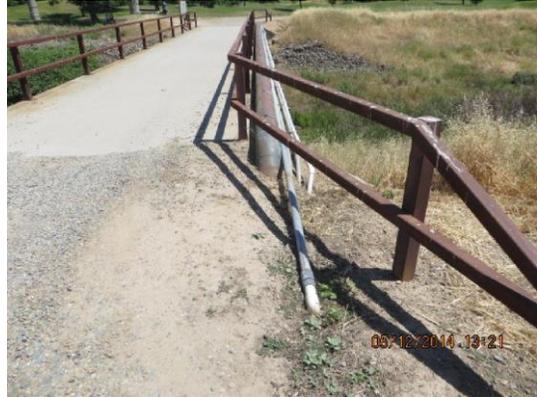
Photo 1 of 2 : UCIP\_FA\_2015\_5875.jpg

LM Start	<b>15.00</b>	Rating **	M	Issue No.	<b>1094</b>
LM End	<b>15.00</b>	Issue Type +	En	Location *	WS
Category	Supplemental			GPS Latitude/Longitude	
				Start	End
Item	DWR UCIP Field Study			38.128797 °	38.128797 °
				-121.160650 °	-121.160650 °
DWR ID					
Action/Comments					
Inspector Comments: FS_ID:41684 DS_ID:24988 EP_NO: N/A FS_HLM: 15.559 Repair Type: Non-Urgent Crossing Status: Found UCIP Comments: No permit identified for this crossing. FIELD_STRUCT_DESC: 10-inch steel irrigation pipe through the levee at an unknown depth below the crown. Pipe visible on upstream side of bridge. FS Date: 05/12/2014

10-inch steel pipe visible on downstream side of bridge.

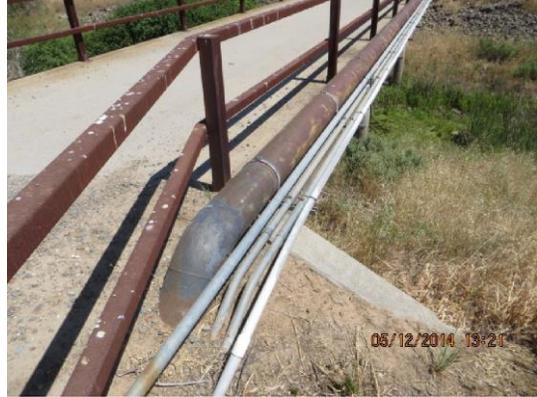
Photo 2 of 2 : UCIP\_FA\_2015\_5878.jpg

LM Start	<b>15.00</b>	Rating **	M	Issue No.	<b>1094 (cont)</b>
LM End	<b>15.00</b>	Issue Type +	En	Location *	WS
Category	Supplemental			GPS Latitude/Longitude	
				Start	End
Item	DWR UCIP Field Study			38.128797 °	38.128797 °
				-121.160650 °	-121.160650 °
DWR ID					
Action/Comments					
Inspector Comments: FS_ID:41684 DS_ID:24988 EP_NO: N/A FS_HLM: 15.559 Repair Type: Non-Urgent Crossing Status: Found UCIP Comments: No permit identified for this crossing. FIELD_STRUCT_DESC: 10-inch steel irrigation pipe through the levee at an unknown depth below the crown. Pipe visible on upstream side of bridge. FS Date: 05/12/2014

10-inch steel pipe visible on downstream side of bridge.

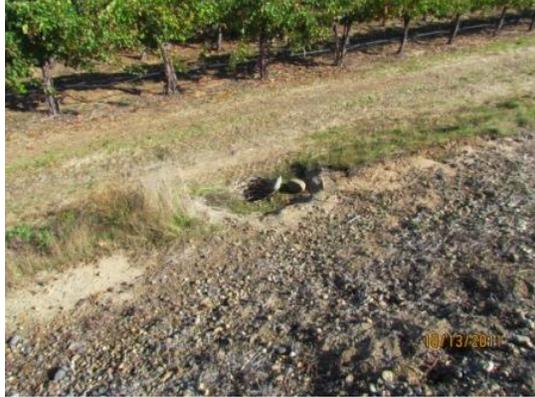
Photo 1 of 1 : FA\_2015\_NA0017\_151\_809\_20150911\_00057.jpg

LM Start	<b>15.21</b>	Rating **	M	Issue No.	<b>809</b>
LM End	<b>15.21</b>	Issue Type +	En	Location *	LS
Category	Earthen Levee		GPS Latitude/Longitude		
			Start	End	
Item	Encroachments		38.130303 °	38.130303 °	
			-121.157451 °	-121.157451 °	
DWR ID	DWR_NA0017_07_s_2012_809				
Action/Comments					
Pipe Inspector Comments: Drain is located at the landside toe of the levee.

A drain was found at the toe of landside of the levee. The picture was taken from the crown looking towards the toe.

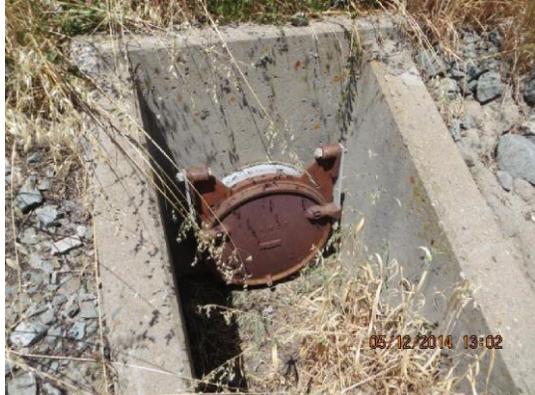
Photo 1 of 3 : UCIP\_FA\_2015\_6648.jpg

LM Start	<b>15.21</b>	Rating **	M	Issue No.	<b>1095</b>
LM End	<b>15.21</b>	Issue Type +	En	Location *	LS
Category	Supplemental		GPS Latitude/Longitude		
			Start	End	
Item	DWR UCIP Field Study		38.130318 °	38.130318 °	
			-121.157417 °	-121.157417 °	
DWR ID					
Action/Comments					
Inspector Comments: FS_ID:37652 DS_ID:23610 EP_NO: N/A FS_HLM: 15.776 Repair Type: Non-Urgent Crossing Status: Found UCIP Comments: No inlet cover or grate at LS toe FIELD_STRUCT_DESC: 24-inch CM stormdrain pipe through the levee, 11.0 feet below the crown. Concrete "U" headwall on the waterward end. Flap gate on the waterward end. 24-inch CMP riser/dropinlet on the landward side. O&M Manual Bear Creek Part 2, 1967. FS Date: 05/12/2014

Pipe, flapgate, and Concrete headwall on WS slope.

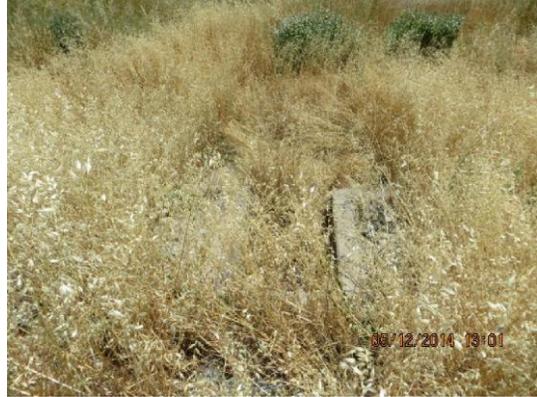
Photo 2 of 3 : UCIP\_FA\_2015\_6649.jpg

**Action/Comments**  
 Inspector Comments: FS\_ID:37652  
 DS\_ID:23610  
 EP\_NO: N/A  
 FS\_HLM: 15.776  
 Repair Type: Non-Urgent  
 Crossing Status: Found  
 UCIP Comments: No inlet cover or grate at LS toe  
 FIELD\_STRUCT\_DESC: 24-inch CM stormdrain pipe through the levee, 11.0 feet below the crown. Concrete "U" headwall on the waterward end. Flap gate on the waterward end. 24-inch CMP riser/dropinlet on the landward side. O&M Manual Bear Creek Part 2, 1967.  
 FS Date: 05/12/2014

Concrete headwall on WS toe.

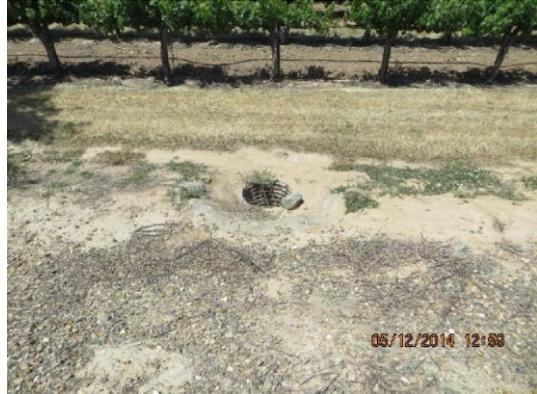
Photo 3 of 3 : UCIP\_FA\_2015\_6650.jpg

24-inch riser/dropinlet on LS toe.

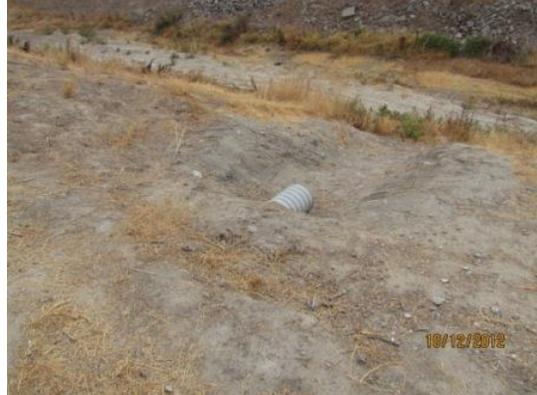
Photo 1 of 1 : FA\_2015\_NA0017\_151\_99\_20150911\_00047.jpg

LM Start	<b>15.50</b>	Rating **	M	Issue No.	<b>99</b>
LM End	<b>15.50</b>	Issue Type +	En	Location *	LS
Category	Earthen Levee		GPS Latitude/Longitude		
			Start	End	
Item	Encroachments		38.132581 °	38.132581 °	
			-121.153872 °	-121.153872 °	
DWR ID	DWR_NA0017_07_f_2012_99				
Action/Comments					
Pipe

A pipe was found on the waterside slope of the levee looking upstream.

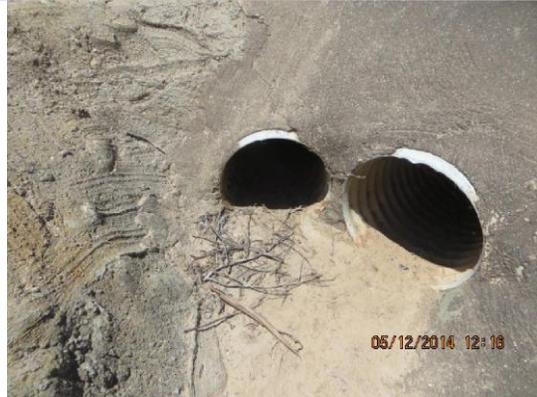
Photo 1 of 3 : UCIP\_FA\_2015\_6541.jpg

LM Start	<b>16.10</b>	Rating **	M	Issue No.	<b>1096</b>
LM End	<b>16.10</b>	Issue Type +	En	Location *	LS
Category	Supplemental		GPS Latitude/Longitude		
			Start	End	
Item	DWR UCIP Field Study		38.140596 °	38.140596 °	
			-121.150998 °	-121.150998 °	
DWR ID					
Action/Comments					
Inspector Comments: FS_ID:41806 DS_ID:23618 EP_NO: N/A FS_HLM: 16.672 Repair Type: Non-Urgent Crossing Status: Found UCIP Comments: Silt buildup in pipe at outlet. FIELD_STRUCT_DESC: 18-inch CM stormdrain pipe through the levee 1.5-feet below the crown. Cobble grouted spillway. Open on both ends. FS Date: 05/12/2014

Pipe visible at outlet on WS shoulder.

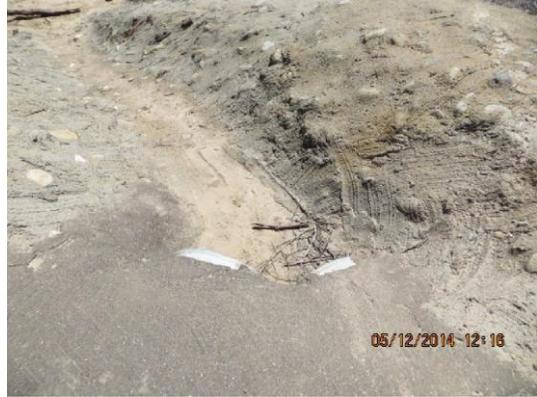
Photo 2 of 3 : UCIP\_FA\_2015\_6542.jpg

LM Start	16.10	Rating **	M	Issue No.	1096 (cont)
LM End	16.10	Issue Type +	En	Location *	LS
Category	Supplemental			GPS Latitude/Longitude	
				Start	End
Item	DWR UCIP Field Study			38.140596 °	38.140596 °
				-121.150998 °	-121.150998 °
DWR ID					
Action/Comments					
Inspector Comments: FS_ID:41806 DS_ID:23618 EP_NO: N/A FS_HLM: 16.672 Repair Type: Non-Urgent Crossing Status: Found UCIP Comments: Silt buildup in pipe at outlet. FIELD_STRUCT_DESC: 18-inch CM stormdrain pipe through the levee 1.5-feet below the crown. Cobble grouted spillway. Open on both ends. FS Date: 05/12/2014

Pipe visible at outlet on WS shoulder.

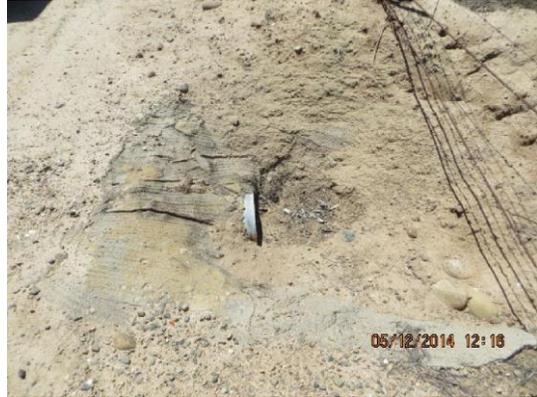
Photo 3 of 3 : UCIP\_FA\_2015\_6543.jpg

Pipe visible at inlet on LS toe.

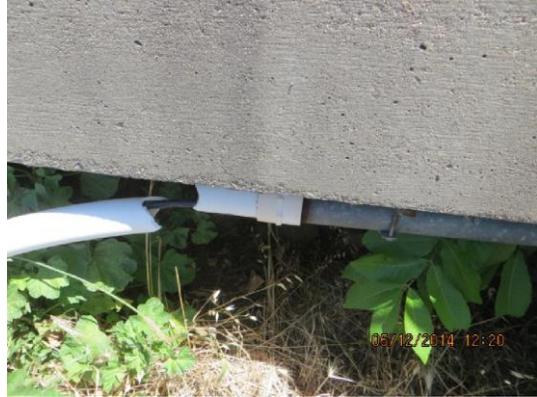
Photo 1 of 2 : UCIP\_FA\_2015\_5873.jpg

LM Start	<b>16.12</b>	Rating **	M	Issue No.	<b>1097</b>
LM End	<b>16.12</b>	Issue Type +	En	Location *	LS
Category	Supplemental			GPS Latitude/Longitude	
				Start	End
Item	DWR UCIP Field Study			38.140811 °	38.140811 °
				-121.150784 °	-121.150784 °
DWR ID					
Action/Comments					
Inspector Comments: FS_ID:41956 DS_ID:24987 EP_NO: N/A FS_HLM: 16.69 Repair Type: Non-Urgent Crossing Status: Found

Communication conduit visible on downstream side of bridge at WS slope.

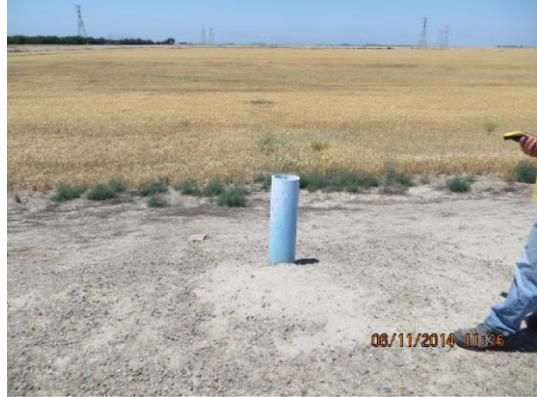
Photo 1 of 2 : UCIP\_FA\_2015\_6165.jpg

LM Start	Rating **	M	Issue No.	1108
LM End	Issue Type +	En	Location *	CR
Category	Supplemental	GPS Latitude/Longitude		
		Start	End	
Item	DWR UCIP Field Study	38.034122 °	38.034122 °	
		-121.370825 °	-121.370825 °	
DWR ID				
<b>Action/Comments</b>				
Inspector Comments: FS_ID:41711 DS_ID:25039 EP_NO: N/A FS_HLM: 0.1 Repair Type: Non-Urgent Crossing Status: Found UCIP Comments: No permit identified for this crossing. FIELD_STRUCT_DESC: 1-inch galvanized iron waterline on LS shoulder and a 8-inch PVC standpipe on the WS shoulder. FS Date: 06/11/2014

8-inch PVC riser on WS slope.

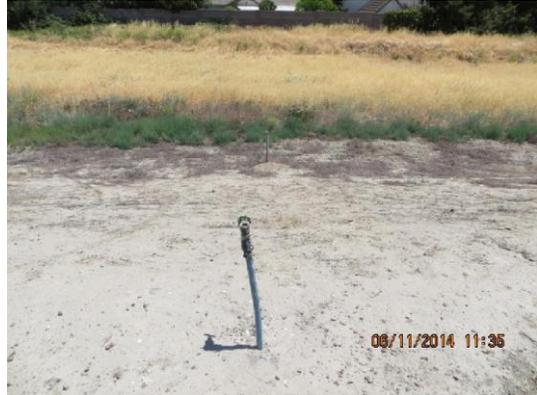
Photo 2 of 2 : UCIP\_FA\_2015\_6166.jpg

Waterline and valves on LS slope.

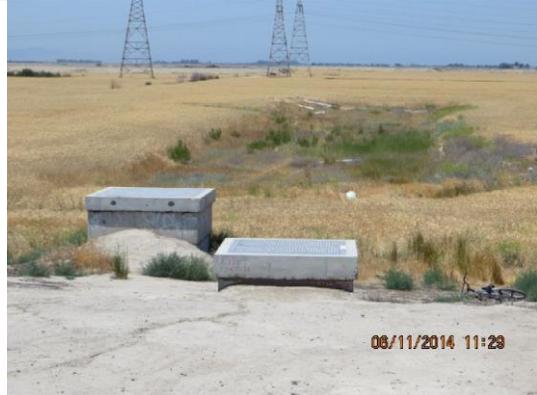
Photo 1 of 2 : UCIP\_FA\_2015\_6163.jpg

LM Start		Rating **	M	Issue No.	<b>1109</b>
LM End		Issue Type +	En	Location *	CR
Category	Supplemental			GPS Latitude/Longitude	
				Start	End
Item	DWR UCIP Field Study			38.036650 °	38.036650 °
				-121.372412 °	-121.372412 °
DWR ID					
Action/Comments					
Inspector Comments: FS_ID:41436 DS_ID:25038 EP_NO: N/A FS_HLM: 0.279 Repair Type: Non-Urgent Crossing Status: Found

Concrete box/manhole on WS slope (at left).

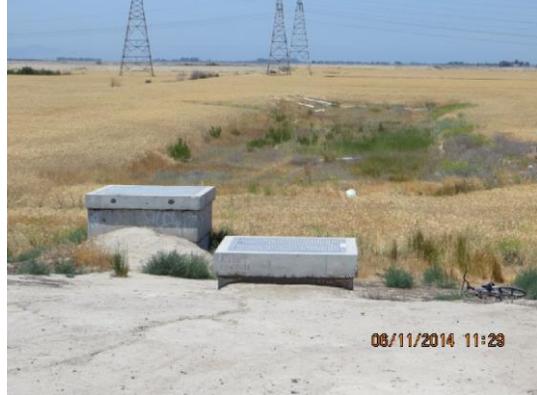
Photo 1 of 2 : UCIP\_FA\_2015\_6161.jpg

LM Start		Rating **	M	Issue No.	<b>1110</b>
LM End		Issue Type +	En	Location *	CR
Category	Supplemental			GPS Latitude/Longitude	
				Start	End
Item	DWR UCIP Field Study			38.036680 °	38.036680 °
				-121.372410 °	-121.372410 °
DWR ID					
Action/Comments					
Inspector Comments: FS_ID:41435 DS_ID:25037 EP_NO: N/A FS_HLM: 0.281 Repair Type: Non-Urgent Crossing Status: Found

Concrete box/manhole on WS toe.

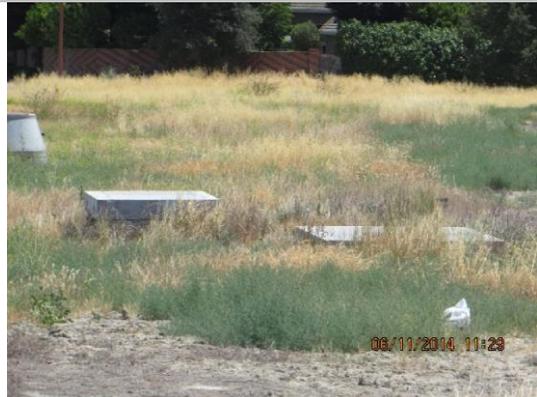
Photo 2 of 2 : UCIP\_FA\_2015\_6162.jpg

Concrete box/manhole off LS toe.

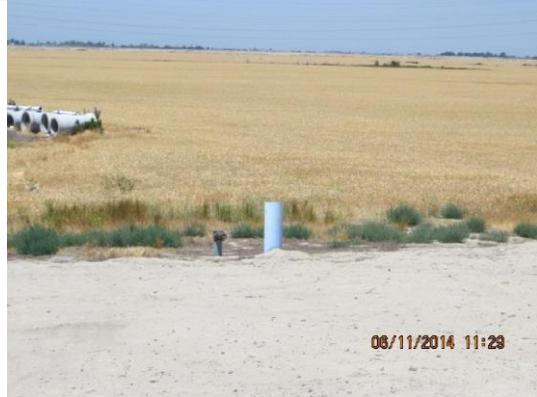
Photo 1 of 2 : UCIP\_FA\_2015\_6159.jpg

LM Start		Rating **	M	Issue No.	<b>1111</b>
LM End		Issue Type +	En	Location *	CR
Category	Supplemental			GPS Latitude/Longitude	
				Start	End
Item	DWR UCIP Field Study			38.036741 °	38.036741 °
				-121.372411 °	-121.372411 °
DWR ID					
Action/Comments					
Inspector Comments: FS_ID:41972 DS_ID:25040 EP_NO: N/A FS_HLM: 0.285 Repair Type: Non-Urgent Crossing Status: Found

4-inch Pipe and valve on WS slope.

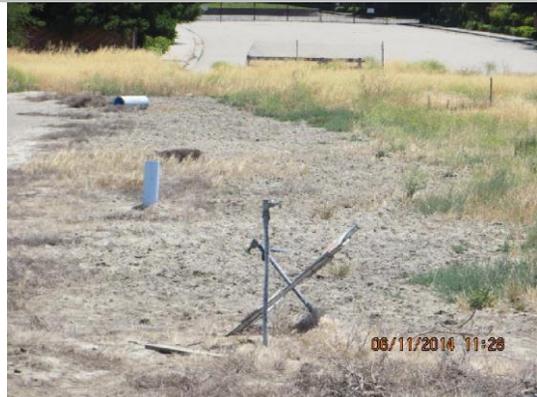
Photo 2 of 2 : UCIP\_FA\_2015\_6160.jpg

1-inch waterline and valve off LS toe.

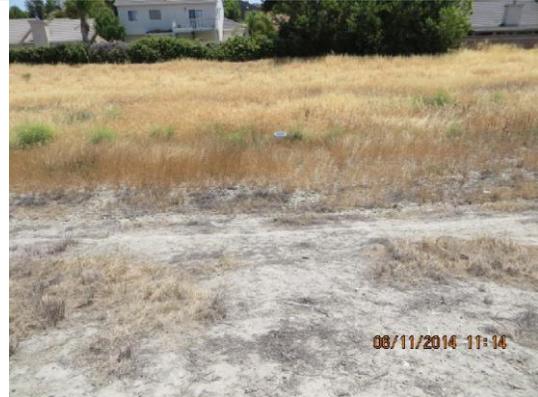
Photo 1 of 2 : UCIP\_FA\_2015\_6157.jpg

LM Start		Rating **	M	Issue No.	<b>1112</b>
LM End		Issue Type +	En	Location *	CR
Category	Supplemental			GPS Latitude/Longitude	
				Start	End
Item	DWR UCIP Field Study			38.039400 °	38.039400 °
				-121.370900 °	-121.370900 °
DWR ID					
<b>Action/Comments</b>					
Inspector Comments: FS_ID:41529 DS_ID:25036 EP_NO: N/A FS_HLM: 0.474 Repair Type: Non-Urgent Crossing Status: Found

16-inch PVC riser off LS toe.

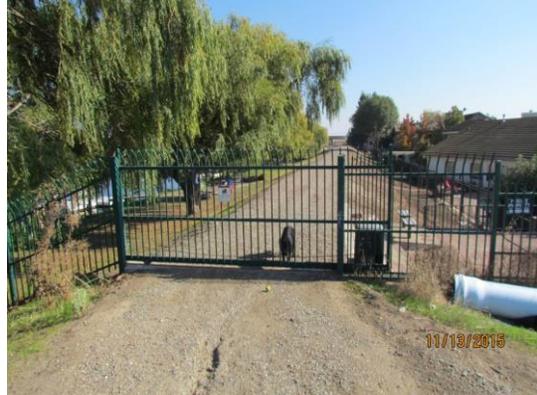
Photo 1 of 1 : FA\_2015\_NA0017\_152\_1054\_20151113\_00113.jpg

LM Start	<b>0.75</b>	Rating **	M	Issue No.	<b>1054</b>
LM End	<b>0.75</b>	Issue Type +	En	Location *	CR
Category	Earthen Levee			GPS Latitude/Longitude	
				Start	End
Item	Encroachments			38.043062 °	38.043062 °
				-121.370498 °	-121.370498 °
DWR ID	DWR_NA0017_08_s_2012_1054				
Action/Comments					
Fence Inspector Comments: Entrance gate.

View of the entrance gate across the crown at the current start of the unit looking upstream. Limited access has been provided.

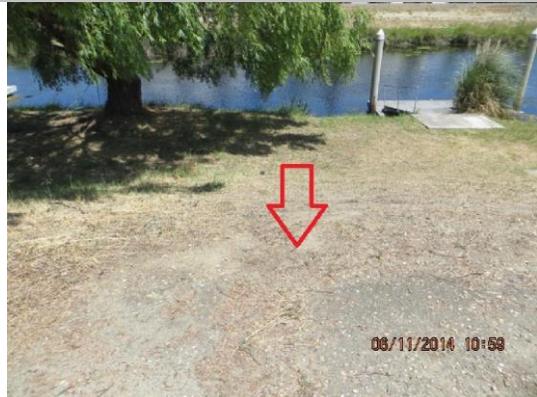
Photo 1 of 3 : UCIP\_FA\_2015\_6156.jpg

LM Start	<b>0.78</b>	Rating **	M	Issue No.	<b>1113</b>
LM End	<b>0.78</b>	Issue Type +	En	Location *	CR
Category	Supplemental			GPS Latitude/Longitude	
				Start	End
Item	DWR UCIP Field Study			38.043080 °	38.043080 °
				-121.369910 °	-121.369910 °
DWR ID					
Action/Comments					
Inspector Comments: FS_ID:41710 DS_ID:25034 EP_NO: N/A FS_HLM: 0.78 Repair Type: Non-Urgent Crossing Status: Found UCIP Comments: No permit identified for this crossing. FIELD_STRUCT_DESC: 1-inch PVC waterline through the levee at an unknown depth below the crown. Sprinklers visible on WS slope. Minor settlement over pipe obvious on crown. FS Date: 06/11/2014

Subsidence over pipe on crown at WS shoulder.

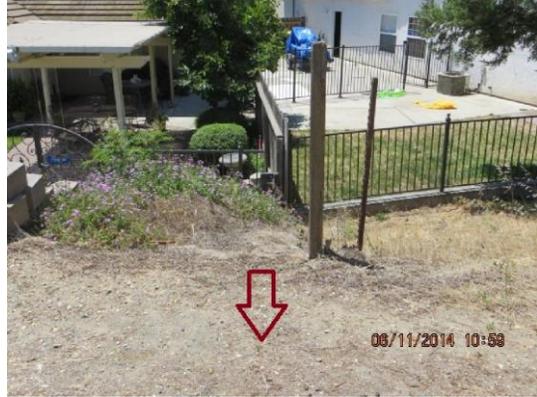
Photo 2 of 3 : UCIP\_FA\_2015\_6833.jpg

LM Start	<b>0.78</b>	Rating **	M	Issue No.	<b>1113 (cont)</b>
LM End	<b>0.78</b>	Issue Type +	En	Location *	CR
Category	Supplemental			GPS Latitude/Longitude	
				Start	End
Item	DWR UCIP Field Study			38.043080 °	38.043080 °
				-121.369910 °	-121.369910 °
DWR ID					
Action/Comments					
Inspector Comments: FS_ID:41710 DS_ID:25034 EP_NO: N/A FS_HLM: 0.78 Repair Type: Non-Urgent Crossing Status: Found UCIP Comments: No permit identified for this crossing. FIELD_STRUCT_DESC: 1-inch PVC waterline through the levee at an unknown depth below the crown. Sprinklers visible on WS slope. Minor settlement over pipe obvious on crown. FS Date: 06/11/2014

Subsidence over pipe on crown at LS shoulder.

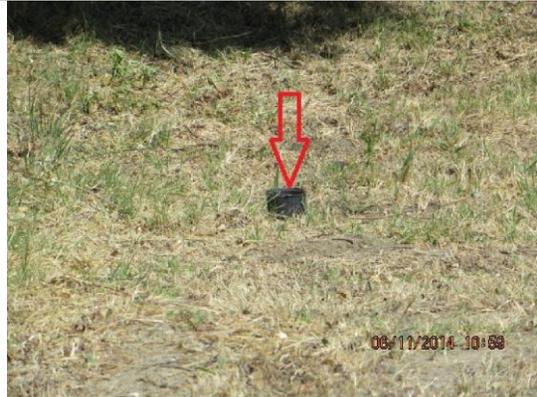
Photo 3 of 3 : UCIP\_FA\_2015\_6834.jpg

Sprinkler on LS slope.

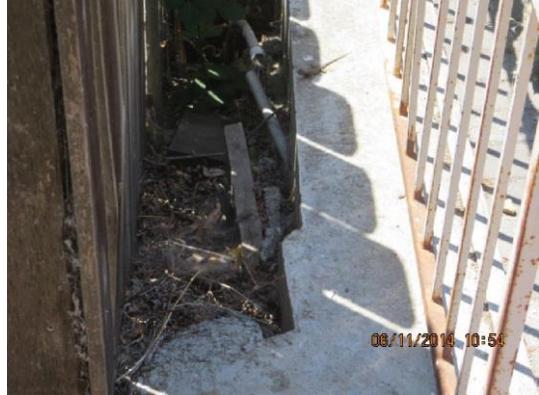
Photo 1 of 3 : UCIP\_FA\_2015\_6830.jpg

LM Start	<b>0.81</b>	Rating **	M	Issue No.	<b>1114</b>
LM End	<b>0.81</b>	Issue Type +	En	Location *	CR
Category	Supplemental			GPS Latitude/Longitude	
				Start	End
Item	DWR UCIP Field Study			38.043066 °	38.043066 °
				-121.369285 °	-121.369285 °
DWR ID					
Action/Comments					
Inspector Comments: FS_ID:39430 DS_ID:25032 EP_NO: N/A FS_HLM: 0.815 Repair Type: Non-Urgent Crossing Status: Found

Pipes may be visible on LS slope next to retaining wall.

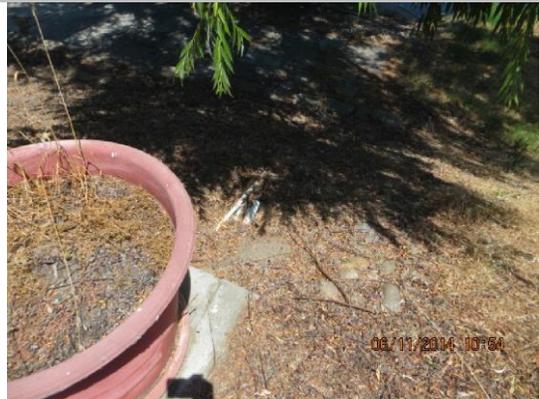
Photo 2 of 3 : UCIP\_FA\_2015\_6831.jpg

LM Start	<b>0.81</b>	Rating **	M	Issue No.	<b>1114 (cont)</b>
LM End	<b>0.81</b>	Issue Type +	En	Location *	CR

PVC pipe visible on WS shoulder.

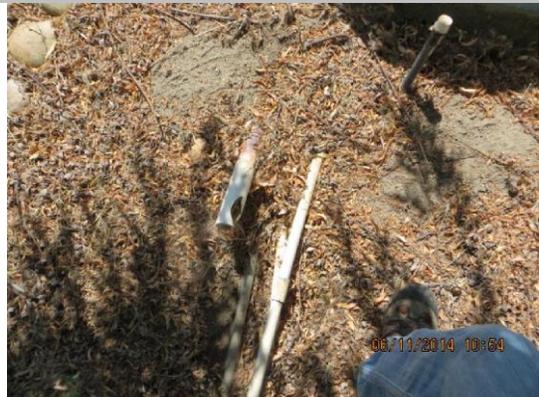
Photo 3 of 3 : UCIP\_FA\_2015\_6832.jpg

PVC pipe visible on WS shoulder. Pipe broken at WS shoulder.

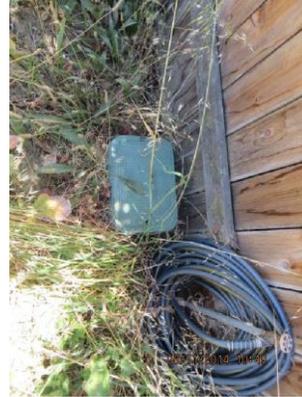
Photo 1 of 3 : UCIP\_FA\_2015\_6827.jpg

LM Start	<b>0.84</b>	Rating **	M	Issue No.	<b>1115</b>
LM End	<b>0.84</b>	Issue Type +	En	Location *	CR
Category	Supplemental			GPS Latitude/Longitude	
				Start	End
Item	DWR UCIP Field Study			38.043044 °	38.043044 °
				-121.368761 °	-121.368761 °
DWR ID					
Action/Comments					
Inspector Comments: FS_ID:41709 DS_ID:25031 EP_NO: N/A FS_HLM: 0.844 Repair Type: Non-Urgent Crossing Status: Found

Christy box on LS shoulder.

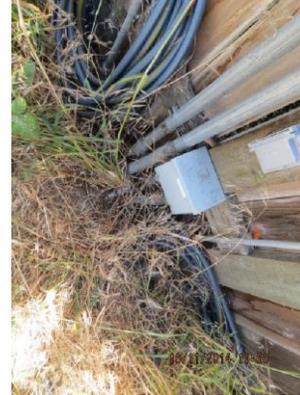
Photo 1 of 2 : UCIP\_FA\_2015\_6825.jpg

LM Start	<b>0.84</b>	Rating **	M	Issue No.	<b>1116</b>
LM End	<b>0.84</b>	Issue Type +	En	Location *	CR
Category	Supplemental			GPS Latitude/Longitude	
				Start	End
Item	DWR UCIP Field Study			38.043046 °	38.043046 °
				-121.368749 °	-121.368749 °
DWR ID					
Action/Comments					
Inspector Comments: FS_ID:41528 DS_ID:25030 EP_NO: N/A FS_HLM: 0.845 Repair Type: Non-Urgent Crossing Status: Found

Conduits visible on fence at LS shoulder.

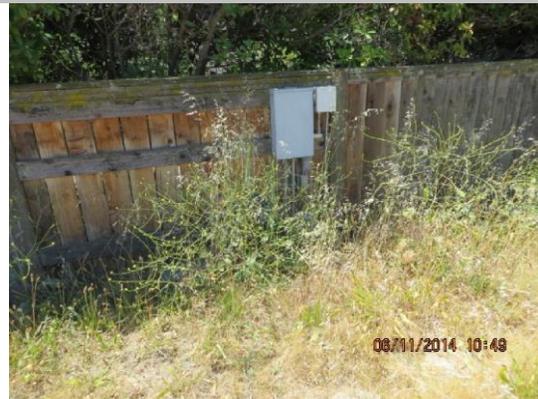
Photo 2 of 2 : UCIP\_FA\_2015\_6826.jpg

Control panel and electrical on fence at LS shoulder.

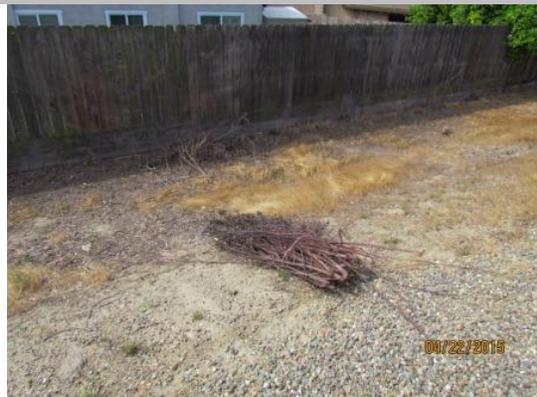
Photo 1 of 1 : FA\_2015\_NA0017\_152\_81\_20150911\_00022.jpg

LM Start	<b>1.66</b>	Rating **	M	Issue No.	<b>81</b>
LM End	<b>1.66</b>	Issue Type +	Ma	Location *	LS
Category	Earthen Levee		GPS Latitude/Longitude		
			Start	End	
Item	Encroachments		38.042783 °	38.042783 °	
			-121.353818 °	-121.353818 °	
DWR ID	DWR_NA0017_08_s_2015_81				
Action/Comments					
Prunings

Prunings were found on the landside slope of the levee looking downstream.

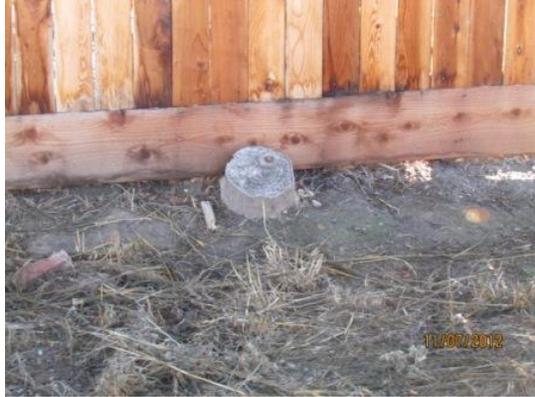
Photo 1 of 1 : FA\_2015\_NA0017\_152\_18\_20150911\_00007.jpg

LM Start	<b>1.82</b>	Rating **	N	Issue No.	<b>18</b>
LM End	<b>1.82</b>	Issue Type +	Ma	Location *	LS
Category	Earthen Levee		GPS Latitude/Longitude		
			Start	End	
Item	Trim / Thin Trees		38.042751 °	38.042751 °	
			-121.353062 °	-121.353062 °	
DWR ID	DWR_NA0017_08_f_2012_18				
Action/Comments					
Tree stumps.

View of a tree stump that was found on the landside toe of the levee. The picture was taken from the crown looking towards the toe.

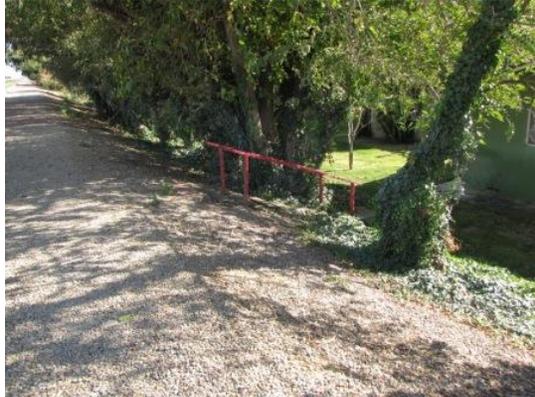
Photo 1 of 1 : FA\_2015\_NA0017\_152\_1007\_20150911\_00045.jpg

LM Start	<b>2.03</b>	Rating **	M	Issue No.	<b>1007</b>
LM End	<b>2.03</b>	Issue Type +	Ma	Location *	LS
Category	Earthen Levee		GPS Latitude/Longitude		
			Start	End	
Item	Encroachments		38.042803 °	38.042803 °	
			-121.347023 °	-121.347023 °	
DWR ID	DWR_NA0017_08_s_2012_1007				
Action/Comments					
Stairway Inspector Comments: Steps were removed but the hand rails still exists at the location.

View of steps dug into the landward slope looking upstream.

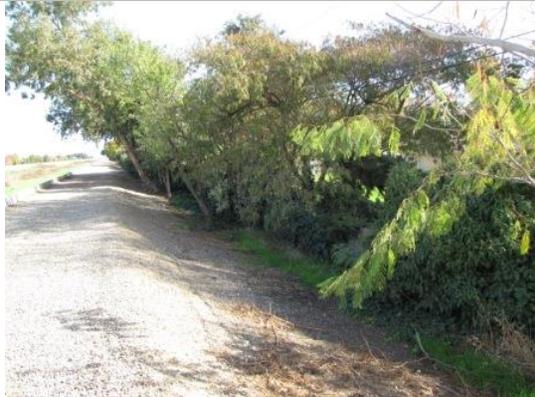
Photo 1 of 1 : FA\_2015\_NA0017\_152\_1008\_20150911\_00046.jpg

LM Start	<b>2.03</b>	Rating **	M	Issue No.	<b>1008</b>
LM End	<b>2.22</b>	Issue Type +	En	Location *	LS
Category	Earthen Levee		GPS Latitude/Longitude		
			Start	End	
Item	Encroachments		38.042800 °	38.042787 °	
			-121.347022 °	-121.345608 °	
DWR ID	DWR_NA0017_08_s_2012_1008				
Action/Comments					
Fence Inspector Comments: The fence is covered by ivy.

View of a fence with landscaping growing on it at the landward toe looking upstream.

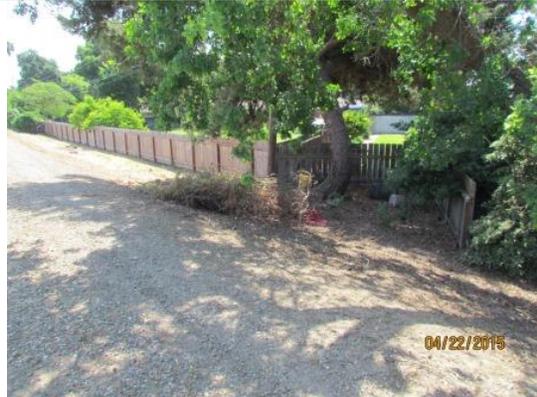
Photo 1 of 1 : FA\_2015\_NA0017\_152\_92\_20150911\_00029.jpg

LM Start	<b>2.04</b>	Rating **	M	Issue No.	<b>92</b>
LM End	<b>2.04</b>	Issue Type +	Ma	Location *	LS
Category	Earthen Levee		GPS Latitude/Longitude		
			Start	End	
Item	Encroachments		38.042803 °	38.042803 °	
			-121.346755 °	-121.346755 °	
DWR ID	DWR_NA0017_08_s_2015_92				
Action/Comments					
Prunings

Prunings were found on the landside of the levee looking upstream.

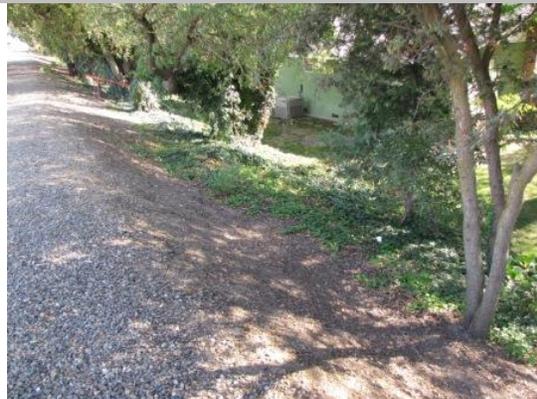
Photo 1 of 1 : FA\_2015\_NA0017\_152\_1006\_20150911\_00044.jpg

LM Start	<b>2.08</b>	Rating **	M	Issue No.	<b>1006</b>
LM End	<b>2.16</b>	Issue Type +	En	Location *	LS
Category	Earthen Levee		GPS Latitude/Longitude		
			Start	End	
Item	Vegetation		38.042791 °	38.042803 °	
			-121.346130 °	-121.346812 °	
DWR ID	DWR_NA0017_08_s_2012_1006				
Action/Comments					
Landscaping Inspector Comments: Ivy and oleanders on landward slope.

View of landscaping along the landward slope looking upstream. County crews have greatly reduced the amount of material and increased visibility and access.

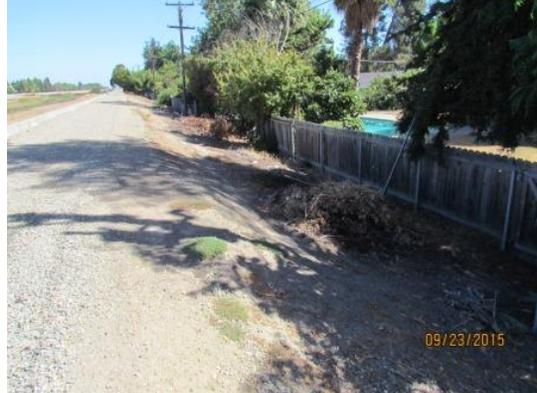
Photo 1 of 1 : FA\_2015\_NA0017\_152\_93\_20150928\_00097.jpg

LM Start	<b>2.16</b>	Rating **	M	Issue No.	<b>93</b>
LM End	<b>2.16</b>	Issue Type +	Ma	Location *	LS
Category	Earthen Levee			GPS Latitude/Longitude	
				Start	End
Item	Encroachments			38.042785 °	38.042785 °
				-121.344686 °	-121.344686 °
DWR ID	DWR_NA0017_08_s_2015_93				
Action/Comments					
Prunings

Prunings were found on the landside of the levee looking upstream.

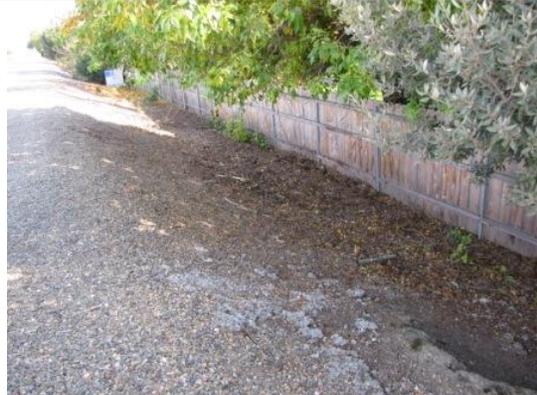
Photo 1 of 1 : FA\_2015\_NA0017\_152\_1011\_20150911\_00048.jpg

LM Start	<b>2.21</b>	Rating **	U	Issue No.	<b>1011</b>
LM End	<b>2.21</b>	Issue Type +	En	Location *	LS
Category	Earthen Levee			GPS Latitude/Longitude	
				Start	End
Item	Encroachments			38.042782 °	38.042770 °
				-121.343703 °	-121.341933 °
DWR ID	DWR_NA0017_08_s_2012_1011				
Action/Comments					
Fence Inspector Comments: Wood fence on landward toe.

View of a fence along the landward toe looking upstream.

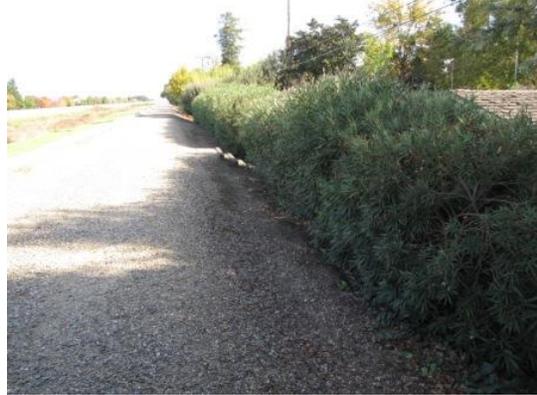
Photo 1 of 1 : FA\_2015\_NA0017\_152\_1009\_20150911\_00047.jpg

LM Start	<b>2.22</b>	Rating **	M	Issue No.	<b>1009</b>
LM End	<b>2.25</b>	Issue Type +	En	Location *	LS
Category	Earthen Levee		GPS Latitude/Longitude		
			Start	End	
Item	Vegetation		38.042786 °	38.042779 °	
			-121.345607 °	-121.345154 °	
DWR ID	DWR_NA0017_08_s_2012_1009				
Action/Comments					
Landscaping

View of landscaping along the landward slope looking upstream.

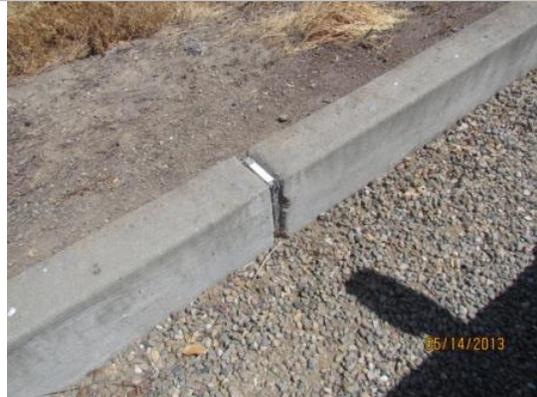
Photo 1 of 1 : FA\_2015\_NA0017\_152\_29\_20150911\_00010.jpg

LM Start	<b>2.24</b>	Rating **	M	Issue No.	<b>29</b>
LM End	<b>2.24</b>	Issue Type +	Ma	Location *	WS
Category	Concrete Floodwalls		GPS Latitude/Longitude		
			Start	End	
Item	Monolith Joints		38.042777 °	38.042777 °	
			-121.343150 °	-121.343150 °	
DWR ID	DWR_NA0017_08_s_2013_29				
Action/Comments

The monolith joint material is deteriorating at this location of the flood wall. The picture was taken from the crown looking upstream.

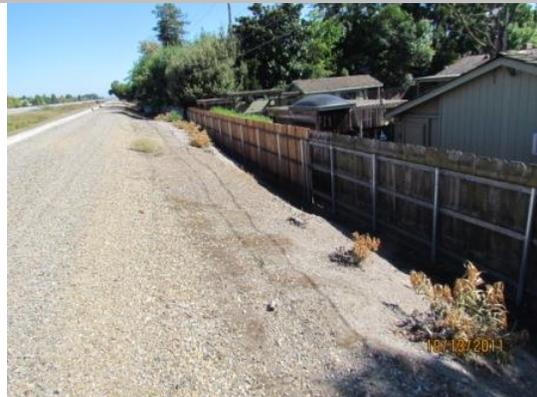
Photo 1 of 1 : FA\_2015\_NA0017\_152\_1018\_20150911\_00049.jpg

LM Start	<b>2.33</b>	Rating **	U	Issue No.	<b>1018</b>
LM End	<b>2.38</b>	Issue Type +	En	Location *	LS
Category	Earthen Levee		GPS Latitude/Longitude		
			Start	End	
Item	Encroachments		38.042764 °	38.042765 °	
			-121.343690 °	-121.342620 °	
DWR ID	DWR_NA0017_08_s_2012_1018				
Action/Comments					
Fence					
Inspector Comments: Wood fence is on the landward toe of the levee.

View of the fence on the landside toe of the levee looking upstream. This picture was taken during fall 2011 inspection.

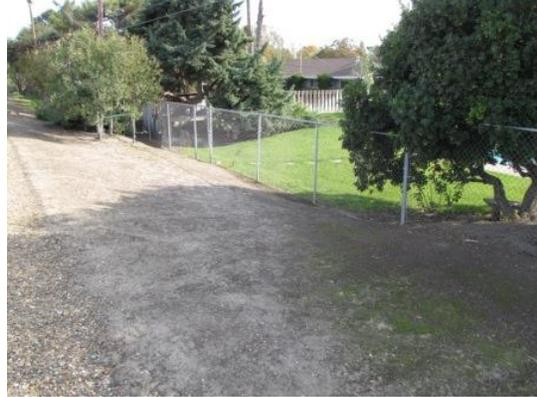
Photo 1 of 1 : FA\_2015\_NA0017\_152\_1021\_20150911\_00051.jpg

LM Start	<b>2.36</b>	Rating **	M	Issue No.	<b>1021</b>
LM End	<b>2.46</b>	Issue Type +	En	Location *	LS
Category	Earthen Levee		GPS Latitude/Longitude		
			Start	End	
Item	Encroachments		38.042763 °	38.042760 °	
			-121.340981 °	-121.341167 °	
DWR ID	DWR_NA0017_08_s_2012_1021				
Action/Comments					
Fence Inspector Comments: Chain link fence on landward slope.

View of a fence on the landward slope looking upstream.

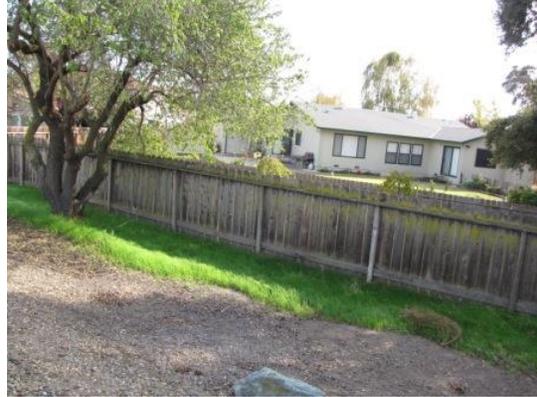
Photo 1 of 1 : FA\_2015\_NA0017\_152\_1023\_20150911\_00052.jpg

LM Start	<b>2.39</b>	Rating **	M	Issue No.	<b>1023</b>
LM End	<b>2.42</b>	Issue Type +	En	Location *	LS
Category	Earthen Levee		GPS Latitude/Longitude		
			Start	End	
Item	Encroachments		38.042758 °	38.042758 °	
			-121.340444 °	-121.339919 °	
DWR ID	DWR_NA0017_08_s_2012_1023				
Action/Comments					
Fence Inspector Comments: Wood fence is within the landside easement of the levee.

View of a fence at the landward toe.

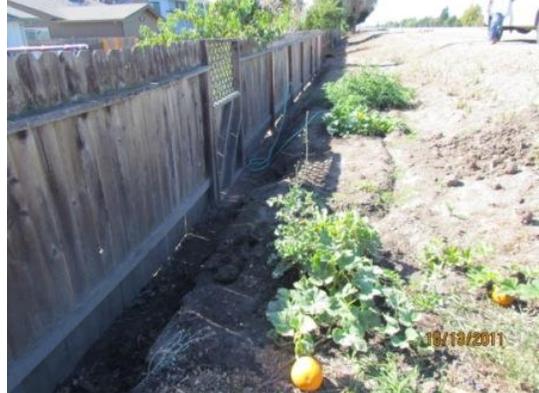
Photo 1 of 2 : FA\_2015\_NA0017\_152\_42\_20150911\_00012.jpg

LM Start	<b>2.46</b>	Rating **	M	Issue No.	<b>42</b>
LM End	<b>2.46</b>	Issue Type +	En	Location *	LS
Category	Earthen Levee		GPS Latitude/Longitude		
			Start	End	
Item	Encroachments		38.042753 °	38.042753 °	
			-121.339088 °	-121.339088 °	
DWR ID	DWR_NA0017_08_s_2012_42				
Action/Comments					
Ditch

View of a ditch at the landside toe of the levee looking downstream.

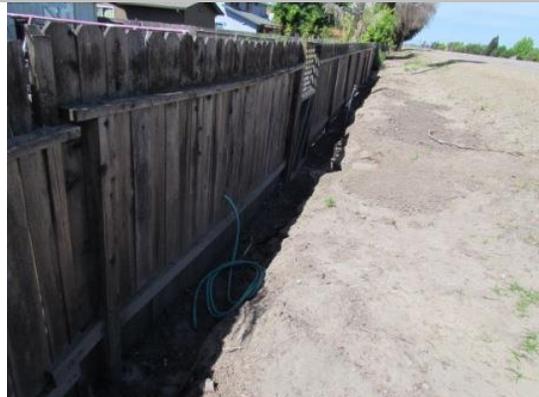
Photo 2 of 2 : FA\_2015\_NA0017\_152\_42\_20150911\_00013.jpg

The owner excavated a ditch on the toe at the landside of the levee. The picture was taken from the landside of the levee looking downstream.

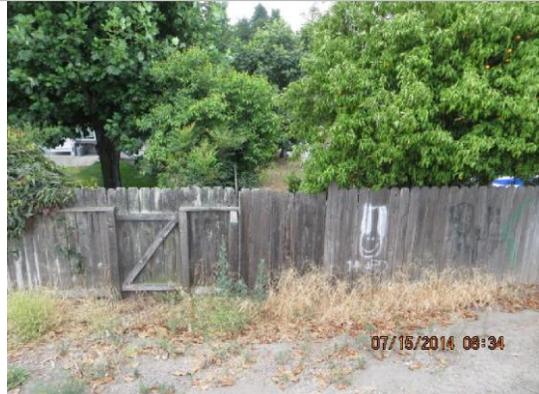
Photo 1 of 2 : UCIP\_FA\_2015\_6637.jpg

LM Start	<b>2.47</b>	Rating **	M	Issue No.	<b>1117</b>
LM End	<b>2.47</b>	Issue Type +	En	Location *	LS
Category	Supplemental		GPS Latitude/Longitude		
			Start	End	
Item	DWR UCIP Field Study		38.042704 °	38.042704 °	
			-121.338851 °	-121.338851 °	
DWR ID					
Action/Comments					
Inspector Comments: FS_ID:39713 DS_ID:23789 EP_NO: 15447 FS_HLM: 2.519 Repair Type: Non-Urgent Crossing Status: Indicator Found

Fence on LS toe at approximate location of pipe crossing.

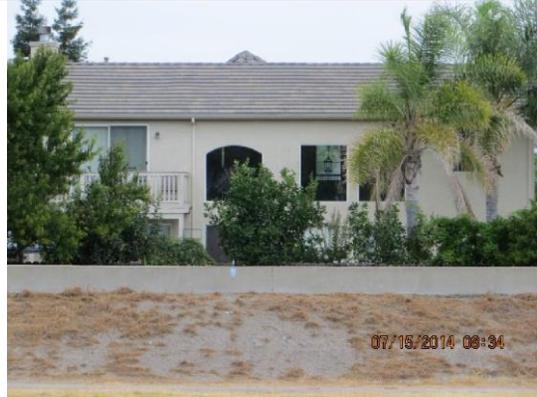
Photo 2 of 2 : UCIP\_FA\_2015\_6639.jpg

LM Start	<b>2.47</b>	Rating **	M	Issue No.	<b>1117 (cont)</b>
LM End	<b>2.47</b>	Issue Type +	En	Location *	LS
Category	Supplemental			GPS Latitude/Longitude	
				Start	End
Item	DWR UCIP Field Study			38.042704 °	38.042704 °
				-121.338851 °	-121.338851 °
DWR ID					
Action/Comments					
Inspector Comments: FS_ID:39713 DS_ID:23789 EP_NO: 15447 FS_HLM: 2.519 Repair Type: Non-Urgent Crossing Status: Indicator Found UCIP Comments: Waterline needs markers installed to identify location. FIELD_STRUCT_DESC: 12-inch steel water pipe through the levee, 11.0 feet below the crown. Shutoff valve on landward side (not found 2014). USAA markings for utility crossing UNIT 7 provide credibility for this location. Permit No. 15447, 1991. FS Date: 06/11/2014

USAA marking on floodwall visible across channel on north side levee.

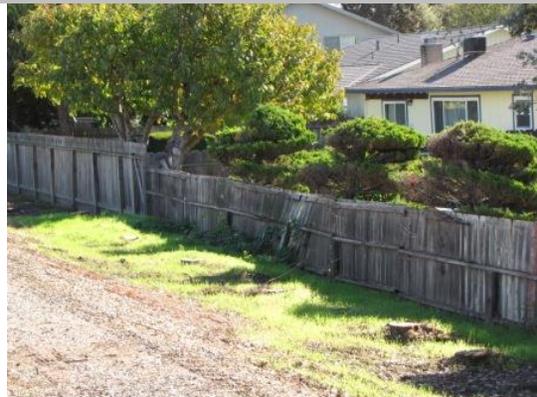
Photo 1 of 1 : FA\_2015\_NA0017\_152\_12\_20150911\_00005.jpg

LM Start	<b>2.50</b>	Rating **	N	Issue No.	<b>12</b>
LM End	<b>2.50</b>	Issue Type +	Ma	Location *	LS
Category	Earthen Levee			GPS Latitude/Longitude	
				Start	End
Item	Trim / Thin Trees			38.042749 °	38.042749 °
				-121.338402 °	-121.338402 °
DWR ID	DWR_NA0017_08_s_2012_12				
Action/Comments					
Tree stumps.

View of stumps along the landward toe looking upstream.

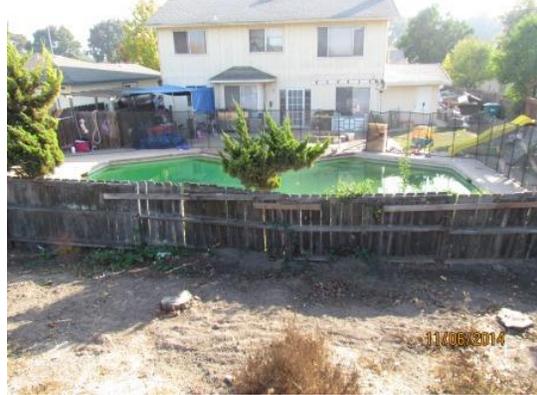
Photo 1 of 1 : FA\_2015\_NA0017\_152\_108\_20150911\_00034.jpg

LM Start	<b>2.50</b>	Rating **	M	Issue No.	<b>108</b>
LM End	<b>2.50</b>	Issue Type +	En	Location *	LS
Category	Earthen Levee			GPS Latitude/Longitude	
				Start	End
Item	Encroachments			38.042749 °	38.042749 °
				-121.338402 °	-121.338402 °
DWR ID	DWR_NA0017_08_f_2014_108				
Action/Comments					
Pool

A pool was found within 10 feet away from the landside toe of the levee.
