**Flood Control Project Maintenance  
Levee Inspections**

**Fall 2015 Levee Maintenance Deficiency Summary Report**

**San Joaquin River Basin**

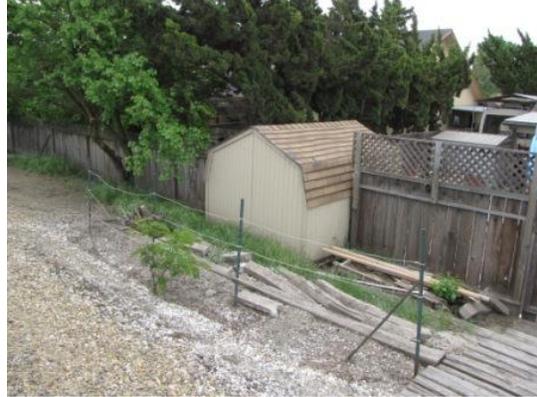
Photo 1 of 1 : FA\_2015\_NA0017\_152\_963\_20150911\_00043.jpg

LM Start	<b>2.69</b>	Rating **	U	Issue No.	<b>963</b>
LM End	<b>2.69</b>	Issue Type +	En	Location *	LS
Category	Earthen Levee			GPS Latitude/Longitude	
				Start	End
Item	Encroachments			38.042724 °	38.042724 °
				-121.337075 °	-121.337075 °
DWR ID	DWR_NA0017_08_s_2012_963				
Action/Comments					
Building Inspector Comments: Fall 2010: Landscaping removed, but shed still exists.

Landscaping and shed placed on landward levee slope and within 10' of the toe.

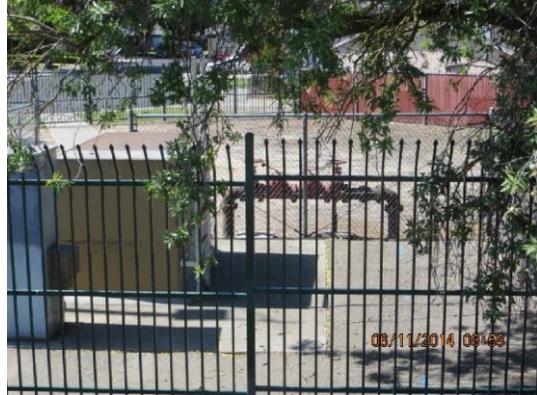
Photo 1 of 2 : UCIP\_FA\_2015\_4720.jpg

**Action/Comments**  
 Inspector Comments: FS\_ID:38521  
 DS\_ID:24012  
 EP\_NO: N/A  
 FS\_HLM: 2.81  
 Repair Type: Non-Urgent  
 Crossing Status: Indicator Found  
 UCIP Comments: Need Permit and drawings to better identify location for crossing.  
 FIELD\_STRUCT\_DESC: Pump station at landside toe with light post, electrical panel, and well. Gatevalve on pipe visible off LS toe within pump station. USAA paint on pavement indicates pipe may go through the levee, but no evidence was found on WS.  
 FS Date: 06/11/2014

Pipe, gatevalve, and USAA marker on pavement at LS toe.

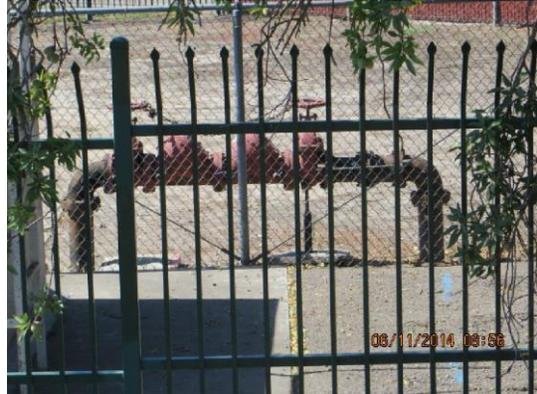
Photo 2 of 2 : UCIP\_FA\_2015\_4721.jpg

Pipe, gatevalve, and USAA marker on pavement at LS toe.

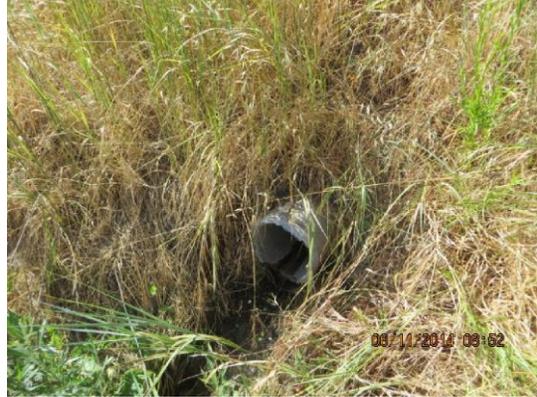
Photo 1 of 2 : UCIP\_FA\_2015\_4718.jpg

LM Start	<b>2.75</b>	Rating **	M	Issue No.	<b>1119</b>
LM End	<b>2.75</b>	Issue Type +	En	Location *	LS
Category	Supplemental			GPS Latitude/Longitude	
				Start	End
Item	DWR UCIP Field Study			38.042710 °	38.042710 °
				-121.333710 °	-121.333710 °
DWR ID					
Action/Comments					
Inspector Comments: FS_ID:38520 DS_ID:24013 EP_NO: N/A FS_HLM: 2.806 Repair Type: Non-Urgent Crossing Status: Found

Pipe visible in grass on WS slope.

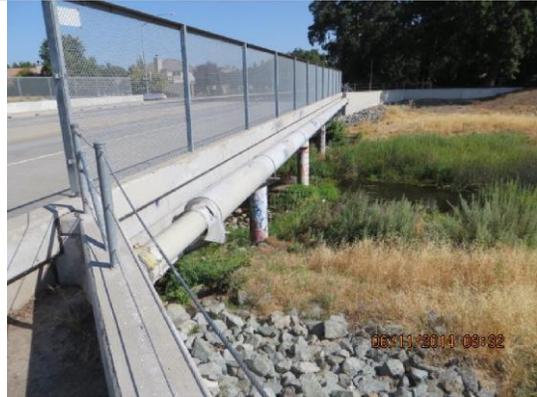
Photo 1 of 2 : UCIP\_FA\_2015\_6789.jpg

LM Start	<b>2.86</b>	Rating **	M	Issue No.	<b>1120</b>
LM End	<b>2.86</b>	Issue Type +	En	Location *	LS
Category	Supplemental			GPS Latitude/Longitude	
				Start	End
Item	DWR UCIP Field Study			38.042700 °	38.042700 °
				-121.331790 °	-121.331790 °
DWR ID					
Action/Comments					
Inspector Comments: FS_ID:41971 DS_ID:25026 EP_NO: N/A FS_HLM: 2.914 Repair Type: Non-Urgent Crossing Status: Found UCIP Comments: No permit identified for this crossing. FIELD_STRUCT_DESC: 12-inch wrapped steel waterline through the levee at an unknown depth below the crown. Pipe visible and attached to upstream side of bridge. FS Date: 06/11/2014

Pipe visible on upstream side of bridge.

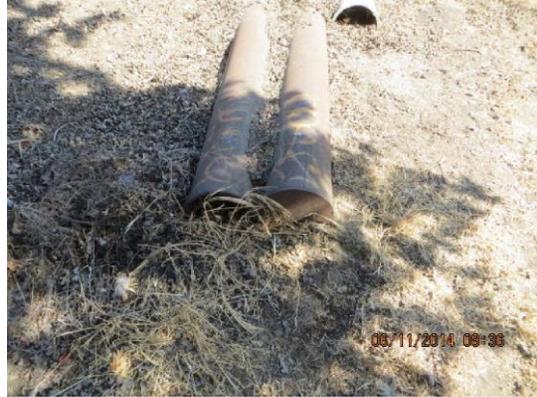
Photo 2 of 2 : UCIP\_FA\_2015\_6824.jpg

LM Start	2.86	Rating **	M	Issue No.	1121 (cont)	
LM End	2.86	Issue Type +	En	Location *	LS	
Category	Supplemental			GPS Latitude/Longitude		
			Start	End		
Item	DWR UCIP Field Study			38.042677 °	38.042677 °	
				-121.331765 °	-121.331765 °	
DWR ID						
Action/Comments						
Inspector Comments: FS_ID:41364 DS_ID:25029 EP_NO: N/A FS_HLM: 2.915 Repair Type: Non-Urgent Crossing Status: Found UCIP Comments: No permit identified for this crossing. FIELD_STRUCT_DESC: 10-inch steel pipe apparently through the levee 4.5-feet below the crown. Unclear what the purpose of this pipe is. Pipe open on LS toe. FS Date: 06/11/2014

Open steel pipe visible on LS of levee (left most pipe in photo).

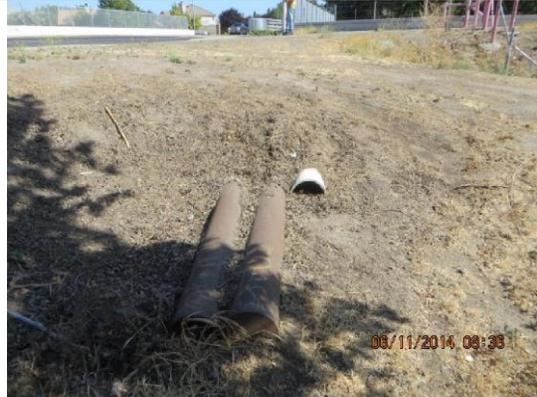
Photo 2 of 2 : UCIP\_FA\_2015\_6792.jpg

LM Start	2.86	Rating **	M	Issue No.	1122 (cont)
LM End	2.86	Issue Type +	En	Location *	LS
Category	Supplemental			GPS Latitude/Longitude	
			Start	End	
Item	DWR UCIP Field Study			38.042677 °	38.042677 °
				-121.331755 °	-121.331755 °
DWR ID					
Action/Comments					
Inspector Comments: FS_ID:41363 DS_ID:25028 EP_NO: N/A FS_HLM: 2.916 Repair Type: Non-Urgent Crossing Status: Found UCIP Comments: No permit identified for this crossing. FIELD_STRUCT_DESC: 10-inch steel pipe apparently through the levee 4.5-feet below the crown. Unclear what the purpose of this pipe is. Welded steel cover at LS end. FS Date: 06/11/2014

Pipe with welded steel cover visible on LS toe.

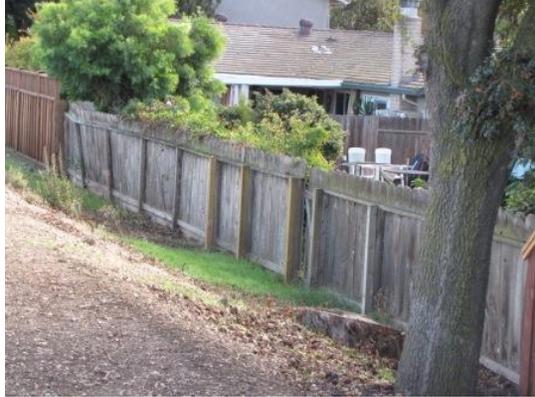
Photo 1 of 1 : FA\_2015\_NA0017\_152\_13\_20150911\_00006.jpg

LM Start	<b>3.19</b>	Rating **	N	Issue No.	<b>13</b>
LM End	<b>3.19</b>	Issue Type +	Ma	Location *	LS
Category	Earthen Levee		GPS Latitude/Longitude		
			Start	End	
Item	Trim / Thin Trees		38.042676 °	38.042676 °	
			-121.325694 °	-121.325694 °	
DWR ID	DWR_NA0017_08_s_2012_13				
Action/Comments					
Tree stumps.

View of a stump on the landward slope looking upstream.

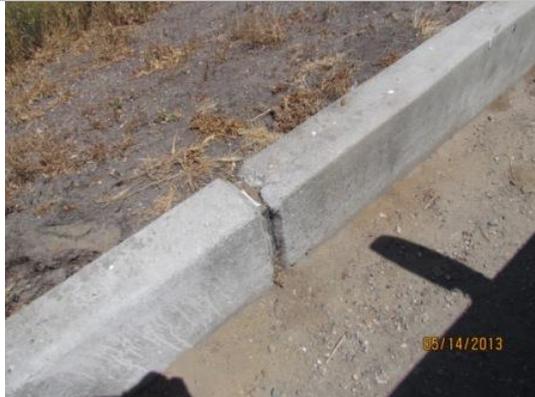
Photo 1 of 1 : FA\_2015\_NA0017\_152\_37\_20150911\_00011.jpg

LM Start	<b>3.24</b>	Rating **	M	Issue No.	<b>37</b>
LM End	<b>3.24</b>	Issue Type +	Ma	Location *	WS
Category	Concrete Floodwalls		GPS Latitude/Longitude		
			Start	End	
Item	Monolith Joints		38.042652 °	38.042652 °	
			-121.326883 °	-121.326883 °	
DWR ID	DWR_NA0017_08_s_2013_37				
Action/Comments

The monolith joint material is deteriorating at this location of the flood wall. The picture was taken from the crown looking upstream.

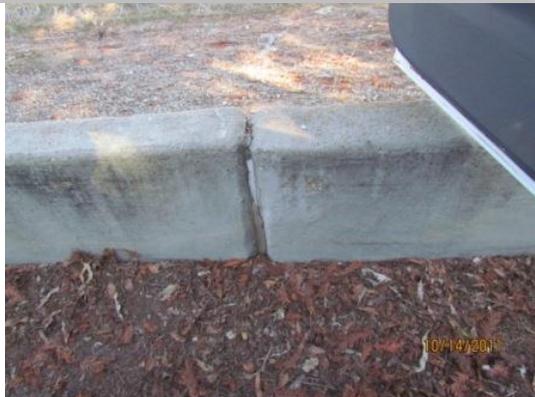
Photo 1 of 1 : FA\_2015\_NA0017\_152\_940\_20150911\_00041.jpg

LM Start	<b>3.31</b>	Rating **	M	Issue No.	<b>940</b>
LM End	<b>3.31</b>	Issue Type +	Ma	Location *	LS
Category	Concrete Floodwalls		GPS Latitude/Longitude		
			Start	End	
Item	Monolith Joints		38.042654 °	38.042654 °	
			-121.325611 °	-121.325611 °	
DWR ID	DWR_NA0017_08_s_2012_940				
Action/Comments

Monolith joint material is deteriorating at the joint of the flood wall. The picture was taken from the crown looking upstream.

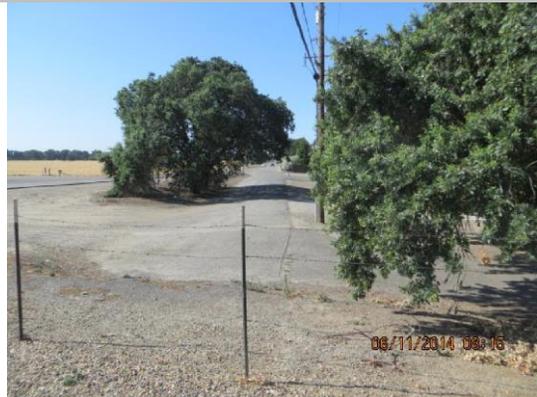
Photo 1 of 2 : UCIP\_FA\_2015\_4375.jpg

LM Start	<b>3.35</b>	Rating **	U	Issue No.	<b>1124</b>
LM End	<b>3.35</b>	Issue Type +	En	Location *	WS
Category	Supplemental			GPS Latitude/Longitude	
				Start	End
Item	DWR UCIP Field Study			38.042660 °	38.042660 °
				-121.322740 °	-121.322740 °
DWR ID					
Action/Comments					
Inspector Comments: FS_ID:38516 DS_ID:23733 EP_NO: 12508 FS_HLM: 3.42 Repair Type: Urgent Crossing Status: Found UCIP Comments: Gasline needs markers. FIELD_STRUCT_DESC: 10-inch high pressure gas main through the levee, 2.5-feet below the crown. Steel cutoff wall around main at center of levee. Regulator and reducing regulator on landward side. Permit No. 12508, 1978. FS Date: 06/11/2014

Signs need to be installed on levee.

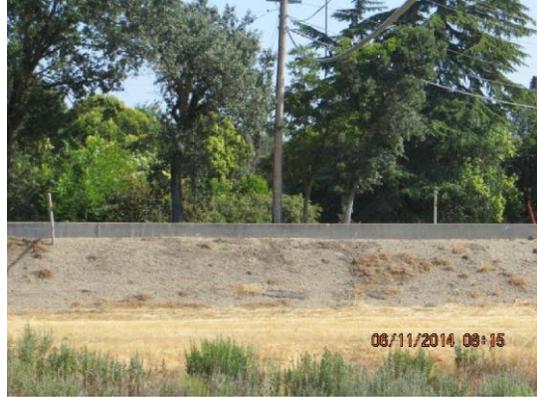
Photo 2 of 2 : UCIP\_FA\_2015\_4376.jpg

LM Start	<b>3.35</b>	Rating **	U	Issue No.	<b>1124 (cont)</b>
LM End	<b>3.35</b>	Issue Type +	En	Location *	WS
Category	Supplemental			GPS Latitude/Longitude	
				Start	End
Item	DWR UCIP Field Study			38.042660 °	38.042660 °
				-121.322740 °	-121.322740 °
DWR ID					
Action/Comments					
Inspector Comments: FS_ID:38516 DS_ID:23733 EP_NO: 12508 FS_HLM: 3.42 Repair Type: Urgent Crossing Status: Found UCIP Comments: Gasline needs markers. FIELD_STRUCT_DESC: 10-inch high pressure gas main through the levee, 2.5-feet below the crown. Steel cutoff wall around main at center of levee. Regulator and reducing regulator on landward side. Permit No. 12508, 1978. FS Date: 06/11/2014

Markers visible on oposite bank.

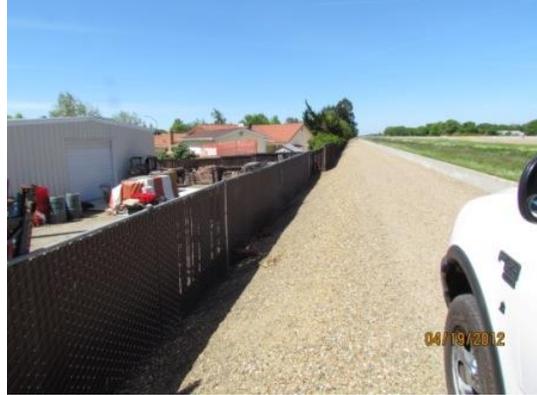
Photo 1 of 1 : FA\_2015\_NA0017\_152\_88\_20150911\_00026.jpg

LM Start	<b>3.46</b>	Rating **	U	Issue No.	<b>88</b>
LM End	<b>3.64</b>	Issue Type +	En	Location *	LS
Category	Earthen Levee		GPS Latitude/Longitude		
			Start	End	
Item	Encroachments		38.042657 °	38.042683 °	
			-121.322933 °	-121.317443 °	
DWR ID	DWR_NA0017_08_s_2012_88				
Action/Comments					
Fence

Fences were found on the landside of the levee looking downstream.

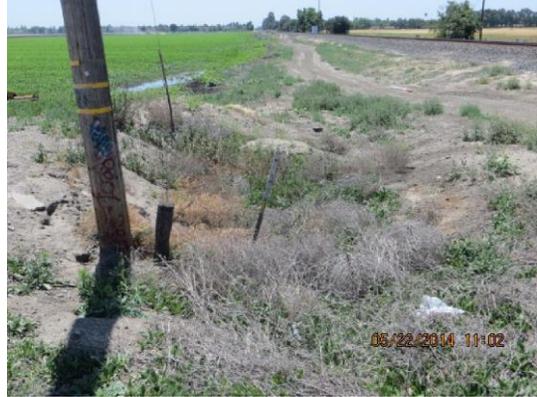
Photo 1 of 3 : UCIP\_FA\_2015\_5246.jpg

LM Start	<b>3.68</b>	Rating **	M	Issue No.	<b>1125</b>
LM End	<b>3.68</b>	Issue Type +	En	Location *	WS
Category	Supplemental			GPS Latitude/Longitude	
				Start	End
Item	DWR UCIP Field Study			38.042654 °	38.042654 °
				-121.316787 °	-121.316787 °
DWR ID					
Action/Comments					
Inspector Comments: FS_ID:41383 DS_ID:23735 EP_NO: N/A FS_HLM: 3.753 Repair Type: Non-Urgent Crossing Status: Indicator Found UCIP Comments: Appears abandoned and if so should be done so properly. Verify pipe status with PG&E or others. FIELD_STRUCT_DESC: 16-inch high pressure gas main through the levee at an unknown depth below the crown. Remnants of gasoline markers visible on LS toe. O&M Manual Bear Creek Part 1, June 1965. FS Date: 05/22/2014

Defunct gasoline marker on post next to powerpole on LS toe.

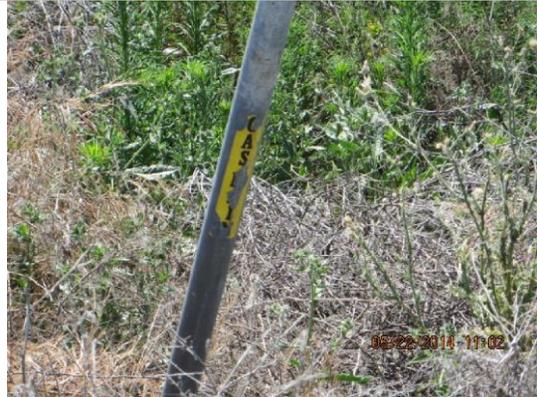
Photo 2 of 3 : UCIP\_FA\_2015\_5247.jpg

Defunct gasoline marker on post next to powerpole on LS toe.

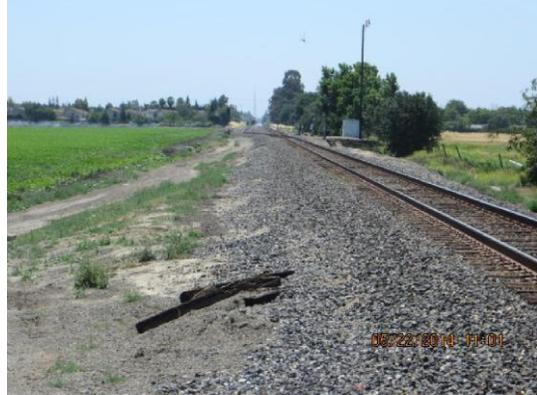
Photo 3 of 3 : UCIP\_FA\_2015\_5248.jpg

LM Start	<b>3.68</b>	Rating **	M	Issue No.	<b>1125 (cont)</b>
LM End	<b>3.68</b>	Issue Type +	En	Location *	WS
Category	Supplemental			GPS Latitude/Longitude	
				Start	End
Item	DWR UCIP Field Study			38.042654 °	38.042654 °
				-121.316787 °	-121.316787 °
DWR ID					
Action/Comments					
Inspector Comments: FS_ID:41383 DS_ID:23735 EP_NO: N/A FS_HLM: 3.753 Repair Type: Non-Urgent Crossing Status: Indicator Found

Looking south along rail line, there are no visible markers.

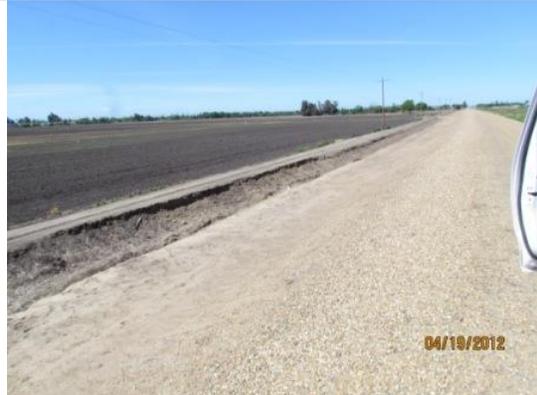
Photo 1 of 1 : FA\_2015\_NA0017\_152\_20\_20150911\_00008.jpg

LM Start	<b>4.06</b>	Rating **	M	Issue No.	<b>20</b>
LM End	<b>4.53</b>	Issue Type +	En	Location *	LS
Category	Earthen Levee			GPS Latitude/Longitude	
				Start	End
Item	Encroachments			38.042529 °	38.042676 °
				-121.309720 °	-121.301179 °
DWR ID	DWR_NA0017_08_s_2012_20				
Action/Comments					
Ditch

An agricultural ditch was found on the landside of the levee looking downstream.

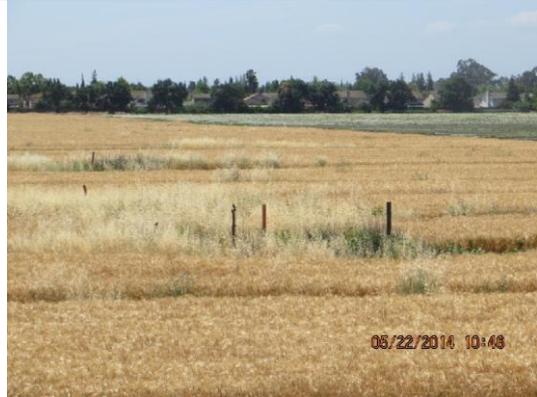
Photo 1 of 2 : UCIP\_FA\_2015\_5245.jpg

**Action/Comments**  
 Inspector Comments: FS\_ID:38506  
 DS\_ID:23837  
 EP\_NO: 17523  
 FS\_HLM: 4.299  
 Repair Type: Non-Urgent  
 Crossing Status: Indicator Found  
 UCIP Comments: Need markers closer to the levee.  
 FIELD\_STRUCT\_DESC: 1 of 2: 30-inch water line sleeved through a 54-inch steel casing through the levee, approximately 5.0 feet below the crown. Annular gap grouted. Blow-off valves at landward toe. Water line crossing markers at landside toe. Permit No. 17523, 2002.  
 FS Date: 05/22/2014

Markers off LS toe.

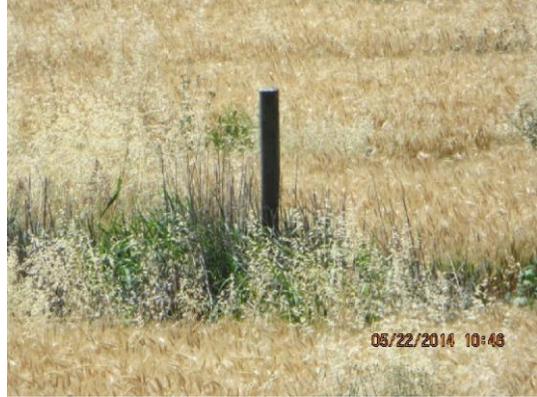
Photo 1 of 1 : UCIP\_FA\_2015\_6656.jpg

LM Start	<b>4.21</b>	Rating **	M	Issue No.	<b>1127</b>
LM End	<b>4.21</b>	Issue Type +	En	Location *	LS
Category	Supplemental			GPS Latitude/Longitude	
				Start	End
Item	DWR UCIP Field Study			38.042500 °	38.042500 °
				-121.307002 °	-121.307002 °
DWR ID					
Action/Comments					
Inspector Comments: FS_ID:38505 DS_ID:23838 EP_NO: 17523 FS_HLM: 4.3011 Repair Type: Non-Urgent Crossing Status: Indicator Found

Sewerline marker well off LS toe.

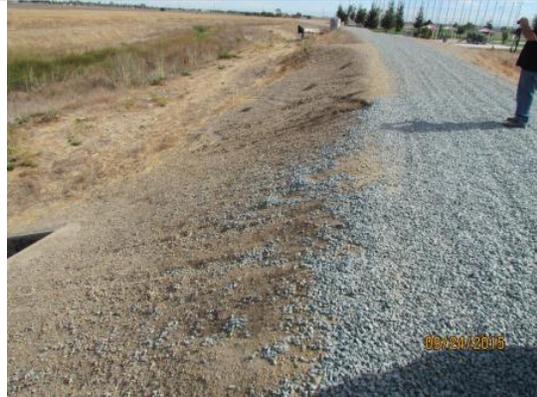
Photo 1 of 1 : FA\_2015\_NA0017\_152\_27\_20150928\_00099.jpg

LM Start	<b>4.56</b>	Rating **	M	Issue No.	<b>27</b>
LM End	<b>4.56</b>	Issue Type +	Ma	Location *	WS
Category	Earthen Levee			GPS Latitude/Longitude	
				Start	End
Item	Erosion / Bank Caving			38.042797 °	38.042797 °
				-121.300782 °	-121.300782 °
DWR ID	DWR_NA0017_08_s_2014_27				
Action/Comments					
Schedule repair of erosion site prior to the next inspection. Inspector Comments: Ruts on the waterside slope of the levee.

Erosion caused by runoffs on the waterside slope of the levee looking upstream.

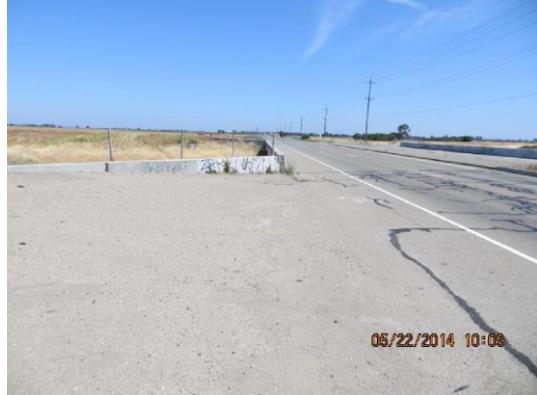
Photo 1 of 2 : UCIP\_FA\_2015\_6785.jpg

LM Start	<b>4.87</b>	Rating **	M	Issue No.	<b>1128</b>
LM End	<b>4.87</b>	Issue Type +	En	Location *	LS
Category	Supplemental			GPS Latitude/Longitude	
				Start	End
Item	DWR UCIP Field Study			38.044000 °	38.044000 °
				-121.295435 °	-121.295435 °
DWR ID					
Action/Comments					
Inspector Comments: FS_ID:41970 DS_ID:25025 EP_NO: N/A FS_HLM: 4.976 Repair Type: Non-Urgent Crossing Status: Found UCIP Comments: No permit identified for this crossing. FIELD_STRUCT_DESC: Waterline of unknown diameter through the levee at an unknown depth below the crown. Valve on LS shoulder. FS Date: 05/22/2014

Valve box visible at edge of roadway on LS of levee.

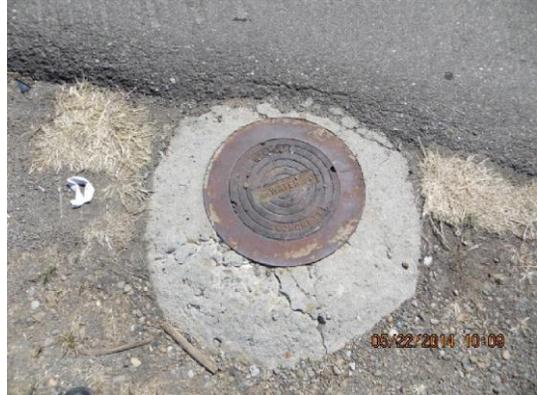
Photo 2 of 2 : UCIP\_FA\_2015\_6786.jpg

Valve box LS of levee at edge of pavement.

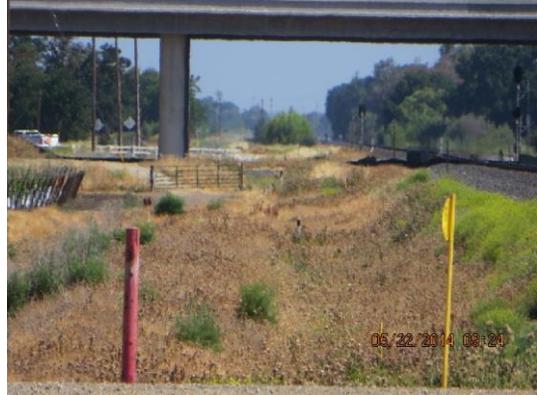
Photo 1 of 2 : UCIP\_FA\_2015\_6651.jpg

LM Start	<b>6.08</b>	Rating **	M	Issue No.	<b>1129</b>
LM End	<b>6.08</b>	Issue Type +	En	Location *	LS
Category	Supplemental			GPS Latitude/Longitude	
				Start	End
Item	DWR UCIP Field Study			38.052236 °	38.052236 °
				-121.277581 °	-121.277581 °
DWR ID					
Action/Comments					
Inspector Comments: FS_ID:38429 DS_ID:23710 EP_NO: N/A FS_HLM: 6.215 Repair Type: Non-Urgent Crossing Status: Indicator Found

Gasline marker visible on opposite bank.

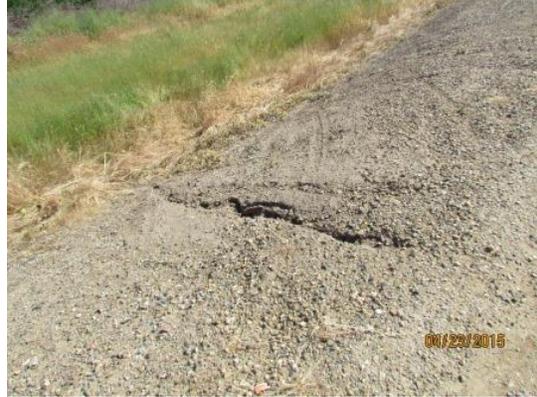
Photo 1 of 1 : FA\_2015\_NA0017\_152\_6\_20150911\_00004.jpg

LM Start	<b>6.16</b>	Rating **	M	Issue No.	<b>6</b>
LM End	<b>6.16</b>	Issue Type +	Ma	Location *	WS
Category	Earthen Levee		GPS Latitude/Longitude		
			Start	End	
Item	Slope Stability		38.052204 °	38.052204 °	
			-121.276014 °	-121.276014 °	
DWR ID	DWR_NA0017_08_s_2015_6				
Action/Comments					
Repair slope instability. Inspector Comments: Runoff

View of a slope instability due to runoff on the waterside of the levee looking upstream.

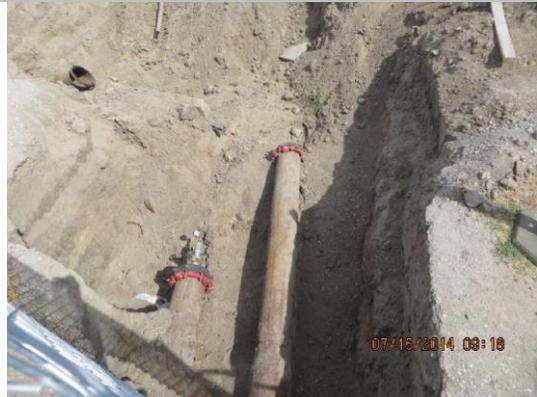
Photo 1 of 2 : UCIP\_FA\_2015\_6273.jpg

LM Start	<b>6.17</b>	Rating **	M	Issue No.	<b>1130</b>
LM End	<b>6.17</b>	Issue Type +	En	Location *	WS
Category	Supplemental		GPS Latitude/Longitude		
			Start	End	
Item	DWR UCIP Field Study		38.052186 °	38.052186 °	
			-121.275812 °	-121.275812 °	
DWR ID					
Action/Comments					
Inspector Comments: FS_ID:41790 DS_ID:23798 EP_NO: 15091 FS_HLM: 6.31 Repair Type: Non-Urgent Crossing Status: Found UCIP Comments: Pipe undergoing maintenance on Unit 7 side of channel. Need to verify status of pipe. If abandoned it should be done so properly. FIELD_STRUCT_DESC: 12-inch steel drainage siphon through the levee, 2.0 feet below the crown. Cutoff wall around pipe under waterward shoulder. Pipe burried on both toes, Permit No. 15091, 1996. FS Date: 07/15/2014

12-inch pipe with two 10-inch pipes attached to it on the LS toe of Unit 7 (pipe normally burried).

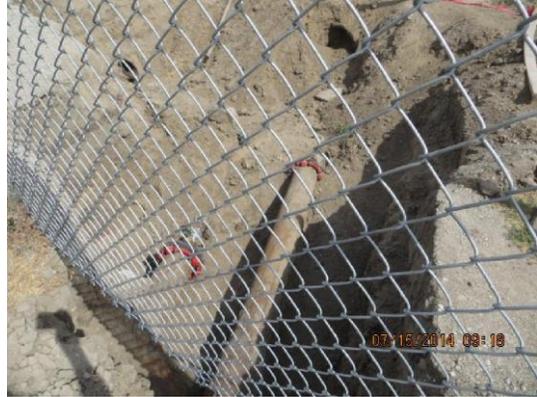
Photo 2 of 2 : UCIP\_FA\_2015\_6274.jpg

12-inch pipe with two 10-inch pipes attached to it on the LS toe of Unit 7 (pipe normally burried).

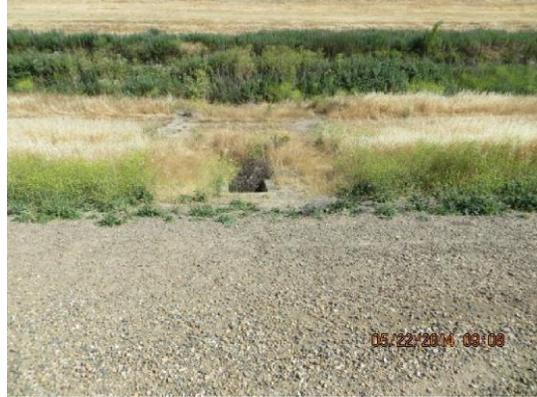
Photo 2 of 3 : UCIP\_FA\_2015\_6293.jpg

LM Start	<b>6.20</b>	Rating **	M	Issue No.	<b>1131 (cont)</b>
LM End	<b>6.20</b>	Issue Type +	En	Location *	WS
Category	Supplemental			GPS Latitude/Longitude	
				Start	End
Item	DWR UCIP Field Study			38.052247 °	38.052247 °
				-121.275311 °	-121.275311 °
DWR ID					
Action/Comments					
Inspector Comments: FS_ID:38373 DS_ID:23713 EP_NO: N/A FS_HLM: 6.342 Repair Type: Non-Urgent Crossing Status: Found UCIP Comments: Gate rusted shut on LS toe. FIELD_STRUCT_DESC: 24-inch CM stormdrain pipe through the levee, 7.9-feet below the crown. Concrete "U" headwalls on both ends. Flap gate on the waterward end. Slide gate on the landward end. Cobble grouted spillway across berm. O&M Manual Bear Creek Part 1, June 1965. Included in O&M Manual Bear Creek Addendum, February 1999. FS Date: 05/22/2014

Headwall, flapgate, and grouted spillway on WS toe.

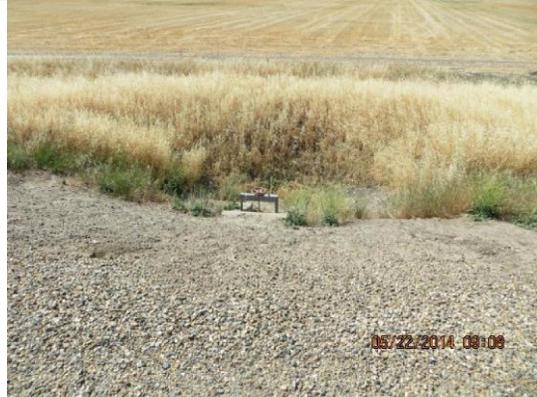
Photo 3 of 3 : UCIP\_FA\_2015\_6294.jpg

Headwall and slidegate on LS toe.

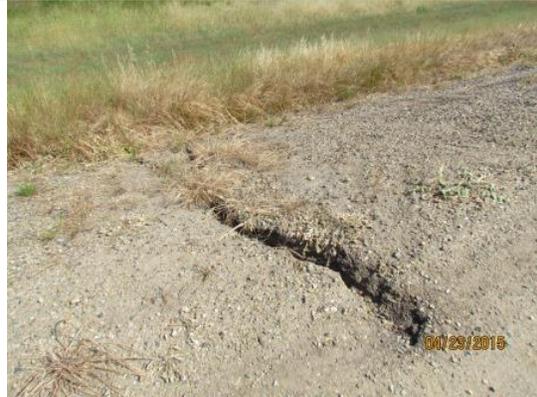
Photo 1 of 1 : FA\_2015\_NA0017\_152\_120\_20150911\_00037.jpg

LM Start	<b>6.53</b>	Rating **	M	Issue No.	<b>120</b>
LM End	<b>6.53</b>	Issue Type +	Ma	Location *	WS
Category	Earthen Levee			GPS Latitude/Longitude	
				Start	End
Item	Erosion / Bank Caving			38.052994 °	38.052994 °
				-121.271526 °	-121.271526 °
DWR ID	DWR_NA0017_08_f_2014_120				
Action/Comments					
Schedule repair of erosion site prior to the next inspection. Inspector Comments: Surface runoff.

View of the erosion due to runoff on the waterside of the levee looking upstream.

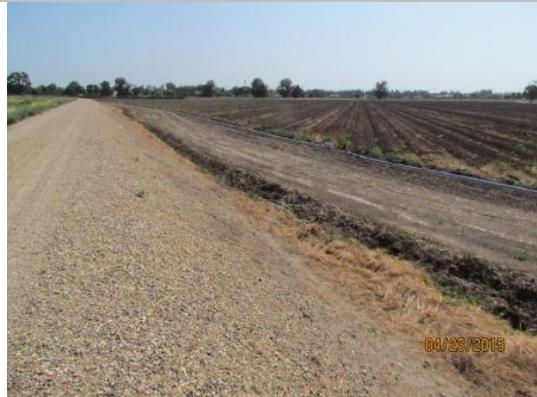
Photo 1 of 1 : FA\_2015\_NA0017\_152\_5\_20150911\_00003.jpg

LM Start	<b>6.84</b>	Rating **	M	Issue No.	<b>5</b>
LM End	<b>7.03</b>	Issue Type +	En	Location *	LS
Category	Earthen Levee			GPS Latitude/Longitude	
				Start	End
Item	Encroachments			38.054541 °	38.056616 °
				-121.264278 °	-121.261937 °
DWR ID	DWR_NA0017_08_s_2015_5				
Action/Comments					
Ditch

View of a ditch on the landside toe of the levee looking upstream.

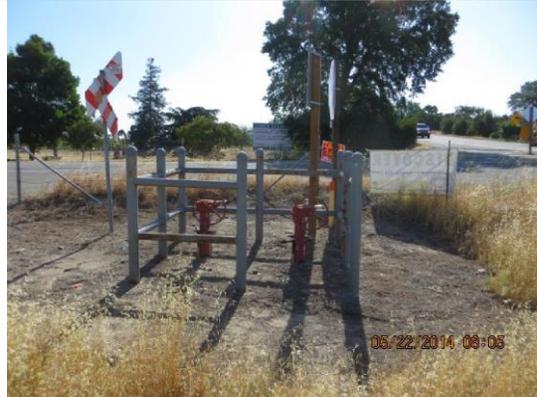
Photo 1 of 1 : UCIP\_FA\_2015\_6784.jpg

LM Start	<b>7.10</b>	Rating **	M	Issue No.	<b>1132</b>
LM End	<b>7.10</b>	Issue Type +	En	Location *	LS
Category	Supplemental			GPS Latitude/Longitude	
				Start	End
Item	DWR UCIP Field Study			38.057557 °	38.057557 °
				-121.261469 °	-121.261469 °
DWR ID					
Action/Comments					
Inspector Comments: FS_ID:41408 DS_ID:25024 EP_NO: N/A FS_HLM: 7.266 Repair Type: Non-Urgent Crossing Status: Indicator Found UCIP Comments: No permit identified for this crossing. FIELD_STRUCT_DESC: Gasline through the levee at an unknown depth below the crown. Signs and shutoff valves on LS. FS Date: 05/21/2014

Gasline markers, stations, and valves on LS of levee.

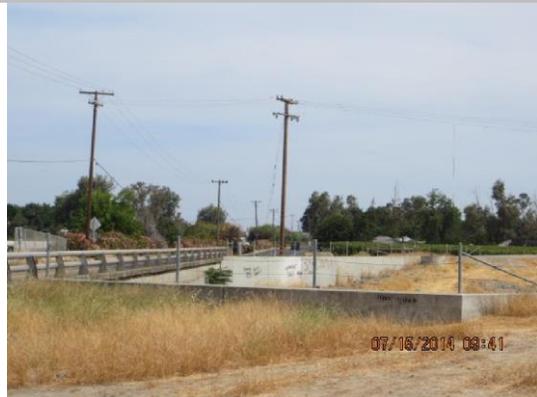
Photo 1 of 1 : UCIP\_FA\_2015\_6267.jpg

LM Start	<b>7.30</b>	Rating **	U	Issue No.	<b>1133</b>
LM End	<b>7.30</b>	Issue Type +	En	Location *	LS
Category	Supplemental			GPS Latitude/Longitude	
				Start	End
Item	DWR UCIP Field Study			38.059986 °	38.059986 °
				-121.260001 °	-121.260001 °
DWR ID					
Action/Comments					
Inspector Comments: FS_ID:39744 DS_ID:23741 EP_NO: 4286A FS_HLM: 7.467 Repair Type: Urgent Crossing Status: Indicator Found UCIP Comments: Need to have PG&E identify and mark crossing. FIELD_STRUCT_DESC: 8-inch high pressure gas main through the levee, 3.7 feet below the crown. No marker visible. Application No. 4286, 1963. Included in O&M Manual Bear Creek Part 1, June 1965. FS Date: 05/22/2014

No markers found on either levee at crossing.

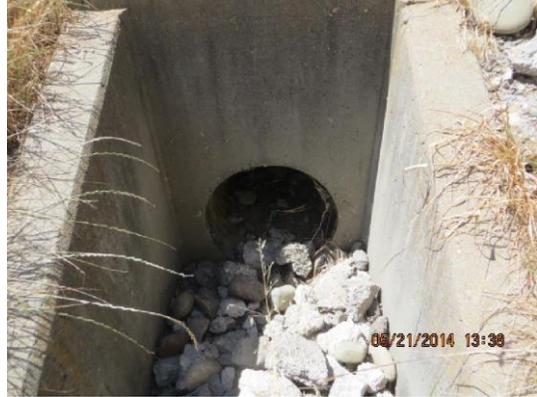
Photo 1 of 3 : UCIP\_FA\_2015\_6645.jpg

LM Start	<b>7.47</b>	Rating **	M	Issue No.	<b>1134</b>
LM End	<b>7.47</b>	Issue Type +	En	Location *	LS
Category	Supplemental			GPS Latitude/Longitude	
				Start	End
Item	DWR UCIP Field Study			38.061845 °	38.061845 °
				-121.257800 °	-121.257800 °
DWR ID					
Action/Comments					
Inspector Comments: FS_ID:41809 DS_ID:23743 EP_NO: N/A FS_HLM: 7.648 Repair Type: Non-Urgent Crossing Status: Found UCIP Comments: Cobbles building up at inlet and inside pipe along with sediment. FIELD_STRUCT_DESC: 24-inch CM stormdrain pipe through the levee, 7.0-feet below the crown. Flap gate on the waterward end. Concrete "U" headwalls on both ends. Cobble grouted spillway across the berm. Cobble grouted apron on the landward end. O&M Manual Bear Creek Part 2, 1967. Included in O&M Manual Bear Creek Addendum, February 1999. FS Date: 05/21/2014

Concrete headwall on LS toe. Cobbles distributed at inlet.

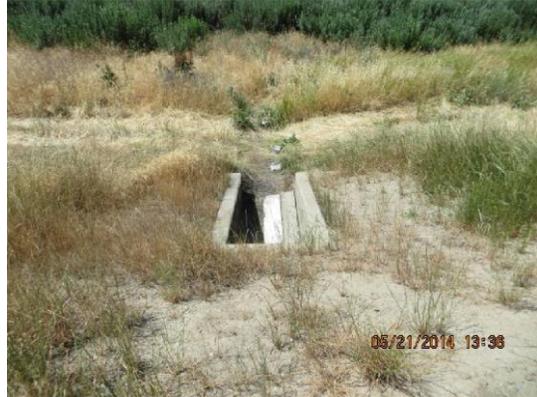
Photo 2 of 3 : UCIP\_FA\_2015\_6646.jpg

Concrete headwall and flapgate at WS toe.

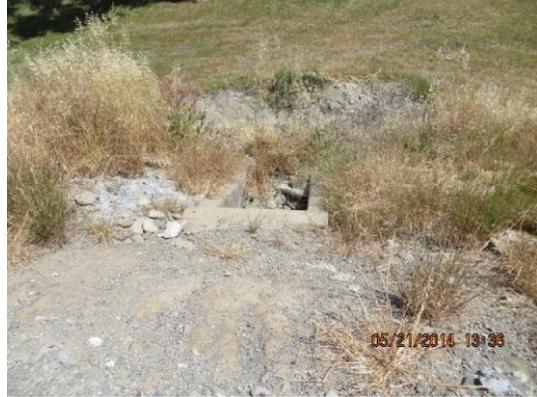
Photo 3 of 3 : UCIP\_FA\_2015\_6647.jpg

Concrete headwall on LS toe.

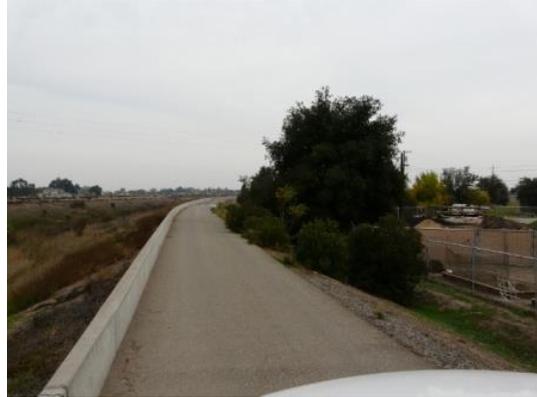
Photo 1 of 1 : FA\_2015\_NA0017\_152\_54\_20150911\_00015.jpg

LM Start	<b>7.51</b>	Rating **	M	Issue No.	<b>54</b>
LM End	<b>7.51</b>	Issue Type +	En	Location *	LS
Category	Earthen Levee			GPS Latitude/Longitude	
				Start	End
Item	Vegetation			38.062223 °	38.062223 °
				-121.257300 °	-121.257300 °
DWR ID	DWR_NA0017_08_s_2012_54				
Action/Comments					
Landscaping

Landscaping along landside slope.

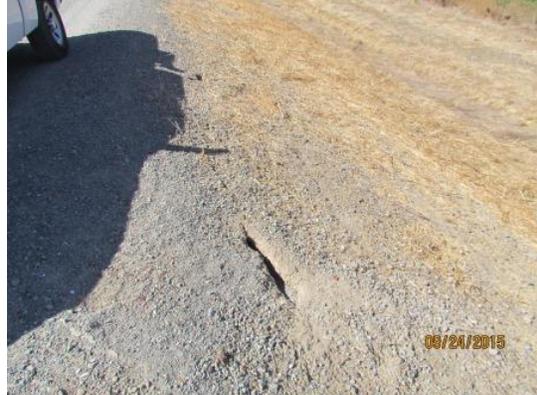
Photo 1 of 1 : FA\_2015\_NA0017\_152\_72\_20150928\_00103.jpg

LM Start	<b>7.86</b>	Rating **	M	Issue No.	<b>72</b>
LM End	<b>7.86</b>	Issue Type +	Ma	Location *	WS
Category	Earthen Levee			GPS Latitude/Longitude	
				Start	End
Item	Animal Control			38.064436 °	38.064436 °
				-121.251746 °	-121.251746 °
DWR ID	DWR_NA0017_08_f_2015_72				
Action/Comments					
No rodents visible, but rodent burrows visible; need to backfill and compact or grout burrows.

An animal hole was found on the waterside shoulder of the levee looking downstream.

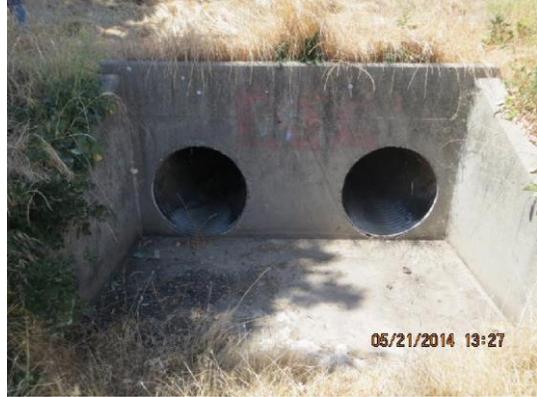
Photo 1 of 3 : UCIP\_FA\_2015\_6642.jpg

LM Start	7.99	Rating **	M	Issue No.	1135
LM End	7.99	Issue Type +	En	Location *	WS
Category	Supplemental			GPS Latitude/Longitude	
				Start	End
Item	DWR UCIP Field Study			38.064918 °	38.064918 °
				-121.249540 °	-121.249540 °
DWR ID					
Action/Comments					
Inspector Comments: FS_ID:38352 DS_ID:23744 EP_NO: N/A FS_HLM: 8.175 Repair Type: Non-Urgent Crossing Status: Found UCIP Comments: Lid damaged/missing from CMP riser on WS slope. FIELD_STRUCT_DESC: 1 of 2: 36-inch CM stormdrain pipe through the levee 9.0-feet below the crown. Flap gate on the waterward end. Slide gate in 48-inch CMP riser on the waterward slope. Concrete "U" headwalls on both ends. Cobble grouted spillway on the channel bank. Cobble grouted apron in ditch on the landward side. O&M Manual Bear Creek Part 2, 1967. Included in O&M Manual Bear Creek Addendum, February 1999. FS Date: 05/21/2014

Headwall at drainage channel on LS toe.

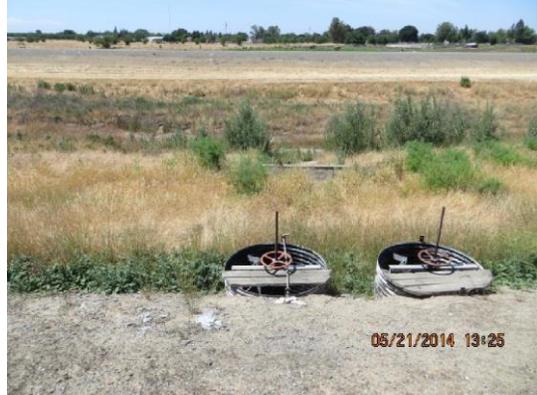
Photo 3 of 3 : UCIP\_FA\_2015\_6644.jpg

Slide gate in CMP riser on WS slope. Lid missing/damaged.

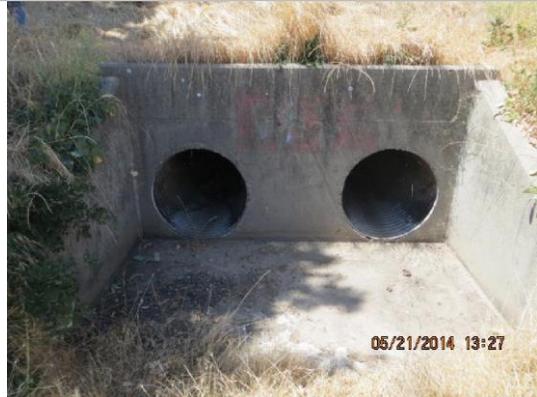
Photo 1 of 3 : UCIP\_FA\_2015\_6614.jpg

Item	DWR UCIP Field Study			38.064927 °	38.064927 °
				-121.249520 °	-121.249520 °
DWR ID					
Action/Comments					
Inspector Comments: FS_ID:38351 DS_ID:23820 EP_NO: N/A FS_HLM: 8.176 Repair Type: Non-Urgent Crossing Status: Found UCIP Comments: Lid damaged/missing on 48-inch CMP riser on WS slope. FIELD_STRUCT_DESC: 2 of 2: 36-inch CM stormdrain pipe through the levee, 9.0-feet below the crown. Flap gate on the waterward end. Slide gate in CMP risers on the waterward slope. Concrete "U" headwalls on both ends. Cobble grouted spillway on the channel bank. Cobble grouted apron in ditch on the landward side. O&M Manual Bear Creek Part 2, 1967. Included in O&M Manual Bear Creek Addendum, February 1999. FS Date: 05/21/2014

Headwall on LS toe at drainage channel.

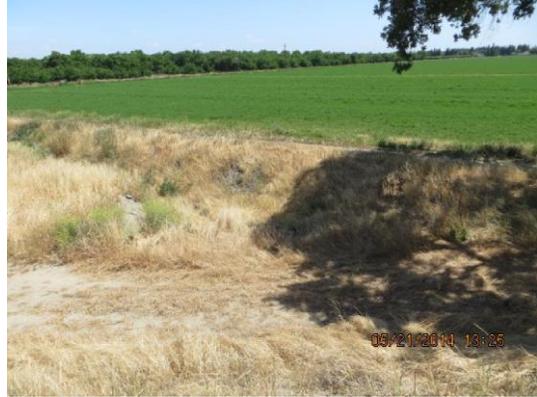
Photo 2 of 3 : UCIP\_FA\_2015\_6640.jpg

Headwall on LS toe at drainage channel.

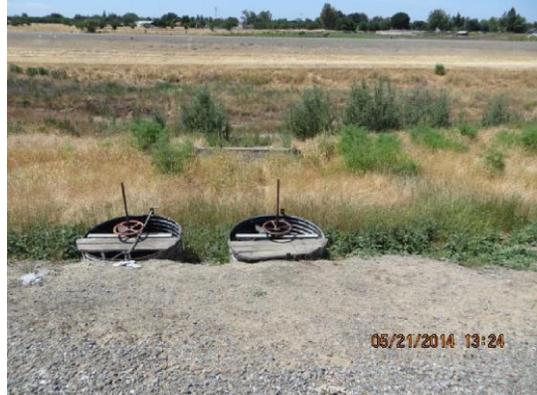
Photo 3 of 3 : UCIP\_FA\_2015\_6641.jpg

Slide gate in 48-inch CMP riser on WS slope. Note the missing lid material.

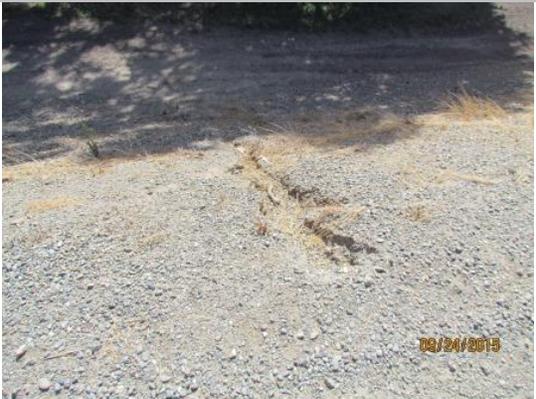
Photo 1 of 1 : FA\_2015\_NA0017\_152\_73\_20150928\_00104.jpg

LM Start	<b>8.83</b>	Rating **	M	Issue No.	<b>73</b>
LM End	<b>8.83</b>	Issue Type +	Ma	Location *	LS
Category	Earthen Levee		GPS Latitude/Longitude		
			Start	End	
Item	Erosion / Bank Caving		38.067130 °	38.067130 °	
			-121.234875 °	-121.234875 °	
DWR ID	DWR_NA0017_08_f_2015_73				
Action/Comments					
Schedule repair of erosion site prior to the next inspection. Inspector Comments: Surface runoff.

Erosion due surface runoff was found on the landside of the levee looking downstream.

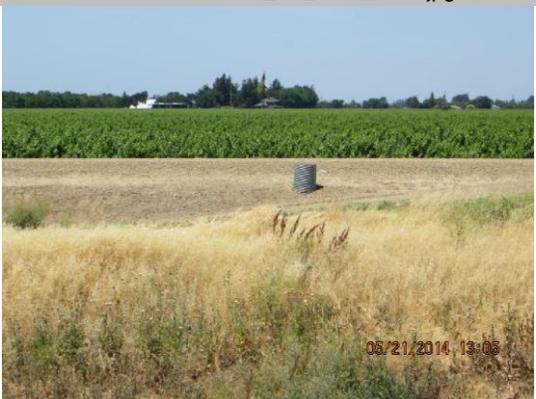
Photo 1 of 2 : UCIP\_FA\_2015\_6612.jpg

CMP riser on Oposite bank in line with this crossing.

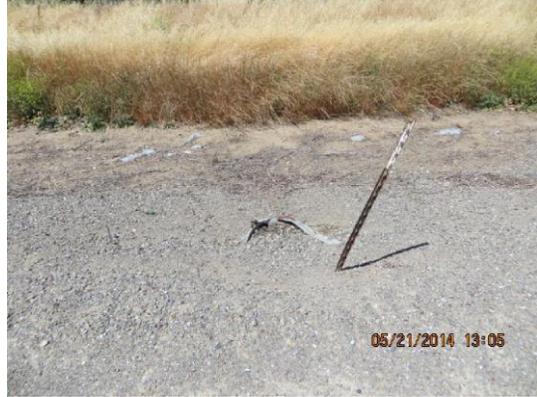
Photo 2 of 2 : UCIP\_FA\_2015\_6613.jpg

CMP riser for siphon breaker filled in with soil on WS shoulder.

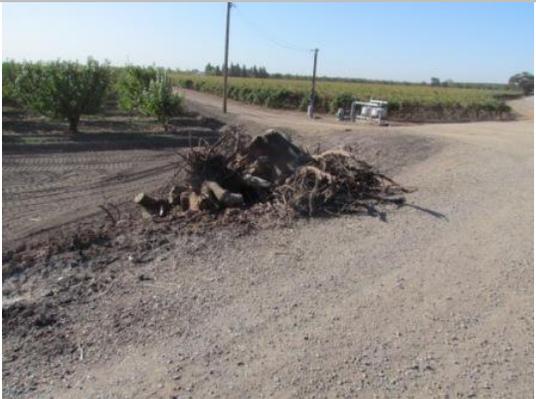
Photo 1 of 1 : FA\_2015\_NA0017\_152\_55\_20150911\_00016.jpg

LM Start	<b>9.30</b>	Rating **	M	Issue No.	<b>55</b>
LM End	<b>9.30</b>	Issue Type +	En	Location *	LS
Category	Earthen Levee		GPS Latitude/Longitude		
			Start	End	
Item	Encroachments		38.069698 °	38.069698 °	
			-121.226930 °	-121.226930 °	
DWR ID	DWR_NA0017_08_s_2012_55				
Action/Comments					
Prunings Inspector Comments: Burn pile has been burned but new material has been placed.

Prunings were found on the landside of the levee looking upstream.

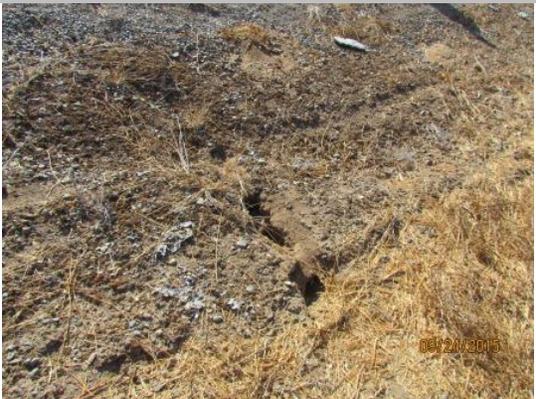
Photo 1 of 1 : FA\_2015\_NA0017\_152\_75\_20150928\_00105.jpg

LM Start	<b>9.42</b>	Rating **	M	Issue No.	<b>75</b>
LM End	<b>9.42</b>	Issue Type +	Ma	Location *	WS
Category	Earthen Levee		GPS Latitude/Longitude		
			Start	End	
Item	Animal Control		38.069797 °	38.069797 °	
			-121.224693 °	-121.224693 °	
DWR ID	DWR_NA0017_08_f_2015_75				
Action/Comments					
No rodents visible, but rodent burrows visible; need to backfill and compact or grout burrows.

Rodent holes were found on the waterside of the levee looking downstream.

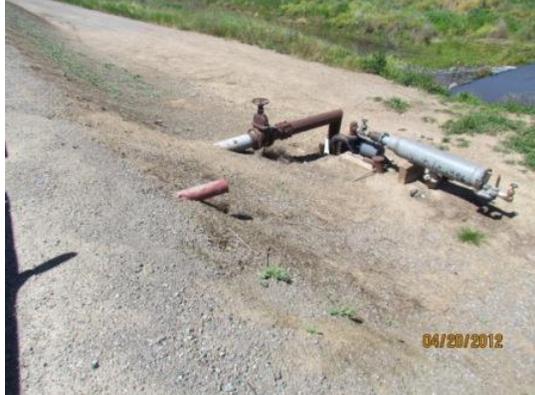
Photo 1 of 1 : FA\_2015\_NA0017\_152\_56\_20150911\_00017.jpg

LM Start	<b>9.52</b>	Rating **	M	Issue No.	<b>56</b>
LM End	<b>9.52</b>	Issue Type +	En	Location *	WS
Category	Earthen Levee			GPS Latitude/Longitude	
				Start	End
Item	Encroachments			38.069845 °	38.069845 °
				-121.222910 °	-121.222910 °
DWR ID	DWR_NA0017_08_s_2012_56				
Action/Comments					
Pipe

An open pipe was found on the waterside of the levee looking downstream.

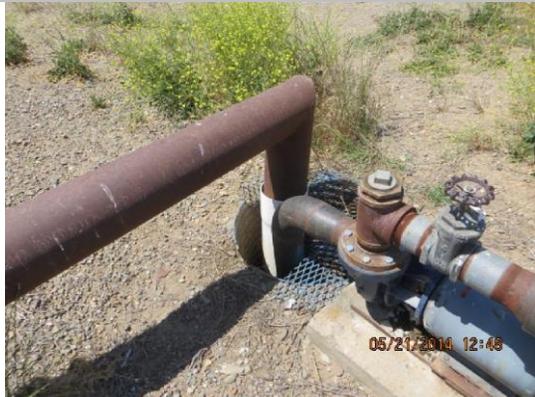
Photo 1 of 3 : UCIP\_FA\_2015\_6606.jpg

Item	DWR UCIP Field Study			38.069812 °	38.069812 °
				-121.222840 °	-121.222840 °
DWR ID					
Action/Comments					
Inspector Comments: FS_ID:41601 DS_ID:23724 EP_NO: N/A FS_HLM: 9.751 Repair Type: Non-Urgent Crossing Status: Found UCIP Comments: Gate valve appears to be rusted closed. FIELD_STRUCT_DESC: 8-inch wrapped steel irrigation pipe through the levee 3.5-feet below the crown. Gate valve on the waterward side. Pump sits on 36-inch CMP sump on the waterward berm . 24-inch CM intake pipe from CMP riser unit for pump to concrete "U" headwall with cobble grouted inlet at waters edge. 44-inch concrete standpipe on the LS toe. 1.5-inch capped galvanized iron electrical conduit at same location. O&M Manual Bear Creek Part 2, 1967. FS Date: 05/21/2014

Pipe and pump over 36-inch CMP sump at WS toe.

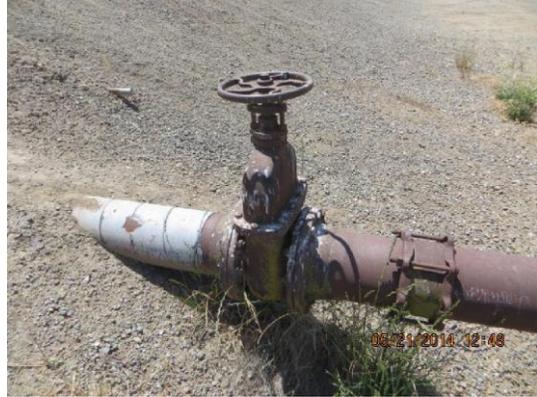
Photo 2 of 3 : UCIP\_FA\_2015\_6607.jpg

Pipe, gate valve, and electrical conduit on WS slope.

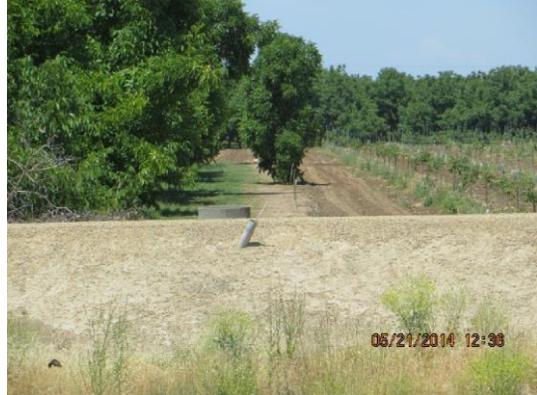
Photo 1 of 3 : UCIP\_FA\_2015\_6609.jpg

concrete standpipe and 4-inch steel riser on opposite bank.

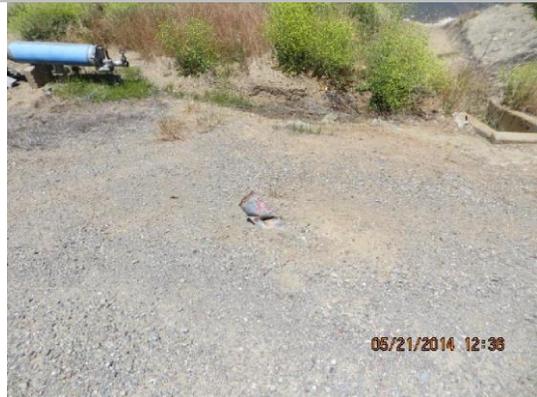
Photo 2 of 3 : UCIP\_FA\_2015\_6610.jpg

Damaged 4-inch steel riser pipe on WS shoulder.

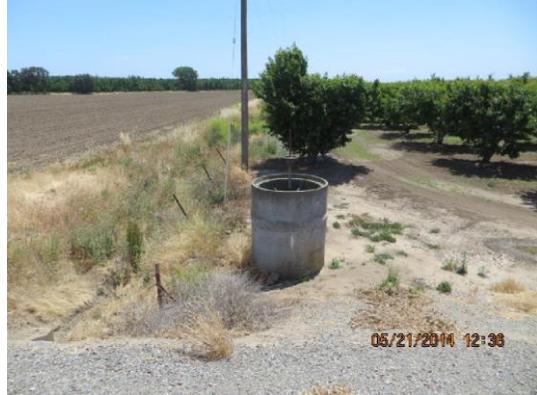
Photo 3 of 3 : UCIP\_FA\_2015\_6611.jpg

60-inch concrete riser with slidegate inside on LS toe.

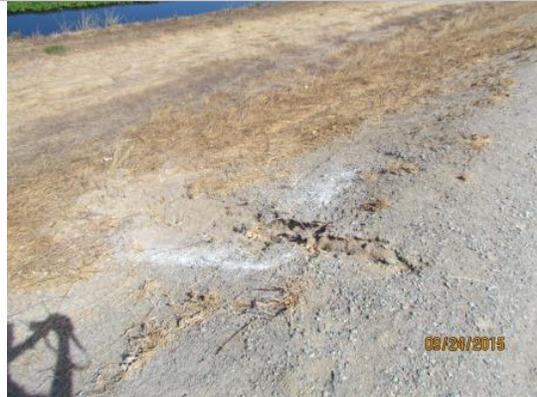
Photo 1 of 1 : FA\_2015\_NA0017\_152\_76\_20150928\_00106.jpg

LM Start	<b>9.63</b>	Rating **	M	Issue No.	<b>76</b>
LM End	<b>9.63</b>	Issue Type +	Ma	Location *	WS
Category	Earthen Levee			GPS Latitude/Longitude	
				Start	End
Item	Slope Stability			38.069807 °	38.069807 °
				-121.220890 °	-121.220890 °
DWR ID	DWR_NA0017_08_f_2015_76				
Action/Comments					
Repair slope instability.

A slope instability was found on the waterside of the levee looking upstream.

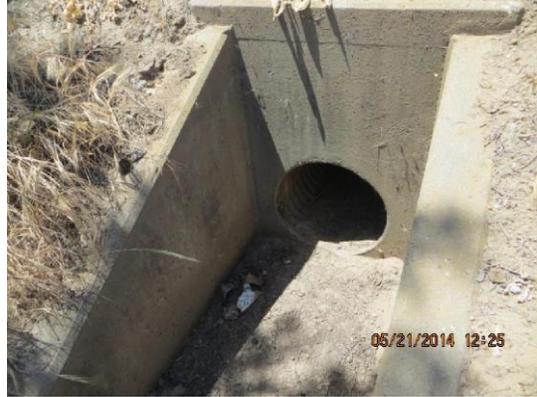
Photo 1 of 3 : UCIP\_FA\_2015\_6458.jpg

Headwall at LS toe.

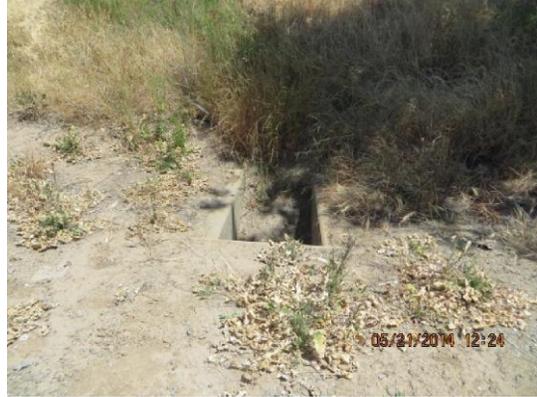
Photo 3 of 3 : UCIP\_FA\_2015\_6460.jpg

Headwall at LS toe.

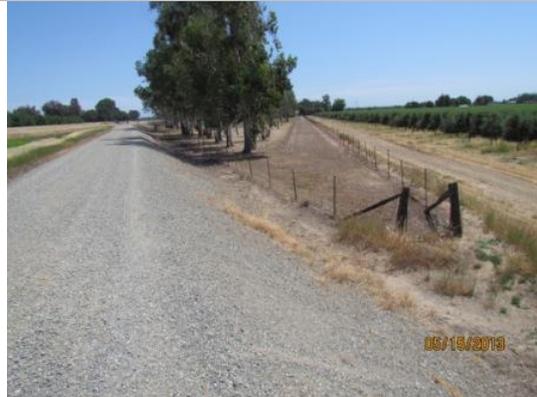
Photo 1 of 1 : FA\_2015\_NA0017\_152\_950\_20150911\_00042.jpg

LM Start	<b>9.99</b>	Rating **	M	Issue No.	<b>950</b>
LM End	<b>10.21</b>	Issue Type +	En	Location *	LS
Category	Earthen Levee			GPS Latitude/Longitude	
				Start	End
Item	Encroachments			38.072645 °	38.073670 °
				-121.215860 °	-121.212145 °
DWR ID	DWR_NA0017_08_s_2012_950				
Action/Comments					
Fence

A fence was found on the landside toe of the levee looking upstream.

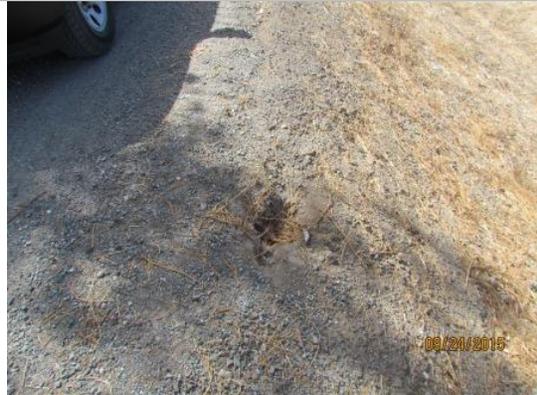
Photo 1 of 1 : FA\_2015\_NA0017\_152\_78\_20150928\_00107.jpg

LM Start	<b>10.04</b>	Rating **	M	Issue No.	<b>78</b>
LM End	<b>10.04</b>	Issue Type +	Ma	Location *	WS
Category	Earthen Levee			GPS Latitude/Longitude	
				Start	End
Item	Animal Control			38.072884 °	38.072884 °
				-121.215102 °	-121.215102 °
DWR ID	DWR_NA0017_08_f_2015_78				
Action/Comments					
No rodents visible, but rodent burrows visible; need to backfill and compact or grout burrows.

An animal borrow was found on the waterside of the levee looking downstream.

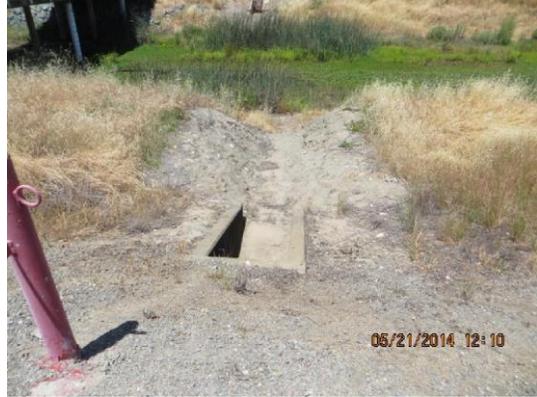
Photo 1 of 2 : UCIP\_FA\_2015\_6303.jpg

**Action/Comments**  
 Inspector Comments: FS\_ID:41808  
 DS\_ID:23729  
 EP\_NO: N/A  
 FS\_HLM: 10.478  
 Repair Type: Non-Urgent  
 Crossing Status: Found  
 UCIP Comments: Some sediment buildup in pipe at LS toe.  
 FIELD\_STRUCT\_DESC: 24-inch CM stormdrain pipe through the levee, 7-feet below the crown. Flap gate on the waterward end. Concrete "U" headwalls on both ends. Cobble grouted spillway across the berm. Cobble grouted apron on the landward end. O&M Manual Bear Creek Part 2, 1967. Included in O&M Manual Bear Creek Addendum, February 1999.  
 FS Date: 05/21/2014

Headwall, flapgate, and grouted spillway on WS slope.

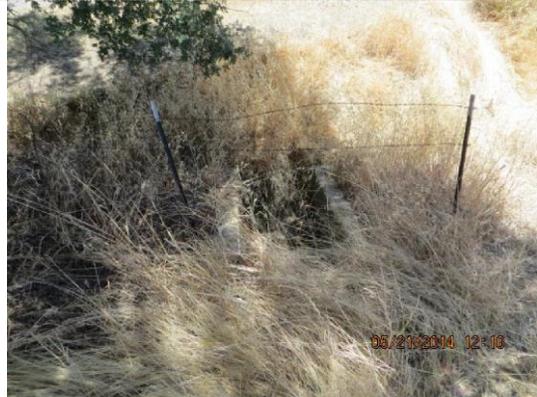
Photo 2 of 2 : UCIP\_FA\_2015\_6304.jpg

Headwall at LS toe.

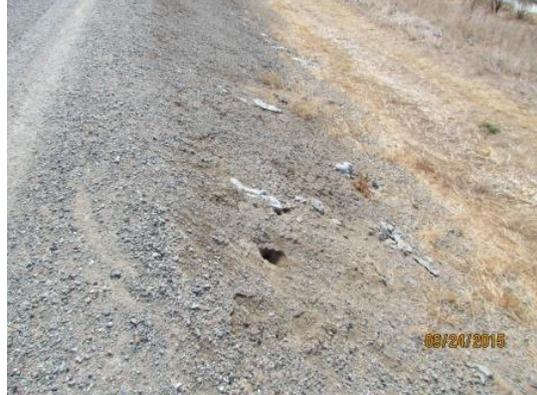
Photo 1 of 1 : FA\_2015\_NA0017\_152\_79\_20150928\_00108.jpg

LM Start	<b>10.39</b>	Rating **	M	Issue No.	<b>79</b>
LM End	<b>10.39</b>	Issue Type +	Ma	Location *	WS
Category	Earthen Levee		GPS Latitude/Longitude		
			Start	End	
Item	Animal Control		38.075132 °	38.075132 °	
			-121.208341 °	-121.208341 °	
DWR ID	DWR_NA0017_08_f_2015_79				
Action/Comments					
No rodents visible, but rodent burrows visible; need to backfill and compact or grout burrows.

Rodent holes were found on the waterside slope of the levee looking downstream.

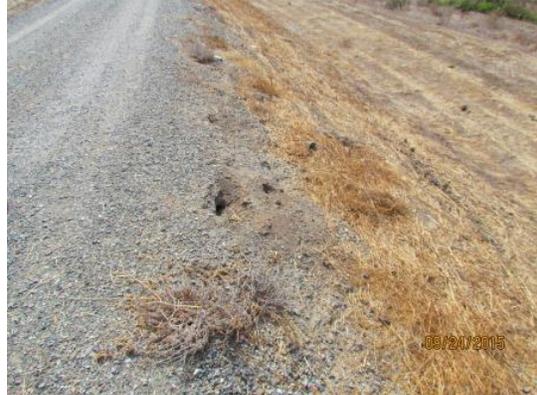
Photo 1 of 2 : FA\_2015\_NA0017\_152\_94\_20150928\_00109.jpg

LM Start	<b>10.52</b>	Rating **	M	Issue No.	<b>94</b>
LM End	<b>10.52</b>	Issue Type +	Ma	Location *	WS
Category	Earthen Levee		GPS Latitude/Longitude		
			Start	End	
Item	Animal Control		38.076880 °	38.076880 °	
			-121.207703 °	-121.207703 °	
DWR ID	DWR_NA0017_08_s_2015_94				
Action/Comments					
No rodents visible, but rodent burrows visible; need to backfill and compact or grout burrows.

Updated picture of the rodent holes on the waterside of the levee looking downstream during fall 2015 inspection.

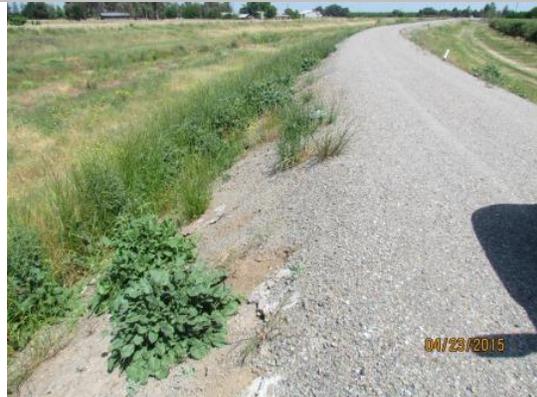
Photo 2 of 2 : FA\_2015\_NA0017\_152\_94\_20150911\_00030.jpg

Rodent holes were found on the waterside of the levee looking upstream.

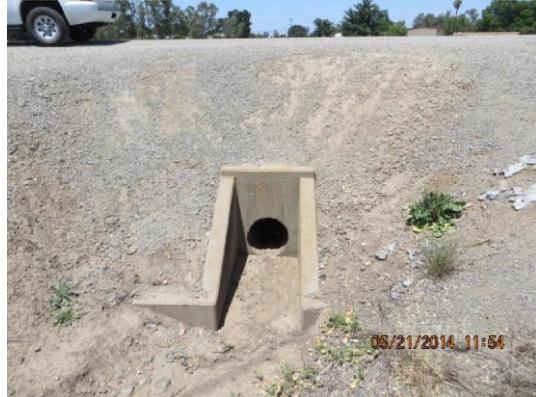
Photo 1 of 3 : UCIP\_FA\_2015\_6300.jpg

Headwall at LS toe.

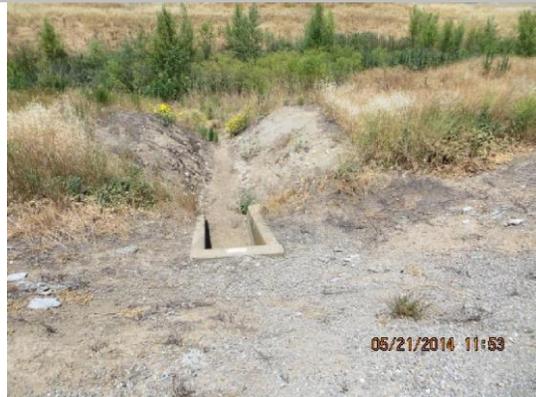
Photo 2 of 3 : UCIP\_FA\_2015\_6301.jpg

Headwall, flapgat, and grouted spillway on WS slope.

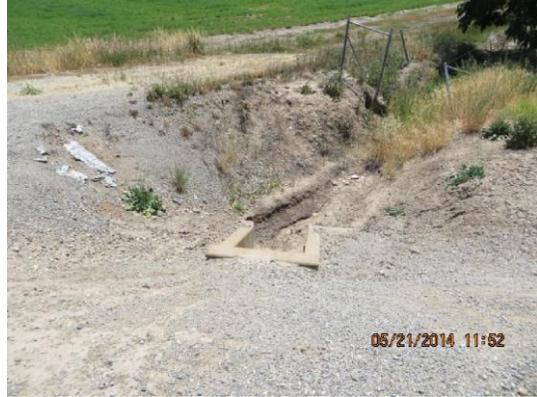
Photo 3 of 3 : UCIP\_FA\_2015\_6302.jpg

Headwall at LS toe.

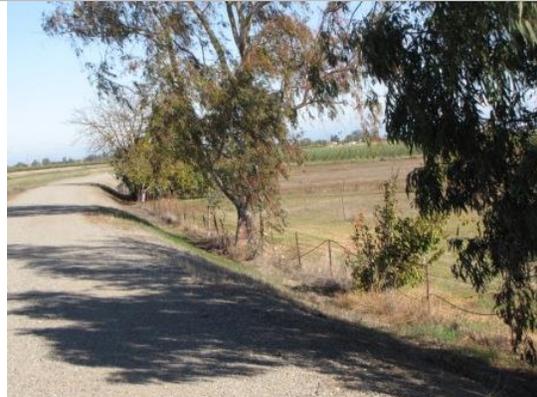
Photo 1 of 1 : FA\_2015\_NA0017\_152\_1107\_20150911\_00094.jpg

LM Start	<b>11.14</b>	Rating **	M	Issue No.	<b>1107</b>
LM End	<b>11.30</b>	Issue Type +	En	Location *	LS
Category	Earthen Levee			GPS Latitude/Longitude	
				Start	End
Item	Encroachments			38.081678 °	38.083292 °
				-121.198682 °	-121.196662 °
DWR ID	DWR_NA0017_08_s_2012_1107				
Action/Comments					
Fence Inspector Comments: Barbed wire fence on landward toe.

View of a fence at the landward toe looking upstream.
