**Flood Control Project Maintenance  
Levee Inspections**

**Fall 2015 Levee Maintenance Deficiency Summary Report**

**San Joaquin River Basin**

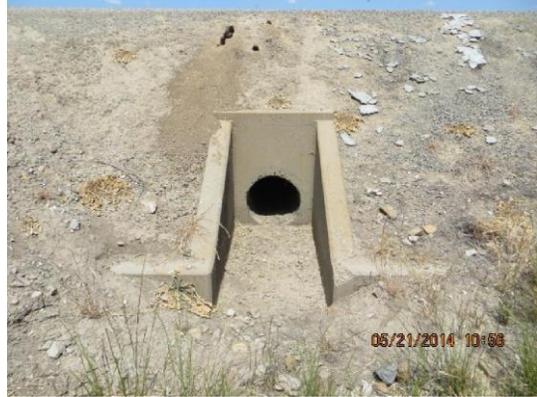
Photo 1 of 3 : UCIP\_FA\_2015\_6251.jpg

Headwall on LS toe.

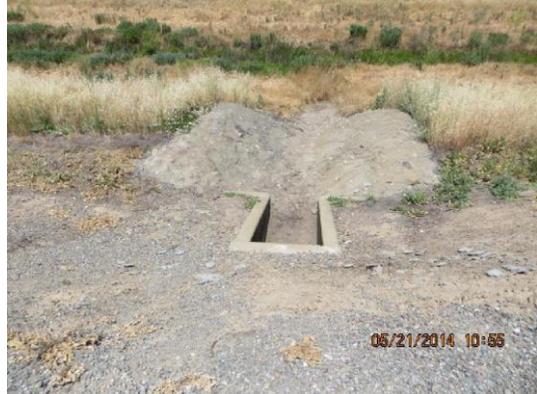
Photo 2 of 3 : UCIP\_FA\_2015\_6252.jpg

Headwall, flapgate, and grouted spillway on WS slope.

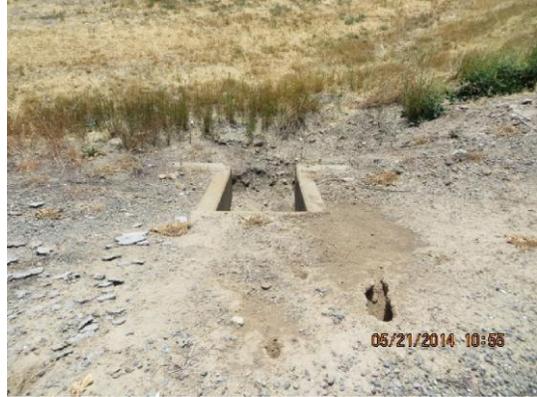
Photo 3 of 3 : UCIP\_FA\_2015\_6253.jpg

Headwall at LS toe.

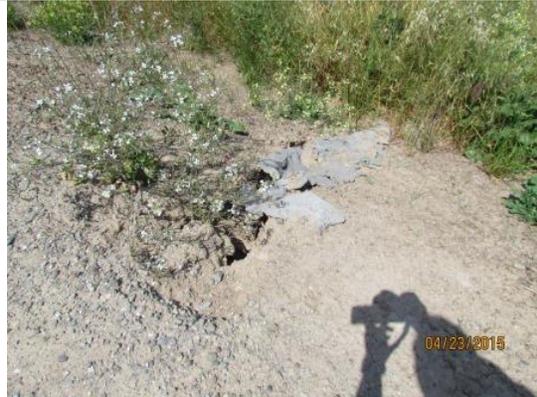
Photo 1 of 1 : FA\_2015\_NA0017\_152\_111\_20150911\_00036.jpg

LM Start	<b>11.69</b>	Rating **	M	Issue No.	<b>111</b>
LM End	<b>11.69</b>	Issue Type +	Ma	Location *	WS
Category	Earthen Levee			GPS Latitude/Longitude	
				Start	End
Item	Slope Stability			38.086135 °	38.086135 °
				-121.190670 °	-121.190670 °
DWR ID	DWR_NA0017_08_s_2015_111				
Action/Comments					
Repair slope instability. Inspector Comments: Slope instability caused by rodent holes.

View of slope instability due to rodent holes on the waterside of the levee looking downstream.

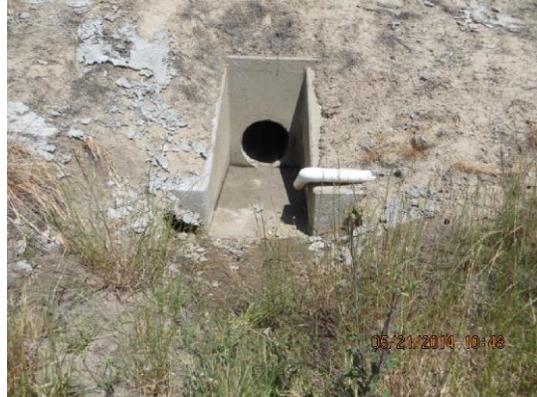
Photo 1 of 3 : UCIP\_FA\_2015\_6248.jpg

Headwall on LS toe.

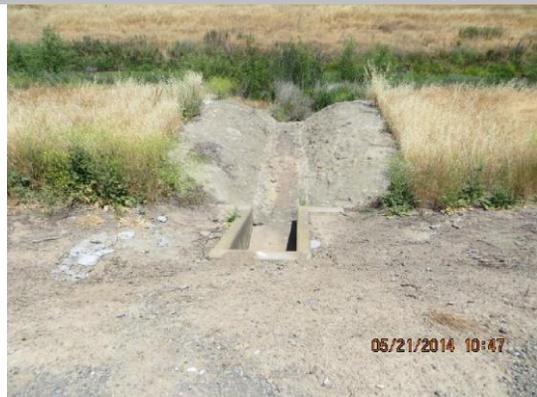
Photo 2 of 3 : UCIP\_FA\_2015\_6249.jpg

Headwall, flapgate, and grouted spillway on WS slope.

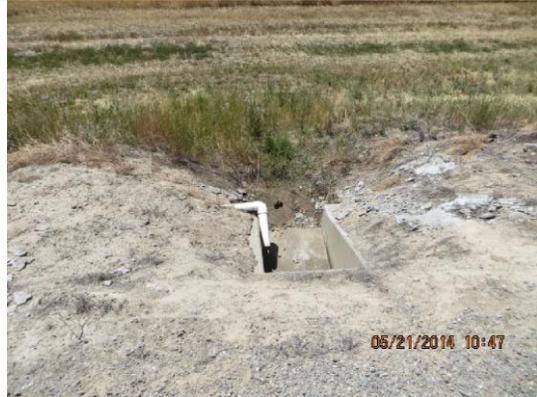
Photo 3 of 3 : UCIP\_FA\_2015\_6250.jpg

Headwall at LS toe. 4-inch PVC backwash from filter plant discharges at headwall.

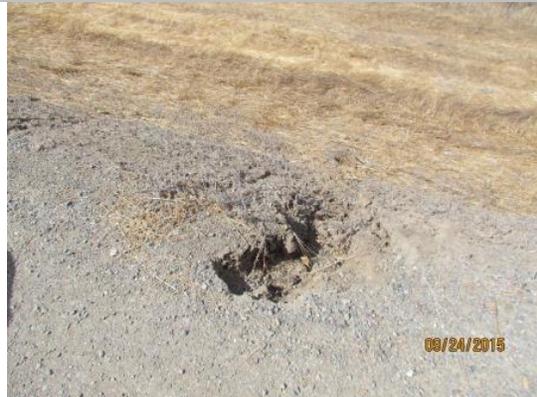
Photo 1 of 1 : FA\_2015\_NA0017\_152\_80\_20150928\_00110.jpg

LM Start	<b>11.73</b>	Rating **	M	Issue No.	<b>80</b>
LM End	<b>11.73</b>	Issue Type +	Ma	Location *	WS
Category	Earthen Levee			GPS Latitude/Longitude	
				Start	End
Item	Slope Stability			38.086219 °	38.086219 °
				-121.190030 °	-121.190030 °
DWR ID	DWR_NA0017_08_f_2015_80				
Action/Comments					
Repair slope instability.

Slope instability was found on the waterside of the levee looking downstream.

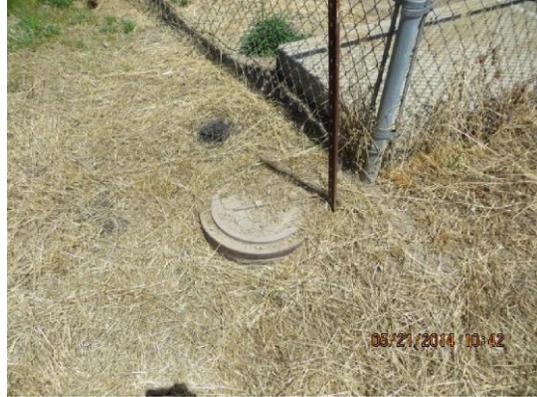
Photo 1 of 2 : UCIP\_FA\_2015\_6246.jpg

Possible turnout at farside of filter plant off LS toe.

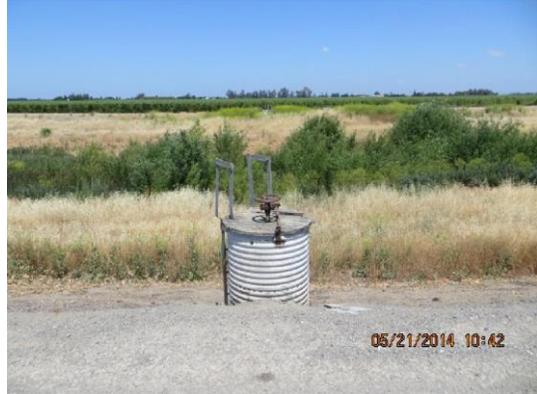
Photo 2 of 2 : UCIP\_FA\_2015\_6247.jpg

Slide gate in CMP riser on WS slope with same on opposite bank visible in background.

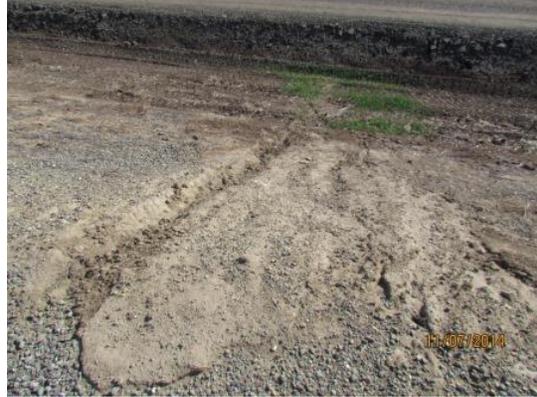
Photo 1 of 1 : FA\_2015\_NA0017\_152\_128\_20150911\_00038.jpg

Erosion was found on the landside of the levee looking upstream.

LM Start	<b>11.81</b>	Rating **	M	Issue No.	<b>128</b>
LM End	<b>11.81</b>	Issue Type +	Ma	Location *	LS
Category	Earthen Levee			GPS Latitude/Longitude	
				Start	End
Item	Erosion / Bank Caving			38.086116 °	38.086116 °
				-121.190630 °	-121.190630 °
DWR ID	DWR_NA0017_08_f_2014_128				
Action/Comments					
Schedule repair of erosion site prior to the next inspection.

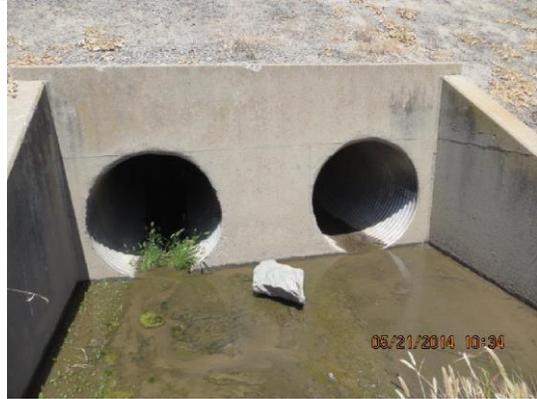
Photo 2 of 3 : UCIP\_FA\_2015\_6816.jpg

Headwall on LS toe.

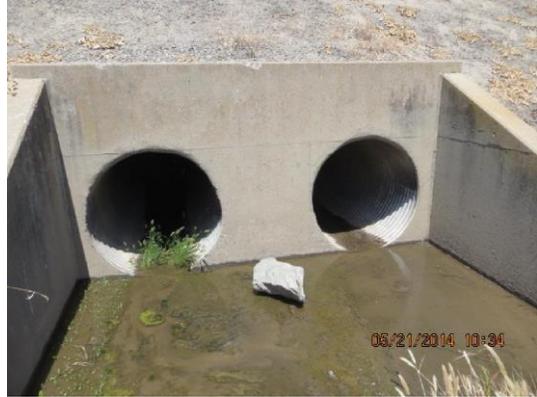
Photo 1 of 3 : UCIP\_FA\_2015\_6813.jpg

Headwall on LS toe.

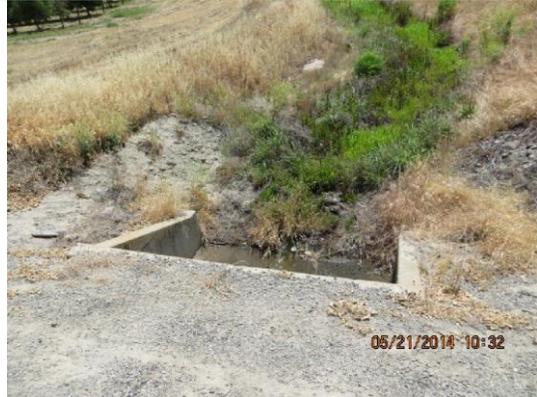
Photo 3 of 3 : UCIP\_FA\_2015\_6815.jpg

Headwall on LS toe.

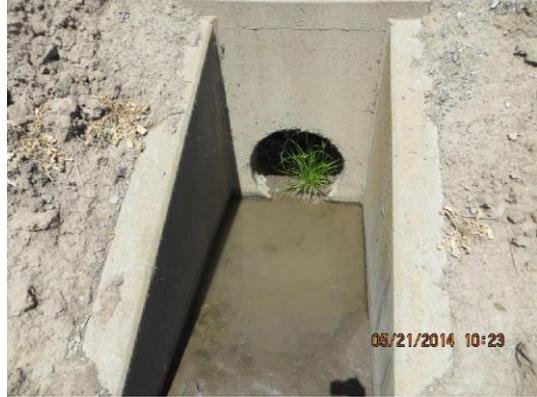
Photo 1 of 3 : UCIP\_FA\_2015\_6762.jpg

Headwall on LS toe.

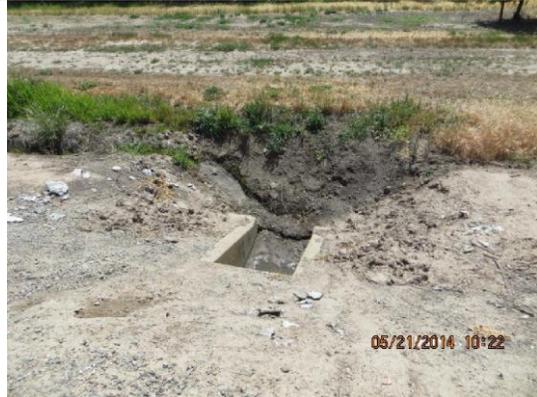
Photo 3 of 3 : UCIP\_FA\_2015\_6764.jpg

Headwall on LS toe.

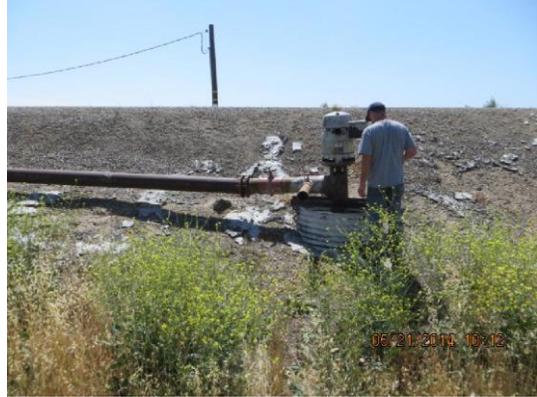
Photo 2 of 3 : UCIP\_FA\_2015\_6760.jpg

LM Start	12.22	Rating **	M	Issue No.	1149 (cont)
LM End	12.22	Issue Type +	En	Location *	WS
Category	Supplemental			GPS Latitude/Longitude	
				Start	End
Item	DWR UCIP Field Study			38.091072 °	38.091072 °
				-121.184289 °	-121.184289 °
DWR ID					
Action/Comments					
Inspector Comments: FS_ID:38212 DS_ID:23760 EP_NO: N/A FS_HLM: 12.581 Repair Type: Non-Urgent Crossing Status: Found UCIP Comments: Pump appears abandoned and if so should be done so properly. Pipe on opposite bank rusted through at connection to CMP standpipe. Good candidate for video inspection. FIELD_STRUCT_DESC: 12-inch steel irrigation pipe through the levee, 9.0-feet below the crown. Two slide gates in a 36-inch CMP riser on the waterward slope. Siphon clean out in the center of channel. 8-inch steel pipe from pump at LM 12.56 discharges into 36-inch CMP riser on WS slope. O&M Manual Bear Creek Part 2, 1967. FS Date: 05/21/2014

Pump and irrigation pipe at LM 12.562- discharges in to this crossing at CMP riser on WS slope.

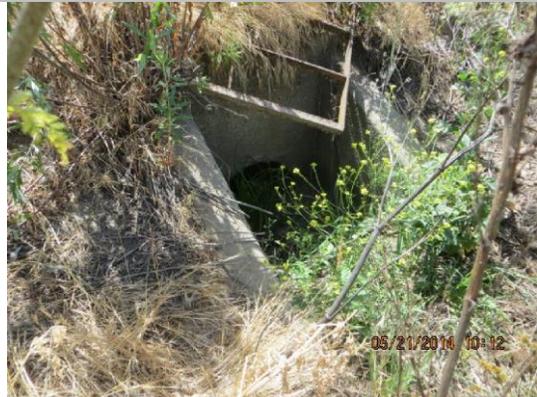
Photo 3 of 3 : UCIP\_FA\_2015\_6761.jpg

24-inch pipe from WS toe to sump over pump at LM 12.562

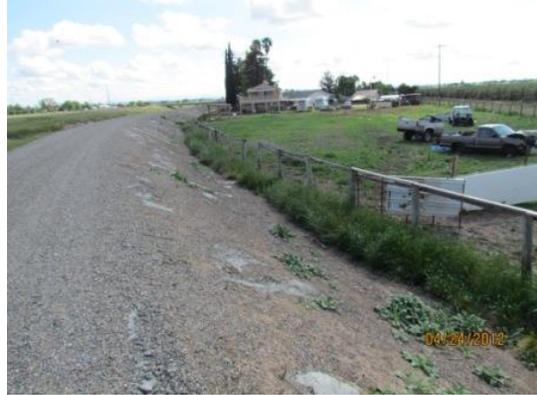
Photo 1 of 1 : FA\_2015\_NA0017\_152\_61\_20150911\_00018.jpg

LM Start	<b>12.23</b>	Rating **	M	Issue No.	<b>61</b>
LM End	<b>12.49</b>	Issue Type +	En	Location *	LS
Category	Earthen Levee		GPS Latitude/Longitude		
			Start	End	
Item	Encroachments		38.091210 °	38.091777 °	
			-121.184147 °	-121.181578 °	
DWR ID	DWR_NA0017_08_s_2012_61				
Action/Comments					
Fence

A fence was found on the landside of the levee looking upstream.

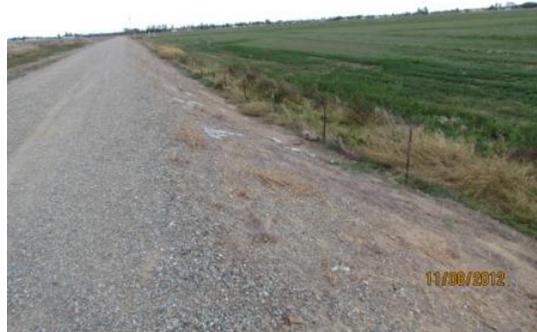
Photo 1 of 1 : FA\_2015\_NA0017\_152\_62\_20150911\_00019.jpg

LM Start	<b>12.41</b>	Rating **	M	Issue No.	<b>62</b>
LM End	<b>12.56</b>	Issue Type +	En	Location *	LS
Category	Earthen Levee		GPS Latitude/Longitude		
			Start	End	
Item	Encroachments		38.091817 °	38.092120 °	
			-121.181053 °	-121.178323 °	
DWR ID	DWR_NA0017_08_s_2012_62				
Action/Comments					
Fence Inspector Comments: Barbed wire fence within 10 feet of the landward toe.

A fence was located on the landside toe of the levee looking upstream.

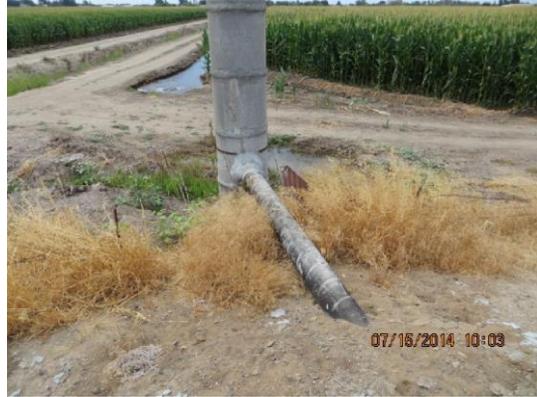
Photo 1 of 3 : UCIP\_FA\_2015\_6268.jpg

LM Start	<b>12.56</b>	Rating **	M	Issue No.	<b>1150</b>
LM End	<b>12.56</b>	Issue Type +	En	Location *	LS
Category	Supplemental			GPS Latitude/Longitude	
				Start	End
Item	DWR UCIP Field Study			38.092099 °	38.092099 °
				-121.178310 °	-121.178310 °
DWR ID					
<b>Action/Comments</b>					
Inspector Comments: FS_ID:39747 DS_ID:23762 EP_NO: 7890 FS_HLM: 12.931 Repair Type: Non-Urgent Crossing Status: Found UCIP Comments: Concrete standpipe at LS toe is leaking. FIELD_STRUCT_DESC: 12-inch steel irrigation pipe through the levee, 3.0-feet below the crown. Steel cutoff wall around pipe at center of levee. Vertical pump in sump at waterward toe. 36-inch Concrete standpipe on landward side. Rock revetment on waterward slope. Permit No. 7890, 1973. FS Date: 05/21/2014

Pipe and standpipe visible on LS toe.

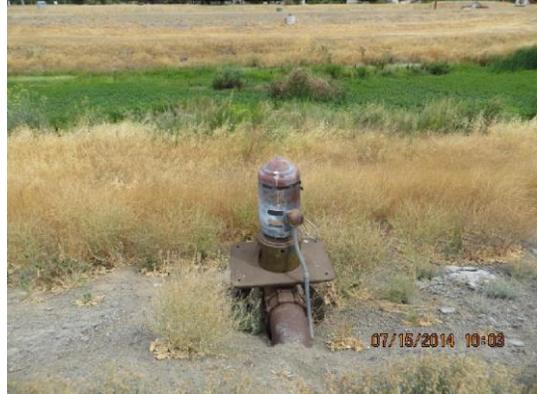
Photo 2 of 3 : UCIP\_FA\_2015\_6269.jpg

Pump over sump on WS slope with electrical conduit.

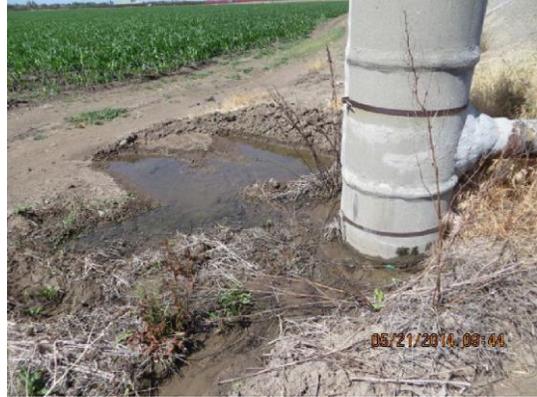
Photo 3 of 3 : UCIP\_FA\_2015\_6755.jpg

36-inch concrete standpipe on LS toe with pipe visible. Standpipe leaks.

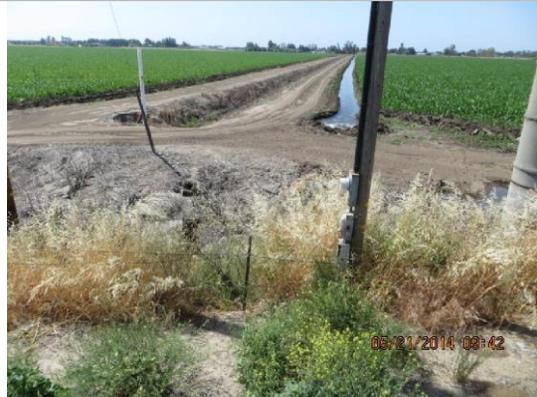
Photo 1 of 3 : UCIP\_FA\_2015\_6756.jpg

LM Start	<b>12.56</b>	Rating **	M	Issue No.	<b>1151</b>
LM End	<b>12.56</b>	Issue Type +	En	Location *	LS
Category	Supplemental			GPS Latitude/Longitude	
				Start	End
Item	DWR UCIP Field Study			38.092110 °	38.092110 °
				-121.178247 °	-121.178247 °
DWR ID					
Action/Comments					
Inspector Comments: FS_ID:38208 DS_ID:23763 EP_NO: N/A FS_HLM: 12.931 Repair Type: Non-Urgent Crossing Status: Found UCIP Comments: Siphon appears abandoned and if so should be done so properly. Good candidate for video inspection. FIELD_STRUCT_DESC: 1 of 2: 10-inch steel irrigation siphon through the levee 8-feet below the crown. Siphon cleanout in center of channel. Two slide gates in 36-inch CMP riser on WS slope. O&M Manual Bear Creek Part 2, 1967. Included in O&M Manual Bear Creek Addendum, February 1999. FS Date: 05/21/2014

No evidence of discharge point at LS toe.

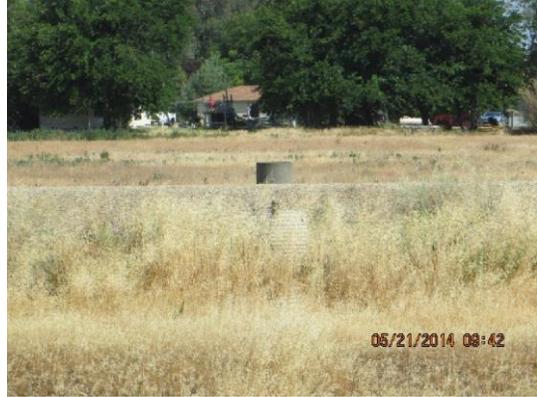
Photo 2 of 3 : UCIP\_FA\_2015\_6757.jpg

CMP riser in alignment with this crossing at opposite bank.

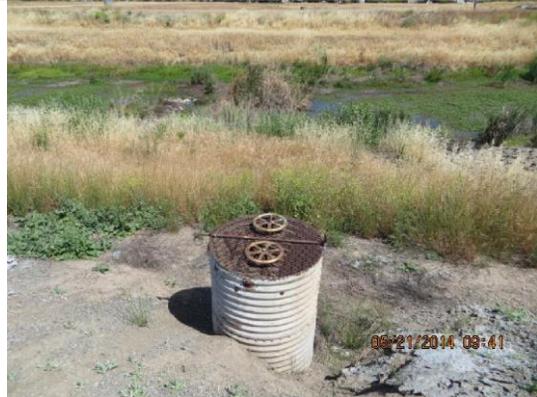
Photo 3 of 3 : UCIP\_FA\_2015\_6758.jpg

Two slide gates in a 36-inch CMP riser on WS slope.

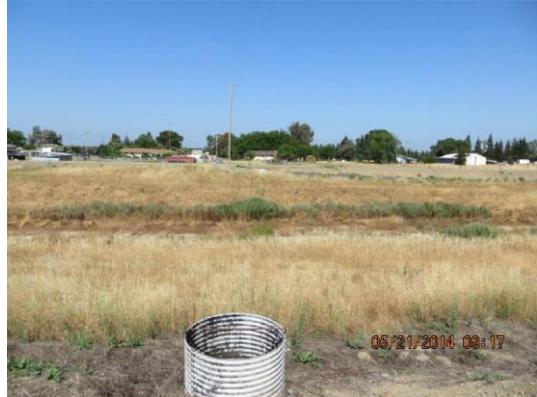
Photo 1 of 3 : UCIP\_FA\_2015\_6615.jpg

LM Start	<b>12.87</b>	Rating **	M	Issue No.	<b>1152</b>
LM End	<b>12.87</b>	Issue Type +	En	Location *	LS
Category	Supplemental			GPS Latitude/Longitude	
				Start	End
Item	DWR UCIP Field Study			38.096928 °	38.096928 °
				-121.175860 °	-121.175860 °
DWR ID					
Action/Comments					
Inspector Comments: FS_ID:38204 DS_ID:23766 EP_NO: N/A FS_HLM: 13.244 Repair Type: Non-Urgent Crossing Status: Found UCIP Comments: Appears abandoned and if so should be done so properly. good candidate for video inspection. FIELD_STRUCT_DESC: 10-inch steel irrigation siphon through the levee, 8.0 feet below the crown. Gate valve in 48-inch CMP riser on the waterward slope. O&M Manual Bear Creek Part 2, 1967. FS Date: 05/21/2014

48-inch CMP riser on WS slope.

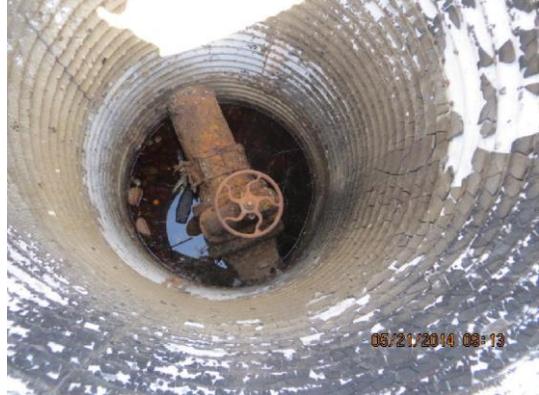
Photo 3 of 3 : UCIP\_FA\_2015\_6617.jpg

Gate valve at bottom of 48-inch CMP riser on WS slope.

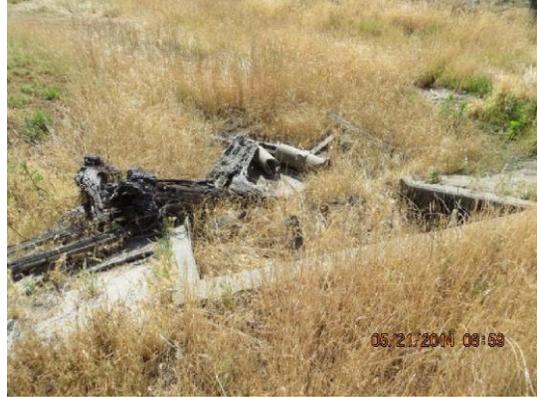
Photo 2 of 3 : UCIP\_FA\_2015\_4379.jpg

LM Start	12.98	Rating **	M	Issue No.	1153 (cont)
LM End	12.98	Issue Type +	En	Location *	LS
Category	Supplemental			GPS Latitude/Longitude	
				Start	End
Item	DWR UCIP Field Study			38.098566 °	38.098566 °
				-121.175704 °	-121.175704 °
DWR ID					
Action/Comments					
Inspector Comments: FS_ID:38144 DS_ID:23768 EP_NO: N/A FS_HLM: 13.358 Repair Type: Non-Urgent Crossing Status: Found UCIP Comments: Some debris buildup at inlet. No lid on CMP riser on WS slope. FIELD_STRUCT_DESC: 1 of 2: 36-inch CM stormdrain pipe through the levee, 10-feet below the crown. Concrete "U" headwall on both ends. Slide gate in CMP riser on the waterward slope. Flap gate on the waterward ends. O&M Manual Bear Creek Part 2, 1967. FS Date: 05/21/2014

Headwall on LS toe. Note debris buildup.

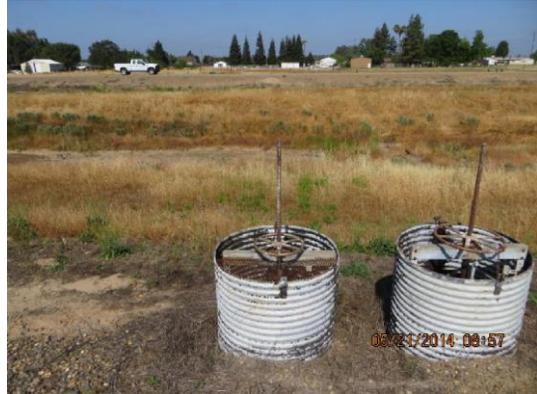
Photo 3 of 3 : UCIP\_FA\_2015\_4380.jpg

Slidegate in CMP riser on WS slope.

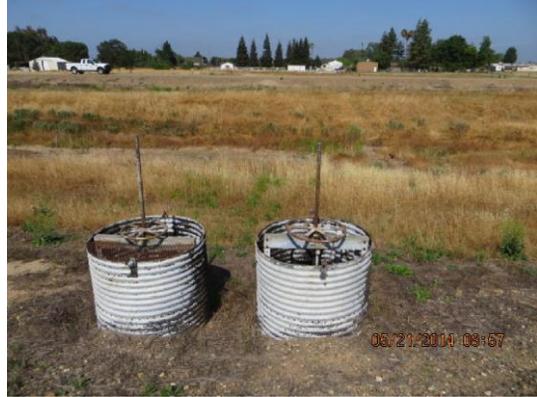
Photo 1 of 3 : UCIP\_FA\_2015\_4377.jpg

LM Start	<b>12.98</b>	Rating **	M	Issue No.	<b>1154</b>
LM End	<b>12.98</b>	Issue Type +	En	Location *	LS
Category	Supplemental			GPS Latitude/Longitude	
				Start	End
Item	DWR UCIP Field Study			38.098582 °	38.098582 °
				-121.175703 °	-121.175703 °
DWR ID					
Action/Comments					
Inspector Comments: FS_ID:38143 DS_ID:23816 EP_NO: N/A FS_HLM: 13.359 Repair Type: Non-Urgent Crossing Status: Found

Slide gate in CMP riser on WS slope.

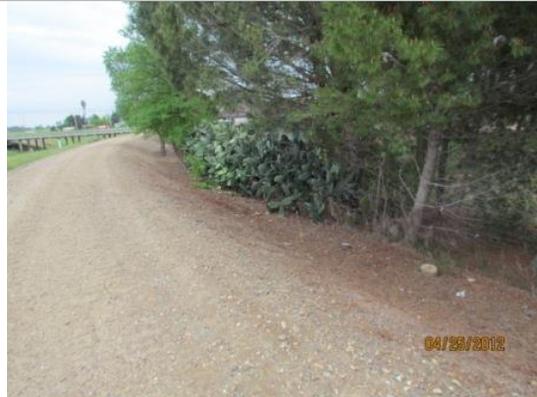
Photo 1 of 1 : FA\_2015\_NA0017\_152\_70\_20150911\_00020.jpg

LM Start	<b>13.16</b>	Rating **	M	Issue No.	<b>70</b>
LM End	<b>13.18</b>	Issue Type +	En	Location *	LS
Category	Earthen Levee			GPS Latitude/Longitude	
				Start	End
Item	Vegetation			38.100862 °	38.101168 °
				-121.176835 °	-121.177063 °
DWR ID	DWR_NA0017_08_s_2012_70				
Action/Comments					
Landscaping Inspector Comments: Cacti was found on the landside of the levee.

Cacti was found on the landside of the levee looking upstream.

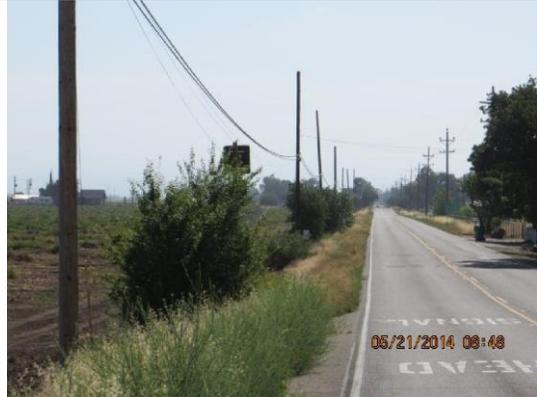
Photo 1 of 3 : UCIP\_FA\_2015\_6781.jpg

**Action/Comments**  
 Inspector Comments: FS\_ID:41527  
 DS\_ID:25023  
 EP\_NO: N/A  
 FS\_HLM: 13.601  
 Repair Type: Non-Urgent  
 Crossing Status: Found  
 UCIP Comments: No permit identified for this crossing.  
 FIELD\_STRUCT\_DESC: 1.5-inch galvanized iron conduit through the levee at an unknowd depth beneath the crown. Pipe visible on upstream side of bridge. Likely electrical power for signal 300-feet to the east of crown. 18"X24" Christy box on LS shoulder.  
 FS Date: 05/20/2014

Signal at center left of photo is likely destination for this conduit.

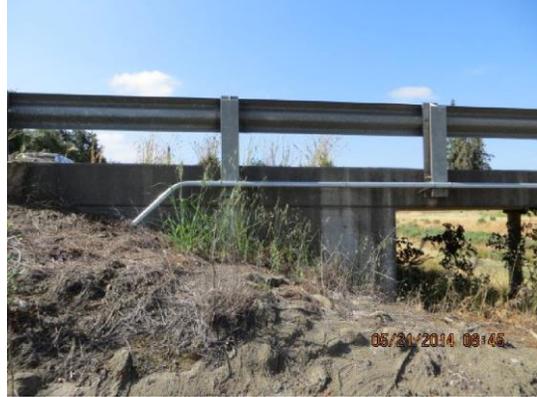
Photo 3 of 3 : UCIP\_FA\_2015\_6783.jpg

Pipe visible on upstream side of bridge.

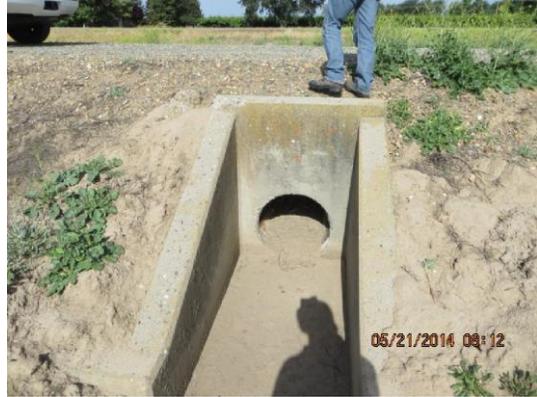
Photo 1 of 3 : UCIP\_FA\_2015\_5077.jpg

**Action/Comments**  
 Inspector Comments: FS\_ID:38133  
 DS\_ID:23776  
 EP\_NO: N/A  
 FS\_HLM: 14.467  
 Repair Type: Non-Urgent  
 Crossing Status: Found  
 UCIP Comments: Some silt buildup inside pipe.  
 FIELD\_STRUCT\_DESC: 24-inch CM stormdrain pipe through the levee, 4-feet below the crown. Concrete "U" headwall on both ends. Flap gate on the waterward end. Cobble grouted spillway. Cobble grouted intake on the landside. O&M Manual Bear Creek Part 2, 1967.  
 FS Date: 05/21/2014

Headwall on LS toe.

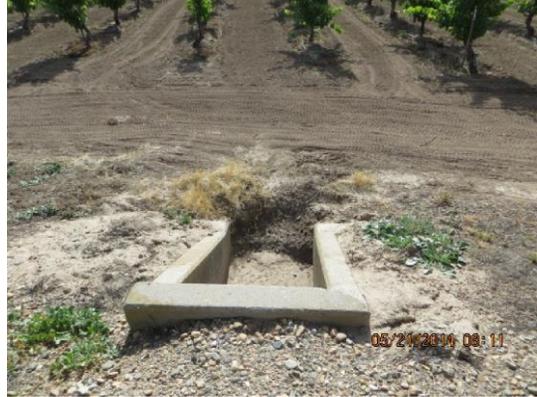
Photo 3 of 3 : UCIP\_FA\_2015\_5079.jpg

Headwall on LS toe.

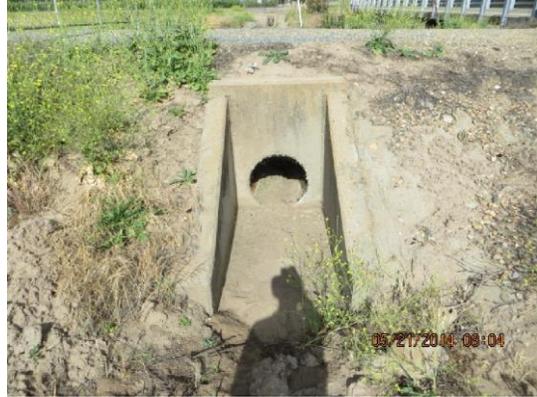
Photo 1 of 3 : UCIP\_FA\_2015\_5019.jpg

**Action/Comments**  
 Inspector Comments: FS\_ID:38130  
 DS\_ID:23778  
 EP\_NO: N/A  
 FS\_HLM: 14.691  
 Repair Type: Non-Urgent  
 Crossing Status: Found  
 UCIP Comments: Some silt buildup inside pipe.  
 FIELD\_STRUCT\_DESC: 24-inch CM stormdrain pipe through the levee, 4-feet below the crown. Concrete "U" headwall on both ends. Flap gate on the waterward end. Cobble grouted spillway. Cobble grouted intake on the landside. O&M Manual Bear Creek Part 2, 1967.  
 FS Date: 05/21/2014

Headwall on LS toe.

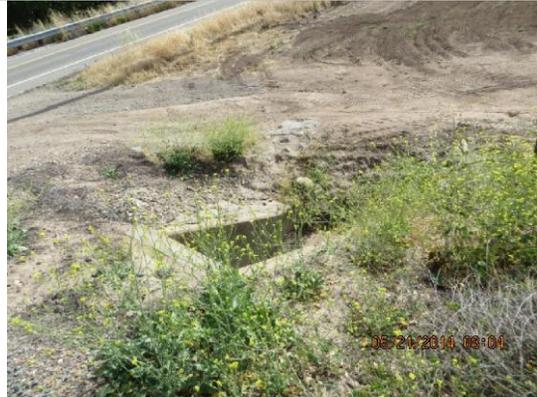
Photo 2 of 3 : UCIP\_FA\_2015\_5020.jpg

Headwall on LS toe.

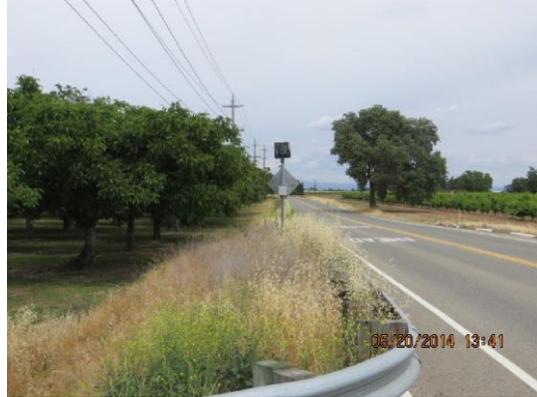
Photo 1 of 3 : UCIP\_FA\_2015\_6778.jpg

LM Start	<b>14.32</b>	Rating **	M	Issue No.	<b>1158</b>
LM End	<b>14.32</b>	Issue Type +	En	Location *	WS
Category	Supplemental			GPS Latitude/Longitude	
				Start	End
Item	DWR UCIP Field Study			38.116372 °	38.116372 °
				-121.171645 °	-121.171645 °
DWR ID					
Action/Comments					
Inspector Comments: FS_ID:41526 DS_ID:25022 EP_NO: N/A FS_HLM: 14.706 Repair Type: Non-Urgent Crossing Status: Found UCIP Comments: No permit identified for this crossing. FIELD_STRUCT_DESC: 2-inch galvanized iron electrical conduit through the levee at an unknown depth below the crown. Attached to upstream side of bridge. FS Date: 05/20/2014

Light signal likely destination for conduit.

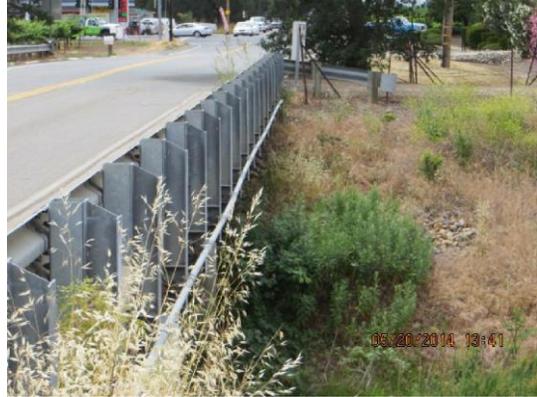
Photo 2 of 3 : UCIP\_FA\_2015\_6779.jpg

LM Start	14.32	Rating **	M	Issue No.	1158 (cont)
LM End	14.32	Issue Type +	En	Location *	WS
Category	Supplemental			GPS Latitude/Longitude	
				Start	End
Item	DWR UCIP Field Study			38.116372 °	38.116372 °
				-121.171645 °	-121.171645 °
DWR ID					
Action/Comments					
Inspector Comments: FS_ID:41526 DS_ID:25022 EP_NO: N/A FS_HLM: 14.706 Repair Type: Non-Urgent Crossing Status: Found UCIP Comments: No permit identified for this crossing. FIELD_STRUCT_DESC: 2-inch galvanized iron electrical conduit through the levee at an unknown depth below the crown. Attached to upstream side of bridge. FS Date: 05/20/2014

Pipe Conduit visible on upstream side of bridge.

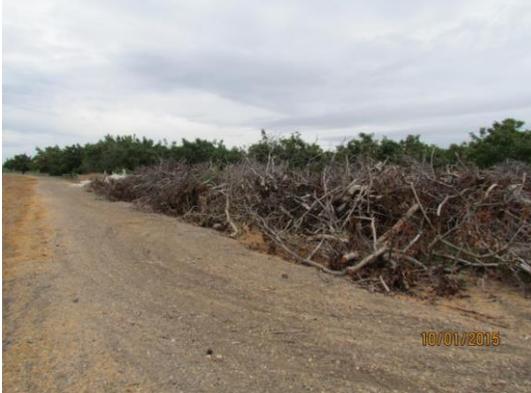
Photo 1 of 1 : FA\_2015\_NA0017\_152\_85\_20151009\_00111.jpg

LM Start	<b>14.65</b>	Rating **	M	Issue No.	<b>85</b>
LM End	<b>14.65</b>	Issue Type +	En	Location *	LS
Category	Earthen Levee		GPS Latitude/Longitude		
			Start	End	
Item	Encroachments		38.120801 °	38.120801 °	
			-121.169515 °	-121.169515 °	
DWR ID	DWR_NA0017_08_f_2015_85				
Action/Comments					
Prunings

Prunings were found on the landside of the levee.

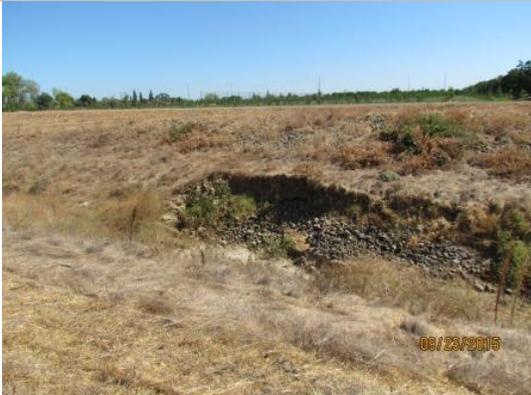
Photo 1 of 1 : FA\_2015\_NA0017\_152\_57\_20150928\_00095.jpg

LM Start	<b>14.75</b>	Rating **	U	Issue No.	<b>57</b>
LM End	<b>14.75</b>	Issue Type +	Ma	Location *	WS
Category	Earthen Levee		GPS Latitude/Longitude		
			Start	End	
Item	Erosion / Bank Caving		38.122152 °	38.122152 °	
			-121.169461 °	-121.169461 °	
DWR ID	DWR_NA0017_08_f_2015_57				
Action/Comments					
Schedule repair of erosion site prior to the next inspection. Inspector Comments: Waterside toe erosion.

Erosion was found on the waterside toe of the levee. The picture was taken from the right bank of the levee.

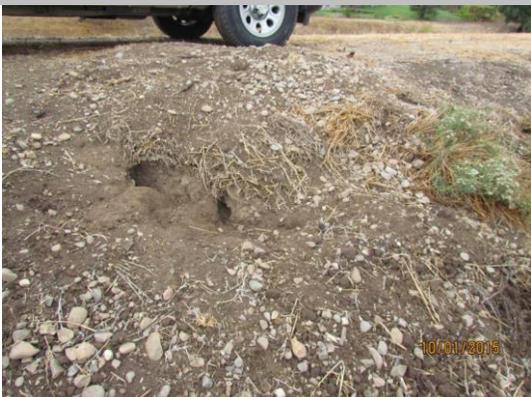
Photo 1 of 1 : FA\_2015\_NA0017\_152\_96\_20151009\_00112.jpg

LM Start	<b>14.79</b>	Rating **	M	Issue No.	<b>96</b>
LM End	<b>14.79</b>	Issue Type +	Ma	Location *	LS
Category	Earthen Levee		GPS Latitude/Longitude		
			Start	End	
Item	Animal Control		38.122664 °	38.122664 °	
			-121.169116 °	-121.169116 °	
DWR ID	DWR_NA0017_08_f_2015_96				
Action/Comments					
No rodents visible, but rodent burrows visible; need to backfill and compact or grout burrows.

Rodent holes were found on the landside slope of the levee looking upstream.

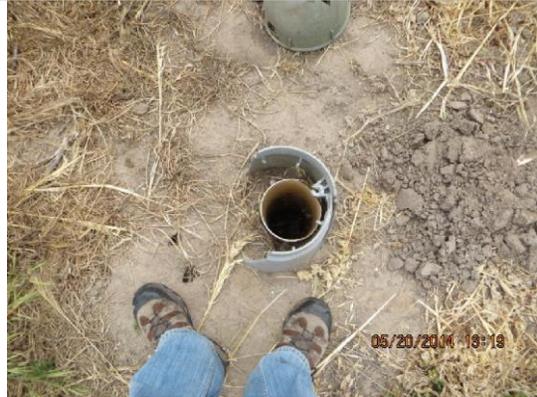
Photo 1 of 3 : UCIP\_FA\_2015\_6775.jpg

LM Start	<b>14.97</b>	Rating **	M	Issue No.	<b>1159</b>
LM End	<b>14.97</b>	Issue Type +	En	Location *	LS
Category	Supplemental			GPS Latitude/Longitude	
				Start	End
Item	DWR UCIP Field Study			38.125103 °	38.125103 °
				-121.168009 °	-121.168009 °
DWR ID					
Action/Comments					
Inspector Comments: FS_ID:41708 DS_ID:25021 EP_NO: N/A FS_HLM: 15.363 Repair Type: Non-Urgent Crossing Status: Found UCIP Comments: No permit identified for this crossing. FIELD_STRUCT_DESC: 4-inch steel waterline through the levee at an unknown depth below the crown. 2-valves in 6-inch PVC standpipe at LS toe. Pipe mounted on downstream side of bridge. FS Date: 05/20/2014

Valve in PVC standpipe on LS toe.

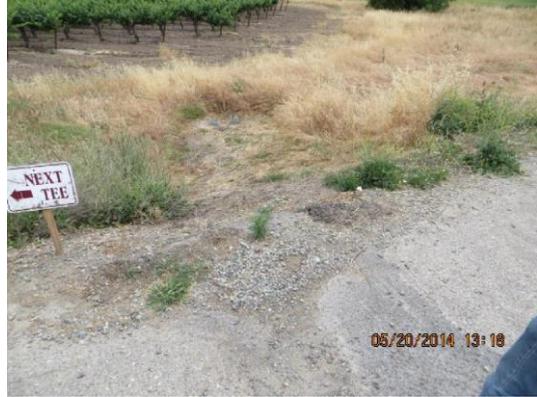
Photo 2 of 3 : UCIP\_FA\_2015\_6776.jpg

LM Start	<b>14.97</b>	Rating **	M	Issue No.	<b>1159 (cont)</b>
LM End	<b>14.97</b>	Issue Type +	En	Location *	LS
Category	Supplemental			GPS Latitude/Longitude	
				Start	End
Item	DWR UCIP Field Study			38.125103 °	38.125103 °
				-121.168009 °	-121.168009 °
DWR ID					
Action/Comments					
Inspector Comments: FS_ID:41708 DS_ID:25021 EP_NO: N/A FS_HLM: 15.363 Repair Type: Non-Urgent Crossing Status: Found UCIP Comments: No permit identified for this crossing. FIELD_STRUCT_DESC: 4-inch steel waterline through the levee at an unknown depth below the crown. 2-valves in 6-inch PVC standpipe at LS toe. Pipe mounted on downstream side of bridge. FS Date: 05/20/2014

Valves in PVC standpipe on LS toe.

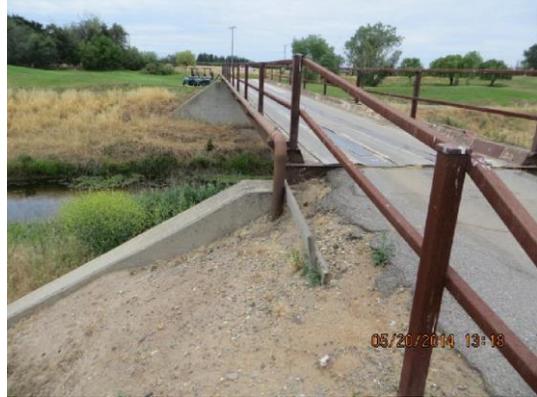
Photo 3 of 3 : UCIP\_FA\_2015\_6777.jpg

4-inch steel irrigation pipe through the levee at an unknown depth.

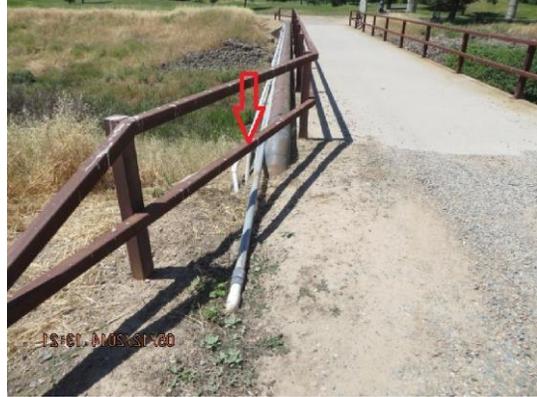
Photo 1 of 1 : UCIP\_FA\_2015\_6774.jpg

LM Start	<b>15.47</b>	Rating **	M	Issue No.	<b>1160</b>
LM End	<b>15.47</b>	Issue Type +	En	Location *	CR
Category	Supplemental			GPS Latitude/Longitude	
				Start	End
Item	DWR UCIP Field Study			38.128489 °	38.128489 °
				-121.160231 °	-121.160231 °
DWR ID					
Action/Comments					
Inspector Comments: FS_ID:42005 DS_ID:25019 EP_NO: N/A FS_HLM: 15.861 Repair Type: Non-Urgent Crossing Status: Found UCIP Comments: No permit identified for this crossing. FIELD_STRUCT_DESC: 1.5-inch PVC electrical conduit through the levee at an unknown depth below the crown. Pipe visible on downstream side of bridge. FS Date: 05/20/2014

Pipe visible on downstream side of bridge (Photo altered).

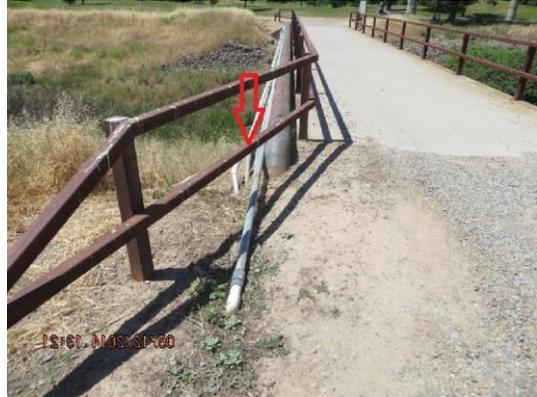
Photo 1 of 1 : UCIP\_FA\_2015\_6773.jpg

LM Start	<b>15.47</b>	Rating **	M	Issue No.	<b>1161</b>
LM End	<b>15.47</b>	Issue Type +	En	Location *	CR
Category	Supplemental			GPS Latitude/Longitude	
				Start	End
Item	DWR UCIP Field Study			38.128513 °	38.128513 °
				-121.160239 °	-121.160239 °
DWR ID					
Action/Comments					
Inspector Comments: FS_ID:42004 DS_ID:25018 EP_NO: N/A FS_HLM: 15.862 Repair Type: Non-Urgent Crossing Status: Found UCIP Comments: No permit identified for this crossing. FIELD_STRUCT_DESC: Two 1.5-inch galvanized iron electrical conduits through the levee at an unknown depth below the crown. Pipes attached to downstream side of bridge. FS Date: 05/20/2014

Pipes visible on downstream side of bridge.

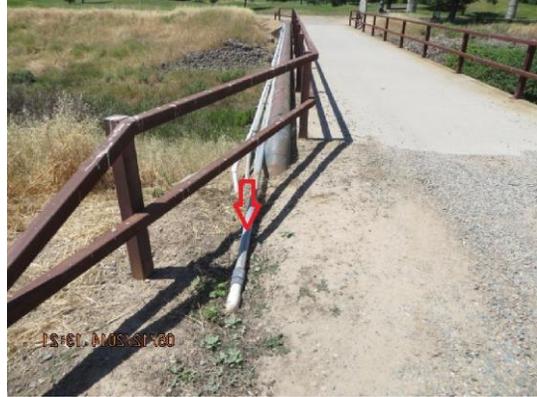
Photo 1 of 1 : UCIP\_FA\_2015\_6772.jpg

LM Start	<b>15.47</b>	Rating **	M	Issue No.	<b>1162</b>
LM End	<b>15.47</b>	Issue Type +	En	Location *	CR
Category	Supplemental			GPS Latitude/Longitude	
				Start	End
Item	DWR UCIP Field Study			38.128521 °	38.128521 °
				-121.160232 °	-121.160232 °
DWR ID					
Action/Comments					
Inspector Comments: FS_ID:41707 DS_ID:25020 EP_NO: N/A FS_HLM: 15.863 Repair Type: Non-Urgent Crossing Status: Found UCIP Comments: No permit identified for this crossing. FIELD_STRUCT_DESC: 2-inch galvanized iron waterline over bridge on downstream side. FS Date: 05/20/2014

2-inch galvanized iron pipe visible on downstream side of bridge (Photo altered).

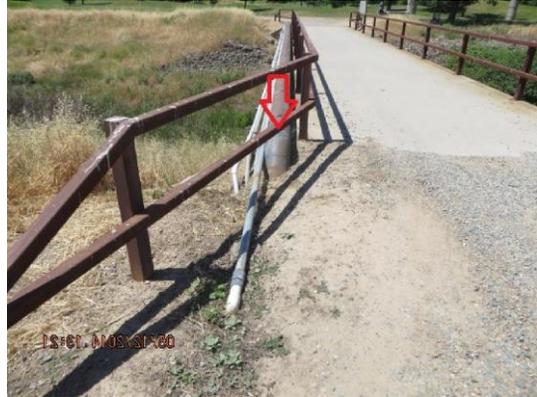
Photo 1 of 1 : UCIP\_FA\_2015\_6771.jpg

LM Start	<b>15.47</b>	Rating **	M	Issue No.	<b>1163</b>
LM End	<b>15.47</b>	Issue Type +	En	Location *	CR
Category	Supplemental			GPS Latitude/Longitude	
				Start	End
Item	DWR UCIP Field Study			38.128523 °	38.128523 °
				-121.160231 °	-121.160231 °
DWR ID					
Action/Comments					
Inspector Comments: FS_ID:41706 DS_ID:25017 EP_NO: N/A FS_HLM: 15.863 Repair Type: Non-Urgent Crossing Status: Found UCIP Comments: No permit identified for this crossing. FIELD_STRUCT_DESC: 10-inch steel irrigation pipe through the levee at an unknown depth beneath the crown. Pipe visible on downstream side of bridge. FS Date: 05/20/2014

10-inch pipe visible on downstream side of bridge (photo altered).

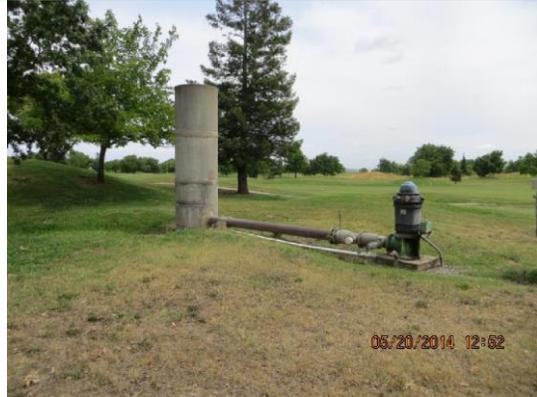
Photo 1 of 2 : UCIP\_FA\_2015\_4371.jpg

Item	DWR UCIP Field Study			38.128586 °	38.128586 °
				-121.160129 °	-121.160129 °
DWR ID					
Action/Comments					
Inspector Comments: FS_ID:38124 DS_ID:23783 EP_NO: 6091 FS_HLM: 15.87 Repair Type: Non-Urgent Crossing Status: Found UCIP Comments: Pump and pipe appear to be abandoned and if so should be done so poperly. Gate valve frozen closed. FIELD_STRUCT_DESC: 8-inch steel irrigation pipe through the levee, 3.0 feet below the crown. Gate valve on the waterward side. 24-inch CM pump sump unit with motor mounted on top of the waterward side. 24-inch CM intake pipe from the channel. Concrete "U" headwall with trash rack on the waterward end. 48-inch Concrete standpipe on the landside. Permit No. 6091, 1969. Included in O&M Manual Bear Creek Part 2, 1967. FS Date: 05/20/2014

Possible standpipe that pipe connects to.

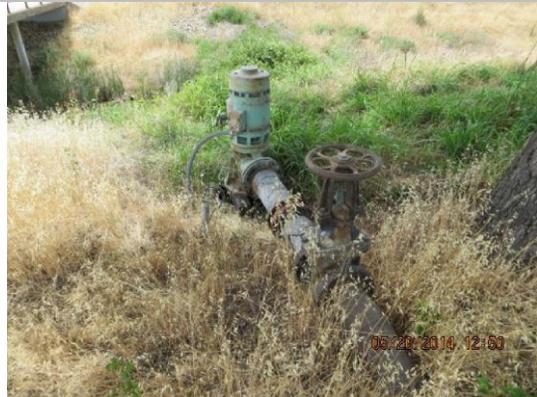
Photo 2 of 2 : UCIP\_FA\_2015\_4372.jpg

Pump, pipe, and gatevalve on WS shoulder.

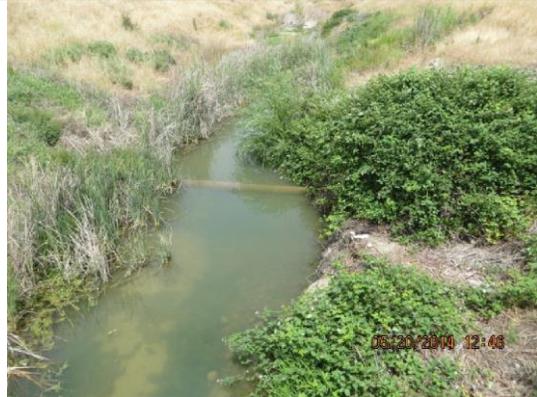
Photo 1 of 3 : UCIP\_FA\_2015\_3727.jpg

LM Start	<b>15.48</b>	Rating **	M	Issue No.	<b>1165</b>
LM End	<b>15.48</b>	Issue Type +	En	Location *	CR
Category	Supplemental			GPS Latitude/Longitude	
				Start	End
Item	DWR UCIP Field Study			38.128632 °	38.128632 °
				-121.160038 °	-121.160038 °
DWR ID					
Action/Comments					
Inspector Comments: FS_ID:38123 DS_ID:23824 EP_NO: N/A FS_HLM: 15.876 Repair Type: Non-Urgent Crossing Status: Found

Pipe visible in center of channel at WS toe from bridge.

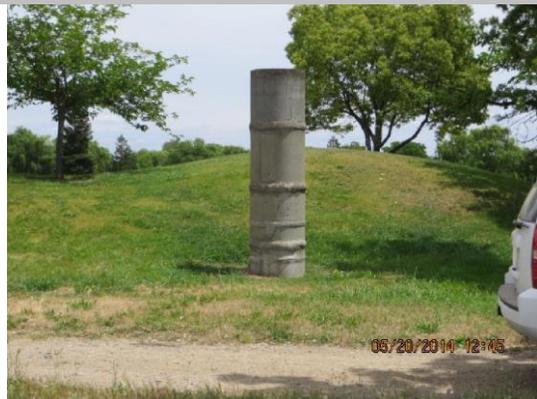
Photo 2 of 3 : UCIP\_FA\_2015\_3728.jpg

Possible point of connection at standpipe on LS shoulder.

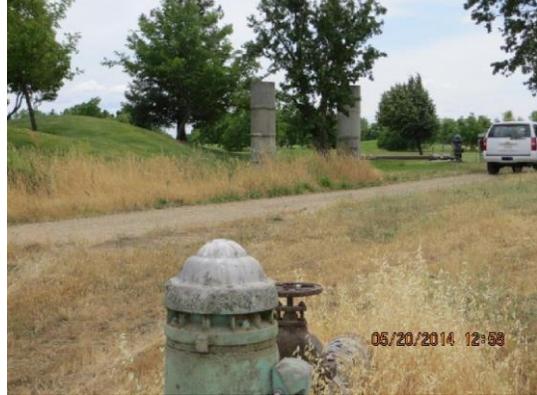
Photo 1 of 3 : UCIP\_FA\_2015\_5946.jpg

LM Start	<b>15.49</b>	Rating **	M	Issue No.	<b>1166</b>
LM End	<b>15.49</b>	Issue Type +	En	Location *	CR
Category	Supplemental			GPS Latitude/Longitude	
				Start	End
Item	DWR UCIP Field Study			38.128769 °	38.128769 °
				-121.159951 °	-121.159951 °
DWR ID					
<b>Action/Comments</b>					
Inspector Comments: FS_ID:41705 DS_ID:25016 EP_NO: N/A FS_HLM: 15.886 Repair Type: Non-Urgent Crossing Status: Found

Pump with Standpipe visible in background.

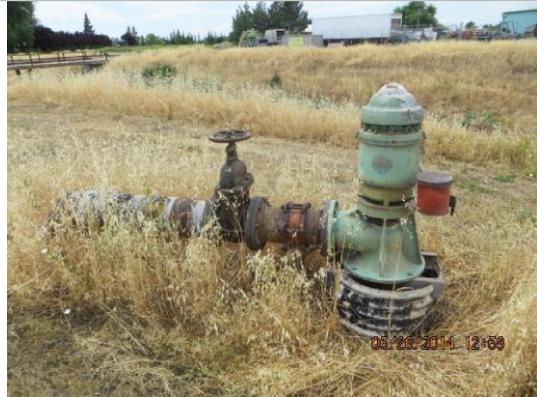
Photo 2 of 3 : UCIP\_FA\_2015\_6769.jpg

Pump, pipe, and gate valve visible on WS shoulder.

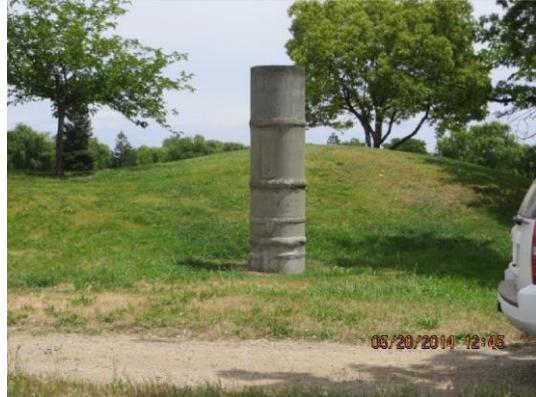
Photo 3 of 3 : UCIP\_FA\_2015\_6770.jpg

LM Start	<b>15.49</b>	Rating **	M	Issue No.	<b>1166 (cont)</b>
LM End	<b>15.49</b>	Issue Type +	En	Location *	CR
Category	Supplemental			GPS Latitude/Longitude	
				Start	End
Item	DWR UCIP Field Study			38.128769 °	38.128769 °
				-121.159951 °	-121.159951 °
DWR ID					
<b>Action/Comments</b>					
Inspector Comments: FS_ID:41705 DS_ID:25016 EP_NO: N/A FS_HLM: 15.886 Repair Type: Non-Urgent Crossing Status: Found

Standpipe on LS shoulder may be discharge point for this 10-inch pipe.

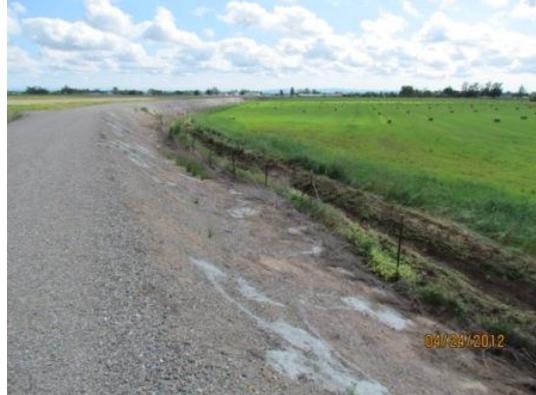
Photo 1 of 1 : FA\_2015\_NA0017\_153\_1\_20150911\_00001.jpg

LM Start	<b>0.02</b>	Rating **	M	Issue No.	<b>1</b>
LM End	<b>0.54</b>	Issue Type +	En	Location *	LS
Category	Earthen Levee		GPS Latitude/Longitude		
			Start	End	
Item	Encroachments		38.093278 °	38.094859 °	
			-121.176164 °	-121.167053 °	
DWR ID	DWR_NA0017_09_s_2012_1				
Action/Comments					
Fence Inspector Comments: Barbed wire fence within 10 feet of the landward toe.

View of fences that were found on the landside toe of the levee looking upstream.

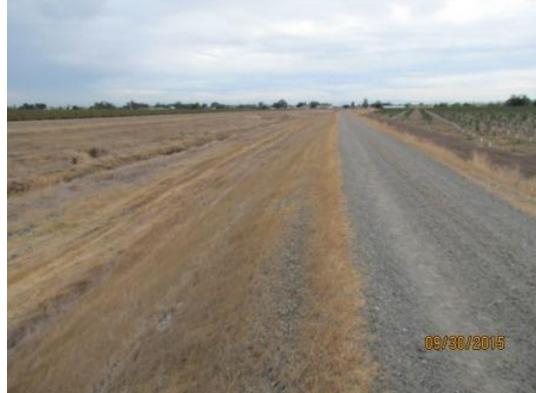
Photo 1 of 1 : FA\_2015\_NA0017\_153\_4\_20151005\_00003.jpg

LM Start	<b>0.12</b>	Rating **	A	Issue No.	<b>4</b>
LM End	<b>0.12</b>	Issue Type +	Ma	Location *	WS
Category	Earthen Levee		GPS Latitude/Longitude		
			Start	End	
Item	Vegetation		38.094053 °	38.094053 °	
			-121.174649 °	-121.174649 °	
DWR ID	DWR_NA0017_09_f_2015_4				
Action/Comments					
Control annual grass and weeds on the levee slopes and easements. Inspector Comments: Vegetation is acceptable.

View of the waterside slope of the levee looking upstream.

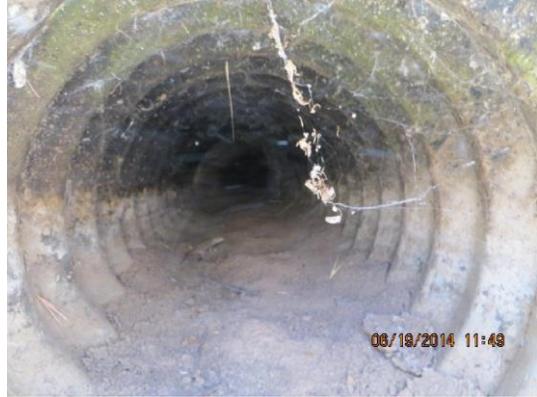
Photo 1 of 3 : UCIP\_FA\_2015\_5965.jpg

**Action/Comments**  
 Inspector Comments: FS\_ID:41812  
 DS\_ID:23841  
 EP\_NO: N/A  
 FS\_HLM: 0.934  
 Repair Type: Non-Urgent  
 Crossing Status: Found  
 UCIP Comments: Sediment buildup inside pipe.  
 FIELD\_STRUCT\_DESC: 12-inch CM stormdrain pipe through the levee, 7.0-feet below the crown. Headwall on LS toe. Flap gate on the waterward end. Cobble grouted spillway. O&M Manual Bear Creek Addendum, February 1999.  
 FS Date: 06/19/2014

Inside pipe at LS toe.

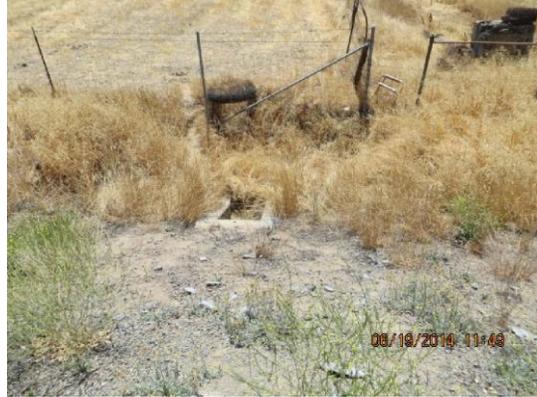
Photo 3 of 3 : UCIP\_FA\_2015\_5967.jpg

LM Start	<b>0.93</b>	Rating **	M	Issue No.	<b>6 (cont)</b>
LM End	<b>0.93</b>	Issue Type +	En	Location *	WS
Category	Supplemental			GPS Latitude/Longitude	
				Start	End
Item	DWR UCIP Field Study			38.094247 °	38.094247 °
				-121.160271 °	-121.160271 °
DWR ID					
Action/Comments					
Inspector Comments: FS_ID:41812 DS_ID:23841 EP_NO: N/A FS_HLM: 0.934 Repair Type: Non-Urgent Crossing Status: Found

Pipe and headwall on LS toe.

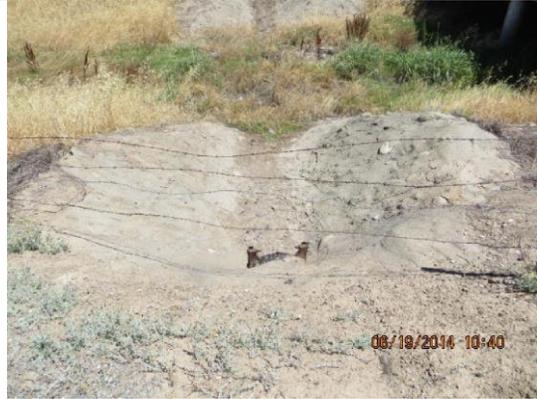
Photo 1 of 2 : UCIP\_FA\_2015\_5897.jpg

Inspector Comments: FS\_ID:38977  
 DS\_ID:23847  
 EP\_NO: N/A  
 FS\_HLM: 1.451  
 Repair Type: Non-Urgent  
 Crossing Status: Found  
 UCIP Comments: Flapgate blocked by soil and possibly concrete on WS slope.  
 FIELD\_STRUCT\_DESC: 21-inch CM stormdrain pipe through the levee, 5.5-feet below the crown. Flap gate on the waterward end. Cobble grouted spillway. O&M Manual Bear Creek Part 2, 1967. Included in O&M Manual Bear Creek Addendum, February 1999. FS Date: 06/19/2014

Pipe, flapgate, and grouted spillway on WS toe.

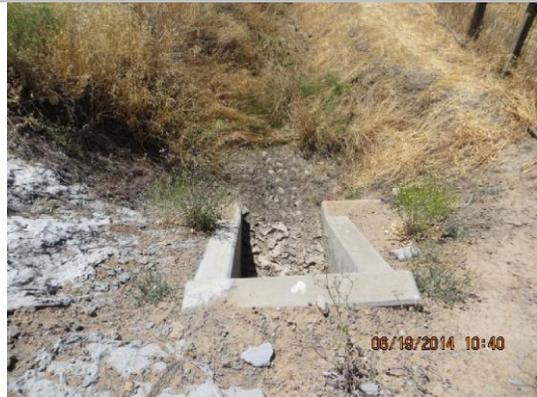
Photo 2 of 2 : UCIP\_FA\_2015\_5898.jpg

Concrete headwall on LS toe.

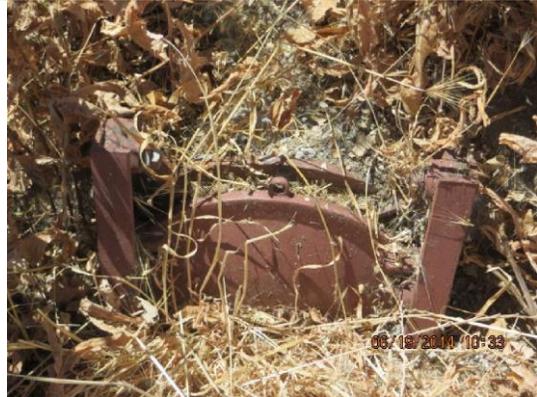
Photo 1 of 3 : UCIP\_FA\_2015\_6684.jpg

LM Start	<b>1.50</b>	Rating **	U	Issue No.	<b>8</b>
LM End	<b>1.50</b>	Issue Type +	En	Location *	LS
Category	Supplemental			GPS Latitude/Longitude	
				Start	End
Item	DWR UCIP Field Study			38.094115 °	38.094115 °
				-121.149759 °	-121.149759 °
DWR ID					
<b>Action/Comments</b>					
Inspector Comments: FS_ID:43099 DS_ID:23849 EP_NO: N/A FS_HLM: 1.516 Repair Type: Urgent Crossing Status: Found

Flapgate blocked by vegetation on WS toe.

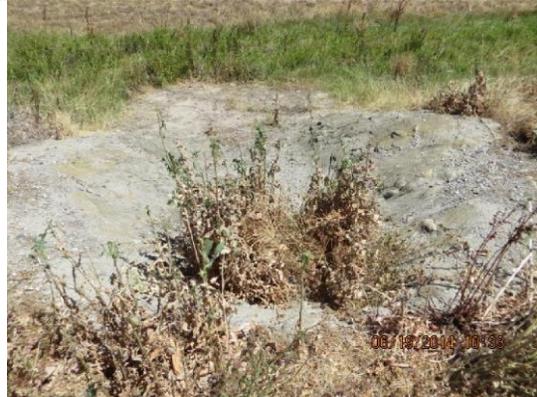
Photo 3 of 3 : UCIP\_FA\_2015\_6686.jpg

Grouted spillway with flapgate blocked by vegetation on WS toe.

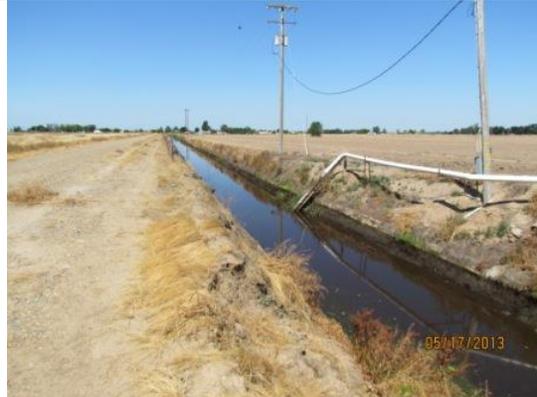
Photo 2 of 2 : FA\_2015\_NA0017\_154\_7\_20150911\_00003.jpg

LM Start	<b>0.71</b>	Rating **	M	Issue No.	<b>7 (cont)</b>
LM End	<b>0.96</b>	Issue Type +	En	Location *	LS
Category	Earthen Levee			GPS Latitude/Longitude	
				Start	End
Item	Encroachments			38.094606 °	38.094708 °
				-121.162138 °	-121.157569 °
DWR ID	DWR_NA0017_10_s_2012_7				
Action/Comments					
Ditch

View of the ditch on the landside of the levee looking downstream.

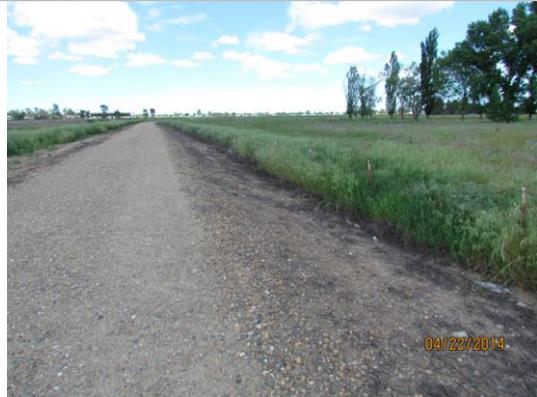
Photo 1 of 1 : FA\_2015\_NA0017\_154\_1\_20150911\_00001.jpg

LM Start	<b>1.12</b>	Rating **	M	Issue No.	<b>1</b>
LM End	<b>1.28</b>	Issue Type +	En	Location *	LS
Category	Earthen Levee			GPS Latitude/Longitude	
				Start	End
Item	Encroachments			38.094670 °	38.094322 °
				-121.154616 °	-121.151764 °
DWR ID	DWR_NA0017_10_s_2014_1				
Action/Comments					
Fence

A fence was found on the landside toe of the levee looking downstream.

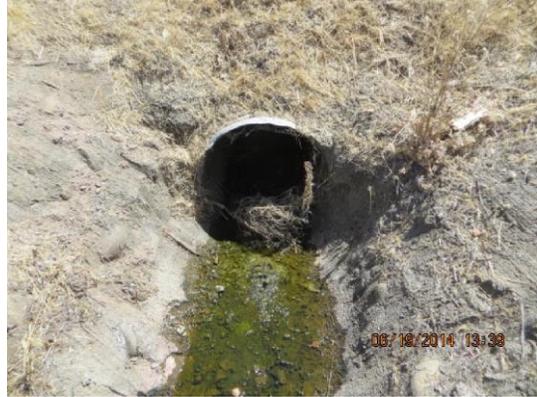
Photo 1 of 3 : UCIP\_FA\_2015\_6437.jpg

**Action/Comments**  
 Inspector Comments: FS\_ID:41813  
 DS\_ID:23868  
 EP\_NO: N/A  
 FS\_HLM: 1.345  
 Repair Type: Non-Urgent  
 Crossing Status: Found  
 UCIP Comments: Some sediment buildup in pipe at LS toe.  
 FIELD\_STRUCT\_DESC: 30-inch CM pipe through the levee, 6.0 feet below the crown. Flap gate on the waterward end. Cobble grouted spillway. Cobble grouted intake on the landward side. O&M Manual Bear Creek Part 2, 1967.  
 FS Date: 06/19/2014

Pipe on LS toe.

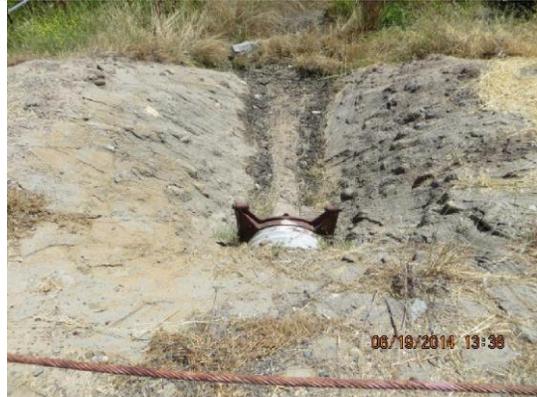
Photo 3 of 3 : UCIP\_FA\_2015\_6439.jpg

Pipe, flapgate, and grouted spillway on WS toe.

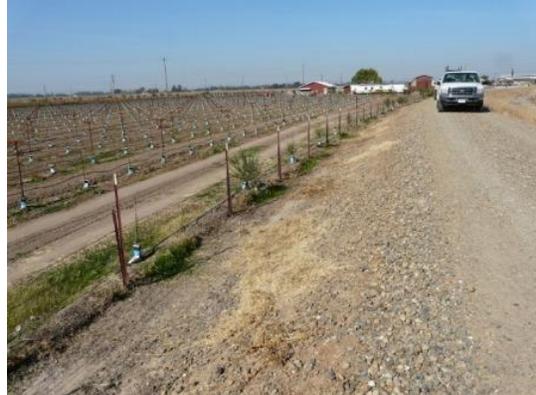
Photo 1 of 1 : FA\_2015\_NA0017\_155\_2\_20150911\_00002.jpg

LM Start	<b>0.17</b>	Rating **	M	Issue No.	<b>2</b>
LM End	<b>0.49</b>	Issue Type +	En	Location *	LS
Category	Earthen Levee			GPS Latitude/Longitude	
				Start	End
Item	Encroachments			38.097243 °	38.101853 °
				-121.169258 °	-121.168563 °
DWR ID	DWR_NA0017_11_s_2012_2				
Action/Comments					
Fence

Fence located from LM 0.17 to LM 0.49 and crops located from LM 0.17 to LM 0.41 within 10' from landside toe of levee.
