**Flood Control Project Maintenance  
Levee Inspections**

**Fall 2015 Levee Maintenance Deficiency Summary Report**

**San Joaquin River Basin**

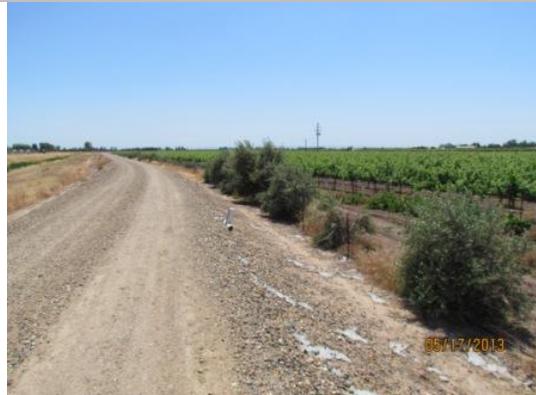
Photo 1 of 1 : FA\_2015\_NA0017\_155\_3\_20150911\_00003.jpg

LM Start	<b>0.17</b>	Rating **	M	Issue No.	<b>3</b>
LM End	<b>0.40</b>	Issue Type +	En	Location *	LS
Category	Earthen Levee			GPS Latitude/Longitude	
				Start	End
Item	Encroachments			38.097342 °	38.100685 °
				-121.169262 °	-121.169112 °
DWR ID	DWR_NA0017_11_s_2012_3				
Action/Comments					
Crops					
Inspector Comments: Newly planted trees within 10' from landside toe

Crops were found on the landside toe of the levee looking downstream.

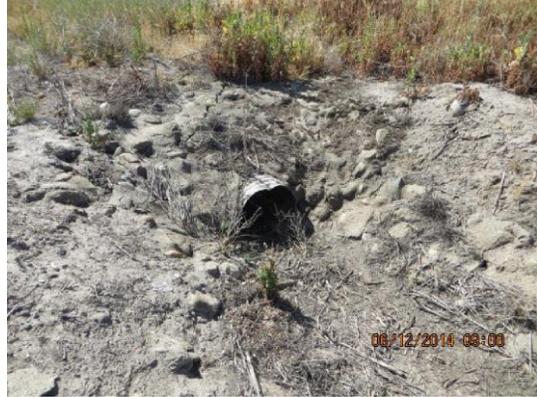
Photo 1 of 3 : UCIP\_FA\_2015\_3138.jpg

Pipe and grouted spillway on WS slope.

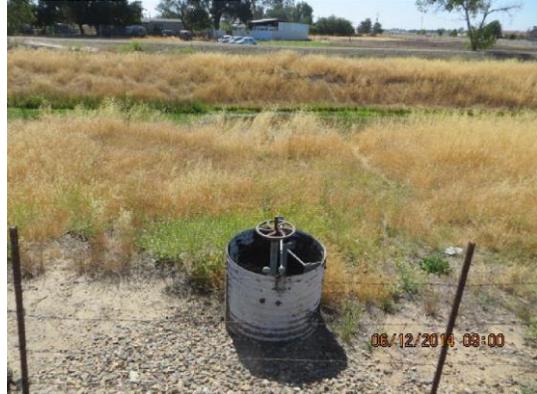
Photo 2 of 3 : UCIP\_FA\_2015\_5154.jpg

Slide gate in 36-inch CMP riser on WS slope. slide gate does not function as handle is detached from mechanism.

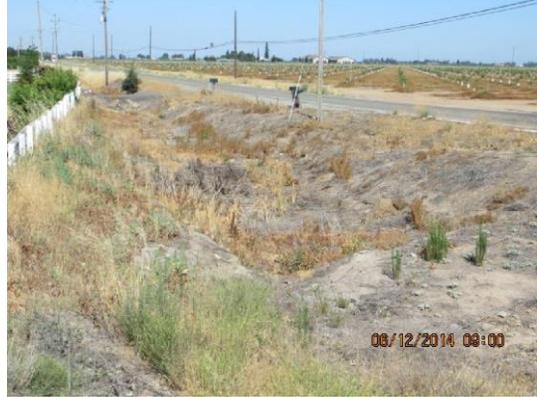
Photo 3 of 3 : UCIP\_FA\_2015\_5155.jpg

Headwall at LS toe.

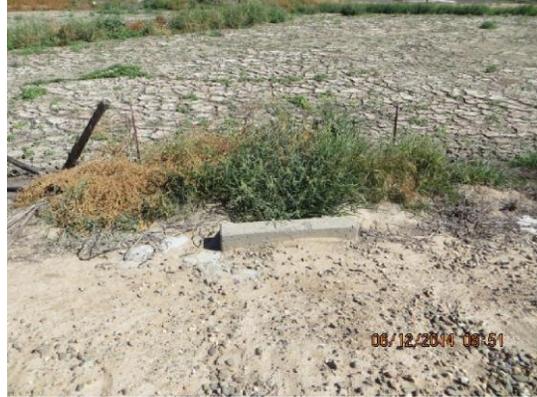
Photo 2 of 3 : UCIP\_FA\_2015\_5147.jpg

Inspector Comments: FS\_ID:38561  
 DS\_ID:23883  
 EP\_NO: N/A  
 FS\_HLM: 0.56  
 Repair Type: Non-Urgent  
 Crossing Status: Found  
 UCIP Comments: Pipe filled in with soil on the LS toe and appears to be temporarily abandoned.  
 FIELD\_STRUCT\_DESC: 24-inch CM pipe through the levee, 6.5 feet below the crown. Concrete "U" headwall on both ends. Flap gate on the waterward end. Cobble grouted spillway. Cobble grouted intake on landside. O&M Manual Bear Creek Part 2, 1967.  
 FS Date: 06/12/2014

Headwall at LS toe has been filled in with soil.

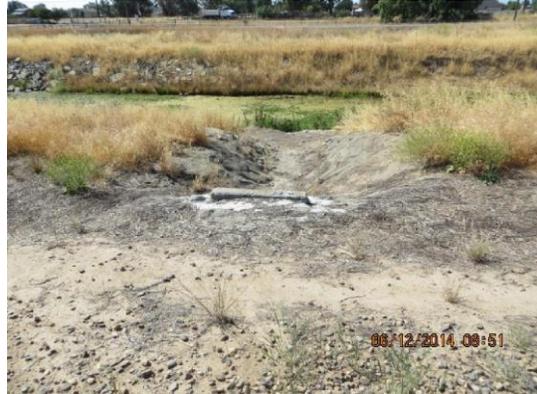
Photo 3 of 3 : UCIP\_FA\_2015\_5148.jpg

Headwall, flapgate, and grouted spillway on WS slope.

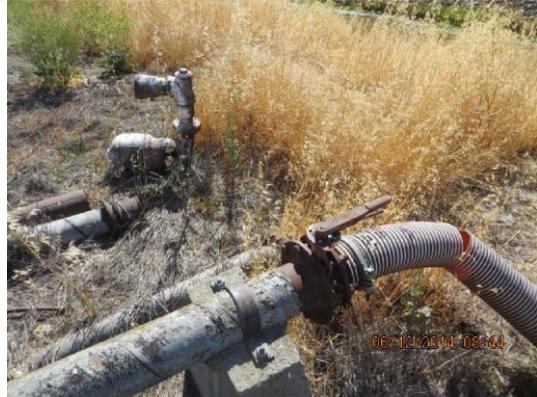
Photo 1 of 3 : UCIP\_FA\_2015\_5143.jpg

Abandoned pump and butterfly valve on WS berm.

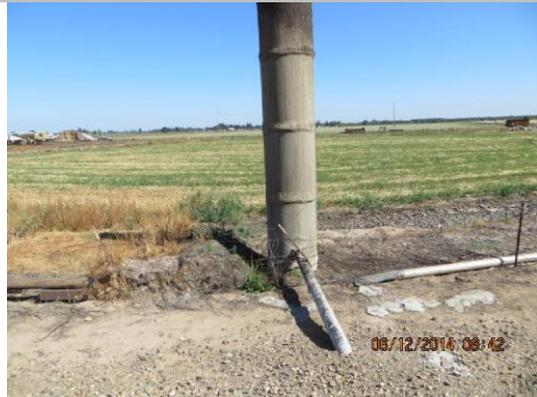
Photo 2 of 3 : UCIP\_FA\_2015\_5144.jpg

36-inch concrete standpipe visible on LS toe.

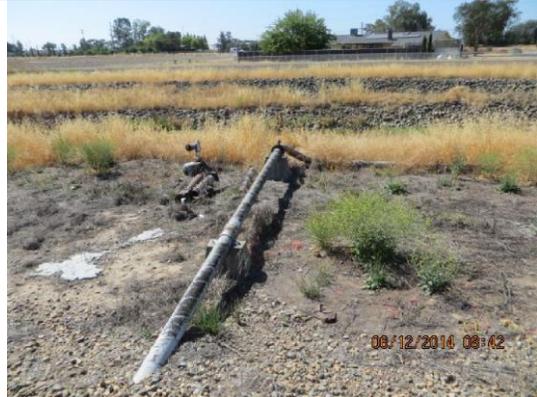
Photo 3 of 3 : UCIP\_FA\_2015\_5145.jpg

Pipe, pump, and butterfly valve visible on WS berm.

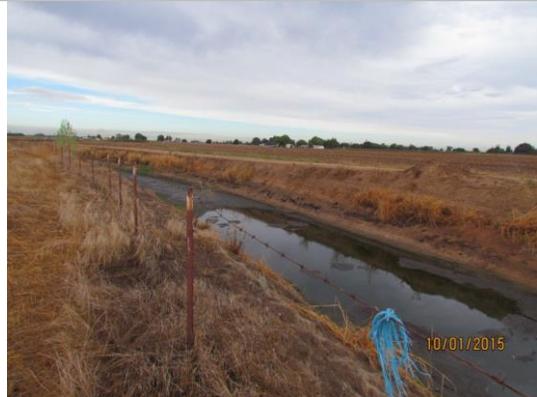
Photo 1 of 5 : FA\_2015\_NA0017\_155\_206\_20151009\_00017.jpg

LM Start	<b>1.06</b>	Rating **	U	Issue No.	<b>206</b>
LM End	<b>1.13</b>	Issue Type +	En	Location *	LS
Category	Earthen Levee			GPS Latitude/Longitude	
				Start	End
Item	Encroachments			38.109070 °	38.109595 °
				-121.165992 °	-121.164954 °
DWR ID	DWR_NA0017_11_s_2012_206				
Action/Comments					
Ditch Inspector Comments: A notice of violation was issued to the owner for this ditch during fall 2011 inspection.

Updated picture of the ditch on the landside of the levee during fall 2015 inspection.

REQUESTED CORRECTION: Repair the ditch at the landside toe of the levee. The ditch is approximately 10 feet in width from the toe of the levee - likely to cause significant levee stability issue.

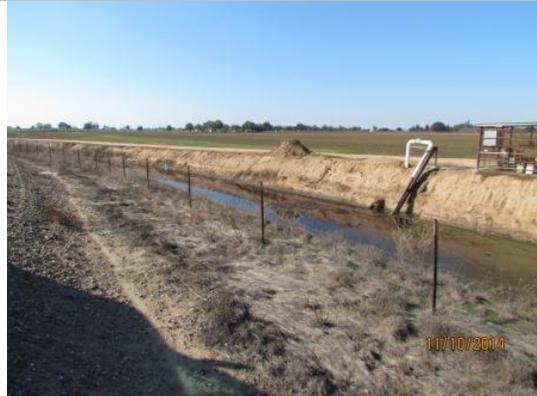
Photo 2 of 5 : FA\_2015\_NA0017\_155\_206\_20150911\_00010.jpg

Updated picture of the ditch on the landside of the levee during fall 2014 inspection looking downstream.

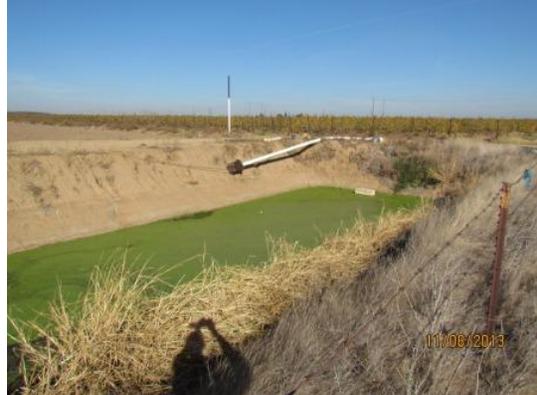
Photo 3 of 5 : FA\_2015\_NA0017\_155\_206\_20150911\_00012.jpg

Updated picture of the ditch on the landside of the levee. The picture was taken during fall 2013 inspection looking upstream.

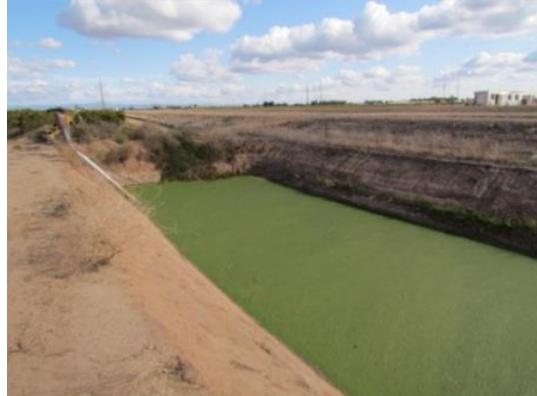
Photo 4 of 5 : FA\_2015\_NA0017\_155\_206\_20150911\_00013.jpg

View of the ditch on the landside of the levee looking upstream. The picture was taken during fall 2011 inspection.

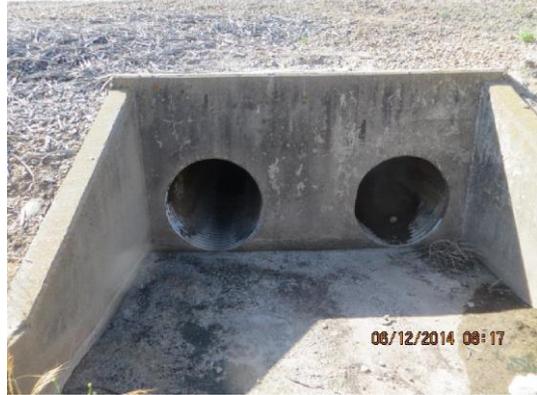
Photo 1 of 3 : UCIP\_FA\_2015\_5140.jpg

Headwall at LS toe.

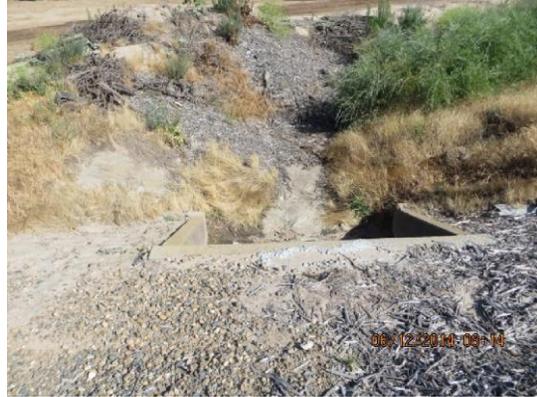
Photo 3 of 3 : UCIP\_FA\_2015\_5142.jpg

Headwall at LS toe.

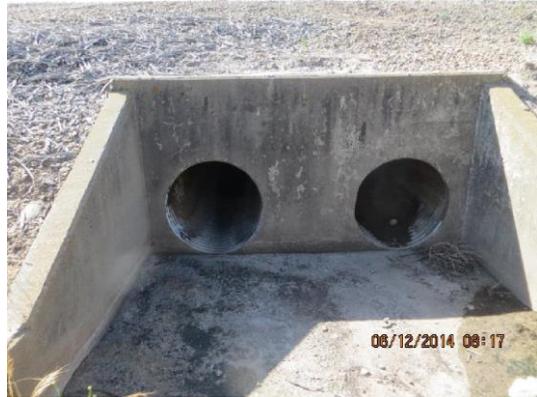
Photo 1 of 3 : UCIP\_FA\_2015\_5137.jpg

Headwall at LS toe.

Inspector Comments: FS\_ID:38556  
 DS\_ID:23897  
 EP\_NO: N/A  
 FS\_HLM: 1.512  
 Repair Type: Non-Urgent  
 Crossing Status: Found  
 UCIP Comments: Slidegate not functional or rusted in place. No lid on CMP riser at WS slope.  
 FIELD\_STRUCT\_DESC: 2 of 2: 36-inch CM stormdrain pipe through the levee, 7-feet below the crown. Slide gate in 48-inch C.M. riser units on the waterward slope. Concrete "U" headwall on both ends. Flap gate on the waterward end. Cobble grouted spillway. Cobble grouted intake on landside. O&M Manual Bear Creek Part 2, 1967.  
 FS Date: 06/12/2014

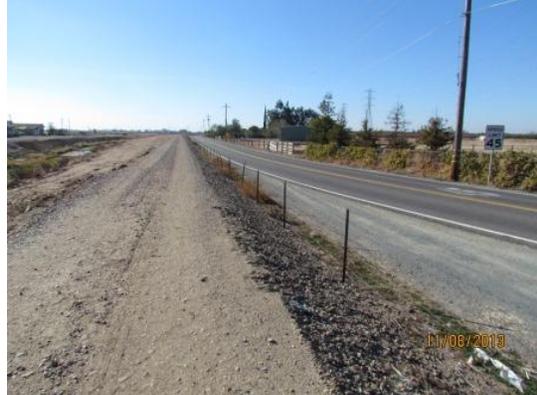
Photo 1 of 1 : FA\_2015\_NA0017\_155\_7\_20150911\_00006.jpg

A fence was found on the landside slope of the levee looking downstream.

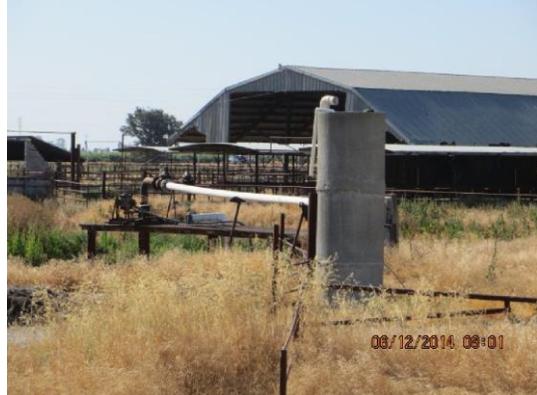
Photo 1 of 3 : UCIP\_FA\_2015\_4997.jpg

Concrete standpipe on opposite bank.

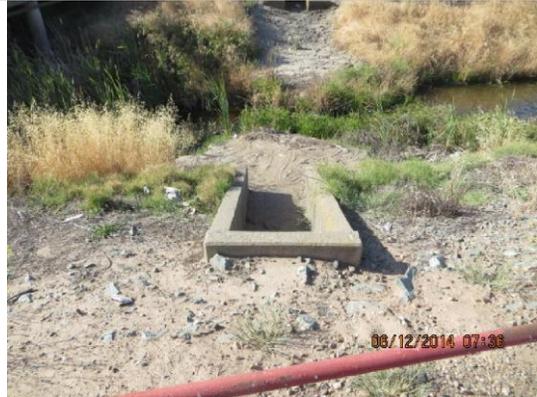
Photo 1 of 3 : UCIP\_FA\_2015\_3194.jpg

Headwall, flapgate, and grouted spillway on WS slope.

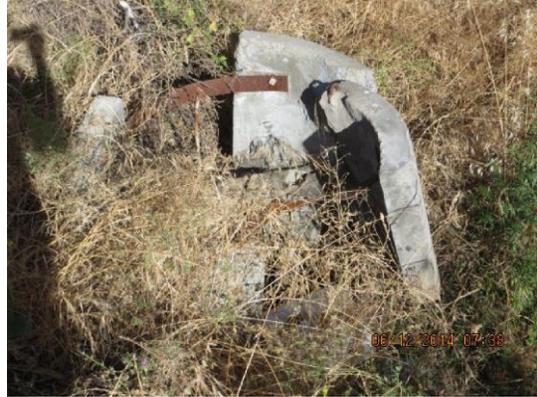
Photo 2 of 3 : UCIP\_FA\_2015\_4971.jpg

Inspector Comments: FS\_ID:38550  
 DS\_ID:23876  
 EP\_NO: N/A  
 FS\_HLM: 2.222  
 Repair Type: Non-Urgent  
 Crossing Status: Found  
 UCIP Comments: Concrete inlet at LS of East Kettleman road is damaged...may or may not be a hazard.  
 FIELD\_STRUCT\_DESC: 24-inch CM stormdrain pipe through the levee, 5-feet below the crown. Concrete "U" headwall on the waterward end. Flap gate on the waterward end. Cobble grouted spillway. 36-inch concrete catch basin on the landward end. O&M Manual Bear Creek Part 2, 1967.  
 FS Date: 06/12/2014

Concrete drop-inlet on North side of East Kettleman road damaged.

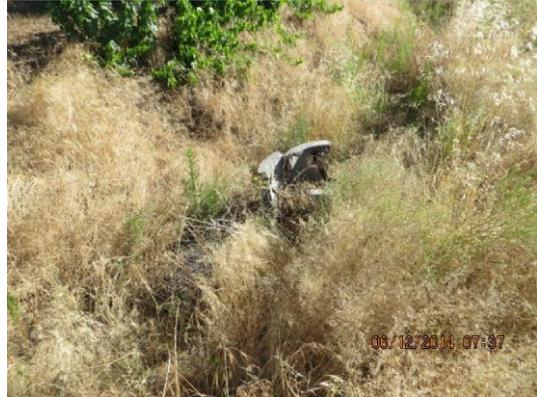
Photo 3 of 3 : UCIP\_FA\_2015\_4972.jpg

Concrete drop-inlet on North side of East Kettleman road damaged.

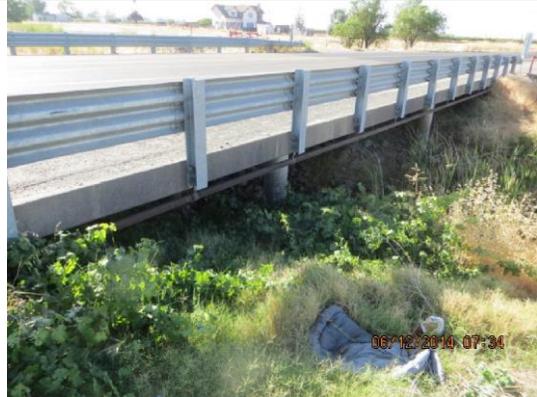
Photo 1 of 2 : UCIP\_FA\_2015\_4969.jpg

Conduit visible at downstream side of bridge.

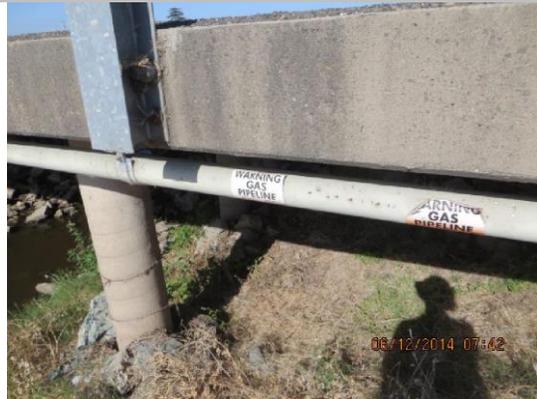
Photo 2 of 2 : UCIP\_FA\_2015\_5945.jpg

Gasline visible on upstream side of bridge

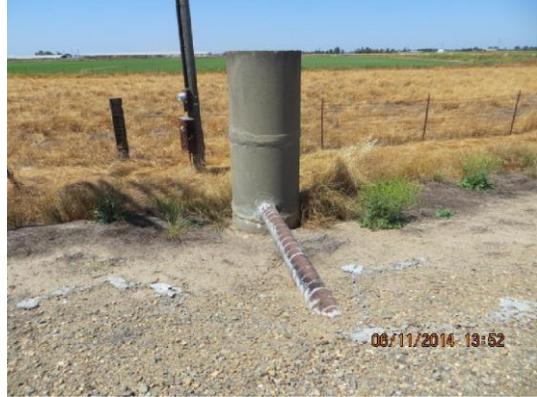
Photo 1 of 2 : UCIP\_FA\_2015\_4836.jpg

Item	DWR UCIP Field Study			38.121860 °	38.121860 °
				-121.145577 °	-121.145577 °
DWR ID					
Action/Comments					
Inspector Comments: FS_ID:38543 DS_ID:23889 EP_NO: N/A FS_HLM: 2.685 Repair Type: Non-Urgent Crossing Status: Found UCIP Comments: Appears abandoned and if so should be done so properly. FIELD_STRUCT_DESC: 10-inch steel irrigation pipe through the levee, 1.5-feet below the crown. Gate valve on the waterward slope. 36-inch C.M. pump sump unit with motor mounted on top on waterward side. 24-inch C.M. intake pipe from channel to sump. Concrete "U" headwall with trash rack on the waterward end. Concrete standpipe on the landward side. Waterward slope cobble grouted. O&M Manual Bear Creek Part 2, 1967. FS Date: 06/11/2014

48-inch concrete standpipe on LS shoulder. Power pole and electrical panel on LS shoulder.

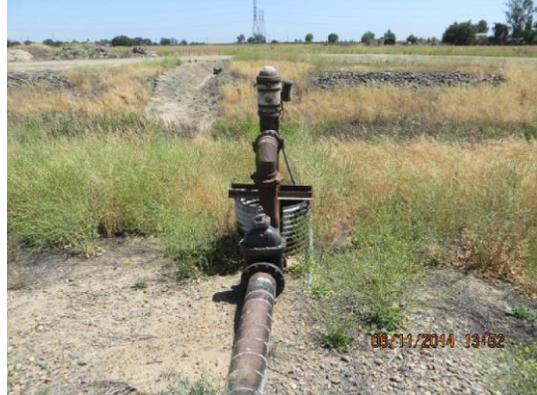
Photo 2 of 2 : UCIP\_FA\_2015\_4837.jpg

Pump over 36-inch CMP sump on WS toe.

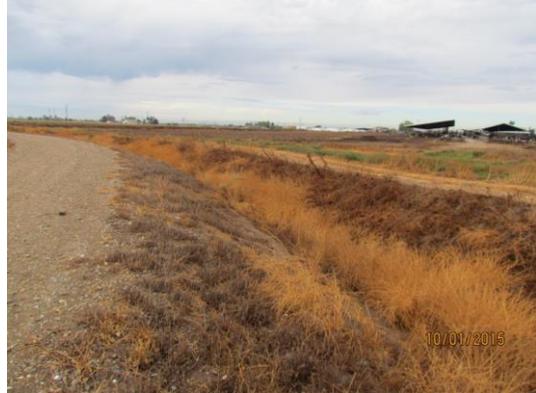
Photo 1 of 2 : FA\_2015\_NA0017\_155\_4\_20151009\_00016.jpg

LM Start	<b>2.88</b>	Rating **	M	Issue No.	<b>4</b>
LM End	<b>3.12</b>	Issue Type +	En	Location *	LS
Category	Earthen Levee		GPS Latitude/Longitude		
			Start	End	
Item	Encroachments		38.124677 °	38.127095 °	
			-121.144272 °	-121.142371 °	
DWR ID	DWR_NA0017_11_s_2012_4				
Action/Comments					
Ditch Inspector Comments: A ditch was dug by the farmer next to the levee.

Updated picture of the ditch on the landside toe of the levee looking upstream during fall 2015 inspection.

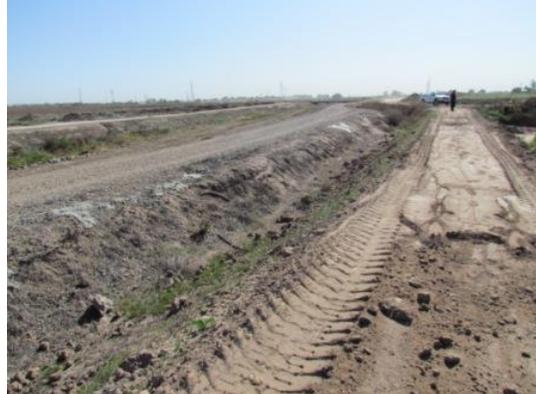
Photo 2 of 2 : FA\_2015\_NA0017\_155\_4\_20150911\_00004.jpg

A ditch was found on the landside of the levee looking downstream.

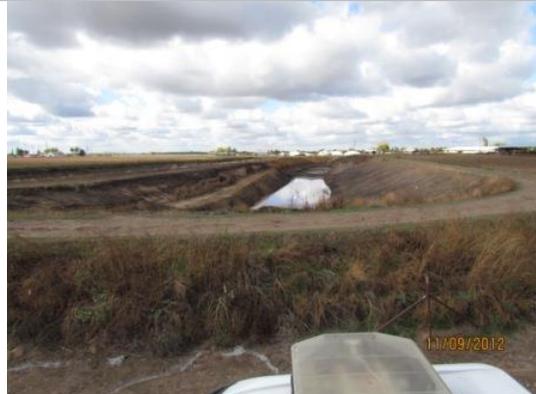
Photo 1 of 1 : FA\_2015\_NA0017\_155\_16\_20150911\_00008.jpg

LM Start	<b>2.94</b>	Rating **	M	Issue No.	<b>16</b>
LM End	<b>2.94</b>	Issue Type +	En	Location *	LS
Category	Earthen Levee		GPS Latitude/Longitude		
			Start	End	
Item	Encroachments		38.125636 °	38.125636 °	
			-121.144298 °	-121.144298 °	
DWR ID	DWR_NA0017_11_f_2012_16				
Action/Comments					
Ditch Inspector Comments: A detention pond was dug by the farmer next to the toe of the levee. It appears that it may interfere with the levee prism.

A detention pond was found next the landside toe of the levee. The pond was approximately 15 feet deep. The picture was taken from the crown looking towards the toe of the levee.

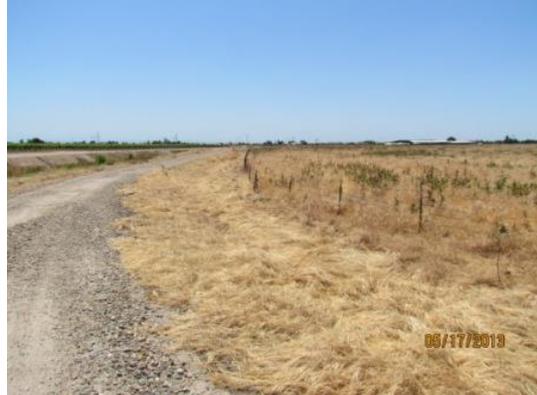
Photo 1 of 1 : FA\_2015\_NA0017\_155\_1\_20150911\_00001.jpg

A fence was found on the landside slope of the levee looking downstream.

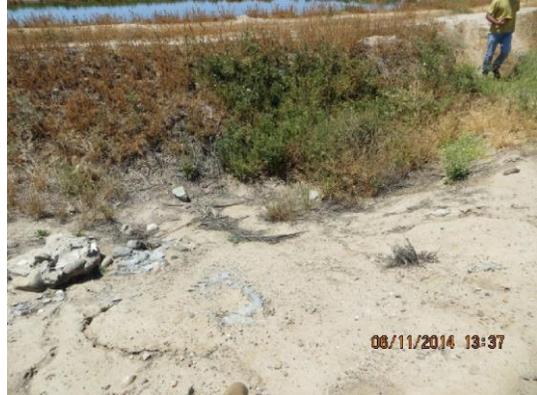
Photo 1 of 3 : UCIP\_FA\_2015\_4824.jpg

LS filled in with concrete per notes.

Inspector Comments: FS\_ID:38539  
 DS\_ID:23892  
 EP\_NO: N/A  
 FS\_HLM: 3.048  
 Repair Type: Non-Urgent  
 Crossing Status: Found  
 UCIP Comments: Pipe abandoned and if so should be done so properly. Verify if possible pipe filled with concrete.  
 FIELD\_STRUCT\_DESC: \*ABANDONED\* 24-inch CM stormdrain pipe through the levee, 6.5-feet below the crown. Concrete "U" headwall on both ends. Flap gate on the waterward end. Cobble grouted spillway. Cobble grouted intake on the landward side. O&M Manual Bear Creek Part 2, 1967. Intake end plugged and pipe filled with concrete under Permit No. 17426 (2003).  
 FS Date: 06/11/2014

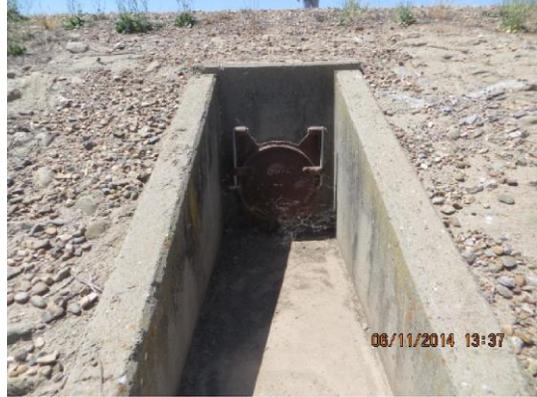
Photo 2 of 3 : UCIP\_FA\_2015\_4825.jpg

Headwall and flapgate on WS slope.

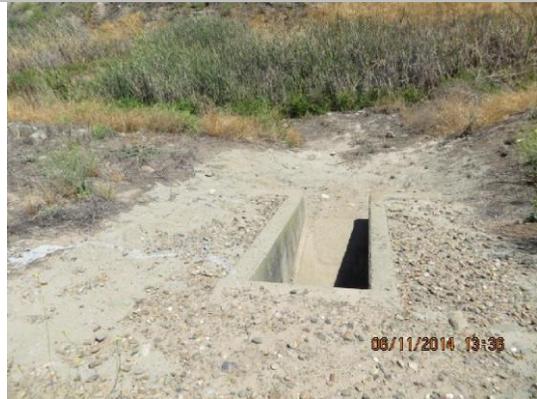
Photo 3 of 3 : UCIP\_FA\_2015\_4826.jpg

Headwall, flapgate, and grouted spillway on WS slope.

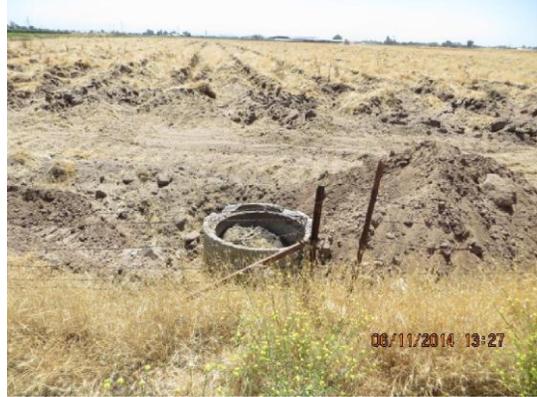
Photo 1 of 2 : UCIP\_FA\_2015\_4822.jpg

Concrete standpipe filled with soil on LS shoulder.

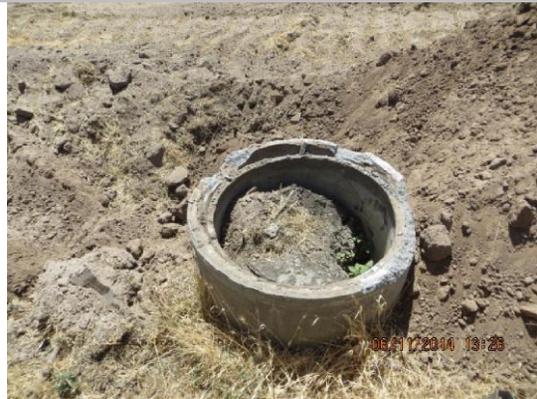
Photo 2 of 2 : UCIP\_FA\_2015\_4823.jpg

Concrete standpipe filled with soil on LS shoulder.

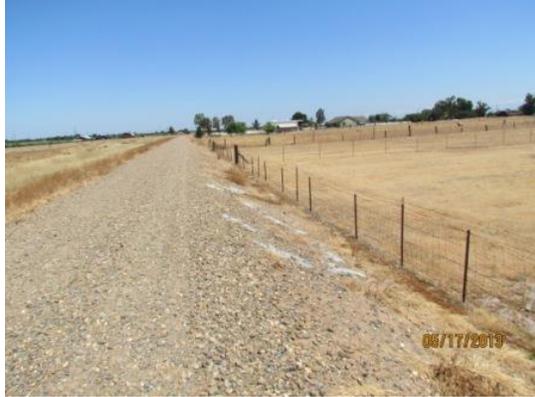
Photo 1 of 1 : FA\_2015\_NA0017\_156\_1\_20150911\_00001.jpg

View of a fence that was found on the landside toe of the levee looking upstream.

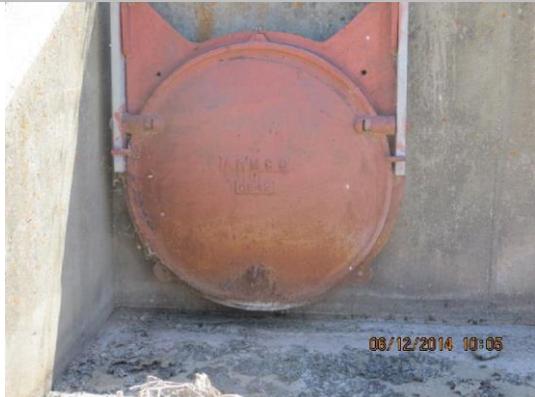
Photo 1 of 3 : UCIP\_FA\_2015\_6475.jpg

Headwall and flapgates on WS slope.

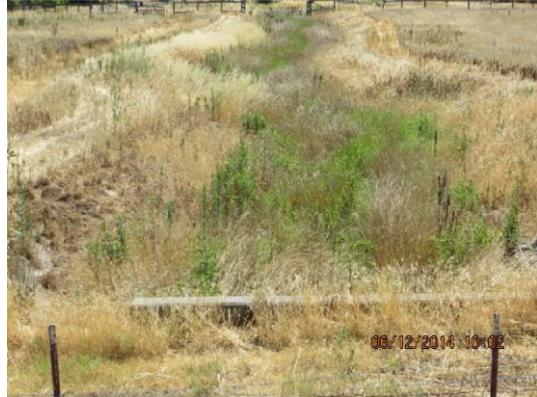
Photo 2 of 3 : UCIP\_FA\_2015\_6476.jpg

Headwall on LS toe.

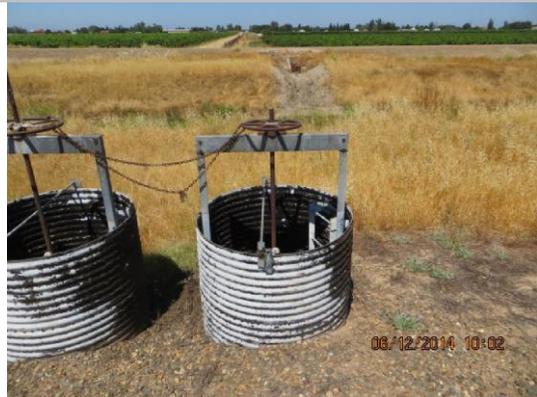
Photo 3 of 3 : UCIP\_FA\_2015\_6477.jpg

Slidegate in CMP riser on WS slope. No lid and gate rusted in place.

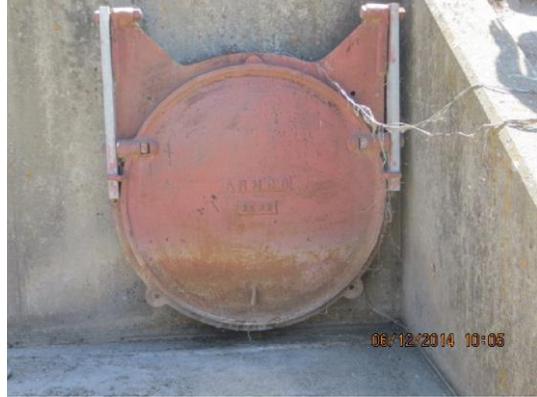
Photo 1 of 3 : UCIP\_FA\_2015\_6472.jpg

LM Start	<b>0.14</b>	Rating **	M	Issue No.	<b>130</b>
LM End	<b>0.14</b>	Issue Type +	En	Location *	LS
Category	Supplemental			GPS Latitude/Longitude	
				Start	End
Item	DWR UCIP Field Study			38.097126 °	38.097126 °
				-121.168760 °	-121.168760 °
DWR ID					
Action/Comments					
Inspector Comments: FS_ID:38569 DS_ID:23930 EP_NO: N/A FS_HLM: 0.144 Repair Type: Non-Urgent Crossing Status: Found

Headwall and flapgate on WS slope.

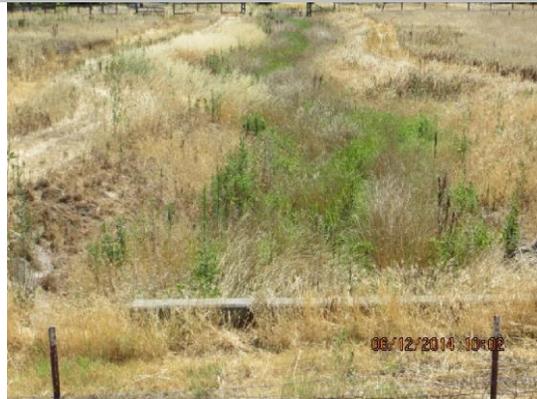
Photo 2 of 3 : UCIP\_FA\_2015\_6473.jpg

Headwall at LS toe not accessible

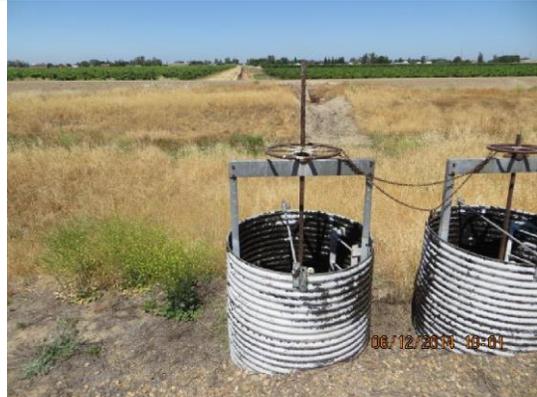
Photo 3 of 3 : UCIP\_FA\_2015\_6474.jpg

Slide gate in CMP riser on WS slope. No lid on riser and gate rusted in place.

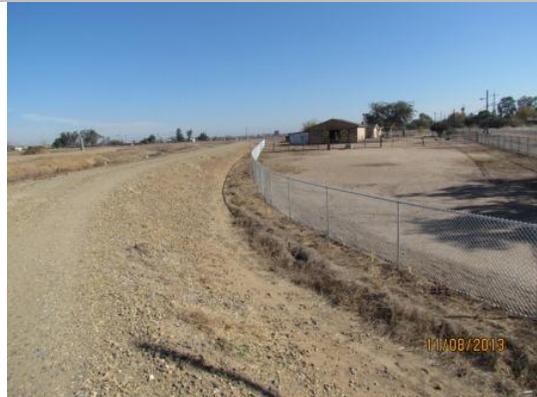
Photo 1 of 1 : FA\_2015\_NA0017\_156\_4\_20150911\_00004.jpg

LM Start	<b>0.48</b>	Rating **	M	Issue No.	<b>4</b>
LM End	<b>0.59</b>	Issue Type +	En	Location *	LS
Category	Earthen Levee			GPS Latitude/Longitude	
				Start	End
Item	Encroachments			38.101926 °	38.102616 °
				-121.167822 °	-121.166169 °
DWR ID	DWR_NA0017_12_f_2013_4				
Action/Comments					
Fence

View of a fence that was found on the landside toe of the levee looking upstream.

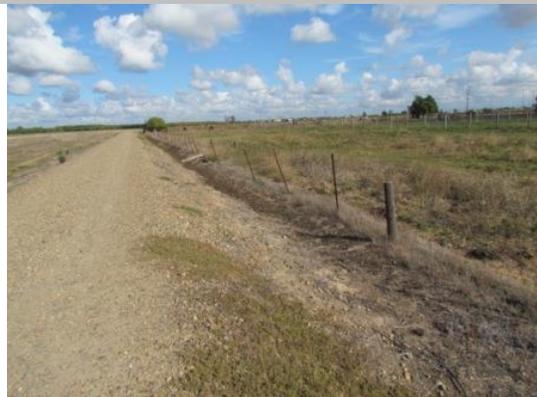
Photo 1 of 1 : FA\_2015\_NA0017\_156\_3\_20150911\_00003.jpg

LM Start	<b>0.59</b>	Rating **	M	Issue No.	<b>3</b>
LM End	<b>1.31</b>	Issue Type +	En	Location *	LS
Category	Earthen Levee			GPS Latitude/Longitude	
				Start	End
Item	Encroachments			38.102617 °	38.109301 °
				-121.166169 °	-121.160586 °
DWR ID	DWR_NA0017_12_s_2012_3				
Action/Comments					
Fence

View of a fence located on the landside toe of the levee looking upstream.

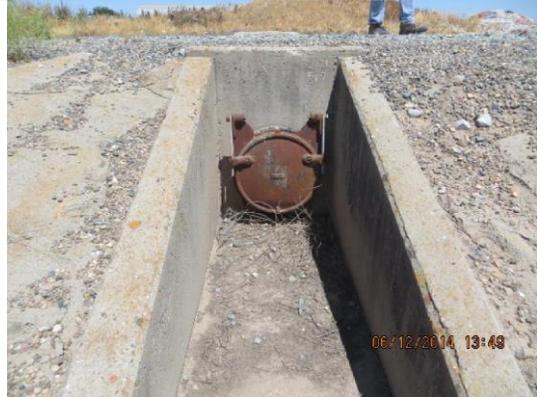
Photo 1 of 3 : UCIP\_FA\_2015\_6131.jpg

Inspector Comments: FS\_ID:38626  
 DS\_ID:23905  
 EP\_NO: N/A  
 FS\_HLM: 1.905  
 Repair Type: Non-Urgent  
 Crossing Status: Found  
 UCIP Comments: Pipe is covered with soil at inlet on LS.  
 FIELD\_STRUCT\_DESC: 24-inch CM stormdrain pipe through the levee, 3.5-feet below the crown. Concrete "U" headwalls on both ends. Flap gate on the waterward end. Cobble grouted spillway. Cobble grouted intake on the landward side. O&M Manual Bear Creek Part 2, 1967.  
 FS Date: 06/12/2014

Headwall and flapgate on WS slope.

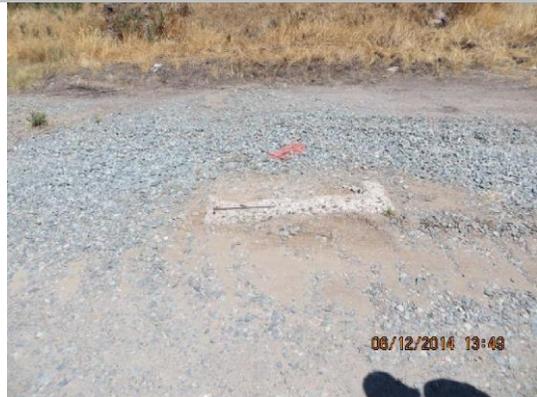
Photo 2 of 3 : UCIP\_FA\_2015\_6132.jpg

Headwall at LS toe buried in soil.

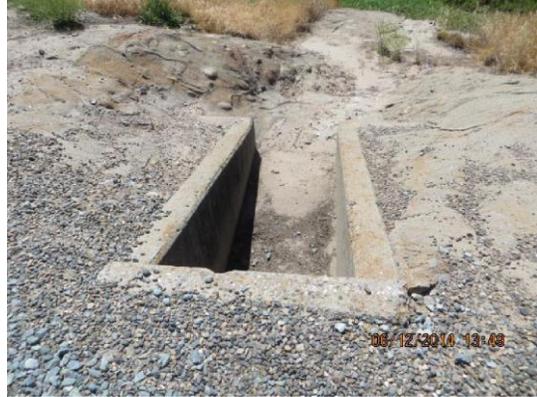
Photo 3 of 3 : UCIP\_FA\_2015\_6133.jpg

Headwall, flapgate, and grouted spillway on WS slope.

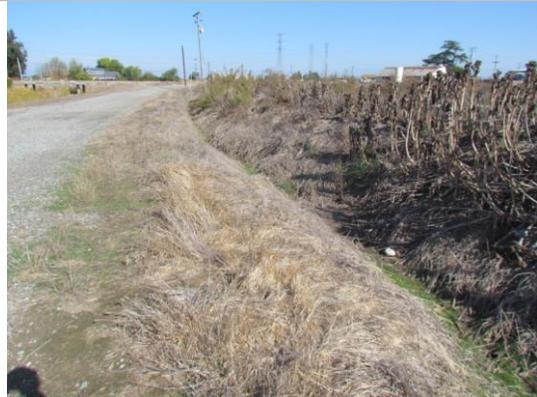
Photo 1 of 1 : FA\_2015\_NA0017\_156\_109\_20150911\_00027.jpg

LM Start	<b>1.91</b>	Rating **	M	Issue No.	<b>109</b>
LM End	<b>1.91</b>	Issue Type +	En	Location *	LS
Category	Earthen Levee			GPS Latitude/Longitude	
				Start	End
Item	Encroachments			38.115993 °	38.115993 °
				-121.154539 °	-121.154539 °
DWR ID	DWR_NA0017_12_s_2012_109				
Action/Comments					
Ditch

View of a ditch located on the landside toe of the levee looking upstream.

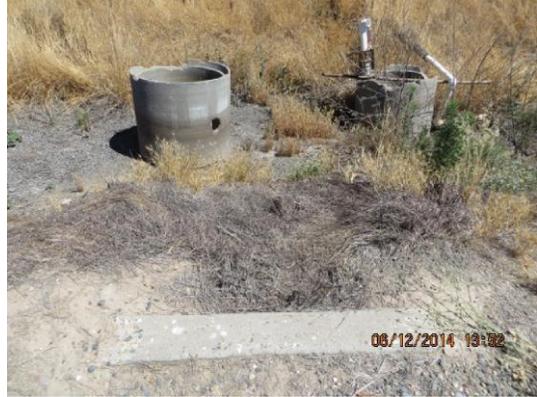
Photo 1 of 2 : UCIP\_FA\_2015\_6134.jpg

**Action/Comments**  
 Inspector Comments: FS\_ID:38627  
 DS\_ID:23906  
 EP\_NO: N/A  
 FS\_HLM: 1.968  
 Repair Type: Non-Urgent  
 Crossing Status: Found  
 UCIP Comments: Pipe burried on both ends and appears to be abandoned. IF so, it should be done so properly.  
 FIELD\_STRUCT\_DESC: 24-inch CM stormdrain pipe through the levee, 4.0-feet below the crown. Concrete "U" headwall on both ends. Flap gate on the waterward end. Cobble grouted spillway. Cobble grouted intake on the landward side. O&M Manual Bear Creek Part 2, 1967.  
 FS Date: 06/12/2014

Headwall burried on LS shoulder.

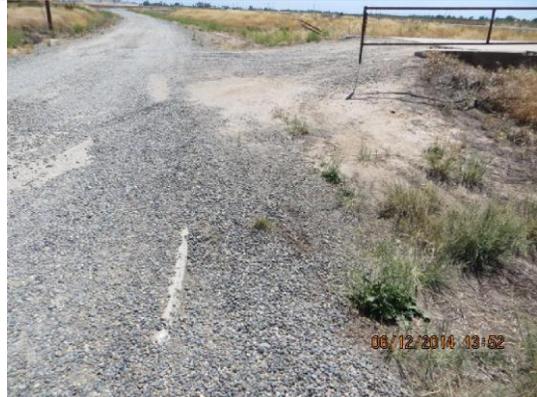
Photo 2 of 2 : UCIP\_FA\_2015\_6135.jpg

Headwall burried on WS shoulder.

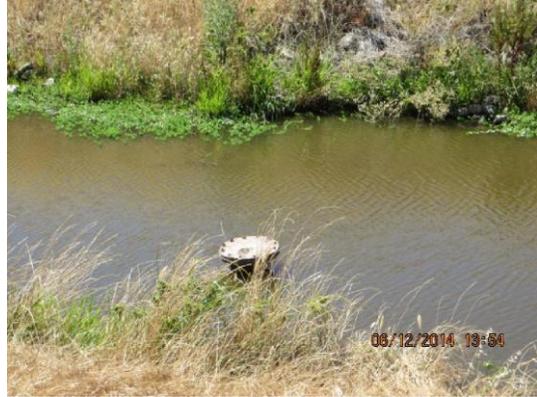
Photo 1 of 3 : UCIP\_FA\_2015\_6136.jpg

Steel cleanout in channel off WS toe.

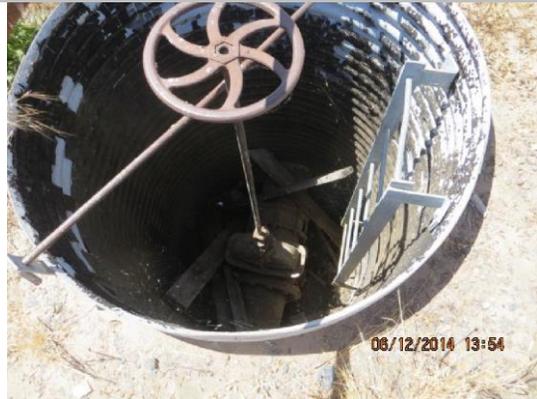
Photo 2 of 3 : UCIP\_FA\_2015\_6137.jpg

54-inch CMP riser with gate valve on WS slope. Gate valve rusted in place.

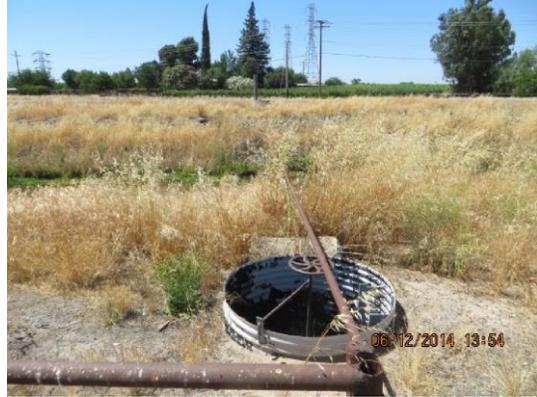
Photo 3 of 3 : UCIP\_FA\_2015\_6138.jpg

54-inch CMP riser with gate valve on WS slope.

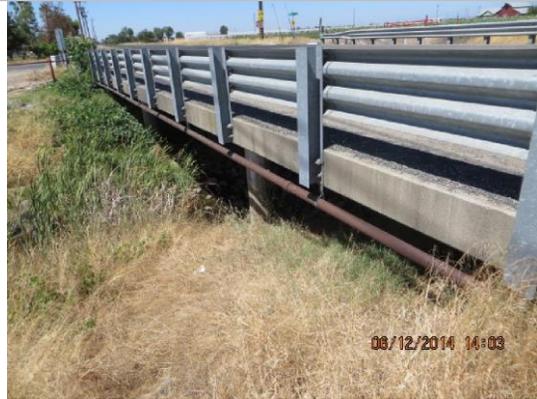
Photo 1 of 1 : UCIP\_FA\_2015\_6174.jpg

LM Start	<b>2.15</b>	Rating **	M	Issue No.	<b>134</b>
LM End	<b>2.15</b>	Issue Type +	En	Location *	CR
Category	Supplemental			GPS Latitude/Longitude	
				Start	End
Item	DWR UCIP Field Study			38.117728 °	38.117728 °
				-121.150986 °	-121.150986 °
DWR ID					
Action/Comments					
Inspector Comments: FS_ID:41960 DS_ID:25007 EP_NO: N/A FS_HLM: 2.157 Repair Type: Non-Urgent Crossing Status: Found UCIP Comments: No permit identified for this crossing. FIELD_STRUCT_DESC: 3.5-inch steel communication conduit through the levee at an unknown depth below the crown. Pipe visible on the downstream side of the bridge. FS Date: 06/12/2014

Pipe visible on the downstream side of the bridge.

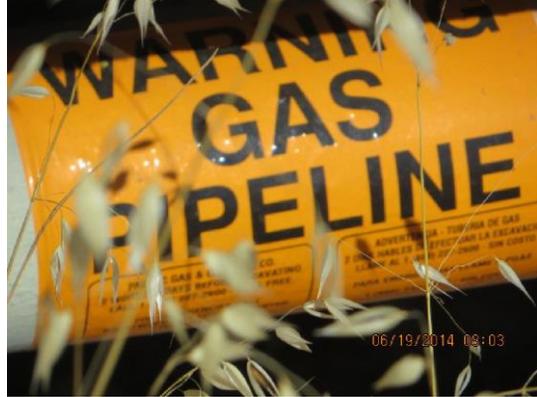
Photo 1 of 3 : UCIP\_FA\_2015\_6175.jpg

LM Start	<b>2.16</b>	Rating **	U	Issue No.	<b>135</b>
LM End	<b>2.16</b>	Issue Type +	En	Location *	CR
Category	Supplemental			GPS Latitude/Longitude	
				Start	End
Item	DWR UCIP Field Study			38.117704 °	38.117704 °
				-121.150823 °	-121.150823 °
DWR ID					
Action/Comments					
Inspector Comments: FS_ID:39450 DS_ID:25008 EP_NO: N/A FS_HLM: 2.166 Repair Type: Urgent Crossing Status: Found UCIP Comments: Need gasline markers on both levees. No permit identified for this crossing. FIELD_STRUCT_DESC: 4.5-inch gas line through the levee at an unknown depth below the crown. Pipe attached to upstream side of bridge. FS Date: 06/19/2014

Gasline visible on upstream side of bridge.

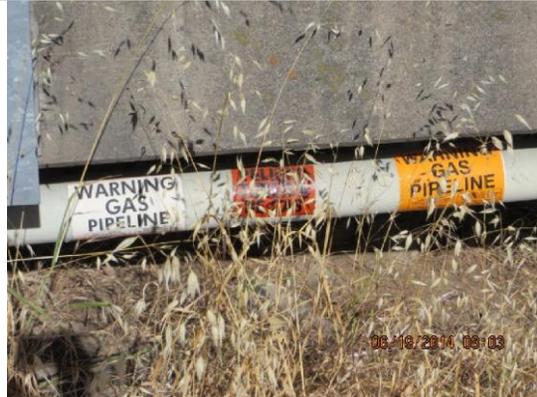
Photo 2 of 3 : UCIP\_FA\_2015\_6176.jpg

Gasline visible on upstream side of bridge.

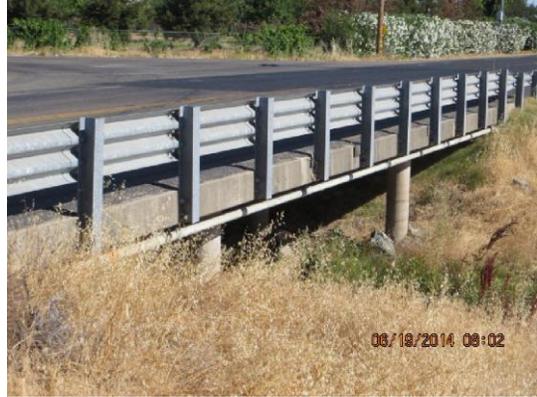
Photo 3 of 3 : UCIP\_FA\_2015\_6177.jpg

Gasoline visible on upstream side of bridge.

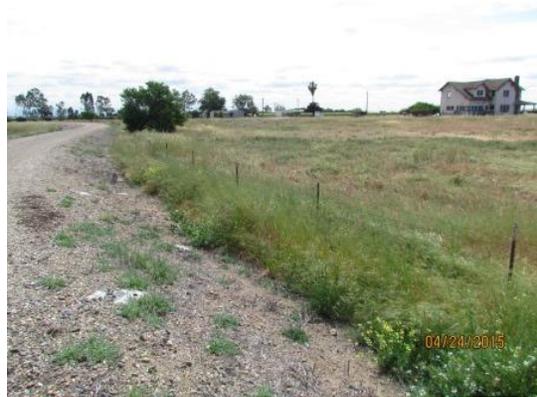
Photo 1 of 1 : FA\_2015\_NA0017\_156\_35\_20150911\_00025.jpg

LM Start	<b>2.18</b>	Rating **	M	Issue No.	<b>35</b>
LM End	<b>2.64</b>	Issue Type +	En	Location *	LS
Category	Earthen Levee			GPS Latitude/Longitude	
				Start	End
Item	Encroachments			38.117792 °	38.121790 °
				-121.150514 °	-121.145020 °
DWR ID	DWR_NA0017_12_s_2015_35				
Action/Comments					
Fence

View of fence on the landside toe of the levee looking upstream.

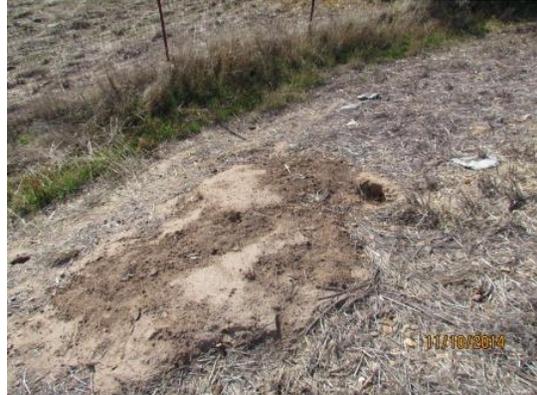
Photo 1 of 2 : FA\_2015\_NA0017\_156\_9\_20150911\_00007.jpg

Updated picture of the rodent holes on the landside of the levee looking downstream.

LM Start	<b>2.22</b>	Rating **	M	Issue No.	<b>9</b>
LM End	<b>2.22</b>	Issue Type +	Ma	Location *	LS
Category	Earthen Levee			GPS Latitude/Longitude	
				Start	End
Item	Animal Control			38.117784 °	38.117784 °
				-121.149763 °	-121.149763 °
DWR ID	DWR_NA0017_12_s_2014_9				
Action/Comments					
No rodents visible, but rodent burrows visible; need to backfill and compact or grout burrows.

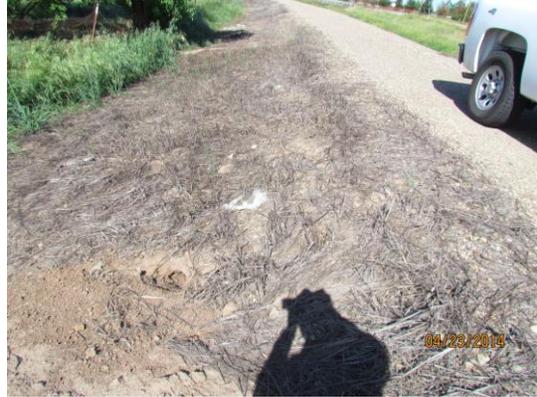
Photo 2 of 2 : FA\_2015\_NA0017\_156\_9\_20150911\_00008.jpg

View of a rodent hole that was found on the landside of the levee looking downstream.

LM Start	<b>2.22</b>	Rating **	M	Issue No.	<b>9 (cont)</b>
LM End	<b>2.22</b>	Issue Type +	Ma	Location *	LS
Category	Earthen Levee		GPS Latitude/Longitude		
			Start	End	
Item	Animal Control		38.117784 °	38.117784 °	
			-121.149763 °	-121.149763 °	
DWR ID	DWR_NA0017_12_s_2014_9				
Action/Comments					
No rodents visible, but rodent burrows visible; need to backfill and compact or grout burrows.

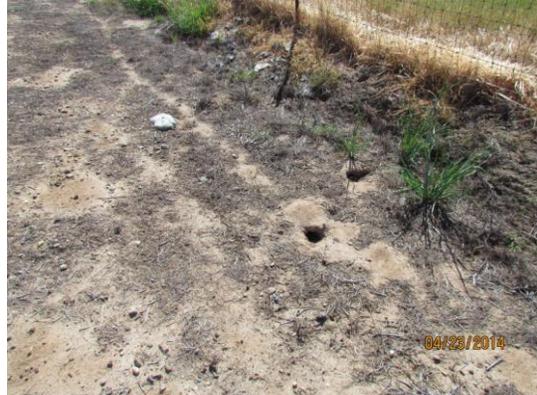
Photo 1 of 1 : FA\_2015\_NA0017\_156\_11\_20150911\_00010.jpg

View of rodent holes that were found on the landside toe of the levee upstream.

LM Start	<b>2.25</b>	Rating **	M	Issue No.	<b>11</b>
LM End	<b>2.25</b>	Issue Type +	Ma	Location *	LS
Category	Earthen Levee		GPS Latitude/Longitude		
			Start	End	
Item	Animal Control		38.117807 °	38.117807 °	
			-121.149233 °	-121.149233 °	
DWR ID	DWR_NA0017_12_s_2014_11				
Action/Comments					
No rodents visible, but rodent burrows visible; need to backfill and compact or grout burrows.

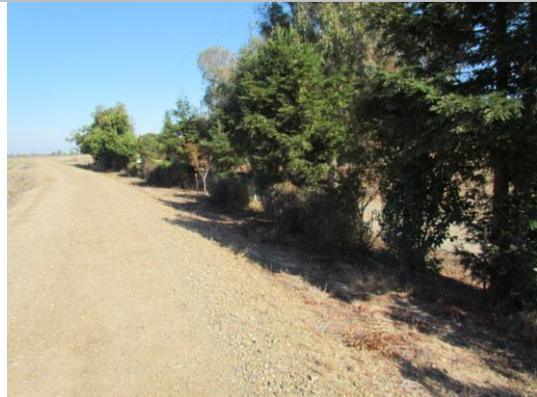
Photo 1 of 1 : FA\_2015\_NA0017\_156\_8\_20150911\_00006.jpg

LM Start	<b>2.36</b>	Rating **	M	Issue No.	<b>8</b>
LM End	<b>2.42</b>	Issue Type +	En	Location *	LS
Category	Earthen Levee		GPS Latitude/Longitude		
			Start	End	
Item	Vegetation		38.118957 °	38.119761 °	
			-121.147865 °	-121.147461 °	
DWR ID	DWR_NA0017_12_s_2012_8				
Action/Comments					
Landscaping

View of trees and landscaping found on the landside of the levee looking upstream.

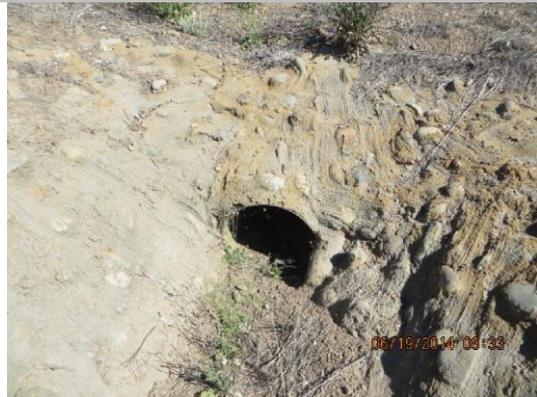
Photo 1 of 3 : UCIP\_FA\_2015\_6178.jpg

LM Start	<b>2.61</b>	Rating **	U	Issue No.	<b>136</b>
LM End	<b>2.61</b>	Issue Type +	En	Location *	WS
Category	Supplemental			GPS Latitude/Longitude	
				Start	End
Item	DWR UCIP Field Study			38.121463 °	38.121463 °
				-121.145437 °	-121.145437 °
DWR ID					
Action/Comments					
Inspector Comments: FS_ID:41766 DS_ID:23913 EP_NO: N/A FS_HLM: 2.618 Repair Type: Urgent Crossing Status: Found UCIP Comments: Silt buildup on WS toe blocking flapgate operation. FIELD_STRUCT_DESC: 24-inch CM stormdrain pipe through the levee, 4-feet below the crown. Flap gate on the waterward end. Cobble grouted spillway. Cobble grouted intake on the landward side. O&M Manual Bear Creek Part 2, 1967. FS Date: 06/19/2014

Inlet at LS toe.

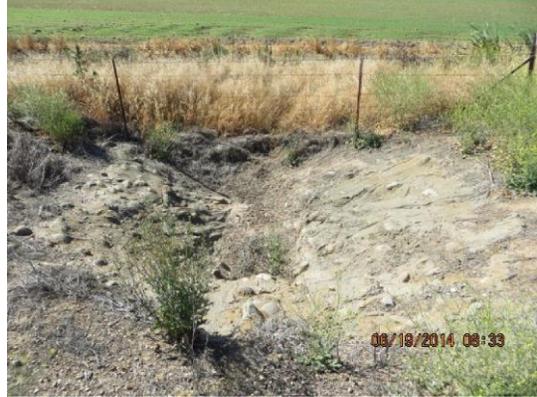
Photo 2 of 3 : UCIP\_FA\_2015\_6179.jpg

LM Start	2.61	Rating **	U	Issue No.	136 (cont)
LM End	2.61	Issue Type +	En	Location *	WS
Category	Supplemental			GPS Latitude/Longitude	
			Start	End	
Item	DWR UCIP Field Study			38.121463 °	38.121463 °
				-121.145437 °	-121.145437 °
DWR ID					
Action/Comments					
Inspector Comments: FS_ID:41766 DS_ID:23913 EP_NO: N/A FS_HLM: 2.618 Repair Type: Urgent Crossing Status: Found UCIP Comments: Silt buildup on WS toe blocking flapgate operation. FIELD_STRUCT_DESC: 24-inch CM stormdrain pipe through the levee, 4-feet below the crown. Flap gate on the waterward end. Cobble grouted spillway. Cobble grouted intake on the landward side. O&M Manual Bear Creek Part 2, 1967. FS Date: 06/19/2014

Inlet at LS toe.

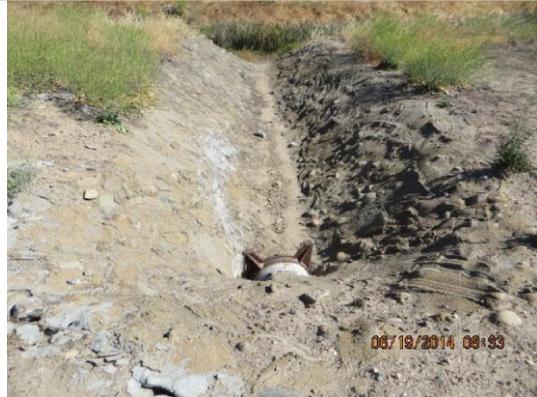
Photo 3 of 3 : UCIP\_FA\_2015\_6180.jpg

Flapgate and grouted spillway on WS slope.

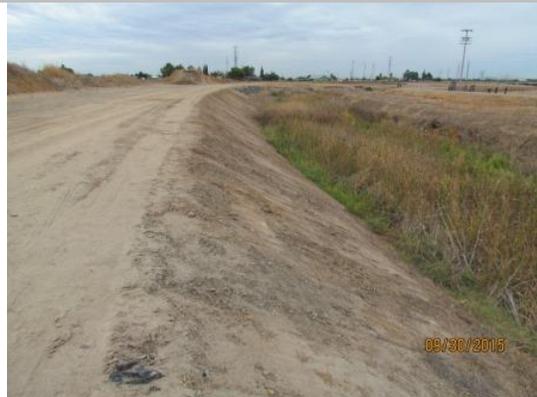
Photo 1 of 1 : FA\_2015\_NA0017\_156\_27\_20151005\_00029.jpg

LM Start	<b>2.68</b>	Rating **	A	Issue No.	<b>27</b>
LM End	<b>2.68</b>	Issue Type +	Ma	Location *	WS
Category	Earthen Levee		GPS Latitude/Longitude		
			Start	End	
Item	Animal Control		38.122240 °	38.122240 °	
			-121.144572 °	-121.144572 °	
DWR ID	DWR_NA0017_12_f_2015_27				
Action/Comments					
No rodents visible, but rodent burrows visible; need to backfill and compact or grout burrows. Inspector Comments: LMA has repaired the rodent holes.

LMA has repaired rodent holes on the waterside of the levee looking downstream.

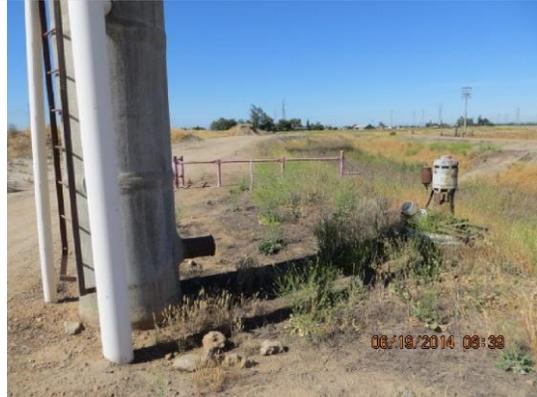
Photo 1 of 1 : UCIP\_FA\_2015\_6210.jpg

LM Start	<b>2.69</b>	Rating **	M	Issue No.	<b>137</b>
LM End	<b>2.69</b>	Issue Type +	En	Location *	WS
Category	Supplemental			GPS Latitude/Longitude	
				Start	End
Item	DWR UCIP Field Study			38.122407 °	38.122407 °
				-121.144447 °	-121.144447 °
DWR ID					
Action/Comments					
Inspector Comments: FS_ID:41687 DS_ID:25011 EP_NO: N/A FS_HLM: 2.706 Repair Type: Non-Urgent Crossing Status: Found UCIP Comments: No permit identified for this crossing. FIELD_STRUCT_DESC: 10-inch PVC irrigation pipe through the levee at an unknown depth. Pipe discharges into a 36-inch concrete standpipe on the WS shoulder. Unclear of pipe alignment. FS Date: 06/12/2014

Pipe visible at discharge point to 36-inch concrete standpipe on WS shoulder.

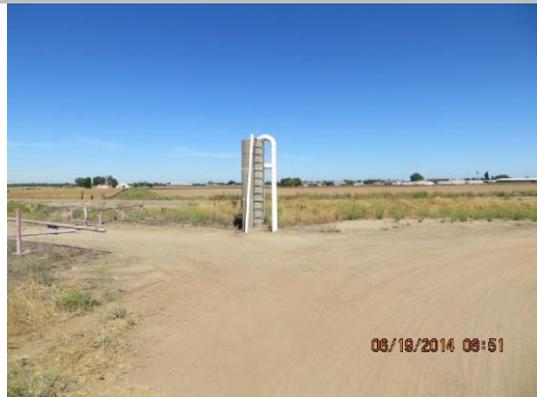
Photo 1 of 2 : UCIP\_FA\_2015\_6211.jpg

LM Start	<b>2.69</b>	Rating **	M	Issue No.	<b>138</b>
LM End	<b>2.69</b>	Issue Type +	En	Location *	WS
Category	Supplemental			GPS Latitude/Longitude	
				Start	End
Item	DWR UCIP Field Study			38.122407 °	38.122407 °
				-121.144447 °	-121.144447 °
DWR ID					
Action/Comments					
Inspector Comments: FS_ID:41686 DS_ID:25010 EP_NO: N/A FS_HLM: 2.706 Repair Type: Non-Urgent Crossing Status: Found UCIP Comments: No permit identified for this crossing. FIELD_STRUCT_DESC: 4-inch PVC irrigation pipe through the levee at an unknown depth. Pipe discharges into a 36-inch concrete standpipe on the WS shoulder. A pump is mounted on a steel frame over a pond off the LS shoulder. FS Date: 06/12/2014

Pipe visible at discharge into 36-inch concrete standpipe on WS shoulder.

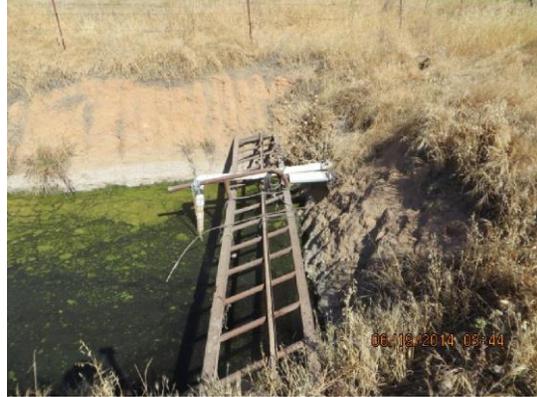
Photo 2 of 2 : UCIP\_FA\_2015\_6212.jpg

LM Start	<b>2.69</b>	Rating **	M	Issue No.	<b>138 (cont)</b>
LM End	<b>2.69</b>	Issue Type +	En	Location *	WS
Category	Supplemental			GPS Latitude/Longitude	
				Start	End
Item	DWR UCIP Field Study			38.122407 °	38.122407 °
				-121.144447 °	-121.144447 °
DWR ID					
Action/Comments					
Inspector Comments: FS_ID:41686 DS_ID:25010 EP_NO: N/A FS_HLM: 2.706 Repair Type: Non-Urgent Crossing Status: Found UCIP Comments: No permit identified for this crossing. FIELD_STRUCT_DESC: 4-inch PVC irrigation pipe through the levee at an unknown depth. Pipe discharges into a 36-inch concrete standpipe on the WS shoulder. A pump is mounted on a steel frame over a pond off the LS shoulder. FS Date: 06/12/2014

Submersible pump at LS in drainage pond. Pipe on metal frame.

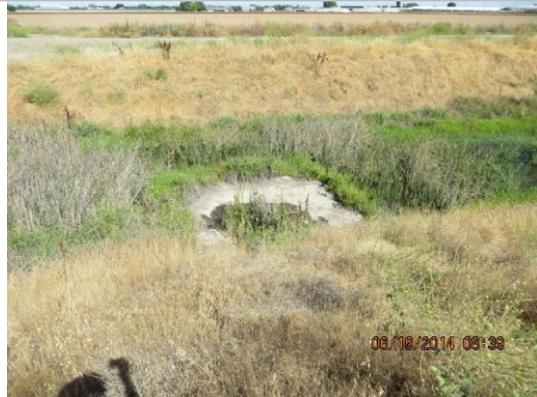
Photo 1 of 3 : UCIP\_FA\_2015\_6181.jpg

Item	DWR UCIP Field Study			38.122419 °	38.122419 °
				-121.144470 °	-121.144470 °
DWR ID					
Action/Comments					
Inspector Comments: FS_ID:38635 DS_ID:23914 EP_NO: N/A FS_HLM: 2.705 Repair Type: Non-Urgent Crossing Status: Found UCIP Comments: Pipe appears to be abandoned as pump has been disconnected. However, Concrete riser on WS shoulder appears to be in use. FIELD_STRUCT_DESC: 8-inch steel pipe through the levee, 3.5-feet below the crown. 36-inch Concrete standpipe on the waterward side. 36-inch CM pump sump unit with motor mounted on top on the waterward side. 24-inch CM intake pipe from channel to sump. Concrete "U" headwall with trash rack on the waterward end. Waterward slope cobble grouted. O&M Manual Bear Creek Part 2, 1967. FS Date: 06/19/2014

Concrete headwall at WS toe.

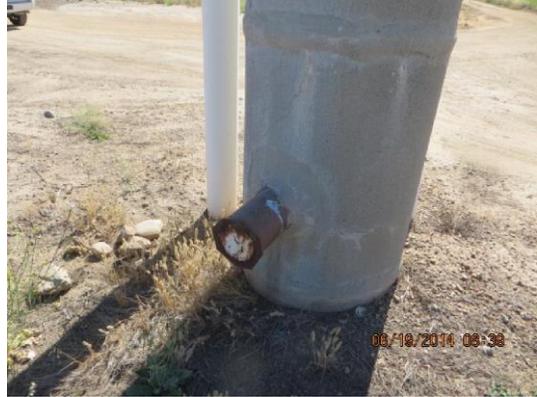
Photo 2 of 3 : UCIP\_FA\_2015\_6182.jpg

LM Start	2.69	Rating **	M	Issue No.	139 (cont)
LM End	2.69	Issue Type +	En	Location *	WS
Category	Supplemental			GPS Latitude/Longitude	
				Start	End
Item	DWR UCIP Field Study			38.122419 °	38.122419 °
				-121.144470 °	-121.144470 °
DWR ID					
<b>Action/Comments</b>					
Inspector Comments: FS_ID:38635 DS_ID:23914 EP_NO: N/A FS_HLM: 2.705 Repair Type: Non-Urgent Crossing Status: Found UCIP Comments: Pipe appears to be abandoned as pump has been disconnected. However, Concrete riser on WS shoulder appears to be in use. FIELD_STRUCT_DESC: 8-inch steel pipe through the levee, 3.5-feet below the crown. 36-inch Concrete standpipe on the waterward side. 36-inch CM pump sump unit with motor mounted on top on the waterward side. 24-inch CM intake pipe from channel to sump. Concrete "U" headwall with trash rack on the waterward end. Waterward slope cobble grouted. O&M Manual Bear Creek Part 2, 1967. FS Date: 06/19/2014

8-inch pipe from pump has welded steel plate over it.

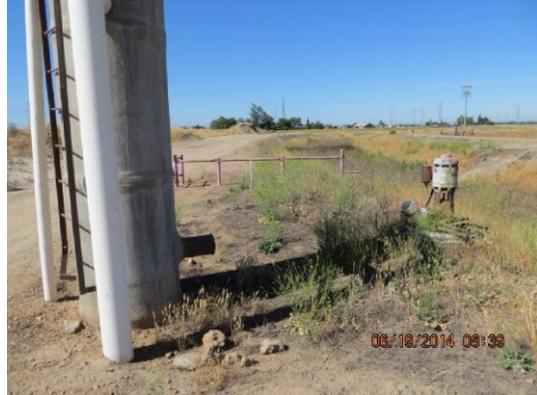
Photo 3 of 3 : UCIP\_FA\_2015\_6183.jpg

Concrete standpipe, pipe section, and pump over 36-inch CMP sump on WS shoulder.

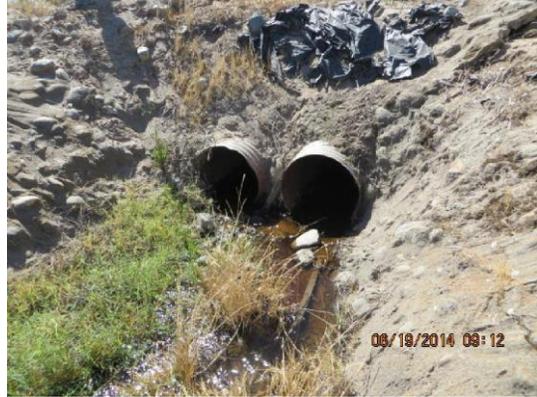
Photo 1 of 3 : UCIP\_FA\_2015\_6282.jpg

LM Start	<b>3.09</b>	Rating **	M	Issue No.	<b>140</b>
LM End	<b>3.09</b>	Issue Type +	En	Location *	WS
Category	Supplemental			GPS Latitude/Longitude	
				Start	End
Item	DWR UCIP Field Study			38.126939 °	38.126939 °
				-121.141925 °	-121.141925 °
DWR ID					
Action/Comments					
Inspector Comments: FS_ID:41555 DS_ID:23928 EP_NO: N/A FS_HLM: 3.109 Repair Type: Non-Urgent Crossing Status: Found UCIP Comments: Pipe open on both ends. FIELD_STRUCT_DESC: 1 of 2: 24-inch CM stormdrain pipe through the levee, 3.0-feet below the crown. O&M Manual Bear Creek Part 2, 1967. FS Date: 06/19/2014

Pipe at grouted spillway on WS slope.

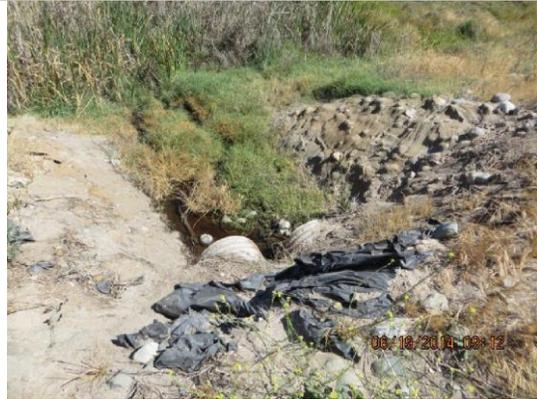
Photo 2 of 3 : UCIP\_FA\_2015\_6283.jpg

Pipe at grouted spillway on WS slope.

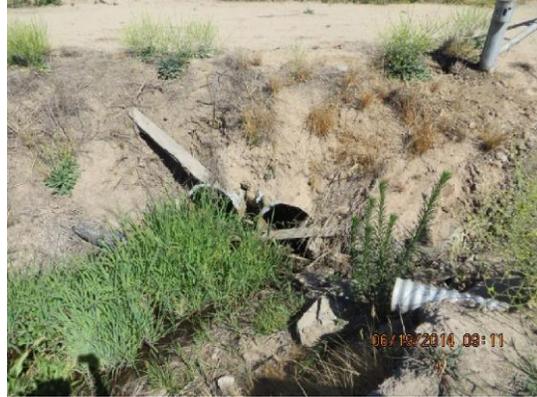
Photo 3 of 3 : UCIP\_FA\_2015\_6284.jpg

LM Start	<b>3.09</b>	Rating **	M	Issue No.	<b>140 (cont)</b>
LM End	<b>3.09</b>	Issue Type +	En	Location *	WS
Category	Supplemental			GPS Latitude/Longitude	
				Start	End
Item	DWR UCIP Field Study			38.126939 °	38.126939 °
				-121.141925 °	-121.141925 °
DWR ID					
Action/Comments					
Inspector Comments: FS_ID:41555 DS_ID:23928 EP_NO: N/A FS_HLM: 3.109 Repair Type: Non-Urgent Crossing Status: Found

Pipe on LS toe.
