**Flood Control Project Maintenance  
Levee Inspections**

**Fall 2015 Levee Maintenance Deficiency Summary Report**

**San Joaquin River Basin**

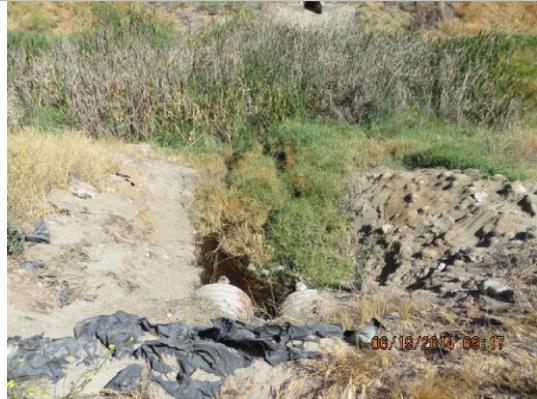
Photo 1 of 3 : UCIP\_FA\_2015\_6285.jpg

LM Start	<b>3.09</b>	Rating **	M	Issue No.	<b>141</b>
LM End	<b>3.09</b>	Issue Type +	En	Location *	WS
Category	Supplemental			GPS Latitude/Longitude	
				Start	End
Item	DWR UCIP Field Study			38.126943 °	38.126943 °
				-121.141916 °	-121.141916 °
DWR ID					
Action/Comments					
Inspector Comments: FS_ID:41554 DS_ID:23926 EP_NO: N/A FS_HLM: 3.11 Repair Type: Non-Urgent Crossing Status: Found UCIP Comments: Pipe open with no flapgate. FIELD_STRUCT_DESC: 2 of 2: 24-inch CM stormdrain pipe through the levee, 3.0-feet below the crown. O&M Manual Bear Creek Part 2, 1967. FS Date: 06/19/2014

Pipe visible on WS slope at grouted spillway.

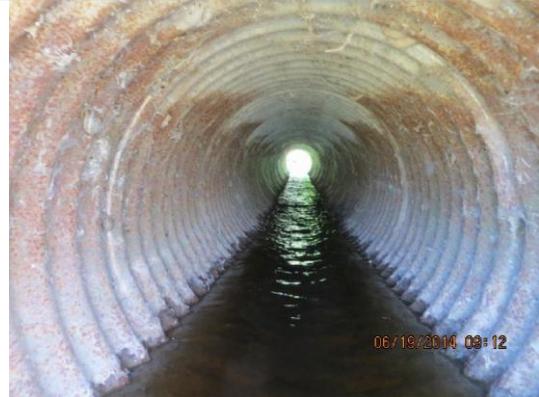
Photo 2 of 3 : UCIP\_FA\_2015\_6286.jpg

LM Start	3.09	Rating **	M	Issue No.	141 (cont)
LM End	3.09	Issue Type +	En	Location *	WS
Category	Supplemental			GPS Latitude/Longitude	
				Start	End
Item	DWR UCIP Field Study			38.126943 °	38.126943 °
				-121.141916 °	-121.141916 °
DWR ID					
Action/Comments					
Inspector Comments: FS_ID:41554 DS_ID:23926 EP_NO: N/A FS_HLM: 3.11 Repair Type: Non-Urgent Crossing Status: Found UCIP Comments: Pipe open with no flapgate. FIELD_STRUCT_DESC: 2 of 2: 24-inch CM stormdrain pipe through the levee, 3.0-feet below the crown. O&M Manual Bear Creek Part 2, 1967. FS Date: 06/19/2014

Inside pipe at WS slope.

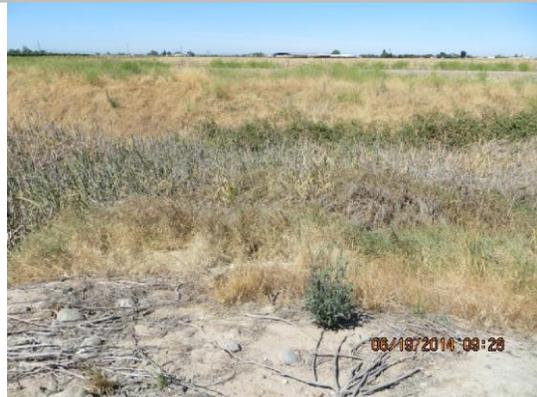
Photo 1 of 3 : UCIP\_FA\_2015\_6431.jpg

LM Start	<b>3.34</b>	Rating **	M	Issue No.	<b>142</b>
LM End	<b>3.34</b>	Issue Type +	En	Location *	WS
Category	Supplemental			GPS Latitude/Longitude	
				Start	End
Item	DWR UCIP Field Study			38.129363 °	38.129363 °
				-121.139007 °	-121.139007 °
DWR ID					
Action/Comments					
Inspector Comments: FS_ID:40219 DS_ID:23918 EP_NO: N/A FS_HLM: 3.354 Repair Type: Non-Urgent Crossing Status: Found

Concrete headwall at 24-inch CMP pipe on WS slope.

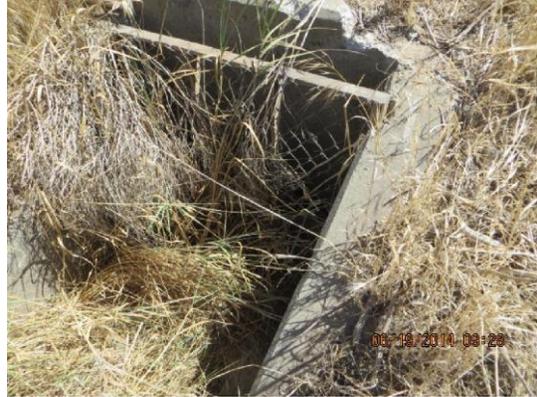
Photo 2 of 3 : UCIP\_FA\_2015\_6432.jpg

LM Start	3.34	Rating **	M	Issue No.	142 (cont)
LM End	3.34	Issue Type +	En	Location *	WS
Category	Supplemental			GPS Latitude/Longitude	
				Start	End
Item	DWR UCIP Field Study			38.129363 °	38.129363 °
				-121.139007 °	-121.139007 °
DWR ID					
<b>Action/Comments</b>					
Inspector Comments: FS_ID:40219 DS_ID:23918 EP_NO: N/A FS_HLM: 3.354 Repair Type: Non-Urgent Crossing Status: Found UCIP Comments: Pipe appears abandoned and should be done so properly as there is still a 24-inch CMP running from the WS slope to the demolished pump on a sump at WS. FIELD_STRUCT_DESC: 12-inch concrete siphon pipe through the levee, 3.0 feet below the crown. 24-inch CM pump sump unit with motor mounted on top on the waterward side has been removed. Remnants of 36-inch concrete standpipe found on LS shoulder around new well and . Concrete headwall adn 24-inch CMP pipe still remain on WS slope. O&M Manual Bear Creek Part 2, 1967. FS Date: 06/19/2014

Concrete headwall at 24-inch CMP pipe on WS slope.

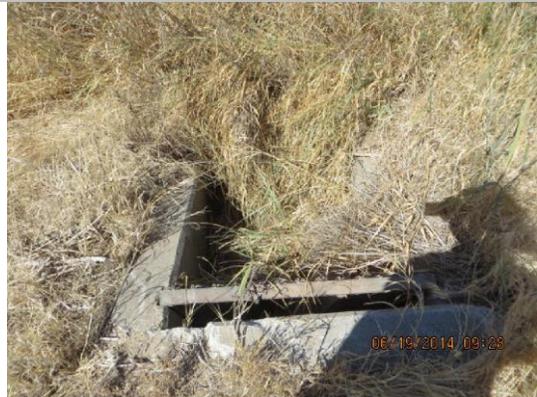
Photo 3 of 3 : UCIP\_FA\_2015\_6433.jpg

Concrete headwall at 24-inch CMP pipe on WS slope.

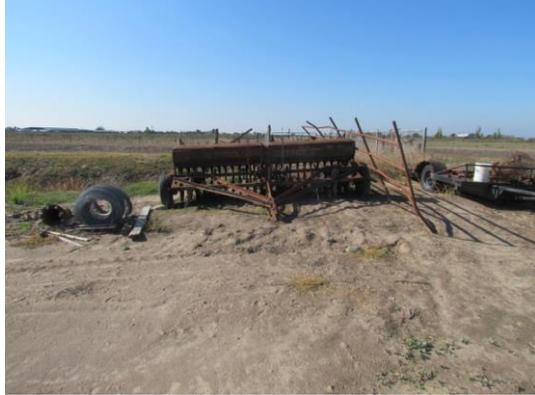
Photo 1 of 1 : FA\_2015\_NA0017\_156\_113\_20150911\_00028.jpg

LM Start	<b>3.38</b>	Rating **	M	Issue No.	<b>113</b>
LM End	<b>3.38</b>	Issue Type +	Ma	Location *	WS
Category	Earthen Levee		GPS Latitude/Longitude		
			Start	End	
Item	Encroachments		38.130018 °	38.130018 °	
			-121.139019 °	-121.139019 °	
DWR ID	DWR_NA0017_12_s_2012_113				
Action/Comments					
Equipment

View of farming equipment that was found on the waterside of the levee looking upstream.

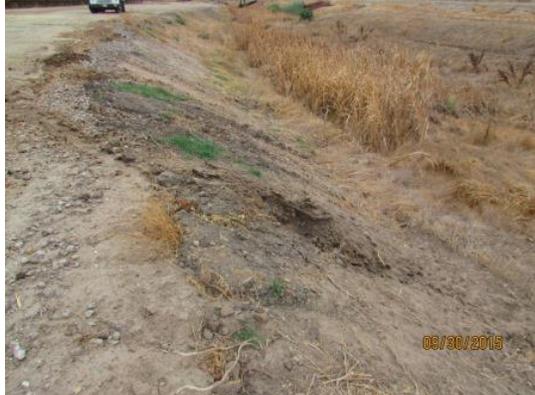
Photo 1 of 2 : FA\_2015\_NA0017\_156\_24\_20151005\_00030.jpg

Updated picture of the erosion on the waterside of the levee during fall 2015 inspection.

LM Start	<b>3.46</b>	Rating **	M	Issue No.	<b>24</b>
LM End	<b>3.46</b>	Issue Type +	Ma	Location *	WS
Category	Earthen Levee		GPS Latitude/Longitude		
			Start	End	
Item	Erosion / Bank Caving		38.131140 °	38.131140 °	
			-121.138541 °	-121.138541 °	
DWR ID	DWR_NA0017_12_f_2012_24				
Action/Comments					
Schedule repair of erosion site prior to the next inspection.

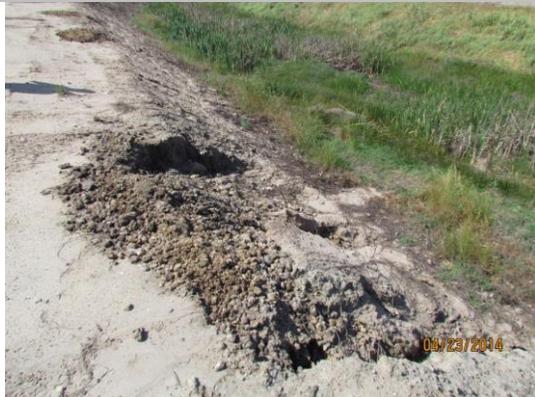
Photo 2 of 2 : FA\_2015\_NA0017\_156\_24\_20150911\_00020.jpg

View of the erosion on the waterside of the levee. The picture was taken during spring 2014 inspection looking downstream.

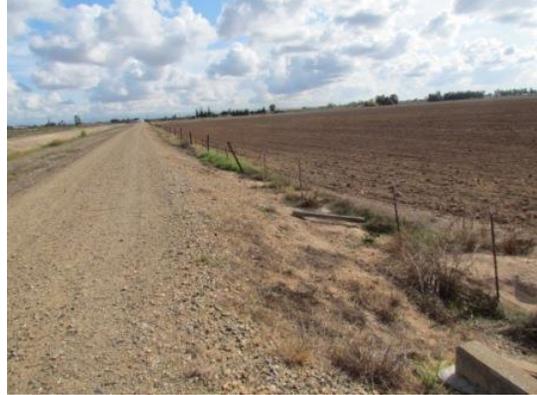
Photo 1 of 2 : FA\_2015\_NA0017\_157\_3\_20150911\_00002.jpg

LM Start	<b>0.02</b>	Rating **	M	Issue No.	<b>3</b>
LM End	<b>1.38</b>	Issue Type +	En	Location *	LS
Category	Earthen Levee		GPS Latitude/Longitude		
			Start	End	
Item	Encroachments		38.109383 °	38.110833 °	
			-121.160137 °	-121.138757 °	
DWR ID	DWR_NA0017_13_s_2012_3				
Action/Comments					
Fence

View of a fence located on the landside of the levee looking upstream.

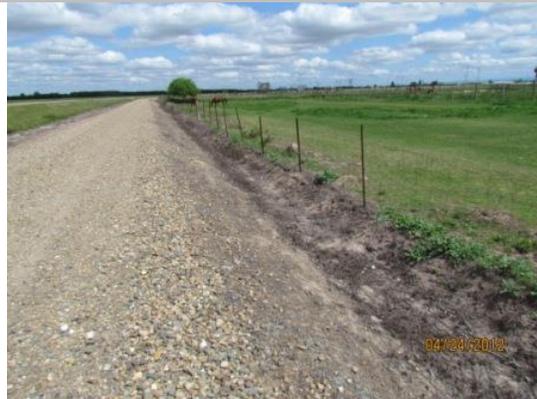
Photo 2 of 2 : FA\_2015\_NA0017\_157\_3\_20150911\_00003.jpg

View of a fence that was found on the landside of the levee looking upstream.

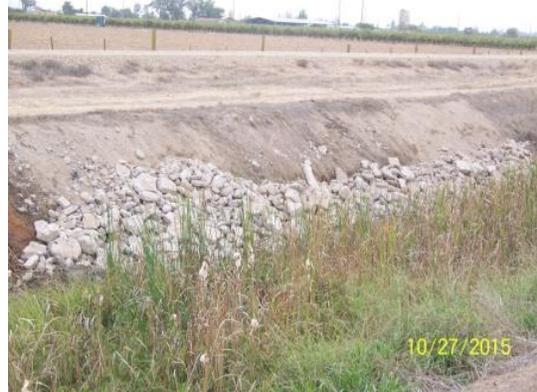
Photo 1 of 2 : FA\_2015\_NA0017\_157\_5\_20151116\_00008.jpg

LM Start	<b>0.11</b>	Rating **	A	Issue No.	<b>5</b>
LM End	<b>0.11</b>	Issue Type +	Ma	Location *	WS
Category	Earthen Levee		GPS Latitude/Longitude		
			Start	End	
Item	Animal Control		38.109687 °	38.109687 °	
			-121.158481 °	-121.158481 °	
DWR ID	DWR_NA0017_13_s_2015_5				
Action/Comments					
Exterminate rodents and backfill and compact or grout burrows. Inspector Comments: LMA has repaired the possible beaver den.

LMA repaired the possible beaver den on the waterside toe of the levee during fall 2015.

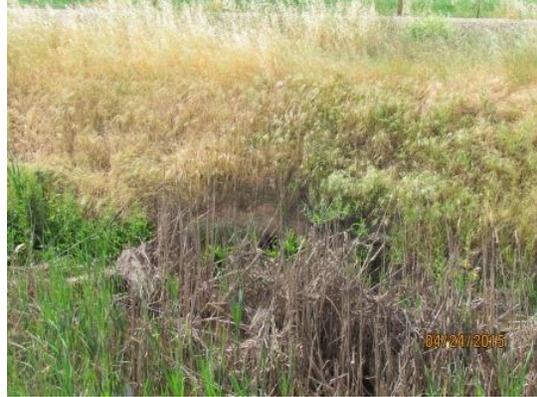
Photo 2 of 2 : FA\_2015\_NA0017\_157\_5\_20150911\_00004.jpg

LM Start	<b>0.11</b>	Rating **	A	Issue No.	<b>5 (cont)</b>
LM End	<b>0.11</b>	Issue Type +	Ma	Location *	WS
Category	Earthen Levee		GPS Latitude/Longitude		
			Start	End	
Item	Animal Control		38.109687 °	38.109687 °	
			-121.158481 °	-121.158481 °	
DWR ID	DWR_NA0017_13_s_2015_5				
Action/Comments					
Exterminate rodents and backfill and compact or grout burrows. Inspector Comments: LMA has repaired the possible beaver den.

View of a beaver den on the waterside toe of the levee. The picture was taken across the levee.

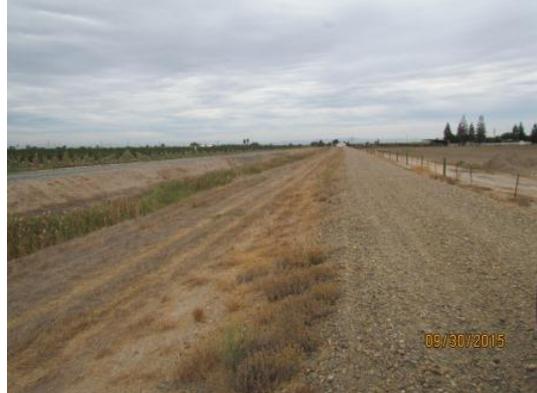
Photo 1 of 1 : FA\_2015\_NA0017\_157\_6\_20151005\_00007.jpg

LM Start	<b>0.17</b>	Rating **	A	Issue No.	<b>6</b>
LM End	<b>0.17</b>	Issue Type +	Ma	Location *	WS
Category	Earthen Levee		GPS Latitude/Longitude		
			Start	End	
Item	Vegetation		38.109467 °	38.109467 °	
			-121.157463 °	-121.157463 °	
DWR ID	DWR_NA0017_13_f_2015_6				
Action/Comments					
Control annual grass and weeds on the levee slopes and easements. Inspector Comments: Acceptable vegetation.

View of acceptable vegetation on the waterside of the levee looking upstream.

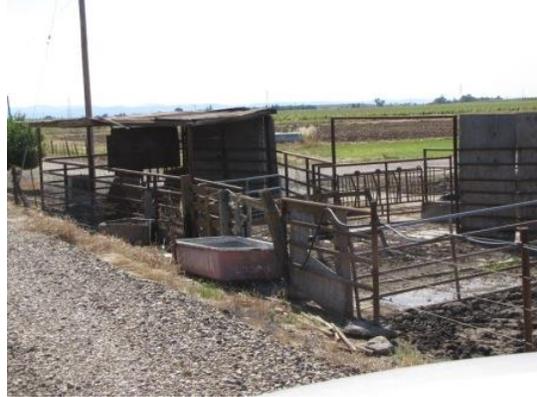
Photo 1 of 1 : FA\_2015\_NA0017\_157\_2\_20150911\_00001.jpg

LM Start	<b>0.38</b>	Rating **	M	Issue No.	<b>2</b>
LM End	<b>0.38</b>	Issue Type +	En	Location *	LS
Category	Earthen Levee		GPS Latitude/Longitude		
			Start	End	
Item	Encroachments		38.109580 °	38.109580 °	
			-121.153445 °	-121.153445 °	
DWR ID	DWR_NA0017_13_s_2012_2				
Action/Comments					
Tank

View of a tub/tank on the landward slope blocking access and visibility looking upstream.

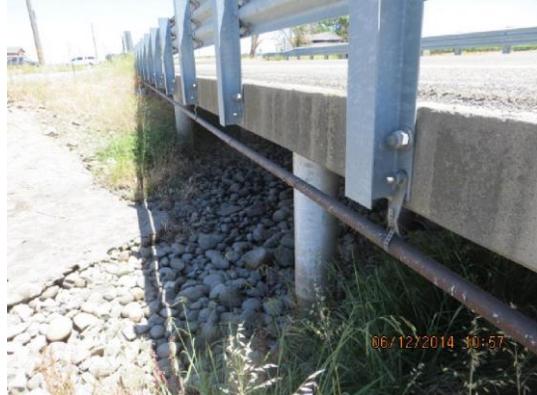
Photo 1 of 1 : UCIP\_FA\_2015\_6167.jpg

LM Start	<b>0.56</b>	Rating **	M	Issue No.	<b>9</b>
LM End	<b>0.56</b>	Issue Type +	En	Location *	LS
Category	Supplemental		GPS Latitude/Longitude		
			Start	End	
Item	DWR UCIP Field Study		38.110953 °	38.110953 °	
			-121.150945 °	-121.150945 °	
DWR ID					
Action/Comments					
Inspector Comments: FS_ID:41958 DS_ID:25003 EP_NO: N/A FS_HLM: 0.559 Repair Type: Non-Urgent Crossing Status: Found UCIP Comments: No permit identified for this crossing. FIELD_STRUCT_DESC: 2.5-inch steel communication line through the levee at an unknown depth below the crown. Pipe visible on downstream side of the bridge. FS Date: 06/12/2014

Pipe visible on downstream side of the bridge.

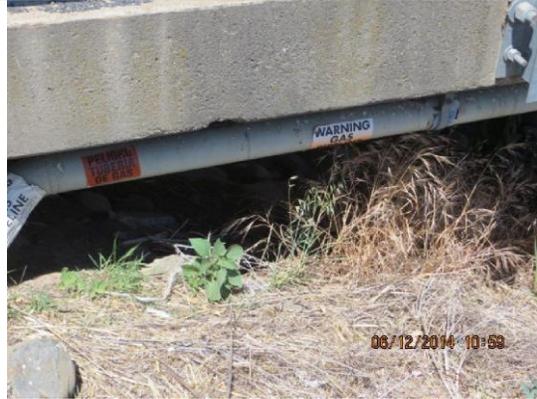
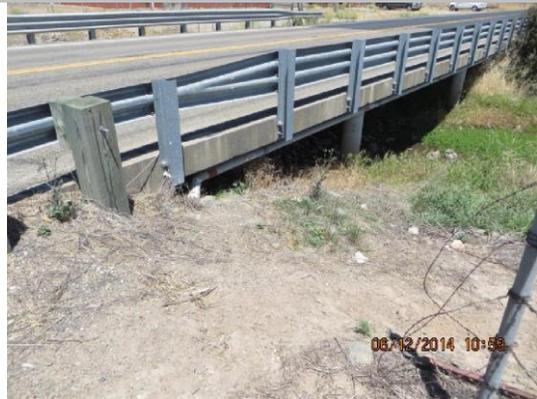
Photo 1 of 2 : UCIP\_FA\_2015\_6168.jpg

LM Start	<b>0.57</b>	Rating **	U	Issue No.	<b>10</b>
LM End	<b>0.57</b>	Issue Type +	En	Location *	LS
Category	Supplemental			GPS Latitude/Longitude	
				Start	End
Item	DWR UCIP Field Study			38.111098 °	38.111098 °
				-121.150802 °	-121.150802 °
DWR ID					
Action/Comments					
Inspector Comments: FS_ID:39444 DS_ID:25004 EP_NO: N/A FS_HLM: 0.57 Repair Type: Urgent Crossing Status: Found UCIP Comments: Gasline markers are needed on both levees. No permit identified for crossing. FIELD_STRUCT_DESC: 4-inch gas line through the levee at an unknown depth below the crown. Pipe attached to the upstream side of the bridge. FS Date: 06/12/2014

Gasline visible under bridge on upstream side.

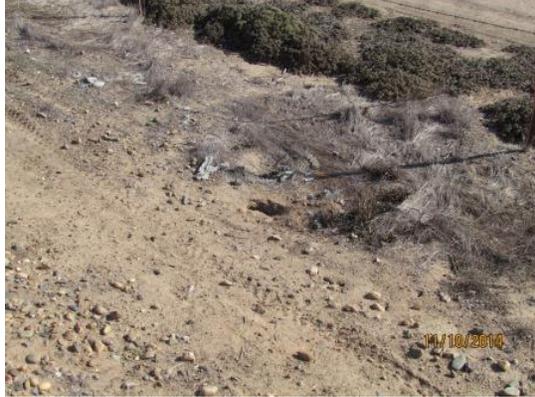
Photo 1 of 1 : FA\_2015\_NA0017\_157\_8\_20150911\_00006.jpg

LM Start	<b>1.02</b>	Rating **	M	Issue No.	<b>8</b>
LM End	<b>1.02</b>	Issue Type +	Ma	Location *	LS
Category	Earthen Levee		GPS Latitude/Longitude		
			Start	End	
Item	Animal Control		38.110906 °	38.110906 °	
			-121.144116 °	-121.144116 °	
DWR ID	DWR_NA0017_13_f_2014_8				
Action/Comments					
No rodents visible, but rodent burrows visible; need to backfill and compact or grout burrows.

View of an animal hole that was found on the landside of the levee looking upstream.

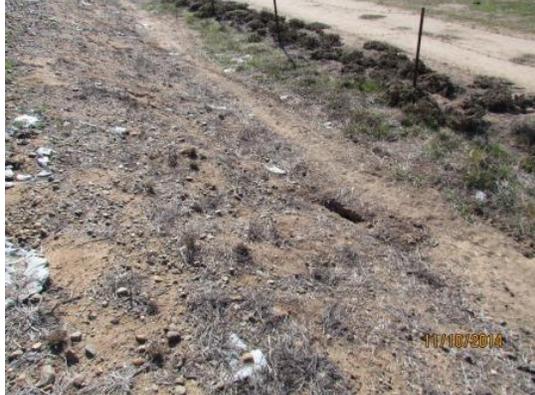
Photo 1 of 1 : FA\_2015\_NA0017\_157\_7\_20150911\_00005.jpg

LM Start	<b>1.21</b>	Rating **	M	Issue No.	<b>7</b>
LM End	<b>1.21</b>	Issue Type +	Ma	Location *	LS
Category	Earthen Levee		GPS Latitude/Longitude		
			Start	End	
Item	Animal Control		38.111513 °	38.111513 °	
			-121.141216 °	-121.141216 °	
DWR ID	DWR_NA0017_13_f_2014_7				
Action/Comments					
No rodents visible, but rodent burrows visible; need to backfill and compact or grout burrows.

View of an animal hole that was found on the landside toe of the levee looking upstream.

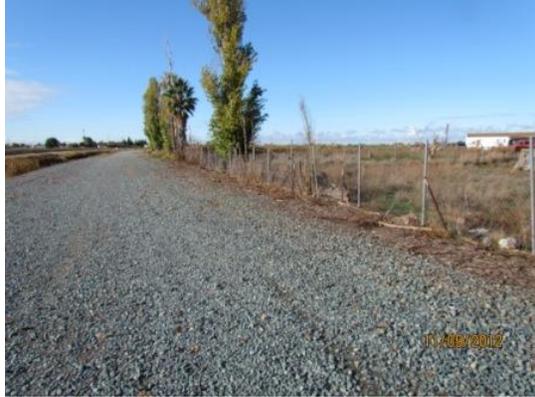
Photo 1 of 1 : FA\_2015\_NA0017\_158\_6\_20150911\_00007.jpg

LM Start	<b>0.02</b>	Rating **	M	Issue No.	<b>6</b>
LM End	<b>0.54</b>	Issue Type +	En	Location *	LS
Category	Earthen Levee		GPS Latitude/Longitude		
			Start	End	
Item	Encroachments		38.109670 °	38.111263 °	
			-121.159889 °	-121.151091 °	
DWR ID	DWR_NA0017_14_s_2012_6				
Action/Comments					
Fence

View of a fence that was found on the landside of the levee looking downstream.

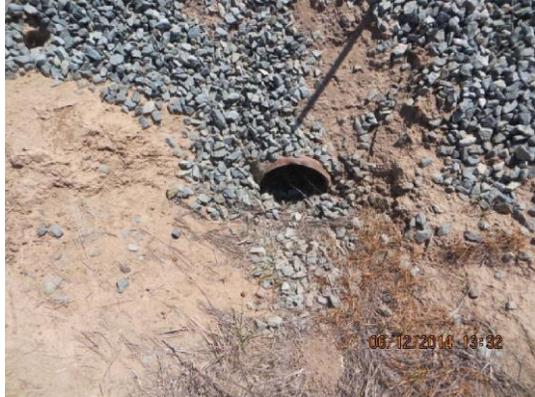
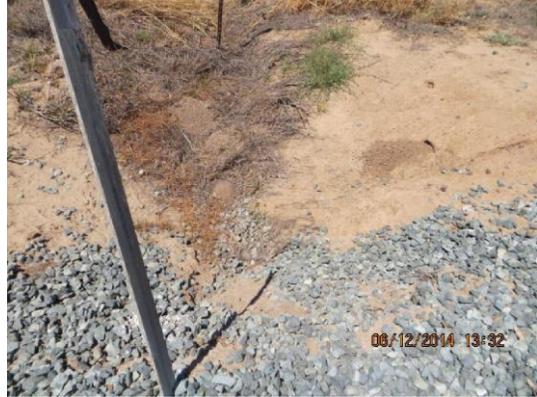
Photo 1 of 3 : UCIP\_FA\_2015\_6740.jpg

LM Start	<b>0.25</b>	Rating **	M	Issue No.	<b>15</b>
LM End	<b>0.25</b>	Issue Type +	En	Location *	LS
Category	Supplemental		GPS Latitude/Longitude		
			Start	End	
Item	DWR UCIP Field Study		38.109799 °	38.109799 °	
			-121.155621 °	-121.155621 °	
DWR ID					
Action/Comments					
Inspector Comments: FS_ID:38615 DS_ID:23940 EP_NO: N/A FS_HLM: 0.256 Repair Type: Non-Urgent Crossing Status: Found UCIP Comments: Debris partially blocking closure of flapgate. FIELD_STRUCT_DESC: 12-inch CM stormdrain pipe through the levee, 3.0-feet below the crown. Flap gate on the waterward end. Cobble grouted spillway. O&M Manual Bear Creek Part 2, 1967. FS Date: 06/12/2014

Pipe at inlet on LS shoulder.

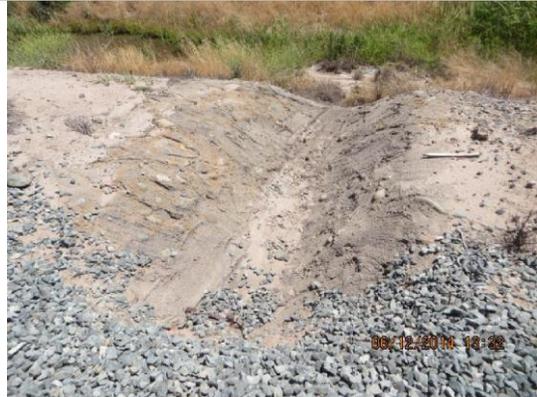
Photo 3 of 3 : UCIP\_FA\_2015\_6742.jpg

Pipe, flapgate, and grouted spillway on WS slope.

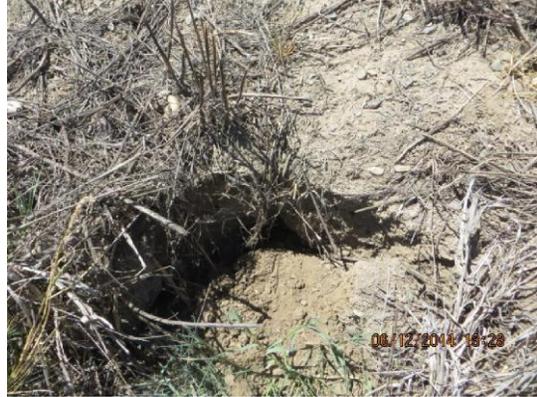
Photo 1 of 3 : UCIP\_FA\_2015\_6737.jpg

LM Start	<b>0.37</b>	Rating **	M	Issue No.	<b>16</b>
LM End	<b>0.37</b>	Issue Type +	En	Location *	LS
Category	Supplemental			GPS Latitude/Longitude	
				Start	End
Item	DWR UCIP Field Study			38.109855 °	38.109855 °
				-121.153390 °	-121.153390 °
DWR ID					
Action/Comments					
Inspector Comments: FS_ID:38614 DS_ID:23941 EP_NO: N/A FS_HLM: 0.38 Repair Type: Non-Urgent Crossing Status: Found

Pipe buried on WS slope.

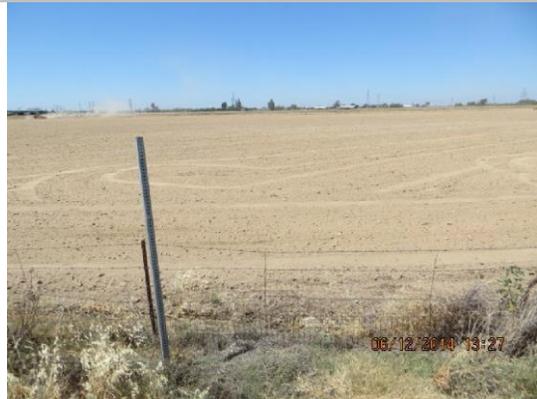
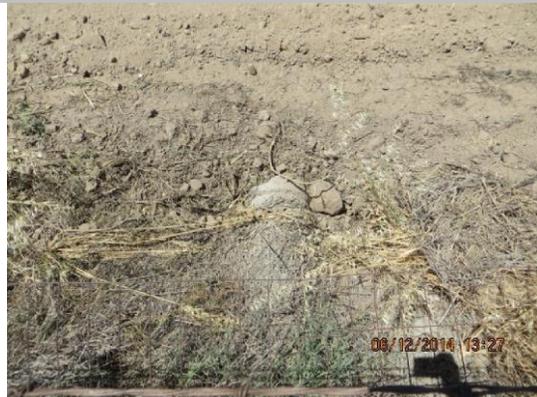
Photo 2 of 3 : UCIP\_FA\_2015\_6738.jpg

Pipe just visible on LS shoulder.

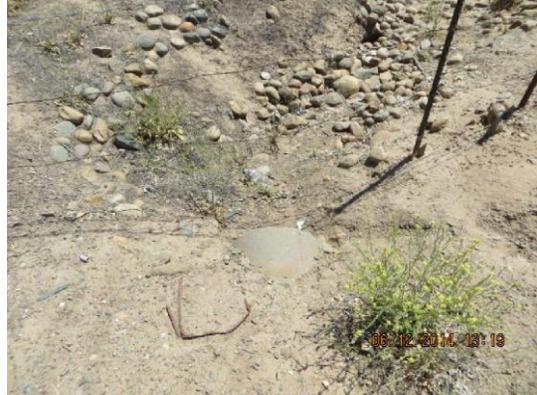
Photo 1 of 2 : UCIP\_FA\_2015\_6735.jpg

LM Start	<b>0.55</b>	Rating **	U	Issue No.	<b>17</b>
LM End	<b>0.55</b>	Issue Type +	En	Location *	WS
Category	Supplemental			GPS Latitude/Longitude	
				Start	End
Item	DWR UCIP Field Study			38.111372 °	38.111372 °
				-121.150985 °	-121.150985 °
DWR ID					
Action/Comments					
Inspector Comments: FS_ID:41243 DS_ID:23943 EP_NO: N/A FS_HLM: 0.555 Repair Type: Urgent Crossing Status: Found UCIP Comments: Pipe inlet and outlet partially blocked by sediment. No flaggate FIELD_STRUCT_DESC: 18-inch CM stormdrain pipe through the levee, 2.5-feet below the crown. Open on both ends. Cobble grouted spillway. O&M Manual Bear Creek Part 2, 1967. FS Date: 06/12/2014

Pipe on WS shoulder.

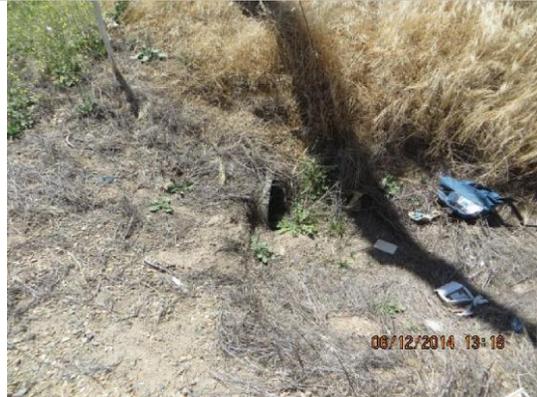
Photo 2 of 2 : UCIP\_FA\_2015\_6736.jpg

Pipe on LS toe.

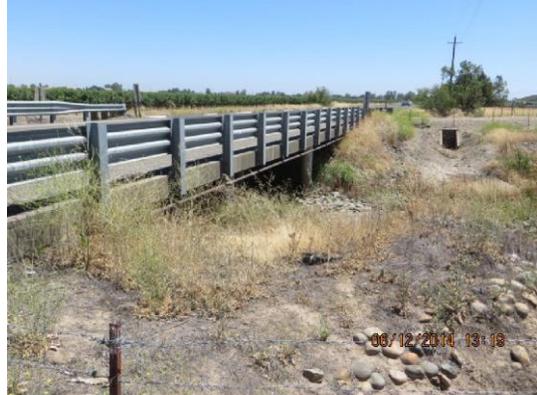
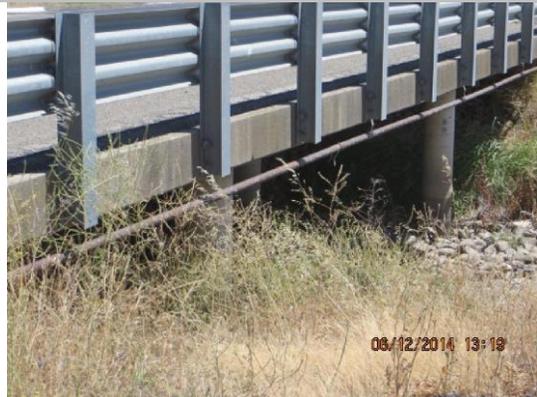
Photo 1 of 2 : UCIP\_FA\_2015\_6170.jpg

LM Start	<b>0.55</b>	Rating **	M	Issue No.	<b>18</b>
LM End	<b>0.55</b>	Issue Type +	En	Location *	WS
Category	Supplemental			GPS Latitude/Longitude	
				Start	End
Item	DWR UCIP Field Study			38.111395 °	38.111395 °
				-121.150949 °	-121.150949 °
DWR ID					
Action/Comments					
Inspector Comments: FS_ID:41959 DS_ID:25006 EP_NO: N/A FS_HLM: 0.558 Repair Type: Non-Urgent Crossing Status: Found

Conduit visible on downstream side of bridge.

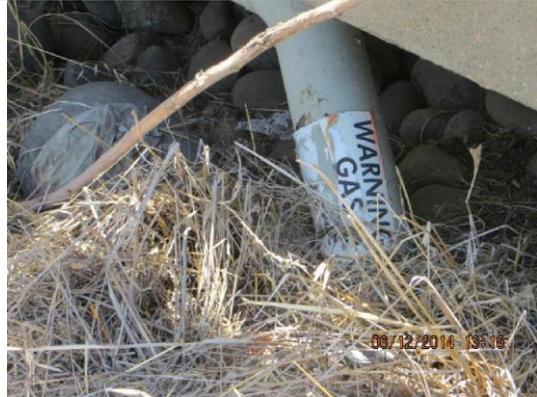
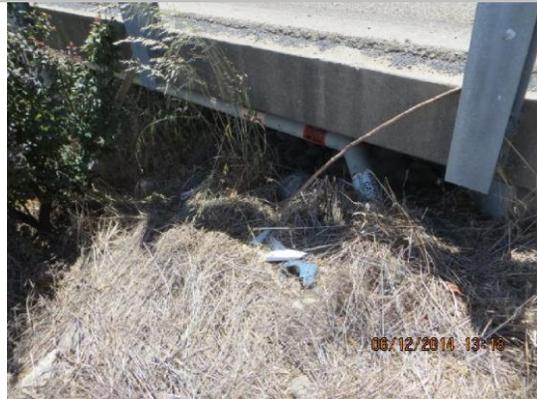
Photo 1 of 2 : UCIP\_FA\_2015\_6172.jpg

LM Start	<b>0.56</b>	Rating **	U	Issue No.	<b>19</b>
LM End	<b>0.56</b>	Issue Type +	En	Location *	WS
Category	Supplemental			GPS Latitude/Longitude	
				Start	End
Item	DWR UCIP Field Study			38.111485 °	38.111485 °
				-121.150806 °	-121.150806 °
DWR ID					
Action/Comments					
Inspector Comments: FS_ID:39447 DS_ID:25005 EP_NO: N/A FS_HLM: 0.567 Repair Type: Urgent Crossing Status: Found

Gasline visible on upstream side of the bridge.

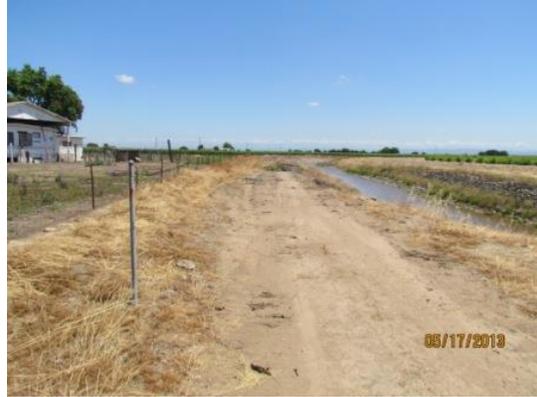
Photo 1 of 1 : FA\_2015\_NA0017\_158\_7\_20150911\_00008.jpg

LM Start	<b>0.56</b>	Rating **	M	Issue No.	<b>7</b>
LM End	<b>0.56</b>	Issue Type +	Ma	Location *	CR
Category	Earthen Levee		GPS Latitude/Longitude		
			Start	End	
Item	Crown Surface / Depressions / Rutting		38.111490 °	38.111490 °	
			-121.150762 °	-121.150762 °	
DWR ID	DWR_NA0017_14_s_2013_7				
Action/Comments					
Repair depressions or ruts in the crown or slope.

View of a crown depression that was found looking upstream.

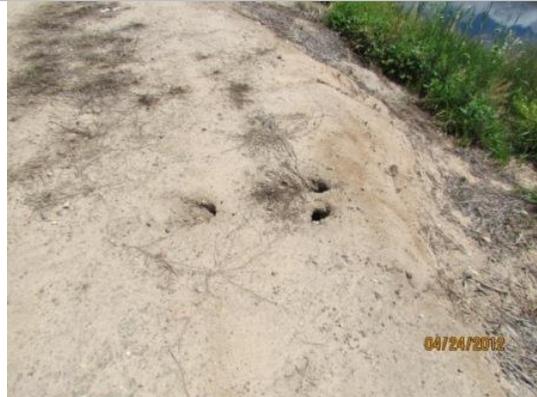
LM Start	<b>0.60</b>	Rating **	M	Issue No.	<b>5</b>
LM End	<b>0.60</b>	Issue Type +	Ma	Location *	WS
Category	Earthen Levee		GPS Latitude/Longitude		
			Start	End	
Item	Animal Control		38.111770 °	38.111770 °	
			-121.150112 °	-121.150112 °	
DWR ID	DWR_NA0017_14_s_2012_5				
Action/Comments					
No rodents visible, but rodent burrows visible; need to backfill and compact or grout burrows.

View of animal holes that were found on the waterside of the levee looking upstream.

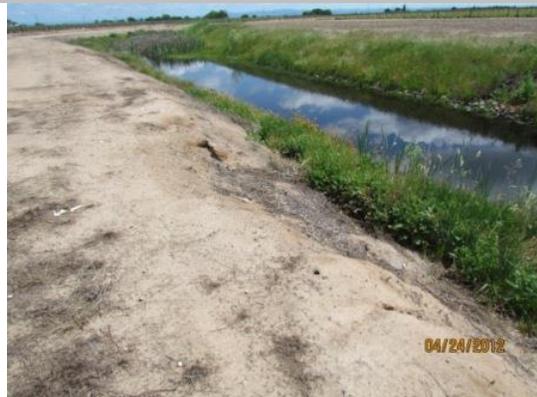
Photo 1 of 2 : FA\_2015\_NA0017\_158\_4\_20150911\_00004.jpg

LM Start	<b>0.60</b>	Rating **	M	Issue No.	<b>4</b>
LM End	<b>0.60</b>	Issue Type +	Ma	Location *	WS
Category	Earthen Levee		GPS Latitude/Longitude		
			Start	End	
Item	Erosion / Bank Caving		38.111774 °	38.111774 °	
			-121.150073 °	-121.150073 °	
DWR ID	DWR_NA0017_14_s_2012_4				
Action/Comments					
Note and monitor erosion site.

View of erosion that was found on the waterside of the levee looking upstream. This picture was taken during spring 2012 inspection.

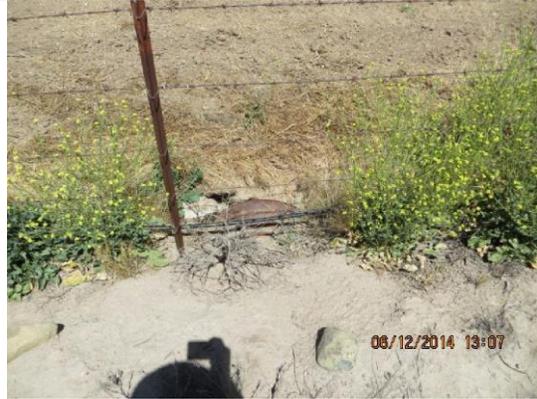
Photo 1 of 3 : UCIP\_FA\_2015\_6732.jpg

LM Start	<b>0.75</b>	Rating **	M	Issue No.	<b>20</b>
LM End	<b>0.75</b>	Issue Type +	En	Location *	WS
Category	Supplemental			GPS Latitude/Longitude	
				Start	End
Item	DWR UCIP Field Study			38.111475 °	38.111475 °
				-121.148081 °	-121.148081 °
DWR ID					
Action/Comments					
Inspector Comments: FS_ID:41365 DS_ID:23945 EP_NO: N/A FS_HLM: 0.762 Repair Type: Non-Urgent Crossing Status: Found UCIP Comments: Pipe open on both ends. Levee appears abandoned. FIELD_STRUCT_DESC: 24-inch CM stormdrain pipe through the levee, 1-foot below the crown. Cobble grouted spillway. Cobble grouted intake on the landward side. Open on both ends. O&M Manual Bear Creek Part 2, 1967. FS Date: 06/12/2014

Pipe on LS shoulder.

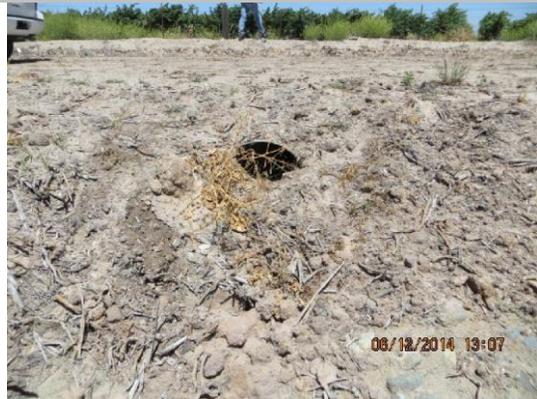
Photo 2 of 3 : UCIP\_FA\_2015\_6733.jpg

Pipe on WS slope.

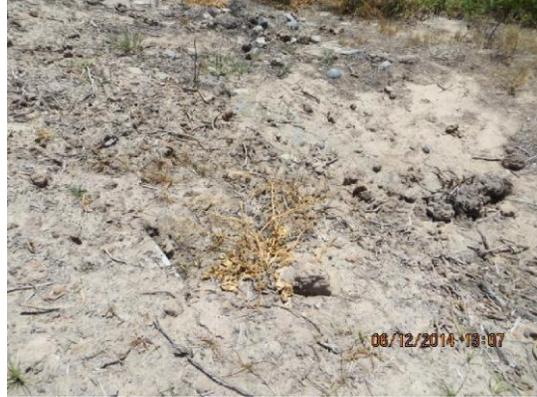
Photo 3 of 3 : UCIP\_FA\_2015\_6734.jpg

LM Start	<b>0.75</b>	Rating **	M	Issue No.	<b>20 (cont)</b>
LM End	<b>0.75</b>	Issue Type +	En	Location *	WS
Category	Supplemental			GPS Latitude/Longitude	
				Start	End
Item	DWR UCIP Field Study			38.111475 °	38.111475 °
				-121.148081 °	-121.148081 °
DWR ID					
Action/Comments					
Inspector Comments: FS_ID:41365 DS_ID:23945 EP_NO: N/A FS_HLM: 0.762 Repair Type: Non-Urgent Crossing Status: Found

Pipe on WS slope.

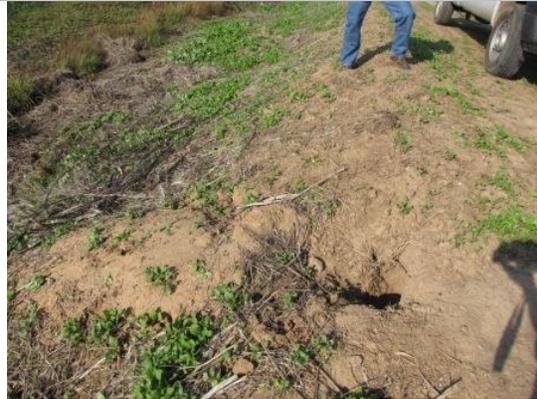
Photo 1 of 1 : FA\_2015\_NA0017\_158\_2\_20150911\_00002.jpg

LM Start	<b>0.81</b>	Rating **	M	Issue No.	<b>2</b>
LM End	<b>0.81</b>	Issue Type +	Ma	Location *	WS
Category	Earthen Levee			GPS Latitude/Longitude	
				Start	End
Item	Animal Control			38.110628 °	38.110628 °
				-121.147429 °	-121.147429 °
DWR ID	DWR_NA0017_14_s_2012_2				
Action/Comments					
Exterminate rodents and backfill and compact or grout burrows.

View of a large diameter rodent hole in the waterward berm looking downstream.

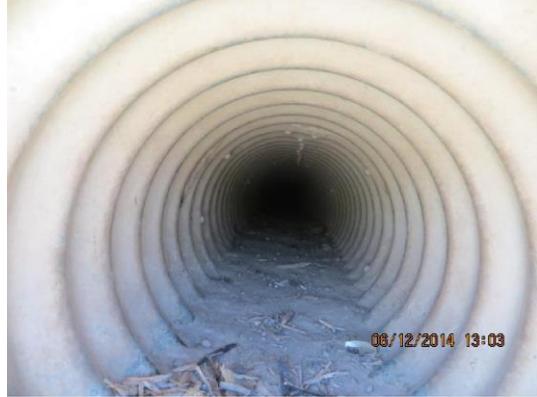
Photo 1 of 3 : UCIP\_FA\_2015\_6729.jpg

LM Start	<b>0.94</b>	Rating **	M	Issue No.	<b>21</b>
LM End	<b>0.94</b>	Issue Type +	En	Location *	WS
Category	Supplemental			GPS Latitude/Longitude	
				Start	End
Item	DWR UCIP Field Study			38.110801 °	38.110801 °
				-121.145174 °	-121.145174 °
DWR ID					
<b>Action/Comments</b>					
Inspector Comments: FS_ID:41791 DS_ID:23946 EP_NO: N/A FS_HLM: 0.957 Repair Type: Non-Urgent Crossing Status: Found UCIP Comments: Pipe burried on LS. Levee appears abandoned. FIELD_STRUCT_DESC: 12-inch CM stormdrain pipe through the levee, 2.0-feet below the crown. Open on both ends. Cobble grouted spillway. O&M Manual Bear Creek Part 2, 1967. FS Date: 06/12/2014

Inside pipe at WS slope.

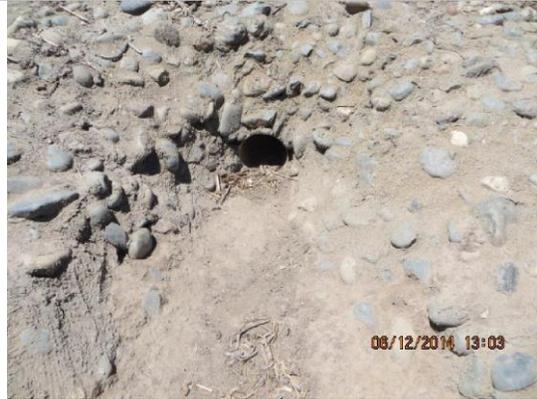
Photo 2 of 3 : UCIP\_FA\_2015\_6730.jpg

Pipe and grouted spillway on WS slope.

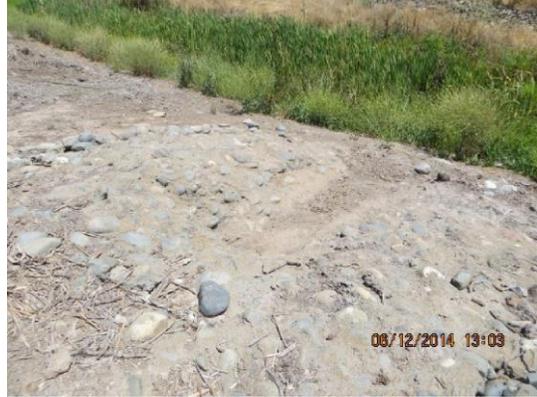
Photo 3 of 3 : UCIP\_FA\_2015\_6731.jpg

LM Start	<b>0.94</b>	Rating **	M	Issue No.	<b>21 (cont)</b>
LM End	<b>0.94</b>	Issue Type +	En	Location *	WS
Category	Supplemental			GPS Latitude/Longitude	
				Start	End
Item	DWR UCIP Field Study			38.110801 °	38.110801 °
				-121.145174 °	-121.145174 °
DWR ID					
Action/Comments					
Inspector Comments: FS_ID:41791 DS_ID:23946 EP_NO: N/A FS_HLM: 0.957 Repair Type: Non-Urgent Crossing Status: Found

Pipe and grouted spillway on WS slope.

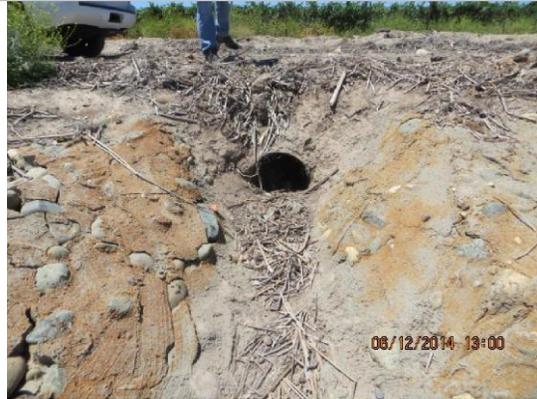
Photo 1 of 2 : UCIP\_FA\_2015\_6727.jpg

LM Start	<b>0.96</b>	Rating **	M	Issue No.	<b>22</b>
LM End	<b>0.96</b>	Issue Type +	En	Location *	WS
Category	Supplemental			GPS Latitude/Longitude	
				Start	End
Item	DWR UCIP Field Study			38.110926 °	38.110926 °
				-121.144799 °	-121.144799 °
DWR ID					
Action/Comments					
Inspector Comments: FS_ID:41792 DS_ID:23947 EP_NO: N/A FS_HLM: 0.98 Repair Type: Non-Urgent Crossing Status: Found UCIP Comments: Pipe buried on LS shoulder and open on WS. Levee appears abandoned. FIELD_STRUCT_DESC: 18-inch CM stormdrain pipe through the levee, 3.0-feet below the crown. Open on both ends. Cobble grouted spillway. Cobble grouted intake on landward side. O&M Manual Bear Creek Part 2, 1967. FS Date: 06/12/2014

Pipe and grouted spillway on WS slope.

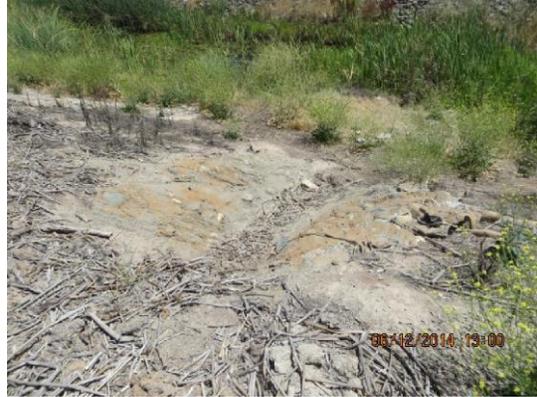
Photo 2 of 2 : UCIP\_FA\_2015\_6728.jpg

LM Start	0.96	Rating **	M	Issue No.	22 (cont)
LM End	0.96	Issue Type +	En	Location *	WS
Category	Supplemental			GPS Latitude/Longitude	
				Start	End
Item	DWR UCIP Field Study			38.110926 °	38.110926 °
DWR ID				-121.144799 °	-121.144799 °
Action/Comments					
Inspector Comments: FS_ID:41792 DS_ID:23947 EP_NO: N/A FS_HLM: 0.98 Repair Type: Non-Urgent Crossing Status: Found UCIP Comments: Pipe burried on LS shoulder and open on WS. Levee appears abandoned. FIELD_STRUCT_DESC: 18-inch CM stormdrain pipe through the levee, 3.0-feet below the crown. Open on both ends. Cobble grouted spillway. Cobble grouted intake on landward side. O&M Manual Bear Creek Part 2, 1967. FS Date: 06/12/2014

Pipe and grouted spillway on WS slope.

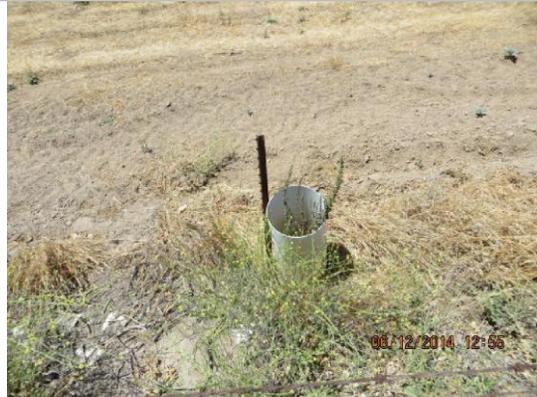
Photo 1 of 3 : UCIP\_FA\_2015\_6724.jpg

LM Start	1.04	Rating **	M	Issue No.	23
LM End	1.04	Issue Type +	En	Location *	WS
Category	Supplemental			GPS Latitude/Longitude	
				Start	End
Item	DWR UCIP Field Study			38.111557 °	38.111557 °
DWR ID				-121.143532 °	-121.143532 °
Action/Comments					
Inspector Comments: FS_ID:42011 DS_ID:23948 EP_NO: N/A FS_HLM: 1.063 Repair Type: Non-Urgent Crossing Status: Found UCIP Comments: Outlet burried in soil. Levee appears abandoned. FIELD_STRUCT_DESC: 12-inch CM pipe through the levee, 2.5 feet below the crown. Cobble grouted spillway. Open on both ends. O&M Manual Bear Creek Part 2, 1967. FS Date: 06/12/2014

Small PVC standpipe where pipe end should be on LS.

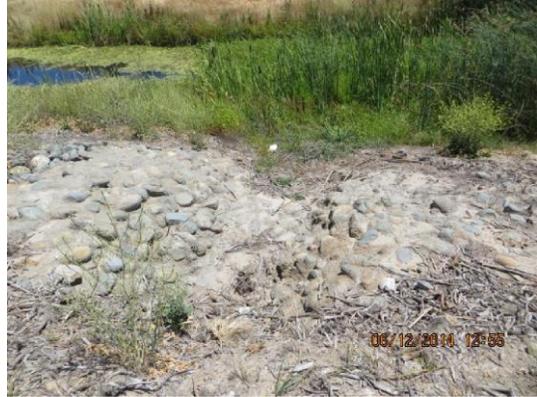
Photo 2 of 3 : UCIP\_FA\_2015\_6725.jpg

LM Start	1.04	Rating **	M	Issue No.	23 (cont)
LM End	1.04	Issue Type +	En	Location *	WS
Category	Supplemental			GPS Latitude/Longitude	
				Start	End
Item	DWR UCIP Field Study			38.111557 °	38.111557 °
				-121.143532 °	-121.143532 °
DWR ID					
Action/Comments					
Inspector Comments: FS_ID:42011 DS_ID:23948 EP_NO: N/A FS_HLM: 1.063 Repair Type: Non-Urgent Crossing Status: Found UCIP Comments: Outlet buried in soil. Levee appears abandoned. FIELD_STRUCT_DESC: 12-inch CM pipe through the levee, 2.5 feet below the crown. Cobble grouted spillway. Open on both ends. O&M Manual Bear Creek Part 2, 1967. FS Date: 06/12/2014

Grouted spillway at pipe location. Pipe covered in debris.

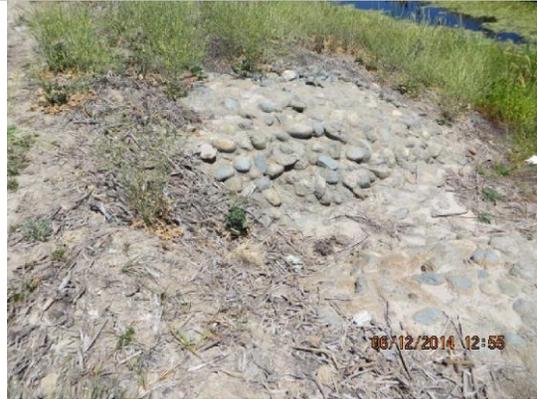
Photo 3 of 3 : UCIP\_FA\_2015\_6726.jpg

Grouted spillway at pipe location. Pipe covered in debris.

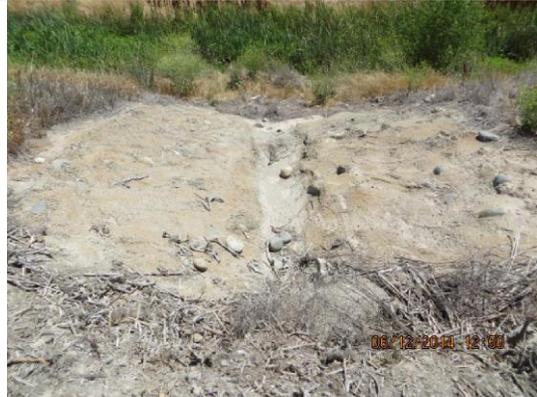
Photo 1 of 3 : UCIP\_FA\_2015\_6588.jpg

LM Start	<b>1.11</b>	Rating **	M	Issue No.	<b>24</b>
LM End	<b>1.11</b>	Issue Type +	En	Location *	WS
Category	Supplemental			GPS Latitude/Longitude	
				Start	End
Item	DWR UCIP Field Study			38.112125 °	38.112125 °
				-121.142568 °	-121.142568 °
DWR ID					
Action/Comments					
Inspector Comments: FS_ID:41793 DS_ID:23949 EP_NO: N/A FS_HLM: 1.129 Repair Type: Non-Urgent Crossing Status: Found

Pipe, flapgate, and grouted spillway on WS slope.

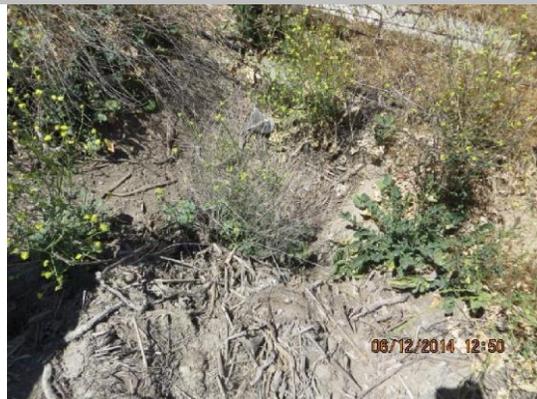
Photo 2 of 3 : UCIP\_FA\_2015\_6589.jpg

LS of levee at pipe. Pipe largely filled in with soil.

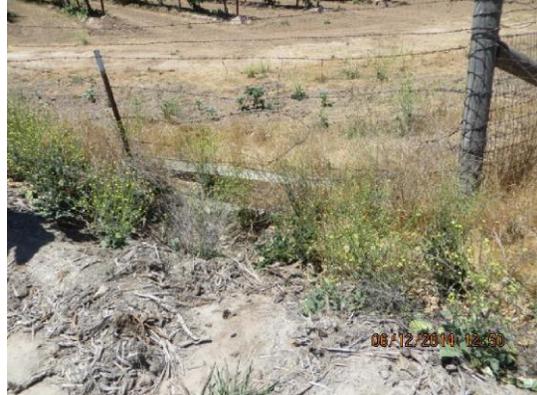
Photo 3 of 3 : UCIP\_FA\_2015\_6590.jpg

LM Start	<b>1.11</b>	Rating **	M	Issue No.	<b>24 (cont)</b>
LM End	<b>1.11</b>	Issue Type +	En	Location *	WS
Category	Supplemental			GPS Latitude/Longitude	
				Start	End
Item	DWR UCIP Field Study			38.112125 °	38.112125 °
				-121.142568 °	-121.142568 °
DWR ID					
Action/Comments					
Inspector Comments: FS_ID:41793 DS_ID:23949 EP_NO: N/A FS_HLM: 1.129 Repair Type: Non-Urgent Crossing Status: Found

LS of levee at pipe. Pipe largely filled in with soil.

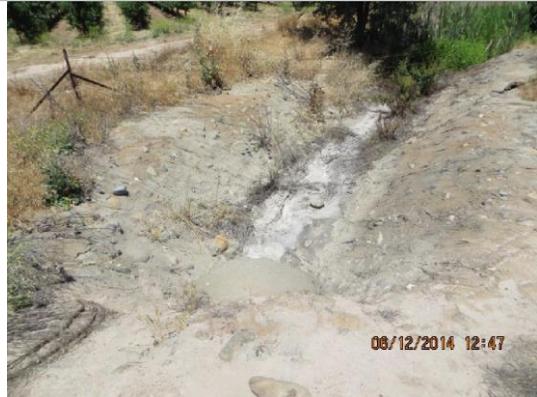
Photo 1 of 3 : UCIP\_FA\_2015\_6585.jpg

LM Start	<b>1.16</b>	Rating **	M	Issue No.	<b>25</b>
LM End	<b>1.16</b>	Issue Type +	En	Location *	WS
Category	Supplemental			GPS Latitude/Longitude	
				Start	End
Item	DWR UCIP Field Study			38.112296 °	38.112296 °
				-121.141654 °	-121.141654 °
DWR ID					
Action/Comments					
Inspector Comments: FS_ID:41794 DS_ID:23950 EP_NO: N/A FS_HLM: 1.182 Repair Type: Non-Urgent Crossing Status: Found UCIP Comments: Pipe open on both ends. Levee appears abandoned. FIELD_STRUCT_DESC: 48-inch concrete pipe through the levee, 5.5 feet below the crown. Cobble grouted spillway. Cobble grouted intake on the landward side. Open on both ends. O&M Manual Bear Creek Part 2, 1967. FS Date: 06/12/2014

Pipe at LS intake.

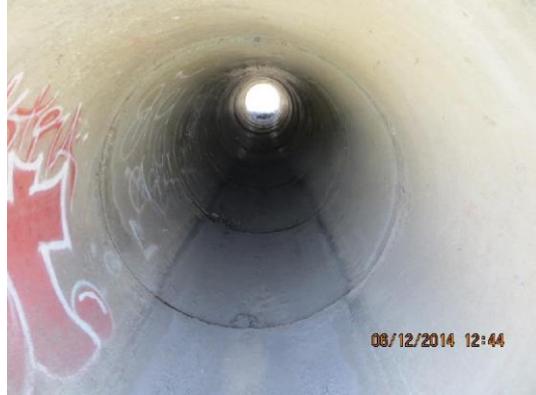
Photo 2 of 3 : UCIP\_FA\_2015\_6586.jpg

LM Start	1.16	Rating **	M	Issue No.	25 (cont)
LM End	1.16	Issue Type +	En	Location *	WS
Category	Supplemental			GPS Latitude/Longitude	
				Start	End
Item	DWR UCIP Field Study			38.112296 °	38.112296 °
				-121.141654 °	-121.141654 °
DWR ID					
Action/Comments					
Inspector Comments: FS_ID:41794 DS_ID:23950 EP_NO: N/A FS_HLM: 1.182 Repair Type: Non-Urgent Crossing Status: Found UCIP Comments: Pipe open on both ends. Levee appears abandoned. FIELD_STRUCT_DESC: 48-inch concrete pipe through the levee, 5.5 feet below the crown. Cobble grouted spillway. Cobble grouted intake on the landward side. Open on both ends. O&M Manual Bear Creek Part 2, 1967. FS Date: 06/12/2014

Inside pipe.

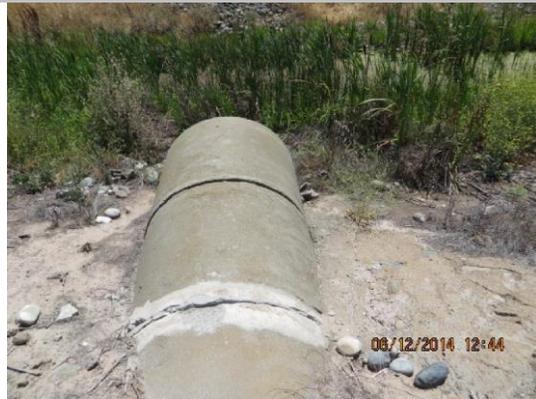
Photo 3 of 3 : UCIP\_FA\_2015\_6587.jpg

Pipe on WS toe.

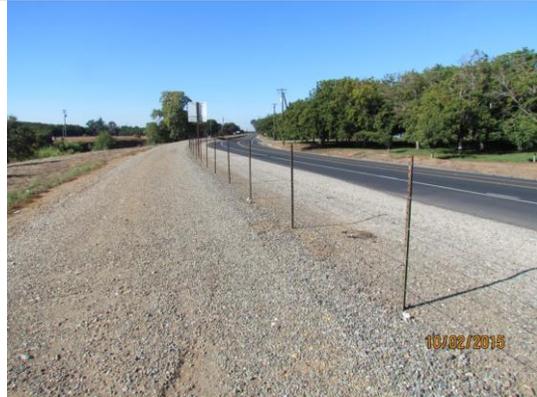
Photo 1 of 1 : FA\_2015\_NA0017\_159\_1\_20151009\_00137.jpg

LM Start	<b>0.28</b>	Rating **	M	Issue No.	<b>1</b>
LM End	<b>0.35</b>	Issue Type +	En	Location *	LS
Category	Earthen Levee			GPS Latitude/Longitude	
				Start	End
Item	Encroachments			38.049557 °	38.048987 °
				-121.014935 °	-121.015907 °
DWR ID	DWR_NA0017_15_f_2015_1				
Action/Comments					
Fence Inspector Comments: An unpermitted fence was found on the landside shoulder of the levee.

A fence was found on the landside shoulder of the levee looking downstream.

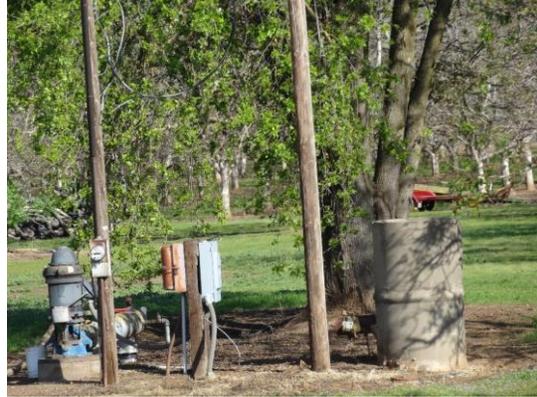
Photo 1 of 3 : UCIP\_FA\_2015\_5631.jpg

Inspector Comments: FS\_ID:40347  
 DS\_ID:23196  
 EP\_NO: N/A  
 FS\_HLM: 0.367  
 Repair Type: Non-Urgent  
 Crossing Status: Found  
 UCIP Comments: Appears to be abandoned and if so should be done so properly. A well pump and concrete standpipe also found on landside across Highway 26.  
 FIELD\_STRUCT\_DESC: Abandoned 10-inch concrete pipe through the levee 7.5 feet below the crown. Concrete headwall on the waterward side. 36-inch concrete standpipe on the waterward side. Pump mounted on concrete pad in stream.  
 FS Date: 04/09/2014

LS view: well pump and concrete standpipe off the levee across the Hiway 26.

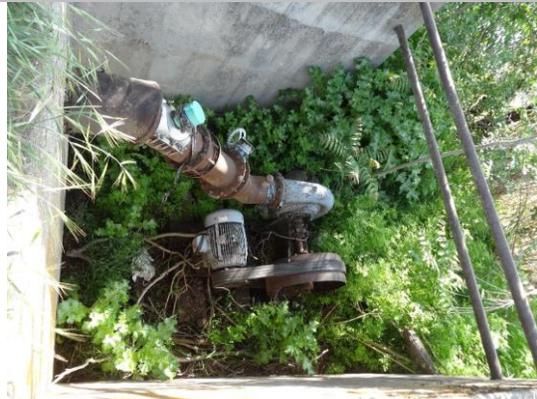
Photo 2 of 3 : UCIP\_FA\_2015\_5632.jpg

WS view: U type headwall and abandoned pump on concrete pad.

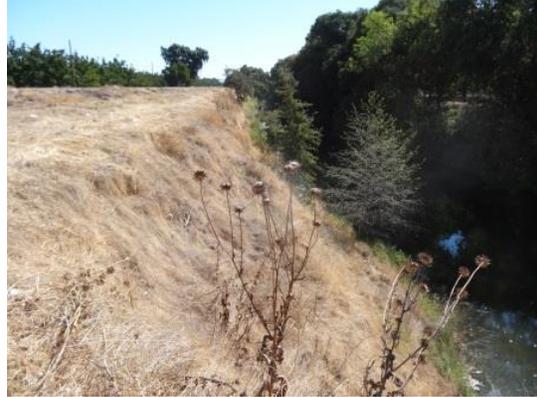
Photo 1 of 3 : SJR2015\_NA0017U15RM22.91\_1.jpg

Inspector Comments: 8/12/2015: No significant change observed.  
 8/20/2014: No significant change has been observed.  
 9/12/2013: No significant change observed.  
 08/22/2012: Site has been revisited. No significant change observed.  
 09/02/2011: No significant change observed on site.  
 11/02/2010: No significant change observed. The mile-long erosion continues to degrade the bank. There are a few trees along the mile-long stretch on the lower bank slope that are affected by the scarp. WS Levee Slope was changed to 2:1. As a result, normalized score increased from 62 to 65.  
 08/05/2010: Recommended for waterside repair, per CLRO; "water velocity is a major factor for accelerating bank slope erosion."  
 8/12/2009: Near-vertical bank erosion; degrading channel is incising the banks; recommend annual assessment and monitoring of critical erosion site, per CLRO CES Evaluation 2008 Report; district is monitoring site for change in condition; site was previously rated "U".

Downstream view of the site.

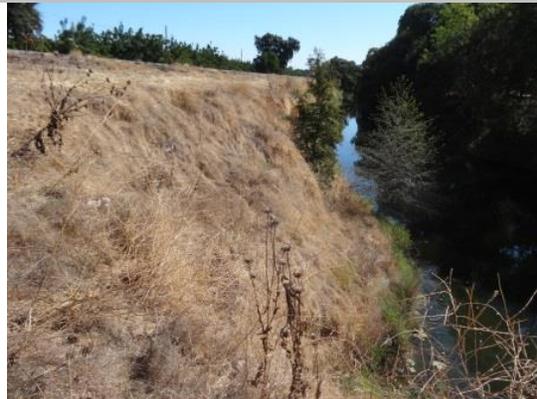
Photo 2 of 3 : SJR2015\_NA0017U15RM22.91\_2.jpg

Close view of the erosion site. Small trees grow at the lower slope of the bank.

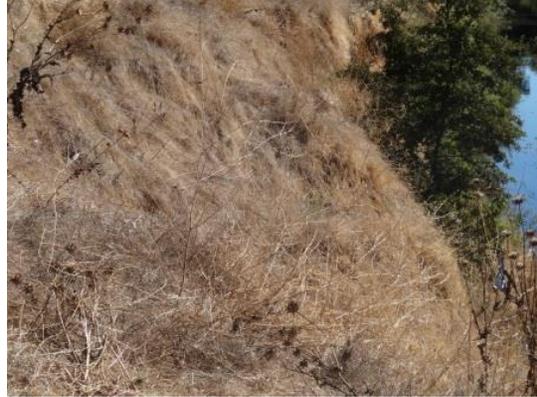
Photo 3 of 3 : SJR2015\_NA0017U15RM22.91\_5.jpg

LM Start	<b>0.39</b>	Rating **	M	Issue No.	<b>7 (cont)</b>
LM End	<b>1.30</b>	Issue Type +	Ma	Location *	WS
Category	Supplemental			GPS Latitude/Longitude	
				Start	End
Item	DWR Erosion Survey			38.045818 °	38.045818 °
				-121.023955 °	-121.023955 °
DWR ID					
Action/Comments					
Inspector Comments: 8/12/2015: No significant change observed. 8/20/2014: No significant change has been observed. 9/12/2013: No significant change observed. 08/22/2012: Site has been revisited. No significant change observed. 09/02/2011: No significant change observed on site. 11/02/2010: No significant change observed. The mile-long erosion

Looking down at the site.

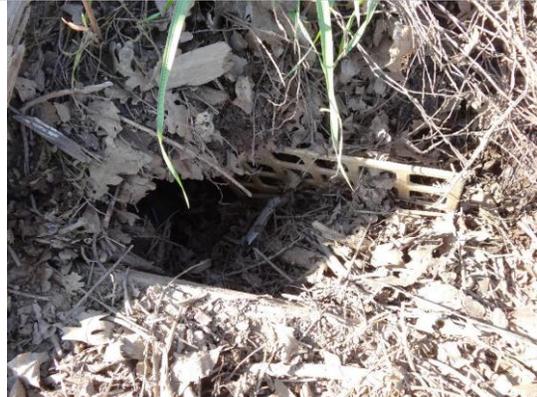
Photo 1 of 1 : UCIP\_FA\_2015\_5389.jpg

LM Start	<b>0.70</b>	Rating **	M	Issue No.	<b>1157</b>
LM End	<b>0.70</b>	Issue Type +	En	Location *	LS
Category	Supplemental			GPS Latitude/Longitude	
				Start	End
Item	DWR UCIP Field Study			38.046589 °	38.046589 °
				-121.021635 °	-121.021635 °
DWR ID					
Action/Comments					
Inspector Comments: FS_ID:34876 DS_ID:23197 EP_NO: N/A FS_HLM: 0.71 Repair Type: Non-Urgent Crossing Status: Found UCIP Comments: Need inlet opening cleaned. FIELD_STRUCT_DESC: 10-inch-diameter steel storm drain pipe through the levee 5 feet below the crown. FS Date: 04/09/2014

LS view: inlet opening and vegetation debris. Needs cleaning and clearing.

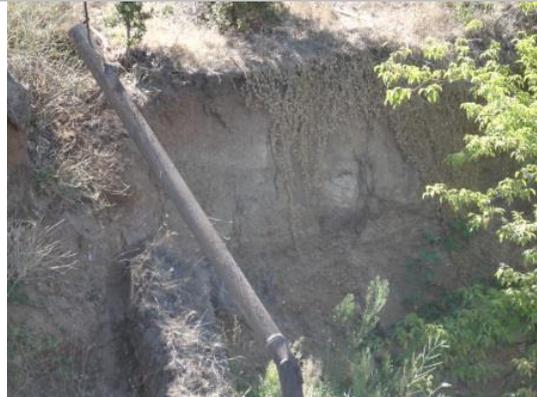
Photo 1 of 2 : SJR2015\_NA0017U16RM22.74\_2.jpg

LM Start	<b>1.05</b>	Rating **	U	Issue No.	<b>36</b>
LM End	<b>1.07</b>	Issue Type +	Ma	Location *	WS
Category	Supplemental			GPS Latitude/Longitude	
				Start	End
Item	DWR Erosion Survey			38.043080 °	38.043080 °
				-121.026280 °	-121.026280 °
DWR ID					
Action/Comments					
Inspector Comments: 8/12/2015: No significant change observed. 8/20/2014: No significant change observed. 09/12/2013: No significant change observed. 08/22/2012: The erosion was surveyed and documented for monitoring purpose. There is no levee structure on the site, only high ground protecting the land behind. The levee crest width and levee height were not measured or estimated in the field. There is a drainage pipe at the site, which might have caused the problem at one pocket erosion. [2015 Site ID:NA0017U16RM22.74]

Close view of the erosion.

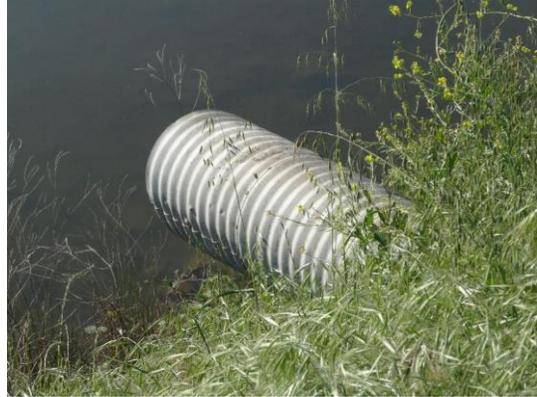
Photo 2 of 2 : UCIP\_FA\_2015\_5391.jpg

LM Start	1.16	Rating **	M	Issue No.	1158 (cont)
LM End	1.16	Issue Type +	En	Location *	WS
Category	Supplemental			GPS Latitude/Longitude	
				Start	End
Item	DWR UCIP Field Study			38.041907 °	38.041907 °
DWR ID				-121.027235 °	-121.027235 °
Action/Comments					
Inspector Comments: FS_ID:34877 DS_ID:23199 EP_NO: N/A FS_HLM: 1.175 Repair Type: Non-Urgent Crossing Status: Found UCIP Comments: Deformed inlet opening. Needs cleaning and clearing on inlet opening on landside. FIELD_STRUCT_DESC: 18-inch CM pipe through the levee 4.5 feet below the crown. Grouted spillway on the waterward end. Open on both ends. O&M Manual SJR Assumed 999. FS Date: 04/09/2014

WS view: CM outfall pipe on channel bank.

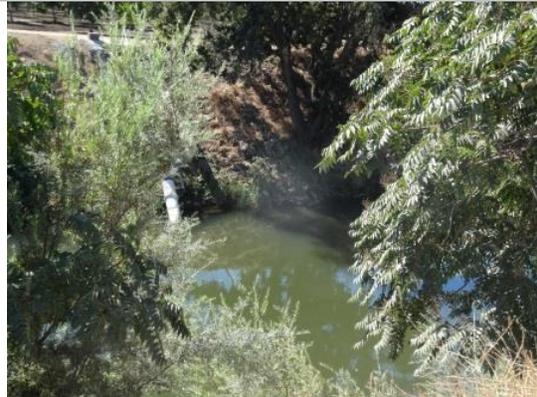
Photo 1 of 3 : SJR2015\_NA0017U16RM22.58\_1.jpg

LM Start	1.21	Rating **	U	Issue No.	35
LM End	1.21	Issue Type +	Ma	Location *	WS
Category	Supplemental			GPS Latitude/Longitude	
				Start	End
Item	DWR Erosion Survey			38.041260 °	38.041260 °
DWR ID				-121.027730 °	-121.027730 °
Action/Comments					
Inspector Comments: 8/12/2015: No significant change observed. 8/20/2014: No significant change observed. 9/12/2013: No significant change observed. 08/22/2012: The erosion is at the outside corner of a river bend, and next to a tree at the levee toe. Irrigation structure presents at the site. There is no levee structure on site. The levee crest width and levee height were not measured or estimated in the field. [2015 Site ID:NA0017U16RM22.58]

Front view of the erosion. The erosion is next to a tree at the levee toe.

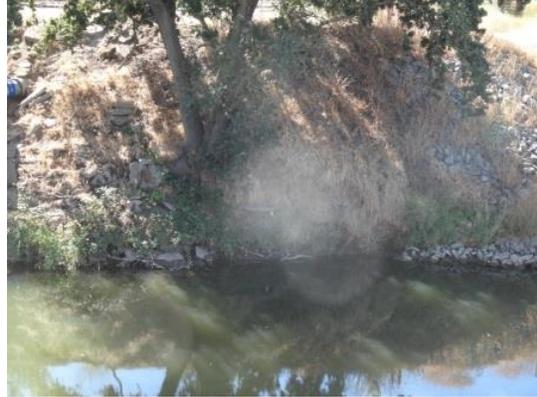
Photo 2 of 3 : SJR2015\_NA0017U16RM22.58\_3.jpg

Closer view of the erosion.

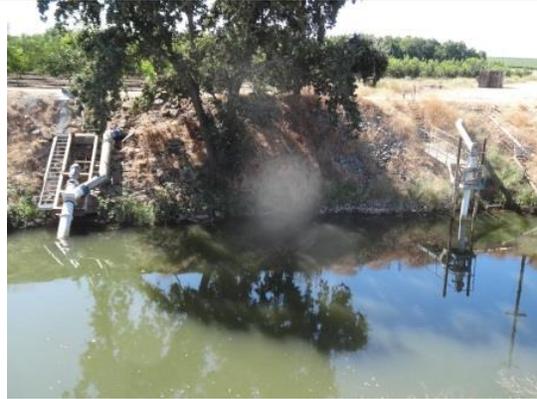
Photo 3 of 3 : SJR2015\_NA0017U16RM22.58\_5.jpg

Front view of the erosion and broken concrete protection on the levee slope.
