**Flood Control Project Maintenance  
Levee Inspections**

**Fall 2015 Levee Maintenance Deficiency Summary Report**

**San Joaquin River Basin**

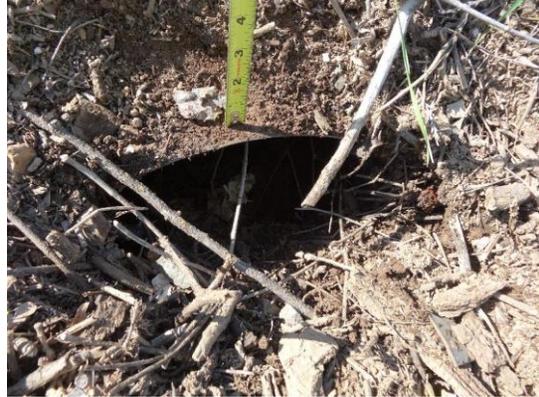
Photo 1 of 3 : UCIP\_FA\_2015\_5392.jpg

LM Start	1.46	Rating **	M	Issue No.	1159
LM End	1.46	Issue Type +	En	Location *	LS
Category	Supplemental			GPS Latitude/Longitude	
				Start	End
Item	DWR UCIP Field Study			38.040197 °	38.040197 °
				-121.032044 °	-121.032044 °
DWR ID					
Action/Comments					
Inspector Comments: FS_ID:40369 DS_ID:23200 EP_NO: N/A FS_HLM: 1.482 Repair Type: Non-Urgent Crossing Status: Found UCIP Comments: Pipe needs cleaning and clearing on both pipe ends. FIELD_STRUCT_DESC: 18-inch pipe through the levee 6.0 feet below the crown. Grouted spillway on the waterward end. An electric conduit through the levee. O&M Manual SJR Assumed 999. FS Date: 04/09/2014

LS view: buried inlet pipe. Needs cleaning and clearing.

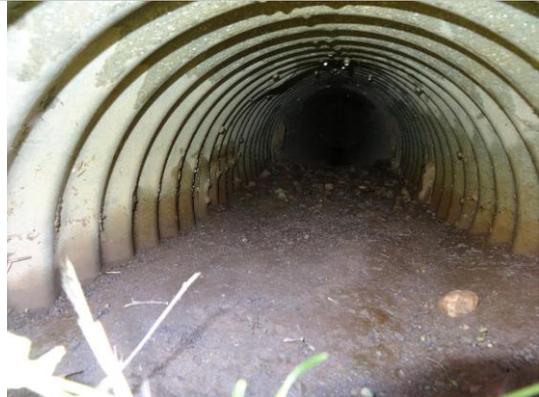
Photo 2 of 3 : UCIP\_FA\_2015\_5393.jpg

WS view: inside view of the outlet pipe. Needs cleaning and clearing.

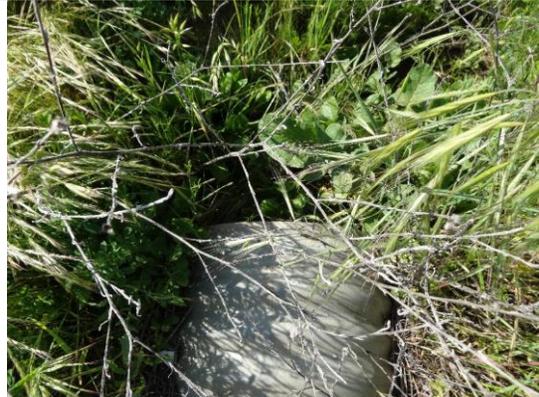
Photo 3 of 3 : UCIP\_FA\_2015\_5394.jpg

WS view: outlet CM pipe on levee slope.

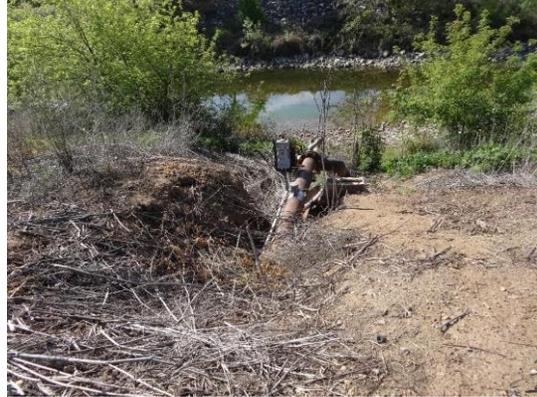
Photo 2 of 3 : UCIP\_FA\_2015\_5451.jpg

LM Start	1.48	Rating **	M	Issue No.	1160 (cont)
LM End	1.48	Issue Type +	En	Location *	LS
Category	Supplemental			GPS Latitude/Longitude	
				Start	End
Item	DWR UCIP Field Study			38.040204 °	38.040204 °
				-121.032566 °	-121.032566 °
DWR ID					
Action/Comments					
Inspector Comments: FS_ID:34879 DS_ID:23201 EP_NO: N/A FS_HLM: 1.511 Repair Type: Non-Urgent Crossing Status: Found UCIP Comments: Erosion around the pump on waterside. Pipes visible across the Hiway 26 on the field. FIELD_STRUCT_DESC: 8-inch pipe sleeved through 12-inch steel pipe through the levee 11.0 feet below the crown. 2-inch breather pipe on the waterward slope. Pump on the waterside. O&M Manual SJR. FS Date: 04/09/2014

WS view: soil erosion around pipe and pump.

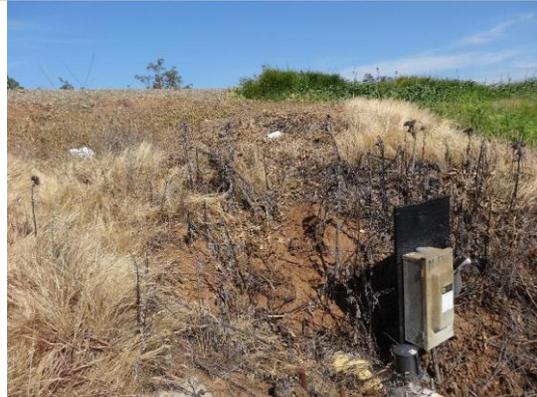
Photo 3 of 3 : UCIP\_FA\_2015\_5477.jpg

WS view: soil erosion and depression around pipe and pump.

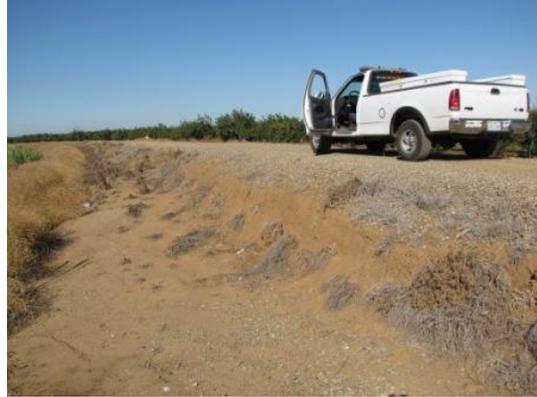
Photo 1 of 1 : FA\_2015\_NA0017\_159\_995\_20150911\_001119.jpg

LM Start	<b>1.49</b>	Rating **	M	Issue No.	<b>995</b>
LM End	<b>1.49</b>	Issue Type +	Ma	Location *	WS
Category	Earthen Levee		GPS Latitude/Longitude		
			Start	End	
Item	Slope Stability		38.040202 °	38.040202 °	
			-121.032659 °	-121.032659 °	
DWR ID	DWR_NA0017_15_s_2012_995				
Action/Comments					
Repair slope instability. Inspector Comments: The LMA was working on fixing the erosion site using an excavator during the inspection.

View of erosion of waterward levee slope looking upstream.

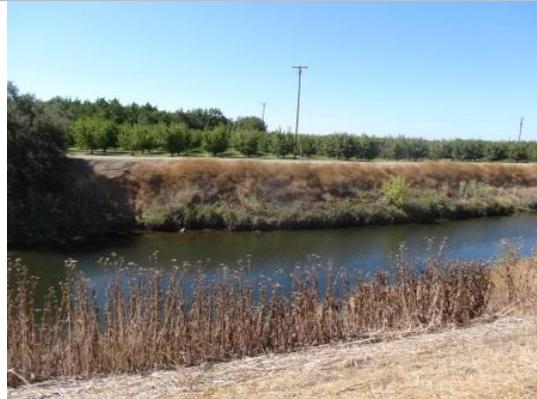
Photo 1 of 3 : SJR2015\_NA0017U16RM22.15\_1.jpg

LM Start	<b>1.64</b>	Rating **	M	Issue No.	<b>33</b>
LM End	<b>1.64</b>	Issue Type +	Ma	Location *	WS
Category	Supplemental		GPS Latitude/Longitude		
			Start	End	
Item	DWR Erosion Survey		38.039940 °	38.039940 °	
			-121.035430 °	-121.035430 °	
DWR ID					
Action/Comments					
Inspector Comments: 8/12/2015: No significant change observed. 8/20/2014: No significant change observed. 9/12/2013: No significant change observed. 08/22/2012: The berm is estimated at 10 ft. Dense vegetation on site. There is no levee structure on site. The levee crest width and levee height were not measured or estimated in the field. [2015 Site ID:NA0017U16RM22.15]

Front view of the erosion.

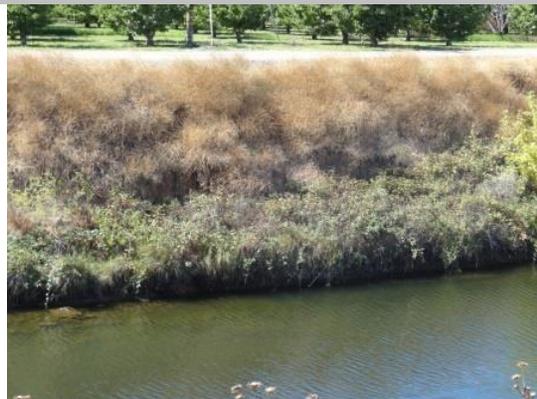
Photo 2 of 3 : SJR2015\_NA0017U16RM22.15\_2.jpg

Close view of the erosion.

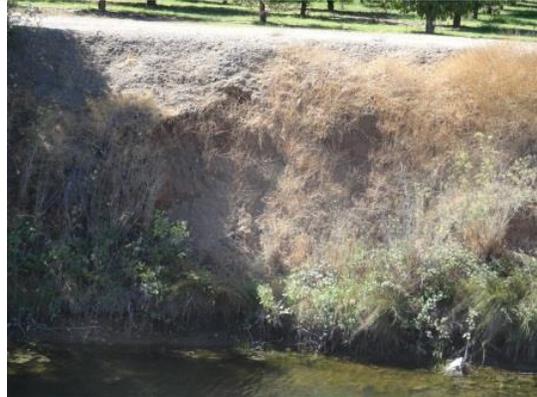
Photo 3 of 3 : SJR2015\_NA0017U16RM22.15\_4.jpg

Close view of the erosion.

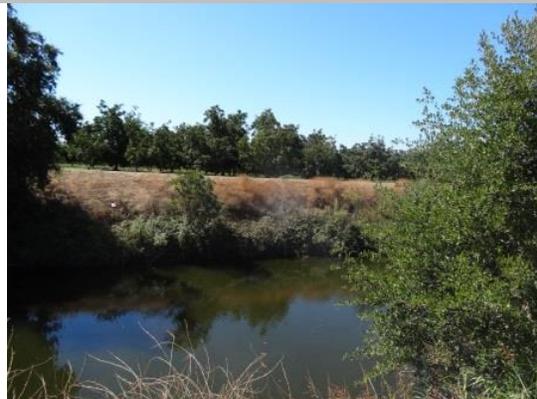
Photo 1 of 3 : SJR2015\_NA0017U16RM22.01\_1.jpg

LM Start	<b>1.78</b>	Rating **	U	Issue No.	<b>29</b>
LM End	<b>1.79</b>	Issue Type +	Ma	Location *	WS
Category	Supplemental			GPS Latitude/Longitude	
				Start	End
Item	DWR Erosion Survey			38.039110 °	38.039110 °
				-121.037840 °	-121.037840 °
DWR ID					
<b>Action/Comments</b>					
Inspector Comments: 8/12/2015: No significant change observed. 8/20/2014: No significant change observed. 9/12/2013: No significant change observed. 08/22/2012: Site is covered with dense vegetation. A scarp erosion is adjacent to a pocket erosion at the downstream. There is no levee structure on site. The levee crest width and levee height were not measured or estimated in the field. [2015 Site ID:NA0017U16RM22.01]

Front view of the erosion site from the left river bank.

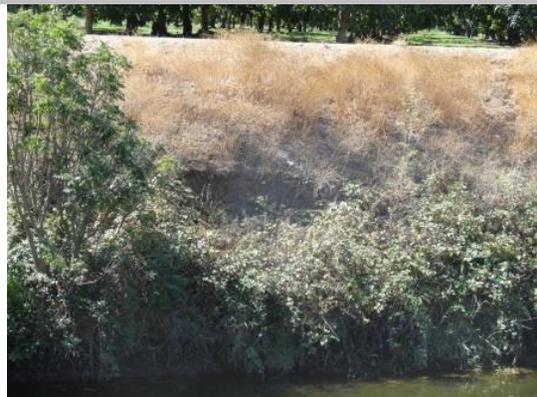
Photo 2 of 3 : SJR2015\_NA0017U16RM22.01\_2.jpg

Front view of the pocket erosion.

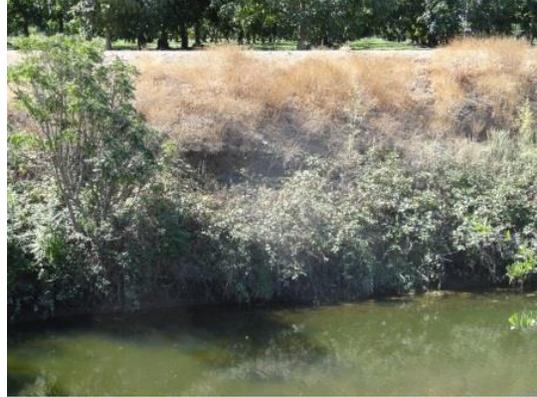
Photo 3 of 3 : SJR2015\_NA0017U16RM22.01\_4.jpg

Close view of the erosion.

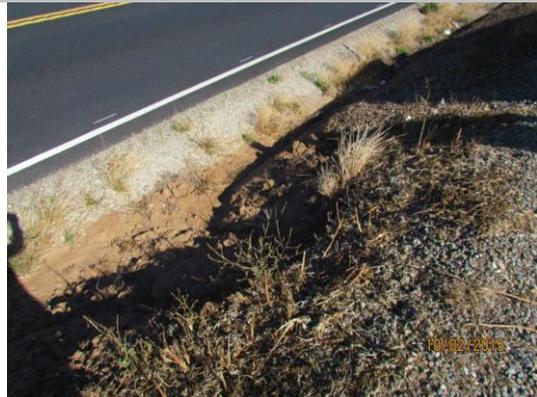
Photo 1 of 1 : FA\_2015\_NA0017\_159\_120\_20151009\_00138.jpg

LM Start	<b>1.92</b>	Rating **	M	Issue No.	<b>120</b>
LM End	<b>1.92</b>	Issue Type +	Ma	Location *	LS
Category	Earthen Levee			GPS Latitude/Longitude	
				Start	End
Item	Slope Stability			38.037919 °	38.037919 °
				-121.039749 °	-121.039749 °
DWR ID	DWR_NA0017_15_f_2015_120				
Action/Comments					
Repair slope instability. Inspector Comments: It was caused by runoff.

A slope instability possible cause by runoff on the landside of the levee looking upstream.

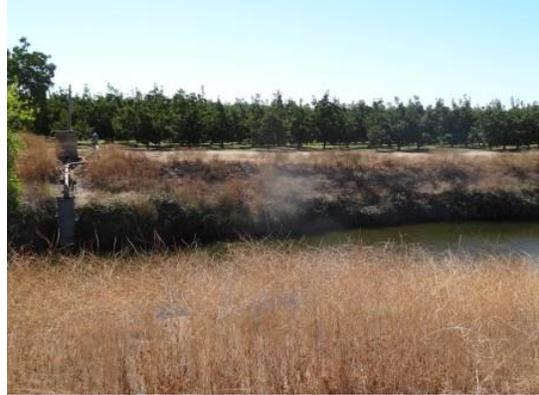
Photo 1 of 3 : SJR2015\_NA0017U16RM21.05\_1.jpg

LM Start	<b>1.98</b>	Rating **	M	Issue No.	<b>28</b>
LM End	<b>2.00</b>	Issue Type +	Ma	Location *	WS
Category	Supplemental			GPS Latitude/Longitude	
				Start	End
Item	DWR Erosion Survey			38.037150 °	38.037150 °
				-121.040580 °	-121.040580 °
DWR ID					
<b>Action/Comments</b>					
Inspector Comments: 8/12/2015: No significant change observed. 8/20/2014: No significant change observed. 9/12/2013: No significant change observed. 08/22/2012: Berm width is estimated as 5 ft. There is no levee structure on site. The levee crest width and levee height were not measured or estimated in the field. [2015 Site ID:NA0017U16RM21.05]

Front view of the erosion

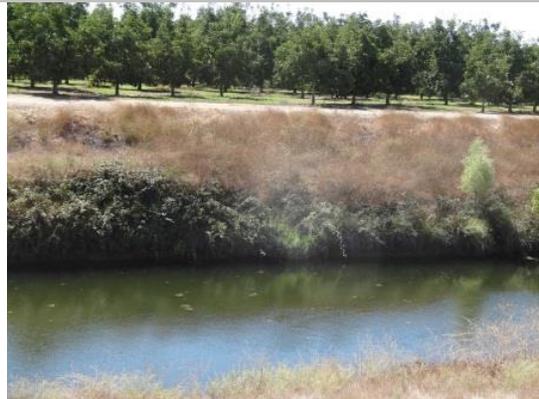
Photo 2 of 3 : SJR2015\_NA0017U16RM21.05\_3.jpg

Close view of the erosion.

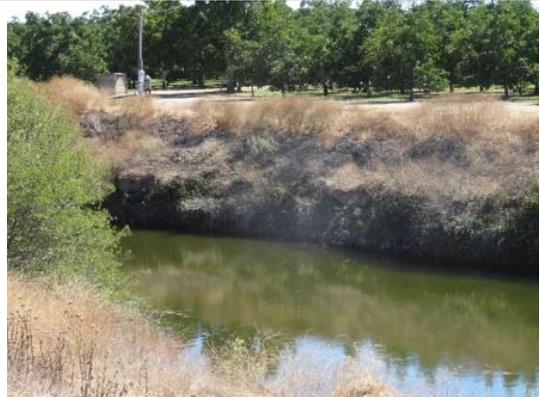
Photo 3 of 3 : SJR2015\_NA0017U16RM21.05\_5.jpg

Close view of the erosion.

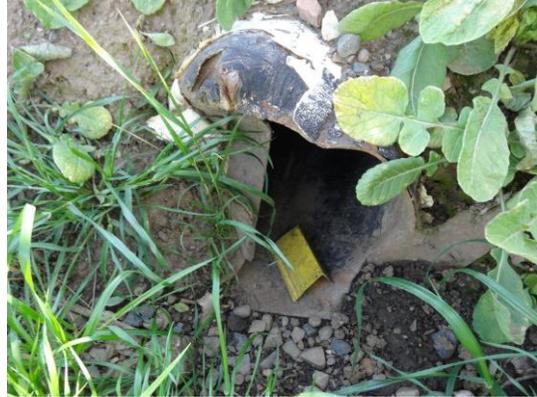
Photo 1 of 2 : UCIP\_FA\_2015\_5452.jpg

LM Start	<b>1.98</b>	Rating **	M	Issue No.	<b>1161</b>
LM End	<b>1.98</b>	Issue Type +	En	Location *	WS
Category	Supplemental			GPS Latitude/Longitude	
				Start	End
Item	DWR UCIP Field Study			38.037100 °	38.037100 °
				-121.040464 °	-121.040464 °
DWR ID					
Action/Comments					
Inspector Comments: FS_ID:34883 DS_ID:23203 EP_NO: N/A FS_HLM: 2.022 Repair Type: Non-Urgent Crossing Status: Found

LS view: distorted inlet pipe and debris inside the pipe.

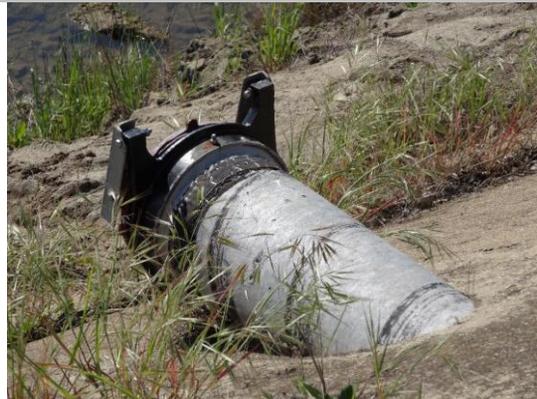
Photo 2 of 2 : UCIP\_FA\_2015\_5453.jpg

WS view: outfall steel pipe with flap gate on levee slope.

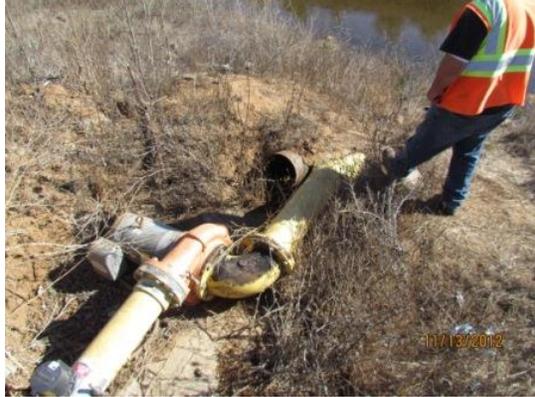
Photo 1 of 1 : FA\_2015\_NA0017\_159\_5\_20150911\_00003.jpg

LM Start	<b>2.05</b>	Rating **	M	Issue No.	<b>5</b>
LM End	<b>2.05</b>	Issue Type +	En	Location *	WS
Category	Earthen Levee		GPS Latitude/Longitude		
			Start	End	
Item	Encroachments		38.036299 °	38.036299 °	
			-121.041091 °	-121.041091 °	
DWR ID	DWR_NA0017_15_f_2012_5				
Action/Comments					
Pipe Inspector Comments: Open abandoned pipe on the waterside toe of the levee.

View of an open abandoned pipe at the waterside toe of the levee looking upstream.

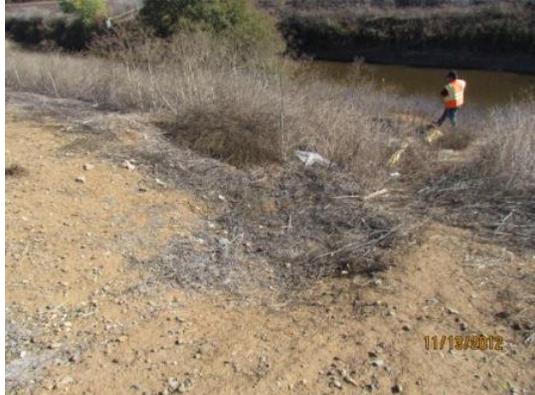
Photo 1 of 2 : FA\_2015\_NA0017\_159\_18\_20150911\_00010.jpg

LM Start	<b>2.05</b>	Rating **	M	Issue No.	<b>18</b>
LM End	<b>2.05</b>	Issue Type +	Ma	Location *	WS
Category	Earthen Levee		GPS Latitude/Longitude		
			Start	End	
Item	Slope Stability		38.036294 °	38.036294 °	
			-121.041089 °	-121.041089 °	
DWR ID	DWR_NA0017_15_s_2012_18				
Action/Comments					
Repair slope instability.

Updated picture of the slope instability at the waterside slope of the levee looking upstream.

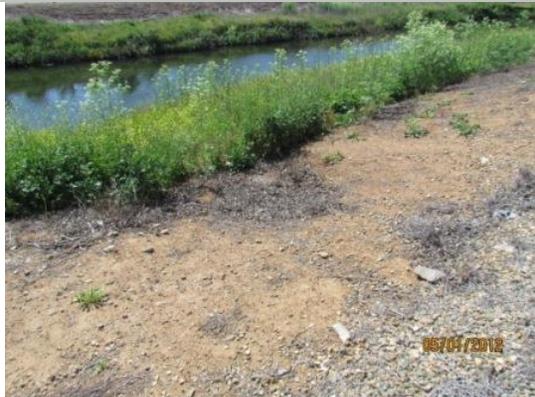
Photo 2 of 2 : FA\_2015\_NA0017\_159\_18\_20150911\_00011.jpg

Slope instability was found on the waterside toe of the levee looking downstream.

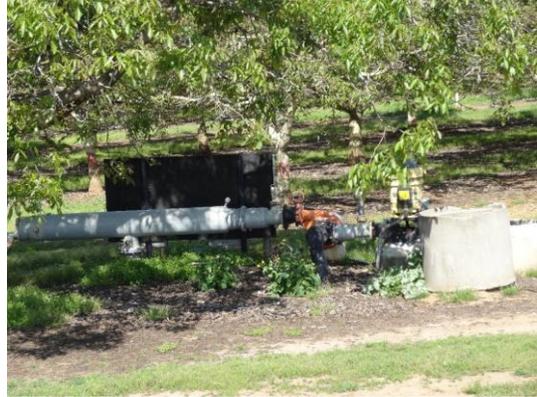
Photo 1 of 2 : UCIP\_FA\_2015\_5472.jpg

LM Start	2.05	Rating **	M	Issue No.	1162
LM End	2.05	Issue Type +	En	Location *	WS
Category	Supplemental			GPS Latitude/Longitude	
				Start	End
Item	DWR UCIP Field Study			38.036269 °	38.036269 °
				-121.041126 °	-121.041126 °
DWR ID					
Action/Comments					
Inspector Comments: FS_ID:40372 DS_ID:23204 EP_NO: N/A FS_HLM: 2.091 Repair Type: Non-Urgent Crossing Status: Found

LS view: pipe, filter, and concrete standpipe off the levee.

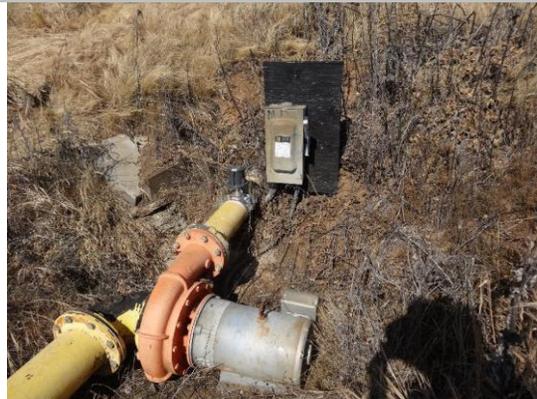
Photo 2 of 2 : UCIP\_FA\_2015\_5473.jpg

WS view: pipe, abandoned pump, and switch panel on waterside slope.

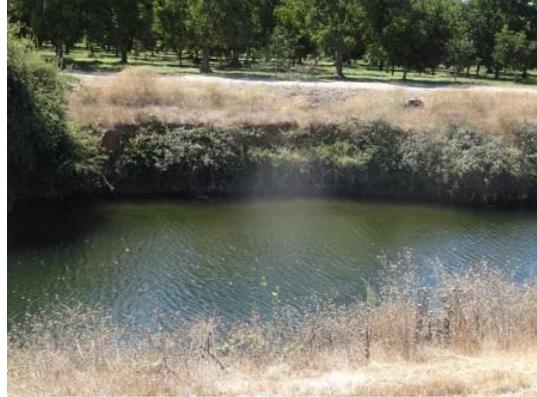
Photo 1 of 3 : SJR2015\_NA0017U16RM20.71\_1.jpg

LM Start	<b>2.36</b>	Rating **	M	Issue No.	<b>26</b>
LM End	<b>2.37</b>	Issue Type +	Ma	Location *	WS
Category	Supplemental			GPS Latitude/Longitude	
				Start	End
Item	DWR Erosion Survey			38.033072 °	38.033072 °
				-121.044970 °	-121.044970 °
DWR ID					
<b>Action/Comments</b>					
Inspector Comments: 8/12/2015: No significant change observed. 8/20/2014: No significant change observed. 9/12/2013: No significant change observed. 08/22/2012: Site is covered with dense vegetation. There is no levee structure on site. The levee crest width and levee height were not measured or estimated in the field. [2015 Site ID:NA0017U16RM20.71]

Front view of the site.

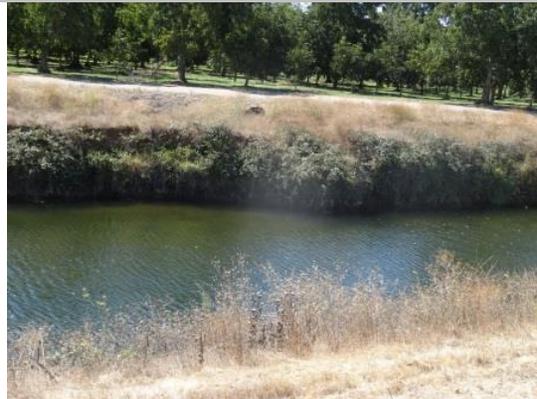
Photo 2 of 3 : SJR2015\_NA0017U16RM20.71\_2.jpg

Front view of the erosion. Site is covered with vegetation and trees.

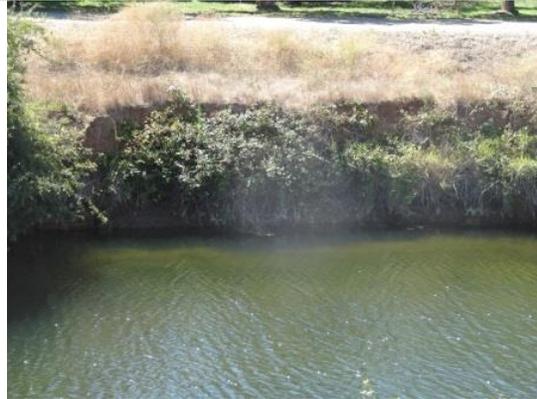
Photo 3 of 3 : SJR2015\_NA0017U16RM20.71\_4.jpg

Closer view of the erosion.

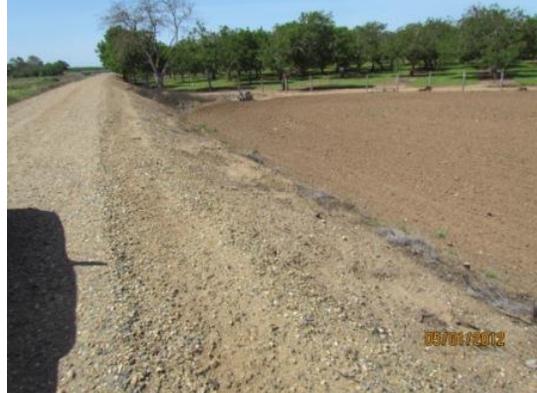
Photo 1 of 1 : FA\_2015\_NA0017\_159\_47\_20150911\_00038.jpg

LM Start	<b>2.37</b>	Rating **	M	Issue No.	<b>47</b>
LM End	<b>2.37</b>	Issue Type +	En	Location *	LS
Category	Earthen Levee		GPS Latitude/Longitude		
			Start	End	
Item	Encroachments		38.032922 °	38.032922 °	
			-121.045198 °	-121.045198 °	
DWR ID	DWR_NA0017_15_s_2012_47				
Action/Comments					
Agricultural tilling

View of agriculture tilling on the landside slope of the levee looking downstream.

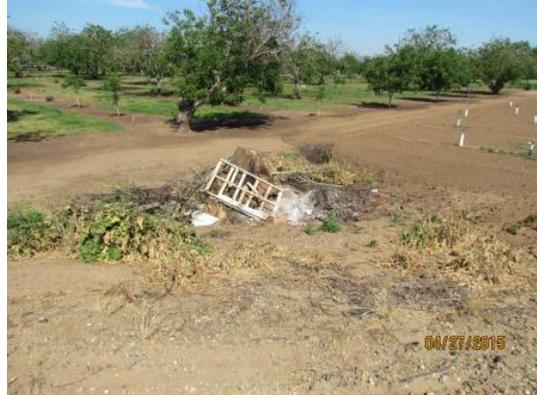
Photo 1 of 1 : FA\_2015\_NA0017\_159\_159\_20150911\_00093.jpg

LM Start	<b>2.56</b>	Rating **	M	Issue No.	<b>159</b>
LM End	<b>2.56</b>	Issue Type +	En	Location *	LS
Category	Earthen Levee		GPS Latitude/Longitude		
			Start	End	
Item	Encroachments		38.030950 °	38.030950 °	
			-121.047557 °	-121.047557 °	
DWR ID	DWR_NA0017_15_f_2014_159				
Action/Comments					
Prunings

Prunings were found on the landside toe of the levee looking upstream.

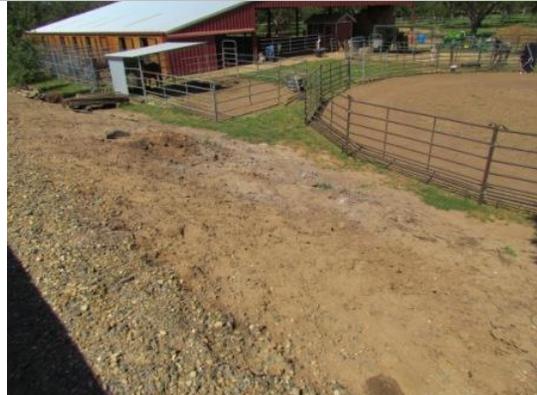
Photo 1 of 1 : FA\_2015\_NA0017\_159\_27\_20150911\_00019.jpg

LM Start	<b>2.63</b>	Rating **	M	Issue No.	<b>27</b>
LM End	<b>2.63</b>	Issue Type +	Ma	Location *	LS
Category	Earthen Levee		GPS Latitude/Longitude		
			Start	End	
Item	Slope Stability		38.030252 °	38.030252 °	
			-121.048311 °	-121.048311 °	
DWR ID	DWR_NA0017_15_s_2012_27				
Action/Comments					
Repair slope instability.

Slope instability was found on the landside of the levee. The picture was taken from the crown looking downstream.

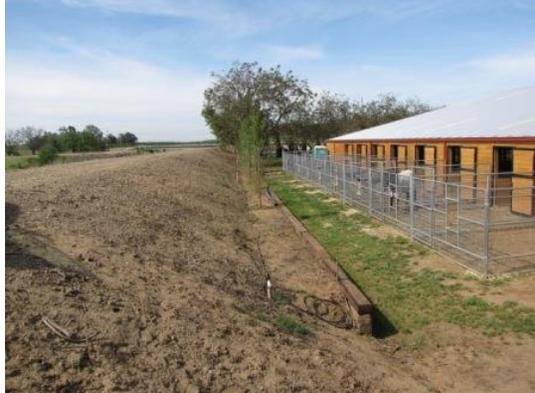
Photo 1 of 2 : FA\_2015\_NA0017\_159\_66\_20150911\_00050.jpg

LM Start	<b>2.63</b>	Rating **	M	Issue No.	<b>66</b>
LM End	<b>2.66</b>	Issue Type +	En	Location *	LS
Category	Earthen Levee		GPS Latitude/Longitude		
			Start	End	
Item	Encroachments		38.030173 °	38.029949 °	
			-121.048432 °	-121.048732 °	
DWR ID	DWR_NA0017_15_s_2012_66				
Action/Comments					
Building Inspector Comments: Retaining wall at toe of slope & irrigation recently placed.

Updated view as of spring 2009. Landscaping and irrigation have been added at the toe of the levee.

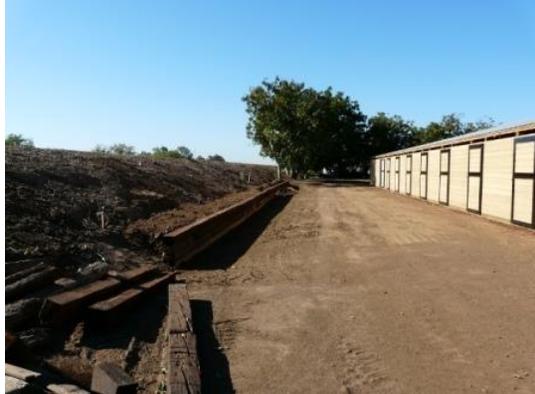
Photo 2 of 2 : FA\_2015\_NA0017\_159\_66\_20150911\_00051.jpg

Recently built retaining wall at toe of landside levee at LM 2.68.

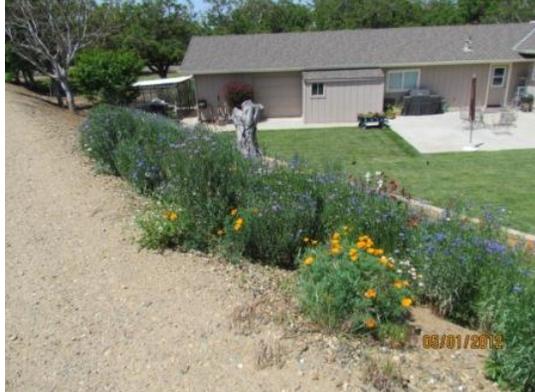
Photo 1 of 1 : FA\_2015\_NA0017\_159\_3\_20150911\_00002.jpg

LM Start	<b>2.69</b>	Rating **	M	Issue No.	<b>3</b>
LM End	<b>2.69</b>	Issue Type +	En	Location *	LS
Category	Earthen Levee		GPS Latitude/Longitude		
			Start	End	
Item	Vegetation		38.029655 °	38.029655 °	
			-121.049110 °	-121.049110 °	
DWR ID	DWR_NA0017_15_s_2012_3				
Action/Comments					
Landscaping

Landscaping was found on the landside of the levee looking downstream.

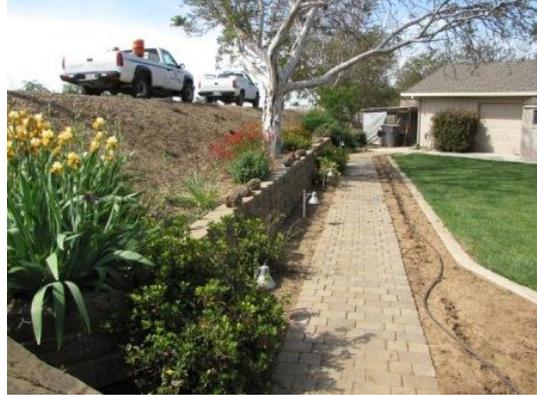
Photo 1 of 1 : FA\_2015\_NA0017\_159\_959\_20150911\_00116.jpg

LM Start	<b>2.69</b>	Rating **	M	Issue No.	<b>959</b>
LM End	<b>2.70</b>	Issue Type +	En	Location *	LS
Category	Earthen Levee		GPS Latitude/Longitude		
			Start	End	
Item	Encroachments		38.029641 °	38.029505 °	
			-121.049165 °	-121.049372 °	
DWR ID	DWR_NA0017_15_s_2012_959				
Action/Comments					
Building Inspector Comments: Retaining wall at landside toe of levee.

View of retaining wall and landscaping along the landward toe of the levee.

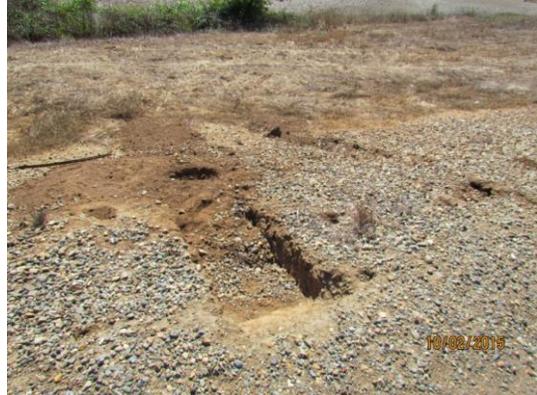
Photo 1 of 1 : FA\_2015\_NA0017\_159\_127\_20151009\_00139.jpg

LM Start	<b>2.82</b>	Rating **	M	Issue No.	<b>127</b>
LM End	<b>2.82</b>	Issue Type +	Ma	Location *	WS
Category	Earthen Levee		GPS Latitude/Longitude		
			Start	End	
Item	Slope Stability		38.028405 °	38.028405 °	
			-121.051062 °	-121.051062 °	
DWR ID	DWR_NA0017_15_f_2015_127				
Action/Comments					
Repair the levee slope damaged by vehicle traffic and prevent access where possible.

Slope instability caused by vehicle on the waterside of the levee looking downstream.

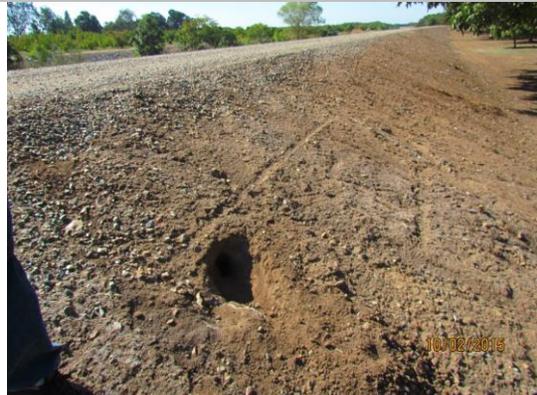
Photo 1 of 1 : FA\_2015\_NA0017\_159\_128\_20151009\_00140.jpg

LM Start	<b>2.83</b>	Rating **	M	Issue No.	<b>128</b>
LM End	<b>2.83</b>	Issue Type +	Ma	Location *	LS
Category	Earthen Levee		GPS Latitude/Longitude		
			Start	End	
Item	Animal Control		38.028356 °	38.028356 °	
			-121.051148 °	-121.051148 °	
DWR ID	DWR_NA0017_15_f_2015_128				
Action/Comments					
No rodents visible, but rodent burrows visible; need to backfill and compact or grout burrows.

Rodent holes were found on the landside of the levee looking downstream.

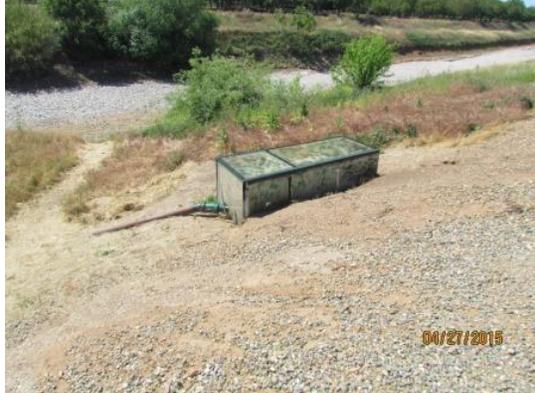
Photo 1 of 1 : FA\_2015\_NA0017\_159\_15\_20150911\_00008.jpg

LM Start	<b>3.33</b>	Rating **	M	Issue No.	<b>15</b>
LM End	<b>3.33</b>	Issue Type +	En	Location *	WS
Category	Earthen Levee			GPS Latitude/Longitude	
				Start	End
Item	Encroachments			38.023895 °	38.023895 °
				-121.058356 °	-121.058356 °
DWR ID	DWR_NA0017_15_s_2015_15				
Action/Comments					
Pipe

View of a pump and a pipe on the waterside slope of the levee looking downstream.

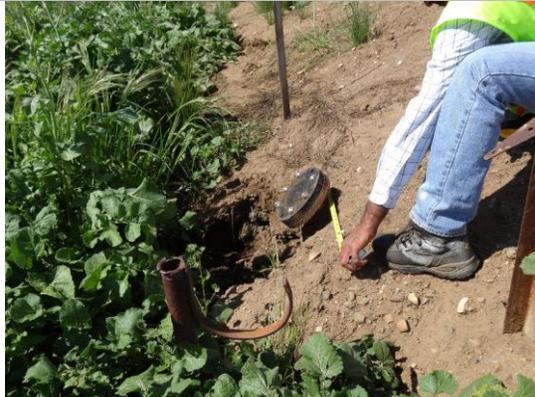
Photo 1 of 3 : UCIP\_FA\_2015\_5474.jpg

LM Start	<b>3.33</b>	Rating **	M	Issue No.	<b>1163</b>
LM End	<b>3.33</b>	Issue Type +	En	Location *	WS
Category	Supplemental			GPS Latitude/Longitude	
				Start	End
Item	DWR UCIP Field Study			38.023850 °	38.023850 °
				-121.058424 °	-121.058424 °
DWR ID					
Action/Comments					
Inspector Comments: FS_ID:40382 DS_ID:23206 EP_NO: 10498 FS_HLM: 3.401 Repair Type: Non-Urgent Crossing Status: Found UCIP Comments: Pump removed. Pipe appears abandoned and if so should be done so properly. Pipe capped with steel plate and bolted. FIELD_STRUCT_DESC: 8-inch steel pipe through the levee 2.0 feet below the crown. Pump on concrete platform on waterward slope with 2-inch electrical conduit through the levee. (App. No.10498 - John Eilers) FS Date: 04/09/2014

WS view: pipe capped with steel plate on levee slope.

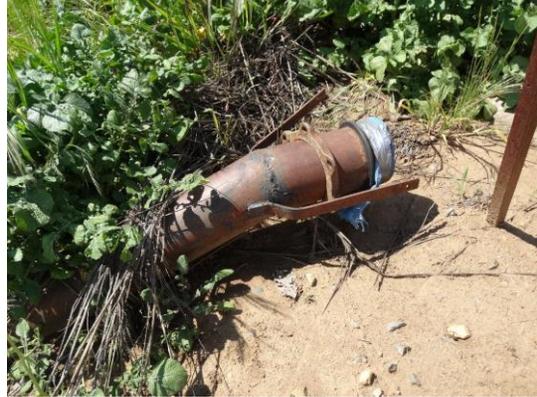
Photo 2 of 3 : UCIP\_FA\_2015\_5475.jpg

WS view: pump removed from steel pipe. Pipe capped with polythin sheet.

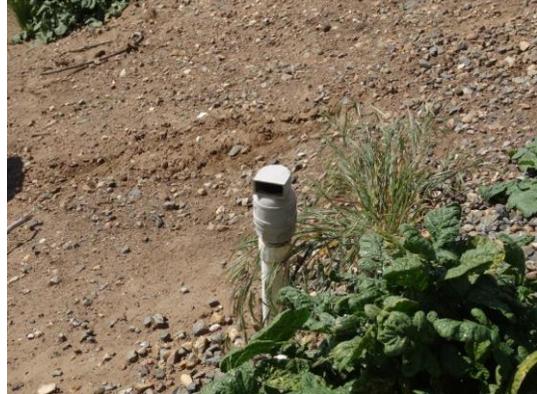
Photo 3 of 3 : UCIP\_FA\_2015\_5476.jpg

WS view: air vent on levee slope.

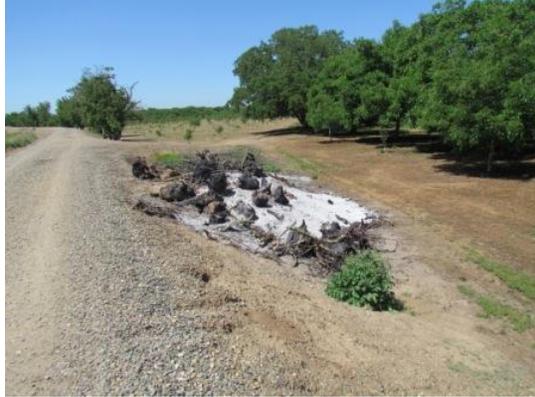
Photo 1 of 1 : FA\_2015\_NA0017\_159\_12\_20150911\_00005.jpg

LM Start	<b>3.34</b>	Rating **	M	Issue No.	<b>12</b>
LM End	<b>3.34</b>	Issue Type +	Ma	Location *	LS
Category	Earthen Levee		GPS Latitude/Longitude		
			Start	End	
Item	Encroachments		38.023817 °	38.023817 °	
			-121.058465 °	-121.058465 °	
DWR ID	DWR_NA0017_15_s_2012_12				
Action/Comments					
Prunings Inspector Comments: Burn pile has been burned but new material has been placed.

New material was placed at the toe of the landside of the levee. The picture was taken from the crown looking downstream.

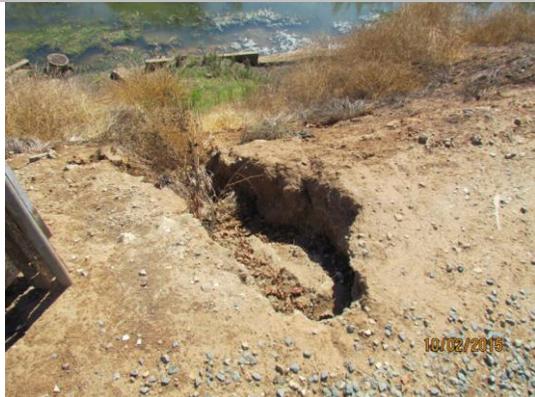
Photo 1 of 1 : FA\_2015\_NA0017\_159\_129\_20151009\_00141.jpg

Erosion was found on the waterside shoulder of the levee looking downstream.

LM Start	<b>3.34</b>	Rating **	M	Issue No.	<b>129</b>
LM End	<b>3.34</b>	Issue Type +	Ma	Location *	WS
Category	Earthen Levee		GPS Latitude/Longitude		
			Start	End	
Item	Erosion / Bank Caving		38.023804 °	38.023804 °	
			-121.058480 °	-121.058480 °	
DWR ID	DWR_NA0017_15_f_2015_129				
Action/Comments					
Schedule repair of erosion site prior to the next inspection.

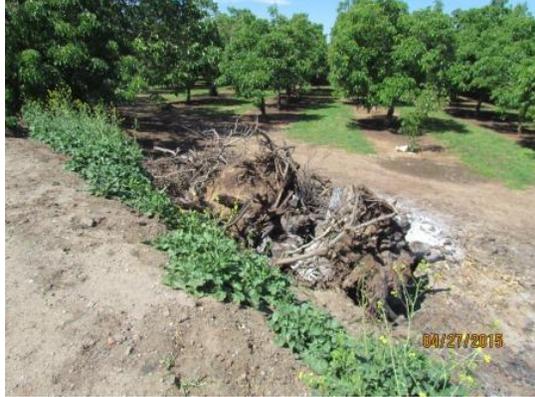
Photo 1 of 2 : FA\_2015\_NA0017\_159\_14\_20150911\_00006.jpg

LM Start	<b>3.54</b>	Rating **	A/W	Issue No.	<b>14</b>
LM End	<b>3.54</b>	Issue Type +	Ma	Location *	LS
Category	Earthen Levee			GPS Latitude/Longitude	
				Start	End
Item	Encroachments			38.021811 °	38.021811 °
				-121.061054 °	-121.061054 °
DWR ID	DWR_NA0017_15_s_2013_14				
Action/Comments					
Prunings Inspector Comments: The pit was repaired by the LMA but the prunings still exist. The burn pile is away from the levee prism.

Updated picture of the prunings on the landside toe of the levee during spring 2015 inspection.

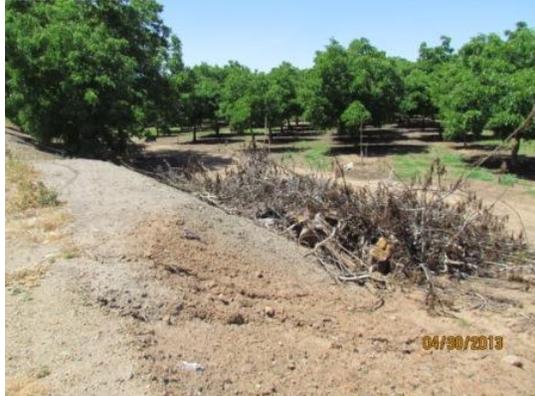
Photo 2 of 2 : FA\_2015\_NA0017\_159\_14\_20150911\_00007.jpg

Prunings were found on the landside toe of the levee looking downstream.

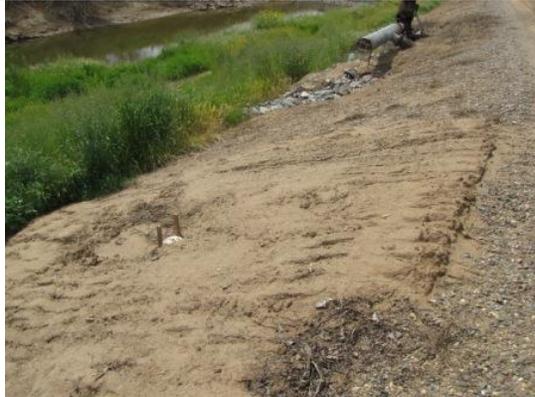
Photo 1 of 1 : FA\_2015\_NA0017\_159\_54\_20150911\_00041.jpg

LM Start	<b>3.56</b>	Rating **	M	Issue No.	<b>54</b>
LM End	<b>3.56</b>	Issue Type +	Ma	Location *	WS
Category	Earthen Levee		GPS Latitude/Longitude		
			Start	End	
Item	Encroachments		38.021601 °	38.021601 °	
			-121.061284 °	-121.061284 °	
DWR ID	DWR_NA0017_15_s_2012_54				
Action/Comments					
Pipe Inspector Comments: A recently placed pipe in the waterward slope may be leaking and was not authorized.

View of a recently placed pipe in the waterward slope looking downstream.

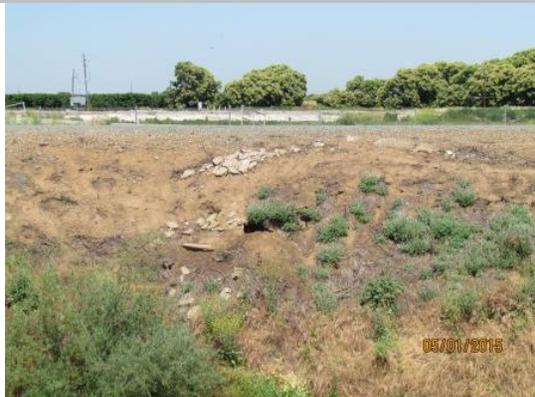
Photo 1 of 1 : FA\_2015\_NA0017\_159\_208\_20150911\_00113.jpg

A rodent hole was found on the waterside of the levee. The picture was taken from the opposite side of the levee.

LM Start	<b>3.77</b>	Rating **	M	Issue No.	<b>208</b>
LM End	<b>3.77</b>	Issue Type +	Ma	Location *	WS
Category	Earthen Levee		GPS Latitude/Longitude		
			Start	End	
Item	Animal Control		38.019026 °	38.019026 °	
			-121.063479 °	-121.063479 °	
DWR ID	DWR_NA0017_15_s_2015_208				
Action/Comments					
No rodents visible, but rodent burrows visible; need to backfill and compact or grout burrows.

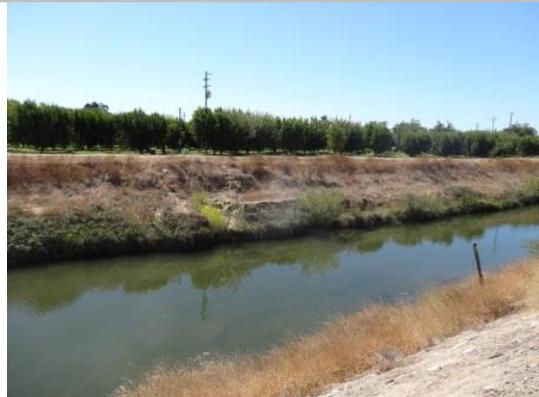
Photo 1 of 3 : SJR2015\_NA0017U16RM19.18\_1.jpg

LM Start	<b>3.87</b>	Rating **	M	Issue No.	<b>17</b>
LM End	<b>3.89</b>	Issue Type +	Ma	Location *	WS
Category	Supplemental		GPS Latitude/Longitude		
			Start	End	
Item	DWR Erosion Survey		38.018100 °	38.018100 °	
			-121.065170 °	-121.065170 °	
DWR ID					
<b>Action/Comments</b>					
Inspector Comments: 8/12/2015: No significant change observed. 8/20/2014: No significant change observed. 9/12/2013: No significant change observed. 08/22/2012: River-induced erosion occurred on the berm, while the runoff-induced erosion occurred on the levee slope. Site is covered with vegetation. There is no levee structure on site. The levee crest width

View of the site from right river bank.

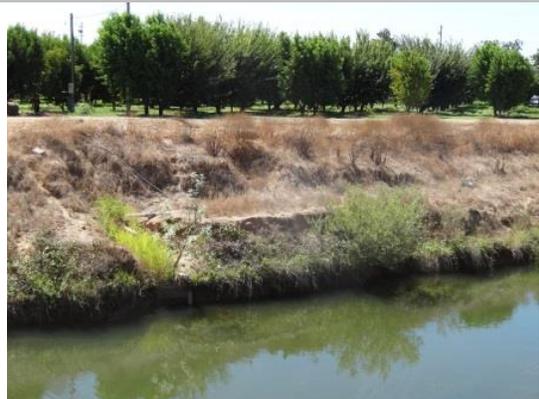
Photo 2 of 3 : SJR2015\_NA0017U16RM19.18\_2.jpg

Closer view of the erosion.

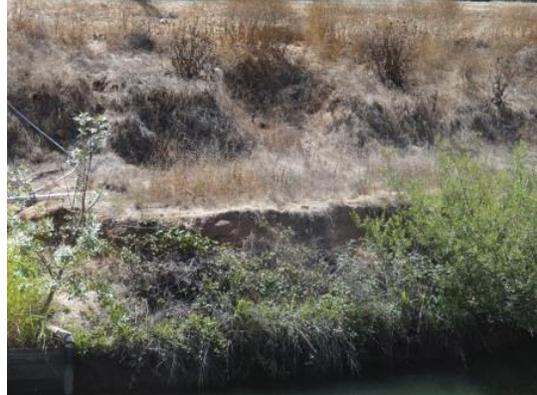
Photo 3 of 3 : SJR2015\_NA0017U16RM19.18\_4.jpg

Closer view of the erosion.

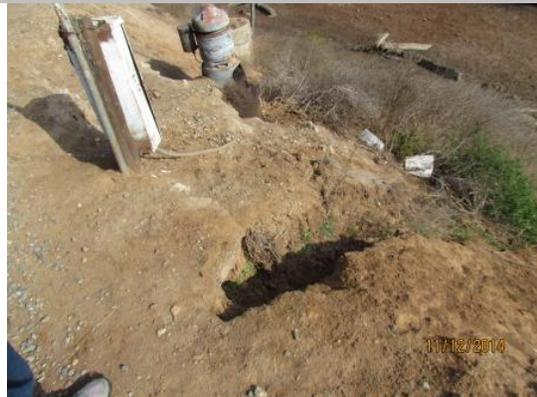
Photo 1 of 2 : FA\_2015\_NA0017\_159\_44\_20150911\_00032.jpg

Updated picture of the slope instability on the waterside slope of the levee looking upstream. This picture was taken during fall 2014 inspection.

LM Start	<b>3.89</b>	Rating **	M	Issue No.	<b>44</b>
LM End	<b>3.89</b>	Issue Type +	Ma	Location *	WS
Category	Earthen Levee			GPS Latitude/Longitude	
				Start	End
Item	Slope Stability			38.017945 °	38.017945 °
				-121.065295 °	-121.065295 °
DWR ID	DWR_NA0017_15_f_2012_44				
Action/Comments					
Repair slope instability.

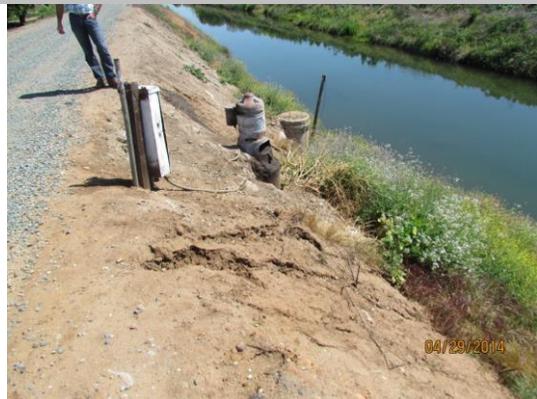
Photo 2 of 2 : FA\_2015\_NA0017\_159\_44\_20150911\_00033.jpg

View of the slope instability on the waterside slope of the levee looking downstream during spring 2014 inspection.

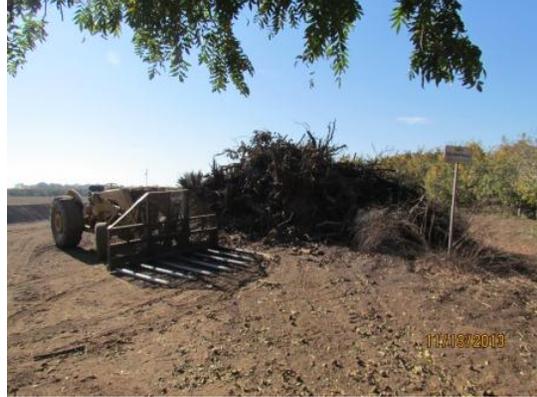
Photo 1 of 2 : FA\_2015\_NA0017\_159\_19\_20150911\_00012.jpg

LM Start	<b>4.20</b>	Rating **	M	Issue No.	<b>19</b>
LM End	<b>4.20</b>	Issue Type +	Ma	Location *	LS
Category	Earthen Levee			GPS Latitude/Longitude	
				Start	End
Item	Encroachments			38.014025 °	38.014025 °
				-121.067983 °	-121.067983 °
DWR ID	DWR_NA0017_15_s_2012_19				
Action/Comments					
Prunings Inspector Comments: Burn pile has been burned but new material has been placed.

Updated picture of the prunings pile on the landside of the levee looking downstream during fall 2013 inspection.

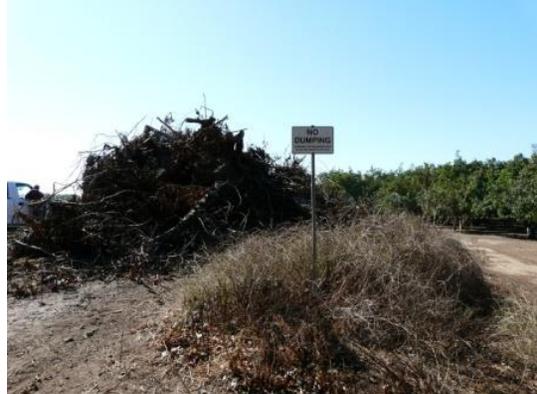
Photo 2 of 2 : FA\_2015\_NA0017\_159\_19\_20150911\_00013.jpg

Example of a prunings pile immediately adjacent to access road. Evidence of habitual burnings at this site.

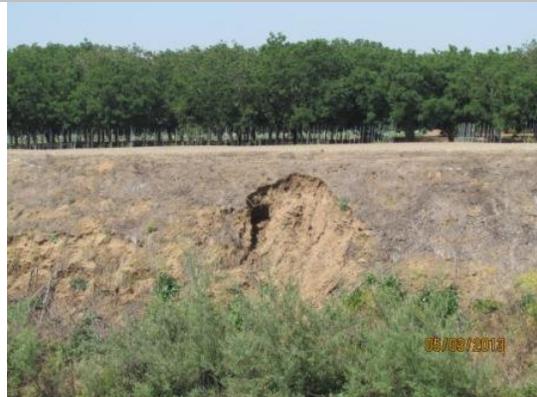
Photo 1 of 1 : FA\_2015\_NA0017\_159\_124\_20150911\_00080.jpg

An animal hole was found on the waterside slope of the levee. The picture was taken from the opposite side of the levee.

LM Start	<b>4.28</b>	Rating **	U	Issue No.	<b>124</b>
LM End	<b>4.28</b>	Issue Type +	Ma	Location *	WS
Category	Earthen Levee			GPS Latitude/Longitude	
				Start	End
Item	Animal Control			38.012910 °	38.012910 °
				-121.067996 °	-121.067996 °
DWR ID	DWR_NA0017_15_s_2013_124				
Action/Comments					
No rodents visible, but rodent burrows visible; need to backfill and compact or grout burrows. Inspector Comments: Picture was taken from the other side of the levee.

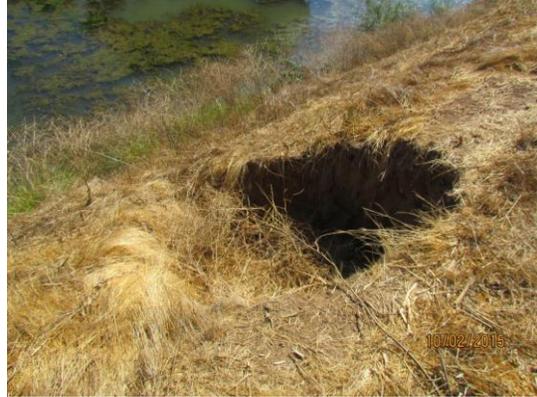
Photo 1 of 2 : FA\_2015\_NA0017\_159\_209\_20151009\_00143.jpg

View of the erosion caused by an animal hole on the waterside shoulder of the levee looking downstream.

LM Start	<b>4.31</b>	Rating **	M	Issue No.	<b>209</b>
LM End	<b>4.31</b>	Issue Type +	Ma	Location *	WS
Category	Earthen Levee			GPS Latitude/Longitude	
				Start	End
Item	Erosion / Bank Caving			38.012474 °	38.012474 °
				-121.068144 °	-121.068144 °
DWR ID	DWR_NA0017_15_s_2015_209				
Action/Comments					
Schedule repair of erosion site prior to the next inspection. Inspector Comments: It was started from rodent holes.

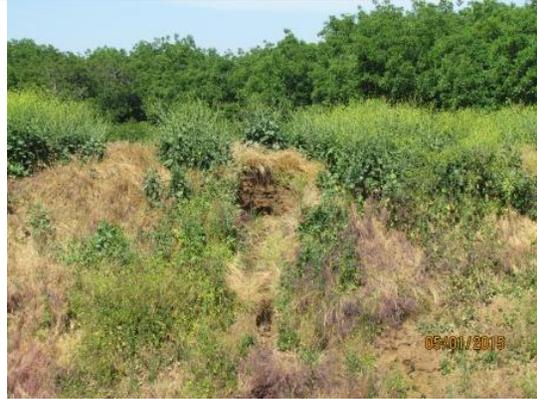
Photo 2 of 2 : FA\_2015\_NA0017\_159\_209\_20150911\_00114.jpg

A large rodent hole was found on the waterside of the levee. The picture was taken across the levee.

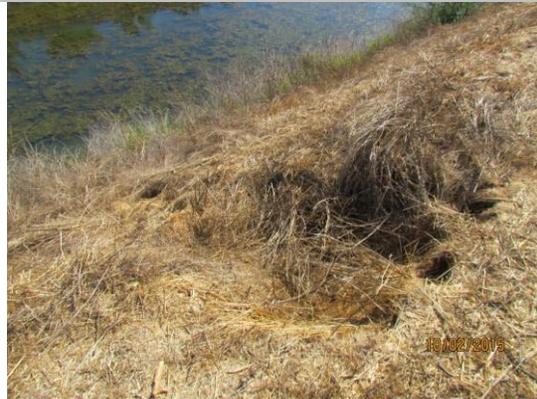
Photo 1 of 1 : FA\_2015\_NA0017\_159\_133\_20151009\_00144.jpg

Erosion was found on the waterside shoulder of the levee looking downstream.

LM Start	<b>4.51</b>	Rating **	M	Issue No.	<b>133</b>
LM End	<b>4.51</b>	Issue Type +	Ma	Location *	WS
Category	Earthen Levee			GPS Latitude/Longitude	
				Start	End
Item	Erosion / Bank Caving			38.009753 °	38.009753 °
				-121.069559 °	-121.069559 °
DWR ID	DWR_NA0017_15_f_2015_133				
Action/Comments					
Schedule repair of erosion site prior to the next inspection.

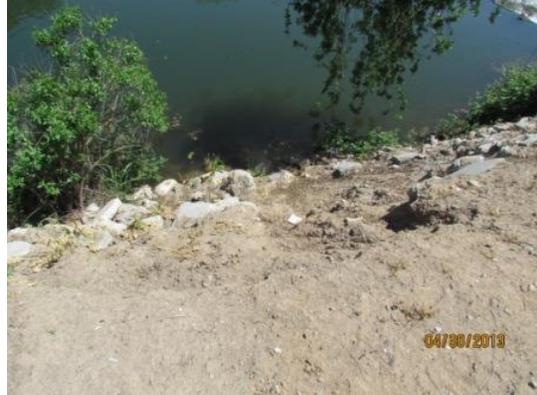
Photo 1 of 3 : FA\_2015\_NA0017\_159\_96\_20150911\_00064.jpg

LM Start	<b>4.63</b>	Rating **	M	Issue No.	<b>96</b>
LM End	<b>4.63</b>	Issue Type +	Ma	Location *	WS
Category	Earthen Levee			GPS Latitude/Longitude	
				Start	End
Item	Erosion / Bank Caving			38.008053 °	38.008053 °
				-121.070141 °	-121.070141 °
DWR ID	DWR_NA0017_15_s_2012_96				
Action/Comments					
Note and monitor erosion site. Inspector Comments: LMA has fixed the issue but the riprap has rebar which would can be dangerous during the flood fighting efforts.

Updated picture of the slope instability on the waterside slope of the levee looking downstream during spring 2013 inspection.

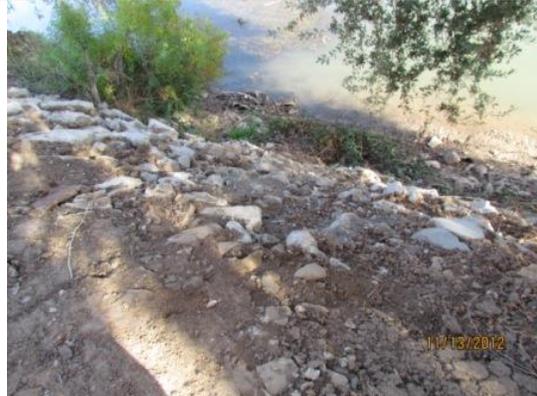
Photo 2 of 3 : FA\_2015\_NA0017\_159\_96\_20150911\_00065.jpg

The LMA has fixed the erosion on the landside slope of the levee but the riprap contains exposed rebar which could be dangerous during a flood fight.

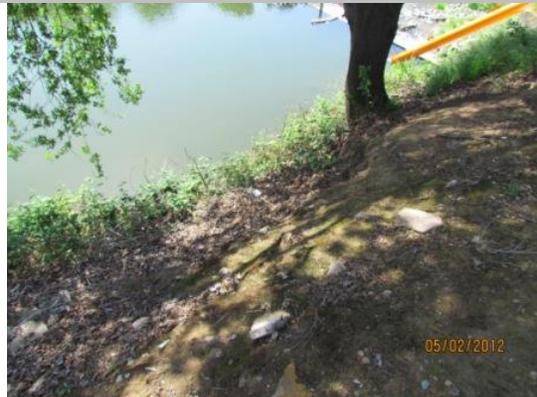
Photo 3 of 3 : FA\_2015\_NA0017\_159\_96\_20150911\_00066.jpg

LM Start	<b>4.63</b>	Rating **	M	Issue No.	<b>96 (cont)</b>
LM End	<b>4.63</b>	Issue Type +	Ma	Location *	WS

Erosion was found on the waterside slope of the levee looking downstream.

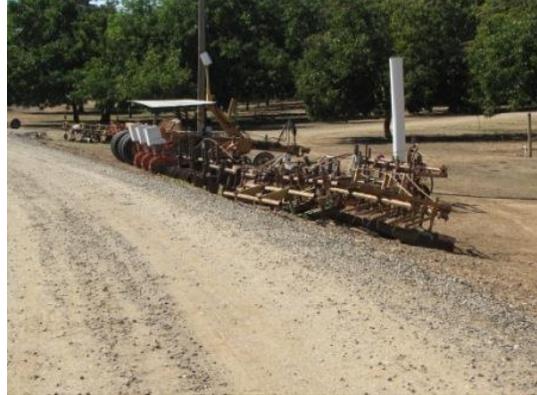
Photo 1 of 1 : FA\_2015\_NA0017\_159\_20\_20150911\_00014.jpg

LM Start	<b>4.85</b>	Rating **	M	Issue No.	<b>20</b>
LM End	<b>4.85</b>	Issue Type +	En	Location *	LS
Category	Earthen Levee		GPS Latitude/Longitude		
			Start	End	
Item	Encroachments		38.005302 °	38.005302 °	
			-121.071867 °	-121.071867 °	
DWR ID	DWR_NA0017_15_s_2012_20				
Action/Comments					
Equipment

View of equipment along the landward slope looking downstream.

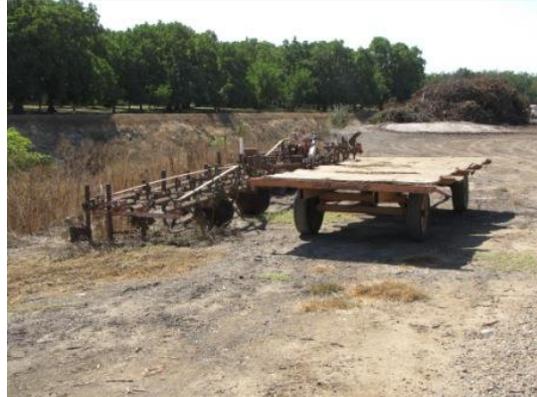
Photo 1 of 1 : FA\_2015\_NA0017\_159\_21\_20150911\_00015.jpg

LM Start	<b>4.85</b>	Rating **	M	Issue No.	<b>21</b>
LM End	<b>4.85</b>	Issue Type +	En	Location *	WS
Category	Earthen Levee		GPS Latitude/Longitude		
			Start	End	
Item	Encroachments		38.005300 °	38.005300 °	
			-121.071863 °	-121.071863 °	
DWR ID	DWR_NA0017_15_s_2012_21				
Action/Comments					
Equipment

View of equipment along the waterward side of the levee crown looking downstream.

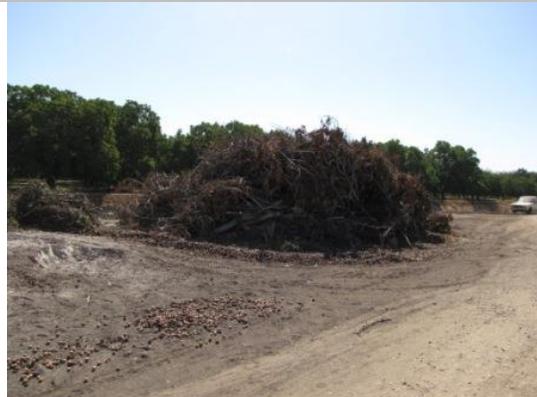
Photo 1 of 1 : FA\_2015\_NA0017\_159\_74\_20150911\_00055.jpg

LM Start	<b>4.87</b>	Rating **	M	Issue No.	<b>74</b>
LM End	<b>4.87</b>	Issue Type +	En	Location *	WS
Category	Earthen Levee		GPS Latitude/Longitude		
			Start	End	
Item	Encroachments		38.005040 °	38.005040 °	
			-121.071886 °	-121.071886 °	
DWR ID	DWR_NA0017_15_s_2012_74				
Action/Comments					
Prunings Inspector Comments: Burn pile has been burned but new material has been placed.

View of prunings pile along the waterward side of the crown looking downstream.

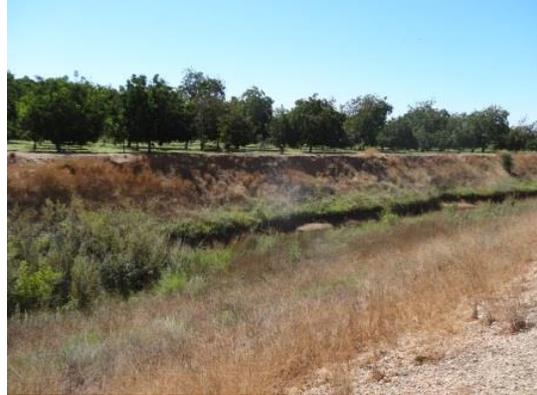
Photo 1 of 2 : SJR2015\_NA0017U16RM17.99\_1.jpg

LM Start	<b>4.98</b>	Rating **	U	Issue No.	<b>11</b>
LM End	<b>4.98</b>	Issue Type +	Ma	Location *	WS
Category	Supplemental			GPS Latitude/Longitude	
				Start	End
Item	DWR Erosion Survey			38.003730 °	38.003730 °
				-121.073080 °	-121.073080 °
DWR ID					
Action/Comments					
Inspector Comments: 8/12/2015: No significant change observed. 8/20/2014: No significant change observed. 9/12/2013: Site has been surveyed and the pocket erosion has developed toward levee crest. 08/22/2012: A pocket erosion at the levee toe and on lower slope. The levee surface at the upper slope also shows signs of erosion due to poor maintenance. There is no levee structure on site. The levee crest width and levee height were not measured or estimated in the field. [2015 Site ID:NA0017U16RM17.99]

View from right river bank.

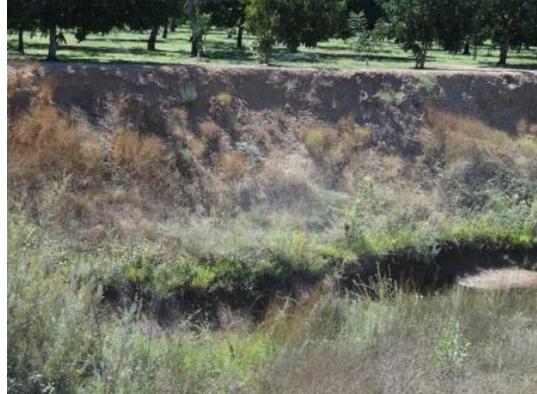
Photo 2 of 2 : SJR2015\_NA0017U16RM17.99\_4.jpg

LM Start	<b>4.98</b>	Rating **	U	Issue No.	<b>11 (cont)</b>
LM End	<b>4.98</b>	Issue Type +	Ma	Location *	WS

A close view of the erosion.

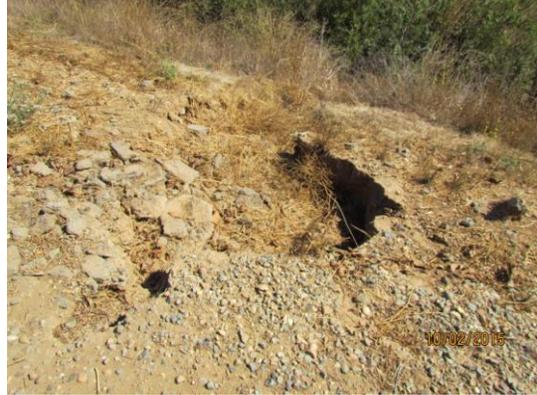
Photo 1 of 2 : FA\_2015\_NA0017\_159\_171\_20151009\_00145.jpg

LM Start	<b>5.03</b>	Rating **	M	Issue No.	<b>171</b>
LM End	<b>5.03</b>	Issue Type +	Ma	Location *	WS
Category	Earthen Levee			GPS Latitude/Longitude	
				Start	End
Item	Erosion / Bank Caving			38.003105 °	38.003105 °
				-121.073585 °	-121.073585 °
DWR ID	DWR_NA0017_15_f_2014_171				
Action/Comments					
Schedule repair of erosion site prior to the next inspection. Inspector Comments: Bank Caving.

Updated picture of the slope instability on the waterside of the levee looking upstream during fall 2015 inspection.

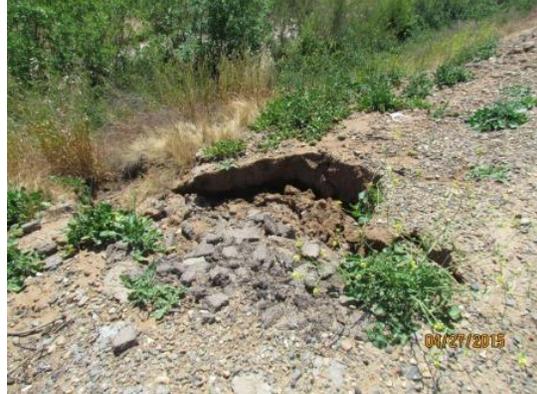
Photo 2 of 2 : FA\_2015\_NA0017\_159\_171\_20150911\_00096.jpg

LM Start	<b>5.03</b>	Rating **	M	Issue No.	<b>171 (cont)</b>
LM End	<b>5.03</b>	Issue Type +	Ma	Location *	WS

Picture of the slope instability on the waterside of the levee looking downstream during spring 2015 inspection.

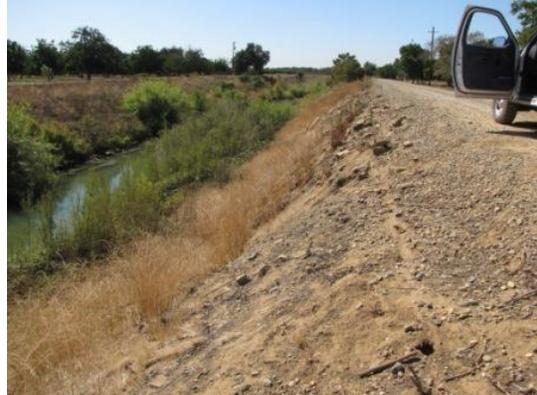
Photo 1 of 1 : FA\_2015\_NA0017\_159\_1009\_20150911\_00120.jpg

LM Start	<b>5.04</b>	Rating **	M	Issue No.	<b>1009</b>
LM End	<b>5.04</b>	Issue Type +	Ma	Location *	WS
Category	Earthen Levee			GPS Latitude/Longitude	
				Start	End
Item	Slope Stability			38.003021 °	38.003021 °
				-121.073658 °	-121.073658 °
DWR ID	DWR_NA0017_15_s_2012_1009				
Action/Comments					
Repair slope instability.

View of a slip in the waterward levee slope looking downstream.

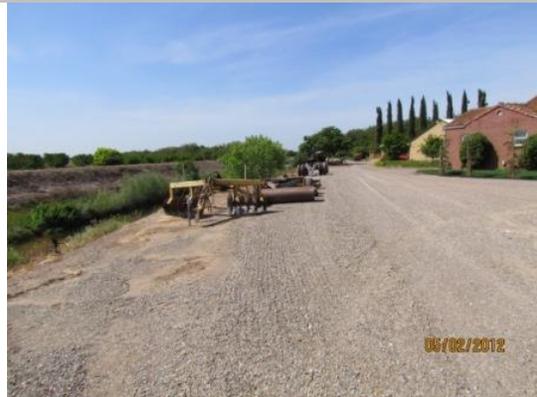
Photo 1 of 1 : FA\_2015\_NA0017\_159\_111\_20150911\_00074.jpg

LM Start	<b>5.27</b>	Rating **	M	Issue No.	<b>111</b>
LM End	<b>5.27</b>	Issue Type +	En	Location *	WS
Category	Earthen Levee			GPS Latitude/Longitude	
				Start	End
Item	Encroachments			38.000297 °	38.000297 °
				-121.076113 °	-121.076113 °
DWR ID	DWR_NA0017_15_s_2012_111				
Action/Comments					
Equipment

Equipment was found on the waterside of the levee looking downstream.

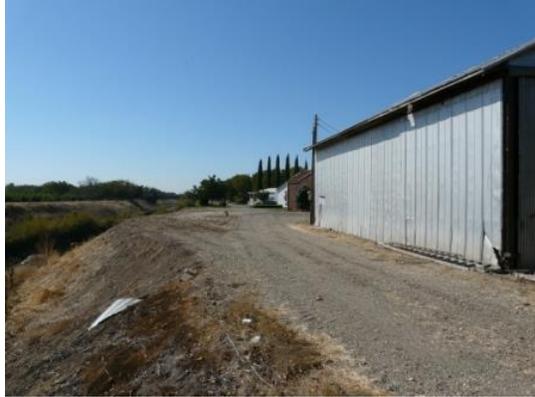
Photo 1 of 1 : FA\_2015\_NA0017\_159\_24\_20150911\_00016.jpg

LM Start	<b>5.27</b>	Rating **	M	Issue No.	<b>24</b>
LM End	<b>5.33</b>	Issue Type +	En	Location *	LS
Category	Earthen Levee		GPS Latitude/Longitude		
			Start	End	
Item	Encroachments		38.000308 °	37.999502 °	
			-121.076133 °	-121.076835 °	
DWR ID	DWR_NA0017_15_s_2012_24				
Action/Comments					
Building

Building located immediately adjacent to access road approximately from LM 5.38 to 5.45
