**Flood Control Project Maintenance  
Levee Inspections**

**Fall 2015 Levee Maintenance Deficiency Summary Report**

**San Joaquin River Basin**

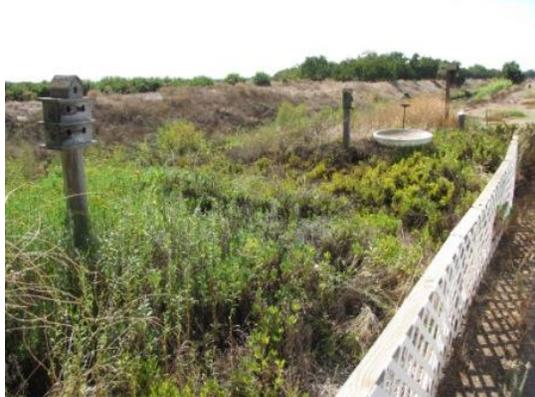
Photo 1 of 1 : FA\_2015\_NA0017\_159\_1012\_20150911\_00121.jpg

LM Start	<b>5.32</b>	Rating **	M	Issue No.	<b>1012</b>
LM End	<b>5.32</b>	Issue Type +	En	Location *	WS
Category	Earthen Levee		GPS Latitude/Longitude		
			Start	End	
Item	Vegetation		37.999718 °	37.999718 °	
			-121.076665 °	-121.076665 °	
DWR ID	DWR_NA0017_15_s_2012_1012				
Action/Comments					
Landscaping

View of landscaping planted along the waterward side of the access road impacting visibility and the ability to floodfight looking downstream.

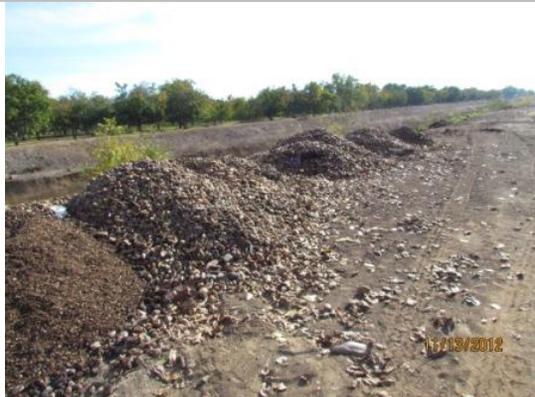
Photo 1 of 2 : FA\_2015\_NA0017\_159\_1014\_20150911\_00122.jpg

LM Start	<b>5.49</b>	Rating **	M	Issue No.	<b>1014</b>
LM End	<b>5.54</b>	Issue Type +	En	Location *	WS
Category	Earthen Levee		GPS Latitude/Longitude		
			Start	End	
Item	Encroachments		37.997619 °	37.997043 °	
			-121.078405 °	-121.078972 °	
DWR ID	DWR_NA0017_15_s_2012_1014				
Action/Comments					
Material Inspector Comments: Walnut piles on waterward shoulder.

In addition to the walnut piles, there were rocks and debris were found at the landside shoulder of the levee looking downstream.

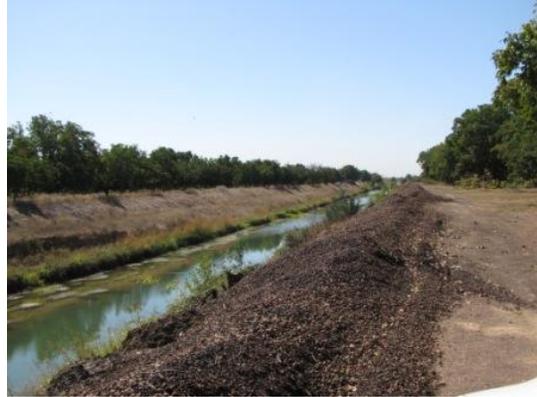
Photo 2 of 2 : FA\_2015\_NA0017\_159\_1014\_20150911\_00123.jpg

LM Start	<b>5.49</b>	Rating **	M	Issue No.	<b>1014 (cont)</b>
LM End	<b>5.54</b>	Issue Type +	En	Location *	WS
Category	Earthen Levee		GPS Latitude/Longitude		
			Start	End	
Item	Encroachments		37.997619 °	37.997043 °	
			-121.078405 °	-121.078972 °	
DWR ID	DWR_NA0017_15_s_2012_1014				
Action/Comments					
Material Inspector Comments: Walnut piles on waterward shoulder.

View of discarded nut shells placed along the waterward slope to be burned looking downstream.

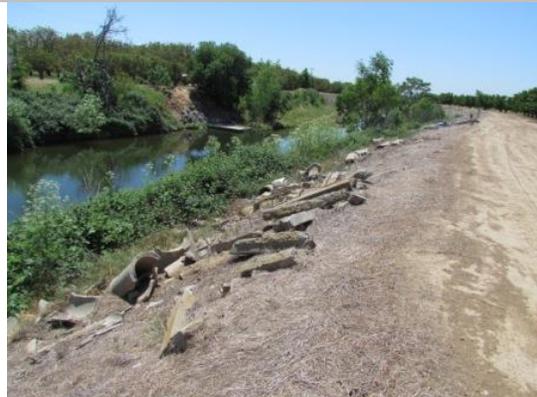
Photo 1 of 2 : FA\_2015\_NA0017\_159\_25\_20150911\_00017.jpg

LM Start	<b>5.65</b>	Rating **	M	Issue No.	<b>25</b>
LM End	<b>5.74</b>	Issue Type +	En	Location *	WS
Category	Earthen Levee		GPS Latitude/Longitude		
			Start	End	
Item	Encroachments		37.995733 °	37.994670 °	
			-121.080102 °	-121.081207 °	
DWR ID	DWR_NA0017_15_s_2012_25				
Action/Comments					
Debris

Broken concrete pipes and other debris were found on the waterside of the levee. The picture was taken from the crown looking downstream.

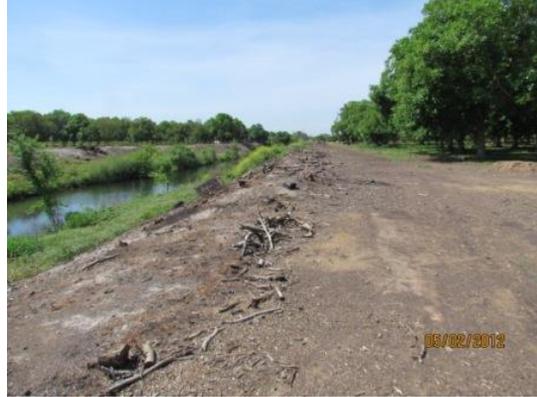
Photo 2 of 2 : FA\_2015\_NA0017\_159\_25\_20150911\_00018.jpg

LM Start	<b>5.65</b>	Rating **	M	Issue No.	<b>25 (cont)</b>
LM End	<b>5.74</b>	Issue Type +	En	Location *	WS
Category	Earthen Levee		GPS Latitude/Longitude		
			Start	End	
Item	Encroachments		37.995733 °	37.994670 °	
			-121.080102 °	-121.081207 °	
DWR ID	DWR_NA0017_15_s_2012_25				
Action/Comments					
Debris

Debris were still on the waterside of the levee looking downstream. This picture was taken during Spring 2012 inspection.

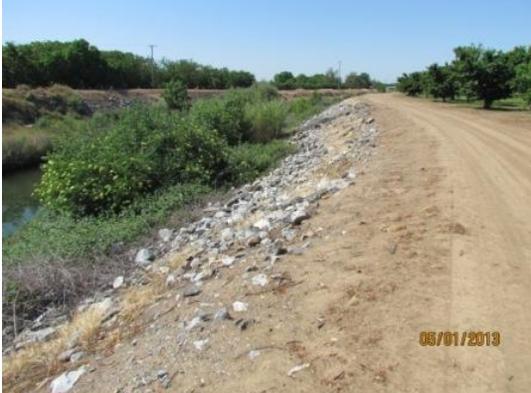
Photo 1 of 1 : FA\_2015\_NA0017\_159\_84\_20150911\_00061.jpg

LM Start	<b>5.84</b>	Rating **	M	Issue No.	<b>84</b>
LM End	<b>5.93</b>	Issue Type +	En	Location *	WS
Category	Earthen Levee		GPS Latitude/Longitude		
			Start	End	
Item	Encroachments		37.993554 °	37.992476 °	
			-121.082192 °	-121.083241 °	
DWR ID	DWR_NA0017_15_s_2012_84				
Action/Comments					
Material

Materials were found on the waterside slope of the levee looking downstream.

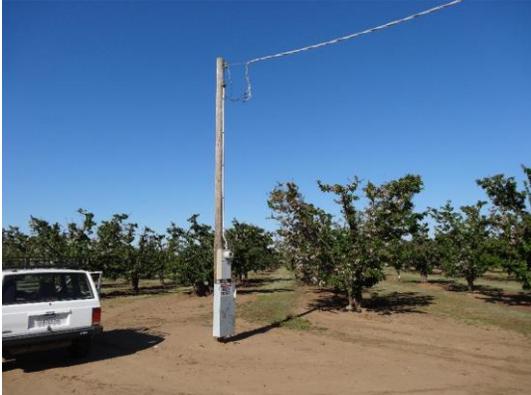
Photo 1 of 2 : UCIP\_FA\_2015\_5610.jpg

LM Start	<b>5.86</b>	Rating **	M	Issue No.	<b>1165</b>
LM End	<b>5.86</b>	Issue Type +	En	Location *	WS
Category	Supplemental		GPS Latitude/Longitude		
			Start	End	
Item	DWR UCIP Field Study		37.993295 °	37.993295 °	
			-121.082498 °	-121.082498 °	
DWR ID					
Action/Comments					
Inspector Comments: FS_ID:34925 DS_ID:24852 EP_NO: N/A FS_HLM: 5.984 Repair Type: Non-Urgent Crossing Status: Found UCIP Comments: Field discovered crossing. Only visible on waterside. Air vent was leaking during field visit. FIELD_STRUCT_DESC: 10-inch steel pipe and electric conduit through the levee, 2.5 ft. below the crown. Pump on concrete pad on waterside shoulder. U type concrete headwall on levee shoulder. Gate valve, air vent, and flow meter on waterside. Power switch panel on landside shoulder. FS Date: 04/10/2014

LS view: power pole and switch panel on landside.

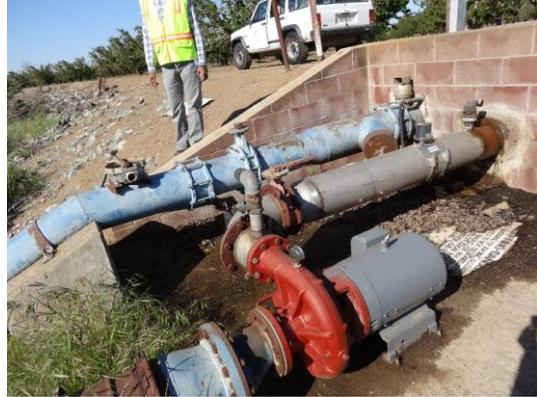
Photo 2 of 2 : UCIP\_FA\_2015\_5613.jpg

LM Start	<b>5.86</b>	Rating **	M	Issue No.	<b>1166 (cont)</b>
LM End	<b>5.86</b>	Issue Type +	En	Location *	WS
Category	Supplemental			GPS Latitude/Longitude	
				Start	End
Item	DWR UCIP Field Study			37.993289 °	37.993289 °
				-121.082503 °	-121.082503 °
DWR ID					
Action/Comments					
Inspector Comments: FS_ID:41630 DS_ID:23298 EP_NO: 12308 FS_HLM: 5.984 Repair Type: Non-Urgent Crossing Status: Found UCIP Comments: Looks abandoned and if so should be done so properly. FIELD_STRUCT_DESC: 12-inch-diameter pipeline 2.5 feet below the roadway. Pump diversion structure and well on slough bank and in channel. (Permit No. 12308-1978) (combination pipe diversion and well discharge) Power pole on landside. Pump connected to new pipe. FS Date: 04/10/2014

WS view: pipe (left), headwall, and appurtenances on concrete pad on levee slope.

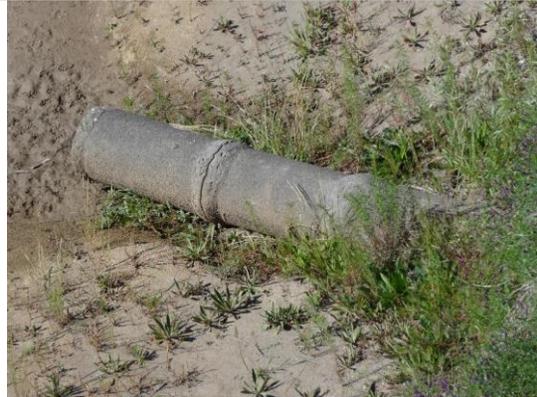
Photo 1 of 2 : UCIP\_FA\_2015\_5614.jpg

LM Start	<b>6.42</b>	Rating **	M	Issue No.	<b>1167</b>
LM End	<b>6.42</b>	Issue Type +	En	Location *	WS
Category	Supplemental			GPS Latitude/Longitude	
				Start	End
Item	DWR UCIP Field Study			37.986776 °	37.986776 °
				-121.088137 °	-121.088137 °
DWR ID					
Action/Comments					
Inspector Comments: FS_ID:41626 DS_ID:23218 EP_NO: N/A FS_HLM: 6.54 Repair Type: Non-Urgent Crossing Status: Found UCIP Comments: Looks abandoned. Pipe found under the bridge and visible on both sides of the channel. FIELD_STRUCT_DESC: Abandoned 16-inch concrete siphon through the levee 4.0 feet below the crown and under the channel. O&M Manual SJR Assumed 999. FS Date: 04/10/2014

WS view: closer view of concrete pipe on channel bank.

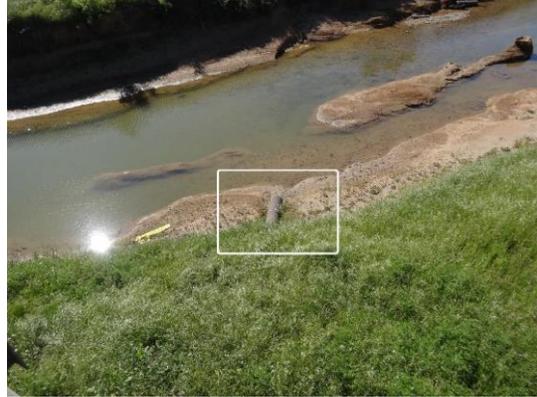
Photo 2 of 2 : UCIP\_FA\_2015\_5615.jpg

LM Start	<b>6.42</b>	Rating **	M	Issue No.	<b>1167 (cont)</b>
LM End	<b>6.42</b>	Issue Type +	En	Location *	WS
Category	Supplemental			GPS Latitude/Longitude	
				Start	End
Item	DWR UCIP Field Study			37.986776 °	37.986776 °
				-121.088137 °	-121.088137 °
DWR ID					
Action/Comments					
Inspector Comments: FS_ID:41626 DS_ID:23218 EP_NO: N/A FS_HLM: 6.54 Repair Type: Non-Urgent Crossing Status: Found UCIP Comments: Looks abandoned. Pipe found under the bridge and visible on both sides of the channel. FIELD_STRUCT_DESC: Abandoned 16-inch concrete siphon through the levee 4.0 feet below the crown and under the channel. O&M Manual SJR Assumed 999. FS Date: 04/10/2014

WS view: concrete pipe on channel bank.

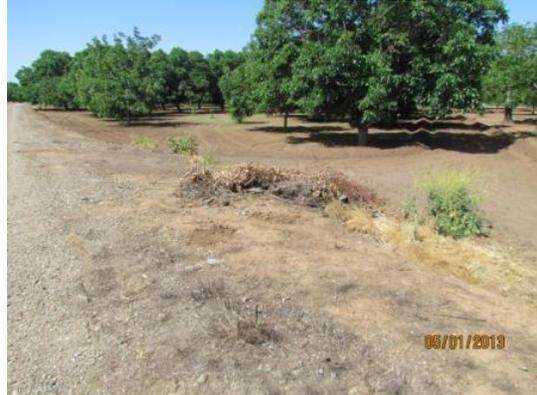
Photo 1 of 1 : FA\_2015\_NA0017\_159\_98\_20150911\_00067.jpg

LM Start	<b>6.46</b>	Rating **	M	Issue No.	<b>98</b>
LM End	<b>6.46</b>	Issue Type +	Ma	Location *	LS
Category	Earthen Levee			GPS Latitude/Longitude	
				Start	End
Item	Encroachments			37.986225 °	37.986225 °
				-121.088704 °	-121.088704 °
DWR ID	DWR_NA0017_15_f_2012_98				
Action/Comments					
Prunings

Prunings were found on the landside of the levee looking downstream.

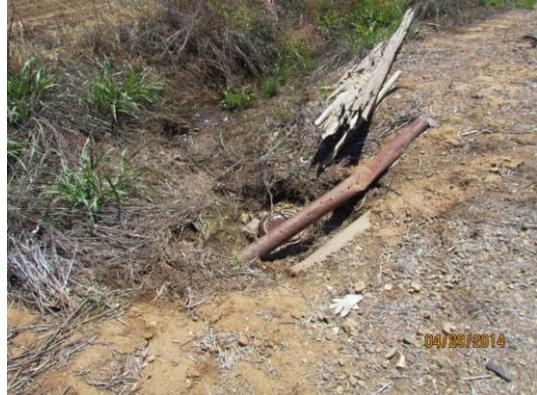
Photo 1 of 1 : FA\_2015\_NA0017\_159\_82\_20150911\_00059.jpg

LM Start	<b>6.59</b>	Rating **	M	Issue No.	<b>82</b>
LM End	<b>6.59</b>	Issue Type +	En	Location *	WS
Category	Earthen Levee			GPS Latitude/Longitude	
				Start	End
Item	Encroachments			37.984696 °	37.984696 °
				-121.090054 °	-121.090054 °
DWR ID	DWR_NA0017_15_s_2014_82				
Action/Comments					
Pipe

An abandoned pipe was found on the waterside slope of the levee looking downstream.

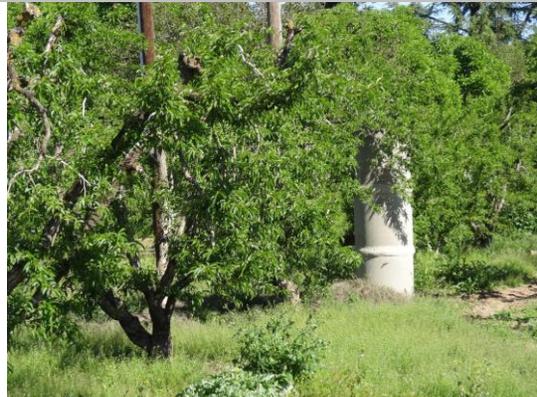
Photo 1 of 3 : UCIP\_FA\_2015\_4092.jpg

LM Start	<b>6.59</b>	Rating **	M	Issue No.	<b>1168</b>
LM End	<b>6.59</b>	Issue Type +	En	Location *	WS
Category	Supplemental			GPS Latitude/Longitude	
				Start	End
Item	DWR UCIP Field Study			37.984667 °	37.984667 °
				-121.090067 °	-121.090067 °
DWR ID					
Action/Comments					
Inspector Comments: FS_ID:40384 DS_ID:23219 EP_NO: N/A FS_HLM: 6.729 Repair Type: Non-Urgent Crossing Status: Found UCIP Comments: No pipe found. An alfalfa valve on waterside shoulder. Needs more info from the LMA or DWR Inspector. Concrete standpipe and power pole on waterside. A concrete standpipe off the levee on landside. FIELD_STRUCT_DESC: 12-inch concrete pipe through the levee 5.0 feet below the crown. 24-inch concrete standpipe on the waterward side. Power pole on berm. Pump mounted on wooden platform in channel. O&M Manual SJR Assumed 999. FS Date: 04/10/2014

LS view: a concrete standpipe off the levee toe.

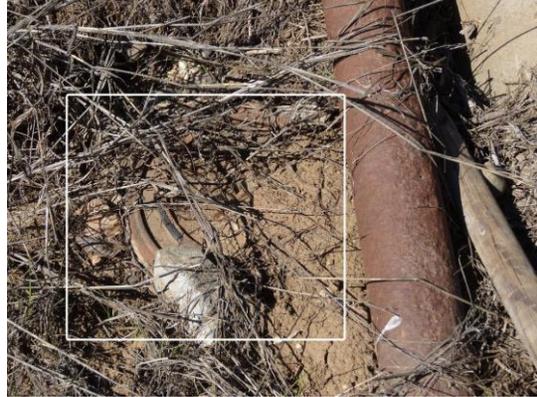
Photo 2 of 3 : UCIP\_FA\_2015\_4093.jpg

WS view: a steel pipe and alfalfa valve also found on levee berm.

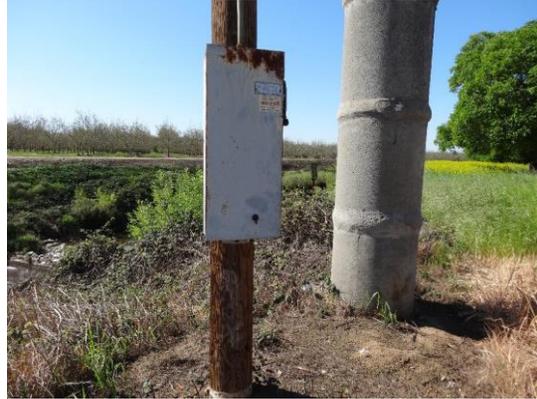
Photo 3 of 3 : UCIP\_FA\_2015\_4094.jpg

WS view: concrete standpipe and switch panel on levee berm.

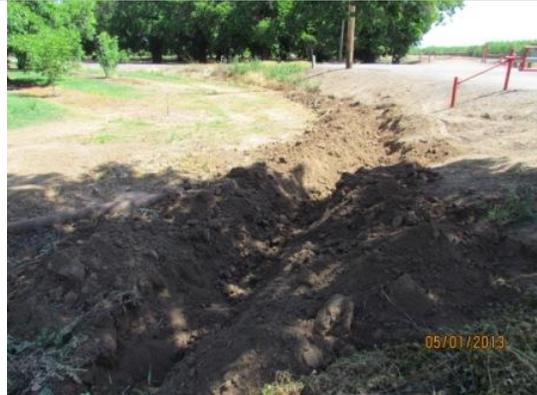
Photo 1 of 1 : FA\_2015\_NA0017\_159\_51\_20150911\_00039.jpg

LM Start	<b>6.94</b>	Rating **	M	Issue No.	<b>51</b>
LM End	<b>6.94</b>	Issue Type +	En	Location *	LS
Category	Earthen Levee			GPS Latitude/Longitude	
				Start	End
Item	Encroachments			37.981517 °	37.981517 °
				-121.095061 °	-121.095061 °
DWR ID	DWR_NA0017_15_s_2013_51				
Action/Comments					
Ditch

An agricultural ditch was found on the landside toe of the levee looking upstream.

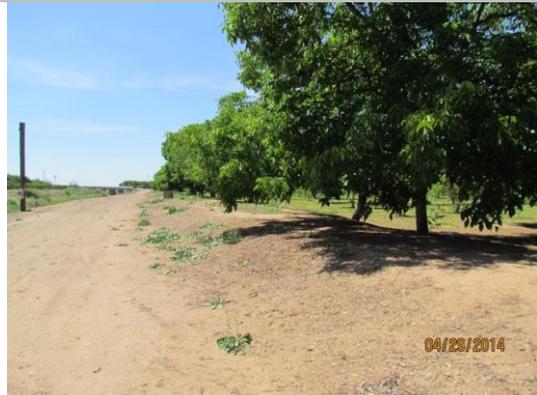
Photo 1 of 1 : FA\_2015\_NA0017\_159\_115\_20150911\_00076.jpg

Tree limbs were obstructing the visibility of the crown of the levee looking downstream.

LM Start	<b>6.96</b>	Rating **	M	Issue No.	<b>115</b>
LM End	<b>7.20</b>	Issue Type +	Ma	Location *	LS
Category	Earthen Levee			GPS Latitude/Longitude	
				Start	End
Item	Trim / Thin Trees			37.981387 °	37.979749 °
				-121.095370 °	-121.099178 °
DWR ID	DWR_NA0017_15_s_2014_115				
Action/Comments					
Trim trees to at least five feet above ground level.

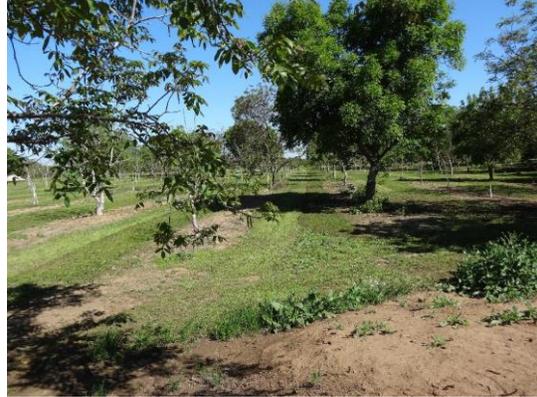
Photo 1 of 3 : UCIP\_FA\_2015\_4095.jpg

LM Start	<b>6.98</b>	Rating **	M	Issue No.	<b>1169</b>
LM End	<b>6.98</b>	Issue Type +	En	Location *	LS
Category	Supplemental			GPS Latitude/Longitude	
				Start	End
Item	DWR UCIP Field Study			37.981279 °	37.981279 °
				-121.095735 °	-121.095735 °
DWR ID					
Action/Comments					
Inspector Comments: FS_ID:41732 DS_ID:23222 EP_NO: N/A FS_HLM: 7.128 Repair Type: Non-Urgent Crossing Status: Found UCIP Comments: 4-inch pvc pipe sleeved through 8-inch steel pipe. Levee surface erosion on waterside. Annular space does not appear to be grouted. FIELD_STRUCT_DESC: A 4-inch pvc pipe sleeved through 8-inch steel pipe through the levee 3.0 feet below the crown. Pump on the waterside. Pole and switch panel on the waterside berm. O&M Manual SJR Assumed 999. FS Date: 04/10/2014

LS view: no pipe and appurtenances found.

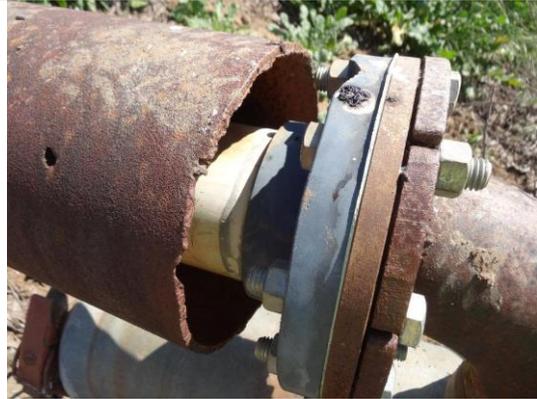
Photo 2 of 3 : UCIP\_FA\_2015\_4096.jpg

WS view: a 4-inch pvc pipe sleeved through steel pipe.

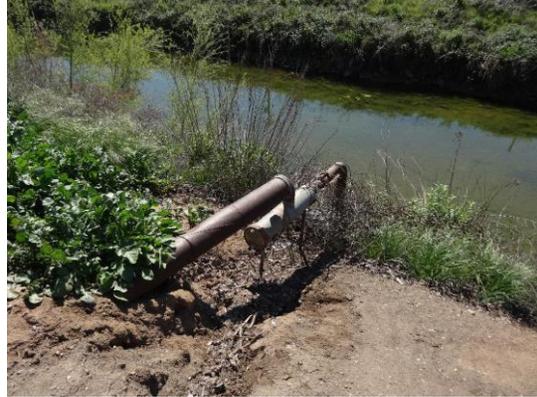
Photo 3 of 3 : UCIP\_FA\_2015\_4097.jpg

WS view: steel pipe and filter on levee slope. Surface erosion on levee slope.

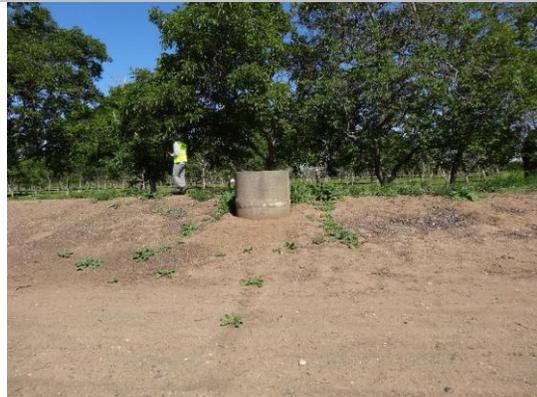
Photo 1 of 3 : UCIP\_FA\_2015\_3506.jpg

LM Start	<b>6.99</b>	Rating **	M	Issue No.	<b>1170</b>
LM End	<b>6.99</b>	Issue Type +	En	Location *	LS
Category	Supplemental			GPS Latitude/Longitude	
				Start	End
Item	DWR UCIP Field Study			37.981222 °	37.981222 °
				-121.095881 °	-121.095881 °
DWR ID					
Action/Comments					
Inspector Comments: FS_ID:40385 DS_ID:23452 EP_NO: N/A FS_HLM: 7.137 Repair Type: Non-Urgent Crossing Status: Found UCIP Comments: Appears abandoned and if so should be done so properly. Only a concrete riser with 12-inch pipe on levee shoulder. FIELD_STRUCT_DESC: A 12-inch concrete pipe through the levee 1.5 feet below the crown. 36-inch concrete standpipe on the landward side. O&M Manual SJR Assumed 999. FS Date: 04/10/2014

WS view: a concrete riser on old levee slope.

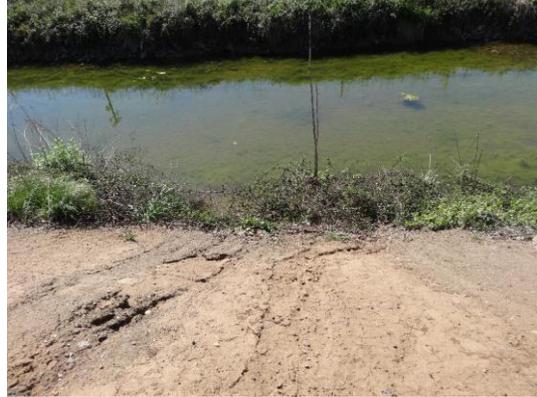
Photo 2 of 3 : UCIP\_FA\_2015\_3507.jpg

WS view: no pipe or appurtenances found on levee slope.

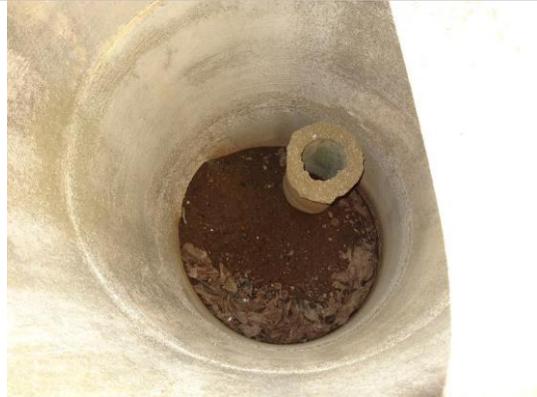
Photo 3 of 3 : UCIP\_FA\_2015\_4098.jpg

WS view: inside view of concrete riser.

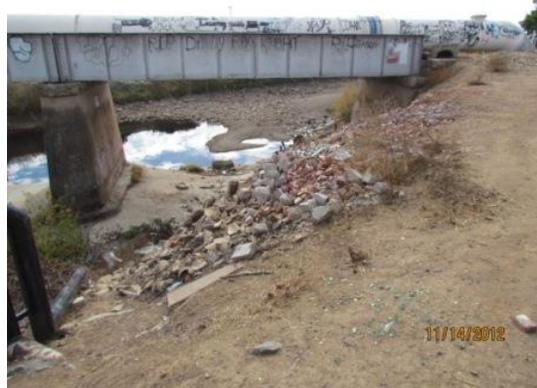
Photo 1 of 1 : FA\_2015\_NA0017\_159\_102\_20150911\_00068.jpg

LM Start	<b>7.21</b>	Rating **	M	Issue No.	<b>102</b>
LM End	<b>7.21</b>	Issue Type +	Ma	Location *	WS
Category	Earthen Levee			GPS Latitude/Longitude	
				Start	End
Item	Encroachments			37.979612 °	37.979612 °
				-121.099390 °	-121.099390 °
DWR ID	DWR_NA0017_15_s_2012_102				
Action/Comments					
Debris

Debris was found on the waterside slope of the levee looking downstream.

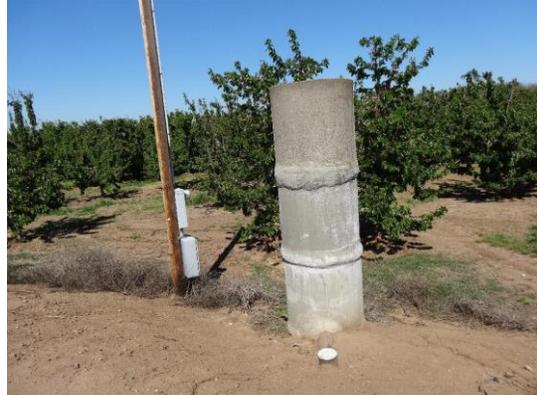
Photo 1 of 2 : UCIP\_FA\_2015\_3508.jpg

LM Start	<b>7.22</b>	Rating **	M	Issue No.	<b>1171</b>
LM End	<b>7.22</b>	Issue Type +	En	Location *	WS
Category	Supplemental			GPS Latitude/Longitude	
				Start	End
Item	DWR UCIP Field Study			37.979557 °	37.979557 °
				-121.099507 °	-121.099507 °
DWR ID					
Action/Comments					
Inspector Comments: FS_ID:34948 DS_ID:23223 EP_NO: 11662 FS_HLM: 7.372 Repair Type: Non-Urgent Crossing Status: Found UCIP Comments: Looks abandoned. May need proper abandonment.Flowmeter on landside pipe. FIELD_STRUCT_DESC: 8-inch steel pipe through the levee 4.0 feet below the crown. 30-inch concrete standpipe on the waterward shoulder. Pump mounted on concrete platform on waterward slope. (App. No. 11662-1977 - Dondero) O&M Manual SJR Assumed 999. FS Date: 04/10/2014

LS view: power pole and concrete standpipe on levee slope.

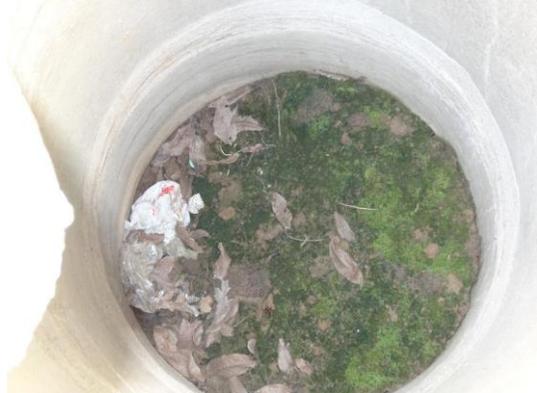
Photo 2 of 3 : UCIP\_FA\_2015\_5690.jpg

WS view: inside view of concrete standpipe on levee shoulder.

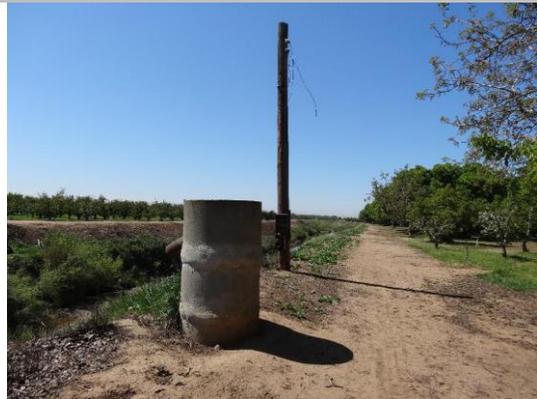
Photo 3 of 3 : UCIP\_FA\_2015\_5691.jpg

WS view: concrete standpipe and power pole (disconnected) on levee shoulder.

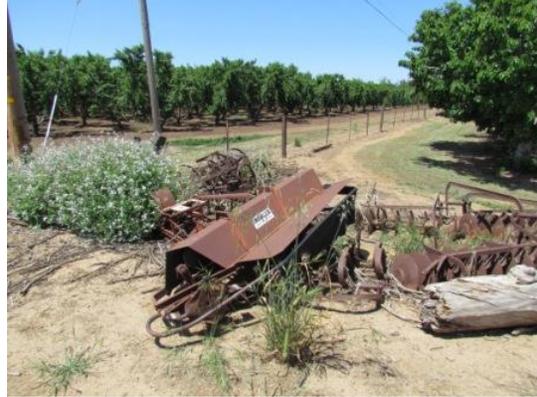
Photo 1 of 1 : FA\_2015\_NA0017\_159\_144\_20150911\_00088.jpg

LM Start	<b>7.82</b>	Rating **	A/W	Issue No.	<b>144</b>
LM End	<b>7.82</b>	Issue Type +	En	Location *	LS
Category	Earthen Levee		GPS Latitude/Longitude		
			Start	End	
Item	Encroachments		37.974829 °	37.974829 °	
			-121.108405 °	-121.108405 °	
DWR ID	DWR_NA0017_15_s_2012_144				
Action/Comments					
Equipment

Equipment was left by the farmers on the landside of the levee. The picture was taken from crown looking toward the landside of the levee.

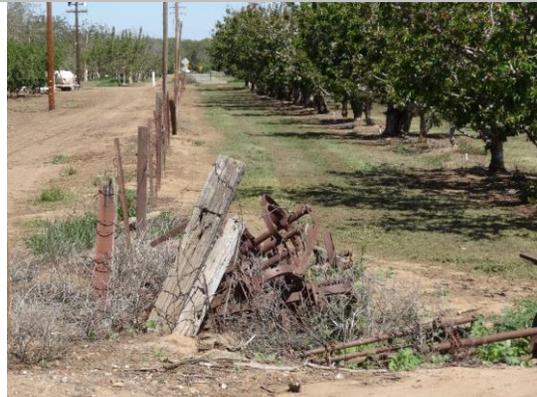
Photo 1 of 3 : UCIP\_FA\_2015\_5692.jpg

LM Start	<b>7.82</b>	Rating **	M	Issue No.	<b>1173</b>
LM End	<b>7.82</b>	Issue Type +	En	Location *	LS
Category	Supplemental		GPS Latitude/Longitude		
			Start	End	
Item	DWR UCIP Field Study		37.974827 °	37.974827 °	
			-121.108515 °	-121.108515 °	
DWR ID					
Action/Comments					
Inspector Comments: FS_ID:41627 DS_ID:23226 EP_NO: 4311 FS_HLM: 7.987 Repair Type: Non-Urgent Crossing Status: Found UCIP Comments: Looks abandoned and if so should be done so properly. No pipe or appurtenances found on landside. FIELD_STRUCT_DESC: Abandoned 10-inch concrete pipe 3.0 feet below the roadway. 8-inch steel intake pipe to pump and 30-inch concrete standpipe. Pump mounted on concrete foundation on the waterward slope. Overhead power line crossing. Pole and switch panel on water, and side. (App. No. 4311 - Joseph Caffese, Jr.) O&M Manual SJR Assumed 999. FS Date: 04/10/2014

LS view: no pipe or appurtenances found.

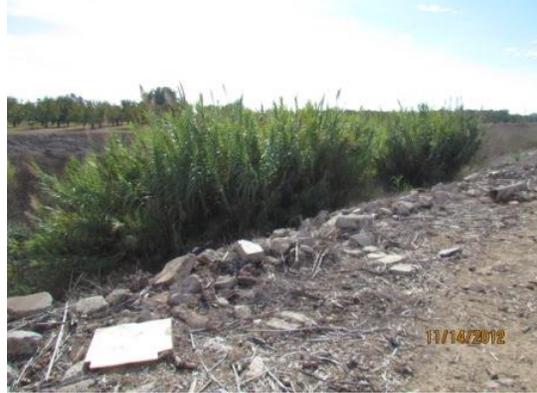
Photo 1 of 2 : FA\_2015\_NA0017\_159\_104\_20150911\_00069.jpg

Updated picture of the Arundo on the waterside slope of the levee looking downstream.

LM Start	<b>7.89</b>	Rating **	M	Issue No.	<b>104</b>
LM End	<b>7.89</b>	Issue Type +	Ma	Location *	WS
Category	Earthen Levee		GPS Latitude/Longitude		
			Start	End	
Item	Vegetation		37.974304 °	37.974304 °	
			-121.109625 °	-121.109625 °	
DWR ID	DWR_NA0017_15_s_2012_104				
Action/Comments					
Remove the wild growth other than native grasses from the levee slopes.

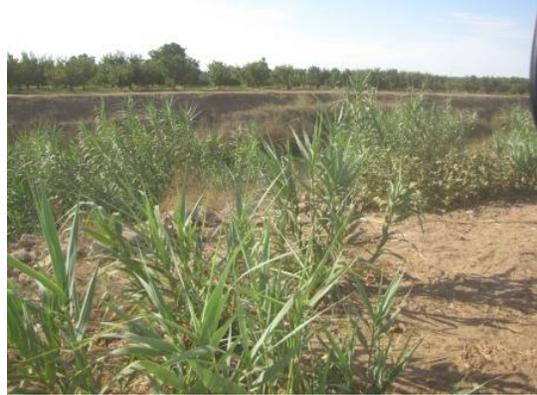
Photo 2 of 2 : FA\_2015\_NA0017\_159\_104\_20150911\_00070.jpg

View of arrundo on the waterward shoulder and slope blocking visibility looking downstream.

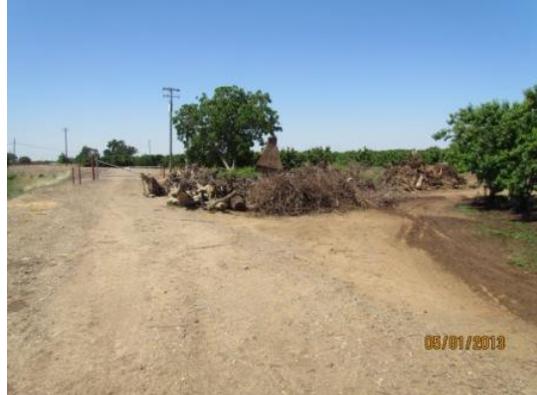
Photo 1 of 1 : FA\_2015\_NA0017\_159\_34\_20150911\_00025.jpg

LM Start	<b>8.07</b>	Rating **	M	Issue No.	<b>34</b>
LM End	<b>8.07</b>	Issue Type +	En	Location *	LS
Category	Earthen Levee		GPS Latitude/Longitude		
			Start	End	
Item	Encroachments		37.972823 °	37.972823 °	
			-121.112400 °	-121.112400 °	
DWR ID	DWR_NA0017_15_s_2012_34				
Action/Comments					
Prunings

Prunings were found on the landside of the levee looking downstream.

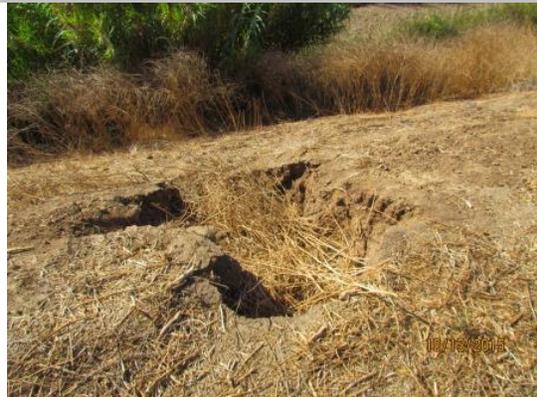
Photo 1 of 1 : FA\_2015\_NA0017\_159\_146\_20151019\_00148.jpg

Erosion was found on the waterside of the levee looking downstream.

LM Start	<b>8.39</b>	Rating **	M	Issue No.	<b>146</b>
LM End	<b>8.39</b>	Issue Type +	Ma	Location *	WS
Category	Earthen Levee			GPS Latitude/Longitude	
				Start	End
Item	Erosion / Bank Caving			37.969822 °	37.969822 °
				-121.116057 °	-121.116057 °
DWR ID	DWR_NA0017_15_f_2015_146				
Action/Comments					
Schedule repair of erosion site prior to the next inspection.

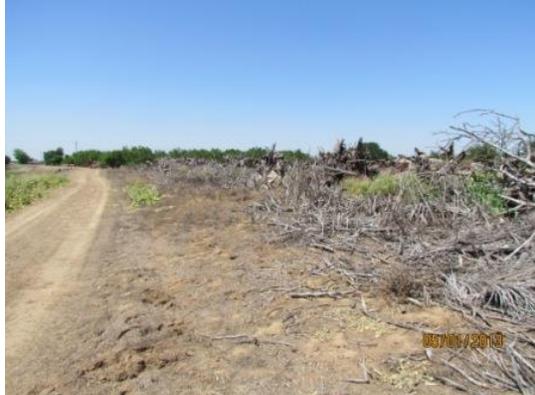
Photo 1 of 1 : FA\_2015\_NA0017\_159\_63\_20150911\_00046.jpg

LM Start	<b>8.40</b>	Rating **	M	Issue No.	<b>63</b>
LM End	<b>8.40</b>	Issue Type +	En	Location *	LS
Category	Earthen Levee		GPS Latitude/Longitude		
			Start	End	
Item	Encroachments		37.969813 °	37.969813 °	
			-121.116192 °	-121.116192 °	
DWR ID	DWR_NA0017_15_s_2013_63				
Action/Comments					
Prunings

Prunings were found on the landside of the levee looking downstream.

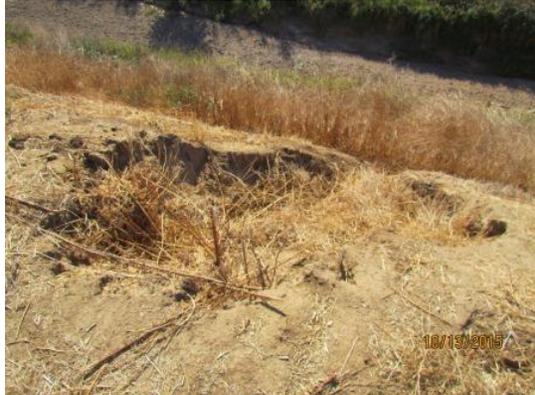
Photo 1 of 2 : FA\_2015\_NA0017\_159\_65\_20151019\_00149.jpg

LM Start	<b>8.43</b>	Rating **	U	Issue No.	<b>65</b>
LM End	<b>8.43</b>	Issue Type +	Ma	Location *	WS
Category	Earthen Levee		GPS Latitude/Longitude		
			Start	End	
Item	Erosion / Bank Caving		37.969748 °	37.969748 °	
			-121.116767 °	-121.116767 °	
DWR ID	DWR_NA0017_15_s_2013_65				
Action/Comments					
Schedule repair of erosion site prior to the next inspection.

Updated picture of the slope instability on the waterside of the levee looking upstream during fall 2015 inspection.

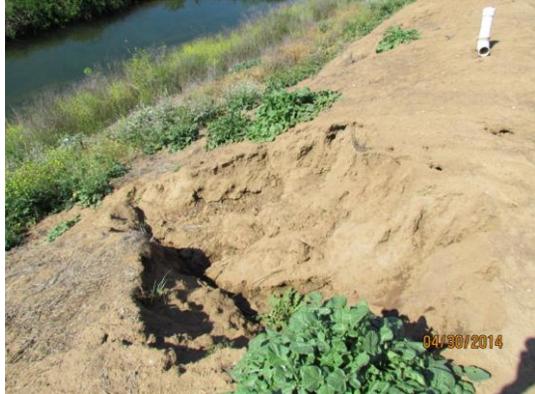
Photo 2 of 2 : FA\_2015\_NA0017\_159\_65\_20150911\_00048.jpg

View of the slope instability on the waterside of the levee looking downstream during spring 2014 inspection.

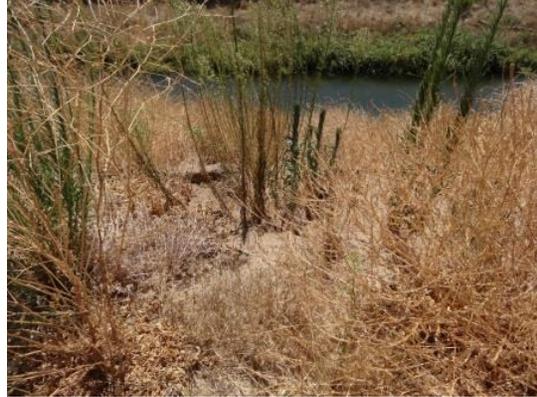
Photo 1 of 3 : SJR2015\_NA0017U15RM14.49\_1.JPG

LM Start	<b>8.43</b>	Rating **	M	Issue No.	<b>6</b>
LM End	<b>8.43</b>	Issue Type +	Ma	Location *	WS
Category	Supplemental			GPS Latitude/Longitude	
				Start	End
Item	DWR Erosion Survey			37.969711 °	37.969711 °
				-121.116739 °	-121.116739 °
DWR ID					
<b>Action/Comments</b>					
Inspector Comments: 8/12/2015: No significant change observed. More vegetation is observed at the site. 8/20/2014: No significant change observed. 09/12/2013: The erosion has been caused by runoff. [2015 Site ID:NA0017U15RM14.49]

Looking down at the erosion from the levee crest.

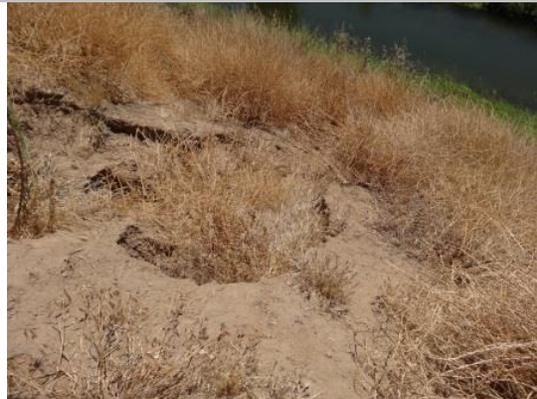
Photo 2 of 3 : SJR2015\_NA0017U15RM14.49\_3.JPG

Close view of the erosion.

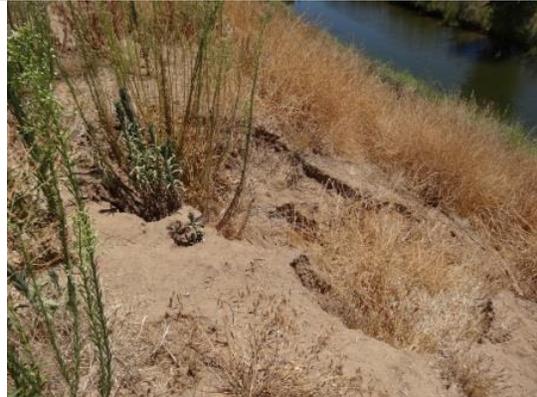
Photo 3 of 3 : SJR2015\_NA0017U15RM14.49\_4.JPG

Close view of the erosion.

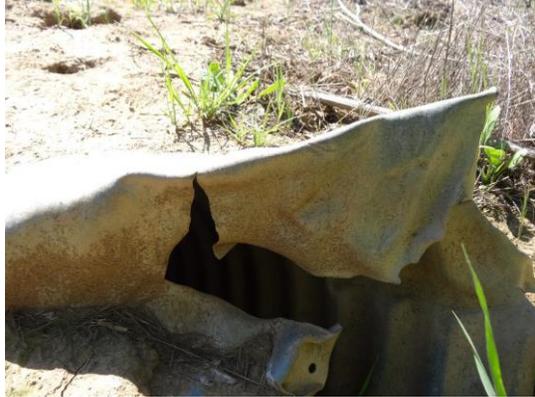
Photo 1 of 3 : UCIP\_FA\_2015\_5634.jpg

LM Start	<b>8.46</b>	Rating **	M	Issue No.	<b>1174</b>
LM End	<b>8.46</b>	Issue Type +	En	Location *	WS
Category	Supplemental			GPS Latitude/Longitude	
				Start	End
Item	DWR UCIP Field Study			37.969690 °	37.969690 °
				-121.117404 °	-121.117404 °
DWR ID					
Action/Comments					
Inspector Comments: FS_ID:40386 DS_ID:23227 EP_NO: N/A FS_HLM: 8.644 Repair Type: Non-Urgent Crossing Status: Found

LS view: closer view of distorted CM outlet pipe on levee slope.

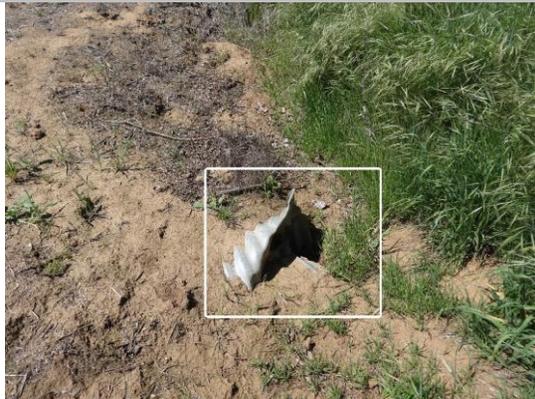
Photo 2 of 3 : UCIP\_FA\_2015\_5635.jpg

LS view: distorted CM outlet pipe on levee slope.

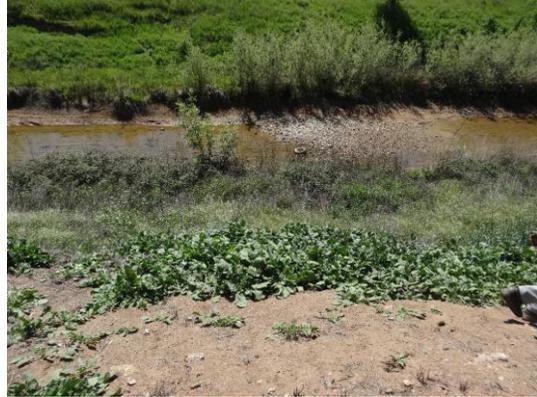
Photo 3 of 3 : UCIP\_FA\_2015\_5636.jpg

WS view: no pipe or appurtenances found on waterside. Dense vegetation.

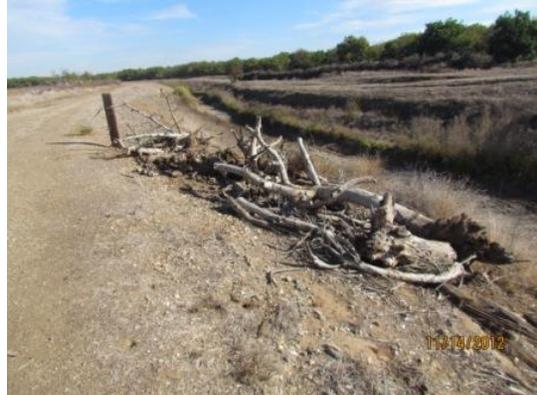
Photo 1 of 1 : FA\_2015\_NA0017\_159\_982\_20150911\_00117.jpg

LM Start	<b>8.48</b>	Rating **	M	Issue No.	<b>982</b>
LM End	<b>8.48</b>	Issue Type +	En	Location *	WS
Category	Earthen Levee			GPS Latitude/Longitude	
				Start	End
Item	Encroachments			37.969611 °	37.969611 °
				-121.117650 °	-121.117650 °
DWR ID	DWR_NA0017_15_s_2012_982				
Action/Comments					
Prunings Inspector Comments: Burn pile has been burned but new material has been placed.

Prunings were found on the waterside slope of the levee looking upstream.

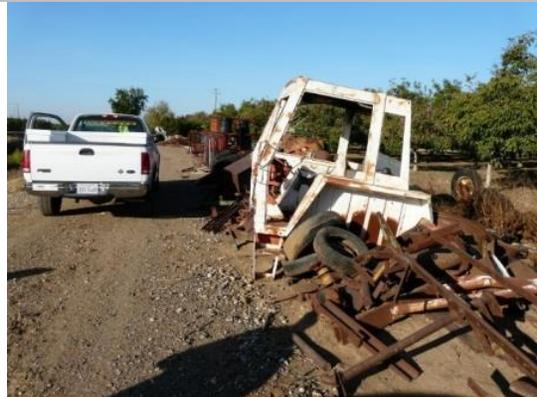
Photo 1 of 1 : FA\_2015\_NA0017\_159\_37\_20150911\_00026.jpg

LM Start	<b>8.49</b>	Rating **	A/W	Issue No.	<b>37</b>
LM End	<b>8.51</b>	Issue Type +	En	Location *	LS
Category	Earthen Levee			GPS Latitude/Longitude	
				Start	End
Item	Encroachments			37.969550 °	37.969391 °
				-121.117927 °	-121.118277 °
DWR ID	DWR_NA0017_15_s_2012_37				
Action/Comments					
Equipment

Remove equipment from landside slope of levee.

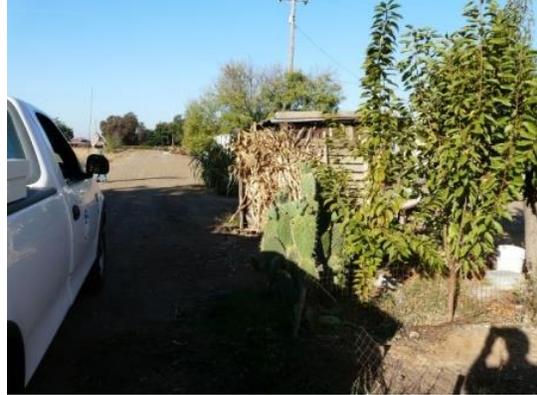
Photo 1 of 1 : FA\_2015\_NA0017\_159\_83\_20150911\_00060.jpg

LM Start	<b>8.54</b>	Rating **	M	Issue No.	<b>83</b>
LM End	<b>8.54</b>	Issue Type +	En	Location *	LS
Category	Earthen Levee		GPS Latitude/Longitude		
			Start	End	
Item	Encroachments		37.969305 °	37.969305 °	
			-121.118664 °	-121.118664 °	
DWR ID	DWR_NA0017_15_s_2012_83				
Action/Comments					
Building

Building, fence and landscaping immediately adjacent to the access road at LM 8.72.

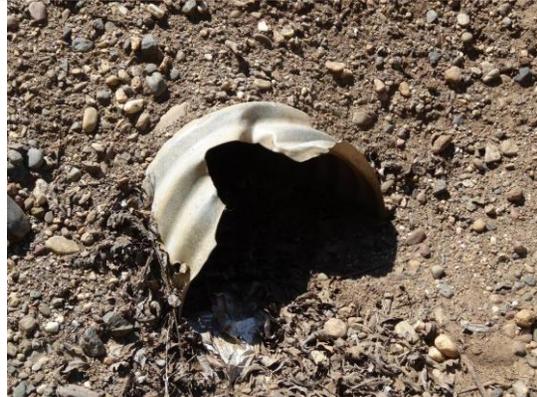
Photo 1 of 2 : UCIP\_FA\_2015\_5305.jpg

Inspector Comments: FS\_ID:40387  
 DS\_ID:23229  
 EP\_NO: N/A  
 FS\_HLM: 8.868  
 Repair Type: Non-Urgent  
 Crossing Status: Found  
 UCIP Comments: Distorted pipe opening on landside. Inlet pipe needs clearing and cleaning.No pipe visible on waterside.  
 FIELD\_STRUCT\_DESC: 18-inch CM pipe and electric conduit through the levee 1.0 feet below the crown. Power pole on landside. Electric conduit through the levee. Outlet of pipe rock revetted. O&M Manual SJR Assumed 999.  
 FS Date: 04/10/2014

LS view: distorted CM inlet pipe. Partially buried.

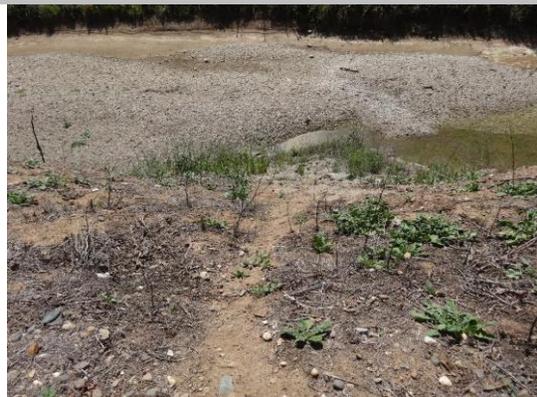
Photo 2 of 2 : UCIP\_FA\_2015\_5306.jpg

WS view: no pipe or appurtenances found. Steep levee slope.

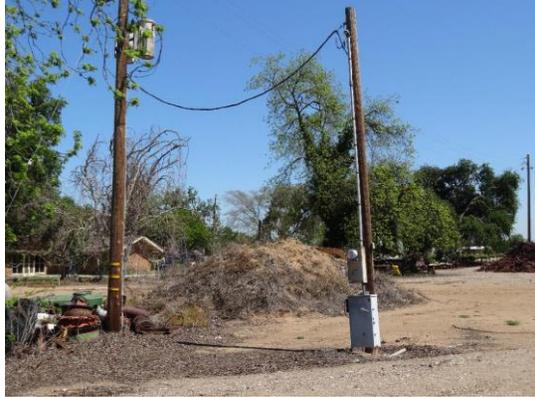
Photo 1 of 2 : UCIP\_FA\_2015\_5307.jpg

LM Start	<b>8.72</b>	Rating **	M	Issue No.	<b>1176</b>
LM End	<b>8.72</b>	Issue Type +	En	Location *	LS
Category	Supplemental			GPS Latitude/Longitude	
				Start	End
Item	DWR UCIP Field Study			37.968582 °	37.968582 °
				-121.121805 °	-121.121805 °
DWR ID					
<b>Action/Comments</b>					
Inspector Comments: FS_ID:41789 DS_ID:23228 EP_NO: 12607 FS_HLM: 8.907 Repair Type: Non-Urgent Crossing Status: Found

LS view: only power pole and switch panel found.

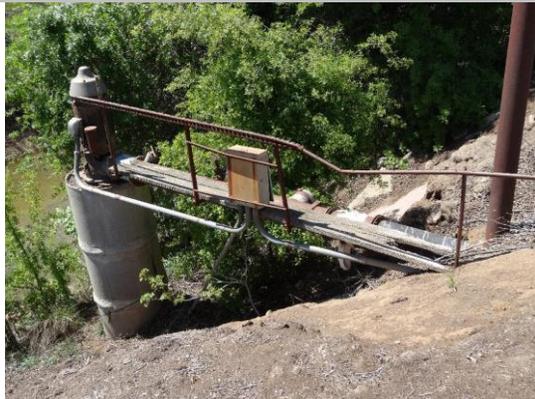
Photo 2 of 2 : UCIP\_FA\_2015\_5308.jpg

WS view: pump on concrete pipe sump. Pipe, walkway, and appurtenance on levee slope.

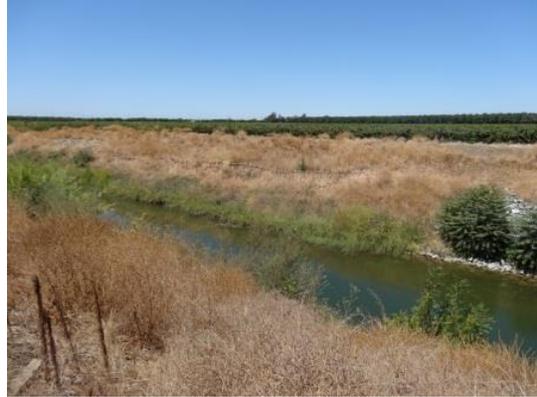
Photo 1 of 3 : SJR2015\_NA0017U15RM13.87\_1.JPG

LM Start	<b>8.81</b>	Rating **	M	Issue No.	<b>4</b>
LM End	<b>8.83</b>	Issue Type +	Ma	Location *	WS
Category	Supplemental			GPS Latitude/Longitude	
				Start	End
Item	DWR Erosion Survey			37.968060 °	37.968060 °
				-121.123299 °	-121.123299 °
DWR ID					
<b>Action/Comments</b>					
Inspector Comments: 8/12/2015: No significant change observed. 8/20/2014: Both ends of the erosion site are protected by riprap. [2015 Site ID:NA0017U15RM13.87]

View of the site from the left river bank.

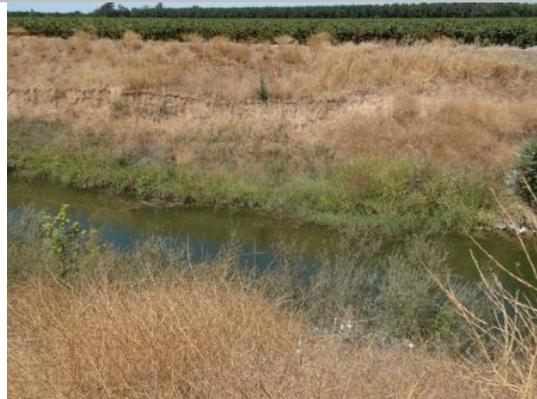
Photo 2 of 3 : SJR2015\_NA0017U15RM13.87\_2.JPG

Close view of the erosion.

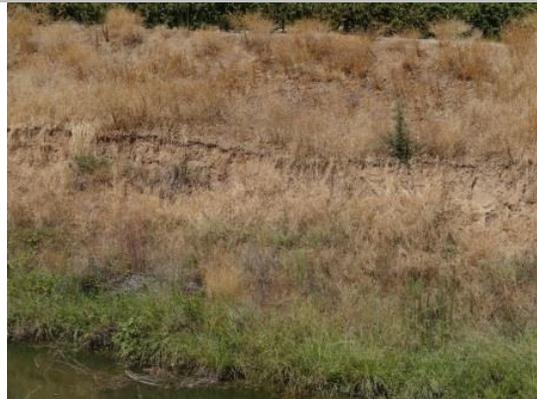
Photo 3 of 3 : SJR2015\_NA0017U15RM13.87\_4.JPG

Close view of the erosion.

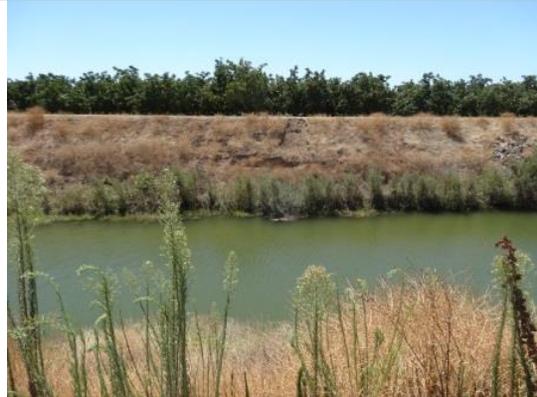
Photo 1 of 2 : SJR2015\_NA0017U16RM13.85\_1.JPG

LM Start	<b>9.07</b>	Rating **	U	Issue No.	<b>10</b>
LM End	<b>9.07</b>	Issue Type +	Ma	Location *	WS
Category	Supplemental			GPS Latitude/Longitude	
				Start	End
Item	DWR Erosion Survey			37.967019 °	37.967019 °
				-121.127581 °	-121.127581 °
DWR ID					
Action/Comments					
Inspector Comments: 8/12/2015: No significant change observed. 8/20/2014: No significant change observed. 9/12/2013: The erosion might have been caused by river flow combined with runoff. Dense vegetation is presents at the site. There is no levee structure on site. The levee crest width and levee height were not measured or estimated in the field. [2015 Site ID:NA0017U16RM13.85]

View of the site from the right river bank.

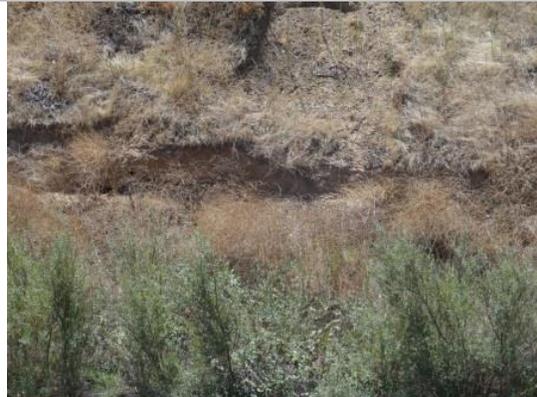
Photo 2 of 2 : SJR2015\_NA0017U16RM13.85\_3.JPG

Close view of the erosion.

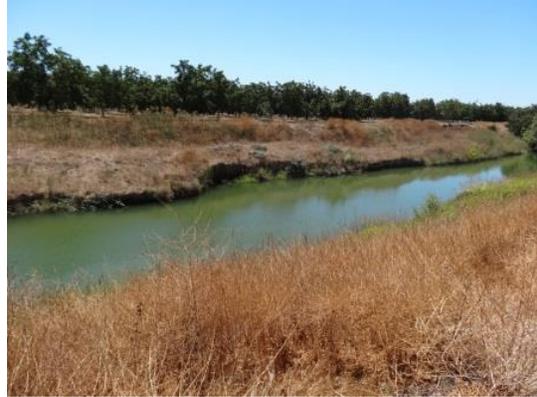
Photo 1 of 3 : SJR2015\_NA0017U16RM13.53\_1.jpg

LM Start	<b>9.37</b>	Rating **	M	Issue No.	<b>8</b>
LM End	<b>9.39</b>	Issue Type +	Ma	Location *	WS
Category	Supplemental			GPS Latitude/Longitude	
				Start	End
Item	DWR Erosion Survey			37.967190 °	37.967190 °
				-121.133080 °	-121.133080 °
DWR ID					
<b>Action/Comments</b>					
Inspector Comments: 8/12/2015: No significant change observed. 8/20/2014: No significant change observed. 9/12/2013: No significant change observed. 08/22/2012: The erosion is on berm. The berm width is estimated. There is no levee structure on site. The levee crest width and levee height were not measured or estimated in the field. [2015 Site

Upstream view of the erosion.

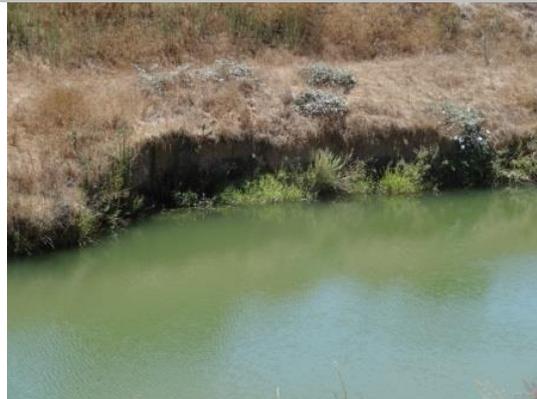
Photo 2 of 3 : SJR2015\_NA0017U16RM13.53\_3.jpg

Close view of the erosion.

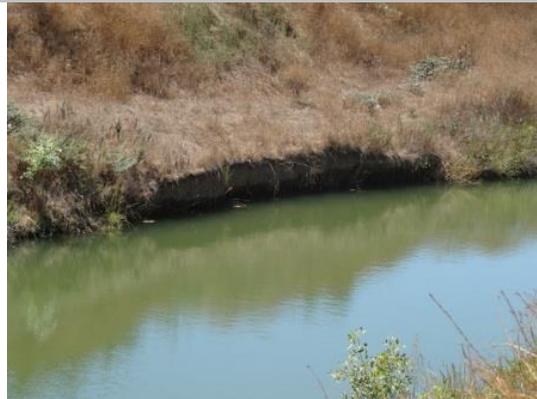
Photo 3 of 3 : SJR2015\_NA0017U16RM13.53\_4.jpg

Close view of the erosion.

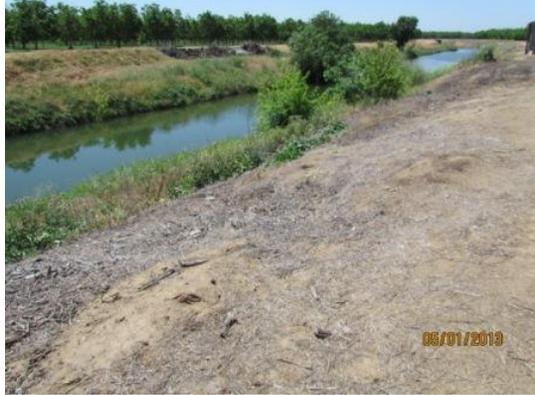
Photo 1 of 1 : FA\_2015\_NA0017\_159\_121\_20150911\_00078.jpg

LM Start	<b>9.39</b>	Rating **	M	Issue No.	<b>121</b>
LM End	<b>9.39</b>	Issue Type +	Ma	Location *	WS
Category	Earthen Levee		GPS Latitude/Longitude		
			Start	End	
Item	Slope Stability		37.967155 °	37.967155 °	
			-121.133277 °	-121.133277 °	
DWR ID	DWR_NA0017_15_f_2012_121				
Action/Comments					
Repair slope instability.

A slope instability was found on the waterside slope of the levee looking downstream.

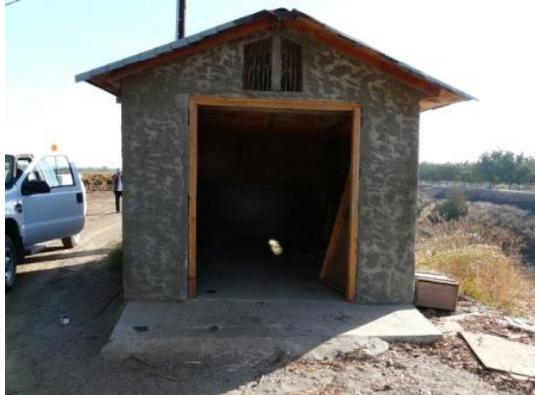
Photo 1 of 2 : FA\_2015\_NA0017\_159\_40\_20150911\_00027.jpg

LM Start	<b>9.42</b>	Rating **	U	Issue No.	<b>40</b>
LM End	<b>9.42</b>	Issue Type +	En	Location *	WS
Category	Earthen Levee		GPS Latitude/Longitude		
			Start	End	
Item	Encroachments		37.967017 °	37.967017 °	
			-121.133863 °	-121.133863 °	
DWR ID	DWR_NA0017_15_s_2012_40				
Action/Comments					
Building

Additional view of building.

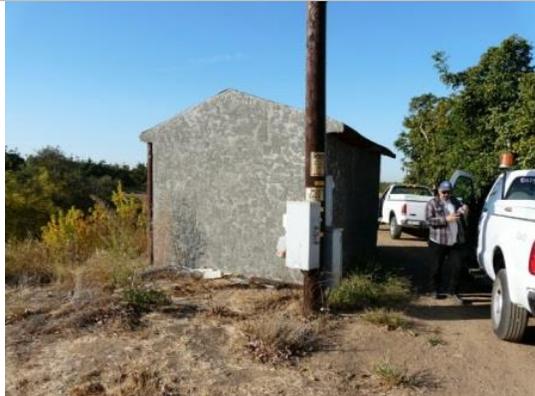
Photo 2 of 2 : FA\_2015\_NA0017\_159\_40\_20150911\_00028.jpg

Building located on waterside of access road. This building appears to be recently constructed and does not currently contain anything.

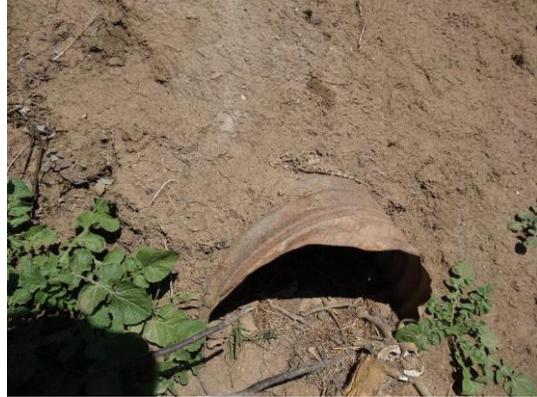
Photo 1 of 3 : UCIP\_FA\_2015\_5355.jpg

LM Start	<b>9.55</b>	Rating **	M	Issue No.	<b>1177</b>
LM End	<b>9.55</b>	Issue Type +	En	Location *	WS
Category	Supplemental			GPS Latitude/Longitude	
				Start	End
Item	DWR UCIP Field Study			37.966327 °	37.966327 °
				-121.135980 °	-121.135980 °
DWR ID					
Action/Comments					
Inspector Comments: FS_ID:34983 DS_ID:23233 EP_NO: N/A FS_HLM: 9.75 Repair Type: Non-Urgent Crossing Status: Found

WS view: closer view of CM outlet pipe on levee slope.

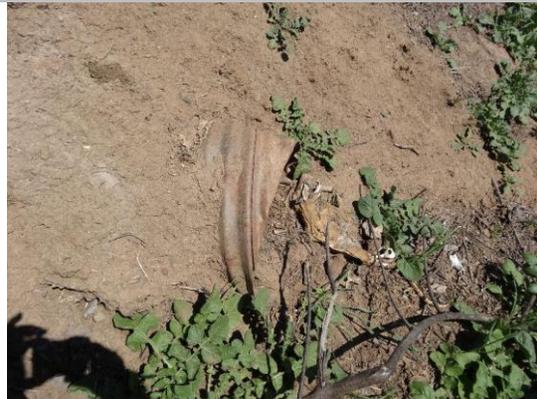
Photo 2 of 3 : UCIP\_FA\_2015\_5356.jpg

WS view: CM outlet pipe on levee slope.

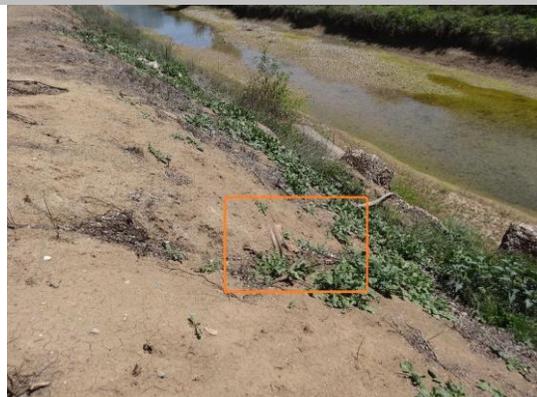
Photo 3 of 3 : UCIP\_FA\_2015\_5357.jpg

WS view: CM outlet pipe on levee slope.

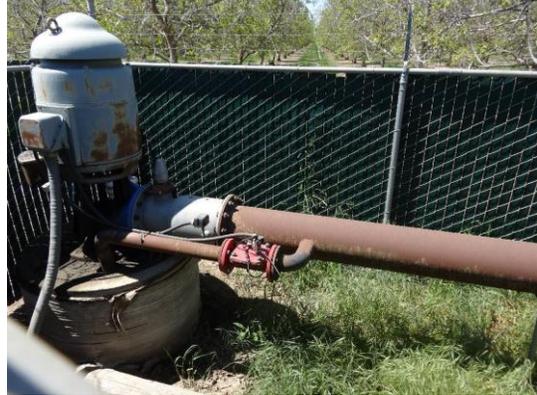
Photo 1 of 3 : UCIP\_FA\_2015\_5358.jpg

LM Start	<b>9.56</b>	Rating **	M	Issue No.	<b>1178</b>
LM End	<b>9.56</b>	Issue Type +	En	Location *	WS
Category	Supplemental			GPS Latitude/Longitude	
				Start	End
Item	DWR UCIP Field Study			37.966250 °	37.966250 °
				-121.136140 °	-121.136140 °
DWR ID					
<b>Action/Comments</b>					
Inspector Comments: FS_ID:40389 DS_ID:23234 EP_NO: N/A FS_HLM: 9.76 Repair Type: Non-Urgent Crossing Status: Found

LS view: pump on concrete pipe sump; steel pipe and appurtenances.

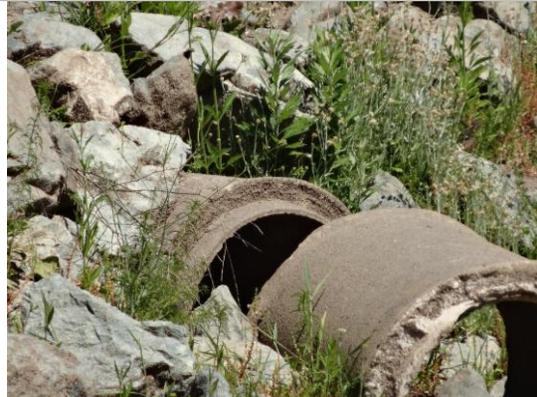
Photo 2 of 3 : UCIP\_FA\_2015\_5420.jpg

WS view: closer view of concrete pipe on channel bank.

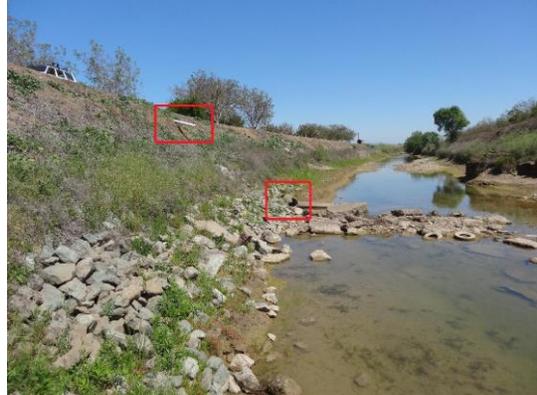
Photo 3 of 3 : UCIP\_FA\_2015\_5421.jpg

WS view: concrete pipe on channel bank (right-bottom).

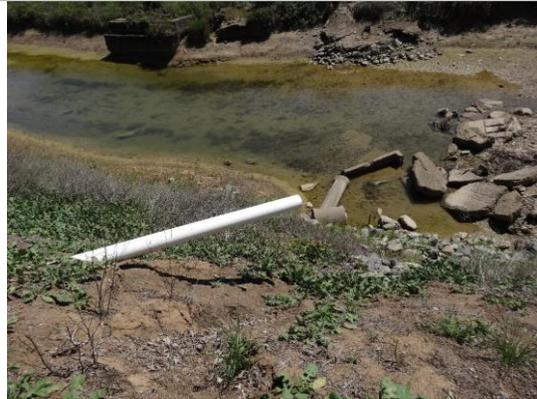
Photo 1 of 2 : UCIP\_FA\_2015\_5422.jpg

LM Start	<b>9.56</b>	Rating **	M	Issue No.	<b>1179</b>
LM End	<b>9.56</b>	Issue Type +	En	Location *	WS
Category	Supplemental			GPS Latitude/Longitude	
				Start	End
Item	DWR UCIP Field Study			37.966255 °	37.966255 °
				-121.136170 °	-121.136170 °
DWR ID					
Action/Comments					
Inspector Comments: FS_ID:40390 DS_ID:24853 EP_NO: N/A FS_HLM: 9.762 Repair Type: Non-Urgent Crossing Status: Found UCIP Comments: Field discovered crossing. Needs more info from LMA or DWR Inspector.No pipe or appurtenances found on landside. FIELD_STRUCT_DESC: 8-inch PVC pipe through the levee, 3.0 ft. below the crown. FS Date: 04/10/2014

WS view: pvc outfall pipe on levee slope with open end.

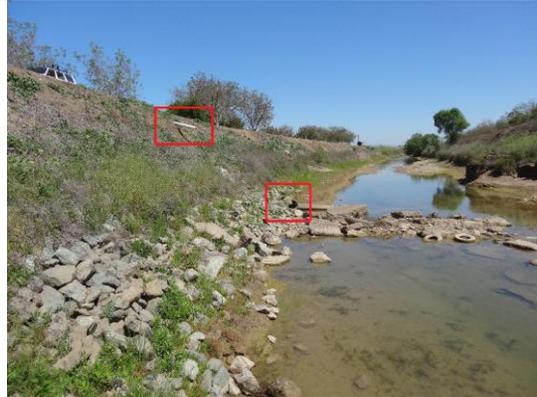
Photo 2 of 2 : UCIP\_FA\_2015\_5423.jpg

WS view: pvc outfall pipe on levee slope (top-left).

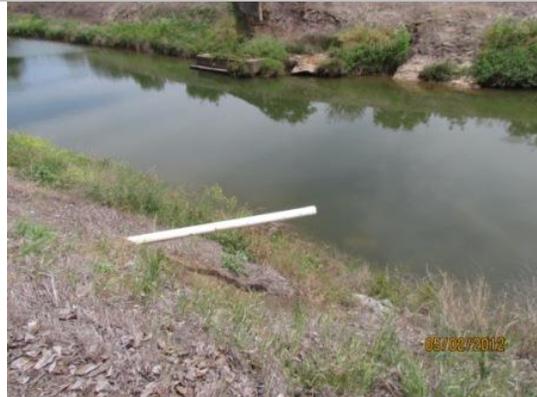
Photo 1 of 1 : FA\_2015\_NA0017\_159\_136\_20150911\_00085.jpg

LM Start	9.56	Rating **	U	Issue No.	136
LM End	9.56	Issue Type +	En	Location *	WS
Category	Earthen Levee			GPS Latitude/Longitude	
	Start		End		
Item	Encroachments			37.966230 °	37.966230 °
				-121.136215 °	-121.136215 °
DWR ID	DWR_NA0017_15_s_2012_136				
Action/Comments					
Pipe Inspector Comments: A PVC drain pipe is going under the levee crown.

A perforated PVC pipe was found on the waterside slope of the levee looking upstream.
