**Flood Control Project Maintenance  
Levee Inspections**

**Fall 2015 Levee Maintenance Deficiency Summary Report**

**San Joaquin River Basin**

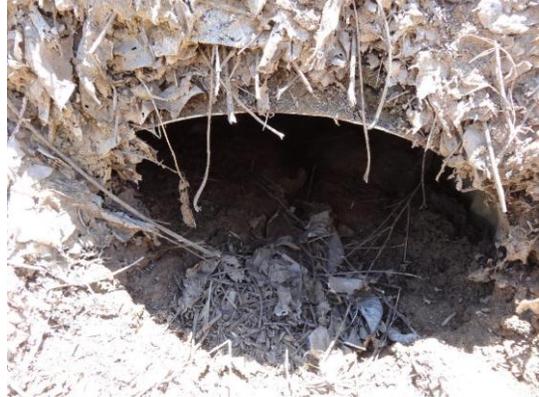
Photo 1 of 3 : UCIP\_FA\_2015\_5424.jpg

LM Start	9.80	Rating **	M	Issue No.	1180
LM End	9.80	Issue Type +	En	Location *	WS
Category	Supplemental			GPS Latitude/Longitude	
				Start	End
Item	DWR UCIP Field Study			37.965294 °	37.965294 °
				-121.140184 °	-121.140184 °
DWR ID					
Action/Comments					
Inspector Comments: FS_ID:34986 DS_ID:23235 EP_NO: N/A FS_HLM: 10.01 Repair Type: Non-Urgent Crossing Status: Found UCIP Comments: Mud/soil in inlet pipe. Needs cleaning.No pipe or appurtenances visible on waterside. Dense vegetation (may be visible from other channel bank). FIELD_STRUCT_DESC: 18-inch CM pipe through the levee 4.0 feet below the crown. Grouted inlet and outlet. O&M Manual SJR Assumed 999. FS Date: 04/10/2014

LS view: closer view of partially buried inlet pipe. Needs cleaning and clearing.

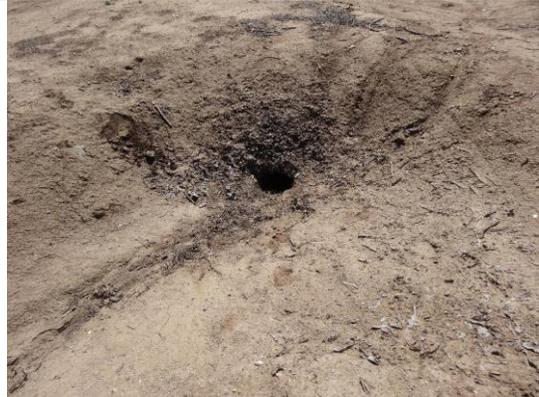
Photo 2 of 3 : UCIP\_FA\_2015\_5425.jpg

LS view: partially buried inlet pipe.

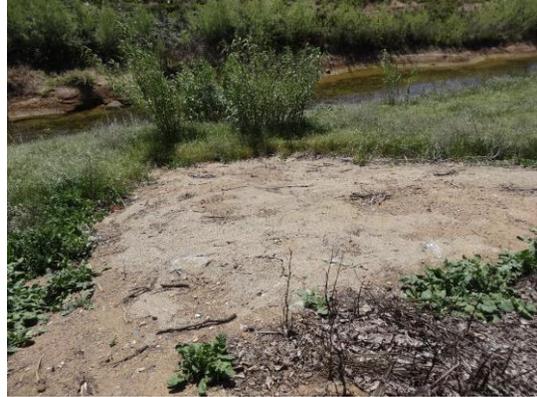
Photo 3 of 3 : UCIP\_FA\_2015\_5426.jpg

WS view: no pipe or appurtenances found.

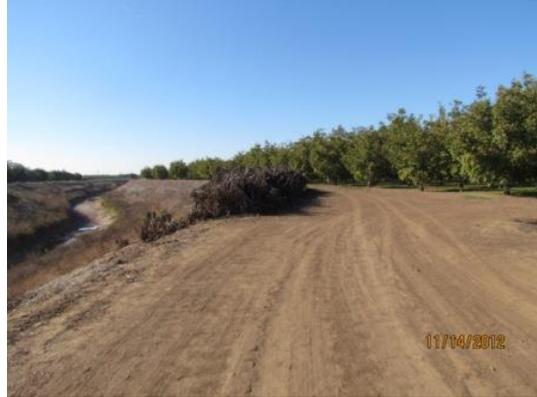
Photo 1 of 1 : FA\_2015\_NA0017\_159\_147\_20150911\_00090.jpg

LM Start	<b>9.81</b>	Rating **	M	Issue No.	<b>147</b>
LM End	<b>9.81</b>	Issue Type +	Ma	Location *	WS
Category	Earthen Levee			GPS Latitude/Longitude	
				Start	End
Item	Encroachments			37.965314 °	37.965314 °
				-121.140296 °	-121.140296 °
DWR ID	DWR_NA0017_15_s_2012_147				
Action/Comments					
Prunings

Prunings were found on the waterside shoulder of the levee looking downstream.

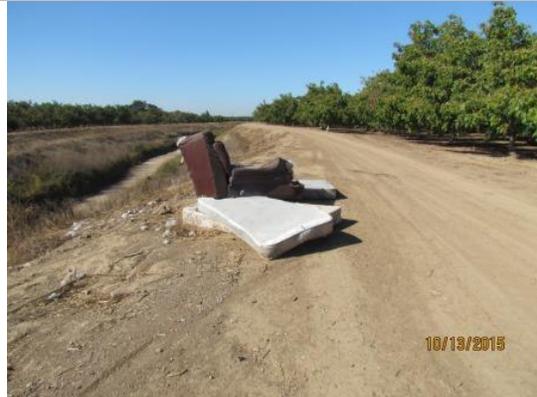
Photo 1 of 1 : FA\_2015\_NA0017\_159\_151\_20151019\_00150.jpg

LM Start	<b>9.82</b>	Rating **	M	Issue No.	<b>151</b>
LM End	<b>9.82</b>	Issue Type +	Ma	Location *	WS
Category	Earthen Levee			GPS Latitude/Longitude	
				Start	End
Item	Encroachments			37.965369 °	37.965369 °
				-121.140559 °	-121.140559 °
DWR ID	DWR_NA0017_15_f_2015_151				
Action/Comments					
Debris

Debris was found on the waterside shoulder of the levee looking downstream.

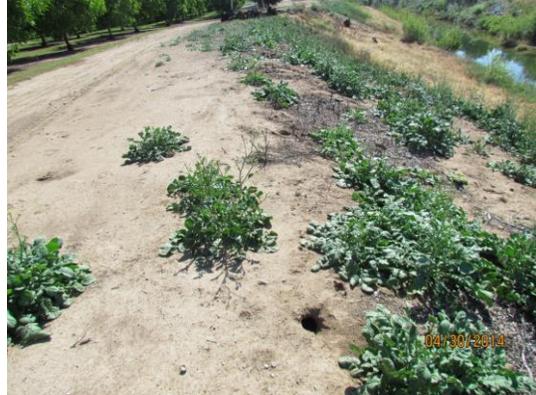
Photo 1 of 1 : FA\_2015\_NA0017\_159\_126\_20150911\_00082.jpg

LM Start	<b>9.83</b>	Rating **	M	Issue No.	<b>126</b>
LM End	<b>9.83</b>	Issue Type +	Ma	Location *	WS
Category	Earthen Levee			GPS Latitude/Longitude	
				Start	End
Item	Animal Control			37.965343 °	37.965343 °
				-121.140761 °	-121.140761 °
DWR ID	DWR_NA0017_15_s_2014_126				
Action/Comments					
No rodents visible, but rodent burrows visible; need to backfill and compact or grout burrows.

View of rodent holes on the waterside of the levee looking upstream.

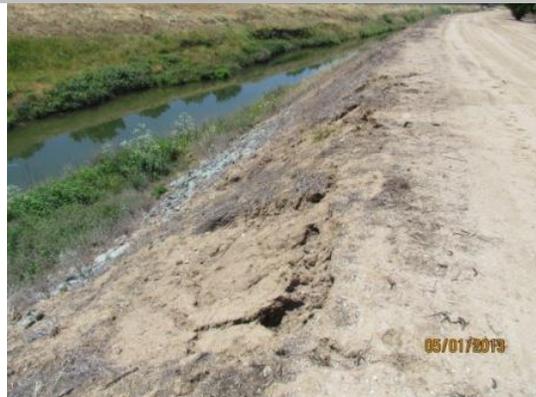
Photo 1 of 1 : FA\_2015\_NA0017\_159\_68\_20150911\_00052.jpg

LM Start	<b>9.90</b>	Rating **	M	Issue No.	<b>68</b>
LM End	<b>9.90</b>	Issue Type +	Ma	Location *	WS
Category	Earthen Levee			GPS Latitude/Longitude	
				Start	End
Item	Slope Stability			37.965165 °	37.965165 °
				-121.141928 °	-121.141928 °
DWR ID	DWR_NA0017_15_s_2013_68				
Action/Comments					
Repair slope instability.

Slope instability was found on the waterside slope of the levee looking downstream.

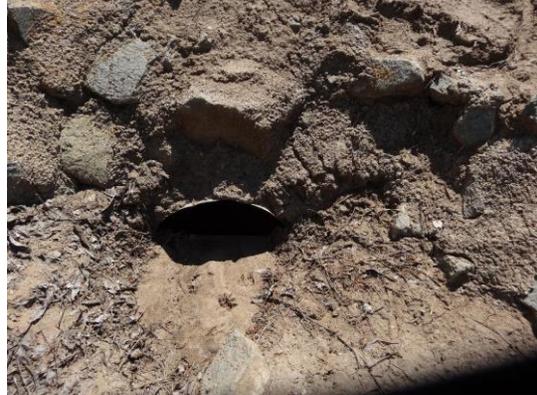
Photo 1 of 3 : UCIP\_FA\_2015\_5427.jpg

LM Start	10.01	Rating **	M	Issue No.	1181
LM End	10.01	Issue Type +	En	Location *	WS
Category	Supplemental			GPS Latitude/Longitude	
				Start	End
Item	DWR UCIP Field Study			37.965085 °	37.965085 °
				-121.143999 °	-121.143999 °
DWR ID					
Action/Comments					
Inspector Comments: FS_ID:34987 DS_ID:23236 EP_NO: N/A FS_HLM: 10.225 Repair Type: Non-Urgent Crossing Status: Found UCIP Comments: May need cleaning of the pipe. Pipe not visible on waterside. FIELD_STRUCT_DESC: 18-inch CM pipe through the levee 4.5 feet below the crown. Grouted inlet and outlet. O&M Manual SJR Assumed 999. FS Date: 04/10/2014

LS view: partially buried inlet pipe on levee toe.

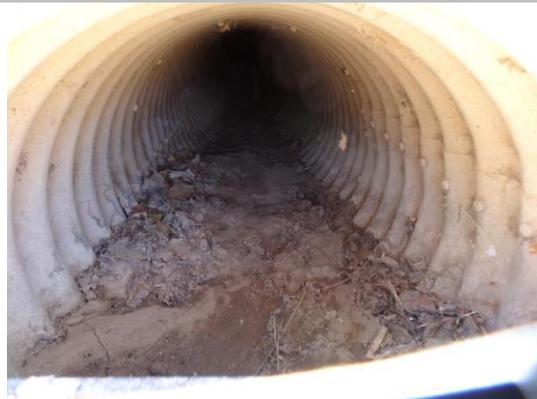
Photo 2 of 3 : UCIP\_FA\_2015\_5428.jpg

LS view: inside view of partially buried inlet pipe. Needs cleaning.

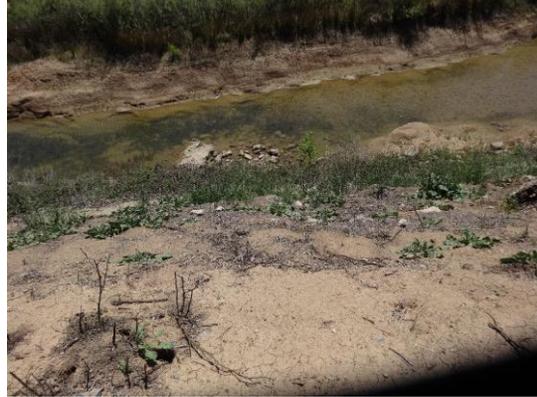
Photo 3 of 3 : UCIP\_FA\_2015\_5429.jpg

WS view: no pipe or appurtenances found.

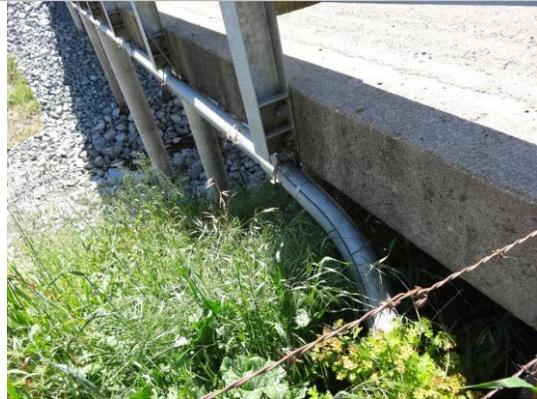
Photo 1 of 2 : UCIP\_FA\_2015\_5430.jpg

LM Start	<b>10.26</b>	Rating **	M	Issue No.	<b>1182</b>
LM End	<b>10.26</b>	Issue Type +	En	Location *	WS
Category	Supplemental			GPS Latitude/Longitude	
				Start	End
Item	DWR UCIP Field Study			37.965115 °	37.965115 °
				-121.148521 °	-121.148521 °
DWR ID					
Action/Comments					
Inspector Comments: FS_ID:41468 DS_ID:24854 EP_NO: N/A FS_HLM: 10.478 Repair Type: Non-Urgent Crossing Status: Found UCIP Comments: Field discovered crossing. Need to determine Permit No. FIELD_STRUCT_DESC: 4-inch galvanized iron communication conduit attached to the bridge and through the levee. Warning post on waterside shoulder. FS Date: 04/10/2014

WS view: closer view of GI conduit attached to the bridge.

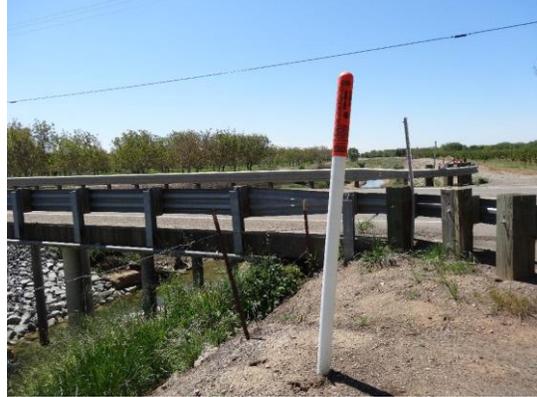
Photo 2 of 2 : UCIP\_FA\_2015\_5431.jpg

WS view: GI conduit attached to the bridge. Warning post on levee shoulder.

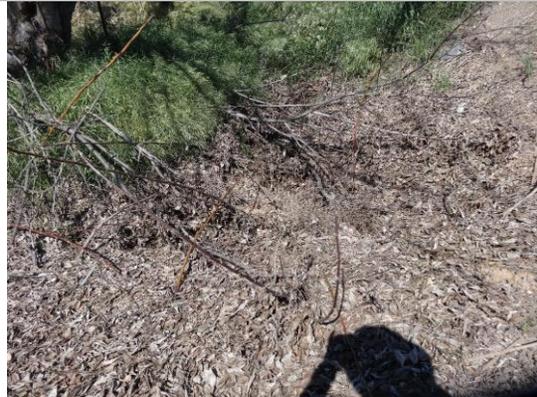
Photo 1 of 2 : UCIP\_FA\_2015\_5432.jpg

LM Start	10.27	Rating **	M	Issue No.	1183
LM End	10.27	Issue Type +	En	Location *	WS
Category	Supplemental			GPS Latitude/Longitude	
				Start	End
Item	DWR UCIP Field Study			37.965097 °	37.965097 °
				-121.148671 °	-121.148671 °
DWR ID					
Action/Comments					
Inspector Comments: FS_ID:35005 DS_ID:23238 EP_NO: N/A FS_HLM: 10.486 Repair Type: Non-Urgent Crossing Status: Found UCIP Comments: Pipe buried on landside. May need cleaning of vegetation debris in inlet opening. FIELD_STRUCT_DESC: 18-inch CM pipe through the levee 7.5 feet below the crown. Flap gate on the waterward side. O&M Manual SJR Assumed 999. FS Date: 04/10/2014

LS view: vegetation debris in inlet area. Needs cleaning and clearing.

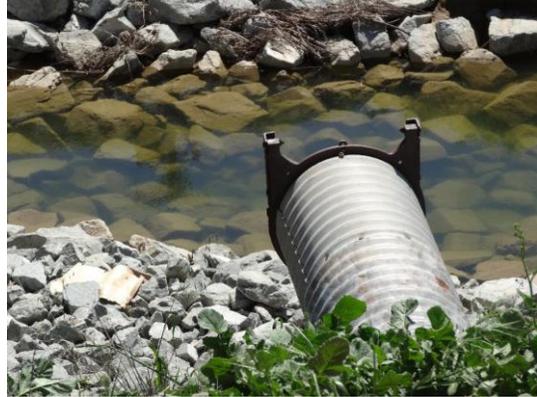
Photo 2 of 2 : UCIP\_FA\_2015\_5433.jpg

WS view: CM outfall pipe with flapgate on levee slope.

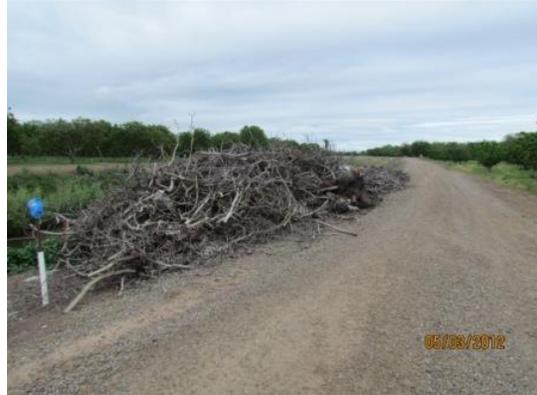
Photo 1 of 2 : FA\_2015\_NA0017\_159\_78\_20150911\_00057.jpg

LM Start	10.40	Rating **	M	Issue No.	78	
LM End	10.40	Issue Type +	Ma	Location *	WS	
Category	Earthen Levee			GPS Latitude/Longitude		
			Start	End		
Item	Encroachments			37.964942 °	37.964942 °	
				-121.151073 °	-121.151073 °	
DWR ID	DWR_NA0017_15_s_2012_78					
Action/Comments						
Prunings

Prunings were found on the waterside of the levee looking downstream.

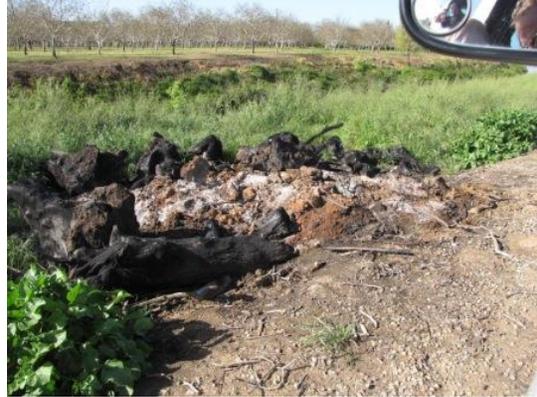
Photo 2 of 2 : FA\_2015\_NA0017\_159\_78\_20150911\_00058.jpg

LM Start	<b>10.40</b>	Rating **	M	Issue No.	<b>78 (cont)</b>
LM End	<b>10.40</b>	Issue Type +	Ma	Location *	WS
Category	Earthen Levee			GPS Latitude/Longitude	
				Start	End
Item	Encroachments			37.964942 °	37.964942 °
				-121.151073 °	-121.151073 °
DWR ID	DWR_NA0017_15_s_2012_78				
Action/Comments					
Prunings

View of the prunings pile on the waterward slope looking downstream.

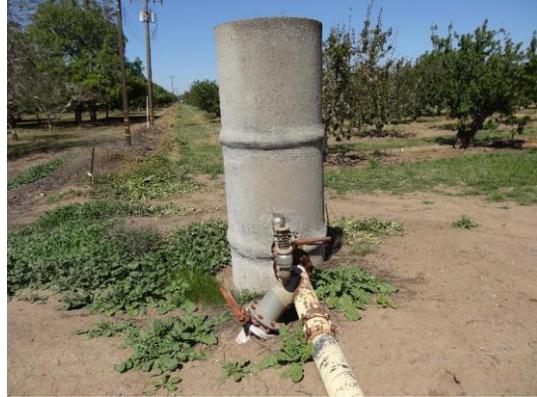
Photo 1 of 3 : UCIP\_FA\_2015\_5485.jpg

Inspector Comments: FS\_ID:40391  
 DS\_ID:23240  
 EP\_NO: N/A  
 FS\_HLM: 10.755  
 Repair Type: Non-Urgent  
 Crossing Status: Found  
 UCIP Comments: Pipe open on WS as Pump removed from the pipe. Tri-action valve on landside pipe.  
 FIELD\_STRUCT\_DESC: 6-inch pipe through the levee 1.0 feet below the crown. Pump, motor and gate valve on waterward berm. 30-inch standpipe on the landward side. Pole on the waterward shoulder.  
 Electric conduit through the levee. O&M Manual SJR Assumed 999.  
 FS Date: 04/10/2014

LS view: concrete standpipe, pipe, and tri-action valve.

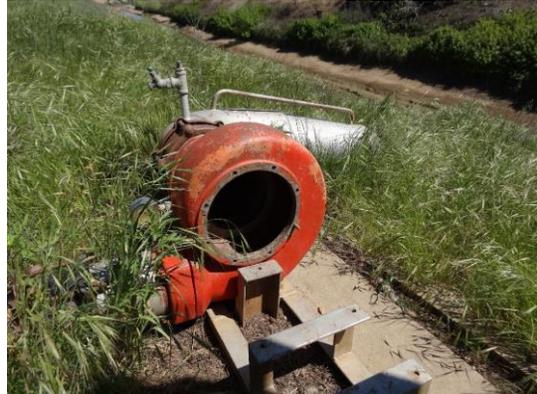
Photo 2 of 3 : UCIP\_FA\_2015\_5486.jpg

WS view: pump removed from the pipe.

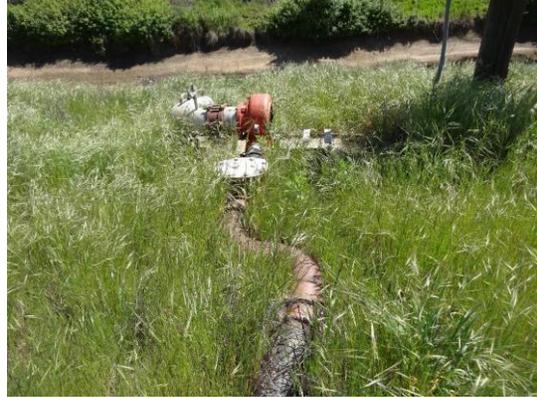
Photo 3 of 3 : UCIP\_FA\_2015\_5487.jpg

LM Start	<b>10.53</b>	Rating **	M	Issue No.	<b>1184 (cont)</b>
LM End	<b>10.53</b>	Issue Type +	En	Location *	LS
Category	Supplemental			GPS Latitude/Longitude	
				Start	End
Item	DWR UCIP Field Study			37.964584 °	37.964584 °
				-121.153474 °	-121.153474 °
DWR ID					
Action/Comments					
Inspector Comments: FS_ID:40391 DS_ID:23240 EP_NO: N/A FS_HLM: 10.755 Repair Type: Non-Urgent Crossing Status: Found

WS view: pipe and pump on levee slope.

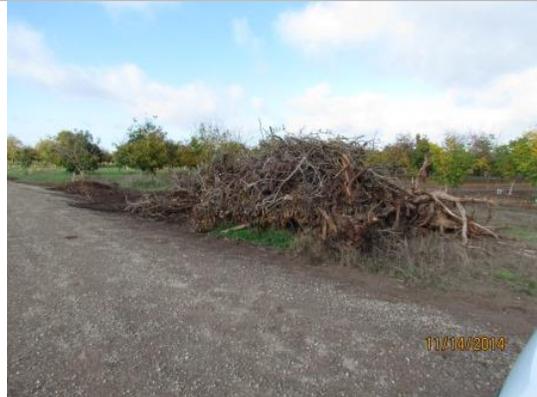
Photo 1 of 1 : FA\_2015\_NA0017\_159\_106\_20150911\_00071.jpg

LM Start	<b>10.77</b>	Rating **	M	Issue No.	<b>106</b>
LM End	<b>10.77</b>	Issue Type +	Ma	Location *	LS
Category	Earthen Levee			GPS Latitude/Longitude	
				Start	End
Item	Encroachments			37.963319 °	37.963319 °
				-121.157557 °	-121.157557 °
DWR ID	DWR_NA0017_15_s_2012_106				
Action/Comments					
Prunings Inspector Comments: Prunings and ashes piled at the toe.

Prunings were found on the landside of the levee looking downstream.

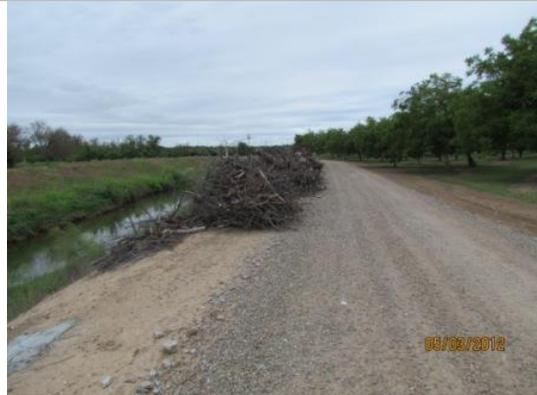
Photo 1 of 1 : FA\_2015\_NA0017\_159\_137\_20150911\_00086.jpg

LM Start	<b>10.83</b>	Rating **	M	Issue No.	<b>137</b>
LM End	<b>10.83</b>	Issue Type +	En	Location *	WS
Category	Earthen Levee			GPS Latitude/Longitude	
				Start	End
Item	Encroachments			37.962885 °	37.962885 °
				-121.158509 °	-121.158509 °
DWR ID	DWR_NA0017_15_s_2012_137				
Action/Comments					
Prunings

Prunings were found on the waterside of the levee looking downstream.

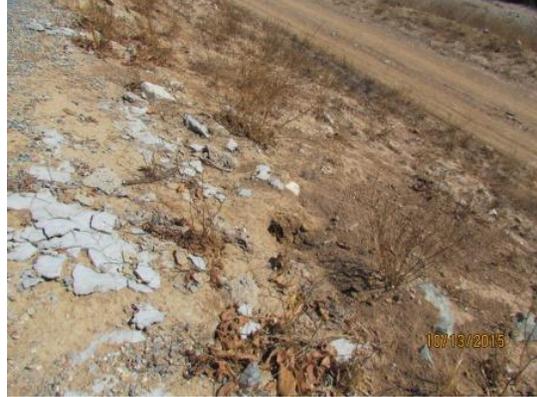
Photo 1 of 1 : FA\_2015\_NA0017\_159\_152\_20151019\_00151.jpg

LM Start	<b>10.90</b>	Rating **	M	Issue No.	<b>152</b>
LM End	<b>10.90</b>	Issue Type +	Ma	Location *	WS
Category	Earthen Levee		GPS Latitude/Longitude		
			Start	End	
Item	Animal Control		37.962272 °	37.962272 °	
			-121.159393 °	-121.159393 °	
DWR ID	DWR_NA0017_15_f_2015_152				
Action/Comments					
No rodents visible, but rodent burrows visible; need to backfill and compact or grout burrows.

A rodent hole was found on the waterside of the levee looking upstream.

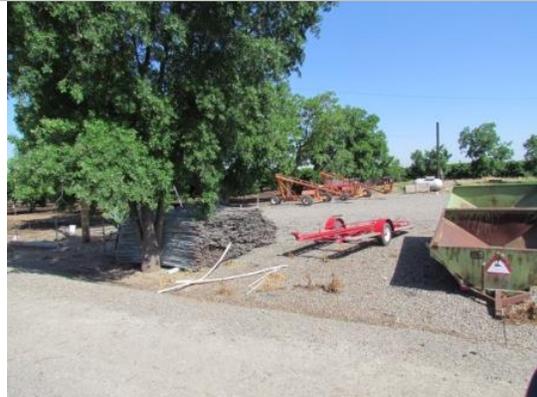
Photo 1 of 1 : FA\_2015\_NA0017\_159\_150\_20150911\_00091.jpg

LM Start	<b>11.35</b>	Rating **	M	Issue No.	<b>150</b>
LM End	<b>11.35</b>	Issue Type +	En	Location *	LS
Category	Earthen Levee		GPS Latitude/Longitude		
			Start	End	
Item	Encroachments		37.960824 °	37.960824 °	
			-121.166996 °	-121.166996 °	
DWR ID	DWR_NA0017_15_s_2012_150				
Action/Comments					
Equipment

Equipment on the landside of the levee. The picture was taken from the crown looking downstream.

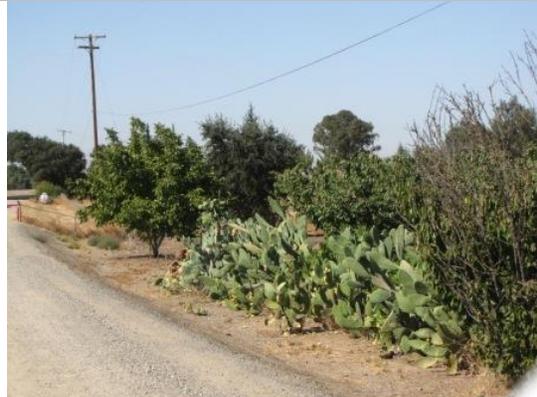
Photo 1 of 1 : FA\_2015\_NA0017\_159\_109\_20150911\_00073.jpg

LM Start	<b>11.37</b>	Rating **	M	Issue No.	<b>109</b>
LM End	<b>11.37</b>	Issue Type +	En	Location *	LS
Category	Earthen Levee		GPS Latitude/Longitude		
			Start	End	
Item	Vegetation		37.960762 °	37.960762 °	
			-121.167528 °	-121.167528 °	
DWR ID	DWR_NA0017_15_s_2012_109				
Action/Comments					
Landscaping

View of cactus within 10 feet of the landward toe blocking visibility and access.

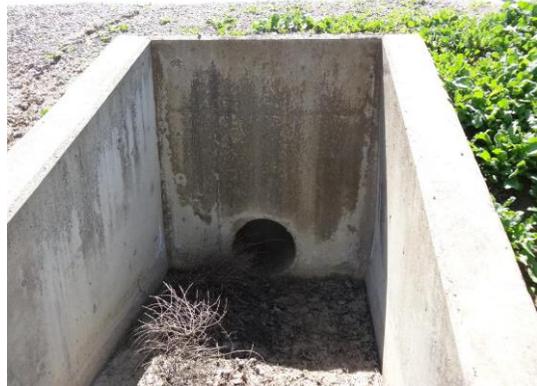
Photo 1 of 2 : UCIP\_FA\_2015\_5488.jpg

LM Start	<b>11.41</b>	Rating **	M	Issue No.	<b>1185</b>
LM End	<b>11.41</b>	Issue Type +	En	Location *	LS
Category	Supplemental			GPS Latitude/Longitude	
				Start	End
Item	DWR UCIP Field Study			37.960784 °	37.960784 °
				-121.168119 °	-121.168119 °
DWR ID					
Action/Comments					
Inspector Comments: FS_ID:35010 DS_ID:23243 EP_NO: N/A FS_HLM: 11.645 Repair Type: Non-Urgent Crossing Status: Found UCIP Comments: Distorted outlet pipe on waterside. FIELD_STRUCT_DESC: 18-inch CM pipe 4.0 feet below the roadway. Grouted outlet on the waterward side. O&M Manual SJR Assumed 999. FS Date: 04/14/2014

LS view: headwall and inlet pipe on levee toe.

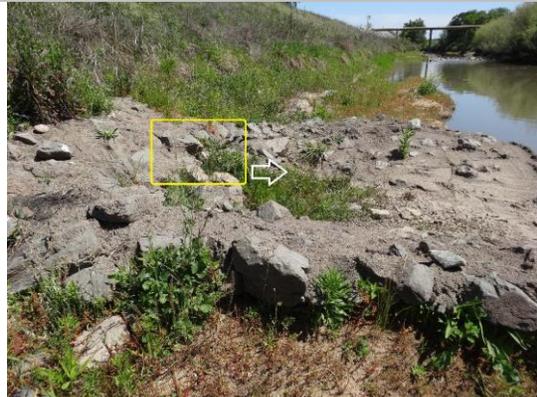
Photo 2 of 2 : UCIP\_FA\_2015\_5489.jpg

WS view: outlet pipe on grouted riprap on levee slope.

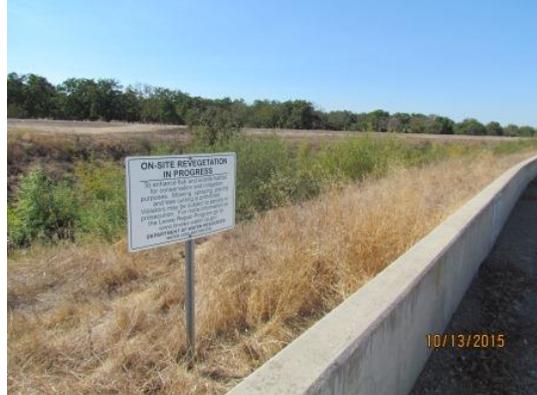
Photo 1 of 1 : FA\_2015\_NA0017\_159\_153\_20151019\_00152.jpg

LM Start	<b>11.49</b>	Rating **	A/W	Issue No.	<b>153</b>
LM End	<b>11.60</b>	Issue Type +	Ob	Location *	WS
Category	Earthen Levee		GPS Latitude/Longitude		
			Start	End	
Item	Vegetation		37.960820 °	37.961237 °	
			-121.169595 °	-121.171659 °	
DWR ID	DWR_NA0017_15_f_2015_153				
Action/Comments					
Environmental Requirements.

View of the re-vegetation area on the waterside of the levee.

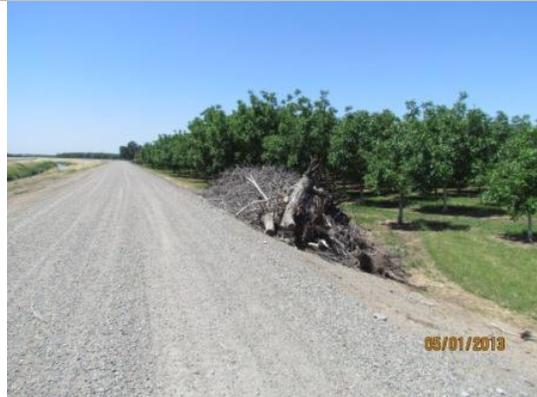
Photo 1 of 1 : FA\_2015\_NA0017\_159\_989\_20150911\_00118.jpg

LM Start	<b>11.84</b>	Rating **	M	Issue No.	<b>989</b>
LM End	<b>11.84</b>	Issue Type +	Ma	Location *	LS
Category	Earthen Levee		GPS Latitude/Longitude		
			Start	End	
Item	Encroachments		37.961901 °	37.961901 °	
			-121.175973 °	-121.175973 °	
DWR ID	DWR_NA0017_15_s_2012_989				
Action/Comments					
Prunings Inspector Comments: Burn pile has been burned but new material has been placed.

Prunings were found on the landside slope of the levee looking downstream.

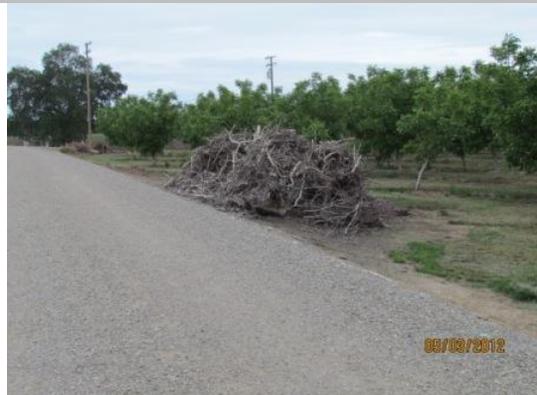
Photo 1 of 1 : FA\_2015\_NA0017\_159\_45\_20150911\_00036.jpg

LM Start	<b>11.97</b>	Rating **	M	Issue No.	<b>45</b>
LM End	<b>11.97</b>	Issue Type +	En	Location *	LS
Category	Earthen Levee		GPS Latitude/Longitude		
			Start	End	
Item	Encroachments		37.961945 °	37.961945 °	
			-121.178268 °	-121.178268 °	
DWR ID	DWR_NA0017_15_s_2012_45				
Action/Comments					
Prunings Inspector Comments: Burn pile has been burned but new material has been placed.

Prunings were found on the landside of the levee looking downstream.

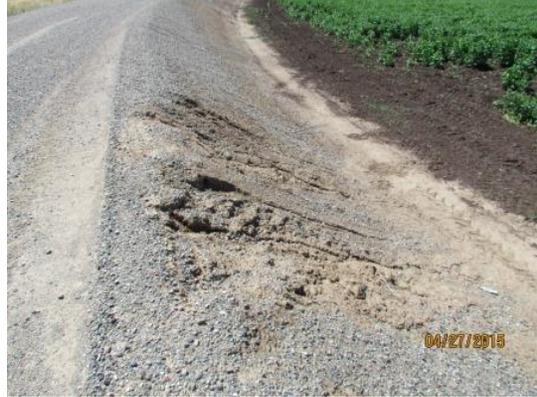
Photo 1 of 1 : FA\_2015\_NA0017\_159\_155\_20150911\_00092.jpg

LM Start	<b>12.30</b>	Rating **	M	Issue No.	<b>155</b>
LM End	<b>12.30</b>	Issue Type +	Ma	Location *	LS
Category	Earthen Levee			GPS Latitude/Longitude	
				Start	End
Item	Erosion / Bank Caving			37.961410 °	37.961410 °
				-121.184231 °	-121.184231 °
DWR ID	DWR_NA0017_15_s_2015_155				
Action/Comments					
Schedule repair of erosion site prior to the next inspection.

View of slope instability on the landside of the levee looking upstream.

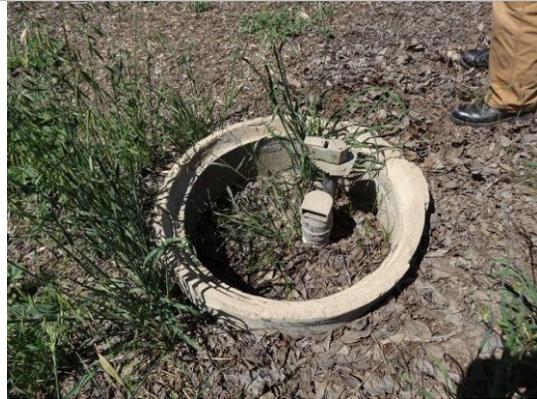
Photo 1 of 2 : UCIP\_FA\_2015\_5661.jpg

LM Start	<b>12.40</b>	Rating **	M	Issue No.	<b>1186</b>
LM End	<b>12.40</b>	Issue Type +	En	Location *	LS
Category	Supplemental			GPS Latitude/Longitude	
				Start	End
Item	DWR UCIP Field Study			37.961191 °	37.961191 °
				-121.185985 °	-121.185985 °
DWR ID					
Action/Comments					
Inspector Comments: FS_ID:41629 DS_ID:23248 EP_NO: N/A FS_HLM: 12.653 Repair Type: Non-Urgent Crossing Status: Found UCIP Comments: Appears abandoned and if so should be done so properly. FIELD_STRUCT_DESC: Abandoned 8-inch pipe and electric conduit through the levee 3.5 feet below the crown. Pump on the waterside. Concrete standpipe on the landward side. Pole on the landward side. O&M Manual SJR Assumed 999. FS Date: 04/14/2014

LS view: air vent and valve in concrete riser.

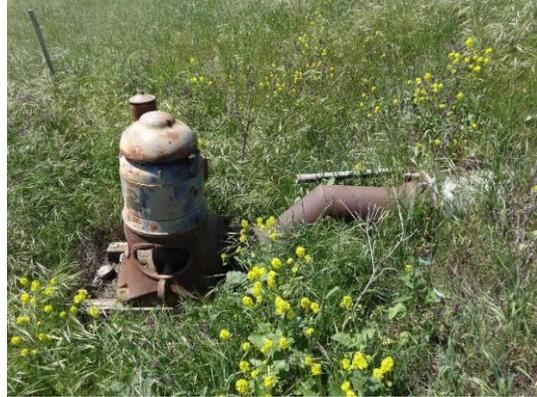
Photo 2 of 2 : UCIP\_FA\_2015\_5662.jpg

LM Start	12.40	Rating **	M	Issue No.	1186 (cont)
LM End	12.40	Issue Type +	En	Location *	LS
Category	Supplemental			GPS Latitude/Longitude	
			Start	End	
Item	DWR UCIP Field Study			37.961191 °	37.961191 °
				-121.185985 °	-121.185985 °
DWR ID					
Action/Comments					
Inspector Comments: FS_ID:41629 DS_ID:23248 EP_NO: N/A FS_HLM: 12.653 Repair Type: Non-Urgent Crossing Status: Found UCIP Comments: Appears abandoned and if so should be done so properly. FIELD_STRUCT_DESC: Abandoned 8-inch pipe and electric conduit through the levee 3.5 feet below the crown. Pump on the waterside. Concrete standpipe on the landward side. Pole on the landward side. O&M Manual SJR Assumed 999. FS Date: 04/14/2014

WS view: an abandoned pipe and pump on levee slope.

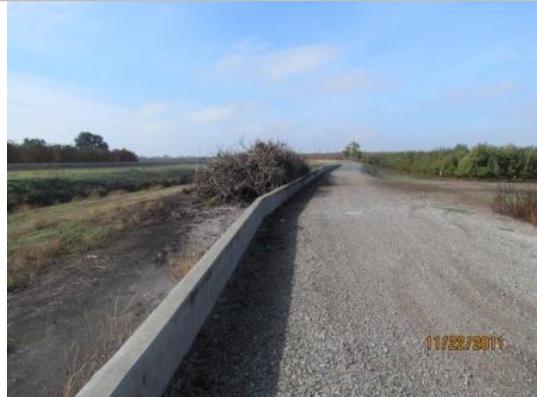
Photo 1 of 1 : FA\_2015\_NA0017\_159\_46\_20150911\_00037.jpg

LM Start	12.57	Rating **	M	Issue No.	46
LM End	12.57	Issue Type +	Ma	Location *	WS
Category	Earthen Levee			GPS Latitude/Longitude	
			Start	End	
Item	Encroachments			37.961012 °	37.961012 °
				-121.189067 °	-121.189067 °
DWR ID	DWR_NA0017_15_f_2015_46				
Action/Comments					
Prunings Inspector Comments: Burn pile has been burned but new material has been placed. Burn piles need to be moved away from the flood wall to prevent further damage.

Prunings were found on the waterside of the levee looking downstream.

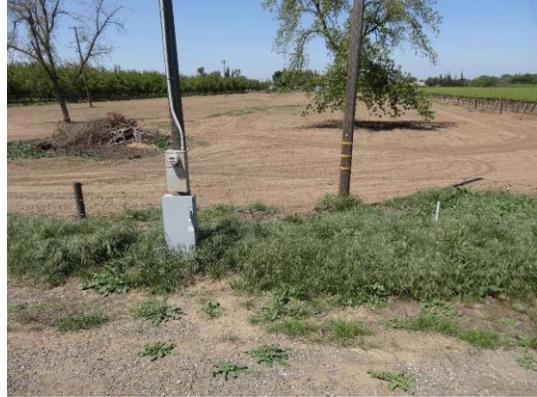
Photo 1 of 2 : UCIP\_FA\_2015\_5663.jpg

LM Start	<b>12.75</b>	Rating **	M	Issue No.	<b>1187</b>
LM End	<b>12.75</b>	Issue Type +	En	Location *	WS
Category	Supplemental			GPS Latitude/Longitude	
				Start	End
Item	DWR UCIP Field Study			37.960591 °	37.960591 °
				-121.192367 °	-121.192367 °
DWR ID					
Action/Comments					
Inspector Comments: FS_ID:35044 DS_ID:23250 EP_NO: N/A FS_HLM: 13.013 Repair Type: Non-Urgent Crossing Status: Found UCIP Comments: Pumped removed. New 12-inch steel pipe. Not found- 36-inch concrete standpipe on the landward side. Siphon valve on the landward shoulder.No pipe and appurtenances found on landside. FIELD_STRUCT_DESC: 12-inch pipe and electric conduit through the levee 3.5 feet below the crown. Pump on concrete pad on channel bank. Air vent on waterside berm and power pole on landside. O&M Manual SJR Assumed 999. FS Date: 04/14/2014

LS view: no pipe found on landside. A power pole with switch panel.

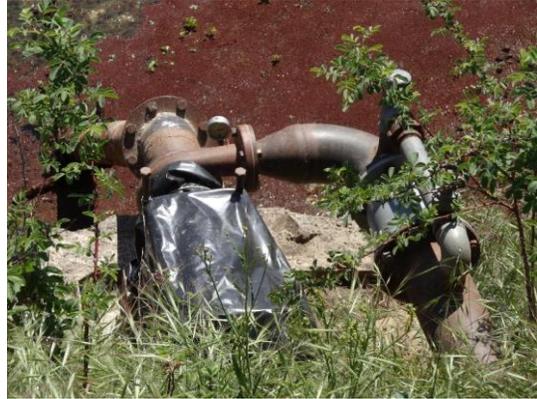
Photo 2 of 2 : UCIP\_FA\_2015\_5664.jpg

WS view: pump on concrete pad on levee slope. Pump has been removed. Pipe and appurtenances on levee slope.

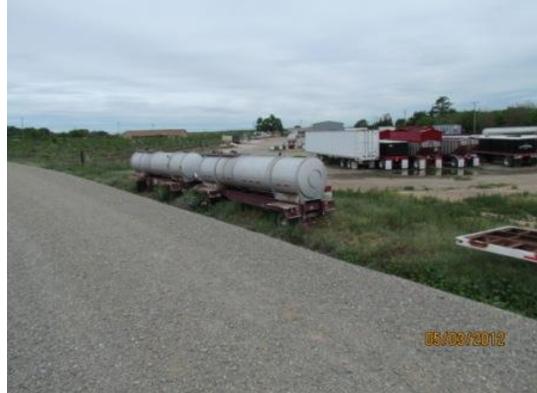
Photo 1 of 1 : FA\_2015\_NA0017\_159\_114\_20150911\_00075.jpg

LM Start	<b>12.99</b>	Rating **	M	Issue No.	<b>114</b>
LM End	<b>12.99</b>	Issue Type +	En	Location *	LS
Category	Earthen Levee			GPS Latitude/Longitude	
				Start	End
Item	Encroachments			37.961002 °	37.961002 °
				-121.196155 °	-121.196155 °
DWR ID	DWR_NA0017_15_s_2012_114				
Action/Comments					
Equipment

Equipment was found on the landside toe of the levee looking downstream.

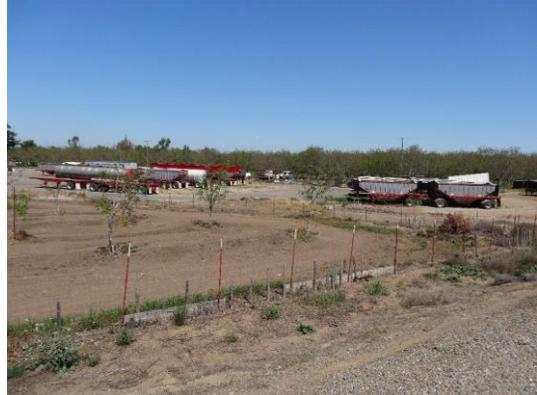
Photo 1 of 2 : UCIP\_FA\_2015\_5665.jpg

LM Start	<b>13.02</b>	Rating **	M	Issue No.	<b>1188</b>
LM End	<b>13.02</b>	Issue Type +	En	Location *	LS
Category	Supplemental			GPS Latitude/Longitude	
				Start	End
Item	DWR UCIP Field Study			37.961175 °	37.961175 °
				-121.196691 °	-121.196691 °
DWR ID					
Action/Comments					
Inspector Comments: FS_ID:35045 DS_ID:23251 EP_NO: 7363 FS_HLM: 13.283 Repair Type: Non-Urgent Crossing Status: Found UCIP Comments: Pump removed. Flowmeter in pvc riser on waterside slope.No pipe found on landside. FIELD_STRUCT_DESC: 6-inch steel pipe through the levee 3 feet below the crown. Slant pump mounted on the waterward slope. Flowmeter in pvc riser on waterside slope. (App. No.7363 - Caffese) FS Date: 04/14/2014

LS view: no pipe or appurtenances found.

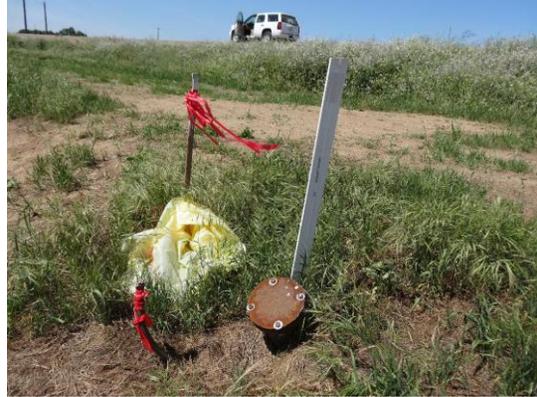
Photo 2 of 2 : UCIP\_FA\_2015\_5666.jpg

WS view: steel plated pipe, pump removed, and appurtenances on levee slope.

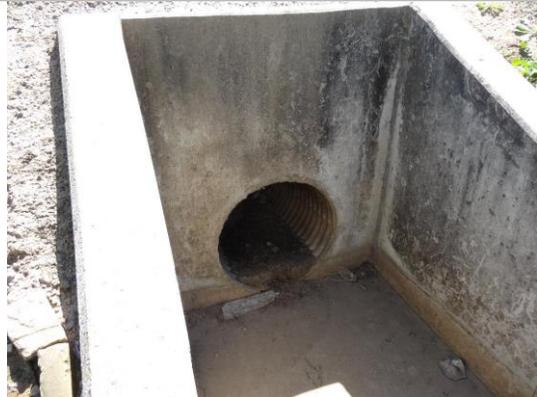
Photo 1 of 3 : UCIP\_FA\_2015\_5667.jpg

LM Start	13.15	Rating **	M	Issue No.	1189	
LM End	13.15	Issue Type +	En	Location *	LS	
Category	Supplemental			GPS Latitude/Longitude		
			Start	End		
Item	DWR UCIP Field Study			37.961186 °	37.961186 °	
DWR ID				-121.199150 °	-121.199150 °	
Action/Comments						
Inspector Comments: FS_ID:35047 DS_ID:23252 EP_NO: N/A FS_HLM: 13.421 Repair Type: Non-Urgent Crossing Status: Found UCIP Comments: Needs pipe cleaning. FIELD_STRUCT_DESC: 30-inch CM pipe through the levee 8.5 feet below the crown. Concrete "U" headwalls on both ends. Grouted spillway on waterside. Flap gate on the waterward end. O&M Manual SJR Assumed 999. FS Date: 04/14/2014

LS view: U type concrete headwall and CM inlet Pipe on levee slope. Soil/mud on inlet box.

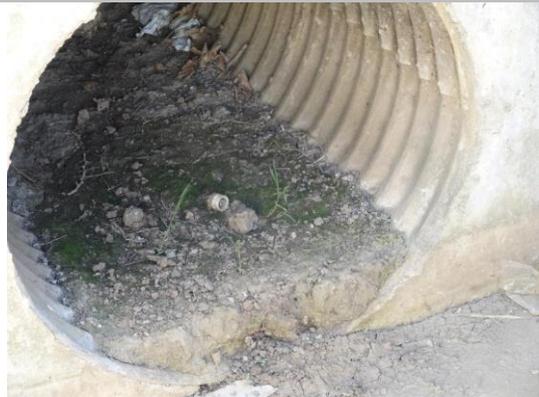
Photo 3 of 3 : UCIP\_FA\_2015\_5669.jpg

LS view: inside view of the CM pipe. Needs cleaning and clearing the pipe.

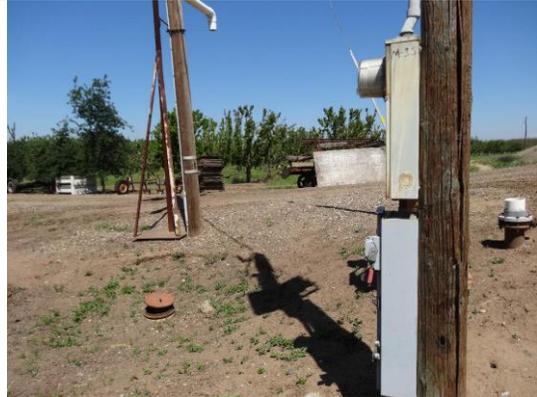
Photo 1 of 3 : UCIP\_FA\_2015\_5670.jpg

LM Start	<b>13.19</b>	Rating **	M	Issue No.	<b>1190</b>
LM End	<b>13.19</b>	Issue Type +	En	Location *	LS
Category	Supplemental			GPS Latitude/Longitude	
				Start	End
Item	DWR UCIP Field Study			37.961068 °	37.961068 °
				-121.199722 °	-121.199722 °
DWR ID					
Action/Comments					
Inspector Comments: FS_ID:35048 DS_ID:23253 EP_NO: N/A FS_HLM: 13.454 Repair Type: Non-Urgent Crossing Status: Found

LS view: power pole and appurtenances on landside toe.

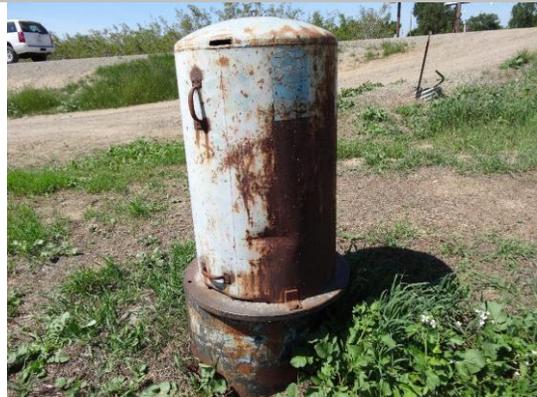
Photo 2 of 3 : UCIP\_FA\_2015\_5695.jpg

WS view: an abandoned pump on steel pedestal.

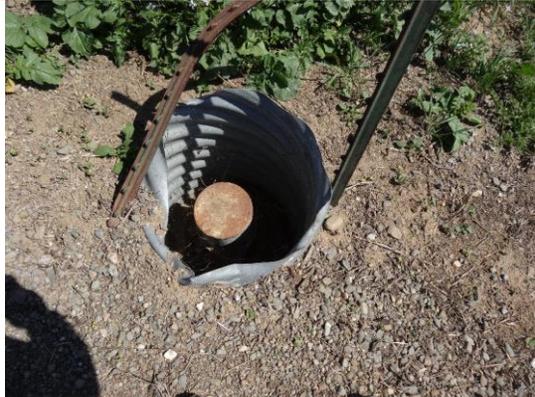
Photo 3 of 3 : UCIP\_FA\_2015\_5696.jpg

WS view: flowmeter in CMP riser on berm.

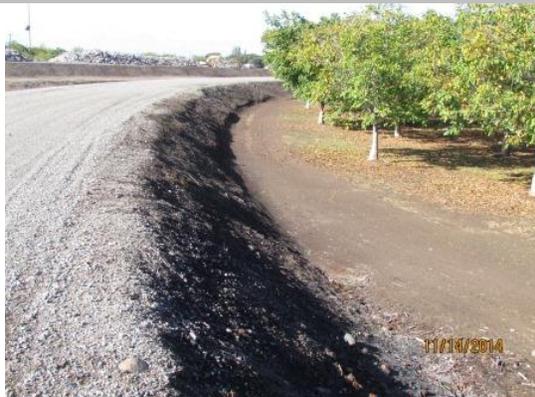
Photo 1 of 1 : FA\_2015\_NA0017\_159\_178\_20150911\_00101.jpg

LM Start	<b>13.31</b>	Rating **	M	Issue No.	<b>178</b>
LM End	<b>13.31</b>	Issue Type +	En	Location *	LS
Category	Earthen Levee			GPS Latitude/Longitude	
				Start	End
Item	Encroachments			37.960483 °	37.960483 °
				-121.201788 °	-121.201788 °
DWR ID	DWR_NA0017_15_f_2014_178				
Action/Comments					
Agricultural tilling

Agriculture tilling was found on the landside toe of the levee looking downstream.

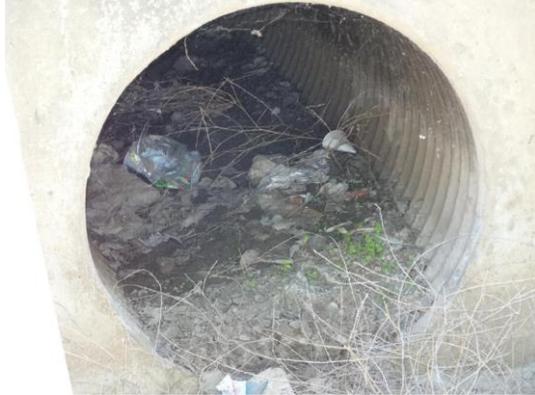
Photo 1 of 3 : UCIP\_FA\_2015\_5309.jpg

LM Start	<b>13.47</b>	Rating **	M	Issue No.	<b>1191</b>
LM End	<b>13.47</b>	Issue Type +	En	Location *	LS
Category	Supplemental			GPS Latitude/Longitude	
				Start	End
Item	DWR UCIP Field Study			37.961446 °	37.961446 °
				-121.204389 °	-121.204389 °
DWR ID					
<b>Action/Comments</b>					
Inspector Comments: FS_ID:35049 DS_ID:23254 EP_NO: N/A FS_HLM: 13.738 Repair Type: Non-Urgent Crossing Status: Found UCIP Comments: Needs cleaning. FIELD_STRUCT_DESC: 36-inch pipe through the levee 8.5 feet below the crown. Concrete "U" headwalls on both ends. Flap gate on waterward side. Grouted spillway. O&M Manual SJR Assumed 999. FS Date: 04/14/2014

LS view: inside view of the CM pipe. Needs cleaning and clearing the pipe.

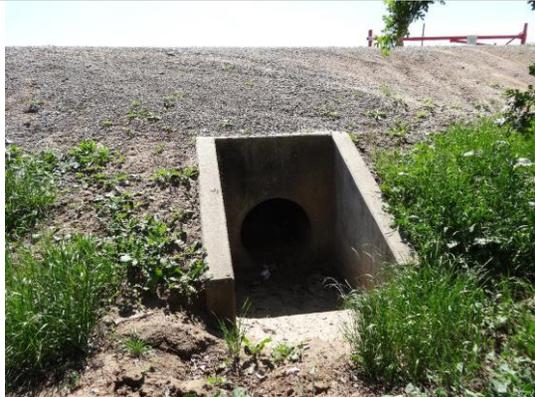
Photo 2 of 3 : UCIP\_FA\_2015\_5310.jpg

LS view: U type concrete headwall and CM inlet Pipe on levee slope. Soil/mud on inlet box.

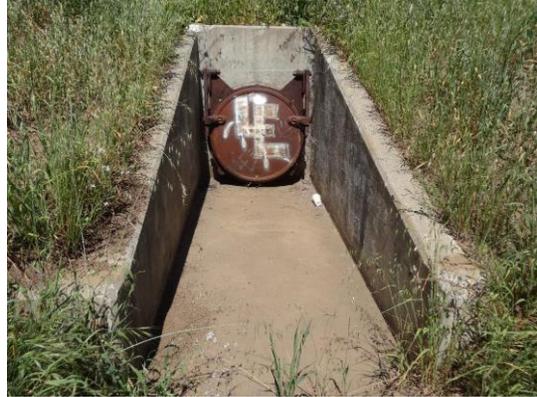
Photo 3 of 3 : UCIP\_FA\_2015\_5311.jpg

WS view: U type concrete headwall, CM pipe with flapgat, and concrete spillway on levee slope.

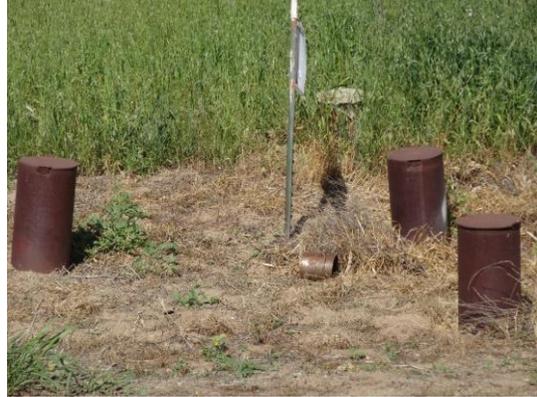
Photo 1 of 3 : UCIP\_FA\_2015\_5312.jpg

Item	DWR UCIP Field Study			37.968450 °	37.968450 °
				-121.218081 °	-121.218081 °
DWR ID					
Action/Comments					
Inspector Comments: FS_ID:40403 DS_ID:23259 EP_NO: 6378 FS_HLM: 14.643 Repair Type: Non-Urgent Crossing Status: Indicator Found UCIP Comments: Needs further evaluation to determine if crossing still exists. Only few appurtenances found on landside.Needs confirmation from LMA. FIELD_STRUCT_DESC: 42-inch concrete pipe through the levee 8.5 feet below the crown. Siphon breaker in 20-inch man hole on landward shoulder. Pressure relief valve on waterward berm. Discharges onto rock. Waterward bank rock revetted. Pad over pipe 4-foot above crown. (App- No.6378-California Water Service) O&M Manual SJR Assumed 999. FS Date: 04/14/2014

LS view: closer view of four steel risers across the wired fence.

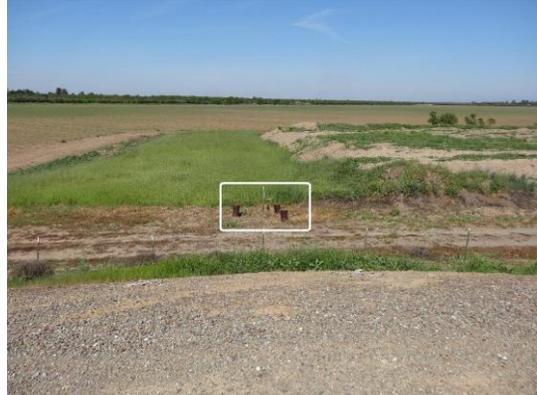
Photo 2 of 3 : UCIP\_FA\_2015\_5313.jpg

LS view: four steel risers across the wired fence.

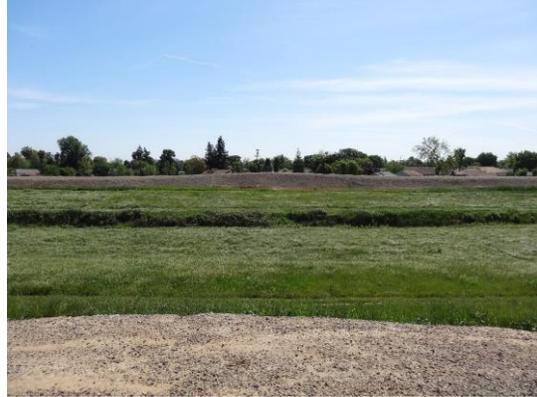
Photo 3 of 3 : UCIP\_FA\_2015\_5314.jpg

WS view: no pipe or appurtenances found. Dense vegetation.

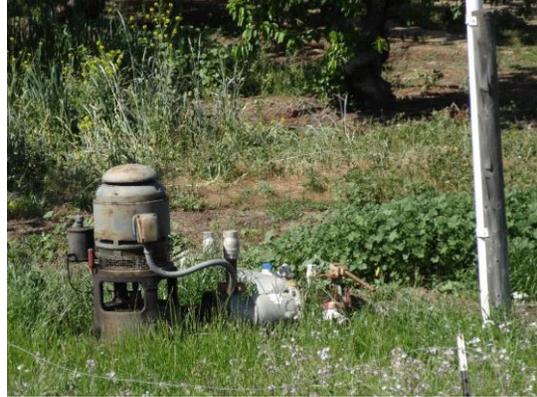
Photo 1 of 2 : UCIP\_FA\_2015\_3519.jpg

LM Start	<b>14.83</b>	Rating **	M	Issue No.	<b>1193</b>
LM End	<b>14.83</b>	Issue Type +	En	Location *	LS
Category	Supplemental			GPS Latitude/Longitude	
				Start	End
Item	DWR UCIP Field Study			37.971974 °	37.971974 °
				-121.225414 °	-121.225414 °
DWR ID					
Action/Comments					
Inspector Comments: FS_ID:40404 DS_ID:23260 EP_NO: N/A FS_HLM: 15.12 Repair Type: Non-Urgent Crossing Status: Found UCIP Comments: Needs further evaluation to determine if pipe crosses through the levee. Only a well and pump found on landside off the levee inside fence. Needs confirmation from the LMA. FIELD_STRUCT_DESC: Abandoned water well at the landward toe. Concrete "U" headwall protects sump and levee slope. Concrete standpipe 3 feet from the landward toe. FS Date: 04/14/2014

LS view: well pump off the levee on landside.

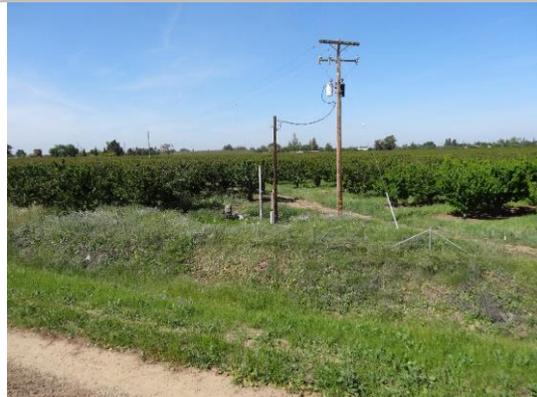
Photo 2 of 2 : UCIP\_FA\_2015\_3520.jpg

LS view: power pole for well pump off the levee on landside.

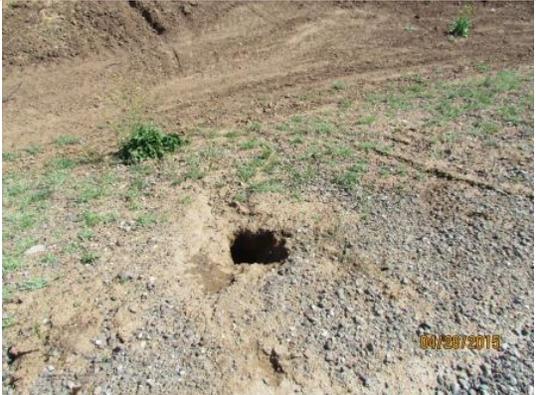
Photo 1 of 2 : FA\_2015\_NA0017\_159\_32\_20150911\_00023.jpg

Updated picture of the rodent hole on the landside of the levee during spring 2015 inspection.

LM Start	<b>15.42</b>	Rating **	M	Issue No.	<b>32</b>
LM End	<b>15.42</b>	Issue Type +	Ma	Location *	LS
Category	Earthen Levee			GPS Latitude/Longitude	
				Start	End
Item	Animal Control			37.975959 °	37.975959 °
				-121.235058 °	-121.235058 °
DWR ID	DWR_NA0017_15_s_2014_32				
Action/Comments					
No rodents visible, but rodent burrows visible; need to backfill and compact or gROUT burrows.

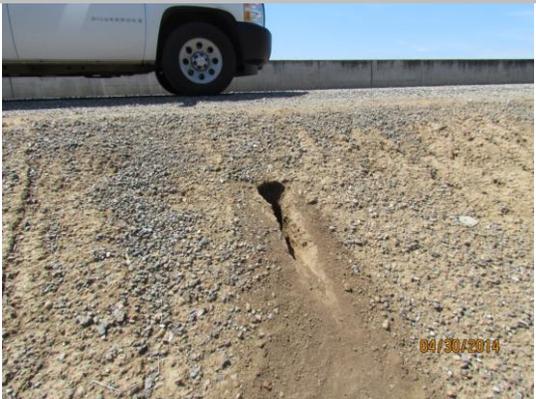
Photo 2 of 2 : FA\_2015\_NA0017\_159\_32\_20150911\_00024.jpg

A rodent hole was found on the landside of the levee looking downstream.

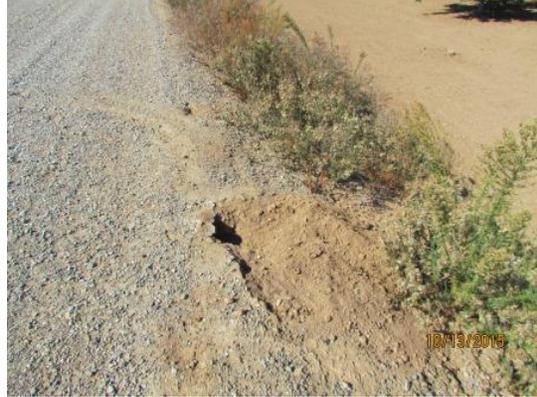
Photo 1 of 2 : FA\_2015\_NA0017\_159\_71\_20151019\_00153.jpg

Updated picture of the rodent holes on the landside of the levee looking downstream during fall 2015 inspection.

LM Start	<b>15.43</b>	Rating **	M	Issue No.	<b>71</b>
LM End	<b>15.43</b>	Issue Type +	Ma	Location *	LS
Category	Earthen Levee			GPS Latitude/Longitude	
				Start	End
Item	Animal Control			37.976000 °	37.976000 °
				-121.235156 °	-121.235156 °
DWR ID	DWR_NA0017_15_s_2013_71				
Action/Comments					
No rodents visible, but rodent burrows visible; need to backfill and compact or grout burrows.

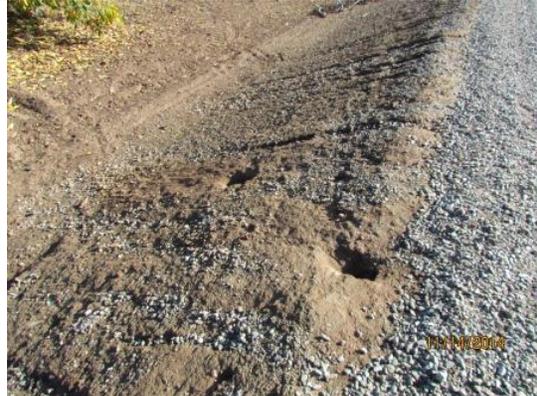
Photo 2 of 2 : FA\_2015\_NA0017\_159\_71\_20150911\_00053.jpg

View of the animal holes on the landside of the levee looking upstream during fall 2014 inspection.

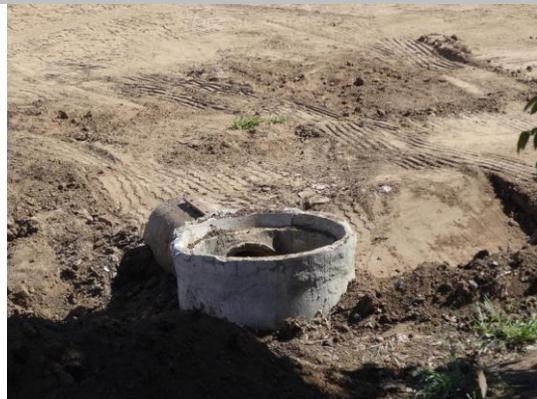
Photo 1 of 3 : UCIP\_FA\_2015\_3757.jpg

LM Start	<b>15.65</b>	Rating **	M	Issue No.	<b>1194</b>
LM End	<b>15.65</b>	Issue Type +	En	Location *	LS
Category	Supplemental			GPS Latitude/Longitude	
				Start	End
Item	DWR UCIP Field Study			37.977487 °	37.977487 °
				-121.238711 °	-121.238711 °
DWR ID					
Action/Comments					
Inspector Comments: FS_ID:40405 DS_ID:23190 EP_NO: N/A FS_HLM: 15.954 Repair Type: Non-Urgent Crossing Status: Found

LS view: concrete riser on levee toe.

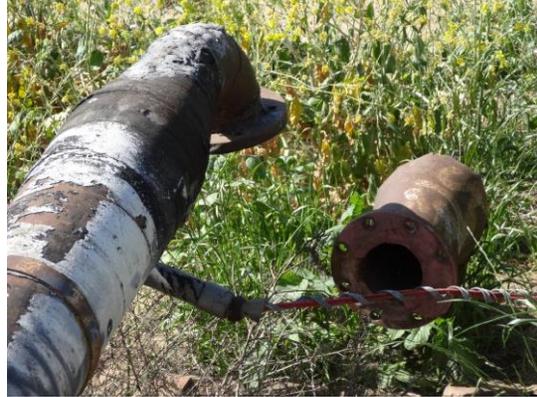
Photo 2 of 3 : UCIP\_FA\_2015\_3758.jpg

Inspector Comments: FS\_ID:40405  
 DS\_ID:23190  
 EP\_NO: N/A  
 FS\_HLM: 15.954  
 Repair Type: Non-Urgent  
 Crossing Status: Found  
 UCIP Comments: Pipe appears abandoned and if so should be done so properly. Pump removed.  
 FIELD\_STRUCT\_DESC: Abandoned 10-inch steel pipe through the levee 3.3 feet below the crown. Pump mounted over riser unit on berm. 24-inch intake pipe with concrete "U" headwall from the channel to riser unit. Electric conduit through the levee. Concrete standpipe on the landward side 25 feet from the toe. O&M Manual SJR Assumed 999.  
 FS Date: 04/15/2014

WS view: steel pipe, pump removed from pipes.

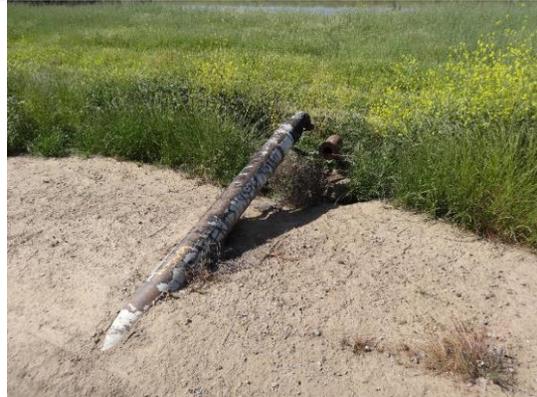
Photo 3 of 3 : UCIP\_FA\_2015\_3759.jpg

WS view: steel irrigation pipe exposed on levee slope.

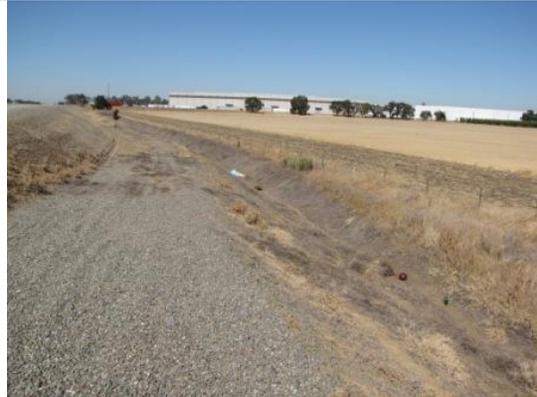
Photo 1 of 1 : FA\_2015\_NA0017\_159\_1045\_20150911\_00124.jpg

LM Start	<b>15.79</b>	Rating **	M	Issue No.	<b>1045</b>
LM End	<b>16.29</b>	Issue Type +	En	Location *	LS
Category	Earthen Levee			GPS Latitude/Longitude	
				Start	End
Item	Encroachments			37.978480 °	37.981949 °
				-121.240909 °	-121.248943 °
DWR ID	DWR_NA0017_15_s_2012_1045				
Action/Comments					
Ditch

View of a ditch adjacent to the landward toe looking downstream.

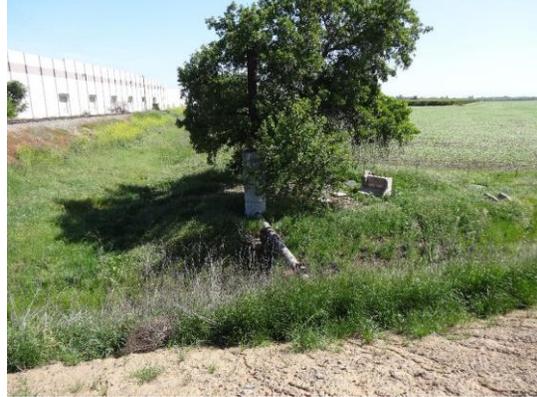
Photo 1 of 2 : UCIP\_FA\_2015\_5564.jpg

**Action/Comments**  
 Inspector Comments: FS\_ID:40406  
 DS\_ID:23191  
 EP\_NO: N/A  
 FS\_HLM: 16.284  
 Repair Type: Non-Urgent  
 Crossing Status: Found  
 UCIP Comments: Appears abandoned and if so should be done so properly. Pump removed.  
 FIELD\_STRUCT\_DESC: Abandoned 12-inch steel pipe through the levee 3.3 feet below the crown. Pump mounted over riser unit on berm. 24-inch intake pipe with concrete "U" headwall from the channel to riser unit. Electric conduit through the levee. Concrete standpipe on the landward side 25 feet from toe. O&M Manual SJR Assumed 999.  
 FS Date: 04/15/2014

LS view: steel pipe crossing ditch, a concrete standpipe across the ditch under the tree.

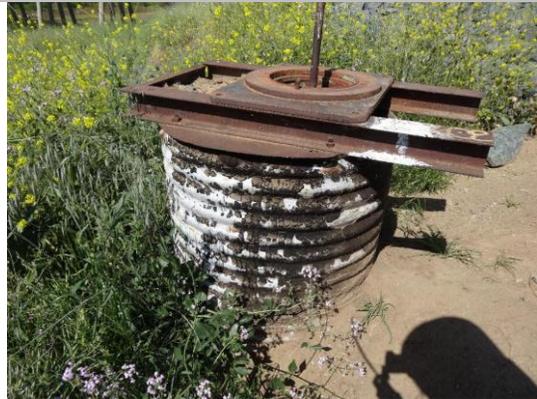
Photo 2 of 2 : UCIP\_FA\_2015\_5565.jpg

WS view: pump removed from CMP pump sump. CMP sump on levee slope.

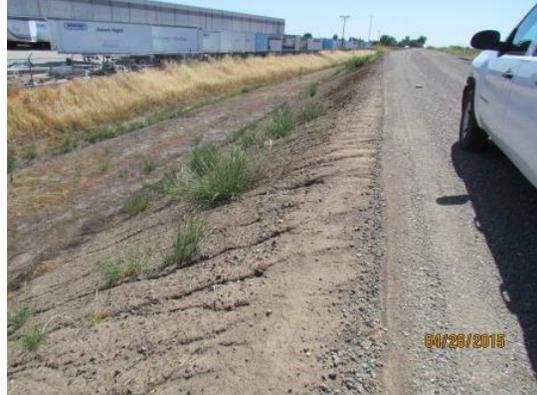
Photo 1 of 1 : FA\_2015\_NA0017\_159\_198\_20150911\_00109.jpg

View of slope instability due to runoff on the landside of the levee looking upstream.

LM Start	<b>16.14</b>	Rating **	M	Issue No.	<b>198</b>
LM End	<b>16.14</b>	Issue Type +	Ma	Location *	LS
Category	Earthen Levee			GPS Latitude/Longitude	
				Start	End
Item	Slope Stability			37.980961 °	37.980961 °
				-121.246553 °	-121.246553 °
DWR ID	DWR_NA0017_15_s_2015_198				
Action/Comments					
Repair slope instability. Inspector Comments: Runoff

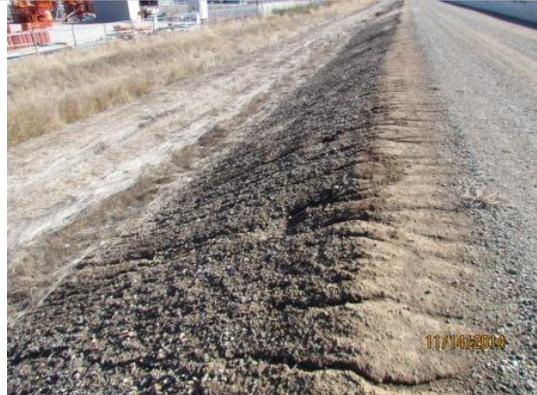
Photo 1 of 1 : FA\_2015\_NA0017\_159\_184\_20150911\_00103.jpg

Erosion caused by surface runoff was found on the landside of the levee looking upstream.

LM Start	<b>16.26</b>	Rating **	M	Issue No.	<b>184</b>
LM End	<b>16.26</b>	Issue Type +	Ma	Location *	LS
Category	Earthen Levee			GPS Latitude/Longitude	
				Start	End
Item	Erosion / Bank Caving			37.981800 °	37.981800 °
				-121.248545 °	-121.248545 °
DWR ID	DWR_NA0017_15_f_2014_184				
Action/Comments					
Schedule repair of erosion site prior to the next inspection. Inspector Comments: Surface runoff.

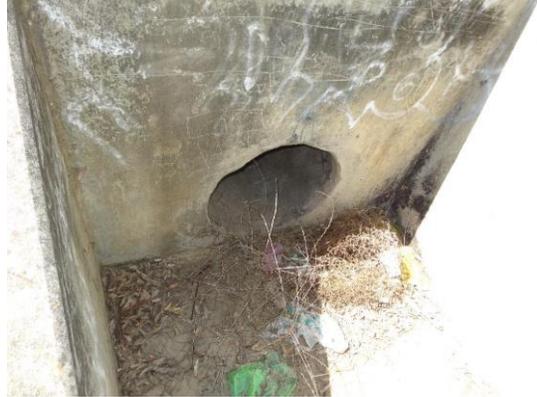
Photo 1 of 2 : UCIP\_FA\_2015\_5490.jpg

**Action/Comments**  
 Inspector Comments: FS\_ID:40407  
 DS\_ID:24855  
 EP\_NO: N/A  
 FS\_HLM: 16.742  
 Repair Type: Non-Urgent  
 Crossing Status: Found  
 UCIP Comments: Needs cleaning and clearing of inlet and distribution box. Due to dense vegetation headwall and flapgate not visible. New field discovered entry. Also mentioned in PI report.  
 FIELD\_STRUCT\_DESC: 30-inch reinforced concrete drain pipe through the levee, about 9.0 ft. below the crown. Slide gate on concrete box on waterside shoulder. Flap gate on pipe end on waterside. U type concrete headwall on both sides of the levee.  
 FS Date: 04/15/2014

LS view: U type concrete headwall and concrete pipe on levee slope.

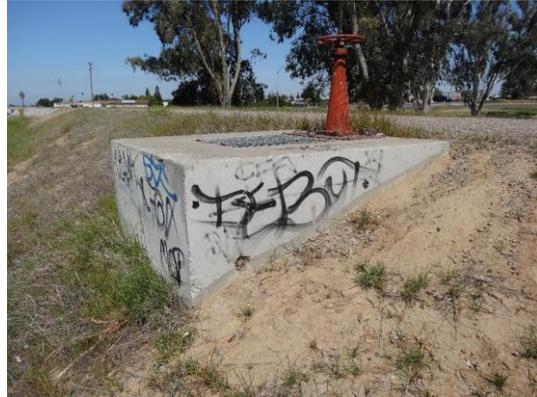
Photo 2 of 2 : UCIP\_FA\_2015\_5491.jpg

WS view: slide gate in a concrete box on levee shoulder.

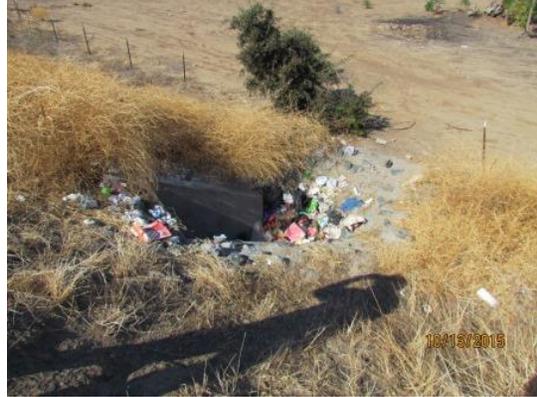
Photo 1 of 1 : FA\_2015\_NA0017\_159\_160\_20151019\_00154.jpg

LM Start	<b>16.50</b>	Rating **	M	Issue No.	<b>160</b>
LM End	<b>16.50</b>	Issue Type +	Ma	Location *	LS
Category	Earthen Levee			GPS Latitude/Longitude	
				Start	End
Item	Encroachments			37.983513 °	37.983513 °
				-121.252295 °	-121.252295 °
DWR ID	DWR_NA0017_15_f_2015_160				
Action/Comments					
Debris

Debris was found on the landside of the levee.
