**Flood Control Project Maintenance  
Levee Inspections**

**Fall 2015 Levee Maintenance Deficiency Summary Report**

**San Joaquin River Basin**

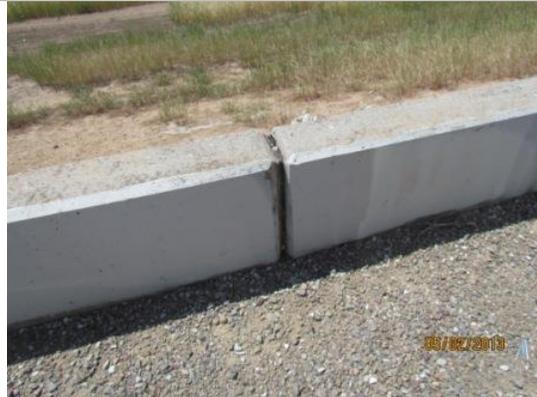
Photo 1 of 1 : FA\_2015\_NA0017\_159\_93\_20150911\_00062.jpg

The monolith joint material is deteriorating at the waterside shoulder of the levee looking downstream.

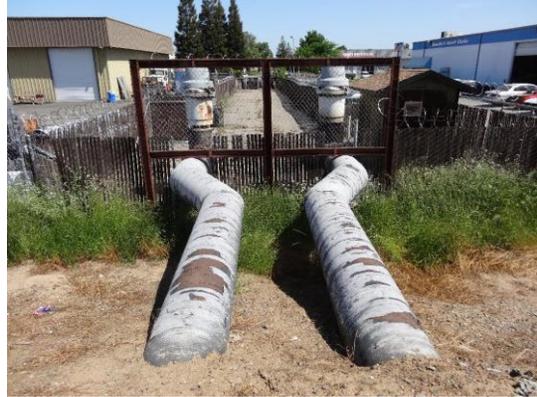
Photo 1 of 3 : UCIP\_FA\_2015\_3510.jpg

LM Start	<b>16.68</b>	Rating **	U	Issue No.	<b>1198</b>
LM End	<b>16.68</b>	Issue Type +	En	Location *	WS
Category	Supplemental			GPS Latitude/Longitude	
				Start	End
Item	DWR UCIP Field Study			37.984621 °	37.984621 °
				-121.255303 °	-121.255303 °
DWR ID					
Action/Comments					
Inspector Comments: FS_ID:40409 DS_ID:23459 EP_NO: 12371 FS_HLM: 17.007 Repair Type: Urgent Crossing Status: Found UCIP Comments: Flap gate missing on waterside pipe end. Siphon breaker in CMP riser on waterside shoulder. FIELD_STRUCT_DESC: 2 of 2: Two 24-inch-diameter steel pipes through the levee 3.0 feet below the crown. Pump and sump area landward of the levee. Siphon breaker in CMP riser on waterside shoulder. Flap gate missing on waterside pipe end. (Permit No. 12371 - Cherokee Industrial Park Investors) FS Date: 04/15/2014

LS view: exposed steel pipes and pumps on landside.

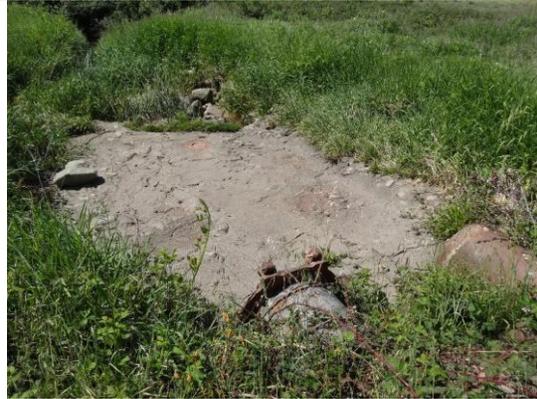
Photo 2 of 3 : UCIP\_FA\_2015\_3511.jpg

WS view: outfall pipes on levee slope. Steel pipe with missing flap gate (right).

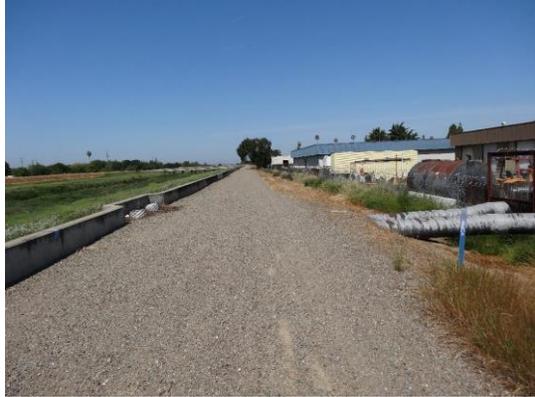
Photo 3 of 3 : UCIP\_FA\_2015\_3512.jpg

Crown view: two steel pipes (right) on landside and siphon breakers (left) on crown. Flood wall along the levee on waterside.

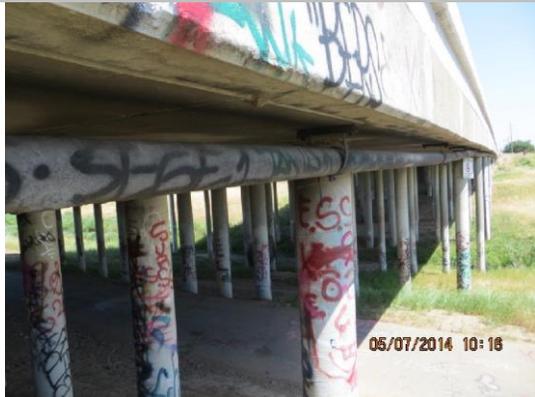
Photo 1 of 1 : UCIP\_FA\_2015\_5815.jpg

LM Start	<b>17.44</b>	Rating **	M	Issue No.	<b>1199</b>
LM End	<b>17.44</b>	Issue Type +	En	Location *	LS
Category	Supplemental			GPS Latitude/Longitude	
				Start	End
Item	DWR UCIP Field Study			37.989830 °	37.989830 °
				-121.267485 °	-121.267485 °
DWR ID					
Action/Comments					
Inspector Comments: FS_ID:39094 DS_ID:24963 EP_NO: N/A FS_HLM: 17.777 Repair Type: Non-Urgent Crossing Status: Found UCIP Comments: Need to determine purpose for conduit. No permit identified for this crossing. FIELD_STRUCT_DESC: Delete, duplicate. FS Date: 05/07/2014

Pipe visible on underside of upstream side of bridge.

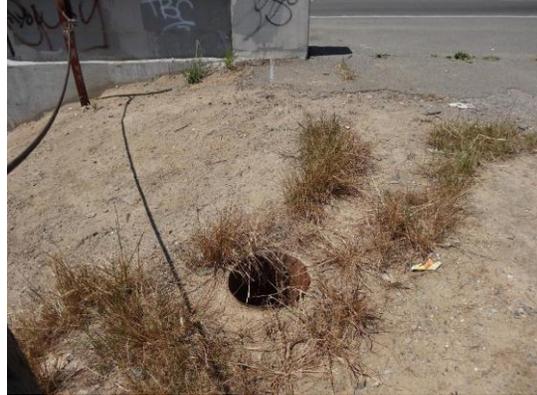
Photo 1 of 2 : UCIP\_FA\_2015\_3642.jpg

**Action/Comments**  
 Inspector Comments: FS\_ID:40410  
 DS\_ID:23180  
 EP\_NO: 16163  
 FS\_HLM: 17.777  
 Repair Type: Non-Urgent  
 Crossing Status: Indicator Found  
 UCIP Comments: Needs more info from LMA. A steel pipe riser found on waterside shoulder. A concrete manhole with steel plate cover found on landside shoulder.  
 FIELD\_STRUCT\_DESC: 12-inch-diameter steel water pipe through both levees and under stockton Diversion Canal. (Permit No. 16163 - California Water Service Company)  
 FS Date: 04/15/2014

WS view: a steel pipe riser found on levee shoulder.

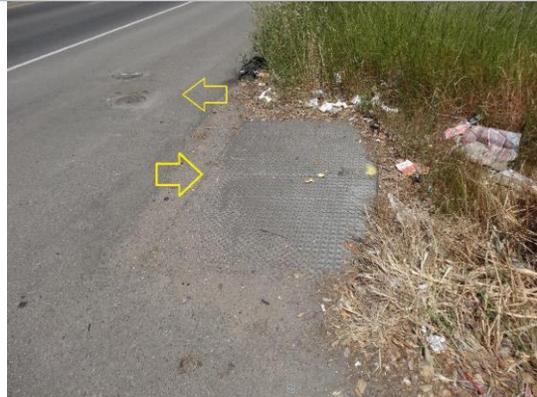
Photo 2 of 2 : UCIP\_FA\_2015\_3677.jpg

LS view: two manholes on road and a concrete manhole on levee shoulder.

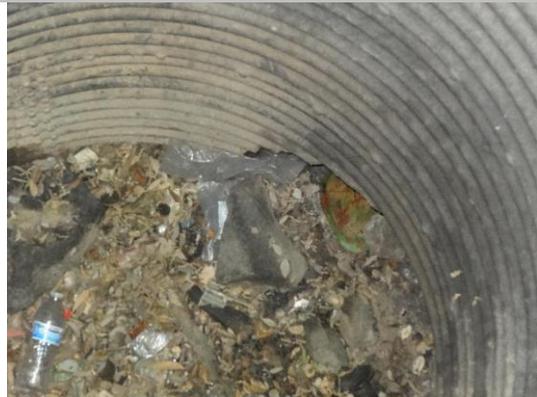
Photo 1 of 3 : UCIP\_FA\_2015\_3678.jpg

LM Start	<b>17.66</b>	Rating **	M	Issue No.	<b>1201</b>
LM End	<b>17.66</b>	Issue Type +	En	Location *	LS
Category	Supplemental			GPS Latitude/Longitude	
				Start	End
Item	DWR UCIP Field Study			37.991126 °	37.991126 °
				-121.271062 °	-121.271062 °
DWR ID					
Action/Comments					
Inspector Comments: FS_ID:35183 DS_ID:23267 EP_NO: N/A FS_HLM: 17.998 Repair Type: Non-Urgent Crossing Status: Found UCIP Comments: CMP riser needs cleaning. FIELD_STRUCT_DESC: 30-inch pipe through the levee 13.0 feet below the crown. Concrete "U" headwall on the waterward side. CMP riser unit at the landward toe. O&M Manual SJR Assumed 999. FS Date: 04/15/2014

LS view: inside view of CMP riser on levee shoulder. It needs cleaning and clearing.

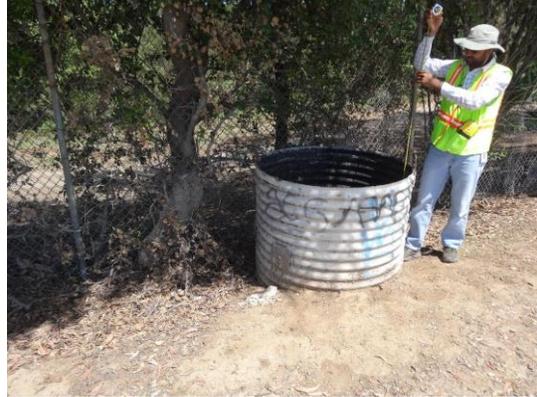
Photo 2 of 3 : UCIP\_FA\_2015\_3679.jpg

LS view: CMP riser on levee shoulder.

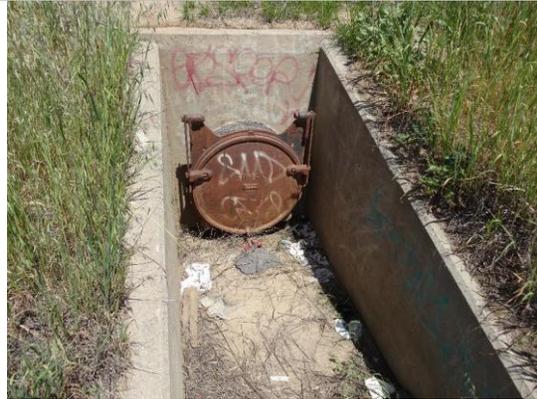
Photo 3 of 3 : UCIP\_FA\_2015\_3680.jpg

WS view: U type concrete headwall, CM pipe with flapgate, and concrete spillway on levee slope.

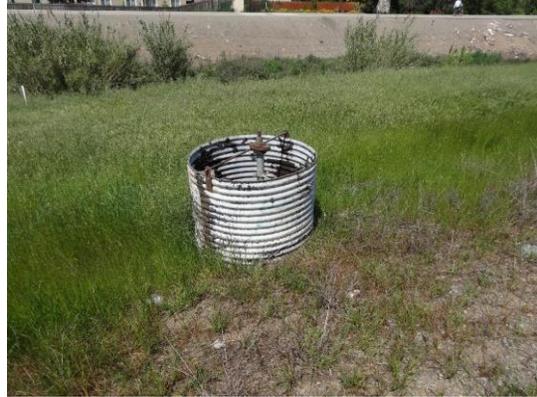
Photo 2 of 3 : UCIP\_FA\_2015\_3848.jpg

WS view: slide gate in CMP riser on levee slope. Slide gate handle missing.

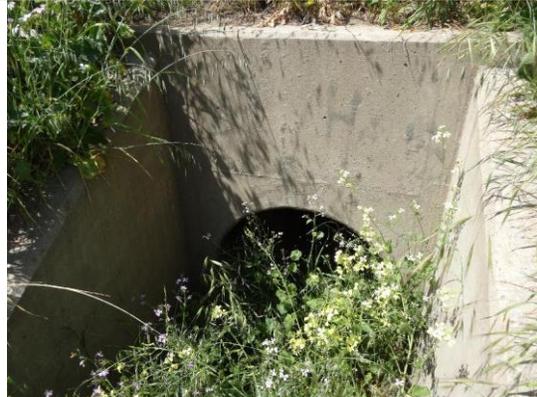
Photo 3 of 3 : UCIP\_FA\_2015\_3849.jpg

LS view: U type concrete headwall and CM pipe on levee slope.

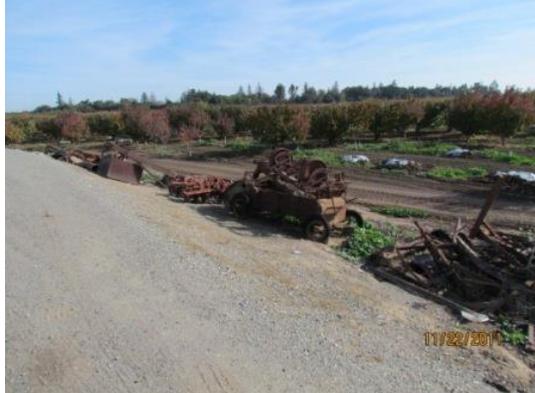
Photo 1 of 1 : FA\_2015\_NA0017\_159\_567\_20150911\_00115.jpg

LM Start	<b>18.30</b>	Rating **	M	Issue No.	<b>567</b>
LM End	<b>18.30</b>	Issue Type +	Ma	Location *	LS
Category	Earthen Levee			GPS Latitude/Longitude	
				Start	End
Item	Encroachments			37.994859 °	37.994859 °
				-121.275862 °	-121.275862 °
DWR ID	DWR_NA0017_15_s_2012_567				
Action/Comments					
Equipment

Equipment was found on the landside of the levee looking downstream.

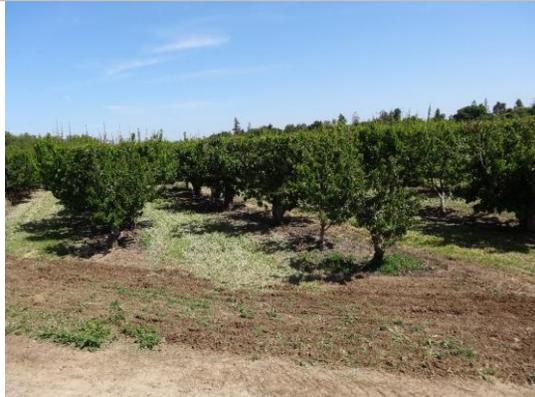
Photo 1 of 3 : UCIP\_FA\_2015\_3850.jpg

LM Start	<b>18.39</b>	Rating **	M	Issue No.	<b>1203</b>
LM End	<b>18.39</b>	Issue Type +	En	Location *	LS
Category	Supplemental			GPS Latitude/Longitude	
				Start	End
Item	DWR UCIP Field Study			37.995907 °	37.995907 °
				-121.274854 °	-121.274854 °
DWR ID					
Action/Comments					
Inspector Comments: FS_ID:40411 DS_ID:23271 EP_NO: N/A FS_HLM: 18.737 Repair Type: Non-Urgent Crossing Status: Found UCIP Comments: Appears abandoned and if so should be done so properly. FIELD_STRUCT_DESC: Abandoned 14-inch concrete pipe through the levee 14.0 feet below the crown. 30-inch concrete standpipe with slide gate at the waterward toe. Pump and well on the berm. 24-inch concrete standpipe near pump. O&M Manual SJR Assumed 999. FS Date: 04/15/2014

LS view: no pipe or any appurtenances found.

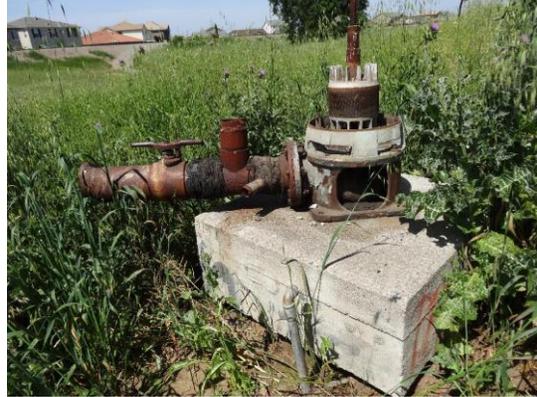
Photo 2 of 3 : UCIP\_FA\_2015\_3868.jpg

WS view: abandoned pump on concrete pad on levee berm.

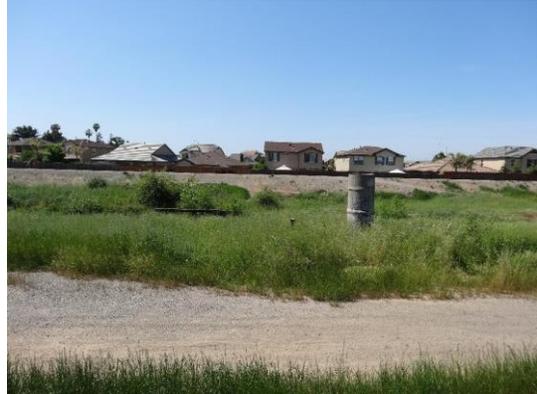
Photo 3 of 3 : UCIP\_FA\_2015\_3869.jpg

WS view: concrete standpipe on levee berm.

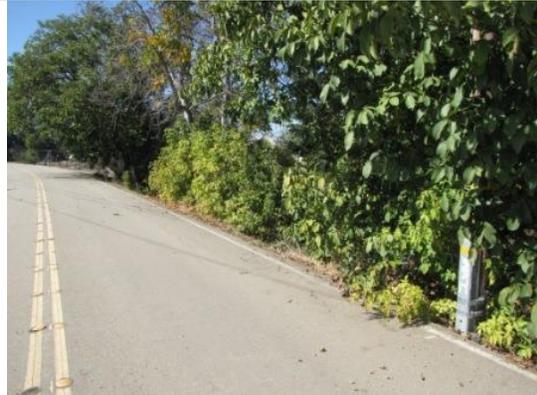
Photo 1 of 1 : FA\_2015\_NA0017\_159\_1052\_20150911\_00125.jpg

LM Start	<b>19.49</b>	Rating **	M	Issue No.	<b>1052</b>
LM End	<b>19.51</b>	Issue Type +	En	Location *	LS
Category	Earthen Levee			GPS Latitude/Longitude	
				Start	End
Item	Vegetation			37.995287 °	37.995215 °
				-121.277404 °	-121.277843 °
DWR ID	DWR_NA0017_15_s_2012_1052				
Action/Comments					
Landscaping

View of landowner planted and maintained vegetation along the landward slope looking downstream.

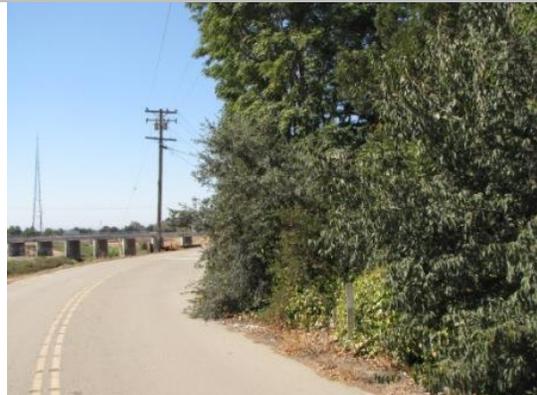
Photo 1 of 1 : FA\_2015\_NA0017\_159\_1054\_20150911\_00126.jpg

LM Start	<b>19.59</b>	Rating **	M	Issue No.	<b>1054</b>
LM End	<b>19.68</b>	Issue Type +	En	Location *	LS
Category	Earthen Levee			GPS Latitude/Longitude	
				Start	End
Item	Vegetation			37.994756 °	37.994729 °
				-121.279161 °	-121.280718 °
DWR ID	DWR_NA0017_15_s_2012_1054				
Action/Comments					
Landscaping

View of landowner planted and maintained vegetation along the landward slope looking downstream.

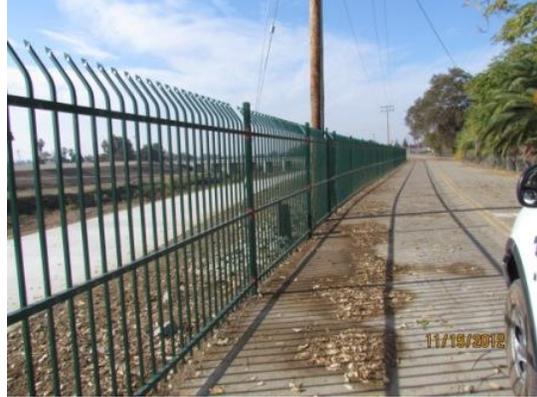
Photo 1 of 1 : FA\_2015\_NA0017\_159\_107\_20150911\_00072.jpg

LM Start	<b>19.62</b>	Rating **	U	Issue No.	<b>107</b>
LM End	<b>19.74</b>	Issue Type +	En	Location *	WS
Category	Earthen Levee		GPS Latitude/Longitude		
			Start	End	
Item	Encroachments		37.994671 °	37.994696 °	
			-121.279658 °	-121.281905 °	
DWR ID	DWR_NA0017_15_f_2012_107				
Action/Comments					
Fence Inspector Comments: City of Stockton placed this fence on the waterside shoulder of the levee.

A fence was placed by the City of Stockton on the waterside shoulder of the levee looking downstream.

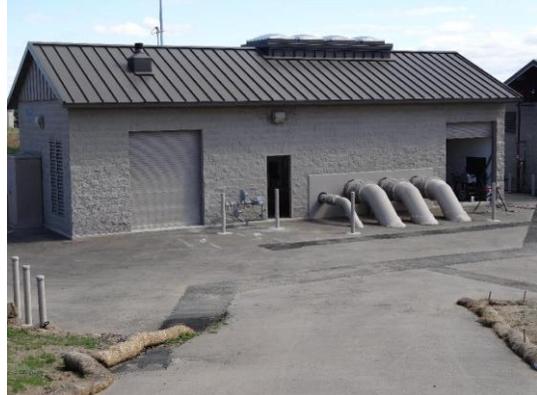
Photo 1 of 3 : UCIP\_FA\_2015\_5637.jpg

LM Start	<b>19.70</b>	Rating **	M	Issue No.	<b>1204</b>
LM End	<b>19.70</b>	Issue Type +	En	Location *	WS
Category	Supplemental		GPS Latitude/Longitude		
			Start	End	
Item	DWR UCIP Field Study		37.994717 °	37.994717 °	
			-121.281074 °	-121.281074 °	
DWR ID					
Action/Comments					
Inspector Comments: FS_ID:35469 DS_ID:23484 EP_NO: 17925 FS_HLM: 19.877 Repair Type: Non-Urgent Crossing Status: Found UCIP Comments: Missing check valve on outfall pipe end. FIELD_STRUCT_DESC: 4 of 4: Three 24-inch and one 12-inch steel discharge pipes through the levee, approx. 5 feet below the crown. Pump station on landside, outfall pipes with check valves on waterside. (App. No. 17925, 2005 - KB Homes). FS Date: 04/22/2014

LS view: exposed pipes and pump house on levee toe.

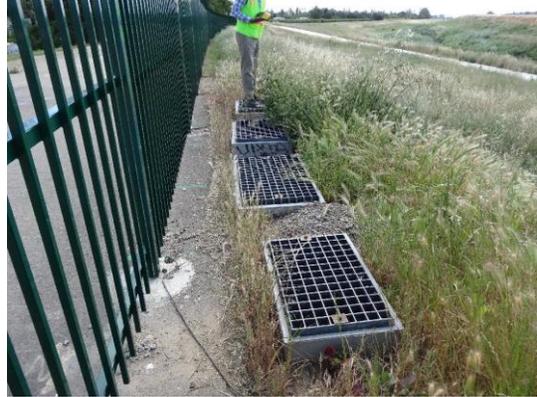
Photo 2 of 3 : UCIP\_FA\_2015\_5638.jpg

Inspector Comments: FS\_ID:35469  
 DS\_ID:23484  
 EP\_NO: 17925  
 FS\_HLM: 19.877  
 Repair Type: Non-Urgent  
 Crossing Status: Found  
 UCIP Comments: Missing check valve on outfall pipe end.  
 FIELD\_STRUCT\_DESC: 4 of 4: Three 24-inch and one 12-inch steel discharge pipes through the levee, approx. 5 feet below the crown.  
 Pump station on landside, outfall pipes with check valves on waterside.  
 (App. No. 17925, 2005 - KB Homes).  
 FS Date: 04/22/2014

WS view: air relief valve in concrete box on levee shoulder.

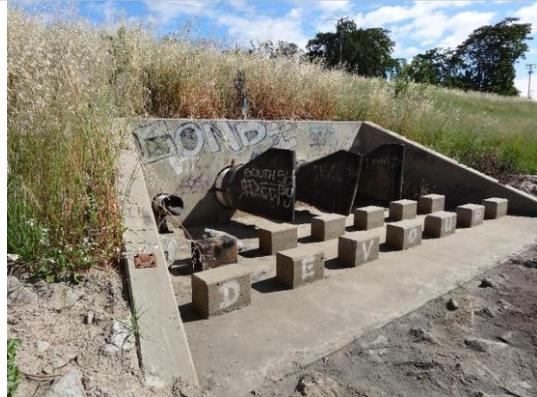
Photo 3 of 3 : UCIP\_FA\_2015\_5639.jpg

WS view: three 24" and one 12" outfall steel pipes, concrete headwall, and spillway with concrete energy dissipators on levee toe.

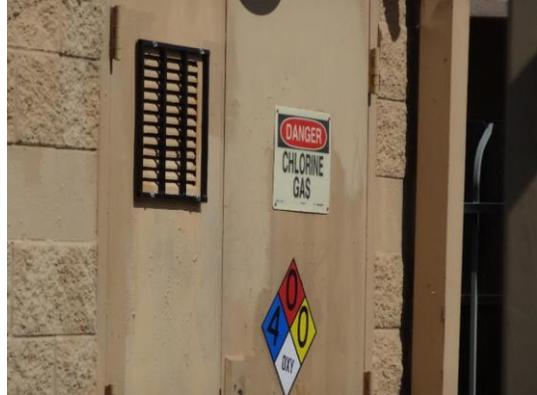
Photo 1 of 1 : UCIP\_FA\_2015\_4014.jpg

LM Start	<b>19.75</b>	Rating **	M	Issue No.	<b>1205</b>
LM End	<b>19.75</b>	Issue Type +	En	Location *	WS
Category	Supplemental			GPS Latitude/Longitude	
				Start	End
Item	DWR UCIP Field Study			37.994657 °	37.994657 °
				-121.282027 °	-121.282027 °
DWR ID					
Action/Comments					
Inspector Comments: FS_ID:41903 DS_ID:23273 EP_NO: N/A FS_HLM: 19.93 Repair Type: Non-Urgent Crossing Status: Indicator Found

LS view: A chlorine gas marker on "PG&E" house on landside.

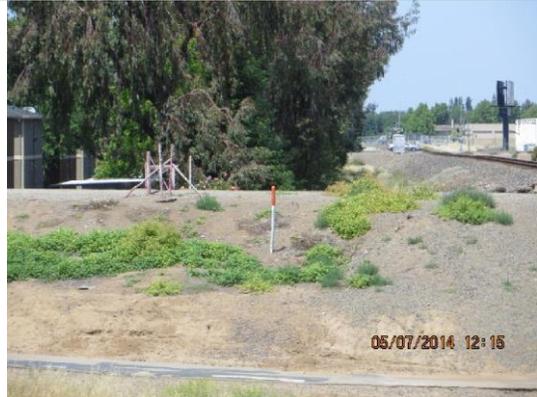
Photo 1 of 1 : UCIP\_FA\_2015\_6597.jpg

LM Start	<b>20.30</b>	Rating **	M	Issue No.	<b>1206</b>
LM End	<b>20.30</b>	Issue Type +	En	Location *	LS
Category	Supplemental			GPS Latitude/Longitude	
				Start	End
Item	DWR UCIP Field Study			37.993334 °	37.993334 °
				-121.291542 °	-121.291542 °
DWR ID					
Action/Comments					
Inspector Comments: FS_ID:41950 DS_ID:24965 EP_NO: N/A FS_HLM: 20.482 Repair Type: Non-Urgent Crossing Status: Found UCIP Comments: No permit identified for this crossing. FIELD_STRUCT_DESC: Communication cable markers along downstream side of bridge. FS Date: 04/29/2014

Communication line markers on WS. Viewed from Unit 16.

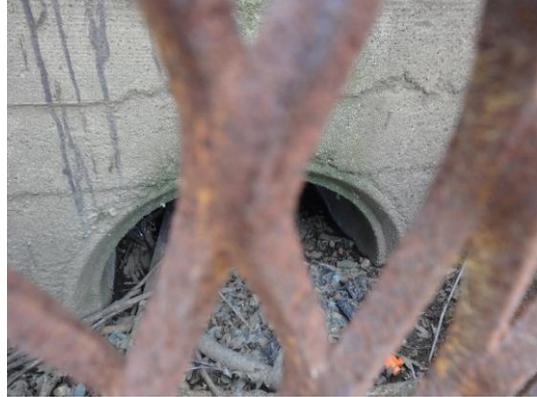
Photo 1 of 3 : UCIP\_FA\_2015\_3643.jpg

LM Start	20.58	Rating **	M	Issue No.	1207
LM End	20.58	Issue Type +	En	Location *	LS
Category	Supplemental			GPS Latitude/Longitude	
				Start	End
Item	DWR UCIP Field Study			37.992395 °	37.992395 °
				-121.296512 °	-121.296512 °
DWR ID					
Action/Comments					
Inspector Comments: FS_ID:40412 DS_ID:23279 EP_NO: 4583 FS_HLM: 20.763 Repair Type: Non-Urgent Crossing Status: Found UCIP Comments: Half inlet opening buried into mud. Needs cleaning and clearing. Intake on storm drain ditch. Trash rack on inlet. FIELD_STRUCT_DESC: 24-inch concrete pipe through the levee 12.5 feet below the crown. Concrete headwall and flap gate on the waterward end. Concrete headwall with flashboard slats on the landward side. (App. No.4583 - San Joaquin Co. Public Works) O&M Manual SJR Assumed 999. FS Date: 05/22/2014

LS view: partially buried intake pipe with trash rack on levee toe. Needs cleaning and clearing.

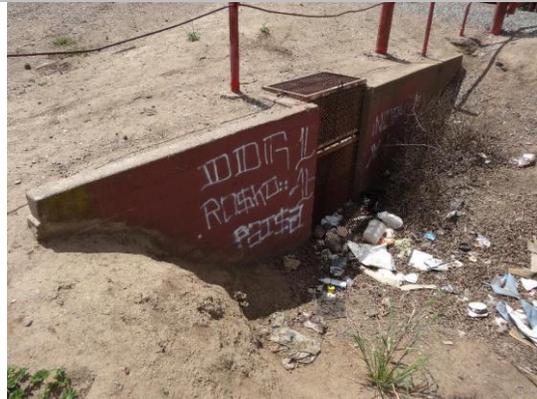
Photo 2 of 3 : UCIP\_FA\_2015\_5540.jpg

LS view: concrete headwall and intake with trash rack on drainage ditch.

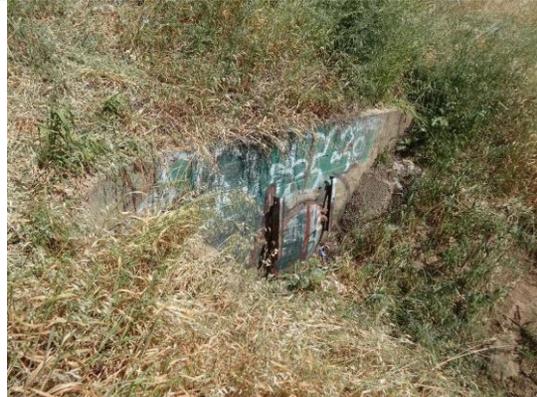
Photo 3 of 3 : UCIP\_FA\_2015\_5541.jpg

LM Start	<b>20.58</b>	Rating **	M	Issue No.	<b>1207 (cont)</b>
LM End	<b>20.58</b>	Issue Type +	En	Location *	LS
Category	Supplemental			GPS Latitude/Longitude	
				Start	End
Item	DWR UCIP Field Study			37.992395 °	37.992395 °
				-121.296512 °	-121.296512 °
DWR ID					
Action/Comments					
Inspector Comments: FS_ID:40412 DS_ID:23279 EP_NO: 4583 FS_HLM: 20.763 Repair Type: Non-Urgent Crossing Status: Found

WS view: concrete headwall and CM outfall pipe with flapgate, and vegetation on spillway.

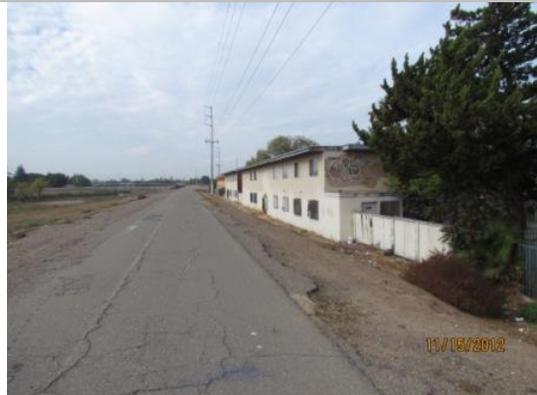
Photo 1 of 1 : FA\_2015\_NA0017\_159\_53\_20150911\_00040.jpg

LM Start	<b>20.70</b>	Rating **	U	Issue No.	<b>53</b>
LM End	<b>20.80</b>	Issue Type +	En	Location *	LS
Category	Earthen Levee			GPS Latitude/Longitude	
				Start	End
Item	Encroachments			37.992015 °	37.992103 °
				-121.298692 °	-121.300505 °
DWR ID	DWR_NA0017_15_s_2012_53				
Action/Comments					
Building

View of the buildings on the landside of the levee looking downstream.

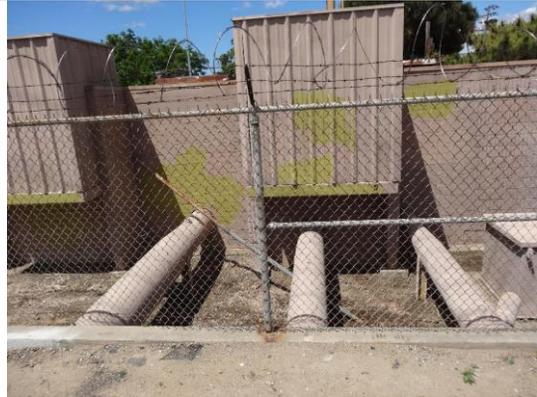
Photo 1 of 3 : UCIP\_FA\_2015\_5542.jpg

LM Start	<b>21.03</b>	Rating **	U	Issue No.	<b>1208</b>
LM End	<b>21.03</b>	Issue Type +	En	Location *	LS
Category	Supplemental			GPS Latitude/Longitude	
				Start	End
Item	DWR UCIP Field Study			37.991479 °	37.991479 °
				-121.304506 °	-121.304506 °
DWR ID					
Action/Comments					
Inspector Comments: FS_ID:40413 DS_ID:23281 EP_NO: 2389 FS_HLM: 21.216 Repair Type: Urgent Crossing Status: Found UCIP Comments: Flapgate does not fully close. FIELD_STRUCT_DESC: 1 of 3: 16-inch steel pipe through the levee 4.6-feet below the crown. Flap gate on the waterward end. Siphon breakers in 42-inch concrete riser on the waterward shoulder. Pump house on the landward side. (Permit No. 2389 - City of Stockton). O&M Manual SJR Assumed 999. FS Date: 05/22/2014

LS view: pipes and pump house in pump station on levee toe.

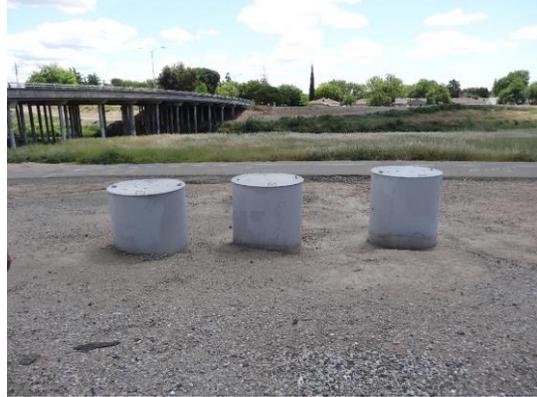
Photo 2 of 3 : UCIP\_FA\_2015\_5543.jpg

LM Start	<b>21.03</b>	Rating **	U	Issue No.	<b>1208 (cont)</b>
LM End	<b>21.03</b>	Issue Type +	En	Location *	LS
Category	Supplemental			GPS Latitude/Longitude	
				Start	End
Item	DWR UCIP Field Study			37.991479 °	37.991479 °
				-121.304506 °	-121.304506 °
DWR ID					
Action/Comments					
Inspector Comments: FS_ID:40413 DS_ID:23281 EP_NO: 2389 FS_HLM: 21.216 Repair Type: Urgent Crossing Status: Found UCIP Comments: Flapgate does not fully close. FIELD_STRUCT_DESC: 1 of 3: 16-inch steel pipe through the levee 4.6-feet below the crown. Flap gate on the waterward end. Siphon breakers in 42-inch concrete riser on the waterward shoulder. Pump house on the landward side. (Permit No. 2389 - City of Stockton). O&M Manual SJR Assumed 999. FS Date: 05/22/2014

WS view: siphon breakers in concrete pipe risers on levee slope.

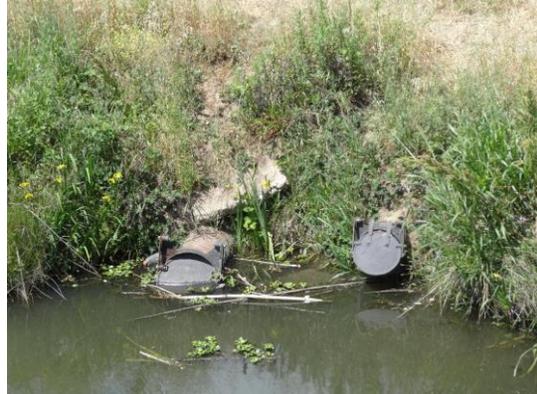
Photo 3 of 3 : UCIP\_FA\_2015\_5544.jpg

WS view: three (one not visible) steel outfall pipes on channel bank.

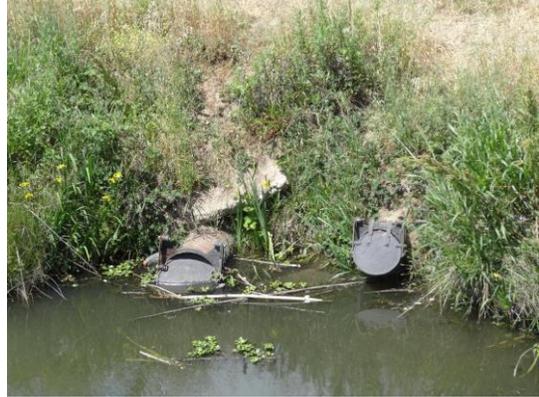
Photo 1 of 2 : UCIP\_FA\_2015\_5545.jpg

LM Start	<b>21.03</b>	Rating **	U	Issue No.	<b>1209</b>
LM End	<b>21.03</b>	Issue Type +	En	Location *	LS
Category	Supplemental			GPS Latitude/Longitude	
				Start	End
Item	DWR UCIP Field Study			37.991470 °	37.991470 °
				-121.304522 °	-121.304522 °
DWR ID					
Action/Comments					
Inspector Comments: FS_ID:40414 DS_ID:23469 EP_NO: 2389 FS_HLM: 21.217 Repair Type: Urgent Crossing Status: Found

WS view: three (one not visible) steel outfall pipes on channel bank.

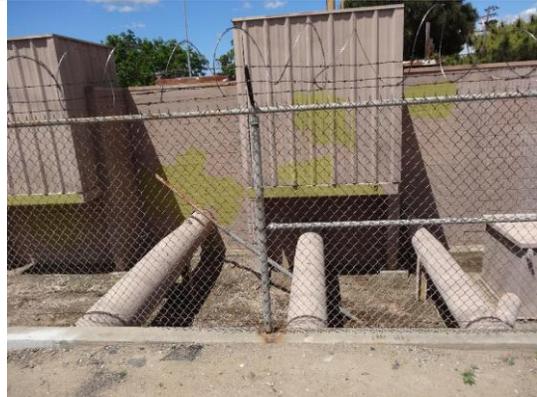
Photo 1 of 3 : UCIP\_FA\_2015\_5578.jpg

LM Start	<b>21.03</b>	Rating **	M	Issue No.	<b>1210</b>
LM End	<b>21.03</b>	Issue Type +	En	Location *	LS
Category	Supplemental			GPS Latitude/Longitude	
				Start	End
Item	DWR UCIP Field Study			37.991458 °	37.991458 °
				-121.304543 °	-121.304543 °
DWR ID					
Action/Comments					
Inspector Comments: FS_ID:35345 DS_ID:23470 EP_NO: 2389 FS_HLM: 21.219 Repair Type: Non-Urgent Crossing Status: Found

LS view: pipes and pump house in pump station on levee toe.

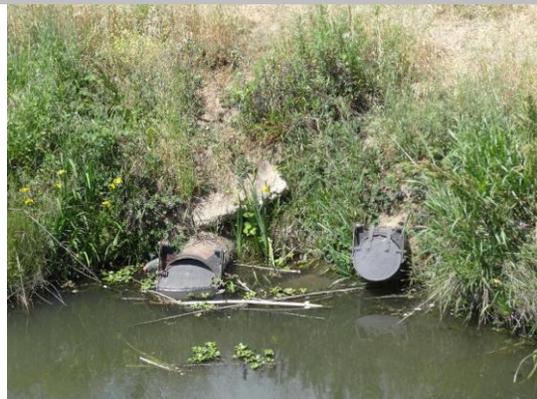
Photo 2 of 3 : UCIP\_FA\_2015\_5579.jpg

WS view: three (one not visible) steel outfall pipes on channel bank.

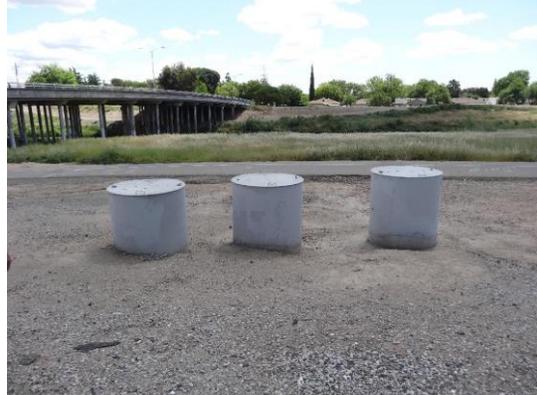
Photo 3 of 3 : UCIP\_FA\_2015\_5580.jpg

LM Start	<b>21.03</b>	Rating **	M	Issue No.	<b>1210 (cont)</b>
LM End	<b>21.03</b>	Issue Type +	En	Location *	LS
Category	Supplemental			GPS Latitude/Longitude	
				Start	End
Item	DWR UCIP Field Study			37.991458 °	37.991458 °
				-121.304543 °	-121.304543 °
DWR ID					
Action/Comments					
Inspector Comments: FS_ID:35345 DS_ID:23470 EP_NO: 2389 FS_HLM: 21.219 Repair Type: Non-Urgent Crossing Status: Found

WS view: siphon breakers in concrete pipe risers on levee slope.

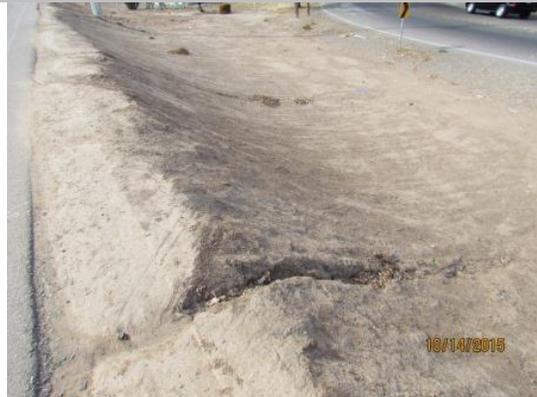
Photo 1 of 1 : FA\_2015\_NA0017\_159\_172\_20151019\_00155.jpg

LM Start	<b>21.25</b>	Rating **	M	Issue No.	<b>172</b>
LM End	<b>21.25</b>	Issue Type +	Ma	Location *	LS
Category	Earthen Levee			GPS Latitude/Longitude	
				Start	End
Item	Erosion / Bank Caving			37.988969 °	37.988969 °
				-121.307009 °	-121.307009 °
DWR ID	DWR_NA0017_15_f_2015_172				
Action/Comments					
Schedule repair of erosion site prior to the next inspection. Inspector Comments: Runoff.

Erosion was found on the landside of the levee looking downstream.

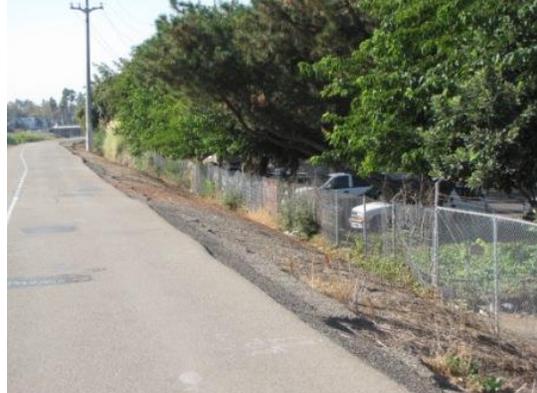
Photo 1 of 1 : FA\_2015\_NA0017\_159\_1062\_20150911\_00127.jpg

LM Start	<b>21.28</b>	Rating **	M	Issue No.	<b>1062</b>
LM End	<b>21.42</b>	Issue Type +	En	Location *	LS
Category	Earthen Levee			GPS Latitude/Longitude	
				Start	End
Item	Encroachments			37.988543 °	37.986783 °
				-121.307211 °	-121.308158 °
DWR ID	DWR_NA0017_15_s_2012_1062				
Action/Comments					
Fence

View of fence along the landward toe looking downstream.

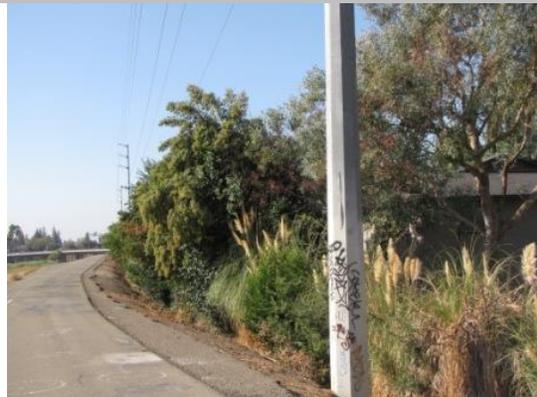
Photo 1 of 1 : FA\_2015\_NA0017\_159\_56\_20150911\_00042.jpg

LM Start	<b>21.34</b>	Rating **	M	Issue No.	<b>56</b>
LM End	<b>21.54</b>	Issue Type +	En	Location *	LS
Category	Earthen Levee			GPS Latitude/Longitude	
				Start	End
Item	Vegetation			37.987718 °	37.985250 °
				-121.307630 °	-121.309249 °
DWR ID	DWR_NA0017_15_s_2012_56				
Action/Comments					
Landscaping

View of landscaping along the landward slope and toe looking downstream.

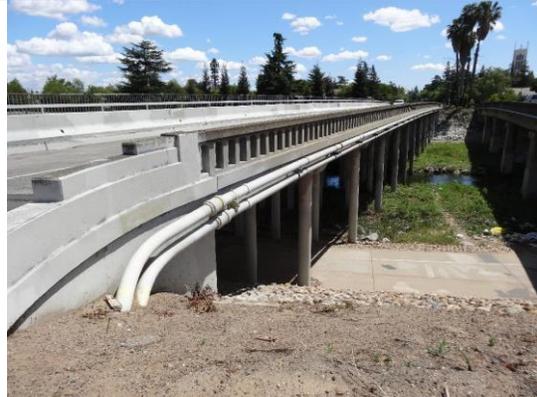
Photo 2 of 2 : UCIP\_FA\_2015\_5630.jpg

LM Start	<b>21.60</b>	Rating **	M	Issue No.	<b>1211 (cont)</b>
LM End	<b>21.60</b>	Issue Type +	En	Location *	LS
Category	Supplemental			GPS Latitude/Longitude	
				Start	End
Item	DWR UCIP Field Study			37.984656 °	37.984656 °
				-121.310032 °	-121.310032 °
DWR ID					
Action/Comments					
Inspector Comments: FS_ID:41543 DS_ID:24860 EP_NO: N/A FS_HLM: 21.792 Repair Type: Non-Urgent Crossing Status: Found UCIP Comments: Field discovered conduits. FIELD_STRUCT_DESC: Two 6-inch galvanized iron pipes attached to the bridge and through the levee, 2 feet below the crown. FS Date: 04/29/2014

WS view: two 6-inch GI pipes attached to the Pacific Avenue Bridge and through the levee.

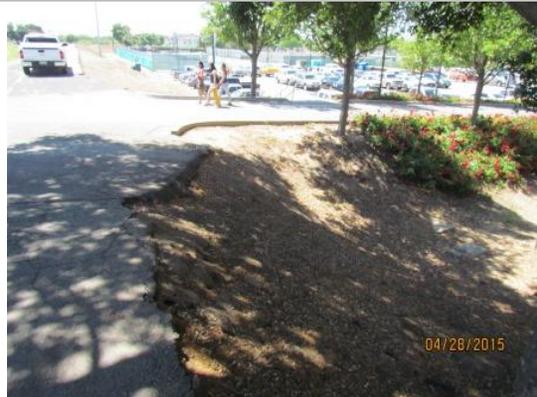
Photo 1 of 4 : FA\_2015\_NA0017\_159\_1065\_20150911\_00129.jpg

LM Start	<b>21.91</b>	Rating **	A/W	Issue No.	<b>1065</b>
LM End	<b>21.91</b>	Issue Type +	En	Location *	LS
Category	Earthen Levee			GPS Latitude/Longitude	
				Start	End
Item	Vegetation			37.981675 °	37.981675 °
				-121.314329 °	-121.314329 °
DWR ID	DWR_NA0017_15_s_2012_1065				
Action/Comments					
Landscaping Inspector Comments: Rose Bush

Rose bushes were removed from the landside slope of the levee looking upstream. This picture was taken during spring 2015 inspection.

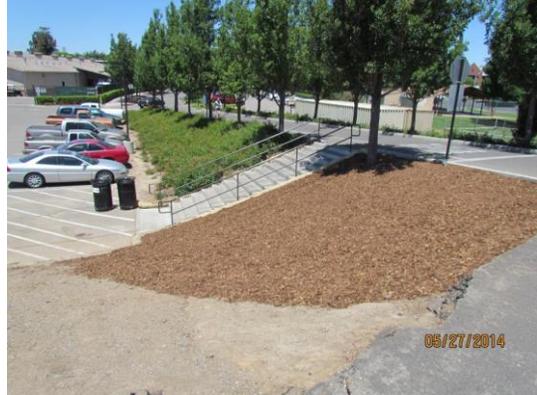
Photo 2 of 4 : FA\_2015\_NA0017\_159\_1065\_20150911\_00130.jpg

Rose bush was removed on the other side of the walkway on the landside slope of the levee looking upstream.

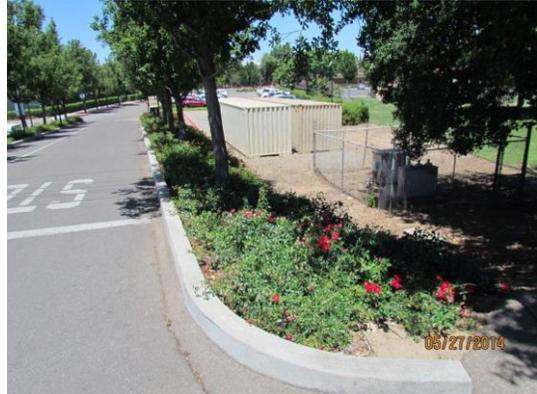
Photo 3 of 4 : FA\_2015\_NA0017\_159\_1065\_20150911\_00131.jpg

Few rose bush was found on the landside slope of the levee looking upstream during fall 2014 inspection.

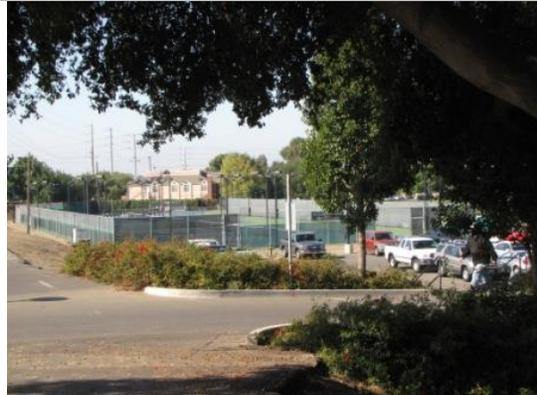
Photo 4 of 4 : FA\_2015\_NA0017\_159\_1065\_20150911\_00132.jpg

View of landscaping maintained by UOP along the landward slope looking downstream.

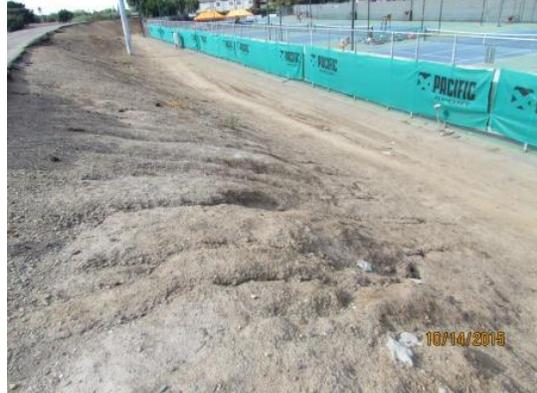
Photo 1 of 2 : FA\_2015\_NA0017\_159\_173\_20151019\_00156.jpg

LM Start	<b>21.96</b>	Rating **	M	Issue No.	<b>173</b>
LM End	<b>21.96</b>	Issue Type +	Ma	Location *	LS
Category	Earthen Levee		GPS Latitude/Longitude		
			Start	End	
Item	Erosion / Bank Caving		37.981147 °	37.981147 °	
			-121.315071 °	-121.315071 °	
DWR ID	DWR_NA0017_15_s_2012_173				
Action/Comments					
Schedule repair of erosion site prior to the next inspection. Inspector Comments: Runoff.

Updated picture of the erosion caused by run off on the landside slope of the levee looking downstream during fall 2015 inspection.

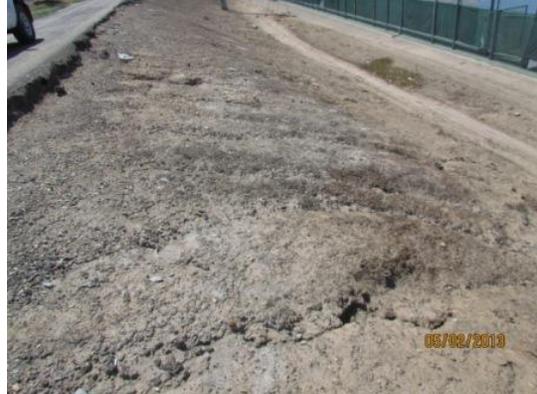
Photo 2 of 2 : FA\_2015\_NA0017\_159\_173\_20150911\_00099.jpg

Erosion caused by run off on the landside slope of the levee looking downstream during spring 2013 inspection.

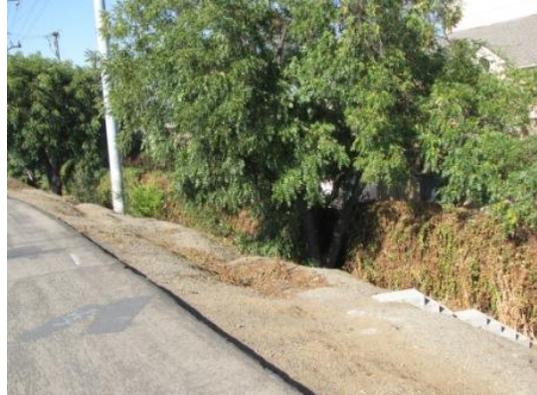
Photo 1 of 1 : FA\_2015\_NA0017\_159\_57\_20150911\_00043.jpg

LM Start	<b>22.05</b>	Rating **	M	Issue No.	<b>57</b>
LM End	<b>22.11</b>	Issue Type +	En	Location *	LS
Category	Earthen Levee		GPS Latitude/Longitude		
			Start	End	
Item	Vegetation		37.980533 °	37.980285 °	
			-121.316473 °	-121.317410 °	
DWR ID	DWR_NA0017_15_s_2012_57				
Action/Comments					
Landscaping

View of landscaping along the landward toe of the levee looking downstream.

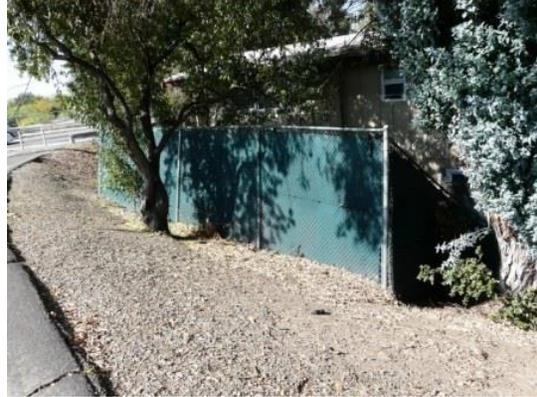
Photo 1 of 1 : FA\_2015\_NA0017\_159\_95\_20150911\_00063.jpg

LM Start	<b>22.15</b>	Rating **	M	Issue No.	<b>95</b>
LM End	<b>22.16</b>	Issue Type +	En	Location *	LS
Category	Earthen Levee			GPS Latitude/Longitude	
				Start	End
Item	Encroachments			37.979996 °	37.979969 °
				-121.318045 °	-121.318236 °
DWR ID	DWR_NA0017_15_s_2012_95				
Action/Comments					
Fence

Fence located from LM 22.36 to LM 22.37 significantly encroaches onto landside levee slope.

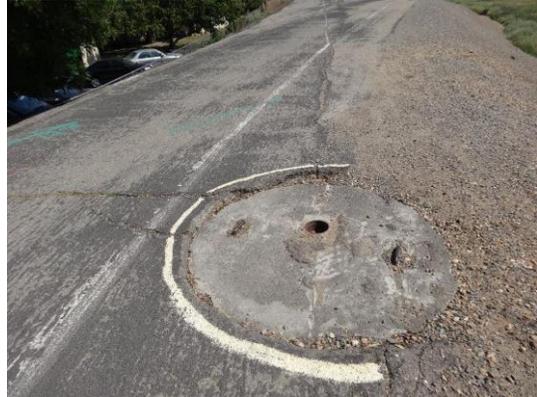
Photo 1 of 1 : UCIP\_FA\_2015\_5640.jpg

LM Start	<b>22.24</b>	Rating **	M	Issue No.	<b>1212</b>
LM End	<b>22.24</b>	Issue Type +	En	Location *	LS
Category	Supplemental			GPS Latitude/Longitude	
				Start	End
Item	DWR UCIP Field Study			37.980740 °	37.980740 °
				-121.319514 °	-121.319514 °
DWR ID					
Action/Comments					
Inspector Comments: FS_ID:35470 DS_ID:23286 EP_NO: N/A FS_HLM: 22.443 Repair Type: Non-Urgent Crossing Status: Indicator Found UCIP Comments: Only a manhole on waterside of the levee crown. Needs more info from the LMA. FIELD_STRUCT_DESC: Water main through the levee and under the channel. Size and depth unknown. A manhole on waterside of the levee crown. FS Date: 04/22/2014

WS view: manhole with concrete cover on levee crown towards waterside.

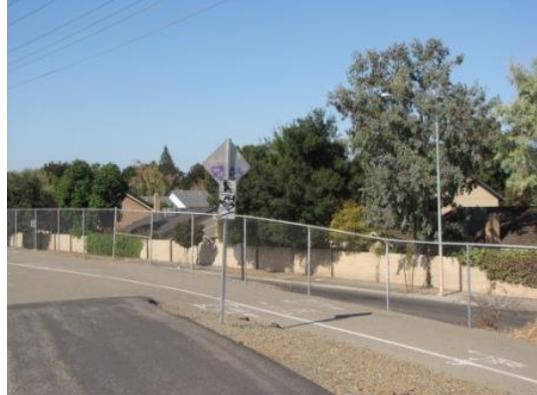
Photo 1 of 1 : FA\_2015\_NA0017\_159\_1067\_20150911\_00133.jpg

LM Start	<b>22.67</b>	Rating **	U	Issue No.	<b>1067</b>
LM End	<b>22.70</b>	Issue Type +	En	Location *	LS
Category	Earthen Levee		GPS Latitude/Longitude		
			Start	End	
Item	Encroachments		37.982270 °	37.982210 °	
			-121.327070 °	-121.327567 °	
DWR ID	DWR_NA0017_15_s_2012_1067				
Action/Comments					
Fence

View of a fence along the landward shoulder looking downstream.

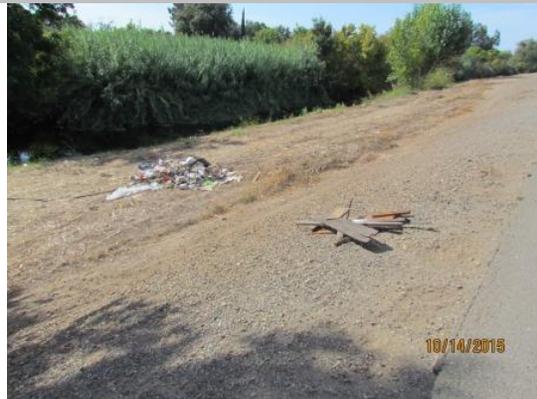
Photo 1 of 1 : FA\_2015\_NA0017\_159\_175\_20151019\_00157.jpg

LM Start	<b>22.79</b>	Rating **	M	Issue No.	<b>175</b>
LM End	<b>22.79</b>	Issue Type +	Ma	Location *	WS
Category	Earthen Levee		GPS Latitude/Longitude		
			Start	End	
Item	Encroachments		37.981721 °	37.981721 °	
			-121.329175 °	-121.329175 °	
DWR ID	DWR_NA0017_15_f_2015_175				
Action/Comments					
Debris

Debris was found on the waterside of the levee.

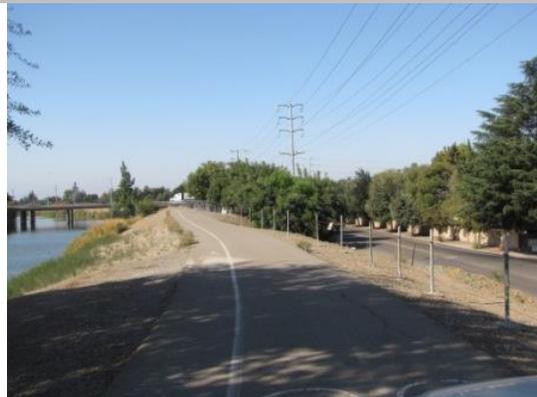
Photo 1 of 1 : FA\_2015\_NA0017\_159\_1068\_20150911\_00134.jpg

LM Start	<b>23.34</b>	Rating **	M	Issue No.	<b>1068</b>
LM End	<b>23.50</b>	Issue Type +	En	Location *	LS
Category	Earthen Levee		GPS Latitude/Longitude		
			Start	End	
Item	Encroachments		37.980240 °	37.979757 °	
			-121.338605 °	-121.341113 °	
DWR ID	DWR_NA0017_15_s_2012_1068				
Action/Comments					
Fence Inspector Comments: Post & Cable Fence

View of a fence along landward shoulder looking downstream.

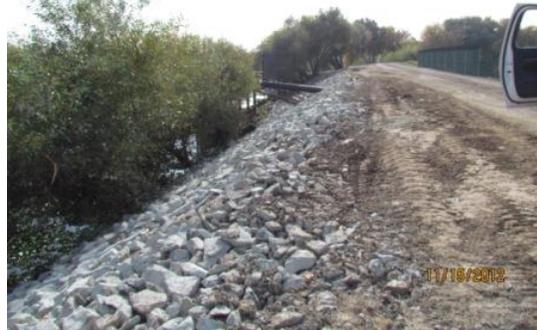
Photo 1 of 1 : FA\_2015\_NA0017\_159\_187\_20150911\_00105.jpg

LM Start	<b>24.00</b>	Rating **	A/W	Issue No.	<b>187</b>
LM End	<b>24.00</b>	Issue Type +	Ma	Location *	WS
Category	Earthen Levee			GPS Latitude/Longitude	
				Start	End
Item	Riprap Revetments			37.974858 °	37.974858 °
				-121.347718 °	-121.347718 °
DWR ID	DWR_NA0017_15_f_2012_187				
Action/Comments

Revetment was placed by the LMA on the waterside slope of the levee looking downstream.

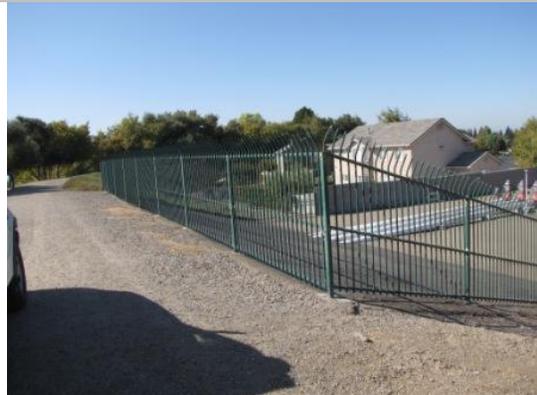
Photo 1 of 1 : FA\_2015\_NA0017\_159\_1070\_20150911\_00135.jpg

LM Start	<b>24.01</b>	Rating **	U	Issue No.	<b>1070</b>
LM End	<b>24.02</b>	Issue Type +	En	Location *	LS
Category	Earthen Levee			GPS Latitude/Longitude	
				Start	End
Item	Encroachments			37.974670 °	37.974499 °
				-121.347822 °	-121.347919 °
DWR ID	DWR_NA0017_15_s_2012_1070				
Action/Comments					
Fence

View of fence along the landward shoulder looking downstream.

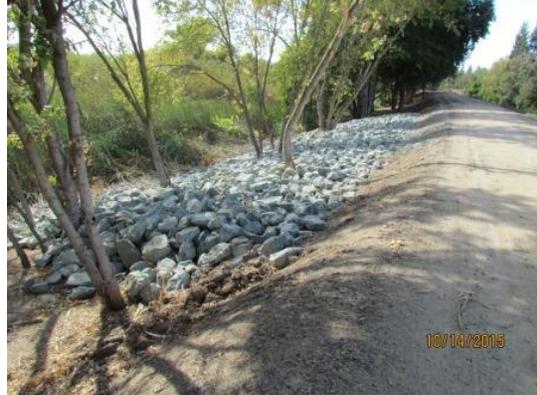
Photo 1 of 1 : FA\_2015\_NA0017\_159\_177\_20151019\_00158.jpg

LM Start	<b>24.09</b>	Rating **	A	Issue No.	<b>177</b>
LM End	<b>24.09</b>	Issue Type +	Ma	Location *	WS
Category	Earthen Levee		GPS Latitude/Longitude		
			Start	End	
Item	Riprap Revetments		37.974089 °	37.974089 °	
			-121.348807 °	-121.348807 °	
DWR ID	DWR_NA0017_15_f_2015_177				
Action/Comments					
Inspector Comments: LMA placed new riprap on the waterside slope of the levee.

LMA placed new riprap on the waterside of the levee looking downstream.

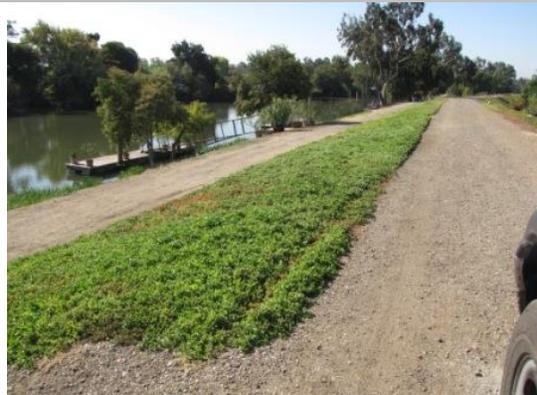
Photo 1 of 1 : FA\_2015\_NA0017\_159\_1071\_20150911\_00136.jpg

LM Start	<b>24.46</b>	Rating **	A/W	Issue No.	<b>1071</b>
LM End	<b>25.40</b>	Issue Type +	En	Location *	LS
Category	Earthen Levee		GPS Latitude/Longitude		
			Start	End	
Item	Vegetation		37.970707 °	37.967737 °	
			-121.353458 °	-121.368923 °	
DWR ID	DWR_NA0017_15_s_2012_1071				
Action/Comments					
Landscaping Inspector Comments: Landowner plantings, iceplant, etc. with irrigation systems. All of them have permits.

View of typical landowner planted and maintained landscaping and irrigation along the waterward shoulder and slope looking downstream.

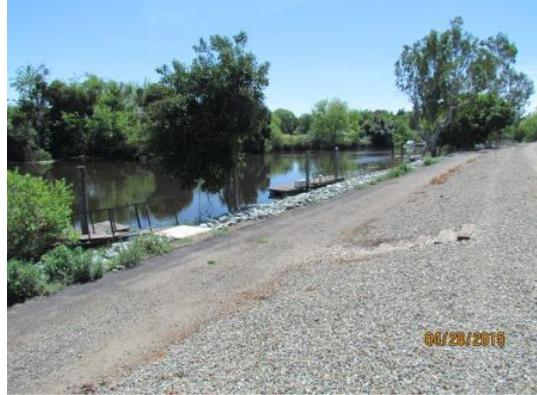
Photo 1 of 1 : FA\_2015\_NA0017\_159\_207\_20150911\_00112.jpg

LM Start	<b>24.47</b>	Rating **	A/W	Issue No.	<b>207</b>
LM End	<b>24.47</b>	Issue Type +	En	Location *	WS
Category	Earthen Levee		GPS Latitude/Longitude		
			Start	End	
Item	Encroachments		37.970646 °	37.970646 °	
			-121.353568 °	-121.353568 °	
DWR ID	DWR_NA0017_15_s_2015_207				
Action/Comments					
Building Inspector Comments: Docks are probably permitted under permit #16522.

View of the docks on the waterside of the levee looking downstream.

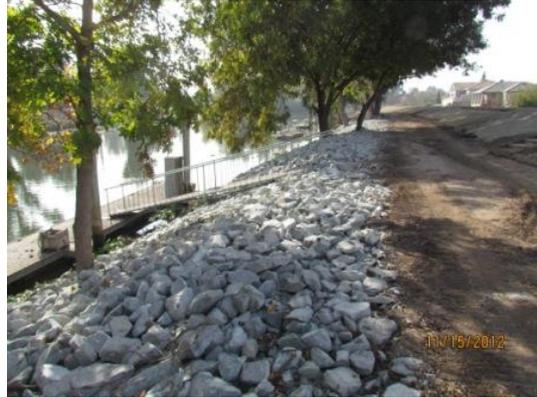
Photo 1 of 1 : FA\_2015\_NA0017\_159\_188\_20150911\_00106.jpg

LM Start	<b>24.65</b>	Rating **	A/W	Issue No.	<b>188</b>
LM End	<b>24.65</b>	Issue Type +	Ma	Location *	WS
Category	Earthen Levee		GPS Latitude/Longitude		
			Start	End	
Item	Riprap Revetments		37.969095 °	37.969095 °	
			-121.356301 °	-121.356301 °	
DWR ID	DWR_NA0017_15_f_2012_188				
Action/Comments

Revetments were placed by the LMA on the waterside slope of the levee looking downstream.

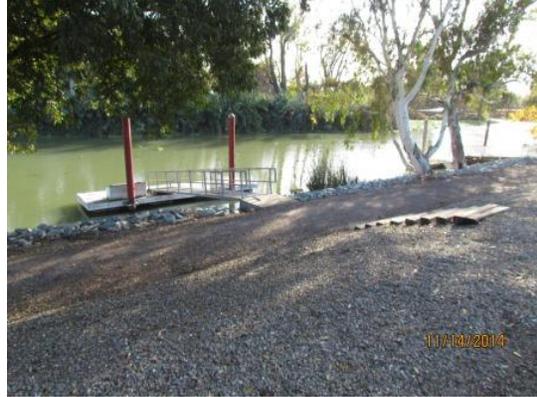
Photo 1 of 1 : FA\_2015\_NA0017\_159\_165\_20150911\_00094.jpg

LM Start	<b>24.78</b>	Rating **	A/W	Issue No.	<b>165</b>
LM End	<b>24.78</b>	Issue Type +	En	Location *	WS
Category	Earthen Levee			GPS Latitude/Longitude	
				Start	End
Item	Encroachments			37.968133 °	37.968133 °
				-121.358222 °	-121.358222 °
DWR ID	DWR_NA0017_15_s_2012_165				
Action/Comments					
Stairway Inspector Comments: This area is approved by permit #16905

A stairway and a dock was found on the waterside slope of the levee looking downstream.

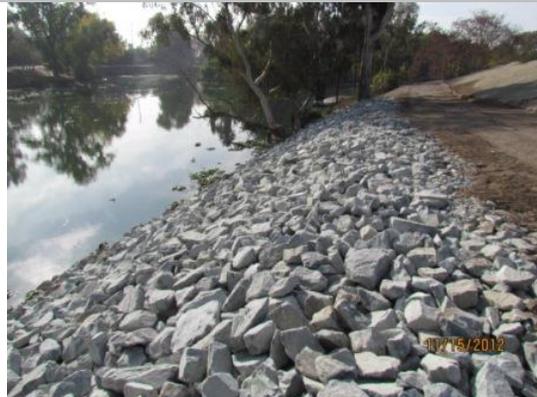
Photo 1 of 1 : FA\_2015\_NA0017\_159\_189\_20150911\_00107.jpg

LM Start	<b>24.81</b>	Rating **	A/W	Issue No.	<b>189</b>
LM End	<b>24.81</b>	Issue Type +	Ma	Location *	WS
Category	Earthen Levee			GPS Latitude/Longitude	
				Start	End
Item	Riprap Revetments			37.967943 °	37.967943 °
				-121.358711 °	-121.358711 °
DWR ID	DWR_NA0017_15_f_2012_189				
Action/Comments

Revetments were placed by the LMA on the waterside slope of the levee looking downstream.

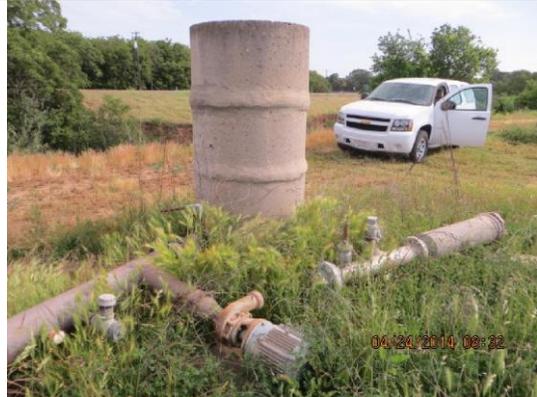
Photo 1 of 3 : UCIP\_FA\_2015\_5403.jpg

LM Start	<b>0.26</b>	Rating **	M	Issue No.	<b>794</b>
LM End	<b>0.26</b>	Issue Type +	En	Location *	WS
Category	Supplemental			GPS Latitude/Longitude	
				Start	End
Item	DWR UCIP Field Study			38.048351 °	38.048351 °
				-121.015919 °	-121.015919 °
DWR ID					
Action/Comments					
Inspector Comments: FS_ID:35483 DS_ID:23313 EP_NO: 6637 FS_HLM: 0.27 Repair Type: Non-Urgent Crossing Status: Indicator Found

Vent, butterfly valve, siphon breaker, and filter on WS at pump.

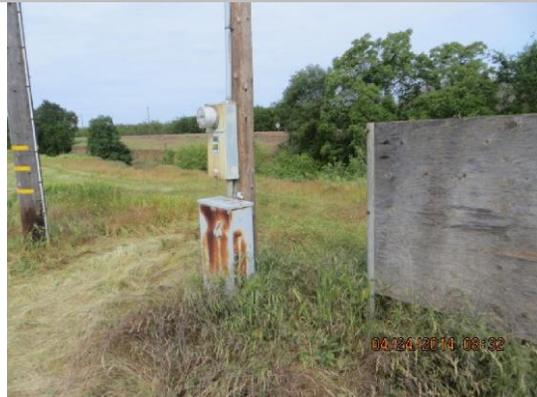
Photo 2 of 3 : UCIP\_FA\_2015\_5404.jpg

Meter and electrical panel on WS.

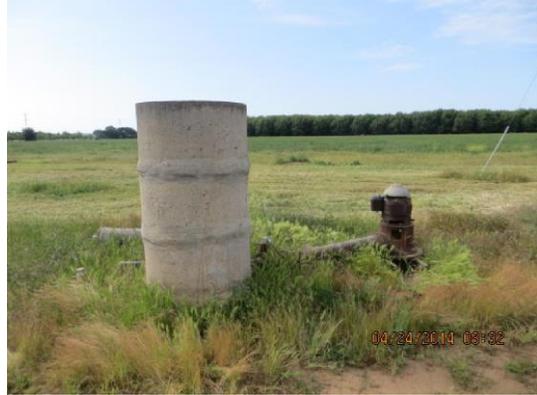
Photo 3 of 3 : UCIP\_FA\_2015\_5405.jpg

LM Start	<b>0.26</b>	Rating **	M	Issue No.	<b>794 (cont)</b>
LM End	<b>0.26</b>	Issue Type +	En	Location *	WS
Category	Supplemental			GPS Latitude/Longitude	
				Start	End
Item	DWR UCIP Field Study			38.048351 °	38.048351 °
				-121.015919 °	-121.015919 °
DWR ID					
Action/Comments					
Inspector Comments: FS_ID:35483 DS_ID:23313 EP_NO: 6637 FS_HLM: 0.27 Repair Type: Non-Urgent Crossing Status: Indicator Found

Pump over sump with concrete standpipe on WS of "levee"

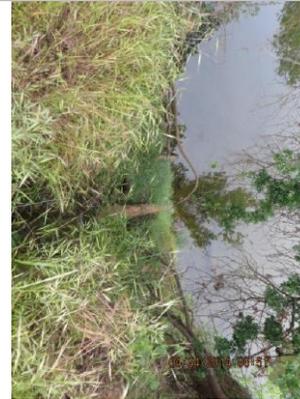
Photo 1 of 3 : UCIP\_FA\_2015\_5406.jpg

LM Start	<b>0.43</b>	Rating **	M	Issue No.	<b>795</b>
LM End	<b>0.43</b>	Issue Type +	En	Location *	WS
Category	Supplemental			GPS Latitude/Longitude	
				Start	End
Item	DWR UCIP Field Study			38.047290 °	38.047290 °
				-121.018619 °	-121.018619 °
DWR ID					
Action/Comments					
Inspector Comments: FS_ID:35484 DS_ID:23314 EP_NO: N/A FS_HLM: 0.44 Repair Type: Non-Urgent Crossing Status: Indicator Found UCIP Comments: Pipe in non-project levee area. Pipe appears to abandoned and if so should be verified has having been removed properly. FIELD_STRUCT_DESC: 14-inch concrete pipe 3.5 feet below the roadway. Pump house removed from the waterward side. 36-inch standpipe on the waterward side. 8-inch intake pipe to standpipe. O&M Manual SJR 611.1 Vol. F. FS Date: 04/24/2014

Suction pipe visible on stream bank.

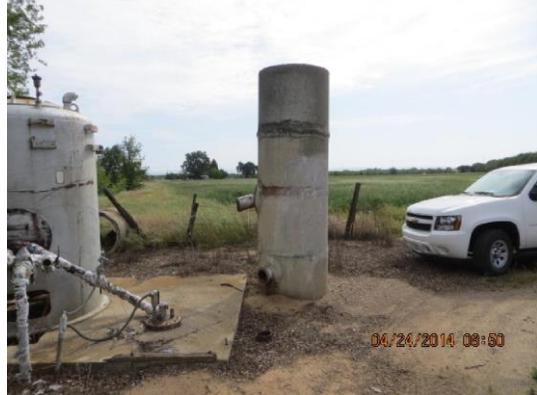
Photo 2 of 3 : UCIP\_FA\_2015\_5407.jpg

LM Start	<b>0.43</b>	Rating **	M	Issue No.	<b>795 (cont)</b>
LM End	<b>0.43</b>	Issue Type +	En	Location *	WS
Category	Supplemental			GPS Latitude/Longitude	
				Start	End
Item	DWR UCIP Field Study			38.047290 °	38.047290 °
				-121.018619 °	-121.018619 °
DWR ID					
Action/Comments					
Inspector Comments: FS_ID:35484 DS_ID:23314 EP_NO: N/A FS_HLM: 0.44 Repair Type: Non-Urgent Crossing Status: Indicator Found UCIP Comments: Pipe in non-project levee area. Pipe appears to abandoned and if so should be verified has having been removed properly. FIELD_STRUCT_DESC: 14-inch concrete pipe 3.5 feet below the roadway. Pump house removed from the waterward side. 36-inch standpipe on the waterward side. 8-inch intake pipe to standpipe. O&M Manual SJR 611.1 Vol. F. FS Date: 04/24/2014

Old pumphouse pad and 42-inch concrete standpipe visible on WS shoulder.

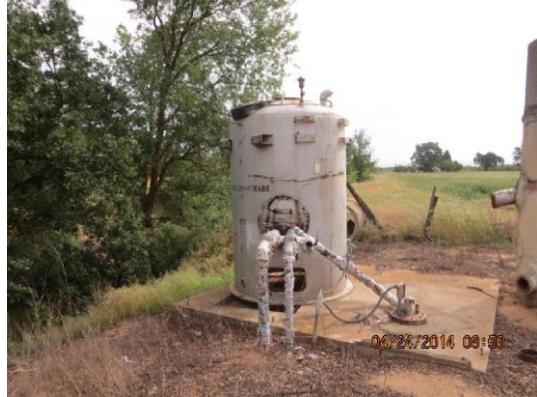
Photo 3 of 3 : UCIP\_FA\_2015\_5408.jpg

Old pumphouse pad visible on WS shoulder.

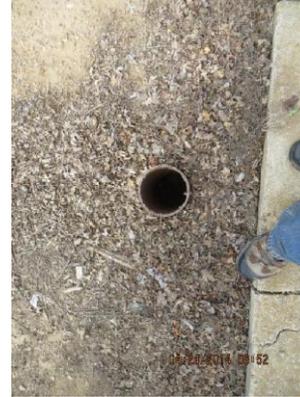
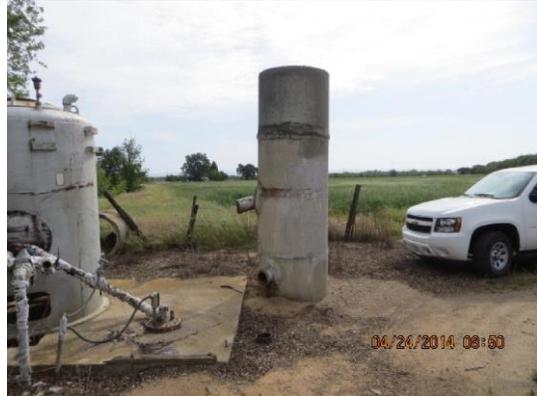
LM Start	<b>0.43</b>	Rating **	M	Issue No.	<b>796</b>
LM End	<b>0.43</b>	Issue Type +	En	Location *	WS
Category	Supplemental			GPS Latitude/Longitude	
				Start	End
Item	DWR UCIP Field Study			38.047315 °	38.047315 °
				-121.018689 °	-121.018689 °
DWR ID					
Action/Comments					
Inspector Comments: FS_ID:39000 DS_ID:24912 EP_NO: N/A FS_HLM: 0.444 Repair Type: Non-Urgent Crossing Status: Found

Pipe visible on ground between standpipe and concrete pad at WS shoulder.
