**Flood Control Project Maintenance  
Levee Inspections**

**Fall 2015 Levee Maintenance Deficiency Summary Report**

**San Joaquin River Basin**

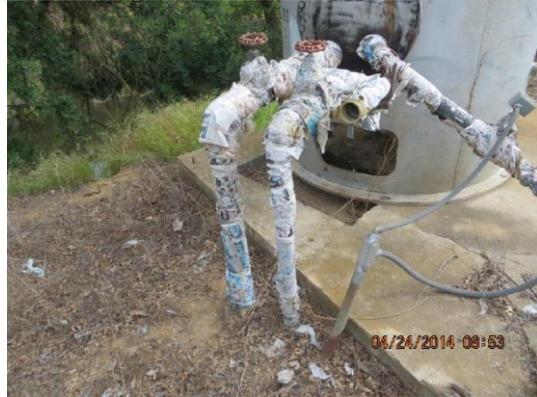
Photo 1 of 3 : UCIP\_FA\_2015\_6049.jpg

LM Start	<b>0.43</b>	Rating **	M	Issue No.	<b>797</b>
LM End	<b>0.43</b>	Issue Type +	En	Location *	WS
Category	Supplemental			GPS Latitude/Longitude	
				Start	End
Item	DWR UCIP Field Study			38.047310 °	38.047310 °
				-121.018705 °	-121.018705 °
DWR ID					
Action/Comments					
Inspector Comments: FS_ID:41675 DS_ID:24915 EP_NO: N/A FS_HLM: 0.445 Repair Type: Non-Urgent Crossing Status: Found

Pipe and shutoff valve next to tank on WS shoulder.

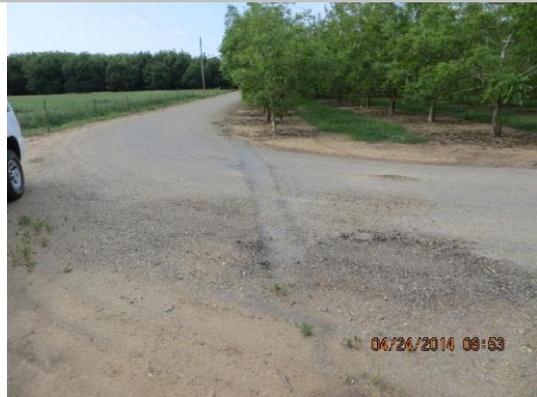
Photo 2 of 3 : UCIP\_FA\_2015\_6050.jpg

Possible alignment of pipe on LS shoulder.

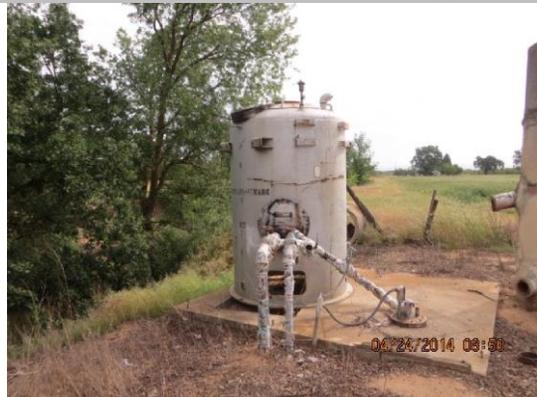
Photo 3 of 3 : UCIP\_FA\_2015\_6051.jpg

Pipe and shutoff valve next to tank on WS shoulder.

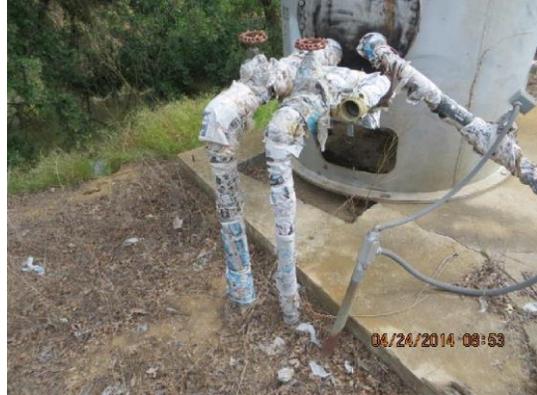
Photo 1 of 3 : UCIP\_FA\_2015\_6046.jpg

LM Start	<b>0.43</b>	Rating **	M	Issue No.	<b>798</b>
LM End	<b>0.43</b>	Issue Type +	En	Location *	WS
Category	Supplemental			GPS Latitude/Longitude	
				Start	End
Item	DWR UCIP Field Study			38.047309 °	38.047309 °
				-121.018708 °	-121.018708 °
DWR ID					
Action/Comments					
Inspector Comments: FS_ID:41676 DS_ID:24919 EP_NO: N/A FS_HLM: 0.445 Repair Type: Non-Urgent Crossing Status: Found

Pipe and shutoff valve next to tank on WS shoulder.

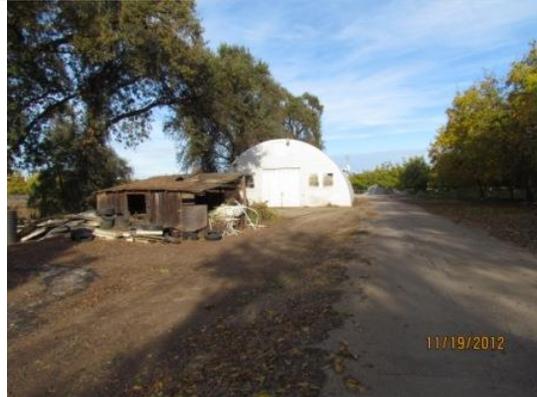
Photo 1 of 1 : FA\_2015\_NA0017\_160\_99\_20150911\_00049.jpg

LM Start	<b>0.52</b>	Rating **	U	Issue No.	<b>99</b>
LM End	<b>0.52</b>	Issue Type +	En	Location *	WS
Category	Earthen Levee		GPS Latitude/Longitude		
			Start	End	
Item	Encroachments		38.046569 °	38.046569 °	
			-121.020075 °	-121.020075 °	
DWR ID	DWR_NA0017_16_s_2012_99				
Action/Comments					
Building

A building was located on the waterside shoulder of the levee looking upstream.

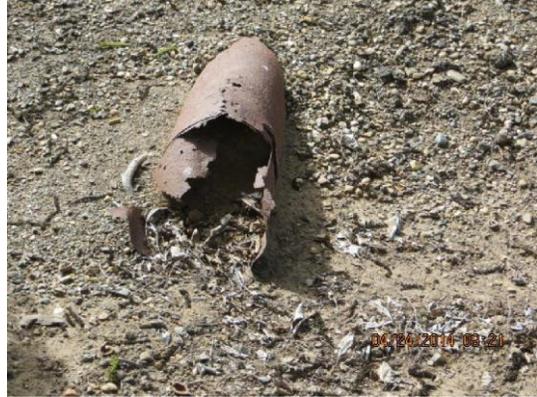
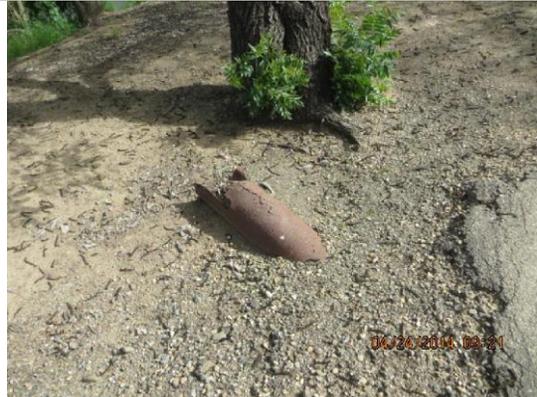
LM Start	<b>0.70</b>	Rating **	M	Issue No.	<b>799</b>
LM End	<b>0.70</b>	Issue Type +	En	Location *	WS
Category	Supplemental			GPS Latitude/Longitude	
				Start	End
Item	DWR UCIP Field Study			38.045480 °	38.045480 °
				-121.022988 °	-121.022988 °
DWR ID					
<b>Action/Comments</b>					
Inspector Comments: FS_ID:41633 DS_ID:24929 EP_NO: N/A FS_HLM: 0.72 Repair Type: Non-Urgent Crossing Status: Found UCIP Comments: Pipe appears abandoned and rusted through. Pipe should be abandoned properly. FIELD_STRUCT_DESC: 12-inch steel irrigation pipe through the levee 6-inches below the crown. Pipe visible on WS slope. FS Date: 04/24/2014

Abandoned pipe visible on WS slope.

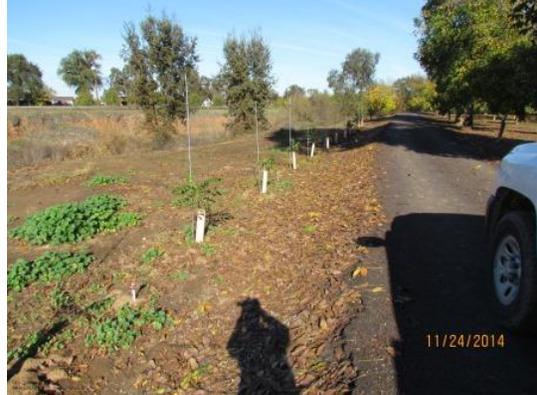
Photo 1 of 1 : FA\_2015\_NA0017\_160\_268\_20150911\_00151.jpg

LM Start	<b>0.77</b>	Rating **	M	Issue No.	<b>268</b>
LM End	<b>0.77</b>	Issue Type +	En	Location *	WS
Category	Earthen Levee			GPS Latitude/Longitude	
				Start	End
Item	Encroachments			38.044767 °	38.044767 °
				-121.023948 °	-121.023948 °
DWR ID	DWR_NA0017_16_f_2014_268				
Action/Comments					
Crops Inspector Comments: Newly planted trees.

Newly planted trees were found on the waterside shoulder of the levee looking upstream.

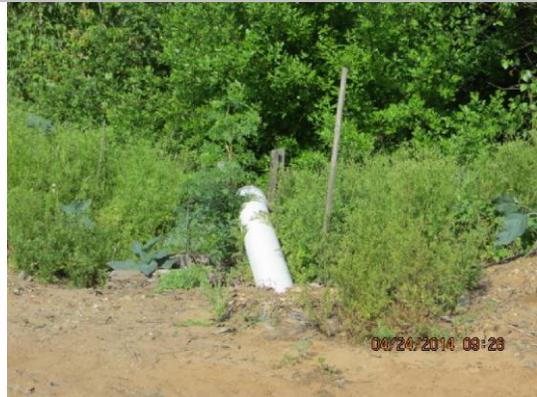
Photo 1 of 2 : UCIP\_FA\_2015\_6054.jpg

LM Start	<b>0.78</b>	Rating **	M	Issue No.	<b>800</b>
LM End	<b>0.78</b>	Issue Type +	En	Location *	WS
Category	Supplemental			GPS Latitude/Longitude	
				Start	End
Item	DWR UCIP Field Study			38.044590 °	38.044590 °
				-121.024097 °	-121.024097 °
DWR ID					
Action/Comments					
Inspector Comments: FS_ID:41358 DS_ID:24930 EP_NO: N/A FS_HLM: 0.81 Repair Type: Non-Urgent Crossing Status: Found UCIP Comments: No permit identified for crossing. FIELD_STRUCT_DESC: 6-inch PVC stormdrain pipe through the levee 1-foot below the crown. Pipe open on both ends. FS Date: 04/24/2014

Pipe on WS slope.

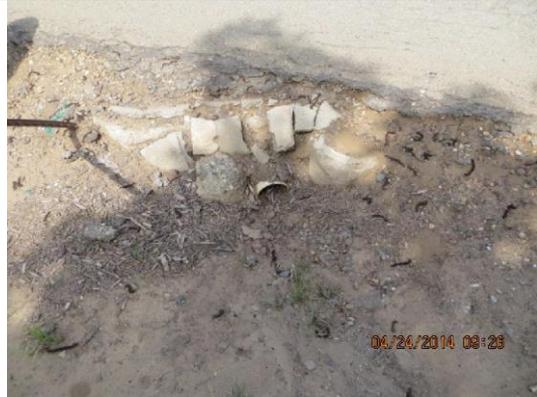
Photo 2 of 2 : UCIP\_FA\_2015\_6055.jpg

LM Start	<b>0.78</b>	Rating **	M	Issue No.	<b>800 (cont)</b>
LM End	<b>0.78</b>	Issue Type +	En	Location *	WS
Category	Supplemental			GPS Latitude/Longitude	
				Start	End
Item	DWR UCIP Field Study			38.044590 °	38.044590 °
				-121.024097 °	-121.024097 °
DWR ID					
Action/Comments					
Inspector Comments: FS_ID:41358 DS_ID:24930 EP_NO: N/A FS_HLM: 0.81 Repair Type: Non-Urgent Crossing Status: Found UCIP Comments: No permit identified for crossing. FIELD_STRUCT_DESC: 6-inch PVC stormdrain pipe through the levee 1-foot below the crown. Pipe open on both ends. FS Date: 04/24/2014

Pipe and makeshift headwall on LS shoulder.

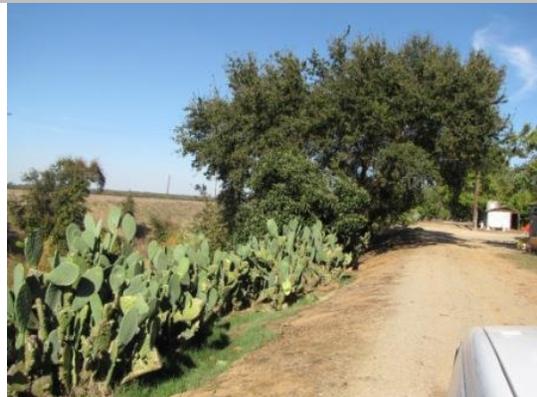
Photo 1 of 1 : FA\_2015\_NA0017\_160\_179\_20150911\_00110.jpg

LM Start	<b>0.81</b>	Rating **	M	Issue No.	<b>179</b>
LM End	<b>0.86</b>	Issue Type +	En	Location *	WS
Category	Earthen Levee			GPS Latitude/Longitude	
				Start	End
Item	Vegetation			38.044312 °	38.043691 °
				-121.024377 °	-121.024946 °
DWR ID	DWR_NA0017_16_s_2012_179				
Action/Comments					
Landscaping

View of landowner maintained landscaping on waterward side looking upstream.

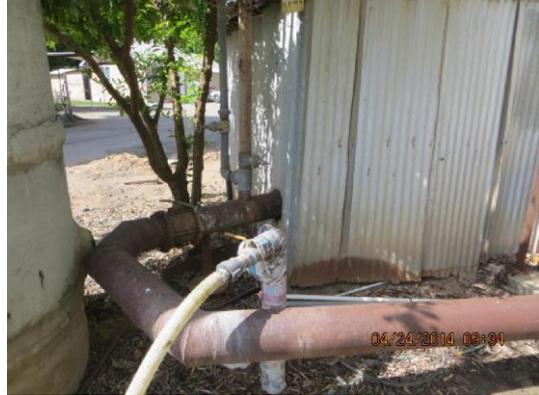
Photo 1 of 3 : UCIP\_FA\_2015\_6056.jpg

LM Start	<b>0.82</b>	Rating **	M	Issue No.	<b>801</b>
LM End	<b>0.82</b>	Issue Type +	En	Location *	WS
Category	Supplemental			GPS Latitude/Longitude	
				Start	End
Item	DWR UCIP Field Study			38.044134 °	38.044134 °
				-121.024526 °	-121.024526 °
DWR ID					
<b>Action/Comments</b>					
Inspector Comments: FS_ID:41677 DS_ID:24932 EP_NO: N/A FS_HLM: 0.851 Repair Type: Non-Urgent Crossing Status: Found UCIP Comments: No permit identified for crossing. FIELD_STRUCT_DESC: 8-inch steel irrigation pipe through the levee 6-inches below the crown. Butterfly valve on LS with pump in pumphouse. This pipe likely pumps irrigation water from a well and dumps it into Mormon Slough. FS Date: 04/24/2014

Pipe and butterfly valve on LS shoulder.

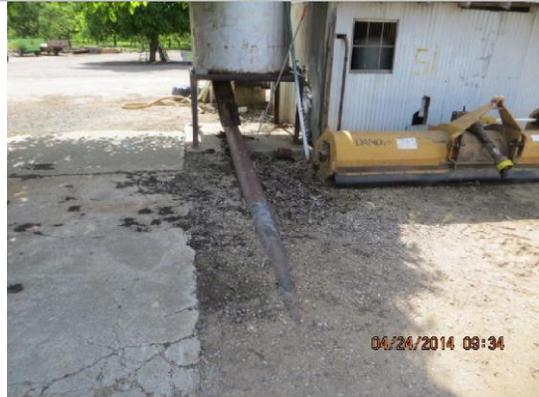
Photo 2 of 3 : UCIP\_FA\_2015\_6057.jpg

Pipe visible on LS shoulder at pumphouse.

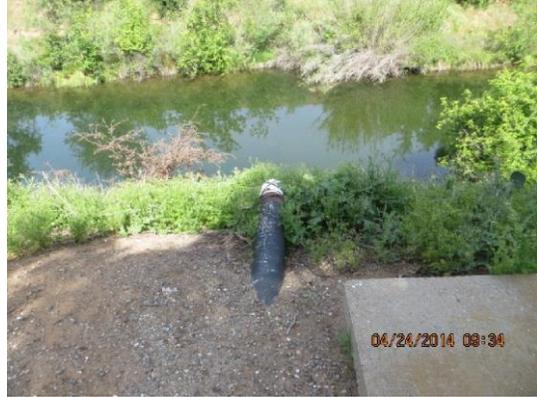
Photo 3 of 3 : UCIP\_FA\_2015\_6058.jpg

Pipe visible on WS slope.

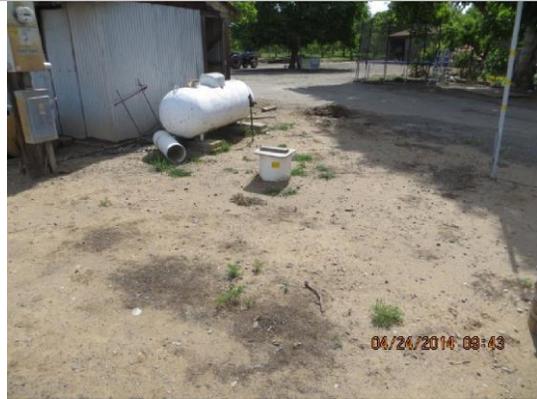
Photo 1 of 3 : UCIP\_FA\_2015\_6059.jpg

LM Start	<b>0.83</b>	Rating **	M	Issue No.	<b>802</b>
LM End	<b>0.83</b>	Issue Type +	En	Location *	WS
Category	Supplemental			GPS Latitude/Longitude	
				Start	End
Item	DWR UCIP Field Study			38.044072 °	38.044072 °
				-121.024608 °	-121.024608 °
DWR ID					
Action/Comments					
Inspector Comments: FS_ID:41678 DS_ID:24933 EP_NO: N/A FS_HLM: 0.858 Repair Type: Non-Urgent Crossing Status: Found UCIP Comments: No permit identified for crossing. FIELD_STRUCT_DESC: 12-inch PVC irrigation pipe through the levee at unknown depth. Slant pump on WS slope with vent and filter on WS shoulder. 1.5-inch galvanized iron electrical conduit 8-feet upstream from pipe crossing. Meter in 16-inch PVC standpipe on LS shoulder. FS Date: 04/24/2014

Water meter in 16-inch PVC standpipe on LS shoulder.

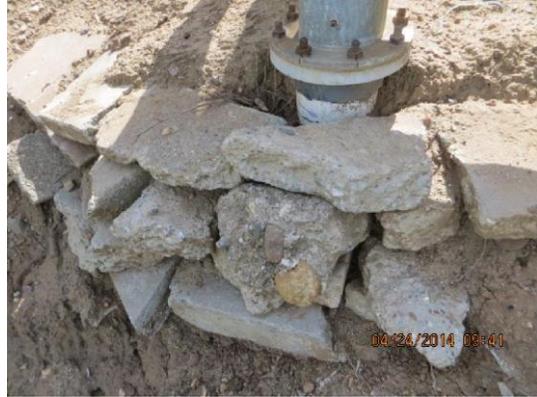
Photo 2 of 3 : UCIP\_FA\_2015\_6060.jpg

PVC pipe visible at outlet from filter on WS shoulder.

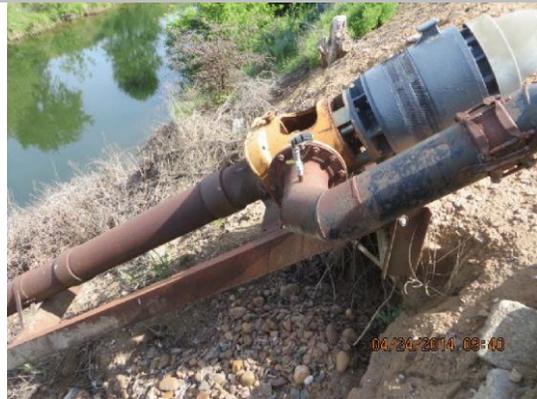
Photo 3 of 3 : UCIP\_FA\_2015\_6061.jpg

Slant pump on WS slope. Note erosion under pump.

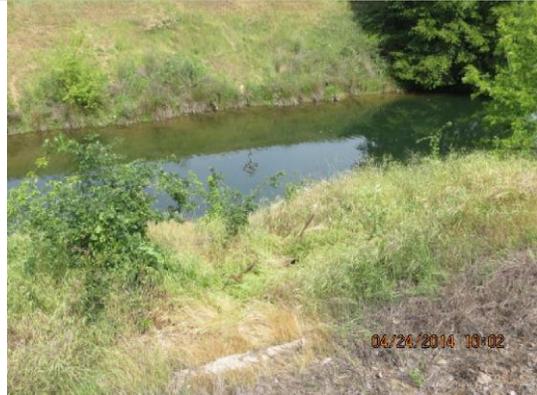
Photo 1 of 3 : UCIP\_FA\_2015\_5547.jpg

LM Start	<b>0.93</b>	Rating **	M	Issue No.	<b>803</b>
LM End	<b>0.93</b>	Issue Type +	En	Location *	WS
Category	Supplemental			GPS Latitude/Longitude	
				Start	End
Item	DWR UCIP Field Study			38.042816 °	38.042816 °
				-121.025626 °	-121.025626 °
DWR ID					
Action/Comments					
Inspector Comments: FS_ID:35506 DS_ID:23316 EP_NO: N/A FS_HLM: 0.963 Repair Type: Non-Urgent Crossing Status: Indicator Found UCIP Comments: Pipe in non-project levee area. Pipe appears to be abandoned and should be verified as having been done so properly. FIELD_STRUCT_DESC: 1 of 2: 12-inch concrete pipes 12.0 feet below the roadway. 8-inch intake pipe visible on WS slope next to concrete headwall. O&M Manual SJR 611.1 Vol. F. FS Date: 04/24/2014

Concrete headwall and 8-inch intake pipe visible on WS slope.

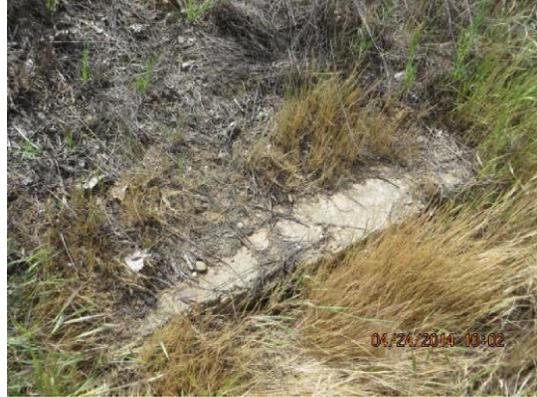
Photo 2 of 3 : UCIP\_FA\_2015\_5548.jpg

**Action/Comments**  
 Inspector Comments: FS\_ID:35506  
 DS\_ID:23316  
 EP\_NO: N/A  
 FS\_HLM: 0.963  
 Repair Type: Non-Urgent  
 Crossing Status: Indicator Found  
 UCIP Comments: Pipe in non-project levee area. Pipe appears to be abandoned and should be verified as having been done so properly.  
 FIELD\_STRUCT\_DESC: 1 of 2: 12-inch concrete pipes 12.0 feet below the roadway. 8-inch intake pipe visible on WS slope next to concrete headwall. O&M Manual SJR 611.1 Vol. F.  
 FS Date: 04/24/2014

Concrete headwall visible on WS slope.

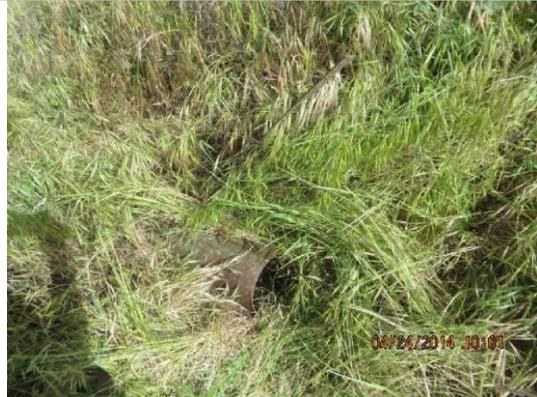
Photo 3 of 3 : UCIP\_FA\_2015\_5549.jpg

8-inch intake pipe visible on WS slope.

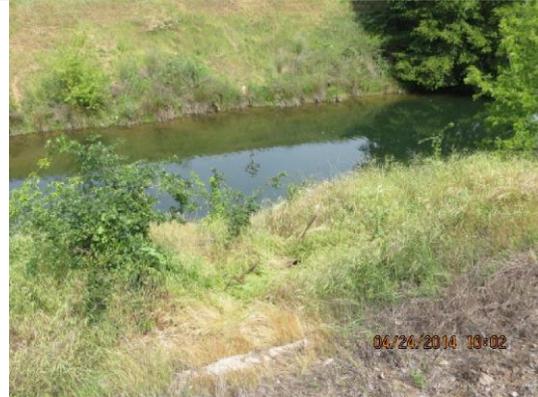
Photo 1 of 3 : UCIP\_FA\_2015\_5478.jpg

LM Start	<b>0.93</b>	Rating **	M	Issue No.	<b>804</b>
LM End	<b>0.93</b>	Issue Type +	En	Location *	WS
Category	Supplemental			GPS Latitude/Longitude	
				Start	End
Item	DWR UCIP Field Study			38.042816 °	38.042816 °
				-121.025627 °	-121.025627 °
DWR ID					
Action/Comments					
Inspector Comments: FS_ID:35505 DS_ID:23485 EP_NO: N/A FS_HLM: 0.963 Repair Type: Non-Urgent Crossing Status: Indicator Found

Concrete headwall and 8-inch intake pipe visible on WS slope.

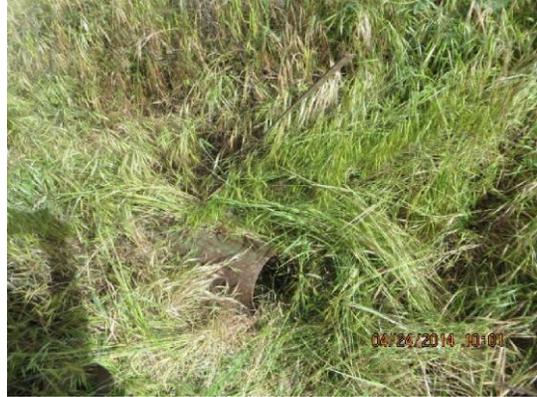
Photo 3 of 3 : UCIP\_FA\_2015\_5526.jpg

8-inch intake pipe visible on WS slope.

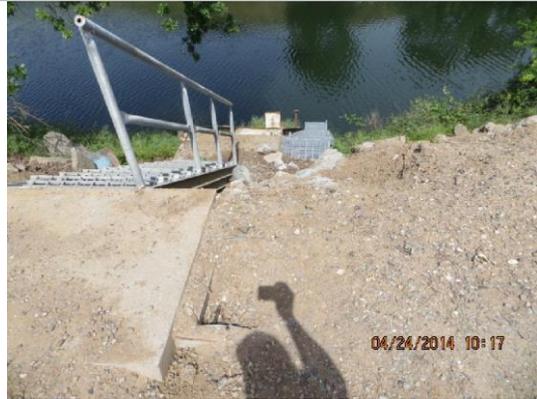
Photo 1 of 3 : UCIP\_FA\_2015\_6062.jpg

LM Start	<b>1.10</b>	Rating **	M	Issue No.	<b>805</b>
LM End	<b>1.10</b>	Issue Type +	En	Location *	WS
Category	Supplemental			GPS Latitude/Longitude	
				Start	End
Item	DWR UCIP Field Study			38.040831 °	38.040831 °
				-121.027540 °	-121.027540 °
DWR ID					
Action/Comments					
Inspector Comments: FS_ID:41532 DS_ID:24935 EP_NO: N/A FS_HLM: 1.142 Repair Type: Non-Urgent Crossing Status: Found UCIP Comments: Appears abandoned. FIELD_STRUCT_DESC: 1.5-inch PVC electrical conduit through the levee 1-foot below the crown. FS Date: 04/24/2014

Conduit visible on WS slope/shoulder.

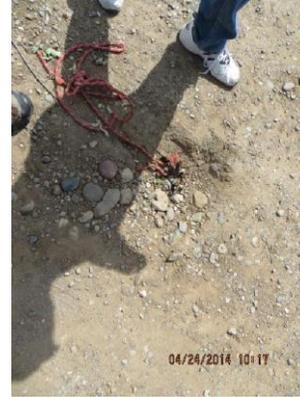
Photo 2 of 3 : UCIP\_FA\_2015\_6069.jpg

Pipe visible at center of roadway on crown.

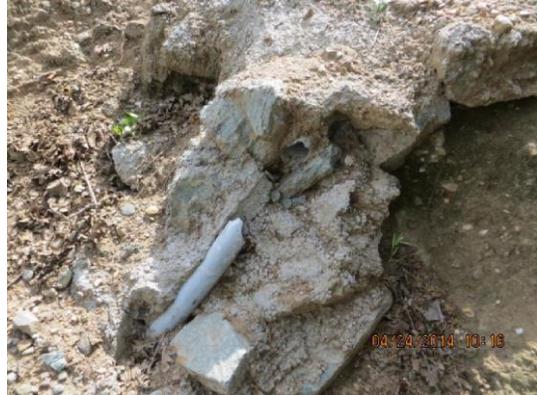
Photo 3 of 3 : UCIP\_FA\_2015\_6070.jpg

Conduit visible on WS slope/shoulder.

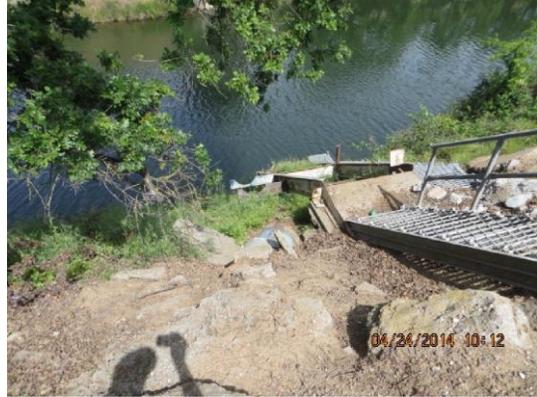
Photo 1 of 2 : UCIP\_FA\_2015\_5550.jpg

LM Start	<b>1.11</b>	Rating **	M	Issue No.	<b>806</b>
LM End	<b>1.11</b>	Issue Type +	En	Location *	WS
Category	Supplemental			GPS Latitude/Longitude	
				Start	End
Item	DWR UCIP Field Study			38.040790 °	38.040790 °
				-121.027574 °	-121.027574 °
DWR ID					
Action/Comments					
Inspector Comments: FS_ID:41372 DS_ID:23317 EP_NO: N/A FS_HLM: 1.142 Repair Type: Non-Urgent Crossing Status: Found

Pipe next to stairway on WS slope.

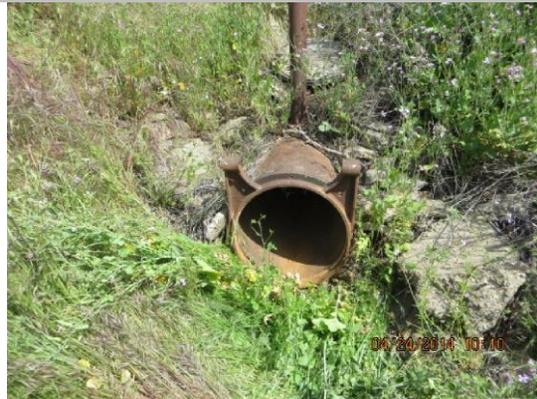
Photo 2 of 2 : UCIP\_FA\_2015\_5551.jpg

Pipe with missing flaggate on LS toe.

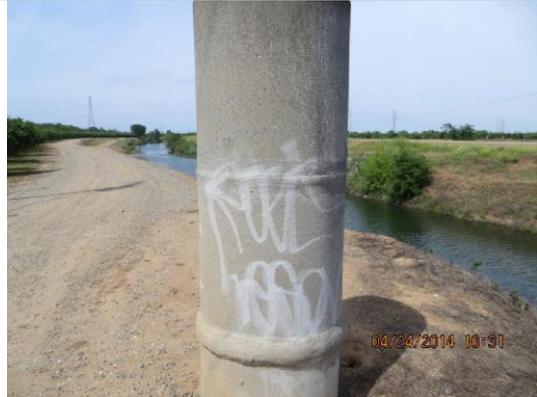
Photo 1 of 1 : UCIP\_FA\_2015\_5552.jpg

LM Start	<b>1.13</b>	Rating **	M	Issue No.	<b>807</b>
LM End	<b>1.13</b>	Issue Type +	En	Location *	WS
Category	Supplemental			GPS Latitude/Longitude	
				Start	End
Item	DWR UCIP Field Study			38.040616 °	38.040616 °
				-121.027866 °	-121.027866 °
DWR ID					
Action/Comments					
Inspector Comments: FS_ID:35524 DS_ID:23318 EP_NO: N/A FS_HLM: 1.159 Repair Type: Non-Urgent Crossing Status: Indicator Found UCIP Comments: Pipe in non-project levee area. Pipe appears abandoned and if so should be verified as having been done so properly. FIELD_STRUCT_DESC: 12-inch concrete pipe 4.0 feet below the roadway. Pump on the waterward slope. 8-inch intake pipe to 30-inch concrete standpipe on the waterward side. O&M Manual SJR 611.1 Vol. F. FS Date: 04/24/2014

30-inch concrete standpipe on WS shoulder.

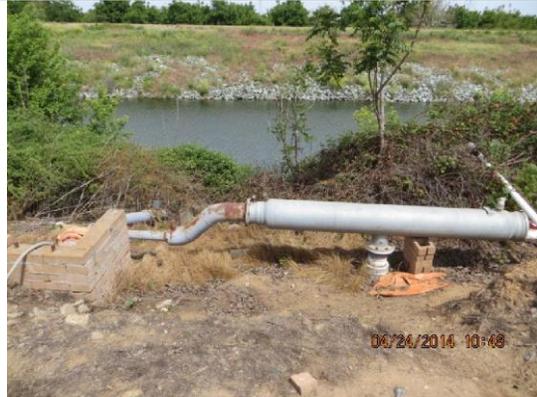
Photo 1 of 3 : UCIP\_FA\_2015\_6071.jpg

LM Start	<b>1.47</b>	Rating **	M	Issue No.	<b>808</b>
LM End	<b>1.47</b>	Issue Type +	En	Location *	WS
Category	Supplemental			GPS Latitude/Longitude	
				Start	End
Item	DWR UCIP Field Study			38.039581 °	38.039581 °
				-121.033895 °	-121.033895 °
DWR ID					
Action/Comments					
Inspector Comments: FS_ID:41679 DS_ID:24937 EP_NO: N/A FS_HLM: 1.516 Repair Type: Non-Urgent Crossing Status: Found UCIP Comments: No permit identified for crossing. FIELD_STRUCT_DESC: 10-inch PVC pipe through the levee at an unknown depth below the crown. Pump and filter on WS slope. FS Date: 04/24/2014

Pump, pipe, vent, and filter on WS slope.

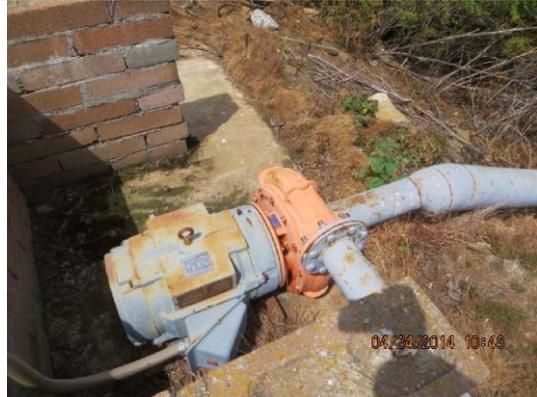
Photo 2 of 3 : UCIP\_FA\_2015\_6072.jpg

Pump on pad at WS slope.

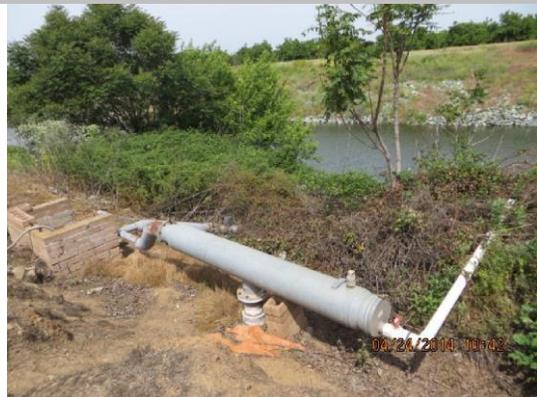
Photo 3 of 3 : UCIP\_FA\_2015\_6073.jpg

Pipe visible under filter on WS shoulder.

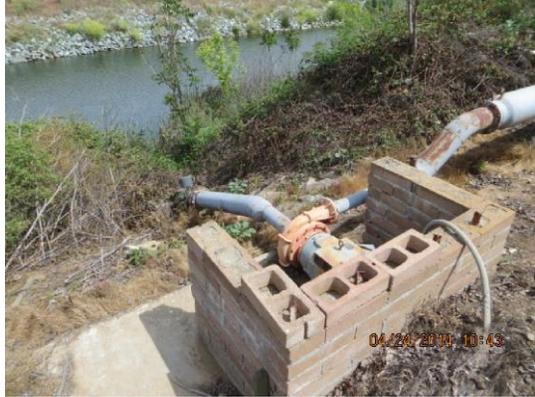
Photo 1 of 2 : UCIP\_FA\_2015\_5553.jpg

LM Start	<b>1.47</b>	Rating **	M	Issue No.	<b>809</b>
LM End	<b>1.47</b>	Issue Type +	En	Location *	WS
Category	Supplemental			GPS Latitude/Longitude	
				Start	End
Item	DWR UCIP Field Study			38.039582 °	38.039582 °
				-121.033945 °	-121.033945 °
DWR ID					
Action/Comments					
Inspector Comments: FS_ID:35525 DS_ID:23319 EP_NO: N/A FS_HLM: 1.518 Repair Type: Non-Urgent Crossing Status: Found

Repurposed pump pad now directs water to 10-inch PVC crossing.

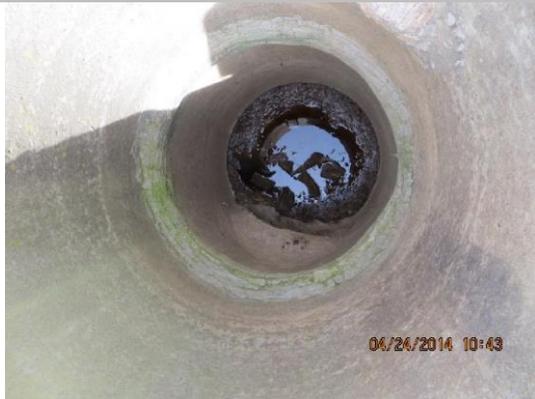
Photo 2 of 2 : UCIP\_FA\_2015\_5554.jpg

LM Start	<b>1.47</b>	Rating **	M	Issue No.	<b>809 (cont)</b>
LM End	<b>1.47</b>	Issue Type +	En	Location *	WS

Inside concrete standpipe on WS shoulder.

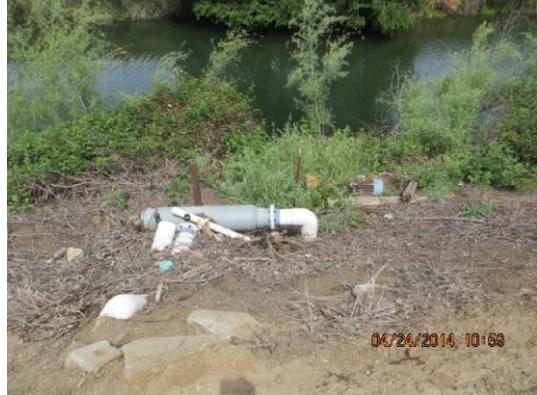
Photo 1 of 1 : UCIP\_FA\_2015\_5555.jpg

LM Start	<b>1.63</b>	Rating **	M	Issue No.	<b>810</b>
LM End	<b>1.63</b>	Issue Type +	En	Location *	WS
Category	Supplemental			GPS Latitude/Longitude	
				Start	End
Item	DWR UCIP Field Study			38.038917 °	38.038917 °
				-121.036745 °	-121.036745 °
DWR ID					
Action/Comments					
Inspector Comments: FS_ID:41631 DS_ID:23320 EP_NO: N/A FS_HLM: 1.686 Repair Type: Non-Urgent Crossing Status: Found

Pump, concrete pad, filter, vent, and pipe visible on WS slope.

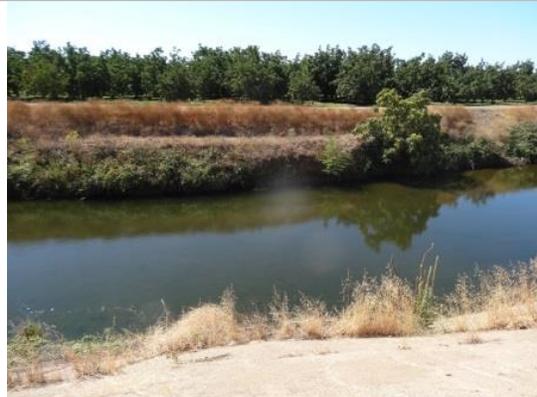
Photo 1 of 3 : SJR2015\_NA0017U16RM21.95\_1.jpg

LM Start	<b>1.75</b>	Rating **	M	Issue No.	<b>76</b>
LM End	<b>1.76</b>	Issue Type +	Ma	Location *	WS
Category	Supplemental			GPS Latitude/Longitude	
				Start	End
Item	DWR Erosion Survey			38.038080 °	38.038080 °
				-121.038676 °	-121.038676 °
DWR ID					
Action/Comments					
Inspector Comments: 8/12/2015: No significant change observed. 8/20/2014: No significant change observed. 9/12/2013: No significant change observed. 08/22/2012: The erosion is covered by dense vegetation. There is no levee structure on site. The levee crest width and levee height were not measured or estimated in the field. [2015 Site ID:NA0017U16RM21.95]

Front view of the erosion site.

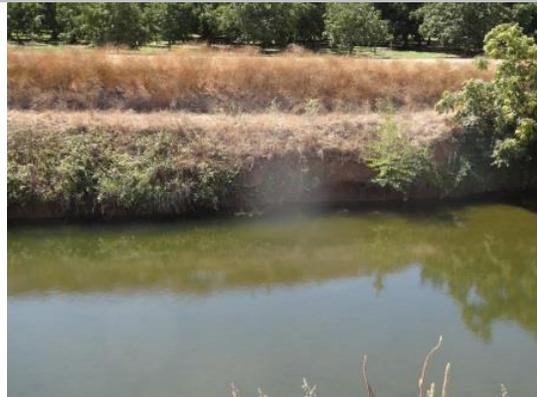
Photo 2 of 3 : SJR2015\_NA0017U16RM21.95\_3.jpg

LM Start	<b>1.75</b>	Rating **	M	Issue No.	<b>76 (cont)</b>
LM End	<b>1.76</b>	Issue Type +	Ma	Location *	WS

Close view of the erosion.

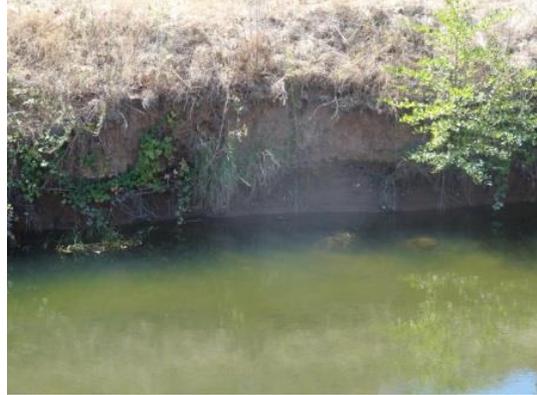
Photo 3 of 3 : SJR2015\_NA0017U16RM21.95\_5.jpg

LM Start	<b>1.75</b>	Rating **	M	Issue No.	<b>76 (cont)</b>
LM End	<b>1.76</b>	Issue Type +	Ma	Location *	WS
Category	Supplemental			GPS Latitude/Longitude	
				Start	End
Item	DWR Erosion Survey			38.038080 °	38.038080 °
				-121.038676 °	-121.038676 °
DWR ID					
Action/Comments					
Inspector Comments: 8/12/2015: No significant change observed. 8/20/2014: No significant change observed. 9/12/2013: No significant change observed. 08/22/2012: The erosion is covered by dense vegetation. There is no levee structure on site. The levee crest width and levee height were not measured or estimated in the field. [2015 Site ID:NA0017U16RM21.95]

Close view of the erosion.

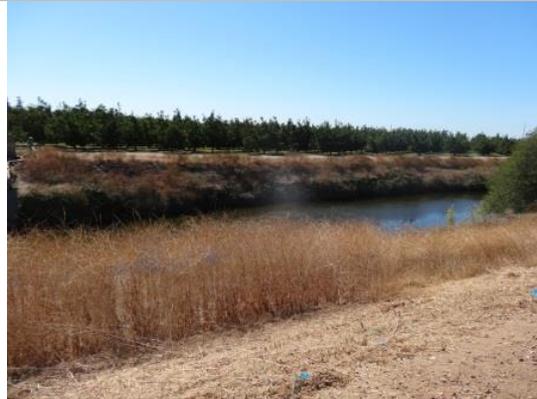
Photo 1 of 3 : SJR2015\_NA0017U16RM21.94\_1.jpg

LM Start	<b>1.77</b>	Rating **	M	Issue No.	<b>75</b>
LM End	<b>1.78</b>	Issue Type +	Ma	Location *	WS
Category	Supplemental			GPS Latitude/Longitude	
				Start	End
Item	DWR Erosion Survey			38.037906 °	38.037906 °
				-121.038949 °	-121.038949 °
DWR ID					
Action/Comments					
Inspector Comments: 8/12/2015: No significant change observed. 8/20/2014: No significant change observed 9/12/2013: No significant change observed. 08/22/2012: Site is covered by dense vegetation. Berm width is estimated as 5 ft. There is no levee structure on site. The levee crest width and levee height were not measured or estimated in the field. [2015 Site ID:NA0017U16RM21.94]

Looking at the erosion from right river bank.

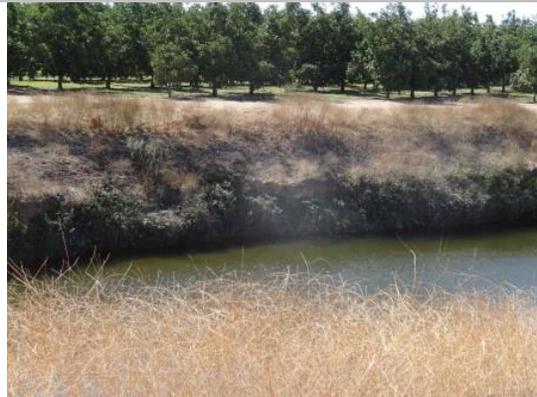
Photo 2 of 3 : SJR2015\_NA0017U16RM21.94\_2.jpg

LM Start	<b>1.77</b>	Rating **	M	Issue No.	<b>75 (cont)</b>
LM End	<b>1.78</b>	Issue Type +	Ma	Location *	WS

Front view of the erosion.

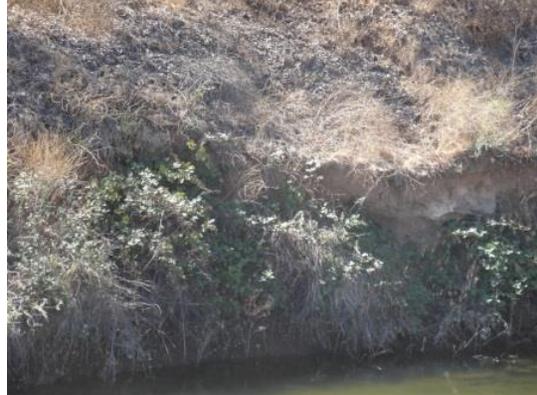
Photo 3 of 3 : SJR2015\_NA0017U16RM21.94\_4.jpg

LM Start	<b>1.77</b>	Rating **	M	Issue No.	<b>75 (cont)</b>
LM End	<b>1.78</b>	Issue Type +	Ma	Location *	WS
Category	Supplemental			GPS Latitude/Longitude	
				Start	End
Item	DWR Erosion Survey			38.037906 °	38.037906 °
				-121.038949 °	-121.038949 °
DWR ID					
Action/Comments					
Inspector Comments: 8/12/2015: No significant change observed. 8/20/2014: No significant change observed 9/12/2013: No significant change observed. 08/22/2012: Site is covered by dense vegetation. Berm width is estimated as 5 ft. There is no levee structure on site. The levee crest width and levee height were not measured or estimated in the field.

Close view of the erosion. Note the dense vegetation.

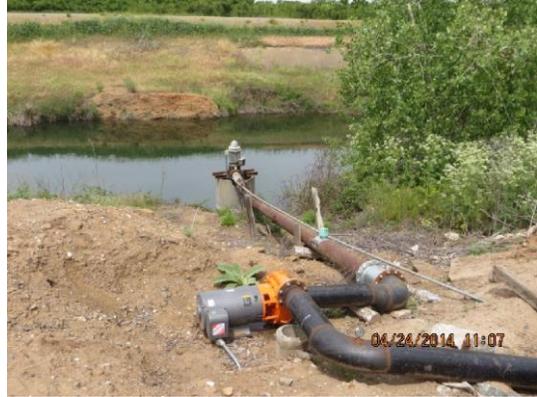
Photo 1 of 3 : UCIP\_FA\_2015\_5556.jpg

LM Start	<b>1.89</b>	Rating **	M	Issue No.	<b>811</b>
LM End	<b>1.89</b>	Issue Type +	En	Location *	WS
Category	Supplemental			GPS Latitude/Longitude	
				Start	End
Item	DWR UCIP Field Study			38.036520 °	38.036520 °
				-121.040155 °	-121.040155 °
DWR ID					
Action/Comments					
Inspector Comments: FS_ID:35543 DS_ID:23321 EP_NO: N/A FS_HLM: 1.949 Repair Type: Non-Urgent Crossing Status: Found UCIP Comments: Appears abandoned and if so should be done so properly. Pipe in non-project levee area. FIELD_STRUCT_DESC: 12-inch concrete irrigation pipe 3.0-feet below the roadway. Pump with 9-inch intake pipe on waterward slope. 4. 5-foot by 4.5 -foot concrete distribution box on the waterward side. Pump mounted over well with 9-inch intake pipe to distribution box on waterward side. 8-inch concrete standpipe on WS shoulder. O&M Manual SJR 611.1 Vol. F. FS Date: 04/24/2014

Pump re-routed for new crossing.

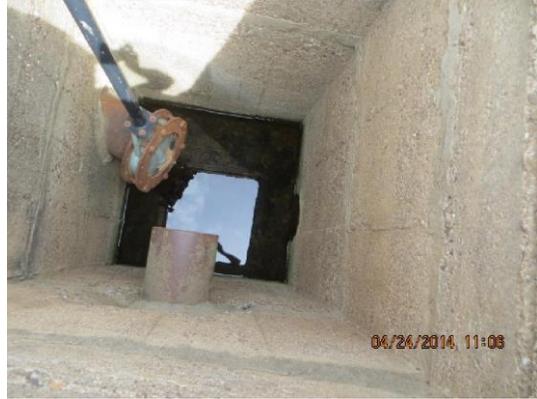
Photo 2 of 3 : UCIP\_FA\_2015\_5557.jpg

LM Start	<b>1.89</b>	Rating **	M	Issue No.	<b>811 (cont)</b>
LM End	<b>1.89</b>	Issue Type +	En	Location *	WS

Inside concrete distribution box on WS shoulder.

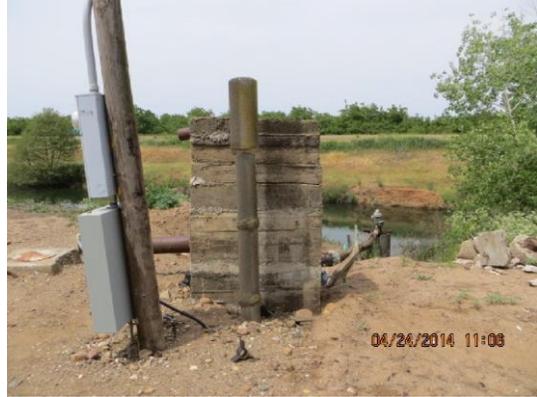
Photo 3 of 3 : UCIP\_FA\_2015\_5558.jpg

LM Start	<b>1.89</b>	Rating **	M	Issue No.	<b>811 (cont)</b>
LM End	<b>1.89</b>	Issue Type +	En	Location *	WS
Category	Supplemental			GPS Latitude/Longitude	
				Start	End
Item	DWR UCIP Field Study			38.036520 °	38.036520 °
				-121.040155 °	-121.040155 °
DWR ID					
Action/Comments					
Inspector Comments: FS_ID:35543 DS_ID:23321 EP_NO: N/A FS_HLM: 1.949 Repair Type: Non-Urgent Crossing Status: Found

Pump, concrete distribution box, and 8-inch standpipe visible on WS shoulder.

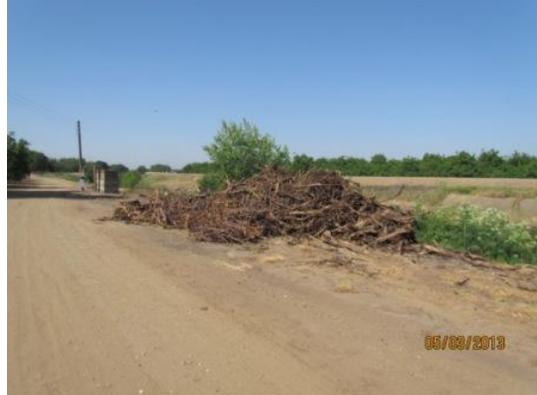
Photo 1 of 1 : FA\_2015\_NA0017\_160\_13\_20150911\_00005.jpg

LM Start	<b>1.89</b>	Rating **	M	Issue No.	<b>13</b>
LM End	<b>1.89</b>	Issue Type +	En	Location *	WS
Category	Earthen Levee			GPS Latitude/Longitude	
				Start	End
Item	Encroachments			38.036468 °	38.036468 °
				-121.040187 °	-121.040187 °
DWR ID	DWR_NA0017_16_s_2013_13				
Action/Comments					
Prunings

Prunings were found on the waterside shoulder of the levee looking downstream.

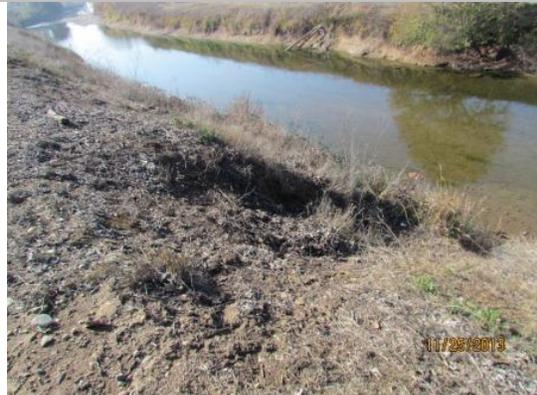
Photo 1 of 1 : FA\_2015\_NA0017\_160\_155\_20150911\_00087.jpg

Erosion was found on the waterside of the levee looking downstream.

LM Start	<b>1.91</b>	Rating **	M	Issue No.	<b>155</b>
LM End	<b>1.91</b>	Issue Type +	Ma	Location *	WS
Category	Earthen Levee			GPS Latitude/Longitude	
				Start	End
Item	Erosion / Bank Caving			38.036248 °	38.036248 °
				-121.040408 °	-121.040408 °
DWR ID	DWR_NA0017_16_f_2013_155				
Action/Comments					
Schedule repair of erosion site prior to the next inspection.

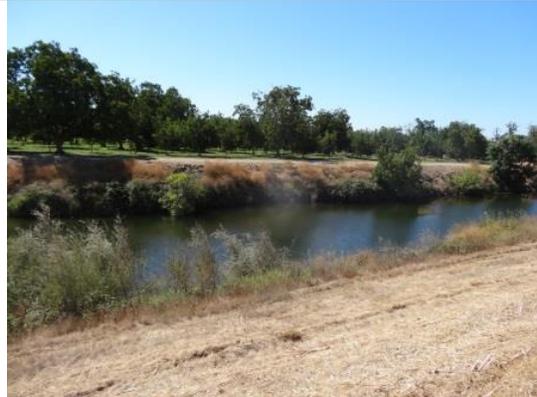
Photo 1 of 3 : SJR2015\_NA0017U16RM20.62\_1.jpg

LM Start	<b>2.30</b>	Rating **	U	Issue No.	<b>70</b>
LM End	<b>2.31</b>	Issue Type +	Ma	Location *	WS
Category	Supplemental			GPS Latitude/Longitude	
				Start	End
Item	DWR Erosion Survey			38.032202 °	38.032202 °
				-121.045226 °	-121.045226 °
DWR ID					
Action/Comments					
Inspector Comments: 8/12/2015: No significant change observed. 8/20/2014: No significant change has been observed. 9/12/2013: No significant change observed. 08/22/2012: The erosion was first reported in the 2012 spring levee inspection report. There is no levee structure on site. The levee crest width and levee height were not measured or estimated in the field. [2015 Site ID:NA0017U16RM20.62]

Front view of the site.

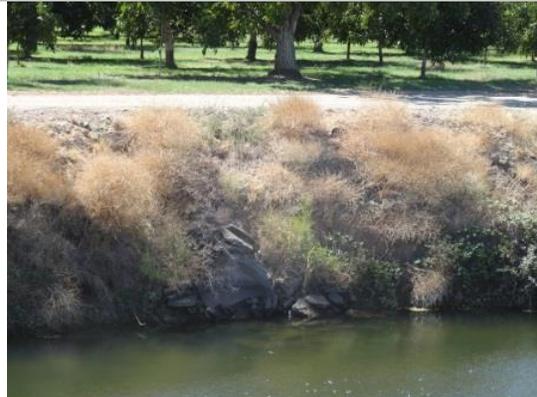
Photo 2 of 3 : SJR2015\_NA0017U16RM20.62\_2.jpg

LM Start	<b>2.30</b>	Rating **	U	Issue No.	<b>70 (cont)</b>
LM End	<b>2.31</b>	Issue Type +	Ma	Location *	WS

Close view of the erosion. Note the vegetation at the site.

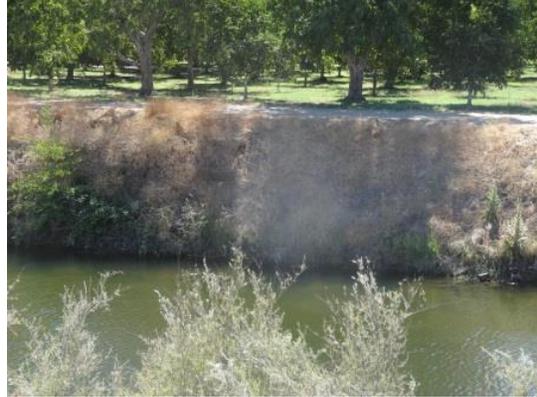
Photo 3 of 3 : SJR2015\_NA0017U16RM20.62\_5.jpg

LM Start	<b>2.30</b>	Rating **	U	Issue No.	<b>70 (cont)</b>
LM End	<b>2.31</b>	Issue Type +	Ma	Location *	WS
Category	Supplemental			GPS Latitude/Longitude	
				Start	End
Item	DWR Erosion Survey			38.032202 °	38.032202 °
				-121.045226 °	-121.045226 °
DWR ID					
Action/Comments					
Inspector Comments: 8/12/2015: No significant change observed. 8/20/2014: No significant change has been observed. 9/12/2013: No significant change observed. 08/22/2012: The erosion was first reported in the 2012 spring levee inspection report. There is no levee structure on site. The levee crest width and levee height were not measured or estimated in the field.

Close view of the site.

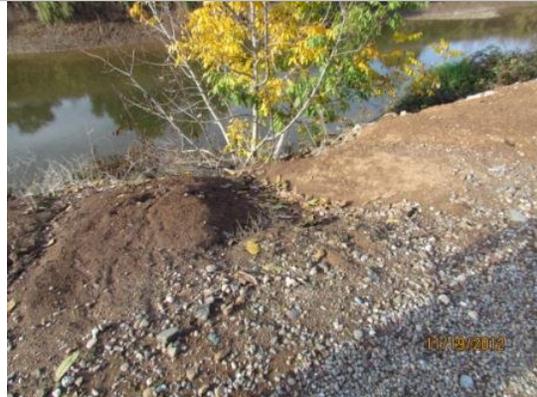
Photo 1 of 2 : FA\_2015\_NA0017\_160\_213\_20150911\_00127.jpg

Updated picture of the slope instability on the waterside shoulder of the levee looking upstream.

LM Start	<b>2.35</b>	Rating **	M	Issue No.	<b>213</b>
LM End	<b>2.35</b>	Issue Type +	Ma	Location *	WS
Category	Earthen Levee			GPS Latitude/Longitude	
				Start	End
Item	Slope Stability			38.031763 °	38.031763 °
				-121.045808 °	-121.045808 °
DWR ID	DWR_NA0017_16_f_2012_213				
Action/Comments					
Repair slope instability.

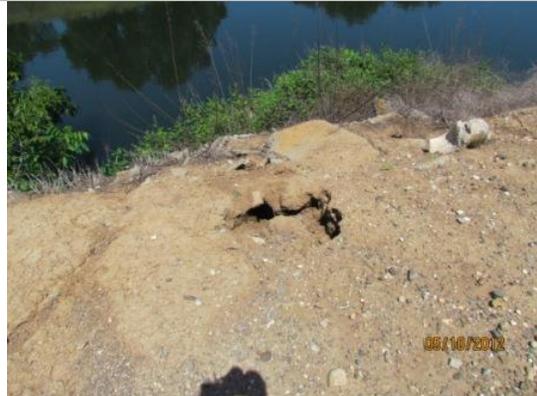
Photo 2 of 2 : FA\_2015\_NA0017\_160\_213\_20150911\_00128.jpg

LM Start	<b>2.35</b>	Rating **	M	Issue No.	<b>213 (cont)</b>
LM End	<b>2.35</b>	Issue Type +	Ma	Location *	WS

Slope instability was found on the waterside of the levee looking upstream.

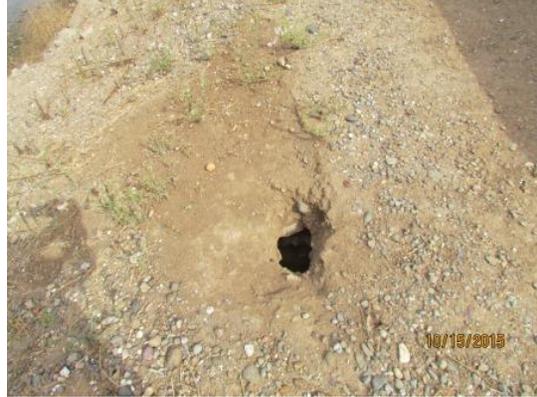
Photo 1 of 1 : FA\_2015\_NA0017\_160\_233\_20151023\_00163.jpg

A rodent hole was found on the waterside of the levee.

LM Start	<b>2.36</b>	Rating **	M	Issue No.	<b>233</b>
LM End	<b>2.36</b>	Issue Type +	Ma	Location *	WS
Category	Earthen Levee		GPS Latitude/Longitude		
			Start	End	
Item	Animal Control		38.031654 °	38.031654 °	
			-121.045925 °	-121.045925 °	
DWR ID	DWR_NA0017_16_f_2015_233				
Action/Comments					
No rodents visible, but rodent burrows visible; need to backfill and compact or grout burrows.

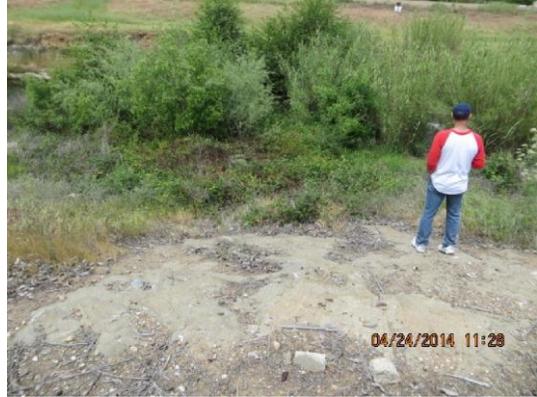
Photo 1 of 2 : UCIP\_FA\_2015\_5559.jpg

LM Start	<b>2.45</b>	Rating **	M	Issue No.	<b>812</b>
LM End	<b>2.45</b>	Issue Type +	En	Location *	WS
Category	Supplemental			GPS Latitude/Longitude	
				Start	End
Item	DWR UCIP Field Study			38.030548 °	38.030548 °
				-121.046998 °	-121.046998 °
DWR ID					
Action/Comments					
Inspector Comments: FS_ID:35551 DS_ID:23323 EP_NO: N/A FS_HLM: 2.529 Repair Type: Non-Urgent Crossing Status: Found UCIP Comments: Heavy vegetation obscuring outlet. remove vegetation and verify flapgate installed. FIELD_STRUCT_DESC: 18-inch CM drainage pipe 3.0 feet below the roadway. Grouted spillway. O&M Manual SJR 611.1 Vol. F. FS Date: 04/24/2014

Grout over pipe on WS. Heavy vegetation blocking view of outlet.

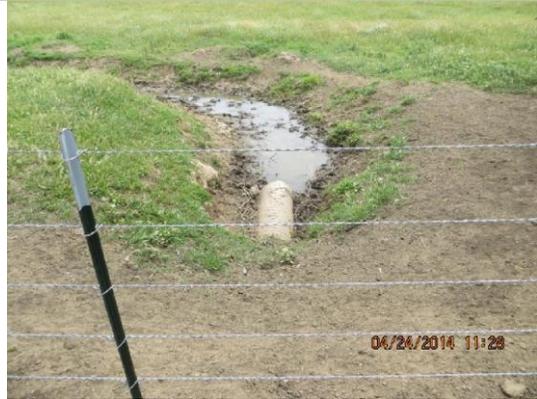
Photo 2 of 2 : UCIP\_FA\_2015\_5560.jpg

Pipe visible on LS toe.

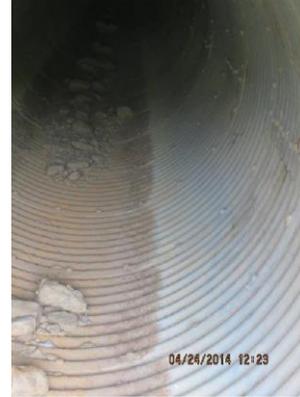
Photo 1 of 3 : UCIP\_FA\_2015\_5561.jpg

LM Start	<b>2.69</b>	Rating **	U	Issue No.	<b>813</b>
LM End	<b>2.69</b>	Issue Type +	En	Location *	WS
Category	Supplemental			GPS Latitude/Longitude	
				Start	End
Item	DWR UCIP Field Study			38.028210 °	38.028210 °
				-121.050220 °	-121.050220 °
DWR ID					
Action/Comments					
Inspector Comments: FS_ID:41244 DS_ID:23446 EP_NO: N/A FS_HLM: 2.78 Repair Type: Urgent Crossing Status: Found

inside pipe on LS toe.

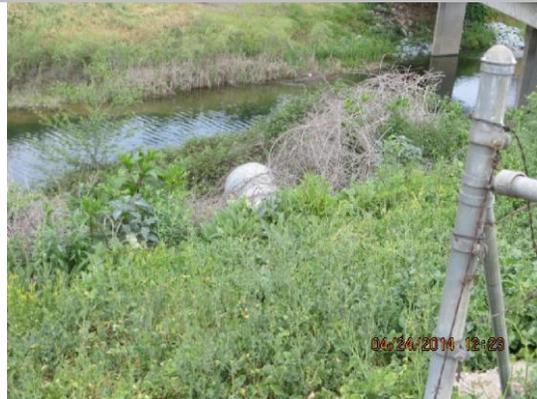
Photo 2 of 3 : UCIP\_FA\_2015\_5562.jpg

LM Start	<b>2.69</b>	Rating **	U	Issue No.	<b>813 (cont)</b>
LM End	<b>2.69</b>	Issue Type +	En	Location *	WS

Pipe outlet on WS slope.

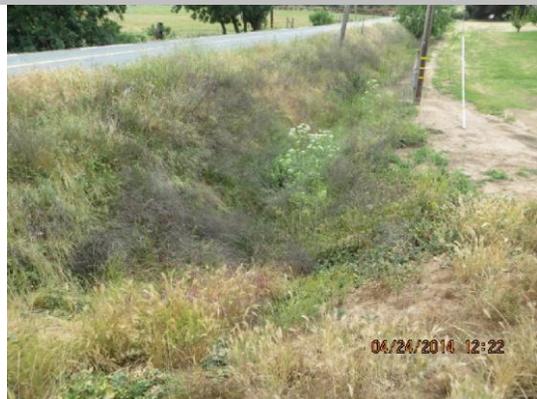
Photo 3 of 3 : UCIP\_FA\_2015\_5563.jpg

LM Start	<b>2.69</b>	Rating **	U	Issue No.	<b>813 (cont)</b>
LM End	<b>2.69</b>	Issue Type +	En	Location *	WS

Pipe inlet on LS toe.

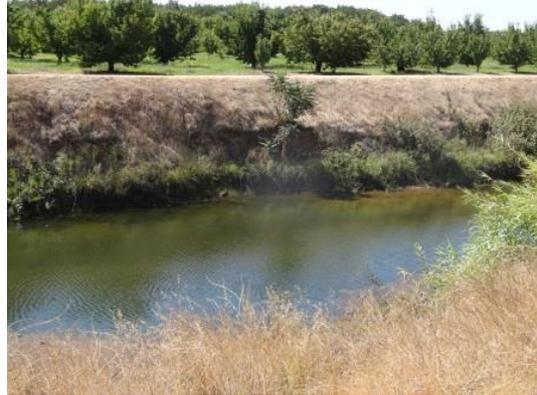
Photo 1 of 4 : SJR2015\_NA0017U16RM20.00\_1.jpg

LM Start	<b>2.85</b>	Rating **	U	Issue No.	<b>64</b>
LM End	<b>2.91</b>	Issue Type +	Ma	Location *	WS
Category	Supplemental			GPS Latitude/Longitude	
				Start	End
Item	DWR Erosion Survey			38.026670 °	38.026670 °
				-121.053031 °	-121.053031 °
DWR ID					
<b>Action/Comments</b>					
Inspector Comments: 8/12/2015: No significant change observed. 8/20/2014: No significant change observed. 9/12/2013: No significant change observed. 08/22/2012: Site Comprised of series of pocket and scarp erosions. Some of erosions are covered by grass or shrubs. There is no levee structure on site. The levee crest width and levee height were not

Front view of the erosion.

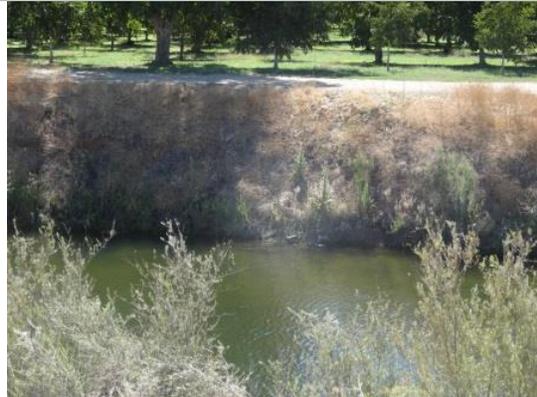
Photo 2 of 4 : SJR2015\_NA0017U16RM20.00\_2.jpg

LM Start	<b>2.85</b>	Rating **	U	Issue No.	<b>64 (cont)</b>
LM End	<b>2.91</b>	Issue Type +	Ma	Location *	WS

Close view of the erosion.

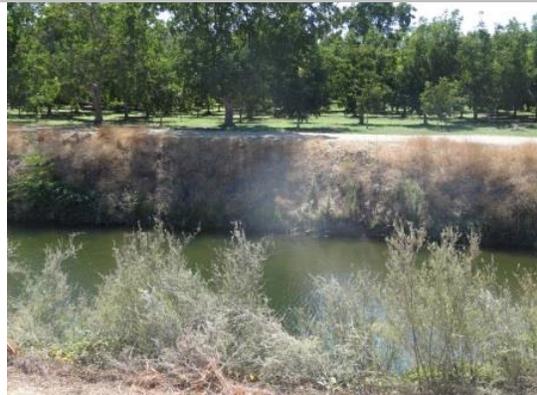
Photo 3 of 4 : SJR2015\_NA0017U16RM20.00\_3.jpg

LM Start	<b>2.85</b>	Rating **	U	Issue No.	<b>64 (cont)</b>
LM End	<b>2.91</b>	Issue Type +	Ma	Location *	WS

Front view of the erosion.

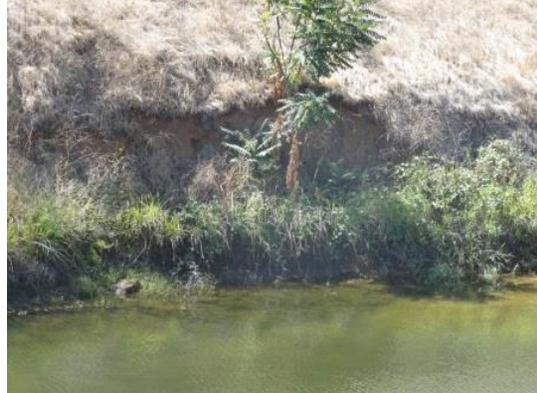
Photo 4 of 4 : SJR2015\_NA0017U16RM20.00\_7.jpg

LM Start	<b>2.85</b>	Rating **	U	Issue No.	<b>64 (cont)</b>
LM End	<b>2.91</b>	Issue Type +	Ma	Location *	WS
Category	Supplemental			GPS Latitude/Longitude	
				Start	End
Item	DWR Erosion Survey			38.026670 °	38.026670 °
				-121.053031 °	-121.053031 °
DWR ID					
Action/Comments					
Inspector Comments: 8/12/2015: No significant change observed. 8/20/2014: No significant change observed. 9/12/2013: No significant change observed. 08/22/2012: Site Comprised of series of pocket and scarp erosions. Some of erosions are covered by grass or shrubs. There is no levee structure on site. The levee crest width and levee height were not

Close view of the scarp erosion. Note the small tree at the erosoion site.

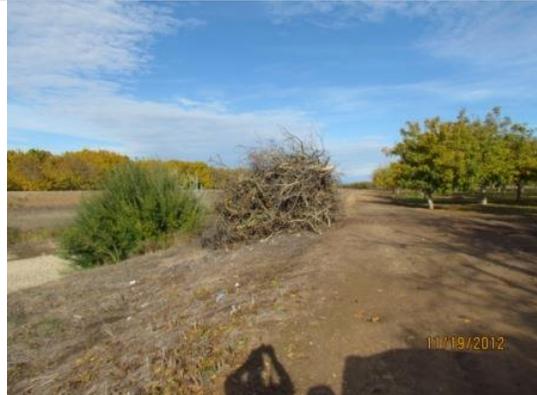
Photo 1 of 1 : FA\_2015\_NA0017\_160\_52\_20150911\_00025.jpg

LM Start	<b>3.25</b>	Rating **	M	Issue No.	<b>52</b>
LM End	<b>3.25</b>	Issue Type +	En	Location *	WS
Category	Earthen Levee			GPS Latitude/Longitude	
				Start	End
Item	Encroachments			38.023257 °	38.023257 °
				-121.058158 °	-121.058158 °
DWR ID	DWR_NA0017_16_s_2012_52				
Action/Comments					
Prunings Inspector Comments: Burn pile has been burned but new material has been placed.

Prunings were found on the waterside shoulder of the levee looking upstream.

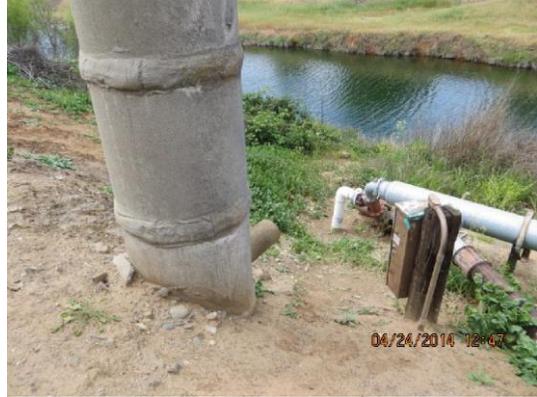
Photo 1 of 1 : UCIP\_FA\_2015\_5616.jpg

LM Start	<b>3.40</b>	Rating **	M	Issue No.	<b>814</b>
LM End	<b>3.40</b>	Issue Type +	En	Location *	WS
Category	Supplemental			GPS Latitude/Longitude	
				Start	End
Item	DWR UCIP Field Study			38.021830 °	38.021830 °
				-121.060181 °	-121.060181 °
DWR ID					
Action/Comments					
Inspector Comments: FS_ID:35583 DS_ID:23325 EP_NO: N/A FS_HLM: 3.508 Repair Type: Non-Urgent Crossing Status: Found UCIP Comments: Pipe appears abandoned and if so should be done so properly. FIELD_STRUCT_DESC: 10-inch steel pipe 3-feet below the roadway. Pump on the waterward slope. 36-inch concrete standpipe on WS shoulder. 1.5-inch galvanized iron electrical conduit at same location. FS Date: 04/24/2014

36-inch concrete standpipe at location of abandoned pipe.

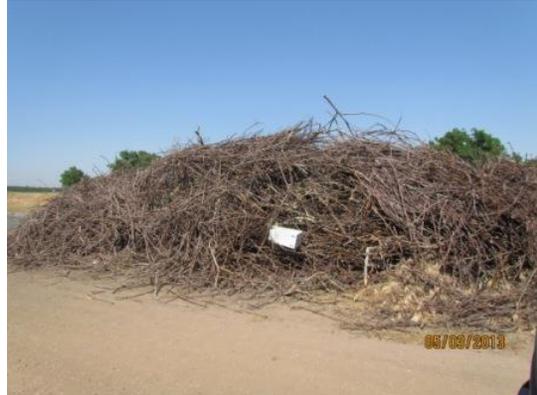
Photo 1 of 1 : FA\_2015\_NA0017\_160\_53\_20150911\_00026.jpg

LM Start	<b>3.41</b>	Rating **	M	Issue No.	<b>53</b>
LM End	<b>3.41</b>	Issue Type +	Ma	Location *	WS
Category	Earthen Levee			GPS Latitude/Longitude	
				Start	End
Item	Encroachments			38.021650 °	38.021650 °
				-121.060312 °	-121.060312 °
DWR ID	DWR_NA0017_16_s_2012_53				
Action/Comments					
Prunings Inspector Comments: Burn pile has been burned but new material has been placed.

Prunings were found on the waterside shoulder of the levee looking downstream.

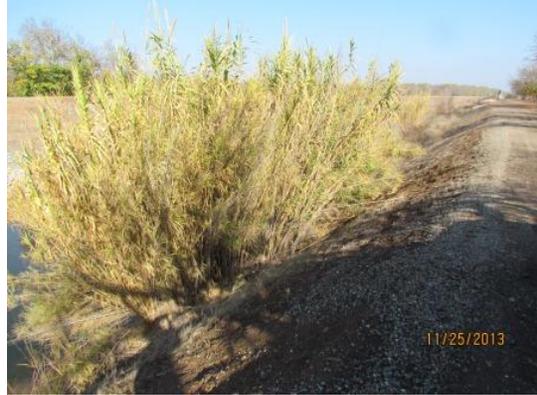
Photo 1 of 1 : FA\_2015\_NA0017\_160\_152\_20150911\_00086.jpg

Arundo was found on the waterside toe of the levee looking upstream.

LM Start	<b>3.48</b>	Rating **	M	Issue No.	<b>152</b>
LM End	<b>3.48</b>	Issue Type +	Ma	Location *	WS
Category	Earthen Levee			GPS Latitude/Longitude	
				Start	End
Item	Vegetation			38.020965 °	38.020965 °
				-121.061215 °	-121.061215 °
DWR ID	DWR_NA0017_16_f_2013_152				
Action/Comments					
Remove the wild growth other than native grasses from the levee slopes.

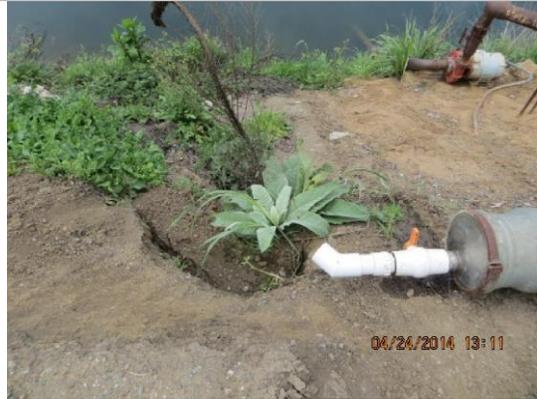
Photo 1 of 2 : UCIP\_FA\_2015\_6074.jpg

LM Start	<b>3.50</b>	Rating **	M	Issue No.	<b>815</b>
LM End	<b>3.50</b>	Issue Type +	En	Location *	WS
Category	Supplemental			GPS Latitude/Longitude	
				Start	End
Item	DWR UCIP Field Study			38.020790 °	38.020790 °
				-121.061470 °	-121.061470 °
DWR ID					
Action/Comments					
Inspector Comments: FS_ID:39020 DS_ID:24941 EP_NO: N/A FS_HLM: 3.612 Repair Type: Non-Urgent Crossing Status: Found UCIP Comments: Filter plant backwash causing erosion on WS slope. FIELD_STRUCT_DESC: 6-inch PVC irrigation pipe through the levee 1.5-feet below the crown. Slant pump, butterfly valve, vent, and filter on WS slope. Pump and filter on Concrete pads. FS Date: 04/24/2014

Backwash from filter causing erosion on WS slope.

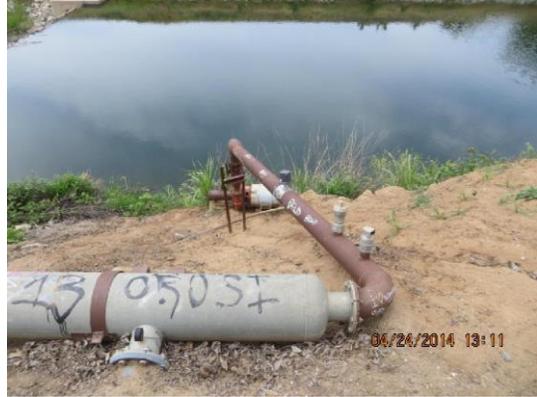
Photo 2 of 2 : UCIP\_FA\_2015\_6075.jpg

LM Start	<b>3.50</b>	Rating **	M	Issue No.	<b>815 (cont)</b>
LM End	<b>3.50</b>	Issue Type +	En	Location *	WS
Category	Supplemental			GPS Latitude/Longitude	
				Start	End
Item	DWR UCIP Field Study			38.020790 °	38.020790 °
				-121.061470 °	-121.061470 °
DWR ID					
Action/Comments					
Inspector Comments: FS_ID:39020 DS_ID:24941 EP_NO: N/A FS_HLM: 3.612 Repair Type: Non-Urgent Crossing Status: Found UCIP Comments: Filter plant backwash causing erosion on WS slope. FIELD_STRUCT_DESC: 6-inch PVC irrigation pipe through the levee 1.5-feet below the crown. Slant pump, butterfly valve, vent, and filter on WS slope. Pump and filter on Concrete pads. FS Date: 04/24/2014

Pump, butterfly valve, meter, siphon breaker, vent, and filter on WS slope.

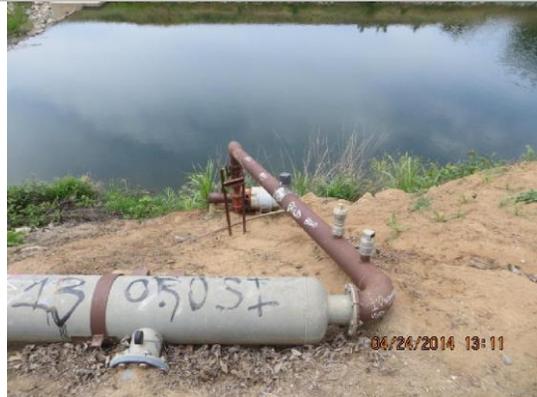
Photo 1 of 1 : UCIP\_FA\_2015\_5617.jpg

LM Start	<b>3.51</b>	Rating **	M	Issue No.	<b>816</b>
LM End	<b>3.51</b>	Issue Type +	En	Location *	WS
Category	Supplemental			GPS Latitude/Longitude	
				Start	End
Item	DWR UCIP Field Study			38.020678 °	38.020678 °
				-121.061595 °	-121.061595 °
DWR ID					
Action/Comments					
Inspector Comments: FS_ID:35584 DS_ID:23326 EP_NO: N/A FS_HLM: 3.616 Repair Type: Non-Urgent Crossing Status: Indicator Found UCIP Comments: Verify 12-inch pipe was properly abandoned when new pipe was installed. FIELD_STRUCT_DESC: 12-inch concrete irrigation pipe 4.0-feet below the roadway. Pump and motor with 8-inch intake pipe to 24-inch concrete standpipe on the waterward side. Electrical conduit through the levee. 30-inch diameter concrete standpipe and pump on landward side. O&M Manual SJR 611.1 Vol. F. FS Date: 04/24/2014

Evidence of crossing at WS.
