**Flood Control Project Maintenance  
Levee Inspections**

**Fall 2015 Levee Maintenance Deficiency Summary Report**

**San Joaquin River Basin**

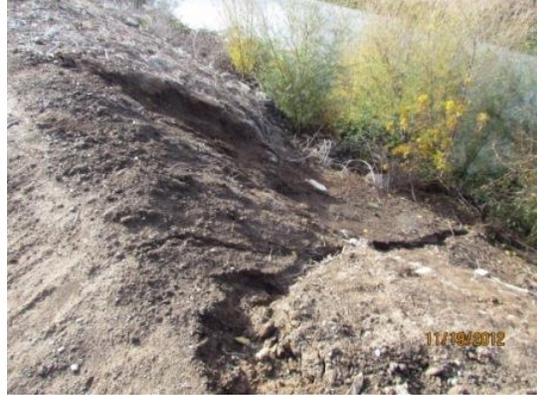
Photo 1 of 2 : FA\_2015\_NA0017\_160\_230\_20150911\_00138.jpg

Slope instability was found on the waterside slope of the levee looking downstream.

LM Start	<b>3.53</b>	Rating **	M	Issue No.	<b>230</b>
LM End	<b>3.53</b>	Issue Type +	Ma	Location *	WS
Category	Earthen Levee			GPS Latitude/Longitude	
				Start	End
Item	Erosion / Bank Caving			38.020433 °	38.020433 °
				-121.061867 °	-121.061867 °
DWR ID	DWR_NA0017_16_f_2012_230				
Action/Comments					
Schedule repair of erosion site prior to the next inspection.

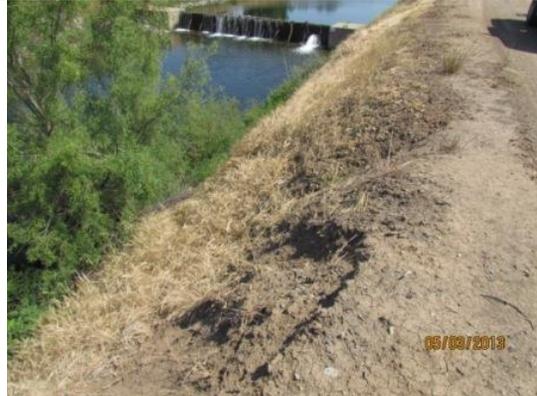
Photo 2 of 2 : FA\_2015\_NA0017\_160\_230\_20150911\_00139.jpg

Erosion was found on the waterside slope of the levee looking upstream.

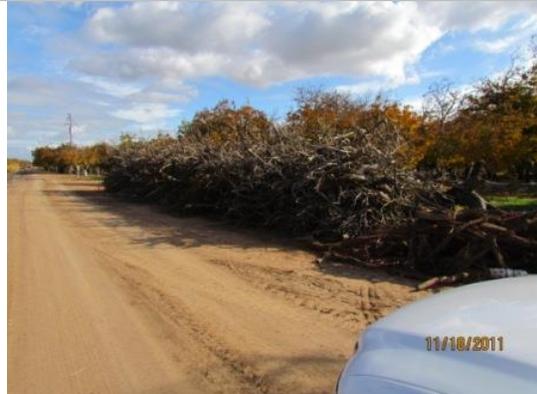
Photo 1 of 1 : FA\_2015\_NA0017\_160\_206\_20150911\_00122.jpg

LM Start	<b>3.54</b>	Rating **	U	Issue No.	<b>206</b>
LM End	<b>3.54</b>	Issue Type +	En	Location *	LS
Category	Earthen Levee			GPS Latitude/Longitude	
				Start	End
Item	Encroachments			38.020351 °	38.020351 °
				-121.061944 °	-121.061944 °
DWR ID	DWR_NA0017_16_s_2012_206				
Action/Comments					
Prunings

Prunings were found on the landside of the levee looking upstream.

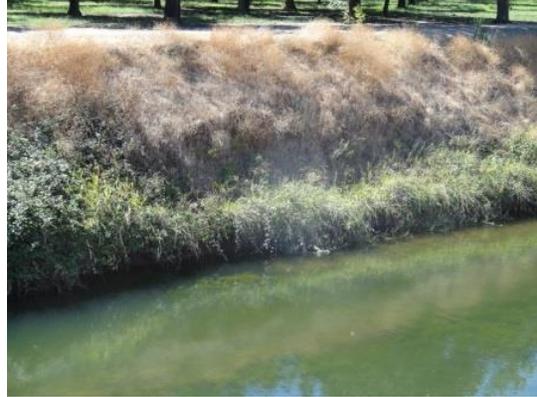
Photo 1 of 2 : SJR2015\_NA0017U16RM19.29\_2.JPG

LM Start	<b>3.61</b>	Rating **	M	Issue No.	<b>54</b>
LM End	<b>3.61</b>	Issue Type +	Ma	Location *	WS
Category	Supplemental			GPS Latitude/Longitude	
				Start	End
Item	DWR Erosion Survey			38.019642 °	38.019642 °
				-121.062917 °	-121.062917 °
DWR ID					
<b>Action/Comments</b>					
Inspector Comments: 8/12/2015: No significant change observed. 8/20/2014: A pocket erosion was found near the water's edge. [2015 Site ID:NA0017U16RM19.29]

Close view of the erosion.

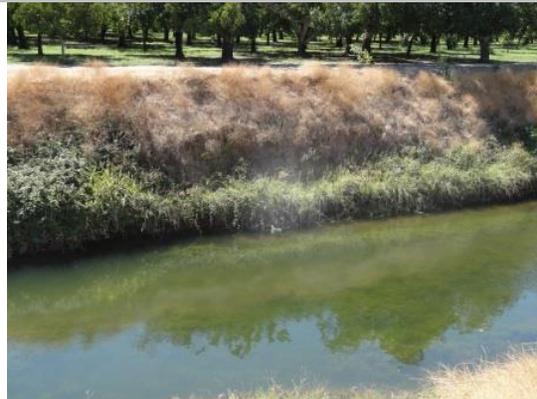
Photo 2 of 2 : SJR2015\_NA0017U16RM19.29\_4.JPG

LM Start	<b>3.61</b>	Rating **	M	Issue No.	<b>54 (cont)</b>
LM End	<b>3.61</b>	Issue Type +	Ma	Location *	WS

View of the site.

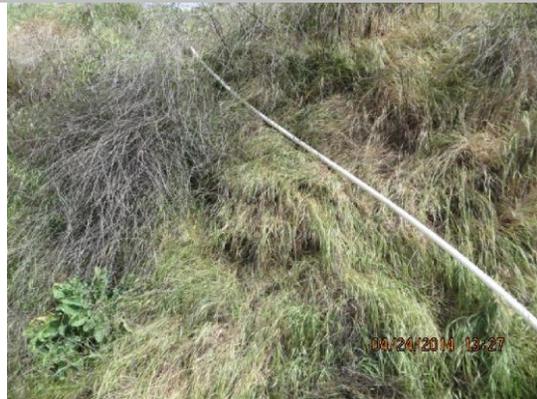
Photo 1 of 3 : UCIP\_FA\_2015\_6110.jpg

LM Start	<b>3.79</b>	Rating **	M	Issue No.	<b>817</b>
LM End	<b>3.79</b>	Issue Type +	En	Location *	WS
Category	Supplemental			GPS Latitude/Longitude	
				Start	End
Item	DWR UCIP Field Study			38.017644 °	38.017644 °
				-121.064954 °	-121.064954 °
DWR ID					
Action/Comments					
Inspector Comments: FS_ID:41680 DS_ID:24942 EP_NO: N/A FS_HLM: 3.91 Repair Type: Non-Urgent Crossing Status: Found UCIP Comments: No permit identified for crossing. FIELD_STRUCT_DESC: 5-inch PVC irrigation pipe through the levee at an unknown depth. Pump on WS toe. Filter, and shutoff valve visible on LS shoulder. Meter and control panel on LS shoulder. 1.5-inch electrical conduit at same location. FS Date: 04/24/2014

Electrical conduit on WS slope.

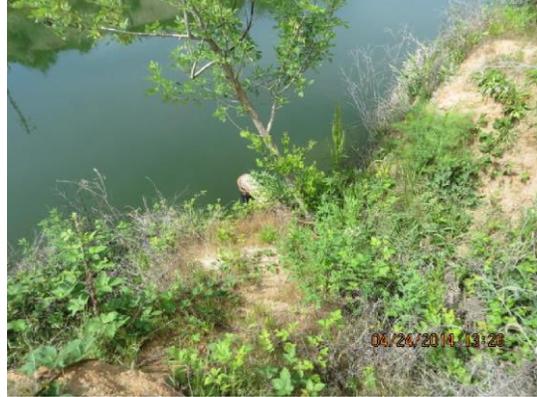
Photo 2 of 3 : UCIP\_FA\_2015\_6111.jpg

LM Start	3.79	Rating **	M	Issue No.	817 (cont)
LM End	3.79	Issue Type +	En	Location *	WS
Category	Supplemental			GPS Latitude/Longitude	
				Start	End
Item	DWR UCIP Field Study			38.017644 °	38.017644 °
				-121.064954 °	-121.064954 °
DWR ID					
Action/Comments					
Inspector Comments: FS_ID:41680 DS_ID:24942 EP_NO: N/A FS_HLM: 3.91 Repair Type: Non-Urgent Crossing Status: Found UCIP Comments: No permit identified for crossing. FIELD_STRUCT_DESC: 5-inch PVC irrigation pipe through the levee at an unknown depth. Pump on WS toe. Filter, and shutoff valve visible on LS shoulder. Meter and control panel on LS shoulder. 1.5-inch electrical conduit at same location. FS Date: 04/24/2014

Pump and pipe visible at WS toe.

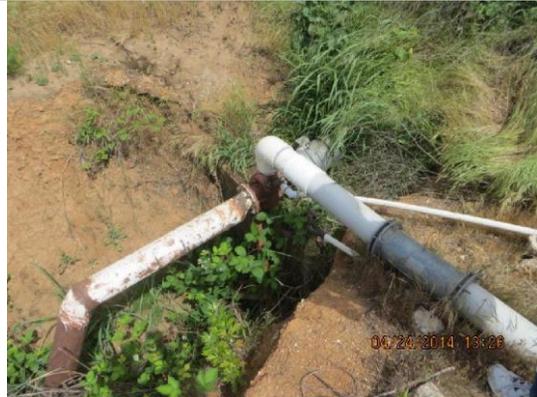
Photo 3 of 3 : UCIP\_FA\_2015\_6112.jpg

Pump and pipe visible at WS toe.

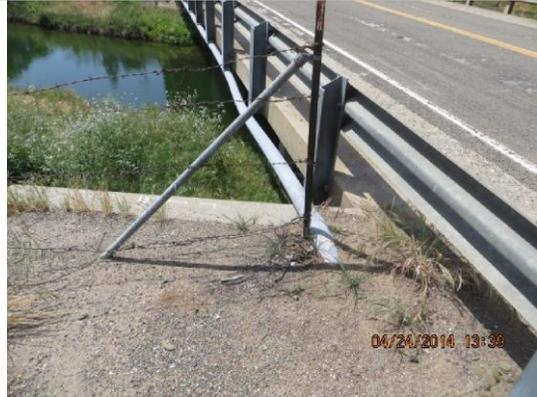
Photo 1 of 2 : UCIP\_FA\_2015\_6113.jpg

LM Start	<b>3.90</b>	Rating **	M	Issue No.	<b>818</b>
LM End	<b>3.90</b>	Issue Type +	En	Location *	WS
Category	Supplemental			GPS Latitude/Longitude	
				Start	End
Item	DWR UCIP Field Study			38.016290 °	38.016290 °
				-121.066213 °	-121.066213 °
DWR ID					
Action/Comments					
Inspector Comments: FS_ID:41947 DS_ID:24944 EP_NO: N/A FS_HLM: 4.03 Repair Type: Non-Urgent Crossing Status: Found UCIP Comments: No permit identified for this crossing. FIELD_STRUCT_DESC: 4-inch PVC communication line through the levee at an unknown depth. Pipe attached to the downstream side of the bridge. FS Date: 04/24/2014

PVC conduit visible on downstream side of bridge.

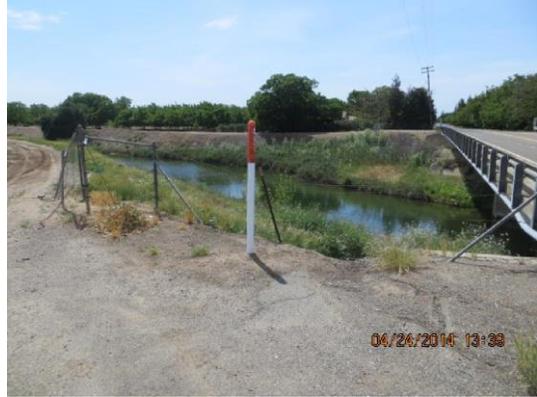
Photo 2 of 2 : UCIP\_FA\_2015\_6114.jpg

LM Start	<b>3.90</b>	Rating **	M	Issue No.	<b>818 (cont)</b>
LM End	<b>3.90</b>	Issue Type +	En	Location *	WS
Category	Supplemental			GPS Latitude/Longitude	
				Start	End
Item	DWR UCIP Field Study			38.016290 °	38.016290 °
				-121.066213 °	-121.066213 °
DWR ID					
Action/Comments					
Inspector Comments: FS_ID:41947 DS_ID:24944 EP_NO: N/A FS_HLM: 4.03 Repair Type: Non-Urgent Crossing Status: Found UCIP Comments: No permit identified for this crossing. FIELD_STRUCT_DESC: 4-inch PVC communication line through the levee at an unknown depth. Pipe attached to the downstream side of the bridge. FS Date: 04/24/2014

Communication line marker on WS shoulder.

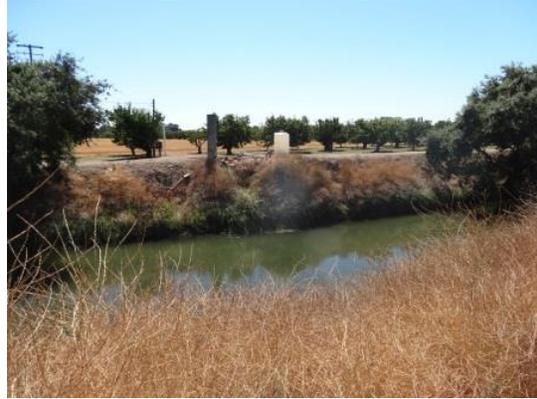
Photo 1 of 2 : SJR2015\_NA0017U16RM18.69\_1.jpg

LM Start	<b>4.16</b>	Rating **	U	Issue No.	<b>47</b>
LM End	<b>4.18</b>	Issue Type +	Ma	Location *	WS
Category	Supplemental			GPS Latitude/Longitude	
				Start	End
Item	DWR Erosion Survey			38.012792 °	38.012792 °
				-121.068073 °	-121.068073 °
DWR ID					
Action/Comments					
Inspector Comments: 8/12/2015: No significant change observed. 8/20/2014: No significant change observed. 9/12/2013: No significant change observed. 08/22/2012: An irrigation pipe is present at the site, but probably did not cause the erosion. There is no levee structure on site. The levee crest width and levee height were not measured or estimated in the field. [2015 Site ID:NA0017U16RM18.69]

View of the erosion site.

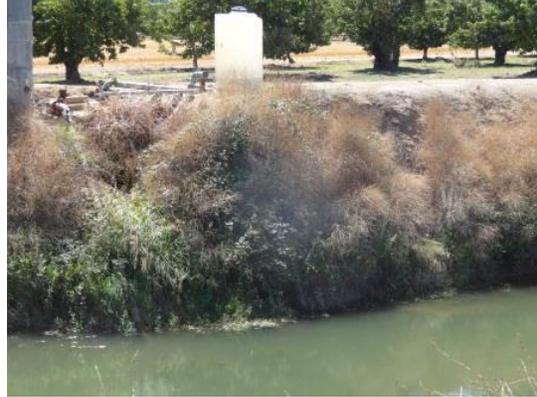
Photo 2 of 2 : SJR2015\_NA0017U16RM18.69\_2.jpg

LM Start	<b>4.16</b>	Rating **	U	Issue No.	<b>47 (cont)</b>
LM End	<b>4.18</b>	Issue Type +	Ma	Location *	WS
Category	Supplemental			GPS Latitude/Longitude	
				Start	End
Item	DWR Erosion Survey			38.012792 °	38.012792 °
				-121.068073 °	-121.068073 °
DWR ID					
Action/Comments					
Inspector Comments: 8/12/2015: No significant change observed. 8/20/2014: No significant change observed. 9/12/2013: No significant change observed. 08/22/2012: An irrigation pipe is present at the site, but probably did not cause the erosion. There is no levee structure on site. The levee crest width and levee height were not measured or estimated in the field. [2015 Site ID:NA0017U16RM18.69]

Closer view of the erosion.

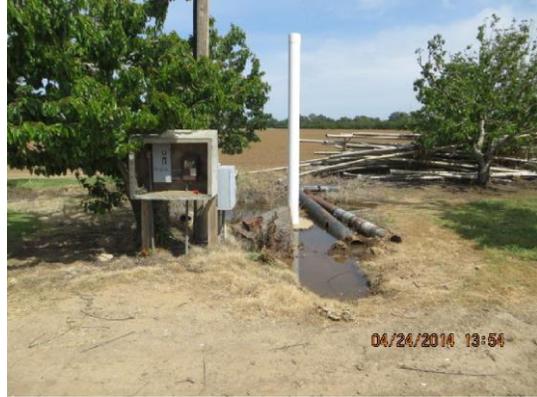
Photo 1 of 2 : UCIP\_FA\_2015\_3566.jpg

Inspector Comments: FS\_ID:42862  
 DS\_ID:23328  
 EP\_NO: N/A  
 FS\_HLM: 4.322  
 Repair Type: Urgent  
 Crossing Status: Found  
 UCIP Comments: Pipe leaking internally at centerline of roadway and at LS near standpipe. Concrete standpipe on WS shoulder leaks as well. FIELD\_STRUCT\_DESC: 12-inch concrete irrigation pipe through the levee 3-feet below the roadway. Two pumps on the waterward side. 8-inch pipe to pumps. 30-inch concrete standpipe on the waterward side. 8-inch PVC standpipe, meter, electrical panel, and pole on LS. O&M Manual SJR 611.1 Vol. F.  
 FS Date: 04/24/2014

Meter, control panel, PVC standpipe, and flooding from leaking pipe on LS of roadway.

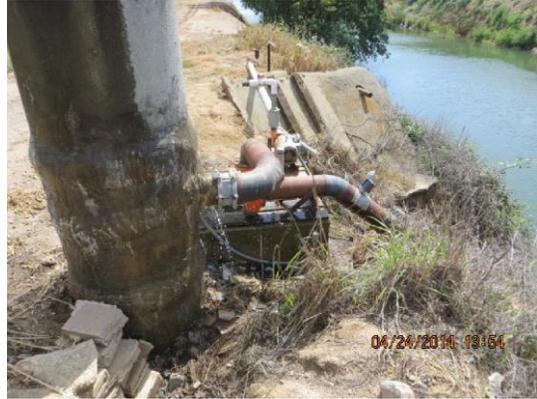
Photo 2 of 2 : UCIP\_FA\_2015\_3567.jpg

Pump and leaking concrete standpipe on WS shoulder.

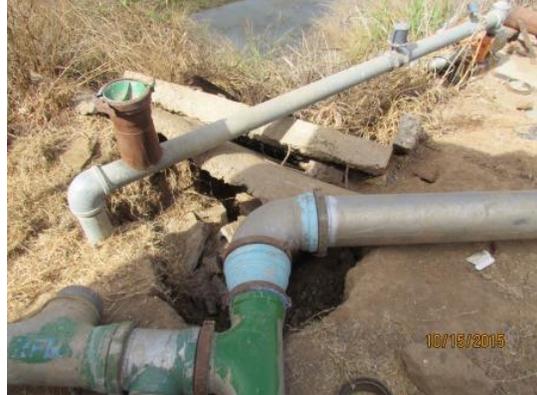
Photo 1 of 1 : FA\_2015\_NA0017\_160\_236\_20151023\_00164.jpg

LM Start	<b>4.19</b>	Rating **	M	Issue No.	<b>236</b>
LM End	<b>4.19</b>	Issue Type +	Ma	Location *	WS
Category	Earthen Levee		GPS Latitude/Longitude		
			Start	End	
Item	Erosion / Bank Caving		38.012491 °	38.012491 °	
			-121.068118 °	-121.068118 °	
DWR ID	DWR_NA0017_16_f_2015_236				
Action/Comments					
Schedule repair of erosion site prior to the next inspection. Inspector Comments: Erosion created by broken pipe.

Erosion caused by a broken pipe on the waterside of the levee.

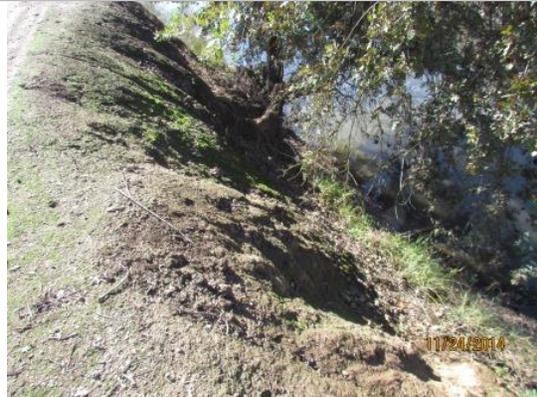
Photo 1 of 2 : FA\_2015\_NA0017\_160\_228\_20150911\_00136.jpg

LM Start	<b>4.20</b>	Rating **	M	Issue No.	<b>228</b>
LM End	<b>4.20</b>	Issue Type +	Ma	Location *	WS
Category	Earthen Levee		GPS Latitude/Longitude		
			Start	End	
Item	Slope Stability		38.012288 °	38.012288 °	
			-121.068239 °	-121.068239 °	
DWR ID	DWR_NA0017_16_f_2012_228				
Action/Comments					
Repair slope instability.

Updated picture of the slope instability on the waterside of the levee looking downstream.

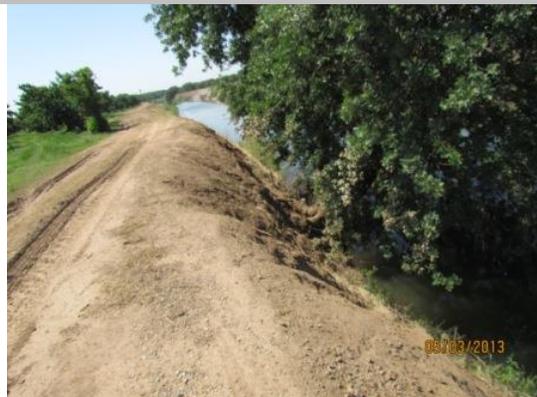
Photo 2 of 2 : FA\_2015\_NA0017\_160\_228\_20150911\_00137.jpg

Slope instability was found on the waterside shoulder of the levee looking downstream.

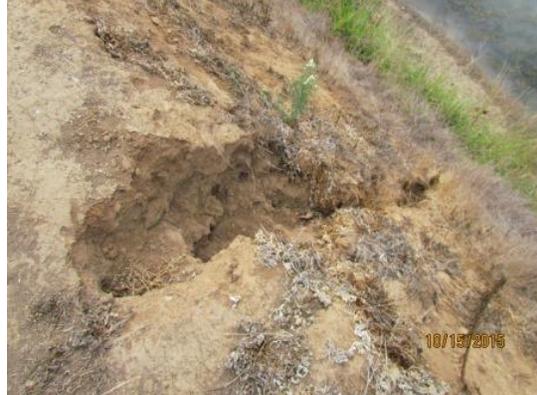
Photo 1 of 1 : FA\_2015\_NA0017\_160\_73\_20151023\_00165.jpg

LM Start	<b>4.28</b>	Rating **	M	Issue No.	<b>73</b>
LM End	<b>4.28</b>	Issue Type +	Ma	Location *	WS
Category	Earthen Levee			GPS Latitude/Longitude	
				Start	End
Item	Erosion / Bank Caving			38.011201 °	38.011201 °
				-121.068581 °	-121.068581 °
DWR ID	DWR_NA0017_16_s_2013_73				
Action/Comments					
Schedule repair of erosion site prior to the next inspection.

Erosion was found on the waterside shoulder of the levee looking upstream.

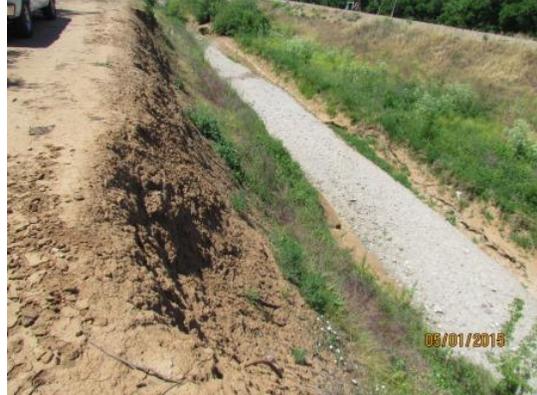
Photo 1 of 1 : FA\_2015\_NA0017\_160\_245\_20150911\_00142.jpg

LM Start	<b>4.85</b>	Rating **	M	Issue No.	<b>245</b>
LM End	<b>4.85</b>	Issue Type +	Ma	Location *	WS
Category	Earthen Levee			GPS Latitude/Longitude	
				Start	End
Item	Erosion / Bank Caving			38.003673 °	38.003673 °
				-121.072496 °	-121.072496 °
DWR ID	DWR_NA0017_16_s_2015_245				
Action/Comments					
Note and monitor erosion site.

View of erosion on the waterside slope of the levee looking downstream.

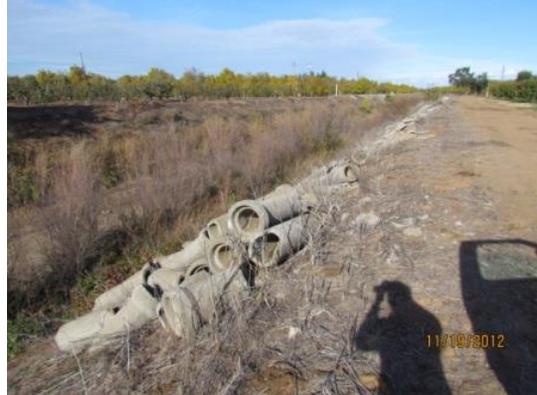
Photo 1 of 2 : FA\_2015\_NA0017\_160\_196\_20150911\_00114.jpg

LM Start	<b>5.05</b>	Rating **	M	Issue No.	<b>196</b>
LM End	<b>5.15</b>	Issue Type +	Ma	Location *	WS
Category	Earthen Levee			GPS Latitude/Longitude	
				Start	End
Item	Encroachments			38.001284 °	38.000116 °
				-121.074596 °	-121.075633 °
DWR ID	DWR_NA0017_16_s_2012_196				
Action/Comments					
Debris

Concrete debris was found on the waterside slope of the levee looking upstream.

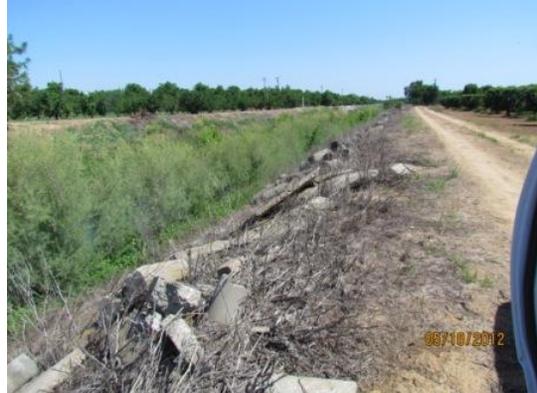
Photo 2 of 2 : FA\_2015\_NA0017\_160\_196\_20150911\_00115.jpg

Debris was found on the waterside of the levee looking upstream.

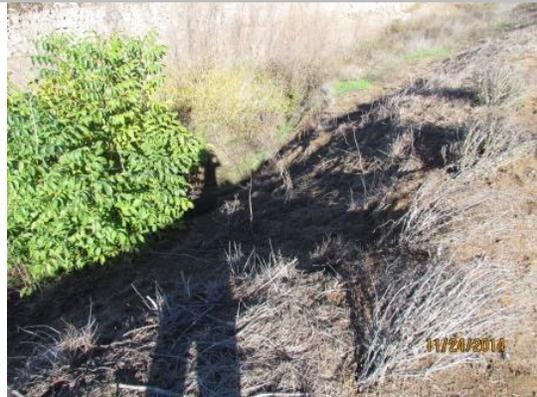
Photo 1 of 1 : FA\_2015\_NA0017\_160\_265\_20150911\_00150.jpg

LM Start	<b>5.20</b>	Rating **	M	Issue No.	<b>265</b>
LM End	<b>5.20</b>	Issue Type +	Ma	Location *	WS
Category	Earthen Levee			GPS Latitude/Longitude	
				Start	End
Item	Slope Stability			37.999537 °	37.999537 °
				-121.076133 °	-121.076133 °
DWR ID	DWR_NA0017_16_f_2014_265				
Action/Comments					
Repair slope instability.

A slope instability was found on the waterside slope of the levee looking upstream.

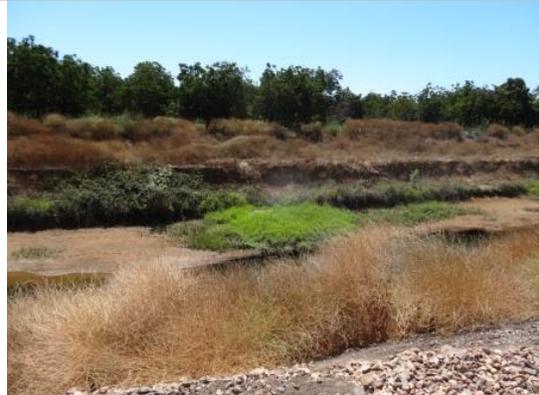
Photo 1 of 2 : SJR2015\_NA0017U16RM17.81\_2.jpg

LM Start	<b>5.33</b>	Rating **	M	Issue No.	<b>41</b>
LM End	<b>5.38</b>	Issue Type +	Ma	Location *	WS
Category	Supplemental		GPS Latitude/Longitude		
			Start	End	
Item	DWR Erosion Survey		37.997720 °	37.997720 °	
			-121.077807 °	-121.077807 °	
DWR ID					
Action/Comments					
Inspector Comments: 8/12/2015: No significant change observed. 8/20/2014: No significant change observed. 9/12/2013: No significant change observed. 08/22/2012: The site is located at the opposite river bank of E. Tobacco Road. There is no levee structure on site. The levee crest width and levee height were not measured or estimated in the field. [2015 Site ID:NA0017U16RM17.81]

Front view of the site.

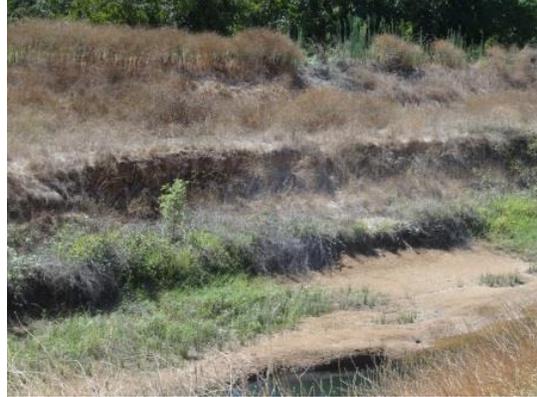
Photo 2 of 2 : SJR2015\_NA0017U16RM17.81\_5.jpg

Close view of the erosion.

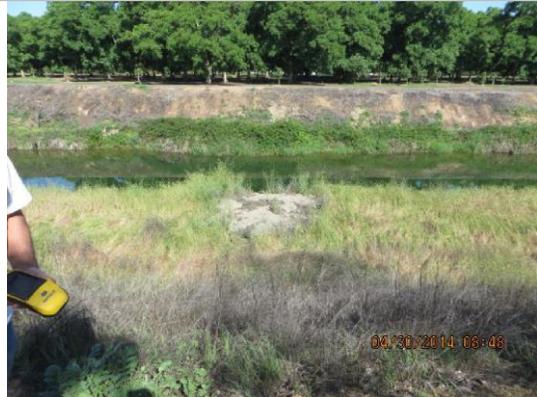
Photo 1 of 3 : UCIP\_FA\_2015\_3681.jpg

LM Start	<b>5.48</b>	Rating **	M	Issue No.	<b>820</b>
LM End	<b>5.48</b>	Issue Type +	En	Location *	WS
Category	Supplemental			GPS Latitude/Longitude	
				Start	End
Item	DWR UCIP Field Study			37.996132 °	37.996132 °
				-121.079127 °	-121.079127 °
DWR ID					
Action/Comments					
Inspector Comments: FS_ID:35686 DS_ID:23332 EP_NO: N/A FS_HLM: 5.662 Repair Type: Non-Urgent Crossing Status: Found UCIP Comments: Pipe appears abandoned and if so should be done so properly. LS of pipe is burried and WS is badly rusted. Pipe should be inspected internally. FIELD_STRUCT_DESC: 18-inch CMP drainpipe through the levee 3.0 feet below the crown. Grout over pipe in channel, with pipe open and visible in water at WS toe. O&M Manual SJR 611.1 Vol. F. FS Date: 04/30/2014

Grout over pipe in channel on WS.

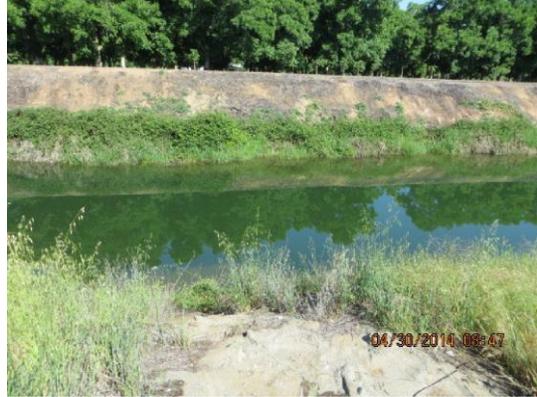
Photo 2 of 3 : UCIP\_FA\_2015\_3682.jpg

Grout over pipe in channel on WS.

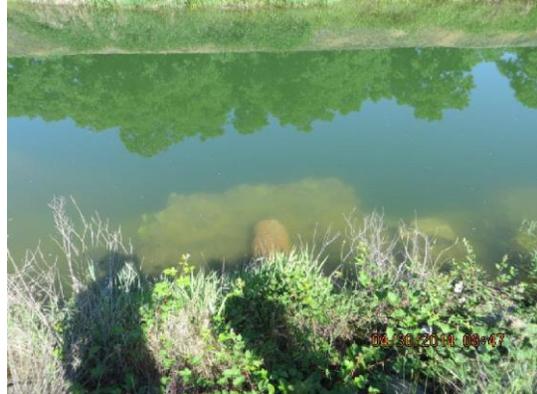
Photo 3 of 3 : UCIP\_FA\_2015\_3683.jpg

Pipe visible in water at WS toe.

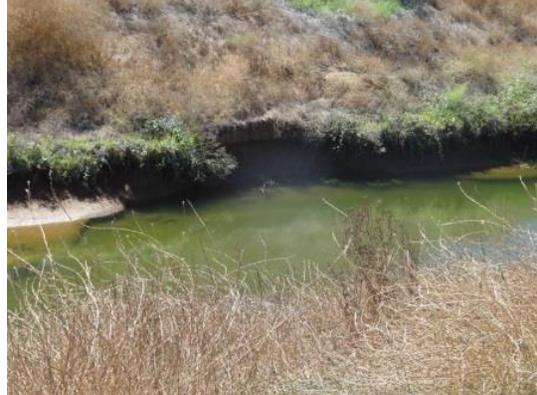
Photo 1 of 3 : SJR2015\_NA0017U16RM17.27\_2.JPG

LM Start	<b>5.56</b>	Rating **	U	Issue No.	<b>40</b>
LM End	<b>5.58</b>	Issue Type +	Ma	Location *	WS
Category	Supplemental			GPS Latitude/Longitude	
				Start	End
Item	DWR Erosion Survey			37.995216 °	37.995216 °
				-121.080159 °	-121.080159 °
DWR ID					
<b>Action/Comments</b>					
Inspector Comments: 8/12/2015: No significant change observed. 8/20/2014: No significant change observed. 9/12/2013: The erosion seems to be caused by high river flow. Dense vegetation is present at the site. Signs of animal activities are visible. There is no levee structure on site. The levee crest width and levee height were not measured or estimated in the field. [2015 Site

Close view of the erosion.

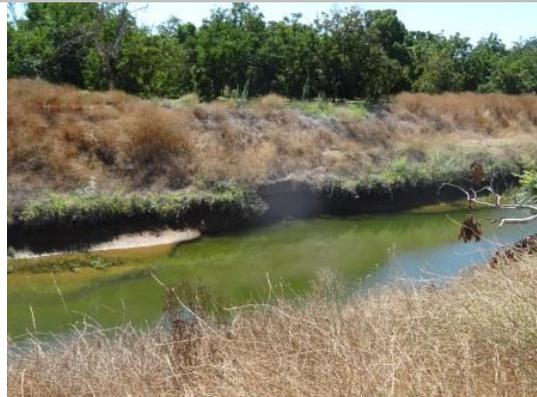
Photo 2 of 3 : SJR2015\_NA0017U16RM17.27\_4.JPG

View from the right river bank.

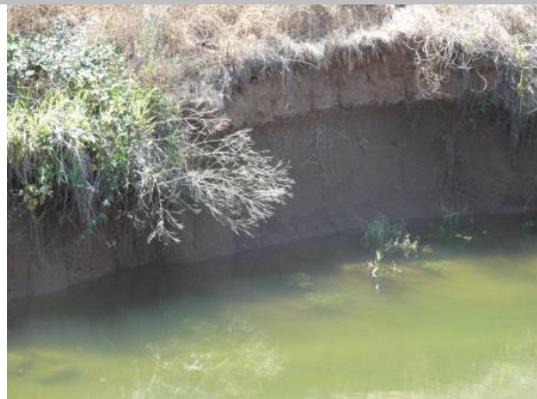
Photo 3 of 3 : SJR2015\_NA0017U16RM17.27\_6.JPG

Close view of the erosion.

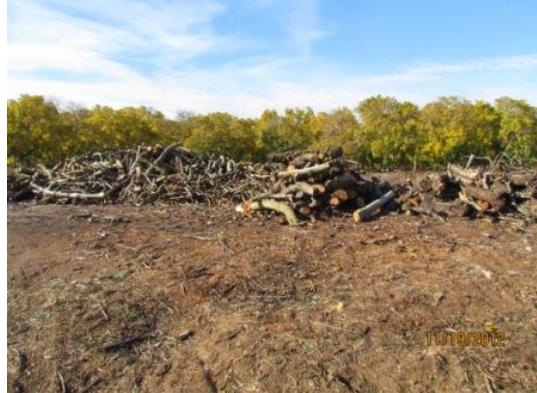
Photo 1 of 1 : FA\_2015\_NA0017\_160\_56\_20150911\_00027.jpg

LM Start	<b>5.64</b>	Rating **	M	Issue No.	<b>56</b>
LM End	<b>5.64</b>	Issue Type +	En	Location *	WS
Category	Earthen Levee		GPS Latitude/Longitude		
			Start	End	
Item	Encroachments		37.994268 °	37.994268 °	
			-121.080850 °	-121.080850 °	
DWR ID	DWR_NA0017_16_s_2012_56				
Action/Comments					
Prunings Inspector Comments: Burn pile has been burned but new material has been placed.

Prunings were found on the waterside shoulder of the levee looking upstream.

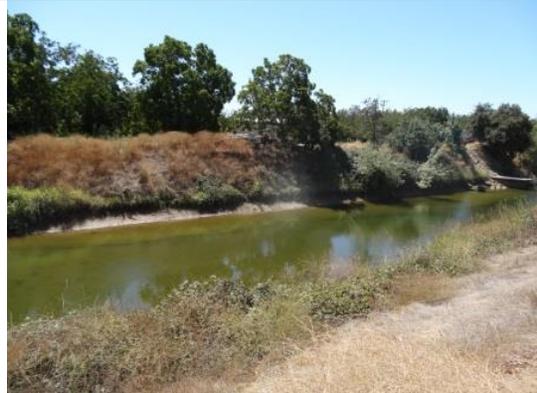
Photo 1 of 2 : SJR2015\_NA0017U16RM17.11\_1.JPG

LM Start	<b>5.71</b>	Rating **	M	Issue No.	<b>39</b>
LM End	<b>5.72</b>	Issue Type +	Ma	Location *	WS
Category	Supplemental		GPS Latitude/Longitude		
			Start	End	
Item	DWR Erosion Survey		37.993525 °	37.993525 °	
			-121.081679 °	-121.081679 °	
DWR ID					
Action/Comments					
Inspector Comments: 8/12/2015: No significant change observed. 8/20/2014: The erosion is near a tree and probably has been made worse by the unstable bank slope. [2015 Site ID:NA0017U16RM17.11]

View of the site from the right river bank.

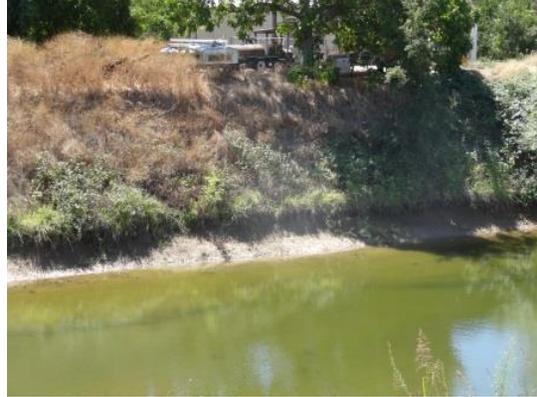
Photo 2 of 2 : SJR2015\_NA0017U16RM17.11\_2.JPG

LM Start	<b>5.71</b>	Rating **	M	Issue No.	<b>39 (cont)</b>
LM End	<b>5.72</b>	Issue Type +	Ma	Location *	WS
Category	Supplemental			GPS Latitude/Longitude	
				Start	End
Item	DWR Erosion Survey			37.993525 °	37.993525 °
				-121.081679 °	-121.081679 °
DWR ID					
Action/Comments					
Inspector Comments: 8/12/2015: No significant change observed. 8/20/2014: The erosion is near a tree and probably has been made worse by the unstable bank slope. [2015 Site ID:NA0017U16RM17.11]

Close view of the erosion.

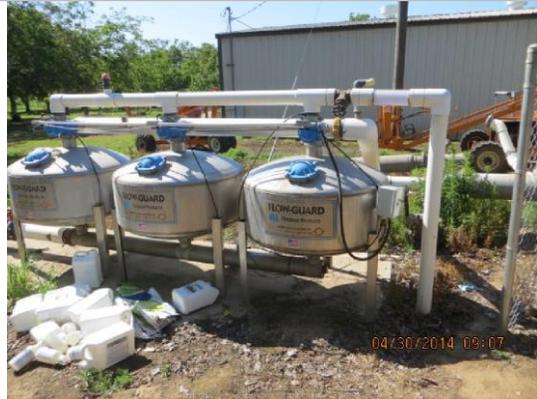
Photo 1 of 3 : UCIP\_FA\_2015\_6115.jpg

LM Start	<b>5.74</b>	Rating **	M	Issue No.	<b>821</b>
LM End	<b>5.74</b>	Issue Type +	En	Location *	WS
Category	Supplemental			GPS Latitude/Longitude	
				Start	End
Item	DWR UCIP Field Study			37.993146 °	37.993146 °
				-121.081870 °	-121.081870 °
DWR ID					
Action/Comments					
Inspector Comments: FS_ID:39048 DS_ID:24946 EP_NO: N/A FS_HLM: 5.92 Repair Type: Non-Urgent Crossing Status: Found UCIP Comments: Pipe causing erosion on WS slope. Damaged concealed by berries on slope. FIELD_STRUCT_DESC: 6-inch PVC drain pipe through the levee 3-feet below the crown. Backwash from sandfilter plant on LS shoulder. Pipe visible on WS slope. FS Date: 04/30/2014

Pipe and filter plant on LS shoulder.

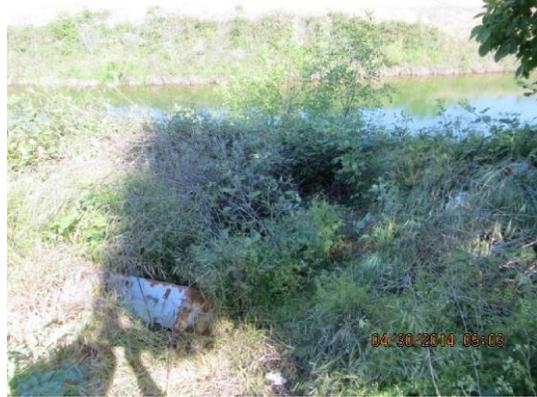
Photo 2 of 3 : UCIP\_FA\_2015\_6116.jpg

Pipe in briar on WS slope. Beware of deep erosion on slope.

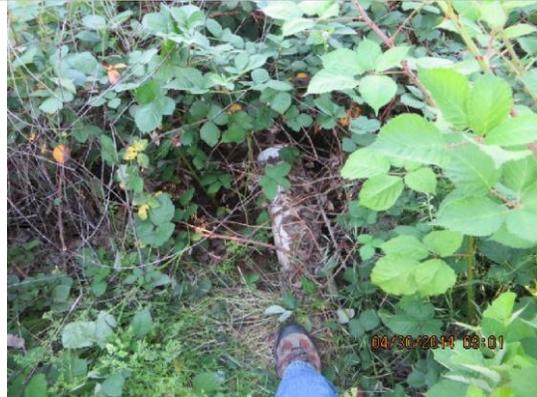
Photo 3 of 3 : UCIP\_FA\_2015\_6117.jpg

Pipe at outlet in briars on WS shoulder. Heavy erosion at outlet on WS slope.

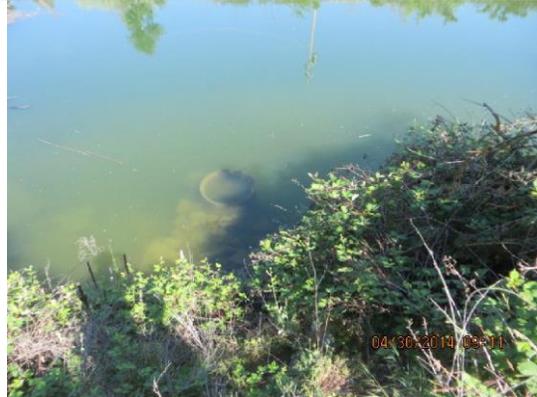
Photo 1 of 3 : UCIP\_FA\_2015\_3684.jpg

LM Start	<b>5.74</b>	Rating **	M	Issue No.	<b>822</b>
LM End	<b>5.74</b>	Issue Type +	En	Location *	WS
Category	Supplemental			GPS Latitude/Longitude	
				Start	End
Item	DWR UCIP Field Study			37.993163 °	37.993163 °
				-121.081926 °	-121.081926 °
DWR ID					
Action/Comments					
Inspector Comments: FS_ID:35687 DS_ID:23333 EP_NO: N/A FS_HLM: 5.927 Repair Type: Non-Urgent Crossing Status: Found

Intake structure in water at WS toe.

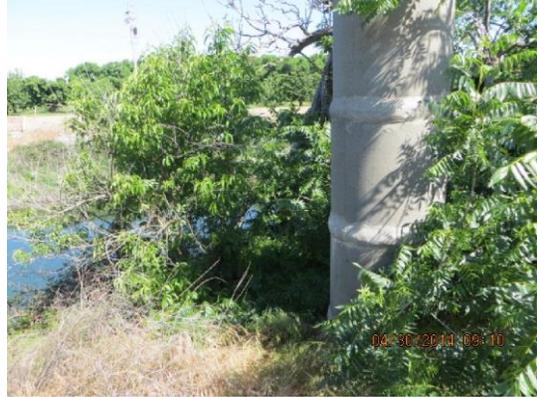
Photo 3 of 3 : UCIP\_FA\_2015\_3719.jpg

Concrete standpipe and slant pump on WS slope.

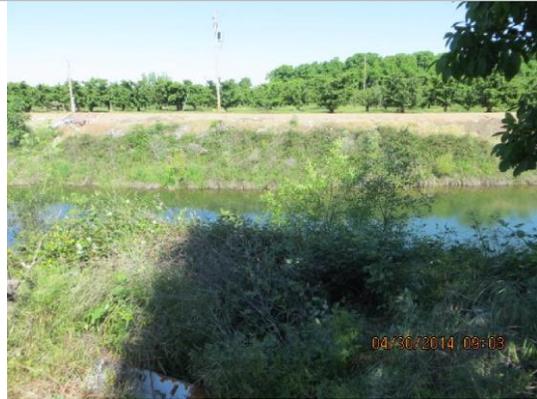
Photo 1 of 2 : UCIP\_FA\_2015\_6118.jpg

LM Start	<b>5.74</b>	Rating **	M	Issue No.	<b>823</b>
LM End	<b>5.74</b>	Issue Type +	En	Location *	WS
Category	Supplemental			GPS Latitude/Longitude	
				Start	End
Item	DWR UCIP Field Study			37.993136 °	37.993136 °
				-121.081890 °	-121.081890 °
DWR ID					
Action/Comments					
Inspector Comments: FS_ID:39049 DS_ID:24947 EP_NO: N/A FS_HLM: 5.926 Repair Type: Non-Urgent Crossing Status: Found UCIP Comments: Severe erosion on WS slope. Damage obscured by berries on WS slope. FIELD_STRUCT_DESC: 8-inch PVC drain pipe through the levee 3-feet below the crown. 8-inch standpipe in front of 36-inch concrete riser on LS shulder. FS Date: 04/30/2014

Pipe visible in briars on WS shoulder.

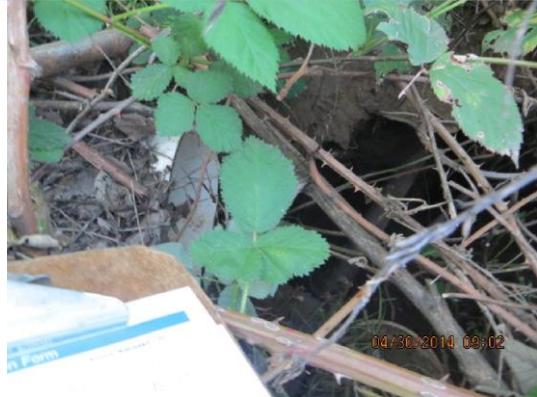
Photo 2 of 2 : UCIP\_FA\_2015\_6119.jpg

Pipe visible in briars on WS shoulder.

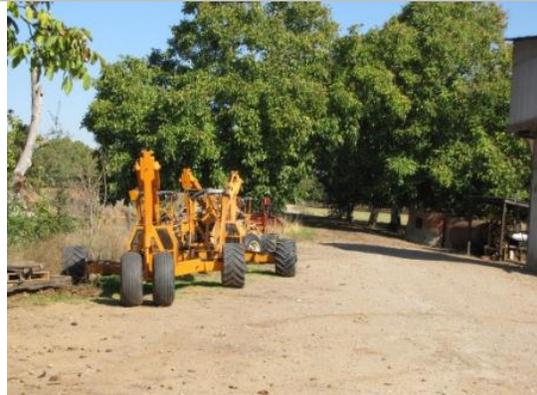
Photo 1 of 1 : FA\_2015\_NA0017\_160\_172\_20150911\_00103.jpg

LM Start	<b>5.75</b>	Rating **	M	Issue No.	<b>172</b>
LM End	<b>5.75</b>	Issue Type +	Ma	Location *	WS
Category	Earthen Levee			GPS Latitude/Longitude	
				Start	End
Item	Encroachments			37.993108 °	37.993108 °
				-121.082033 °	-121.082033 °
DWR ID	DWR_NA0017_16_s_2012_172				
Action/Comments					
Equipment

View of equipment located on the waterward side looking upstream.

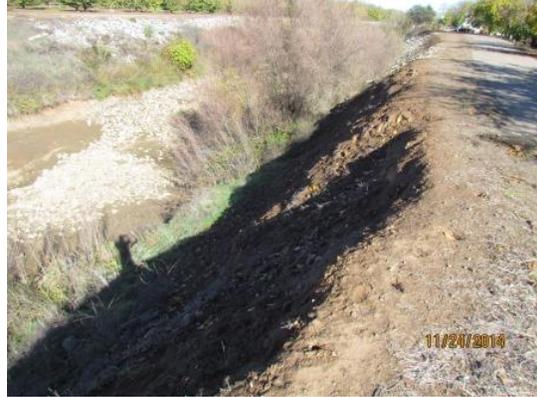
Photo 1 of 1 : FA\_2015\_NA0017\_160\_264\_20150911\_00149.jpg

A slope instability was found on the waterside of the levee looking upstream.

LM Start	<b>5.87</b>	Rating **	M	Issue No.	<b>264</b>
LM End	<b>5.87</b>	Issue Type +	Ma	Location *	WS
Category	Earthen Levee			GPS Latitude/Longitude	
				Start	End
Item	Slope Stability			37.991628 °	37.991628 °
				-121.083312 °	-121.083312 °
DWR ID	DWR_NA0017_16_f_2014_264				
Action/Comments					
Repair slope instability.

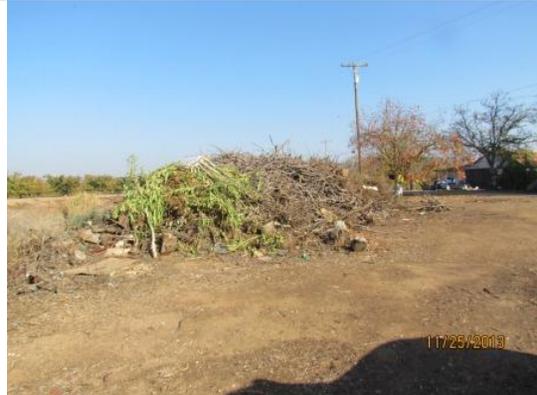
Photo 1 of 2 : FA\_2015\_NA0017\_160\_59\_20150911\_00028.jpg

LM Start	<b>6.12</b>	Rating **	M	Issue No.	<b>59</b>
LM End	<b>6.12</b>	Issue Type +	En	Location *	WS
Category	Earthen Levee			GPS Latitude/Longitude	
				Start	End
Item	Encroachments			37.988708 °	37.988708 °
				-121.085845 °	-121.085845 °
DWR ID	DWR_NA0017_16_s_2012_59				
Action/Comments					
Prunings

View of the prunings pile on the waterside shoulder of the levee looking upstream during fall 2013 inspection.

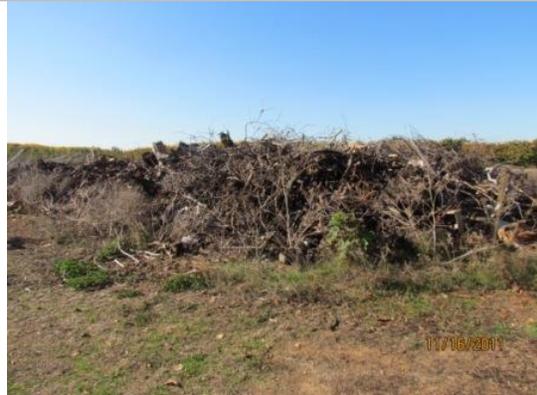
Photo 2 of 2 : FA\_2015\_NA0017\_160\_59\_20150911\_00029.jpg

Prunings were found on the waterside of the levee looking upstream. This picture was taken during fall 2011 inspection.

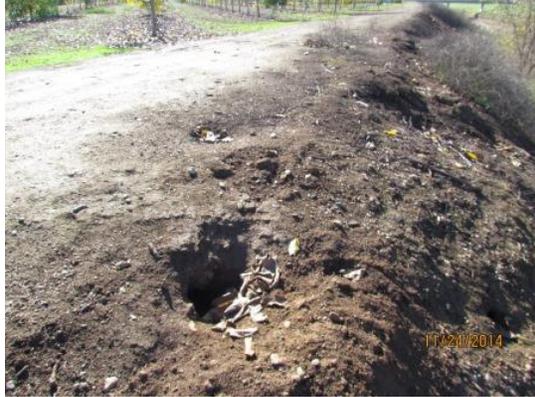
Photo 1 of 2 : FA\_2015\_NA0017\_160\_170\_20150911\_00100.jpg

Updated picture of the rodent holes on the waterside shoulder of the levee looking downstream.

LM Start	<b>6.15</b>	Rating **	M	Issue No.	<b>170</b>
LM End	<b>6.15</b>	Issue Type +	Ma	Location *	WS
Category	Earthen Levee			GPS Latitude/Longitude	
				Start	End
Item	Animal Control			37.988385 °	37.988385 °
				-121.086292 °	-121.086292 °
DWR ID	DWR_NA0017_16_s_2012_170				
Action/Comments					
No rodents visible, but rodent burrows visible; need to backfill and compact or grout burrows.

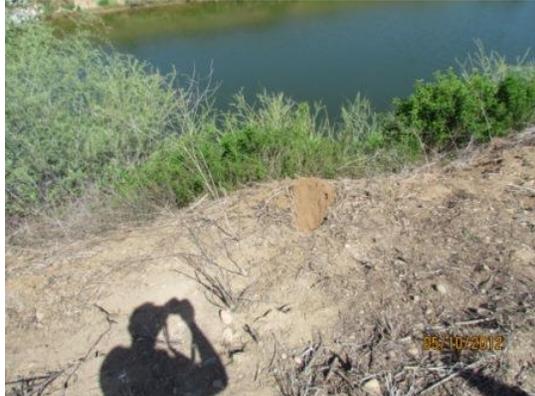
Photo 2 of 2 : FA\_2015\_NA0017\_160\_170\_20150911\_00101.jpg

An animal hole was found on the waterside of the levee looking upstream.

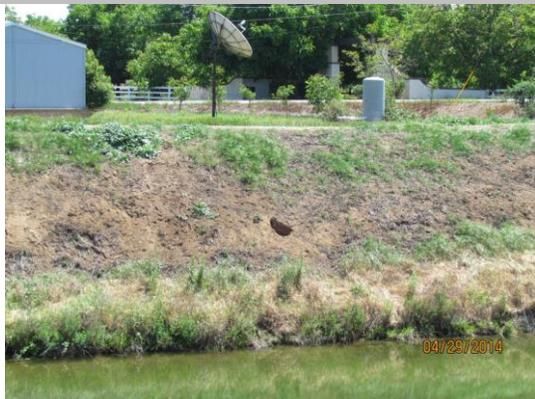
Photo 1 of 1 : FA\_2015\_NA0017\_160\_50\_20150911\_00024.jpg

View of a rodent hole on the waterside slope of the levee. The picture was taken from the opposite side of the levee.

LM Start	<b>6.24</b>	Rating **	M	Issue No.	<b>50</b>
LM End	<b>6.24</b>	Issue Type +	Ma	Location *	WS
Category	Earthen Levee			GPS Latitude/Longitude	
				Start	End
Item	Animal Control			37.987303 °	37.987303 °
				-121.087292 °	-121.087292 °
DWR ID	DWR_NA0017_16_s_2014_50				
Action/Comments					
No rodents visible, but rodent burrows visible; need to backfill and compact or grout burrows.

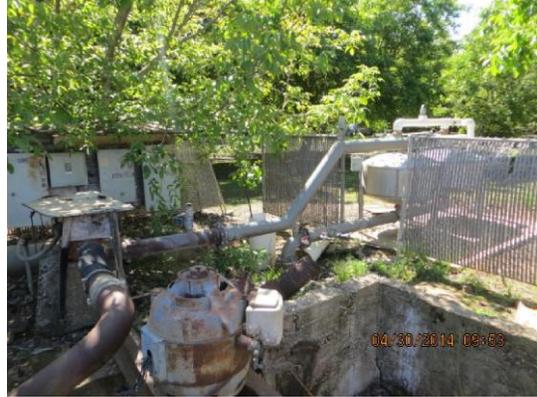
Photo 1 of 3 : UCIP\_FA\_2015\_3720.jpg

LM Start	<b>6.32</b>	Rating **	M	Issue No.	<b>824</b>
LM End	<b>6.32</b>	Issue Type +	En	Location *	WS
Category	Supplemental			GPS Latitude/Longitude	
				Start	End
Item	DWR UCIP Field Study			37.986326 °	37.986326 °
				-121.087901 °	-121.087901 °
DWR ID					
Action/Comments					
Inspector Comments: FS_ID:35690 DS_ID:23504 EP_NO: N/A FS_HLM: 6.521 Repair Type: Non-Urgent Crossing Status: Indicator Found UCIP Comments: Appears abandoned and if so should be verified as having been done so properly. FIELD_STRUCT_DESC: 2 of 2: 12-inch concrete siphon pipe 3.0 feet below the roadway and under the channel. Abandoned pump over concrete sump inside fenced in facility on LS shoulder likely indicator of pipe location. FS Date: 04/30/2014

Abandoned pump and sump inside fenced in area on LS of roadway.

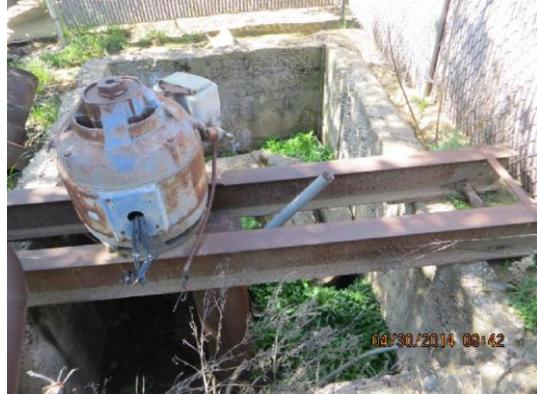
Photo 2 of 3 : UCIP\_FA\_2015\_3791.jpg

Abandoned pump and sump inside fenced in area on LS of roadway.

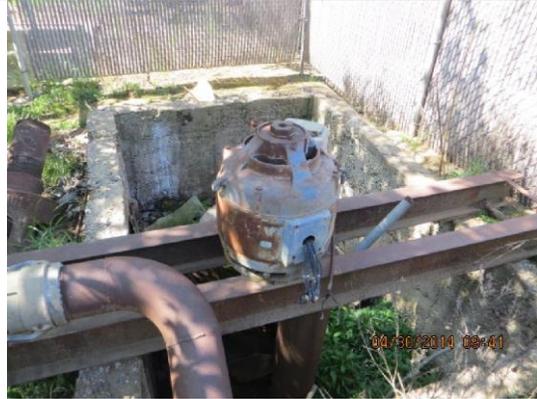
Photo 3 of 3 : UCIP\_FA\_2015\_3792.jpg

Abandoned pump and sump inside fenced in area on LS of roadway.

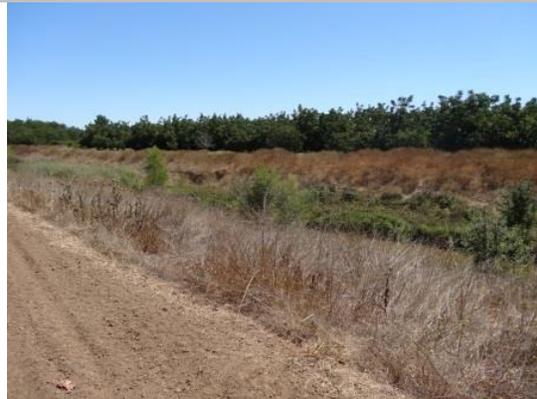
Photo 1 of 3 : SJR2015\_NA0017U16RM16.27\_1.jpg

LM Start	<b>6.49</b>	Rating **	U	Issue No.	<b>38</b>
LM End	<b>6.68</b>	Issue Type +	Ma	Location *	WS
Category	Supplemental			GPS Latitude/Longitude	
				Start	End
Item	DWR Erosion Survey			37.983279 °	37.983279 °
				-121.090843 °	-121.090843 °
DWR ID					
Action/Comments					
Inspector Comments: 8/12/2015: No significant change observed. 8/20/2014: No significant change observed. 9/12/2013: Site has been surveyed and the erosion has worsened since last year. 08/22/2012: Discontinuous scarp or pocket erosions occurred along a long stretch of the river, with an erosion height greater than 25 ft. at certain points. There is no levee structure on site. The levee crest width and levee height were not measured or estimated in the field. [2015 Site ID:NA0017U16RM16.27]

Downstream view of the site from the right river bank.

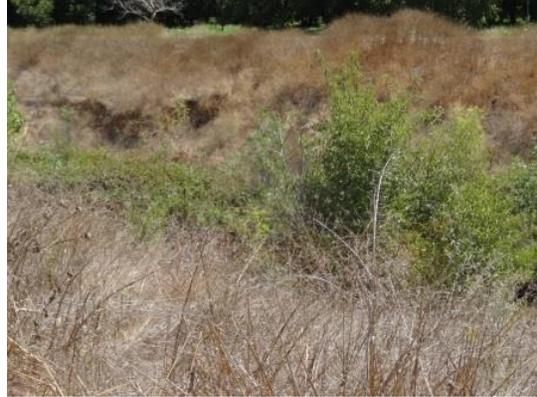
Photo 2 of 3 : SJR2015\_NA0017U16RM16.27\_2.jpg

Closer view of the erosion.

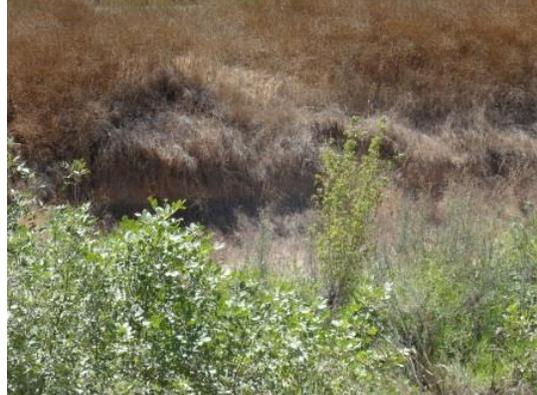
Photo 3 of 3 : SJR2015\_NA0017U16RM16.27\_7.jpg

Close view of the erosion.

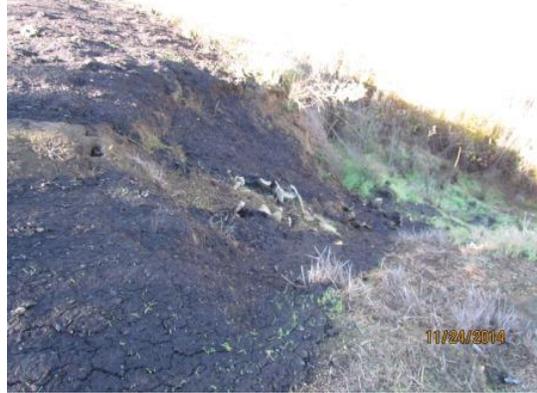
Photo 1 of 2 : FA\_2015\_NA0017\_160\_120\_20150911\_00063.jpg

LM Start	<b>6.70</b>	Rating **	M	Issue No.	<b>120</b>
LM End	<b>6.70</b>	Issue Type +	Ma	Location *	WS
Category	Earthen Levee		GPS Latitude/Longitude		
			Start	End	
Item	Slope Stability		37.982299 °	37.982299 °	
			-121.092665 °	-121.092665 °	
DWR ID	DWR_NA0017_16_s_2014_120				
Action/Comments					
Repair slope instability.

Updated picture of the slope instability on the waterside of the levee looking downstream.

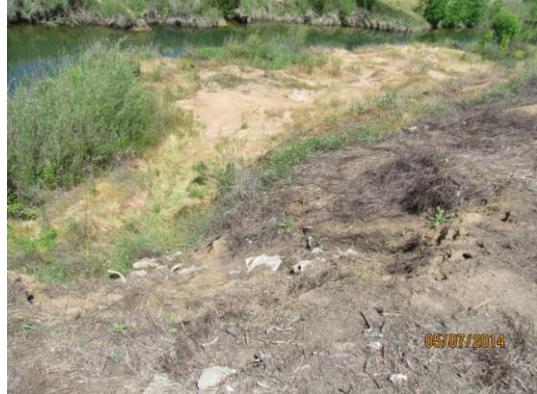
Photo 2 of 2 : FA\_2015\_NA0017\_160\_120\_20150911\_00064.jpg

LM Start	<b>6.70</b>	Rating **	M	Issue No.	<b>120 (cont)</b>
LM End	<b>6.70</b>	Issue Type +	Ma	Location *	WS

Slope instability was found on the waterside of the levee looking upstream.

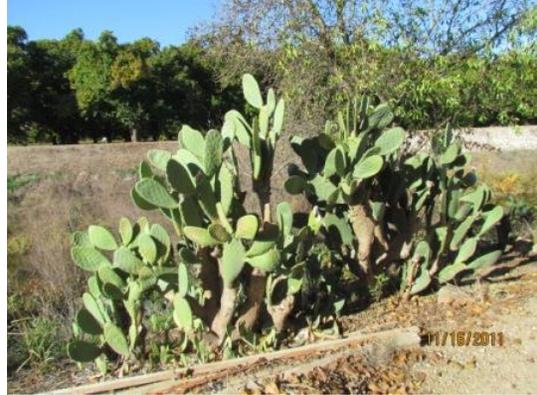
Photo 1 of 1 : FA\_2015\_NA0017\_160\_60\_20150911\_00030.jpg

LM Start	<b>7.01</b>	Rating **	M	Issue No.	<b>60</b>
LM End	<b>7.01</b>	Issue Type +	En	Location *	WS
Category	Earthen Levee			GPS Latitude/Longitude	
				Start	End
Item	Vegetation			°	°
				°	°
DWR ID	DWR_NA0017_16_s_2012_60				
Action/Comments					
Landscaping

Cacti were found on the waterside of the levee looking upstream.

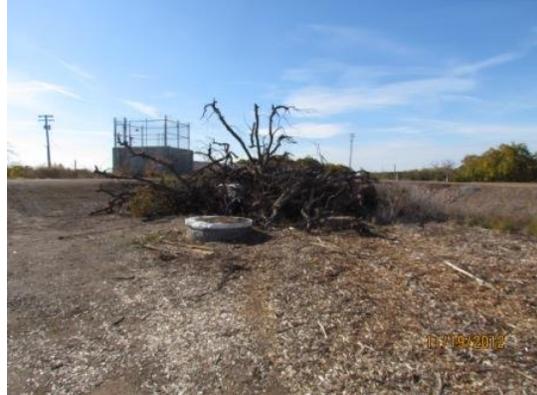
Photo 1 of 1 : FA\_2015\_NA0017\_160\_167\_20150911\_00097.jpg

LM Start	<b>7.08</b>	Rating **	M	Issue No.	<b>167</b>
LM End	<b>7.08</b>	Issue Type +	En	Location *	WS
Category	Earthen Levee			GPS Latitude/Longitude	
				Start	End
Item	Encroachments			37.979642 °	37.979642 °
				-121.098161 °	-121.098161 °
DWR ID	DWR_NA0017_16_s_2012_167				
Action/Comments					
Prunings

Prunings were found on the waterside shoulder of the levee looking downstream.

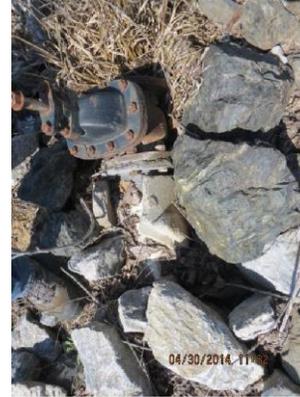
Photo 1 of 3 : UCIP\_FA\_2015\_4051.jpg

LM Start	<b>7.15</b>	Rating **	M	Issue No.	<b>825</b>
LM End	<b>7.15</b>	Issue Type +	En	Location *	WS
Category	Supplemental			GPS Latitude/Longitude	
				Start	End
Item	DWR UCIP Field Study			37.979000 °	37.979000 °
				-121.099088 °	-121.099088 °
DWR ID					
Action/Comments					
Inspector Comments: FS_ID:35765 DS_ID:23338 EP_NO: N/A FS_HLM: 7.354 Repair Type: Non-Urgent Crossing Status: Found UCIP Comments: Pipe appears abandoned and if so should be done so properly. FIELD_STRUCT_DESC: 6-inch PVC irrigation pipe sleeved through a 10-inch steel pipe 2.5 feet below the roadway. Pump missing from concrete base on the waterward slope. 36-inch and 12-inch concrete standpipes on the landward side. 1-inch Electrical conduit below the roadway. O&M Manual SJR 611.1 Vol. F. FS Date: 04/30/2014

Gate valve on WS slope

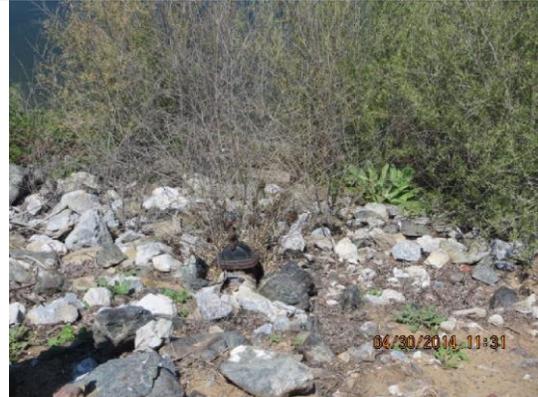
Photo 2 of 3 : UCIP\_FA\_2015\_4052.jpg

LM Start	<b>7.15</b>	Rating **	M	Issue No.	<b>825 (cont)</b>
LM End	<b>7.15</b>	Issue Type +	En	Location *	WS

Gate valve on WS slope

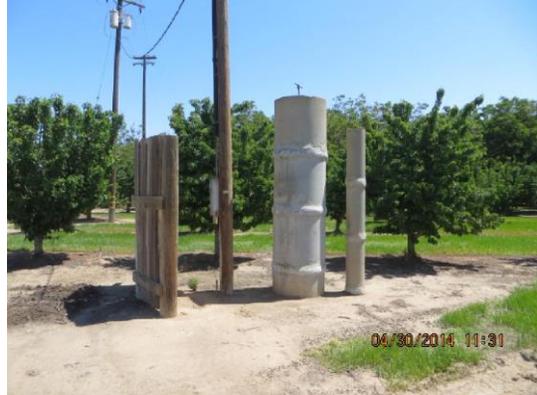
Photo 3 of 3 : UCIP\_FA\_2015\_4053.jpg

LM Start	<b>7.15</b>	Rating **	M	Issue No.	<b>825 (cont)</b>
LM End	<b>7.15</b>	Issue Type +	En	Location *	WS
Category	Supplemental			GPS Latitude/Longitude	
				Start	End
Item	DWR UCIP Field Study			37.979000 °	37.979000 °
				-121.099088 °	-121.099088 °
DWR ID					
Action/Comments					
Inspector Comments: FS_ID:35765 DS_ID:23338 EP_NO: N/A FS_HLM: 7.354 Repair Type: Non-Urgent Crossing Status: Found

Concrete standpipes, pole, and electrical panel on LS shoulder.

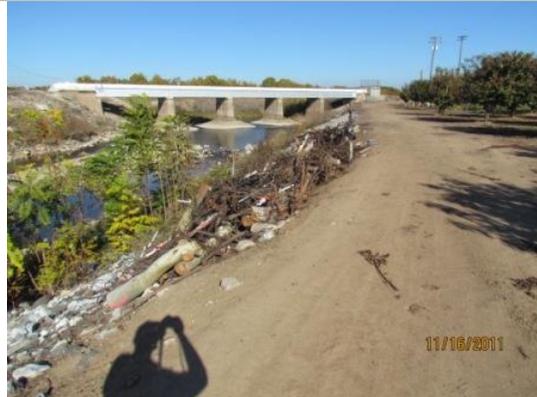
Photo 1 of 1 : FA\_2015\_NA0017\_160\_61\_20150911\_00031.jpg

LM Start	<b>7.16</b>	Rating **	M	Issue No.	<b>61</b>
LM End	<b>7.16</b>	Issue Type +	Ma	Location *	WS
Category	Earthen Levee			GPS Latitude/Longitude	
				Start	End
Item	Encroachments			37.978850 °	37.978850 °
				-121.099325 °	-121.099325 °
DWR ID	DWR_NA0017_16_s_2012_61				
Action/Comments					
Debris Inspector Comments: Farmer has burned the material, but some new material has been placed. Farmer has been told to not put any material at this location in the future.

Debris and prunings were found on the waterside of the levee looking upstream.

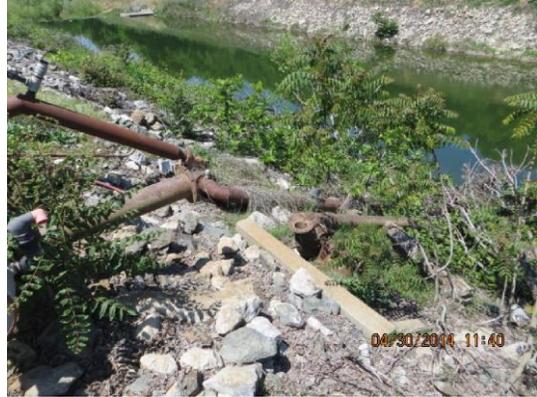
Photo 1 of 3 : UCIP\_FA\_2015\_3139.jpg

Inspector Comments: FS\_ID:35768  
 DS\_ID:23339  
 EP\_NO: N/A  
 FS\_HLM: 7.443  
 Repair Type: Non-Urgent  
 Crossing Status: Found  
 UCIP Comments: Pipe open on WS end. Appears abandoned and if so, should be done so properly.  
 FIELD\_STRUCT\_DESC: 8-inch steel irrigation pipe 3-feet below the roadway. Pipe disconnected from pump mounted on concrete base on the waterward slope. 30-inch concrete standpipe on the landward side. Electrical conduit below the roadway. O&M Manual SJR 611.1 Vol. F. FS Date: 04/30/2014

Pipe not connected to abandoned pump on WS slope.

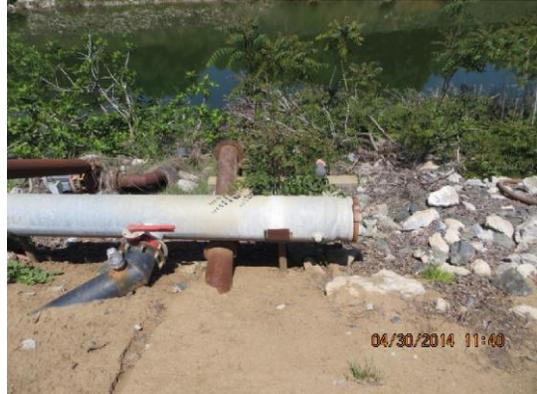
Photo 2 of 3 : UCIP\_FA\_2015\_3140.jpg

pipe abandoned and open on WS slope.

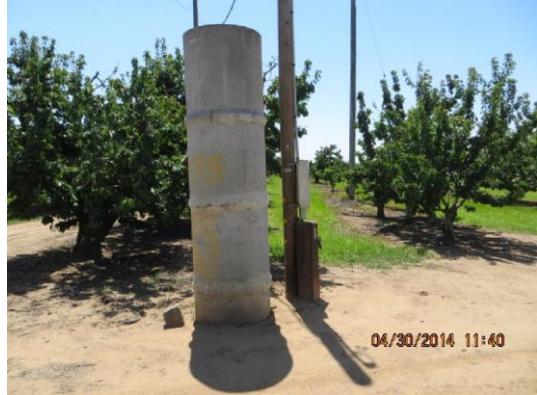
Photo 3 of 3 : UCIP\_FA\_2015\_3141.jpg

LM Start	<b>7.23</b>	Rating **	M	Issue No.	<b>826 (cont)</b>
LM End	<b>7.23</b>	Issue Type +	En	Location *	WS
Category	Supplemental			GPS Latitude/Longitude	
				Start	End
Item	DWR UCIP Field Study			37.978396 °	37.978396 °
				-121.100466 °	-121.100466 °
DWR ID					
Action/Comments					
Inspector Comments: FS_ID:35768 DS_ID:23339 EP_NO: N/A FS_HLM: 7.443 Repair Type: Non-Urgent Crossing Status: Found

Power pole, electrical panel, and concrete standpipe on LS shoulder.

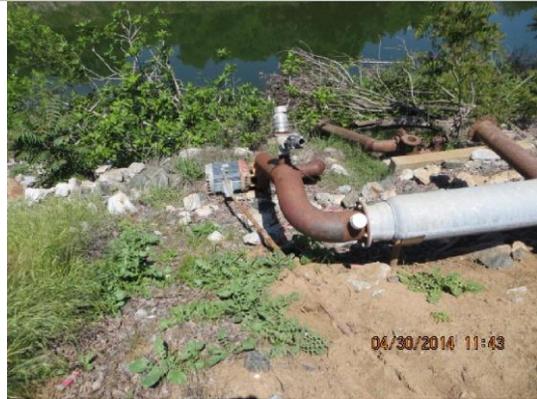
Photo 1 of 2 : UCIP\_FA\_2015\_5768.jpg

LM Start	<b>7.24</b>	Rating **	M	Issue No.	<b>827</b>
LM End	<b>7.24</b>	Issue Type +	En	Location *	WS
Category	Supplemental			GPS Latitude/Longitude	
				Start	End
Item	DWR UCIP Field Study			37.978375 °	37.978375 °
				-121.100541 °	-121.100541 °
DWR ID					
Action/Comments					
Inspector Comments: FS_ID:41681 DS_ID:24951 EP_NO: N/A FS_HLM: 7.448 Repair Type: Non-Urgent Crossing Status: Found UCIP Comments: No permit identified for crossing. FIELD_STRUCT_DESC: 10-inch steel irrigation pipe through the levee 2-feet below the crown. Butterfly valve on WS with pump and vent. FS Date: 04/30/2014

Pump, vent, and filter on WS slope.

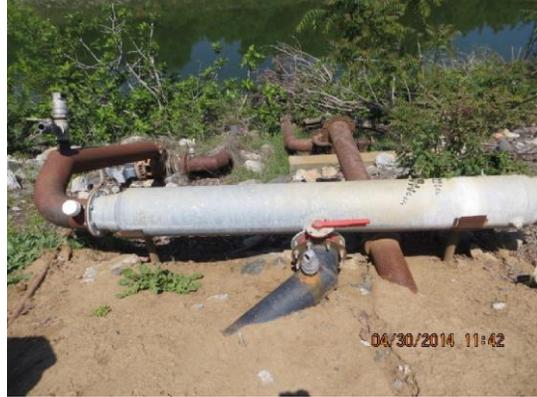
Photo 2 of 2 : UCIP\_FA\_2015\_5769.jpg

LM Start	<b>7.24</b>	Rating **	M	Issue No.	<b>827 (cont)</b>
LM End	<b>7.24</b>	Issue Type +	En	Location *	WS
Category	Supplemental			GPS Latitude/Longitude	
				Start	End
Item	DWR UCIP Field Study			37.978375 °	37.978375 °
				-121.100541 °	-121.100541 °
DWR ID					
Action/Comments					
Inspector Comments: FS_ID:41681 DS_ID:24951 EP_NO: N/A FS_HLM: 7.448 Repair Type: Non-Urgent Crossing Status: Found UCIP Comments: No permit identified for crossing. FIELD_STRUCT_DESC: 10-inch steel irrigation pipe through the levee 2-feet below the crown. Butterfly valve on WS with pump and vent. FS Date: 04/30/2014

Pipe, vent, butterfly valve, filter, and pump on WS slope.

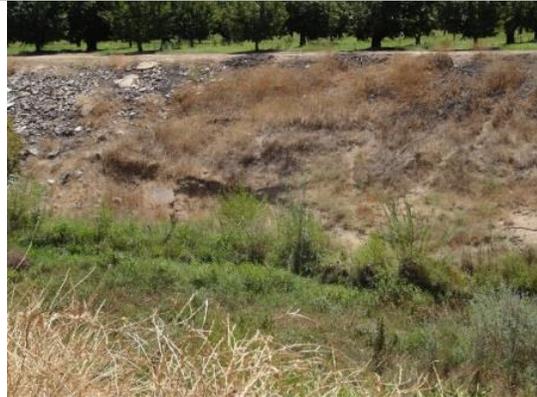
Photo 1 of 2 : SJR2015\_NA0017U16RM15.57\_3.JPG

LM Start	<b>7.27</b>	Rating **	U	Issue No.	<b>37</b>
LM End	<b>7.33</b>	Issue Type +	Ma	Location *	WS
Category	Supplemental			GPS Latitude/Longitude	
				Start	End
Item	DWR Erosion Survey			37.978194 °	37.978194 °
				-121.101696 °	-121.101696 °
DWR ID					
Action/Comments					
Inspector Comments: 8/12/2015: No significant change observed. 8/20/2014: No significant change observed. Note the site ID changed from NA0017U16RM10.82 to NA0017U16RM15.57 to reflect the correct river mile. 09/12/2013: The site is located at immediately downstream of a levee segment protected by broken concrete. There is no levee structure on site. The levee crest width and levee height were not measured or estimated in the field. [2015 Site ID:NA0017U16RM15.57]

Close view of the erosion.
