**Flood Control Project Maintenance  
Levee Inspections**

**Fall 2015 Levee Maintenance Deficiency Summary Report**

**San Joaquin River Basin**

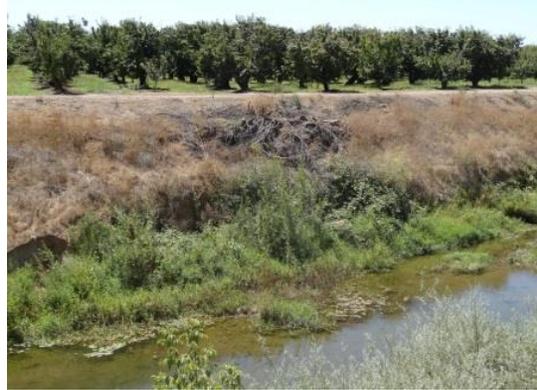
Photo 2 of 2 : SJR2015\_NA0017U16RM15.57\_5.JPG

LM Start	<b>7.27</b>	Rating **	U	Issue No.	<b>37 (cont)</b>
LM End	<b>7.33</b>	Issue Type +	Ma	Location *	WS
Category	Supplemental			GPS Latitude/Longitude	
				Start	End
Item	DWR Erosion Survey			37.978194 °	37.978194 °
				-121.101696 °	-121.101696 °
DWR ID					
Action/Comments					
Inspector Comments: 8/12/2015: No significant change observed. 8/20/2014: No significant change observed. Note the site ID changed from NA0017U16RM10.82 to NA0017U16RM15.57 to reflect the correct river mile. 09/12/2013: The site is located at immediately downstream of a levee segment protected by broken concrete. There is no levee structure on site. The levee crest width and levee height were not measured or estimated in the field. [2015 Site ID:NA0017U16RM15.57]

Close view of the erosion.

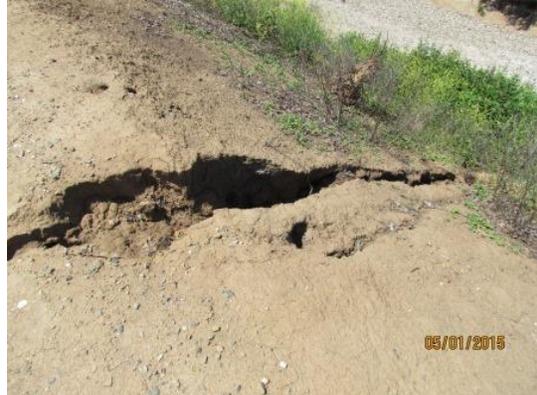
Photo 1 of 1 : FA\_2015\_NA0017\_160\_246\_20150911\_00143.jpg

LM Start	<b>7.39</b>	Rating **	M	Issue No.	<b>246</b>
LM End	<b>7.39</b>	Issue Type +	Ma	Location *	WS
Category	Earthen Levee			GPS Latitude/Longitude	
				Start	End
Item	Erosion / Bank Caving			37.977610 °	37.977610 °
				-121.103159 °	-121.103159 °
DWR ID	DWR_NA0017_16_s_2015_246				
Action/Comments					
Note and monitor erosion site.

Erosion was found on the waterside shoulder of the levee looking downstream.

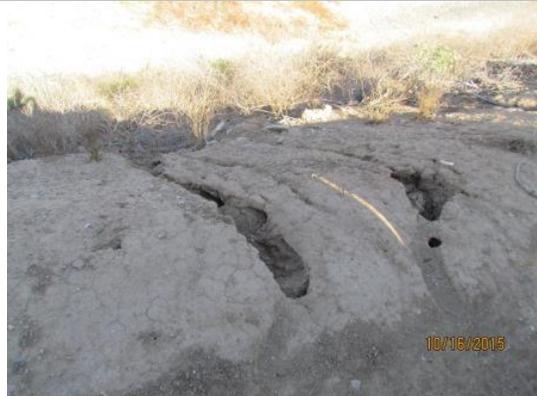
Photo 1 of 1 : FA\_2015\_NA0017\_160\_237\_20151023\_00166.jpg

LM Start	<b>7.42</b>	Rating **	M	Issue No.	<b>237</b>
LM End	<b>7.42</b>	Issue Type +	Ma	Location *	WS
Category	Earthen Levee			GPS Latitude/Longitude	
				Start	End
Item	Erosion / Bank Caving			37.977421 °	37.977421 °
				-121.103507 °	-121.103507 °
DWR ID	DWR_NA0017_16_f_2015_237				
Action/Comments					
Schedule repair of erosion site prior to the next inspection.

Erosion caused by runoff was found on the waterside shoulder of the levee.

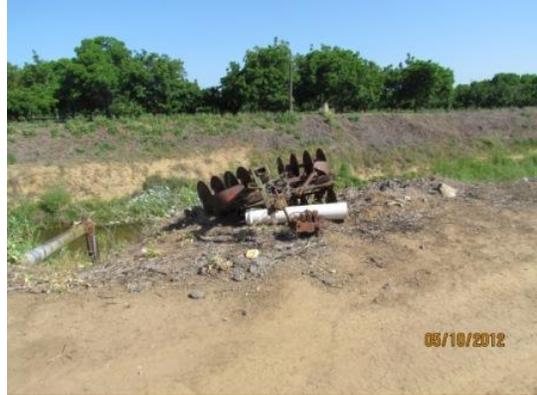
Photo 1 of 1 : FA\_2015\_NA0017\_160\_162\_20150911\_00092.jpg

LM Start	<b>7.47</b>	Rating **	M	Issue No.	<b>162</b>
LM End	<b>7.47</b>	Issue Type +	En	Location *	WS
Category	Earthen Levee			GPS Latitude/Longitude	
				Start	End
Item	Encroachments			37.977000 °	37.977000 °
				-121.104234 °	-121.104234 °
DWR ID	DWR_NA0017_16_s_2012_162				
Action/Comments					
Equipment

Equipment was found on the waterside of the levee looking upstream.

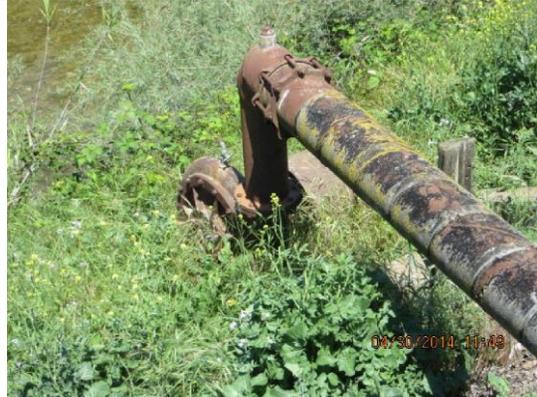
Photo 1 of 2 : UCIP\_FA\_2015\_3142.jpg

LM Start	<b>7.47</b>	Rating **	M	Issue No.	<b>828</b>
LM End	<b>7.47</b>	Issue Type +	En	Location *	WS
Category	Supplemental			GPS Latitude/Longitude	
				Start	End
Item	DWR UCIP Field Study			37.976975 °	37.976975 °
				-121.104270 °	-121.104270 °
DWR ID					
Action/Comments					
Inspector Comments: FS_ID:35769 DS_ID:23340 EP_NO: N/A FS_HLM: 7.685 Repair Type: Non-Urgent Crossing Status: Found UCIP Comments: Pipe appears abandoned and if so should be done so properly. FIELD_STRUCT_DESC: 10-inch steel irrigation pipe 3.0-feet below the crown. Pump mounted on concrete base on the waterward slope. Power to pumps is supplied by 1915 Holt Tractor. 36-inch concrete standpipe on the landward side. O&M Manual SJR 611.1 Vol. F. FS Date: 04/30/2014

Pump and pipe visible on WS slope.

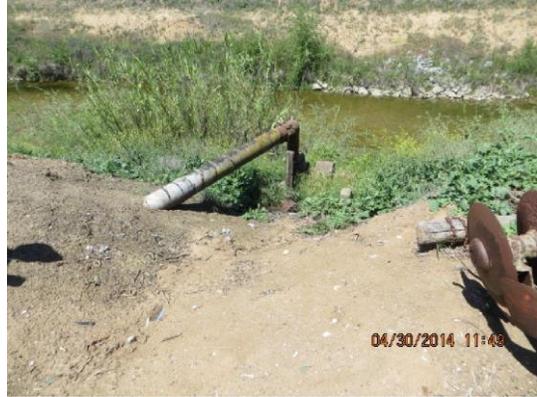
Photo 2 of 2 : UCIP\_FA\_2015\_3143.jpg

LM Start	<b>7.47</b>	Rating **	M	Issue No.	<b>828 (cont)</b>
LM End	<b>7.47</b>	Issue Type +	En	Location *	WS
Category	Supplemental			GPS Latitude/Longitude	
				Start	End
Item	DWR UCIP Field Study			37.976975 °	37.976975 °
				-121.104270 °	-121.104270 °
DWR ID					
Action/Comments					
Inspector Comments: FS_ID:35769 DS_ID:23340 EP_NO: N/A FS_HLM: 7.685 Repair Type: Non-Urgent Crossing Status: Found UCIP Comments: Pipe appears abandoned and if so should be done so properly. FIELD_STRUCT_DESC: 10-inch steel irrigation pipe 3.0-feet below the crown. Pump mounted on concrete base on the waterward slope. Power to pumps is supplied by 1915 Holt Tractor. 36-inch concrete standpipe on the landward side. O&M Manual SJR 611.1 Vol. F. FS Date: 04/30/2014

Pump and pipe visible on WS slope.

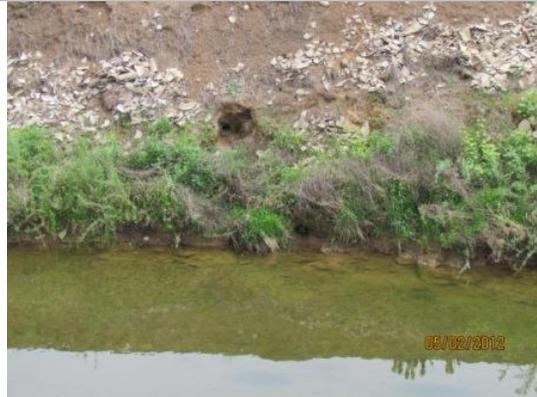
Photo 1 of 1 : FA\_2015\_NA0017\_160\_218\_20150911\_00132.jpg

LM Start	<b>7.57</b>	Rating **	U	Issue No.	<b>218</b>
LM End	<b>7.57</b>	Issue Type +	Ma	Location *	WS
Category	Earthen Levee			GPS Latitude/Longitude	
				Start	End
Item	Animal Control			°	°
				°	°
DWR ID	DWR_NA0017_16_s_2012_218				
Action/Comments					
No rodents visible, but rodent burrows visible; need to backfill and compact or grout burrows.

A possible beaver den was found on waterside slope of the levee. The picture was taken from the opposite bank of the levee.

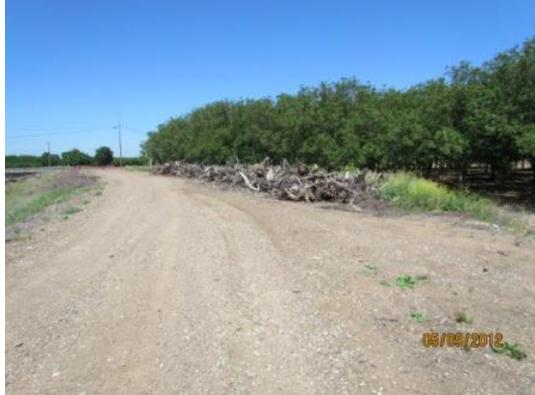
Photo 1 of 1 : FA\_2015\_NA0017\_160\_93\_20150911\_00048.jpg

LM Start	<b>8.10</b>	Rating **	M	Issue No.	<b>93</b>
LM End	<b>8.10</b>	Issue Type +	En	Location *	WS
Category	Earthen Levee			GPS Latitude/Longitude	
				Start	End
Item	Encroachments			37.971311 °	37.971311 °
				-121.113033 °	-121.113033 °
DWR ID	DWR_NA0017_16_s_2012_93				
Action/Comments					
Prunings

Prunings were found on the landside of the levee looking upstream.

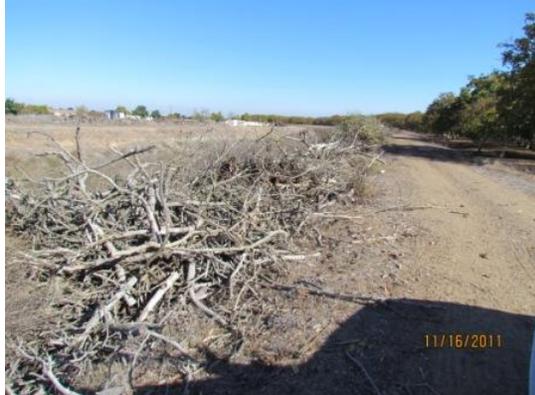
LM Start	<b>8.29</b>	Rating **	M	Issue No.	<b>79</b>
LM End	<b>8.41</b>	Issue Type +	En	Location *	WS
Category	Earthen Levee			GPS Latitude/Longitude	
				Start	End
Item	Encroachments			37.969472 °	37.969114 °
				-121.115350 °	-121.117417 °
DWR ID	DWR_NA0017_16_s_2012_79				
Action/Comments					
Prunings

Prunings were found on the waterside of the levee looking upstream.

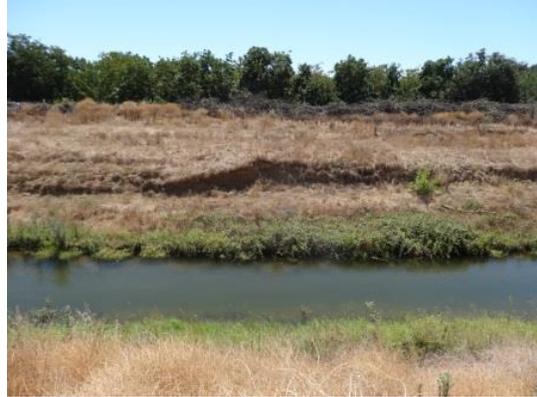
LM Start	<b>8.34</b>	Rating **	M	Issue No.	<b>36</b>
LM End	<b>8.38</b>	Issue Type +	Ma	Location *	WS
Category	Supplemental			GPS Latitude/Longitude	
				Start	End
Item	DWR Erosion Survey			37.969213 °	37.969213 °
				-121.116574 °	-121.116574 °
DWR ID					
Action/Comments					
Inspector Comments: 8/12/2015: No significant change observed. 8/20/2014: No significant change observed. 9/12/2013: No significant change observed. 08/22/2012: The erosion occurred on a berm of approximately 25 ft. wide. Site is covered with dense vegetation. There is no levee structure on site. The levee crest width and levee height were not measured or estimated in the field. [2015 Site ID:NA0017U16RM14.48]

View of the site from the right river bank.

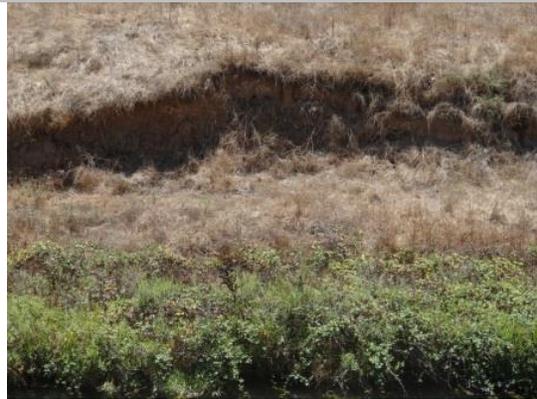
Close view of the erosion.

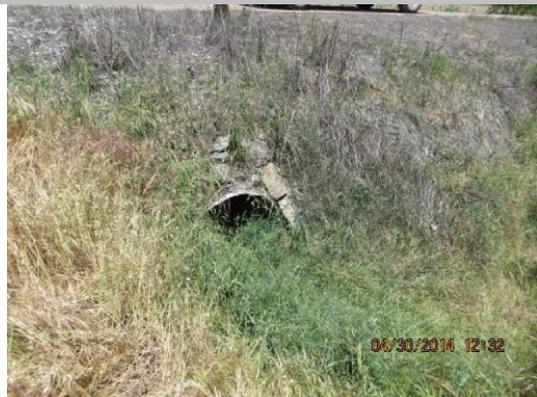
LM Start	<b>8.44</b>	Rating **	U	Issue No.	<b>829</b>
LM End	<b>8.44</b>	Issue Type +	En	Location *	WS
Category	Supplemental			GPS Latitude/Longitude	
				Start	End
Item	DWR UCIP Field Study			37.968980 °	37.968980 °
				-121.117942 °	-121.117942 °
DWR ID					
Action/Comments					
Inspector Comments: FS_ID:43086 DS_ID:23438 EP_NO: 12607 FS_HLM: 8.687 Repair Type: Urgent Crossing Status: Found

Pipe visible at LS toe.

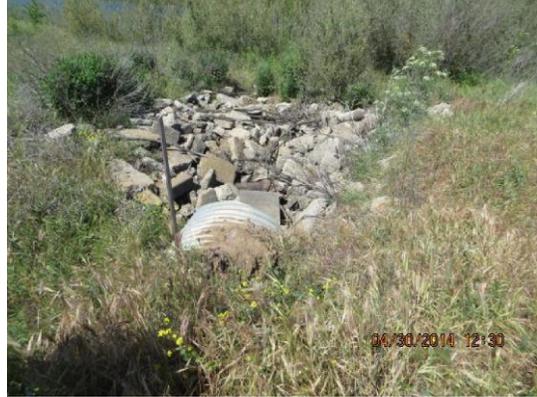
LM Start	<b>8.44</b>	Rating **	U	Issue No.	<b>829 (cont)</b>
LM End	<b>8.44</b>	Issue Type +	En	Location *	WS
Category	Supplemental			GPS Latitude/Longitude	
				Start	End
Item	DWR UCIP Field Study			37.968980 °	37.968980 °
				-121.117942 °	-121.117942 °
DWR ID					
Action/Comments					
Inspector Comments: FS_ID:43086 DS_ID:23438 EP_NO: 12607 FS_HLM: 8.687 Repair Type: Urgent Crossing Status: Found UCIP Comments: No flapgate installed as designed and permitted. FIELD_STRUCT_DESC: 42-inch diameter CM drainage pipe through the levee. 4-feet below the crown. (Permit No. 12607 - Keiji & Steve Fujinaka) FS Date: 04/30/2014

Pipe visible on WS slope.

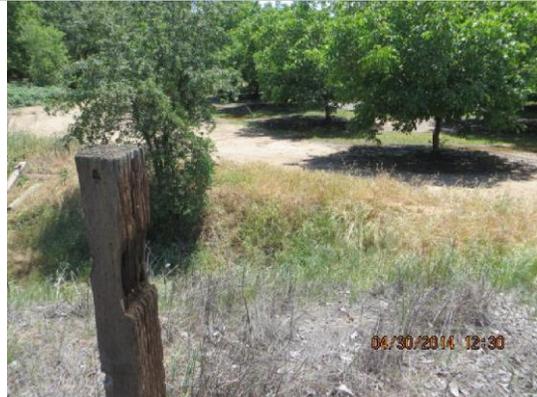
Pipe visible at LS toe.

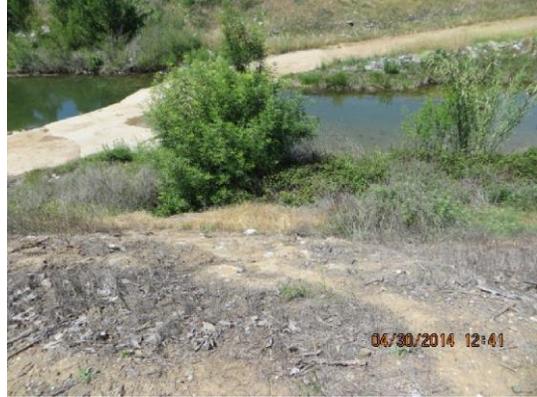
LM Start	<b>8.56</b>	Rating **	M	Issue No.	<b>830</b>
LM End	<b>8.56</b>	Issue Type +	En	Location *	WS
Category	Supplemental			GPS Latitude/Longitude	
				Start	End
Item	DWR UCIP Field Study			37.968420 °	37.968420 °
				-121.120037 °	-121.120037 °
DWR ID					
Action/Comments					
Inspector Comments: FS_ID:35791 DS_ID:23341 EP_NO: N/A FS_HLM: 8.815 Repair Type: Non-Urgent Crossing Status: Indicator Found

Grout over pipe on WS slope visible.

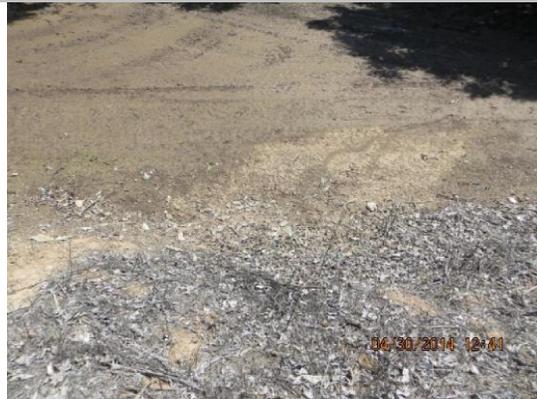
Low point on LS toe is likely location of pipe entrance.

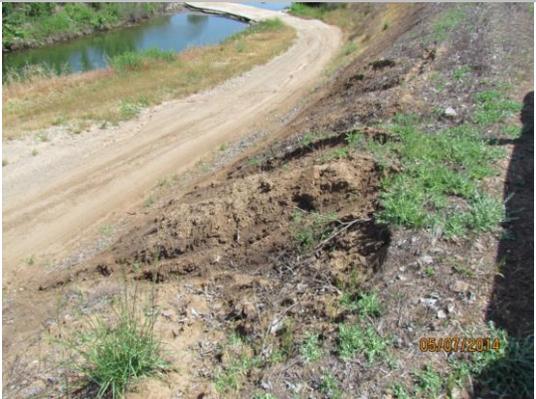
Updated picture of the slope instability on the waterside of the levee looking upstream during spring 2014 inspection.

LM Start	<b>8.60</b>	Rating **	M	Issue No.	<b>128</b>
LM End	<b>8.60</b>	Issue Type +	Ma	Location *	WS
Category	Earthen Levee		GPS Latitude/Longitude		
			Start	End	
Item	Slope Stability		37.968157 °	37.968157 °	
			-121.120620 °	-121.120620 °	
DWR ID	DWR_NA0017_16_s_2013_128				
Action/Comments					
Repair slope instability.

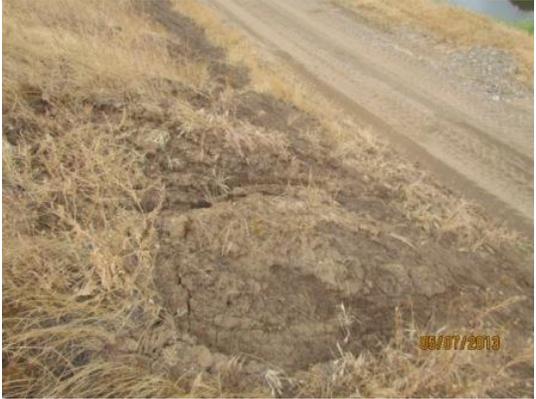
Slope instability was found on the waterside slope of the levee looking downstream.

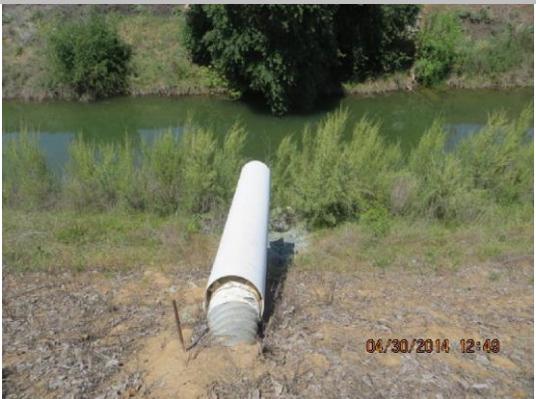
LM Start	<b>8.67</b>	Rating **	M	Issue No.	<b>831</b>
LM End	<b>8.67</b>	Issue Type +	En	Location *	WS
Category	Supplemental		GPS Latitude/Longitude		
			Start	End	
Item	DWR UCIP Field Study		37.968170 °	37.968170 °	
			-121.121919 °	-121.121919 °	
DWR ID					
Action/Comments					
Inspector Comments: FS_ID:41359 DS_ID:24953 EP_NO: N/A FS_HLM: 8.928 Repair Type: Non-Urgent Crossing Status: Found

Pipe and riprap on WS slope.

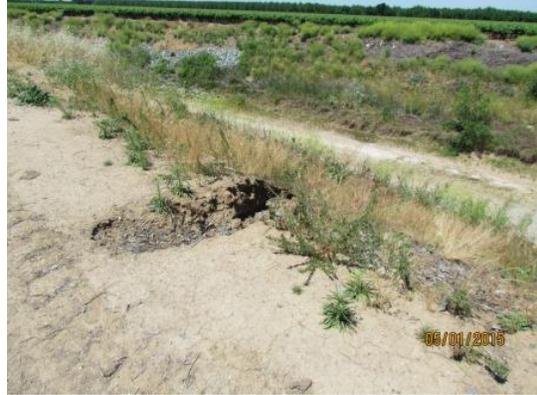
Erosion was found on the waterside looking downstream.

LM Start	<b>8.68</b>	Rating **	M	Issue No.	<b>248</b>
LM End	<b>8.68</b>	Issue Type +	Ma	Location *	WS
Category	Earthen Levee		GPS Latitude/Longitude		
			Start	End	
Item	Erosion / Bank Caving		37.968169 °	37.968169 °	
			-121.122047 °	-121.122047 °	
DWR ID	DWR_NA0017_16_s_2015_248				
Action/Comments					
Note and monitor erosion site. Inspector Comments: Runoff

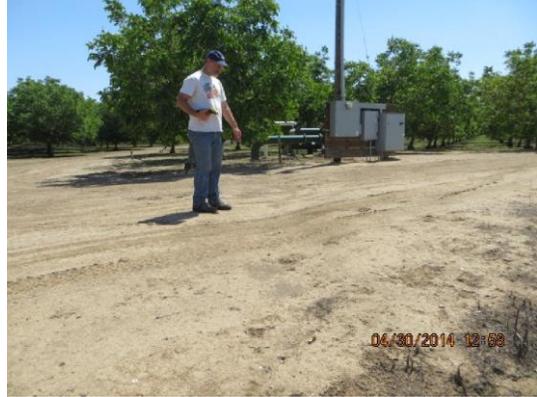
LM Start	<b>8.75</b>	Rating **	M	Issue No.	<b>832</b>
LM End	<b>8.75</b>	Issue Type +	En	Location *	WS
Category	Supplemental			GPS Latitude/Longitude	
				Start	End
Item	DWR UCIP Field Study			37.967740 °	37.967740 °
				-121.123197 °	-121.123197 °
DWR ID					
Action/Comments					
Inspector Comments: FS_ID:36143 DS_ID:23343 EP_NO: N/A FS_HLM: 9.008 Repair Type: Non-Urgent Crossing Status: Found UCIP Comments: Subsidence over pipe on crown of "levee". Likely a result of bad compaction during installation. FIELD_STRUCT_DESC: 12-inch steel irrigation pipe through the levee 3-feet below the crown. Slant pump, meter, and one-way check valve on WS slope. Power pole, electrical panel, filter plant, and butterfly valve off LS shoulder. FS Date: 04/30/2014

Subsidence over pipe with electrical panel, booster pump, butterfly valve, and filter plant visible in background.

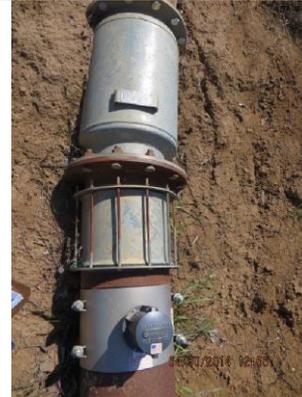
Meter and checkvalve on WS slope.

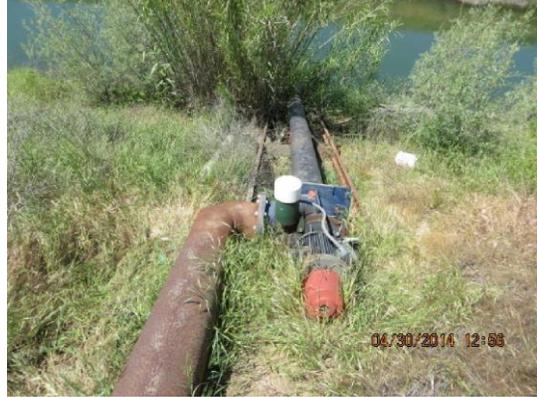
Slant pump on WS slope.

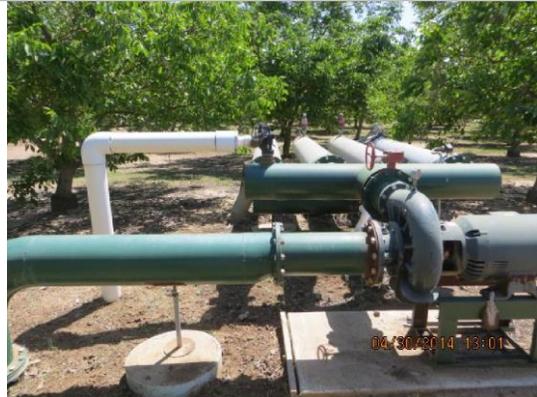
LM Start	<b>8.75</b>	Rating **	M	Issue No.	<b>833</b>
LM End	<b>8.75</b>	Issue Type +	En	Location *	WS
Category	Supplemental			GPS Latitude/Longitude	
				Start	End
Item	DWR UCIP Field Study			37.967738 °	37.967738 °
				-121.123210 °	-121.123210 °
DWR ID					
Action/Comments					
Inspector Comments: FS_ID:41360 DS_ID:24954 EP_NO: N/A FS_HLM: 9.009 Repair Type: Non-Urgent Crossing Status: Found UCIP Comments: No permit identified for crossing. FIELD_STRUCT_DESC: 6-inch PVC backwash pipe through the levee at an unknown depth below the crown. Pump and filter plant on LS. FS Date: 04/30/2014

PVC backwash pipe at filter plant on LS shoulder.

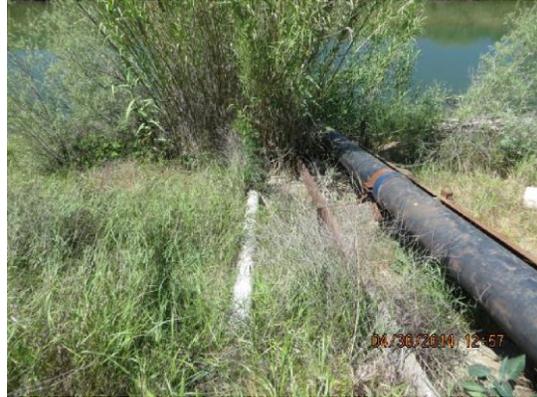
White PVC pipe visible on WS slope.

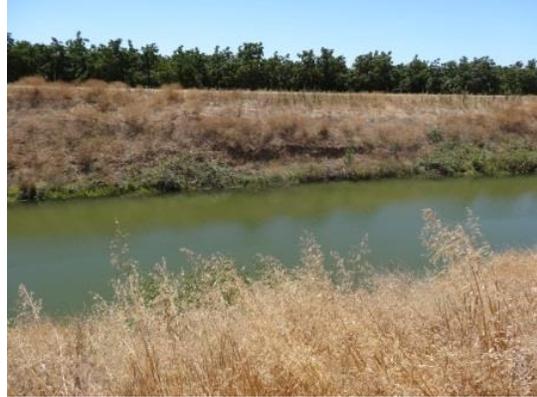
LM Start	<b>9.00</b>	Rating **	M	Issue No.	<b>18</b>
LM End	<b>9.00</b>	Issue Type +	Ma	Location *	WS
Category	Supplemental			GPS Latitude/Longitude	
				Start	End
Item	DWR Erosion Survey			37.966615 °	37.966615 °
				-121.127328 °	-121.127328 °
DWR ID					
Action/Comments					
Inspector Comments: 8/12/2015: No significant change observed. 8/20/2014: No significant change observed. 9/12/2013: No significant change observed. 08/22/2012: Pocket erosion at the levee toe and slope. The erosion is covered with dense vegetation. There is no levee structure on site. The levee crest width and levee height were not measured or estimated in

Front view of the erosion.

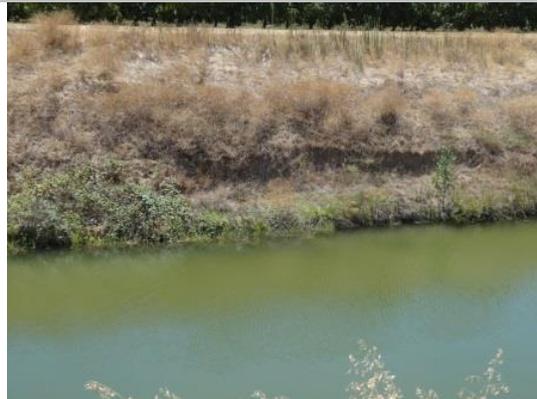
Closer view of the erosion.

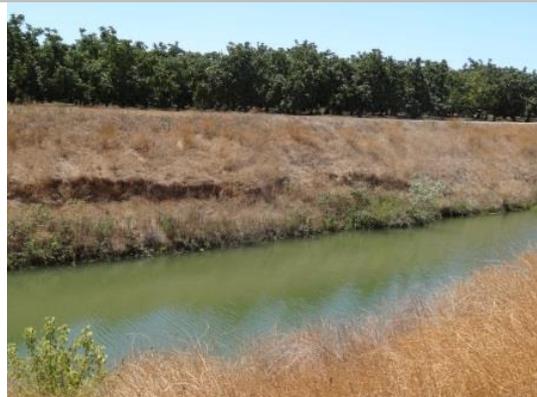
LM Start	<b>9.11</b>	Rating **	M	Issue No.	<b>14</b>
LM End	<b>9.13</b>	Issue Type +	Ma	Location *	WS
Category	Supplemental			GPS Latitude/Longitude	
				Start	End
Item	DWR Erosion Survey			37.966922 °	37.966922 °
				-121.129533 °	-121.129533 °
DWR ID					
Action/Comments					
Inspector Comments: 8/12/2015: No significant change observed. 8/20/2014: No significant change observed. 9/12/2013: No significant change observed. 08/22/2012: The erosion is covered with dense vegetation. There is no levee structure on site. The levee crest width and levee height were not measured or estimated in the field. [2015 Site ID:NA0017U16RM13.72]

Close view of the erosion.

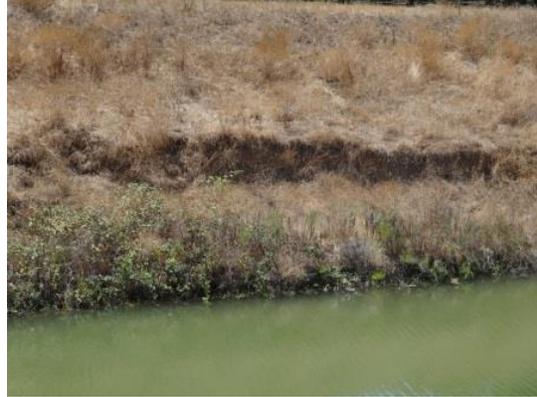
Close view of the erosion.

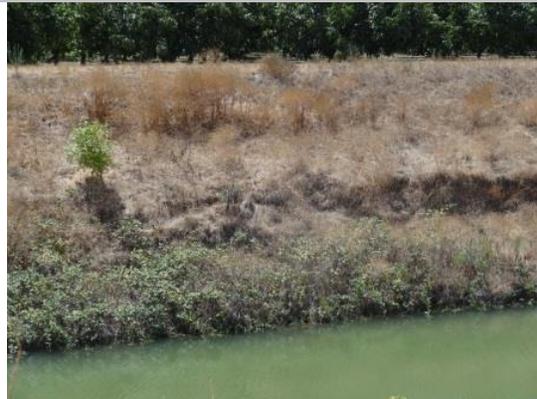
Front view of the erosion.

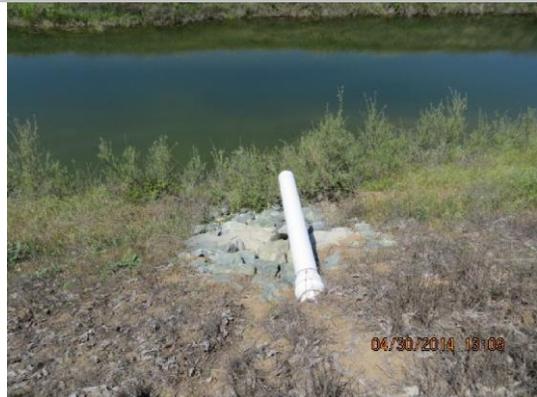
LM Start	9.21	Rating **	M	Issue No.	834
LM End	9.21	Issue Type +	En	Location *	WS
Category	Supplemental			GPS Latitude/Longitude	
				Start	End
Item	DWR UCIP Field Study			37.966980 °	37.966980 °
				-121.131216 °	-121.131216 °
DWR ID					
Action/Comments					
Inspector Comments: FS_ID:41361 DS_ID:24955 EP_NO: N/A FS_HLM: 9.491 Repair Type: Non-Urgent Crossing Status: Found

pipe and riprap visible on WS slope.

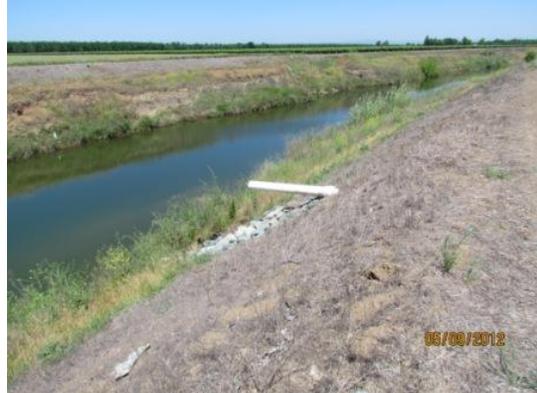
LM Start	<b>9.22</b>	Rating **	U	Issue No.	<b>147</b>
LM End	<b>9.22</b>	Issue Type +	En	Location *	WS
Category	Earthen Levee		GPS Latitude/Longitude		
			Start	End	
Item	Encroachments		37.966952 °	37.966952 °	
			-121.131360 °	-121.131360 °	
DWR ID	DWR_NA0017_16_s_2012_147				
Action/Comments					
Pipe Inspector Comments: PVC pipe under the crown of the levee.

A PVC pipe was found on the waterside slope of the levee looking upstream.

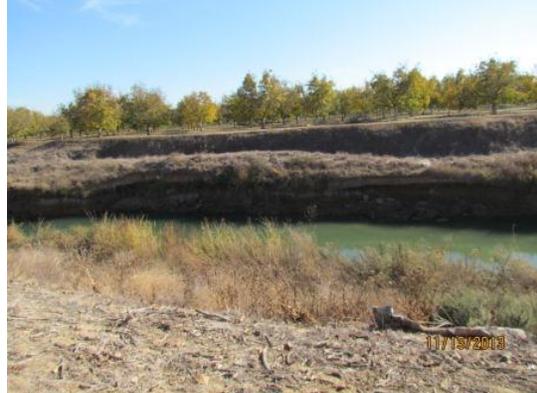
Photo 1 of 1 : FA\_2015\_NA0017\_160\_28\_20150911\_00011.jpg

LM Start	<b>9.48</b>	Rating **	M	Issue No.	<b>28</b>
LM End	<b>9.48</b>	Issue Type +	Ma	Location *	WS
Category	Earthen Levee		GPS Latitude/Longitude		
			Start	End	
Item	Erosion / Bank Caving		37.966239 °	37.966239 °	
			-121.136172 °	-121.136172 °	
DWR ID	DWR_NA0017_16_f_2013_28				
Action/Comments					
Schedule repair of erosion site prior to the next inspection. Inspector Comments: Erosion was found on the waterside toe of the levee.

View of the erosion on the waterside toe of the levee looking from the opposite side of the levee.

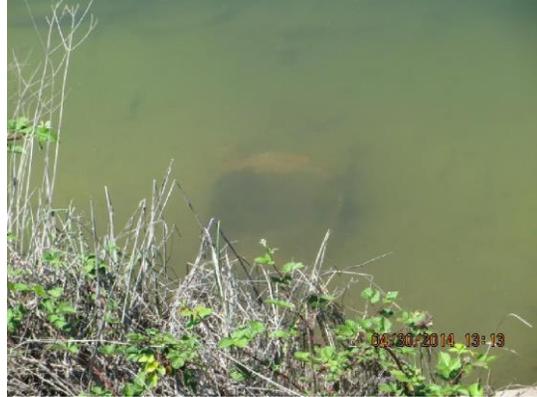
Photo 1 of 3 : UCIP\_FA\_2015\_4881.jpg

**Action/Comments**  
 Inspector Comments: FS\_ID:36144  
 DS\_ID:23344  
 EP\_NO: N/A  
 FS\_HLM: 9.768  
 Repair Type: Non-Urgent  
 Crossing Status: Found  
 UCIP Comments: Inlet appears to be buried with soil on LS. Pipe heavily corroded at outlet on WS toe. Good candidate for video inspection.  
 FIELD\_STRUCT\_DESC: 18-inch CM stormdrain pipe 3.5 feet below the roadway. Grouted spillway and inlet. O&M Manual SJR 611.1 Vol. F.  
 FS Date: 04/30/2014

Pipe completely rusted through at outlet on WS toe.

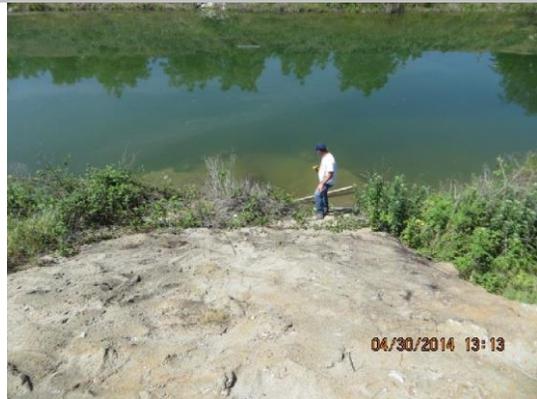
Photo 2 of 3 : UCIP\_FA\_2015\_4882.jpg

Grout over pipe on WS slope with pipe visible in water at WS toe.

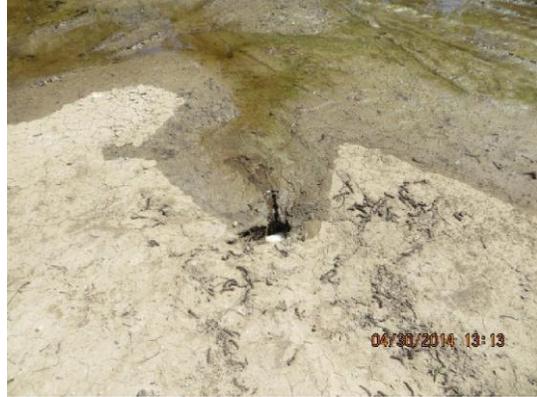
Photo 3 of 3 : UCIP\_FA\_2015\_4883.jpg

Inlet on LS shoulder burried in soil.

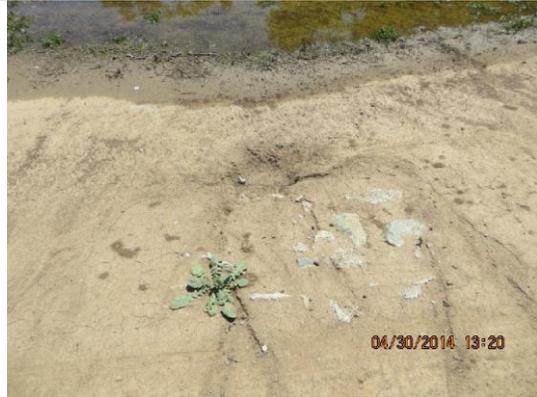
Photo 1 of 3 : UCIP\_FA\_2015\_4884.jpg

LM Start	<b>9.78</b>	Rating **	M	Issue No.	<b>836</b>
LM End	<b>9.78</b>	Issue Type +	En	Location *	LS
Category	Supplemental			GPS Latitude/Longitude	
				Start	End
Item	DWR UCIP Field Study			37.964912 °	37.964912 °
				-121.140827 °	-121.140827 °
DWR ID					
Action/Comments					
Inspector Comments: FS_ID:36145 DS_ID:23345 EP_NO: N/A FS_HLM: 10.071 Repair Type: Non-Urgent Crossing Status: Found UCIP Comments: Inlet on LS burried in soil. FIELD_STRUCT_DESC: 18-inch CM stormdrain pipe through the levee 3.5 feet below the crown. Grouted spillway and inlet. O&M Manual SJR 611.1 Vol. F. FS Date: 04/30/2014

Inlet appears to be burried in soil on LS shoulder.

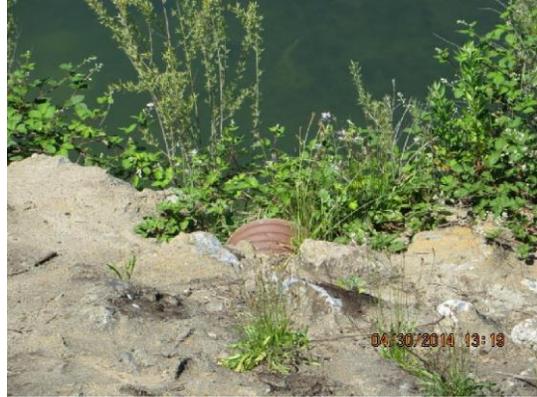
Photo 2 of 3 : UCIP\_FA\_2015\_4885.jpg

Pipe at outlet on WS toe.

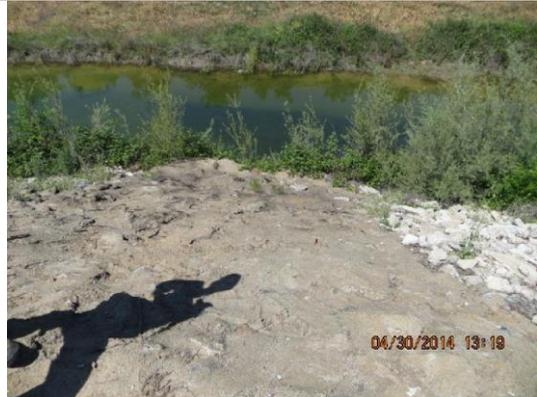
Photo 3 of 3 : UCIP\_FA\_2015\_4886.jpg

Grout over pipe on WS slope.

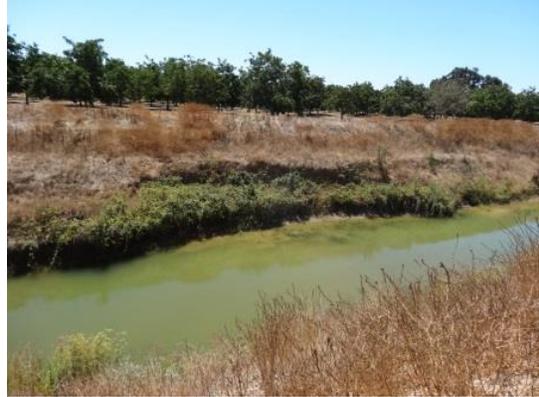
Photo 1 of 2 : SJR2015\_NA0017U16RM12.95\_2.jpg

LM Start	<b>9.86</b>	Rating **	M	Issue No.	<b>10</b>
LM End	<b>9.88</b>	Issue Type +	Ma	Location *	WS
Category	Supplemental		GPS Latitude/Longitude		
			Start	End	
Item	DWR Erosion Survey		37.964735 °	37.964735 °	
			-121.142503 °	-121.142503 °	
DWR ID					
Action/Comments					
Inspector Comments: 8/12/2015: No significant change observed. 8/20/2014: No significant change observed. 9/12/2013: No significant change observed. 08/22/2012: Dense vegetation on site. There is no levee structure on site. The levee crest width and levee height were not measured or estimated in the field. [2015 Site ID:NA0017U16RM12.95]

Front view of the erosion.

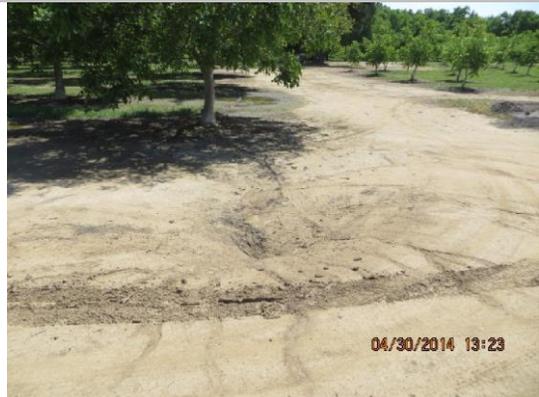
Photo 1 of 3 : UCIP\_FA\_2015\_5775.jpg

LM Start	<b>9.94</b>	Rating **	M	Issue No.	<b>837</b>
LM End	<b>9.94</b>	Issue Type +	En	Location *	WS
Category	Supplemental		GPS Latitude/Longitude		
			Start	End	
Item	DWR UCIP Field Study		37.964720 °	37.964720 °	
			-121.143880 °	-121.143880 °	
DWR ID					
Action/Comments					
Inspector Comments: FS_ID:39070 DS_ID:24956 EP_NO: N/A FS_HLM: 10.245 Repair Type: Non-Urgent Crossing Status: Found

Pipe visible on LS toe.

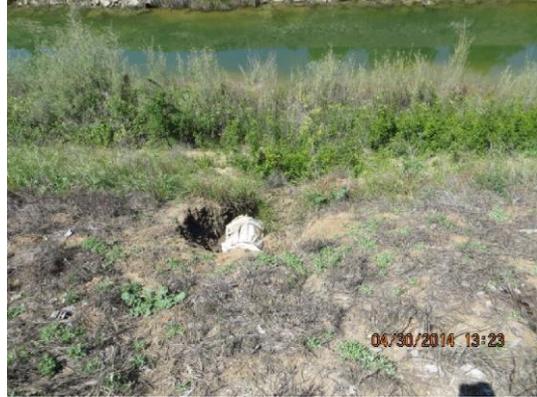
Photo 2 of 3 : UCIP\_FA\_2015\_5776.jpg

LM Start	<b>9.94</b>	Rating **	M	Issue No.	<b>837 (cont)</b>
LM End	<b>9.94</b>	Issue Type +	En	Location *	WS
Category	Supplemental			GPS Latitude/Longitude	
				Start	End
Item	DWR UCIP Field Study			37.964720 °	37.964720 °
				-121.143880 °	-121.143880 °
DWR ID					
Action/Comments					
Inspector Comments: FS_ID:39070 DS_ID:24956 EP_NO: N/A FS_HLM: 10.245 Repair Type: Non-Urgent Crossing Status: Found UCIP Comments: WS slope is being eroded by flow. FIELD_STRUCT_DESC: 12-inch CMP drain pipe through the levee 3-feet below the crown. FS Date: 04/30/2014

Pipe visible on slope. Note erosion on WS slope.

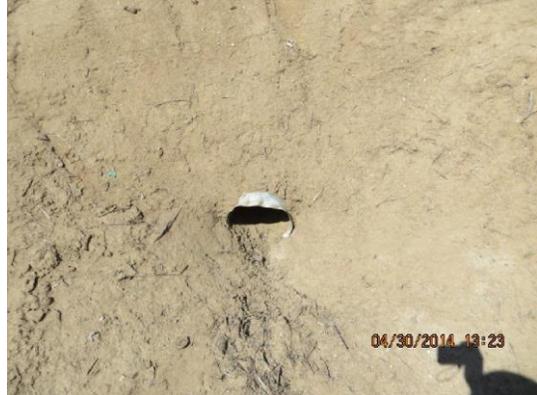
Photo 3 of 3 : UCIP\_FA\_2015\_5777.jpg

Pipe visible on LS toe.

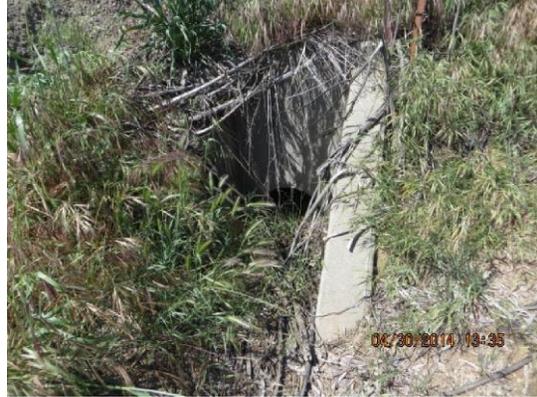
Photo 1 of 3 : UCIP\_FA\_2015\_4921.jpg

LM Start	<b>10.19</b>	Rating **	M	Issue No.	<b>838</b>
LM End	<b>10.19</b>	Issue Type +	En	Location *	WS
Category	Supplemental			GPS Latitude/Longitude	
				Start	End
Item	DWR UCIP Field Study			37.964670 °	37.964670 °
				-121.148455 °	-121.148455 °
DWR ID					
Action/Comments					
Inspector Comments: FS_ID:36163 DS_ID:23347 EP_NO: N/A FS_HLM: 10.505 Repair Type: Non-Urgent Crossing Status: Found

Headwall and pipe with heavy sediment buildup on LS toe.

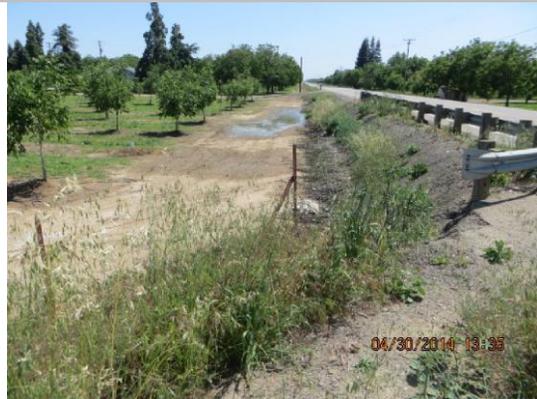
Photo 2 of 3 : UCIP\_FA\_2015\_4922.jpg

Pipe and headwall visible at LS toe.

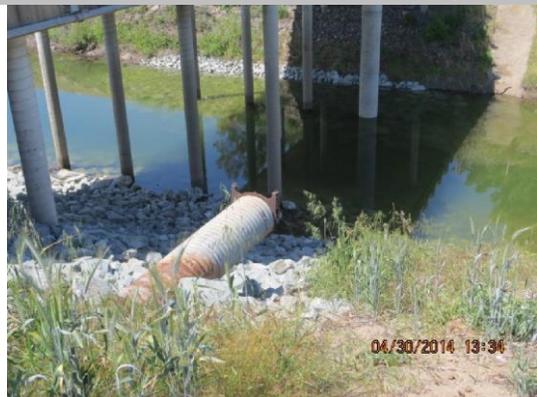
Photo 3 of 3 : UCIP\_FA\_2015\_4923.jpg

Pipe and flapgate visible on WS slope.

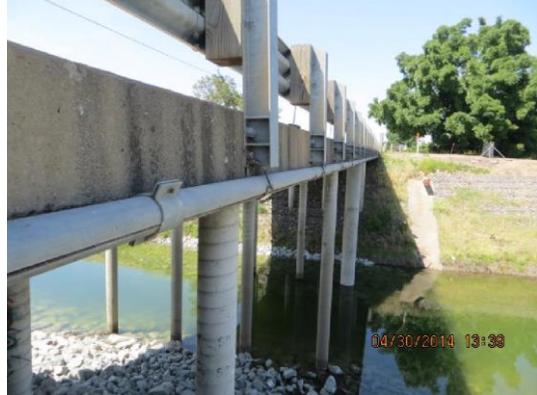
Photo 1 of 1 : UCIP\_FA\_2015\_5804.jpg

LM Start	<b>10.20</b>	Rating **	M	Issue No.	<b>839</b>
LM End	<b>10.20</b>	Issue Type +	En	Location *	WS
Category	Supplemental			GPS Latitude/Longitude	
				Start	End
Item	DWR UCIP Field Study			37.964657 °	37.964657 °
				-121.148499 °	-121.148499 °
DWR ID					
Action/Comments					
Inspector Comments: FS_ID:41948 DS_ID:24957 EP_NO: N/A FS_HLM: 10.507 Repair Type: Non-Urgent Crossing Status: Found

Conduit visible on upstream side of the bridge.

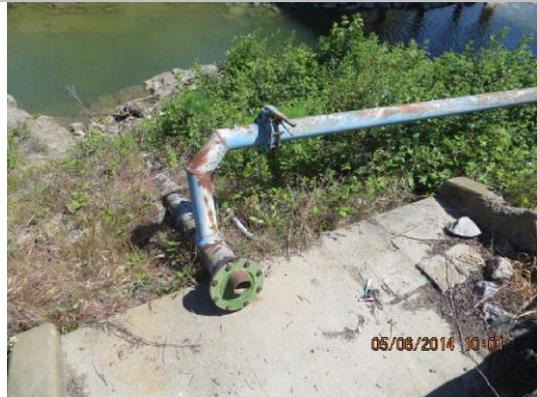
Photo 1 of 3 : UCIP\_FA\_2015\_4924.jpg

LM Start	<b>10.21</b>	Rating **	M	Issue No.	<b>840</b>
LM End	<b>10.21</b>	Issue Type +	En	Location *	WS
Category	Supplemental			GPS Latitude/Longitude	
				Start	End
Item	DWR UCIP Field Study			37.964659 °	37.964659 °
				-121.148717 °	-121.148717 °
DWR ID					
Action/Comments					
Inspector Comments: FS_ID:36170 DS_ID:23349 EP_NO: N/A FS_HLM: 10.519 Repair Type: Non-Urgent Crossing Status: Found UCIP Comments: Pipe appears abandoned and if so should be done so properly. FIELD_STRUCT_DESC: 12-inch steel irrigation pipe through the levee 5.0-feet below the roadway. Pump missing from concrete base on the waterward slope. Butterfly valve on pipe at pump location on WS slope. 36-inch concrete standpipe, power pole, and electrical panel on the landward side. 2-inch galvanized iron electrical conduit 10-feet downstream from pipe crossing. O&M Manual SJR 611.1 Vol. F. FS Date: 05/06/2014

Pipe and butterfly valve at concrete pump pad on WS slope.

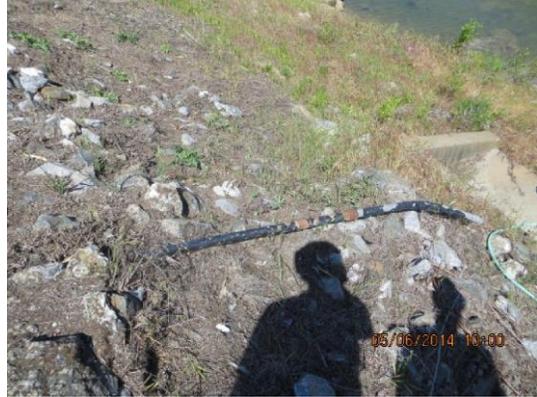
Photo 2 of 3 : UCIP\_FA\_2015\_4925.jpg

Inspector Comments: FS\_ID:36170  
 DS\_ID:23349  
 EP\_NO: N/A  
 FS\_HLM: 10.519  
 Repair Type: Non-Urgent  
 Crossing Status: Found  
 UCIP Comments: Pipe appears abandoned and if so should be done so properly.  
 FIELD\_STRUCT\_DESC: 12-inch steel irrigation pipe through the levee 5.0-feet below the roadway. Pump missing from concrete base on the waterward slope. Butterfly valve on pipe at pump location on WS slope. 36-inch concrete standpipe, power pole, and electrical panel on the landward side. 2-inch galvanized iron electrical conduit 10-feet downstream from pipe crossing. O&M Manual SJR 611.1 Vol. F. FS Date: 05/06/2014

Electrical conduit on WS slope.

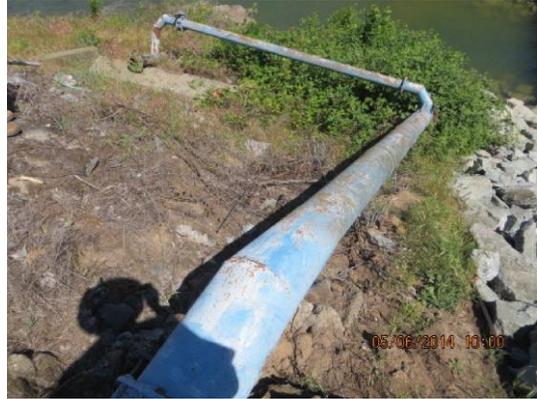
Photo 3 of 3 : UCIP\_FA\_2015\_4926.jpg

Pipe and pump pad on WS slope.

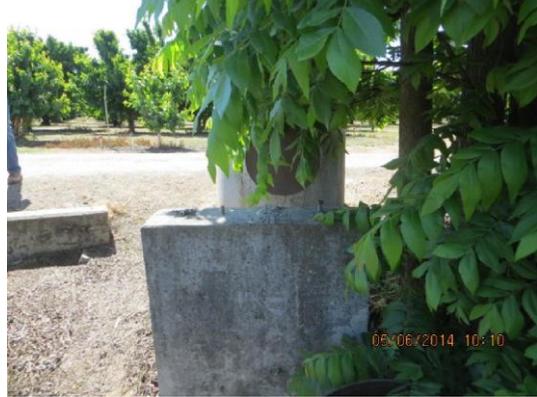
Photo 1 of 2 : UCIP\_FA\_2015\_5016.jpg

LM Start	<b>10.53</b>	Rating **	M	Issue No.	<b>841</b>
LM End	<b>10.53</b>	Issue Type +	En	Location *	WS
Category	Supplemental			GPS Latitude/Longitude	
				Start	End
Item	DWR UCIP Field Study			37.963754 °	37.963754 °
				-121.154344 °	-121.154344 °
DWR ID					
Action/Comments					
Inspector Comments: FS_ID:36175 DS_ID:23488 EP_NO: N/A FS_HLM: 10.841 Repair Type: Non-Urgent Crossing Status: Indicator Found UCIP Comments: Verify type of abandonment as standpipe still present on WS shoulder may indicate pipe is still installed. FIELD_STRUCT_DESC: 2 of 2: *ABANDONED* 12-inch concrete pipe through the levee 5.0-feet below the roadway. Pump mounted on steel pilings with 10-inch intake pipe. 36-inch concrete standpipe and service pole on the waterward side. O&M Manual SJR 611.1 Vol. F. FS Date: 05/06/2014

Pipe with steel plate welded over end visible at standpipe on WS shoulder.

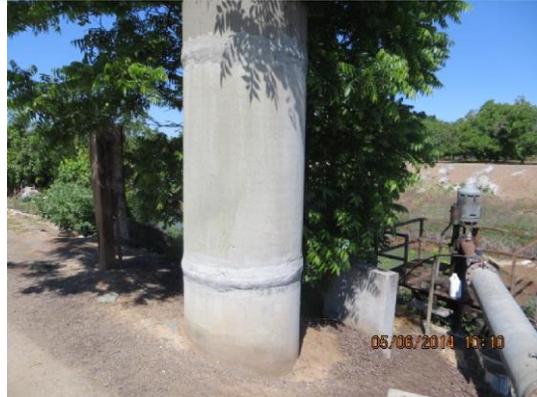
Photo 2 of 2 : UCIP\_FA\_2015\_5017.jpg

Concrete standpipe and pump platform visible on WS shoulder.

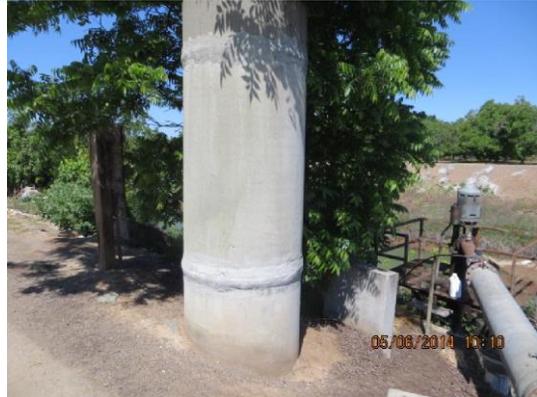
Photo 1 of 2 : UCIP\_FA\_2015\_4359.jpg

LM Start	<b>10.53</b>	Rating **	M	Issue No.	<b>842</b>
LM End	<b>10.53</b>	Issue Type +	En	Location *	WS
Category	Supplemental			GPS Latitude/Longitude	
				Start	End
Item	DWR UCIP Field Study			37.963754 °	37.963754 °
				-121.154344 °	-121.154344 °
DWR ID					
Action/Comments					
Inspector Comments: FS_ID:36176 DS_ID:23350 EP_NO: N/A FS_HLM: 10.841 Repair Type: Non-Urgent Crossing Status: Indicator Found

Pump, standpipe, and pipe visible on WS shoulder.

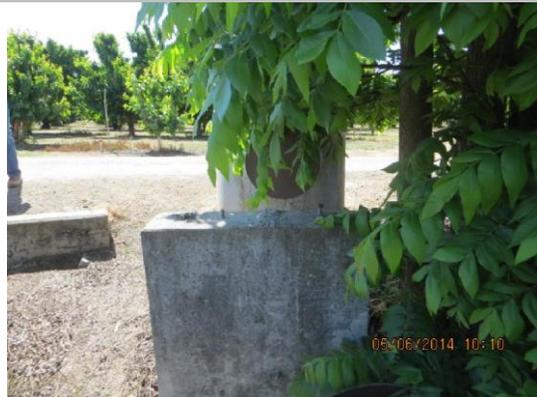
Photo 2 of 2 : UCIP\_FA\_2015\_5018.jpg

Steel plate welded over pipe on WS shoulder.

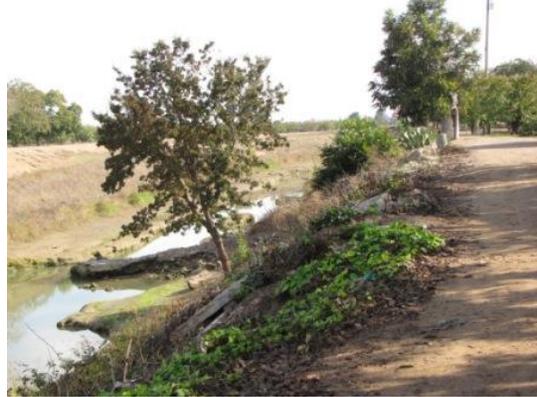
Photo 1 of 1 : FA\_2015\_NA0017\_160\_159\_20150911\_00089.jpg

LM Start	<b>10.53</b>	Rating **	M	Issue No.	<b>159</b>
LM End	<b>10.57</b>	Issue Type +	En	Location *	WS
Category	Earthen Levee		GPS Latitude/Longitude		
			Start	End	
Item	Vegetation		37.963704 °	37.963524 °	
			-121.154321 °	-121.155045 °	
DWR ID	DWR_NA0017_16_s_2012_159				
Action/Comments					
Landscaping

View of landscaping on waterward side looking upstream.

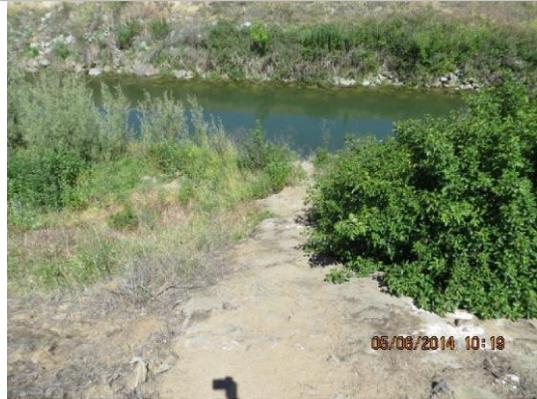
Photo 1 of 1 : UCIP\_FA\_2015\_4360.jpg

LM Start	<b>10.73</b>	Rating **	M	Issue No.	<b>843</b>
LM End	<b>10.73</b>	Issue Type +	En	Location *	WS
Category	Supplemental		GPS Latitude/Longitude		
			Start	End	
Item	DWR UCIP Field Study		37.962755 °	37.962755 °	
			-121.157857 °	-121.157857 °	
DWR ID					
Action/Comments					
Inspector Comments: FS_ID:36179 DS_ID:23351 EP_NO: N/A FS_HLM: 11.05 Repair Type: Non-Urgent Crossing Status: Indicator Found UCIP Comments: Inlet appears to be burried on LS toe. FIELD_STRUCT_DESC: 18-inch CM stormdrain pipe 3.5 feet below the roadway. Grout over pipe in spillway. O&M Manual SJR 611.1 Vol. F. FS Date: 05/06/2014

Grout over pipe visible on WS slope.

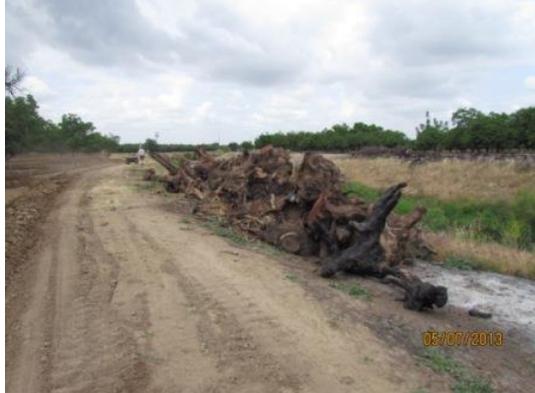
Photo 1 of 2 : FA\_2015\_NA0017\_160\_90\_20150911\_00046.jpg

LM Start	<b>10.75</b>	Rating **	M	Issue No.	<b>90</b>
LM End	<b>10.75</b>	Issue Type +	Ma	Location *	WS
Category	Earthen Levee		GPS Latitude/Longitude		
			Start	End	
Item	Encroachments		37.962472 °	37.962472 °	
			-121.158112 °	-121.158112 °	
DWR ID	DWR_NA0017_16_s_2012_90				
Action/Comments					
Prunings

Prunings were found on the waterside shoulder of the levee looking downstream.

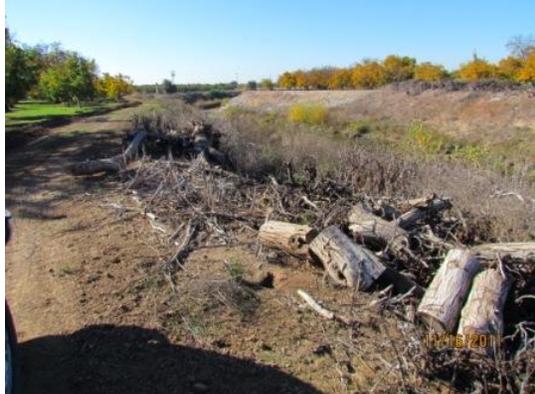
Photo 2 of 2 : FA\_2015\_NA0017\_160\_90\_20150911\_00047.jpg

Prunings were found on the waterside of the levee looking downstream.

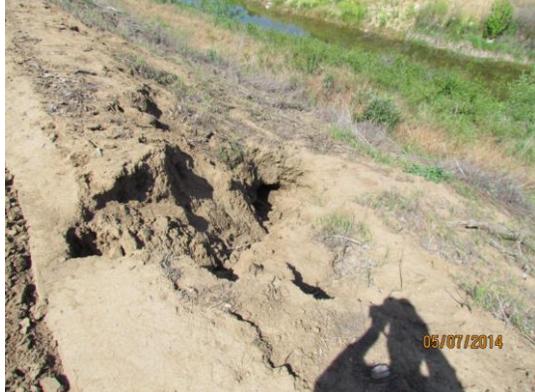
Photo 1 of 2 : FA\_2015\_NA0017\_160\_139\_20150911\_00078.jpg

Updated picture of the erosion on the waterside shoulder of the levee looking downstream.

LM Start	<b>10.79</b>	Rating **	M	Issue No.	<b>139</b>
LM End	<b>10.79</b>	Issue Type +	Ma	Location *	WS
Category	Earthen Levee		GPS Latitude/Longitude		
			Start	End	
Item	Erosion / Bank Caving		37.962182 °	37.962182 °	
			-121.158684 °	-121.158684 °	
DWR ID	DWR_NA0017_16_s_2013_139				
Action/Comments					
Schedule repair of erosion site prior to the next inspection.

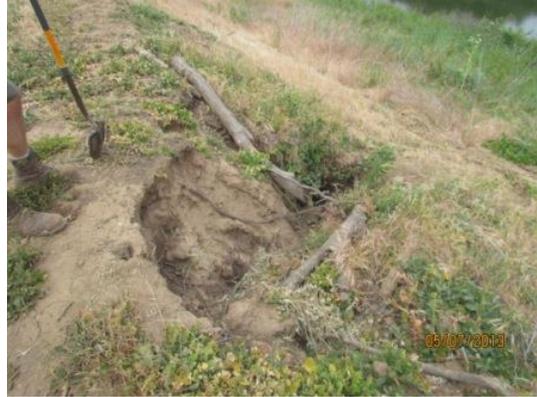
Photo 2 of 2 : FA\_2015\_NA0017\_160\_139\_20150911\_00079.jpg

Erosion was found on the waterside of the levee looking downstream.

LM Start	<b>10.79</b>	Rating **	M	Issue No.	<b>139 (cont)</b>
LM End	<b>10.79</b>	Issue Type +	Ma	Location *	WS
Category	Earthen Levee			GPS Latitude/Longitude	
				Start	End
Item	Erosion / Bank Caving			37.962182 °	37.962182 °
				-121.158684 °	-121.158684 °
DWR ID	DWR_NA0017_16_s_2013_139				
Action/Comments					
Schedule repair of erosion site prior to the next inspection.

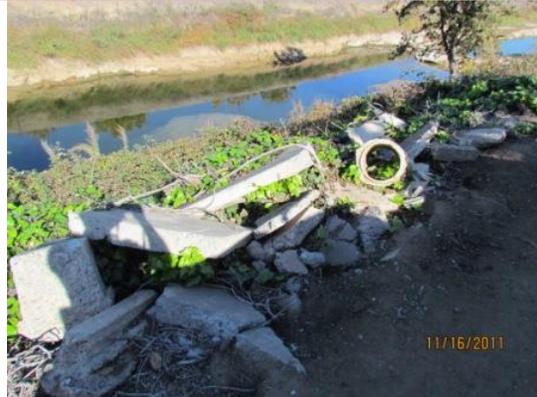
Photo 1 of 1 : FA\_2015\_NA0017\_160\_787\_20150911\_00162.jpg

LM Start	<b>10.87</b>	Rating **	M	Issue No.	<b>787</b>
LM End	<b>10.87</b>	Issue Type +	En	Location *	WS
Category	Earthen Levee			GPS Latitude/Longitude	
				Start	End
Item	Encroachments			°	°
				°	°
DWR ID	DWR_NA0017_16_s_2012_787				
Action/Comments					
Debris

Concrete debris was found on the waterside of the levee looking upstream.

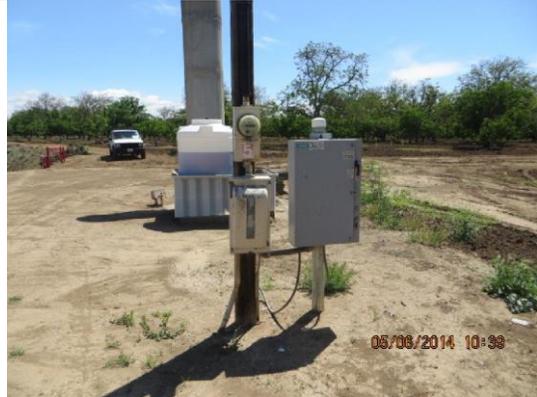
Photo 1 of 3 : UCIP\_FA\_2015\_5805.jpg

LM Start	<b>10.87</b>	Rating **	M	Issue No.	<b>844</b>
LM End	<b>10.87</b>	Issue Type +	En	Location *	WS
Category	Supplemental			GPS Latitude/Longitude	
				Start	End
Item	DWR UCIP Field Study			37.961525 °	37.961525 °
				-121.159876 °	-121.159876 °
DWR ID					
Action/Comments					
Inspector Comments: FS_ID:41682 DS_ID:24959 EP_NO: N/A FS_HLM: 11.194 Repair Type: Non-Urgent Crossing Status: Found UCIP Comments: No permit identified for crossing. FIELD_STRUCT_DESC: 8-inch steel irrigation pipe 3-feet below the crown. Pump on concrete pad on WS slope. Butterfly valve and vent on the WS slope. Filter and butterfly valve on LS. FS Date: 05/06/2014

Meter and electrical panel on LS shoulder.

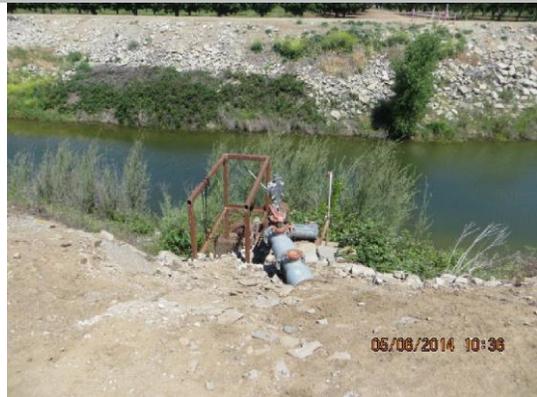
Photo 2 of 3 : UCIP\_FA\_2015\_5806.jpg

Pump, butterfly valve, and vent on WS slope.

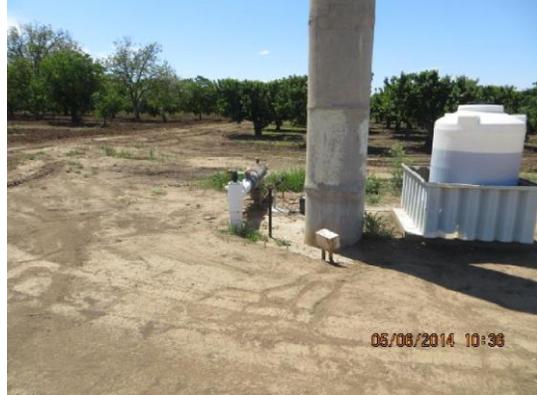
Photo 3 of 3 : UCIP\_FA\_2015\_5807.jpg

Pipe, vent, butterfly valve, filter, and standpipe on LS shoulder.

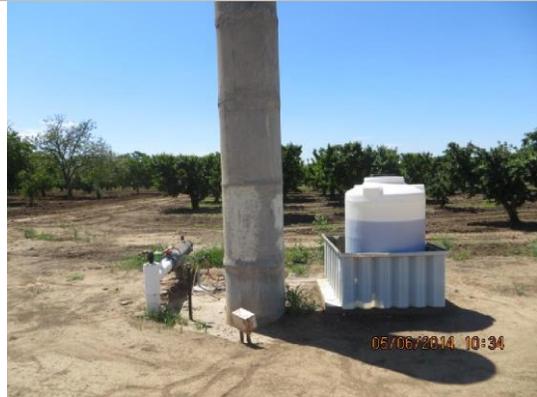
Photo 1 of 3 : UCIP\_FA\_2015\_4361.jpg

LM Start	<b>10.88</b>	Rating **	M	Issue No.	<b>845</b>
LM End	<b>10.88</b>	Issue Type +	En	Location *	WS
Category	Supplemental			GPS Latitude/Longitude	
				Start	End
Item	DWR UCIP Field Study			37.961534 °	37.961534 °
				-121.159906 °	-121.159906 °
DWR ID					
Action/Comments					
Inspector Comments: FS_ID:36185 DS_ID:23419 EP_NO: 15943 FS_HLM: 11.196 Repair Type: Non-Urgent Crossing Status: Found UCIP Comments: Pipe abandoned and open on WS end. Pipe should be abandoned properly. FIELD_STRUCT_DESC: 12-inch pipe 3.0 feet below the roadway. Pump mounted on concrete pad on the waterward side. Switch box the waterward side. Electrical conduit through the levee. 30-inch concrete standpipe on the landward side. (Permit No. 15943-1992 Ralph Panella Enterprises) O&M Manual SJR 611.1 Vol. F. FS Date: 05/06/2014

Standpipe on LS shoulder.

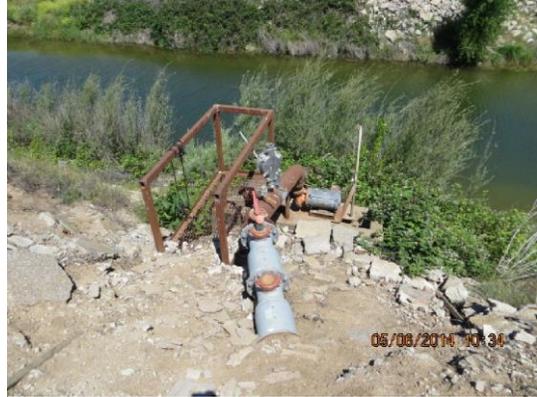
Photo 2 of 3 : UCIP\_FA\_2015\_4362.jpg

Abandoned pipe visible at pump platform/headwall on WS slope.

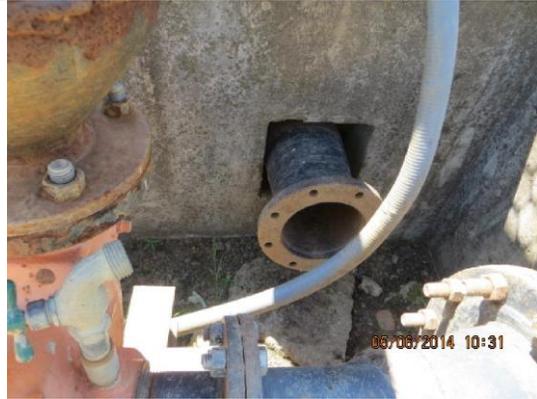
Photo 3 of 3 : UCIP\_FA\_2015\_4363.jpg

Abandoned pipe visible at pump platform/headwall on WS slope.

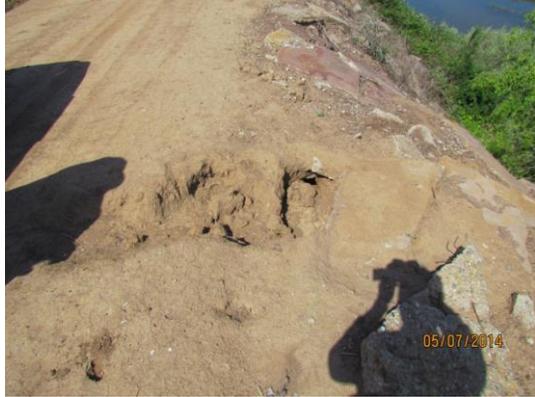
Photo 1 of 1 : FA\_2015\_NA0017\_160\_108\_20150911\_00053.jpg

Rodent holes were found on the waterside shoulder of the levee looking downstream.

LM Start	<b>10.89</b>	Rating **	M	Issue No.	<b>108</b>
LM End	<b>10.89</b>	Issue Type +	Ma	Location *	WS
Category	Earthen Levee		GPS Latitude/Longitude		
			Start	End	
Item	Animal Control		37.961494 °	37.961494 °	
			-121.160196 °	-121.160196 °	
DWR ID	DWR_NA0017_16_s_2014_108				
Action/Comments					
No rodents visible, but rodent burrows visible; need to backfill and compact or grout burrows.

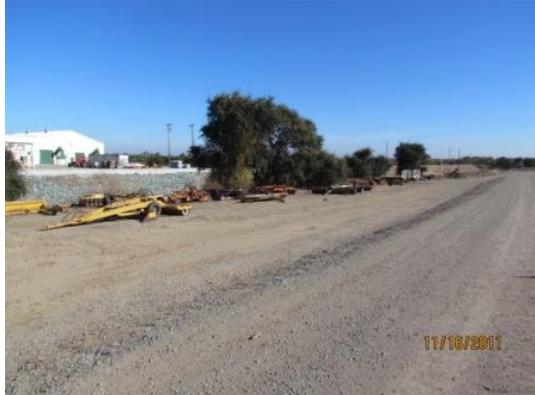
Photo 1 of 1 : FA\_2015\_NA0017\_160\_88\_20150911\_00045.jpg

LM Start	<b>11.20</b>	Rating **	M	Issue No.	<b>88</b>
LM End	<b>11.26</b>	Issue Type +	En	Location *	WS
Category	Earthen Levee		GPS Latitude/Longitude		
			Start	End	
Item	Encroachments		37.960282 °	37.960118 °	
			-121.165380 °	-121.166580 °	
DWR ID	DWR_NA0017_16_s_2012_88				
Action/Comments					
Equipment

Equipment was found on the waterside of the levee looking upstream.
