**Flood Control Project Maintenance  
Levee Inspections**

**Fall 2015 Levee Maintenance Deficiency Summary Report**

**San Joaquin River Basin**

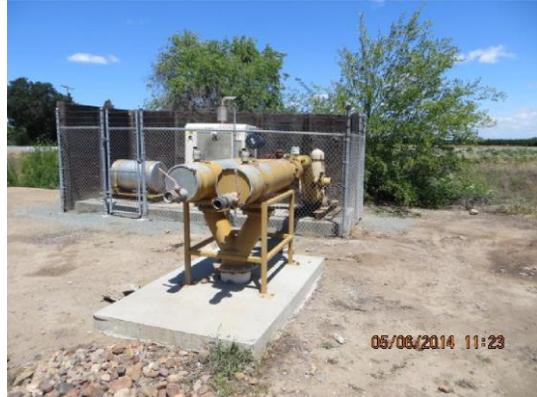
Photo 1 of 3 : UCIP\_FA\_2015\_5808.jpg

LM Start	<b>11.43</b>	Rating **	M	Issue No.	<b>846</b>
LM End	<b>11.43</b>	Issue Type +	En	Location *	WS
Category	Supplemental			GPS Latitude/Longitude	
				Start	End
Item	DWR UCIP Field Study			37.960208 °	37.960208 °
				-121.169534 °	-121.169534 °
DWR ID					
Action/Comments					
Inspector Comments: FS_ID:41683 DS_ID:24960 EP_NO: N/A FS_HLM: 11.754 Repair Type: Non-Urgent Crossing Status: Found UCIP Comments: No permit identified for this crossing. FIELD_STRUCT_DESC: 12-inch PVC irrigation pipe through the levee at an unknown depth below the crown. Pump, vent, filter, and butterfly valve on WS berm. Butterfly valve and vent off LS toe. FS Date: 05/06/2014

Pump, vent, butterfly valve, filter, and pipe visible on WS berm. Gravel likely covers pipe alignment.

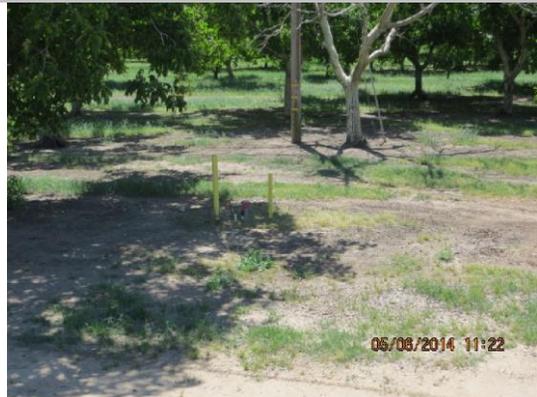
Photo 2 of 3 : UCIP\_FA\_2015\_5809.jpg

Likely butterfly valve and vent for this crossing on LS shoulder.

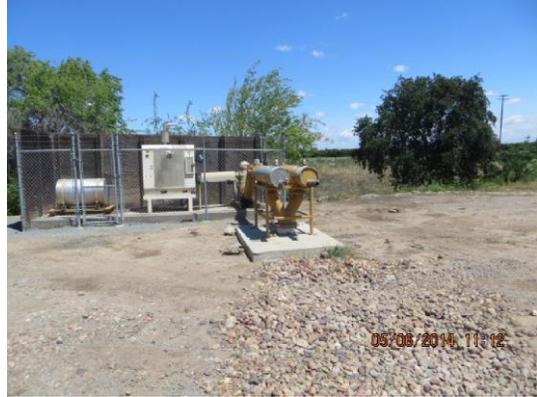
Photo 3 of 3 : UCIP\_FA\_2015\_5810.jpg

Pump, vent, butterfly valve, filter, and pipe visible on WS berm. Gravel likely covers pipe alignment.

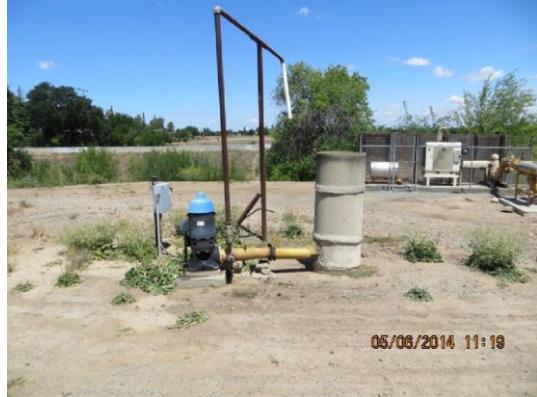
Photo 1 of 3 : UCIP\_FA\_2015\_4364.jpg

LM Start	<b>11.43</b>	Rating **	M	Issue No.	<b>847</b>
LM End	<b>11.43</b>	Issue Type +	En	Location *	WS
Category	Supplemental			GPS Latitude/Longitude	
				Start	End
Item	DWR UCIP Field Study			37.960216 °	37.960216 °
				-121.169618 °	-121.169618 °
DWR ID					
Action/Comments					
Inspector Comments: FS_ID:36207 DS_ID:23357 EP_NO: N/A FS_HLM: 11.76 Repair Type: Non-Urgent Crossing Status: Found UCIP Comments: Verify status of crossing as pipe is disconnected at pump and appears abandoned. FIELD_STRUCT_DESC: 10-inch pipe through the levee 4.0 feet below the crown. 36-inch concrete standpipe on the waterward side. Pump mounted over well on the waterward side. 8-inch intake pipe from channel to standpipe appears disconnected. Switch panel on the waterward side. Underground electric conduit to pump. O&M Manual SJR 611.1 Vol. F. FS Date: 05/06/2014

Pump and concrete standpipe on WS berm.

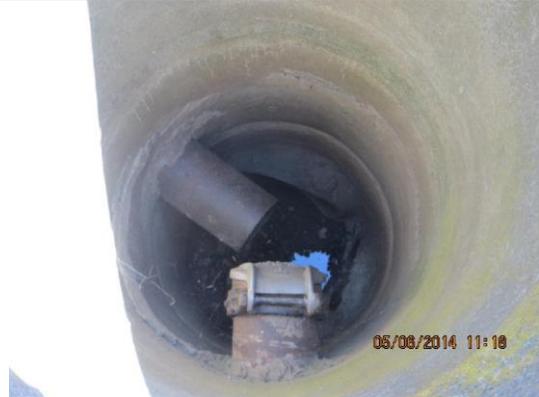
Photo 2 of 3 : UCIP\_FA\_2015\_4365.jpg

Inspector Comments: FS\_ID:36207  
 DS\_ID:23357  
 EP\_NO: N/A  
 FS\_HLM: 11.76  
 Repair Type: Non-Urgent  
 Crossing Status: Found  
 UCIP Comments: Verify status of crossing as pipe is disconnected at pump and appears abandoned.  
 FIELD\_STRUCT\_DESC: 10-inch pipe through the levee 4.0 feet below the crown. 36-inch concrete standpipe on the waterward side. Pump mounted over well on the waterward side. 8-inch intake pipe from channel to standpipe appears disconnected. Switch panel on the waterward side. Underground electric conduit to pump. O&M Manual SJR 611.1 Vol. F.  
 FS Date: 05/06/2014

Inside standpipe on WS berm. Flapgate on pipe to pump in previous picture. Note 10-inch pipe below and to right of flapgate is one that goes through the levee.

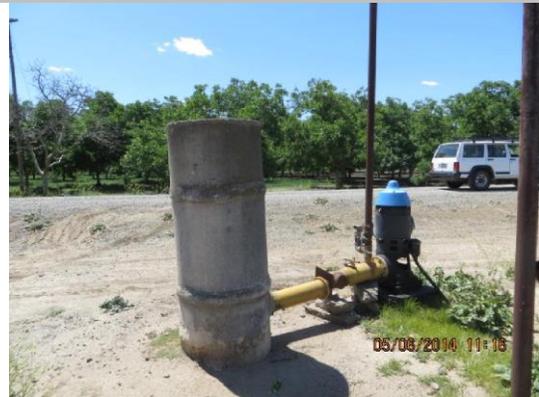
Photo 3 of 3 : UCIP\_FA\_2015\_4366.jpg

Pump and concrete standpipe on WS berm.

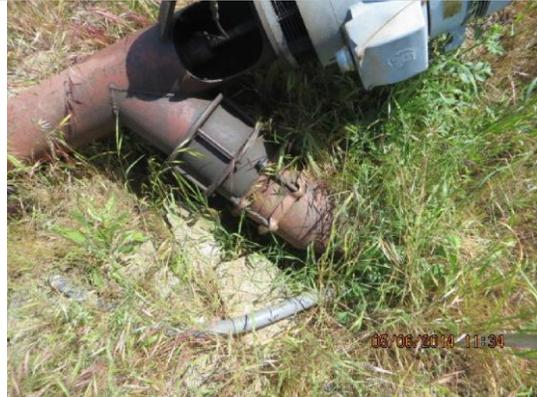
Photo 1 of 3 : UCIP\_FA\_2015\_4367.jpg

LM Start	<b>11.95</b>	Rating **	M	Issue No.	<b>848</b>
LM End	<b>11.95</b>	Issue Type +	En	Location *	LS
Category	Supplemental			GPS Latitude/Longitude	
				Start	End
Item	DWR UCIP Field Study			37.961434 °	37.961434 °
				-121.178942 °	-121.178942 °
DWR ID					
Action/Comments					
Inspector Comments: FS_ID:36223 DS_ID:23386 EP_NO: N/A FS_HLM: 12.286 Repair Type: Non-Urgent Crossing Status: Found UCIP Comments: Abandoned concrete standpipe on LS slope. Pipe has been excavated on LS toe area should be restored. FIELD_STRUCT_DESC: 12-inch steel irrigation pipe through the levee 5.0-feet below the crown. Slant Pump on waterward bank. Cobble grouted pooling area in channel. 10-inch PVC standpipe at LS toe. Deep water levee. Deep water well on berm. 1.5-inch galvanized iron electrical conduit at same location O&M Manual SJR 611.1 Vol. F. Permit No. 7638, 1972. FS Date: 05/06/2014

Pipe and pump visible on WS slope.

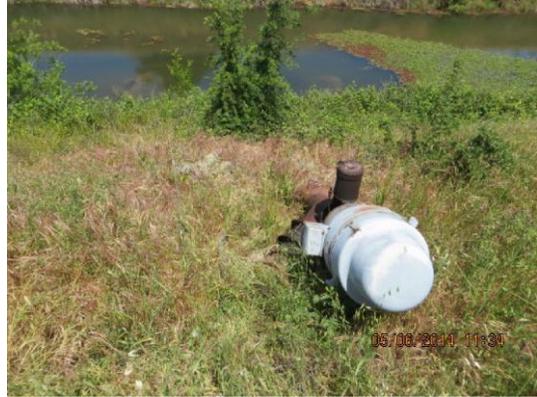
Photo 2 of 3 : UCIP\_FA\_2015\_4368.jpg

Slant pump on WS slope.

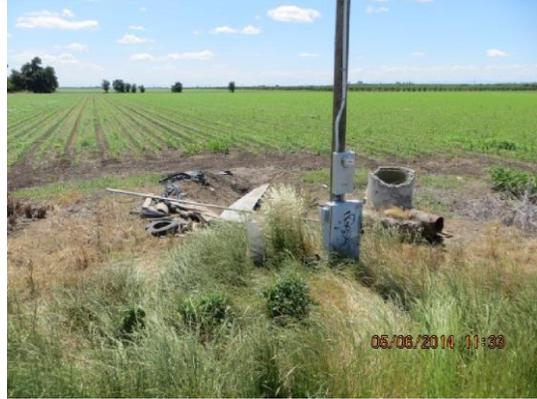
Photo 3 of 3 : UCIP\_FA\_2015\_4369.jpg

Power pole, electrical panel, abandoned concrete standpipe, and turnout area on LS toe.

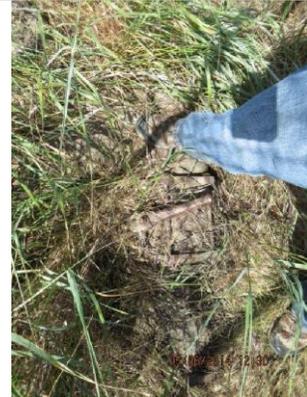
Photo 1 of 3 : UCIP\_FA\_2015\_5706.jpg

LM Start	<b>12.84</b>	Rating **	M	Issue No.	<b>849</b>
LM End	<b>12.84</b>	Issue Type +	En	Location *	WS
Category	Supplemental			GPS Latitude/Longitude	
				Start	End
Item	DWR UCIP Field Study			37.959523 °	37.959523 °
				-121.194876 °	-121.194876 °
DWR ID					
Action/Comments					
Inspector Comments: FS_ID:36245 DS_ID:23391 EP_NO: 6095 FS_HLM: 13.192 Repair Type: Non-Urgent Crossing Status: Found UCIP Comments: Appears abandoned and if so should be done so properly. FIELD_STRUCT_DESC: 18-inch steel irrigation pipe through the levee on an angle, 4.5 feet below the crown. Wire cage around slant pump on the waterward slope. Abandoned water well at the landward toe. Underground electric conduit through the levee. (App. No. 6095 - Ray Camera) O&M Manual SJR 611.1 Vol. F. FS Date: 05/06/2014

Butterfly valve on WS shoulder.

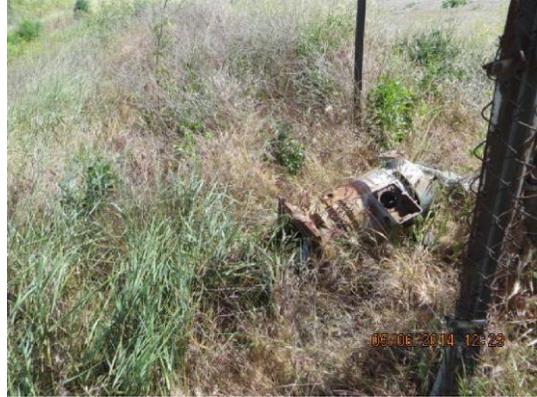
Photo 2 of 3 : UCIP\_FA\_2015\_5707.jpg

Pump missing parts on WS shoulder.

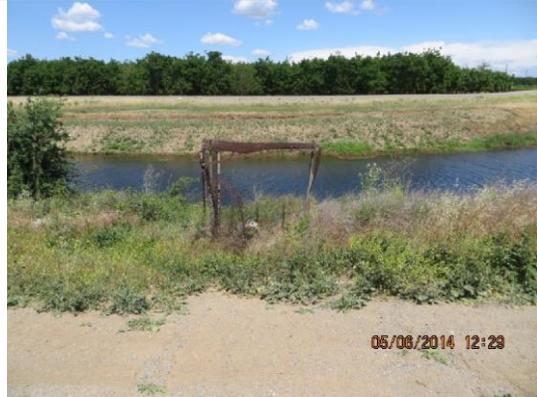
Photo 3 of 3 : UCIP\_FA\_2015\_5708.jpg

Pump in fenced pen on WS shoulder.

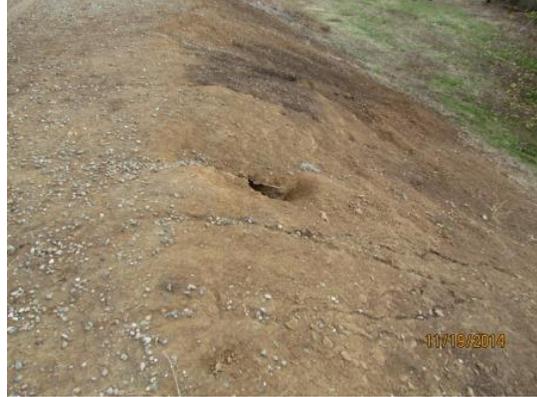
Photo 1 of 1 : FA\_2015\_NA0017\_160\_260\_20150911\_00147.jpg

LM Start	<b>14.48</b>	Rating **	U	Issue No.	<b>260</b>
LM End	<b>14.48</b>	Issue Type +	Ma	Location *	LS
Category	Earthen Levee			GPS Latitude/Longitude	
				Start	End
Item	Animal Control			37.968800 °	37.968800 °
				-121.220755 °	-121.220755 °
DWR ID	DWR_NA0017_16_f_2014_260				
Action/Comments					
No rodents visible, but rodent burrows visible; need to backfill and compact or grout burrows.

Rodent holes were found on the landside slope of the levee looking upstream.

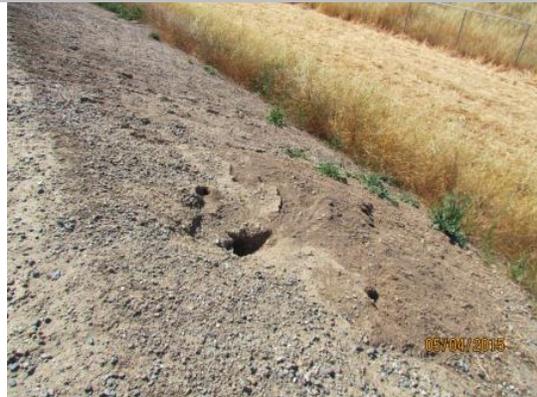
Photo 1 of 1 : FA\_2015\_NA0017\_160\_273\_20150911\_00156.jpg

LM Start	<b>14.61</b>	Rating **	U	Issue No.	<b>273</b>
LM End	<b>14.61</b>	Issue Type +	Ma	Location *	LS
Category	Earthen Levee			GPS Latitude/Longitude	
				Start	End
Item	Animal Control			37.969913 °	37.969913 °
				-121.222870 °	-121.222870 °
DWR ID	DWR_NA0017_16_s_2015_273				
Action/Comments					
No rodents visible, but rodent burrows visible; need to backfill and compact or grout burrows.

Rodent holes were found on the landside of the levee looking upstream.

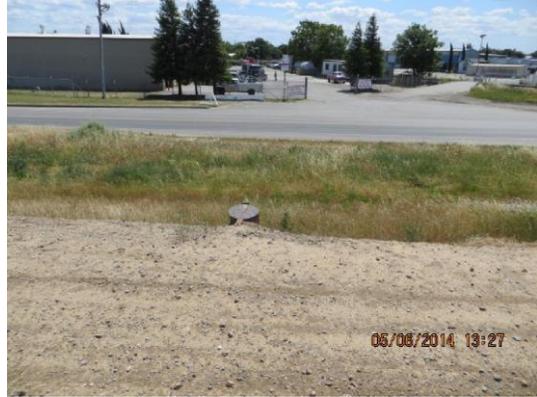
Photo 1 of 1 : UCIP\_FA\_2015\_5741.jpg

LM Start	<b>14.76</b>	Rating **	M	Issue No.	<b>850</b>
LM End	<b>14.76</b>	Issue Type +	En	Location *	LS
Category	Supplemental			GPS Latitude/Longitude	
				Start	End
Item	DWR UCIP Field Study			37.970975 °	37.970975 °
				-121.225127 °	-121.225127 °
DWR ID					
Action/Comments					
Inspector Comments: FS_ID:36284 DS_ID:23395 EP_NO: 14796 FS_HLM: 15.137 Repair Type: Non-Urgent Crossing Status: Indicator Found UCIP Comments: Appears abandoned as Siphon breaker is filled with soil and no pipe is visible at WS toe. Verify status of pipe. FIELD_STRUCT_DESC: 4-inch steel stormdrain pipe through levee, 2.5-feet below the crown. Siphon breaker in 12-inch steel standpipe on LS shoulder (Permit No. 14796 - Search Development, Inc.) FS Date: 05/06/2014

Siphon breaker in 12-inch standpipe on LS shoulder. Standpipe filled with soil.

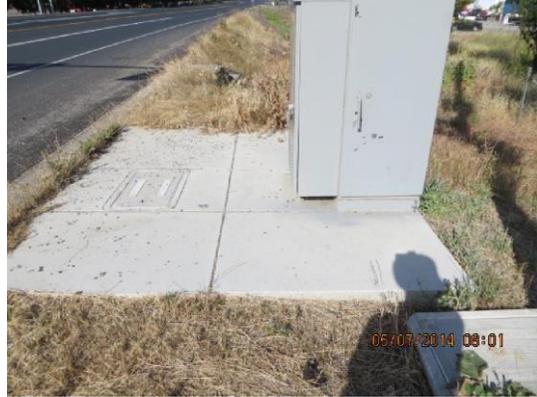
Photo 1 of 3 : UCIP\_FA\_2015\_5811.jpg

LM Start	<b>15.21</b>	Rating **	M	Issue No.	<b>851</b>
LM End	<b>15.21</b>	Issue Type +	En	Location *	LS
Category	Supplemental			GPS Latitude/Longitude	
				Start	End
Item	DWR UCIP Field Study			37.974060 °	37.974060 °
				-121.232510 °	-121.232510 °
DWR ID					
Action/Comments					
Inspector Comments: FS_ID:41524 DS_ID:24961 EP_NO: N/A FS_HLM: 15.6 Repair Type: Non-Urgent Crossing Status: Indicator Found UCIP Comments: No permit identified for crossing. FIELD_STRUCT_DESC: Electrical conduit through the levee at an unknown depth below the crown. Cut in pavement visible across crown. 3'X2' Christy box on WS shoulder next to control panel. FS Date: 05/07/2014

Christy box and control panel off LS toe along edge of roadway. Likely source of crossing.

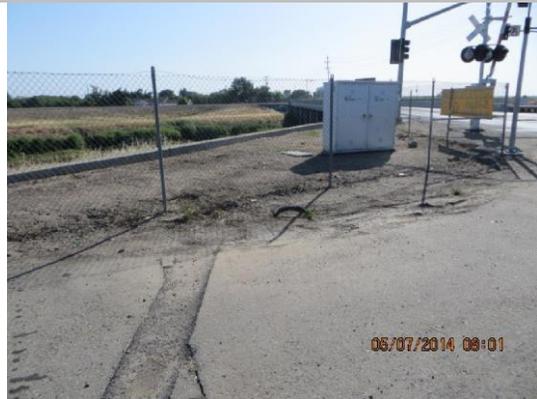
Photo 2 of 3 : UCIP\_FA\_2015\_5812.jpg

Cut in pavement over conduit at crown, looking toward WS shoulder.

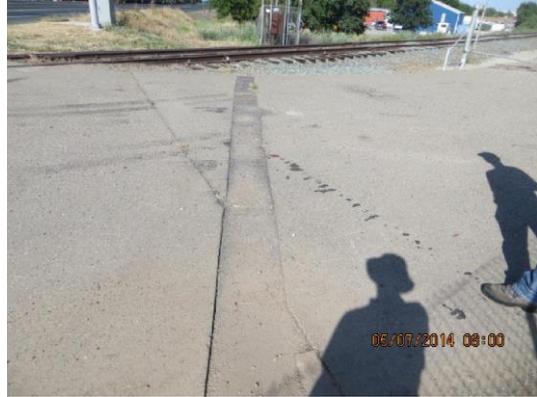
Photo 3 of 3 : UCIP\_FA\_2015\_5813.jpg

Cut in pavement over conduit at crown, looking toward LS toe.

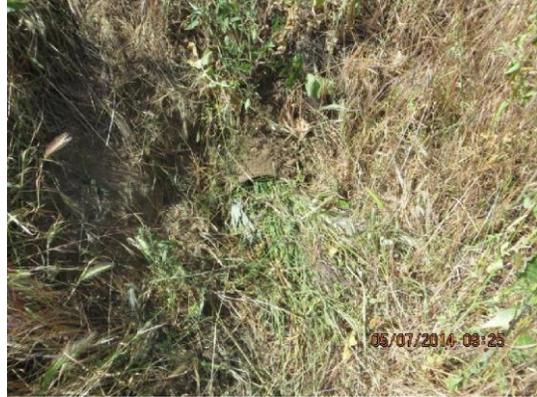
Photo 1 of 3 : UCIP\_FA\_2015\_5674.jpg

LM Start	<b>16.39</b>	Rating **	U	Issue No.	<b>852</b>
LM End	<b>16.39</b>	Issue Type +	En	Location *	LS
Category	Supplemental			GPS Latitude/Longitude	
				Start	End
Item	DWR UCIP Field Study			37.982114 °	37.982114 °
				-121.251592 °	-121.251592 °
DWR ID					
Action/Comments					
Inspector Comments: FS_ID:41245 DS_ID:23441 EP_NO: 13142 FS_HLM: 16.8 Repair Type: Urgent Crossing Status: Found UCIP Comments: Outlet on WS slope appears to be filled with soil and should be cleared. No flapgate. FIELD_STRUCT_DESC: 10-inch steel stormdrain discharge pipe through the levee 5-feet below the crown. Two pumps and two gatevalves at LS toe. Pipe visible on WS slope (Permit No. 13142 - Operating Engineers Local Union No. 3) FS Date: 05/07/2014

Vegetation and soil blocking outlet on WS slope.

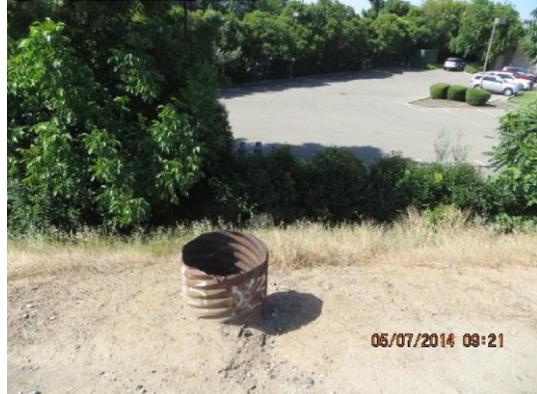
Photo 2 of 3 : UCIP\_FA\_2015\_5675.jpg

Siphon breaker in 22-inch CMP riser on LS shoulder.

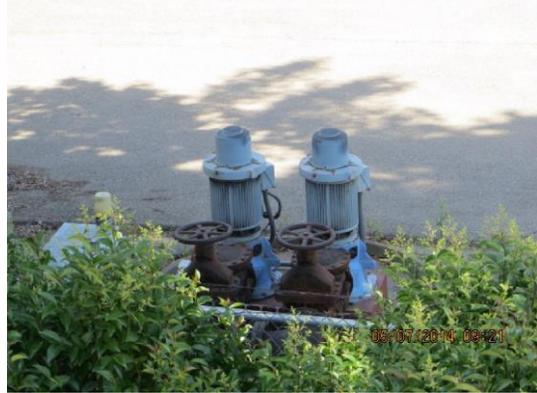
Photo 3 of 3 : UCIP\_FA\_2015\_5676.jpg

Pumps and gatevalves on LS toe.

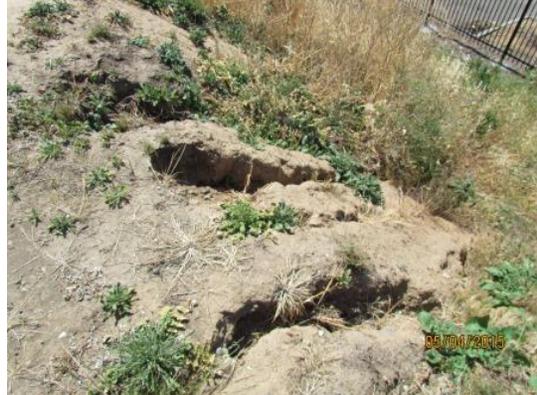
Photo 1 of 2 : FA\_2015\_NA0017\_160\_150\_20150911\_00084.jpg

LM Start	<b>16.43</b>	Rating **	M	Issue No.	<b>150</b>
LM End	<b>16.43</b>	Issue Type +	Ma	Location *	LS
Category	Earthen Levee			GPS Latitude/Longitude	
				Start	End
Item	Erosion / Bank Caving			37.982318 °	37.982318 °
				-121.252095 °	-121.252095 °
DWR ID	DWR_NA0017_16_s_2013_150				
Action/Comments					
Schedule repair of erosion site prior to the next inspection. Inspector Comments: Runoff

Updated picture of the erosion on the landside shoulder of the levee looking upstream during spring 2015 inspection.

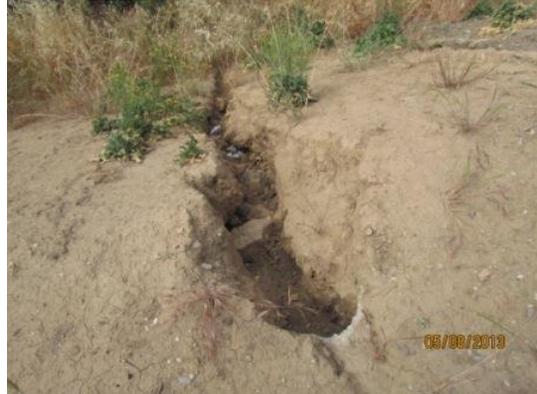
Photo 2 of 2 : FA\_2015\_NA0017\_160\_150\_20150911\_00085.jpg

Erosion was found on the landside of the levee looking downstream.

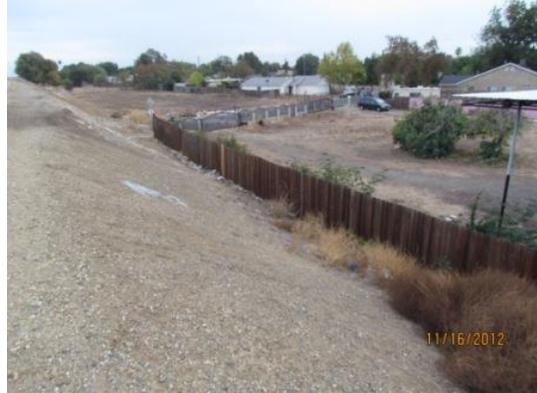
Photo 1 of 1 : FA\_2015\_NA0017\_160\_69\_20150911\_00037.jpg

LM Start	<b>17.15</b>	Rating **	M	Issue No.	<b>69</b>
LM End	<b>17.19</b>	Issue Type +	En	Location *	LS
Category	Earthen Levee		GPS Latitude/Longitude		
			Start	End	
Item	Encroachments		37.987313 °	37.987607 °	
			-121.263725 °	-121.264392 °	
DWR ID	DWR_NA0017_16_s_2012_69				
Action/Comments					
Fence

A fence was found on the landside toe of the levee looking upstream.

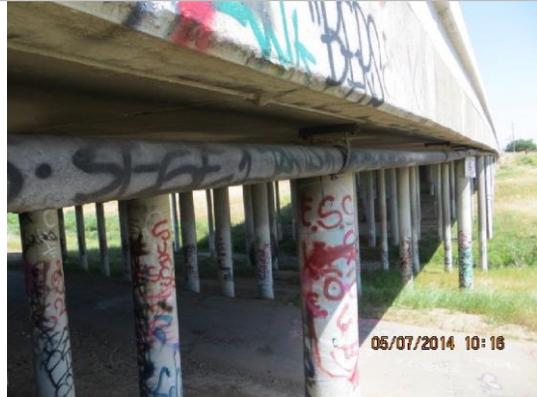
Photo 1 of 1 : UCIP\_FA\_2015\_5814.jpg

LM Start	<b>17.41</b>	Rating **	M	Issue No.	<b>853</b>
LM End	<b>17.41</b>	Issue Type +	En	Location *	LS
Category	Supplemental		GPS Latitude/Longitude		
			Start	End	
Item	DWR UCIP Field Study		37.989070 °	37.989070 °	
			-121.267940 °	-121.267940 °	
DWR ID					
Action/Comments					
Inspector Comments: FS_ID:39088 DS_ID:24962 EP_NO: N/A FS_HLM: 17.829 Repair Type: Non-Urgent Crossing Status: Found UCIP Comments: Need to determine what conduit is for. No permit identified for crossing. FIELD_STRUCT_DESC: 4-inch steel conduit through the levee at an unknown depth. Pipe attached to upstream side of bridge. FS Date: 05/07/2014

Pipe visible on uderside of upstream side of bridge.

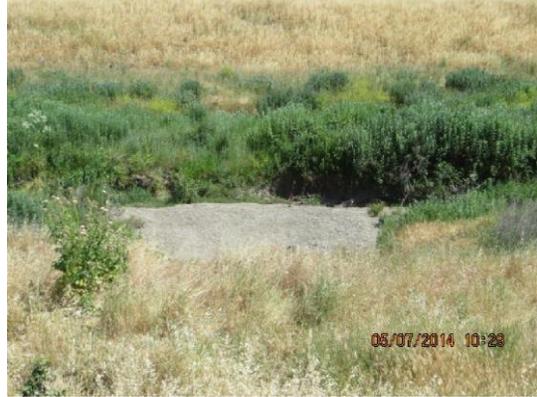
Photo 1 of 3 : UCIP\_FA\_2015\_4706.jpg

**Action/Comments**  
 Inspector Comments: FS\_ID:41246  
 DS\_ID:23366  
 EP\_NO: 10515  
 FS\_HLM: 18.22  
 Repair Type: Non-Urgent  
 Crossing Status: Found  
 UCIP Comments: Some erosion on upstream side of headwall. No flapgate.  
 FIELD\_STRUCT\_DESC: 1 of 4: 27-inch steel drainpipe through the levee 5.0-feet below the crown. Pumping plant on the landward side. 44-inch concrete riser on WS shoulder and concrete headwall at WS toe  
 (Permit No.10515 - Southern Pacific Industrial Development Co.)  
 FS Date: 05/07/2014

Headwall and pipe visible on WS toe.

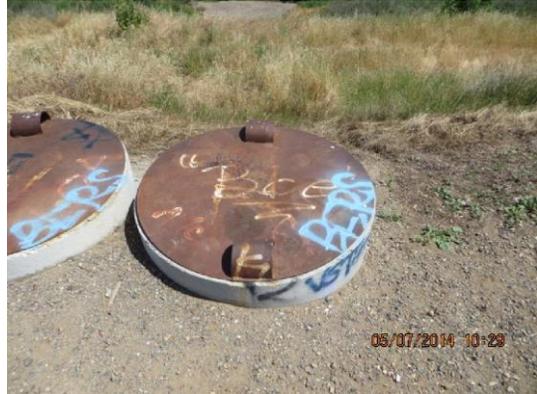
Photo 2 of 3 : UCIP\_FA\_2015\_4707.jpg

Concrete riser on WS shoulder.

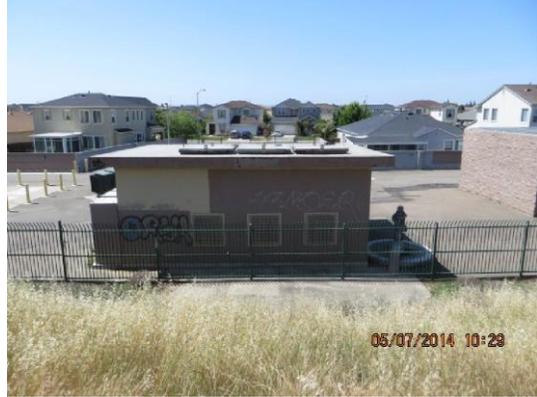
Photo 3 of 3 : UCIP\_FA\_2015\_4708.jpg

Pumphouse on LS toe.

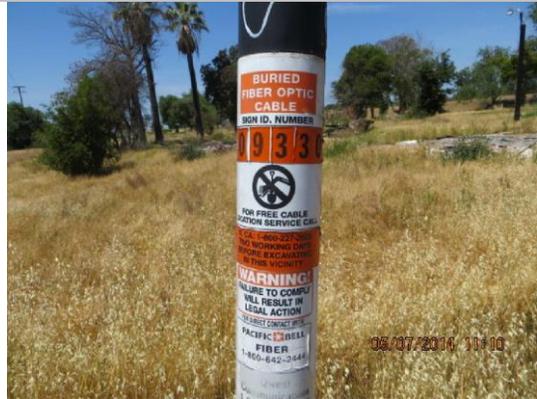
Photo 1 of 2 : UCIP\_FA\_2015\_4723.jpg

LM Start	<b>18.25</b>	Rating **	M	Issue No.	<b>857</b>
LM End	<b>18.25</b>	Issue Type +	En	Location *	LS
Category	Supplemental			GPS Latitude/Longitude	
				Start	End
Item	DWR UCIP Field Study			37.993714 °	37.993714 °
				-121.281763 °	-121.281763 °
DWR ID					
Action/Comments					
Inspector Comments: FS_ID:41945 DS_ID:23368 EP_NO: 14322 FS_HLM: 18.676 Repair Type: Non-Urgent Crossing Status: Indicator Found UCIP Comments: Need to determine Permit No. for crossing as PN: 14322 appears to have been for GTE, not pac bell and was withdrawn by applicant. FIELD_STRUCT_DESC: Communication line-Fiber optic line through the levee at unknown depth beneath the crown. Pacific Bell Fiber Optic line markers along rail tracks on downstream side of railroad tracks on both sides of Mormon Slough. FS Date: 05/07/2014

Fiber optic line markers on south side of slough.

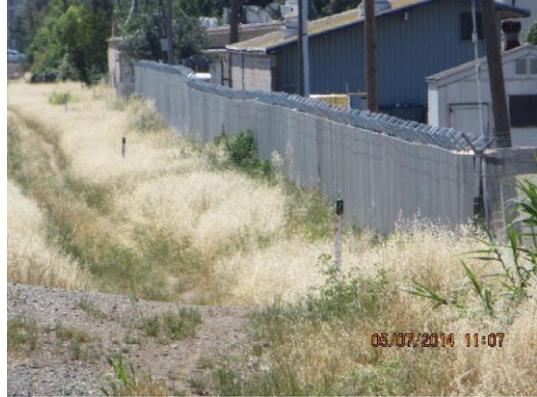
Photo 2 of 2 : UCIP\_FA\_2015\_4724.jpg

Fiber optic line markers on south side of slough.

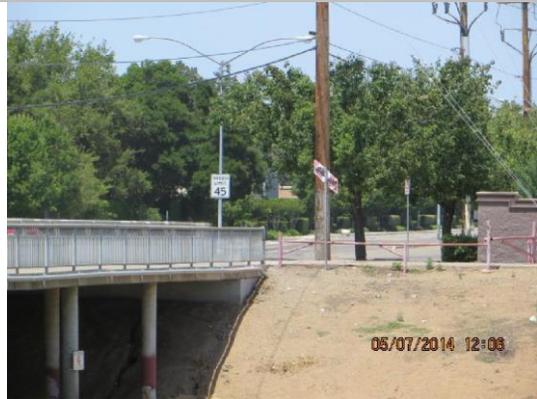
Photo 1 of 1 : UCIP\_FA\_2015\_4901.jpg

LM Start	18.54	Rating **	M	Issue No.	858	
LM End	18.54	Issue Type +	En	Location *	LS	
Category	Supplemental			GPS Latitude/Longitude		
			Start	End		
Item	DWR UCIP Field Study			37.992476 °	37.992476 °	
				-121.286713 °	-121.286713 °	
DWR ID						
Action/Comments						
Inspector Comments: FS_ID:37224 DS_ID:23500 EP_NO: 14601 FS_HLM: 18.968 Repair Type: Non-Urgent Crossing Status: Indicator Found UCIP Comments: Verify with PG&E that this pipe is still in use. FIELD_STRUCT_DESC: 10-inch steel gas pipeline through the levee and under the channel at unknown depth. (Permit No. 14601 references this existing pipe but is not for this pipe) FS Date: 05/07/2014

Gasline marker on oposite bank.

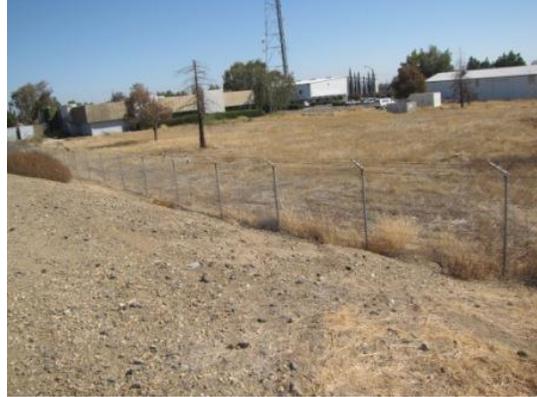
Photo 1 of 1 : FA\_2015\_NA0017\_160\_143\_20150911\_00082.jpg

LM Start	<b>18.57</b>	Rating **	M	Issue No.	<b>143</b>
LM End	<b>18.77</b>	Issue Type +	En	Location *	LS
Category	Earthen Levee			GPS Latitude/Longitude	
				Start	End
Item	Encroachments			37.992385 °	37.992564 °
				-121.287251 °	-121.290846 °
DWR ID	DWR_NA0017_16_s_2012_143				
Action/Comments					
Fence

View of a fence along the landward toe looking upstream.

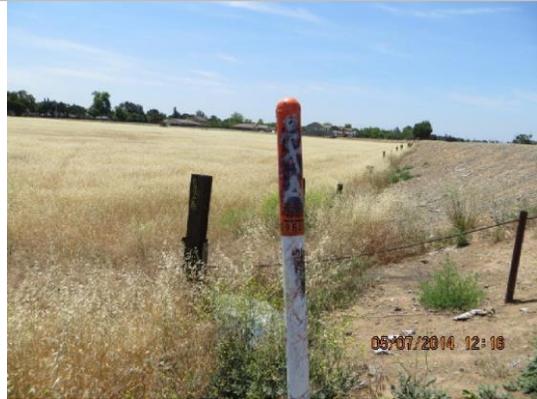
Photo 1 of 3 : UCIP\_FA\_2015\_5816.jpg

LM Start	<b>18.79</b>	Rating **	M	Issue No.	<b>859</b>
LM End	<b>18.79</b>	Issue Type +	En	Location *	LS
Category	Supplemental			GPS Latitude/Longitude	
				Start	End
Item	DWR UCIP Field Study			37.992483 °	37.992483 °
				-121.291215 °	-121.291215 °
DWR ID					
Action/Comments					
Inspector Comments: FS_ID:41949 DS_ID:24964 EP_NO: N/A FS_HLM: 19.226 Repair Type: Non-Urgent Crossing Status: Indicator Found UCIP Comments: No permit identified for this crossing. FIELD_STRUCT_DESC: Communication cable markers along downstream side of bridge. FS Date: 05/07/2014

Comm line marker on LS toe.

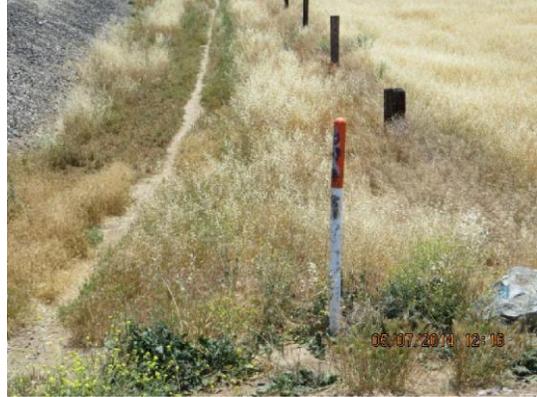
Photo 2 of 3 : UCIP\_FA\_2015\_5817.jpg

Comm line marker on LS toe.

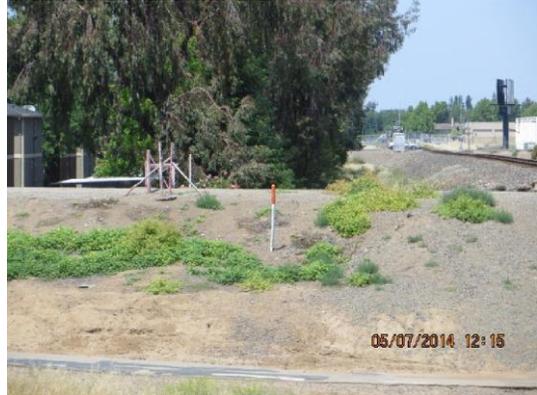
Photo 3 of 3 : UCIP\_FA\_2015\_5818.jpg

Comm line marker on opposite bank.

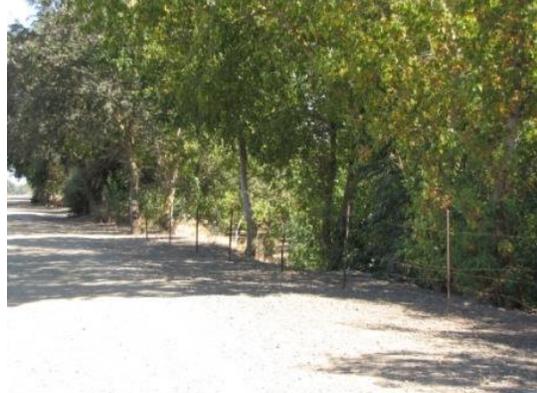
Photo 1 of 1 : FA\_2015\_NA0017\_160\_137\_20150911\_00077.jpg

LM Start	<b>19.03</b>	Rating **	M	Issue No.	<b>137</b>
LM End	<b>19.16</b>	Issue Type +	En	Location *	LS
Category	Earthen Levee		GPS Latitude/Longitude		
			Start	End	
Item	Encroachments		37.991653 °	37.991169 °	
			-121.295441 °	-121.297768 °	
DWR ID	DWR_NA0017_16_s_2012_137				
Action/Comments					
Fence Inspector Comments: Barbed wire

View of a barbed wire fence and landscaping along the landward shoulder and slope looking upstream.

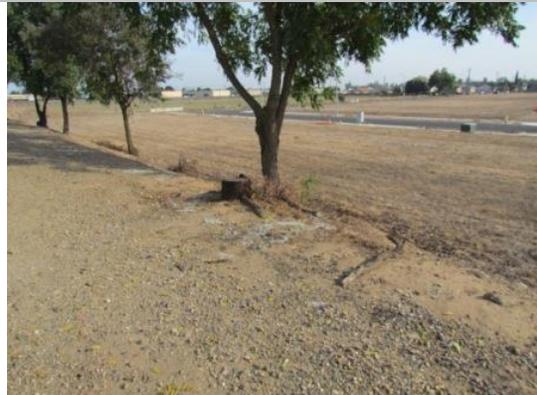
Photo 1 of 1 : FA\_2015\_NA0017\_160\_65\_20150911\_00033.jpg

LM Start	<b>19.04</b>	Rating **	N	Issue No.	<b>65</b>
LM End	<b>19.04</b>	Issue Type +	Ma	Location *	LS
Category	Earthen Levee		GPS Latitude/Longitude		
			Start	End	
Item	Trim / Thin Trees		37.991617 °	37.991617 °	
			-121.295628 °	-121.295628 °	
DWR ID	DWR_NA0017_16_s_2012_65				
Action/Comments					
Tree stumps.

A tree stump was found on the landside of the levee looking upstream.

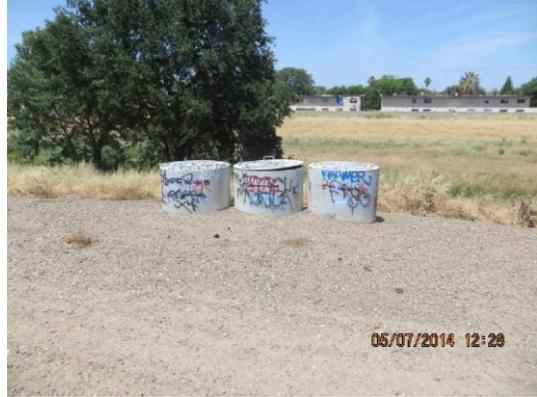
Photo 1 of 3 : UCIP\_FA\_2015\_4902.jpg

**Action/Comments**  
 Inspector Comments: FS\_ID:42863  
 DS\_ID:23374  
 EP\_NO: 3175  
 FS\_HLM: 19.679  
 Repair Type: Urgent  
 Crossing Status: Found  
 UCIP Comments: Wet hole over pipe on LS slope indicating pipe failure.  
 FIELD\_STRUCT\_DESC: 1 of 3: 16-inch steel stormdrain pipe through the levee 3.5 feet. Below crown. Flap gate on waterward end. Siphon breaker in 42-inch concrete riser units at the waterward shoulder. Concrete headwall at the landward toe. Concrete block pump house on the landward side. Chain link fence around pump house. (Permit No.3175 - City of Stockton) O&M Manual SJR Assumed 999.  
 FS Date: 05/07/2014

vent in concrete standpipe on WS shoulder.

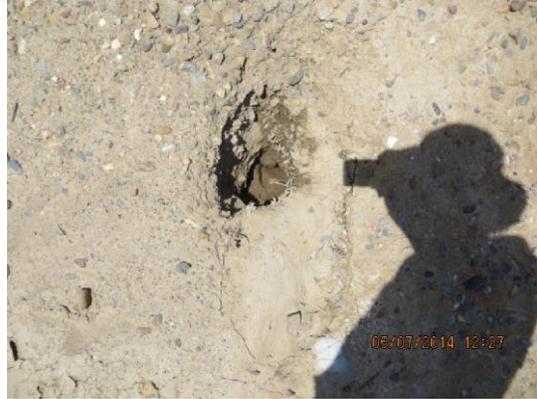
Photo 2 of 3 : UCIP\_FA\_2015\_4903.jpg

Hole over pipe on LS slope.

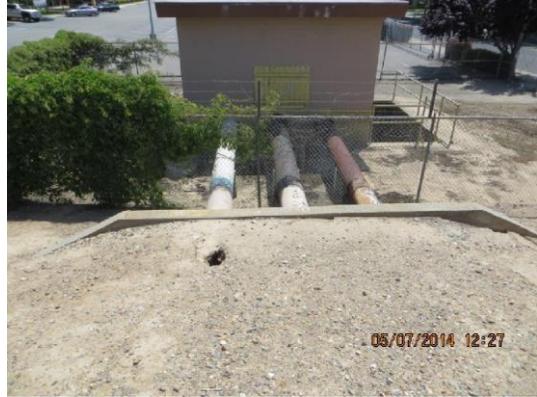
Photo 3 of 3 : UCIP\_FA\_2015\_4904.jpg

Hole over pipe on LS slope.

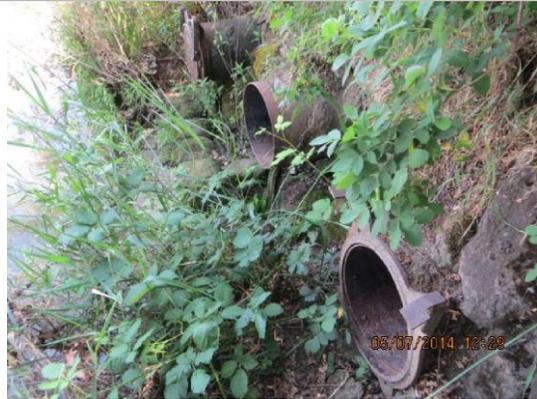
Photo 1 of 3 : UCIP\_FA\_2015\_4905.jpg

LM Start	<b>19.24</b>	Rating **	U	Issue No.	<b>861</b>
LM End	<b>19.24</b>	Issue Type +	En	Location *	LS
Category	Supplemental			GPS Latitude/Longitude	
				Start	End
Item	DWR UCIP Field Study			37.991048 °	37.991048 °
				-121.299203 °	-121.299203 °
DWR ID					
Action/Comments					
Inspector Comments: FS_ID:42984 DS_ID:23496 EP_NO: 3175 FS_HLM: 19.681 Repair Type: Urgent Crossing Status: Found UCIP Comments: Flapgate missing from WS toe. FIELD_STRUCT_DESC: 2 of 3: 18-inch steel drainage pipe through the levee 3.5 feet. Below crown. Flap gate on waterward end. Siphon breaker in 42-inch concrete riser units at the waterward shoulder. Concrete headwall at the landward toe. Concrete block pump house on the landward side. Chain link fence around pump house. (Permit No.3175 - City of Stockton) O&M Manual SJR Assumed 999. FS Date: 05/07/2014

Flapgate missing from pipe on WS toe.

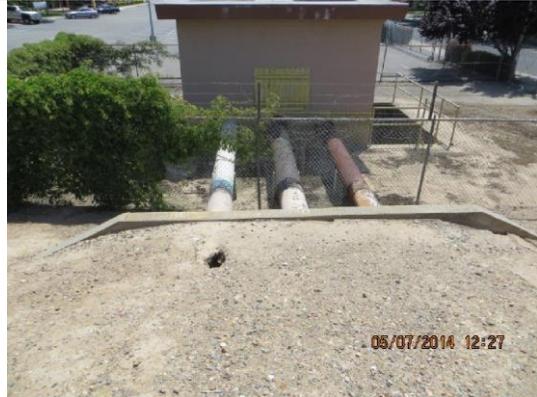
Photo 3 of 3 : UCIP\_FA\_2015\_4907.jpg

Pipe at center of picture.

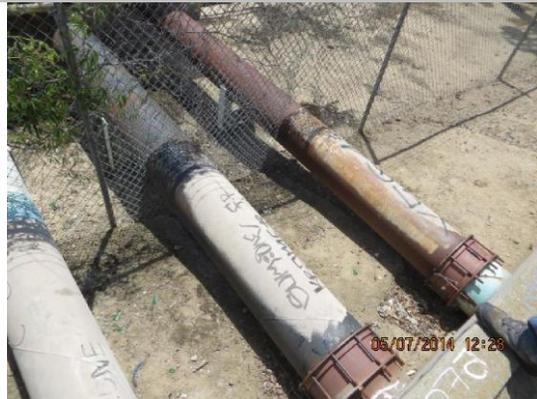
Photo 2 of 3 : UCIP\_FA\_2015\_4909.jpg

Pipe to right in picture.

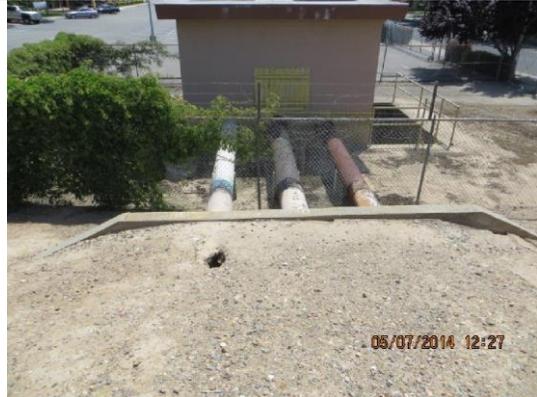
Photo 3 of 3 : UCIP\_FA\_2015\_4910.jpg

Pipe to right in picture.

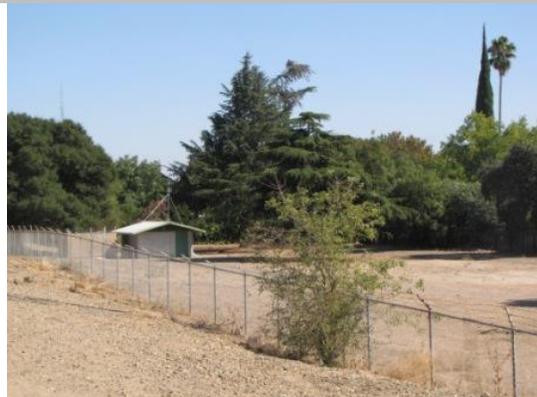
Photo 1 of 1 : FA\_2015\_NA0017\_160\_134\_20150911\_00074.jpg

LM Start	<b>19.38</b>	Rating **	M	Issue No.	<b>134</b>
LM End	<b>19.45</b>	Issue Type +	En	Location *	LS
Category	Earthen Levee			GPS Latitude/Longitude	
				Start	End
Item	Encroachments			37.991130 °	37.990950 °
				-121.301742 °	-121.303084 °
DWR ID	DWR_NA0017_16_s_2012_134				
Action/Comments					
Fence

View of a fence along the landward toe looking upstream.

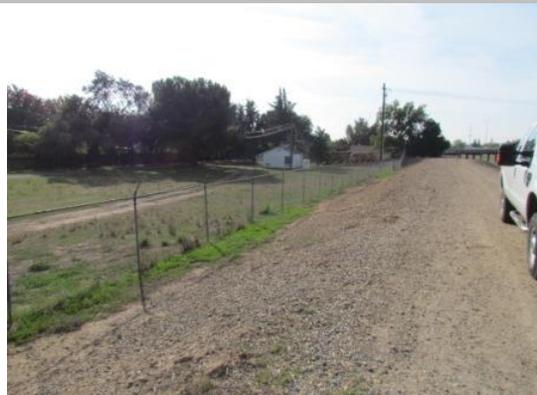
Photo 1 of 1 : FA\_2015\_NA0017\_160\_133\_20150911\_00073.jpg

LM Start	<b>19.45</b>	Rating **	M	Issue No.	<b>133</b>
LM End	<b>19.47</b>	Issue Type +	En	Location *	LS
Category	Earthen Levee			GPS Latitude/Longitude	
				Start	End
Item	Encroachments			37.990948 °	37.990903 °
				-121.303099 °	-121.303354 °
DWR ID	DWR_NA0017_16_s_2012_133				
Action/Comments					
Fence Inspector Comments: Wire fence

Wire fence was found on the toe of landside of the levee looking downstream.

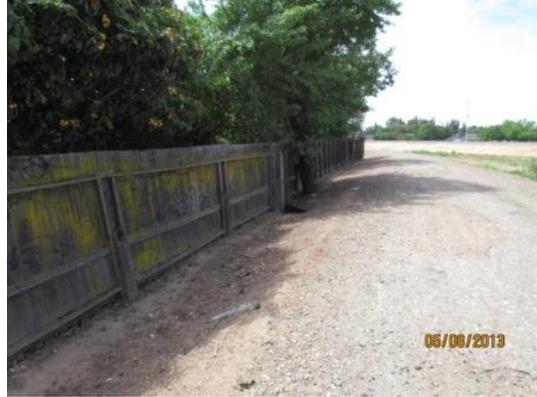
Photo 1 of 1 : FA\_2015\_NA0017\_160\_78\_20150911\_00041.jpg

LM Start	<b>19.60</b>	Rating **	U	Issue No.	<b>78</b>
LM End	<b>19.79</b>	Issue Type +	En	Location *	LS
Category	Earthen Levee		GPS Latitude/Longitude		
			Start	End	
Item	Encroachments		37.989681 °	37.987126 °	
			-121.305221 °	-121.306587 °	
DWR ID	DWR_NA0017_16_s_2012_78				
Action/Comments					
Fence Inspector Comments: Fences were found on the slope of the levee.

Fences were obstructing the landside slope of the levee looking downstream.

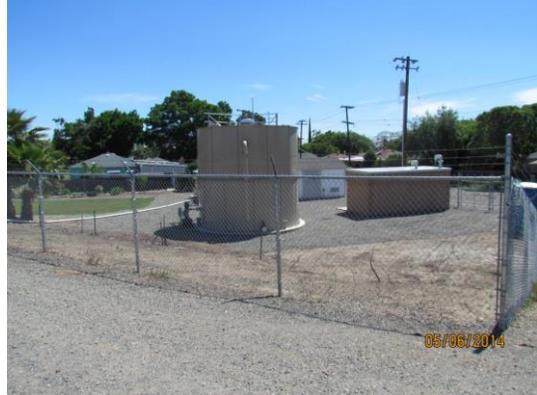
Photo 1 of 2 : FA\_2015\_NA0017\_160\_161\_20150911\_00090.jpg

LM Start	<b>19.81</b>	Rating **	M	Issue No.	<b>161</b>
LM End	<b>19.81</b>	Issue Type +	En	Location *	LS
Category	Earthen Levee		GPS Latitude/Longitude		
			Start	End	
Item	Encroachments		37.986848 °	37.986848 °	
			-121.306716 °	-121.306716 °	
DWR ID	DWR_NA0017_16_s_2013_161				
Action/Comments					
Tank Inspector Comments: An unpermitted tank was found on the landside toe of the levee.

View of the tank (unpermitted) on the landside toe of the levee looking upstream.

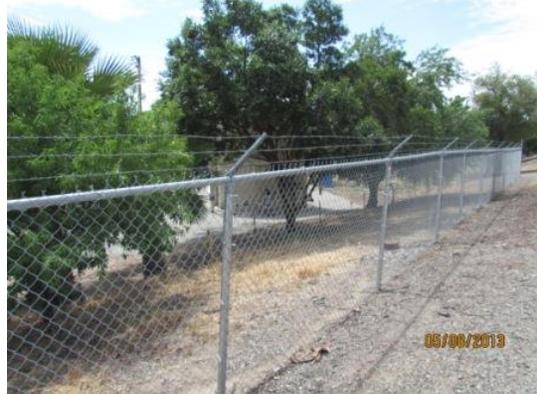
Photo 2 of 2 : FA\_2015\_NA0017\_160\_161\_20150911\_00091.jpg

A newly installed tank (unpermitted) was found on the landside toe of the levee looking downstream.

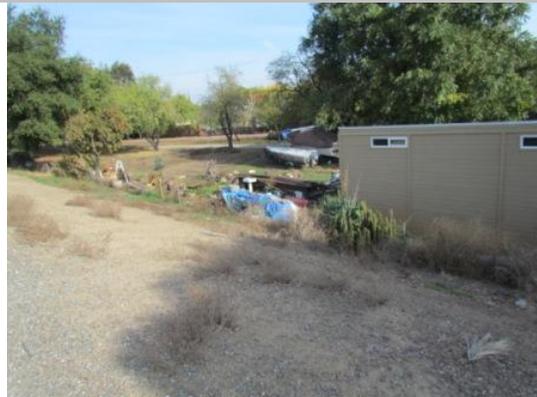
Photo 1 of 1 : FA\_2015\_NA0017\_160\_178\_20150911\_00109.jpg

LM Start	<b>19.99</b>	Rating **	M	Issue No.	<b>178</b>
LM End	<b>20.03</b>	Issue Type +	En	Location *	LS
Category	Earthen Levee		GPS Latitude/Longitude		
			Start	End	
Item	Vegetation		37.984576 °	37.984215 °	
			-121.308320 °	-121.308818 °	
DWR ID	DWR_NA0017_16_s_2012_178				
Action/Comments					
Landscaping

Landscaping was found on the toe of landside of the levee looking upstream.

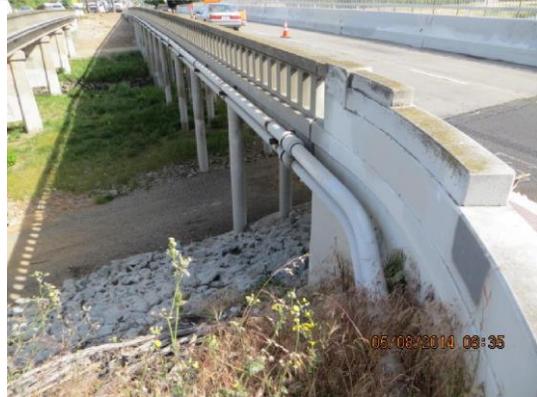
Photo 1 of 2 : UCIP\_FA\_2015\_5819.jpg

LM Start	<b>20.08</b>	Rating **	M	Issue No.	<b>863</b>
LM End	<b>20.08</b>	Issue Type +	En	Location *	LS
Category	Supplemental			GPS Latitude/Longitude	
				Start	End
Item	DWR UCIP Field Study			37.983699 °	37.983699 °
				-121.309523 °	-121.309523 °
DWR ID					
Action/Comments					
Inspector Comments: FS_ID:41951 DS_ID:24966 EP_NO: N/A FS_HLM: 20.537 Repair Type: Non-Urgent Crossing Status: Found UCIP Comments: No permit identified for this crossing. FIELD_STRUCT_DESC: 1 of 2: 6-inch steel conduit through the levee at an unknown depth below the crown. Pipe visible at attachment to downstream side of north bound lane bridge. There is a 42-inch steel manhole 100-feet LS of the bridge. FS Date: 05/08/2014

Steel conduit mounted on downstream side of northbound bridge.

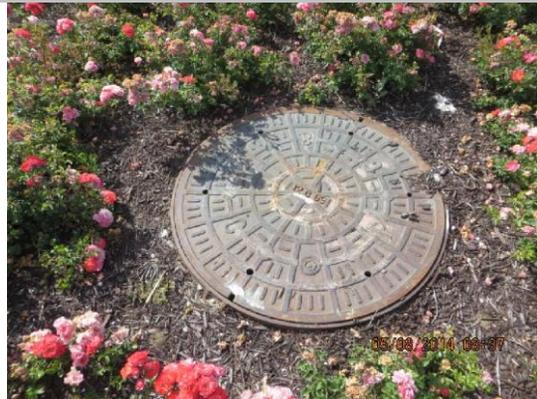
Photo 2 of 2 : UCIP\_FA\_2015\_5825.jpg

Manhole off LS shoulder in median.

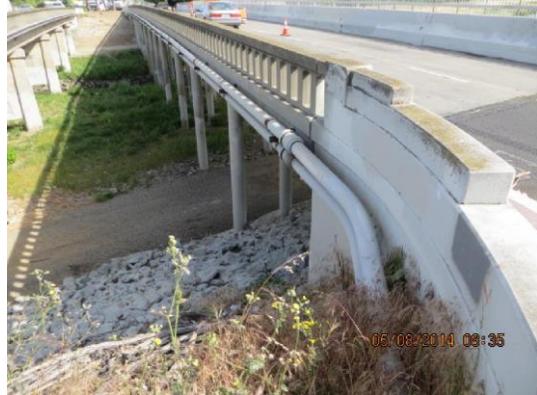
Photo 1 of 2 : UCIP\_FA\_2015\_5820.jpg

LM Start	<b>20.08</b>	Rating **	M	Issue No.	<b>864</b>
LM End	<b>20.08</b>	Issue Type +	En	Location *	LS
Category	Supplemental			GPS Latitude/Longitude	
				Start	End
Item	DWR UCIP Field Study			37.983697 °	37.983697 °
				-121.309529 °	-121.309529 °
DWR ID					
Action/Comments					
Inspector Comments: FS_ID:41952 DS_ID:24967 EP_NO: N/A FS_HLM: 20.537 Repair Type: Non-Urgent Crossing Status: Found

Steel conduit mounted on downstream side of northbound bridge.

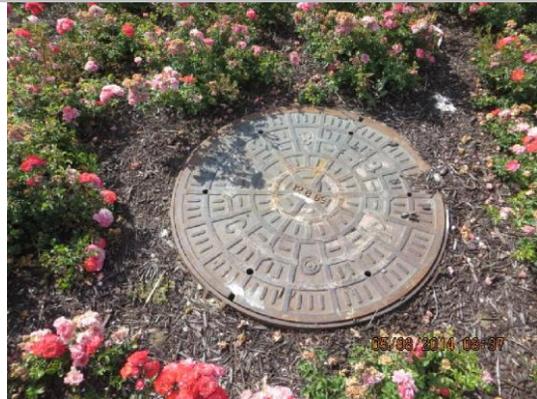
Photo 2 of 2 : UCIP\_FA\_2015\_5824.jpg

Comm line manhole in median off LS shoulder.

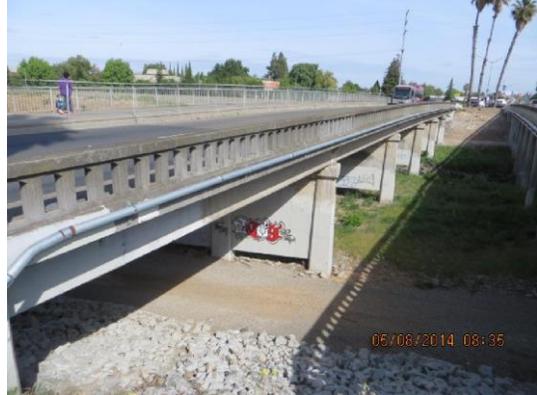
Photo 1 of 3 : UCIP\_FA\_2015\_5821.jpg

LM Start	<b>20.08</b>	Rating **	M	Issue No.	<b>865</b>
LM End	<b>20.08</b>	Issue Type +	En	Location *	LS
Category	Supplemental			GPS Latitude/Longitude	
				Start	End
Item	DWR UCIP Field Study			37.983671 °	37.983671 °
				-121.309566 °	-121.309566 °
DWR ID					
Action/Comments					
Inspector Comments: FS_ID:41953 DS_ID:24970 EP_NO: N/A FS_HLM: 20.4 Repair Type: Non-Urgent Crossing Status: Found

Conduit mounted on upstream side of southbound lane bridge.

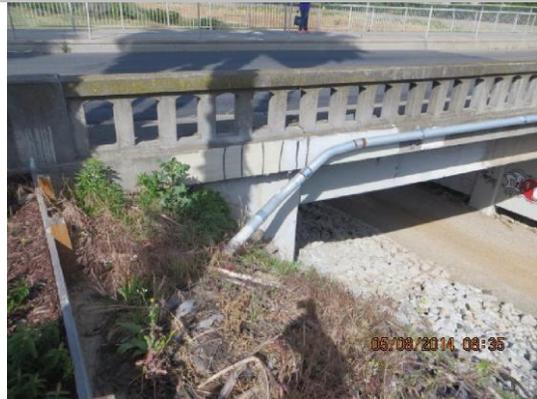
Photo 2 of 3 : UCIP\_FA\_2015\_5822.jpg

Conduit mounted on upstream side of southbound lane bridge.

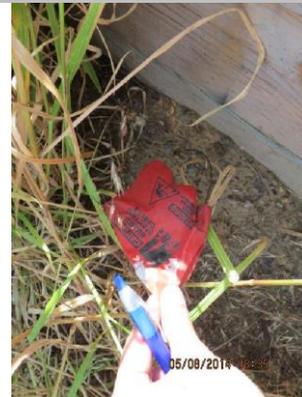
Photo 3 of 3 : UCIP\_FA\_2015\_5823.jpg

PG&E electrical line marker on WS slope.

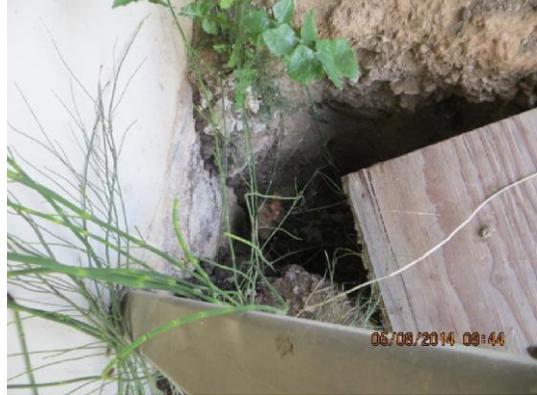
Photo 1 of 3 : UCIP\_FA\_2015\_4827.jpg

LM Start	<b>20.09</b>	Rating **	M	Issue No.	<b>866</b>
LM End	<b>20.09</b>	Issue Type +	En	Location *	LS
Category	Supplemental			GPS Latitude/Longitude	
				Start	End
Item	DWR UCIP Field Study			37.983583 °	37.983583 °
				-121.309708 °	-121.309708 °
DWR ID					
<b>Action/Comments</b>					
Inspector Comments: FS_ID:39121 DS_ID:23379 EP_NO: N/A FS_HLM: 20.55 Repair Type: Non-Urgent Crossing Status: Indicator Found

Excavation over pipe and valve at bridge abutment.

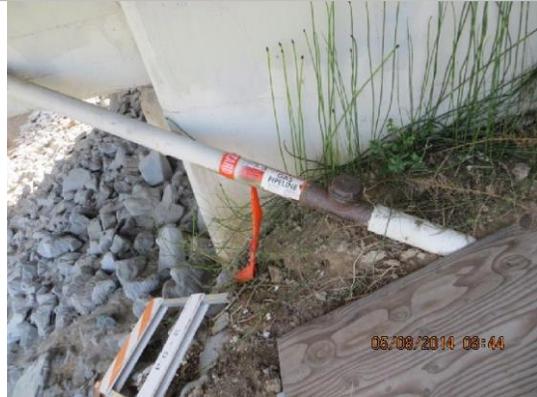
Photo 2 of 3 : UCIP\_FA\_2015\_4828.jpg

Pipe visible on downstream side of bridge.

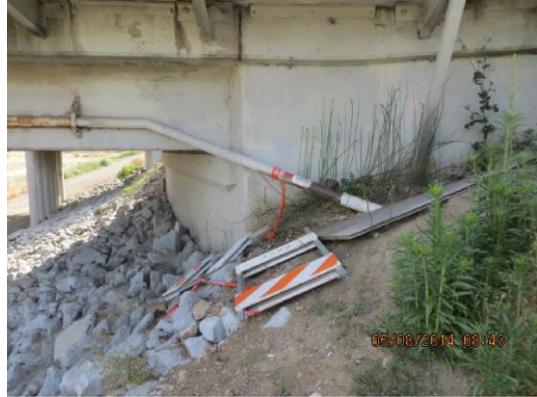
Photo 3 of 3 : UCIP\_FA\_2015\_4829.jpg

LM Start	<b>20.09</b>	Rating **	M	Issue No.	<b>866 (cont)</b>
LM End	<b>20.09</b>	Issue Type +	En	Location *	LS
Category	Supplemental			GPS Latitude/Longitude	
				Start	End
Item	DWR UCIP Field Study			37.983583 °	37.983583 °
DWR ID				-121.309708 °	-121.309708 °
Action/Comments					
Inspector Comments: FS_ID:39121 DS_ID:23379 EP_NO: N/A FS_HLM: 20.55 Repair Type: Non-Urgent Crossing Status: Indicator Found

Pipe visible on downstream side of bridge.

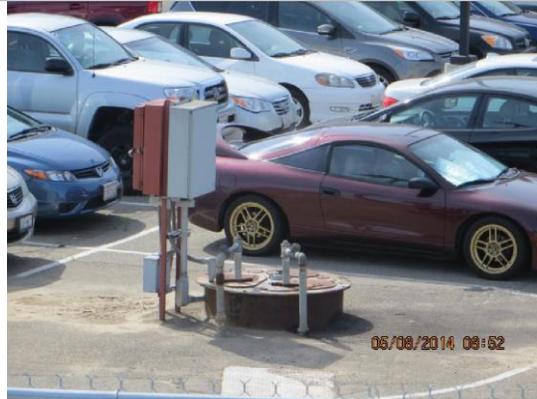
Photo 1 of 2 : UCIP\_FA\_2015\_4830.jpg

LM Start	<b>20.16</b>	Rating **	M	Issue No.	<b>867</b>
LM End	<b>20.16</b>	Issue Type +	En	Location *	LS
Category	Supplemental			GPS Latitude/Longitude	
				Start	End
Item	DWR UCIP Field Study			37.982958 °	37.982958 °
DWR ID				-121.310697 °	-121.310697 °
Action/Comments					
Inspector Comments: FS_ID:37268 DS_ID:23380 EP_NO: 14392 FS_HLM: 20.621 Repair Type: Non-Urgent Crossing Status: Indicator Found UCIP Comments: Vent in christy box on LS shoulder covered in soil may need maintenance. FIELD_STRUCT_DESC: 6-inch steel pipe, 2.0 feet below crown. 3'X2' Christy box on LS shoulder. 4-foot diameter steel sump and pump in parking lot 100-feet off LS toe (Permit No. 14392-1986) FS Date: 05/08/2014

Sump pump visible in parking lot off LS toe.

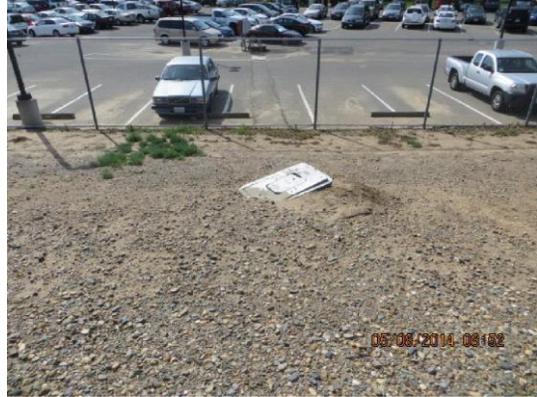
Photo 2 of 2 : UCIP\_FA\_2015\_4831.jpg

LM Start	20.16	Rating **	M	Issue No.	867 (cont)	
LM End	20.16	Issue Type +	En	Location *	LS	
Category	Supplemental			GPS Latitude/Longitude		
			Start	End		
Item	DWR UCIP Field Study			37.982958 °	37.982958 °	
				-121.310697 °	-121.310697 °	
DWR ID						
Action/Comments						
Inspector Comments: FS_ID:37268 DS_ID:23380 EP_NO: 14392 FS_HLM: 20.621 Repair Type: Non-Urgent Crossing Status: Indicator Found UCIP Comments: Vent in christy box on LS shoulder covered in soil may need maintenance. FIELD_STRUCT_DESC: 6-inch steel pipe, 2.0 feet below crown. 3'X2' Christy box on LS shoulder. 4-foot diameter steel sump and pump in parking lot 100-feet off LS toe (Permit No. 14392-1986) FS Date: 05/08/2014

Christy box on LS shoulder with sump pump visible in parking lot off LS toe.

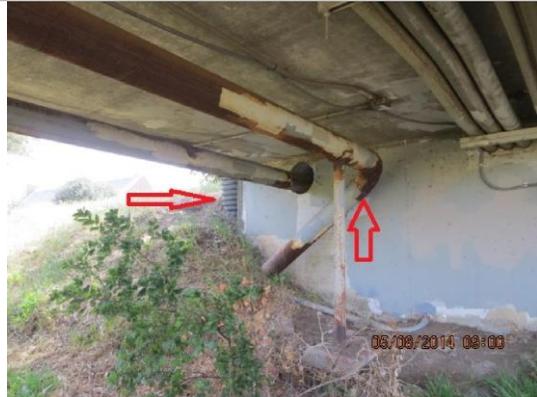
Photo 1 of 1 : UCIP\_FA\_2015\_5826.jpg

LM Start	20.37	Rating **	M	Issue No.	868	
LM End	20.37	Issue Type +	En	Location *	LS	
Category	Supplemental			GPS Latitude/Longitude		
			Start	End		
Item	DWR UCIP Field Study			37.981019 °	37.981019 °	
				-121.313574 °	-121.313574 °	
DWR ID						
Action/Comments						
Inspector Comments: FS_ID:42003 DS_ID:24975 EP_NO: N/A FS_HLM: 20.83 Repair Type: Non-Urgent Crossing Status: Found UCIP Comments: No permit identified for this crossing. FIELD_STRUCT_DESC: 8-inch steel conduit through the levee at an unknown depth below the crown. 24-inch HDPE riser on WS slope. FS Date: 05/08/2014

Pipe and HDPE standpipe visible under footbridge on WS slope.

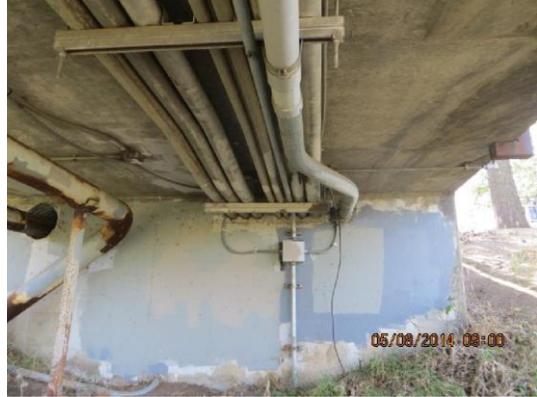
Photo 1 of 1 : UCIP\_FA\_2015\_5828.jpg

LM Start	<b>20.37</b>	Rating **	M	Issue No.	<b>869</b>
LM End	<b>20.37</b>	Issue Type +	En	Location *	LS
Category	Supplemental			GPS Latitude/Longitude	
				Start	End
Item	DWR UCIP Field Study			37.980996 °	37.980996 °
				-121.313595 °	-121.313595 °
DWR ID					
Action/Comments					
Inspector Comments: FS_ID:41954 DS_ID:24972 EP_NO: N/A FS_HLM: 20.832 Repair Type: Non-Urgent Crossing Status: Found UCIP Comments: No permit identified for this crossing. FIELD_STRUCT_DESC: Six 4-inch steel conduits through the levee at an unknown depth below the crown. Visible on underside of foot bridge. 3'X5' steel access box/sump on WS shoulder. FS Date: 05/08/2014

Six 4-inch steel conduits visible in rack under footbridge on WS slope.

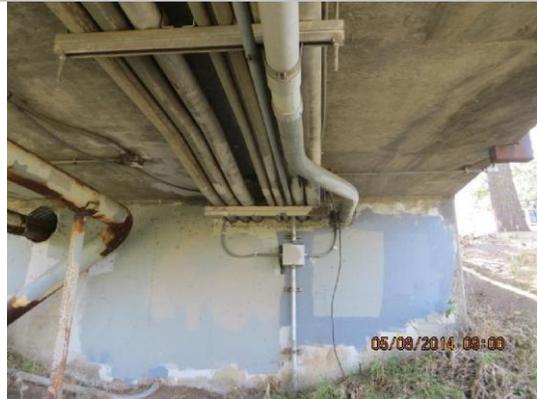
Photo 1 of 1 : UCIP\_FA\_2015\_5827.jpg

LM Start	<b>20.37</b>	Rating **	M	Issue No.	<b>870</b>
LM End	<b>20.37</b>	Issue Type +	En	Location *	LS
Category	Supplemental			GPS Latitude/Longitude	
				Start	End
Item	DWR UCIP Field Study			37.980993 °	37.980993 °
				-121.313607 °	-121.313607 °
DWR ID					
Action/Comments					
Inspector Comments: FS_ID:41955 DS_ID:24973 EP_NO: N/A FS_HLM: 20.832 Repair Type: Non-Urgent Crossing Status: Found UCIP Comments: No permit identified for this crossing. FIELD_STRUCT_DESC: Two 2-inch steel conduits through the levee at an unknown depth below the crown. Visible on underside of foot bridge. 3'X5' steel access box/sump on WS shoulder. FS Date: 05/08/2014

Two 2-inch conduits at center of group in photo.

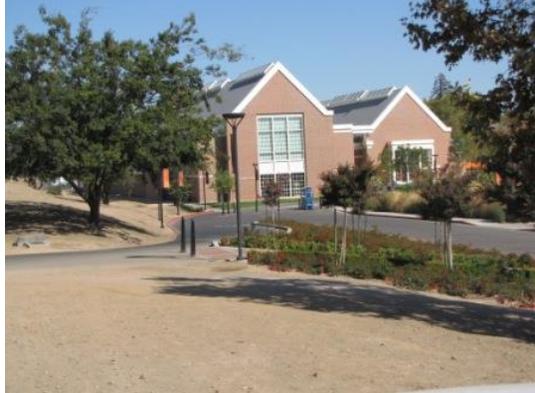
Photo 1 of 1 : FA\_2015\_NA0017\_160\_130\_20150911\_00071.jpg

LM Start	<b>20.37</b>	Rating **	M	Issue No.	<b>130</b>
LM End	<b>20.37</b>	Issue Type +	En	Location *	LS
Category	Earthen Levee		GPS Latitude/Longitude		
			Start	End	
Item	Vegetation		37.980958 °	37.980958 °	
			-121.313596 °	-121.313596 °	
DWR ID	DWR_NA0017_16_s_2012_130				
Action/Comments					
Landscaping

View of landscaping planted and maintained by UOP along the landward slope and toe looking upstream.

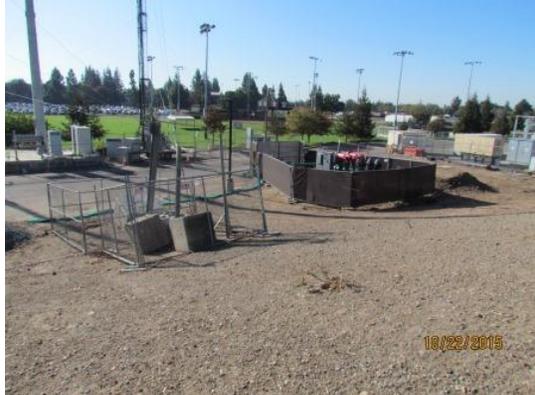
Photo 1 of 2 : FA\_2015\_NA0017\_160\_277\_20151023\_00168.jpg

LM Start	<b>20.50</b>	Rating **	U	Issue No.	<b>277</b>
LM End	<b>20.50</b>	Issue Type +	En	Location *	LS
Category	Earthen Levee		GPS Latitude/Longitude		
			Start	End	
Item	Encroachments		37.979717 °	37.979717 °	
			-121.315241 °	-121.315241 °	
DWR ID	DWR_NA0017_16_s_2015_277				
Action/Comments					
Building					
Inspector Comments: Existing permit #15851. New construction of the well was not part of the permit. An NOV was issued to UOP.

Updated picture of the well on the landside slope of the levee during fall 2015 inspection.

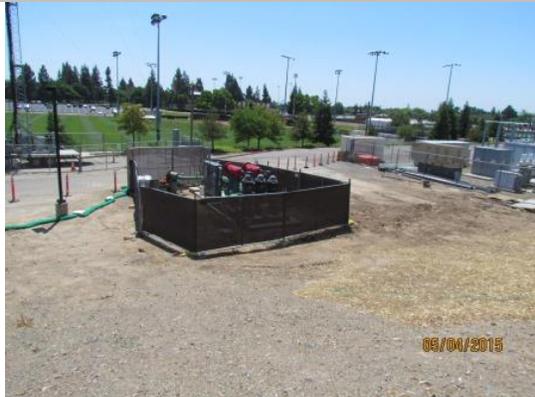
Photo 2 of 2 : FA\_2015\_NA0017\_160\_277\_20150911\_00158.jpg

View of the newly construction well on the landside slope of the levee looking downstream.
