**Flood Control Project Maintenance  
Levee Inspections**

**Fall 2015 Levee Maintenance Deficiency Summary Report**

**San Joaquin River Basin**

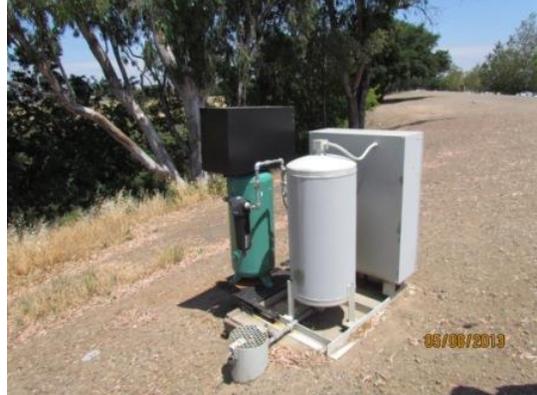
Photo 1 of 1 : FA\_2015\_NA0017\_160\_174\_20150911\_00105.jpg

LM Start	<b>20.50</b>	Rating **	U	Issue No.	<b>174</b>
LM End	<b>20.50</b>	Issue Type +	En	Location *	WS
Category	Earthen Levee		GPS Latitude/Longitude		
			Start	End	
Item	Encroachments		37.979679 °	37.979679 °	
			-121.315359 °	-121.315359 °	
DWR ID	DWR_NA0017_16_s_2013_174				
Action/Comments					
Tank Inspector Comments: It appears to be a compressor on the waterside shoulder of the levee.

A compressor was found on the waterside shoulder of the levee looking upstream.

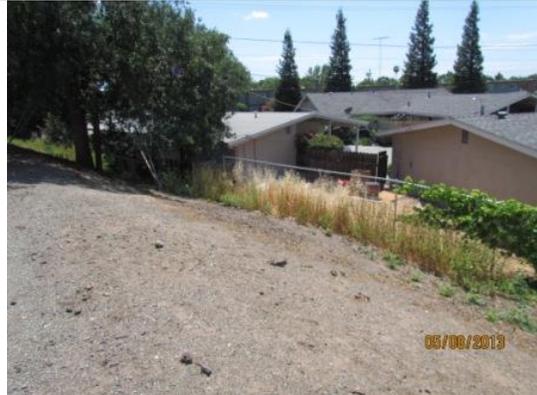
Photo 1 of 1 : FA\_2015\_NA0017\_160\_23\_20150911\_00009.jpg

LM Start	<b>20.74</b>	Rating **	U	Issue No.	<b>23</b>
LM End	<b>20.74</b>	Issue Type +	En	Location *	LS
Category	Earthen Levee		GPS Latitude/Longitude		
			Start	End	
Item	Encroachments		37.979107 °	37.979107 °	
			-121.319415 °	-121.319415 °	
DWR ID	DWR_NA0017_16_s_2012_23				
Action/Comments					
Fence

A fence was found on the landside toe of the levee looking upstream.

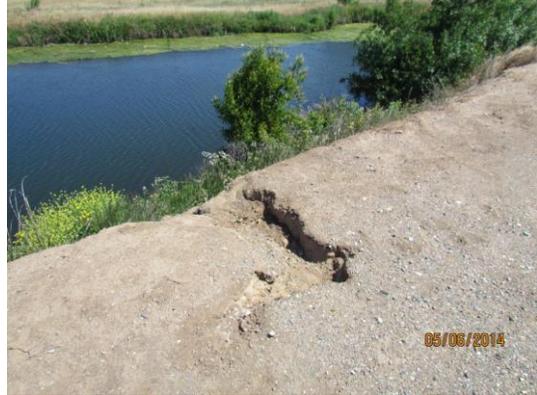
Photo 1 of 2 : FA\_2015\_NA0017\_160\_197\_20150911\_00116.jpg

Updated picture of the erosion on the waterside of the levee looking upstream during spring 2014 inspection.

LM Start	<b>20.97</b>	Rating **	M	Issue No.	<b>197</b>
LM End	<b>20.97</b>	Issue Type +	Ma	Location *	WS
Category	Earthen Levee			GPS Latitude/Longitude	
				Start	End
Item	Erosion / Bank Caving			37.980569 °	37.980569 °
				-121.322985 °	-121.322985 °
DWR ID	DWR_NA0017_16_s_2013_197				
Action/Comments					
Schedule repair of erosion site prior to the next inspection.

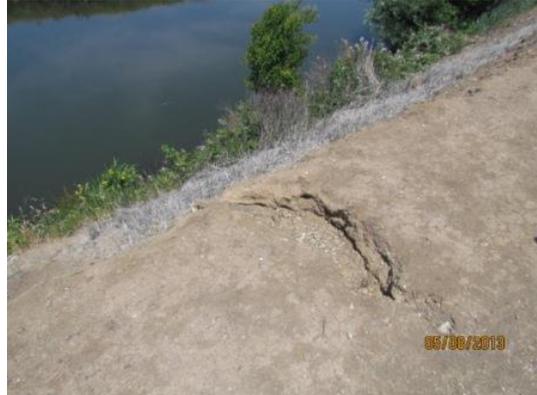
Photo 2 of 2 : FA\_2015\_NA0017\_160\_197\_20150911\_00117.jpg

Erosion was found on the waterside slope of the levee looking upstream.

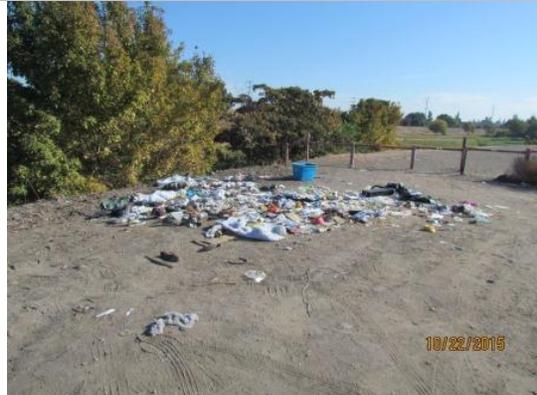
Photo 1 of 1 : FA\_2015\_NA0017\_160\_279\_20151023\_00169.jpg

LM Start	<b>21.07</b>	Rating **	M	Issue No.	<b>279</b>
LM End	<b>21.07</b>	Issue Type +	Ma	Location *	WS
Category	Earthen Levee			GPS Latitude/Longitude	
				Start	End
Item	Encroachments			37.980866 °	37.980866 °
				-121.324682 °	-121.324682 °
DWR ID	DWR_NA0017_16_s_2015_279				
Action/Comments					
Debris

Debris was found on the waterside shoulder of the levee.

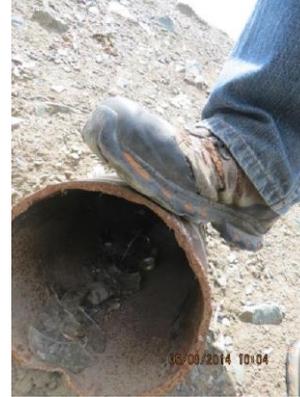
Photo 1 of 3 : UCIP\_FA\_2015\_3788.jpg

LM Start	<b>21.08</b>	Rating **	M	Issue No.	<b>871</b>
LM End	<b>21.08</b>	Issue Type +	En	Location *	WS
Category	Supplemental			GPS Latitude/Longitude	
				Start	End
Item	DWR UCIP Field Study			37.980905 °	37.980905 °
				-121.324926 °	-121.324926 °
DWR ID					
Action/Comments					
Inspector Comments: FS_ID:37383 DS_ID:23401 EP_NO: N/A FS_HLM: 21.553 Repair Type: Non-Urgent Crossing Status: Found UCIP Comments: Pipe appears abandoned and if so should be done so properly. Pipe open on waterward end. FIELD_STRUCT_DESC: *ABANDONED* 8-inch steel pipe through the levee 4.2 feet below the crown. Pipe open on the waterward end. Plate welded on the landward end. O&M Manual SJR Assumed 999. FS Date: 05/08/2014

Pipe open on WS slope.

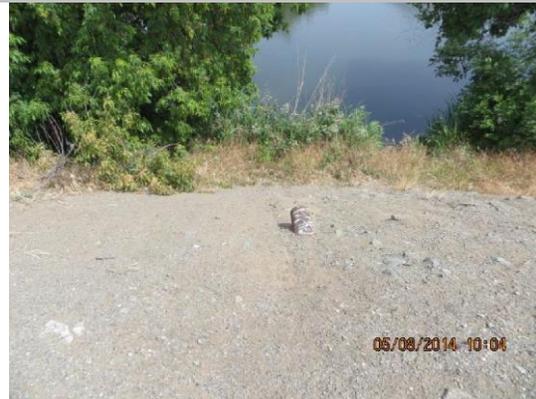
Photo 2 of 3 : UCIP\_FA\_2015\_3789.jpg

Pipe on WS slope.

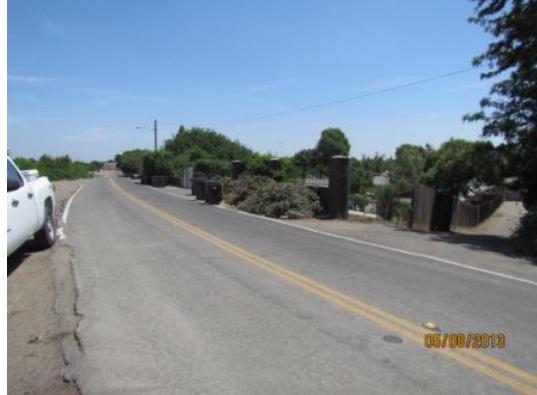
Photo 1 of 1 : FA\_2015\_NA0017\_160\_21\_20150911\_00008.jpg

LM Start	<b>21.18</b>	Rating **	M	Issue No.	<b>21</b>
LM End	<b>21.18</b>	Issue Type +	En	Location *	LS
Category	Earthen Levee		GPS Latitude/Longitude		
			Start	End	
Item	Vegetation		37.981132 °	37.981132 °	
			-121.326753 °	-121.326753 °	
DWR ID	DWR_NA0017_16_s_2012_21				
Action/Comments					
Landscaping

Landscaping was found on the landside of the levee looking upstream.

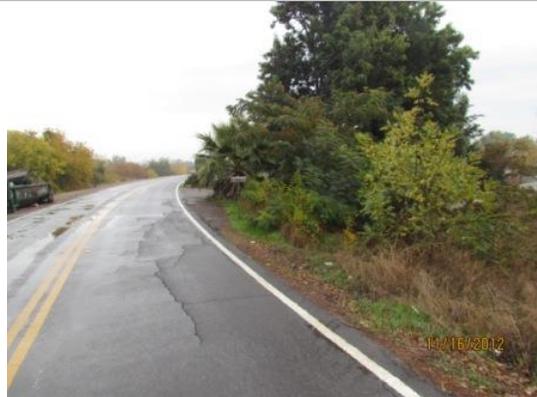
Photo 1 of 1 : FA\_2015\_NA0017\_160\_20\_20150911\_00007.jpg

LM Start	<b>21.25</b>	Rating **	U	Issue No.	<b>20</b>
LM End	<b>21.25</b>	Issue Type +	En	Location *	LS
Category	Earthen Levee		GPS Latitude/Longitude		
			Start	End	
Item	Vegetation		37.981185 °	37.981185 °	
			-121.327822 °	-121.327822 °	
DWR ID	DWR_NA0017_16_s_2012_20				
Action/Comments					
Landscaping

Landscaping was found on the landside shoulder of the levee looking upstream.

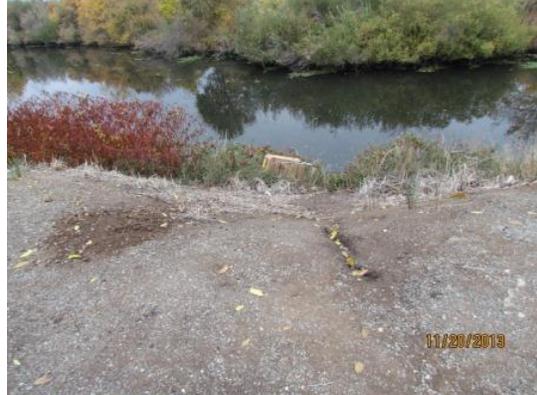
Photo 1 of 1 : FA\_2015\_NA0017\_160\_74\_20150911\_00040.jpg

LM Start	<b>21.31</b>	Rating **	M	Issue No.	<b>74</b>
LM End	<b>21.31</b>	Issue Type +	Ma	Location *	WS
Category	Earthen Levee		GPS Latitude/Longitude		
			Start	End	
Item	Erosion / Bank Caving		37.980773 °	37.980773 °	
			-121.328866 °	-121.328866 °	
DWR ID	DWR_NA0017_16_f_2013_74				
Action/Comments					
Schedule repair of erosion site prior to the next inspection. Inspector Comments: Runoff

Erosion due to runoff was found on the waterside of the levee looking upstream.

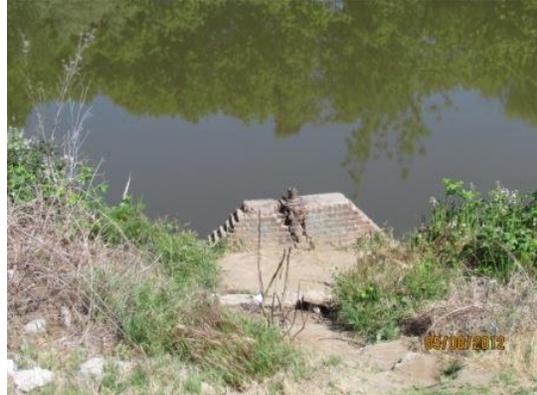
Photo 1 of 1 : FA\_2015\_NA0017\_160\_67\_20150911\_00035.jpg

LM Start	<b>21.37</b>	Rating **	M	Issue No.	<b>67</b>
LM End	<b>21.37</b>	Issue Type +	En	Location *	WS
Category	Earthen Levee		GPS Latitude/Longitude		
			Start	End	
Item	Encroachments		37.980529 °	37.980529 °	
			-121.329822 °	-121.329822 °	
DWR ID	DWR_NA0017_16_s_2012_67				
Action/Comments					
Retaining Wall Inspector Comments: Retaining wall on waterside toe of the levee.

A retaining wall was found on the waterside toe of the levee looking upstream.

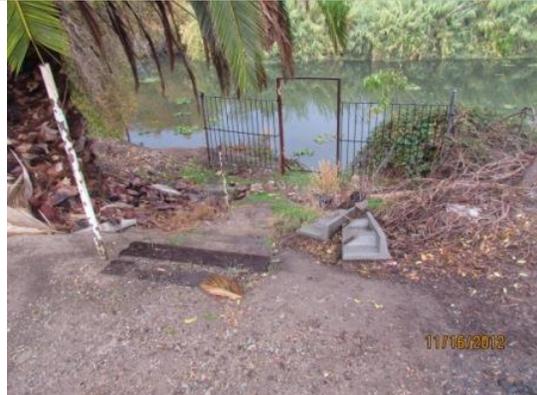
Photo 1 of 1 : FA\_2015\_NA0017\_160\_9\_20150911\_00002.jpg

LM Start	<b>21.43</b>	Rating **	M	Issue No.	<b>9</b>
LM End	<b>21.43</b>	Issue Type +	En	Location *	WS
Category	Earthen Levee		GPS Latitude/Longitude		
			Start	End	
Item	Encroachments		37.980147 °	37.980147 °	
			-121.330945 °	-121.330945 °	
DWR ID	DWR_NA0017_16_f_2012_9				
Action/Comments					
Stairway

Stairs and fence were located on the waterside slope of the levee looking downstream.

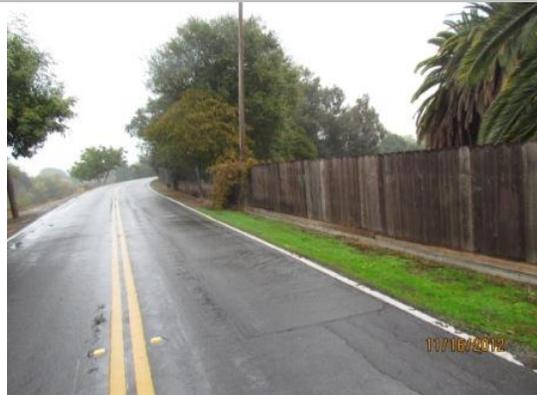
Photo 1 of 1 : FA\_2015\_NA0017\_160\_12\_20150911\_00004.jpg

LM Start	<b>21.43</b>	Rating **	U	Issue No.	<b>12</b>
LM End	<b>21.43</b>	Issue Type +	En	Location *	LS
Category	Earthen Levee		GPS Latitude/Longitude		
			Start	End	
Item	Encroachments		37.980147 °	37.980147 °	
			-121.330947 °	-121.330947 °	
DWR ID	DWR_NA0017_16_f_2012_12				
Action/Comments					
Fence

A fence was found on the landside shoulder of the levee looking upstream.

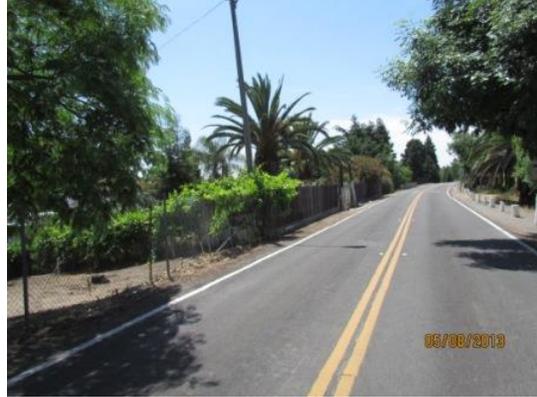
Photo 1 of 1 : FA\_2015\_NA0017\_160\_15\_20150911\_00006.jpg

LM Start	<b>21.44</b>	Rating **	M	Issue No.	<b>15</b>
LM End	<b>21.44</b>	Issue Type +	En	Location *	WS
Category	Earthen Levee		GPS Latitude/Longitude		
			Start	End	
Item	Vegetation		37.980042 °	37.980042 °	
			-121.330953 °	-121.330953 °	
DWR ID	DWR_NA0017_16_s_2012_15				
Action/Comments					
Landscaping

Landscaping was found on the landside of the levee looking downstream.

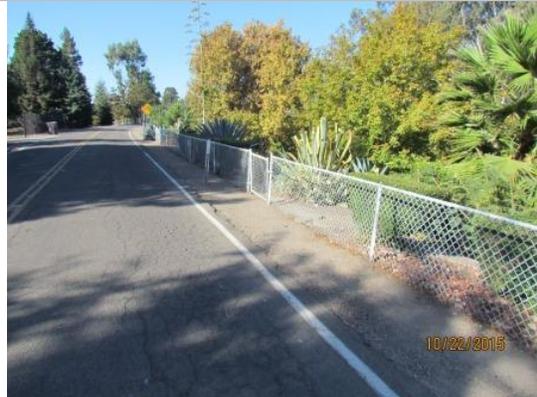
Photo 1 of 1 : FA\_2015\_NA0017\_160\_35\_20151023\_00170.jpg

LM Start	<b>21.45</b>	Rating **	U	Issue No.	<b>35</b>
LM End	<b>21.45</b>	Issue Type +	En	Location *	WS
Category	Earthen Levee		GPS Latitude/Longitude		
			Start	End	
Item	Encroachments		37.980048 °	37.980048 °	
			-121.331246 °	-121.331246 °	
DWR ID	DWR_NA0017_16_f_2015_35				
Action/Comments					
Fence

A fence was found on the waterside shoulder of the levee.

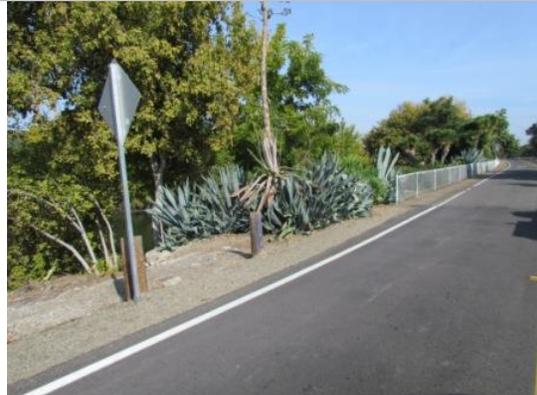
Photo 1 of 1 : FA\_2015\_NA0017\_160\_11\_20150911\_00003.jpg

LM Start	<b>21.51</b>	Rating **	M	Issue No.	<b>11</b>
LM End	<b>21.51</b>	Issue Type +	En	Location *	WS
Category	Earthen Levee		GPS Latitude/Longitude		
			Start	End	
Item	Vegetation		37.979652 °	37.979652 °	
			-121.332265 °	-121.332265 °	
DWR ID	DWR_NA0017_16_s_2012_11				
Action/Comments					
Landscaping

View of landscaping on the waterside of the levee looking upstream.

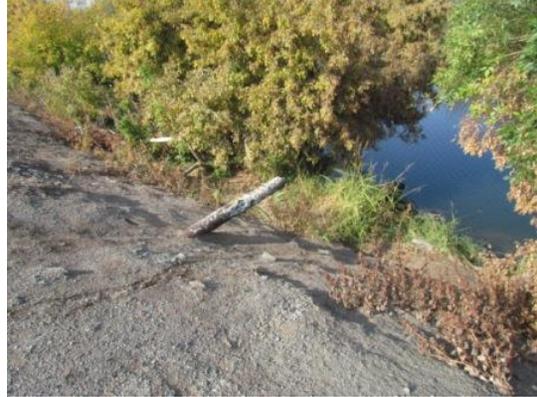
Photo 1 of 1 : FA\_2015\_NA0017\_160\_761\_20150911\_00161.jpg

LM Start	21.54	Rating **	M	Issue No.	761
LM End	21.54	Issue Type +	Ma	Location *	WS
Category	Earthen Levee		GPS Latitude/Longitude		
			Start	End	
Item	Encroachments			°	°
DWR ID	DWR_NA0017_16_s_2012_761				
Action/Comments					
Pipe

An abandoned pipe was found on the waterside of the levee looking downstream.

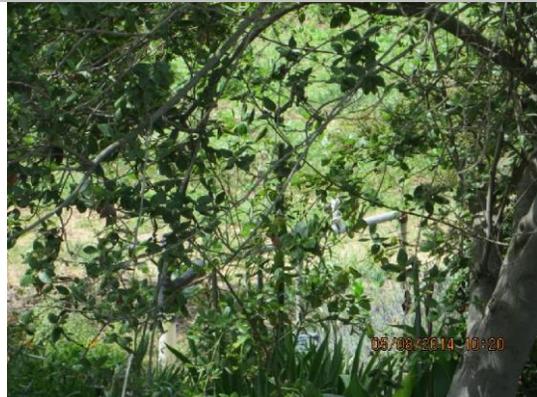
Photo 1 of 3 : UCIP\_FA\_2015\_6513.jpg

LM Start	21.54	Rating **	M	Issue No.	872
LM End	21.54	Issue Type +	En	Location *	WS
Category	Supplemental		GPS Latitude/Longitude		
			Start	End	
Item	DWR UCIP Field Study		37.979776	°	37.979776
			-121.332826	°	-121.332826
DWR ID					
Action/Comments					
Inspector Comments: FS_ID:37386 DS_ID:23402 EP_NO: N/A FS_HLM: 22.017 Repair Type: Non-Urgent Crossing Status: Found UCIP Comments: Determine if there is a permit for this crossing. FIELD_STRUCT_DESC: 2-inch galvanized pipe through the levee approximately 3-feet below the crown. FS Date: 05/08/2014

Siphon breaker, valve, and likely a pump visible off LS toe.

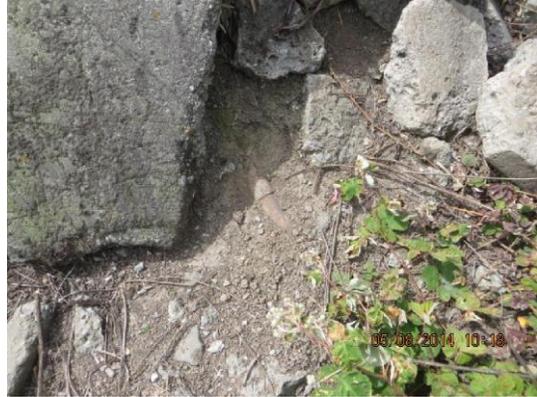
Photo 2 of 3 : UCIP\_FA\_2015\_6514.jpg

LM Start	21.54	Rating **	M	Issue No.	872 (cont)
LM End	21.54	Issue Type +	En	Location *	WS
Category	Supplemental			GPS Latitude/Longitude	
				Start	End
Item	DWR UCIP Field Study			37.979776 °	37.979776 °
				-121.332826 °	-121.332826 °
DWR ID					
Action/Comments					
Inspector Comments: FS_ID:37386 DS_ID:23402 EP_NO: N/A FS_HLM: 22.017 Repair Type: Non-Urgent Crossing Status: Found UCIP Comments: Determine if there is a permit for this crossing. FIELD_STRUCT_DESC: 2-inch galvanized pipe through the levee approximately 3-feet below the crown. FS Date: 05/08/2014

Pipe visible on WS slope in places.

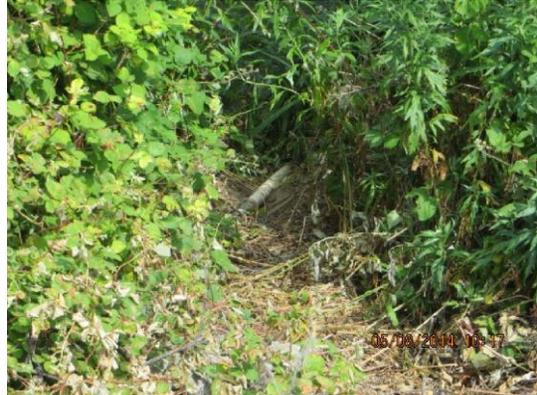
Photo 3 of 3 : UCIP\_FA\_2015\_6515.jpg

Pipe visible at WS toe.

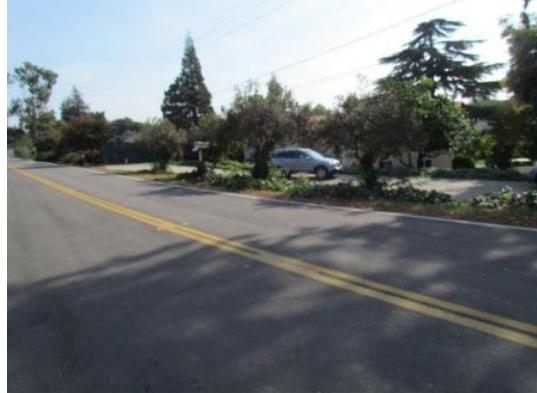
Photo 1 of 1 : FA\_2015\_NA0017\_160\_8\_20150911\_00001.jpg

LM Start	<b>21.61</b>	Rating **	M	Issue No.	<b>8</b>
LM End	<b>21.61</b>	Issue Type +	En	Location *	LS
Category	Earthen Levee		GPS Latitude/Longitude		
			Start	End	
Item	Vegetation		37.979820 °	37.979820 °	
			-121.334107 °	-121.334107 °	
DWR ID	DWR_NA0017_16_s_2012_8				
Action/Comments					
Landscaping

View of the landscape on the landside of the levee looking upstream.

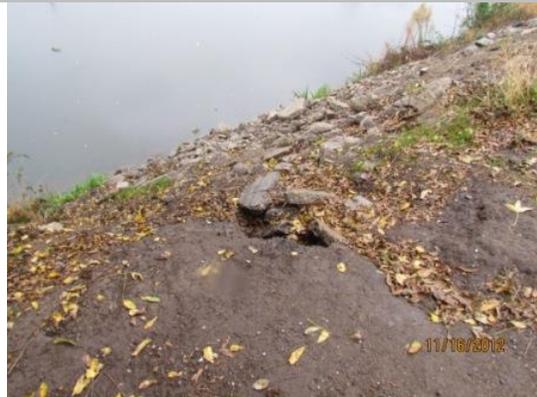
Photo 1 of 1 : FA\_2015\_NA0017\_160\_68\_20150911\_00036.jpg

LM Start	<b>21.68</b>	Rating **	M	Issue No.	<b>68</b>
LM End	<b>21.68</b>	Issue Type +	Ma	Location *	WS
Category	Earthen Levee		GPS Latitude/Longitude		
			Start	End	
Item	Erosion / Bank Caving		37.979674 °	37.979674 °	
			-121.335228 °	-121.335228 °	
DWR ID	DWR_NA0017_16_f_2012_68				
Action/Comments					
Schedule repair of erosion site prior to the next inspection.

Erosion was found on the waterside slope of the levee looking upstream.

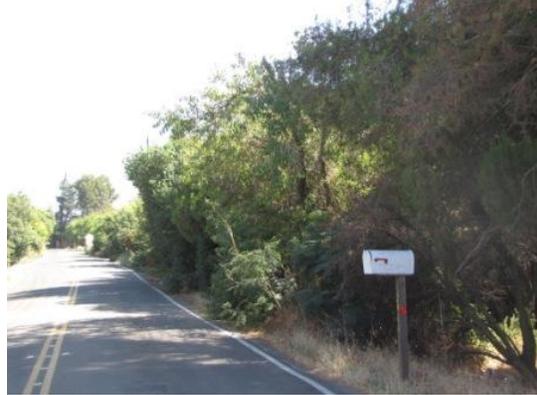
Photo 1 of 1 : FA\_2015\_NA0017\_160\_118\_20150911\_00062.jpg

LM Start	<b>21.69</b>	Rating **	U	Issue No.	<b>118</b>
LM End	<b>21.89</b>	Issue Type +	En	Location *	LS
Category	Earthen Levee		GPS Latitude/Longitude		
			Start	End	
Item	Vegetation		37.979630 °	37.979450 °	
			-121.335440 °	-121.339030 °	
DWR ID	DWR_NA0017_16_s_2012_118				
Action/Comments					
Landscaping

View of landscaping along landward slope looking upstream.

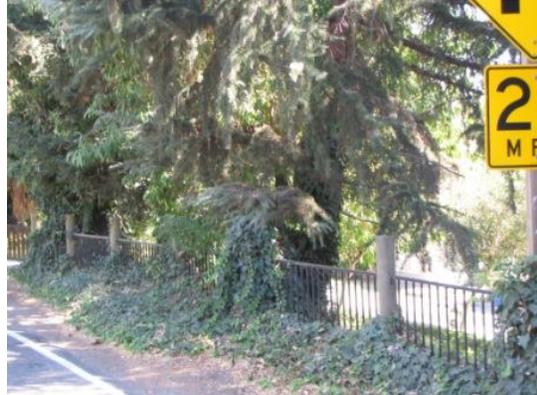
Photo 1 of 1 : FA\_2015\_NA0017\_160\_124\_20150911\_00067.jpg

LM Start	<b>21.69</b>	Rating **	M	Issue No.	<b>124</b>
LM End	<b>21.70</b>	Issue Type +	En	Location *	LS
Category	Earthen Levee		GPS Latitude/Longitude		
			Start	End	
Item	Encroachments		37.979622 °	37.979570 °	
			-121.335440 °	-121.335620 °	
DWR ID	DWR_NA0017_16_s_2012_124				
Action/Comments					
Fence Inspector Comments: Metal open fence

View of a fence and landscaping along the landward shoulder and slope looking upstream.

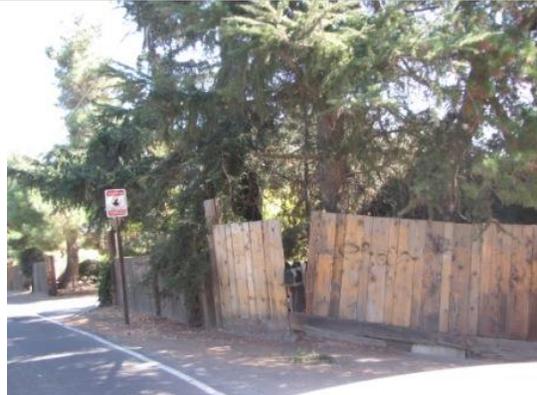
Photo 1 of 1 : FA\_2015\_NA0017\_160\_123\_20150911\_00066.jpg

LM Start	<b>21.71</b>	Rating **	U	Issue No.	<b>123</b>
LM End	<b>21.74</b>	Issue Type +	En	Location *	LS
Category	Earthen Levee			GPS Latitude/Longitude	
				Start	End
Item	Encroachments			37.979453 °	37.979400 °
				-121.335830 °	-121.336337 °
DWR ID	DWR_NA0017_16_s_2012_123				
Action/Comments					
Fence Inspector Comments: Solid wood fence

View of a fence along the landward shoulder and slope looking upstream.

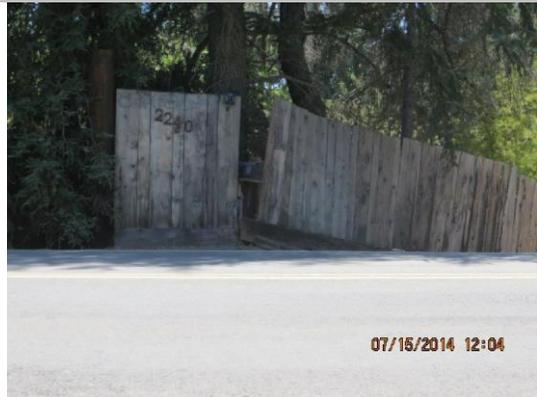
Photo 1 of 3 : UCIP\_FA\_2015\_6270.jpg

LM Start	<b>21.73</b>	Rating **	M	Issue No.	<b>873</b>
LM End	<b>21.73</b>	Issue Type +	En	Location *	LS
Category	Supplemental			GPS Latitude/Longitude	
				Start	End
Item	DWR UCIP Field Study			37.979447 °	37.979447 °
				-121.336268 °	-121.336268 °
DWR ID					
Action/Comments					
Inspector Comments: FS_ID:39753 DS_ID:23403 EP_NO: N/A FS_HLM: 22.214 Repair Type: Non-Urgent Crossing Status: Found UCIP Comments: Pipe abandoned and if so should be done so properly. FIELD_STRUCT_DESC: 5-inch steel irrigation pipe through the levee 4.0-feet below the crown. Slant pump and other appurtances still visible on WS slope. O&M Manual SJR Assumed 999. FS Date: 05/08/2014

Pipe outlet behind fence on LS shoulder.

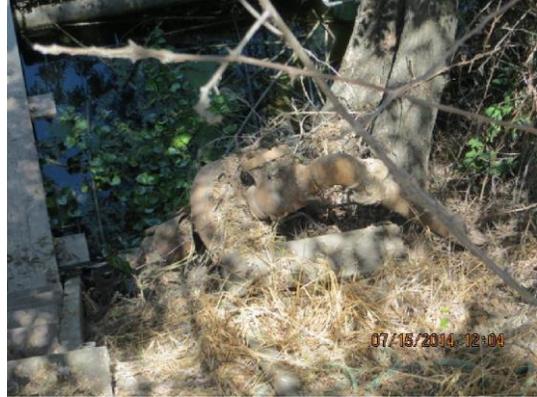
Photo 2 of 3 : UCIP\_FA\_2015\_6271.jpg

LM Start	<b>21.73</b>	Rating **	M	Issue No.	<b>873 (cont)</b>
LM End	<b>21.73</b>	Issue Type +	En	Location *	LS
Category	Supplemental			GPS Latitude/Longitude	
				Start	End
Item	DWR UCIP Field Study			37.979447 °	37.979447 °
				-121.336268 °	-121.336268 °
DWR ID					
<b>Action/Comments</b>					
Inspector Comments: FS_ID:39753 DS_ID:23403 EP_NO: N/A FS_HLM: 22.214 Repair Type: Non-Urgent Crossing Status: Found UCIP Comments: Pipe abandoned and if so should be done so properly. FIELD_STRUCT_DESC: 5-inch steel irrigation pipe through the levee 4.0-feet below the crown. Slant pump and other appurtances still visible on WS slope. O&M Manual SJR Assumed 999. FS Date: 05/08/2014

Old discarded pump and appurtances visible on WS slope.

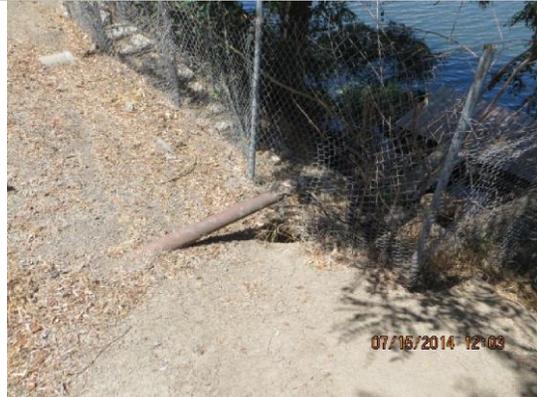
Photo 3 of 3 : UCIP\_FA\_2015\_6272.jpg

Pipe open on WS slope.

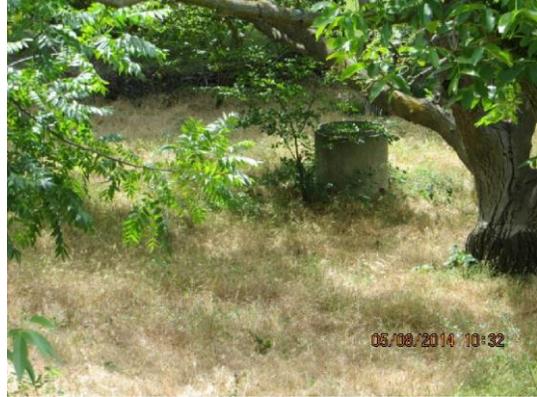
Photo 1 of 3 : UCIP\_FA\_2015\_6516.jpg

**Action/Comments**  
 Inspector Comments: FS\_ID:37387  
 DS\_ID:23404  
 EP\_NO: 18638  
 FS\_HLM: 22.272  
 Repair Type: Non-Urgent  
 Crossing Status: Found  
 UCIP Comments: Pipe appears abandoned and if so should be done so properly.  
 FIELD\_STRUCT\_DESC: 9-inch steel irrigation pipe through the levee 3.7 feet below the crown. 2-inch galvanized iron electrical conduit at same location. Concrete Standpipe off LS toe. Wooden blankoff plate bolted over pipe end on WS. O&M Manual SJR Assumed 999.  
 FS Date: 05/08/2014

Possible concrete stanpipe for this crossing off LS toe.

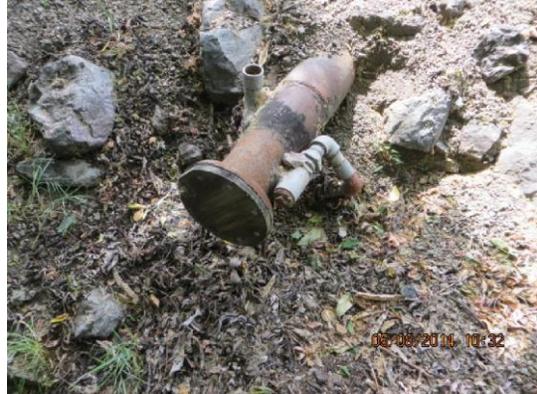
Photo 2 of 3 : UCIP\_FA\_2015\_6517.jpg

Pipes and concrete pad visible on WS slope. Wooden blank off plate visible on pipe end.

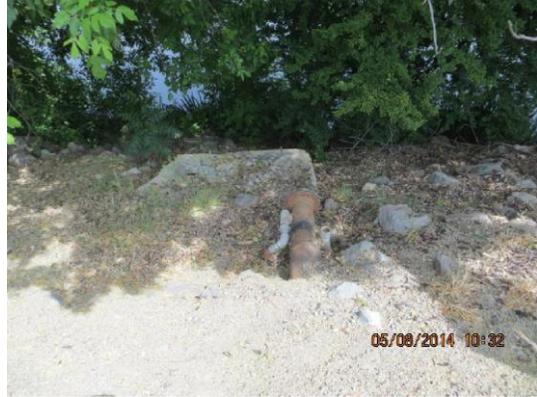
Photo 3 of 3 : UCIP\_FA\_2015\_6518.jpg

LM Start	<b>21.79</b>	Rating **	M	Issue No.	<b>874 (cont)</b>
LM End	<b>21.79</b>	Issue Type +	En	Location *	LS
Category	Supplemental			GPS Latitude/Longitude	
				Start	End
Item	DWR UCIP Field Study			37.979411 °	37.979411 °
				-121.337308 °	-121.337308 °
DWR ID					
Action/Comments					
Inspector Comments: FS_ID:37387 DS_ID:23404 EP_NO: 18638 FS_HLM: 22.272 Repair Type: Non-Urgent Crossing Status: Found

Pipes and concrete pad visible on WS slope.

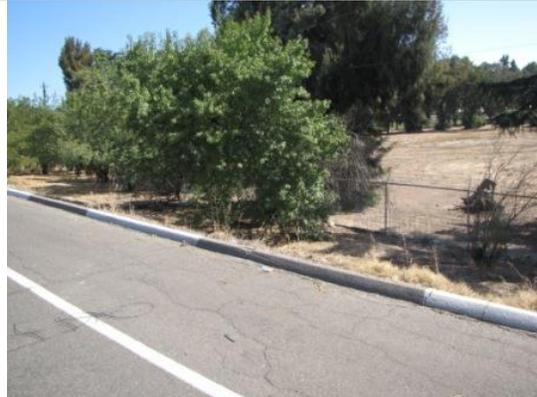
Photo 1 of 1 : FA\_2015\_NA0017\_160\_117\_20150911\_00061.jpg

LM Start	<b>21.89</b>	Rating **	M	Issue No.	<b>117</b>
LM End	<b>21.95</b>	Issue Type +	En	Location *	LS
Category	Earthen Levee			GPS Latitude/Longitude	
				Start	End
Item	Encroachments			37.979454 °	37.979138 °
				-121.339031 °	-121.340034 °
DWR ID	DWR_NA0017_16_s_2012_117				
Action/Comments					
Fence

View of fence and landscaping along landward slope looking upstream.

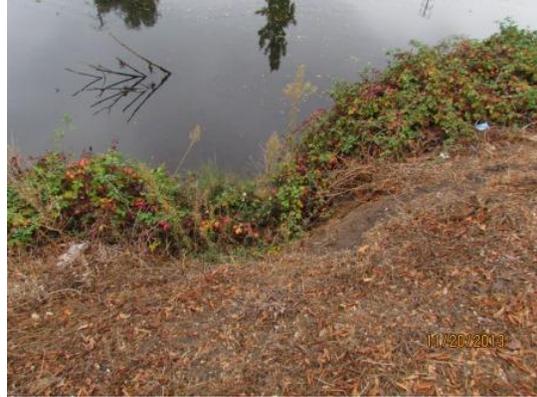
Photo 1 of 1 : FA\_2015\_NA0017\_160\_62\_20150911\_00032.jpg

LM Start	<b>21.94</b>	Rating **	M	Issue No.	<b>62</b>
LM End	<b>21.94</b>	Issue Type +	Ma	Location *	WS
Category	Earthen Levee		GPS Latitude/Longitude		
			Start	End	
Item	Erosion / Bank Caving		37.979251 °	37.979251 °	
			-121.340012 °	-121.340012 °	
DWR ID	DWR_NA0017_16_f_2013_62				
Action/Comments					
Schedule repair of erosion site prior to the next inspection.

Erosion was found on the waterside slope of the levee looking upstream.

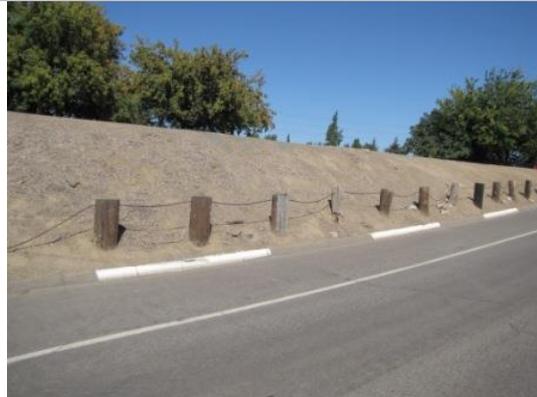
Photo 1 of 1 : FA\_2015\_NA0017\_160\_116\_20150911\_00060.jpg

LM Start	<b>21.95</b>	Rating **	M	Issue No.	<b>116</b>
LM End	<b>21.98</b>	Issue Type +	En	Location *	LS
Category	Earthen Levee		GPS Latitude/Longitude		
			Start	End	
Item	Encroachments		37.979094 °	37.978845 °	
			-121.340095 °	-121.340572 °	
DWR ID	DWR_NA0017_16_s_2012_116				
Action/Comments					
Fence Inspector Comments: Post and cable fence

View of a post and cable fence along the landward slope looking upstream.

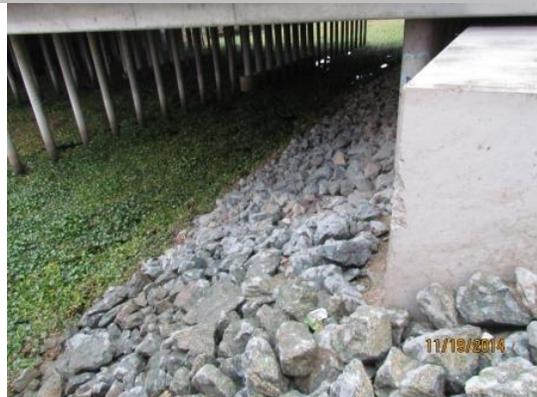
Photo 1 of 5 : FA\_2015\_NA0017\_160\_48\_20150911\_00018.jpg

LM Start	<b>22.04</b>	Rating **	A/W	Issue No.	<b>48</b>
LM End	<b>22.04</b>	Issue Type +	Ma	Location *	WS
Category	Earthen Levee		GPS Latitude/Longitude		
			Start	End	
Item	Erosion / Bank Caving		37.978697 °	37.978697 °	
			-121.341581 °	-121.341581 °	
DWR ID	DWR_NA0017_16_s_2012_48				
Action/Comments					
Schedule repair of erosion site prior to the next inspection. Inspector Comments: Caltrans repaired the issue. (Permit # 18532) Another repair might be needed if it deteriorates.

Caltrans repaired the erosion under the southbound (I-5) bridge. The picture was taken from the crown looking upstream during fall 2014 inspection.

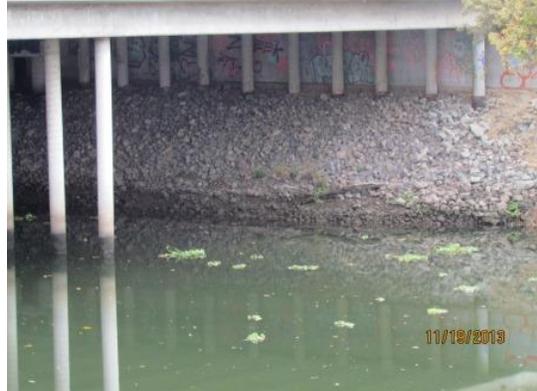
Photo 2 of 5 : FA\_2015\_NA0017\_160\_48\_20150911\_00020.jpg

LM Start	<b>22.04</b>	Rating **	A/W	Issue No.	<b>48 (cont)</b>
LM End	<b>22.04</b>	Issue Type +	Ma	Location *	WS
Category	Earthen Levee			GPS Latitude/Longitude	
				Start	End
Item	Erosion / Bank Caving			37.978697 °	37.978697 °
				-121.341581 °	-121.341581 °
DWR ID	DWR_NA0017_16_s_2012_48				
Action/Comments					
Schedule repair of erosion site prior to the next inspection. Inspector Comments: Caltrans repaired the issue. (Permit # 18532) Another repair might be needed if it deteriorates.

Updated picture of erosion was found on the waterside toe of the levee looking from the opposite side of the levee.

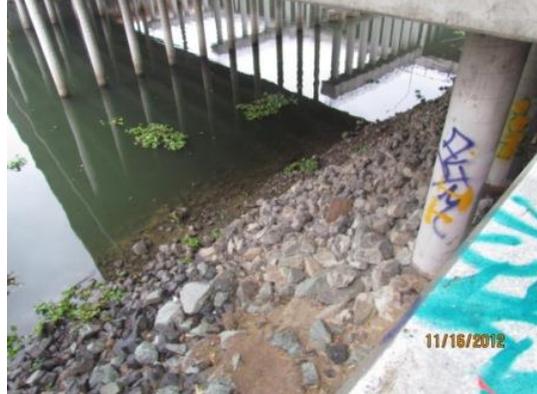
Photo 3 of 5 : FA\_2015\_NA0017\_160\_48\_20150911\_00021.jpg

Updated view of the erosion site repaired by Caltrans on the waterside slope of the levee looking upstream.

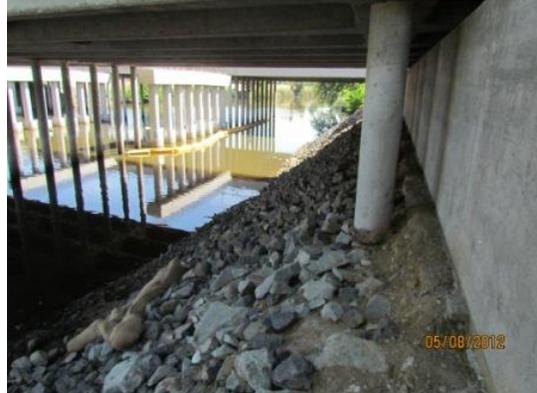
Photo 4 of 5 : FA\_2015\_NA0017\_160\_48\_20150911\_00022.jpg

View of the erosion site repaired by Caltrans under the I-5 freeway going southbound. This picture was taken from the toe of the levee looking upstream.

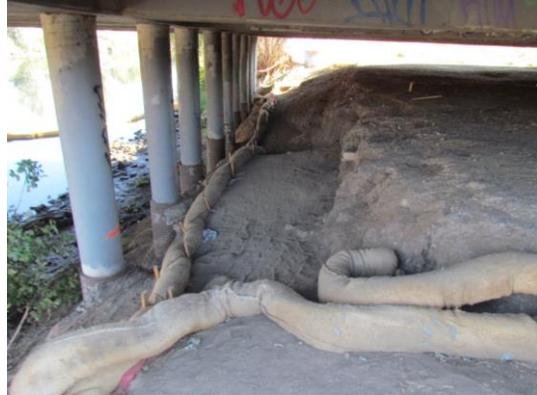
Photo 5 of 5 : FA\_2015\_NA0017\_160\_48\_20150911\_00023.jpg

LM Start	<b>22.04</b>	Rating **	A/W	Issue No.	<b>48 (cont)</b>
LM End	<b>22.04</b>	Issue Type +	Ma	Location *	WS
Category	Earthen Levee			GPS Latitude/Longitude	
				Start	End
Item	Erosion / Bank Caving			37.978697 °	37.978697 °
				-121.341581 °	-121.341581 °
DWR ID	DWR_NA0017_16_s_2012_48				
Action/Comments					
Schedule repair of erosion site prior to the next inspection. Inspector Comments: Caltrans repaired the issue. (Permit # 18532) Another repair might be needed if it deteriorates.

View of the erosion under the I-5 bridge looking upstream.

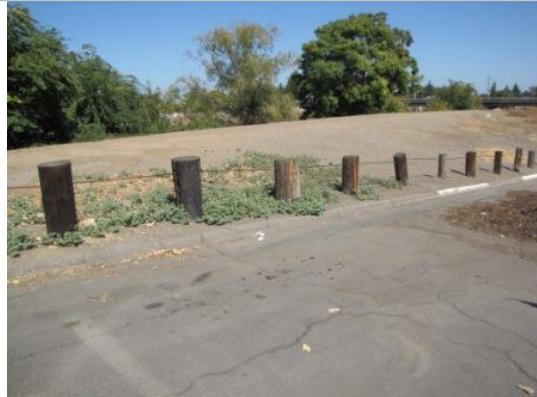
Photo 1 of 1 : FA\_2015\_NA0017\_160\_114\_20150911\_00057.jpg

LM Start	<b>22.05</b>	Rating **	M	Issue No.	<b>114</b>
LM End	<b>22.08</b>	Issue Type +	En	Location *	LS
Category	Earthen Levee			GPS Latitude/Longitude	
				Start	End
Item	Encroachments			37.978464 °	37.978208 °
				-121.341620 °	-121.342190 °
DWR ID	DWR_NA0017_16_s_2012_114				
Action/Comments					
Fence Inspector Comments: Post and cable fence

View of post and cable fence along the landward levee slope looking upstream.

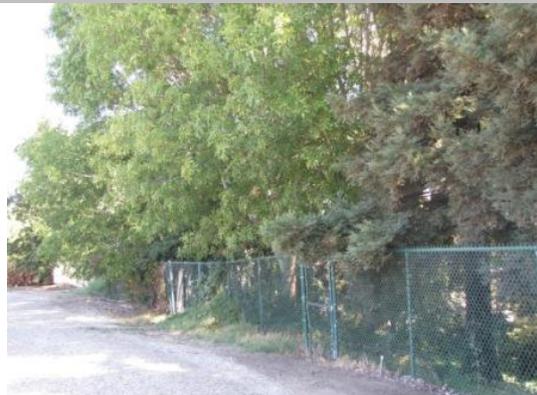
Photo 1 of 1 : FA\_2015\_NA0017\_160\_110\_20150911\_00055.jpg

LM Start	<b>22.10</b>	Rating **	M	Issue No.	<b>110</b>
LM End	<b>22.39</b>	Issue Type +	En	Location *	LS
Category	Earthen Levee			GPS Latitude/Longitude	
				Start	End
Item	Encroachments			37.978081 °	37.975086 °
				-121.342519 °	-121.346027 °
DWR ID	DWR_NA0017_16_s_2012_110				
Action/Comments					
Fence

View of fence and landscaping along the landward shoulder and slope looking upstream.

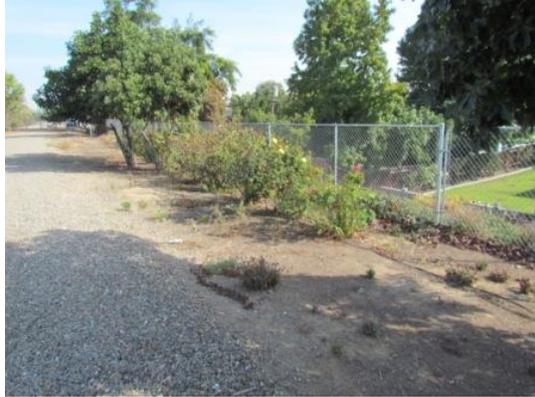
Photo 1 of 1 : FA\_2015\_NA0017\_160\_111\_20150911\_00056.jpg

LM Start	<b>22.10</b>	Rating **	M	Issue No.	<b>111</b>
LM End	<b>22.39</b>	Issue Type +	En	Location *	LS
Category	Earthen Levee			GPS Latitude/Longitude	
				Start	End
Item	Vegetation			37.978078 °	37.975086 °
				-121.342523 °	-121.346027 °
DWR ID	DWR_NA0017_16_s_2012_111				
Action/Comments					
Landscaping

Landscape was found on the landside of the levee looking upstream.

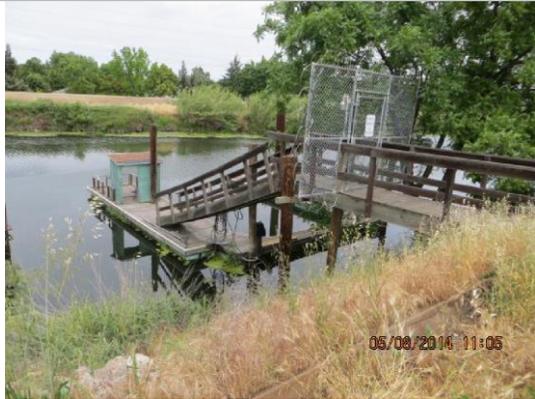
Photo 1 of 2 : UCIP\_FA\_2015\_5862.jpg

LM Start	<b>22.14</b>	Rating **	M	Issue No.	<b>875</b>
LM End	<b>22.14</b>	Issue Type +	En	Location *	LS
Category	Supplemental			GPS Latitude/Longitude	
				Start	End
Item	DWR UCIP Field Study			37.977695 °	37.977695 °
				-121.343038 °	-121.343038 °
DWR ID					
Action/Comments					
Inspector Comments: FS_ID:41963 DS_ID:24977 EP_NO: N/A FS_HLM: 22.626 Repair Type: Non-Urgent Crossing Status: Found UCIP Comments: No permit identified for this crossing. FIELD_STRUCT_DESC: Three PVC conduits through the levee 1-foot below the crown. A 1-inch electrical, a 1-inch irrigation, and a 1.5-inch domestic waterline. All 3 are visible under the ramp to the boat dock on the WS shoulder. FS Date: 05/08/2014

Pipes visible under walkway to dock on WS slope.

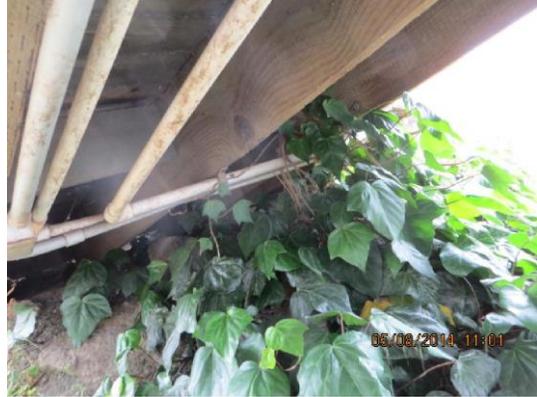
Photo 2 of 2 : UCIP\_FA\_2015\_5863.jpg

LM Start	22.14	Rating **	M	Issue No.	875 (cont)	
LM End	22.14	Issue Type +	En	Location *	LS	
Category	Supplemental			GPS Latitude/Longitude		
			Start	End		
Item	DWR UCIP Field Study			37.977695 °	37.977695 °	
				-121.343038 °	-121.343038 °	
DWR ID						
Action/Comments						
Inspector Comments: FS_ID:41963 DS_ID:24977 EP_NO: N/A FS_HLM: 22.626 Repair Type: Non-Urgent Crossing Status: Found UCIP Comments: No permit identified for this crossing. FIELD_STRUCT_DESC: Three PVC conduits through the levee 1-foot below the crown. A 1-inch electrical, a 1-inch irrigation, and a 1.5-inch domestic waterline. All 3 are visible under the ramp to the boat dock on the WS shoulder. FS Date: 05/08/2014

Pipes visible under walkway to dock on WS slope.

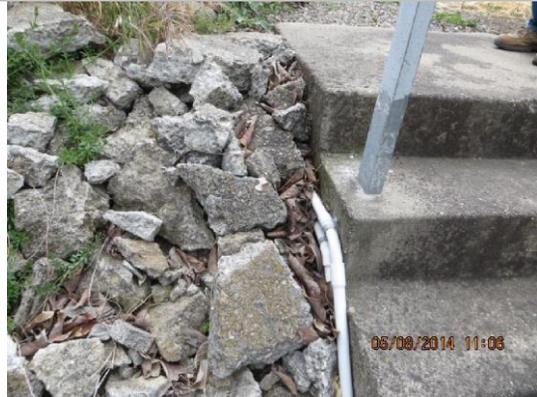
Photo 1 of 2 : UCIP\_FA\_2015\_5864.jpg

LM Start	22.15	Rating **	M	Issue No.	876	
LM End	22.15	Issue Type +	En	Location *	LS	
Category	Supplemental			GPS Latitude/Longitude		
			Start	End		
Item	DWR UCIP Field Study			37.977662 °	37.977662 °	
				-121.343094 °	-121.343094 °	
DWR ID						
Action/Comments						
Inspector Comments: FS_ID:41964 DS_ID:24978 EP_NO: N/A FS_HLM: 22.63 Repair Type: Non-Urgent Crossing Status: Found UCIP Comments: No permit identified for this crossing. FIELD_STRUCT_DESC: Two PVC conduits through the levee 1-foot below the crown. A 1-inch electrical, and a 1-inch waterline. Both are visible on the upstream side of the stairs on the WS slope. FS Date: 05/08/2014

PVC conduit visible on upstream side of stairs to dock.

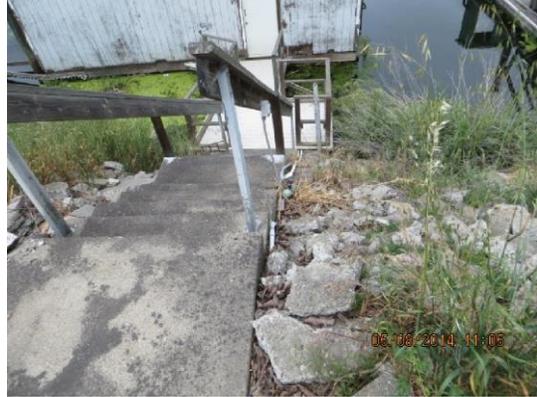
Photo 2 of 2 : UCIP\_FA\_2015\_5865.jpg

LM Start	22.15	Rating **	M	Issue No.	876 (cont)
LM End	22.15	Issue Type +	En	Location *	LS
Category	Supplemental			GPS Latitude/Longitude	
			Start	End	
Item	DWR UCIP Field Study			37.977662 °	37.977662 °
DWR ID				-121.343094 °	-121.343094 °
Action/Comments					
Inspector Comments: FS_ID:41964 DS_ID:24978 EP_NO: N/A FS_HLM: 22.63 Repair Type: Non-Urgent Crossing Status: Found UCIP Comments: No permit identified for this crossing. FIELD_STRUCT_DESC: Two PVC conduits through the levee 1-foot below the crown. A 1-inch electrical, and a 1-inch waterline. Both are visible on the upstream side of the stairs on the WS slope. FS Date: 05/08/2014

PVC conduit visible on upstream side of stairs to dock.

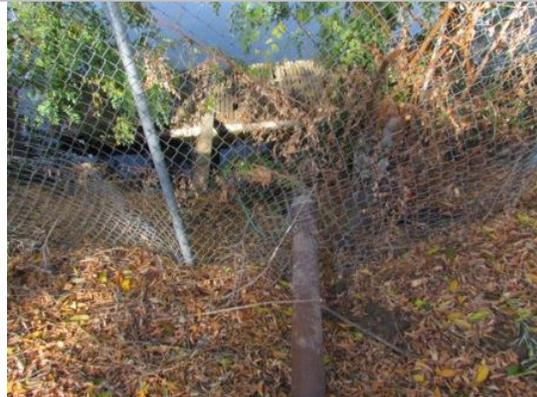
Photo 1 of 2 : FA\_2015\_NA0017\_160\_115\_20150911\_00058.jpg

LM Start	22.21	Rating **	M	Issue No.	115
LM End	22.21	Issue Type +	En	Location *	WS
Category	Earthen Levee			GPS Latitude/Longitude	
			Start	End	
Item	Encroachments				
DWR ID	DWR_NA0017_16_s_2012_115				
Action/Comments					
Pipe Inspector Comments: Abandoned pipe was found on the waterside shoulder of the levee.

View of the electrical wires through the pipe is found on the waterside of the levee. The picture was taken from the crown looking towards the toe of the levee.

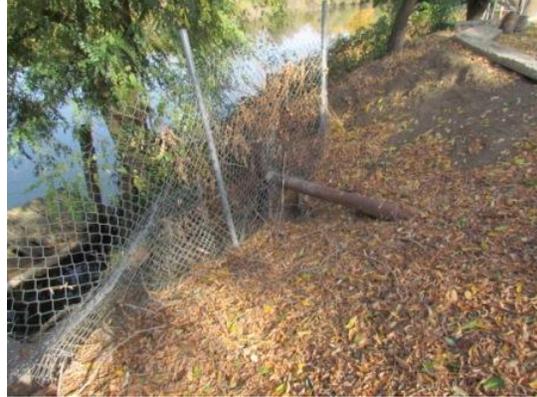
Photo 2 of 2 : FA\_2015\_NA0017\_160\_115\_20150911\_00059.jpg

LM Start	<b>22.21</b>	Rating **	M	Issue No.	<b>115 (cont)</b>
LM End	<b>22.21</b>	Issue Type +	En	Location *	WS
Category	Earthen Levee			GPS Latitude/Longitude	
				Start	End
Item	Encroachments			°	°
DWR ID	DWR_NA0017_16_s_2012_115				
Action/Comments					
Pipe Inspector Comments: Abandoned pipe was found on the waterside shoulder of the levee.

An unpermitted abandoned pipe was found with electrical wires running through it on the waterside shoulder of the levee looking upstream.

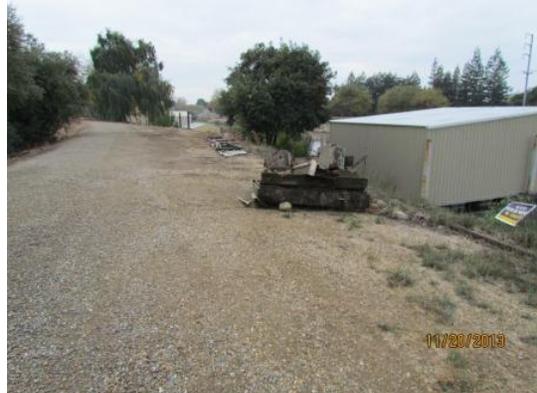
Photo 1 of 1 : FA\_2015\_NA0017\_160\_43\_20150911\_00016.jpg

LM Start	<b>22.27</b>	Rating **	M	Issue No.	<b>43</b>
LM End	<b>22.27</b>	Issue Type +	Ma	Location *	WS
Category	Earthen Levee			GPS Latitude/Longitude	
				Start	End
Item	Encroachments			37.976308 °	37.976308 °
				-121.344698 °	-121.344698 °
DWR ID	DWR_NA0017_16_f_2013_43				
Action/Comments					
Debris

Debris was found on the waterside shoulder of the levee looking downstream.

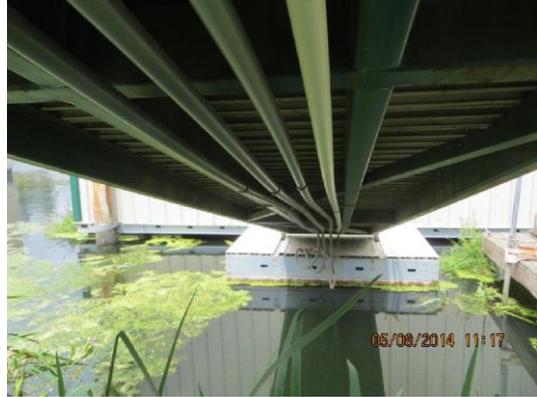
Photo 1 of 1 : UCIP\_FA\_2015\_5866.jpg

LM Start	<b>22.27</b>	Rating **	M	Issue No.	<b>877</b>
LM End	<b>22.27</b>	Issue Type +	En	Location *	WS
Category	Supplemental			GPS Latitude/Longitude	
				Start	End
Item	DWR UCIP Field Study			37.976312 °	37.976312 °
				-121.344728 °	-121.344728 °
DWR ID					
Action/Comments					
Inspector Comments: FS_ID:41965 DS_ID:24980 EP_NO: N/A FS_HLM: 22.761 Repair Type: Non-Urgent Crossing Status: Found UCIP Comments: No permit identified for this crossing. FIELD_STRUCT_DESC: Four 1-inch PVC conduits through the levee at an unknown depth below the crown. All are attached to the dock on the WS slope. FS Date: 05/08/2014

Conduits visible under walkway on WS slope.

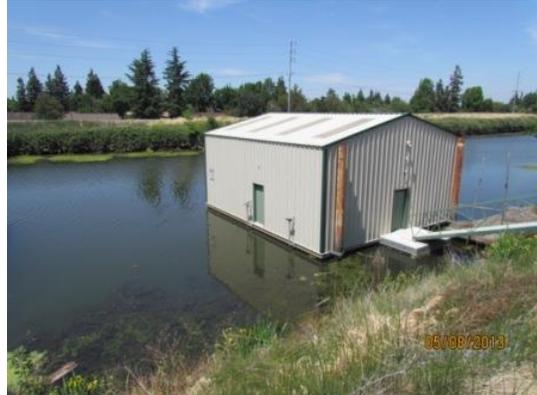
Photo 1 of 1 : FA\_2015\_NA0017\_160\_204\_20150911\_00120.jpg

LM Start	<b>22.28</b>	Rating **	U	Issue No.	<b>204</b>
LM End	<b>22.28</b>	Issue Type +	En	Location *	WS
Category	Earthen Levee			GPS Latitude/Longitude	
				Start	End
Item	Encroachments			37.976226 °	37.976226 °
				-121.344848 °	-121.344848 °
DWR ID	DWR_NA0017_16_s_2013_204				
Action/Comments					
Building Inspector Comments: Unpermitted dock

A dock was found on the waterside toe of the levee looking upstream.

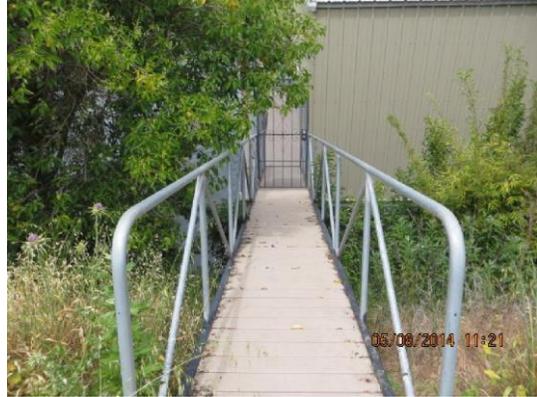
Photo 1 of 2 : UCIP\_FA\_2015\_5867.jpg

LM Start	<b>22.29</b>	Rating **	M	Issue No.	<b>878</b>
LM End	<b>22.29</b>	Issue Type +	En	Location *	WS
Category	Supplemental			GPS Latitude/Longitude	
				Start	End
Item	DWR UCIP Field Study			37.976143 °	37.976143 °
				-121.344994 °	-121.344994 °
DWR ID					
Action/Comments					
Inspector Comments: FS_ID:41966 DS_ID:24981 EP_NO: N/A FS_HLM: 22.78 Repair Type: Non-Urgent Crossing Status: Found UCIP Comments: No permit identified for this crossing. FIELD_STRUCT_DESC: Two PVC conduits through the levee 3-foot below the crown. A 4-inch, and a 2-inch. Pipes are attached to the gangway on the WS slope. FS Date: 05/08/2014

Pipes visible under walkway on WS slope.

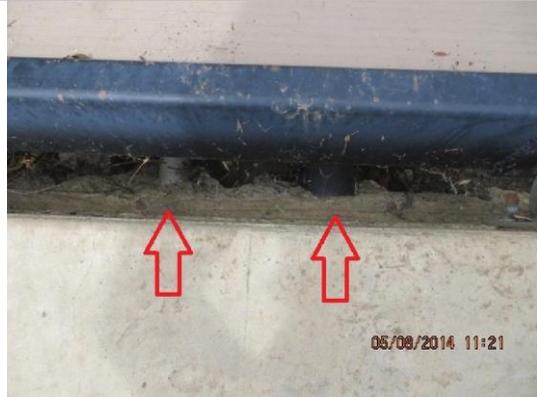
Photo 2 of 2 : UCIP\_FA\_2015\_5868.jpg

Both pipes visible at connection between boat dock ramp and concrete pad on WS shoulder.

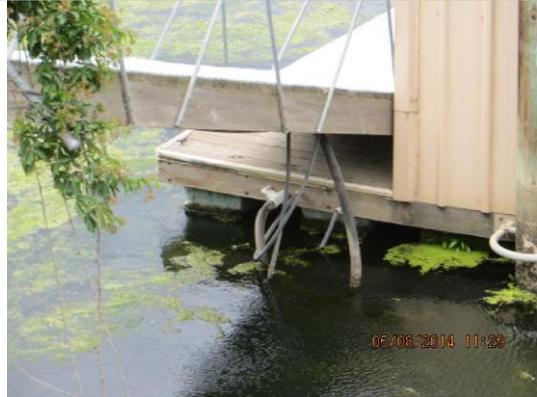
Photo 1 of 2 : UCIP\_FA\_2015\_5869.jpg

LM Start	<b>22.37</b>	Rating **	M	Issue No.	<b>879</b>
LM End	<b>22.37</b>	Issue Type +	En	Location *	WS
Category	Supplemental			GPS Latitude/Longitude	
				Start	End
Item	DWR UCIP Field Study			37.975296 °	37.975296 °
				-121.345792 °	-121.345792 °
DWR ID					
Action/Comments					
Inspector Comments: FS_ID:41967 DS_ID:24982 EP_NO: N/A FS_HLM: 22.854 Repair Type: Non-Urgent Crossing Status: Found UCIP Comments: No permit identified for this crossing. FIELD_STRUCT_DESC: Three 1-inch PVC conduits through the levee at an unknown depth below the crown. Pipes are attached to the gangway on the WS slope. FS Date: 05/08/2014

Conduits visible under walkway on WS slope.

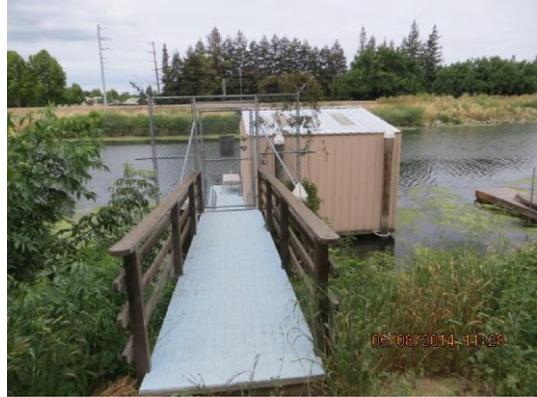
Photo 2 of 2 : UCIP\_FA\_2015\_5870.jpg

Conduits visible under walkway on WS slope.

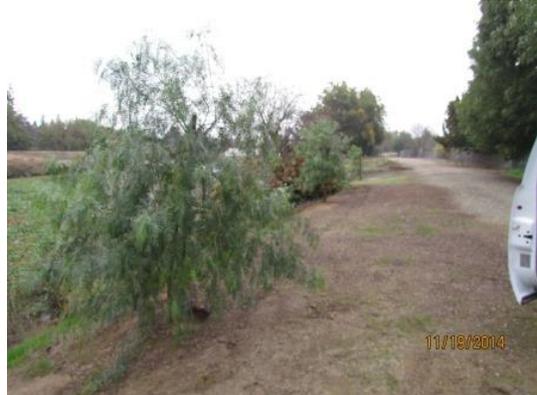
Photo 1 of 1 : FA\_2015\_NA0017\_160\_253\_20150911\_00145.jpg

LM Start	<b>22.37</b>	Rating **	M	Issue No.	<b>253</b>
LM End	<b>22.37</b>	Issue Type +	En	Location *	WS
Category	Earthen Levee			GPS Latitude/Longitude	
				Start	End
Item	Encroachments			37.975243 °	37.975243 °
				-121.345882 °	-121.345882 °
DWR ID	DWR_NA0017_16_f_2014_253				
Action/Comments					
Crops Inspector Comments: Newly planted tree.

New planted tree was found on the waterside shoulder of the levee looking upstream.

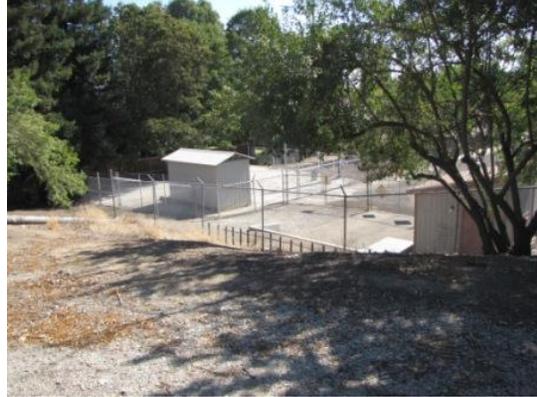
Photo 1 of 1 : FA\_2015\_NA0017\_160\_109\_20150911\_00054.jpg

LM Start	<b>22.39</b>	Rating **	M	Issue No.	<b>109</b>
LM End	<b>22.41</b>	Issue Type +	En	Location *	LS
Category	Earthen Levee		GPS Latitude/Longitude		
			Start	End	
Item	Encroachments		37.975087 °	37.974883 °	
			-121.346027 °	-121.346298 °	
DWR ID	DWR_NA0017_16_s_2012_109				
Action/Comments					
Fence

View of fence along the landward slope.

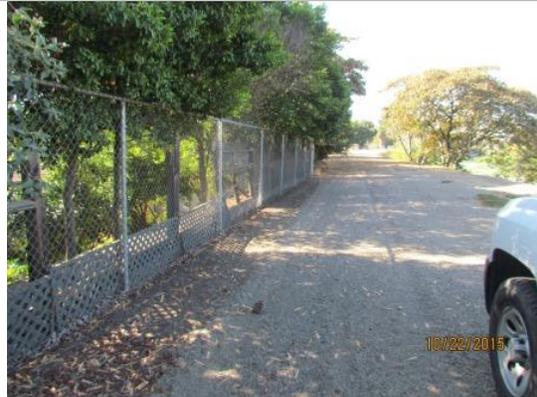
Photo 1 of 1 : FA\_2015\_NA0017\_160\_46\_20151023\_00171.jpg

LM Start	<b>22.40</b>	Rating **	U	Issue No.	<b>46</b>
LM End	<b>22.59</b>	Issue Type +	En	Location *	LS
Category	Earthen Levee		GPS Latitude/Longitude		
			Start	End	
Item	Encroachments		37.974889 °	37.973127 °	
			-121.346274 °	-121.348756 °	
DWR ID	DWR_NA0017_16_s_2012_46				
Action/Comments					
Fence Inspector Comments: Fence is on the shoulder of the levee.

Fence was found on the shoulder of the levee.

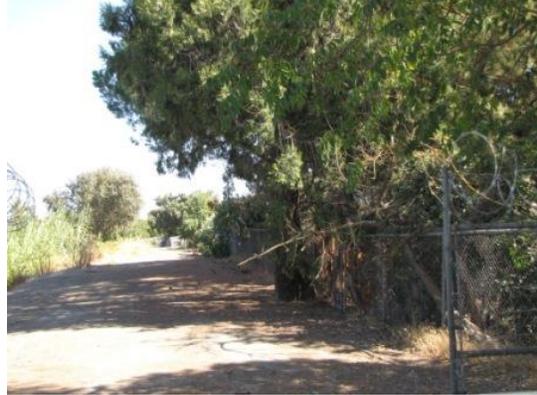
Photo 1 of 1 : FA\_2015\_NA0017\_160\_106\_20150911\_00052.jpg

LM Start	<b>22.41</b>	Rating **	M	Issue No.	<b>106</b>
LM End	<b>22.59</b>	Issue Type +	En	Location *	LS
Category	Earthen Levee		GPS Latitude/Longitude		
			Start	End	
Item	Encroachments		37.974869 °	37.973108 °	
			-121.346317 °	-121.348820 °	
DWR ID	DWR_NA0017_16_s_2012_106				
Action/Comments					
Fence

View of fence and landscaping along the landward shoulder looking upstream.

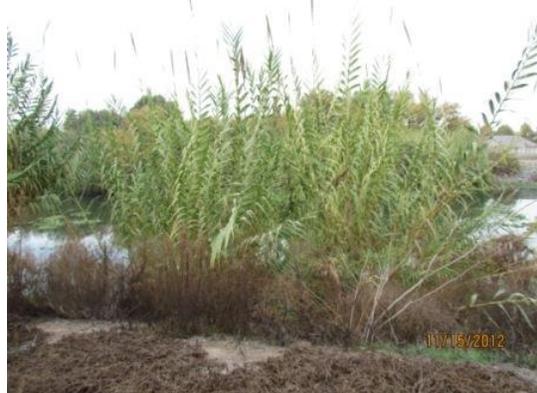
Photo 1 of 1 : FA\_2015\_NA0017\_160\_45\_20150911\_00017.jpg

LM Start	<b>22.55</b>	Rating **	U	Issue No.	<b>45</b>
LM End	<b>22.55</b>	Issue Type +	Ma	Location *	WS
Category	Earthen Levee		GPS Latitude/Longitude		
			Start	End	
Item	Vegetation		37.973386 °	37.973386 °	
			-121.348241 °	-121.348241 °	
DWR ID	DWR_NA0017_16_f_2012_45				
Action/Comments					
Remove the wild growth other than native grasses from the levee slopes. Inspector Comments: Arrundo on the waterside of the levee.

Arundo was found on the waterside slope of the levee looking upstream.

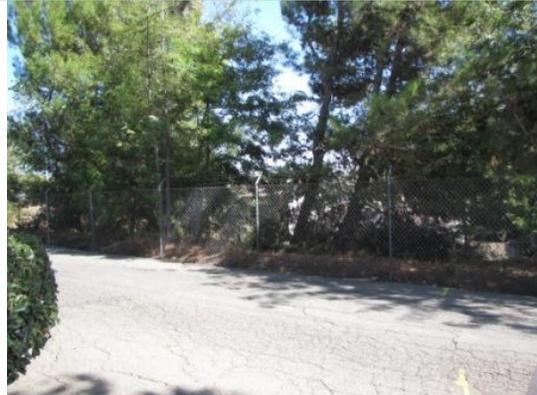
Photo 1 of 1 : FA\_2015\_NA0017\_160\_104\_20150911\_00051.jpg

LM Start	<b>22.59</b>	Rating **	M	Issue No.	<b>104</b>
LM End	<b>22.72</b>	Issue Type +	En	Location *	LS
Category	Earthen Levee			GPS Latitude/Longitude	
				Start	End
Item	Encroachments			37.973094 °	37.971660 °
				-121.348809 °	-121.350233 °
DWR ID	DWR_NA0017_16_s_2012_104				
Action/Comments					
Fence

View of fence along the landward shoulder looking upstream.

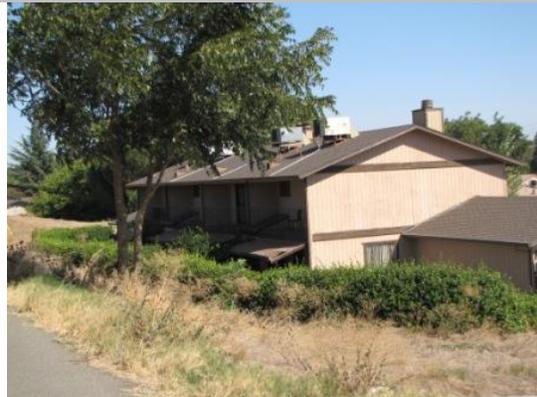
Photo 1 of 1 : FA\_2015\_NA0017\_160\_103\_20150911\_00050.jpg

LM Start	<b>22.75</b>	Rating **	M	Issue No.	<b>103</b>
LM End	<b>22.78</b>	Issue Type +	En	Location *	LS
Category	Earthen Levee			GPS Latitude/Longitude	
				Start	End
Item	Vegetation			37.971257 °	37.970858 °
				-121.350300 °	-121.350450 °
DWR ID	DWR_NA0017_16_s_2012_103				
Action/Comments					
Landscaping

View of landscaping along the landward slope looking upstream.

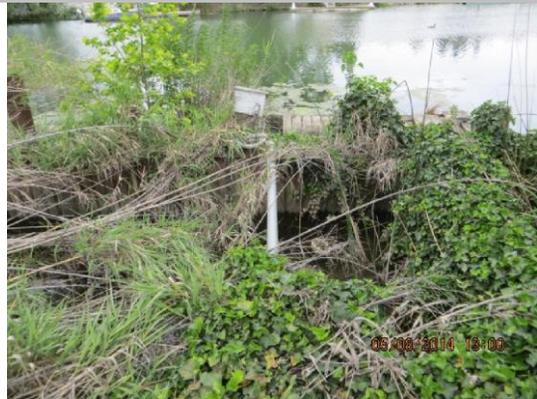
Photo 1 of 2 : UCIP\_FA\_2015\_5871.jpg

LM Start	<b>23.12</b>	Rating **	M	Issue No.	<b>880</b>
LM End	<b>23.12</b>	Issue Type +	En	Location *	LS
Category	Supplemental		GPS Latitude/Longitude		
			Start	End	
Item	DWR UCIP Field Study		37.968770 °	37.968770 °	
			-121.355204 °	-121.355204 °	
DWR ID					
Action/Comments					
Inspector Comments: FS_ID:41968 DS_ID:24986 EP_NO: N/A FS_HLM: 23.655 Repair Type: Non-Urgent Crossing Status: Found UCIP Comments: No permit identified for this crossing. FIELD_STRUCT_DESC: 3-inch galvanized iron waterline through the levee at an unknown depth. FS Date: 05/08/2014

3-inch galvanized iron pipe visible off WS toe.

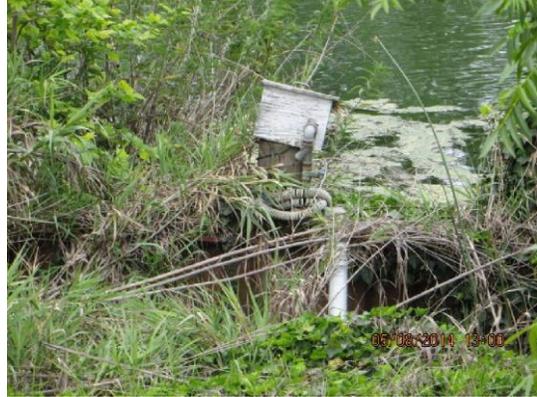
Photo 2 of 2 : UCIP\_FA\_2015\_5872.jpg

3-inch galvanized iron pipe visible off WS toe.
