**Flood Control Project Maintenance  
Levee Inspections**

**Fall 2015 Levee Maintenance Deficiency Summary Report**

**San Joaquin River Basin**

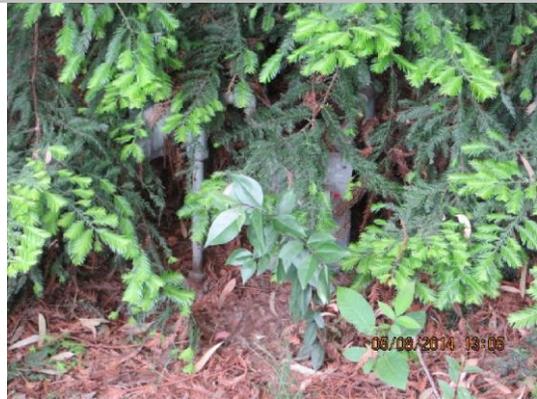
Photo 1 of 1 : UCIP\_FA\_2015\_6540.jpg

LM Start	<b>23.15</b>	Rating **	M	Issue No.	<b>881</b>
LM End	<b>23.15</b>	Issue Type +	En	Location *	LS
Category	Supplemental			GPS Latitude/Longitude	
				Start	End
Item	DWR UCIP Field Study			37.968522 °	37.968522 °
				-121.355664 °	-121.355664 °
DWR ID					
<b>Action/Comments</b>					
Inspector Comments: FS_ID:37425 DS_ID:23415 EP_NO: N/A FS_HLM: 23.69 Repair Type: Non-Urgent Crossing Status: Found UCIP Comments: Determine routing of gasline and if it goes through levee. FIELD_STRUCT_DESC: Domestic gas line (1-inch) and meter on LS shoulder. Unclear if pipe passes through levee. FS Date: 05/08/2014

Gasline and meter under tree on LS shoulder.

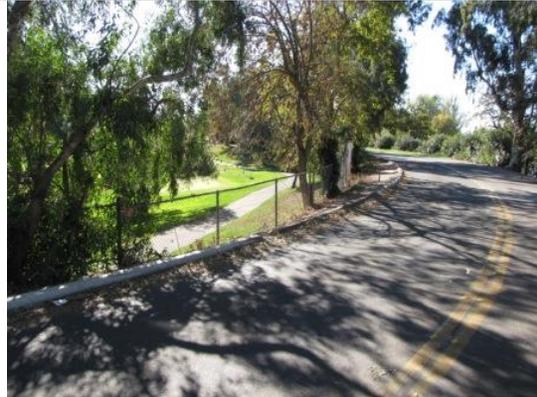
Photo 1 of 1 : FA\_2015\_NA0017\_160\_182\_20150911\_00111.jpg

LM Start	<b>23.17</b>	Rating **	M	Issue No.	<b>182</b>
LM End	<b>23.49</b>	Issue Type +	En	Location *	LS
Category	Earthen Levee		GPS Latitude/Longitude		
			Start	End	
Item	Encroachments		37.968438 °	37.965997 °	
			-121.355882 °	-121.360479 °	
DWR ID	DWR_NA0017_16_s_2012_182				
Action/Comments					
Fence Inspector Comments: Chainlink fence along the landward slope.

View of the fence along the landward slope looking downstream.

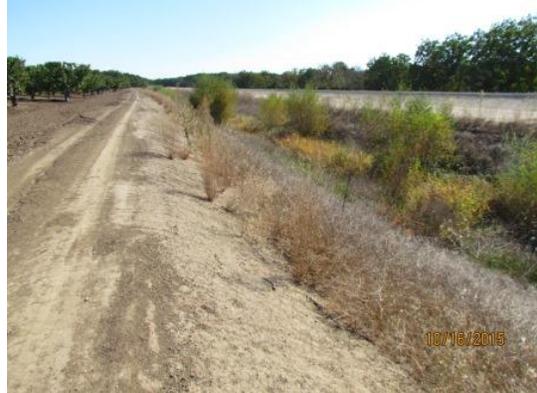
Photo 1 of 1 : FA\_2015\_NA0017\_161\_7\_20151023\_00008.jpg

LM Start	<b>0.13</b>	Rating **	M	Issue No.	<b>7</b>
LM End	<b>0.31</b>	Issue Type +	Ma	Location *	WS
Category	Earthen Levee			GPS Latitude/Longitude	
				Start	End
Item	Vegetation			37.959971 °	37.959505 °
				-121.161177 °	-121.157914 °
DWR ID	DWR_NA0017_17_f_2015_7				
Action/Comments					
Control annual grass and weeds on the levee slopes and easements.

View of the vegetation on the waterside of the levee looking upstream.

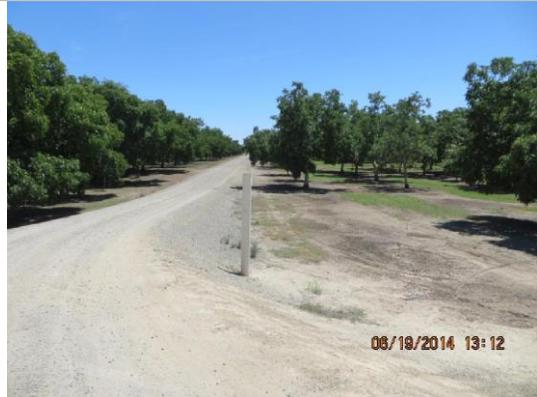
Photo 1 of 3 : UCIP\_FA\_2015\_1292.jpg

LM Start	<b>0.32</b>	Rating **	M	Issue No.	<b>11</b>
LM End	<b>0.32</b>	Issue Type +	En	Location *	WS
Category	Supplemental			GPS Latitude/Longitude	
				Start	End
Item	DWR UCIP Field Study			37.959423 °	37.959423 °
				-121.157769 °	-121.157769 °
DWR ID					
Action/Comments					
Inspector Comments: FS_ID:41625 DS_ID:18537 EP_NO: N/A FS_HLM: 0.317 Repair Type: Non-Urgent Crossing Status: Found UCIP Comments: Appears this crossing may be abandoned. FIELD_STRUCT_DESC: 16-inch concrete irrigation siphon through the levee 4-feet below the crown. Pipe visible at bottom of 36-inch concrete riser on LS shoulder. 16-inch concrete standpipe on landside shoulder. 9-inch PVC standpipe on opposite bank may provide indication that pipe does cross channel. O&M manual SJR 611.1 Vol. F- revised in 2010. FS Date: 06/19/2014

PVC standpipe visible on opposite bank may be connected.

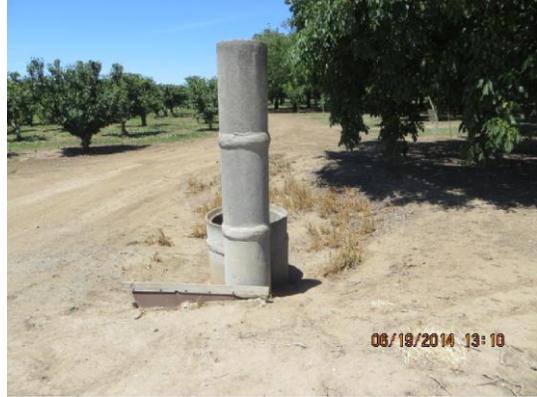
Photo 2 of 3 : UCIP\_FA\_2015\_6435.jpg

Two concrete standpipes at LS toe.

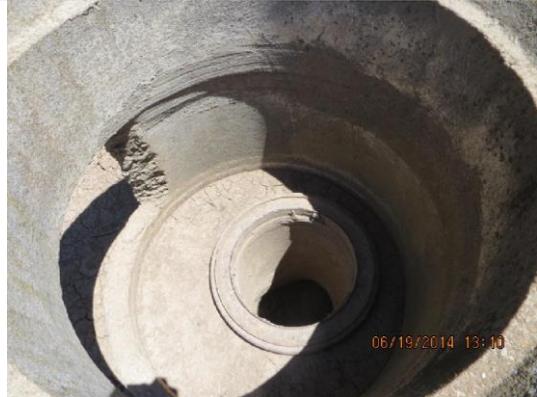
Photo 3 of 3 : UCIP\_FA\_2015\_6436.jpg

Pipe may be visible at bottom of concrete standpipe on LS toe.

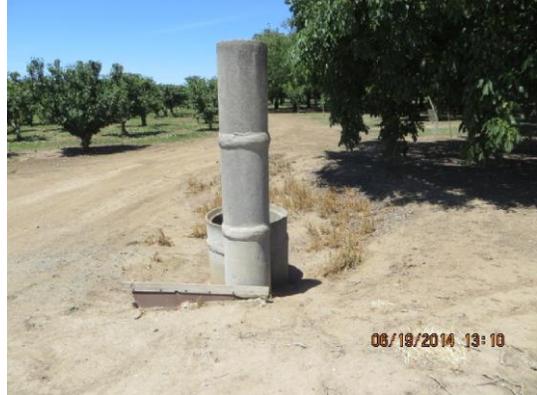
Photo 1 of 3 : UCIP\_FA\_2015\_2506.jpg

LM Start	<b>0.32</b>	Rating **	M	Issue No.	<b>12</b>
LM End	<b>0.32</b>	Issue Type +	En	Location *	WS
Category	Supplemental			GPS Latitude/Longitude	
				Start	End
Item	DWR UCIP Field Study			37.959423 °	37.959423 °
				-121.157769 °	-121.157769 °
DWR ID					
Action/Comments					
Inspector Comments: FS_ID:41703 DS_ID:25012 EP_NO: N/A FS_HLM: 0.317 Repair Type: Non-Urgent Crossing Status: Found

16-inch and 36-inch concrete standpipes on LS toe.

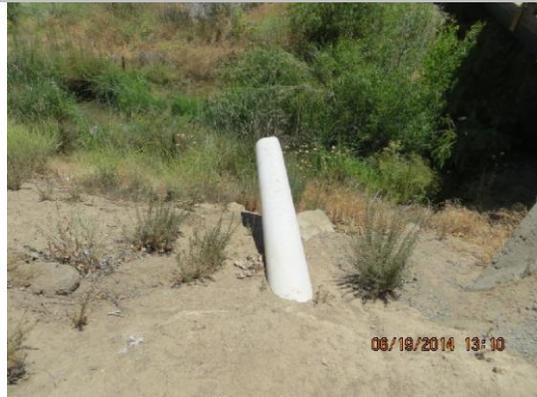
Photo 2 of 3 : UCIP\_FA\_2015\_2528.jpg

PVC Pipe visible on WS slope.

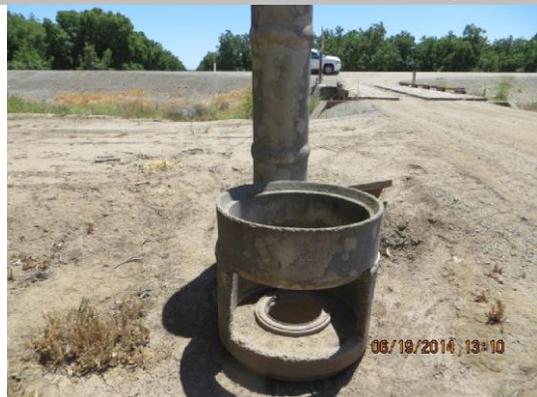
Photo 3 of 3 : UCIP\_FA\_2015\_6434.jpg

16-inch and 36-inch concrete standpipes on LS toe.

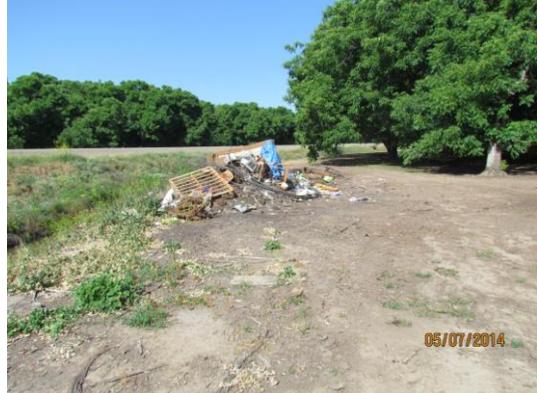
Photo 1 of 1 : FA\_2015\_NA0017\_161\_6\_20150911\_00006.jpg

LM Start	<b>0.50</b>	Rating **	M	Issue No.	<b>6</b>
LM End	<b>0.50</b>	Issue Type +	En	Location *	WS
Category	Earthen Levee			GPS Latitude/Longitude	
				Start	End
Item	Encroachments			37.958883 °	37.958883 °
				-121.154581 °	-121.154581 °
DWR ID	DWR_NA0017_17_s_2014_6				
Action/Comments					
Debris

Debris was found on the waterside shoulder of the levee looking downstream.

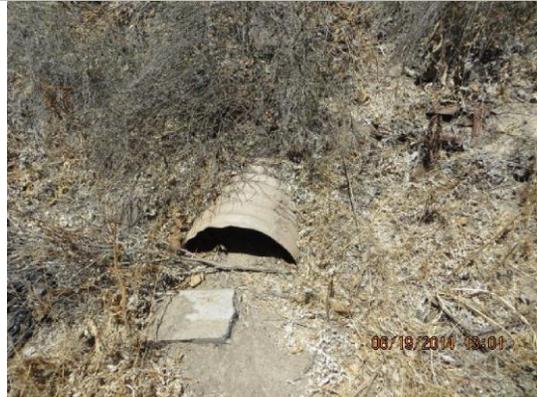
Photo 1 of 2 : UCIP\_FA\_2015\_1637.jpg

LM Start	<b>0.58</b>	Rating **	M	Issue No.	<b>13</b>
LM End	<b>0.58</b>	Issue Type +	En	Location *	WS
Category	Supplemental			GPS Latitude/Longitude	
				Start	End
Item	DWR UCIP Field Study			37.958976 °	37.958976 °
				-121.153087 °	-121.153087 °
DWR ID					
Action/Comments					
Inspector Comments: FS_ID:38978 DS_ID:18535 EP_NO: N/A FS_HLM: 0.581 Repair Type: Non-Urgent Crossing Status: Found UCIP Comments: Pipe appears abandoned and if so should be done so properly. FIELD_STRUCT_DESC: 18-inch CM pipe 5.5-feet below the roadway. Open on waterside end. O&M manual SJR 611.1 Vol. F- revised in 2010. FS Date: 06/19/2014

Pipe visible on WS slope.

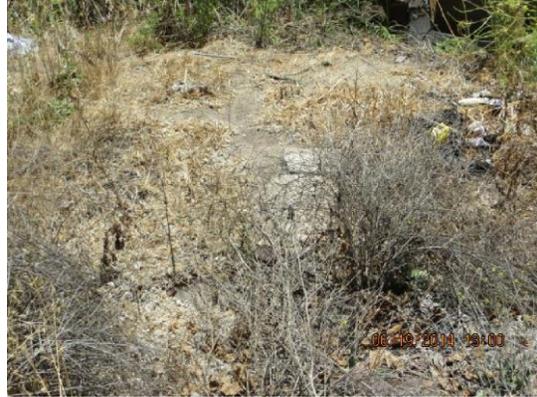
Photo 2 of 2 : UCIP\_FA\_2015\_1640.jpg

Pipe visible on WS slope.

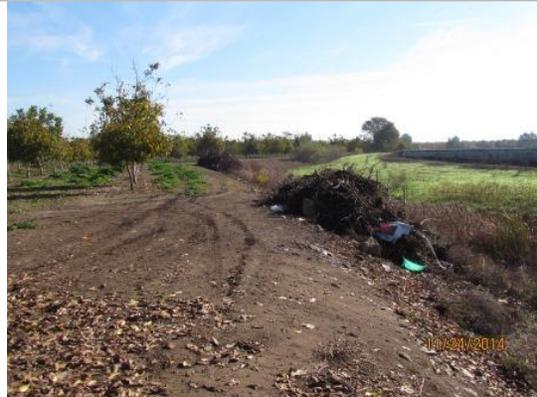
Photo 1 of 2 : FA\_2015\_NA0017\_161\_5\_20150911\_00004.jpg

LM Start	<b>0.60</b>	Rating **	M	Issue No.	<b>5</b>
LM End	<b>0.60</b>	Issue Type +	Ma	Location *	WS
Category	Earthen Levee			GPS Latitude/Longitude	
				Start	End
Item	Encroachments			37.958966 °	37.958966 °
				-121.152641 °	-121.152641 °
DWR ID	DWR_NA0017_17_s_2012_5				
Action/Comments					
Prunings

Updated picture of the prunings on the waterside of the levee looking upstream during fall 2014 inspection.

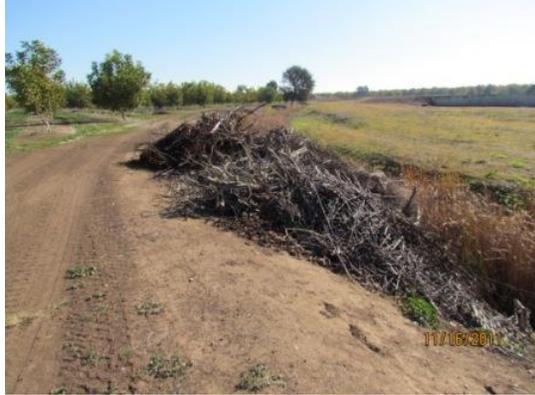
Photo 2 of 2 : FA\_2015\_NA0017\_161\_5\_20150911\_00005.jpg

Prunings were found on the waterside of the levee looking upstream.

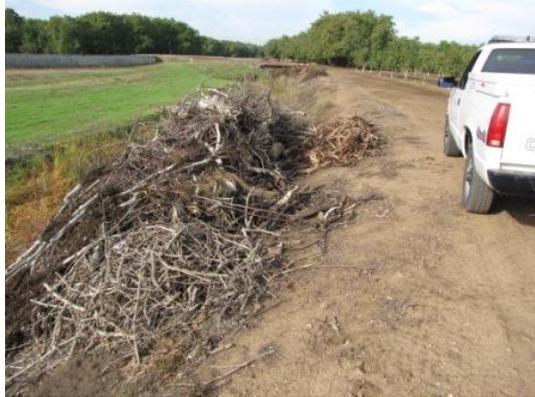
Photo 1 of 1 : FA\_2015\_NA0017\_161\_4\_20150911\_00003.jpg

LM Start	<b>0.62</b>	Rating **	M	Issue No.	<b>4</b>
LM End	<b>0.62</b>	Issue Type +	En	Location *	WS
Category	Earthen Levee		GPS Latitude/Longitude		
			Start	End	
Item	Encroachments		37.958943 °	37.958943 °	
			-121.152261 °	-121.152261 °	
DWR ID	DWR_NA0017_17_s_2012_4				
Action/Comments					
Prunings

View of a prunings pile along the waterward bank looking downstream.

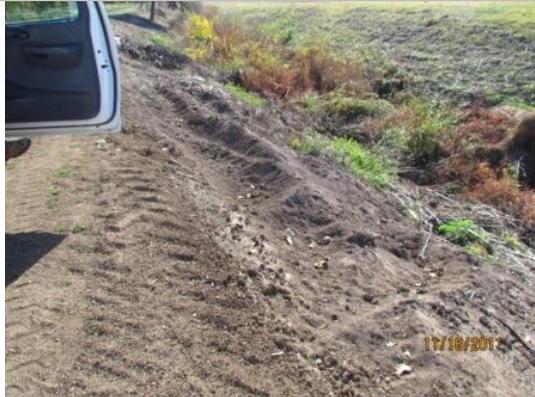
Photo 1 of 1 : FA\_2015\_NA0017\_161\_10\_20150911\_00007.jpg

Slope instability was found on the waterside of the levee looking upstream.

LM Start	<b>0.67</b>	Rating **	M	Issue No.	<b>10</b>
LM End	<b>0.67</b>	Issue Type +	Ma	Location *	WS
Category	Earthen Levee		GPS Latitude/Longitude		
			Start	End	
Item	Slope Stability		37.958702 °	37.958702 °	
			-121.151544 °	-121.151544 °	
DWR ID	DWR_NA0017_17_s_2012_10				
Action/Comments					
Repair the levee slope damaged by vehicle traffic and prevent access where possible.

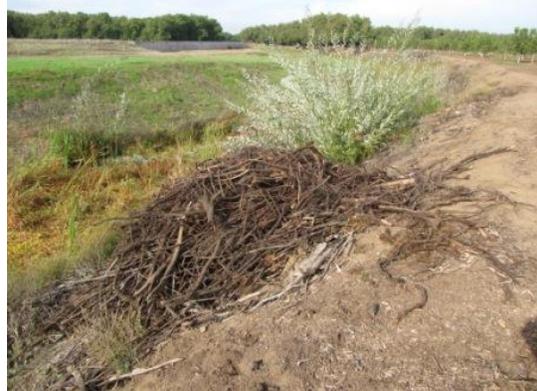
Photo 1 of 1 : FA\_2015\_NA0017\_161\_3\_20150911\_00002.jpg

LM Start	<b>0.68</b>	Rating **	M	Issue No.	<b>3</b>
LM End	<b>0.68</b>	Issue Type +	Ma	Location *	WS
Category	Earthen Levee		GPS Latitude/Longitude		
			Start	End	
Item	Encroachments		37.958590 °	37.958590 °	
			-121.151408 °	-121.151408 °	
DWR ID	DWR_NA0017_17_s_2012_3				
Action/Comments					
Prunings

View of a prunings pile along the waterward bank looking downstream.

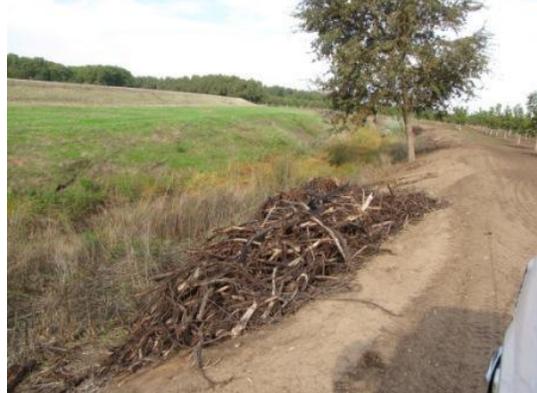
Photo 1 of 1 : FA\_2015\_NA0017\_161\_2\_20150911\_00001.jpg

LM Start	<b>0.78</b>	Rating **	M	Issue No.	<b>2</b>
LM End	<b>0.78</b>	Issue Type +	Ma	Location *	WS
Category	Earthen Levee		GPS Latitude/Longitude		
			Start	End	
Item	Encroachments		37.957934 °	37.957934 °	
			-121.149911 °	-121.149911 °	
DWR ID	DWR_NA0017_17_s_2012_2				
Action/Comments					
Prunings

View of a prunings pile along the waterward bank looking downstream.

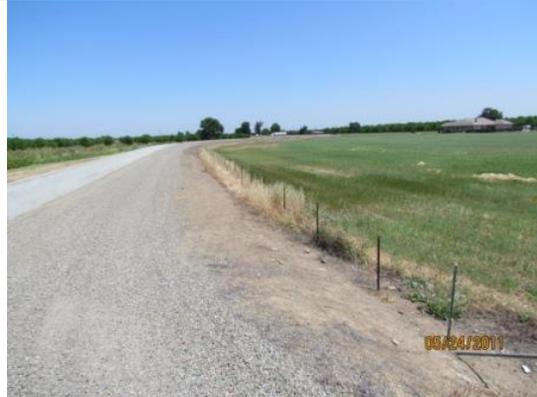
Photo 1 of 1 : FA\_2015\_NA0017\_162\_1\_20150911\_00001.jpg

LM Start	<b>0.07</b>	Rating **	M	Issue No.	<b>1</b>
LM End	<b>0.29</b>	Issue Type +	En	Location *	LS
Category	Earthen Levee		GPS Latitude/Longitude		
			Start	End	
Item	Encroachments		37.957534 °	37.958657 °	
			-121.149739 °	-121.153146 °	
DWR ID	DWR_NA0017_18_s_2012_1				
Action/Comments					
Fence

Fences along the landside toe of the levee. The picture was taken from the crown looking upstream.

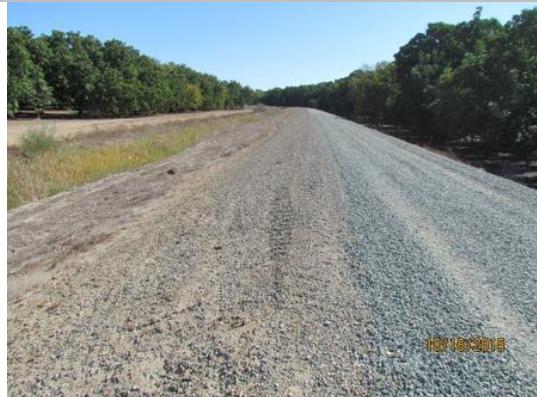
Photo 1 of 1 : FA\_2015\_NA0017\_162\_3\_20151023\_00002.jpg

View of the waterside slope of the levee.

LM Start	<b>0.52</b>	Rating **	A	Issue No.	<b>3</b>
LM End	<b>0.52</b>	Issue Type +	Ma	Location *	WS
Category	Earthen Levee		GPS Latitude/Longitude		
			Start	End	
Item	Vegetation		37.959061 °	37.959061 °	
			-121.157343 °	-121.157343 °	
DWR ID	DWR_NA0017_18_f_2015_3				
Action/Comments					
Control annual grass and weeds on the levee slopes and easements. Inspector Comments: Acceptable vegetation.

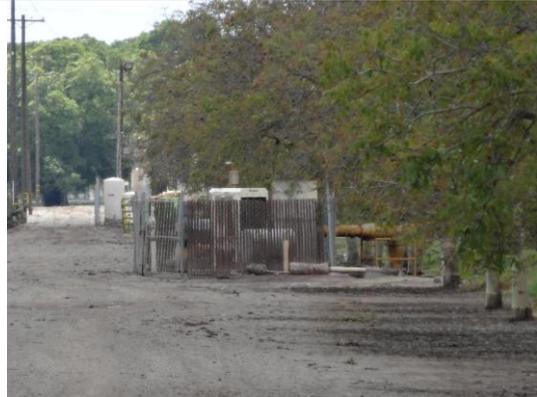
Photo 1 of 2 : UCIP\_FA\_2015\_3629.jpg

Inspector Comments: FS\_ID:33115  
 DS\_ID:18538  
 EP\_NO: N/A  
 FS\_HLM: 0.55  
 Repair Type: Non-Urgent  
 Crossing Status: Indicator Found  
 UCIP Comments: PVC standpipe on landside. It is not clear whether this standpipe belongs to the crossing. Need more info from LMA or DWR Inspector. A pump station located about 500 ft from the levee.  
 FIELD\_STRUCT\_DESC: 16-inch concrete siphon pipe through the levee 5.0 feet below the crown and under the channel. O&M manual SJR 611.1 Vol. F- revised in 2010.  
 FS Date: 04/04/2014

LS view: a pump station located about 500 ft from the levee. It is not clear whether this has connection with the levee crossing.

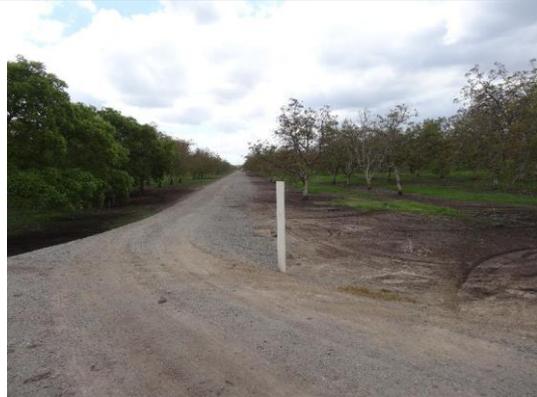
Photo 2 of 2 : UCIP\_FA\_2015\_3630.jpg

LS view: a PVC standpipe on levee toe. It is not clear whether this has connection with the levee crossing.

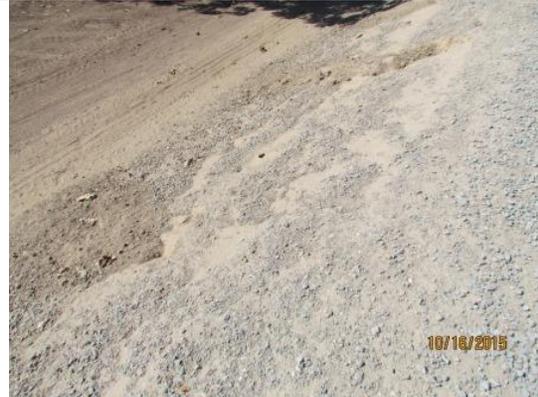
Photo 1 of 1 : FA\_2015\_NA0017\_162\_4\_20151023\_00003.jpg

Rodent holes were found on the landside of the levee.

LM Start	<b>0.87</b>	Rating **	M	Issue No.	<b>4</b>
LM End	<b>0.87</b>	Issue Type +	Ma	Location *	LS
Category	Earthen Levee		GPS Latitude/Longitude		
			Start	End	
Item	Animal Control		37.960206 °	37.960206 °	
			-121.163559 °	-121.163559 °	
DWR ID	DWR_NA0017_18_f_2015_4				
<b>Action/Comments</b>					
No rodents visible, but rodent burrows visible; need to backfill and compact or grout burrows.
