**Flood Control Project Maintenance
Levee Inspections**

Maintenance Issue Types Only, Levee Inspection Report By Mile - Fall 2014

San Joaquin County Flood Control and Water Conservation District

Waterway	Bank	Unit Miles	Inspection Start/End	Inspector
Unit No. 01 Littlejohn Creek	Left	2.59	11/24/2014 11/24/2014	Pavel Kazi

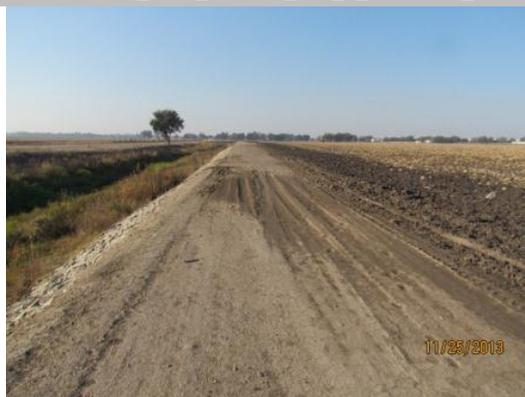
Photo 1 of 1 : FA_2014_NA0017_149_1_20141105_00001.jpg

LM Start	2.01	Rating **	M	Issue No.	1
LM End	2.01	Issue Type +	Ma	Location *	CR
Category	Earthen Levee		GPS Latitude/Longitude		
			Start	End	
Item	Crown Surface / Depressions / Rutting		37.882528 °	37.882528 °	
			-121.250601 °	-121.250601 °	
DWR ID	DWR_NA0017_02_f_2013_1				
Action/Comments					
Add appropriate gravel or road base. Grade and compact.

Crown depression was found looking downstream.

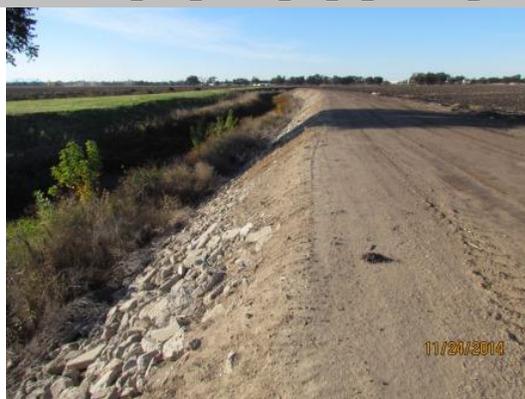
Photo 1 of 1 : FA_2014_NA0017_149_71_20141125_00087.jpg

LM Start	2.07	Rating **	A	Issue No.	71
LM End	2.07	Issue Type +	Ma	Location *	WS
Category	Earthen Levee		GPS Latitude/Longitude		
			Start	End	
Item	Erosion / Bank Caving		37.883128 °	37.883128 °	
			-121.251565 °	-121.251565 °	
DWR ID	DWR_NA0017_02_f_2014_71				
Action/Comments					
Note and monitor erosion site. Inspector Comments: LMA has fixed the issue.

LMA has repaired erosion on the waterside of the levee looking downstream.

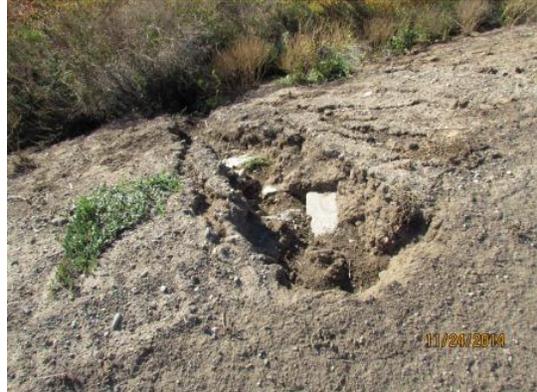
Photo 1 of 2 : FA_2014_NA0017_149_4_20141125_00088.jpg

LM Start	2.24	Rating **	M	Issue No.	4
LM End	2.24	Issue Type +	Ma	Location *	WS
Category	Earthen Levee		GPS Latitude/Longitude		
			Start	End	
Item	Erosion / Bank Caving		37.884741 °	37.884741 °	
			-121.253808 °	-121.253808 °	
DWR ID	DWR_NA0017_02_s_2014_4				
Action/Comments					
Schedule repair of erosion site prior to the next inspection.

Updated picture of the erosion on the waterside of the levee looking downstream.

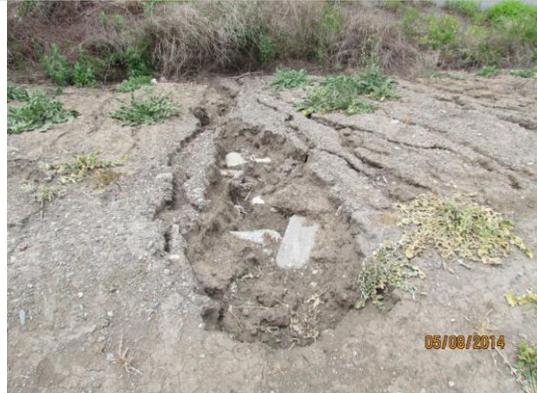
Photo 2 of 2 : FA_2014_NA0017_149_4_20141105_00003.jpg

LM Start	2.24	Rating **	M	Issue No.	4 (cont)
LM End	2.24	Issue Type +	Ma	Location *	WS

Erosion was found on the waterside slope of the levee looking downstream.

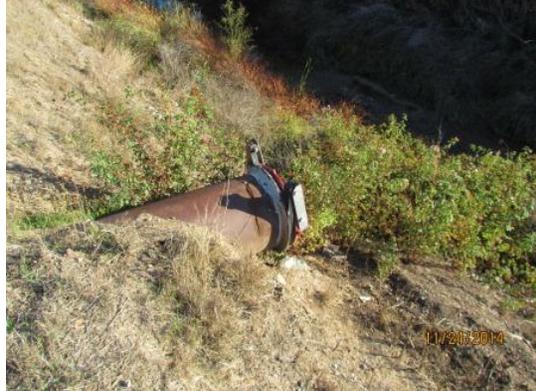
Photo 1 of 2 : FA_2014_NA0017_149_8_20141125_00089.jpg

LM Start	2.66	Rating **	A/W	Issue No.	8
LM End	2.66	Issue Type +	Ma	Location *	WS
Category	Earthen Levee		GPS Latitude/Longitude		
			Start	End	
Item	Encroachments		37.888853 °	37.888853 °	
			-121.258640 °	-121.258640 °	
DWR ID	DWR_NA0017_02_s_2012_8				
Action/Comments					
Pipe Inspector Comments: Pipe crossing the channel has corroded and can carry water to/from the channel. A flap gate was installed by the LMA, but the pipe appeared to be damaged.

A flap gate was installed at the end of the pipe, but the pipe appeared to have cracks. The picture was taken from the crown looking upstream during fall 2014 inspection.

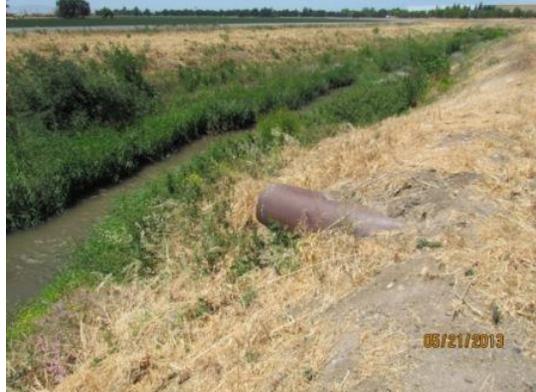
Photo 2 of 2 : FA_2014_NA0017_149_8_20141105_00005.jpg

LM Start	2.66	Rating **	A/W	Issue No.	8 (cont)
LM End	2.66	Issue Type +	Ma	Location *	WS

A pipe was found without a flap gate on waterside slope of the levee looking downstream. This pipe may predate the project.

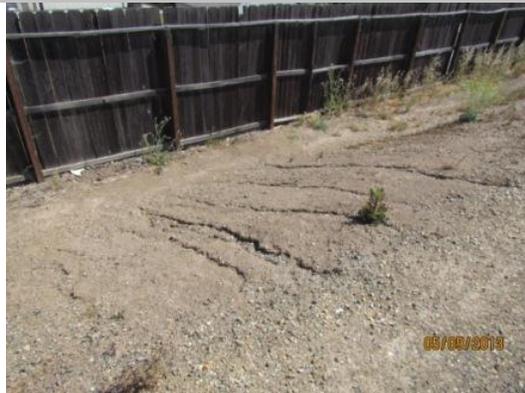
Photo 1 of 1 : FA_2014_NA0017_151_2_20141021_00002.jpg

LM Start	0.92	Rating **	M	Issue No.	2
LM End	0.92	Issue Type +	Ma	Location *	LS
Category	Earthen Levee		GPS Latitude/Longitude		
			Start	End	
Item	Erosion / Bank Caving		38.043468 °	38.043468 °	
			-121.361022 °	-121.361022 °	
DWR ID	DWR_NA0017_07_s_2013_2				
Action/Comments					
Schedule repair of erosion site prior to the next inspection.

Erosion was found on the landside of the levee looking upstream.

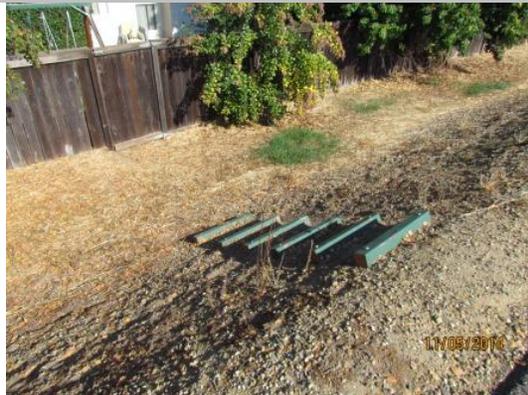
Photo 1 of 1 : FA_2014_NA0017_151_76_20141109_00062.jpg

LM Start	1.79	Rating **	M	Issue No.	76
LM End	1.79	Issue Type +	Ma	Location *	LS
Category	Earthen Levee		GPS Latitude/Longitude		
			Start	End	
Item	Encroachments		38.043304 °	38.043304 °	
			-121.345485 °	-121.345485 °	
DWR ID	DWR_NA0017_07_f_2014_76				
Action/Comments					
Stairway

A stairway was found on the landside of the levee looking upstream.

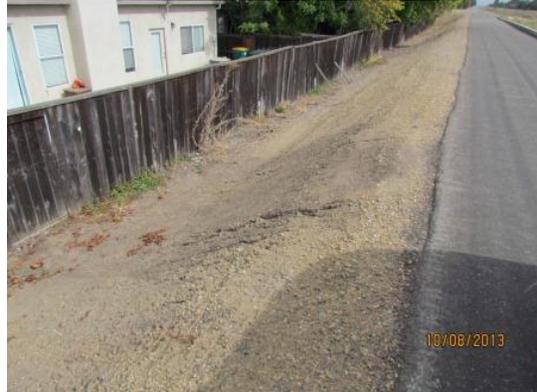
Photo 1 of 1 : FA_2014_NA0017_151_11_20141021_00008.jpg

LM Start	1.94	Rating **	M	Issue No.	11
LM End	1.94	Issue Type +	Ma	Location *	LS
Category	Earthen Levee		GPS Latitude/Longitude		
			Start	End	
Item	Erosion / Bank Caving		38.043276 °	38.043276 °	
			-121.342812 °	-121.342812 °	
DWR ID	DWR_NA0017_07_f_2013_11				
Action/Comments					
Schedule repair of erosion site prior to the next inspection. Inspector Comments: Runoff on the landside slope.

Runoff was discovered on the landside slope of the levee looking upstream.

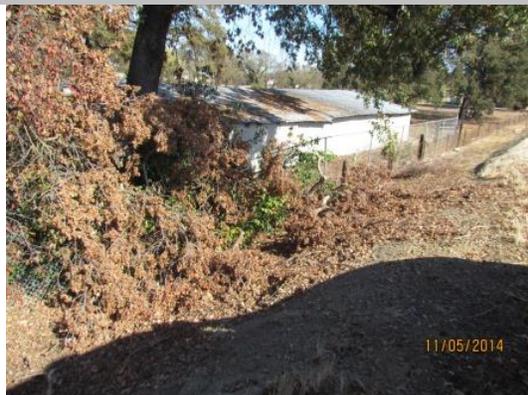
Photo 1 of 1 : FA_2014_NA0017_151_81_20141109_00063.jpg

LM Start	2.59	Rating **	M	Issue No.	81
LM End	2.59	Issue Type +	Ma	Location *	LS
Category	Earthen Levee		GPS Latitude/Longitude		
			Start	End	
Item	Encroachments		38.043213 °	38.043213 °	
			-121.331189 °	-121.331189 °	
DWR ID	DWR_NA0017_07_f_2014_81				
Action/Comments					
Prunings

Prunings were found on the landside toe of the levee looking upstream.

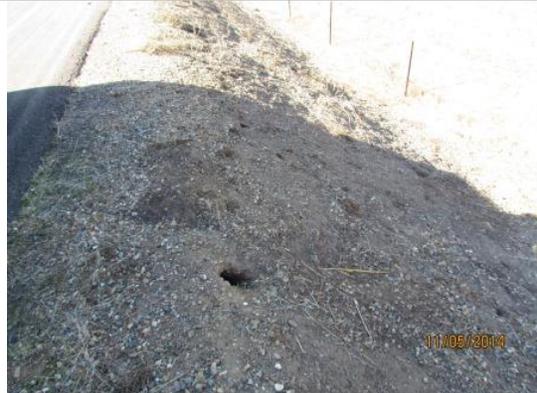
Photo 1 of 1 : FA_2014_NA0017_151_83_20141109_00064.jpg

LM Start	3.00	Rating **	M	Issue No.	83
LM End	3.00	Issue Type +	Ma	Location *	LS
Category	Earthen Levee		GPS Latitude/Longitude		
			Start	End	
Item	Animal Control		38.043189 °	38.043189 °	
			-121.323881 °	-121.323881 °	
DWR ID	DWR_NA0017_07_f_2014_83				
Action/Comments					
No rodents visible, but rodent burrows visible; need to backfill and compact or grout burrows.

Rodent holes were found on the landside of the levee looking downstream.

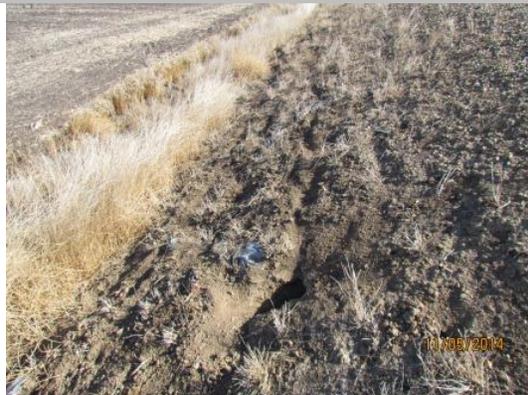
Photo 1 of 1 : FA_2014_NA0017_151_86_20141109_00065.jpg

LM Start	3.64	Rating **	M	Issue No.	86
LM End	3.64	Issue Type +	Ma	Location *	LS
Category	Earthen Levee		GPS Latitude/Longitude		
			Start	End	
Item	Animal Control		38.043126 °	38.043126 °	
			-121.312462 °	-121.312462 °	
DWR ID	DWR_NA0017_07_f_2014_86				
Action/Comments					
No rodents visible, but rodent burrows visible; need to backfill and compact or grout burrows.

An animal hole was found on the landside of the levee looking upstream.

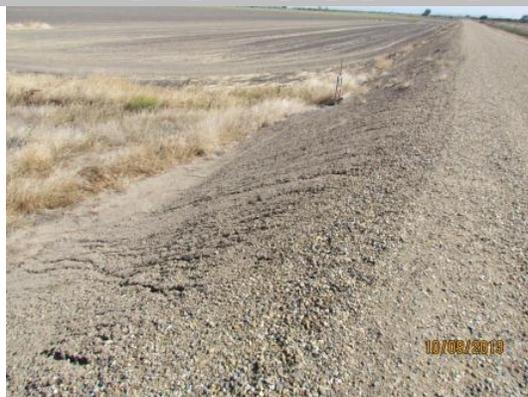
Photo 1 of 1 : FA_2014_NA0017_151_24_20141021_00015.jpg

LM Start	3.78	Rating **	M	Issue No.	24
LM End	3.78	Issue Type +	Ma	Location *	LS
Category	Earthen Levee		GPS Latitude/Longitude		
			Start	End	
Item	Erosion / Bank Caving		38.043025 °	38.043025 °	
			-121.309918 °	-121.309918 °	
DWR ID	DWR_NA0017_07_f_2013_24				
Action/Comments					
Schedule repair of erosion site prior to the next inspection. Inspector Comments: Runoff was discovered.

View of erosion occurred due to runoff on the landside slope of the levee looking upstream.

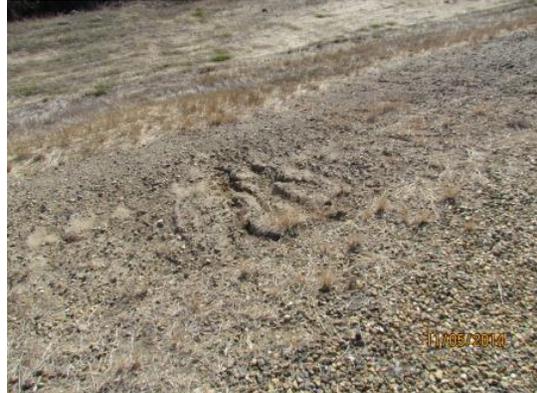
Photo 1 of 1 : FA_2014_NA0017_151_92_20141109_00067.jpg

LM Start	6.10	Rating **	M	Issue No.	92
LM End	6.10	Issue Type +	Ma	Location *	WS
Category	Earthen Levee		GPS Latitude/Longitude		
			Start	End	
Item	Slope Stability		38.053335 °	38.053335 °	
			-121.273287 °	-121.273287 °	
DWR ID	DWR_NA0017_07_f_2014_92				
Action/Comments					
Repair the levee slope damaged by vehicle traffic and prevent access where possible.

Slope instability was found on the waterside of the levee looking downstream.

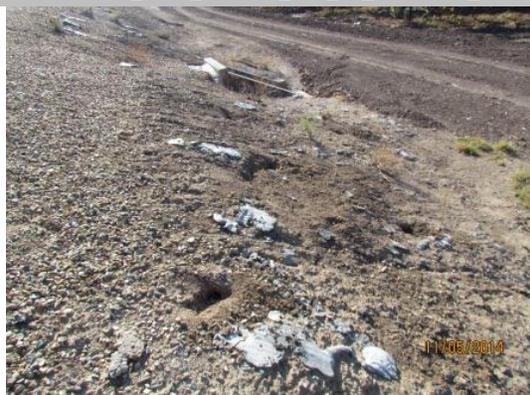
Photo 1 of 1 : FA_2014_NA0017_151_97_20141109_00069.jpg

LM Start	7.00	Rating **	M	Issue No.	97
LM End	7.00	Issue Type +	Ma	Location *	LS
Category	Earthen Levee		GPS Latitude/Longitude		
			Start	End	
Item	Animal Control		38.059547 °	38.059547 °	
			-121.261447 °	-121.261447 °	
DWR ID	DWR_NA0017_07_f_2014_97				
Action/Comments					
No rodents visible, but rodent burrows visible; need to backfill and compact or grout burrows.

View of rodent holes found on the landside of the levee looking upstream.

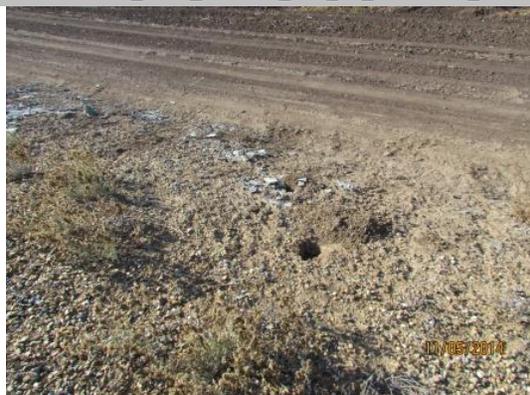
Photo 1 of 1 : FA_2014_NA0017_151_98_20141109_00070.jpg

LM Start	7.02	Rating **	M	Issue No.	98
LM End	7.02	Issue Type +	Ma	Location *	LS
Category	Earthen Levee		GPS Latitude/Longitude		
			Start	End	
Item	Animal Control		38.059756 °	38.059756 °	
			-121.261209 °	-121.261209 °	
DWR ID	DWR_NA0017_07_f_2014_98				
Action/Comments					
No rodents visible, but rodent burrows visible; need to backfill and compact or grout burrows.

View of rodent holes found on the landside of the levee looking downstream.

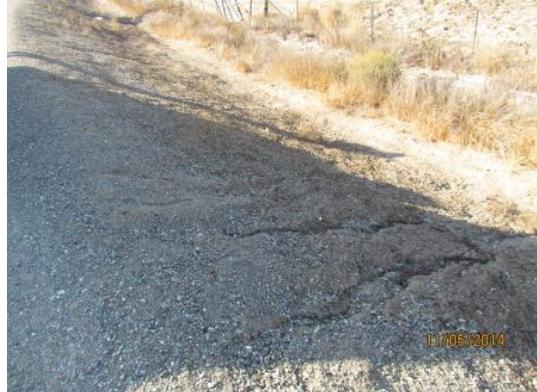
Photo 1 of 1 : FA_2014_NA0017_151_102_20141109_00071.jpg

LM Start	7.73	Rating **	M	Issue No.	102
LM End	7.73	Issue Type +	Ma	Location *	LS
Category	Earthen Levee		GPS Latitude/Longitude		
			Start	End	
Item	Erosion / Bank Caving		38.064983 °	38.064983 °	
			-121.251043 °	-121.251043 °	
DWR ID	DWR_NA0017_07_f_2014_102				
Action/Comments					
Schedule repair of erosion site prior to the next inspection. Inspector Comments: Runoff

View of Erosion caused by runoff found on the landside of the levee looking downstream.

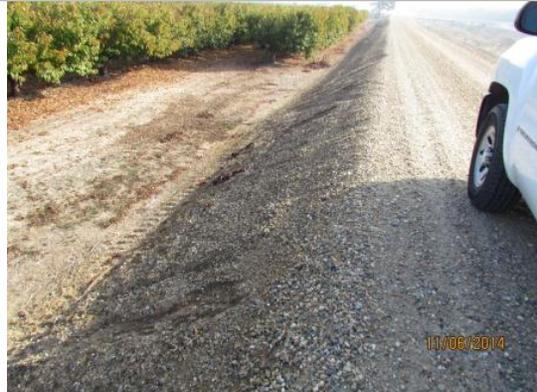
Photo 1 of 1 : FA_2014_NA0017_151_96_20141109_00072.jpg

LM Start	8.37	Rating **	M	Issue No.	96
LM End	8.37	Issue Type +	Ma	Location *	LS
Category	Earthen Levee		GPS Latitude/Longitude		
			Start	End	
Item	Erosion / Bank Caving		38.067468 °	38.067468 °	
			-121.240487 °	-121.240487 °	
DWR ID	DWR_NA0017_07_f_2014_96				
Action/Comments					
Schedule repair of erosion site prior to the next inspection. Inspector Comments: Runoff caused by surface water.

View of erosion caused by surface runoff found on the landside slope of the levee looking upstream.

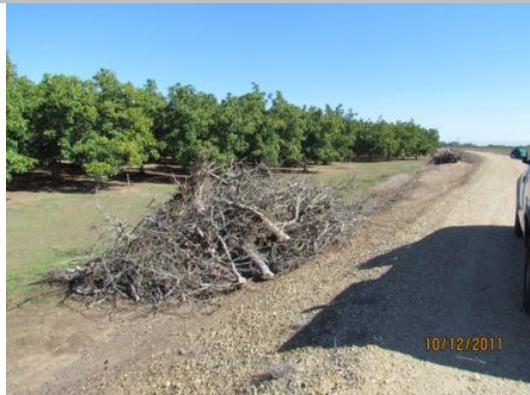
Photo 1 of 1 : FA_2014_NA0017_151_29_20141021_00018.jpg

LM Start	8.87	Rating **	M	Issue No.	29
LM End	8.87	Issue Type +	Ma	Location *	LS
Category	Earthen Levee		GPS Latitude/Longitude		
			Start	End	
Item	Encroachments		38.068319 °	38.068319 °	
			-121.231559 °	-121.231559 °	
DWR ID	DWR_NA0017_07_s_2012_29				
Action/Comments					
Prunings Inspector Comments: Burn pile has been burned but new material has been placed.

View of prunings found on the landside of the levee looking upstream.

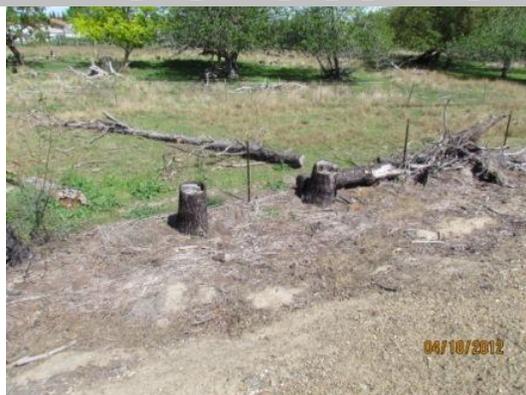
Photo 1 of 1 : FA_2014_NA0017_151_46_20141021_00031.jpg

LM Start	10.23	Rating **	N	Issue No.	46
LM End	10.23	Issue Type +	Ma	Location *	LS
Category	Earthen Levee		GPS Latitude/Longitude		
			Start	End	
Item	Trim / Thin Trees		38.074613 °	38.074613 °	
			-121.209882 °	-121.209882 °	
DWR ID	DWR_NA0017_07_s_2012_46				
Action/Comments					
Tree stumps.

View of tree stumps found on the landside of the levee looking upstream.

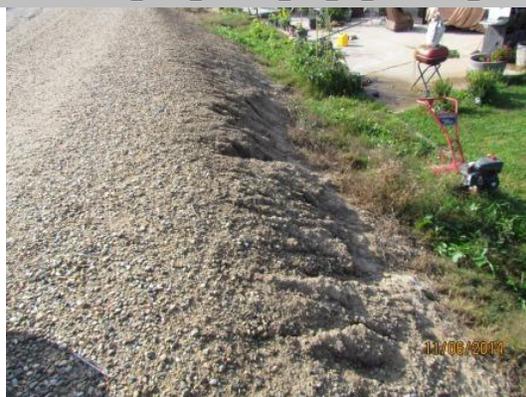
Photo 1 of 1 : FA_2014_NA0017_151_89_20141109_00076.jpg

LM Start	10.39	Rating **	M	Issue No.	89
LM End	10.39	Issue Type +	Ma	Location *	LS
Category	Earthen Levee		GPS Latitude/Longitude		
			Start	End	
Item	Erosion / Bank Caving		38.076529 °	38.076529 °	
			-121.208658 °	-121.208658 °	
DWR ID	DWR_NA0017_07_f_2014_89				
Action/Comments					
Schedule repair of erosion site prior to the next inspection. Inspector Comments: Runoff

View of erosion caused by runoff found on the landside slope of the levee looking downstream.

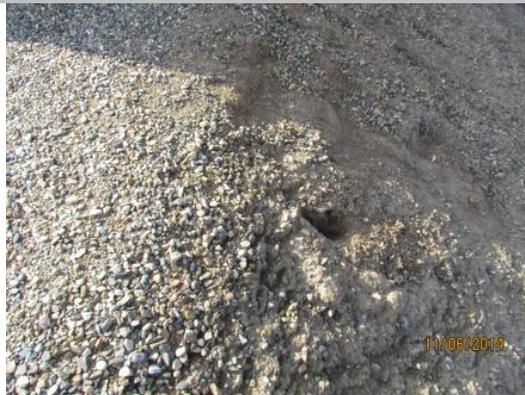
Photo 1 of 1 : FA_2014_NA0017_151_105_20141109_00077.jpg

LM Start	10.49	Rating **	M	Issue No.	105
LM End	10.49	Issue Type +	Ma	Location *	LS
Category	Earthen Levee		GPS Latitude/Longitude		
			Start	End	
Item	Animal Control		38.077665 °	38.077665 °	
			-121.207662 °	-121.207662 °	
DWR ID	DWR_NA0017_07_f_2014_105				
Action/Comments					
No rodents visible, but rodent burrows visible; need to backfill and compact or grout burrows.

An animal hole was found on the landside shoulder of the levee looking downstream.

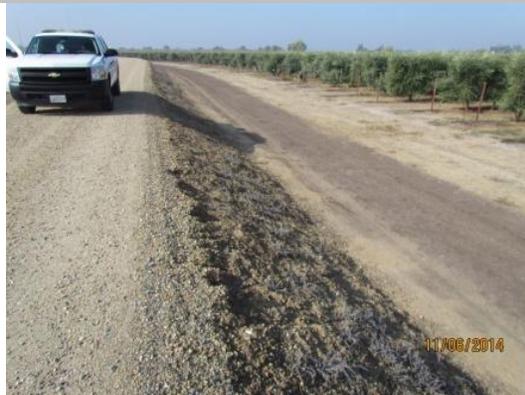
Photo 1 of 1 : FA_2014_NA0017_151_106_20141109_00078.jpg

LM Start	11.57	Rating **	M	Issue No.	106
LM End	11.57	Issue Type +	Ma	Location *	LS
Category	Earthen Levee		GPS Latitude/Longitude		
			Start	End	
Item	Erosion / Bank Caving		38.086375 °	38.086375 °	
			-121.192541 °	-121.192541 °	
DWR ID	DWR_NA0017_07_f_2014_106				
Action/Comments					
Schedule repair of erosion site prior to the next inspection. Inspector Comments: runoff

Erosion caused by runoff was found on the landside slope of the levee looking downstream.

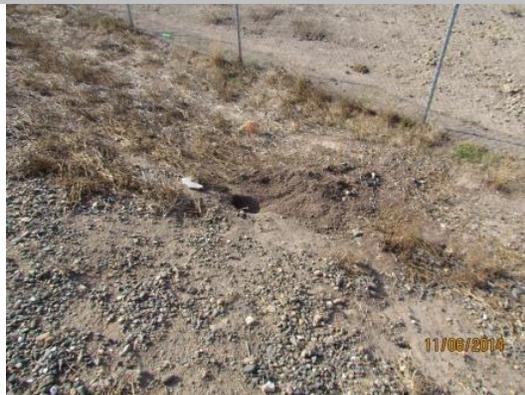
Photo 1 of 1 : FA_2014_NA0017_151_107_20141109_00079.jpg

LM Start	12.88	Rating **	M	Issue No.	107
LM End	12.88	Issue Type +	Ma	Location *	LS
Category	Earthen Levee		GPS Latitude/Longitude		
			Start	End	
Item	Animal Control		38.096788 °	38.096788 °	
			-121.176614 °	-121.176614 °	
DWR ID	DWR_NA0017_07_f_2014_107				
Action/Comments					
No rodents visible, but rodent burrows visible; need to backfill and compact or grout burrows.

An animal hole was found on the landside of the levee looking downstream.

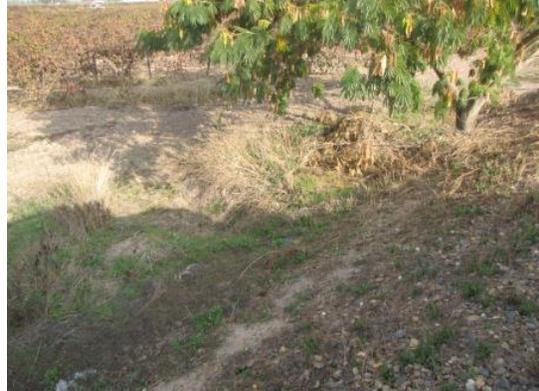
Photo 1 of 1 : FA_2014_NA0017_151_72_20141021_00043.jpg

LM Start	13.55	Rating **	M	Issue No.	72
LM End	13.55	Issue Type +	Ma	Location *	LS
Category	Earthen Levee		GPS Latitude/Longitude		
			Start	End	
Item	Slope Stability		38.105846 °	38.105846 °	
			-121.176552 °	-121.176552 °	
DWR ID	DWR_NA0017_07_s_2012_72				
Action/Comments					
Repair slope instability. Inspector Comments: Shallow pit at the landward toe with nearby prunings.

View of a pit along the landward levee toe looking upstream.

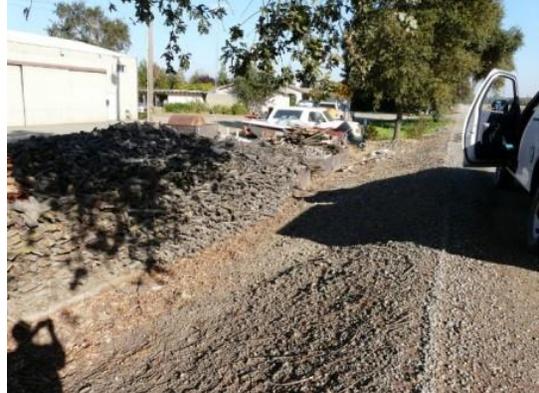
Photo 1 of 1 : FA_2014_NA0017_151_39_20141021_00025.jpg

LM Start	14.08	Rating **	M	Issue No.	39
LM End	14.08	Issue Type +	Ma	Location *	LS
Category	Earthen Levee		GPS Latitude/Longitude		
			Start	End	
Item	Encroachments		38.111902 °	38.111902 °	
			-121.172685 °	-121.172685 °	
DWR ID	DWR_NA0017_07_s_2012_39				
Action/Comments					
Firewood

Move firewood to outside of 10' from landside toe of levee at LM 14.08.

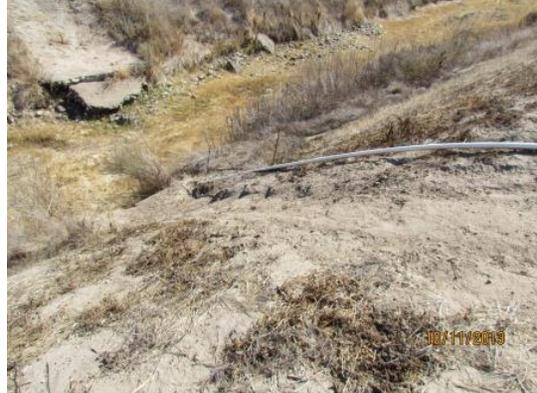
Photo 1 of 1 : FA_2014_NA0017_151_61_20141021_00040.jpg

LM Start	14.77	Rating **	M	Issue No.	61
LM End	14.77	Issue Type +	Ma	Location *	WS
Category	Earthen Levee		GPS Latitude/Longitude		
			Start	End	
Item	Encroachments		38.121625 °	38.121625 °	
			-121.169563 °	-121.169563 °	
DWR ID	DWR_NA0017_07_f_2013_61				
Action/Comments					
Stairway

Steps were found on the waterside slope of the levee looking downstream.

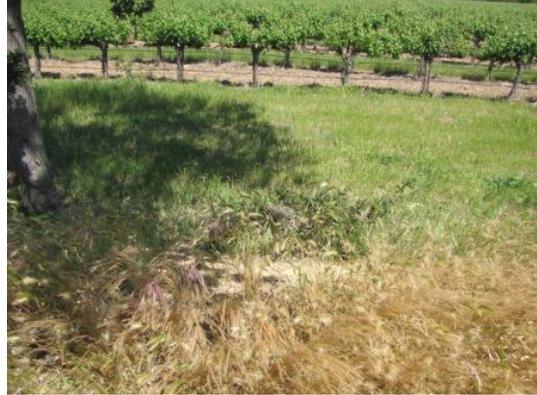
Photo 1 of 1 : FA_2014_NA0017_151_53_20141021_00036.jpg

LM Start	15.60	Rating **	N	Issue No.	53
LM End	15.72	Issue Type +	Ma	Location *	LS
Category	Earthen Levee		GPS Latitude/Longitude		
			Start	End	
Item	Trim / Thin Trees		38.129236 °	38.130205 °	
			-121.160163 °	-121.158466 °	
DWR ID	DWR_NA0017_07_s_2012_53				
Action/Comments					
Tree stumps.

View of a stump in the landward slope.

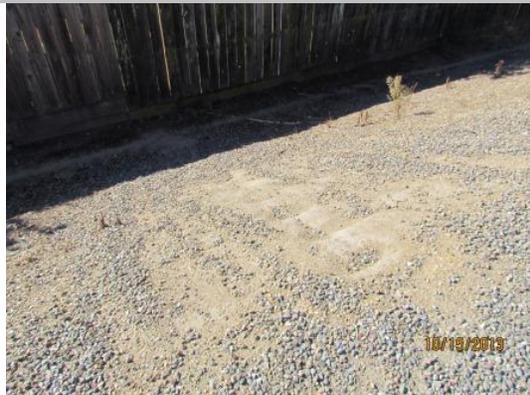
Photo 1 of 1 : FA_2014_NA0017_152_31_20141021_00014.jpg

LM Start	1.31	Rating **	M	Issue No.	31
LM End	1.31	Issue Type +	Ma	Location *	LS
Category	Earthen Levee		GPS Latitude/Longitude		
			Start	End	
Item	Encroachments		38.042894 °	38.042894 °	
			-121.360467 °	-121.360467 °	
DWR ID	DWR_NA0017_08_f_2013_31				
Action/Comments					
Stairway

View of steps that were dug on the landside slope of the levee looking downstream.

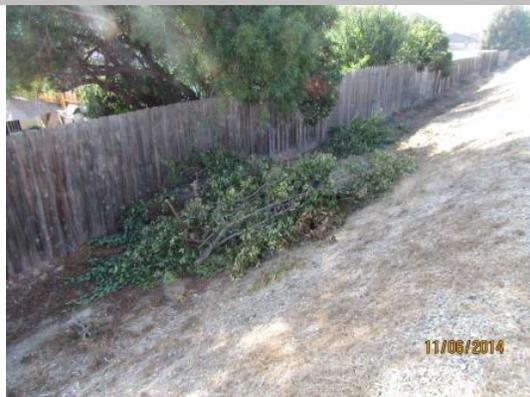
Photo 1 of 1 : FA_2014_NA0017_152_99_20141111_00106.jpg

LM Start	1.48	Rating **	M	Issue No.	99
LM End	1.48	Issue Type +	Ma	Location *	LS
Category	Earthen Levee		GPS Latitude/Longitude		
			Start	End	
Item	Encroachments		38.042821 °	38.042821 °	
			-121.357347 °	-121.357347 °	
DWR ID	DWR_NA0017_08_f_2014_99				
Action/Comments					
Prunings

View of prunings that were found on the landside toe of the levee looking downstream.

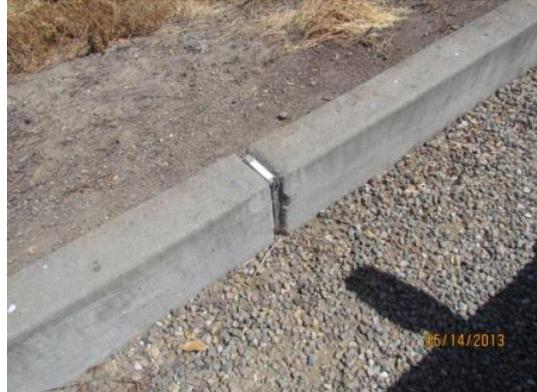
Photo 1 of 1 : FA_2014_NA0017_152_29_20141021_00013.jpg

LM Start	2.20	Rating **	M	Issue No.	29
LM End	2.20	Issue Type +	Ma	Location *	WS
Category	Concrete Floodwalls		GPS Latitude/Longitude		
			Start	End	
Item	Monolith Joints		38.042771 °	38.042771 °	
			-121.344443 °	-121.344443 °	
DWR ID	DWR_NA0017_08_s_2013_29				
Action/Comments

The monolith joint material is deteriorating at this location of the flood wall. The picture was taken from the crown looking upstream.

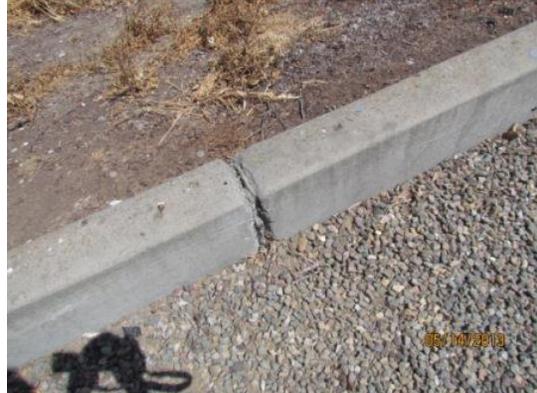
Photo 1 of 1 : FA_2014_NA0017_152_32_20141021_00015.jpg

LM Start	2.22	Rating **	M	Issue No.	32
LM End	2.22	Issue Type +	Ma	Location *	WS
Category	Concrete Floodwalls		GPS Latitude/Longitude		
			Start	End	
Item	Monolith Joints		38.042767 °	38.042767 °	
			-121.344245 °	-121.344245 °	
DWR ID	DWR_NA0017_08_s_2013_32				
Action/Comments

The monolith joint material is deteriorating at this location of the flood wall. The picture was taken from the crown looking upstream.

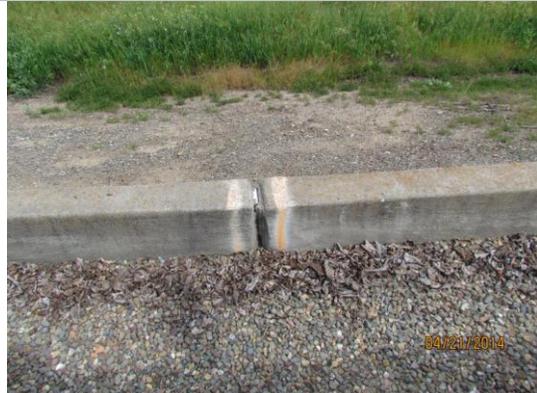
Photo 1 of 1 : FA_2014_NA0017_152_22_20141021_00010.jpg

LM Start	2.25	Rating **	M	Issue No.	22
LM End	2.25	Issue Type +	Ma	Location *	WS
Category	Concrete Floodwalls		GPS Latitude/Longitude		
			Start	End	
Item	Monolith Joints		38.042770 °	38.042770 °	
			-121.343590 °	-121.343590 °	
DWR ID	DWR_NA0017_08_s_2014_22				
Action/Comments

View of a deteriorating monolith joint on the wall that was found on the waterside of the levee looking upstream.

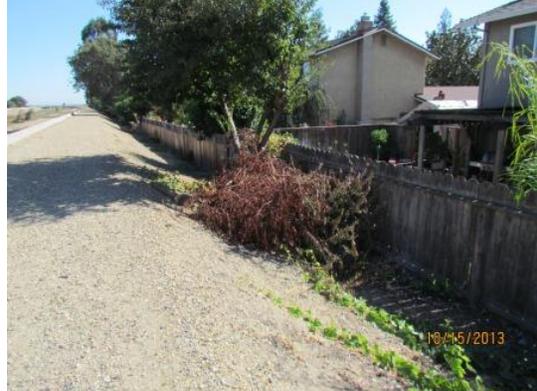
Photo 1 of 1 : FA_2014_NA0017_152_38_20141021_00017.jpg

LM Start	3.11	Rating **	M	Issue No.	38
LM End	3.11	Issue Type +	Ma	Location *	LS
Category	Earthen Levee		GPS Latitude/Longitude		
			Start	End	
Item	Encroachments		38.042661 °	38.042661 °	
			-121.328178 °	-121.328178 °	
DWR ID	DWR_NA0017_08_f_2013_38				
Action/Comments					
Prunings

View of prunings were found on the landside toe of the levee looking upstream.

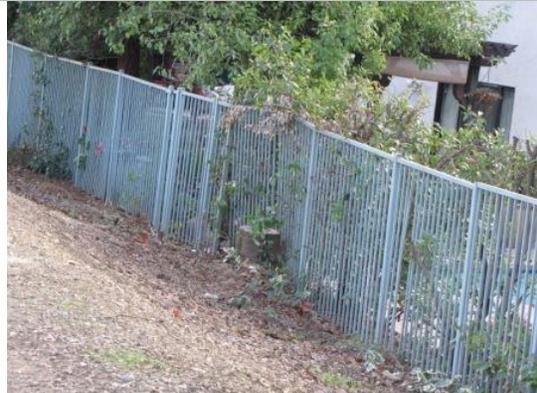
Photo 1 of 1 : FA_2014_NA0017_152_14_20141021_00005.jpg

LM Start	3.15	Rating **	N	Issue No.	14
LM End	3.15	Issue Type +	Ma	Location *	LS
Category	Earthen Levee		GPS Latitude/Longitude		
			Start	End	
Item	Trim / Thin Trees		38.042638 °	38.042638 °	
			-121.327479 °	-121.327479 °	
DWR ID	DWR_NA0017_08_s_2012_14				
Action/Comments					
Tree stumps.

View of a stump on the landward slope looking upstream.

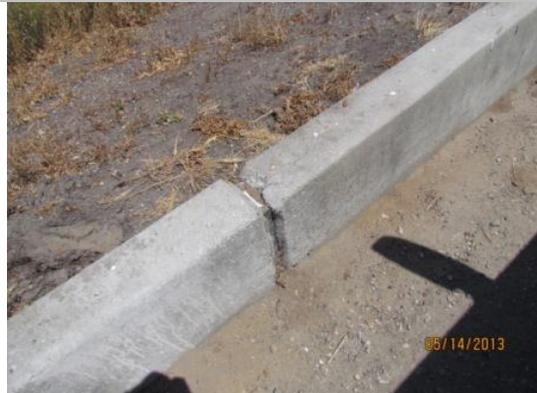
Photo 1 of 1 : FA_2014_NA0017_152_37_20141021_00016.jpg

LM Start	3.19	Rating **	M	Issue No.	37
LM End	3.19	Issue Type +	Ma	Location *	WS
Category	Concrete Floodwalls		GPS Latitude/Longitude		
			Start	End	
Item	Monolith Joints		38.042652 °	38.042652 °	
			-121.326883 °	-121.326883 °	
DWR ID	DWR_NA0017_08_s_2013_37				
Action/Comments

The monolith joint material is deteriorating at this location of the flood wall. The picture was taken from the crown looking upstream.

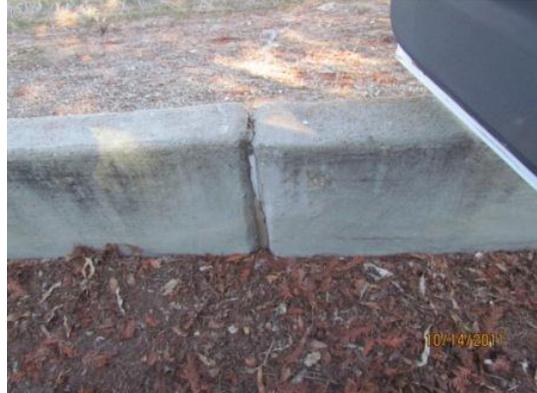
Photo 1 of 1 : FA_2014_NA0017_152_940_20141021_00049.jpg

LM Start	3.22	Rating **	M	Issue No.	940
LM End	3.22	Issue Type +	Ma	Location *	LS
Category	Concrete Floodwalls		GPS Latitude/Longitude		
			Start	End	
Item	Monolith Joints		38.042654 °	38.042654 °	
			-121.325611 °	-121.325611 °	
DWR ID	DWR_NA0017_08_s_2012_940				
Action/Comments

Monolith joint material is deteriorating at the joint of the flood wall. The picture was taken from the crown looking upstream.

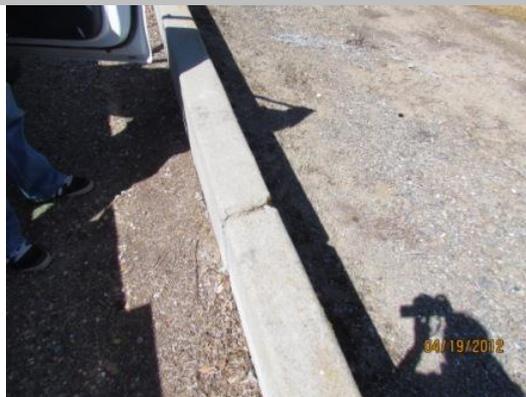
Photo 1 of 1 : FA_2014_NA0017_152_28_20141021_00012.jpg

LM Start	3.40	Rating **	M	Issue No.	28
LM End	3.40	Issue Type +	Ma	Location *	WS
Category	Concrete Floodwalls		GPS Latitude/Longitude		
			Start	End	
Item	Monolith Joints		38.042652 °	38.042652 °	
			-121.323034 °	-121.323034 °	
DWR ID	DWR_NA0017_08_s_2012_28				
Action/Comments

The monolith joint material is deteriorating on the waterside of the levee looking downstream.

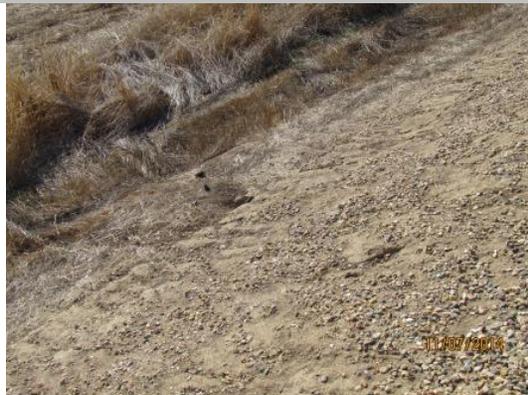
Photo 1 of 1 : FA_2014_NA0017_152_121_20141111_00113.jpg

LM Start	6.39	Rating **	M	Issue No.	121
LM End	6.39	Issue Type +	Ma	Location *	LS
Category	Earthen Levee		GPS Latitude/Longitude		
			Start	End	
Item	Animal Control		38.052362 °	38.052362 °	
			-121.274558 °	-121.274558 °	
DWR ID	DWR_NA0017_08_f_2014_121				
Action/Comments					
No rodents visible, but rodent burrows visible; need to backfill and compact or grout burrows.

Rodent holes were found on landside slope of the levee looking upstream.

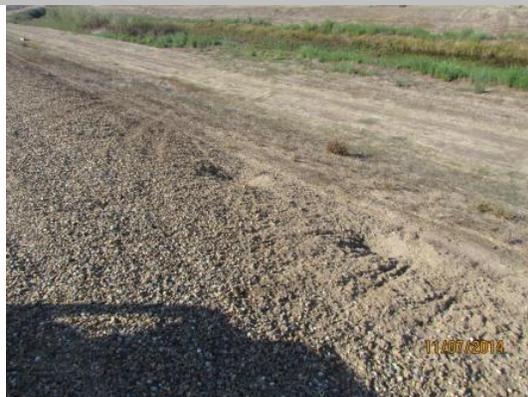
Photo 1 of 1 : FA_2014_NA0017_152_123_20141111_00114.jpg

LM Start	6.46	Rating **	M	Issue No.	123
LM End	6.46	Issue Type +	Ma	Location *	WS
Category	Earthen Levee		GPS Latitude/Longitude		
			Start	End	
Item	Erosion / Bank Caving		38.052744 °	38.052744 °	
			-121.273279 °	-121.273279 °	
DWR ID	DWR_NA0017_08_f_2014_123				
Action/Comments					
Schedule repair of erosion site prior to the next inspection. Inspector Comments: Surface runoff.

Erosion caused by surface runoff was found on the waterside of the levee looking downstream.

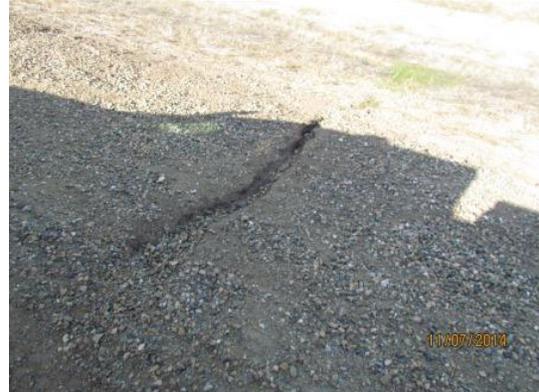
Photo 1 of 1 : FA_2014_NA0017_152_119_20141111_00112.jpg

LM Start	6.69	Rating **	M	Issue No.	119
LM End	6.69	Issue Type +	Ma	Location *	WS
Category	Earthen Levee		GPS Latitude/Longitude		
			Start	End	
Item	Erosion / Bank Caving		38.053203 °	38.053203 °	
			-121.269111 °	-121.269111 °	
DWR ID	DWR_NA0017_08_f_2014_119				
Action/Comments					
Schedule repair of erosion site prior to the next inspection. Inspector Comments: Surface runoff.

An erosion was found due to surface runoff on the waterside of the levee looking downstream.

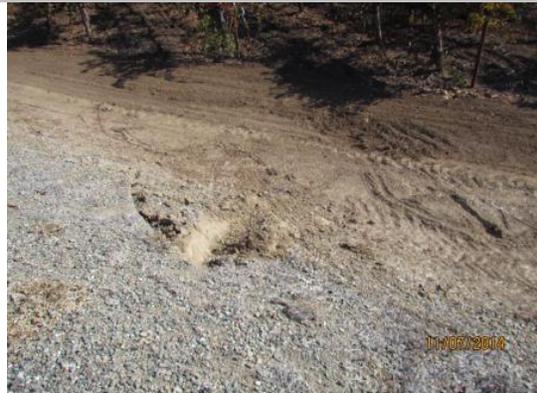
Photo 1 of 1 : FA_2014_NA0017_152_125_20141111_00116.jpg

LM Start	9.47	Rating **	M	Issue No.	125
LM End	9.47	Issue Type +	Ma	Location *	LS
Category	Earthen Levee		GPS Latitude/Longitude		
			Start	End	
Item	Slope Stability		38.069338 °	38.069338 °	
			-121.227689 °	-121.227689 °	
DWR ID	DWR_NA0017_08_f_2014_125				
Action/Comments					
Repair the levee slope damaged by vehicle traffic and prevent access where possible.

A slope instability was found on the landside of the levee looking upstream.

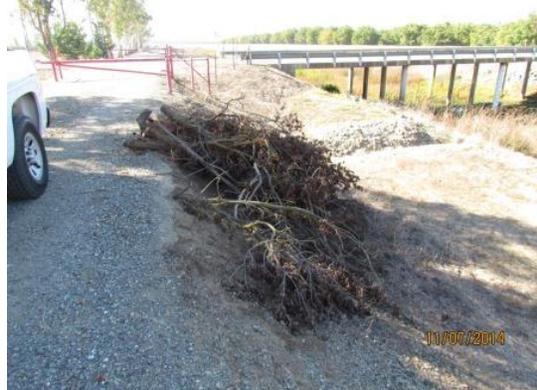
Photo 1 of 1 : FA_2014_NA0017_152_127_20141111_00117.jpg

LM Start	10.48	Rating **	M	Issue No.	127
LM End	10.48	Issue Type +	Ma	Location *	WS
Category	Earthen Levee		GPS Latitude/Longitude		
			Start	End	
Item	Encroachments		38.073721 °	38.073721 °	
			-121.211623 °	-121.211623 °	
DWR ID	DWR_NA0017_08_f_2014_127				
Action/Comments					
Prunings

Prunings were found on the waterside of the levee looking downstream.

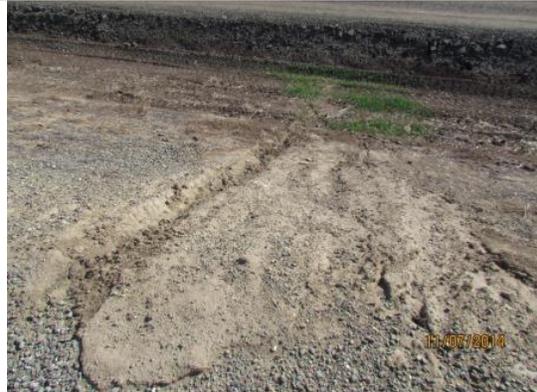
Photo 1 of 1 : FA_2014_NA0017_152_128_20141111_00118.jpg

LM Start	12.04	Rating **	M	Issue No.	128
LM End	12.04	Issue Type +	Ma	Location *	LS
Category	Earthen Levee		GPS Latitude/Longitude		
			Start	End	
Item	Erosion / Bank Caving		38.086116 °	38.086116 °	
			-121.190630 °	-121.190630 °	
DWR ID	DWR_NA0017_08_f_2014_128				
Action/Comments					
Schedule repair of erosion site prior to the next inspection.

Erosion was found on the landside of the levee looking upstream.

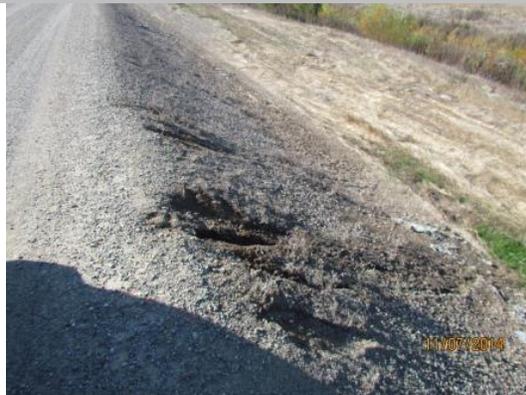
Photo 1 of 1 : FA_2014_NA0017_152_74_20141111_00119.jpg

LM Start	12.07	Rating **	M	Issue No.	74
LM End	12.07	Issue Type +	Ma	Location *	WS
Category	Earthen Levee		GPS Latitude/Longitude		
			Start	End	
Item	Slope Stability		38.086226 °	38.086226 °	
			-121.190051 °	-121.190051 °	
DWR ID	DWR_NA0017_08_s_2014_74				
Action/Comments					
Repair slope instability.

A slope instability was found on the waterside of the levee looking downstream.

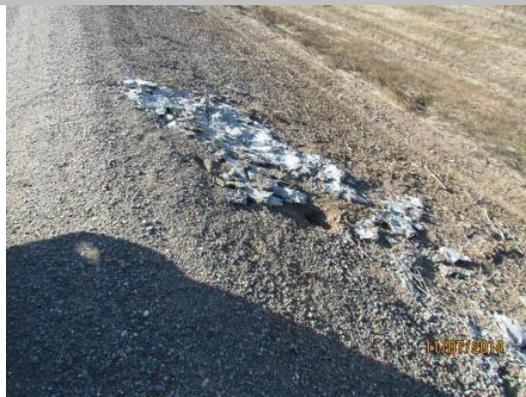
Photo 1 of 1 : FA_2014_NA0017_152_129_20141111_00120.jpg

LM Start	12.30	Rating **	M	Issue No.	129
LM End	12.30	Issue Type +	Ma	Location *	WS
Category	Earthen Levee		GPS Latitude/Longitude		
			Start	End	
Item	Animal Control		38.088030 °	38.088030 °	
			-121.186976 °	-121.186976 °	
DWR ID	DWR_NA0017_08_f_2014_129				
Action/Comments					
No rodents visible, but rodent burrows visible; need to backfill and compact or grout burrows.

An animal hole was found on the waterside of the levee looking downstream.

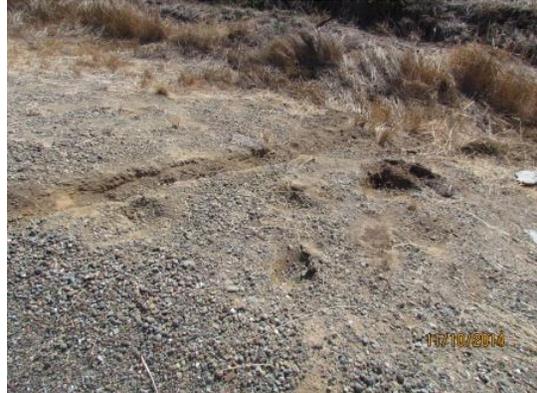
Photo 1 of 1 : FA_2014_NA0017_152_130_20141111_00121.jpg

LM Start	13.00	Rating **	M	Issue No.	130
LM End	13.00	Issue Type +	Ma	Location *	LS
Category	Earthen Levee		GPS Latitude/Longitude		
			Start	End	
Item	Slope Stability		38.092636 °	38.092636 °	
			-121.177188 °	-121.177188 °	
DWR ID	DWR_NA0017_08_f_2014_130				
Action/Comments					
Repair the levee slope damaged by vehicle traffic and prevent access where possible.

A slope instability was found on the landside of the levee looking upstream.

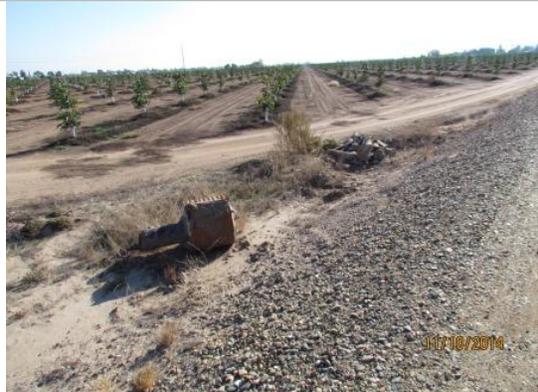
Photo 1 of 1 : FA_2014_NA0017_152_85_20141111_00122.jpg

LM Start	14.10	Rating **	M	Issue No.	85
LM End	14.10	Issue Type +	Ma	Location *	LS
Category	Earthen Levee		GPS Latitude/Longitude		
			Start	End	
Item	Encroachments		38.107827 °	38.107827 °	
			-121.173156 °	-121.173156 °	
DWR ID	DWR_NA0017_08_s_2014_85				
Action/Comments					
Debris

Debris was found on the landside toe of the levee looking downstream.

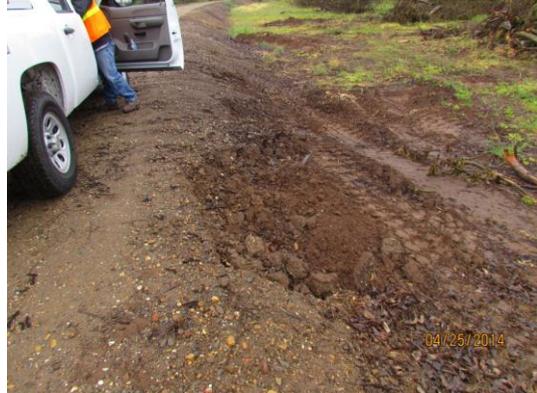
Photo 1 of 1 : FA_2014_NA0017_152_86_20141021_00040.jpg

LM Start	15.18	Rating **	M	Issue No.	86
LM End	15.18	Issue Type +	Ma	Location *	LS
Category	Earthen Levee		GPS Latitude/Longitude		
			Start	End	
Item	Slope Stability		38.122684 °	38.122684 °	
			-121.169123 °	-121.169123 °	
DWR ID	DWR_NA0017_08_s_2014_86				
Action/Comments					
Repair the levee slope damaged by vehicle traffic and prevent access where possible.

Slope instability was found on landside toe of the levee looking upstream.

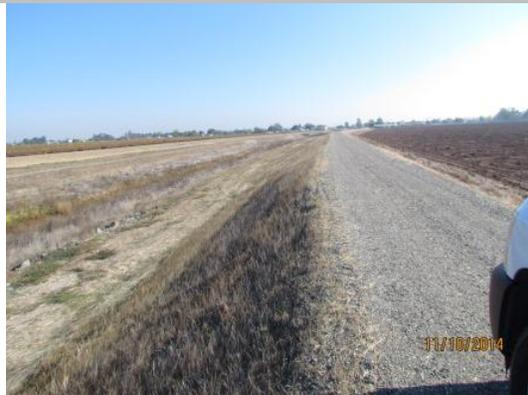
Photo 1 of 1 : FA_2014_NA0017_153_4_20141111_00002.jpg

LM Start	0.11	Rating **	A	Issue No.	4
LM End	0.11	Issue Type +	Ma	Location *	WS
Category	Earthen Levee		GPS Latitude/Longitude		
			Start	End	
Item	Vegetation		38.094052 °	38.094052 °	
			-121.174726 °	-121.174726 °	
DWR ID	DWR_NA0017_09_f_2014_4				
Action/Comments					
Control annual grass and weeds on the levee slopes and easements.

View of the waterside of the levee looking upstream.

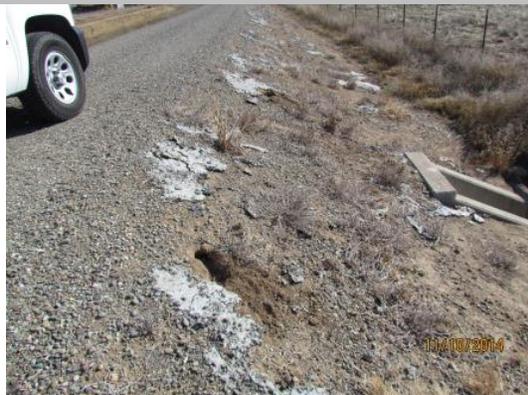
Photo 1 of 1 : FA_2014_NA0017_153_5_20141111_00003.jpg

LM Start	1.32	Rating **	M	Issue No.	5
LM End	1.32	Issue Type +	Ma	Location *	LS
Category	Earthen Levee		GPS Latitude/Longitude		
			Start	End	
Item	Animal Control		38.094020 °	38.094020 °	
			-121.153255 °	-121.153255 °	
DWR ID	DWR_NA0017_09_f_2014_5				
Action/Comments					
No rodents visible, but rodent burrows visible; need to backfill and compact or grout burrows.

View of rodent holes that were found on the landside of the levee looking upstream.

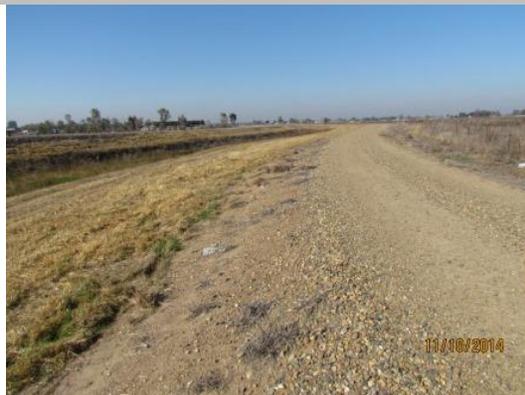
Photo 1 of 1 : FA_2014_NA0017_154_4_20141111_00009.jpg

LM Start	1.20	Rating **	A	Issue No.	4
LM End	1.20	Issue Type +	Ma	Location *	WS
Category	Earthen Levee		GPS Latitude/Longitude		
			Start	End	
Item	Vegetation		38.094289 °	38.094289 °	
			-121.153233 °	-121.153233 °	
DWR ID	DWR_NA0017_10_f_2014_4				
Action/Comments					
Control annual grass and weeds on the levee slopes and easements.

View of the waterside of the levee looking downstream.

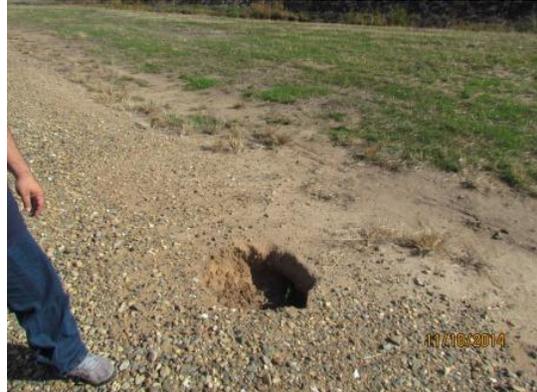
Photo 1 of 1 : FA_2014_NA0017_155_23_20141111_00014.jpg

LM Start	2.09	Rating **	M	Issue No.	23
LM End	2.09	Issue Type +	Ma	Location *	WS
Category	Earthen Levee		GPS Latitude/Longitude		
			Start	End	
Item	Slope Stability		38.117370 °	38.117370 °	
			-121.153446 °	-121.153446 °	
DWR ID	DWR_NA0017_11_f_2014_23				
Action/Comments					
Repair slope instability.

A slope instability was found on the waterside shoulder of the levee looking upstream.

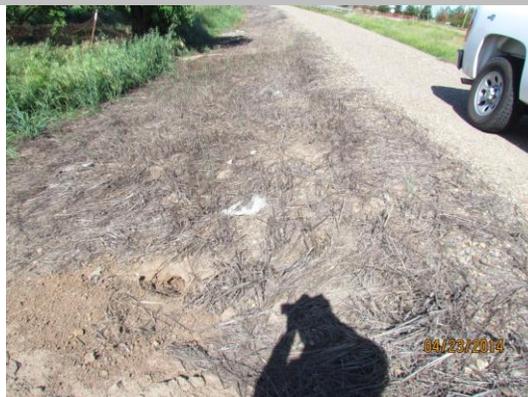
Photo 2 of 2 : FA_2014_NA0017_156_9_20141021_00008.jpg

LM Start	2.22	Rating **	M	Issue No.	9 (cont)
LM End	2.22	Issue Type +	Ma	Location *	LS
Category	Earthen Levee		GPS Latitude/Longitude		
			Start	End	
Item	Animal Control		38.117784 °	38.117784 °	
			-121.149763 °	-121.149763 °	
DWR ID	DWR_NA0017_12_s_2014_9				
Action/Comments					
No rodents visible, but rodent burrows visible; need to backfill and compact or grout burrows.

View of a rodent hole that was found on the landside of the levee looking downstream.

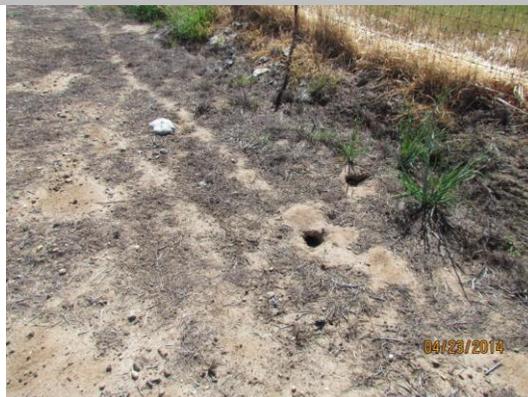
Photo 1 of 1 : FA_2014_NA0017_156_11_20141021_00010.jpg

LM Start	2.25	Rating **	M	Issue No.	11
LM End	2.25	Issue Type +	Ma	Location *	LS
Category	Earthen Levee		GPS Latitude/Longitude		
			Start	End	
Item	Animal Control		38.117807 °	38.117807 °	
			-121.149233 °	-121.149233 °	
DWR ID	DWR_NA0017_12_s_2014_11				
Action/Comments					
No rodents visible, but rodent burrows visible; need to backfill and compact or grout burrows.

View of rodent holes that were found on the landside toe of the levee upstream.

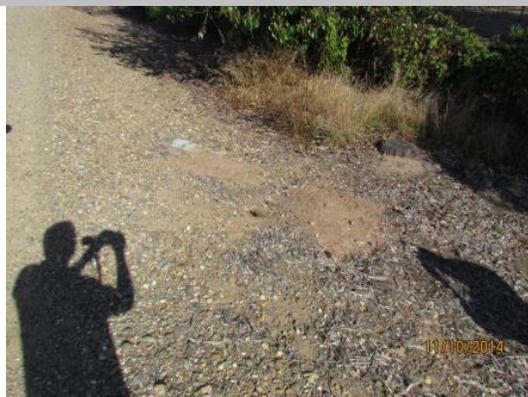
Photo 1 of 1 : FA_2014_NA0017_156_31_20141111_00025.jpg

LM Start	2.41	Rating **	M	Issue No.	31
LM End	2.41	Issue Type +	Ma	Location *	LS
Category	Earthen Levee		GPS Latitude/Longitude		
			Start	End	
Item	Animal Control		38.119524 °	38.119524 °	
			-121.147546 °	-121.147546 °	
DWR ID	DWR_NA0017_12_f_2014_31				
Action/Comments					
No rodents visible, but rodent burrows visible; need to backfill and compact or grout burrows.

View of rodent holes that were found on the landside of the levee looking upstream.

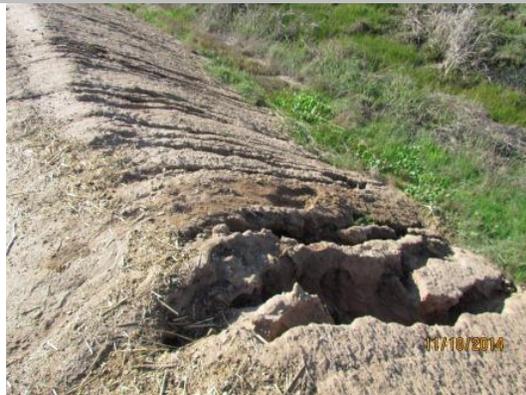
Photo 1 of 3 : FA_2014_NA0017_156_23_20141111_00027.jpg

LM Start	3.28	Rating **	M	Issue No.	23
LM End	3.28	Issue Type +	Ma	Location *	WS
Category	Earthen Levee		GPS Latitude/Longitude		
			Start	End	
Item	Erosion / Bank Caving		38.128445 °	38.128445 °	
			-121.139594 °	-121.139594 °	
DWR ID	DWR_NA0017_12_f_2012_23				
Action/Comments					
Schedule repair of erosion site prior to the next inspection.

Updated picture of the slope instability on the waterside of the levee. The picture was taken during the fall 2014 inspection looking upstream.

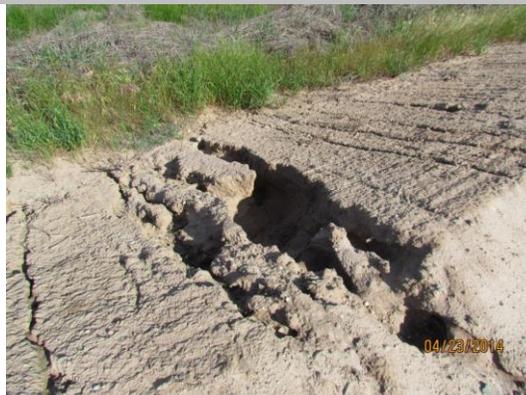
Photo 2 of 3 : FA_2014_NA0017_156_23_20141021_00016.jpg

Updated picture of the slope instability on the waterside of the levee. The picture was taken during the spring 2014 inspection looking upstream.

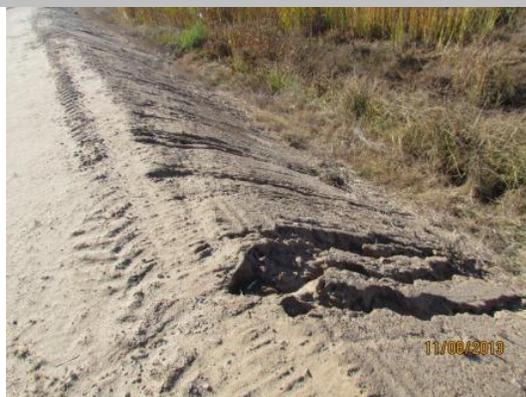
Photo 3 of 3 : FA_2014_NA0017_156_23_20141021_00015.jpg

A slope instability was found on the waterside of the levee. The picture was taken during fall 2013 inspection looking downstream.

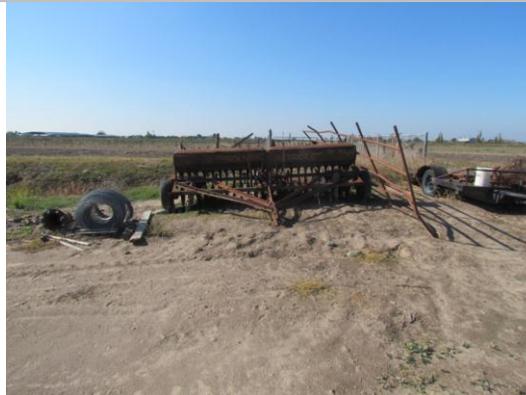
Photo 1 of 1 : FA_2014_NA0017_156_113_20141021_00023.jpg

LM Start	3.39	Rating **	M	Issue No.	113
LM End	3.39	Issue Type +	Ma	Location *	WS
Category	Earthen Levee			GPS Latitude/Longitude	
				Start	End
Item	Encroachments			38.130018 °	38.130018 °
				-121.139019 °	-121.139019 °
DWR ID	DWR_NA0017_12_s_2012_113				
Action/Comments					
Equipment

View of farming equipment that was found on the waterside of the levee looking upstream.

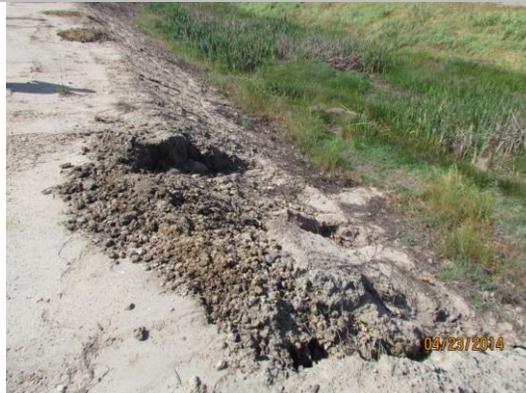
Photo 1 of 3 : FA_2014_NA0017_156_24_20141021_00018.jpg

LM Start	3.48	Rating **	M	Issue No.	24
LM End	3.48	Issue Type +	Ma	Location *	WS
Category	Earthen Levee			GPS Latitude/Longitude	
				Start	End
Item	Erosion / Bank Caving			38.131140 °	38.131140 °
				-121.138541 °	-121.138541 °
DWR ID	DWR_NA0017_12_f_2012_24				
Action/Comments					
Schedule repair of erosion site prior to the next inspection.

Updated picture of the erosion on the waterside of the levee. The picture was taken during spring 2014 inspection looking downstream.

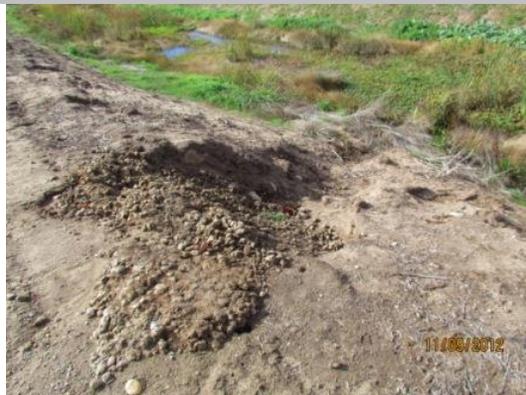
Photo 2 of 3 : FA_2014_NA0017_156_24_20141021_00019.jpg

View of erosion that was found on the waterside slope of the levee looking downstream.

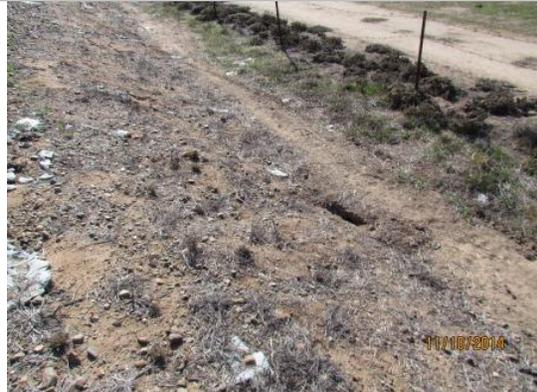
Photo 1 of 1 : FA_2014_NA0017_157_7_20141111_00004.jpg

LM Start	1.22	Rating **	M	Issue No.	7
LM End	1.22	Issue Type +	Ma	Location *	LS
Category	Earthen Levee		GPS Latitude/Longitude		
			Start	End	
Item	Animal Control		38.111513 °	38.111513 °	
			-121.141216 °	-121.141216 °	
DWR ID	DWR_NA0017_13_f_2014_7				
Action/Comments					
No rodents visible, but rodent burrows visible; need to backfill and compact or grout burrows.

View of an animal hole that was found on the landside toe of the levee looking upstream.

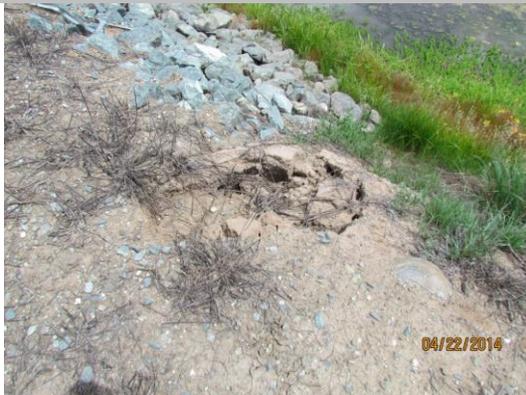
Photo 1 of 2 : FA_2014_NA0017_158_8_20141021_00009.jpg

LM Start	0.43	Rating **	M	Issue No.	8
LM End	0.43	Issue Type +	Ma	Location *	WS
Category	Earthen Levee		GPS Latitude/Longitude		
			Start	End	
Item	Animal Control		38.110031 °	38.110031 °	
			-121.152630 °	-121.152630 °	
DWR ID	DWR_NA0017_14_f_2013_8				
Action/Comments					
No rodents visible, but rodent burrows visible; need to backfill and compact or grout burrows.

Updated picture of the rodent hole on the waterside shoulder of the levee looking upstream during the spring 2014 inspection.

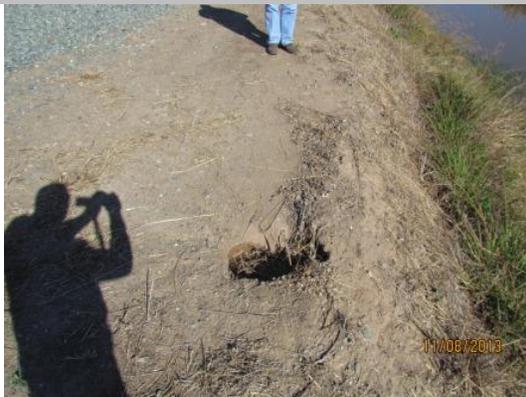
Photo 2 of 2 : FA_2014_NA0017_158_8_20141021_00010.jpg

View of a rodent hole on the waterside shoulder of the levee looking upstream.

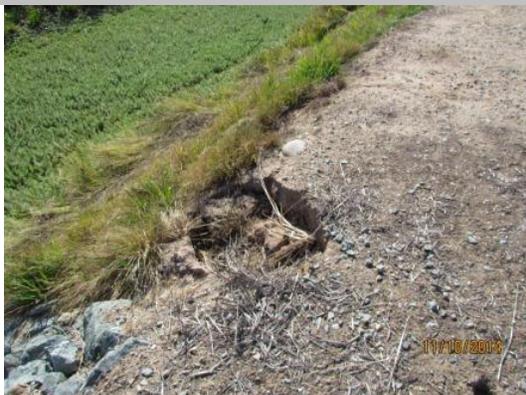
Photo 1 of 1 : FA_2014_NA0017_158_13_20141111_00011.jpg

View of a slope instability that was found on the waterside shoulder of the levee looking downstream.

LM Start	0.44	Rating **	M	Issue No.	13
LM End	0.44	Issue Type +	Ma	Location *	WS
Category	Earthen Levee		GPS Latitude/Longitude		
			Start	End	
Item	Slope Stability		38.110133 °	38.110133 °	
			-121.152486 °	-121.152486 °	
DWR ID	DWR_NA0017_14_f_2014_13				
Action/Comments					
Repair slope instability.
