**Flood Control Project Maintenance
Levee Inspections**

Maintenance Issue Types Only, Levee Inspection Report By Mile - Fall 2014

San Joaquin County Flood Control and Water Conservation District

Waterway	Bank	Unit Miles	Inspection Start/End	Inspector
Unit No. 01 Littlejohn Creek	Left	2.59	11/24/2014 11/24/2014	Pavel Kazi

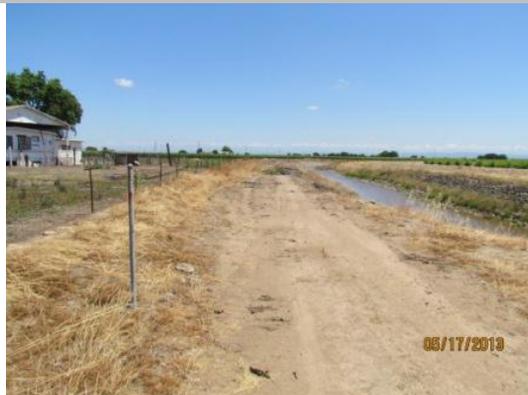
Photo 1 of 1 : FA_2014_NA0017_158_7_20141021_00008.jpg

View of a crown depression that was found looking upstream.

LM Start	0.57	Rating **	M	Issue No.	7
LM End	0.57	Issue Type +	Ma	Location *	CR
Category	Earthen Levee		GPS Latitude/Longitude		
			Start	End	
Item	Crown Surface / Depressions / Rutting		38.111490 °	38.111490 °	
			-121.150762 °	-121.150762 °	
DWR ID	DWR_NA0017_14_s_2013_7				
Action/Comments					
Repair depressions or ruts in the crown or slope.

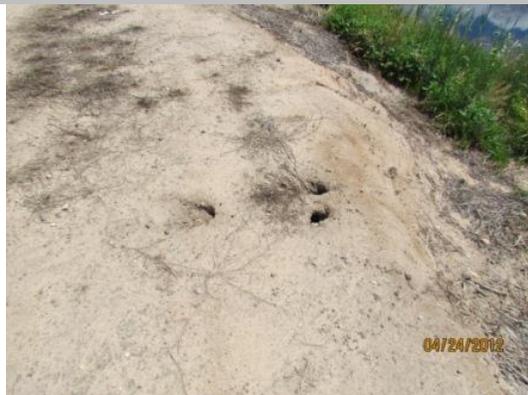
Photo 1 of 1 : FA_2014_NA0017_158_5_20141021_00006.jpg

View of animal holes that were found on the waterside of the levee looking upstream.

LM Start	0.61	Rating **	M	Issue No.	5
LM End	0.61	Issue Type +	Ma	Location *	WS
Category	Earthen Levee		GPS Latitude/Longitude		
			Start	End	
Item	Animal Control		38.111770 °	38.111770 °	
			-121.150112 °	-121.150112 °	
DWR ID	DWR_NA0017_14_s_2012_5				
Action/Comments					
No rodents visible, but rodent burrows visible; need to backfill and compact or grout burrows.

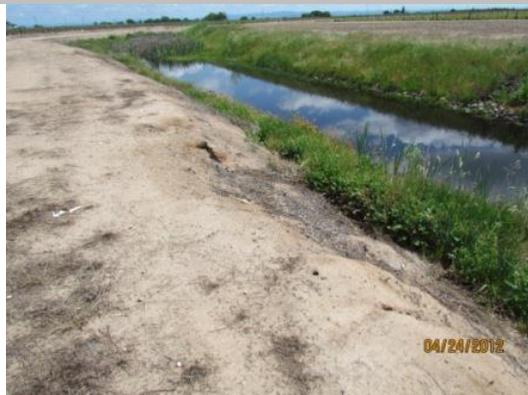
Photo 1 of 2 : FA_2014_NA0017_158_4_20141021_00004.jpg

View of erosion that was found on the waterside of the levee looking upstream. This picture was taken during spring 2012 inspection.

LM Start	0.61	Rating **	M	Issue No.	4
LM End	0.61	Issue Type +	Ma	Location *	WS
Category	Earthen Levee		GPS Latitude/Longitude		
			Start	End	
Item	Erosion / Bank Caving		38.111774 °	38.111774 °	
			-121.150073 °	-121.150073 °	
DWR ID	DWR_NA0017_14_s_2012_4				
Action/Comments					
Note and monitor erosion site.

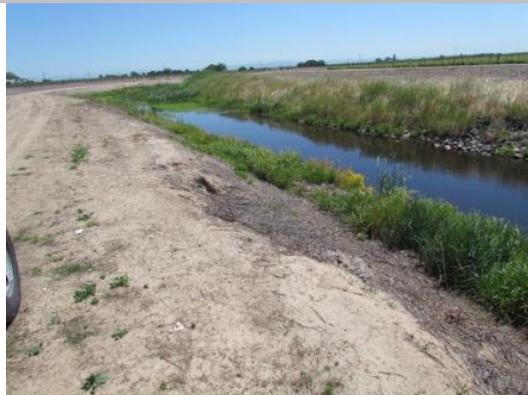
Photo 2 of 2 : FA_2014_NA0017_158_4_20141021_00005.jpg

View of erosion that was found on the waterside of the levee.

LM Start	0.61	Rating **	M	Issue No.	4 (cont)
LM End	0.61	Issue Type +	Ma	Location *	WS
Category	Earthen Levee		GPS Latitude/Longitude		
			Start	End	
Item	Erosion / Bank Caving		38.111774 °	38.111774 °	
			-121.150073 °	-121.150073 °	
DWR ID	DWR_NA0017_14_s_2012_4				
Action/Comments					
Note and monitor erosion site.

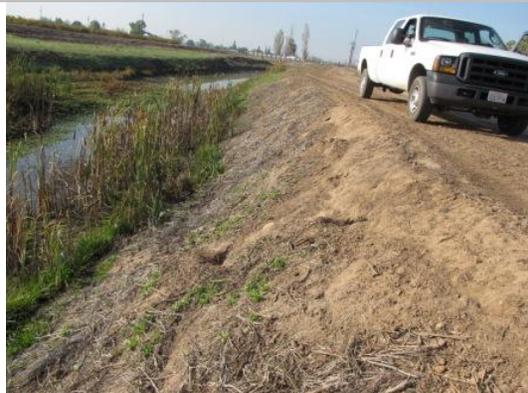
Photo 1 of 1 : FA_2014_NA0017_158_1_20141021_00001.jpg

View of rodent holes in the waterward berm looking downstream.

LM Start	0.65	Rating **	M	Issue No.	1
LM End	0.65	Issue Type +	Ma	Location *	WS
Category	Earthen Levee		GPS Latitude/Longitude		
			Start	End	
Item	Animal Control		38.112050 °	38.112050 °	
			-121.149524 °	-121.149524 °	
DWR ID	DWR_NA0017_14_s_2012_1				
Action/Comments					
Exterminate rodents and backfill and compact or grout burrows.

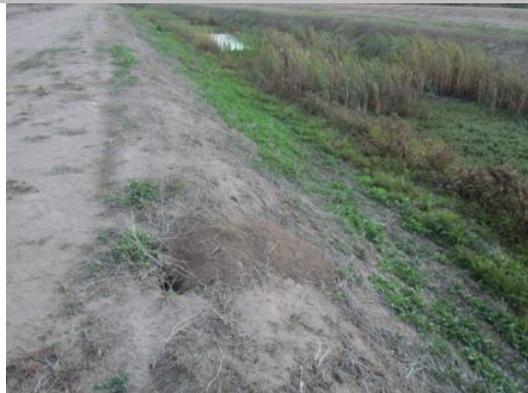
Photo 1 of 1 : FA_2014_NA0017_158_3_20141021_00003.jpg

View of a rodent hole that was found on the waterside shoulder of the levee looking upstream.

LM Start	0.73	Rating **	M	Issue No.	3
LM End	0.73	Issue Type +	Ma	Location *	WS
Category	Earthen Levee		GPS Latitude/Longitude		
			Start	End	
Item	Animal Control		38.111851 °	38.111851 °	
			-121.148358 °	-121.148358 °	
DWR ID	DWR_NA0017_14_s_2012_3				
Action/Comments					
No rodents visible, but rodent burrows visible; need to backfill and compact or grout burrows.

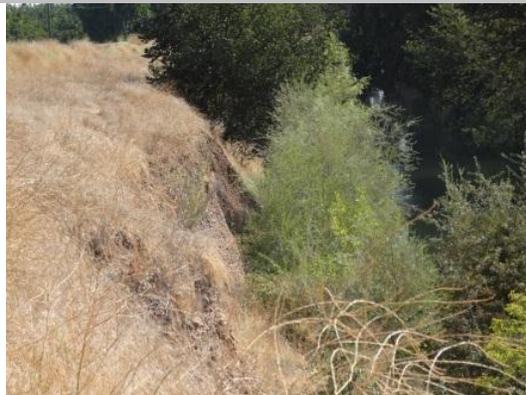
Photo 1 of 1 : SJR2014_NA0017U15RM22.91_1.jpg

Close view of the erosion site. Small trees grow at the lower slope of the bank.

Action/Comments
 Inspector Comments: 8/20/2014: No significant change has been observed.
 9/12/2013: No significant change observed.
 08/22/2012: Site has been revisited. No significant change observed.
 09/02/2011: No significant change observed on site.
 11/02/2010: No significant change observed. The mile-long erosion continues to degrade the bank. There are a few trees along the mile-long stretch on the lower bank slope that are affected by the scarp. WS Levee Slope was changed to 2:1. As a result, normalized score increased from 62 to 65.
 08/05/2010: Recommended for waterside repair, per CLRO; "water velocity is a major factor for accelerating bank slope erosion."
 8/12/2009: Near-vertical bank erosion; degrading channel is incising the banks; recommend annual assessment and monitoring of critical erosion site, per CLRO CES Evaluation 2008 Report; district is monitoring site for change in condition; site was previously rated "U".

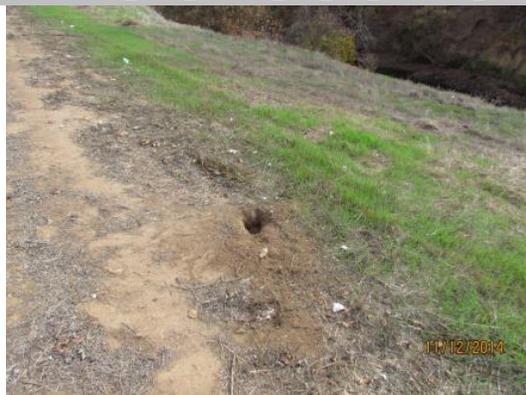
Photo 1 of 1 : FA_2014_NA0017_159_158_20141118_00131.jpg

An animal hole was found on the waterside of the levee looking upstream.

Action/Comments
 No rodents visible, but rodent burrows visible; need to backfill and compact or grout burrows.

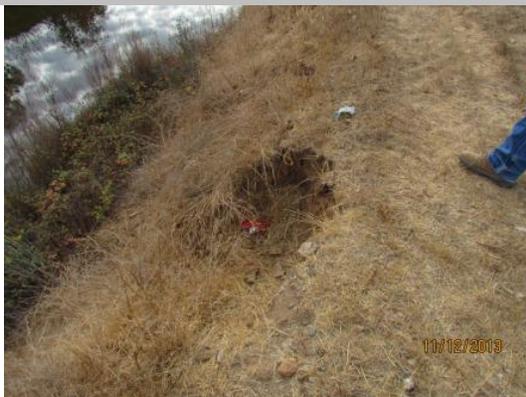
Photo 1 of 1 : FA_2014_NA0017_159_4_20141021_00003.jpg

Slope instability was found on the waterside slope of the levee looking downstream.

LM Start	0.87	Rating **	M	Issue No.	4
LM End	0.87	Issue Type +	Ma	Location *	WS
Category	Earthen Levee		GPS Latitude/Longitude		
			Start	End	
Item	Slope Stability		38.045390 °	38.045390 °	
			-121.024111 °	-121.024111 °	
DWR ID	DWR_NA0017_15_f_2013_4				
Action/Comments					
Repair slope instability.

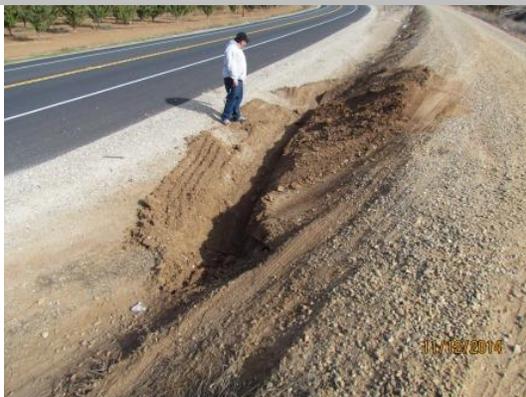
Photo 1 of 1 : FA_2014_NA0017_159_160_20141118_00132.jpg

A slope instability was found on the landside toe of the levee looking upstream.

LM Start	1.39	Rating **	M	Issue No.	160
LM End	1.39	Issue Type +	Ma	Location *	LS
Category	Earthen Levee		GPS Latitude/Longitude		
			Start	End	
Item	Slope Stability		38.040482 °	38.040482 °	
			-121.030357 °	-121.030357 °	
DWR ID	DWR_NA0017_15_f_2014_160				
Action/Comments					
Repair the levee slope damaged by vehicle traffic and prevent access where possible.

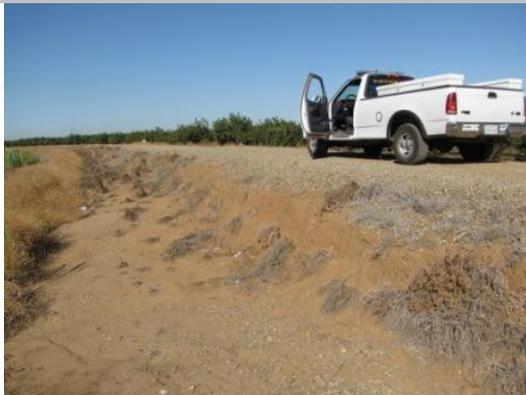
Photo 1 of 1 : FA_2014_NA0017_159_995_20141021_00116.jpg

LM Start	1.52	Rating **	M	Issue No.	995
LM End	1.52	Issue Type +	Ma	Location *	WS
Category	Earthen Levee		GPS Latitude/Longitude		
			Start	End	
Item	Erosion / Bank Caving		38.040202 °	38.040202 °	
			-121.032659 °	-121.032659 °	
DWR ID	DWR_NA0017_15_s_2012_995				
Action/Comments					
Schedule repair of erosion site prior to the next inspection. Inspector Comments: The LMA was working on fixing the erosion site using an excavator during the inspection.

View of erosion of waterward levee slope looking upstream.

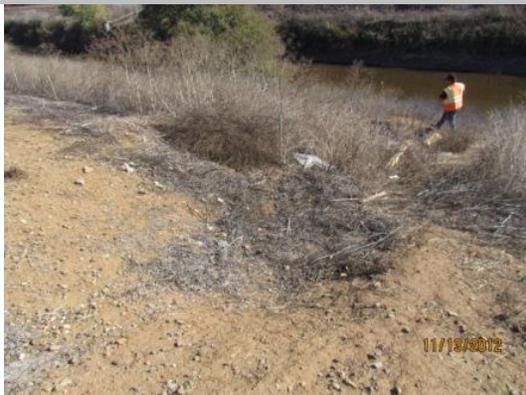
Photo 1 of 2 : FA_2014_NA0017_159_18_20141021_00010.jpg

Updated picture of the slope instability at the waterside slope of the levee looking upstream.

LM Start	2.09	Rating **	M	Issue No.	18
LM End	2.09	Issue Type +	Ma	Location *	WS
Category	Earthen Levee		GPS Latitude/Longitude		
			Start	End	
Item	Slope Stability		38.036294 °	38.036294 °	
			-121.041089 °	-121.041089 °	
DWR ID	DWR_NA0017_15_s_2012_18				
Action/Comments					
Repair slope instability.

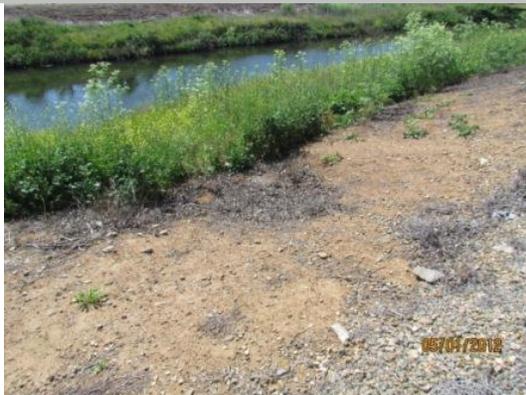
Photo 2 of 2 : FA_2014_NA0017_159_18_20141021_00011.jpg

Slope instability was found on the waterside toe of the levee looking downstream.

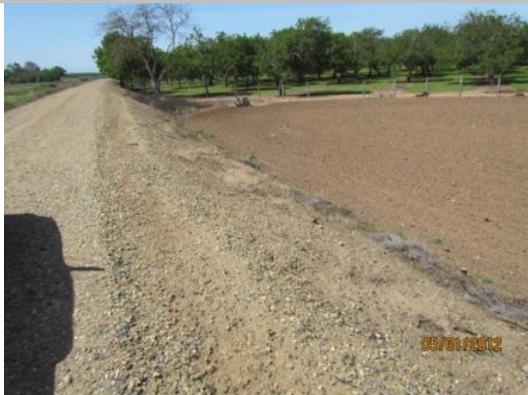
Photo 1 of 1 : FA_2014_NA0017_159_47_20141021_00040.jpg

Slope instability was found on the landside slope of the levee looking downstream.

LM Start	2.59	Rating **	M	Issue No.	47
LM End	2.59	Issue Type +	Ma	Location *	LS
Category	Earthen Levee		GPS Latitude/Longitude		
			Start	End	
Item	Slope Stability		38.031234 °	38.031234 °	
			-121.047254 °	-121.047254 °	
DWR ID	DWR_NA0017_15_s_2012_47				
Action/Comments					
Repair slope instability.

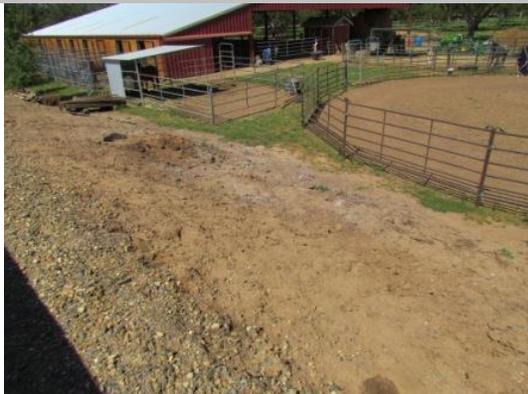
Photo 1 of 1 : FA_2014_NA0017_159_27_20141021_00020.jpg

Slope instability was found on the landside of the levee. The picture was taken from the crown looking downstream.

LM Start	2.68	Rating **	M	Issue No.	27
LM End	2.68	Issue Type +	Ma	Location *	LS
Category	Earthen Levee		GPS Latitude/Longitude		
			Start	End	
Item	Slope Stability		38.030252 °	38.030252 °	
			-121.048311 °	-121.048311 °	
DWR ID	DWR_NA0017_15_s_2012_27				
Action/Comments					
Repair slope instability.

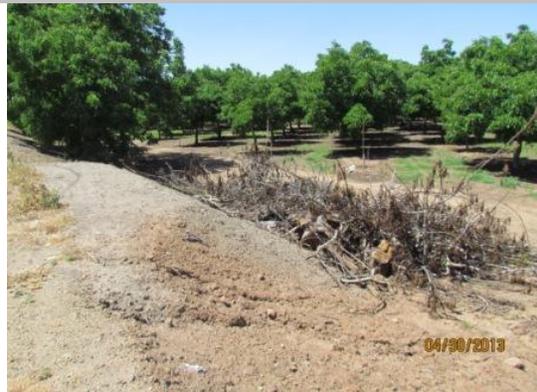
Photo 1 of 1 : FA_2014_NA0017_159_14_20141021_00007.jpg

LM Start	3.61	Rating **	A/W	Issue No.	14
LM End	3.61	Issue Type +	Ma	Location *	LS
Category	Earthen Levee		GPS Latitude/Longitude		
			Start	End	
Item	Encroachments		38.021811 °	38.021811 °	
			-121.061054 °	-121.061054 °	
DWR ID	DWR_NA0017_15_s_2013_14				
Action/Comments					
Prunings Inspector Comments: The pit was repaired by the LMA but the prunings still exist. The burn pile is away from the levee prism.

Prunings were found on the landside toe of the levee looking downstream.

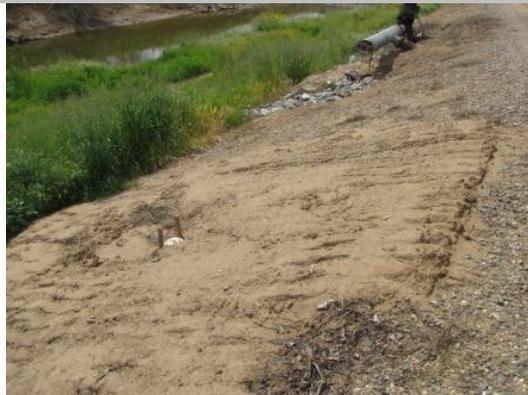
Photo 1 of 1 : FA_2014_NA0017_159_54_20141021_00043.jpg

LM Start	3.62	Rating **	M	Issue No.	54
LM End	3.62	Issue Type +	Ma	Location *	WS
Category	Earthen Levee		GPS Latitude/Longitude		
			Start	End	
Item	Encroachments		38.021601 °	38.021601 °	
			-121.061284 °	-121.061284 °	
DWR ID	DWR_NA0017_15_s_2012_54				
Action/Comments					
Pipe Inspector Comments: A recently placed pipe in the waterward slope may be leaking and was not authorized.

View of a recently placed pipe in the waterward slope looking downstream.

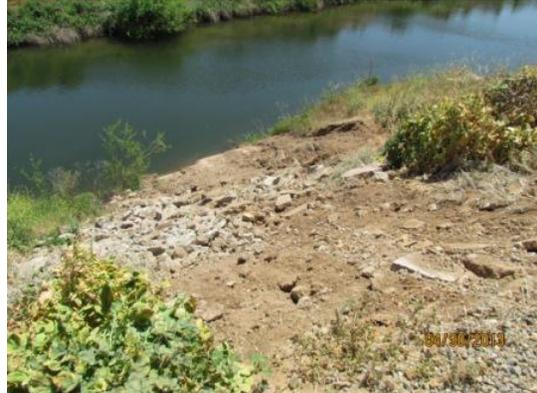
Photo 1 of 2 : FA_2014_NA0017_159_43_20141021_00032.jpg

Updated picture of the slope instability on the waterside slope of the levee looking downstream.

LM Start	3.86	Rating **	M	Issue No.	43
LM End	3.86	Issue Type +	Ma	Location *	WS
Category	Earthen Levee		GPS Latitude/Longitude		
			Start	End	
Item	Slope Stability		38.019119 °	38.019119 °	
			-121.064034 °	-121.064034 °	
DWR ID	DWR_NA0017_15_f_2012_43				
Action/Comments					
Repair slope instability.

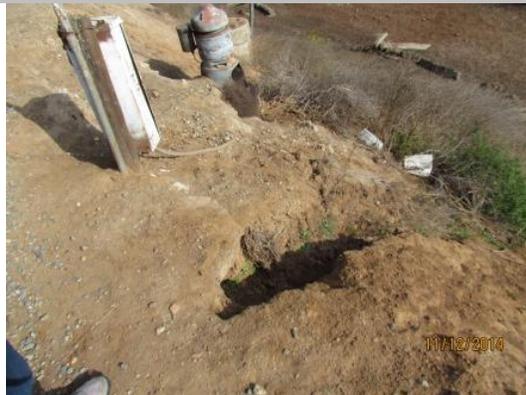
Photo 1 of 5 : FA_2014_NA0017_159_44_20141118_00133.jpg

Updated picture of the slope instability on the waterside slope of the levee looking upstream. This picture was taken during fall 2014 inspection.

LM Start	3.97	Rating **	M	Issue No.	44
LM End	3.97	Issue Type +	Ma	Location *	WS
Category	Earthen Levee		GPS Latitude/Longitude		
			Start	End	
Item	Slope Stability		38.017945 °	38.017945 °	
			-121.065295 °	-121.065295 °	
DWR ID	DWR_NA0017_15_f_2012_44				
Action/Comments					
Repair slope instability.

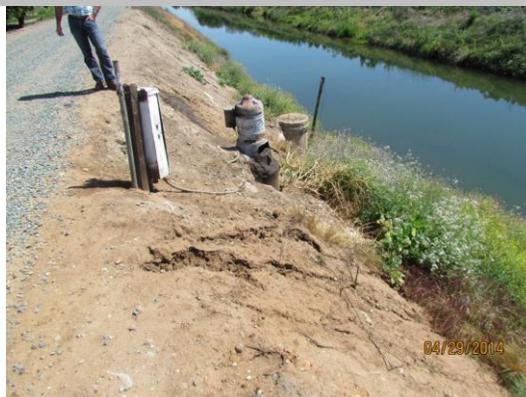
Photo 2 of 5 : FA_2014_NA0017_159_44_20141021_00035.jpg

LM Start	3.97	Rating **	M	Issue No.	44 (cont)
LM End	3.97	Issue Type +	Ma	Location *	WS

Updated picture of the slope instability on the waterside slope of the levee looking downstream during spring 2014 inspection.

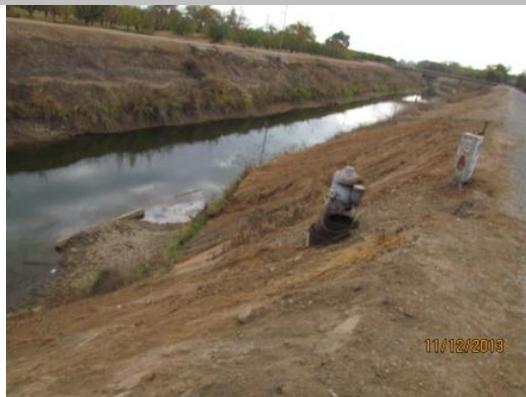
Photo 3 of 5 : FA_2014_NA0017_159_44_20141021_00034.jpg

LM Start	3.97	Rating **	M	Issue No.	44 (cont)
LM End	3.97	Issue Type +	Ma	Location *	WS

Updated picture of the slope instability on the waterside slope of the levee looking downstream during fall 2013 inspection.

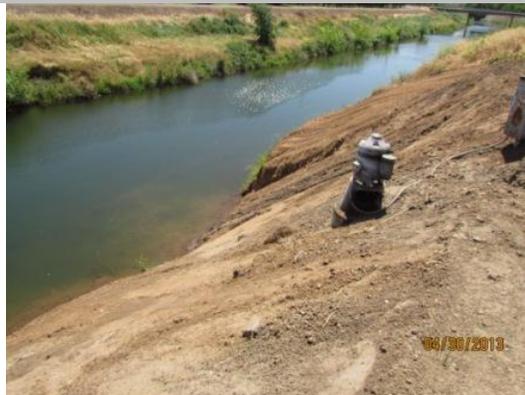
Photo 4 of 5 : FA_2014_NA0017_159_44_20141021_00036.jpg

LM Start	3.97	Rating **	M	Issue No.	44 (cont)
LM End	3.97	Issue Type +	Ma	Location *	WS
Category	Earthen Levee		GPS Latitude/Longitude		
			Start	End	
Item	Slope Stability		38.017945 °	38.017945 °	
			-121.065295 °	-121.065295 °	
DWR ID	DWR_NA0017_15_f_2012_44				
Action/Comments					
Repair slope instability.

Updated picture of the slope instability on the waterside slope of the levee looking downstream.

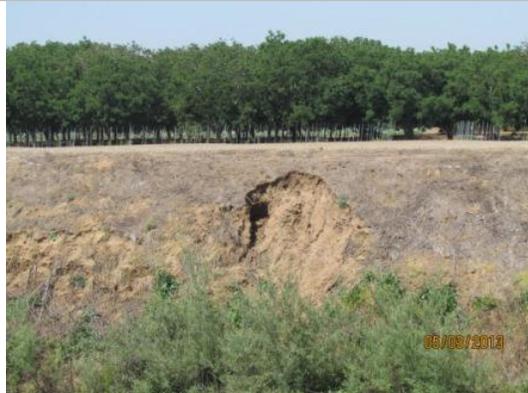
Photo 1 of 1 : FA_2014_NA0017_159_124_20141021_00093.jpg

LM Start	4.44	Rating **	U	Issue No.	124
LM End	4.44	Issue Type +	Ma	Location *	WS
Category	Earthen Levee		GPS Latitude/Longitude		
			Start	End	
Item	Animal Control		38.012910 °	38.012910 °	
			-121.067996 °	-121.067996 °	
DWR ID	DWR_NA0017_15_s_2013_124				
Action/Comments					
No rodents visible, but rodent burrows visible; need to backfill and compact or grout burrows. Inspector Comments: Picture was taken from the other side of the levee.

An animal hole was found on the waterside slope of the levee. The picture was taken from the opposite side of the levee.

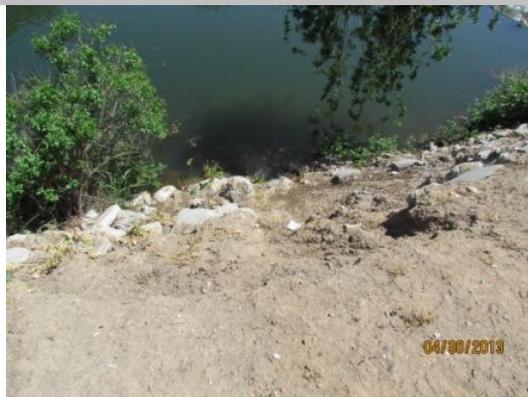
Photo 1 of 3 : FA_2014_NA0017_159_96_20141021_00073.jpg

LM Start	4.73	Rating **	M	Issue No.	96
LM End	4.73	Issue Type +	Ma	Location *	WS
Category	Earthen Levee		GPS Latitude/Longitude		
			Start	End	
Item	Erosion / Bank Caving		38.008053 °	38.008053 °	
			-121.070141 °	-121.070141 °	
DWR ID	DWR_NA0017_15_s_2012_96				
Action/Comments					
Note and monitor erosion site. Inspector Comments: LMA has fixed the issue but the riprap has rebar which would can be dangerous during the flood fighting efforts.

Updated picture of the slope instability on the waterside slope of the levee looking downstream during spring 2013 inspection.

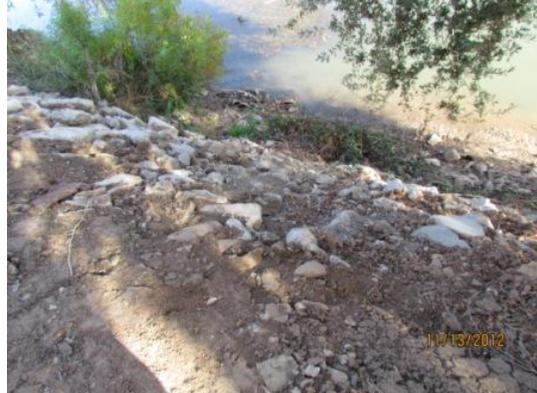
Photo 2 of 3 : FA_2014_NA0017_159_96_20141021_00074.jpg

LM Start	4.73	Rating **	M	Issue No.	96 (cont)
LM End	4.73	Issue Type +	Ma	Location *	WS
Category	Earthen Levee		GPS Latitude/Longitude		
			Start	End	
Item	Erosion / Bank Caving		38.008053 °	38.008053 °	
			-121.070141 °	-121.070141 °	
DWR ID	DWR_NA0017_15_s_2012_96				
Action/Comments					
Note and monitor erosion site. Inspector Comments: LMA has fixed the issue but the riprap has rebar which would can be dangerous during the flood fighting efforts.

The LMA has fixed the erosion on the landside slope of the levee but the riprap contains exposed rebar which could be dangerous during a flood fight.

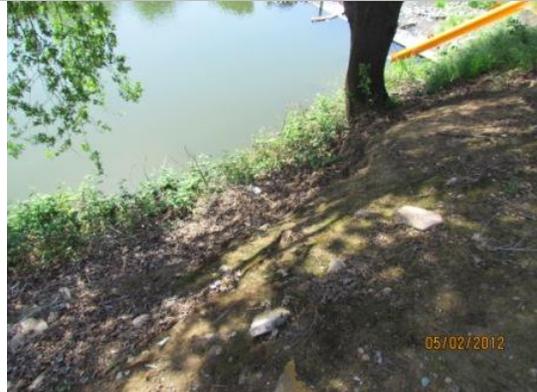
Photo 3 of 3 : FA_2014_NA0017_159_96_20141021_00075.jpg

LM Start	4.73	Rating **	M	Issue No.	96 (cont)
LM End	4.73	Issue Type +	Ma	Location *	WS

Erosion was found on the waterside slope of the levee looking downstream.

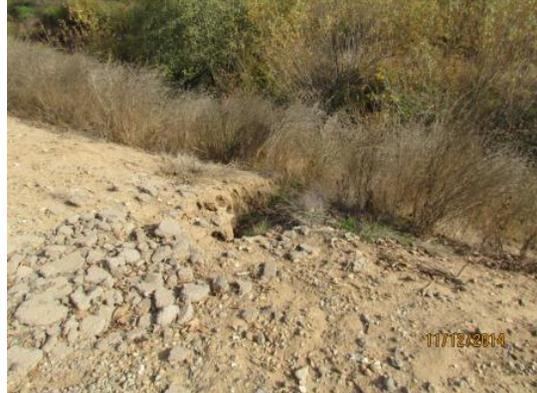
Photo 1 of 1 : FA_2014_NA0017_159_171_20141118_00134.jpg

LM Start	5.13	Rating **	M	Issue No.	171
LM End	5.13	Issue Type +	Ma	Location *	WS
Category	Earthen Levee		GPS Latitude/Longitude		
			Start	End	
Item	Slope Stability		38.003105 °	38.003105 °	
			-121.073585 °	-121.073585 °	
DWR ID	DWR_NA0017_15_f_2014_171				
Action/Comments					
Repair slope instability.

A slope instability was found on the waterside of the levee looking upstream.

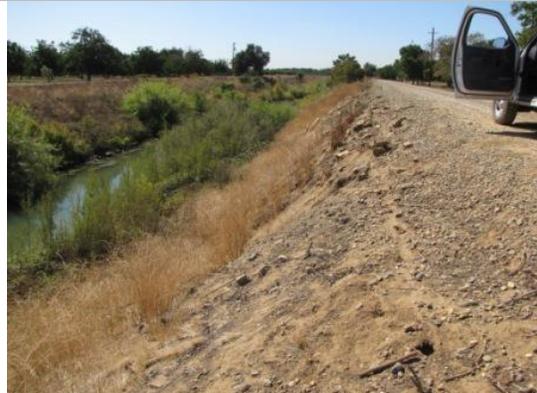
Photo 1 of 1 : FA_2014_NA0017_159_1009_20141021_00117.jpg

LM Start	5.14	Rating **	M	Issue No.	1009
LM End	5.14	Issue Type +	Ma	Location *	WS
Category	Earthen Levee		GPS Latitude/Longitude		
			Start	End	
Item	Slope Stability		38.003021 °	38.003021 °	
			-121.073658 °	-121.073658 °	
DWR ID	DWR_NA0017_15_s_2012_1009				
Action/Comments					
Repair slope instability.

View of a slip in the waterward levee slope looking downstream.

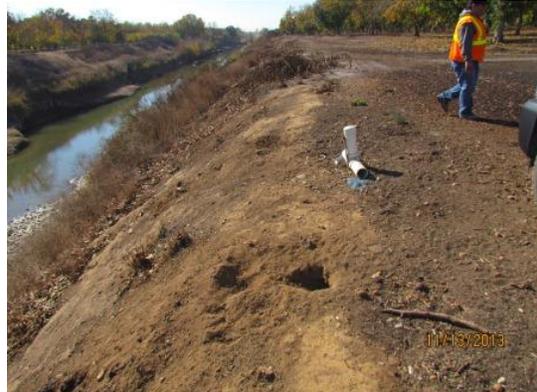
Photo 1 of 2 : FA_2014_NA0017_159_30_20141021_00021.jpg

LM Start	5.77	Rating **	M	Issue No.	30
LM End	5.77	Issue Type +	Ma	Location *	WS
Category	Earthen Levee		GPS Latitude/Longitude		
			Start	End	
Item	Animal Control		37.995679 °	37.995679 °	
			-121.080267 °	-121.080267 °	
DWR ID	DWR_NA0017_15_s_2013_30				
Action/Comments					
No rodents visible, but rodent burrows visible; need to backfill and compact or grout burrows.

Updated picture of the animal holes on the waterside of the levee looking downstream.

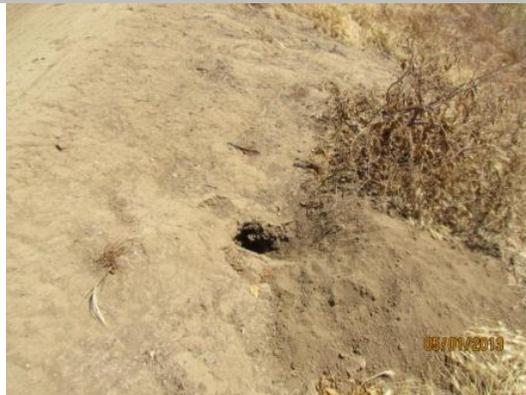
Photo 1 of 1 : FA_2014_NA0017_159_41_20141021_00030.jpg

LM Start	6.12	Rating **	M	Issue No.	41
LM End	6.12	Issue Type +	Ma	Location *	WS
Category	Earthen Levee		GPS Latitude/Longitude		
			Start	End	
Item	Animal Control		37.991648 °	37.991648 °	
			-121.083924 °	-121.083924 °	
DWR ID	DWR_NA0017_15_s_2013_41				
Action/Comments					
No rodents visible, but rodent burrows visible; need to backfill and compact or grout burrows.

An animal hole was found on the waterside slope of the levee looking upstream.

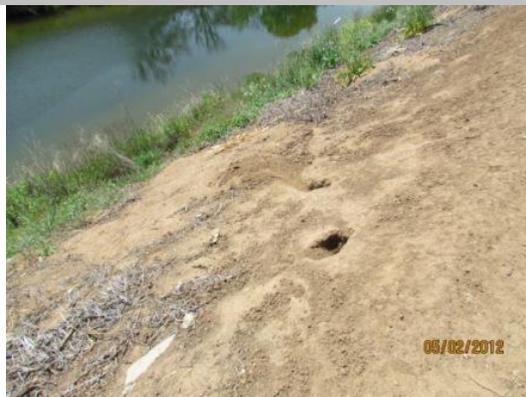
Photo 1 of 1 : FA_2014_NA0017_159_116_20141021_00087.jpg

LM Start	6.20	Rating **	M	Issue No.	116
LM End	6.20	Issue Type +	Ma	Location *	WS
Category	Earthen Levee		GPS Latitude/Longitude		
			Start	End	
Item	Animal Control		37.990773 °	37.990773 °	
			-121.084706 °	-121.084706 °	
DWR ID	DWR_NA0017_15_s_2012_116				
Action/Comments					
No rodents visible, but rodent burrows visible; need to backfill and compact or grout burrows.

Animal holes were found on the waterside of the levee looking downstream.

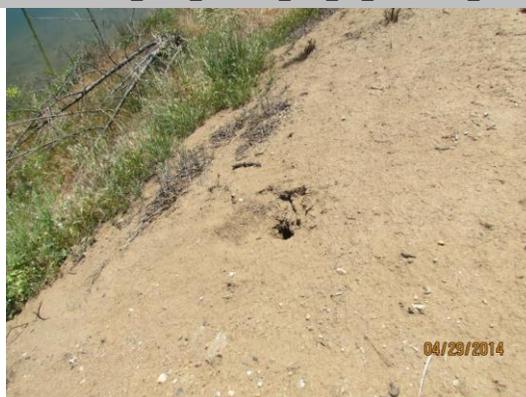
Photo 1 of 1 : FA_2014_NA0017_159_75_20141021_00058.jpg

LM Start	6.30	Rating **	M	Issue No.	75
LM End	6.30	Issue Type +	Ma	Location *	WS
Category	Earthen Levee		GPS Latitude/Longitude		
			Start	End	
Item	Animal Control		37.989630 °	37.989630 °	
			-121.085754 °	-121.085754 °	
DWR ID	DWR_NA0017_15_s_2014_75				
Action/Comments					
No rodents visible, but rodent burrows visible; need to backfill and compact or grout burrows.

A rodent hole was found on the waterside shoulder of the levee looking downstream.

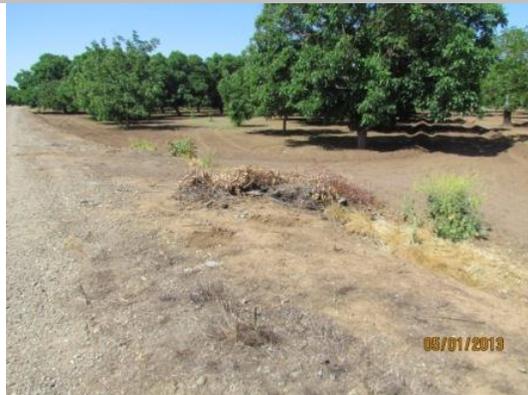
Photo 1 of 1 : FA_2014_NA0017_159_98_20141021_00076.jpg

LM Start	6.59	Rating **	M	Issue No.	98
LM End	6.59	Issue Type +	Ma	Location *	LS
Category	Earthen Levee		GPS Latitude/Longitude		
			Start	End	
Item	Encroachments		37.986225 °	37.986225 °	
			-121.088704 °	-121.088704 °	
DWR ID	DWR_NA0017_15_f_2012_98				
Action/Comments					
Prunings

Prunings were found on the landside of the levee looking downstream.

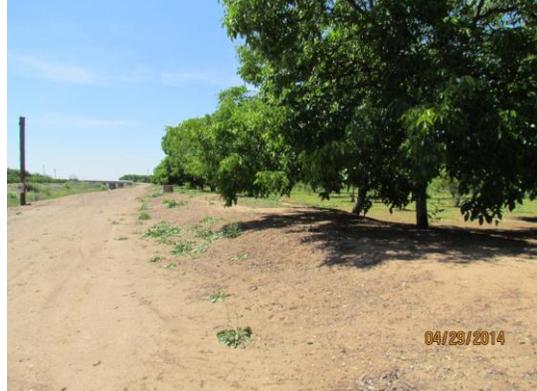
Photo 1 of 1 : FA_2014_NA0017_159_115_20141021_00086.jpg

LM Start	7.11	Rating **	M	Issue No.	115
LM End	7.35	Issue Type +	Ma	Location *	LS
Category	Earthen Levee		GPS Latitude/Longitude		
			Start	End	
Item	Trim / Thin Trees		37.981387 °	37.979749 °	
			-121.095370 °	-121.099178 °	
DWR ID	DWR_NA0017_15_s_2014_115				
Action/Comments					
Trim trees to at least five feet above ground level.

Tree limbs were obstructing the visibility of the crown of the levee looking downstream.

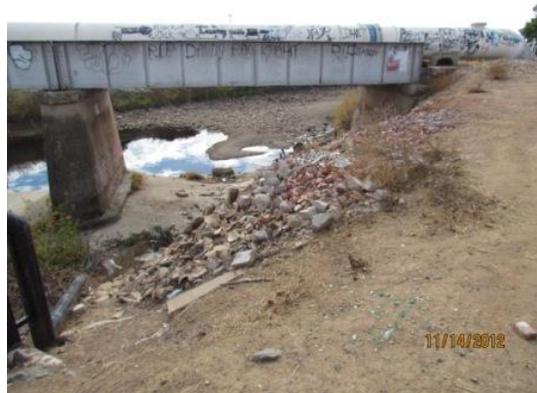
Photo 1 of 1 : FA_2014_NA0017_159_102_20141021_00077.jpg

LM Start	7.36	Rating **	M	Issue No.	102
LM End	7.36	Issue Type +	Ma	Location *	WS
Category	Earthen Levee		GPS Latitude/Longitude		
			Start	End	
Item	Encroachments		37.979612 °	37.979612 °	
			-121.099390 °	-121.099390 °	
DWR ID	DWR_NA0017_15_s_2012_102				
Action/Comments					
Debris

Debris was found on the waterside slope of the levee looking downstream.

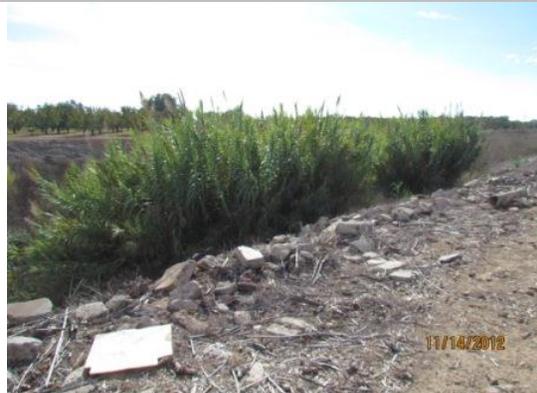
Photo 1 of 2 : FA_2014_NA0017_159_104_20141021_00078.jpg

LM Start	8.06	Rating **	M	Issue No.	104
LM End	8.06	Issue Type +	Ma	Location *	WS
Category	Earthen Levee		GPS Latitude/Longitude		
			Start	End	
Item	Vegetation		37.974304 °	37.974304 °	
			-121.109625 °	-121.109625 °	
DWR ID	DWR_NA0017_15_s_2012_104				
Action/Comments					
Remove the wild growth other than native grasses from the levee slopes.

Updated picture of the Arundo on the waterside slope of the levee looking downstream.

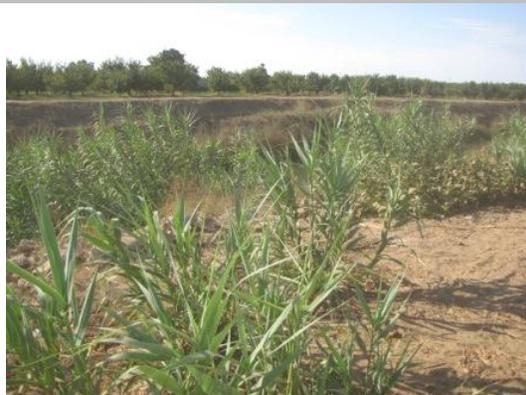
Photo 2 of 2 : FA_2014_NA0017_159_104_20141021_00079.jpg

LM Start	8.06	Rating **	M	Issue No.	104 (cont)
LM End	8.06	Issue Type +	Ma	Location *	WS
Category	Earthen Levee		GPS Latitude/Longitude		
			Start	End	
Item	Vegetation		37.974304 °	37.974304 °	
			-121.109625 °	-121.109625 °	
DWR ID	DWR_NA0017_15_s_2012_104				
Action/Comments					
Remove the wild growth other than native grasses from the levee slopes.

View of arrundo on the waterward shoulder and slope blocking visibility looking downstream.

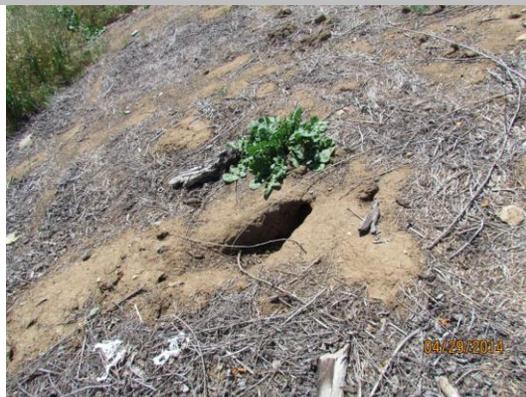
Photo 1 of 1 : FA_2014_NA0017_159_122_20141021_00092.jpg

LM Start	8.28	Rating **	M	Issue No.	122
LM End	8.28	Issue Type +	Ma	Location *	WS
Category	Earthen Levee		GPS Latitude/Longitude		
			Start	End	
Item	Animal Control		37.972590 °	37.972590 °	
			-121.112938 °	-121.112938 °	
DWR ID	DWR_NA0017_15_s_2014_122				
Action/Comments					
No rodents visible, but rodent burrows visible; need to backfill and compact or grout burrows.

A rodent hole was found on the waterside of the levee looking downstream.

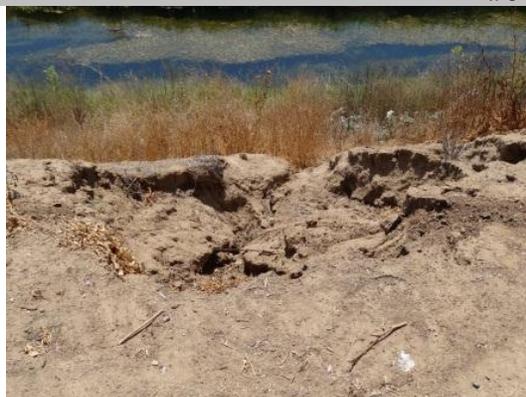
Photo 1 of 1 : SJR2014_NA0017U15RM14.49_1.jpg

LM Start	8.43	Rating **	M	Issue No.	125
LM End	8.43	Issue Type +	Ma	Location *	WS
Category	Supplemental		GPS Latitude/Longitude		
			Start	End	
Item	DWR Erosion Survey		37.969711 °	37.969711 °	
			-121.116739 °	-121.116739 °	
DWR ID					
Action/Comments					
Inspector Comments: 8/20/2014: No significant change observed. 09/12/2013: The erosion has been caused by runoff. [2014 Site ID:NA0017U15RM14.49]

Looking down at the erosion from the levee crest.

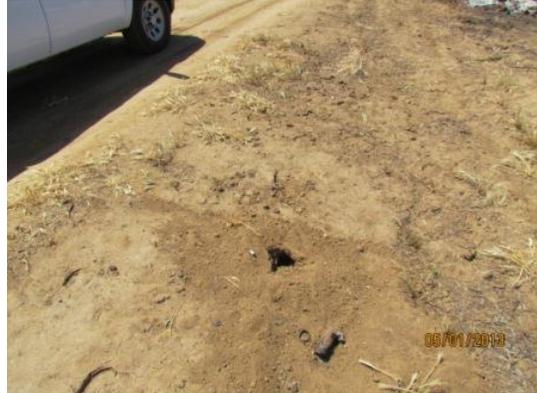
Photo 1 of 1 : FA_2014_NA0017_159_62_20141021_00047.jpg

LM Start	8.49	Rating **	M	Issue No.	62
LM End	8.49	Issue Type +	Ma	Location *	LS
Category	Earthen Levee		GPS Latitude/Longitude		
			Start	End	
Item	Animal Control		37.970147 °	37.970147 °	
			-121.114849 °	-121.114849 °	
DWR ID	DWR_NA0017_15_s_2013_62				
Action/Comments					
No rodents visible, but rodent burrows visible; need to backfill and compact or grout burrows.

An animal hole was found on the landside slope of the levee looking downstream.

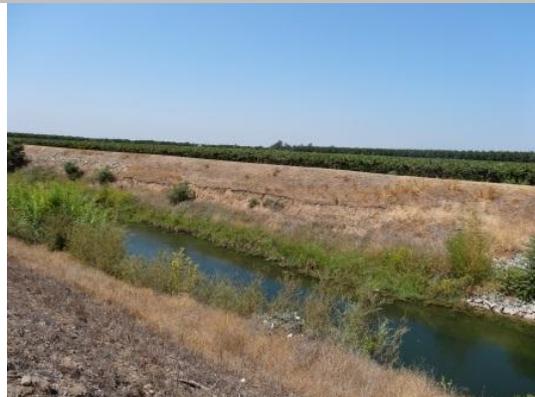
Photo 1 of 1 : SJR2014_NA0017U15RM13.87_1.jpg

LM Start	8.93	Rating **	M	Issue No.	7
LM End	8.95	Issue Type +	Ma	Location *	WS
Category	Supplemental		GPS Latitude/Longitude		
			Start	End	
Item	DWR Erosion Survey		37.968060 °	37.968060 °	
			-121.123299 °	-121.123299 °	
DWR ID					
Action/Comments					
Inspector Comments: 8/20/2014: Both ends of the erosion site are protected by riprap. [2014 Site ID:NA0017U15RM13.87]

View of the site from the left river bank.

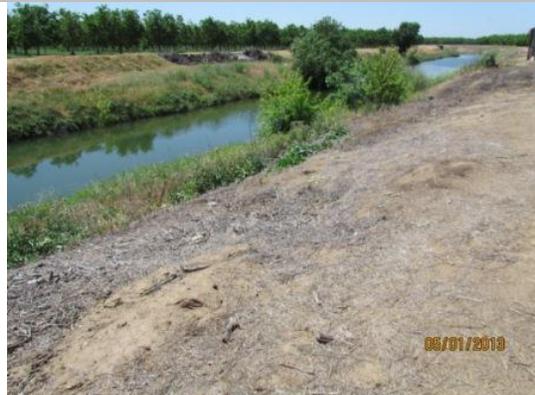
Photo 1 of 1 : FA_2014_NA0017_159_121_20141021_00091.jpg

A slope instability was found on the waterside slope of the levee looking downstream.

LM Start	9.59	Rating **	M	Issue No.	121
LM End	9.59	Issue Type +	Ma	Location *	WS
Category	Earthen Levee		GPS Latitude/Longitude		
			Start	End	
Item	Slope Stability		37.967155 °	37.967155 °	
			-121.133277 °	-121.133277 °	
DWR ID	DWR_NA0017_15_f_2012_121				
Action/Comments					
Repair slope instability.

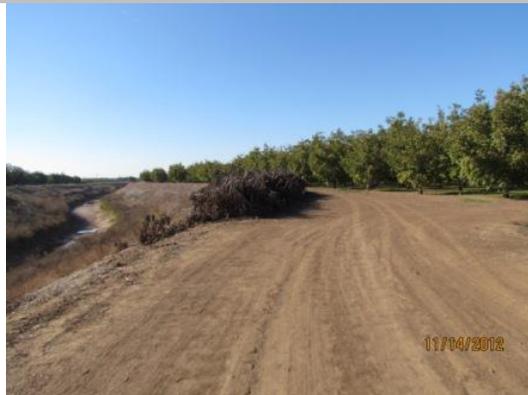
Photo 1 of 1 : FA_2014_NA0017_159_147_20141021_00104.jpg

Prunings were found on the waterside shoulder of the levee looking downstream.

LM Start	10.01	Rating **	M	Issue No.	147
LM End	10.01	Issue Type +	Ma	Location *	WS
Category	Earthen Levee		GPS Latitude/Longitude		
			Start	End	
Item	Encroachments		37.965314 °	37.965314 °	
			-121.140296 °	-121.140296 °	
DWR ID	DWR_NA0017_15_s_2012_147				
Action/Comments					
Prunings

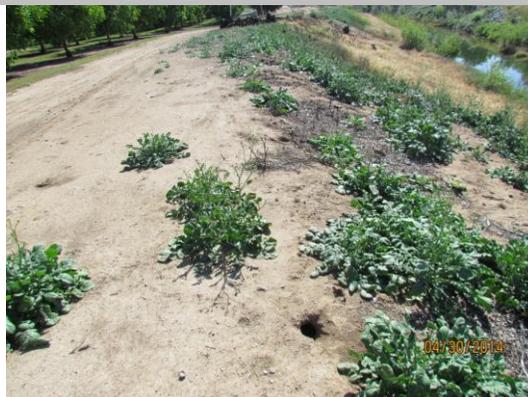
Photo 1 of 1 : FA_2014_NA0017_159_126_20141021_00095.jpg

View of rodent holes on the waterside of the levee looking upstream.

LM Start	10.04	Rating **	M	Issue No.	126
LM End	10.04	Issue Type +	Ma	Location *	WS
Category	Earthen Levee		GPS Latitude/Longitude		
			Start	End	
Item	Animal Control		37.965343 °	37.965343 °	
			-121.140761 °	-121.140761 °	
DWR ID	DWR_NA0017_15_s_2014_126				
Action/Comments					
No rodents visible, but rodent burrows visible; need to backfill and compact or grout burrows.

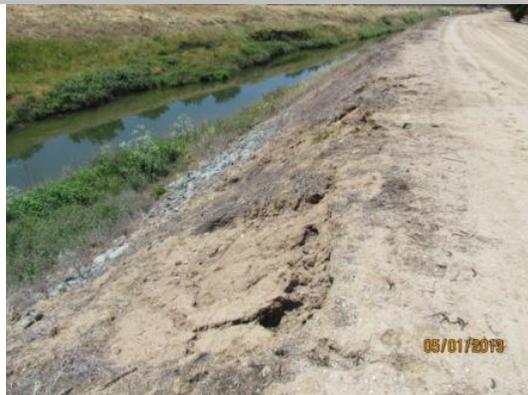
Photo 1 of 1 : FA_2014_NA0017_159_68_20141021_00055.jpg

Slope instability was found on the waterside slope of the levee looking downstream.

LM Start	10.11	Rating **	M	Issue No.	68
LM End	10.11	Issue Type +	Ma	Location *	WS
Category	Earthen Levee		GPS Latitude/Longitude		
			Start	End	
Item	Slope Stability		37.965165 °	37.965165 °	
			-121.141928 °	-121.141928 °	
DWR ID	DWR_NA0017_15_s_2013_68				
Action/Comments					
Repair slope instability.

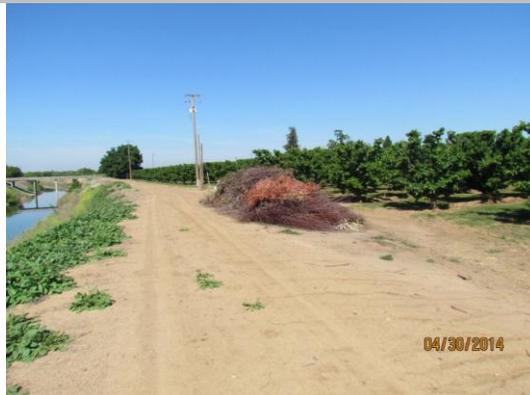
Photo 1 of 1 : FA_2014_NA0017_159_87_20141021_00066.jpg

LM Start	10.35	Rating **	M	Issue No.	87
LM End	10.35	Issue Type +	Ma	Location *	CR
Category	Earthen Levee		GPS Latitude/Longitude		
			Start	End	
Item	Encroachments		37.965055 °	37.965055 °	
			-121.146293 °	-121.146293 °	
DWR ID	DWR_NA0017_15_s_2012_87				
Action/Comments					
Prunings Inspector Comments: Burn pile has been burned but new material has been placed.

Prunings were found on the crown of the levee looking downstream.

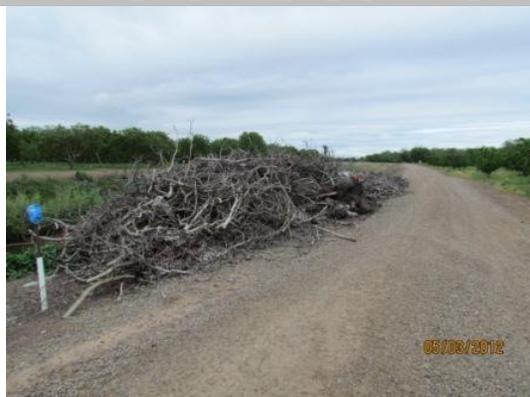
Photo 1 of 2 : FA_2014_NA0017_159_78_20141021_00059.jpg

Prunings were found on the waterside of the levee looking downstream.

LM Start	10.62	Rating **	M	Issue No.	78
LM End	10.62	Issue Type +	Ma	Location *	WS
Category	Earthen Levee		GPS Latitude/Longitude		
			Start	End	
Item	Encroachments		37.964942 °	37.964942 °	
			-121.151073 °	-121.151073 °	
DWR ID	DWR_NA0017_15_s_2012_78				
Action/Comments					
Prunings

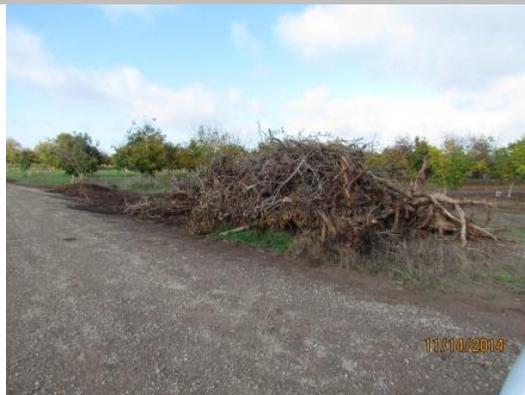
Photo 1 of 1 : FA_2014_NA0017_159_106_20141118_00135.jpg

LM Start	11.00	Rating **	M	Issue No.	106
LM End	11.00	Issue Type +	Ma	Location *	LS
Category	Earthen Levee		GPS Latitude/Longitude		
			Start	End	
Item	Encroachments		37.963319 °	37.963319 °	
			-121.157557 °	-121.157557 °	
DWR ID	DWR_NA0017_15_s_2012_106				
Action/Comments					
Prunings					
Inspector Comments: Prunings and ashes piled at the toe.

Prunings were found on the landside of the levee looking downstream.

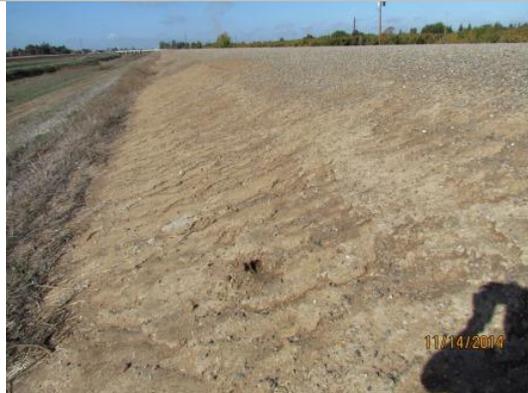
Photo 1 of 1 : FA_2014_NA0017_159_179_20141118_00138.jpg

An animal hole was found on the waterside of the levee looking downstream.

LM Start	13.75	Rating **	M	Issue No.	179
LM End	13.75	Issue Type +	Ma	Location *	WS
Category	Earthen Levee		GPS Latitude/Longitude		
			Start	End	
Item	Animal Control		37.961557 °	37.961557 °	
			-121.204627 °	-121.204627 °	
DWR ID	DWR_NA0017_15_f_2014_179				
Action/Comments					
No rodents visible, but rodent burrows visible; need to backfill and compact or grout burrows.

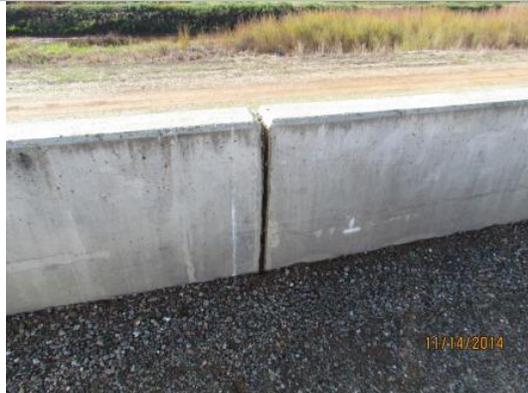
Photo 1 of 1 : FA_2014_NA0017_159_180_20141118_00139.jpg

The monolith joint is deteriorating on the waterside shoulder of the levee.

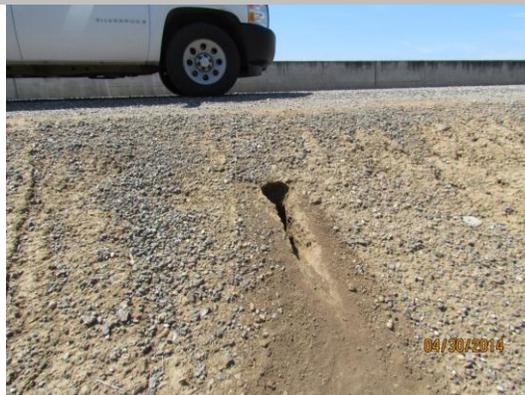
Photo 1 of 1 : FA_2014_NA0017_159_32_20141021_00024.jpg

A rodent hole was found on the waterside of the levee looking downstream.

LM Start	15.72	Rating **	M	Issue No.	32
LM End	15.72	Issue Type +	Ma	Location *	LS
Category	Earthen Levee		GPS Latitude/Longitude		
			Start	End	
Item	Animal Control		37.975959 °	37.975959 °	
			-121.235058 °	-121.235058 °	
DWR ID	DWR_NA0017_15_s_2014_32				
Action/Comments					
No rodents visible, but rodent burrows visible; need to backfill and compact or grout burrows.

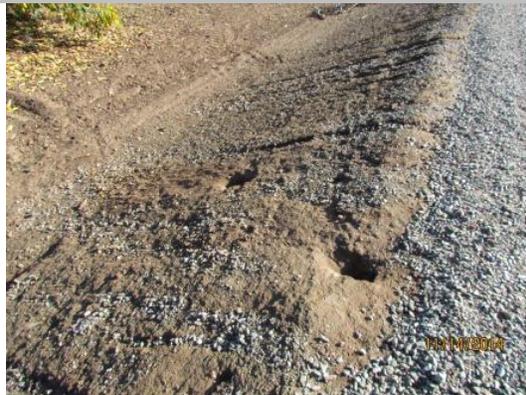
Photo 1 of 2 : FA_2014_NA0017_159_71_20141118_00140.jpg

Updated picture of the animal hole on the landside of the levee looking upstream during fall 2014 inspection.

LM Start	15.73	Rating **	M	Issue No.	71
LM End	15.73	Issue Type +	Ma	Location *	LS
Category	Earthen Levee		GPS Latitude/Longitude		
			Start	End	
Item	Animal Control		37.976000 °	37.976000 °	
			-121.235156 °	-121.235156 °	
DWR ID	DWR_NA0017_15_s_2013_71				
Action/Comments					
No rodents visible, but rodent burrows visible; need to backfill and compact or grout burrows.

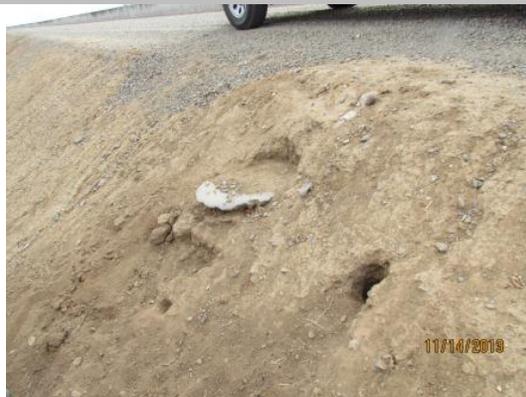
Photo 2 of 2 : FA_2014_NA0017_159_71_20141021_00056.jpg

An animal hole was found on the landside slope of the levee looking upstream.

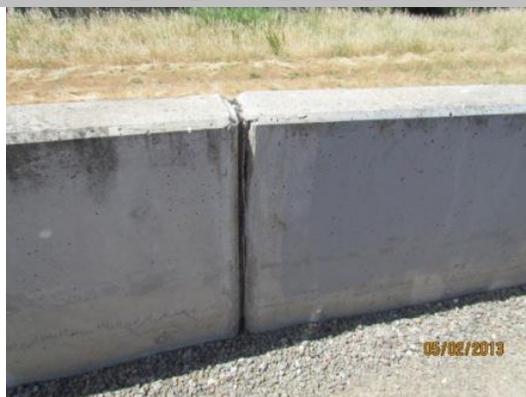
Photo 1 of 1 : FA_2014_NA0017_159_80_20141021_00061.jpg

The monolith joint material is deteriorating at the waterside shoulder of the levee looking downstream.

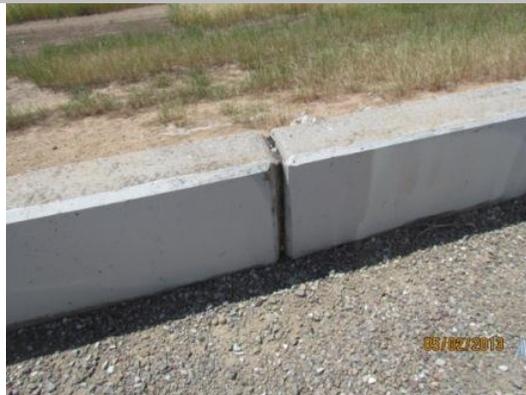
Photo 1 of 1 : FA_2014_NA0017_159_93_20141021_00071.jpg

The monolith joint material is deteriorating at the waterside shoulder of the levee looking downstream.

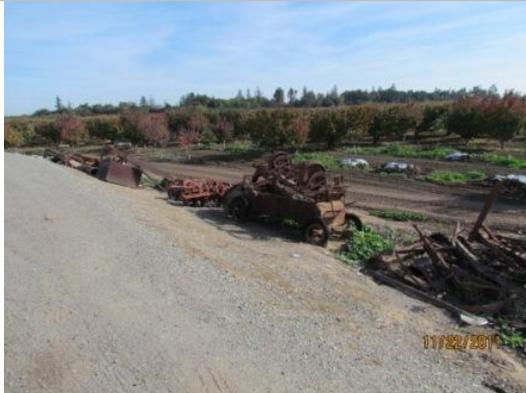
Photo 1 of 1 : FA_2014_NA0017_159_567_20141021_00112.jpg

Equipment was found on the landside of the levee looking downstream.

LM Start	18.44	Rating **	M	Issue No.	567
LM End	18.44	Issue Type +	Ma	Location *	LS
Category	Earthen Levee		GPS Latitude/Longitude		
			Start	End	
Item	Encroachments		37.994859 °	37.994859 °	
			-121.275862 °	-121.275862 °	
DWR ID	DWR_NA0017_15_s_2012_567				
Action/Comments					
Equipment

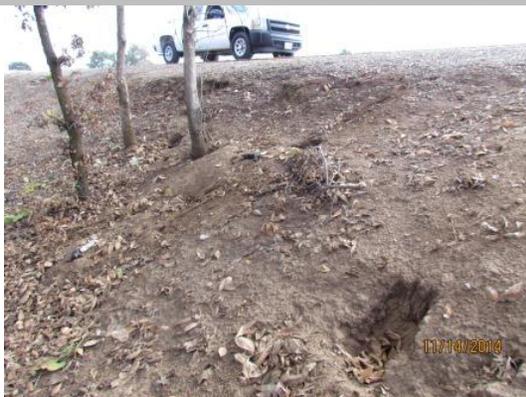
Photo 1 of 2 : FA_2014_NA0017_159_132_20141118_00142.jpg

Updated picture of the animal hole on the landside of the levee during fall 2014 inspection.

LM Start	20.09	Rating **	M	Issue No.	132
LM End	20.09	Issue Type +	Ma	Location *	LS
Category	Earthen Levee		GPS Latitude/Longitude		
			Start	End	
Item	Animal Control		37.993719 °	37.993719 °	
			-121.284698 °	-121.284698 °	
DWR ID	DWR_NA0017_15_s_2014_132				
Action/Comments					
No rodents visible, but rodent burrows visible; need to backfill and compact or grout burrows.

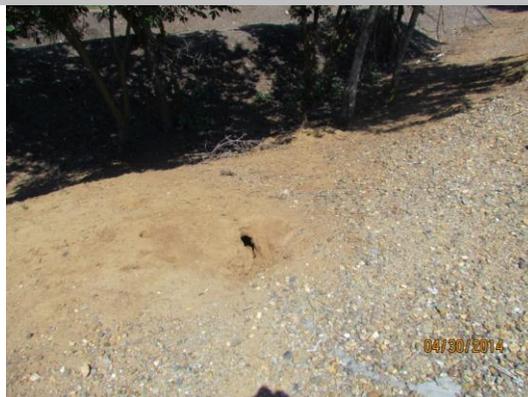
Photo 2 of 2 : FA_2014_NA0017_159_132_20141021_00097.jpg

A rodent hole was found on the landside of the levee looking from the crown.

LM Start	20.09	Rating **	M	Issue No.	132 (cont)
LM End	20.09	Issue Type +	Ma	Location *	LS
Category	Earthen Levee		GPS Latitude/Longitude		
			Start	End	
Item	Animal Control		37.993719 °	37.993719 °	
			-121.284698 °	-121.284698 °	
DWR ID	DWR_NA0017_15_s_2014_132				
Action/Comments					
No rodents visible, but rodent burrows visible; need to backfill and compact or grout burrows.

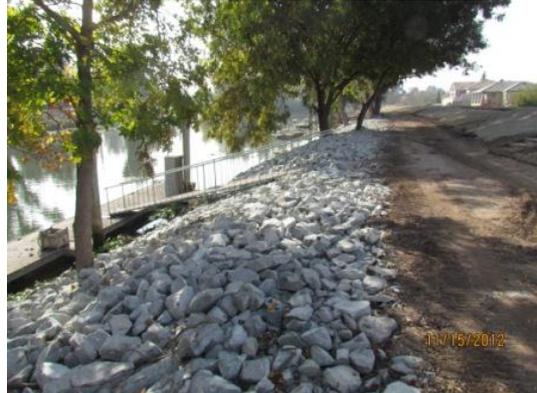
Photo 1 of 1 : FA_2014_NA0017_159_188_20141021_00110.jpg

Revetments were placed by the LMA on the waterside slope of the levee looking downstream.

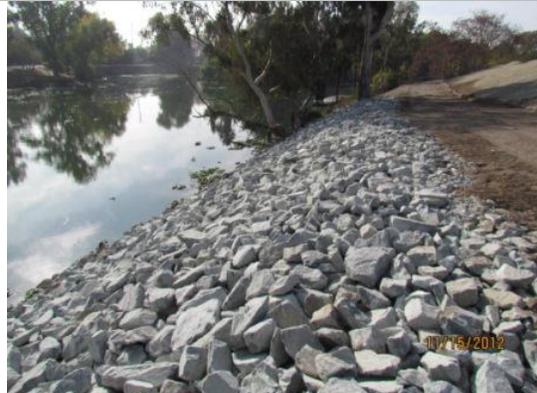
Photo 1 of 1 : FA_2014_NA0017_159_189_20141021_00111.jpg

Revetments were placed by the LMA on the waterside slope of the levee looking downstream.

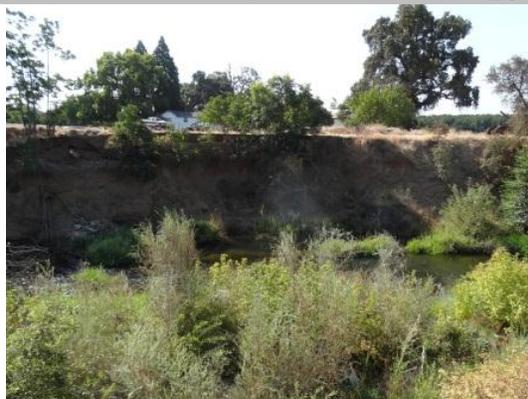
Photo 1 of 1 : SJR2014_NA0017U16RM23.35_1.jpg

LM Start	0.12	Rating **	U	Issue No.	272
LM End	0.48	Issue Type +	Ma	Location *	WS
Category	Supplemental		GPS Latitude/Longitude		
			Start	End	
Item	DWR Erosion Survey		38.048159 °	38.048159 °	
			-121.016427 °	-121.016427 °	
DWR ID					
Action/Comments					
Inspector Comments: 8/20/2014: The erosion at the site has worsened. The erosion increased both in both length and in height. 09/12/2013: Site has been visited and signs of new erosion are visible. 08/22/2012: The erosion was surveyed and documented for monitoring purpose. There is no levee structure on the site, only high ground protecting the land behind. The levee crest width and levee height were not measured or estimated in the field. [2014 Site ID:NA0017U16RM23.35]

Close view of the erosion.

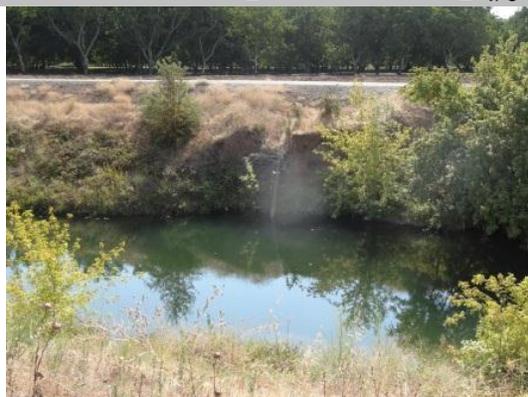
Photo 1 of 1 : SJR2014_NA0017U16RM22.74_1.jpg

LM Start	0.97	Rating **	U	Issue No.	271
LM End	0.99	Issue Type +	Ma	Location *	WS
Category	Supplemental		GPS Latitude/Longitude		
			Start	End	
Item	DWR Erosion Survey		38.043080 °	38.043080 °	
			-121.026280 °	-121.026280 °	
DWR ID					
Action/Comments					
Inspector Comments: 8/20/2014: No significant change observed. 09/12/2013: No significant change observed. 08/22/2012: The erosion was surveyed and documented for monitoring purpose. There is no levee structure on the site, only high ground protecting the land behind. The levee crest width and levee height were not measured or estimated in the field. There is a drainage pipe at the site, which might have caused the problem at one pocket erosion. [2014 Site ID:NA0017U16RM22.74]

View of the site from right river bank.

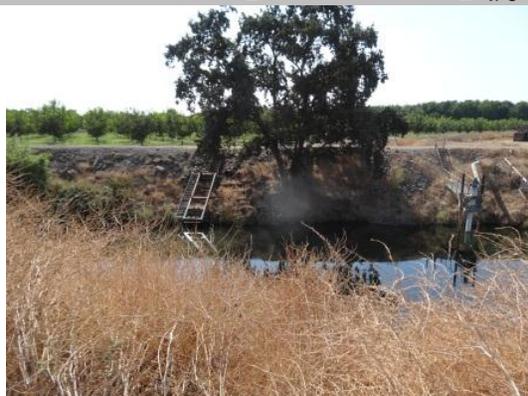
Photo 1 of 1 : SJR2014_NA0017U16RM22.58_1.jpg

LM Start	1.13	Rating **	U	Issue No.	270
LM End	1.13	Issue Type +	Ma	Location *	WS
Category	Supplemental		GPS Latitude/Longitude		
			Start	End	
Item	DWR Erosion Survey		38.041260 °	38.041260 °	
			-121.027730 °	-121.027730 °	
DWR ID					
Action/Comments					
Inspector Comments: 8/20/2014: No significant change observed. 9/12/2013: No significant change observed. 08/22/2012: The erosion is at the outside corner of a river bend, and next to a tree at the levee toe. Irrigation structure presents at the site. There is no levee structure on site. The levee crest width and levee height were not measured or estimated in the field. [2014 Site ID:NA0017U16RM22.58]

Front view of the erosion and broken concrete protection on the levee slope.

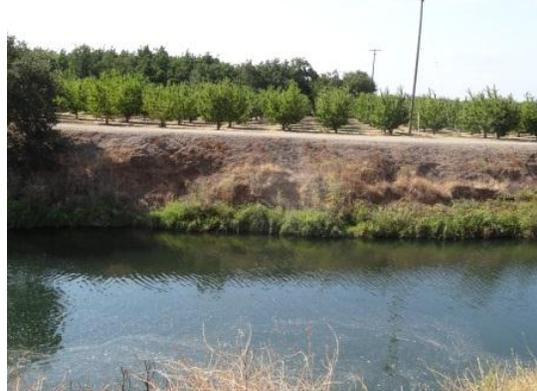
Photo 1 of 1 : SJR2014_NA0017U16RM22.15_1.jpg

LM Start	1.59	Rating **	M	Issue No.	269
LM End	1.59	Issue Type +	Ma	Location *	WS
Category	Supplemental			GPS Latitude/Longitude	
				Start	End
Item	DWR Erosion Survey			38.039940 °	38.039940 °
				-121.035430 °	-121.035430 °
DWR ID					
Action/Comments					
Inspector Comments: 8/20/2014: No significant change observed. 9/12/2013: No significant change observed. 08/22/2012: The berm is estimated at 10 ft. Dense vegetation on site. There is no levee structure on site. The levee crest width and levee height were not measured or estimated in the field. [2014 Site ID:NA0017U16RM22.15]

Front view of the erosion.

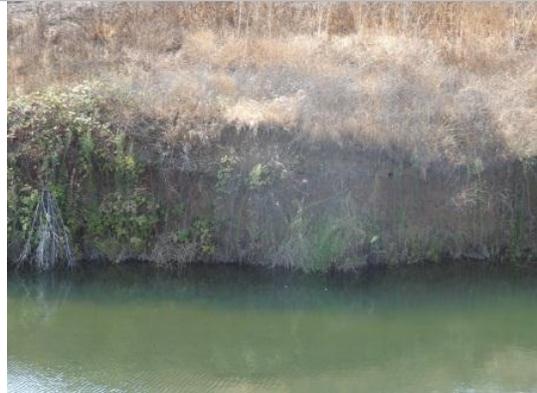
Photo 1 of 1 : SJR2014_NA0017U16RM21.95_1.jpg

LM Start	1.75	Rating **	M	Issue No.	222
LM End	1.76	Issue Type +	Ma	Location *	WS
Category	Supplemental			GPS Latitude/Longitude	
				Start	End
Item	DWR Erosion Survey			38.038080 °	38.038080 °
				-121.038676 °	-121.038676 °
DWR ID					
Action/Comments					
Inspector Comments: 8/20/2014: No significant change observed. 9/12/2013: No significant change observed. 08/22/2012: The erosion is covered by dense vegetation. There is no levee structure on site. The levee crest width and levee height were not measured or estimated in the field. [2014 Site ID:NA0017U16RM21.95]

Front view of the erosion site.
