**Flood Control Project Maintenance
Levee Inspections**

Maintenance Issue Types Only, Levee Inspection Report By Mile - Fall 2014

San Joaquin County Flood Control and Water Conservation District

Waterway	Bank	Unit Miles	Inspection Start/End	Inspector
Unit No. 01 Littlejohn Creek	Left	2.59	11/24/2014 11/24/2014	Pavel Kazi

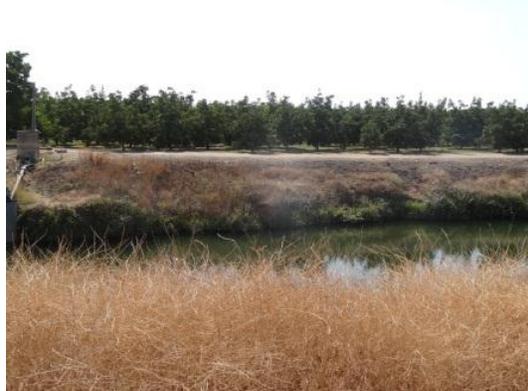
Photo 1 of 1 : SJR2014_NA0017U16RM21.94_1.jpg

LM Start	1.77	Rating **	M	Issue No.	219
LM End	1.78	Issue Type +	Ma	Location *	WS
Category	Supplemental			GPS Latitude/Longitude	
				Start	End
Item	DWR Erosion Survey			38.037906 °	38.037906 °
				-121.038949 °	-121.038949 °
DWR ID					
Action/Comments					
Inspector Comments: 8/20/2014: No significant change observed 9/12/2013: No significant change observed. 08/22/2012: Site is covered by dense vegetation. Berm width is estimated as 5 ft. There is no levee structure on site. The levee crest width and levee height were not measured or estimated in the field. [2014 Site ID:NA0017U16RM21.94]

Looking at the erosion from right river bank.

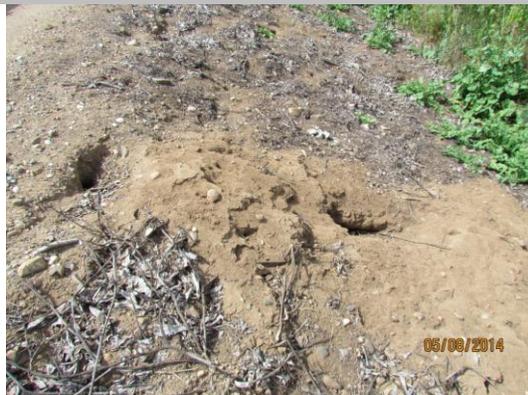
Photo 1 of 1 : FA_2014_NA0017_160_183_20141021_00128.jpg

Rodent holes were found on the waterside of the levee looking downstream.

LM Start	1.88	Rating **	M	Issue No.	183
LM End	1.88	Issue Type +	Ma	Location *	WS
Category	Earthen Levee			GPS Latitude/Longitude	
				Start	End
Item	Animal Control			38.037320 °	38.037320 °
				-121.039563 °	-121.039563 °
DWR ID	DWR_NA0017_16_s_2014_183				
Action/Comments					
No rodents visible, but rodent burrows visible; need to backfill and compact or grout burrows.

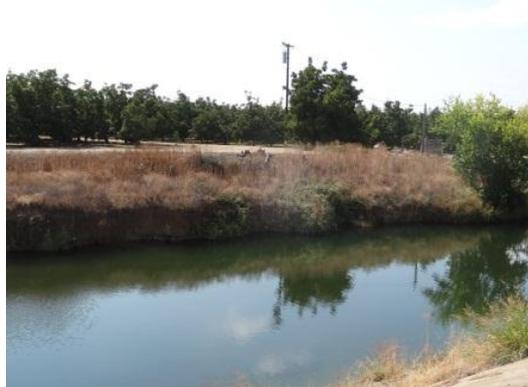
Photo 1 of 1 : SJR2014_NA0017U16RM21.05_1.jpg

LM Start	1.93	Rating **	M	Issue No.	217
LM End	1.95	Issue Type +	Ma	Location *	WS
Category	Supplemental			GPS Latitude/Longitude	
				Start	End
Item	DWR Erosion Survey			38.037150 °	38.037150 °
				-121.040580 °	-121.040580 °
DWR ID					
Action/Comments					
Inspector Comments: 8/20/2014: No significant change observed. 9/12/2013: No significant change observed. 08/22/2012: Berm width is estimated as 5 ft. There is no levee structure on site. The levee crest width and levee height were not measured or estimated in the field. [2014 Site ID:NA0017U16RM21.05]

Front view of the erosion

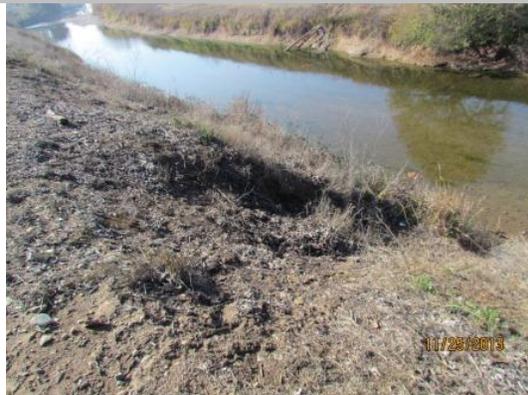
Photo 1 of 1 : FA_2014_NA0017_160_155_20141021_00104.jpg

Erosion was found on the waterside of the levee looking downstream.

LM Start	1.97	Rating **	M	Issue No.	155
LM End	1.97	Issue Type +	Ma	Location *	WS
Category	Earthen Levee		GPS Latitude/Longitude		
			Start	End	
Item	Erosion / Bank Caving		38.036248 °	38.036248 °	
			-121.040408 °	-121.040408 °	
DWR ID	DWR_NA0017_16_f_2013_155				
Action/Comments					
Schedule repair of erosion site prior to the next inspection.

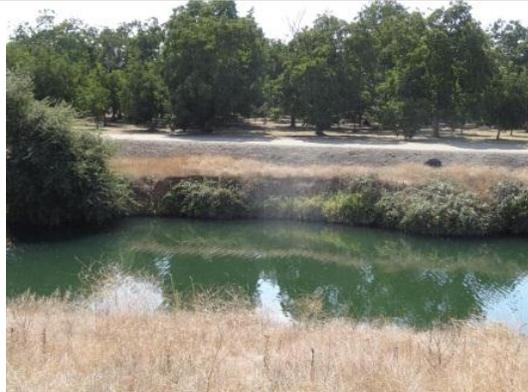
Photo 1 of 1 : SJR2014_NA0017U16RM20.71_1.jpg

LM Start	2.31	Rating **	M	Issue No.	215
LM End	2.32	Issue Type +	Ma	Location *	WS
Category	Supplemental		GPS Latitude/Longitude		
			Start	End	
Item	DWR Erosion Survey		38.033072 °	38.033072 °	
			-121.044970 °	-121.044970 °	
DWR ID					
Action/Comments					
Inspector Comments: 8/20/2014: No significant change observed. 9/12/2013: No significant change observed. 08/22/2012: Site is covered with dense vegetation. There is no levee structure on site. The levee crest width and levee height were not measured or estimated in the field. [2014 Site ID:NA0017U16RM20.71]

Closer view of the erosion.

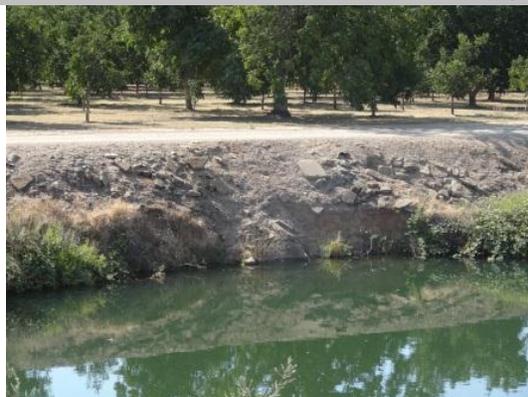
Photo 1 of 1 : SJR2014_NA0017U16RM20.62_1.jpg

LM Start	2.37	Rating **	U	Issue No.	214
LM End	2.38	Issue Type +	Ma	Location *	WS
Category	Supplemental		GPS Latitude/Longitude		
			Start	End	
Item	DWR Erosion Survey		38.032202 °	38.032202 °	
			-121.045226 °	-121.045226 °	
DWR ID					
Action/Comments					
Inspector Comments: 8/20/2014: No significant change has been observed. 9/12/2013: No significant change observed. 08/22/2012: The erosion was first reported in the 2012 spring levee inspection report. There is no levee structure on site. The levee crest width and levee height were not measured or estimated in the field. [2014 Site ID:NA0017U16RM20.62]

Close view of the erosion. Note the vegetation at the site.

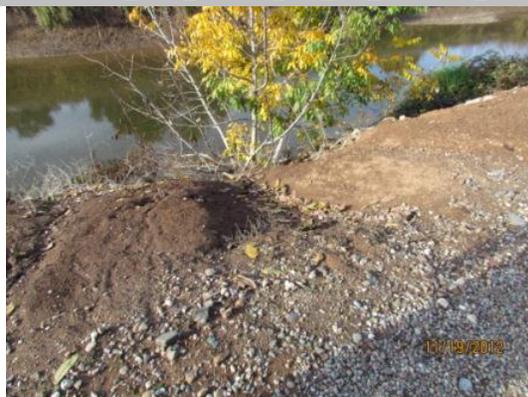
Photo 1 of 2 : FA_2014_NA0017_160_213_20141021_00146.jpg

Updated picture of the slope instability on the waterside shoulder of the levee looking upstream.

LM Start	2.42	Rating **	M	Issue No.	213
LM End	2.42	Issue Type +	Ma	Location *	WS
Category	Earthen Levee		GPS Latitude/Longitude		
			Start	End	
Item	Slope Stability		38.031763 °	38.031763 °	
			-121.045808 °	-121.045808 °	
DWR ID	DWR_NA0017_16_f_2012_213				
Action/Comments					
Repair slope instability.

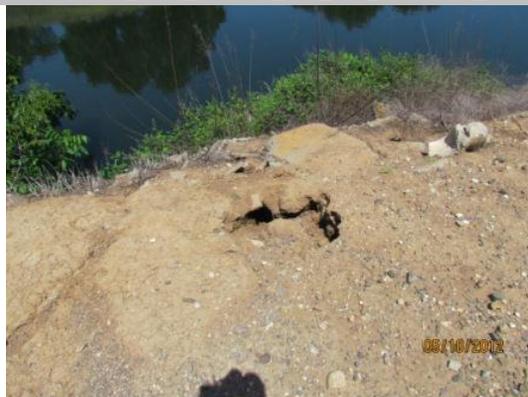
Photo 2 of 2 : FA_2014_NA0017_160_213_20141021_00147.jpg

Slope instability was found on the waterside of the levee looking upstream.

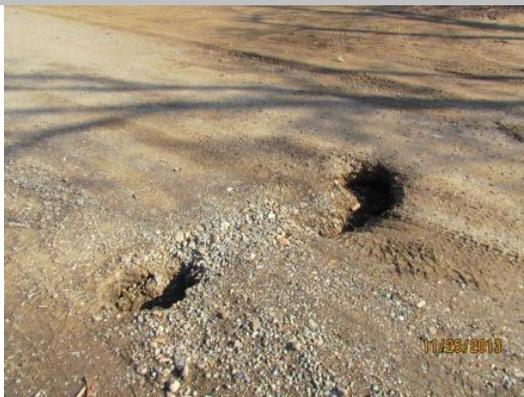
Photo 1 of 1 : FA_2014_NA0017_160_153_20141021_00103.jpg

Rodent holes were found on the crown of the levee looking upstream.

LM Start	2.47	Rating **	M	Issue No.	153
LM End	2.47	Issue Type +	Ma	Location *	CR
Category	Earthen Levee		GPS Latitude/Longitude		
			Start	End	
Item	Animal Control		38.031208 °	38.031208 °	
			-121.046362 °	-121.046362 °	
DWR ID	DWR_NA0017_16_f_2013_153				
Action/Comments					
No rodents visible, but rodent burrows visible; need to backfill and compact or grout burrows.

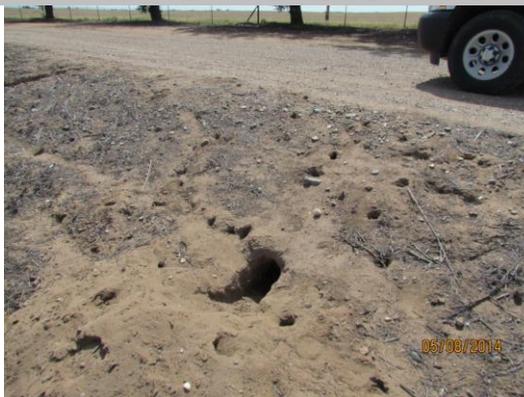
Photo 1 of 1 : FA_2014_NA0017_160_176_20141021_00123.jpg

Rodent holes were found on the waterside of the levee.

LM Start	2.68	Rating **	M	Issue No.	176
LM End	2.68	Issue Type +	Ma	Location *	WS
Category	Earthen Levee		GPS Latitude/Longitude		
			Start	End	
Item	Animal Control		38.029061 °	38.029061 °	
			-121.048870 °	-121.048870 °	
DWR ID	DWR_NA0017_16_s_2014_176				
Action/Comments					
No rodents visible, but rodent burrows visible; need to backfill and compact or grout burrows.

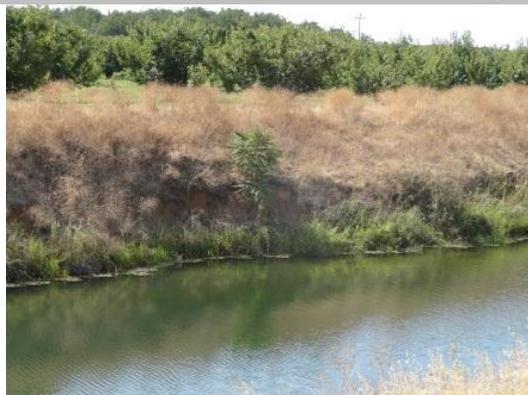
Photo 1 of 1 : SJR2014_NA0017U16RM20_1.jpg

LM Start	3.00	Rating **	U	Issue No.	212
LM End	3.06	Issue Type +	Ma	Location *	WS
Category	Supplemental		GPS Latitude/Longitude		
			Start	End	
Item	DWR Erosion Survey		38.026670 °	38.026670 °	
			-121.053031 °	-121.053031 °	
DWR ID					
Action/Comments					
Inspector Comments: 8/20/2014: No significant change observed. 9/12/2013: No significant change observed. 08/22/2012: Site Comprised of series of pocket and scarp erosions. Some of erosions are covered by grass or shrubs. There is no levee structure on site. The levee crest width and levee height were not measured or estimated in the field. [2014 Site ID:NA0017U16RM20]

Front view of the erosion.

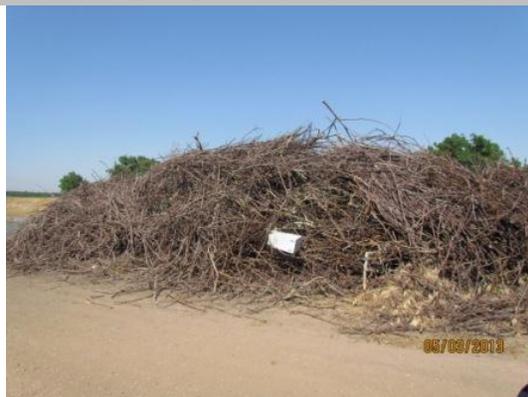
Photo 1 of 1 : FA_2014_NA0017_160_53_20141021_00027.jpg

LM Start	3.52	Rating **	M	Issue No.	53
LM End	3.52	Issue Type +	Ma	Location *	WS
Category	Earthen Levee		GPS Latitude/Longitude		
			Start	End	
Item	Encroachments		38.021650 °	38.021650 °	
			-121.060312 °	-121.060312 °	
DWR ID	DWR_NA0017_16_s_2012_53				
Action/Comments					
Prunings Inspector Comments: Burn pile has been burned but new material has been placed.

Prunings were found on the waterside shoulder of the levee looking downstream.

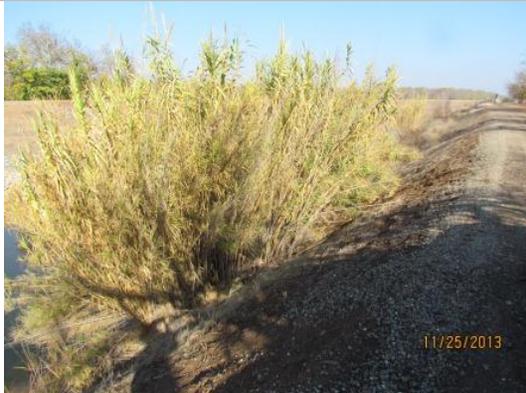
Photo 1 of 1 : FA_2014_NA0017_160_152_20141021_00102.jpg

Arundo was found on the waterside toe of the levee looking upstream.

LM Start	3.59	Rating **	M	Issue No.	152
LM End	3.59	Issue Type +	Ma	Location *	WS
Category	Earthen Levee		GPS Latitude/Longitude		
			Start	End	
Item	Vegetation		38.020965 °	38.020965 °	
			-121.061215 °	-121.061215 °	
DWR ID	DWR_NA0017_16_f_2013_152				
Action/Comments					
Remove the wild growth other than native grasses from the levee slopes.

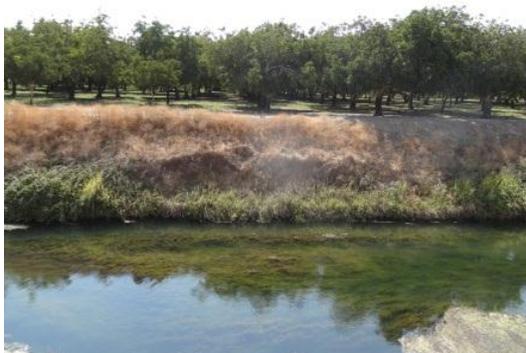
Photo 1 of 1 : SJR2014_NA0017U16RM19.29_1.jpg

LM Start	3.61	Rating **	M	Issue No.	210
LM End	3.61	Issue Type +	Ma	Location *	WS
Category	Supplemental		GPS Latitude/Longitude		
			Start	End	
Item	DWR Erosion Survey		38.019642 °	38.019642 °	
			-121.062917 °	-121.062917 °	
DWR ID					
Action/Comments					
Inspector Comments: 8/20/2014: A pocket erosion was found near the water's edge. [2014 Site ID:NA0017U16RM19.29]

View of the site from the right river bank.

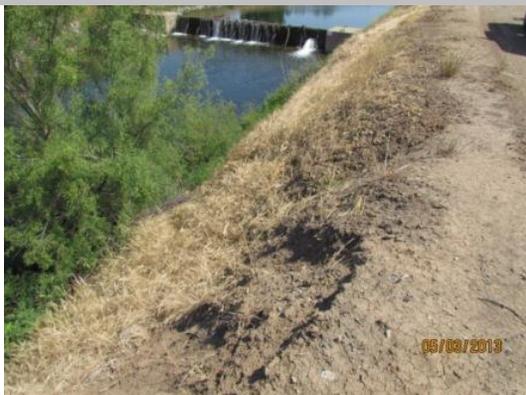
Photo 1 of 2 : FA_2014_NA0017_160_230_20141021_00156.jpg

Erosion was found on the waterside slope of the levee looking upstream.

LM Start	3.65	Rating **	M	Issue No.	230
LM End	3.65	Issue Type +	Ma	Location *	WS
Category	Earthen Levee		GPS Latitude/Longitude		
			Start	End	
Item	Erosion / Bank Caving		38.020433 °	38.020433 °	
			-121.061867 °	-121.061867 °	
DWR ID	DWR_NA0017_16_f_2012_230				
Action/Comments					
Schedule repair of erosion site prior to the next inspection.

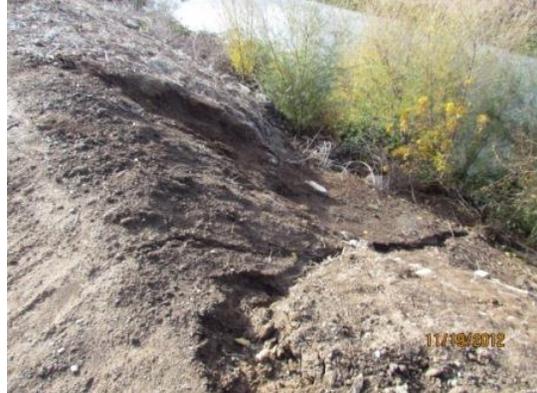
Photo 2 of 2 : FA_2014_NA0017_160_230_20141021_00157.jpg

Slope instability was found on the waterside slope of the levee looking downstream.

LM Start	3.65	Rating **	M	Issue No.	230 (cont)
LM End	3.65	Issue Type +	Ma	Location *	WS
Category	Earthen Levee			GPS Latitude/Longitude	
				Start	End
Item	Erosion / Bank Caving			38.020433 °	38.020433 °
				-121.061867 °	-121.061867 °
DWR ID	DWR_NA0017_16_f_2012_230				
Action/Comments					
Schedule repair of erosion site prior to the next inspection.

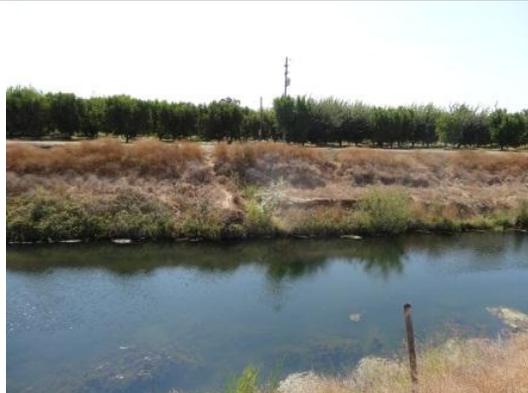
Photo 1 of 1 : SJR2014_NA0017U16RM19.18_1.jpg

LM Start	3.89	Rating **	M	Issue No.	207
LM End	3.91	Issue Type +	Ma	Location *	WS
Category	Supplemental		GPS Latitude/Longitude		
			Start	End	
Item	DWR Erosion Survey		38.018100 °	38.018100 °	
			-121.065170 °	-121.065170 °	
DWR ID					
Action/Comments					
Inspector Comments: 8/20/2014: No significant change observed. 9/12/2013: No significant change observed. 08/22/2012: River-induced erosion occurred on the berm, while the runoff-induced erosion occurred on the levee slope. Site is covered with vegetation. There is no levee structure on site. The levee crest width and levee height were not measured or estimated in the field. [2014 Site ID:NA0017U16RM19.18]

View of the site from right river bank.

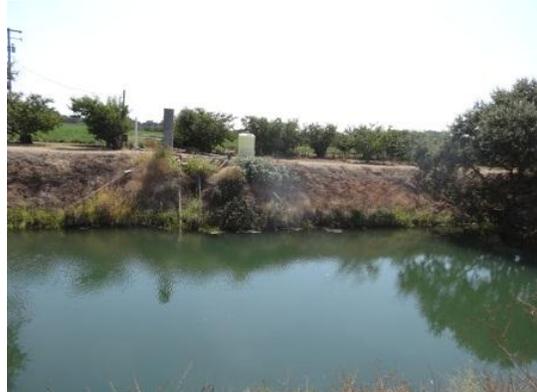
Photo 1 of 1 : SJR2014_NA0017U16RM18.69_1.jpg

LM Start	4.32	Rating **	U	Issue No.	205
LM End	4.34	Issue Type +	Ma	Location *	WS
Category	Supplemental		GPS Latitude/Longitude		
			Start	End	
Item	DWR Erosion Survey		38.012792 °	38.012792 °	
			-121.068073 °	-121.068073 °	
DWR ID					
Action/Comments					
Inspector Comments: 8/20/2014: No significant change observed. 9/12/2013: No significant change observed. 08/22/2012: An irrigation pipe is present at the site, but probably did not cause the erosion. There is no levee structure on site. The levee crest width and levee height were not measured or estimated in the field. [2014 Site ID:NA0017U16RM18.69]

View of the erosion site.

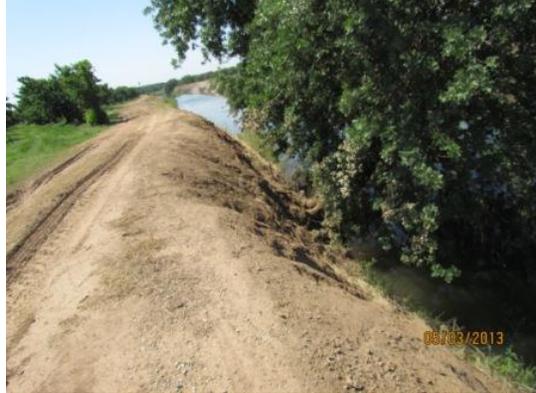
Photo 2 of 2 : FA_2014_NA0017_160_228_20141021_00155.jpg

Slope instability was found on the waterside shoulder of the levee looking downstream.

LM Start	4.34	Rating **	M	Issue No.	228 (cont)
LM End	4.34	Issue Type +	Ma	Location *	WS
Category	Earthen Levee			GPS Latitude/Longitude	
				Start	End
Item	Slope Stability			38.012288 °	38.012288 °
				-121.068239 °	-121.068239 °
DWR ID	DWR_NA0017_16_f_2012_228				
Action/Comments					
Repair slope instability.

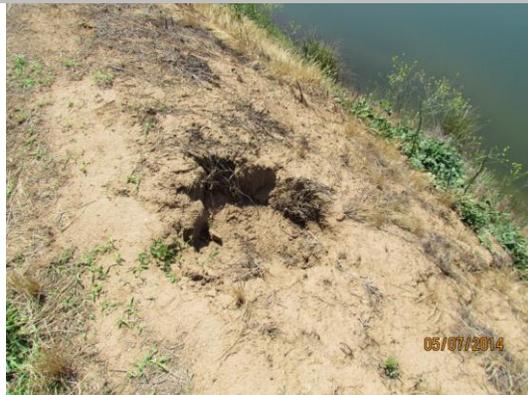
Photo 1 of 1 : FA_2014_NA0017_160_141_20141021_00093.jpg

A slope instability was found on the waterside of the levee looking downstream.

LM Start	4.52	Rating **	M	Issue No.	141
LM End	4.52	Issue Type +	Ma	Location *	WS
Category	Earthen Levee		GPS Latitude/Longitude		
			Start	End	
Item	Slope Stability		38.009858 °	38.009858 °	
			-121.069005 °	-121.069005 °	
DWR ID	DWR_NA0017_16_s_2014_141				
Action/Comments					
Repair slope instability.

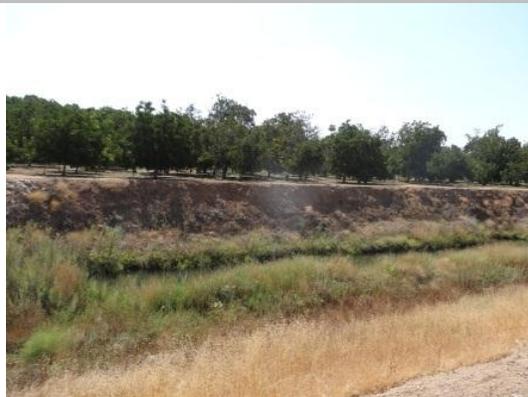
Photo 1 of 1 : SJR2014_NA0017U16RM17.99_1.jpg

LM Start	5.03	Rating **	U	Issue No.	201
LM End	5.03	Issue Type +	Ma	Location *	WS
Category	Supplemental		GPS Latitude/Longitude		
			Start	End	
Item	DWR Erosion Survey		38.003730 °	38.003730 °	
			-121.073080 °	-121.073080 °	
DWR ID					
Action/Comments					
Inspector Comments: 8/20/2014: No significant change observed. 9/12/2013: Site has been surveyed and the pocket erosion has developed toward levee crest. 08/22/2012: A pocket erosion at the levee toe and on lower slope. The levee surface at the upper slope also shows signs of erosion due to poor maintenance. There is no levee structure on site. The levee crest width and levee height were not measured or estimated in the field. [2014 Site ID:NA0017U16RM17.99]

View from right river bank.

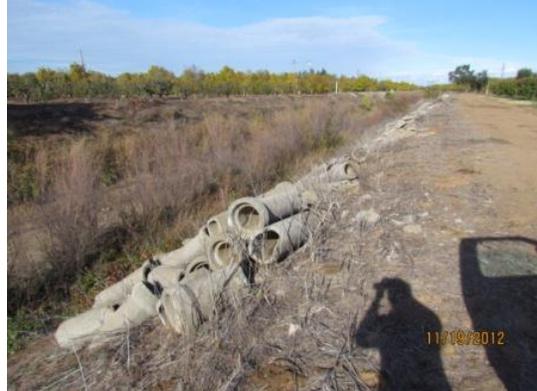
Photo 1 of 2 : FA_2014_NA0017_160_196_20141021_00131.jpg

Concrete debris was found on the waterside slope of the levee looking upstream.

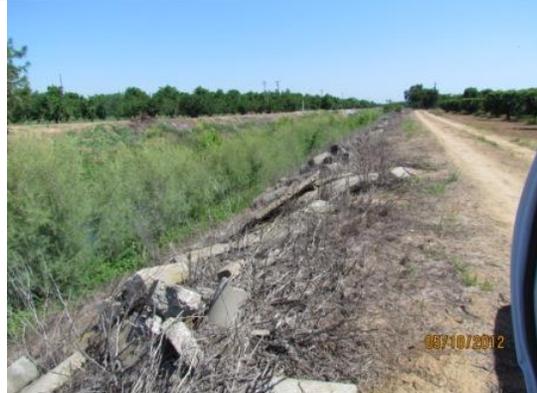
Photo 2 of 2 : FA_2014_NA0017_160_196_20141021_00132.jpg

Debris was found on the waterside of the levee looking upstream.

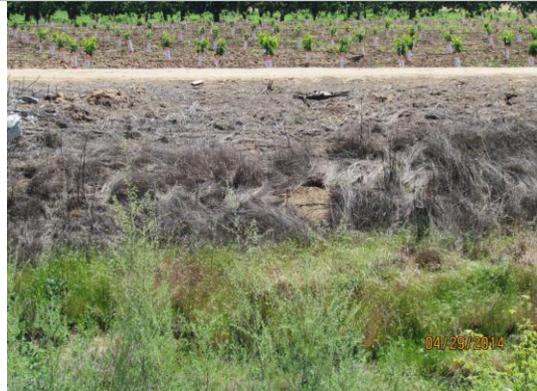
Photo 1 of 1 : FA_2014_NA0017_160_42_20141021_00016.jpg

View of the animal hole on the waterside slope of the levee. The picture was taken from the opposite side of the levee.

LM Start	5.33	Rating **	M	Issue No.	42
LM End	5.33	Issue Type +	Ma	Location *	WS
Category	Earthen Levee		GPS Latitude/Longitude		
			Start	End	
Item	Animal Control		38.000057 °	38.000057 °	
			-121.075773 °	-121.075773 °	
DWR ID	DWR_NA0017_16_s_2014_42				
Action/Comments					
No rodents visible, but rodent burrows visible; need to backfill and compact or grout burrows.

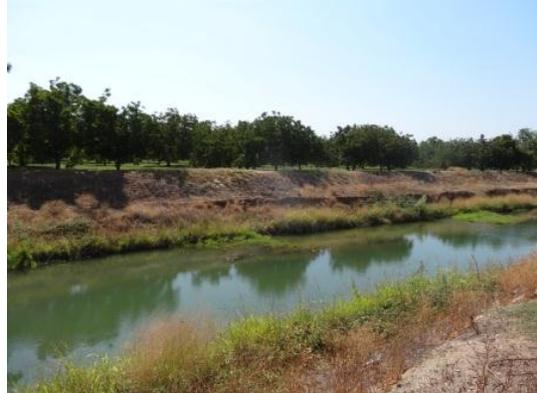
Photo 1 of 1 : SJR2014_NA0017U16RM17.81_1.jpg

LM Start	5.52	Rating **	M	Issue No.	177
LM End	5.57	Issue Type +	Ma	Location *	WS
Category	Supplemental		GPS Latitude/Longitude		
			Start	End	
Item	DWR Erosion Survey		37.997720 °	37.997720 °	
			-121.077807 °	-121.077807 °	
DWR ID					
Action/Comments					
Inspector Comments: 8/20/2014: No significant change observed. 9/12/2013: No significant change observed. 08/22/2012: The site is located at the opposite river bank of E. Tobacco Road. There is no levee structure on site. The levee crest width and levee height were not measured or estimated in the field. [2014 Site ID:NA0017U16RM17.81]

Upstream view of the site.

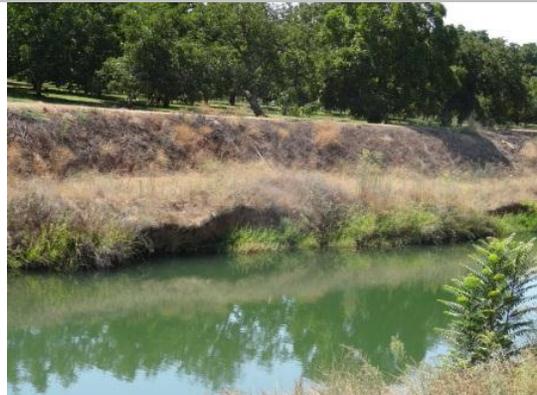
Photo 1 of 1 : SJR2014_NA0017U16RM17.27_1.jpg

LM Start	5.55	Rating **	U	Issue No.	173
LM End	5.57	Issue Type +	Ma	Location *	WS
Category	Supplemental		GPS Latitude/Longitude		
			Start	End	
Item	DWR Erosion Survey		37.995216 °	37.995216 °	
			-121.080159 °	-121.080159 °	
DWR ID					
Action/Comments					
Inspector Comments: 8/20/2014: No significant change observed. 9/12/2013: The erosion seems to be caused by high river flow. Dense vegetation is present at the site. Signs of animal activities are visible. There is no levee structure on site. The levee crest width and levee height were not measured or estimated in the field. [2014 Site ID:NA0017U16RM17.27]

View from the right river bank.

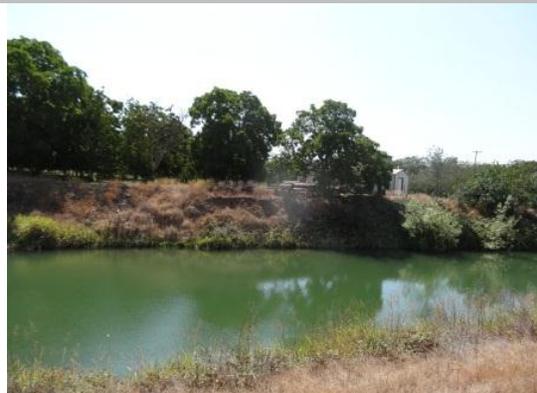
Photo 1 of 1 : SJR2014_NA0017U16RM17.11_1.jpg

LM Start	5.71	Rating **	M	Issue No.	171
LM End	5.72	Issue Type +	Ma	Location *	WS
Category	Supplemental		GPS Latitude/Longitude		
			Start	End	
Item	DWR Erosion Survey		37.993525 °	37.993525 °	
			-121.081679 °	-121.081679 °	
DWR ID					
Action/Comments					
Inspector Comments: 8/20/2014: The erosion is near a tree and probably has been made worse by the unstable bank slope. [2014 Site ID:NA0017U16RM17.11]

View of the site from the right river bank.

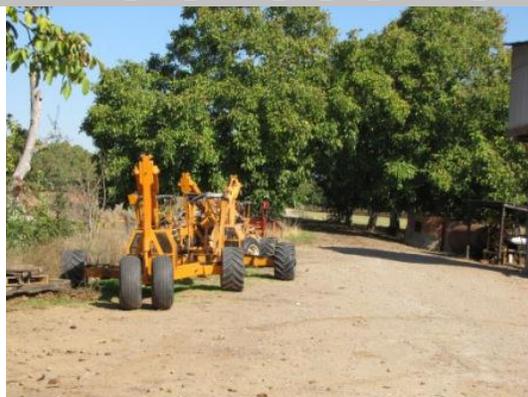
Photo 1 of 1 : FA_2014_NA0017_160_172_20141021_00119.jpg

View of equipment located on the waterward side looking upstream.

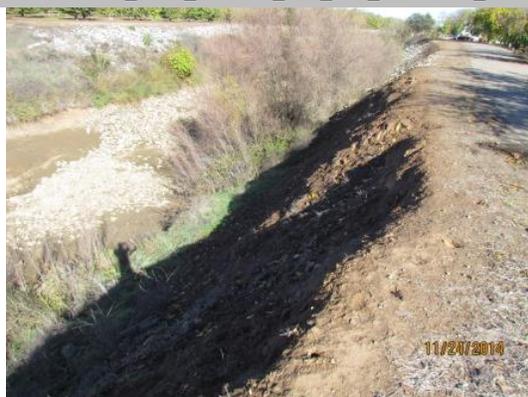
Photo 1 of 1 : FA_2014_NA0017_160_264_20141125_00172.jpg

A slope instability was found on the waterside of the levee looking upstream.

LM Start	6.06	Rating **	M	Issue No.	264
LM End	6.06	Issue Type +	Ma	Location *	WS
Category	Earthen Levee		GPS Latitude/Longitude		
			Start	End	
Item	Slope Stability		37.991628 °	37.991628 °	
			-121.083312 °	-121.083312 °	
DWR ID	DWR_NA0017_16_f_2014_264				
Action/Comments					
Repair slope instability.

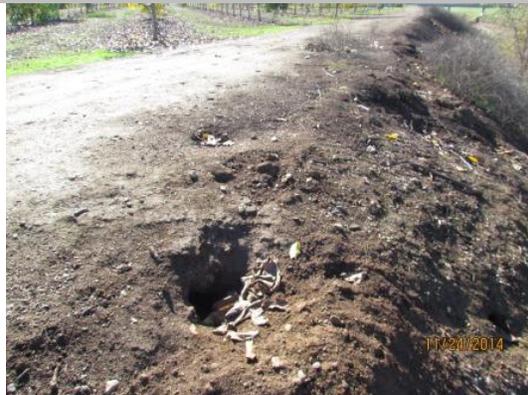
Photo 1 of 2 : FA_2014_NA0017_160_170_20141125_00171.jpg

Updated picture of the rodent holes on the waterside shoulder of the levee looking downstream.

LM Start	6.35	Rating **	M	Issue No.	170
LM End	6.35	Issue Type +	Ma	Location *	WS
Category	Earthen Levee		GPS Latitude/Longitude		
			Start	End	
Item	Animal Control		37.988385 °	37.988385 °	
			-121.086292 °	-121.086292 °	
DWR ID	DWR_NA0017_16_s_2012_170				
Action/Comments					
No rodents visible, but rodent burrows visible; need to backfill and compact or grout burrows.

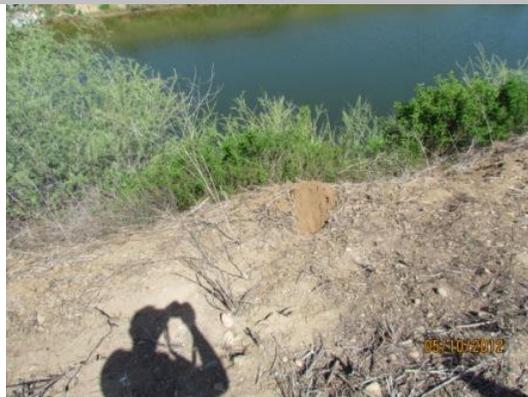
Photo 2 of 2 : FA_2014_NA0017_160_170_20141021_00117.jpg

An animal hole was found on the waterside of the levee looking upstream.

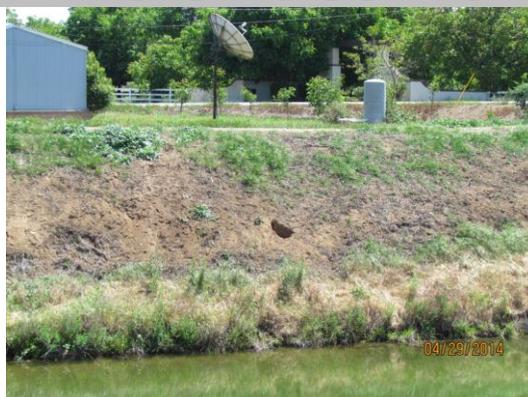
Photo 1 of 1 : FA_2014_NA0017_160_50_20141021_00025.jpg

View of a rodent hole on the waterside slope of the levee. The picture was taken from the opposite side of the levee.

LM Start	6.44	Rating **	M	Issue No.	50
LM End	6.44	Issue Type +	Ma	Location *	WS
Category	Earthen Levee		GPS Latitude/Longitude		
			Start	End	
Item	Animal Control		37.987303 °	37.987303 °	
			-121.087292 °	-121.087292 °	
DWR ID	DWR_NA0017_16_s_2014_50				
Action/Comments					
No rodents visible, but rodent burrows visible; need to backfill and compact or grout burrows.

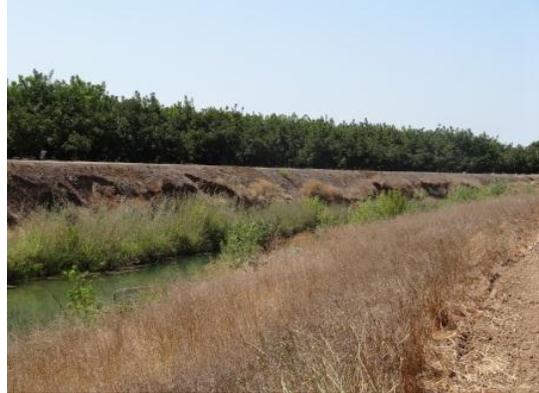
Photo 1 of 1 : SJR2014_NA0017U16RM16.27_1.jpg

LM Start	6.72	Rating **	U	Issue No.	169
LM End	6.91	Issue Type +	Ma	Location *	WS
Category	Supplemental		GPS Latitude/Longitude		
			Start	End	
Item	DWR Erosion Survey		37.983279 °	37.983279 °	
			-121.090843 °	-121.090843 °	
DWR ID					
Action/Comments					
Inspector Comments: 8/20/2014: No significant change observed. 9/12/2013: Site has been surveyed and the erosion has worsened since last year. 08/22/2012: Discontinuous scarp or pocket erosions occurred along a long stretch of the river, with an erosion height greater than 25 ft. at certain points. There is no levee structure on site. The levee crest width and levee height were not measured or estimated in the field. [2014 Site ID:NA0017U16RM16.27]

Downstream view of the site from the right river bank.

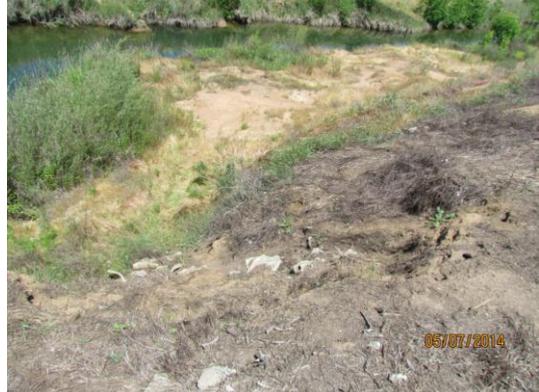
Photo 2 of 2 : FA_2014_NA0017_160_120_20141021_00072.jpg

Slope instability was found on the waterside of the levee looking upstream.

LM Start	6.92	Rating **	M	Issue No.	120
LM End	6.92	Issue Type +	Ma	Location *	WS
Category	Earthen Levee		GPS Latitude/Longitude		
			Start	End	
Item	Slope Stability		37.982299 °	37.982299 °	
			-121.092665 °	-121.092665 °	
DWR ID	DWR_NA0017_16_s_2014_120				
Action/Comments					
Repair slope instability.

LM Start	6.92	Rating **	M	Issue No.	120 (cont)
LM End	6.92	Issue Type +	Ma	Location *	WS

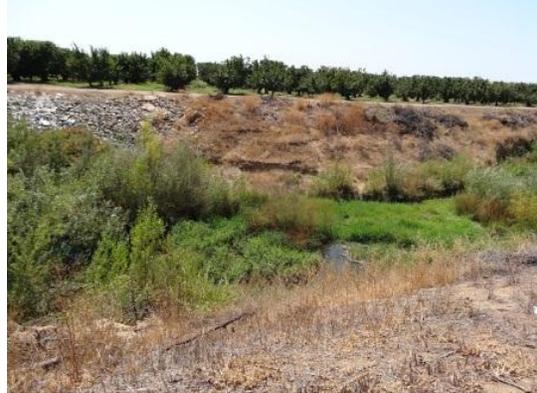
Photo 1 of 1 : SJR2014_NA0017U16RM15.57_1.jpg

LM Start	7.35	Rating **	U	Issue No.	168
LM End	7.41	Issue Type +	Ma	Location *	WS
Category	Supplemental		GPS Latitude/Longitude		
			Start	End	
Item	DWR Erosion Survey		37.978194 °	37.978194 °	
			-121.101696 °	-121.101696 °	
DWR ID					
Action/Comments					
Inspector Comments: 8/20/2014: No significant change observed. Note the site ID changed from NA0017U16RM10.82 to NA0017U16RM15.57 to reflect the correct river mile. 09/12/2013: The site is located at immediately downstream of a levee segment protected by broken concrete. There is no levee structure on site. The levee crest width and levee height were not measured or

View of the site from the right river bank.

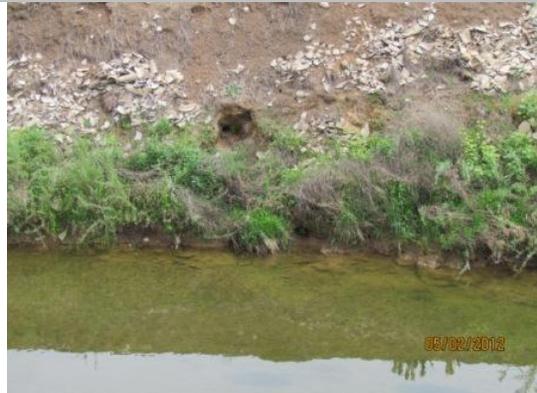
Photo 1 of 1 : FA_2014_NA0017_160_218_20141021_00151.jpg

A possible beaver den was found on waterside slope of the levee. The picture was taken from the opposite bank of the levee.

LM Start	7.57	Rating **	U	Issue No.	218
LM End	7.57	Issue Type +	Ma	Location *	WS
Category	Earthen Levee		GPS Latitude/Longitude		
			Start	End	
Item	Animal Control				
DWR ID	DWR_NA0017_16_s_2012_218				
Action/Comments					
No rodents visible, but rodent burrows visible; need to backfill and compact or grout burrows.

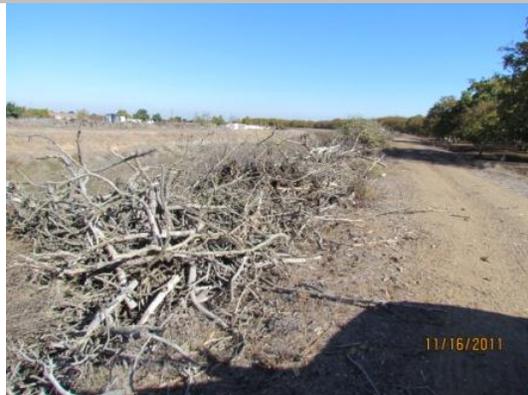
Photo 1 of 1 : FA_2014_NA0017_160_79_20141021_00046.jpg

Prunings were found on the waterside of the levee looking upstream.

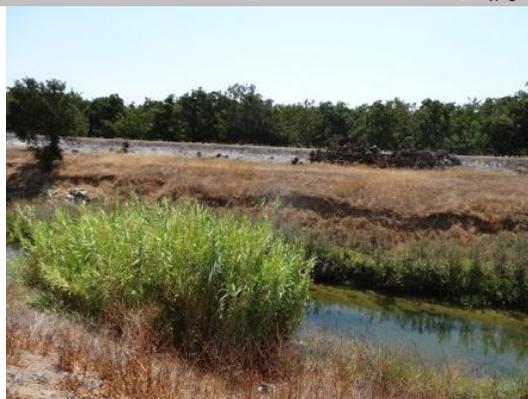
Photo 1 of 1 : SJR2014_NA0017U16RM14.48_1.jpg

LM Start	8.61	Rating **	M	Issue No.	166
LM End	8.65	Issue Type +	Ma	Location *	WS
Category	Supplemental		GPS Latitude/Longitude		
			Start	End	
Item	DWR Erosion Survey		37.969213 °	37.969213 °	
			-121.116574 °	-121.116574 °	
DWR ID					
Action/Comments					
Inspector Comments: 8/20/2014: No significant change observed. 9/12/2013: No significant change observed. 08/22/2012: The erosion occurred on a berm of approximately 25 ft. wide. Site is covered with dense vegetation. There is no levee structure on site. The levee crest width and levee height were not measured or estimated in the field. [2014 Site ID:NA0017U16RM14.48]

View of the site from the right river bank.

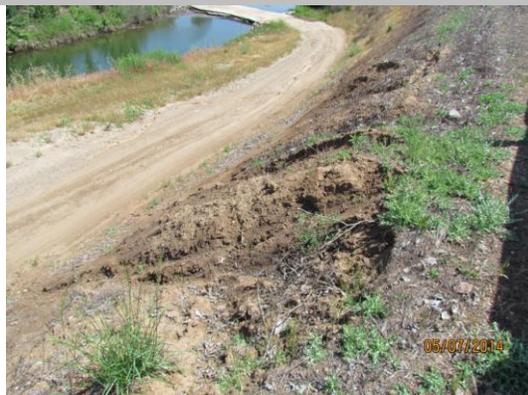
Photo 1 of 2 : FA_2014_NA0017_160_128_20141021_00078.jpg

LM Start	8.85	Rating **	M	Issue No.	128
LM End	8.85	Issue Type +	Ma	Location *	WS
Category	Earthen Levee		GPS Latitude/Longitude		
			Start	End	
Item	Slope Stability		37.968157 °	37.968157 °	
			-121.120620 °	-121.120620 °	
DWR ID	DWR_NA0017_16_s_2013_128				
Action/Comments					
Repair slope instability.

Updated picture of the slope instability on the waterside of the levee looking upstream during spring 2014 inspection.

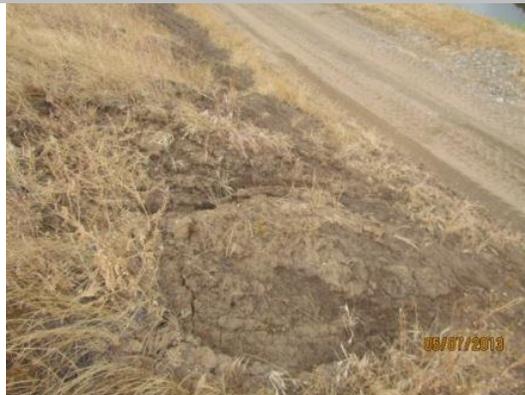
Photo 2 of 2 : FA_2014_NA0017_160_128_20141021_00079.jpg

LM Start	8.85	Rating **	M	Issue No.	128 (cont)
LM End	8.85	Issue Type +	Ma	Location *	WS
Category	Earthen Levee		GPS Latitude/Longitude		
			Start	End	
Item	Slope Stability		37.968157 °	37.968157 °	
			-121.120620 °	-121.120620 °	
DWR ID	DWR_NA0017_16_s_2013_128				
Action/Comments					
Repair slope instability.

Slope instability was found on the waterside slope of the levee looking downstream.

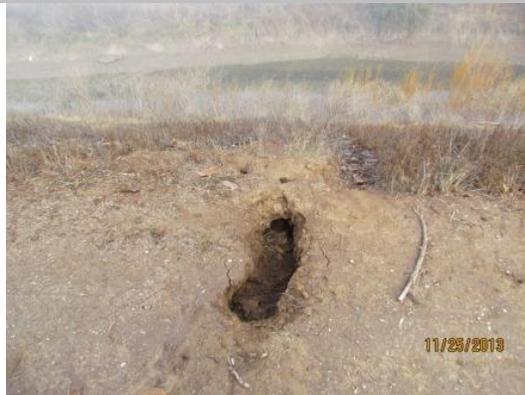
Photo 1 of 1 : FA_2014_NA0017_160_127_20141021_00077.jpg

LM Start	8.94	Rating **	M	Issue No.	127
LM End	8.94	Issue Type +	Ma	Location *	WS
Category	Earthen Levee		GPS Latitude/Longitude		
			Start	End	
Item	Animal Control		37.968164 °	37.968164 °	
			-121.122184 °	-121.122184 °	
DWR ID	DWR_NA0017_16_f_2013_127				
Action/Comments					
No rodents visible, but rodent burrows visible; need to backfill and compact or grout burrows. Inspector Comments: Collapsed animal hole on the waterside shoulder of the levee.

A collapsed animal hole was found on the waterside shoulder of the levee looking upstream.

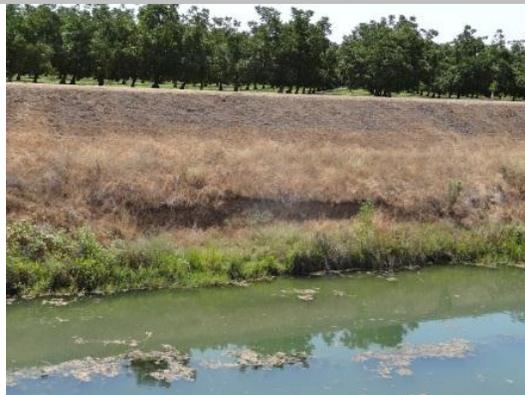
Photo 1 of 1 : SJR2014_NA0017U16RM13.86_1.jpg

LM Start	8.99	Rating **	M	Issue No.	165
LM End	8.99	Issue Type +	Ma	Location *	WS
Category	Supplemental		GPS Latitude/Longitude		
			Start	End	
Item	DWR Erosion Survey		37.966615 °	37.966615 °	
			-121.127328 °	-121.127328 °	
DWR ID					
Action/Comments					
Inspector Comments: 8/20/2014: No significant change observed. 9/12/2013: No significant change observed. 08/22/2012: Pocket erosion at the levee toe and slope. The erosion is covered with dense vegetation. There is no levee structure on site. The levee crest width and levee height were not measured or estimated in the field. [2014 Site ID:NA0017U16RM13.86]

Front view of the erosion.

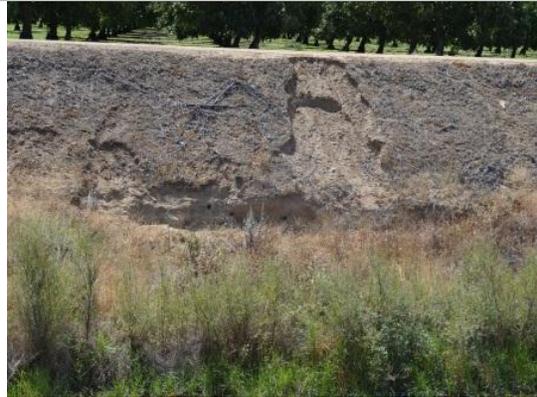
Photo 1 of 1 : SJR2014_NA0017U16RM13.85_1.jpg

LM Start	9.07	Rating **	U	Issue No.	164
LM End	9.07	Issue Type +	Ma	Location *	WS
Category	Supplemental		GPS Latitude/Longitude		
			Start	End	
Item	DWR Erosion Survey		37.967019 °	37.967019 °	
			-121.127581 °	-121.127581 °	
DWR ID					
Action/Comments					
Inspector Comments: 8/20/2014: No significant change observed. 9/12/2013: The erosion might have been caused by river flow combined with runoff. Dense vegetation is presents at the site. There is no levee structure on site. The levee crest width and levee height were not measured or estimated in the field. [2014 Site ID:NA0017U16RM13.85]

View of the site from the right river bank.

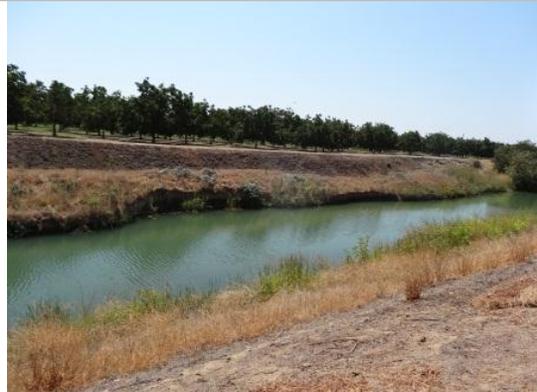
Photo 1 of 1 : SJR2014_NA0017U16RM13.53_1.jpg

LM Start	9.58	Rating **	M	Issue No.	157
LM End	9.60	Issue Type +	Ma	Location *	WS
Category	Supplemental		GPS Latitude/Longitude		
			Start	End	
Item	DWR Erosion Survey		37.967190 °	37.967190 °	
			-121.133080 °	-121.133080 °	
DWR ID					
Action/Comments					
Inspector Comments: 8/20/2014: No significant change observed. 9/12/2013: No significant change observed. 08/22/2012: The erosion is on berm. The berm width is estimated. There is no levee structure on site. The levee crest width and levee height were not measured or estimated in the field. [2014 Site ID:NA0017U16RM13.53]

Upstream view of the erosion.

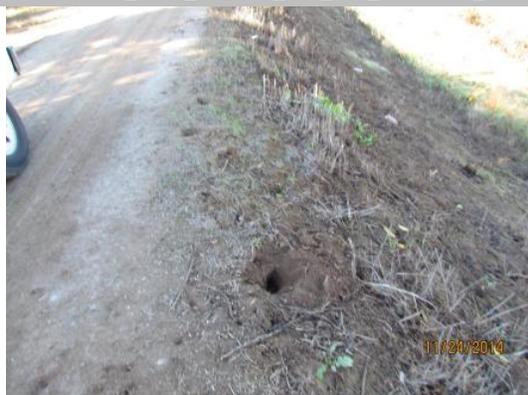
Photo 1 of 1 : FA_2014_NA0017_160_263_20141125_00169.jpg

LM Start	10.10	Rating **	M	Issue No.	263
LM End	10.10	Issue Type +	Ma	Location *	WS
Category	Earthen Levee		GPS Latitude/Longitude		
			Start	End	
Item	Animal Control		37.964825 °	37.964825 °	
			-121.141395 °	-121.141395 °	
DWR ID	DWR_NA0017_16_f_2014_263				
Action/Comments					
No rodents visible, but rodent burrows visible; need to backfill and compact or grout burrows.

A rodent hole was found on the waterside shoulder of the levee looking downstream.

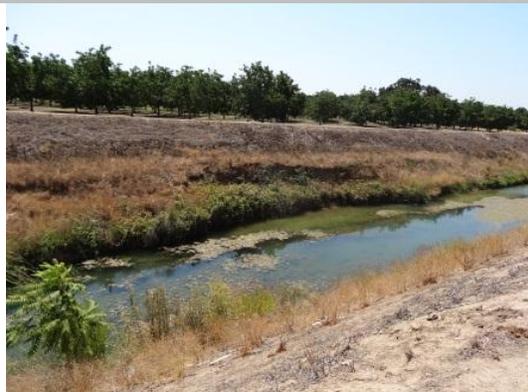
Photo 1 of 1 : SJR2014_NA0017U16RM12.95_1.jpg

LM Start	10.16	Rating **	M	Issue No.	41
LM End	10.18	Issue Type +	Ma	Location *	WS
Category	Supplemental		GPS Latitude/Longitude		
			Start	End	
Item	DWR Erosion Survey		37.964735 °	37.964735 °	
			-121.142503 °	-121.142503 °	
DWR ID					
Action/Comments					
Inspector Comments: 8/20/2014: No significant change observed. 9/12/2013: No significant change observed. 08/22/2012: Dense vegetation on site. There is no levee structure on site. The levee crest width and levee height were not measured or estimated in the field. [2014 Site ID:NA0017U16RM12.95]

Downstream view of the site from the right river bank.

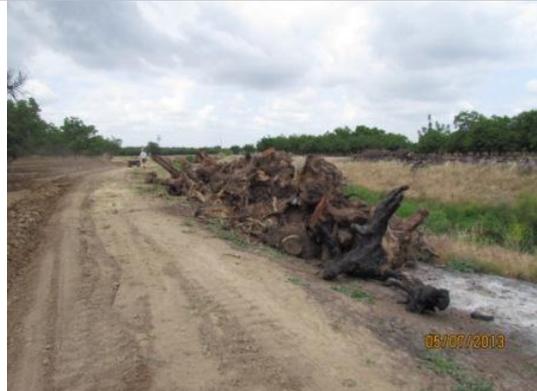
Photo 1 of 2 : FA_2014_NA0017_160_90_20141021_00053.jpg

LM Start	11.07	Rating **	M	Issue No.	90
LM End	11.07	Issue Type +	Ma	Location *	WS
Category	Earthen Levee		GPS Latitude/Longitude		
			Start	End	
Item	Encroachments		37.962472 °	37.962472 °	
			-121.158112 °	-121.158112 °	
DWR ID	DWR_NA0017_16_s_2012_90				
Action/Comments					
Prunings

Prunings were found on the waterside shoulder of the levee looking downstream.

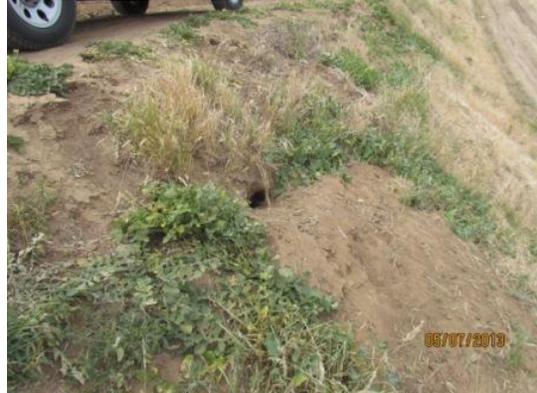
Photo 1 of 1 : FA_2014_NA0017_160_140_20141021_00092.jpg

LM Start	11.16	Rating **	M	Issue No.	140
LM End	11.16	Issue Type +	Ma	Location *	WS
Category	Earthen Levee		GPS Latitude/Longitude		
			Start	End	
Item	Animal Control		37.961681 °	37.961681 °	
			-121.159346 °	-121.159346 °	
DWR ID	DWR_NA0017_16_s_2013_140				
Action/Comments					
No rodents visible, but rodent burrows visible; need to backfill and compact or grout burrows.

An animal hole was found on the waterside slope of the levee looking downstream.

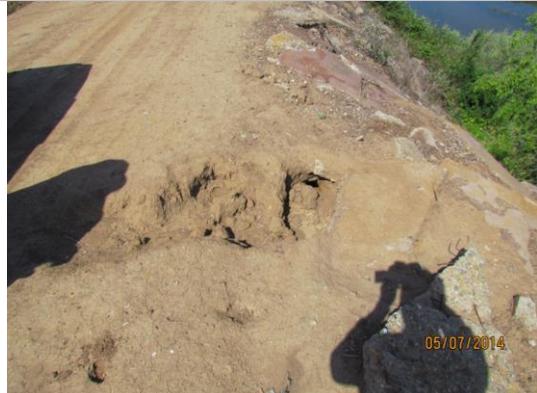
Photo 1 of 1 : FA_2014_NA0017_160_108_20141021_00061.jpg

LM Start	11.21	Rating **	M	Issue No.	108
LM End	11.21	Issue Type +	Ma	Location *	WS
Category	Earthen Levee		GPS Latitude/Longitude		
			Start	End	
Item	Animal Control		37.961494 °	37.961494 °	
			-121.160196 °	-121.160196 °	
DWR ID	DWR_NA0017_16_s_2014_108				
Action/Comments					
No rodents visible, but rodent burrows visible; need to backfill and compact or grout burrows.

Rodent holes were found on the waterside shoulder of the levee looking downstream.

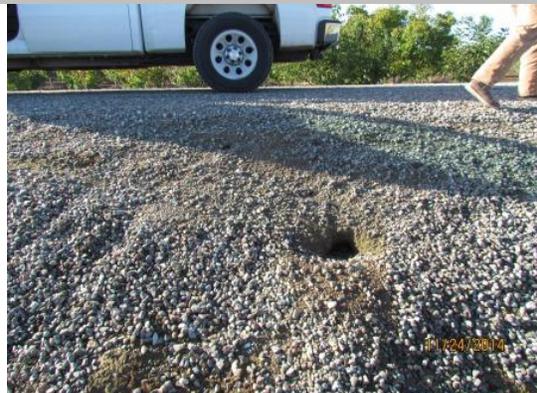
Photo 1 of 1 : FA_2014_NA0017_160_261_20141125_00168.jpg

LM Start	13.29	Rating **	M	Issue No.	261
LM End	13.29	Issue Type +	Ma	Location *	WS
Category	Earthen Levee		GPS Latitude/Longitude		
			Start	End	
Item	Animal Control		37.960292 °	37.960292 °	
			-121.196308 °	-121.196308 °	
DWR ID	DWR_NA0017_16_f_2014_261				
Action/Comments					
No rodents visible, but rodent burrows visible; need to backfill and compact or grout burrows.

An animal hole was found on the waterside shoulder of the levee looking downstream.

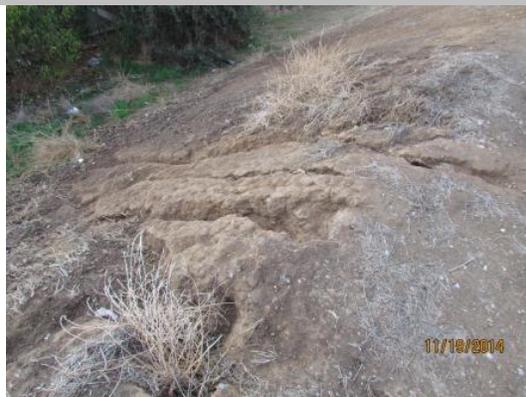
Photo 1 of 2 : FA_2014_NA0017_160_150_20141125_00166.jpg

LM Start	16.83	Rating **	M	Issue No.	150
LM End	16.83	Issue Type +	Ma	Location *	LS
Category	Earthen Levee		GPS Latitude/Longitude		
			Start	End	
Item	Erosion / Bank Caving		37.982318 °	37.982318 °	
			-121.252095 °	-121.252095 °	
DWR ID	DWR_NA0017_16_s_2013_150				
Action/Comments					
Schedule repair of erosion site prior to the next inspection. Inspector Comments: Runoff

Updated picture of the erosion on the landside of the levee looking downstream.

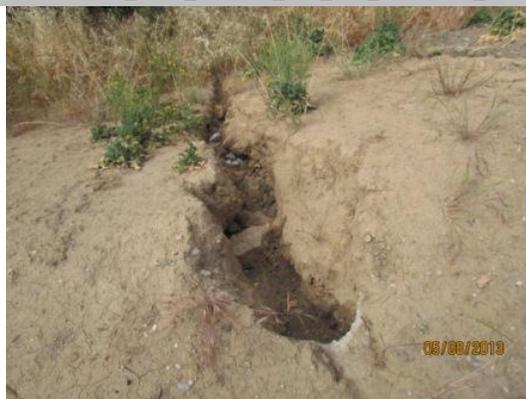
Photo 2 of 2 : FA_2014_NA0017_160_150_20141021_00099.jpg

Erosion was found on the landside of the levee looking downstream.

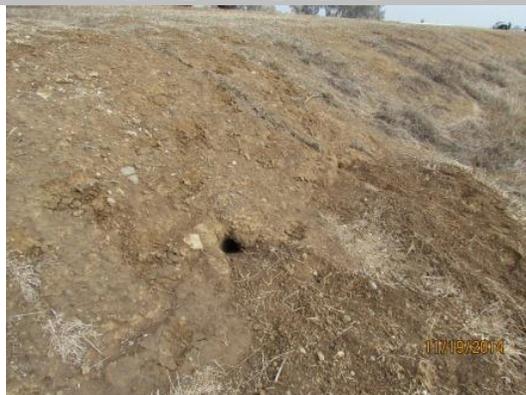
Photo 1 of 1 : FA_2014_NA0017_160_258_20141125_00165.jpg

LM Start	16.99	Rating **	M	Issue No.	258
LM End	16.99	Issue Type +	Ma	Location *	LS
Category	Earthen Levee		GPS Latitude/Longitude		
			Start	End	
Item	Animal Control		37.983432 °	37.983432 °	
			-121.254645 °	-121.254645 °	
DWR ID	DWR_NA0017_16_f_2014_258				
Action/Comments					
No rodents visible, but rodent burrows visible; need to backfill and compact or grout burrows.

An animal hole was found landside of the levee looking upstream.

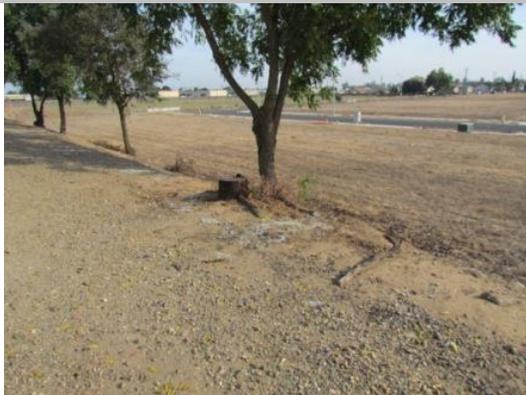
Photo 1 of 1 : FA_2014_NA0017_160_65_20141021_00035.jpg

LM Start	19.48	Rating **	N	Issue No.	65
LM End	19.48	Issue Type +	Ma	Location *	LS
Category	Earthen Levee		GPS Latitude/Longitude		
			Start	End	
Item	Trim / Thin Trees		37.991617 °	37.991617 °	
			-121.295628 °	-121.295628 °	
DWR ID	DWR_NA0017_16_s_2012_65				
Action/Comments					
Tree stumps.

Tree stump was found on the landside of the levee looking upstream.

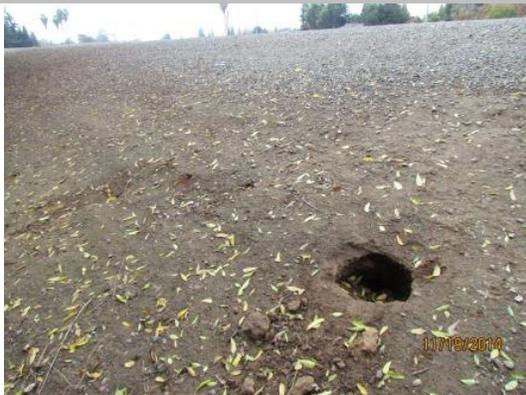
Photo 1 of 1 : FA_2014_NA0017_160_256_20141125_00164.jpg

LM Start	20.38	Rating **	M	Issue No.	256
LM End	20.38	Issue Type +	Ma	Location *	LS
Category	Earthen Levee		GPS Latitude/Longitude		
			Start	End	
Item	Animal Control		37.985457 °	37.985457 °	
			-121.307658 °	-121.307658 °	
DWR ID	DWR_NA0017_16_f_2014_256				
Action/Comments					
No rodents visible, but rodent burrows visible; need to backfill and compact or grout burrows.

An animal hole was found on the landside toe of the levee looking downstream.

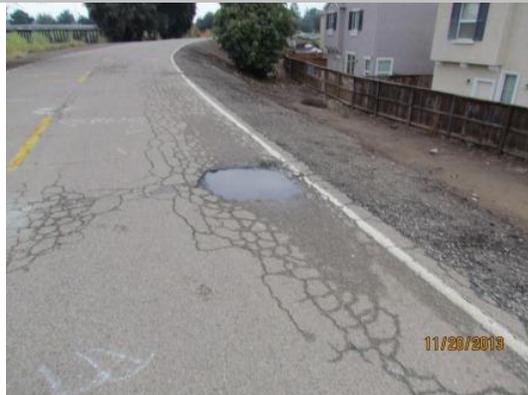
Photo 1 of 1 : FA_2014_NA0017_160_86_20141021_00051.jpg

LM Start	21.31	Rating **	M	Issue No.	86
LM End	21.31	Issue Type +	Ma	Location *	CR
Category	Earthen Levee		GPS Latitude/Longitude		
			Start	End	
Item	Crown Surface / Depressions / Rutting		37.980156 °	37.980156 °	
			-121.320615 °	-121.320615 °	
DWR ID	DWR_NA0017_16_f_2013_86				
Action/Comments					
Add appropriate material and re-grade the levee to bring the crown above the design elevation.

Crown depression was found on the levee looking upstream.

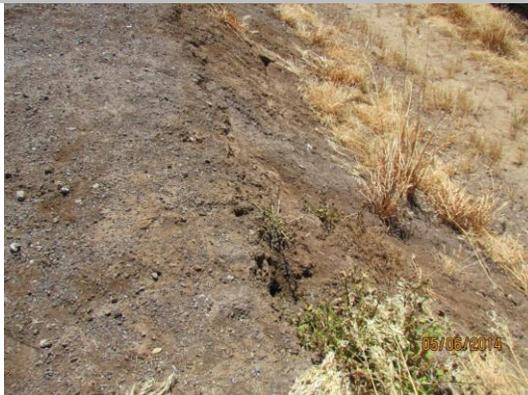
Photo 1 of 2 : FA_2014_NA0017_160_83_20141021_00049.jpg

LM Start	21.31	Rating **	M	Issue No.	83
LM End	21.31	Issue Type +	Ma	Location *	LS
Category	Earthen Levee		GPS Latitude/Longitude		
			Start	End	
Item	Animal Control		37.980192 °	37.980192 °	
			-121.320720 °	-121.320720 °	
DWR ID	DWR_NA0017_16_f_2013_83				
Action/Comments					
No rodents visible, but rodent burrows visible; need to backfill and compact or grout burrows.

View of rodent holes on the landside of the levee looking upstream during spring 2014 inspection.

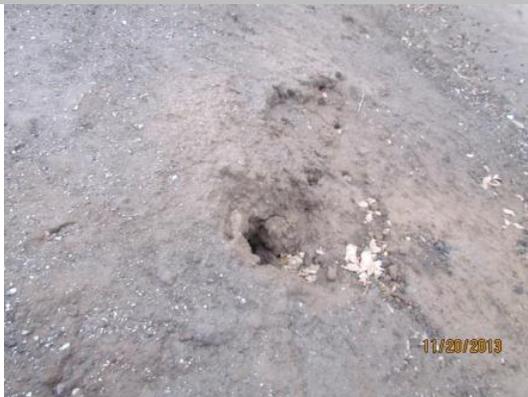
Photo 2 of 2 : FA_2014_NA0017_160_83_20141021_00050.jpg

LM Start	21.31	Rating **	M	Issue No.	83 (cont)
LM End	21.31	Issue Type +	Ma	Location *	LS

A rodent hole was found on the landside of the levee looking upstream.

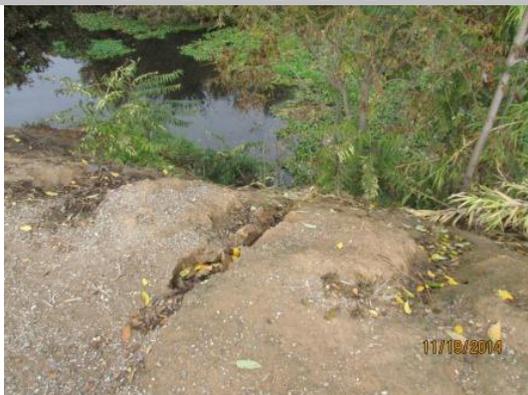
Photo 1 of 1 : FA_2014_NA0017_160_255_20141125_00163.jpg

LM Start	21.34	Rating **	M	Issue No.	255
LM End	21.34	Issue Type +	Ma	Location *	WS
Category	Earthen Levee		GPS Latitude/Longitude		
			Start	End	
Item	Erosion / Bank Caving		37.980367 °	37.980367 °	
			-121.321213 °	-121.321213 °	
DWR ID	DWR_NA0017_16_f_2014_255				
Action/Comments					
Note and monitor erosion site.

Erosion occurred due to surface runoff on the waterside shoulder of the levee looking downstream.

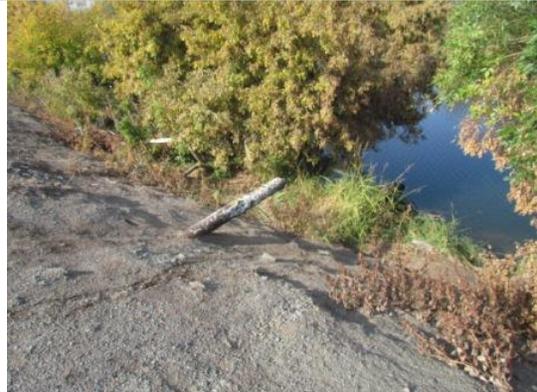
Photo 1 of 1 : FA_2014_NA0017_160_761_20141021_00158.jpg

LM Start	21.54	Rating **	M	Issue No.	761
LM End	21.54	Issue Type +	Ma	Location *	WS
Category	Earthen Levee			GPS Latitude/Longitude	
				Start	End
Item	Encroachments				
DWR ID	DWR_NA0017_16_s_2012_761				
Action/Comments					
Pipe

An abandoned pipe was found on the waterside of the levee looking downstream.

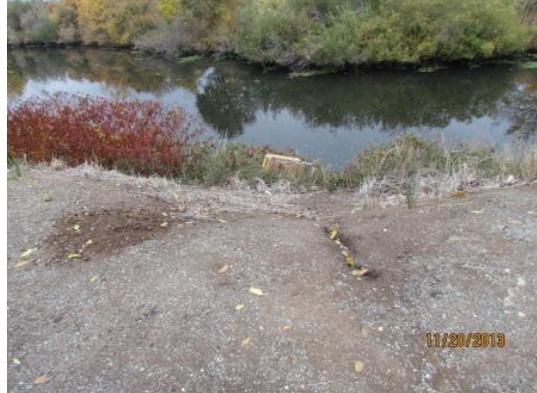
Photo 1 of 1 : FA_2014_NA0017_160_74_20141021_00043.jpg

LM Start	21.78	Rating **	M	Issue No.	74
LM End	21.78	Issue Type +	Ma	Location *	WS
Category	Earthen Levee		GPS Latitude/Longitude		
			Start	End	
Item	Erosion / Bank Caving		37.980773 °	37.980773 °	
			-121.328866 °	-121.328866 °	
DWR ID	DWR_NA0017_16_f_2013_74				
Action/Comments					
Schedule repair of erosion site prior to the next inspection. Inspector Comments: Runoff

Erosion due to runoff was found on the waterside of the levee looking upstream.

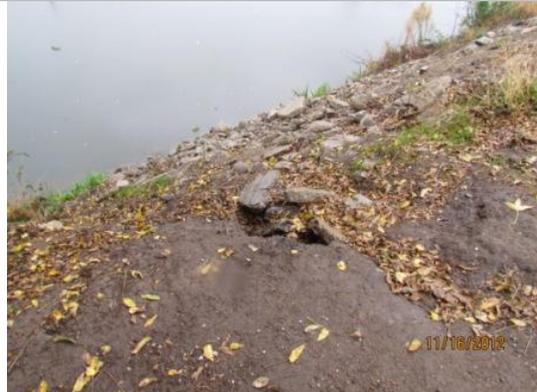
Photo 1 of 1 : FA_2014_NA0017_160_68_20141021_00038.jpg

LM Start	22.15	Rating **	M	Issue No.	68
LM End	22.15	Issue Type +	Ma	Location *	WS
Category	Earthen Levee		GPS Latitude/Longitude		
			Start	End	
Item	Erosion / Bank Caving		37.979674 °	37.979674 °	
			-121.335228 °	-121.335228 °	
DWR ID	DWR_NA0017_16_f_2012_68				
Action/Comments					
Schedule repair of erosion site prior to the next inspection.

Erosion was found on the waterside slope of the levee looking upstream.

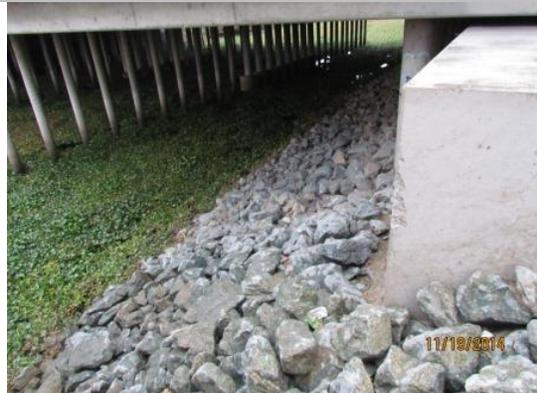
Photo 1 of 6 : FA_2014_NA0017_160_48_20141125_00161.jpg

LM Start	22.52	Rating **	A/W	Issue No.	48
LM End	22.52	Issue Type +	Ma	Location *	WS
Category	Earthen Levee		GPS Latitude/Longitude		
			Start	End	
Item	Erosion / Bank Caving		37.978697 °	37.978697 °	
			-121.341581 °	-121.341581 °	
DWR ID	DWR_NA0017_16_s_2012_48				
Action/Comments					
Schedule repair of erosion site prior to the next inspection. Inspector Comments: Caltrans just repaired the issue. (Permit # 18532)

Caltrans repaired the erosion under the southbound (I-5) bridge. The picture was taken from the crown looking upstream during fall 2014 inspection.
