**Flood Control Project Maintenance
Levee Inspections**

Maintenance Issue Types Only, Levee Inspection Report By Mile - Fall 2014

San Joaquin County Flood Control and Water Conservation District

Waterway	Bank	Unit Miles	Inspection Start/End	Inspector
Unit No. 01 Littlejohn Creek	Left	2.59	11/24/2014 11/24/2014	Pavel Kazi

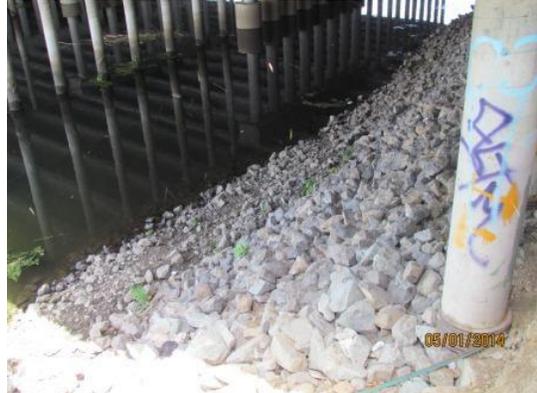
Photo 2 of 6 : FA_2014_NA0017_160_48_20141021_00020.jpg

LM Start	22.52	Rating **	A/W	Issue No.	48 (cont)
LM End	22.52	Issue Type +	Ma	Location *	WS
Category	Earthen Levee		GPS Latitude/Longitude		
			Start	End	
Item	Erosion / Bank Caving		37.978697 °	37.978697 °	
			-121.341581 °	-121.341581 °	
DWR ID	DWR_NA0017_16_s_2012_48				
Action/Comments					
Schedule repair of erosion site prior to the next inspection. Inspector Comments: Caltrans just repaired the issue. (Permit # 18532)

Updated picture of the erosion under the (I-5) bridge by Caltrans. The picture was taken from the crown of the levee during spring 2014 inspection.

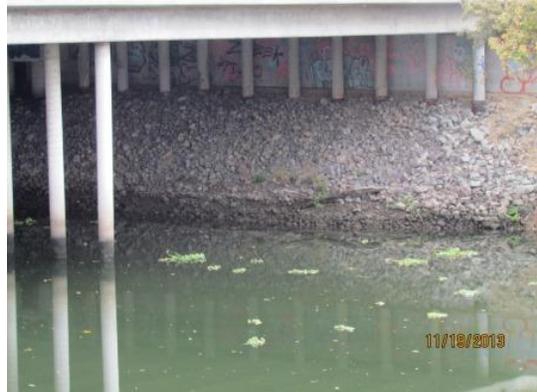
Photo 3 of 6 : FA_2014_NA0017_160_48_20141021_00019.jpg

Updated picture of erosion was found on the waterside toe of the levee looking from the opposite side of the levee.

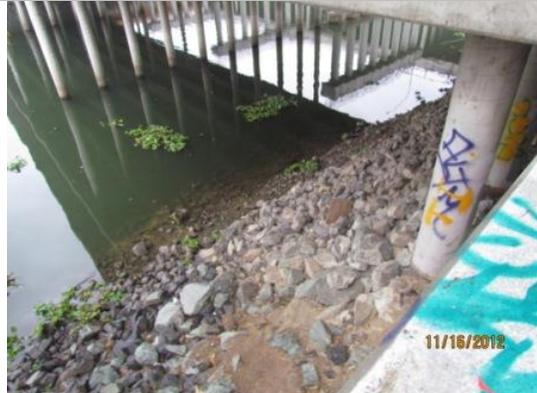
Photo 4 of 6 : FA_2014_NA0017_160_48_20141021_00022.jpg

Updated view of the erosion site repaired by Caltrans on the waterside slope of the levee looking upstream.

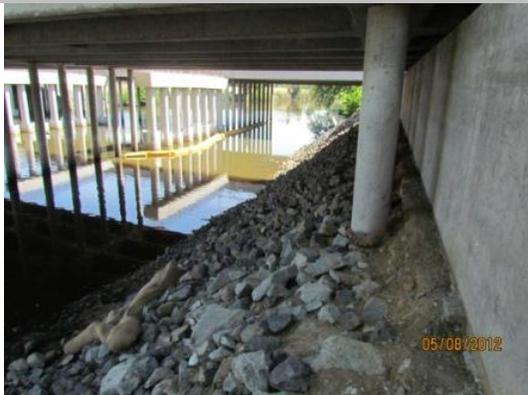
Photo 5 of 6 : FA_2014_NA0017_160_48_20141021_00023.jpg

LM Start	22.52	Rating **	A/W	Issue No.	48 (cont)
LM End	22.52	Issue Type +	Ma	Location *	WS
Category	Earthen Levee			GPS Latitude/Longitude	
				Start	End
Item	Erosion / Bank Caving			37.978697 °	37.978697 °
				-121.341581 °	-121.341581 °
DWR ID	DWR_NA0017_16_s_2012_48				
Action/Comments					
Schedule repair of erosion site prior to the next inspection. Inspector Comments: Caltrans just repaired the issue. (Permit # 18532)

View of the erosion site repaired by Caltrans under the I-5 freeway going southbound. This picture was taken from the toe of the levee looking upstream.

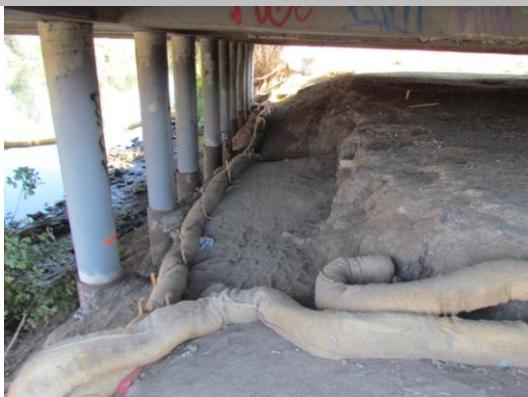
Photo 6 of 6 : FA_2014_NA0017_160_48_20141021_00024.jpg

View of the erosion under the I-5 bridge looking upstream.

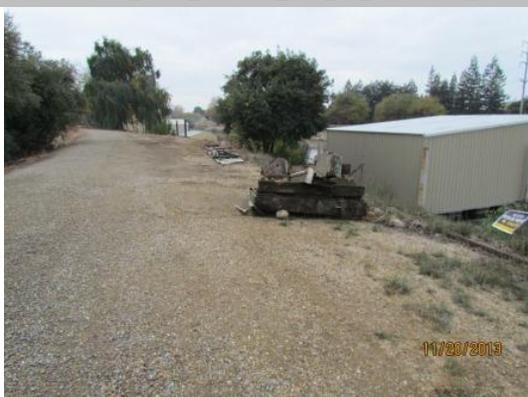
Photo 1 of 1 : FA_2014_NA0017_160_43_20141021_00017.jpg

LM Start	22.76	Rating **	M	Issue No.	43
LM End	22.76	Issue Type +	Ma	Location *	WS
Category	Earthen Levee			GPS Latitude/Longitude	
				Start	End
Item	Encroachments			37.976308 °	37.976308 °
				-121.344698 °	-121.344698 °
DWR ID	DWR_NA0017_16_f_2013_43				
Action/Comments					
Debris

Debris was found on the waterside shoulder of the levee looking downstream.

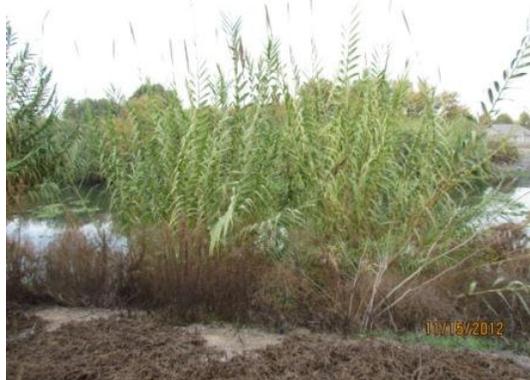
Photo 1 of 1 : FA_2014_NA0017_160_45_20141021_00018.jpg

LM Start	23.05	Rating **	M	Issue No.	45
LM End	23.05	Issue Type +	Ma	Location *	WS
Category	Earthen Levee		GPS Latitude/Longitude		
			Start	End	
Item	Vegetation		37.973386 °	37.973386 °	
			-121.348241 °	-121.348241 °	
DWR ID	DWR_NA0017_16_f_2012_45				
Action/Comments					
Remove the wild growth other than native grasses from the levee slopes. Inspector Comments: Arrundo on the waterside of the levee.

Arundo was found on the waterside slope of the levee looking upstream.

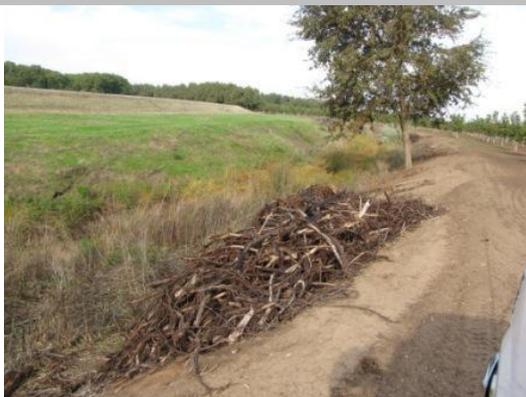
Photo 1 of 1 : FA_2014_NA0017_161_2_20141021_00001.jpg

LM Start	0.13	Rating **	M	Issue No.	2
LM End	0.13	Issue Type +	Ma	Location *	WS
Category	Earthen Levee		GPS Latitude/Longitude		
			Start	End	
Item	Encroachments		37.957934 °	37.957934 °	
			-121.149911 °	-121.149911 °	
DWR ID	DWR_NA0017_17_s_2012_2				
Action/Comments					
Prunings

View of a prunings pile along the waterward bank looking downstream.

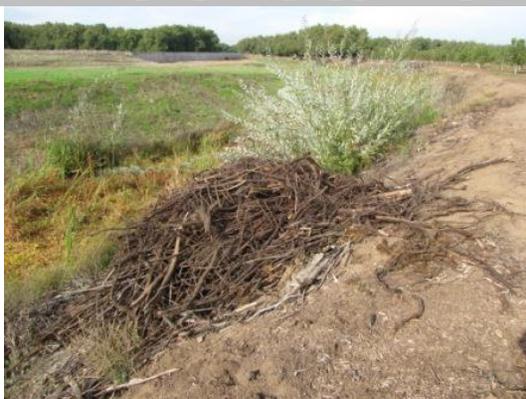
Photo 1 of 1 : FA_2014_NA0017_161_3_20141021_00002.jpg

LM Start	0.17	Rating **	M	Issue No.	3
LM End	0.17	Issue Type +	Ma	Location *	WS
Category	Earthen Levee		GPS Latitude/Longitude		
			Start	End	
Item	Encroachments		37.958590 °	37.958590 °	
			-121.151408 °	-121.151408 °	
DWR ID	DWR_NA0017_17_s_2012_3				
Action/Comments					
Prunings

View of a prunings pile along the waterward bank looking downstream.

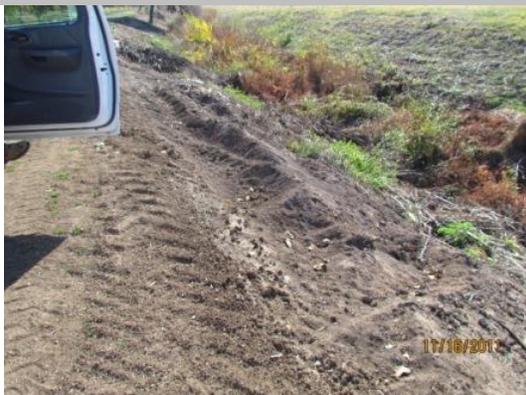
Photo 1 of 1 : FA_2014_NA0017_161_10_20141021_00006.jpg

LM Start	0.19	Rating **	M	Issue No.	10
LM End	0.19	Issue Type +	Ma	Location *	WS
Category	Earthen Levee		GPS Latitude/Longitude		
			Start	End	
Item	Slope Stability		37.958702 °	37.958702 °	
			-121.151544 °	-121.151544 °	
DWR ID	DWR_NA0017_17_s_2012_10				
Action/Comments					
Repair the levee slope damaged by vehicle traffic and prevent access where possible.

Slope instability was found on the waterside of the levee looking upstream.

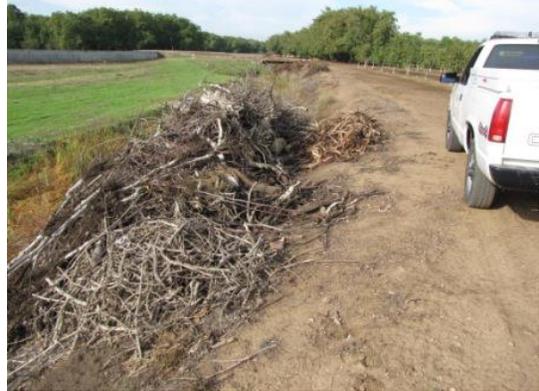
Photo 1 of 1 : FA_2014_NA0017_161_4_20141021_00003.jpg

LM Start	0.22	Rating **	M	Issue No.	4
LM End	0.22	Issue Type +	Ma	Location *	WS
Category	Earthen Levee		GPS Latitude/Longitude		
			Start	End	
Item	Encroachments		37.958943 °	37.958943 °	
			-121.152261 °	-121.152261 °	
DWR ID	DWR_NA0017_17_s_2012_4				
Action/Comments					
Prunings

View of a prunings pile along the waterward bank looking downstream.

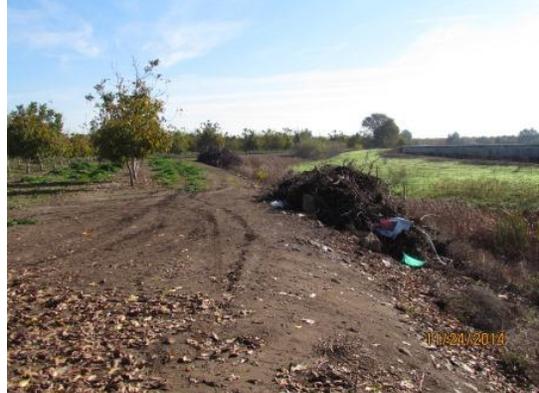
Photo 1 of 2 : FA_2014_NA0017_161_5_20141125_00007.jpg

LM Start	0.25	Rating **	M	Issue No.	5
LM End	0.25	Issue Type +	Ma	Location *	WS
Category	Earthen Levee		GPS Latitude/Longitude		
			Start	End	
Item	Encroachments		37.958966 °	37.958966 °	
			-121.152641 °	-121.152641 °	
DWR ID	DWR_NA0017_17_s_2012_5				
Action/Comments					
Prunings

Updated picture of the prunings on the waterside of the levee looking upstream during fall 2014 inspection.

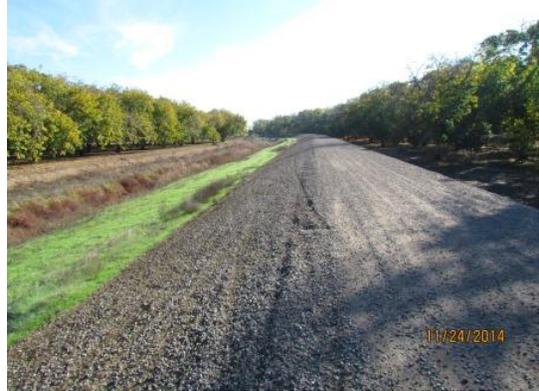
Photo 1 of 1 : FA_2014_NA0017_162_5_20141125_00002.jpg

LM Start	0.50	Rating **	A	Issue No.	5
LM End	0.50	Issue Type +	Ma	Location *	WS
Category	Earthen Levee		GPS Latitude/Longitude		
			Start	End	
Item	Vegetation		37.958970 °	37.958970 °	
			-121.156882 °	-121.156882 °	
DWR ID	DWR_NA0017_18_f_2014_5				
Action/Comments					
Control annual grass and weeds on the levee slopes and easements.

View of the waterside slope of the levee looking upstream.
