**Flood Control Project Maintenance
Levee Inspections**

Maintenance Issue Types Only, Levee Inspection Report By Mile - Fall 2015

San Joaquin County Flood Control and Water Conservation District

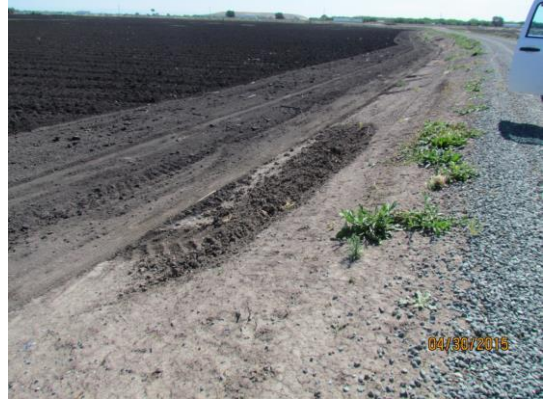
Photo 1 of 1 : FA_2015_NA0017_149_125_20150911_00006.jpg

LM Start	0.29	Rating **	M	Issue No.	125
LM End	0.29	Issue Type +	Ma	Location *	LS
Category	Earthen Levee			GPS Latitude/Longitude	
				Start	End
Item	Slope Stability			37.875189 °	37.875189
				-121.225048 °	-121.225048
DWR ID	DWR_NA0017_02_s_2015_125				
Action/Comments					
Repair the levee slope damaged by vehicle traffic and prevent access where possible.

A slope instability was found on the landside of the levee looking upstream.

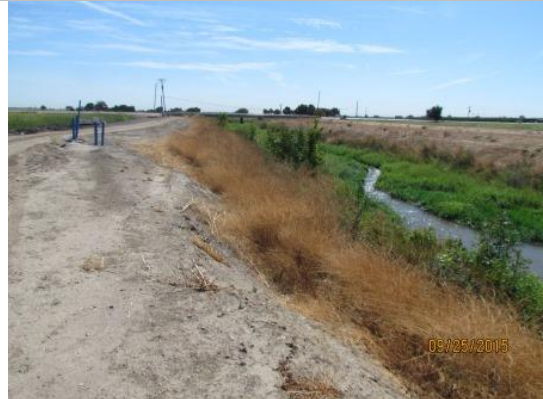
Photo 1 of 1 : FA_2015_NA0017_149_14_20150928_00011.jpg

LM Start	1.91	Rating **	M	Issue No.	14
LM End	1.97	Issue Type +	Ma	Location *	WS
Category	Earthen Levee			GPS Latitude/Longitude	
				Start	End
Item	Vegetation			37.881857 °	37.882421 °
				-121.249441 °	-121.250336 °
DWR ID	DWR_NA0017_02_f_2015_14				
Action/Comments					
Control annual grass and weeds on the levee slopes and easements.

View of the vegetation on the waterside of the levee looking upstream.

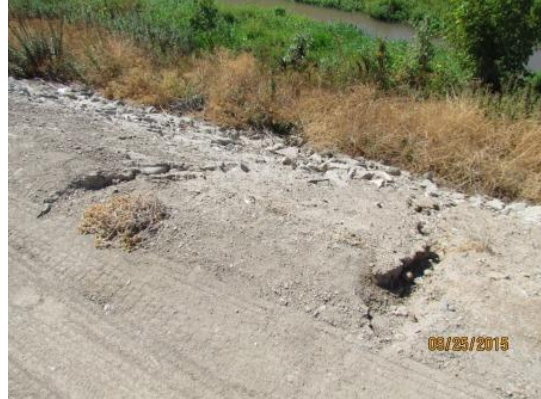
Photo 1 of 1 : FA_2015_NA0017_149_12_20150928_00009.jpg

LM Start	2.06	Rating **	M	Issue No.	12
LM End	2.06	Issue Type +	Ma	Location *	WS
Category	Earthen Levee			GPS Latitude/Longitude	
				Start	End
Item	Erosion / Bank Caving			37.883147 °	37.883147 °
				-121.251649 °	-121.251649 °
DWR ID	DWR_NA0017_02_f_2015_12				
Action/Comments					
Schedule repair of erosion site prior to the next inspection.					
Inspector Comments: Runoff

View of erosion due to runoff on the waterside slope of the levee looking upstream.

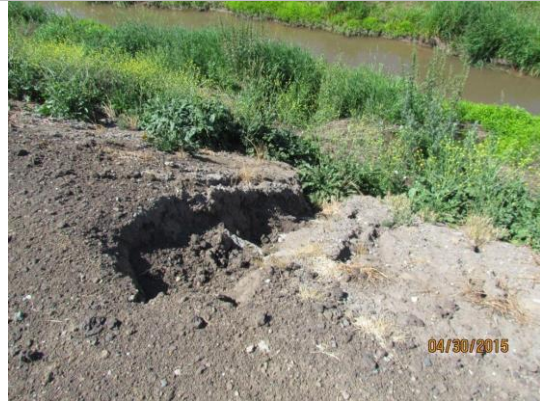
Photo 2 of 2 : FA_2015_NA0017_149_4_20150911_00002.jpg

LM Start	2.22	Rating **	M	Issue No.	4 (cont)
LM End	2.22	Issue Type +	Ma	Location *	WS
Category	Earthen Levee			GPS Latitude/Longitude	
				Start	End
Item	Erosion / Bank Caving			37.884741 °	37.884741 °
				-121.253808 °	-121.253808 °
DWR ID	DWR_NA0017_02_s_2014_4				
Action/Comments					
Schedule repair of erosion site prior to the next inspection.

View of the erosion on the waterside shoulder looking upstream during spring 2015 inspection.

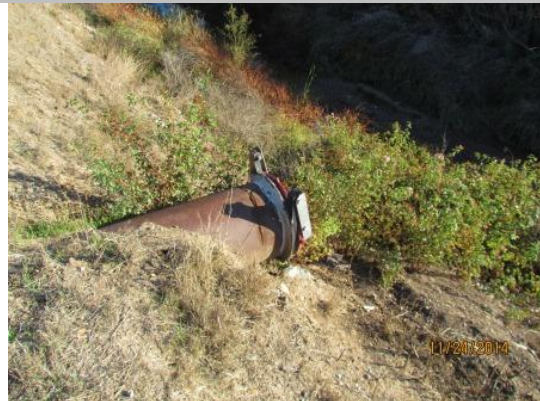
Photo 1 of 2 : FA_2015_NA0017_149_8_20150911_00004.jpg

LM Start	2.65	Rating **	A/W	Issue No.	8
LM End	2.65	Issue Type +	Ma	Location *	WS
Category	Earthen Levee			GPS Latitude/Longitude	
				Start	End
Item	Encroachments			37.888853 °	37.888853 °
				-121.258640 °	-121.258640 °
DWR ID	DWR_NA0017_02_s_2012_8				
Action/Comments					
Pipe					
Inspector Comments: Pipe crossing the channel has corroded and can carry water to/from the channel. A flap gate was installed by the LMA, but the pipe appeared to be damaged.

A flap gate was installed at the end of the pipe, but the pipe appeared to have cracks. The picture was taken from the crown looking upstream during fall 2014 inspection.

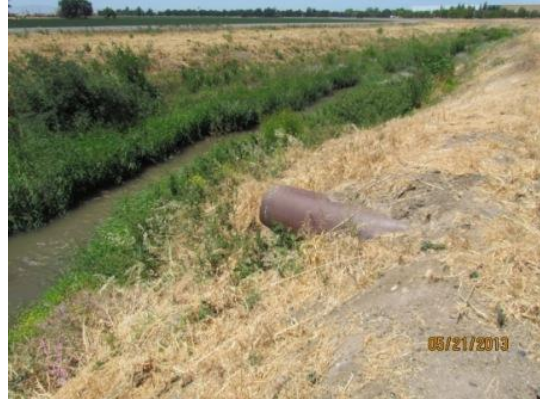
Photo 2 of 2 : FA_2015_NA0017_149_8_20150911_00005.jpg

LM Start	2.65	Rating **	A/W	Issue No.	8 (cont)	
LM End	2.65	Issue Type +	Ma	Location *	WS	
Category	Earthen Levee			GPS Latitude/Longitude		
				Start		End
Item	Encroachments			37.888853 °		37.888853 °
				-121.258640 °		-121.258640 °
DWR ID	DWR_NA0017_02_s _ 2012_8					
Action/Comments						
Pipe						
Inspector Comments: Pipe crossing the channel has corroded and can carry water to/from the channel. A flap gate was installed by the LMA, but the pipe appeared to be damaged.

A pipe was found without a flap gate on waterside slope of the levee looking downstream. This pipe may predate the project.

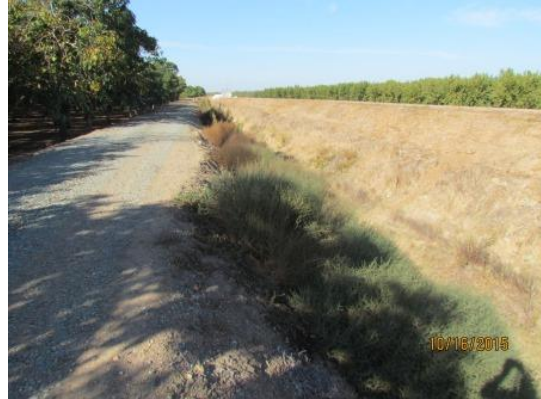
Photo 1 of 1 : FA_2015_NA0017_150_3_20151023_00001.jpg

LM Start	0.06	Rating **	M	Issue No.	3
LM End	0.16	Issue Type +	Ma	Location *	WS
Category	Earthen Levee			GPS Latitude/Longitude	
				Start	End
Item	Vegetation			37.979193 °	37.979229 °
				-121.097709 °	-121.095906 °
DWR ID	DWR_NA0017_06_f_2015_3				
Action/Comments					
Control annual grass and weeds on the levee slopes and easements.

View of the vegetation on the waterside of the levee.

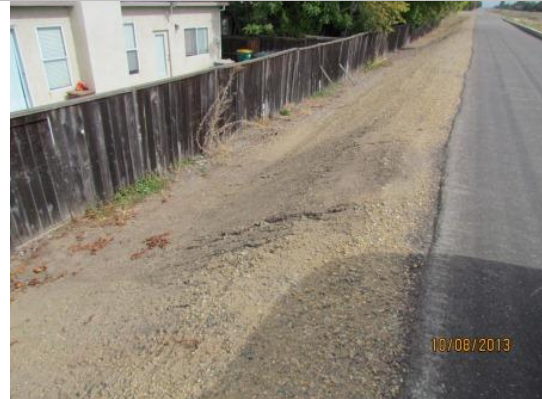
Photo 1 of 1 : FA_2015_NA0017_151_11_20150911_00004.jpg

LM Start	1.68	Rating **	M	Issue No.	11
LM End	1.68	Issue Type +	Ma	Location *	LS
Category	Earthen Levee			GPS Latitude/Longitude	
				Start	End
Item	Erosion / Bank Caving			38.043276 °	38.043276 °
				-121.342812 °	-121.342812 °
DWR ID	DWR_NA0017_07_f_2013_11				
Action/Comments					
Schedule repair of erosion site prior to the next inspection.					
Inspector Comments: Runoff on the landside slope.

Runoff was discovered on the landside slope of the levee looking upstream.

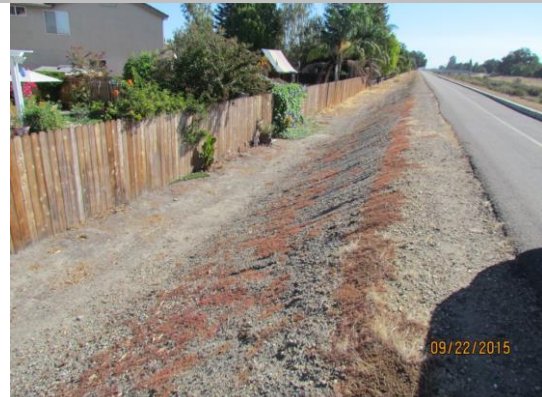
Photo 1 of 2 : FA_2015_NA0017_151_35_20150928_00062.jpg

LM Start	2.01	Rating **	M	Issue No.	35
LM End	2.01	Issue Type +	Ma	Location *	LS
Category	Earthen Levee			GPS Latitude/Longitude	
				Start	End
Item	Erosion / Bank Caving			38.043243 °	38.043243 °
				-121.336780 °	-121.336780 °
DWR ID	DWR_NA0017_07_s_2015_35				
Action/Comments					
Schedule repair of erosion site prior to the next inspection.					
Inspector Comments: Runoff

Updated picture of the erosion on the landside of the levee during fall 2015 inspection.

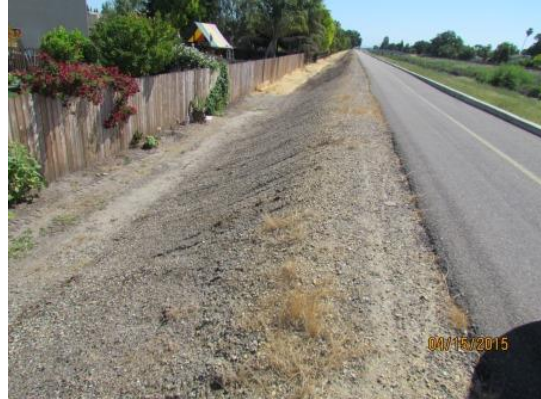
Photo 2 of 2 : FA_2015_NA0017_151_35_20150911_00012.jpg

LM Start	2.01	Rating **	M	Issue No.	35 (cont)
LM End	2.01	Issue Type +	Ma	Location *	LS
Category	Earthen Levee			GPS Latitude/Longitude	
				Start	End
Item	Erosion / Bank Caving			38.043243 °	38.043243
				-121.336780 °	-121.336780
DWR ID	DWR_NA0017_07_s _ 2015_35				
Action/Comments					
Schedule repair of erosion site prior to the next inspection.					
Inspector Comments: Runoff

Erosion caused by runoff on the landside of the levee looking upstream.

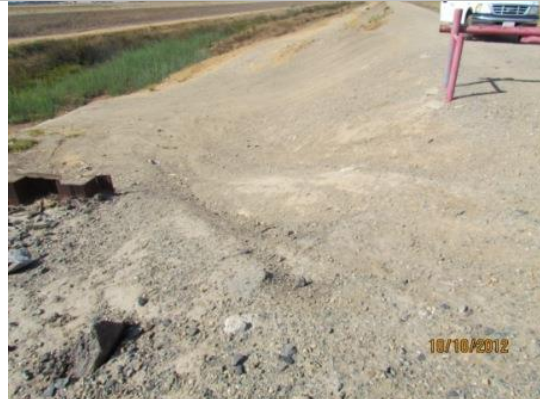
Photo 1 of 1 : FA_2015_NA0017_151_73_20150911_00033.jpg

LM Start	5.50	Rating **	M	Issue No.	73
LM End	5.50	Issue Type +	Ma	Location *	WS
Category	Earthen Levee			GPS Latitude/Longitude	
				Start	End
Item	Erosion / Bank Caving			38.052753 °	38.052753
				-121.277680 °	-121.277680
DWR ID	DWR_NA0017_07_f_2012_73				
Action/Comments					
Schedule repair of erosion site prior to the next inspection. Inspector Comments: Erosion caused by vehicle, and the slopes are stable.

Slope instability was found on the landside of the levee looking upstream.

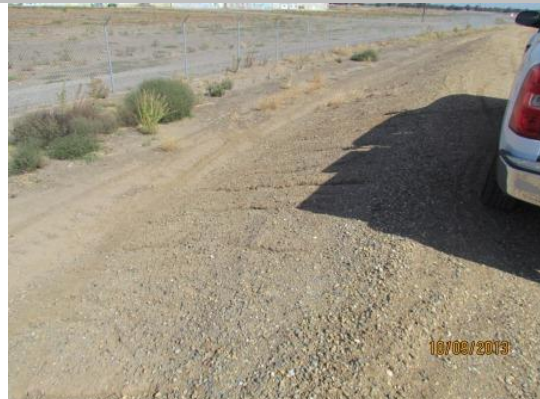
Photo 1 of 1 : FA_2015_NA0017_151_43_20150911_00017.jpg

LM Start	5.53	Rating **	M	Issue No.	43
LM End	5.53	Issue Type +	Ma	Location *	LS
Category	Earthen Levee			GPS Latitude/Longitude	
				Start	End
Item	Erosion / Bank Caving			38.052794 °	38.052794 °
				-121.277035 °	-121.277035 °
DWR ID	DWR_NA0017_07_f_2013_43				
Action/Comments					
Schedule repair of erosion site prior to the next inspection. Inspector Comments: Runoff on the landside.

Runoff was found on the landside slope of the levee looking upstream.

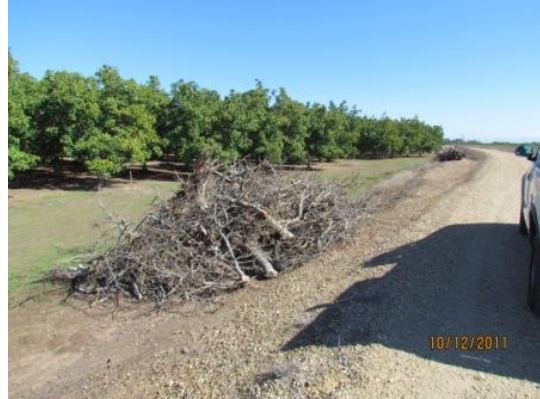
Photo 1 of 1 : FA_2015_NA0017_151_29_20150911_00009.jpg

LM Start	8.44	Rating **	M	Issue No.	29
LM End	8.44	Issue Type +	Ma	Location *	LS
Category	Earthen Levee			GPS Latitude/Longitude	
				Start	End
Item	Encroachments			38.068319 °	38.068319
				-121.231559 °	-121.231559
DWR ID	DWR_NA0017_07_s_2012_29				
Action/Comments					
Prunings					
Inspector Comments: Burn pile has been burned but new material has been placed.

View of prunings found on the landside of the levee looking upstream.

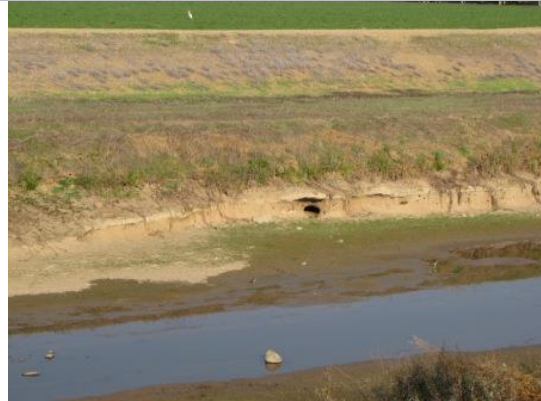
Photo 1 of 1 : FA_2015_NA0017_151_80_20150911_00035.jpg

LM Start	9.65	Rating **	U	Issue No.	80
LM End	9.65	Issue Type +	Ma	Location *	WS
Category	Earthen Levee			GPS Latitude/Longitude	
				Start	End
Item	Animal Control			38.070458 °	38.070458
				-121.218596 °	-121.218596
DWR ID	DWR_NA0017_07_s _ 2012_80				
Action/Comments					
No rodents visible, but rodent burrows visible; need to backfill and compact or grout burrows.					
Inspector Comments: Beaver den in the waterward berm visible from the opposite bank.

View of a large hole and several smaller holes from across the channel.

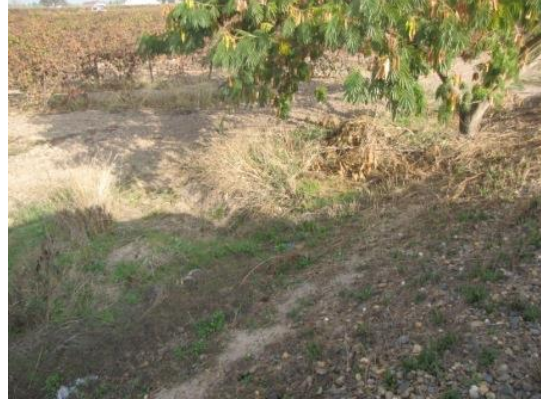
Photo 1 of 1 : FA_2015_NA0017_151_72_20150911_00032.jpg

LM Start	13.03	Rating **	M	Issue No.	72
LM End	13.03	Issue Type +	Ma	Location *	LS
Category	Earthen Levee			GPS Latitude/Longitude	
				Start	End
Item	Slope Stability			38.105846 °	38.105846 °
				-121.176552 °	-121.176552 °
DWR ID	DWR_NA0017_07_s_2012_72				
Action/Comments					
Repair slope instability. Inspector Comments: Shallow pit at the landward toe with nearby prunings.

View of a pit along the landward levee toe looking upstream.

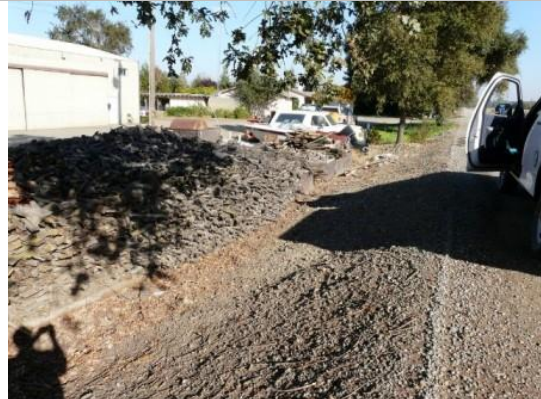
Photo 1 of 1 : FA_2015_NA0017_151_39_20150911_00015.jpg

LM Start	13.52	Rating **	M	Issue No.	39
LM End	13.52	Issue Type +	Ma	Location *	LS
Category	Earthen Levee			GPS Latitude/Longitude	
				Start	End
Item	Encroachments			38.111902 °	38.111902 °
				-121.172685 °	-121.172685 °
DWR ID	DWR_NA0017_07_s_2012_39				
Action/Comments					
Firewood

Firewood was found on the landside toe of the levee.

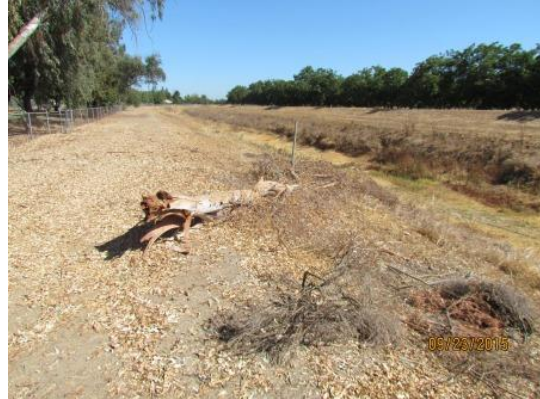
Photo 1 of 1 : FA_2015_NA0017_151_52_20150928_00066.jpg

LM Start	13.88	Rating **	M	Issue No.	52
LM End	13.88	Issue Type +	Ma	Location *	CR
Category	Earthen Levee			GPS Latitude/Longitude	
				Start	End
Item	Encroachments			38.116971 °	38.116971 °
				-121.172043 °	-121.172043 °
DWR ID	DWR_NA0017_07_f_2015_52				
Action/Comments					
Prunings

Prunings were found on the crown of the levee looking upstream.

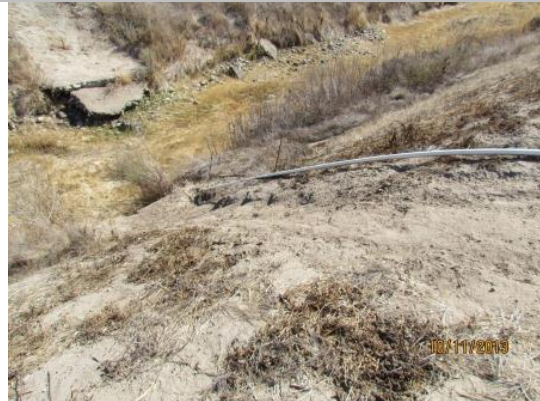
Photo 1 of 1 : FA_2015_NA0017_151_61_20150911_00029.jpg

LM Start	14.23	Rating **	M	Issue No.	61
LM End	14.23	Issue Type +	Ma	Location *	WS
Category	Earthen Levee			GPS Latitude/Longitude	
				Start	End
Item	Encroachments			38.121625 °	38.121625
				-121.169563 °	-121.169563
DWR ID	DWR_NA0017_07_f_2013_61				
Action/Comments					
Stairway

Steps were found on the waterside slope of the levee looking downstream.

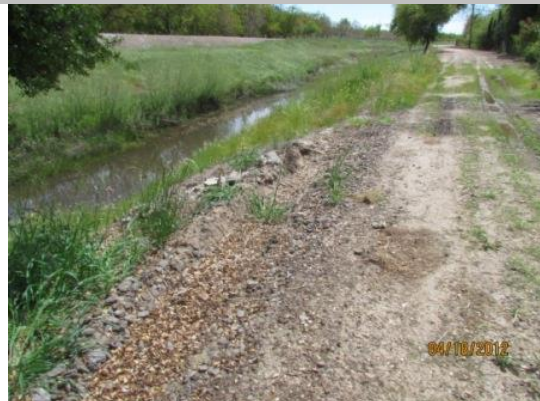
Photo 1 of 1 : FA_2015_NA0017_151_60_20150911_00028.jpg

LM Start	14.35	Rating **	M	Issue No.	60
LM End	14.35	Issue Type +	Ma	Location *	CR
Category	Earthen Levee			GPS Latitude/Longitude	
				Start	End
Item	Crown Surface / Depressions / Rutting			38.123286 °	38.123286 °
				-121.169609 °	-121.169609 °
DWR ID	DWR_NA0017_07_s_2012_60				
Action/Comments					
Repair depressions or ruts in the crown or slope.

Crown depression was found on the waterside shoulder of the levee looking downstream.

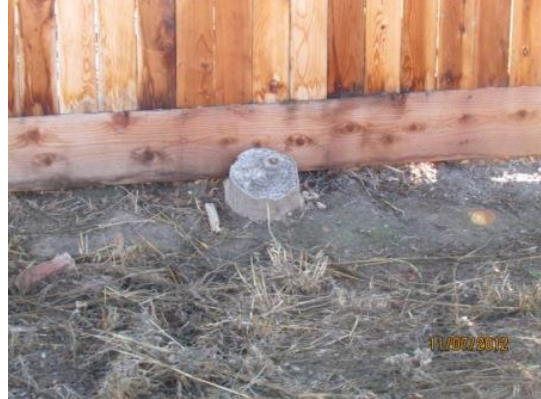
Photo 1 of 1 : FA_2015_NA0017_152_18_20150911_00007.jpg

LM Start	1.82	Rating **	N	Issue No.	18
LM End	1.82	Issue Type +	Ma	Location *	LS
Category	Earthen Levee			GPS Latitude/Longitude	
				Start	End
Item	Trim / Thin Trees			38.042751 °	38.042751 °
				-121.353062 °	-121.353062 °
DWR ID	DWR_NA0017_08_f_2012_18				
Action/Comments					
Tree stumps.

View of a tree stump that was found on the landside toe of the levee.
The picture was taken from the crown looking towards the toe.

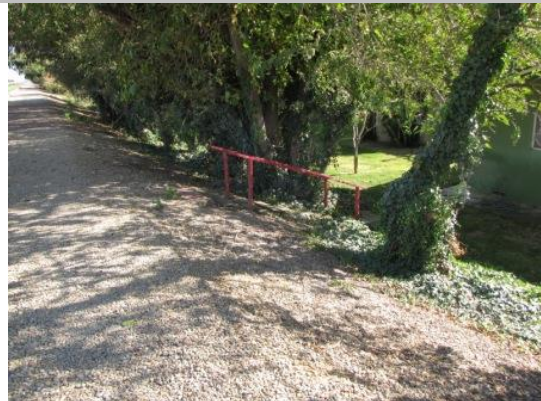
Photo 1 of 1 : FA_2015_NA0017_152_1007_20150911_00045.jpg

LM Start	2.03	Rating **	M	Issue No.	1007
LM End	2.03	Issue Type +	Ma	Location *	LS
Category	Earthen Levee			GPS Latitude/Longitude	
				Start	End
Item	Encroachments			38.042803 °	38.042803 °
				-121.347023 °	-121.347023 °
DWR ID	DWR_NA0017_08_s_2012_1007				
Action/Comments					
Stairway Inspector Comments: Steps were removed but the hand rails still exists at the location.

View of steps dug into the landward slope looking upstream.

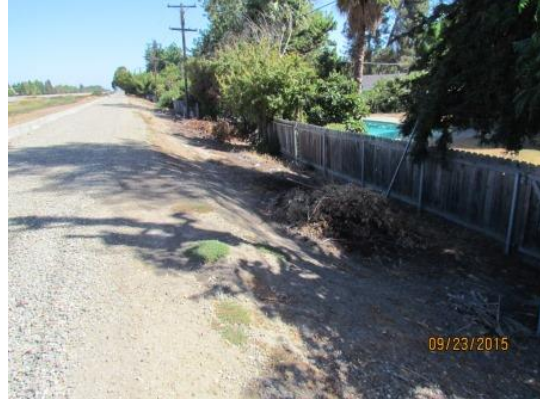
Photo 1 of 1 : FA_2015_NA0017_152_93_20150928_00097.jpg

LM Start	2.16	Rating **	M	Issue No.	93
LM End	2.16	Issue Type +	Ma	Location *	LS
Category	Earthen Levee			GPS Latitude/Longitude	
				Start	End
Item	Encroachments			38.042785 °	38.042785
				-121.344686 °	-121.344686
DWR ID	DWR_NA0017_08_s_2015_93				
Action/Comments					
Prunings

Prunings were found on the landside of the levee looking upstream.

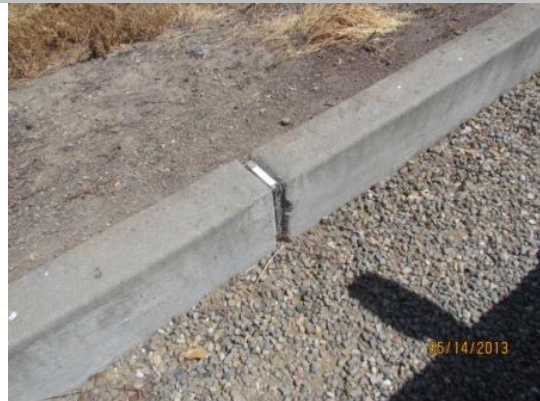
Photo 1 of 1 : FA_2015_NA0017_152_29_20150911_00010.jpg

LM Start	2.24	Rating **	M	Issue No.	29
LM End	2.24	Issue Type +	Ma	Location *	WS
Category	Concrete Floodwalls			GPS Latitude/Longitude	
				Start	End
Item	Monolith Joints			38.042777 °	38.042777 °
				-121.343150 °	-121.343150 °
DWR ID	DWR_NA0017_08_s_2013_29				
Action/Comments

The monolith joint material is deteriorating at this location of the flood wall. The picture was taken from the crown looking upstream.

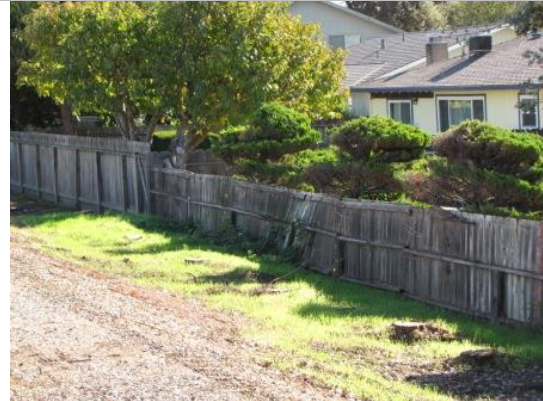
Photo 1 of 1 : FA_2015_NA0017_152_12_20150911_00005.jpg

LM Start	2.50	Rating **	N	Issue No.	12
LM End	2.50	Issue Type +	Ma	Location *	LS
Category	Earthen Levee			GPS Latitude/Longitude	
				Start	End
Item	Trim / Thin Trees			38.042749 °	38.042749
				-121.338402 °	-121.338402
DWR ID	DWR_NA0017_08_s _ 2012_12				
Action/Comments					
Tree stumps.

View of stumps along the landward toe looking upstream.

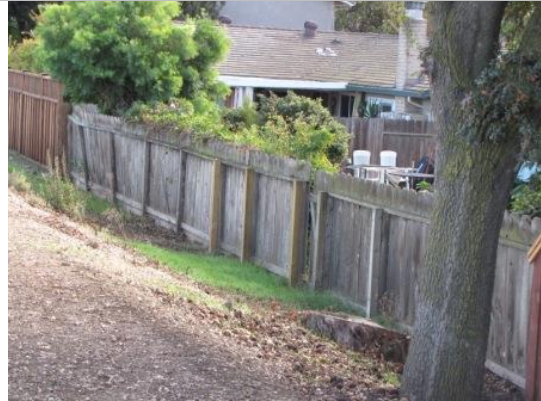
Photo 1 of 1 : FA_2015_NA0017_152_13_20150911_00006.jpg

LM Start	3.19	Rating **	N	Issue No.	13
LM End	3.19	Issue Type +	Ma	Location *	LS
Category	Earthen Levee			GPS Latitude/Longitude	
				Start	End
Item	Trim / Thin Trees			38.042676 °	38.042676 °
				-121.325694 °	-121.325694 °
DWR ID	DWR_NA0017_08_s_2012_13				
Action/Comments					
Tree stumps.

View of a stump on the landward slope looking upstream.

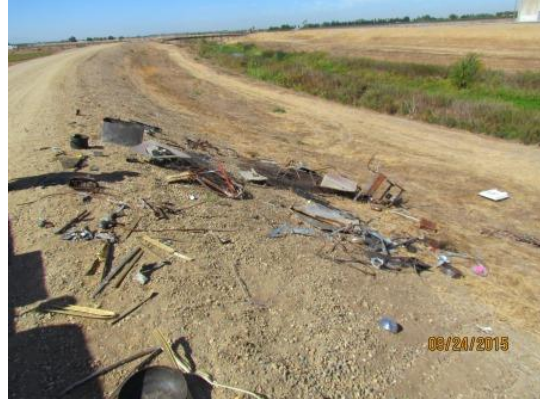
Photo 1 of 1 : FA_2015_NA0017_152_71_20150928_00101.jpg

LM Start	6.23	Rating **	M	Issue No.	71
LM End	6.23	Issue Type +	Ma	Location *	WS
Category	Earthen Levee			GPS Latitude/Longitude	
				Start	End
Item	Encroachments			38.052305 °	38.052305 °
				-121.274854 °	-121.274854 °
DWR ID	DWR_NA0017_08_f_2015_71				
Action/Comments					
Debris

Debris was found on the landside slope of the levee looking downstream.

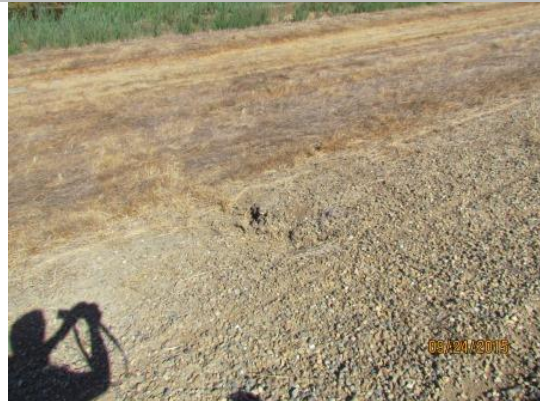
Photo 1 of 1 : FA_2015_NA0017_152_28_20150928_00102.jpg

LM Start	6.27	Rating **	M	Issue No.	28
LM End	6.27	Issue Type +	Ma	Location *	WS
Category	Earthen Levee			GPS Latitude/Longitude	
				Start	End
Item	Slope Stability			38.052499 °	38.052499 °
				-121.274173 °	-121.274173 °
DWR ID	DWR_NA0017_08_s_2015_28				
Action/Comments					
Repair slope instability.					
Inspector Comments: Runoff

Slope instability was found on the waterside of the levee looking upstream.

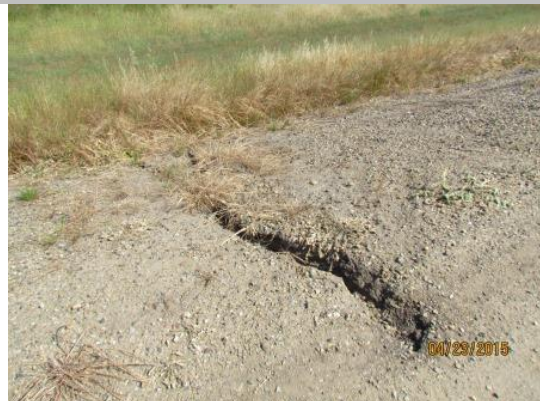
Photo 1 of 1 : FA_2015_NA0017_152_120_20150911_00037.jpg

LM Start	6.53	Rating **	M	Issue No.	120
LM End	6.53	Issue Type +	Ma	Location *	WS
Category	Earthen Levee			GPS Latitude/Longitude	
				Start	End
Item	Erosion / Bank Caving			38.052994 °	38.052994 °
				-121.271526 °	-121.271526 °
DWR ID	DWR_NA0017_08_f_2014_120				
Action/Comments					
Schedule repair of erosion site prior to the next inspection.					
Inspector Comments: Surface runoff.

View of the erosion due to runoff on the waterside of the levee looking upstream.

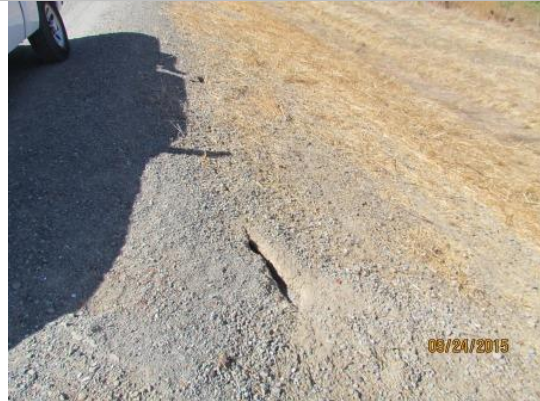
Photo 1 of 1 : FA_2015_NA0017_152_72_20150928_00103.jpg

LM Start	7.86	Rating **	M	Issue No.	72
LM End	7.86	Issue Type +	Ma	Location *	WS
Category	Earthen Levee			GPS Latitude/Longitude	
				Start	End
Item	Animal Control			38.064436 °	38.064436 °
				-121.251746 °	-121.251746 °
DWR ID	DWR_NA0017_08_f _ 2015_72				
Action/Comments					
No rodents visible, but rodent burrows visible; need to backfill and compact or grout burrows.

An animal hole was found on the waterside shoulder of the levee looking downstream.

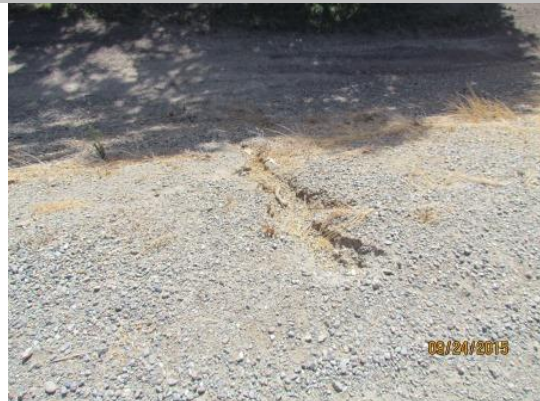
Photo 1 of 1 : FA_2015_NA0017_152_73_20150928_00104.jpg

LM Start	8.83	Rating **	M	Issue No.	73
LM End	8.83	Issue Type +	Ma	Location *	LS
Category	Earthen Levee			GPS Latitude/Longitude	
				Start	End
Item	Erosion / Bank Caving			38.067130 °	38.067130 °
				-121.234875 °	-121.234875 °
DWR ID	DWR_NA0017_08_f_2015_73				
Action/Comments					
Schedule repair of erosion site prior to the next inspection.					
Inspector Comments: Surface runoff.

Erosion due surface runoff was found on the landside of the levee looking downstream.

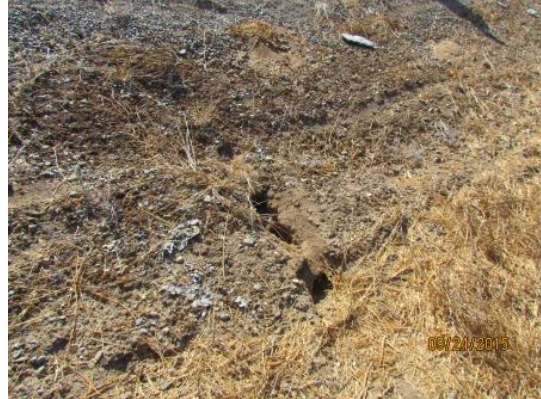
Photo 1 of 1 : FA_2015_NA0017_152_75_20150928_00105.jpg

LM Start	9.42	Rating **	M	Issue No.	75
LM End	9.42	Issue Type +	Ma	Location *	WS
Category	Earthen Levee			GPS Latitude/Longitude	
				Start	End
Item	Animal Control			38.069797 °	38.069797 °
				-121.224693 °	-121.224693 °
DWR ID	DWR_NA0017_08_f_2015_75				
Action/Comments					
No rodents visible, but rodent burrows visible; need to backfill and compact or grout burrows.

Rodent holes were found on the waterside of the levee looking downstream.

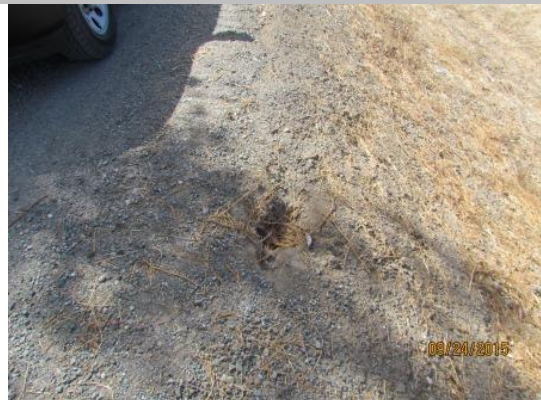
Photo 1 of 1 : FA_2015_NA0017_152_78_20150928_00107.jpg

LM Start	10.04	Rating **	M	Issue No.	78
LM End	10.04	Issue Type +	Ma	Location *	WS
Category	Earthen Levee			GPS Latitude/Longitude	
				Start	End
Item	Animal Control			38.072884 °	38.072884 °
				-121.215102 °	-121.215102 °
DWR ID	DWR_NA0017_08_f_2015_78				
Action/Comments					
No rodents visible, but rodent burrows visible; need to backfill and compact or grout burrows.

An animal borrow was found on the waterside of the levee looking downstream.

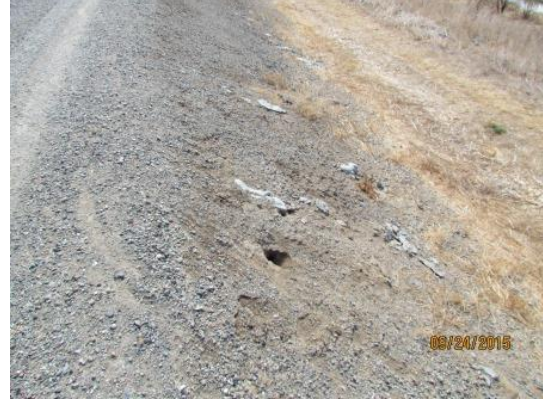
Photo 1 of 1 : FA_2015_NA0017_152_79_20150928_00108.jpg

LM Start	10.39	Rating **	M	Issue No.	79
LM End	10.39	Issue Type +	Ma	Location *	WS
Category	Earthen Levee			GPS Latitude/Longitude	
				Start	End
Item	Animal Control			38.075132 °	38.075132 °
				-121.208341 °	-121.208341 °
DWR ID	DWR_NA0017_08_f_2015_79				
Action/Comments					
No rodents visible, but rodent burrows visible; need to backfill and compact or grout burrows.

Rodent holes were found on the waterside slope of the levee looking downstream.

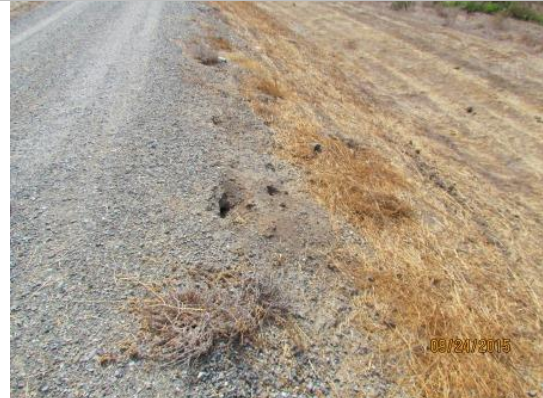
Photo 1 of 2 : FA_2015_NA0017_152_94_20150928_00109.jpg

LM Start	10.52	Rating **	M	Issue No.	94
LM End	10.52	Issue Type +	Ma	Location *	WS
Category	Earthen Levee			GPS Latitude/Longitude	
				Start	End
Item	Animal Control			38.076880 °	38.076880 °
				-121.207703 °	-121.207703 °
DWR ID	DWR_NA0017_08_s_2015_94				
Action/Comments					
No rodents visible, but rodent burrows visible; need to backfill and compact or grout burrows.

Updated picture of the rodent holes on the waterside of the levee looking downstream during fall 2015 inspection.

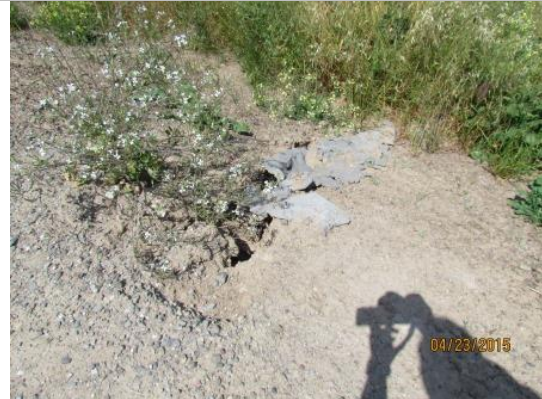
Photo 1 of 1 : FA_2015_NA0017_152_111_20150911_00036.jpg

LM Start	11.69	Rating **	M	Issue No.	111
LM End	11.69	Issue Type +	Ma	Location *	WS
Category	Earthen Levee			GPS Latitude/Longitude	
				Start	End
Item	Slope Stability			38.086135 °	38.086135 °
				-121.190670 °	-121.190670 °
DWR ID	DWR_NA0017_08_s_2015_111				
Action/Comments					
Repair slope instability.					
Inspector Comments: Slope instability caused by rodent holes.

View of slope instability due to rodent holes on the waterside of the levee looking downstream.

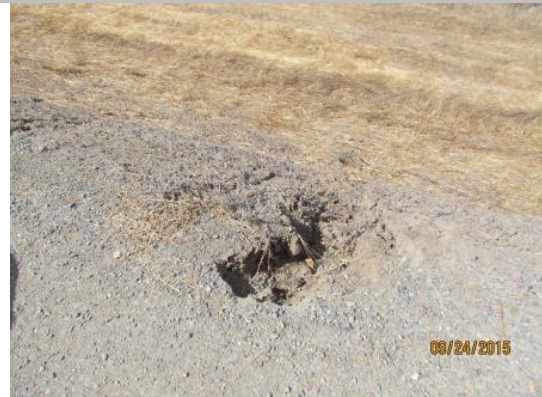
Photo 1 of 1 : FA_2015_NA0017_152_80_20150928_00110.jpg

LM Start	11.73	Rating **	M	Issue No.	80
LM End	11.73	Issue Type +	Ma	Location *	WS
Category	Earthen Levee			GPS Latitude/Longitude	
				Start	End
Item	Slope Stability			38.086219 °	38.086219 °
				-121.190030 °	-121.190030 °
DWR ID	DWR_NA0017_08_f_2015_80				
Action/Comments					
Repair slope instability.

Slope instability was found on the waterside of the levee looking downstream.

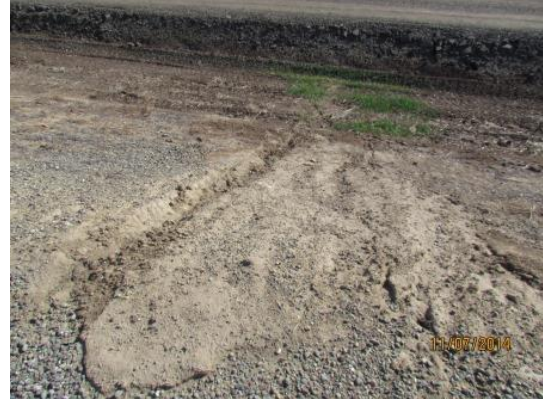
Photo 1 of 1 : FA_2015_NA0017_152_128_20150911_00038.jpg

LM Start	11.81	Rating **	M	Issue No.	128
LM End	11.81	Issue Type +	Ma	Location *	LS
Category	Earthen Levee			GPS Latitude/Longitude	
				Start	End
Item	Erosion / Bank Caving			38.086116 °	38.086116 °
				-121.190630 °	-121.190630 °
DWR ID	DWR_NA0017_08_f_2014_128				
Action/Comments					
Schedule repair of erosion site prior to the next inspection.

Erosion was found on the landside of the levee looking upstream.

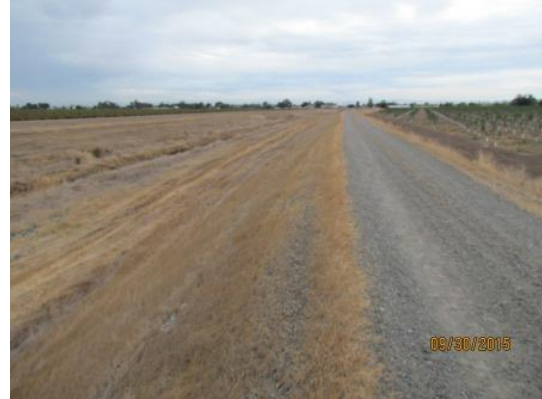
Photo 1 of 1 : FA_2015_NA0017_153_4_20151005_00003.jpg

LM Start	0.12	Rating **	A	Issue No.	4
LM End	0.12	Issue Type +	Ma	Location *	WS
Category	Earthen Levee			GPS Latitude/Longitude	
				Start	End
Item	Vegetation			38.094053 °	38.094053 °
				-121.174649 °	-121.174649 °
DWR ID	DWR_NA0017_09_f _ 2015_4				
Action/Comments					
Control annual grass and weeds on the levee slopes and easements. Inspector Comments: Vegetation is acceptable.

View of the waterside slope of the levee looking upstream.

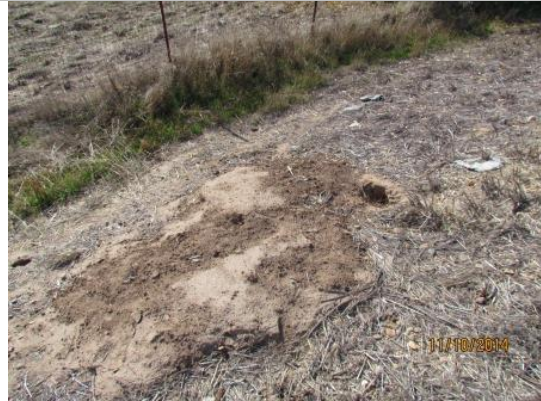
Photo 1 of 2 : FA_2015_NA0017_156_9_20150911_00007.jpg

LM Start	2.22	Rating **	M	Issue No.	9
LM End	2.22	Issue Type +	Ma	Location *	LS
Category	Earthen Levee			GPS Latitude/Longitude	
				Start	End
Item	Animal Control			38.117784 °	38.117784 °
				-121.149763 °	-121.149763 °
DWR ID	DWR_NA0017_12_s_2014_9				
Action/Comments					
No rodents visible, but rodent burrows visible; need to backfill and compact or grout burrows.

Updated picture of the rodent holes on the landside of the levee looking downstream.

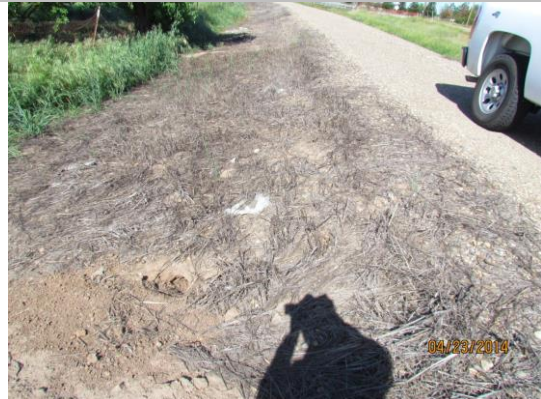
Photo 2 of 2 : FA_2015_NA0017_156_9_20150911_00008.jpg

View of a rodent hole that was found on the landside of the levee looking downstream.

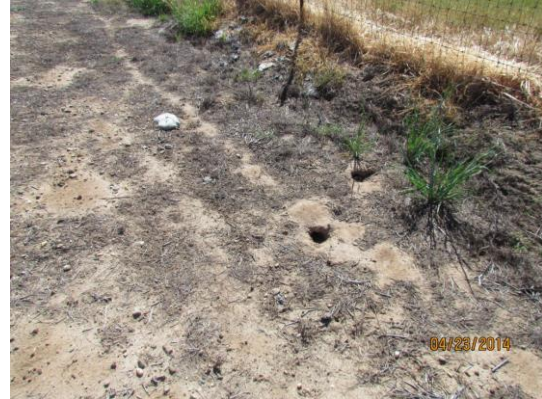
Photo 1 of 1 : FA_2015_NA0017_156_11_20150911_00010.jpg

LM Start	2.25	Rating **	M	Issue No.	11
LM End	2.25	Issue Type +	Ma	Location *	LS
Category	Earthen Levee			GPS Latitude/Longitude	
				Start	End
Item	Animal Control			38.117807 °	38.117807 °
				-121.149233 °	-121.149233 °
DWR ID	DWR_NA0017_12_s _ 2014_11				
Action/Comments					
No rodents visible, but rodent burrows visible; need to backfill and compact or grout burrows.

View of rodent holes that were found on the landside toe of the levee upstream.

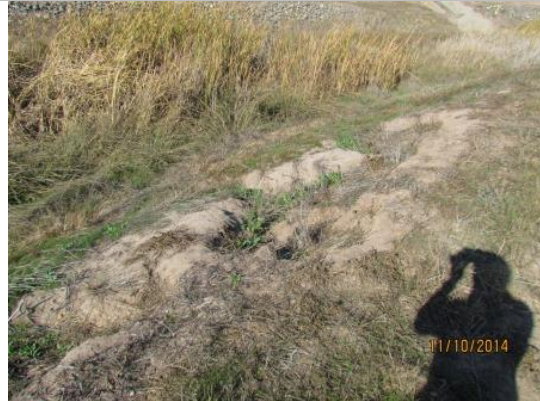
Photo 1 of 1 : FA_2015_NA0017_156_32_20150911_00023.jpg

View of a slope instability that was found on the waterside of the levee looking upstream.

LM Start	2.97	Rating **	M	Issue No.	32
LM End	2.97	Issue Type +	Ma	Location *	WS
Category	Earthen Levee			GPS Latitude/Longitude	
				Start	End
Item	Slope Stability			38.126304 °	38.126304 °
				-121.143996 °	-121.143996 °
DWR ID	DWR_NA0017_12_f_2014_32				
Action/Comments					
Repair slope instability.

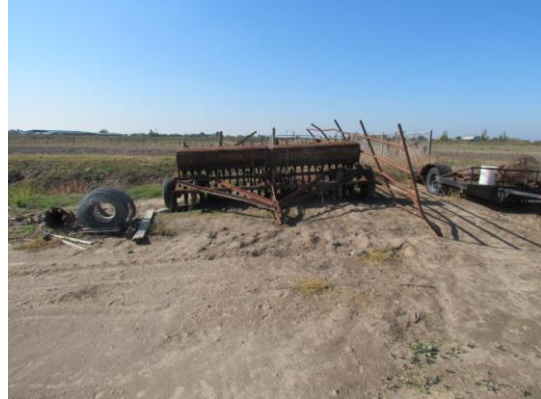
Photo 1 of 1 : FA_2015_NA0017_156_113_20150911_00028.jpg

View of farming equipment that was found on the waterside of the levee looking upstream.

LM Start	3.38	Rating **	M	Issue No.	113
LM End	3.38	Issue Type +	Ma	Location *	WS
Category	Earthen Levee			GPS Latitude/Longitude	
				Start	End
Item	Encroachments			38.130018 °	38.130018 °
				-121.139019 °	-121.139019 °
DWR ID	DWR_NA0017_12_s_2012_113				
Action/Comments					
Equipment

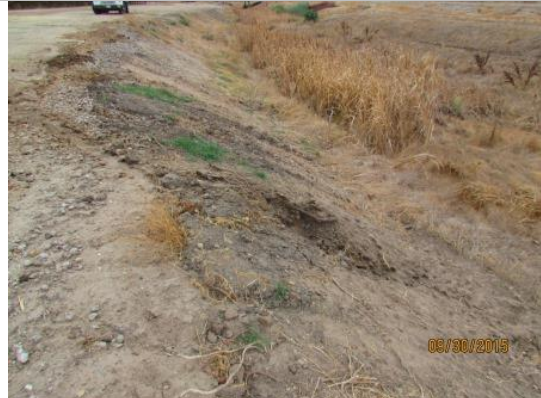
Photo 1 of 2 : FA_2015_NA0017_156_24_20151005_00030.jpg

Updated picture of the erosion on the waterside of the levee during fall 2015 inspection.

LM Start	3.46	Rating **	M	Issue No.	24
LM End	3.46	Issue Type +	Ma	Location *	WS
Category	Earthen Levee			GPS Latitude/Longitude	
				Start	End
Item	Erosion / Bank Caving			38.131140 °	38.131140 °
				-121.138541 °	-121.138541 °
DWR ID	DWR_NA0017_12_f_2012_24				
Action/Comments					
Schedule repair of erosion site prior to the next inspection.

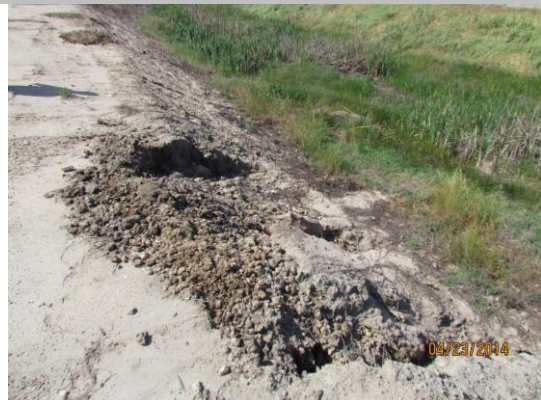
Photo 2 of 2 : FA_2015_NA0017_156_24_20150911_00020.jpg

View of the erosion on the waterside of the levee. The picture was taken during spring 2014 inspection looking downstream.

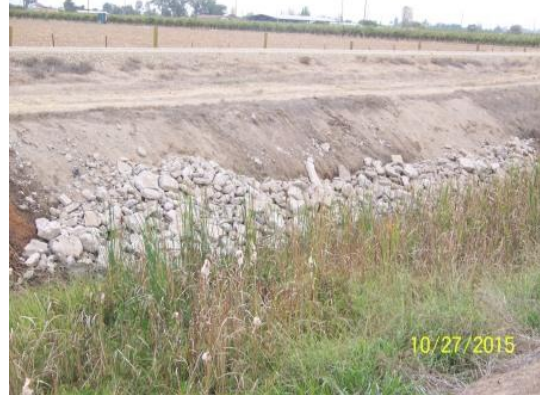
Photo 1 of 2 : FA_2015_NA0017_157_5_20151116_00008.jpg

LMA repaired the possible beaver den on the waterside toe of the levee during fall 2015.

LM Start	0.11	Rating **	A	Issue No.	5
LM End	0.11	Issue Type +	Ma	Location *	WS
Category	Earthen Levee			GPS Latitude/Longitude	
				Start	End
Item	Animal Control			38.109687 °	38.109687 °
				-121.158481 °	-121.158481 °
DWR ID	DWR_NA0017_13_s_2015_5				
Action/Comments					
Exterminate rodents and backfill and compact or grout burrows. Inspector Comments: LMA has repaired the possible beaver den.

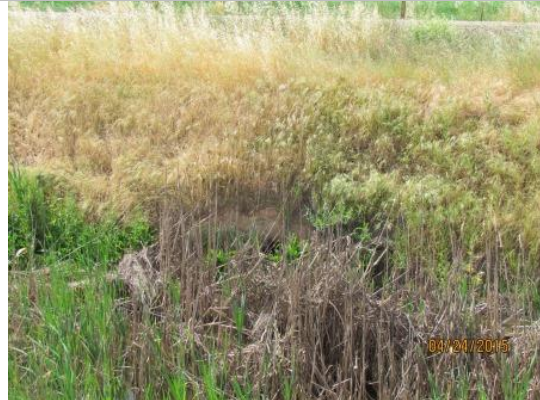
Photo 2 of 2 : FA_2015_NA0017_157_5_20150911_00004.jpg

View of a beaver den on the waterside toe of the levee. The picture was taken across the levee.

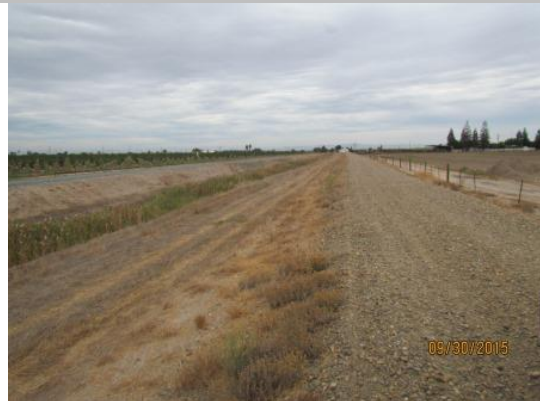
Photo 1 of 1 : FA_2015_NA0017_157_6_20151005_00007.jpg

View of acceptable vegetation on the waterside of the levee looking upstream.

LM Start	0.17	Rating **	A	Issue No.	6
LM End	0.17	Issue Type +	Ma	Location *	WS
Category	Earthen Levee			GPS Latitude/Longitude	
				Start	End
Item	Vegetation			38.109467 °	38.109467 °
				-121.157463 °	-121.157463 °
DWR ID	DWR_NA0017_13_f_2015_6				
Action/Comments					
Control annual grass and weeds on the levee slopes and easements.					
Inspector Comments: Acceptable vegetation.

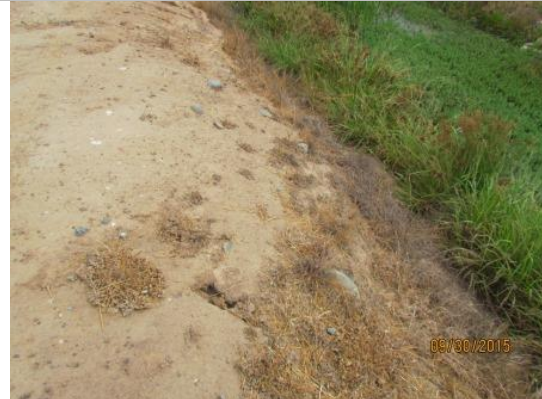
Photo 1 of 1 : FA_2015_NA0017_158_14_20151005_00012.jpg

Rodent holes were found on the waterside slope of the levee looking upstream.

LM Start	0.39	Rating **	M	Issue No.	14
LM End	0.39	Issue Type +	Ma	Location *	WS
Category	Earthen Levee			GPS Latitude/Longitude	
				Start	End
Item	Animal Control			38.109866 °	38.109866 °
				-121.153096 °	-121.153096 °
DWR ID	DWR_NA0017_14_f_2015_14				
Action/Comments					
No rodents visible, but rodent burrows visible; need to backfill and compact or grout burrows.

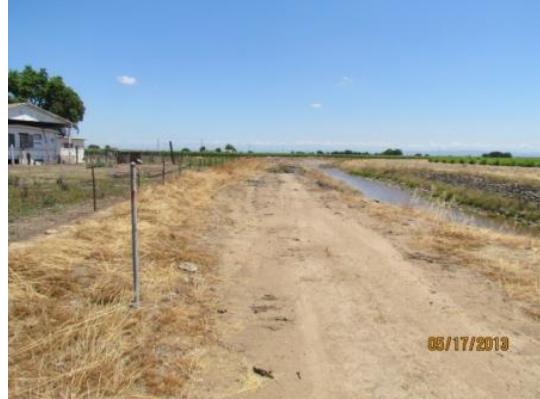
Photo 1 of 1 : FA_2015_NA0017_158_7_20150911_00008.jpg

View of a crown depression that was found looking upstream.

LM Start	0.56	Rating **	M	Issue No.	7
LM End	0.56	Issue Type +	Ma	Location *	CR
Category	Earthen Levee			GPS Latitude/Longitude	
				Start	End
Item	Crown Surface / Depressions / Rutting			38.111490 °	38.111490 °
				-121.150762 °	-121.150762 °
DWR ID	DWR_NA0017_14_s_2013_7				
Action/Comments					
Repair depressions or ruts in the crown or slope.

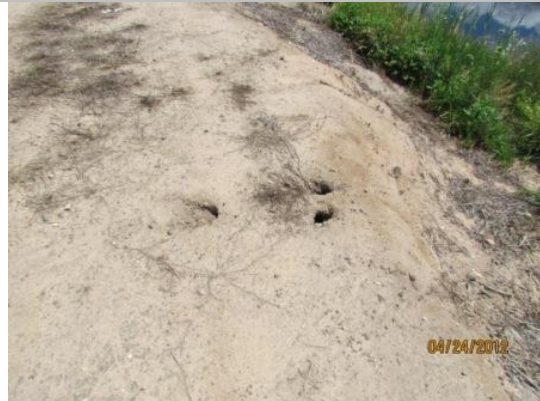
Photo 1 of 1 : FA_2015_NA0017_158_5_20150911_00006.jpg

View of animal holes that were found on the waterside of the levee looking upstream.

LM Start	0.60	Rating **	M	Issue No.	5
LM End	0.60	Issue Type +	Ma	Location *	WS
Category	Earthen Levee			GPS Latitude/Longitude	
				Start	End
Item	Animal Control			38.111770 °	38.111770 °
				-121.150112 °	-121.150112 °
DWR ID	DWR_NA0017_14_s_2012_5				
Action/Comments					
No rodents visible, but rodent burrows visible; need to backfill and compact or grout burrows.

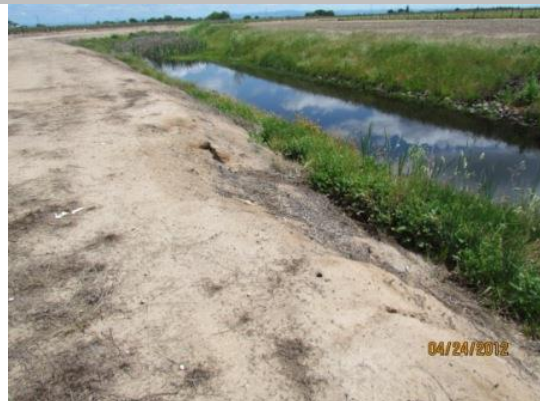
Photo 1 of 2 : FA_2015_NA0017_158_4_20150911_00004.jpg

View of erosion that was found on the waterside of the levee looking upstream. This picture was taken during spring 2012 inspection.

LM Start	0.60	Rating **	M	Issue No.	4
LM End	0.60	Issue Type +	Ma	Location *	WS
Category	Earthen Levee			GPS Latitude/Longitude	
				Start	End
Item	Erosion / Bank Caving			38.111774 °	38.111774 °
				-121.150073 °	-121.150073 °
DWR ID	DWR_NA0017_14_s_2012_4				
Action/Comments					
Note and monitor erosion site.

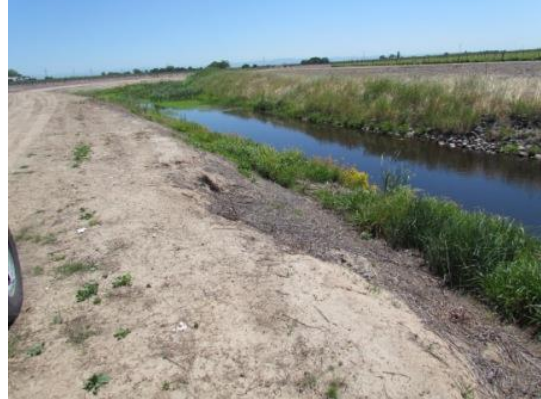
Photo 2 of 2 : FA_2015_NA0017_158_4_20150911_00005.jpg

View of erosion that was found on the waterside of the levee.

LM Start	0.60	Rating **	M	Issue No.	4 (cont)	
LM End	0.60	Issue Type +	Ma	Location *	WS	
Category	Earthen Levee			GPS Latitude/Longitude		
				Start		End
Item	Erosion / Bank Caving			38.111774 °		38.111774 °
				-121.150073 °		-121.150073 °
DWR ID	DWR_NA0017_14_s_2012_4					
Action/Comments						
Note and monitor erosion site.

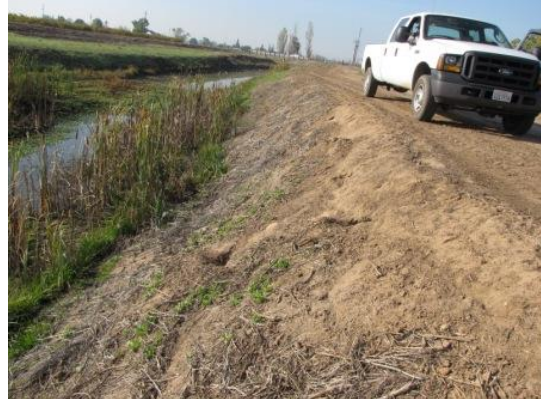
Photo 1 of 1 : FA_2015_NA0017_158_1_20150911_00001.jpg

View of rodent holes in the waterward berm looking downstream.

LM Start	0.64	Rating **	M	Issue No.	1
LM End	0.64	Issue Type +	Ma	Location *	WS
Category	Earthen Levee			GPS Latitude/Longitude	
				Start	End
Item	Animal Control			38.112050 °	38.112050
				-121.149524 °	-121.149524
DWR ID	DWR_NA0017_14_s_2012_1				
Action/Comments					
Exterminate rodents and backfill and compact or grout burrows.

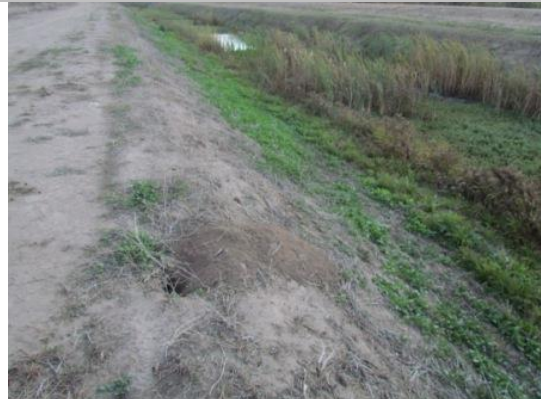
Photo 1 of 1 : FA_2015_NA0017_158_3_20150911_00003.jpg

View of a rodent hole that was found on the waterside shoulder of the levee looking upstream.

LM Start	0.72	Rating **	M	Issue No.	3
LM End	0.72	Issue Type +	Ma	Location *	WS
Category	Earthen Levee			GPS Latitude/Longitude	
				Start	End
Item	Animal Control			38.111851 °	38.111851 °
				-121.148358 °	-121.148358 °
DWR ID	DWR_NA0017_14_s_2012_3				
Action/Comments					
No rodents visible, but rodent burrows visible; need to backfill and compact or grout burrows.

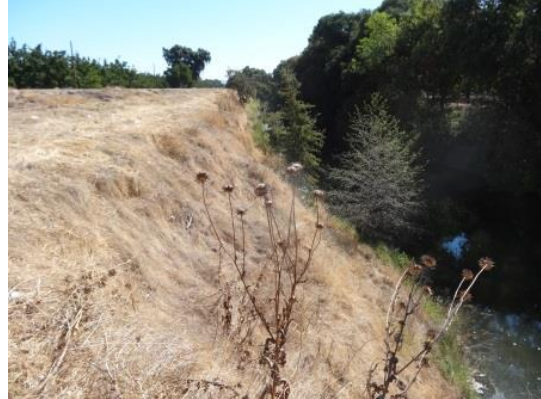
Photo 1 of 3 : SJR2015_NA0017U15RM22.91_1.jpg

Inspector Comments: 8/12/2015: No significant change observed.
 8/20/2014: No significant change has been observed.
 9/12/2013: No significant change observed.
 08/22/2012: Site has been revisited. No significant change observed.
 09/02/2011: No significant change observed on site.
 11/02/2010: No significant change observed. The mile-long erosion continues to degrade the bank. There are a few trees along the mile-long stretch on the lower bank slope that are affected by the scarp. WS Levee Slope was changed to 2:1. As a result, normalized score increased from 62 to 65.
 08/05/2010: Recommended for waterside repair, per CLRO; "water velocity is a major factor for accelerating bank slope erosion."
 8/12/2009: Near-vertical bank erosion; degrading channel is incising the banks; recommend annual assessment and monitoring of critical erosion site, per CLRO CES Evaluation 2008 Report; district is monitoring site for change in condition; site was previously rated "U".

Downstream view of the site.

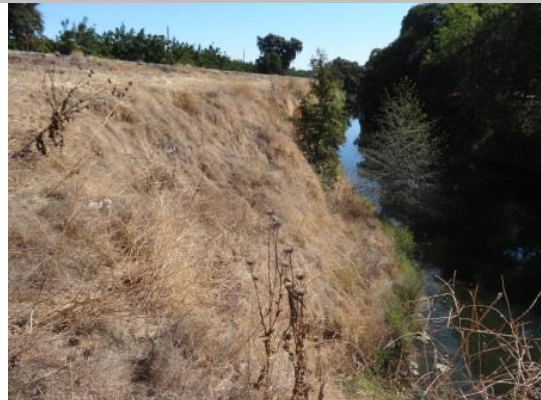
Photo 2 of 3 : SJR2015_NA0017U15RM22.91_2.jpg

Close view of the erosion site. Small trees grow at the lower slope of the bank.

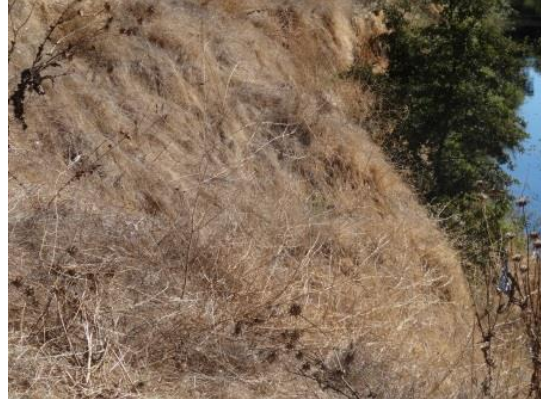
Photo 3 of 3 : SJR2015_NA0017U15RM22.91_5.jpg

LM Start	0.39	Rating **	M	Issue No.	7 (cont)
LM End	1.30	Issue Type +	Ma	Location *	WS
Category	Supplemental			GPS Latitude/Longitude	
				Start	End
Item	DWR Erosion Survey			38.045818 °	38.045818 °
				-121.023955 °	-121.023955 °
DWR ID					
Action/Comments					
Inspector Comments: 8/12/2015: No significant change observed. 8/20/2014: No significant change has been observed. 9/12/2013: No significant change observed. 08/22/2012: Site has been revisited. No significant change observed. 09/02/2011: No significant change observed on site. 11/02/2010: No significant change observed. The mile-long erosion

Looking down at the site.

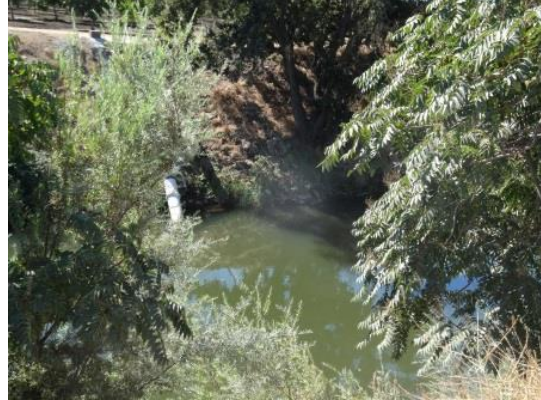
Photo 1 of 3 : SJR2015_NA0017U16RM22.58_1.jpg

LM Start	1.21	Rating **	U	Issue No.	35
LM End	1.21	Issue Type +	Ma	Location *	WS
Category	Supplemental			GPS Latitude/Longitude	
				Start	End
Item	DWR Erosion Survey			38.041260 °	38.041260 °
				-121.027730 °	-121.027730 °
DWR ID					
Action/Comments					
Inspector Comments: 8/12/2015: No significant change observed. 8/20/2014: No significant change observed. 9/12/2013: No significant change observed. 08/22/2012: The erosion is at the outside corner of a river bend, and next to a tree at the levee toe. Irrigation structure presents at the site. There is no levee structure on site. The levee crest width and levee height were not measured or estimated in the field. [2015 Site ID:NA0017U16RM22.58]

Front view of the erosion. The erosion is next to a tree at the levee toe.

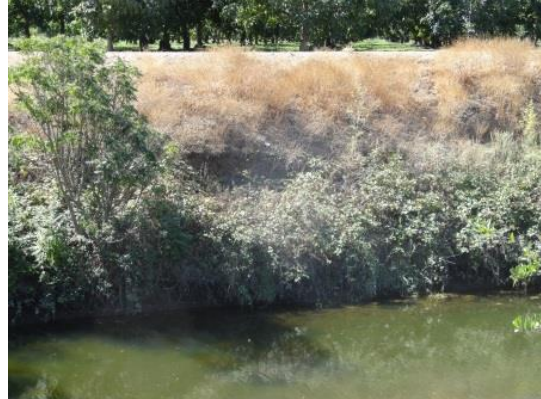
Photo 3 of 3 : SJR2015_NA0017U16RM22.01_4.jpg

LM Start	1.78	Rating **	U	Issue No.	29 (cont)
LM End	1.79	Issue Type +	Ma	Location *	WS
Category	Supplemental			GPS Latitude/Longitude	
				Start	End
Item	DWR Erosion Survey			38.039110 °	38.039110 °
				-121.037840 °	-121.037840 °
DWR ID					
Action/Comments					
Inspector Comments: 8/12/2015: No significant change observed. 8/20/2014: No significant change observed. 9/12/2013: No significant change observed. 08/22/2012: Site is covered with dense vegetation. A scarp erosion is adjacent to a pocket erosion at the downstream. There is no levee structure on site. The levee crest width and levee height were not

Close view of the erosion.

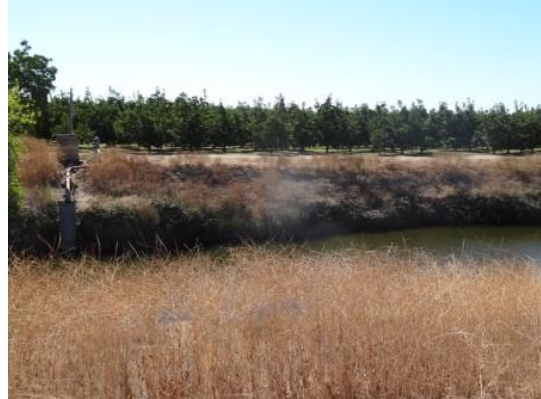
Photo 1 of 3 : SJR2015_NA0017U16RM21.05_1.jpg

LM Start	1.98	Rating **	M	Issue No.	28
LM End	2.00	Issue Type +	Ma	Location *	WS
Category	Supplemental			GPS Latitude/Longitude	
				Start	End
Item	DWR Erosion Survey			38.037150 °	38.037150 °
				-121.040580 °	-121.040580 °
DWR ID					
Action/Comments					
Inspector Comments: 8/12/2015: No significant change observed. 8/20/2014: No significant change observed. 9/12/2013: No significant change observed. 08/22/2012: Berm width is estimated as 5 ft. There is no levee structure on site. The levee crest width and levee height were not measured or estimated in the field. [2015 Site ID:NA0017U16RM21.05]

Front view of the erosion

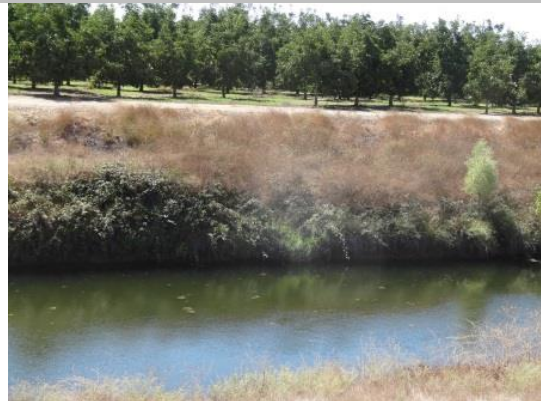
Photo 2 of 3 : SJR2015_NA0017U16RM21.05_3.jpg

Close view of the erosion.

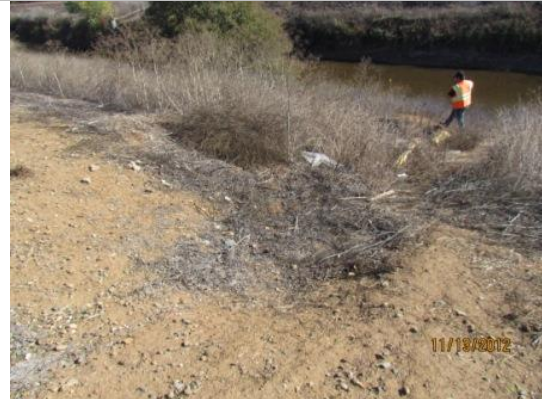
Photo 1 of 2 : FA_2015_NA0017_159_18_20150911_00010.jpg

Updated picture of the slope instability at the waterside slope of the levee looking upstream.

LM Start	2.05	Rating **	M	Issue No.	18
LM End	2.05	Issue Type +	Ma	Location *	WS
Category	Earthen Levee			GPS Latitude/Longitude	
				Start	End
Item	Slope Stability			38.036294 °	38.036294
				-121.041089 °	-121.041089
DWR ID	DWR_NA0017_15_s_2012_18				
Action/Comments					
Repair slope instability.
