**Flood Control Project Maintenance
Levee Inspections**

Maintenance Issue Types Only, Levee Inspection Report By Mile - Fall 2015

San Joaquin County Flood Control and Water Conservation District

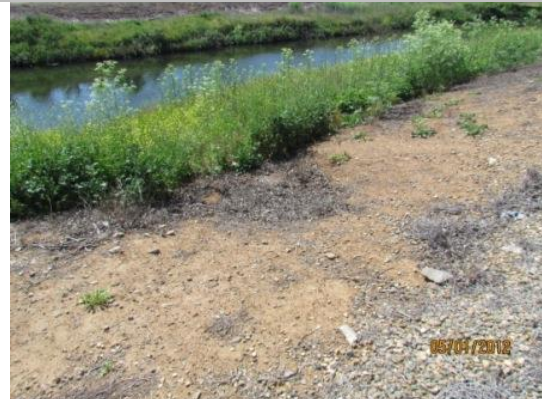
Photo 2 of 2 : FA_2015_NA0017_159_18_20150911_00011.jpg

Slope instability was found on the waterside toe of the levee looking downstream.

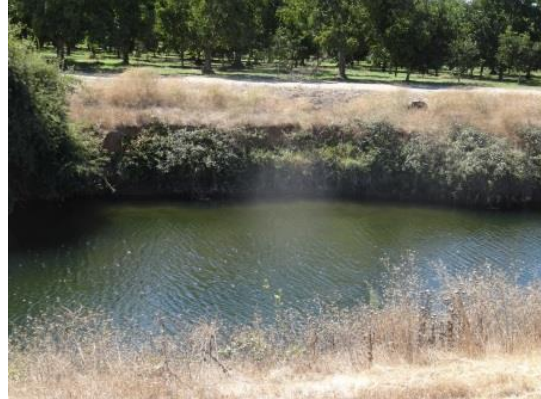
Photo 1 of 3 : SJR2015_NA0017U16RM20.71_1.jpg

LM Start	2.36	Rating **	M	Issue No.	26
LM End	2.37	Issue Type +	Ma	Location *	WS
Category	Supplemental			GPS Latitude/Longitude	
				Start	End
Item	DWR Erosion Survey			38.033072 °	38.033072 °
				-121.044970 °	-121.044970 °
DWR ID					
Action/Comments					
Inspector Comments: 8/12/2015: No significant change observed. 8/20/2014: No significant change observed. 9/12/2013: No significant change observed. 08/22/2012: Site is covered with dense vegetation. There is no levee structure on site. The levee crest width and levee height were not measured or estimated in the field. [2015 Site ID:NA0017U16RM20.71]

Front view of the site.

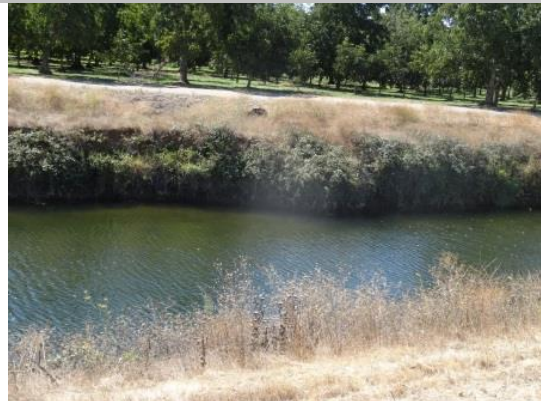
Photo 2 of 3 : SJR2015_NA0017U16RM20.71_2.jpg

Front view of the erosion. Site is covered with vegetation and trees.

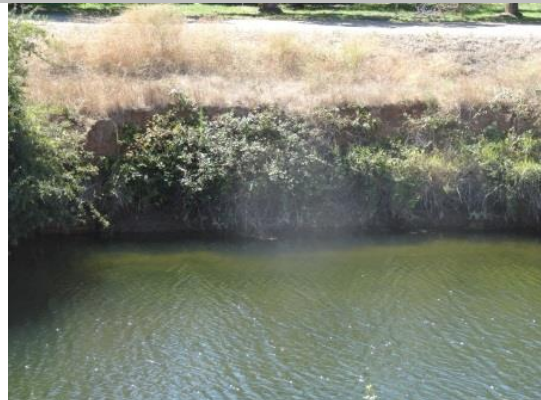
Photo 3 of 3 : SJR2015_NA0017U16RM20.71_4.jpg

Closer view of the erosion.

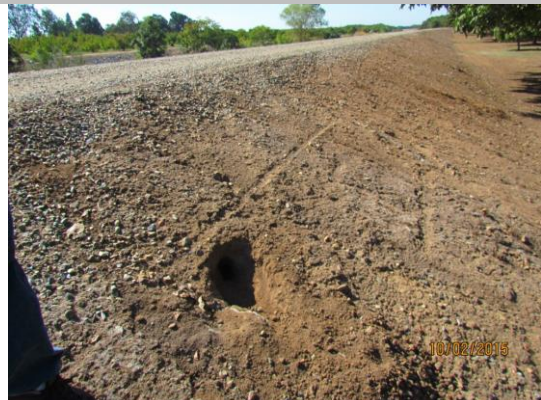
Photo 1 of 1 : FA_2015_NA0017_159_128_20151009_00140.jpg

LM Start	2.83	Rating **	M	Issue No.	128
LM End	2.83	Issue Type +	Ma	Location *	LS
Category	Earthen Levee			GPS Latitude/Longitude	
				Start	End
Item	Animal Control			38.028356 °	38.028356 °
				-121.051148 °	-121.051148 °
DWR ID	DWR_NA0017_15_f_2015_128				
Action/Comments					
No rodents visible, but rodent burrows visible; need to backfill and compact or grout burrows.

Rodent holes were found on the landside of the levee looking downstream.

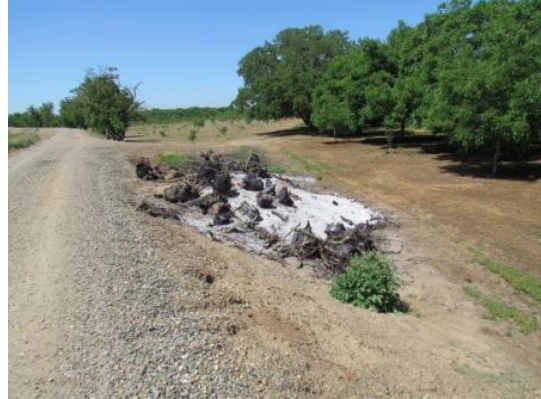
Photo 1 of 1 : FA_2015_NA0017_159_12_20150911_00005.jpg

LM Start	3.34	Rating **	M	Issue No.	12
LM End	3.34	Issue Type +	Ma	Location *	LS
Category	Earthen Levee			GPS Latitude/Longitude	
				Start	End
Item	Encroachments			38.023817 °	38.023817 °
				-121.058465 °	-121.058465 °
DWR ID	DWR_NA0017_15_s_2012_12				
Action/Comments					
Prunings					
Inspector Comments: Burn pile has been burned but new material has been placed.

New material was placed at the toe of the landside of the levee. The picture was taken from the crown looking downstream.

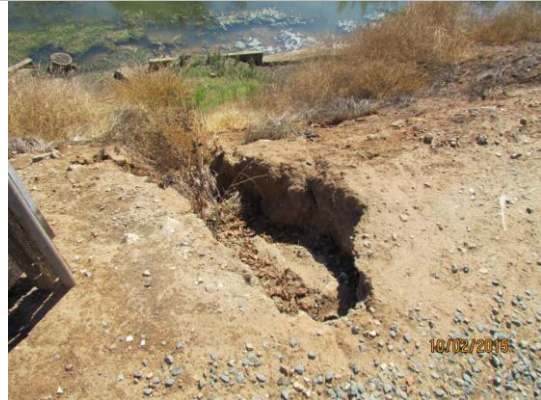
Photo 1 of 1 : FA_2015_NA0017_159_129_20151009_00141.jpg

Erosion was found on the waterside shoulder of the levee looking downstream.

LM Start	3.34	Rating **	M	Issue No.	129
LM End	3.34	Issue Type +	Ma	Location *	WS
Category	Earthen Levee			GPS Latitude/Longitude	
				Start	End
Item	Erosion / Bank Caving			38.023804 °	38.023804 °
				-121.058480 °	-121.058480 °
DWR ID	DWR_NA0017_15_f_2015_129				
Action/Comments					
Schedule repair of erosion site prior to the next inspection.

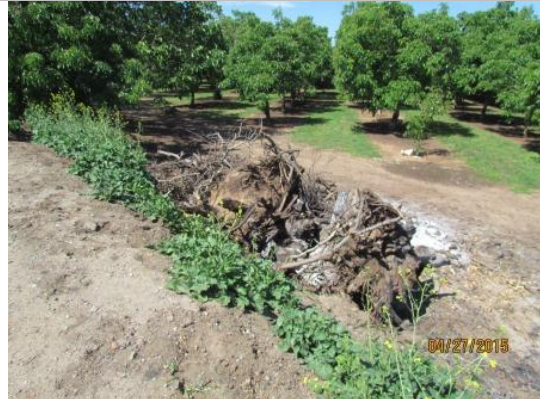
Photo 1 of 2 : FA_2015_NA0017_159_14_20150911_00006.jpg

LM Start	3.54	Rating **	A/W	Issue No.	14
LM End	3.54	Issue Type +	Ma	Location *	LS
Category	Earthen Levee			GPS Latitude/Longitude	
				Start	End
Item	Encroachments			38.021811 °	38.021811 °
				-121.061054 °	-121.061054 °
DWR ID	DWR_NA0017_15_s _ 2013_14				
Action/Comments					
Prunings Inspector Comments: The pit was repaired by the LMA but the prunings still exist. The burn pile is away from the levee prism.

Updated picture of the prunings on the landside toe of the levee during spring 2015 inspection.

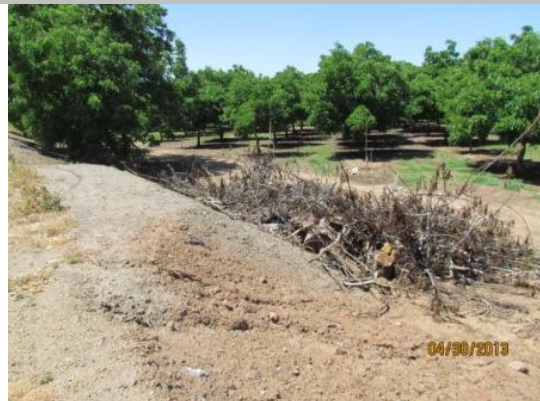
Photo 2 of 2 : FA_2015_NA0017_159_14_20150911_00007.jpg

Prunings were found on the landside toe of the levee looking downstream.

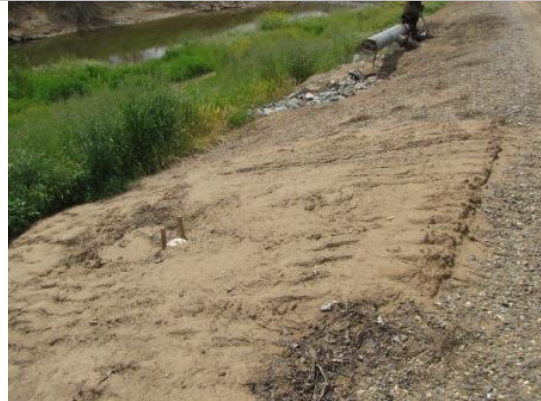
Photo 1 of 1 : FA_2015_NA0017_159_54_20150911_00041.jpg

LM Start	3.56	Rating **	M	Issue No.	54
LM End	3.56	Issue Type +	Ma	Location *	WS
Category	Earthen Levee			GPS Latitude/Longitude	
				Start	End
Item	Encroachments			38.021601 °	38.021601 °
				-121.061284 °	-121.061284 °
DWR ID	DWR_NA0017_15_s_2012_54				
Action/Comments					
Pipe					
Inspector Comments: A recently placed pipe in the waterward slope may be leaking and was not authorized.

View of a recently placed pipe in the waterward slope looking downstream.

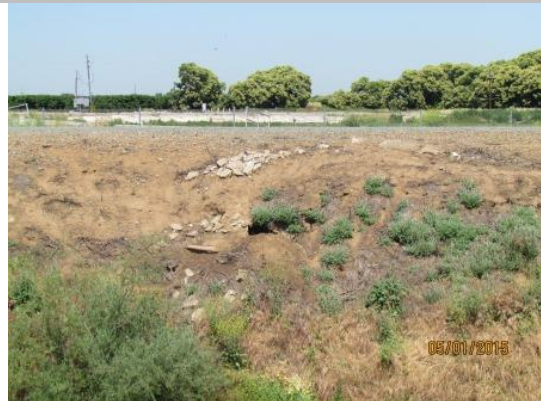
Photo 1 of 1 : FA_2015_NA0017_159_208_20150911_00113.jpg

A rodent hole was found on the waterside of the levee. The picture was taken from the opposite side of the levee.

LM Start	3.77	Rating **	M	Issue No.	208
LM End	3.77	Issue Type +	Ma	Location *	WS
Category	Earthen Levee			GPS Latitude/Longitude	
				Start	End
Item	Animal Control			38.019026 °	38.019026 °
				-121.063479 °	-121.063479 °
DWR ID	DWR_NA0017_15_s_2015_208				
Action/Comments					
No rodents visible, but rodent burrows visible; need to backfill and compact or grout burrows.

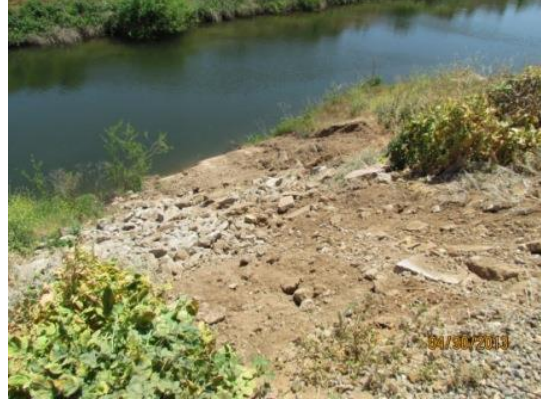
Photo 1 of 2 : FA_2015_NA0017_159_43_20150911_00030.jpg

Updated picture of the slope instability on the waterside slope of the levee looking downstream.

LM Start	3.78	Rating **	M	Issue No.	43
LM End	3.78	Issue Type +	Ma	Location *	WS
Category	Earthen Levee			GPS Latitude/Longitude	
				Start	End
Item	Slope Stability			38.019119 °	38.019119
				-121.064034 °	-121.064034
DWR ID	DWR_NA0017_15_f_2012_43				
Action/Comments					
Repair slope instability.

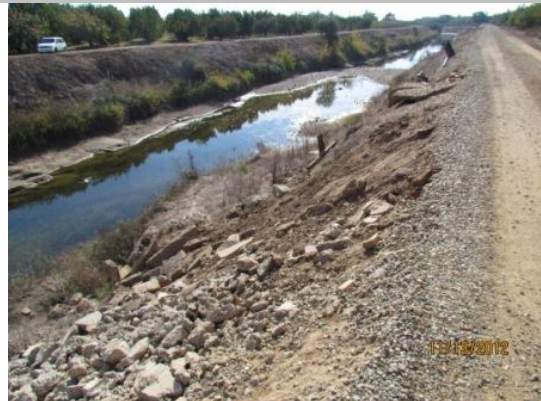
Photo 2 of 2 : FA_2015_NA0017_159_43_20150911_00031.jpg

Slope instability was found on the landside slope of the levee looking downstream.

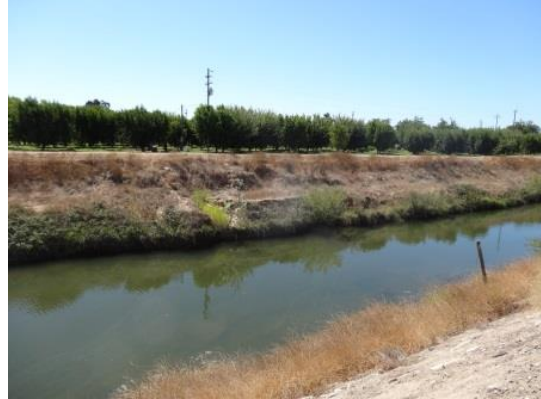
Photo 1 of 3 : SJR2015_NA0017U16RM19.18_1.jpg

LM Start	3.87	Rating **	M	Issue No.	17
LM End	3.89	Issue Type +	Ma	Location *	WS
Category	Supplemental			GPS Latitude/Longitude	
				Start	End
Item	DWR Erosion Survey			38.018100 °	38.018100 °
				-121.065170 °	-121.065170 °
DWR ID					
Action/Comments					
Inspector Comments: 8/12/2015: No significant change observed. 8/20/2014: No significant change observed. 9/12/2013: No significant change observed. 08/22/2012: River-induced erosion occurred on the berm, while the runoff-induced erosion occurred on the levee slope. Site is covered with vegetation. There is no levee structure on site. The levee crest width

View of the site from right river bank.

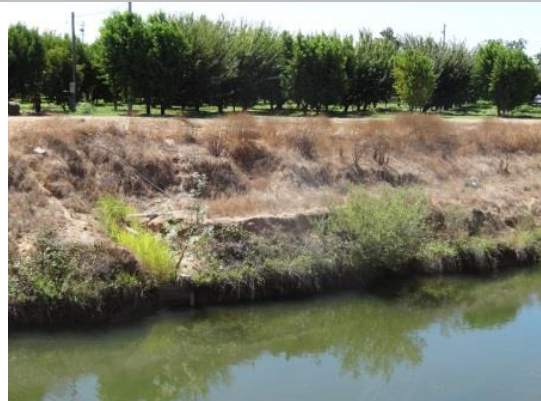
Photo 2 of 3 : SJR2015_NA0017U16RM19.18_2.jpg

Closer view of the erosion.

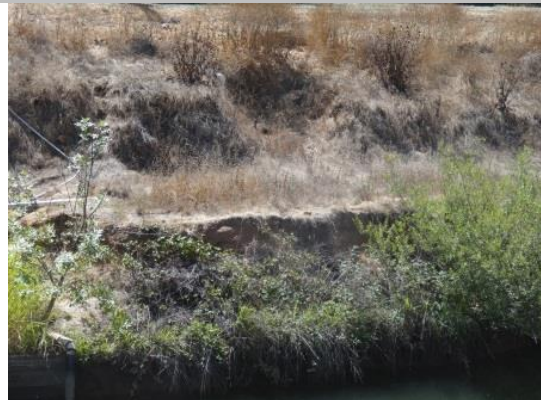
Photo 3 of 3 : SJR2015_NA0017U16RM19.18_4.jpg

Closer view of the erosion.

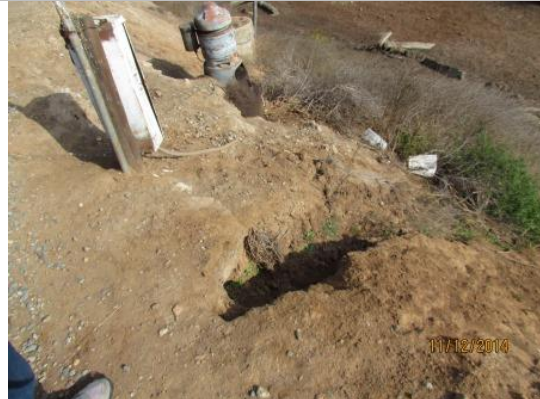
Photo 1 of 2 : FA_2015_NA0017_159_44_20150911_00032.jpg

Updated picture of the slope instability on the waterside slope of the levee looking upstream. This picture was taken during fall 2014 inspection.

LM Start	3.89	Rating **	M	Issue No.	44
LM End	3.89	Issue Type +	Ma	Location *	WS
Category	Earthen Levee			GPS Latitude/Longitude	
				Start	End
Item	Slope Stability			38.017945 °	38.017945
				-121.065295 °	-121.065295
DWR ID	DWR_NA0017_15_f_2012_44				
Action/Comments					
Repair slope instability.

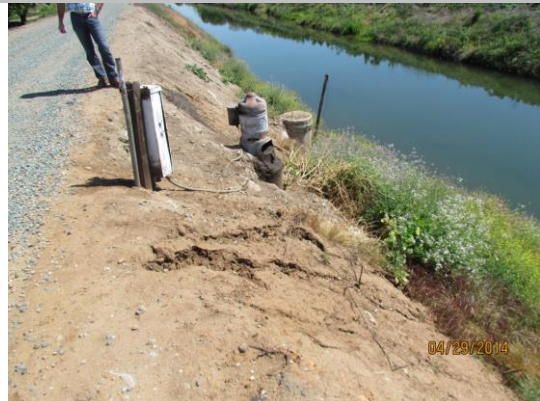
Photo 2 of 2 : FA_2015_NA0017_159_44_20150911_00033.jpg

View of the slope instability on the waterside slope of the levee looking downstream during spring 2014 inspection.

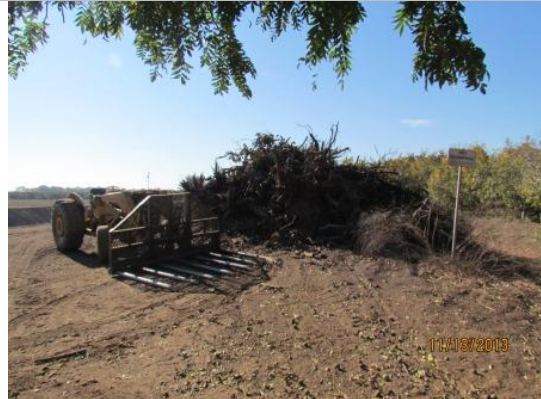
Photo 1 of 2 : FA_2015_NA0017_159_19_20150911_00012.jpg

LM Start	4.20	Rating **	M	Issue No.	19
LM End	4.20	Issue Type +	Ma	Location *	LS
Category	Earthen Levee			GPS Latitude/Longitude	
				Start	End
Item	Encroachments			38.014025 °	38.014025 °
				-121.067983 °	-121.067983 °
DWR ID	DWR_NA0017_15_s_2012_19				
Action/Comments					
Prunings					
Inspector Comments: Burn pile has been burned but new material has been placed.

Updated picture of the prunings pile on the landside of the levee looking downstream during fall 2013 inspection.

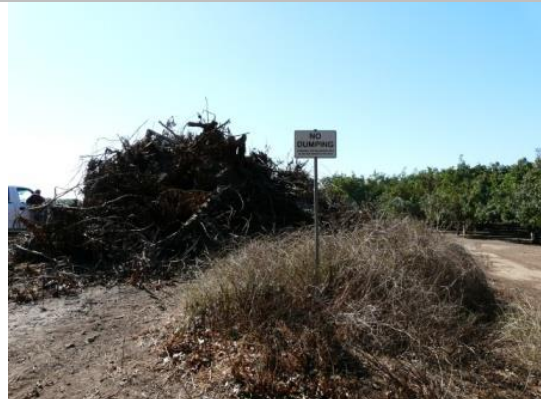
Photo 2 of 2 : FA_2015_NA0017_159_19_20150911_00013.jpg

Example of a prunings pile immediately adjacent to access road.
Evidence of habitual burnings at this site.

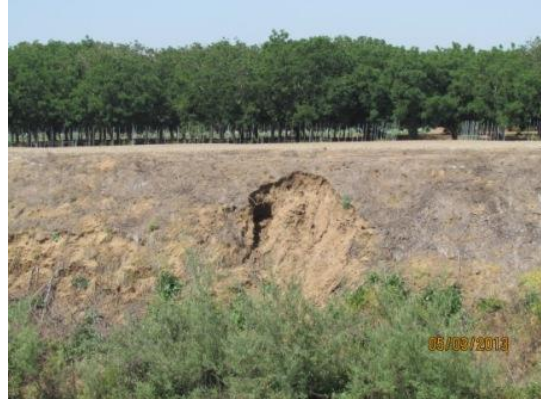
Photo 1 of 1 : FA_2015_NA0017_159_124_20150911_00080.jpg

LM Start	4.28	Rating **	U	Issue No.	124
LM End	4.28	Issue Type +	Ma	Location *	WS
Category	Earthen Levee			GPS Latitude/Longitude	
				Start	End
Item	Animal Control			38.012910 °	38.012910 °
				-121.067996 °	-121.067996 °
DWR ID	DWR_NA0017_15_s_2013_124				
Action/Comments					
No rodents visible, but rodent burrows visible; need to backfill and compact or grout burrows. Inspector Comments: Picture was taken from the other side of the levee.

An animal hole was found on the waterside slope of the levee. The picture was taken from the opposite side of the levee.

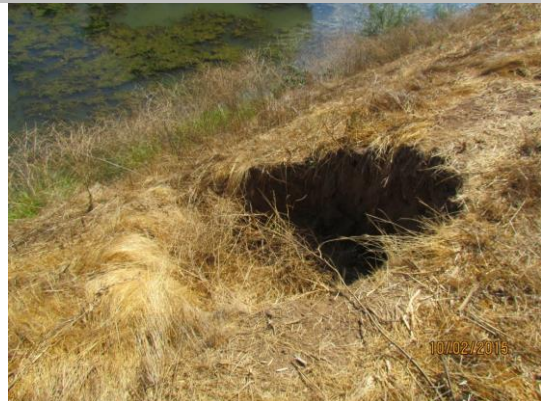
Photo 1 of 2 : FA_2015_NA0017_159_209_20151009_00143.jpg

LM Start	4.31	Rating **	M	Issue No.	209
LM End	4.31	Issue Type +	Ma	Location *	WS
Category	Earthen Levee			GPS Latitude/Longitude	
				Start	End
Item	Erosion / Bank Caving			38.012474 °	38.012474 °
				-121.068144 °	-121.068144 °
DWR ID	DWR_NA0017_15_s_2015_209				
Action/Comments					
Schedule repair of erosion site prior to the next inspection.					
Inspector Comments: It was started from rodent holes.

View of the erosion caused by an animal hole on the waterside shoulder of the levee looking downstream.

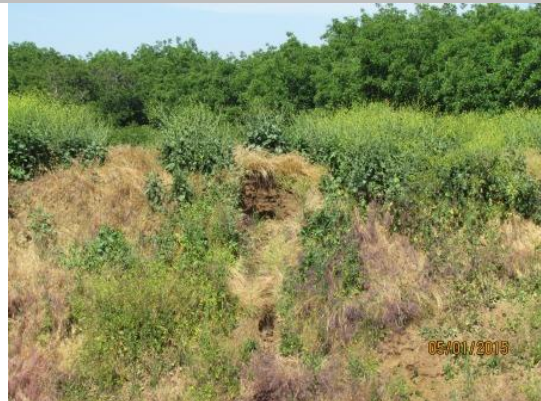
Photo 2 of 2 : FA_2015_NA0017_159_209_20150911_00114.jpg

A large rodent hole was found on the waterside of the levee. The picture was taken across the levee.

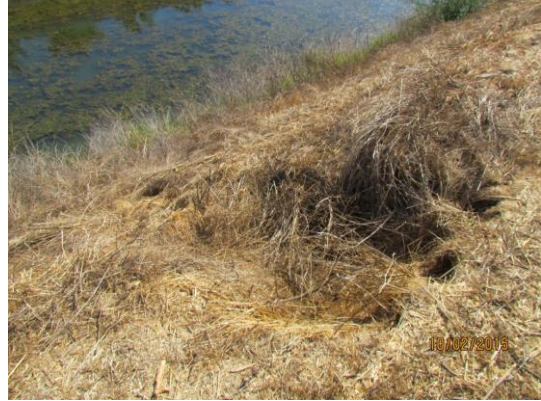
Photo 1 of 1 : FA_2015_NA0017_159_133_20151009_00144.jpg

Erosion was found on the waterside shoulder of the levee looking downstream.

LM Start	4.51	Rating **	M	Issue No.	133
LM End	4.51	Issue Type +	Ma	Location *	WS
Category	Earthen Levee			GPS Latitude/Longitude	
				Start	End
Item	Erosion / Bank Caving			38.009753 °	38.009753 °
				-121.069559 °	-121.069559 °
DWR ID	DWR_NA0017_15_f _ 2015_133				
Action/Comments					
Schedule repair of erosion site prior to the next inspection.

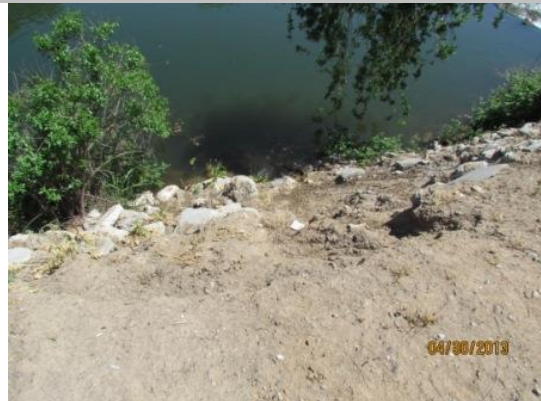
Photo 1 of 3 : FA_2015_NA0017_159_96_20150911_00064.jpg

LM Start	4.63	Rating **	M	Issue No.	96
LM End	4.63	Issue Type +	Ma	Location *	WS
Category	Earthen Levee			GPS Latitude/Longitude	
				Start	End
Item	Erosion / Bank Caving			38.008053 °	38.008053 °
				-121.070141 °	-121.070141 °
DWR ID	DWR_NA0017_15_s_2012_96				
Action/Comments					
Note and monitor erosion site. Inspector Comments: LMA has fixed the issue but the riprap has rebar which would can be dangerous during the flood fighting efforts.

Updated picture of the slope instability on the waterside slope of the levee looking downstream during spring 2013 inspection.

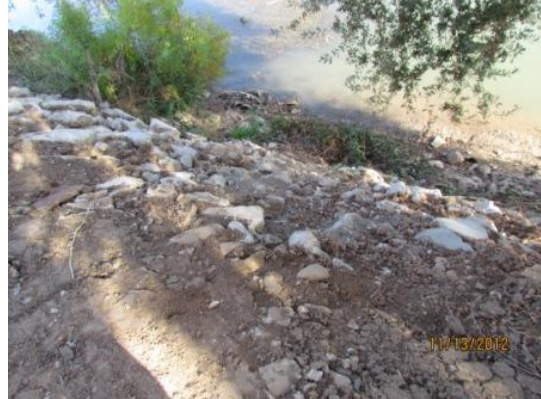
Photo 2 of 3 : FA_2015_NA0017_159_96_20150911_00065.jpg

LM Start	4.63	Rating **	M	Issue No.	96 (cont)
LM End	4.63	Issue Type +	Ma	Location *	WS
Category	Earthen Levee			GPS Latitude/Longitude	
				Start	End
Item	Erosion / Bank Caving			38.008053 °	38.008053 °
				-121.070141 °	-121.070141 °
DWR ID	DWR_NA0017_15_s_2012_96				
Action/Comments					
Note and monitor erosion site. Inspector Comments: LMA has fixed the issue but the riprap has rebar which would can be dangerous during the flood fighting efforts.

The LMA has fixed the erosion on the landside slope of the levee but the riprap contains exposed rebar which could be dangerous during a flood fight.

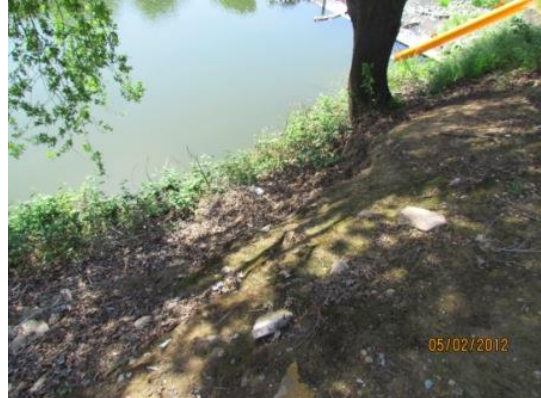
Photo 3 of 3 : FA_2015_NA0017_159_96_20150911_00066.jpg

LM Start	4.63	Rating **	M	Issue No.	96 (cont)
LM End	4.63	Issue Type +	Ma	Location *	WS

Erosion was found on the waterside slope of the levee looking downstream.

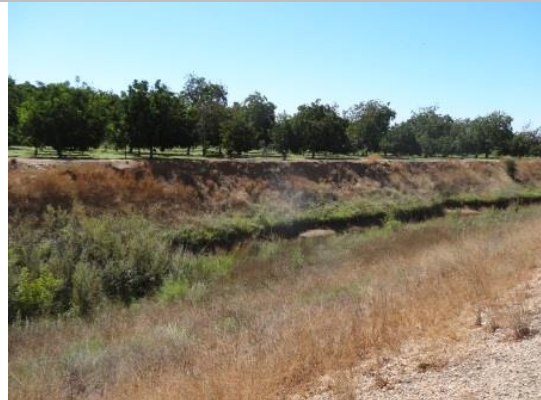
Photo 1 of 2 : SJR2015_NA0017U16RM17.99_1.jpg

LM Start	4.98	Rating **	U	Issue No.	11
LM End	4.98	Issue Type +	Ma	Location *	WS
Category	Supplemental			GPS Latitude/Longitude	
				Start	End
Item	DWR Erosion Survey			38.003730 °	38.003730 °
				-121.073080 °	-121.073080 °
DWR ID					
Action/Comments					
Inspector Comments: 8/12/2015: No significant change observed. 8/20/2014: No significant change observed. 9/12/2013: Site has been surveyed and the pocket erosion has developed toward levee crest. 08/22/2012: A pocket erosion at the levee toe and on lower slope. The levee surface at the upper slope also shows signs of erosion due to

View from right river bank.

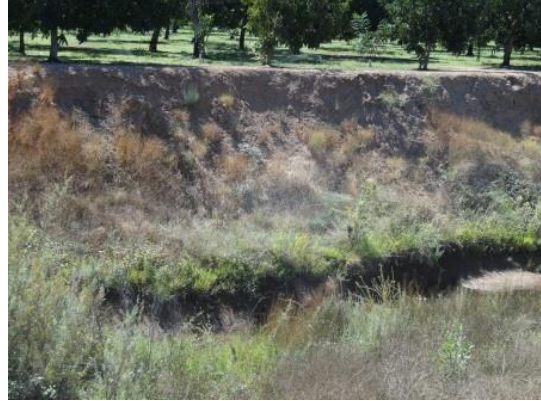
Photo 2 of 2 : SJR2015_NA0017U16RM17.99_4.jpg

LM Start	4.98	Rating **	U	Issue No.	11 (cont)
LM End	4.98	Issue Type +	Ma	Location *	WS
Category	Supplemental			GPS Latitude/Longitude	
				Start	End
Item	DWR Erosion Survey			38.003730 °	38.003730 °
				-121.073080 °	-121.073080 °
DWR ID					
Action/Comments					
Inspector Comments: 8/12/2015: No significant change observed. 8/20/2014: No significant change observed. 9/12/2013: Site has been surveyed and the pocket erosion has developed toward levee crest. 08/22/2012: A pocket erosion at the levee toe and on lower slope. The levee surface at the upper slope also shows signs of erosion due to poor maintenance. There is no levee structure on site. The levee crest width and levee height were not measured or estimated in the field. [2015 Site ID:NA0017U16RM17.99]

A close view of the erosion.

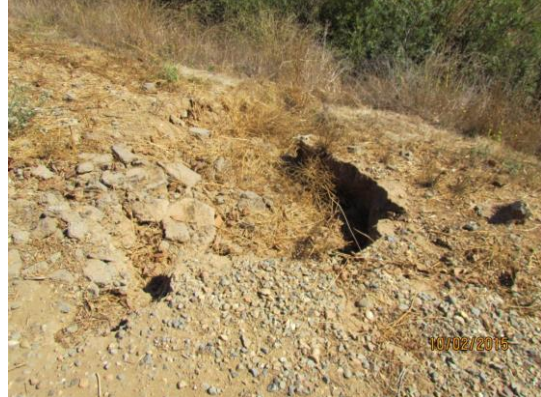
Photo 1 of 2 : FA_2015_NA0017_159_171_20151009_00145.jpg

LM Start	5.03	Rating **	M	Issue No.	171
LM End	5.03	Issue Type +	Ma	Location *	WS
Category	Earthen Levee			GPS Latitude/Longitude	
				Start	End
Item	Erosion / Bank Caving			38.003105 °	38.003105 °
				-121.073585 °	-121.073585 °
DWR ID	DWR_NA0017_15_f_2014_171				
Action/Comments					
Schedule repair of erosion site prior to the next inspection.					
Inspector Comments: Bank Caving.

Updated picture of the slope instability on the waterside of the levee looking upstream during fall 2015 inspection.

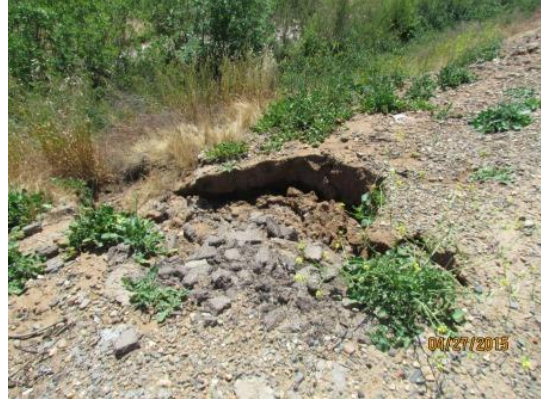
Photo 2 of 2 : FA_2015_NA0017_159_171_20150911_00096.jpg

LM Start	5.03	Rating **	M	Issue No.	171 (cont)
LM End	5.03	Issue Type +	Ma	Location *	WS
Category	Earthen Levee			GPS Latitude/Longitude	
				Start	End
Item	Erosion / Bank Caving			38.003105 °	38.003105
				-121.073585 °	-121.073585
DWR ID	DWR_NA0017_15_f_2014_171				
Action/Comments					
Schedule repair of erosion site prior to the next inspection. Inspector Comments: Bank Caving.

Picture of the slope instability on the waterside of the levee looking downstream during spring 2015 inspection.

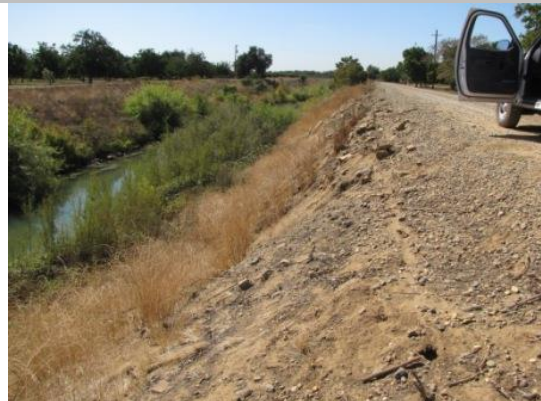
Photo 1 of 1 : FA_2015_NA0017_159_1009_20150911_00120.jpg

LM Start	5.04	Rating **	M	Issue No.	1009
LM End	5.04	Issue Type +	Ma	Location *	WS
Category	Earthen Levee			GPS Latitude/Longitude	
				Start	End
Item	Slope Stability			38.003021 °	38.003021 °
				-121.073658 °	-121.073658 °
DWR ID	DWR_NA0017_15_s_2012_1009				
Action/Comments					
Repair slope instability.

View of a slip in the waterward levee slope looking downstream.

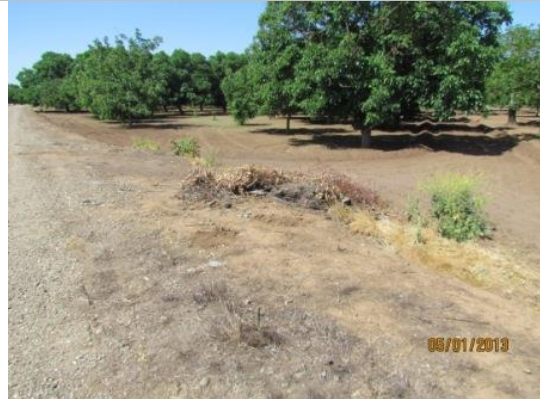
Photo 1 of 1 : FA_2015_NA0017_159_98_20150911_00067.jpg

LM Start	6.46	Rating **	M	Issue No.	98
LM End	6.46	Issue Type +	Ma	Location *	LS
Category	Earthen Levee			GPS Latitude/Longitude	
				Start	End
Item	Encroachments			37.986225 °	37.986225 °
				-121.088704 °	-121.088704 °
DWR ID	DWR_NA0017_15_f_2012_98				
Action/Comments					
Prunings

Prunings were found on the landside of the levee looking downstream.

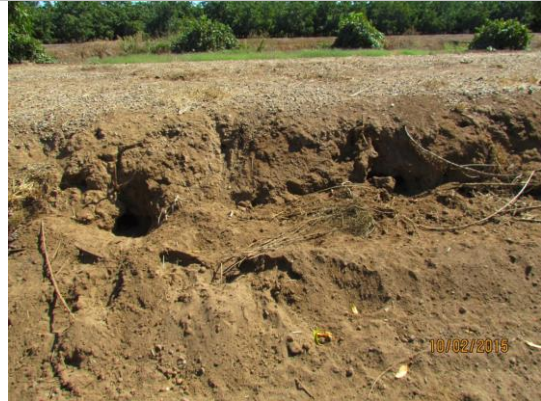
Photo 1 of 1 : FA_2015_NA0017_159_140_20151009_00147.jpg

LM Start	6.67	Rating **	M	Issue No.	140
LM End	6.67	Issue Type +	Ma	Location *	LS
Category	Earthen Levee			GPS Latitude/Longitude	
				Start	End
Item	Animal Control			37.983817 °	37.983817 °
				-121.091141 °	-121.091141 °
DWR ID	DWR_NA0017_15_f _ 2015_140				
Action/Comments					
No rodents visible, but rodent burrows visible; need to backfill and compact or grout burrows.

Rodent holes were found on the landside shoulder of the levee looking downstream.

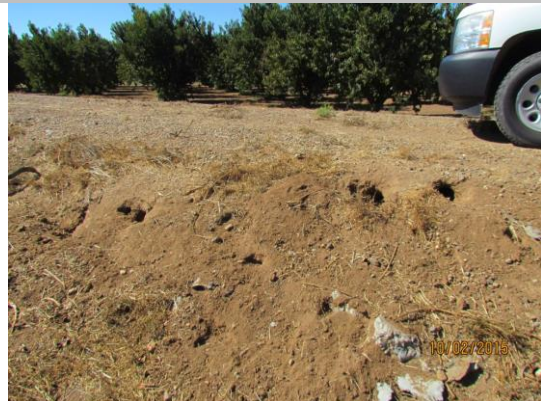
Photo 1 of 1 : FA_2015_NA0017_159_139_20151009_00146.jpg

LM Start	6.68	Rating **	M	Issue No.	139
LM End	6.68	Issue Type +	Ma	Location *	WS
Category	Earthen Levee			GPS Latitude/Longitude	
				Start	End
Item	Animal Control			37.983817 °	37.983817 °
				-121.091142 °	-121.091142 °
DWR ID	DWR_NA0017_15_f_2015_139				
Action/Comments					
No rodents visible, but rodent burrows visible; need to backfill and compact or grout burrows.

Rodent holes were found on the waterside of the levee.

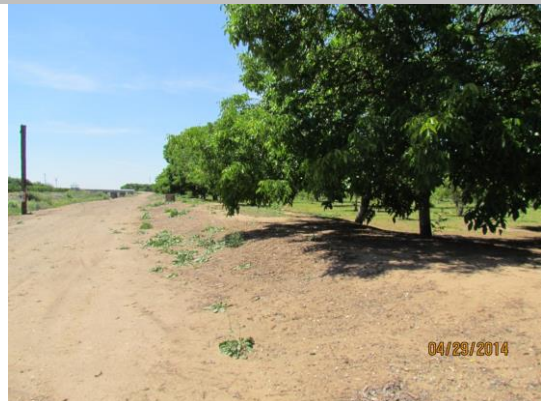
Photo 1 of 1 : FA_2015_NA0017_159_115_20150911_00076.jpg

LM Start	6.96	Rating **	M	Issue No.	115
LM End	7.20	Issue Type +	Ma	Location *	LS
Category	Earthen Levee			GPS Latitude/Longitude	
				Start	End
Item	Trim / Thin Trees			37.981387 °	37.979749 °
				-121.095370 °	-121.099178 °
DWR ID	DWR_NA0017_15_s_2014_115				
Action/Comments					
Trim trees to at least five feet above ground level.

Tree limbs were obstructing the visibility of the crown of the levee looking downstream.

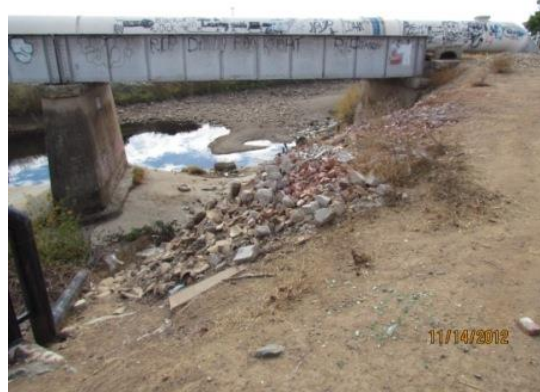
Photo 1 of 1 : FA_2015_NA0017_159_102_20150911_00068.jpg

LM Start	7.21	Rating **	M	Issue No.	102
LM End	7.21	Issue Type +	Ma	Location *	WS
Category	Earthen Levee			GPS Latitude/Longitude	
				Start	End
Item	Encroachments			37.979612 °	37.979612 °
				-121.099390 °	-121.099390 °
DWR ID	DWR_NA0017_15_s_2012_102				
Action/Comments					
Debris

Debris was found on the waterside slope of the levee looking downstream.

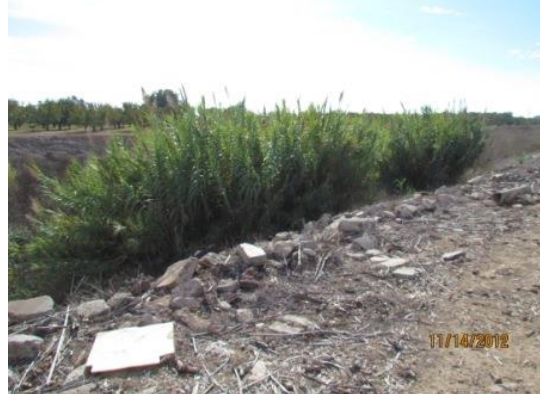
Photo 1 of 2 : FA_2015_NA0017_159_104_20150911_00069.jpg

LM Start	7.89	Rating **	M	Issue No.	104
LM End	7.89	Issue Type +	Ma	Location *	WS
Category	Earthen Levee			GPS Latitude/Longitude	
				Start	End
Item	Vegetation			37.974304 °	37.974304 °
				-121.109625 °	-121.109625 °
DWR ID	DWR_NA0017_15_s_2012_104				
Action/Comments					
Remove the wild growth other than native grasses from the levee slopes.

Updated picture of the Arundo on the waterside slope of the levee looking downstream.

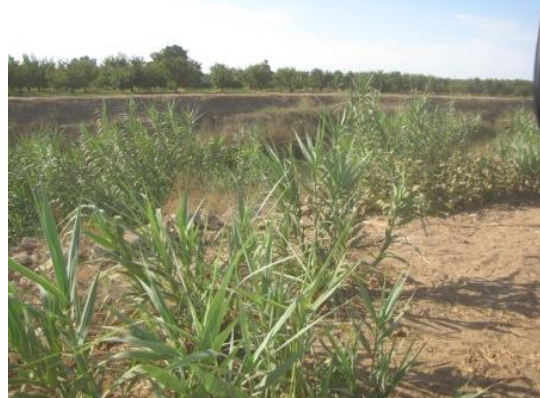
Photo 2 of 2 : FA_2015_NA0017_159_104_20150911_00070.jpg

LM Start	7.89	Rating **	M	Issue No.	104 (cont)
LM End	7.89	Issue Type +	Ma	Location *	WS

View of arrundo on the waterward shoulder and slope blocking visibility looking downstream.

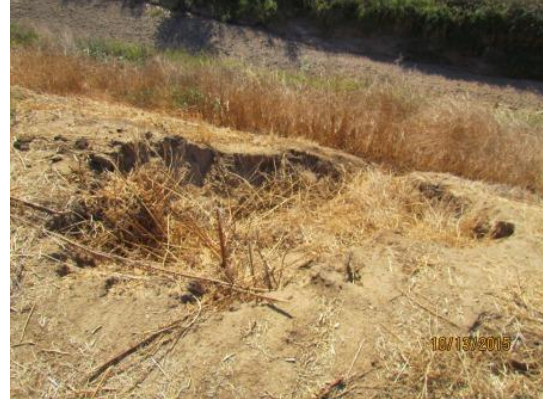
Photo 1 of 2 : FA_2015_NA0017_159_65_20151019_00149.jpg

LM Start	8.43	Rating **	U	Issue No.	65
LM End	8.43	Issue Type +	Ma	Location *	WS
Category	Earthen Levee			GPS Latitude/Longitude	
				Start	End
Item	Erosion / Bank Caving			37.969748 °	37.969748 °
				-121.116767 °	-121.116767 °
DWR ID	DWR_NA0017_15_s _ 2013_65				
Action/Comments					
Schedule repair of erosion site prior to the next inspection.

Updated picture of the slope instability on the waterside of the levee looking upstream during fall 2015 inspection.

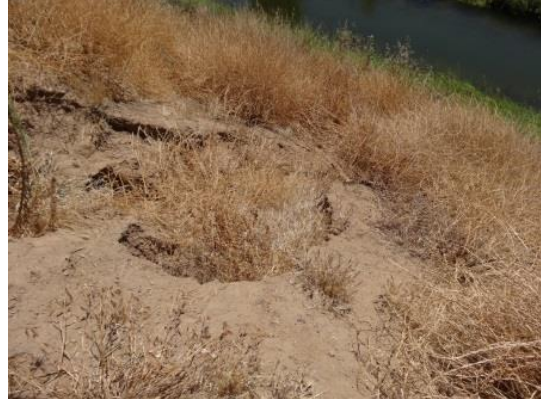
Photo 2 of 3 : SJR2015_NA0017U15RM14.49_3.JPG

LM Start	8.43	Rating **	M	Issue No.	6 (cont)	
LM End	8.43	Issue Type +	Ma	Location *	WS	
Category	Supplemental			GPS Latitude/Longitude		
				Start		End
Item	DWR Erosion Survey			37.969711 °		37.969711 °
				-121.116739 °		-121.116739 °
DWR ID						
Action/Comments						
Inspector Comments: 8/12/2015: No significant change observed. More vegetation is observed at the site. 8/20/2014: No significant change observed. 09/12/2013: The erosion has been caused by runoff. [2015 Site ID:NA0017U15RM14.49]

Close view of the erosion.

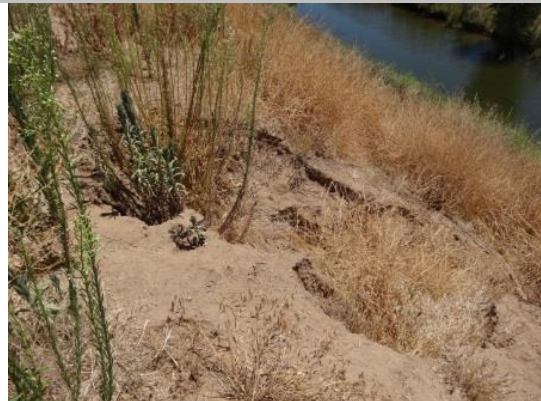
Photo 3 of 3 : SJR2015_NA0017U15RM14.49_4.JPG

LM Start	8.43	Rating **	M	Issue No.	6 (cont)
LM End	8.43	Issue Type +	Ma	Location *	WS

Close view of the erosion.

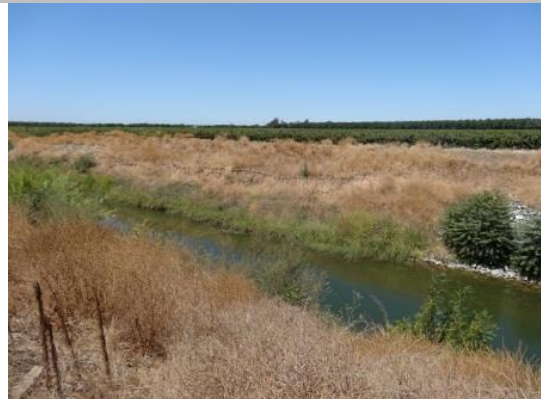
Photo 1 of 3 : SJR2015_NA0017U15RM13.87_1.JPG

LM Start	8.81	Rating **	M	Issue No.	4
LM End	8.83	Issue Type +	Ma	Location *	WS
Category	Supplemental			GPS Latitude/Longitude	
				Start	End
Item	DWR Erosion Survey			37.968060 °	37.968060 °
				-121.123299 °	-121.123299 °
DWR ID					
Action/Comments					
Inspector Comments: 8/12/2015: No significant change observed. 8/20/2014: Both ends of the erosion site are protected by riprap. [2015 Site ID:NA0017U15RM13.87]

View of the site from the left river bank.

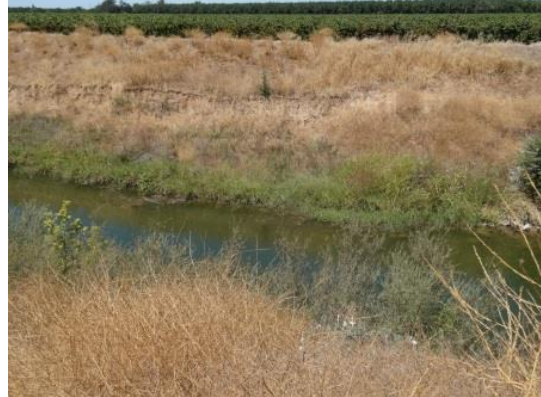
Photo 2 of 3 : SJR2015_NA0017U15RM13.87_2.JPG

LM Start	8.81	Rating **	M	Issue No.	4 (cont)	
LM End	8.83	Issue Type +	Ma	Location *	WS	
Category	Supplemental			GPS Latitude/Longitude		
				Start	End	
Item	DWR Erosion Survey			37.968060 °	37.968060 °	
				-121.123299 °	-121.123299 °	
DWR ID						
Action/Comments						
Inspector Comments: 8/12/2015: No significant change observed. 8/20/2014: Both ends of the erosion site are protected by riprap. [2015 Site ID:NA0017U15RM13.87]

Close view of the erosion.

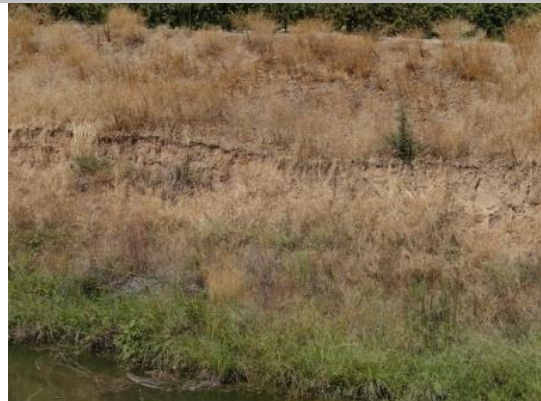
Photo 3 of 3 : SJR2015_NA0017U15RM13.87_4.JPG

LM Start	8.81	Rating **	M	Issue No.	4 (cont)
LM End	8.83	Issue Type +	Ma	Location *	WS

Close view of the erosion.

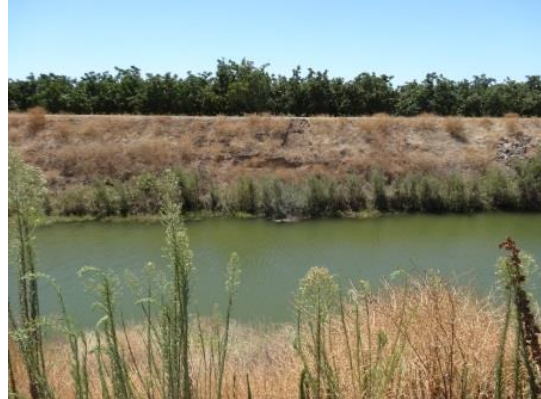
Photo 1 of 2 : SJR2015_NA0017U16RM13.85_1.JPG

LM Start	9.07	Rating **	U	Issue No.	10
LM End	9.07	Issue Type +	Ma	Location *	WS
Category	Supplemental			GPS Latitude/Longitude	
				Start	End
Item	DWR Erosion Survey			37.967019 °	37.967019 °
				-121.127581 °	-121.127581 °
DWR ID					
Action/Comments					
Inspector Comments: 8/12/2015: No significant change observed. 8/20/2014: No significant change observed. 9/12/2013: The erosion might have been caused by river flow combined with runoff. Dense vegetation is presents at the site. There is no levee structure on site. The levee crest width and levee height were not measured or estimated in the field. [2015 Site ID:NA0017U16RM13.85]

View of the site from the right river bank.

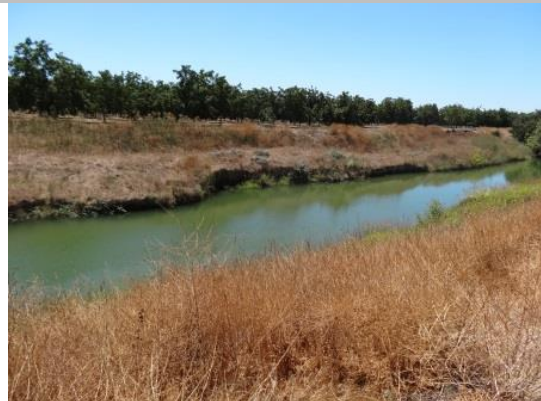
Photo 1 of 3 : SJR2015_NA0017U16RM13.53_1.jpg

LM Start	9.37	Rating **	M	Issue No.	8
LM End	9.39	Issue Type +	Ma	Location *	WS
Category	Supplemental			GPS Latitude/Longitude	
				Start	End
Item	DWR Erosion Survey			37.967190 °	37.967190 °
				-121.133080 °	-121.133080 °
DWR ID					
Action/Comments					
Inspector Comments: 8/12/2015: No significant change observed. 8/20/2014: No significant change observed. 9/12/2013: No significant change observed. 08/22/2012: The erosion is on berm. The berm width is estimated. There is no levee structure on site. The levee crest width and levee height were not measured or estimated in the field. [2015 Site

Upstream view of the erosion.

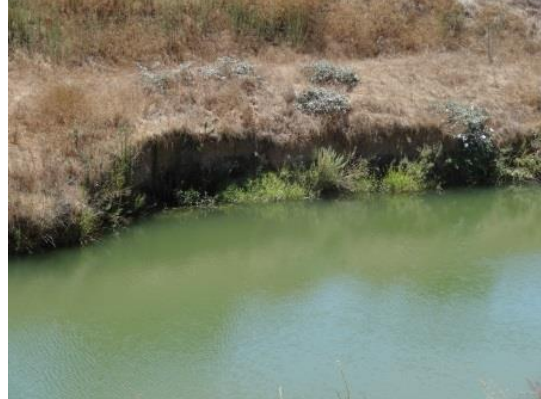
Photo 2 of 3 : SJR2015_NA0017U16RM13.53_3.jpg

LM Start	9.37	Rating **	M	Issue No.	8 (cont)	
LM End	9.39	Issue Type +	Ma	Location *	WS	
Category	Supplemental			GPS Latitude/Longitude		
				Start		End
Item	DWR Erosion Survey			37.967190 °		37.967190 °
				-121.133080 °		-121.133080 °
DWR ID						
Action/Comments						
Inspector Comments: 8/12/2015: No significant change observed. 8/20/2014: No significant change observed. 9/12/2013: No significant change observed. 08/22/2012: The erosion is on berm. The berm width is estimated. There is no levee structure on site. The levee crest width and levee height were not measured or estimated in the field. [2015 Site ID:NA0017U16RM13.53]

Close view of the erosion.

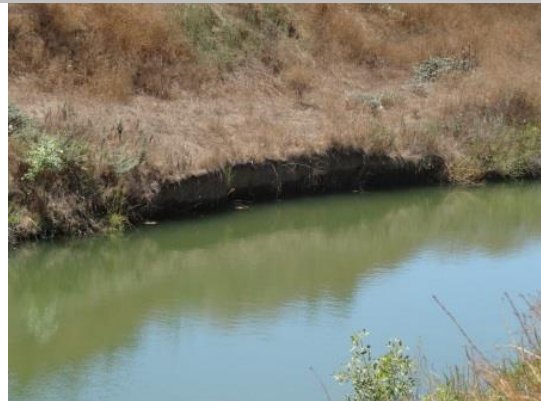
Photo 3 of 3 : SJR2015_NA0017U16RM13.53_4.jpg

LM Start	9.37	Rating **	M	Issue No.	8 (cont)
LM End	9.39	Issue Type +	Ma	Location *	WS

Close view of the erosion.

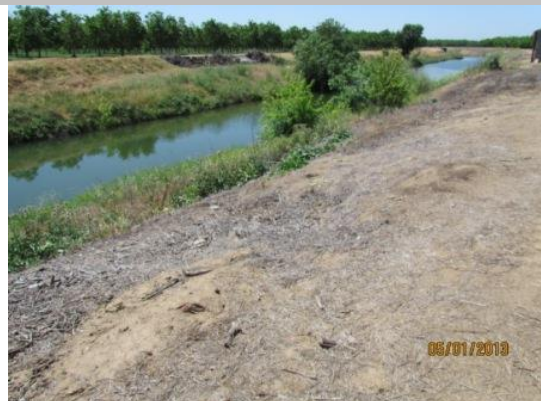
Photo 1 of 1 : FA_2015_NA0017_159_121_20150911_00078.jpg

A slope instability was found on the waterside slope of the levee looking downstream.

LM Start	9.39	Rating **	M	Issue No.	121
LM End	9.39	Issue Type +	Ma	Location *	WS
Category	Earthen Levee			GPS Latitude/Longitude	
				Start	End
Item	Slope Stability			37.967155 °	37.967155 °
				-121.133277 °	-121.133277 °
DWR ID	DWR_NA0017_15_f_2012_121				
Action/Comments					
Repair slope instability.

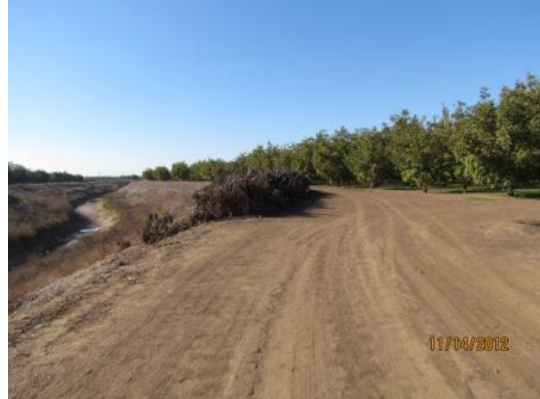
Photo 1 of 1 : FA_2015_NA0017_159_147_20150911_00090.jpg

LM Start	9.81	Rating **	M	Issue No.	147
LM End	9.81	Issue Type +	Ma	Location *	WS
Category	Earthen Levee			GPS Latitude/Longitude	
				Start	End
Item	Encroachments			37.965314 °	37.965314 °
				-121.140296 °	-121.140296 °
DWR ID	DWR_NA0017_15_s_2012_147				
Action/Comments					
Prunings

Prunings were found on the waterside shoulder of the levee looking downstream.

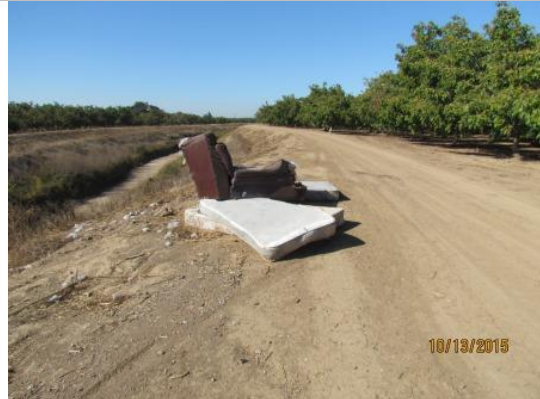
Photo 1 of 1 : FA_2015_NA0017_159_151_20151019_00150.jpg

LM Start	9.82	Rating **	M	Issue No.	151
LM End	9.82	Issue Type +	Ma	Location *	WS
Category	Earthen Levee			GPS Latitude/Longitude	
				Start	End
Item	Encroachments			37.965369 °	37.965369 °
				-121.140559 °	-121.140559 °
DWR ID	DWR_NA0017_15_f_2015_151				
Action/Comments					
Debris

Debris was found on the waterside shoulder of the levee looking downstream.

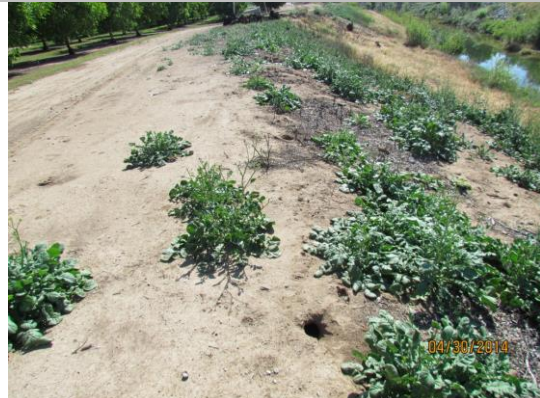
Photo 1 of 1 : FA_2015_NA0017_159_126_20150911_00082.jpg

View of rodent holes on the waterside of the levee looking upstream.

LM Start	9.83	Rating **	M	Issue No.	126
LM End	9.83	Issue Type +	Ma	Location *	WS
Category	Earthen Levee			GPS Latitude/Longitude	
				Start	End
Item	Animal Control			37.965343 °	37.965343 °
				-121.140761 °	-121.140761 °
DWR ID	DWR_NA0017_15_s_2014_126				
Action/Comments					
No rodents visible, but rodent burrows visible; need to backfill and compact or grout burrows.

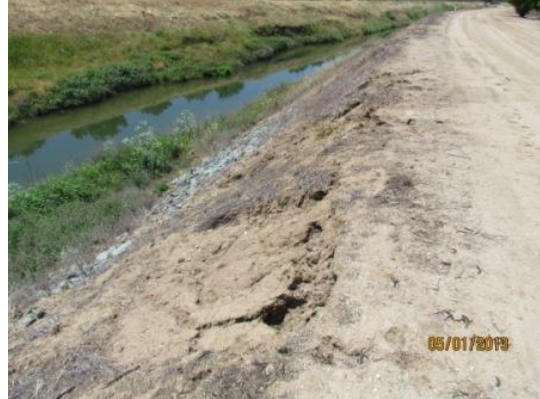
Photo 1 of 1 : FA_2015_NA0017_159_68_20150911_00052.jpg

Slope instability was found on the waterside slope of the levee looking downstream.

LM Start	9.90	Rating **	M	Issue No.	68
LM End	9.90	Issue Type +	Ma	Location *	WS
Category	Earthen Levee			GPS Latitude/Longitude	
				Start	End
Item	Slope Stability			37.965165 °	37.965165
				-121.141928 °	-121.141928
DWR ID	DWR_NA0017_15_s_2013_68				
Action/Comments					
Repair slope instability.

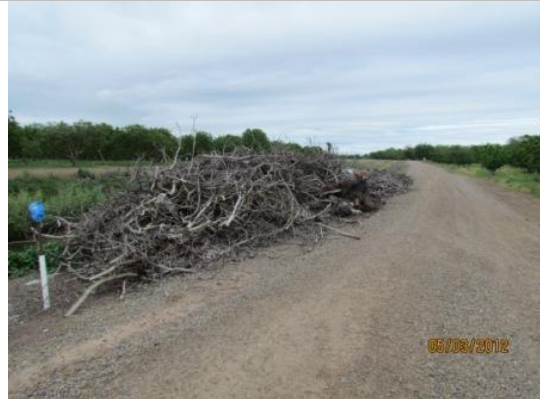
Photo 1 of 2 : FA_2015_NA0017_159_78_20150911_00057.jpg

LM Start	10.40	Rating **	M	Issue No.	78
LM End	10.40	Issue Type +	Ma	Location *	WS
Category	Earthen Levee			GPS Latitude/Longitude	
				Start	End
Item	Encroachments			37.964942 °	37.964942 °
				-121.151073 °	-121.151073 °
DWR ID	DWR_NA0017_15_s_2012_78				
Action/Comments					
Prunings

Prunings were found on the waterside of the levee looking downstream.

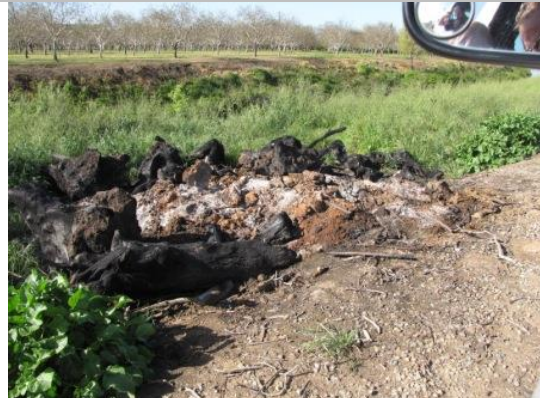
Photo 2 of 2 : FA_2015_NA0017_159_78_20150911_00058.jpg

View of the prunings pile on the waterward slope looking downstream.

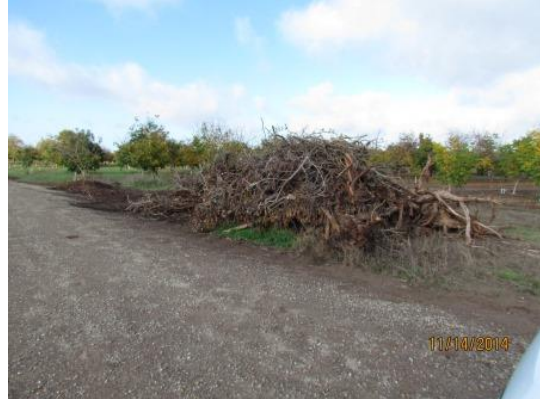
Photo 1 of 1 : FA_2015_NA0017_159_106_20150911_00071.jpg

LM Start	10.77	Rating **	M	Issue No.	106
LM End	10.77	Issue Type +	Ma	Location *	LS
Category	Earthen Levee			GPS Latitude/Longitude	
				Start	End
Item	Encroachments			37.963319 °	37.963319 °
				-121.157557 °	-121.157557 °
DWR ID	DWR_NA0017_15_s_2012_106				
Action/Comments					
Prunings					
Inspector Comments: Prunings and ashes piled at the toe.

Prunings were found on the landside of the levee looking downstream.

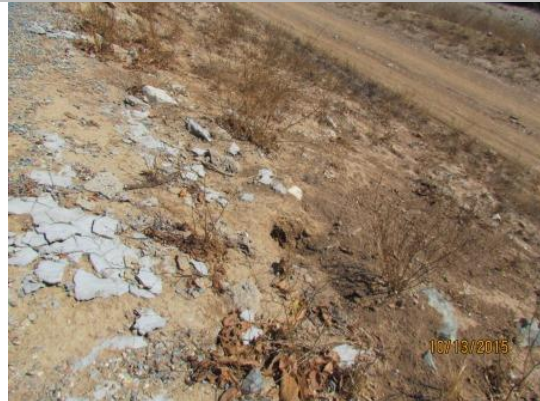
Photo 1 of 1 : FA_2015_NA0017_159_152_20151019_00151.jpg

A rodent hole was found on the waterside of the levee looking upstream.

LM Start	10.90	Rating **	M	Issue No.	152
LM End	10.90	Issue Type +	Ma	Location *	WS
Category	Earthen Levee			GPS Latitude/Longitude	
				Start	End
Item	Animal Control			37.962272 °	37.962272 °
				-121.159393 °	-121.159393 °
DWR ID	DWR_NA0017_15_f_2015_152				
Action/Comments					
No rodents visible, but rodent burrows visible; need to backfill and compact or grout burrows.

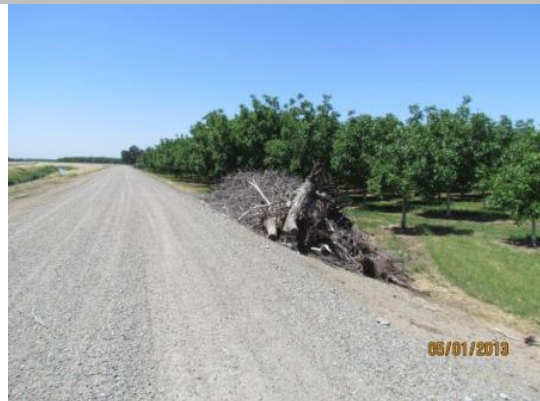
Photo 1 of 1 : FA_2015_NA0017_159_989_20150911_00118.jpg

LM Start	11.84	Rating **	M	Issue No.	989
LM End	11.84	Issue Type +	Ma	Location *	LS
Category	Earthen Levee			GPS Latitude/Longitude	
				Start	End
Item	Encroachments			37.961901 °	37.961901 °
				-121.175973 °	-121.175973 °
DWR ID	DWR_NA0017_15_s_2012_989				
Action/Comments					
Prunings Inspector Comments: Burn pile has been burned but new material has been placed.

Prunings were found on the landside slope of the levee looking downstream.

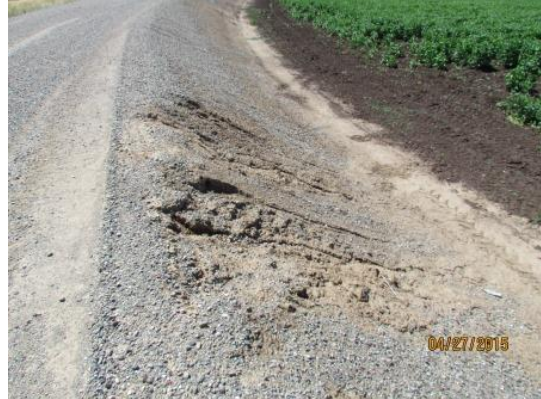
Photo 1 of 1 : FA_2015_NA0017_159_155_20150911_00092.jpg

View of slope instability on the landside of the levee looking upstream.

LM Start	12.30	Rating **	M	Issue No.	155
LM End	12.30	Issue Type +	Ma	Location *	LS
Category	Earthen Levee			GPS Latitude/Longitude	
				Start	End
Item	Erosion / Bank Caving			37.961410 °	37.961410 °
				-121.184231 °	-121.184231 °
DWR ID	DWR_NA0017_15_s_2015_155				
Action/Comments					
Schedule repair of erosion site prior to the next inspection.

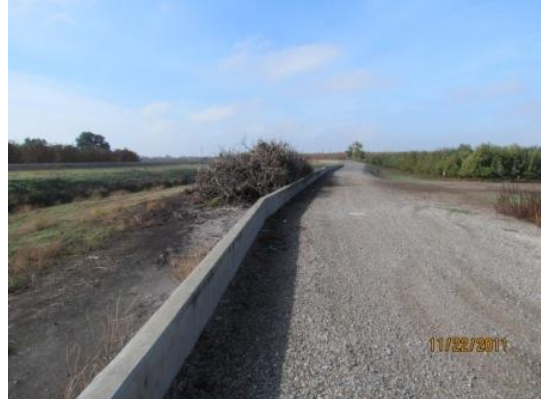
Photo 1 of 1 : FA_2015_NA0017_159_46_20150911_00037.jpg

Prunings were found on the waterside of the levee looking downstream.

LM Start	12.57	Rating **	M	Issue No.	46
LM End	12.57	Issue Type +	Ma	Location *	WS
Category	Earthen Levee			GPS Latitude/Longitude	
				Start	End
Item	Encroachments			37.961012 °	37.961012 °
				-121.189067 °	-121.189067 °
DWR ID	DWR_NA0017_15_f_2015_46				
Action/Comments					
Prunings					
Inspector Comments: Burn pile has been burned but new material has been placed. Burn piles need to be moved away from the flood wall to prevent further damage.

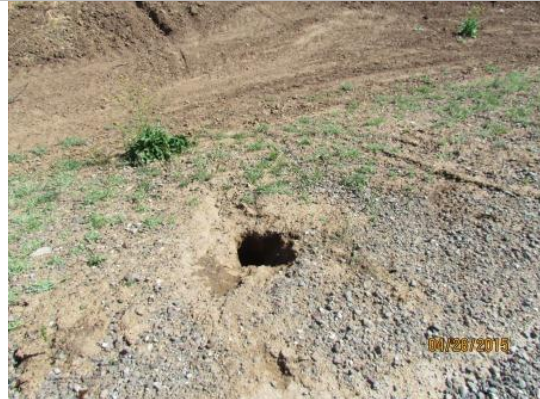
Photo 1 of 2 : FA_2015_NA0017_159_32_20150911_00023.jpg

Updated picture of the rodent hole on the landside of the levee during spring 2015 inspection.

LM Start	15.42	Rating **	M	Issue No.	32
LM End	15.42	Issue Type +	Ma	Location *	LS
Category	Earthen Levee			GPS Latitude/Longitude	
				Start	End
Item	Animal Control			37.975959 °	37.975959
				-121.235058 °	-121.235058
DWR ID	DWR_NA0017_15_s_2014_32				
Action/Comments					
No rodents visible, but rodent burrows visible; need to backfill and compact or grout burrows.

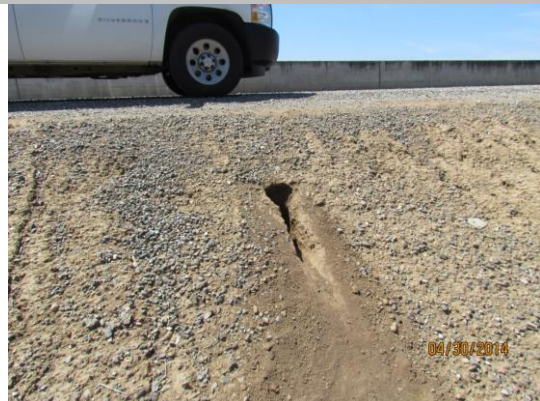
Photo 2 of 2 : FA_2015_NA0017_159_32_20150911_00024.jpg

A rodent hole was found on the landside of the levee looking downstream.

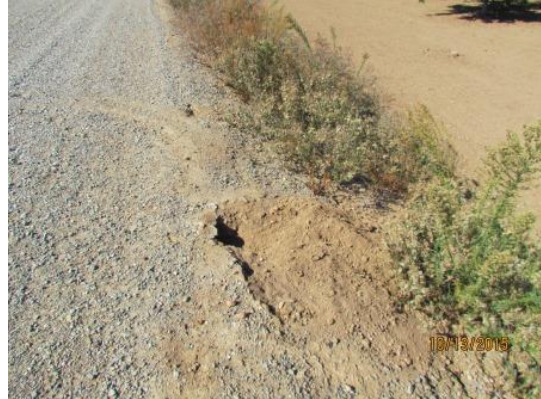
Photo 1 of 2 : FA_2015_NA0017_159_71_20151019_00153.jpg

Updated picture of the rodent holes on the landside of the levee looking downstream during fall 2015 inspection.

LM Start	15.43	Rating **	M	Issue No.	71
LM End	15.43	Issue Type +	Ma	Location *	LS
Category	Earthen Levee			GPS Latitude/Longitude	
				Start	End
Item	Animal Control			37.976000 °	37.976000 °
				-121.235156 °	-121.235156 °
DWR ID	DWR_NA0017_15_s_2013_71				
Action/Comments					
No rodents visible, but rodent burrows visible; need to backfill and compact or grout burrows.

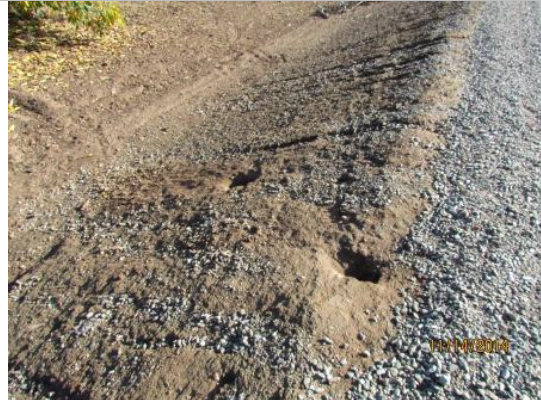
Photo 2 of 2 : FA_2015_NA0017_159_71_20150911_00053.jpg

View of the animal holes on the landside of the levee looking upstream during fall 2014 inspection.

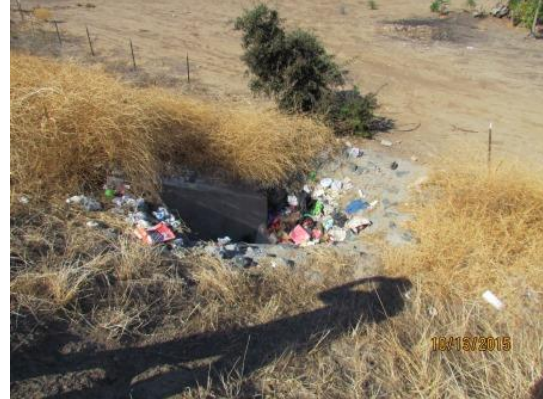
Photo 1 of 1 : FA_2015_NA0017_159_160_20151019_00154.jpg

LM Start	16.50	Rating **	M	Issue No.	160
LM End	16.50	Issue Type +	Ma	Location *	LS
Category	Earthen Levee			GPS Latitude/Longitude	
				Start	End
Item	Encroachments			37.983513 °	37.983513
				-121.252295 °	-121.252295
DWR ID	DWR_NA0017_15_f_2015_160				
Action/Comments					
Debris

Debris was found on the landside of the levee.
