**Flood Control Project Maintenance
Levee Inspections**

Maintenance Issue Types Only, Levee Inspection Report By Mile - Fall 2015

San Joaquin County Flood Control and Water Conservation District

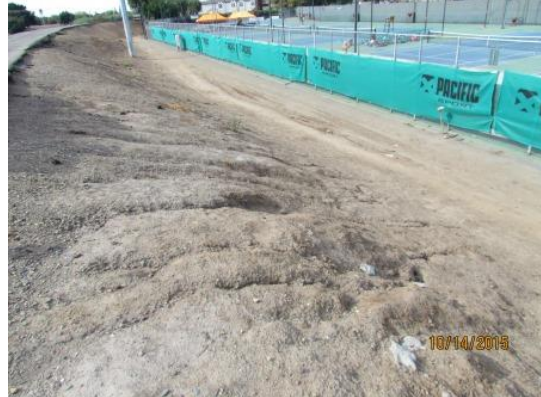
Photo 1 of 2 : FA_2015_NA0017_159_173_20151019_00156.jpg

Updated picture of the erosion caused by run off on the landside slope of the levee looking downstream during fall 2015 inspection.

LM Start	21.96	Rating **	M	Issue No.	173
LM End	21.96	Issue Type +	Ma	Location *	LS
Category	Earthen Levee			GPS Latitude/Longitude	
				Start	End
Item	Erosion / Bank Caving			37.981147 °	37.981147 °
				-121.315071 °	-121.315071 °
DWR ID	DWR_NA0017_15_s_2012_173				
Action/Comments					
Schedule repair of erosion site prior to the next inspection.					
Inspector Comments: Runoff.

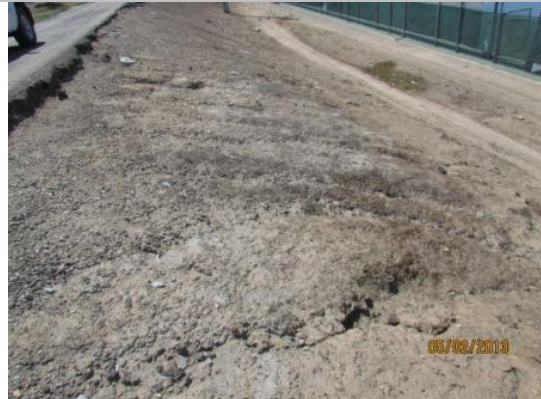
Photo 2 of 2 : FA_2015_NA0017_159_173_20150911_00099.jpg

Erosion caused by run off on the landside slope of the levee looking downstream during spring 2013 inspection.

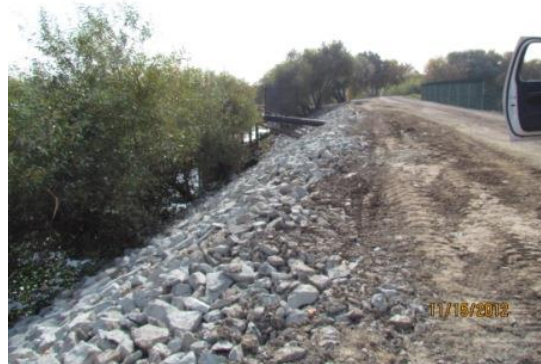
Photo 1 of 1 : FA_2015_NA0017_159_187_20150911_00105.jpg

LM Start	24.00	Rating **	A/W	Issue No.	187
LM End	24.00	Issue Type +	Ma	Location *	WS
Category	Earthen Levee			GPS Latitude/Longitude	
				Start	End
Item	Riprap Revetments			37.974858 °	37.974858 °
				-121.347718 °	-121.347718 °
DWR ID	DWR_NA0017_15_f_2012_187				
Action/Comments

Revetment was placed by the LMA on the waterside slope of the levee looking downstream.

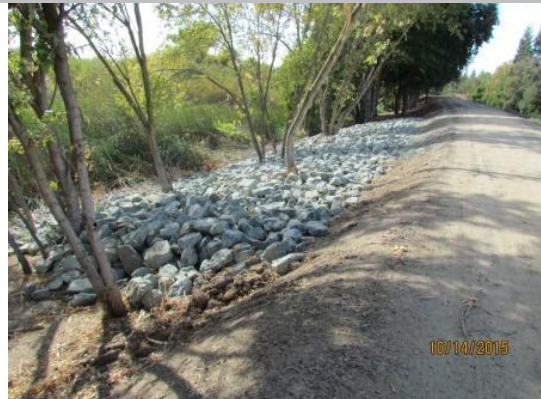
Photo 1 of 1 : FA_2015_NA0017_159_177_20151019_00158.jpg

LM Start	24.09	Rating **	A	Issue No.	177
LM End	24.09	Issue Type +	Ma	Location *	WS
Category	Earthen Levee			GPS Latitude/Longitude	
				Start	End
Item	Riprap Revetments			37.974089 °	37.974089 °
				-121.348807 °	-121.348807 °
DWR ID	DWR_NA0017_15_f_2015_177				
Action/Comments					
Inspector Comments: LMA placed new riprap on the waterside slope of the levee.

LMA placed new riprap on the waterside of the levee looking downstream.

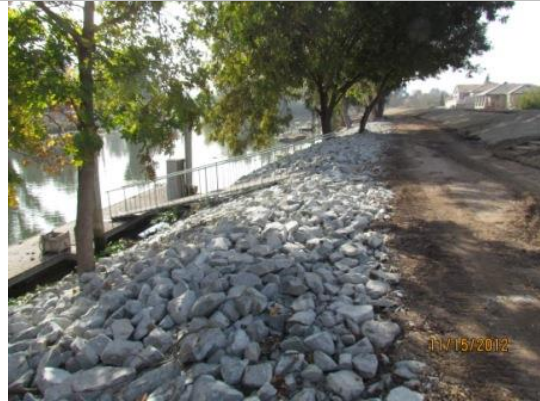
Photo 1 of 1 : FA_2015_NA0017_159_188_20150911_00106.jpg

LM Start	24.65	Rating **	A/W	Issue No.	188
LM End	24.65	Issue Type +	Ma	Location *	WS
Category	Earthen Levee			GPS Latitude/Longitude	
				Start	End
Item	Riprap Revetments			37.969095 °	37.969095 °
				-121.356301 °	-121.356301 °
DWR ID	DWR_NA0017_15_f_2012_188				
Action/Comments

Revetments were placed by the LMA on the waterside slope of the levee looking downstream.

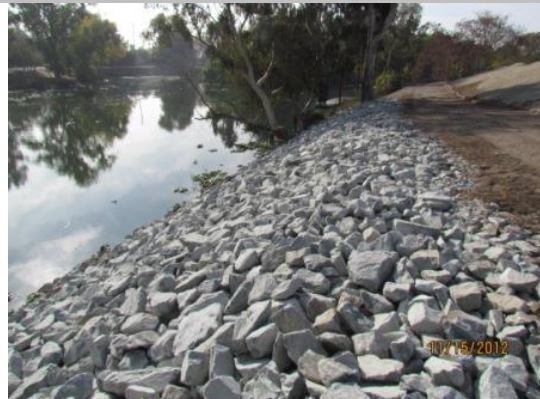
Photo 1 of 1 : FA_2015_NA0017_159_189_20150911_00107.jpg

LM Start	24.81	Rating **	A/W	Issue No.	189
LM End	24.81	Issue Type +	Ma	Location *	WS
Category	Earthen Levee			GPS Latitude/Longitude	
				Start	End
Item	Riprap Revetments			37.967943 °	37.967943 °
				-121.358711 °	-121.358711 °
DWR ID	DWR_NA0017_15_f_2012_189				
Action/Comments

Revetments were placed by the LMA on the waterside slope of the levee looking downstream.

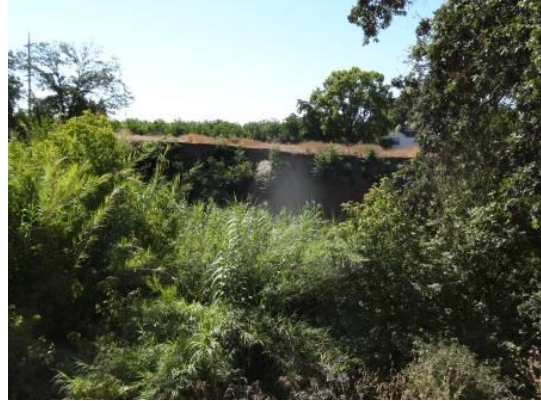
Photo 2 of 3 : SJR2015_NA0017U16RM23.35_3.jpg

LM Start	0.11	Rating **	U	Issue No.	82 (cont)
LM End	0.47	Issue Type +	Ma	Location *	WS
Category	Supplemental			GPS Latitude/Longitude	
				Start	End
Item	DWR Erosion Survey			38.048159 °	38.048159 °
				-121.016427 °	-121.016427 °
DWR ID					
Action/Comments					
Inspector Comments: 8/12/2015: The erosion progressed at the site. Newly collapsed material is observed at the bottom of the erosion. 8/20/2014: The erosion at the site has worsened. The erosion increased in both length and in height. 09/12/2013: Site has been visited and signs of new erosion are visible. 08/22/2012: The erosion was surveyed and documented for monitoring purpose. There is no levee structure on the site, only high ground protecting the land behind. The levee crest width and levee height were not measured or estimated in the field. [2015 Site ID:NA0017U16RM23.35]

Front view of the erosion. Looking from the right side of the river.

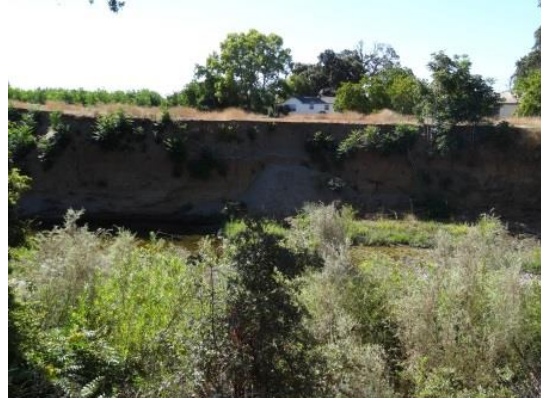
Photo 3 of 3 : SJR2015_NA0017U16RM23.35_4.jpg

Close view of the erosion. Signs of new erosion along the site.

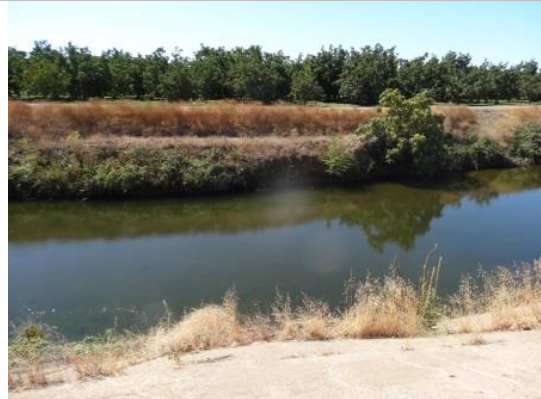
Photo 1 of 3 : SJR2015_NA0017U16RM21.95_1.jpg

LM Start	1.75	Rating **	M	Issue No.	76
LM End	1.76	Issue Type +	Ma	Location *	WS
Category	Supplemental			GPS Latitude/Longitude	
				Start	End
Item	DWR Erosion Survey			38.038080 °	38.038080 °
				-121.038676 °	-121.038676 °
DWR ID					
Action/Comments					
Inspector Comments: 8/12/2015: No significant change observed. 8/20/2014: No significant change observed. 9/12/2013: No significant change observed. 08/22/2012: The erosion is covered by dense vegetation. There is no levee structure on site. The levee crest width and levee height were not measured or estimated in the field. [2015 Site ID:NA0017U16RM21.95]

Front view of the erosion site.

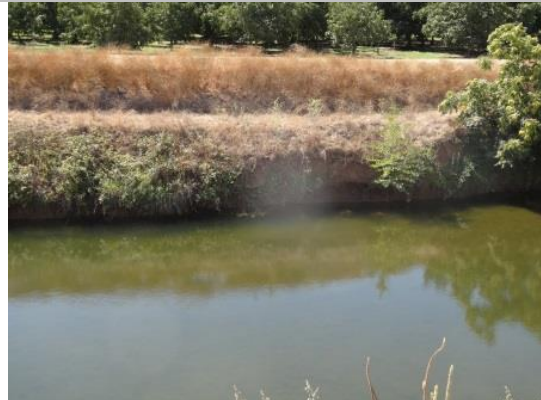
Photo 2 of 3 : SJR2015_NA0017U16RM21.95_3.jpg

Close view of the erosion.

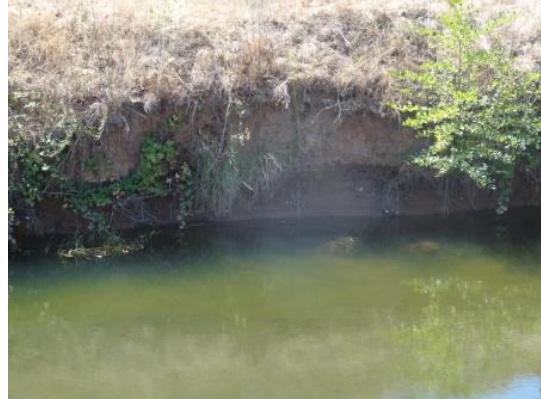
Photo 3 of 3 : SJR2015_NA0017U16RM21.95_5.jpg

Close view of the erosion.

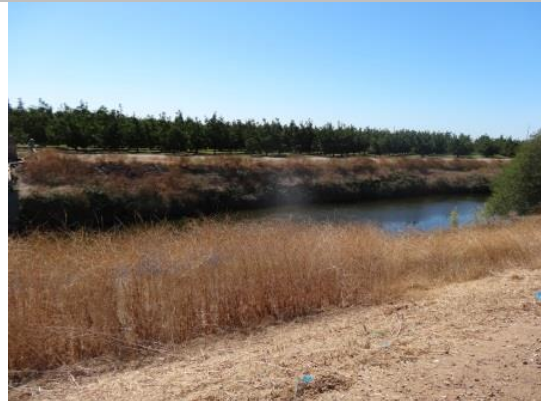
Photo 1 of 3 : SJR2015_NA0017U16RM21.94_1.jpg

LM Start	1.77	Rating **	M	Issue No.	75
LM End	1.78	Issue Type +	Ma	Location *	WS
Category	Supplemental			GPS Latitude/Longitude	
				Start	End
Item	DWR Erosion Survey			38.037906 °	38.037906 °
				-121.038949 °	-121.038949 °
DWR ID					
Action/Comments					
Inspector Comments: 8/12/2015: No significant change observed. 8/20/2014: No significant change observed 9/12/2013: No significant change observed. 08/22/2012: Site is covered by dense vegetation. Berm width is estimated as 5 ft. There is no levee structure on site. The levee crest width and levee height were not measured or estimated in the field. [2015 Site ID:NA0017U16RM21.94]

Looking at the erosion from right river bank.

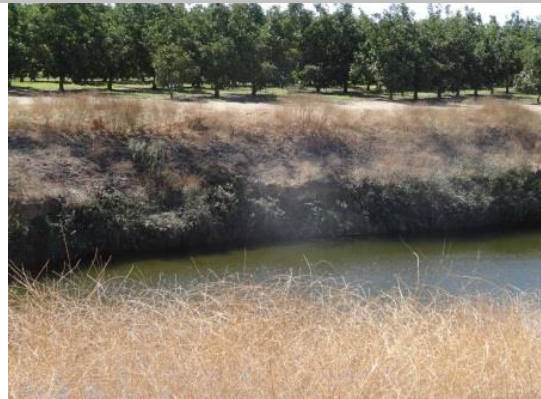
Photo 2 of 3 : SJR2015_NA0017U16RM21.94_2.jpg

Front view of the erosion.

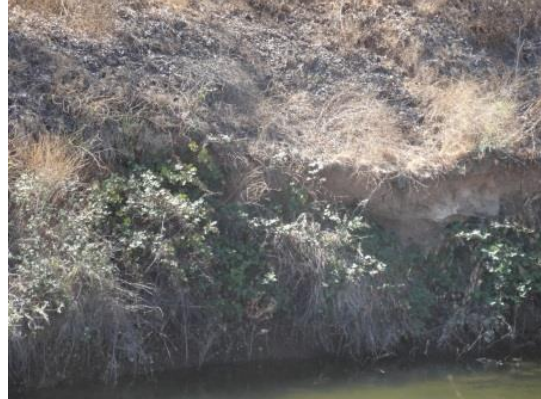
Photo 3 of 3 : SJR2015_NA0017U16RM21.94_4.jpg

Close view of the erosion. Note the dense vegetation.

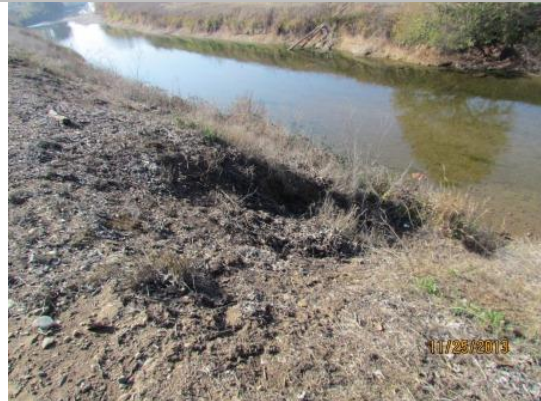
Photo 1 of 1 : FA_2015_NA0017_160_155_20150911_00087.jpg

Erosion was found on the waterside of the levee looking downstream.

LM Start	1.91	Rating **	M	Issue No.	155
LM End	1.91	Issue Type +	Ma	Location *	WS
Category	Earthen Levee			GPS Latitude/Longitude	
				Start	End
Item	Erosion / Bank Caving			38.036248 °	38.036248 °
				-121.040408 °	-121.040408 °
DWR ID	DWR_NA0017_16_f_2013_155				
Action/Comments					
Schedule repair of erosion site prior to the next inspection.

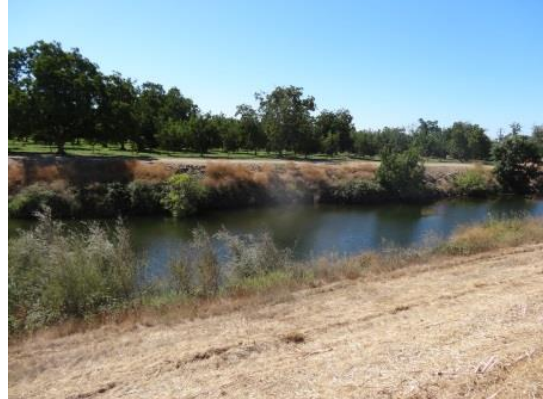
Photo 1 of 3 : SJR2015_NA0017U16RM20.62_1.jpg

LM Start	2.30	Rating **	U	Issue No.	70
LM End	2.31	Issue Type +	Ma	Location *	WS
Category	Supplemental			GPS Latitude/Longitude	
				Start	End
Item	DWR Erosion Survey			38.032202 °	38.032202 °
				-121.045226 °	-121.045226 °
DWR ID					
Action/Comments					
Inspector Comments: 8/12/2015: No significant change observed. 8/20/2014: No significant change has been observed. 9/12/2013: No significant change observed. 08/22/2012: The erosion was first reported in the 2012 spring levee inspection report. There is no levee structure on site. The levee crest width and levee height were not measured or estimated in the field. [2015 Site ID:NA0017U16RM20.62]

Front view of the site.

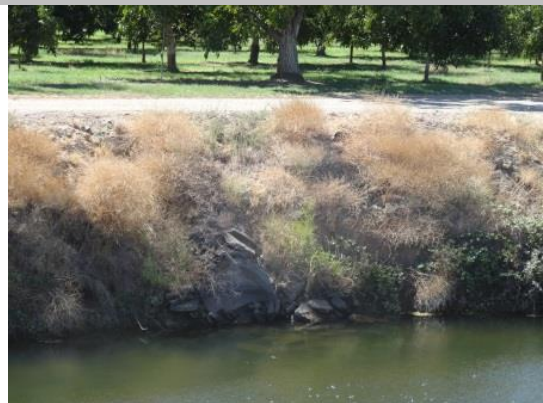
Photo 2 of 3 : SJR2015_NA0017U16RM20.62_2.jpg

Close view of the erosion. Note the vegetation at the site.

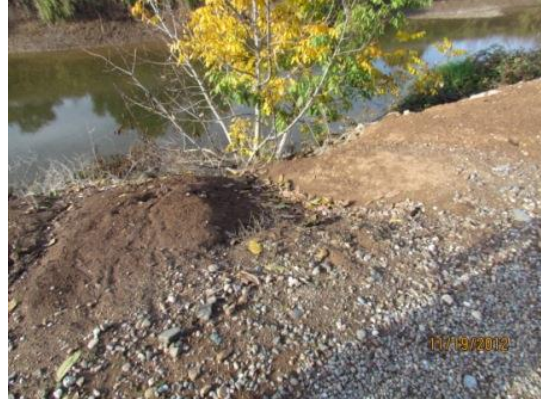
Photo 1 of 2 : FA_2015_NA0017_160_213_20150911_00127.jpg

Updated picture of the slope instability on the waterside shoulder of the levee looking upstream.

LM Start	2.35	Rating **	M	Issue No.	213
LM End	2.35	Issue Type +	Ma	Location *	WS
Category	Earthen Levee			GPS Latitude/Longitude	
				Start	End
Item	Slope Stability			38.031763 °	38.031763
				-121.045808 °	-121.045808
DWR ID	DWR_NA0017_16_f_2012_213				
Action/Comments					
Repair slope instability.

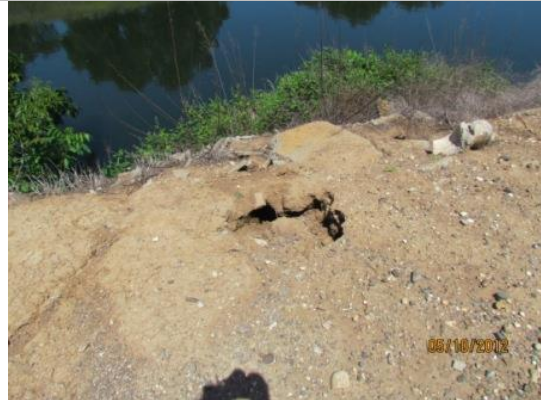
Photo 2 of 2 : FA_2015_NA0017_160_213_20150911_00128.jpg

Slope instability was found on the waterside of the levee looking upstream.

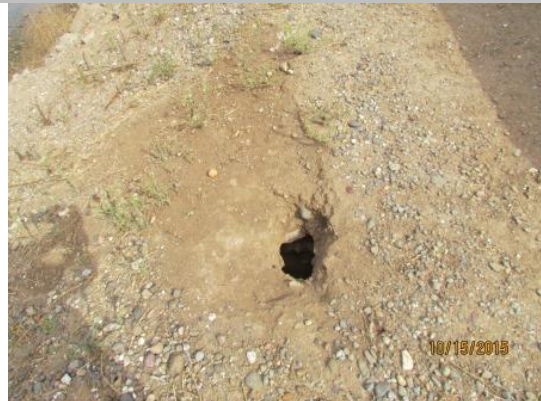
Photo 1 of 1 : FA_2015_NA0017_160_233_20151023_00163.jpg

A rodent hole was found on the waterside of the levee.

LM Start	2.36	Rating **	M	Issue No.	233
LM End	2.36	Issue Type +	Ma	Location *	WS
Category	Earthen Levee			GPS Latitude/Longitude	
				Start	End
Item	Animal Control			38.031654 °	38.031654
				-121.045925 °	-121.045925
DWR ID	DWR_NA0017_16_f_2015_233				
Action/Comments					
No rodents visible, but rodent burrows visible; need to backfill and compact or grout burrows.

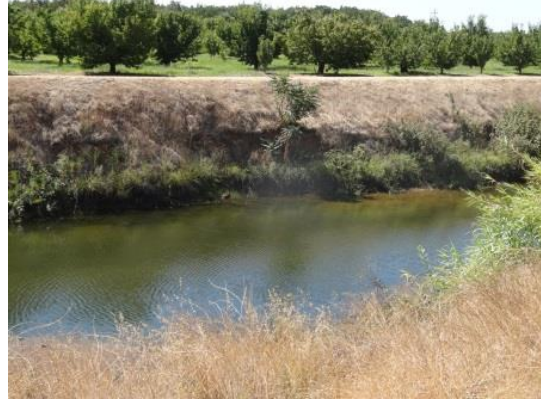
Photo 1 of 4 : SJR2015_NA0017U16RM20.00_1.jpg

LM Start	2.85	Rating **	U	Issue No.	64
LM End	2.91	Issue Type +	Ma	Location *	WS
Category	Supplemental			GPS Latitude/Longitude	
				Start	End
Item	DWR Erosion Survey			38.026670 °	38.026670 °
				-121.053031 °	-121.053031 °
DWR ID					
Action/Comments					
Inspector Comments: 8/12/2015: No significant change observed. 8/20/2014: No significant change observed. 9/12/2013: No significant change observed. 08/22/2012: Site Comprised of series of pocket and scarp erosions. Some of erosions are covered by grass or shrubs. There is no levee structure on site. The levee crest width and levee height were not measured or estimated in the field. [2015 Site ID:NA0017U16RM20]

Front view of the erosion.

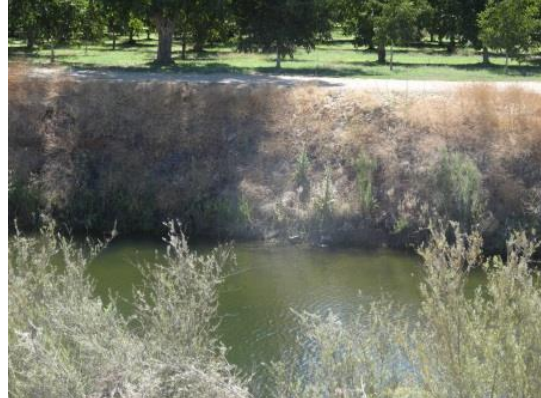
Photo 2 of 4 : SJR2015_NA0017U16RM20.00_2.jpg

Close view of the erosion.

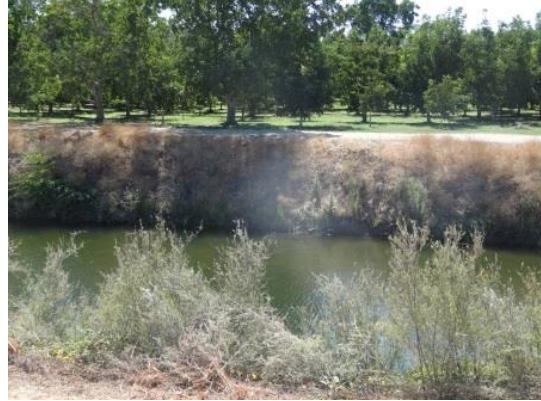
Photo 3 of 4 : SJR2015_NA0017U16RM20.00_3.jpg

Front view of the erosion.

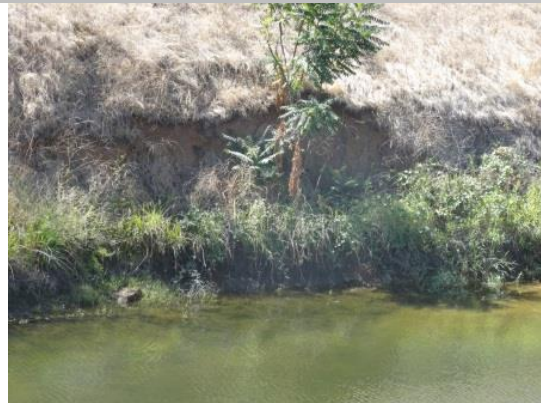
Photo 4 of 4 : SJR2015_NA0017U16RM20.00_7.jpg

Close view of the scarp erosion. Note the small tree at the erosion site.

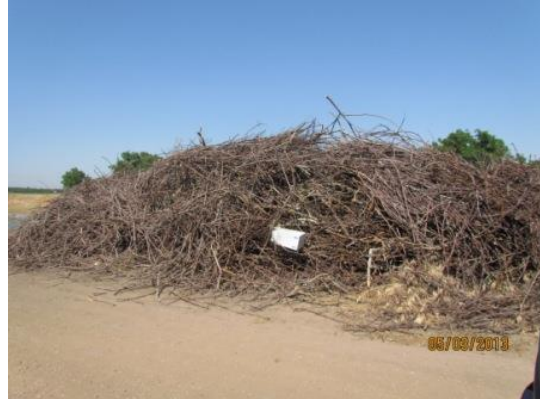
Photo 1 of 1 : FA_2015_NA0017_160_53_20150911_00026.jpg

LM Start	3.41	Rating **	M	Issue No.	53
LM End	3.41	Issue Type +	Ma	Location *	WS
Category	Earthen Levee			GPS Latitude/Longitude	
				Start	End
Item	Encroachments			38.021650 °	38.021650 °
				-121.060312 °	-121.060312 °
DWR ID	DWR_NA0017_16_s_2012_53				
Action/Comments					
Prunings					
Inspector Comments: Burn pile has been burned but new material has been placed.

Prunings were found on the waterside shoulder of the levee looking downstream.

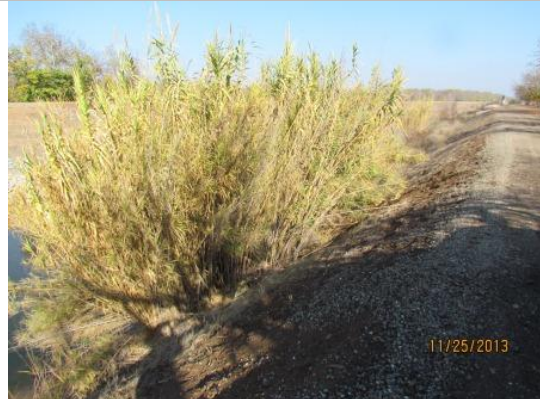
Photo 1 of 1 : FA_2015_NA0017_160_152_20150911_00086.jpg

Arundo was found on the waterside toe of the levee looking upstream.

LM Start	3.48	Rating **	M	Issue No.	152
LM End	3.48	Issue Type +	Ma	Location *	WS
Category	Earthen Levee			GPS Latitude/Longitude	
				Start	End
Item	Vegetation			38.020965 °	38.020965 °
				-121.061215 °	-121.061215 °
DWR ID	DWR_NA0017_16_f_2013_152				
Action/Comments					
Remove the wild growth other than native grasses from the levee slopes.

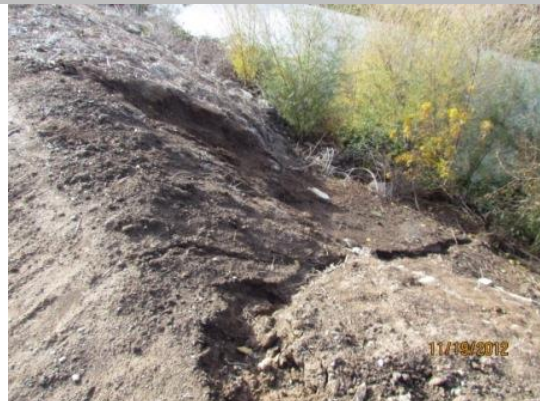
Photo 1 of 2 : FA_2015_NA0017_160_230_20150911_00138.jpg

Slope instability was found on the waterside slope of the levee looking downstream.

LM Start	3.53	Rating **	M	Issue No.	230
LM End	3.53	Issue Type +	Ma	Location *	WS
Category	Earthen Levee			GPS Latitude/Longitude	
				Start	End
Item	Erosion / Bank Caving			38.020433 °	38.020433 °
				-121.061867 °	-121.061867 °
DWR ID	DWR_NA0017_16_f_2012_230				
Action/Comments					
Schedule repair of erosion site prior to the next inspection.

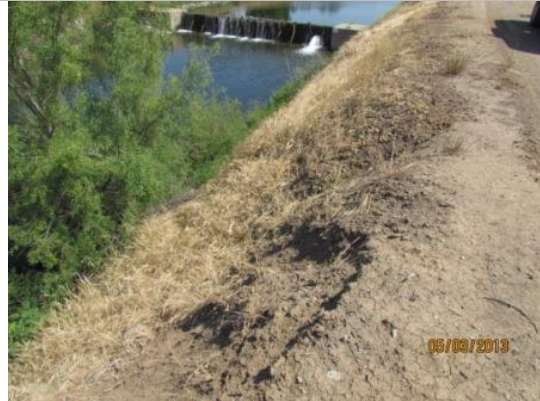
Photo 2 of 2 : FA_2015_NA0017_160_230_20150911_00139.jpg

Erosion was found on the waterside slope of the levee looking upstream.

LM Start	3.53	Rating **	M	Issue No.	230 (cont)
LM End	3.53	Issue Type +	Ma	Location *	WS
Category	Earthen Levee			GPS Latitude/Longitude	
				Start	End
Item	Erosion / Bank Caving			38.020433 °	38.020433 °
				-121.061867 °	-121.061867 °
DWR ID	DWR_NA0017_16_f_2012_230				
Action/Comments					
Schedule repair of erosion site prior to the next inspection.

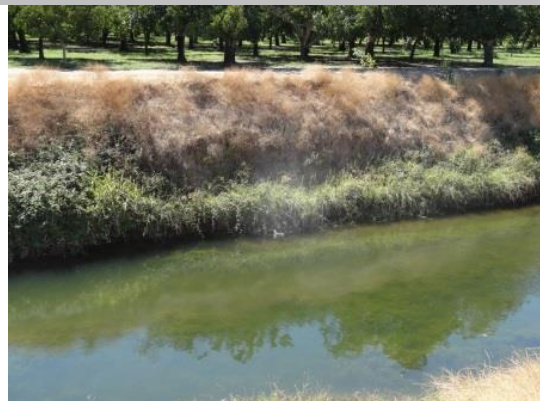
Photo 2 of 2 : SJR2015_NA0017U16RM19.29_4.JPG

LM Start	3.61	Rating **	M	Issue No.	54
LM End	3.61	Issue Type +	Ma	Location *	WS
Category	Supplemental			GPS Latitude/Longitude	
				Start	End
Item	DWR Erosion Survey			38.019642 °	38.019642 °
				-121.062917 °	-121.062917 °
DWR ID					
Action/Comments					
Inspector Comments: 8/12/2015: No significant change observed. 8/20/2014: A pocket erosion was found near the water's edge. [2015 Site ID:NA0017U16RM19.29]

View of the site.

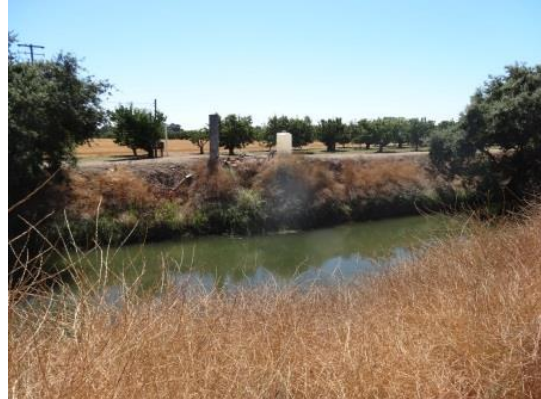
Photo 1 of 2 : SJR2015_NA0017U16RM18.69_1.jpg

LM Start	4.16	Rating **	U	Issue No.	47
LM End	4.18	Issue Type +	Ma	Location *	WS
Category	Supplemental			GPS Latitude/Longitude	
				Start	End
Item	DWR Erosion Survey			38.012792 °	38.012792 °
				-121.068073 °	-121.068073 °
DWR ID					
Action/Comments					
Inspector Comments: 8/12/2015: No significant change observed. 8/20/2014: No significant change observed. 9/12/2013: No significant change observed. 08/22/2012: An irrigation pipe is present at the site, but probably did not cause the erosion. There is no levee structure on site. The levee crest width and levee height were not measured or estimated in the field. [2015 Site ID:NA0017U16RM18.69]

View of the erosion site.

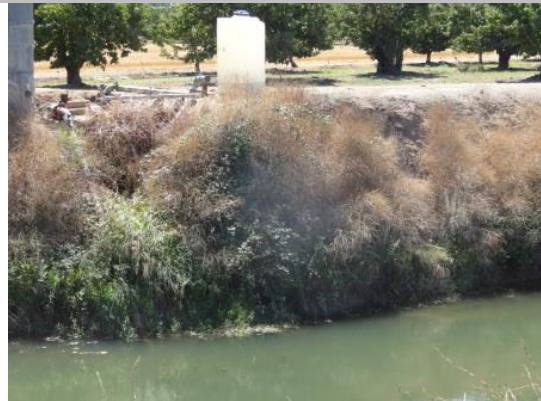
Photo 2 of 2 : SJR2015_NA0017U16RM18.69_2.jpg

Closer view of the erosion.

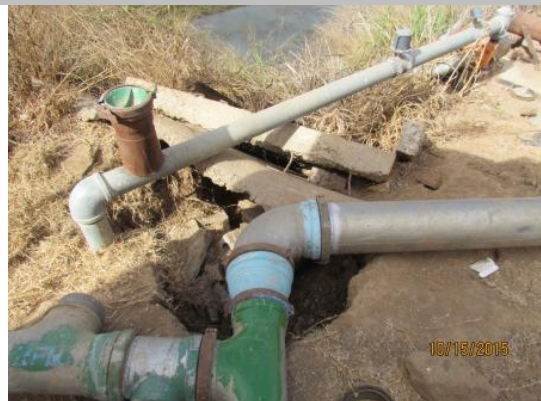
Photo 1 of 1 : FA_2015_NA0017_160_236_20151023_00164.jpg

LM Start	4.19	Rating **	M	Issue No.	236
LM End	4.19	Issue Type +	Ma	Location *	WS
Category	Earthen Levee			GPS Latitude/Longitude	
				Start	End
Item	Erosion / Bank Caving			38.012491 °	38.012491 °
				-121.068118 °	-121.068118 °
DWR ID	DWR_NA0017_16_f_2015_236				
Action/Comments					
Schedule repair of erosion site prior to the next inspection.					
Inspector Comments: Erosion created by broken pipe.

Erosion caused by a broken pipe on the waterside of the levee.

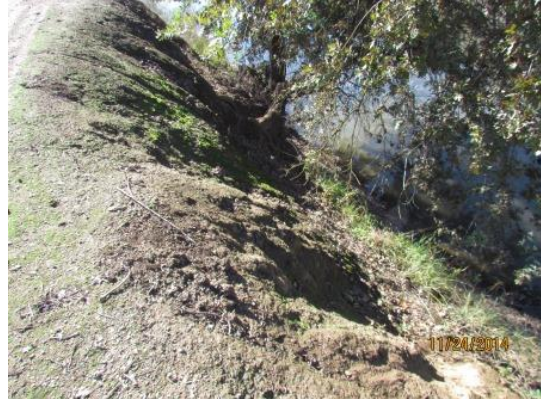
Photo 1 of 2 : FA_2015_NA0017_160_228_20150911_00136.jpg

Updated picture of the slope instability on the waterside of the levee looking downstream.

LM Start	4.20	Rating **	M	Issue No.	228
LM End	4.20	Issue Type +	Ma	Location *	WS
Category	Earthen Levee			GPS Latitude/Longitude	
				Start	End
Item	Slope Stability			38.012288 °	38.012288 °
				-121.068239 °	-121.068239 °
DWR ID	DWR_NA0017_16_f_2012_228				
Action/Comments					
Repair slope instability.

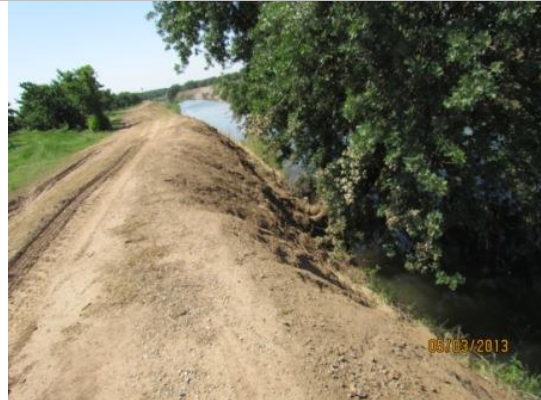
Photo 2 of 2 : FA_2015_NA0017_160_228_20150911_00137.jpg

LM Start	4.20	Rating **	M	Issue No.	228 (cont)
LM End	4.20	Issue Type +	Ma	Location *	WS

Slope instability was found on the waterside shoulder of the levee looking downstream.

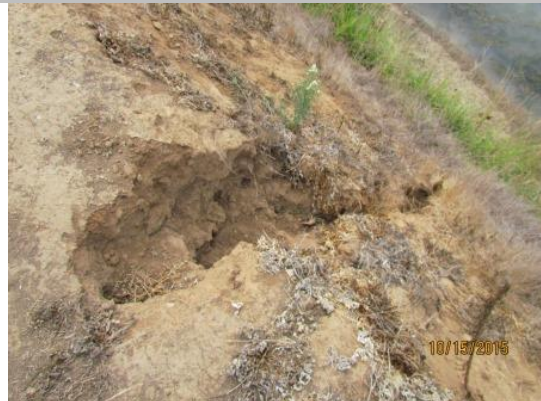
Photo 1 of 1 : FA_2015_NA0017_160_73_20151023_00165.jpg

Erosion was found on the waterside shoulder of the levee looking upstream.

LM Start	4.28	Rating **	M	Issue No.	73
LM End	4.28	Issue Type +	Ma	Location *	WS
Category	Earthen Levee			GPS Latitude/Longitude	
				Start	End
Item	Erosion / Bank Caving			38.011201 °	38.011201 °
				-121.068581 °	-121.068581 °
DWR ID	DWR_NA0017_16_s_2013_73				
Action/Comments					
Schedule repair of erosion site prior to the next inspection.

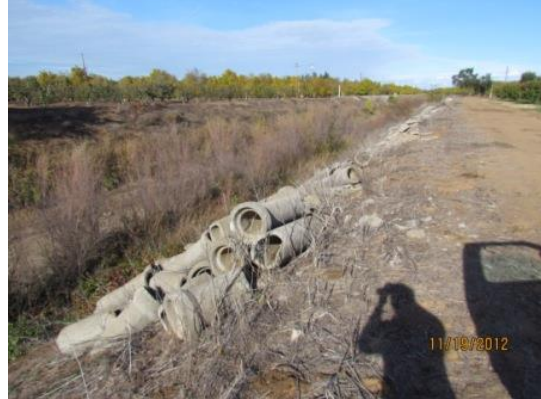
Photo 1 of 2 : FA_2015_NA0017_160_196_20150911_00114.jpg

Concrete debris was found on the waterside slope of the levee looking upstream.

LM Start	5.05	Rating **	M	Issue No.	196
LM End	5.15	Issue Type +	Ma	Location *	WS
Category	Earthen Levee			GPS Latitude/Longitude	
				Start	End
Item	Encroachments			38.001284 °	38.000116 °
				-121.074596 °	-121.075633 °
DWR ID	DWR_NA0017_16_s_2012_196				
Action/Comments					
Debris

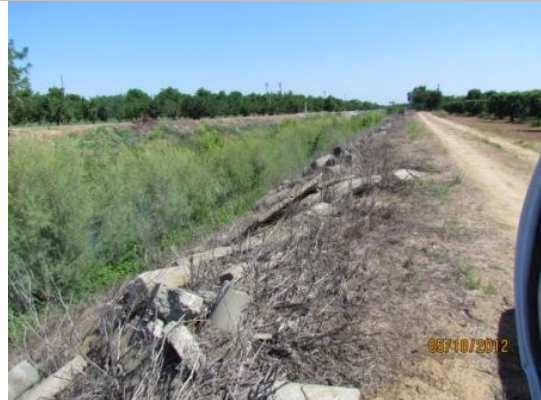
Photo 2 of 2 : FA_2015_NA0017_160_196_20150911_00115.jpg

Debris was found on the waterside of the levee looking upstream.

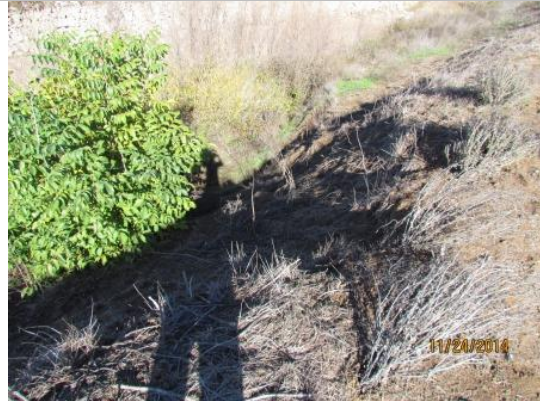
Photo 1 of 1 : FA_2015_NA0017_160_265_20150911_00150.jpg

A slope instability was found on the waterside slope of the levee looking upstream.

LM Start	5.20	Rating **	M	Issue No.	265
LM End	5.20	Issue Type +	Ma	Location *	WS
Category	Earthen Levee			GPS Latitude/Longitude	
				Start	End
Item	Slope Stability			37.999537 °	37.999537 °
				-121.076133 °	-121.076133 °
DWR ID	DWR_NA0017_16_f_2014_265				
Action/Comments					
Repair slope instability.

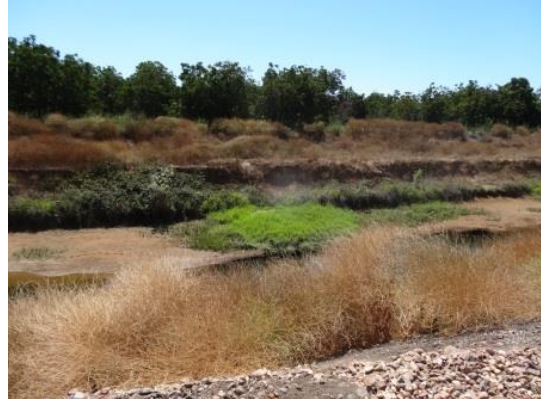
Photo 1 of 2 : SJR2015_NA0017U16RM17.81_2.jpg

LM Start	5.33	Rating **	M	Issue No.	41
LM End	5.38	Issue Type +	Ma	Location *	WS
Category	Supplemental			GPS Latitude/Longitude	
				Start	End
Item	DWR Erosion Survey			37.997720 °	37.997720 °
				-121.077807 °	-121.077807 °
DWR ID					
Action/Comments					
Inspector Comments: 8/12/2015: No significant change observed. 8/20/2014: No significant change observed. 9/12/2013: No significant change observed. 08/22/2012: The site is located at the opposite river bank of E. Tobacco Road. There is no levee structure on site. The levee crest width and levee height were not measured or estimated in the field. [2015 Site ID:NA0017U16RM17.81]

Front view of the site.

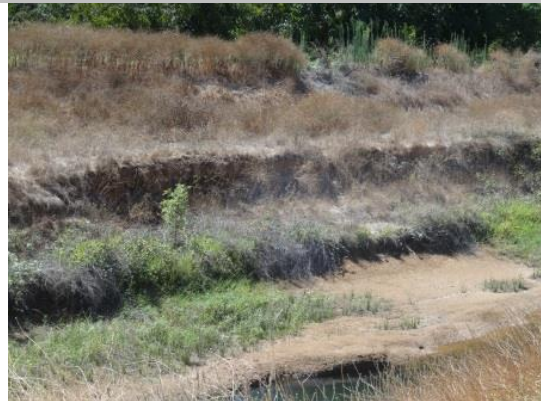
Photo 2 of 2 : SJR2015_NA0017U16RM17.81_5.jpg

Close view of the erosion.

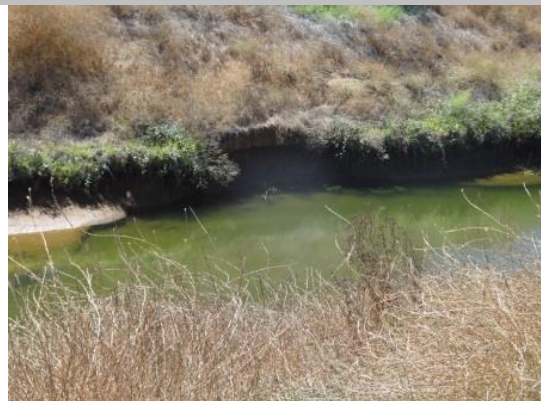
Photo 1 of 3 : SJR2015_NA0017U16RM17.27_2.JPG

LM Start	5.56	Rating **	U	Issue No.	40
LM End	5.58	Issue Type +	Ma	Location *	WS
Category	Supplemental			GPS Latitude/Longitude	
				Start	End
Item	DWR Erosion Survey			37.995216 °	37.995216 °
				-121.080159 °	-121.080159 °
DWR ID					
Action/Comments					
Inspector Comments: 8/12/2015: No significant change observed. 8/20/2014: No significant change observed. 9/12/2013: The erosion seems to be caused by high river flow. Dense vegetation is present at the site. Signs of animal activities are visible. There is no levee structure on site. The levee crest width and levee height were not measured or estimated in the field. [2015 Site

Close view of the erosion.

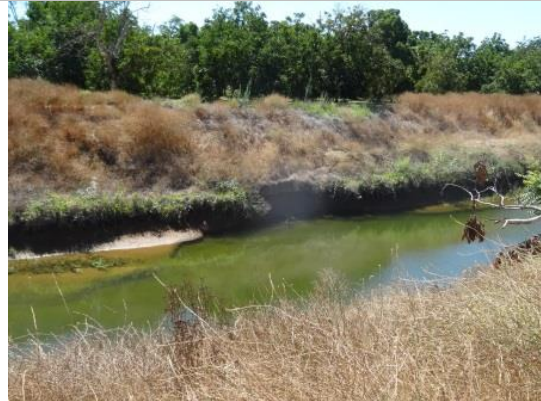
Photo 2 of 3 : SJR2015_NA0017U16RM17.27_4.JPG

LM Start	5.56	Rating **	U	Issue No.	40 (cont)
LM End	5.58	Issue Type +	Ma	Location *	WS
Category	Supplemental			GPS Latitude/Longitude	
				Start	End
Item	DWR Erosion Survey			37.995216 °	37.995216 °
				-121.080159 °	-121.080159 °
DWR ID					
Action/Comments					
Inspector Comments: 8/12/2015: No significant change observed. 8/20/2014: No significant change observed. 9/12/2013: The erosion seems to be caused by high river flow. Dense vegetation is present at the site. Signs of animal activities are visible. There is no levee structure on site. The levee crest width and levee height were not measured or estimated in the field. [2015 Site ID:NA0017U16RM17.27]

View from the right river bank.

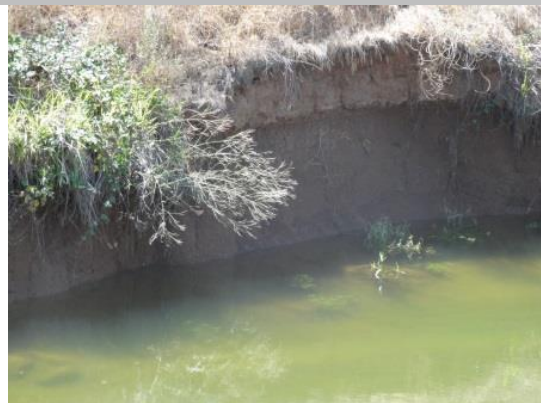
Photo 3 of 3 : SJR2015_NA0017U16RM17.27_6.JPG

Close view of the erosion.

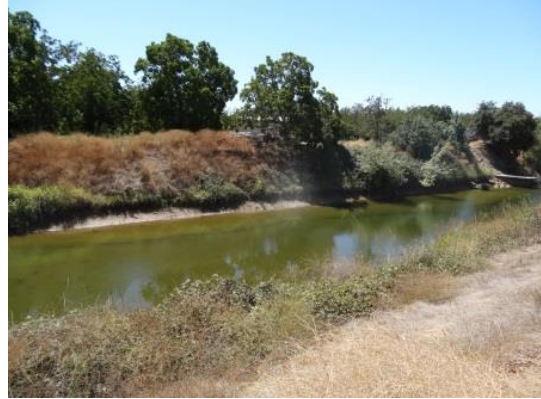
Photo 1 of 2 : SJR2015_NA0017U16RM17.11_1.JPG

LM Start	5.71	Rating **	M	Issue No.	39
LM End	5.72	Issue Type +	Ma	Location *	WS
Category	Supplemental			GPS Latitude/Longitude	
				Start	End
Item	DWR Erosion Survey			37.993525 °	37.993525 °
				-121.081679 °	-121.081679 °
DWR ID					
Action/Comments					
Inspector Comments: 8/12/2015: No significant change observed. 8/20/2014: The erosion is near a tree and probably has been made worse by the unstable bank slope. [2015 Site ID:NA0017U16RM17.11]

View of the site from the right river bank.

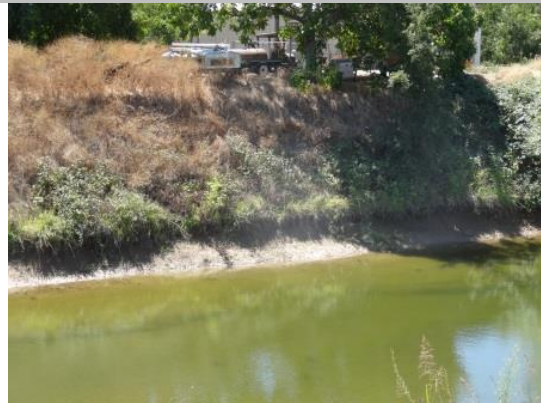
Photo 2 of 2 : SJR2015_NA0017U16RM17.11_2.JPG

Close view of the erosion.

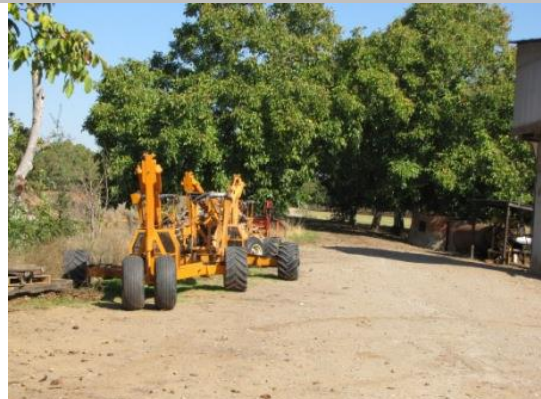
Photo 1 of 1 : FA_2015_NA0017_160_172_20150911_00103.jpg

LM Start	5.75	Rating **	M	Issue No.	172
LM End	5.75	Issue Type +	Ma	Location *	WS
Category	Earthen Levee			GPS Latitude/Longitude	
				Start	End
Item	Encroachments			37.993108 °	37.993108 °
				-121.082033 °	-121.082033 °
DWR ID	DWR_NA0017_16_s_2012_172				
Action/Comments					
Equipment

View of equipment located on the waterward side looking upstream.

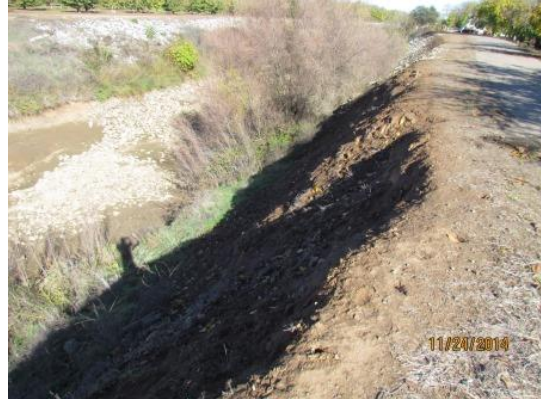
Photo 1 of 1 : FA_2015_NA0017_160_264_20150911_00149.jpg

A slope instability was found on the waterside of the levee looking upstream.

LM Start	5.87	Rating **	M	Issue No.	264
LM End	5.87	Issue Type +	Ma	Location *	WS
Category	Earthen Levee			GPS Latitude/Longitude	
				Start	End
Item	Slope Stability			37.991628 °	37.991628 °
				-121.083312 °	-121.083312 °
DWR ID	DWR_NA0017_16_f_2014_264				
Action/Comments					
Repair slope instability.

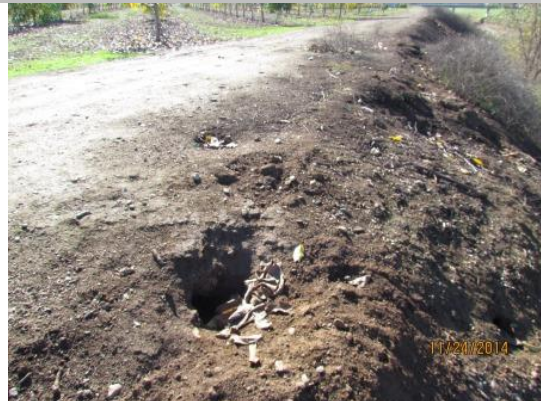
Photo 1 of 2 : FA_2015_NA0017_160_170_20150911_00100.jpg

Updated picture of the rodent holes on the waterside shoulder of the levee looking downstream.

LM Start	6.15	Rating **	M	Issue No.	170
LM End	6.15	Issue Type +	Ma	Location *	WS
Category	Earthen Levee			GPS Latitude/Longitude	
				Start	End
Item	Animal Control			37.988385 °	37.988385 °
				-121.086292 °	-121.086292 °
DWR ID	DWR_NA0017_16_s_2012_170				
Action/Comments					
No rodents visible, but rodent burrows visible; need to backfill and compact or grout burrows.

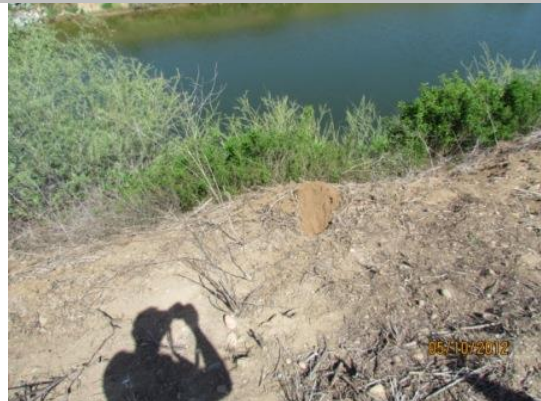
Photo 2 of 2 : FA_2015_NA0017_160_170_20150911_00101.jpg

An animal hole was found on the waterside of the levee looking upstream.

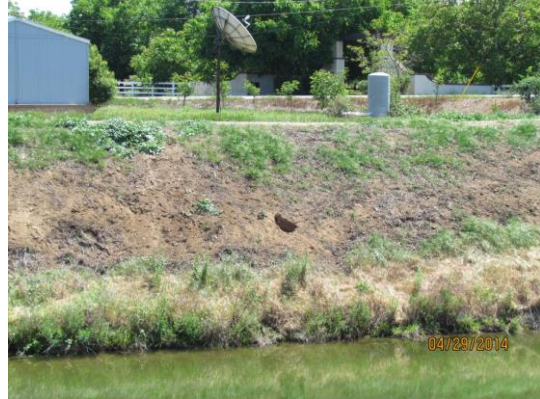
Photo 1 of 1 : FA_2015_NA0017_160_50_20150911_00024.jpg

View of a rodent hole on the waterside slope of the levee. The picture was taken from the opposite side of the levee.

LM Start	6.24	Rating **	M	Issue No.	50
LM End	6.24	Issue Type +	Ma	Location *	WS
Category	Earthen Levee			GPS Latitude/Longitude	
				Start	End
Item	Animal Control			37.987303 °	37.987303 °
				-121.087292 °	-121.087292 °
DWR ID	DWR_NA0017_16_s_2014_50				
Action/Comments					
No rodents visible, but rodent burrows visible; need to backfill and compact or grout burrows.

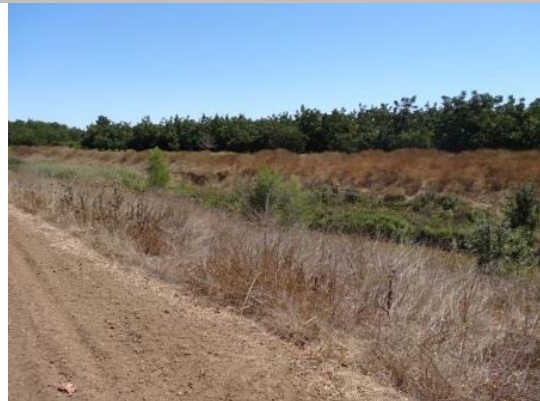
Photo 1 of 3 : SJR2015_NA0017U16RM16.27_1.jpg

LM Start	6.49	Rating **	U	Issue No.	38
LM End	6.68	Issue Type +	Ma	Location *	WS
Category	Supplemental			GPS Latitude/Longitude	
				Start	End
Item	DWR Erosion Survey			37.983279 °	37.983279 °
				-121.090843 °	-121.090843 °
DWR ID					
Action/Comments					
Inspector Comments: 8/12/2015: No significant change observed. 8/20/2014: No significant change observed. 9/12/2013: Site has been surveyed and the erosion has worsened since last year. 08/22/2012: Discontinuous scarp or pocket erosions occurred along a long stretch of the river, with an erosion height greater than 25 ft. at certain points. There is no levee structure on site. The levee crest width and levee height were not measured or estimated in the field. [2015 Site ID:NA0017U16RM16.27]

Downstream view of the site from the right river bank.

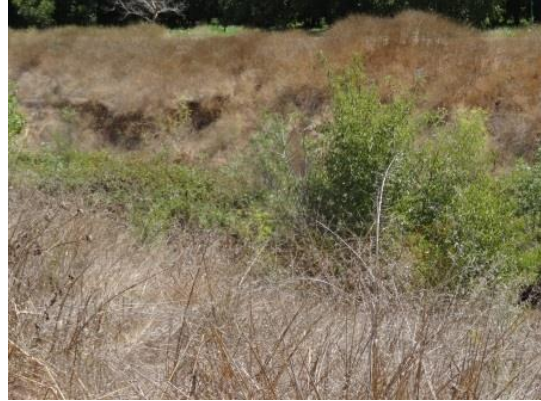
Photo 2 of 3 : SJR2015_NA0017U16RM16.27_2.jpg

LM Start	6.49	Rating **	U	Issue No.	38 (cont)	
LM End	6.68	Issue Type +	Ma	Location *	WS	
Category	Supplemental			GPS Latitude/Longitude		
				Start	End	
Item	DWR Erosion Survey			37.983279 °	37.983279 °	
				-121.090843 °	-121.090843 °	
DWR ID						
Action/Comments						
Inspector Comments: 8/12/2015: No significant change observed. 8/20/2014: No significant change observed. 9/12/2013: Site has been surveyed and the erosion has worsened since last year. 08/22/2012: Discontinuous scarp or pocket erosions occurred along a long stretch of the river, with an erosion height greater than 25 ft. at certain points. There is no levee structure on site. The levee crest width and levee height were not measured or estimated in the field. [2015 Site ID:NA0017U16RM16.27]

Closer view of the erosion.

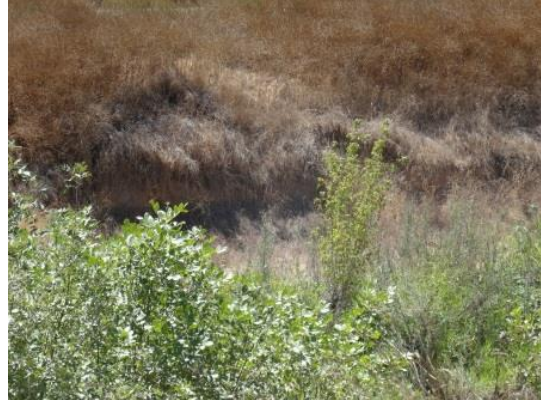
Photo 3 of 3 : SJR2015_NA0017U16RM16.27_7.jpg

Close view of the erosion.

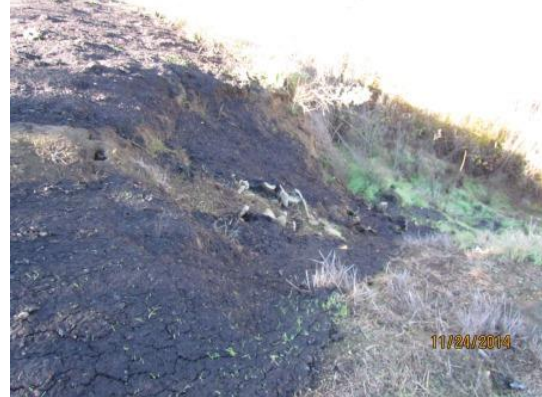
Photo 1 of 2 : FA_2015_NA0017_160_120_20150911_00063.jpg

Updated picture of the slope instability on the waterside of the levee looking downstream.

LM Start	6.70	Rating **	M	Issue No.	120
LM End	6.70	Issue Type +	Ma	Location *	WS
Category	Earthen Levee			GPS Latitude/Longitude	
				Start	End
Item	Slope Stability			37.982299 °	37.982299 °
				-121.092665 °	-121.092665 °
DWR ID	DWR_NA0017_16_s _ 2014_120				
Action/Comments					
Repair slope instability.

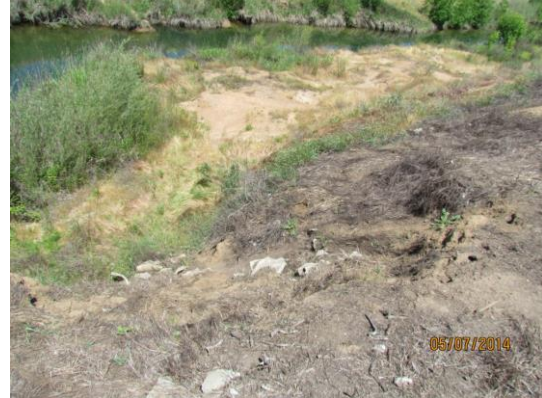
Photo 2 of 2 : FA_2015_NA0017_160_120_20150911_00064.jpg

Slope instability was found on the waterside of the levee looking upstream.

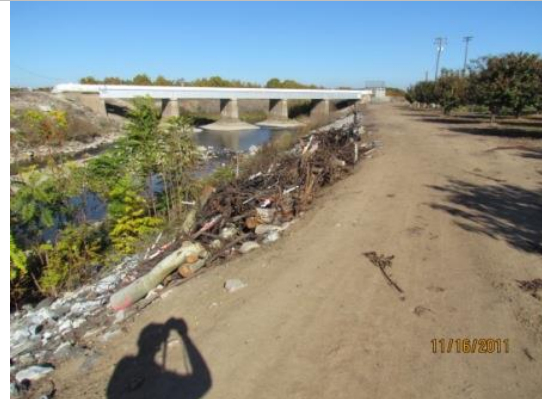
Photo 1 of 1 : FA_2015_NA0017_160_61_20150911_00031.jpg

LM Start	7.16	Rating **	M	Issue No.	61
LM End	7.16	Issue Type +	Ma	Location *	WS
Category	Earthen Levee			GPS Latitude/Longitude	
				Start	End
Item	Encroachments			37.978850 °	37.978850 °
				-121.099325 °	-121.099325 °
DWR ID	DWR_NA0017_16_s _ 2012_61				
Action/Comments					
Debris					
Inspector Comments: Farmer has burned the material, but some new material has been placed. Farmer has been told to not put any material at this location in the future.

Debris and prunings were found on the waterside of the levee looking upstream.

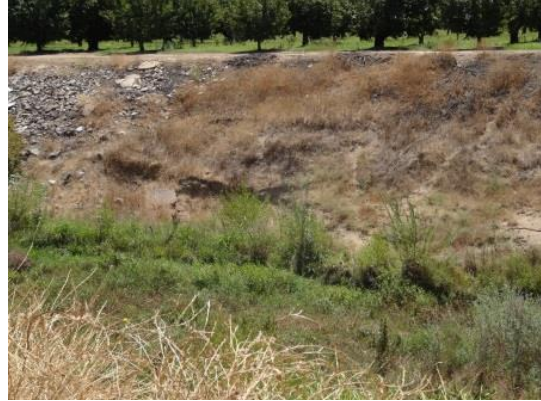
Photo 1 of 2 : SJR2015_NA0017U16RM15.57_3.JPG

LM Start	7.27	Rating **	U	Issue No.	37
LM End	7.33	Issue Type +	Ma	Location *	WS
Category	Supplemental			GPS Latitude/Longitude	
				Start	End
Item	DWR Erosion Survey			37.978194 °	37.978194 °
				-121.101696 °	-121.101696 °
DWR ID					
Action/Comments					
Inspector Comments: 8/12/2015: No significant change observed. 8/20/2014: No significant change observed. Note the site ID changed from NA0017U16RM10.82 to NA0017U16RM15.57 to reflect the correct river mile. 09/12/2013: The site is located at immediately downstream of a levee segment protected by broken concrete. There is no levee structure on site. The levee crest width and levee height were not measured or estimated in the field. [2015 Site ID:NA0017U16RM15.57]

Close view of the erosion.

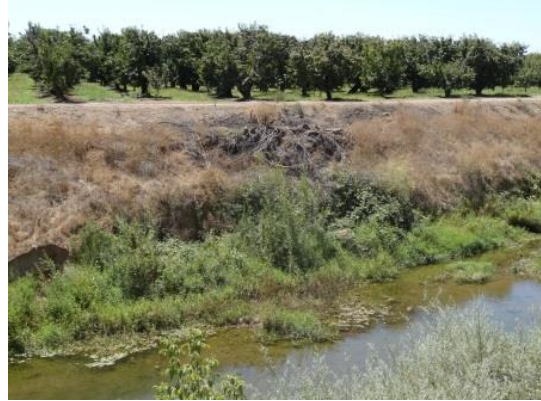
Photo 2 of 2 : SJR2015_NA0017U16RM15.57_5.JPG

Close view of the erosion.

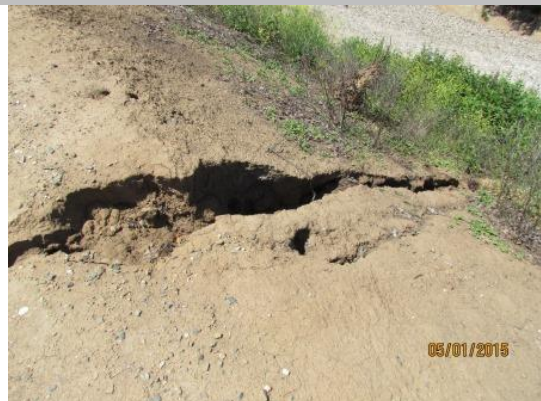
Photo 1 of 1 : FA_2015_NA0017_160_246_20150911_00143.jpg

Erosion was found on the waterside shoulder of the levee looking downstream.

LM Start	7.39	Rating **	M	Issue No.	246
LM End	7.39	Issue Type +	Ma	Location *	WS
Category	Earthen Levee			GPS Latitude/Longitude	
				Start	End
Item	Erosion / Bank Caving			37.977610 °	37.977610 °
				-121.103159 °	-121.103159 °
DWR ID	DWR_NA0017_16_s_2015_246				
Action/Comments					
Note and monitor erosion site.

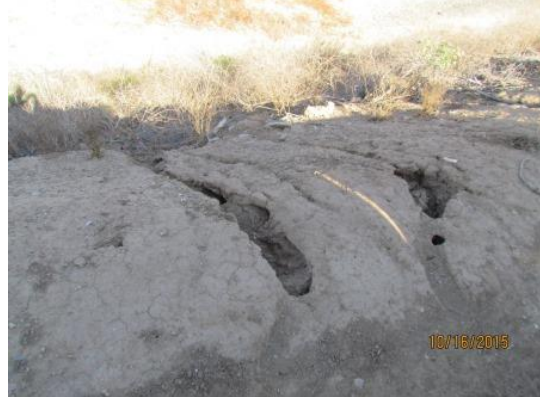
Photo 1 of 1 : FA_2015_NA0017_160_237_20151023_00166.jpg

Erosion caused by runoff was found on the waterside shoulder of the levee.

LM Start	7.42	Rating **	M	Issue No.	237
LM End	7.42	Issue Type +	Ma	Location *	WS
Category	Earthen Levee			GPS Latitude/Longitude	
				Start	End
Item	Erosion / Bank Caving			37.977421 °	37.977421 °
				-121.103507 °	-121.103507 °
DWR ID	DWR_NA0017_16_f _ 2015_237				
Action/Comments					
Schedule repair of erosion site prior to the next inspection.

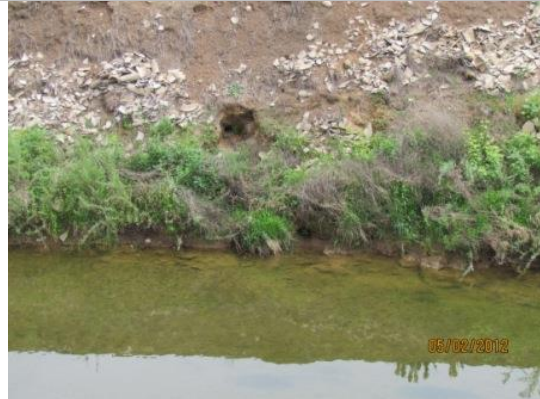
Photo 1 of 1 : FA_2015_NA0017_160_218_20150911_00132.jpg

LM Start	7.57	Rating **	U	Issue No.	218
LM End	7.57	Issue Type +	Ma	Location *	WS
Category	Earthen Levee			GPS Latitude/Longitude	
				Start	End
Item	Animal Control				°
					°
DWR ID	DWR_NA0017_16_s_2012_218				
Action/Comments					
No rodents visible, but rodent burrows visible; need to backfill and compact or grout burrows.

A possible beaver den was found on waterside slope of the levee. The picture was taken from the opposite bank of the levee.

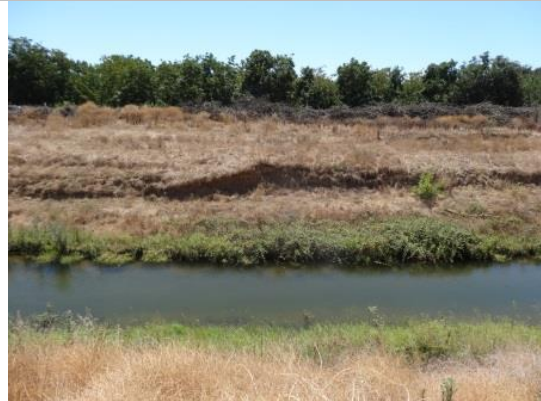
Photo 1 of 2 : SJR2015_NA0017U16RM14.48_1.jpg

LM Start	8.34	Rating **	M	Issue No.	36
LM End	8.38	Issue Type +	Ma	Location *	WS
Category	Supplemental			GPS Latitude/Longitude	
				Start	End
Item	DWR Erosion Survey			37.969213 °	37.969213 °
				-121.116574 °	-121.116574 °
DWR ID					
Action/Comments					
Inspector Comments: 8/12/2015: No significant change observed. 8/20/2014: No significant change observed. 9/12/2013: No significant change observed. 08/22/2012: The erosion occurred on a berm of approximately 25 ft. wide. Site is covered with dense vegetation. There is no levee structure on site. The levee crest width and levee height were not measured or estimated in the field. [2015 Site ID:NA0017U16RM14.48]

View of the site from the right river bank.

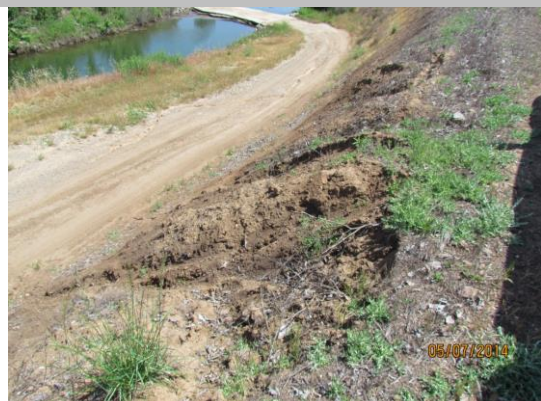
Photo 1 of 2 : FA_2015_NA0017_160_128_20150911_00069.jpg

Updated picture of the slope instability on the waterside of the levee looking upstream during spring 2014 inspection.

LM Start	8.60	Rating **	M	Issue No.	128
LM End	8.60	Issue Type +	Ma	Location *	WS
Category	Earthen Levee			GPS Latitude/Longitude	
				Start	End
Item	Slope Stability			37.968157 °	37.968157 °
				-121.120620 °	-121.120620 °
DWR ID	DWR_NA0017_16_s_2013_128				
Action/Comments					
Repair slope instability.

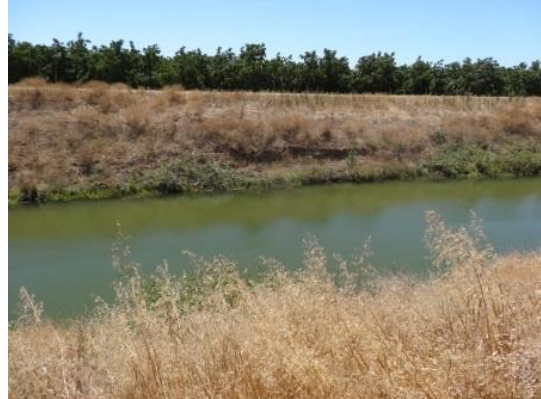
Photo 1 of 2 : SJR2015_NA0017U16RM13.86_2.jpg

LM Start	9.00	Rating **	M	Issue No.	18
LM End	9.00	Issue Type +	Ma	Location *	WS
Category	Supplemental			GPS Latitude/Longitude	
				Start	End
Item	DWR Erosion Survey			37.966615 °	37.966615 °
				-121.127328 °	-121.127328 °
DWR ID					
Action/Comments					
Inspector Comments: 8/12/2015: No significant change observed. 8/20/2014: No significant change observed. 9/12/2013: No significant change observed. 08/22/2012: Pocket erosion at the levee toe and slope. The erosion is covered with dense vegetation. There is no levee structure on site. The levee crest width and levee height were not measured or estimated in the field. [2015 Site ID:NA0017U16RM13.86]

Front view of the erosion.

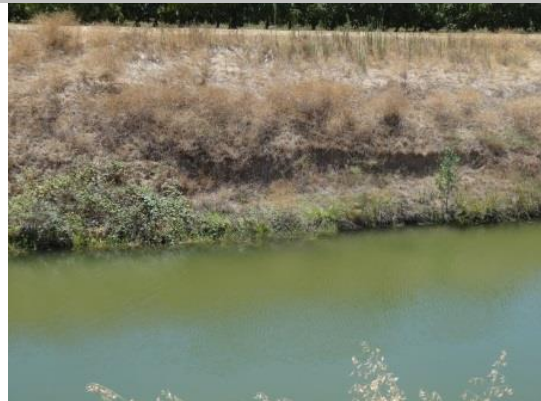
Photo 2 of 2 : SJR2015_NA0017U16RM13.86_5.jpg

Closer view of the erosion.

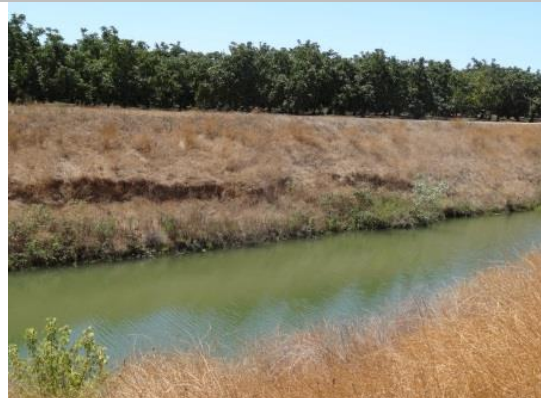
Photo 1 of 3 : SJR2015_NA0017U16RM13.72_3.jpg

LM Start	9.11	Rating **	M	Issue No.	14
LM End	9.13	Issue Type +	Ma	Location *	WS
Category	Supplemental			GPS Latitude/Longitude	
				Start	End
Item	DWR Erosion Survey			37.966922 °	37.966922 °
				-121.129533 °	-121.129533 °
DWR ID					
Action/Comments					
Inspector Comments: 8/12/2015: No significant change observed. 8/20/2014: No significant change observed. 9/12/2013: No significant change observed. 08/22/2012: The erosion is covered with dense vegetation. There is no levee structure on site. The levee crest width and levee height were not measured or estimated in the field. [2015 Site ID:NA0017U16RM13.72]

Close view of the erosion.

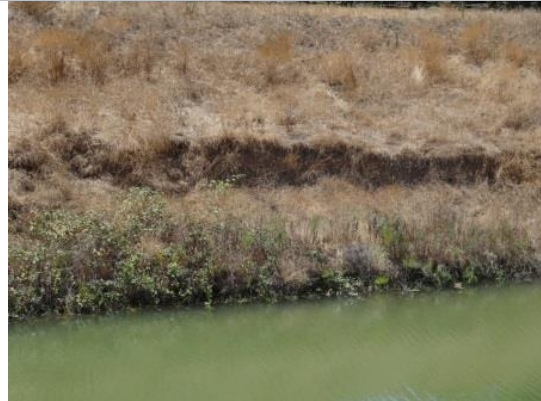
Photo 2 of 3 : SJR2015_NA0017U16RM13.72_4.jpg

Close view of the erosion.
