**Flood Control Project Maintenance
Levee Inspections**

Maintenance Issue Types Only, Levee Inspection Report By Mile - Fall 2015

San Joaquin County Flood Control and Water Conservation District

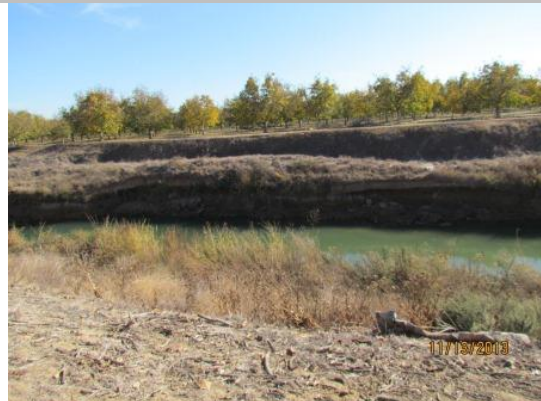
Photo 1 of 1 : FA_2015_NA0017_160_28_20150911_00011.jpg

LM Start	9.48	Rating **	M	Issue No.	28
LM End	9.48	Issue Type +	Ma	Location *	WS
Category	Earthen Levee			GPS Latitude/Longitude	
				Start	End
Item	Erosion / Bank Caving			37.966239 °	37.966239 °
				-121.136172 °	-121.136172 °
DWR ID	DWR_NA0017_16_f _ 2013_28				
Action/Comments					
Schedule repair of erosion site prior to the next inspection. Inspector Comments: Erosion was found on the waterside toe of the levee.

View of the erosion on the waterside toe of the levee looking from the opposite side of the levee.

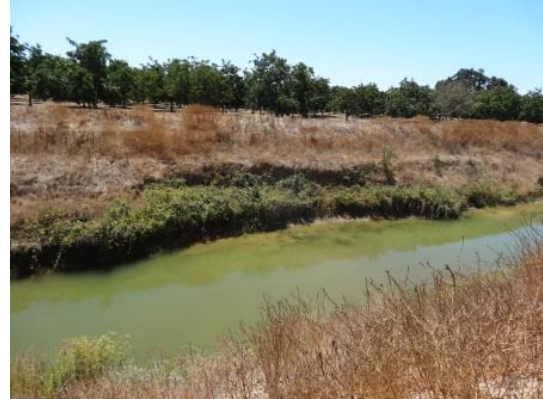
Photo 1 of 2 : SJR2015_NA0017U16RM12.95_2.jpg

LM Start	9.86	Rating **	M	Issue No.	10
LM End	9.88	Issue Type +	Ma	Location *	WS
Category	Supplemental			GPS Latitude/Longitude	
				Start	End
Item	DWR Erosion Survey			37.964735 °	37.964735 °
				-121.142503 °	-121.142503 °
DWR ID					
Action/Comments					
Inspector Comments: 8/12/2015: No significant change observed. 8/20/2014: No significant change observed. 9/12/2013: No significant change observed. 08/22/2012: Dense vegetation on site. There is no levee structure on site. The levee crest width and levee height were not measured or estimated in the field. [2015 Site ID:NA0017U16RM12.95]

Front view of the erosion.

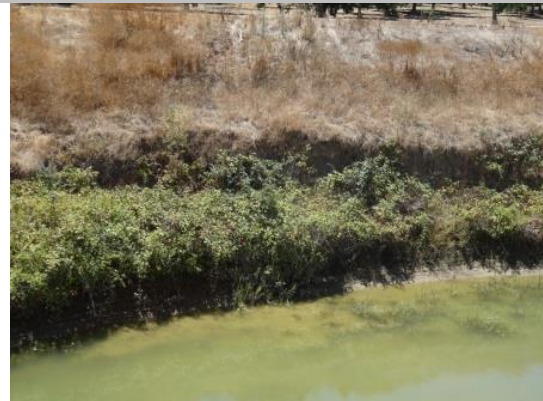
Photo 2 of 2 : SJR2015_NA0017U16RM12.95_5.jpg

Closer view of the erosion.

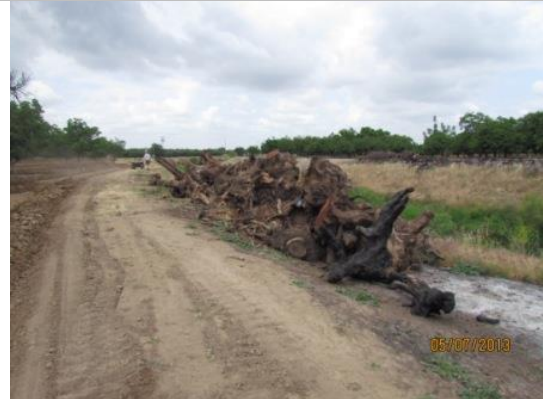
Photo 1 of 2 : FA_2015_NA0017_160_90_20150911_00046.jpg

LM Start	10.75	Rating **	M	Issue No.	90
LM End	10.75	Issue Type +	Ma	Location *	WS
Category	Earthen Levee			GPS Latitude/Longitude	
				Start	End
Item	Encroachments			37.962472 °	37.962472 °
				-121.158112 °	-121.158112 °
DWR ID	DWR_NA0017_16_s_2012_90				
Action/Comments					
Prunings

Prunings were found on the waterside shoulder of the levee looking downstream.

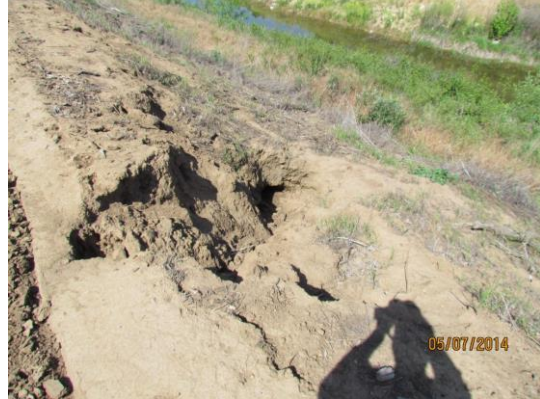
Photo 1 of 2 : FA_2015_NA0017_160_139_20150911_00078.jpg

Updated picture of the erosion on the waterside shoulder of the levee looking downstream.

LM Start	10.79	Rating **	M	Issue No.	139
LM End	10.79	Issue Type +	Ma	Location *	WS
Category	Earthen Levee			GPS Latitude/Longitude	
				Start	End
Item	Erosion / Bank Caving			37.962182 °	37.962182
				-121.158684 °	-121.158684
DWR ID	DWR_NA0017_16_s_2013_139				
Action/Comments					
Schedule repair of erosion site prior to the next inspection.

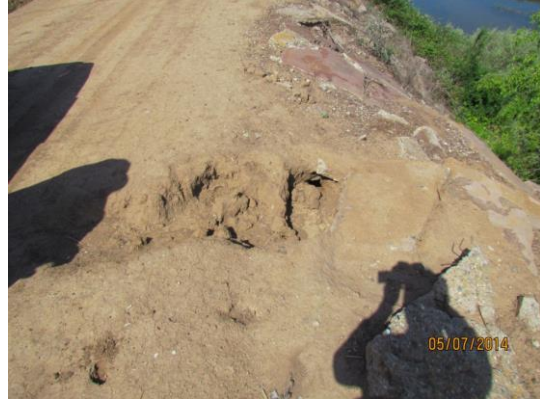
Photo 1 of 1 : FA_2015_NA0017_160_108_20150911_00053.jpg

Rodent holes were found on the waterside shoulder of the levee looking downstream.

LM Start	10.89	Rating **	M	Issue No.	108
LM End	10.89	Issue Type +	Ma	Location *	WS
Category	Earthen Levee			GPS Latitude/Longitude	
				Start	End
Item	Animal Control			37.961494 °	37.961494
				-121.160196 °	-121.160196
DWR ID	DWR_NA0017_16_s_2014_108				
Action/Comments					
No rodents visible, but rodent burrows visible; need to backfill and compact or grout burrows.

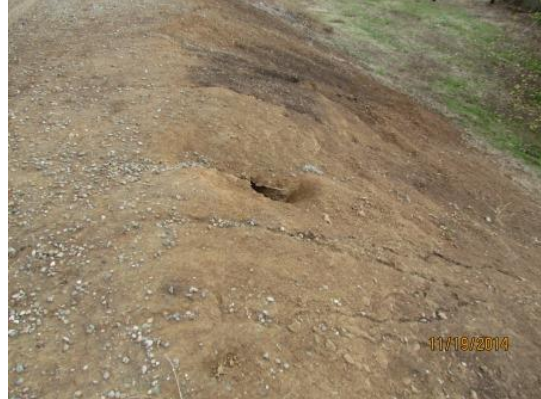
Photo 1 of 1 : FA_2015_NA0017_160_260_20150911_00147.jpg

Rodent holes were found on the landside slope of the levee looking upstream.

LM Start	14.48	Rating **	U	Issue No.	260
LM End	14.48	Issue Type +	Ma	Location *	LS
Category	Earthen Levee			GPS Latitude/Longitude	
				Start	End
Item	Animal Control			37.968800 °	37.968800 °
				-121.220755 °	-121.220755 °
DWR ID	DWR_NA0017_16_f _ 2014_260				
Action/Comments					
No rodents visible, but rodent burrows visible; need to backfill and compact or grout burrows.

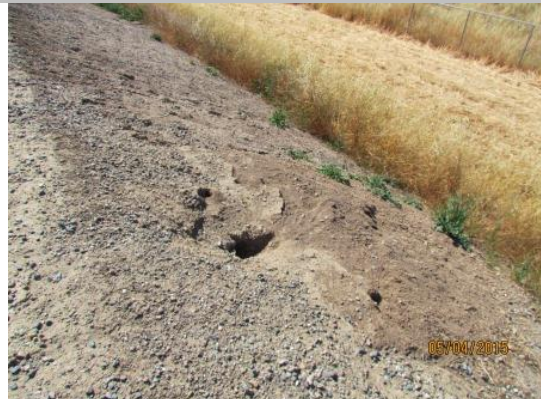
Photo 1 of 1 : FA_2015_NA0017_160_273_20150911_00156.jpg

Rodent holes were found on the landside of the levee looking upstream.

LM Start	14.61	Rating **	U	Issue No.	273
LM End	14.61	Issue Type +	Ma	Location *	LS
Category	Earthen Levee			GPS Latitude/Longitude	
				Start	End
Item	Animal Control			37.969913 °	37.969913 °
				-121.222870 °	-121.222870 °
DWR ID	DWR_NA0017_16_s_2015_273				
Action/Comments					
No rodents visible, but rodent burrows visible; need to backfill and compact or grout burrows.

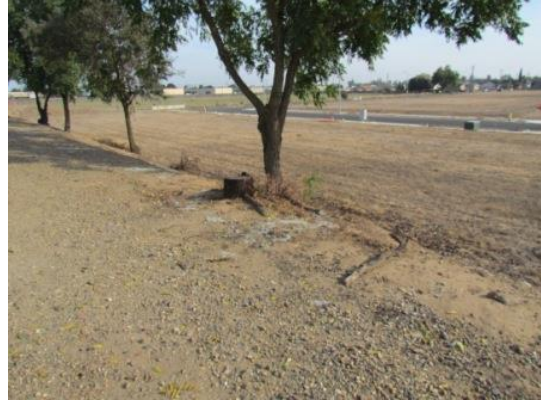
Photo 1 of 1 : FA_2015_NA0017_160_65_20150911_00033.jpg

LM Start	19.04	Rating **	N	Issue No.	65
LM End	19.04	Issue Type +	Ma	Location *	LS
Category	Earthen Levee			GPS Latitude/Longitude	
				Start	End
Item	Trim / Thin Trees			37.991617 °	37.991617 °
				-121.295628 °	-121.295628 °
DWR ID	DWR_NA0017_16_s _ 2012_65				
Action/Comments					
Tree stumps.

A tree stump was found on the landside of the levee looking upstream.

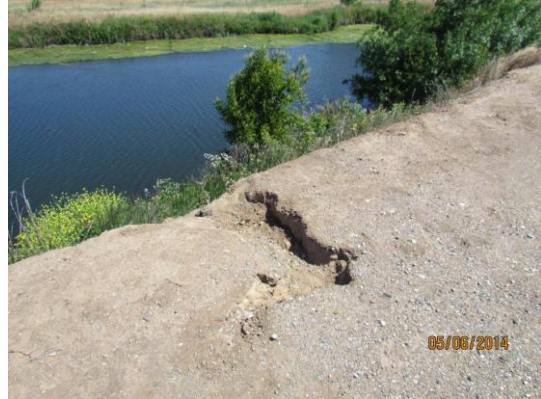
Photo 1 of 2 : FA_2015_NA0017_160_197_20150911_00116.jpg

Updated picture of the erosion on the waterside of the levee looking upstream during spring 2014 inspection.

LM Start	20.97	Rating **	M	Issue No.	197
LM End	20.97	Issue Type +	Ma	Location *	WS
Category	Earthen Levee			GPS Latitude/Longitude	
				Start	End
Item	Erosion / Bank Caving			37.980569 °	37.980569
				-121.322985 °	-121.322985
DWR ID	DWR_NA0017_16_s_2013_197				
Action/Comments					
Schedule repair of erosion site prior to the next inspection.

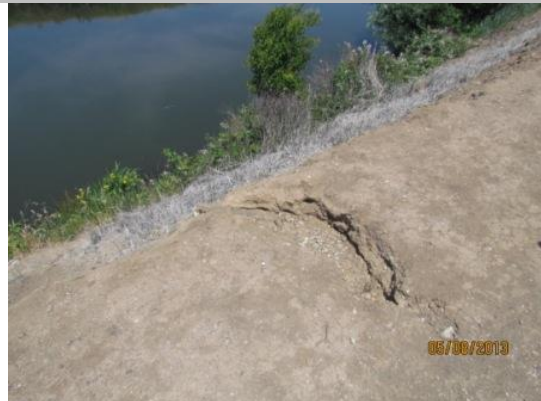
Photo 2 of 2 : FA_2015_NA0017_160_197_20150911_00117.jpg

Erosion was found on the waterside slope of the levee looking upstream.

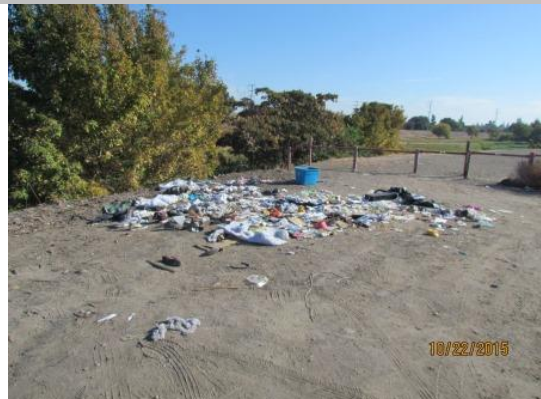
Photo 1 of 1 : FA_2015_NA0017_160_279_20151023_00169.jpg

LM Start	21.07	Rating **	M	Issue No.	279
LM End	21.07	Issue Type +	Ma	Location *	WS
Category	Earthen Levee			GPS Latitude/Longitude	
				Start	End
Item	Encroachments			37.980866 °	37.980866 °
				-121.324682 °	-121.324682 °
DWR ID	DWR_NA0017_16_s_2015_279				
Action/Comments					
Debris

Debris was found on the waterside shoulder of the levee.

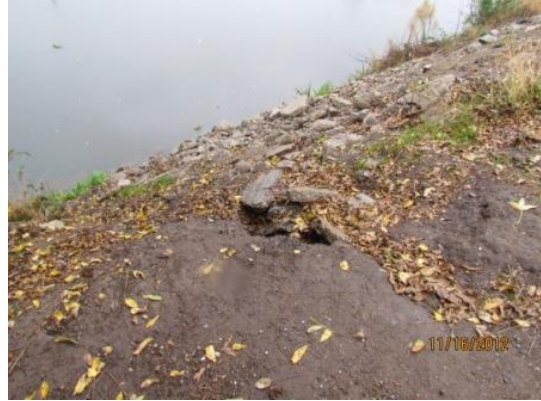
Photo 1 of 1 : FA_2015_NA0017_160_68_20150911_00036.jpg

Erosion was found on the waterside slope of the levee looking upstream.

LM Start	21.68	Rating **	M	Issue No.	68
LM End	21.68	Issue Type +	Ma	Location *	WS
Category	Earthen Levee			GPS Latitude/Longitude	
				Start	End
Item	Erosion / Bank Caving			37.979674 °	37.979674 °
				-121.335228 °	-121.335228 °
DWR ID	DWR_NA0017_16_f_2012_68				
Action/Comments					
Schedule repair of erosion site prior to the next inspection.

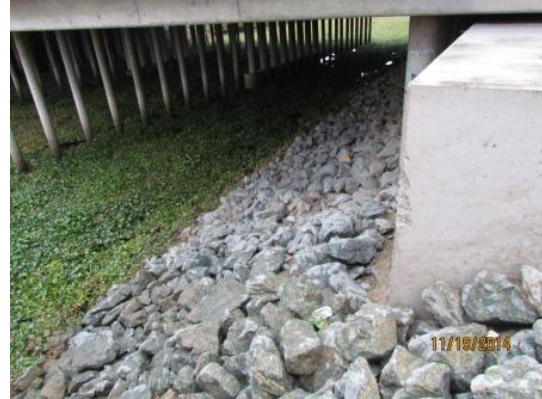
Photo 1 of 5 : FA_2015_NA0017_160_48_20150911_00018.jpg

LM Start	22.04	Rating **	A/W	Issue No.	48
LM End	22.04	Issue Type +	Ma	Location *	WS
Category	Earthen Levee			GPS Latitude/Longitude	
				Start	End
Item	Erosion / Bank Caving			37.978697 °	37.978697 °
				-121.341581 °	-121.341581 °
DWR ID	DWR_NA0017_16_s _ 2012_48				
Action/Comments					
Schedule repair of erosion site prior to the next inspection. Inspector Comments: Caltrans repaired the issue. (Permit # 18532) Another repair might be needed if it deteriorates.

Caltrans repaired the erosion under the southbound (I-5) bridge. The picture was taken from the crown looking upstream during fall 2014 inspection.

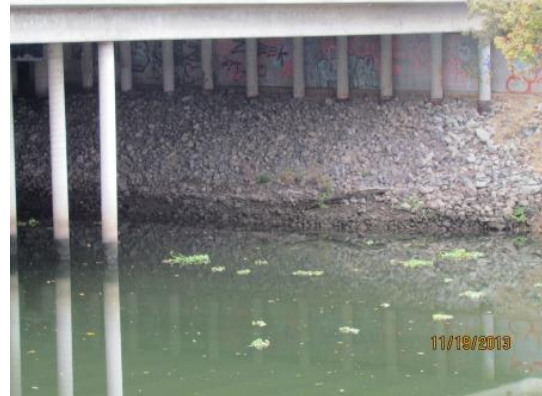
Photo 2 of 5 : FA_2015_NA0017_160_48_20150911_00020.jpg

Updated picture of erosion was found on the waterside toe of the levee looking from the opposite side of the levee.

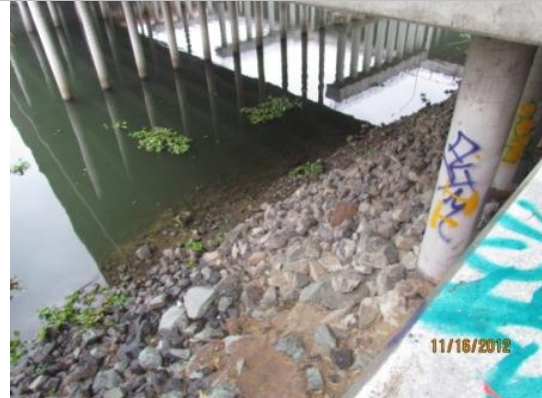
Photo 3 of 5 : FA_2015_NA0017_160_48_20150911_00021.jpg

Updated view of the erosion site repaired by Caltrans on the waterside slope of the levee looking upstream.

LM Start	22.04	Rating **	A/W	Issue No.	48 (cont)
LM End	22.04	Issue Type +	Ma	Location *	WS
Category	Earthen Levee			GPS Latitude/Longitude	
				Start	End
Item	Erosion / Bank Caving			37.978697 °	37.978697 °
				-121.341581 °	-121.341581 °
DWR ID	DWR_NA0017_16_s _ 2012_48				
Action/Comments					
Schedule repair of erosion site prior to the next inspection. Inspector Comments: Caltrans repaired the issue. (Permit # 18532) Another repair might be needed if it deteriorates.

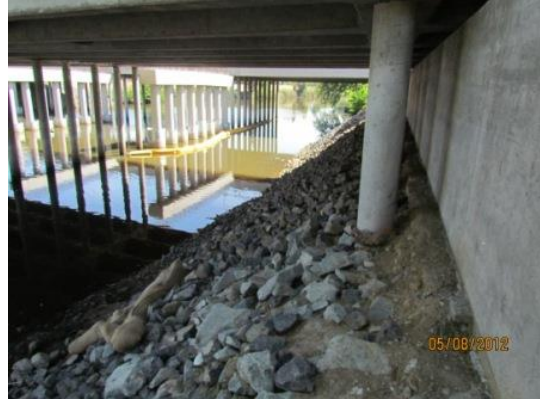
Photo 4 of 5 : FA_2015_NA0017_160_48_20150911_00022.jpg

View of the erosion site repaired by Caltrans under the I-5 freeway going southbound. This picture was taken from the toe of the levee looking upstream.

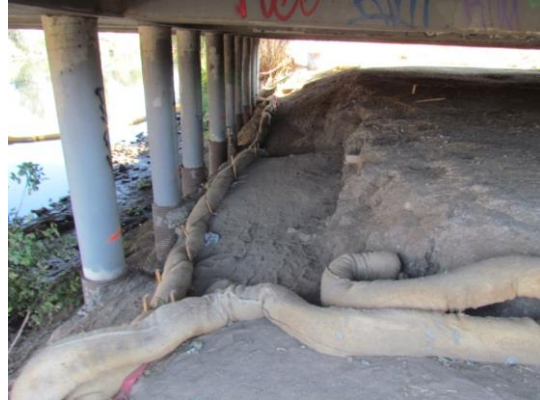
Photo 5 of 5 : FA_2015_NA0017_160_48_20150911_00023.jpg

View of the erosion under the I-5 bridge looking upstream.

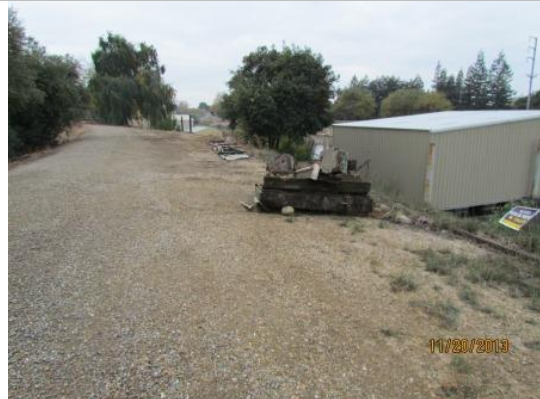
Photo 1 of 1 : FA_2015_NA0017_160_43_20150911_00016.jpg

LM Start	22.27	Rating **	M	Issue No.	43
LM End	22.27	Issue Type +	Ma	Location *	WS
Category	Earthen Levee			GPS Latitude/Longitude	
				Start	End
Item	Encroachments			37.976308 °	37.976308 °
				-121.344698 °	-121.344698 °
DWR ID	DWR_NA0017_16_f _ 2013_43				
Action/Comments					
Debris

Debris was found on the waterside shoulder of the levee looking downstream.

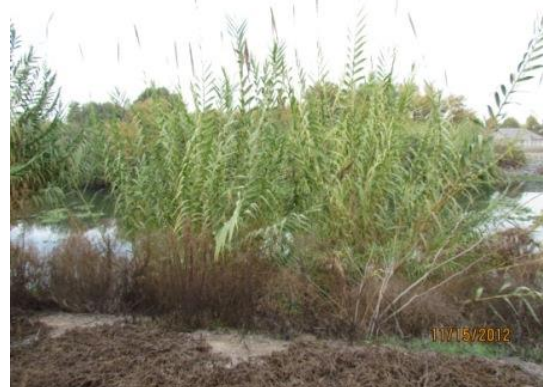
Photo 1 of 1 : FA_2015_NA0017_160_45_20150911_00017.jpg

Arundo was found on the waterside slope of the levee looking upstream.

LM Start	22.55	Rating **	U	Issue No.	45
LM End	22.55	Issue Type +	Ma	Location *	WS
Category	Earthen Levee			GPS Latitude/Longitude	
				Start	End
Item	Vegetation			37.973386 °	37.973386 °
				-121.348241 °	-121.348241 °
DWR ID	DWR_NA0017_16_f_2012_45				
Action/Comments					
Remove the wild growth other than native grasses from the levee slopes.					
Inspector Comments: Arrundo on the waterside of the levee.

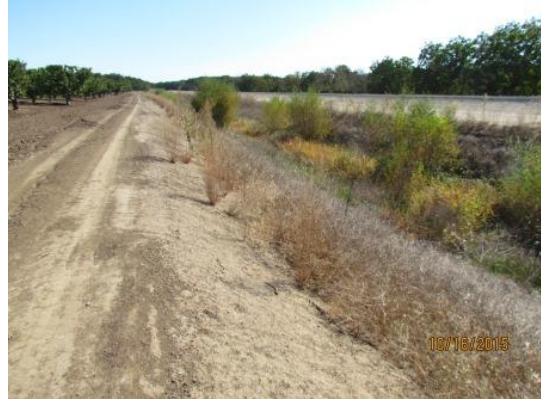
Photo 1 of 1 : FA_2015_NA0017_161_7_20151023_00008.jpg

View of the vegetation on the waterside of the levee looking upstream.

LM Start	0.13	Rating **	M	Issue No.	7
LM End	0.31	Issue Type +	Ma	Location *	WS
Category	Earthen Levee			GPS Latitude/Longitude	
				Start	End
Item	Vegetation			37.959971 °	37.959505 °
				-121.161177 °	-121.157914 °
DWR ID	DWR_NA0017_17_f _ 2015_7				
Action/Comments					
Control annual grass and weeds on the levee slopes and easements.

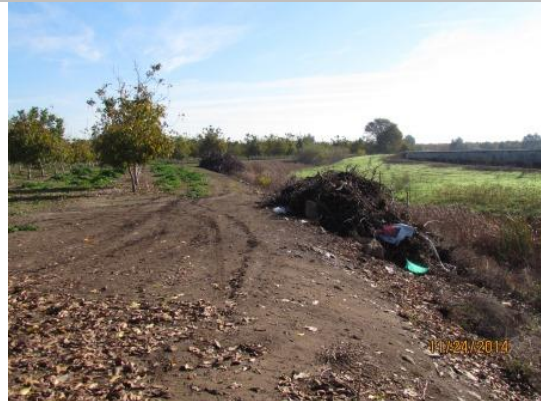
Photo 1 of 2 : FA_2015_NA0017_161_5_20150911_00004.jpg

Updated picture of the prunings on the waterside of the levee looking upstream during fall 2014 inspection.

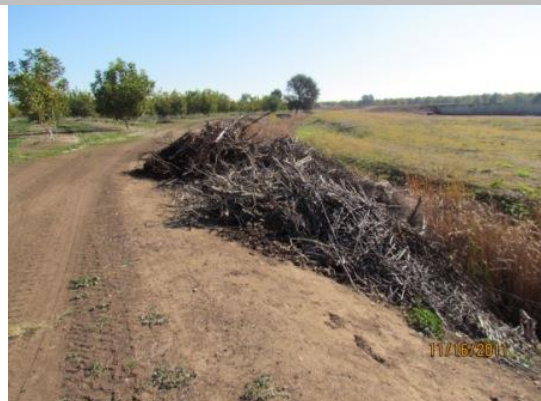
Photo 2 of 2 : FA_2015_NA0017_161_5_20150911_00005.jpg

Prunings were found on the waterside of the levee looking upstream.

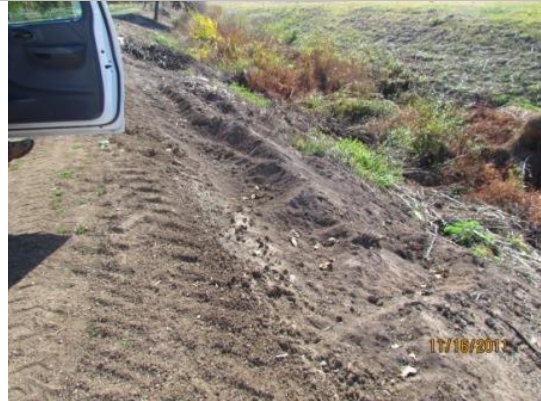
Photo 1 of 1 : FA_2015_NA0017_161_10_20150911_00007.jpg

Slope instability was found on the waterside of the levee looking upstream.

LM Start	0.67	Rating **	M	Issue No.	10
LM End	0.67	Issue Type +	Ma	Location *	WS
Category	Earthen Levee			GPS Latitude/Longitude	
				Start	End
Item	Slope Stability			37.958702 °	37.958702 °
				-121.151544 °	-121.151544 °
DWR ID	DWR_NA0017_17_s_2012_10				
Action/Comments					
Repair the levee slope damaged by vehicle traffic and prevent access where possible.

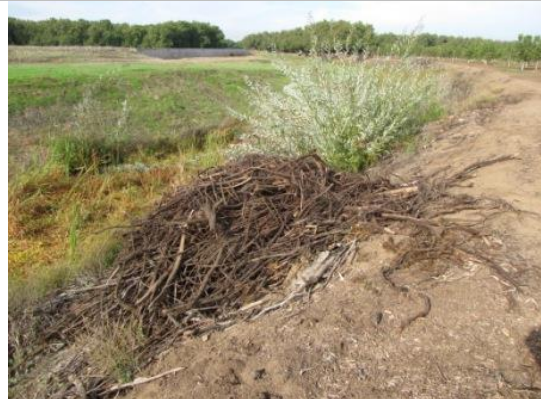
Photo 1 of 1 : FA_2015_NA0017_161_3_20150911_00002.jpg

View of a prunings pile along the waterward bank looking downstream.

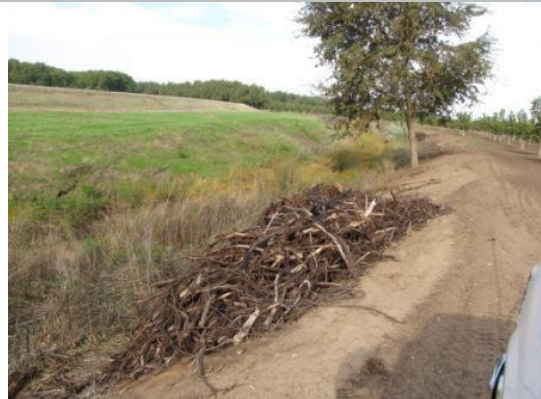
Photo 1 of 1 : FA_2015_NA0017_161_2_20150911_00001.jpg

View of a prunings pile along the waterward bank looking downstream.

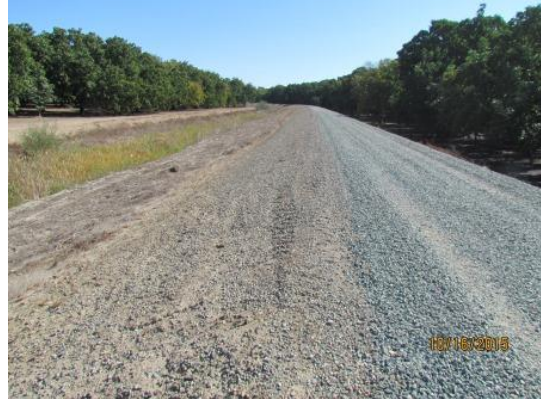
Photo 1 of 1 : FA_2015_NA0017_162_3_20151023_00002.jpg

View of the waterside slope of the levee.

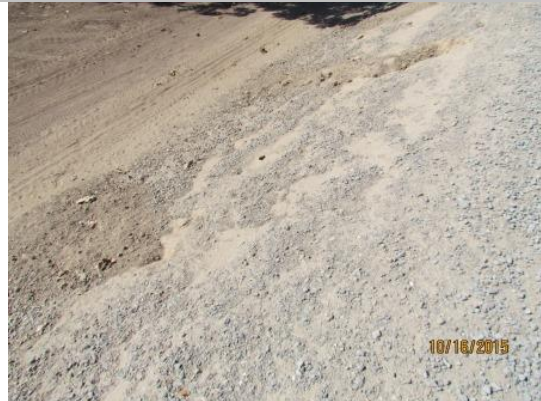
Photo 1 of 1 : FA_2015_NA0017_162_4_20151023_00003.jpg

Rodent holes were found on the landside of the levee.

LM Start	0.87	Rating **	M	Issue No.	4
LM End	0.87	Issue Type +	Ma	Location *	LS
Category	Earthen Levee			GPS Latitude/Longitude	
				Start	End
Item	Animal Control			37.960206 °	37.960206 °
				-121.163559 °	-121.163559 °
DWR ID	DWR_NA0017_18_f_2015_4				
Action/Comments					
No rodents visible, but rodent burrows visible; need to backfill and compact or grout burrows.
