**Flood Control Project Maintenance  
Levee Inspections**

**Maintenance Issue Types Only, Levee Inspection Report By Mile - Fall 2016**

**San Joaquin County Flood Control and Water Conservation District**

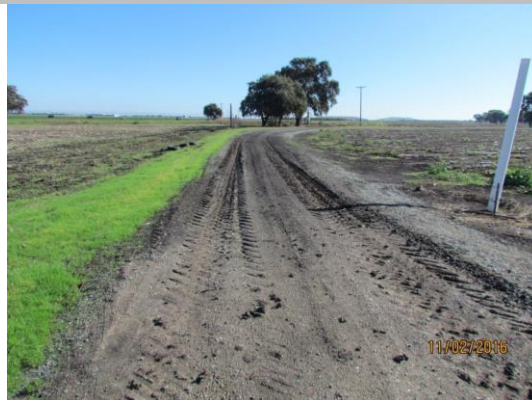
Photo 1 of 1 : FA\_2016\_NA0017\_148\_11\_20161104\_00025.jpg

LM Start	0.79	Rating **	M	Issue No.	11
LM End	0.79	Issue Type +	Ma	Location *	CR
Category	Earthen Levee			GPS Latitude/Longitude	
				Start	End
Item	Crown Surface / Depressions / Rutting			37.878523 °	37.878523 °
				-121.242328 °	-121.242328 °
DWR ID	DWR_NA0017_01_f_2016_11				
Comment Code					
C3 : Add appropriate gravel or road base. Grade and compact.					
Inspector Comment

View of the crown depression on the levee looking upstream. Fall 2016

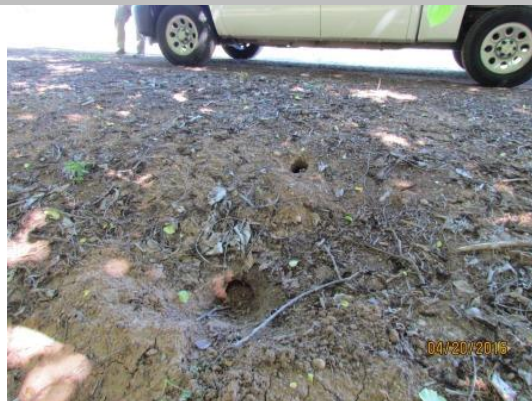
Photo 1 of 1 : FA\_2016\_NA0017\_150\_5\_20160823\_00001.jpg

LM Start	<b>0.05</b>	Rating **	M	Issue No.	<b>5</b>
LM End	<b>0.05</b>	Issue Type +	Ma	Location *	LS
Category	Earthen Levee			GPS Latitude/Longitude	
				Start	End
Item	Animal Control			37.979182°	37.979182°
				-121.097977°	-121.097977°
DWR ID	DWR_NA0017_06_s_2016_5				
Comment Code					
A3 : No rodents visible, but rodent burrows visible; need to backfill and compact or grout burrows.					
Inspector Comment

View of rodent holes on the landside of the levee.

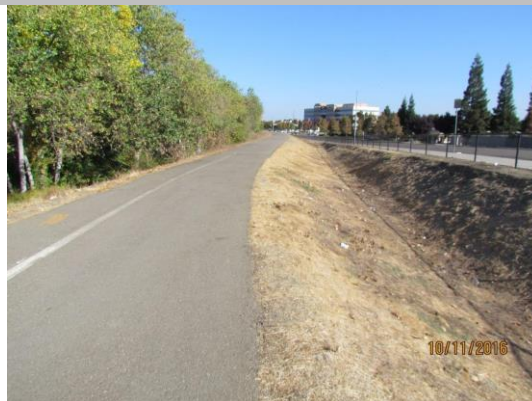
Photo 1 of 1 : FA\_2016\_NA0017\_151\_68\_20161014\_00142.jpg

LM Start	0.15	Rating **	A	Issue No.	68	
LM End	0.15	Issue Type +	Ma	Location *	LS	
Category	Earthen Levee			GPS Latitude/Longitude		
				Start		End
Item	Vegetation			38.043768 °		38.043768 °
				-121.370862 °		-121.370862 °
DWR ID	DWR_NA0017_07_f_2016_68					
Comment Code						
V1 : Control annual grass and weeds on the levee slopes and easements.						
Inspector Comment						
Acceptable landside vegetation.

View of the landside of the levee. Fall 2016.

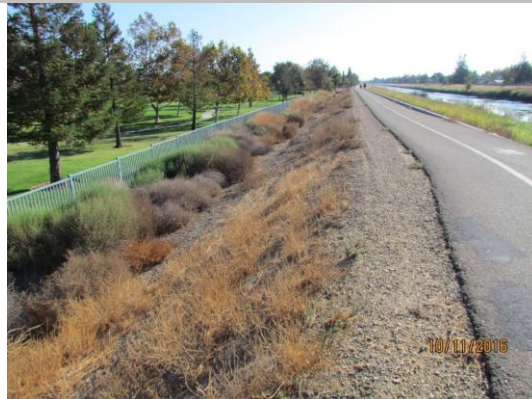
Photo 1 of 1 : FA\_2016\_NA0017\_151\_69\_20161014\_00143.jpg

LM Start	0.38	Rating **	M	Issue No.	69
LM End	0.53	Issue Type +	Ma	Location *	LS
Category	Earthen Levee			GPS Latitude/Longitude	
				Start	End
Item	Vegetation			38.043585°	38.043556°
				-121.366732°	-121.363954°
DWR ID	DWR_NA0017_07_f_2016_69				
Comment Code					
V1 : Control annual grass and weeds on the levee slopes and easements.					
Inspector Comment

View of the vegetation on the landside of the levee looking upstream.

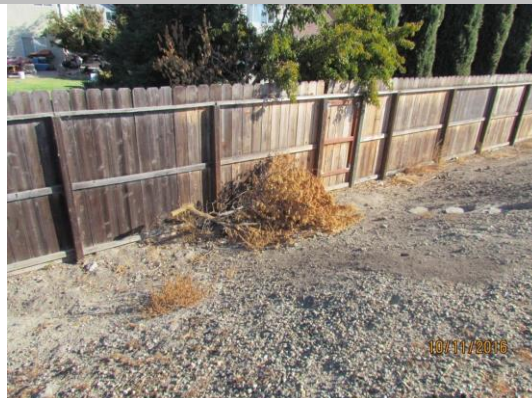
Photo 1 of 1 : FA\_2016\_NA0017\_151\_71\_20161014\_00144.jpg

LM Start	0.53	Rating **	M	Issue No.	71
LM End	0.53	Issue Type +	Ma	Location *	LS
Category	Earthen Levee			GPS Latitude/Longitude	
				Start	End
Item	Encroachments			38.043555 °	38.043555 °
				-121.363955 °	-121.363955 °
DWR ID	DWR_NA0017_07_f_2016_71				
Comment Code					
PR : Prunings					
Inspector Comment

View of prunings on the landside toe of the levee.

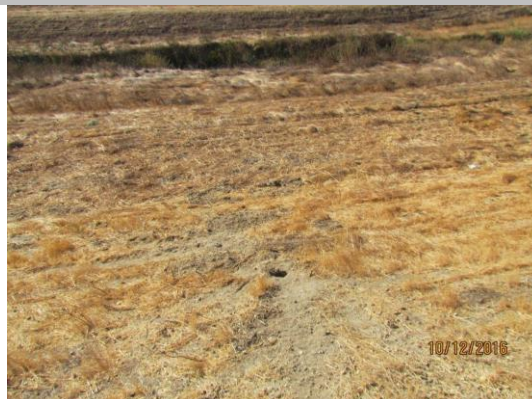
Photo 1 of 1 : FA\_2016\_NA0017\_151\_79\_20161014\_00145.jpg

LM Start	4.80	Rating **	M	Issue No.	79
LM End	4.80	Issue Type +	Ma	Location *	WS
Category	Earthen Levee			GPS Latitude/Longitude	
				Start	End
Item	Animal Control			38.049833 °	38.049833 °
				-121.289359 °	-121.289359 °
DWR ID	DWR_NA0017_07_f_2016_79				
Comment Code					
A3 : No rodents visible, but rodent burrows visible; need to backfill and compact or grout burrows.					
Inspector Comment

View of a rodent hole on the waterside of the levee.

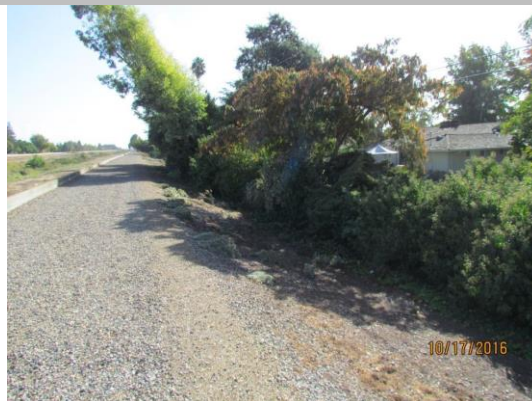
Photo 1 of 1 : FA\_2016\_NA0017\_152\_115\_20161021\_00197.jpg

LM Start	2.08	Rating **	M	Issue No.	115
LM End	2.11	Issue Type +	Ma	Location *	LS
Category	Earthen Levee			GPS Latitude/Longitude	
				Start	End
Item	Trim / Thin Trees			38.042780 °	38.042778 °
				-121.346134 °	-121.345589 °
DWR ID	DWR_NA0017_08_f_2016_115				
Comment Code					
T2 : Thin trees to allow visibility of the ground and room to flood fight.					
Inspector Comment

View of the tree limbs on the landside of the levee. Fall 2016.

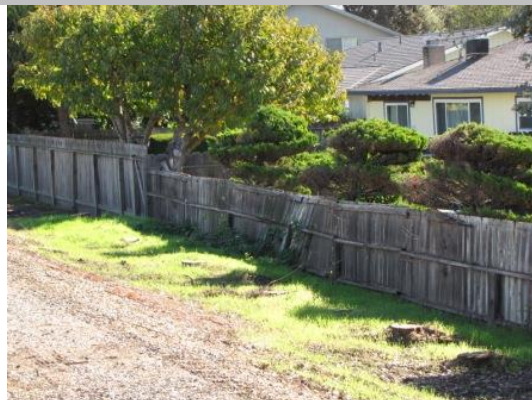
Photo 1 of 1 : FA\_2016\_NA0017\_152\_12\_20160823\_00003.jpg

LM Start	2.50	Rating **	N	Issue No.	12
LM End	2.50	Issue Type +	Ma	Location *	LS
Category	Earthen Levee			GPS Latitude/Longitude	
				Start	End
Item	Trim / Thin Trees			38.042749 °	38.042749 °
				-121.338402 °	-121.338402 °
DWR ID	DWR_NA0017_08_s_2012_12				
Comment Code					
T5 : Tree stumps.					
Inspector Comment

View of stumps along the landward toe looking upstream.

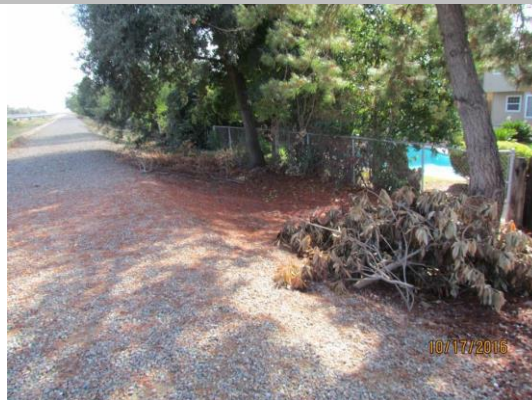
Photo 1 of 1 : FA\_2016\_NA0017\_152\_136\_20161021\_00202.jpg

LM Start	2.64	Rating **	M	Issue No.	136
LM End	2.64	Issue Type +	Ma	Location *	LS
Category	Earthen Levee			GPS Latitude/Longitude	
				Start	End
Item	Encroachments			38.042718 °	38.042718 °
				-121.335727 °	-121.335727 °
DWR ID	DWR_NA0017_08_s_2016_136				
Comment Code					
PR : Prunings					
Inspector Comment

View of prunings on the landside of the levee looking upstream.

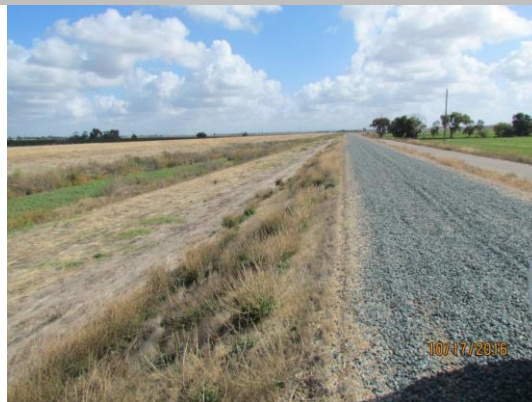
Photo 1 of 1 : FA\_2016\_NA0017\_152\_120\_20161021\_00204.jpg

LM Start	3.74	Rating **	M	Issue No.	120
LM End	3.83	Issue Type +	Ma	Location *	WS
Category	Earthen Levee			GPS Latitude/Longitude	
				Start	End
Item	Vegetation			38.042616 °	38.042615 °
				-121.315701 °	-121.314050 °
DWR ID	DWR_NA0017_08_f_2016_120				
Comment Code					
V2 : Remove the wild growth other than native grasses from the levee slopes.					
Inspector Comment

View of vegetation on the waterside of the levee.

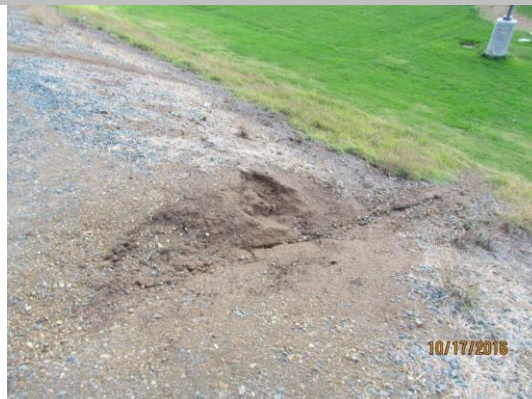
Photo 1 of 1 : FA\_2016\_NA0017\_152\_121\_20161021\_00205.jpg

LM Start	4.82	Rating **	M	Issue No.	121
LM End	4.82	Issue Type +	Ma	Location *	LS
Category	Earthen Levee			GPS Latitude/Longitude	
				Start	End
Item	Erosion / Bank Caving			38.043928 °	38.043928 °
				-121.296386 °	-121.296386 °
DWR ID	DWR_NA0017_08_f_2016_121				
Comment Code					
E2 : Schedule repair of erosion site prior to the next inspection.					
Inspector Comment					
Runoff

View of an erosion due to runoff on the waterside slope of the levee.

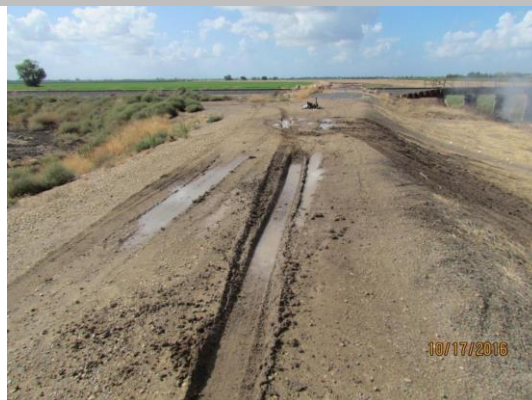
Photo 1 of 1 : FA\_2016\_NA0017\_152\_125\_20161024\_00211.jpg

LM Start	6.13	Rating **	M	Issue No.	125
LM End	6.13	Issue Type +	Ma	Location *	CR
Category	Earthen Levee			GPS Latitude/Longitude	
				Start	End
Item	Crown Surface / Depressions / Rutting			38.052180 °	38.052180 °
				-121.276697 °	-121.276697 °
DWR ID	DWR_NA0017_08_f_2016_125				
Comment Code					
C2 : Repair depressions or ruts in the crown or slope.					
Inspector Comment

View of crown depression on the levee looking downstream. Fall 2016.

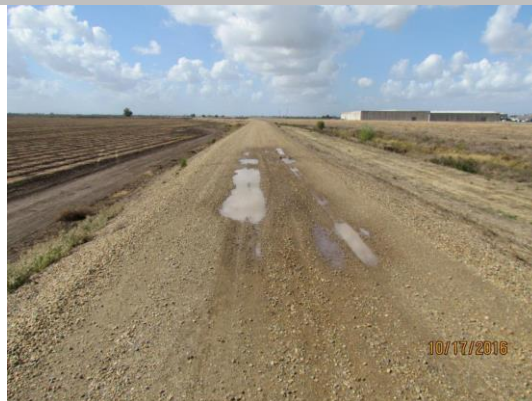
Photo 1 of 2 : FA\_2016\_NA0017\_152\_145\_20161024\_00210.jpg

LM Start	6.47	Rating **	M	Issue No.	145
LM End	6.47	Issue Type +	Ma	Location *	CR
Category	Earthen Levee			GPS Latitude/Longitude	
				Start	End
Item	Crown Surface / Depressions / Rutting			38.053039 °	38.053039 °
				-121.270543 °	-121.270543 °
DWR ID	DWR_NA0017_08_s_2016_145				
Comment Code					
C1 : Add appropriate material and re-grade the levee to bring the crown above the design elevation.					
Inspector Comment

Updated picture of the crown depression looking downstream. Fall 2016.

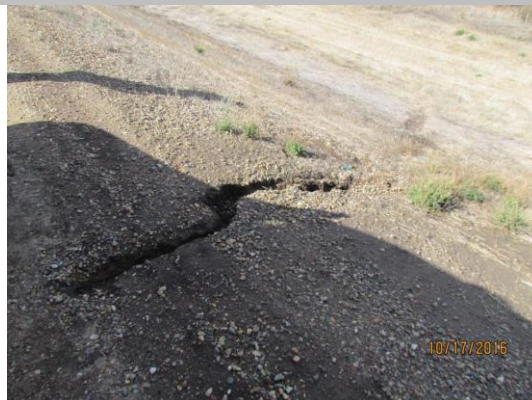
Photo 1 of 1 : FA\_2016\_NA0017\_152\_124\_20161021\_00209.jpg

LM Start	6.53	Rating **	M	Issue No.	124
LM End	6.53	Issue Type +	Ma	Location *	WS
Category	Earthen Levee			GPS Latitude/Longitude	
				Start	End
Item	Erosion / Bank Caving			38.053139 °	38.053139 °
				-121.269405 °	-121.269405 °
DWR ID	DWR_NA0017_08_f_2016_124				
Comment Code					
E2 : Schedule repair of erosion site prior to the next inspection.					
Inspector Comment					
Runoff

View of an erosion due to runoff on the waterside of the levee. Fall 2016.

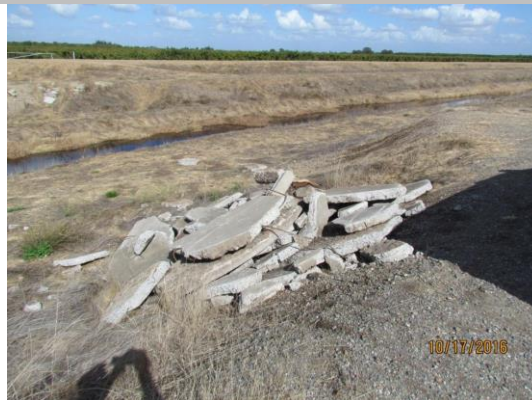
Photo 1 of 1 : FA\_2016\_NA0017\_152\_126\_20161024\_00212.jpg

LM Start	8.43	Rating **	M	Issue No.	126
LM End	8.43	Issue Type +	Ma	Location *	WS
Category	Earthen Levee			GPS Latitude/Longitude	
				Start	End
Item	Encroachments			38.066939 °	38.066939 °
				-121.242196 °	-121.242196 °
DWR ID	DWR_NA0017_08_f_2016_126				
Comment Code					
DE : Debris					
Inspector Comment					
Concrete Debris

View of concrete debris on the waterside of the levee. Fall 2016.

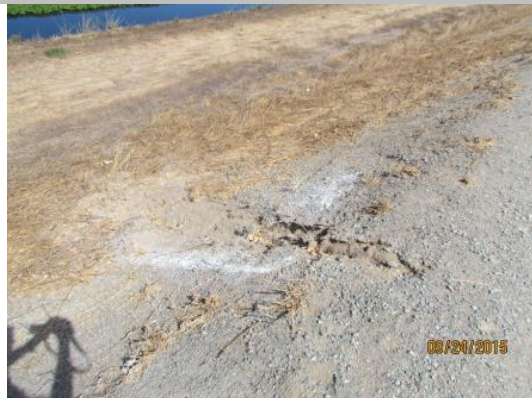
Photo 1 of 1 : FA\_2016\_NA0017\_152\_76\_20160823\_00023.jpg

LM Start	9.63	Rating **	M	Issue No.	76
LM End	9.63	Issue Type +	Ma	Location *	WS
Category	Earthen Levee			GPS Latitude/Longitude	
				Start	End
Item	Slope Stability			38.069807 °	38.069807 °
				-121.220890 °	-121.220890 °
DWR ID	DWR_NA0017_08_f_2015_76				
Comment Code					
S1 : Repair slope instability.					
Inspector Comment

A slope instability was found on the waterside of the levee looking upstream.

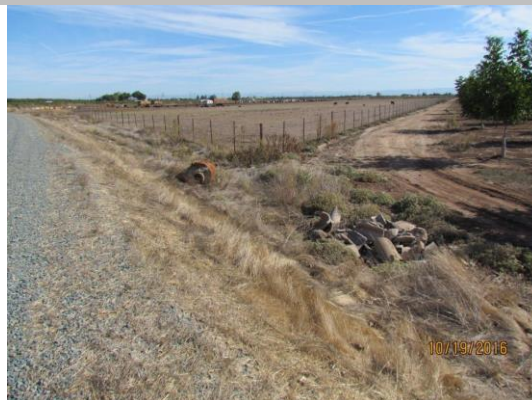
Photo 1 of 1 : FA\_2016\_NA0017\_152\_82\_20161024\_00213.jpg

LM Start	13.72	Rating **	M	Issue No.	82
LM End	13.72	Issue Type +	Ma	Location *	LS
Category	Earthen Levee			GPS Latitude/Longitude	
				Start	End
Item	Encroachments			38.107803 °	38.107803 °
				-121.173179 °	-121.173179 °
DWR ID	DWR_NA0017_08_f_2015_82				
Comment Code					
DE : Debris					
Inspector Comment

View of debris on the landside toe of the levee. Fall 2016

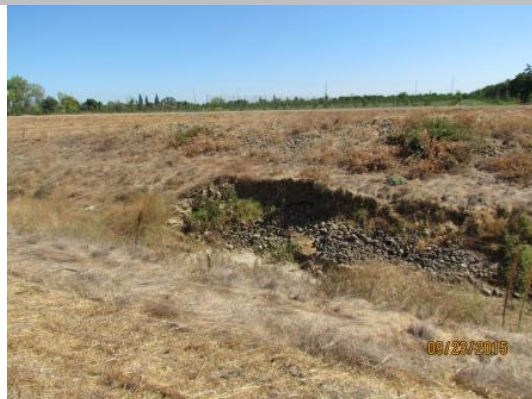
Photo 1 of 1 : FA\_2016\_NA0017\_152\_57\_20160823\_00016.jpg

LM Start	14.75	Rating **	U	Issue No.	57
LM End	14.75	Issue Type +	Ma	Location *	WS
Category	Earthen Levee			GPS Latitude/Longitude	
				Start	End
Item	Erosion / Bank Caving			38.122152 °	38.122152 °
				-121.169461 °	-121.169461 °
DWR ID	DWR_NA0017_08_f_2015_57				
Comment Code					
E2 : Schedule repair of erosion site prior to the next inspection.					
Inspector Comment					
Waterside toe erosion.

Erosion was found on the waterside toe of the levee. The picture was taken from the right bank of the levee.

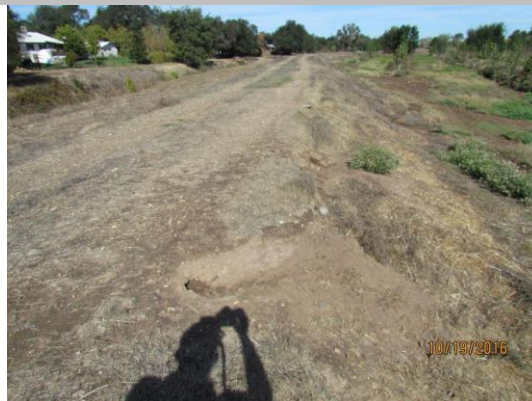
Photo 1 of 1 : FA\_2016\_NA0017\_152\_129\_20161024\_00215.jpg

LM Start	14.76	Rating **	M	Issue No.	129
LM End	14.76	Issue Type +	Ma	Location *	LS
Category	Earthen Levee			GPS Latitude/Longitude	
				Start	End
Item	Animal Control			38.122329°	38.122329°
				-121.169028°	-121.169028°
DWR ID	DWR_NA0017_08_f_2016_129				
Comment Code					
A3 : No rodents visible, but rodent burrows visible; need to backfill and compact or grout burrows.					
Inspector Comment

View of rodent holes on the landside slope of the levee looking upstream. Fall 2016

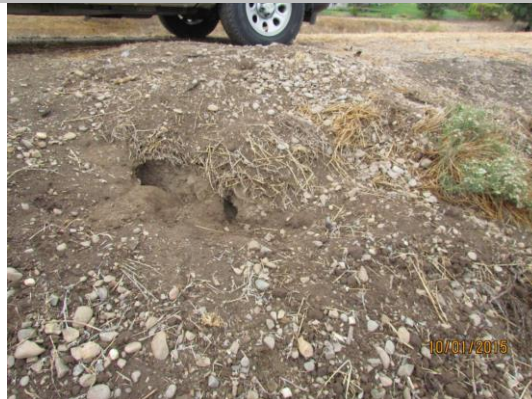
Photo 1 of 1 : FA\_2016\_NA0017\_152\_96\_20160823\_00031.jpg

LM Start	14.79	Rating **	M	Issue No.	96
LM End	14.79	Issue Type +	Ma	Location *	LS
Category	Earthen Levee			GPS Latitude/Longitude	
				Start	End
Item	Animal Control			38.122664°	38.122664°
				-121.169116°	-121.169116°
DWR ID	DWR_NA0017_08_f_2015_96				
Comment Code					
A3 : No rodents visible, but rodent burrows visible; need to backfill and compact or grout burrows.					
Inspector Comment

Rodent holes were found on the landside slope of the levee looking upstream.

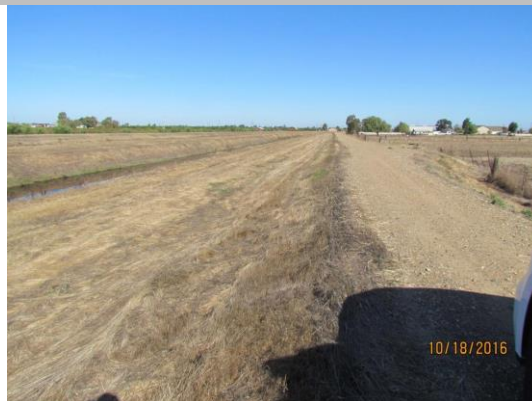
Photo 1 of 1 : FA\_2016\_NA0017\_156\_27\_20161024\_00054.jpg

LM Start	0.17	Rating **	A	Issue No.	27	
LM End	0.17	Issue Type +	Ma	Location *	WS	
Category	Earthen Levee			GPS Latitude/Longitude		
				Start		End
Item	Vegetation			38.097440°		38.097440°
				-121.168760°		-121.168760°
DWR ID	DWR_NA0017_12_f_2016_27					
Comment Code						
V1 : Control annual grass and weeds on the levee slopes and easements.						
Inspector Comment						
Acceptable vegetation.

View of the waterside slope of the levee. Fall 2016.

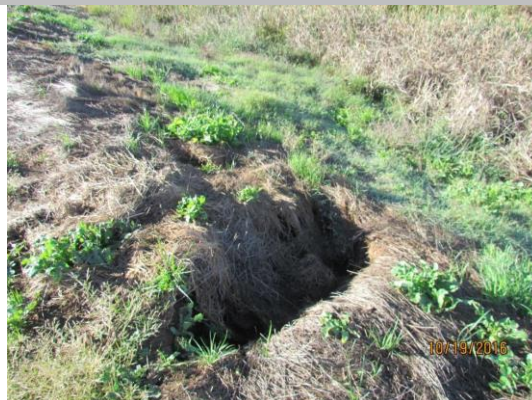
Photo 1 of 1 : FA\_2016\_NA0017\_156\_29\_20161024\_00057.jpg

LM Start	2.92	Rating **	M	Issue No.	29
LM End	2.92	Issue Type +	Ma	Location *	WS
Category	Earthen Levee			GPS Latitude/Longitude	
				Start	End
Item	Erosion / Bank Caving			38.125654 °	38.125654 °
				-121.143946 °	-121.143946 °
DWR ID	DWR_NA0017_12_f_2016_29				
Comment Code					
E2 : Schedule repair of erosion site prior to the next inspection.					
Inspector Comment

View of an erosion on the waterside shoulder of the levee. Fall 2016.

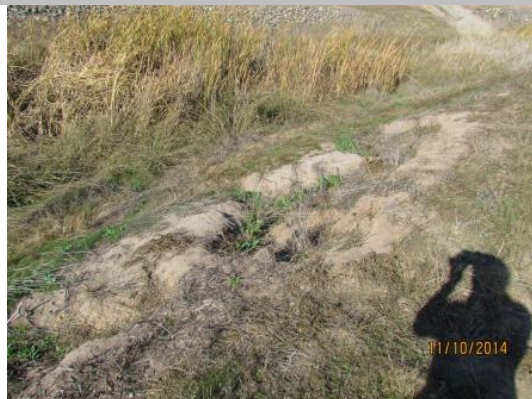
Photo 1 of 1 : FA\_2016\_NA0017\_156\_32\_20160823\_00014.jpg

LM Start	2.97	Rating **	M	Issue No.	32
LM End	2.97	Issue Type +	Ma	Location *	WS
Category	Earthen Levee			GPS Latitude/Longitude	
				Start	End
Item	Slope Stability			38.126304 °	38.126304 °
				-121.143996 °	-121.143996 °
DWR ID	DWR_NA0017_12_f_2014_32				
Comment Code					
S1 : Repair slope instability.					
Inspector Comment

View of a slope instability that was found on the waterside of the levee looking upstream.

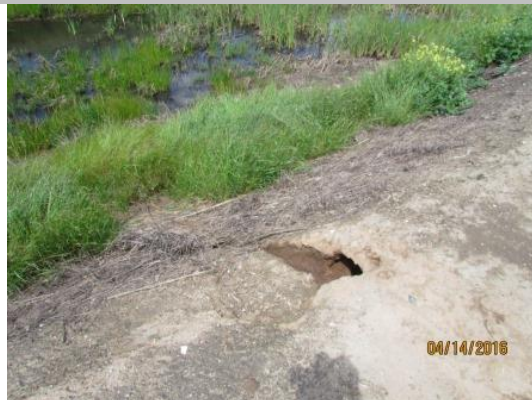
Photo 2 of 2 : FA\_2016\_NA0017\_156\_31\_20160823\_00013.jpg

View of an erosion on the waterside shoulder of the levee.

LM Start	3.14	Rating **	M	Issue No.	31
LM End	3.14	Issue Type +	Ma	Location *	WS
Category	Earthen Levee			GPS Latitude/Longitude	
				Start	End
Item	Erosion / Bank Caving			38.127390 °	38.127390 °
				-121.141197 °	-121.141197 °
DWR ID	DWR_NA0017_12_s_2016_31				
Comment Code					
E2 : Schedule repair of erosion site prior to the next inspection.					
Inspector Comment

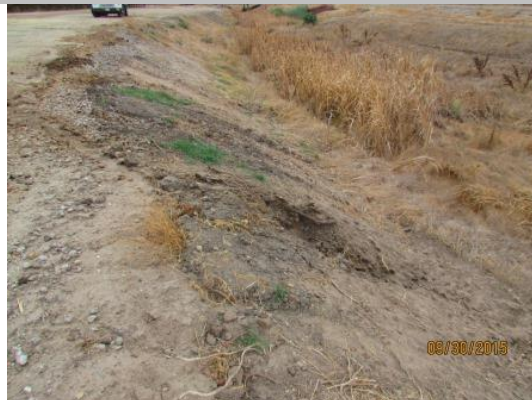
Photo 2 of 2 : FA\_2016\_NA0017\_156\_24\_20160823\_00012.jpg

View of the erosion on the waterside of the levee during fall 2015 inspection.

LM Start	3.46	Rating **	M	Issue No.	24
LM End	3.46	Issue Type +	Ma	Location *	WS
Category	Earthen Levee			GPS Latitude/Longitude	
				Start	End
Item	Erosion / Bank Caving			38.131140°	38.131140°
				-121.138541°	-121.138541°
DWR ID	DWR_NA0017_12_f_2012_24				
Comment Code					
E2 : Schedule repair of erosion site prior to the next inspection.					
Inspector Comment

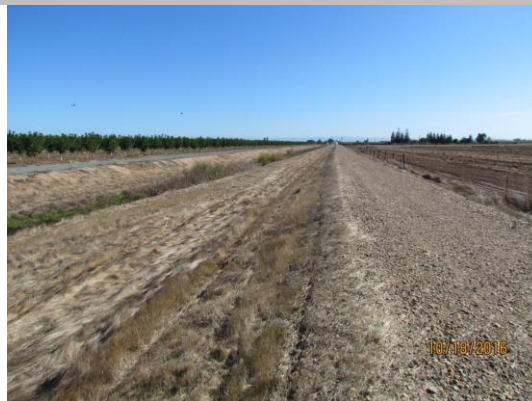
Photo 1 of 1 : FA\_2016\_NA0017\_157\_5\_20161024\_00009.jpg

LM Start	0.13	Rating **	A	Issue No.	5
LM End	0.13	Issue Type +	Ma	Location *	WS
Category	Earthen Levee			GPS Latitude/Longitude	
				Start	End
Item	Vegetation			38.109437°	38.109437°
				-121.158060°	-121.158060°
DWR ID	DWR_NA0017_13_f_2016_5				
Comment Code					
V1 : Control annual grass and weeds on the levee slopes and easements.					
Inspector Comment					
Acceptable vegetation

View of the waterside slope of the levee. Fall 2016

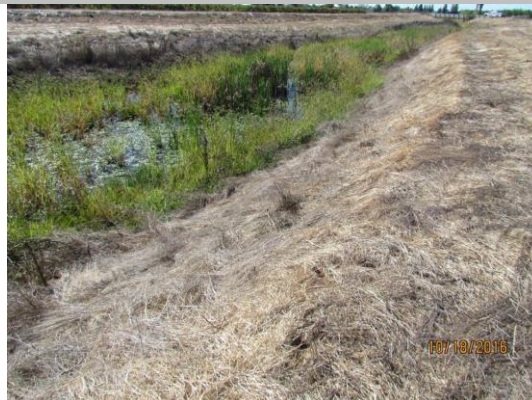
Photo 1 of 2 : FA\_2016\_NA0017\_158\_1\_20161024\_00038.jpg

LM Start	0.64	Rating **	M	Issue No.	1
LM End	0.64	Issue Type +	Ma	Location *	WS
Category	Earthen Levee			GPS Latitude/Longitude	
				Start	End
Item	Animal Control			38.112050 °	38.112050 °
				-121.149524 °	-121.149524 °
DWR ID	DWR_NA0017_14_s_2012_1				
Comment Code					
A1 : Exterminate rodents and backfill and compact or grout burrows.					
Inspector Comment

Updated picture of the rodent holes on the waterside of the levee. Fall 2016

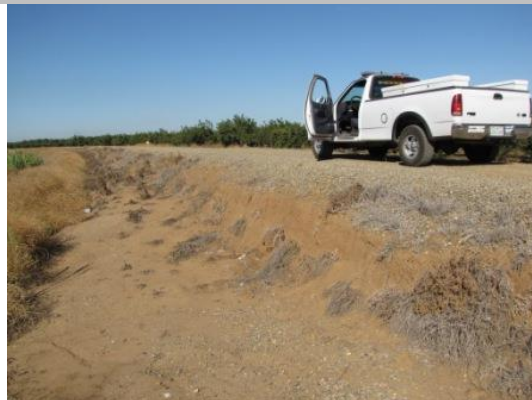
Photo 1 of 1 : FA\_2016\_NA0017\_159\_995\_20160823\_00154.jpg

LM Start	1.49	Rating **	M	Issue No.	995
LM End	1.49	Issue Type +	Ma	Location *	WS
Category	Earthen Levee			GPS Latitude/Longitude	
				Start	End
Item	Slope Stability			38.040202 °	38.040202 °
				-121.032659 °	-121.032659 °
DWR ID	DWR_NA0017_15_s_2012_995				
Comment Code					
S1 : Repair slope instability.					
Inspector Comment					
The LMA was working on fixing the erosion site using an excavator during the inspection.

View of erosion of waterward levee slope looking upstream.

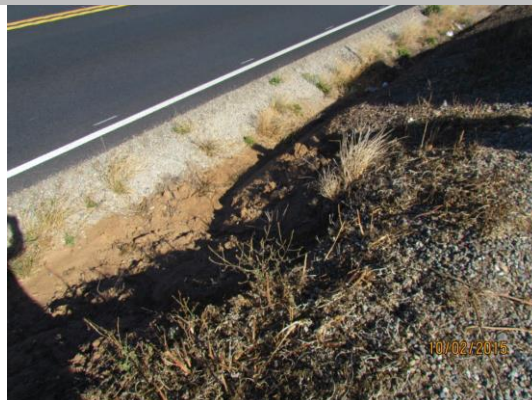
Photo 1 of 1 : FA\_2016\_NA0017\_159\_120\_20160823\_00104.jpg

LM Start	1.92	Rating **	M	Issue No.	120
LM End	1.92	Issue Type +	Ma	Location *	LS
Category	Earthen Levee			GPS Latitude/Longitude	
				Start	End
Item	Slope Stability			38.037919 °	38.037919 °
				-121.039749 °	-121.039749 °
DWR ID	DWR_NA0017_15_f_2015_120				
Comment Code					
S1 : Repair slope instability.					
Inspector Comment					
It was caused by runoff.

A slope instability possible cause by runoff on the landside of the levee looking upstream.

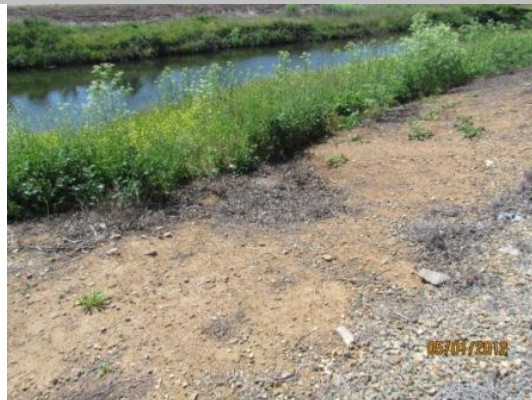
Photo 2 of 2 : FA\_2016\_NA0017\_159\_18\_20160823\_00027.jpg

Slope instability was found on the waterside toe of the levee looking downstream.

LM Start	2.05	Rating **	M	Issue No.	18
LM End	2.05	Issue Type +	Ma	Location *	WS
Category	Earthen Levee			GPS Latitude/Longitude	
				Start	End
Item	Slope Stability			38.036294 °	38.036294 °
				-121.041089 °	-121.041089 °
DWR ID	DWR_NA0017_15_s_2012_18				
Comment Code					
S1 : Repair slope instability.					
Inspector Comment

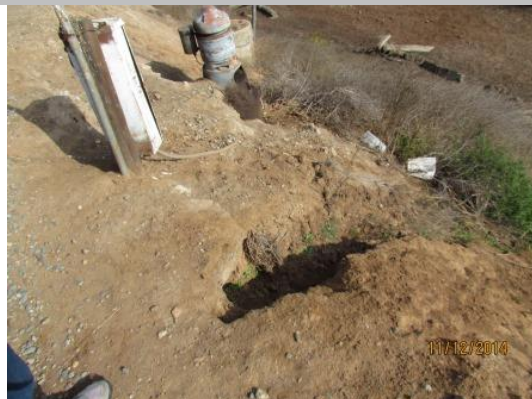
Photo 2 of 2 : FA\_2016\_NA0017\_159\_44\_20160823\_00062.jpg

LM Start	3.89	Rating **	M	Issue No.	44 (cont)	
LM End	3.89	Issue Type +	Ma	Location *	WS	
Category	Earthen Levee			GPS Latitude/Longitude		
				Start		End
Item	Slope Stability			38.017945°		38.017945°
				-121.065295°		-121.065295°
DWR ID	DWR_NA0017_15_f_2012_44					
Comment Code						
S1 : Repair slope instability.						
Inspector Comment

Updated picture of the slope instability on the waterside slope of the levee looking upstream. This picture was taken during fall 2014 inspection.

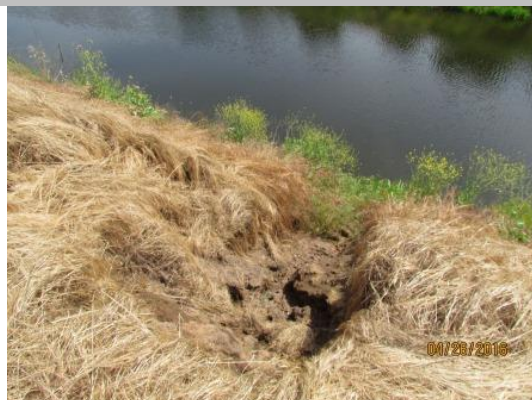
Photo 1 of 2 : FA\_2016\_NA0017\_159\_133\_20160823\_00109.jpg

LM Start	4.51	Rating **	M	Issue No.	133
LM End	4.51	Issue Type +	Ma	Location *	WS
Category	Earthen Levee			GPS Latitude/Longitude	
				Start	End
Item	Erosion / Bank Caving			38.009753 °	38.009753 °
				-121.069559 °	-121.069559 °
DWR ID	DWR_NA0017_15_f_2015_133				
Comment Code					
E2 : Schedule repair of erosion site prior to the next inspection.					
Inspector Comment

Updated view of the erosion on the waterside shoulder during spring 2016 inspection.

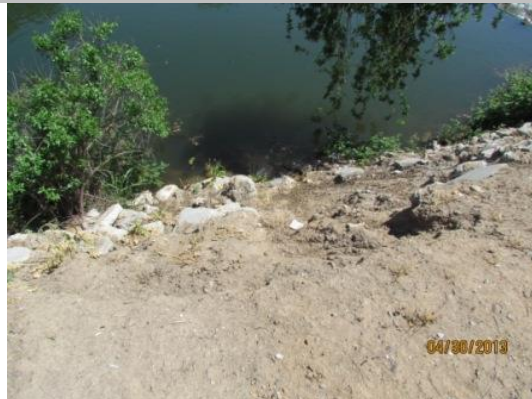
Photo 1 of 3 : FA\_2016\_NA0017\_159\_96\_20160823\_00090.jpg

LM Start	4.63	Rating **	M	Issue No.	96
LM End	4.63	Issue Type +	Ma	Location *	WS
Category	Earthen Levee			GPS Latitude/Longitude	
				Start	End
Item	Erosion / Bank Caving			38.008053 °	38.008053 °
				-121.070141 °	-121.070141 °
DWR ID	DWR_NA0017_15_s_2012_96				
Comment Code					
E1 : Note and monitor erosion site.					
Inspector Comment					
LMA has fixed the issue but the riprap has rebar which can be dangerous during a flood fighting effort.

Updated picture of the slope instability on the waterside slope of the levee looking downstream during spring 2013 inspection.

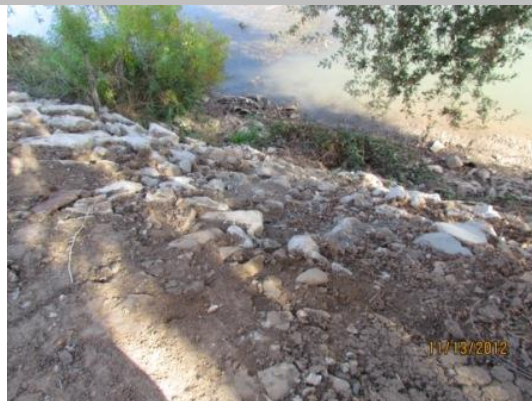
Photo 2 of 3 : FA\_2016\_NA0017\_159\_96\_20160823\_00091.jpg

LM Start	4.63	Rating **	M	Issue No.	96 (cont)	
LM End	4.63	Issue Type +	Ma	Location *	WS	
Category	Earthen Levee			GPS Latitude/Longitude		
				Start		End
Item	Erosion / Bank Caving			38.008053 °		38.008053 °
				-121.070141 °		-121.070141 °
DWR ID	DWR_NA0017_15_s_2012_96					
Comment Code						
E1 : Note and monitor erosion site.						
Inspector Comment						
LMA has fixed the issue but the riprap has rebar which can be dangerous during a flood fighting effort.

The LMA has fixed the erosion on the landside slope of the levee but the riprap contains exposed rebar which could be dangerous during a flood fight.

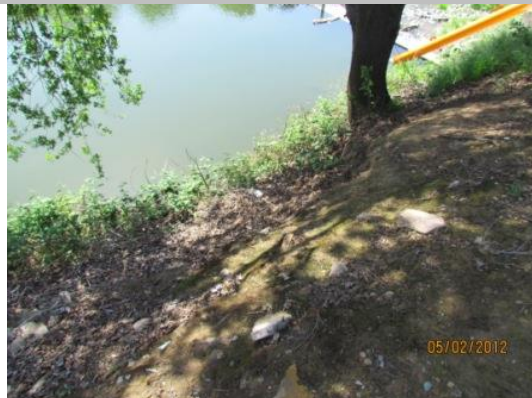
Photo 3 of 3 : FA\_2016\_NA0017\_159\_96\_20160823\_00092.jpg

Erosion was found on the waterside slope of the levee looking downstream.

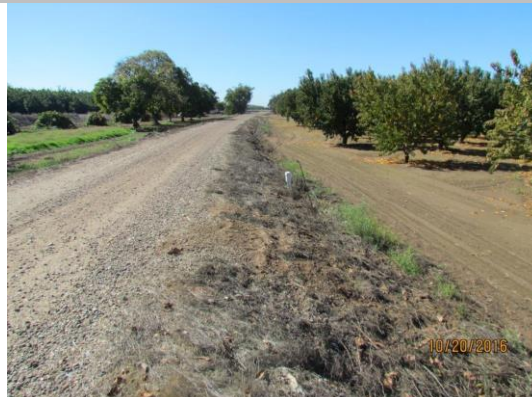
Photo 1 of 2 : FA\_2016\_NA0017\_159\_140\_20161024\_00314.jpg

LM Start	6.67	Rating **	A/W	Issue No.	140
LM End	6.67	Issue Type +	Ma	Location *	LS
Category	Earthen Levee			GPS Latitude/Longitude	
				Start	End
Item	Animal Control			37.983817 °	37.983817 °
				-121.091141 °	-121.091141 °
DWR ID	DWR_NA0017_15_f_2015_140				
Comment Code					
A3 : No rodents visible, but rodent burrows visible; need to backfill and compact or grout burrows.					
Inspector Comment					
This portion of the levee is non-project. Therefore, the rating was given as A/W.

Updated picture of the rodent holes on the landside of the levee. Fall 2016

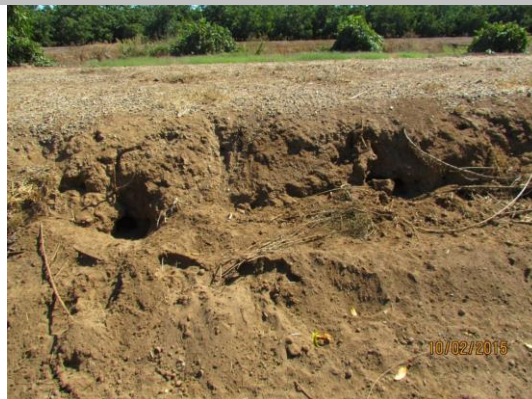
Photo 2 of 2 : FA\_2016\_NA0017\_159\_140\_20160823\_00113.jpg

LM Start	6.67	Rating **	A/W	Issue No.	140 (cont)	
LM End	6.67	Issue Type +	Ma	Location *	LS	
Category	Earthen Levee			GPS Latitude/Longitude		
				Start		End
Item	Animal Control			37.983817 °		37.983817 °
				-121.091141 °		-121.091141 °
DWR ID	DWR_NA0017_15_f_2015_140					
Comment Code						
A3 : No rodents visible, but rodent burrows visible; need to backfill and compact or grout burrows.						
Inspector Comment						
This portion of the levee is non-project. Therefore, the rating was given as A/W.

Rodent holes were found on the landside shoulder of the levee looking downstream.

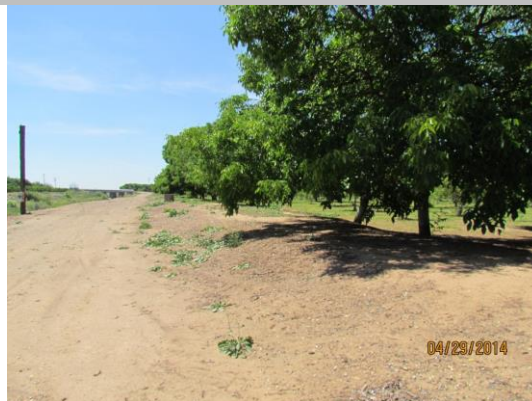
Photo 1 of 1 : FA\_2016\_NA0017\_159\_115\_20160823\_00102.jpg

LM Start	6.96	Rating **	M	Issue No.	115
LM End	7.20	Issue Type +	Ma	Location *	LS
Category	Earthen Levee			GPS Latitude/Longitude	
				Start	End
Item	Trim / Thin Trees			37.981387°	37.979749°
				-121.095370°	-121.099178°
DWR ID	DWR_NA0017_15_s_2014_115				
Comment Code					
T1 : Trim trees to at least five feet above ground level.					
Inspector Comment					
Trees branches were obstructing the access/patrol road.

Tree limbs were obstructing the visibility of the crown of the levee looking downstream.

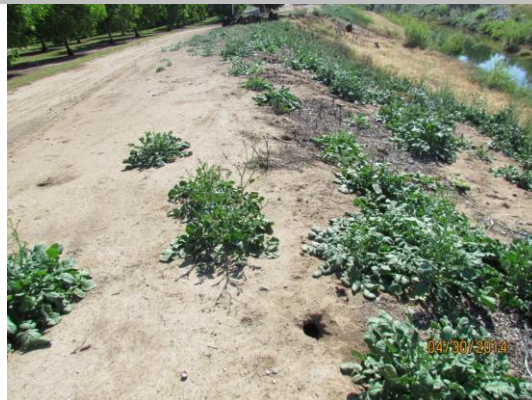
Photo 1 of 1 : FA\_2016\_NA0017\_159\_126\_20160823\_00107.jpg

LM Start	9.83	Rating **	A/W	Issue No.	126
LM End	9.83	Issue Type +	Ma	Location *	WS
Category	Earthen Levee			GPS Latitude/Longitude	
				Start	End
Item	Animal Control			37.965343 °	37.965343 °
				-121.140761 °	-121.140761 °
DWR ID	DWR_NA0017_15_s_2014_126				
Comment Code					
A3 : No rodents visible, but rodent burrows visible; need to backfill and compact or grout burrows.					
Inspector Comment					
This portion of the levee is non-project. Therefore, the rating was given as A/W.

View of rodent holes on the waterside of the levee looking upstream.

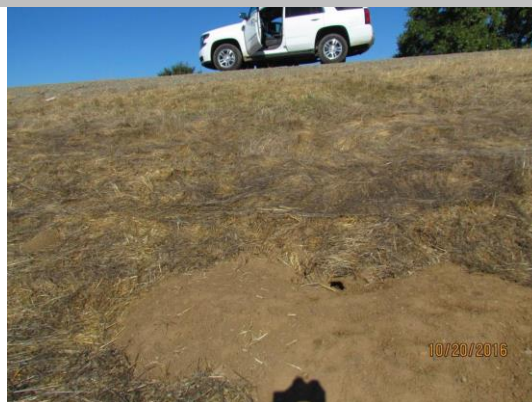
Photo 1 of 1 : FA\_2016\_NA0017\_159\_201\_20161024\_00320.jpg

LM Start	14.59	Rating **	M	Issue No.	201
LM End	14.59	Issue Type +	Ma	Location *	WS
Category	Earthen Levee			GPS Latitude/Longitude	
				Start	End
Item	Animal Control			37.970281 °	37.970281 °
				-121.221683 °	-121.221683 °
DWR ID	DWR_NA0017_15_f_2016_201				
Comment Code					
A3 : No rodents visible, but rodent burrows visible; need to backfill and compact or grout burrows.					
Inspector Comment

View of a rodent hole on the waterside toe of the levee. Fall 2016

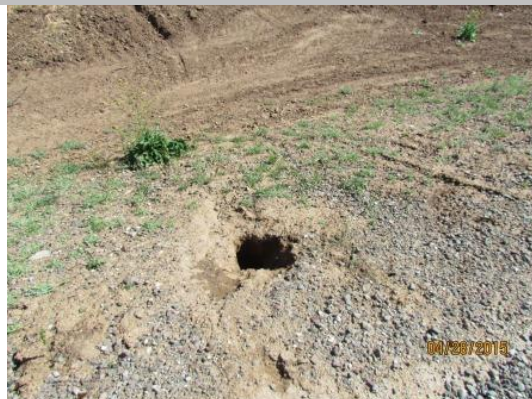
Photo 1 of 2 : FA\_2016\_NA0017\_159\_32\_20160823\_00046.jpg

LM Start	15.42	Rating **	M	Issue No.	32
LM End	15.42	Issue Type +	Ma	Location *	LS
Category	Earthen Levee			GPS Latitude/Longitude	
				Start	End
Item	Animal Control			37.975959 °	37.975959 °
				-121.235058 °	-121.235058 °
DWR ID	DWR_NA0017_15_s_2014_32				
Comment Code					
A3 : No rodents visible, but rodent burrows visible; need to backfill and compact or grout burrows.					
Inspector Comment

Updated picture of the rodent hole on the landside of the levee during spring 2015 inspection.

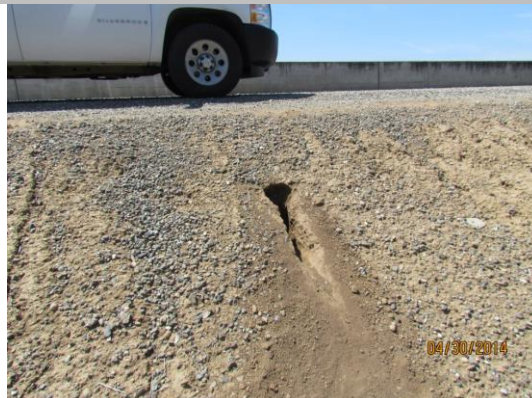
Photo 2 of 2 : FA\_2016\_NA0017\_159\_32\_20160823\_00047.jpg

A rodent hole was found on the landside of the levee looking downstream.

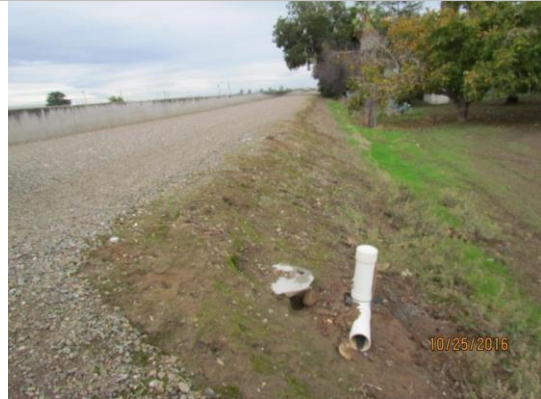
Photo 1 of 2 : FA\_2016\_NA0017\_159\_71\_20161028\_00323.jpg

LM Start	15.43	Rating **	M	Issue No.	71
LM End	15.43	Issue Type +	Ma	Location *	LS
Category	Earthen Levee			GPS Latitude/Longitude	
				Start	End
Item	Animal Control			37.976000 °	37.976000 °
				-121.235156 °	-121.235156 °
DWR ID	DWR_NA0017_15_s_2013_71				
Comment Code					
A3 : No rodents visible, but rodent burrows visible; need to backfill and compact or grout burrows.					
Inspector Comment					
Rodent control program has been in place.

Updated picture of the rodent holes on the landside shoulder of the levee. Fall 2016

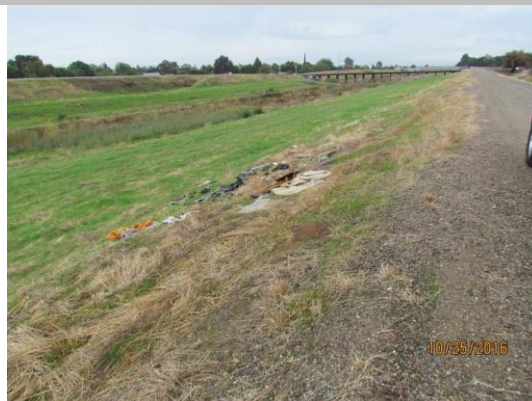
Photo 1 of 1 : FA\_2016\_NA0017\_159\_210\_20161028\_00325.jpg

LM Start	17.11	Rating **	M	Issue No.	210
LM End	17.11	Issue Type +	Ma	Location *	WS
Category	Earthen Levee			GPS Latitude/Longitude	
				Start	End
Item	Encroachments			37.987521°	37.987521°
				-121.262115°	-121.262115°
DWR ID	DWR_NA0017_15_f_2016_210				
Comment Code					
DE : Debris					
Inspector Comment

View of debris on the waterside slope of the levee. Fall 2016

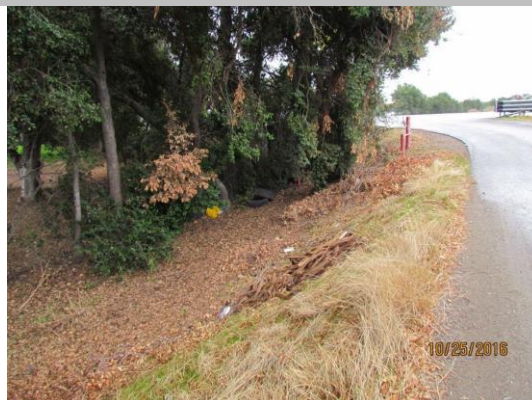
Photo 1 of 1 : FA\_2016\_NA0017\_159\_211\_20161028\_00326.jpg

LM Start	17.47	Rating **	M	Issue No.	211
LM End	17.47	Issue Type +	Ma	Location *	LS
Category	Earthen Levee			GPS Latitude/Longitude	
				Start	End
Item	Encroachments			37.989976 °	37.989976 °
				-121.267934 °	-121.267934 °
DWR ID	DWR_NA0017_15_f_2016_211				
Comment Code					
DE : Debris					
Inspector Comment

View of the debris on the landside of the levee.

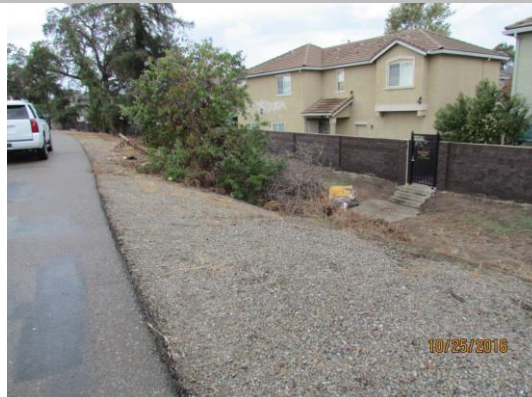
Photo 1 of 1 : FA\_2016\_NA0017\_159\_206\_20161028\_00327.jpg

LM Start	19.98	Rating **	M	Issue No.	206
LM End	19.98	Issue Type +	Ma	Location *	LS
Category	Earthen Levee			GPS Latitude/Longitude	
				Start	End
Item	Encroachments			37.993639 °	37.993639 °
				-121.285925 °	-121.285925 °
DWR ID	DWR_NA0017_15_s_2016_206				
Comment Code					
DE : Debris					
Inspector Comment

View of debris and prunnings on the landside of the levee.

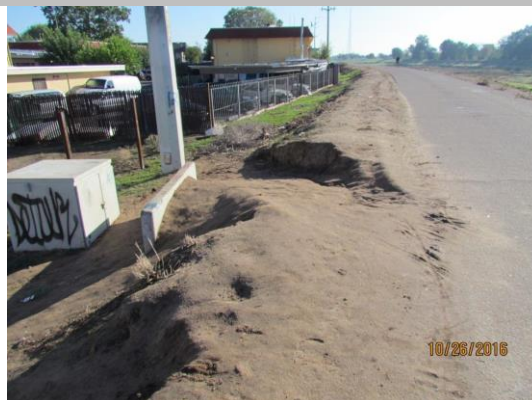
Photo 1 of 1 : FA\_2016\_NA0017\_159\_222\_20161028\_00330.jpg

LM Start	20.82	Rating **	M	Issue No.	222
LM End	20.82	Issue Type +	Ma	Location *	LS
Category	Earthen Levee			GPS Latitude/Longitude	
				Start	End
Item	Slope Stability			37.991998 °	37.991998 °
				-121.300859 °	-121.300859 °
DWR ID	DWR_NA0017_15_f_2016_222				
Comment Code					
S3 : Repair the levee slope damaged by vehicle traffic and prevent access where possible.					
Inspector Comment

View of slope instability due to foot traffic on the landside of the levee.  
Fall 2016

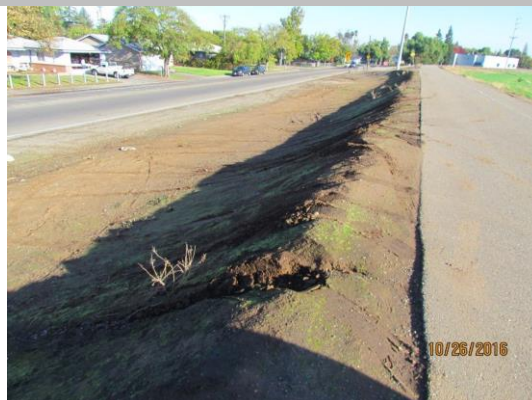
Photo 1 of 1 : FA\_2016\_NA0017\_159\_221\_20161028\_00328.jpg

LM Start	21.26	Rating **	M	Issue No.	221
LM End	21.26	Issue Type +	Ma	Location *	LS
Category	Earthen Levee			GPS Latitude/Longitude	
				Start	End
Item	Slope Stability			37.988897 °	37.988897 °
				-121.307064 °	-121.307064 °
DWR ID	DWR_NA0017_15_f_2016_221				
Comment Code					
S3 : Repair the levee slope damaged by vehicle traffic and prevent access where possible.					
Inspector Comment

View of the slope instability on the landside shoulder of the levee. Fall 2016

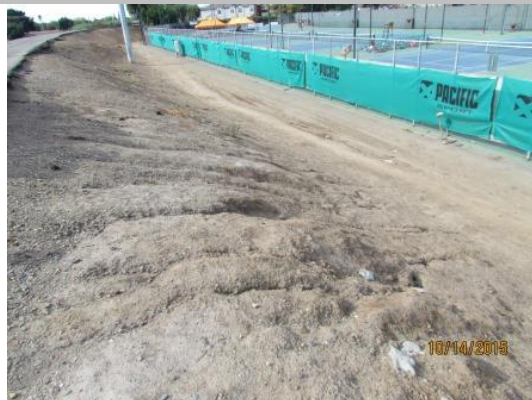
Photo 2 of 2 : FA\_2016\_NA0017\_159\_173\_20160823\_00128.jpg

LM Start	21.96	Rating **	M	Issue No.	173
LM End	21.96	Issue Type +	Ma	Location *	LS
Category	Earthen Levee			GPS Latitude/Longitude	
				Start	End
Item	Erosion / Bank Caving			37.981147°	37.981147°
				-121.315071°	-121.315071°
DWR ID	DWR_NA0017_15_s_2012_173				
Comment Code					
E2 : Schedule repair of erosion site prior to the next inspection.					
Inspector Comment					
Runoff.

View of the erosion caused by run off on the landside slope of the levee looking downstream during fall 2015 inspection.

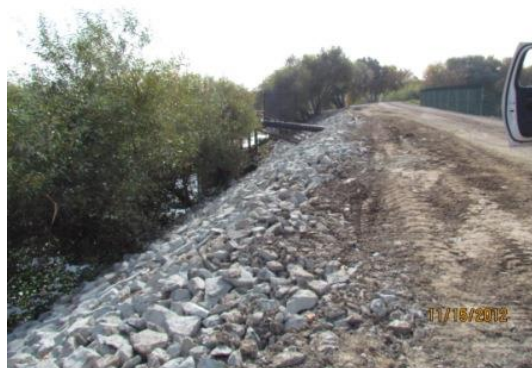
Photo 1 of 1 : FA\_2016\_NA0017\_159\_187\_20160823\_00132.jpg

LM Start	24.00	Rating **	A	Issue No.	187
LM End	24.00	Issue Type +	Ma	Location *	WS
Category	Earthen Levee			GPS Latitude/Longitude	
				Start	End
Item	Riprap Revetments			37.974858 °	37.974858 °
				-121.347718 °	-121.347718 °
DWR ID	DWR_NA0017_15_f_2012_187				
Comment Code					
Inspector Comment

Revetment was placed by the LMA on the waterside slope of the levee looking downstream.

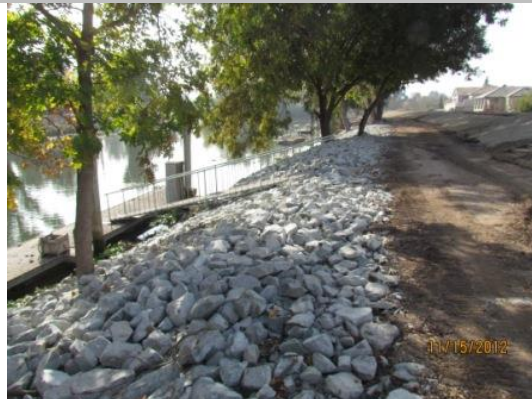
Photo 1 of 1 : FA\_2016\_NA0017\_159\_188\_20160823\_00133.jpg

LM Start	24.65	Rating **	A	Issue No.	188
LM End	24.65	Issue Type +	Ma	Location *	WS
Category	Earthen Levee			GPS Latitude/Longitude	
				Start	End
Item	Riprap Revetments			37.969095 °	37.969095 °
				-121.356301 °	-121.356301 °
DWR ID	DWR_NA0017_15_f_2012_188				
Comment Code					
Inspector Comment

Revetments were placed by the LMA on the waterside slope of the levee looking downstream.

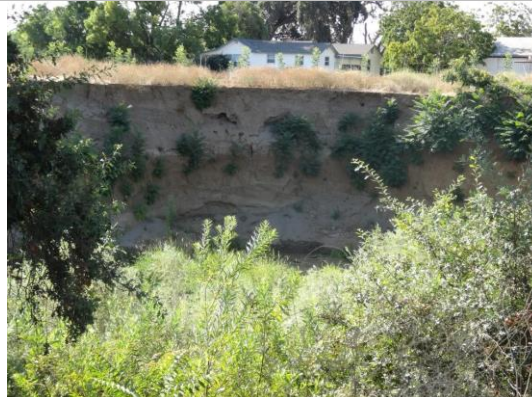
Photo 2 of 3 : SJR2016\_NA0017U16RM23.35\_3.jpg

08/16/2016: The erosion site was found progressed with signs of bank slipping.  
 08/12/2015: The erosion progressed at the site. Newly collapsed material is observed at the bottom of the erosion.  
 08/20/2014: The erosion at the site has worsened. The erosion increased in both length and in height.  
 09/12/2013: Site has been visited and signs of new erosion are visible.  
 08/22/2012: The erosion was surveyed and documented for monitoring purpose. There is no levee structure on the site, only high ground protecting the land behind. The levee crest width and levee height were not measured or estimated in the field. [2016 Site ID:NA0017U16RM23.35]

Close view of the erosion.

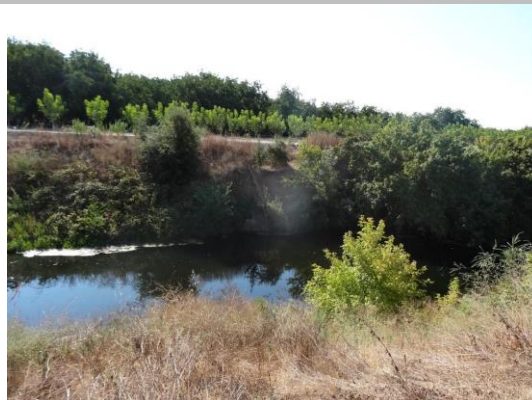
Photo 1 of 2 : SJR2016\_NA0017U16RM22.74\_1.jpg

LM Start	0.93	Rating **	U	Issue No.	267
LM End	0.95	Issue Type +	Ma	Location *	WS
Category	Supplemental			GPS Latitude/Longitude	
				Start	End
Item	DWR Erosion Survey			38.042833 °	38.042833 °
				-121.025776 °	-121.025776 °
DWR ID					
Comment Code					
Inspector Comment					
08/16/2016: No significant change observed. 08/12/2015: No significant change observed. 08/20/2014: No significant change observed. 09/12/2013: No significant change observed. 08/22/2012: The erosion was surveyed and documented for monitoring purpose. There is no levee structure on the site, only high ground protecting the land behind. The levee crest width and levee height were not measured or estimated in the field. There is a drainage pipe at the site, which might have caused the problem at one pocket erosion. [2016 Site ID:NA0017U16RM22.74]

View of the site from right river bank.

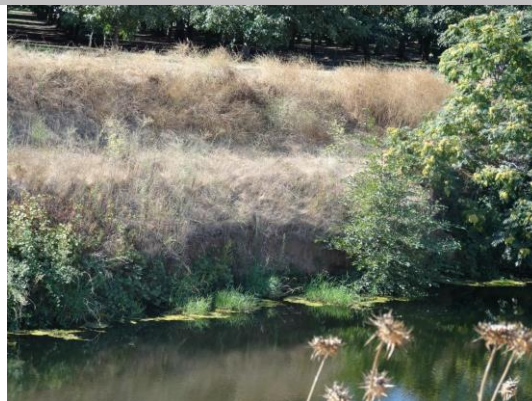
Photo 2 of 3 : SJR2016\_NA0017U16RM21.95\_2.jpg

Close view of the erosion.

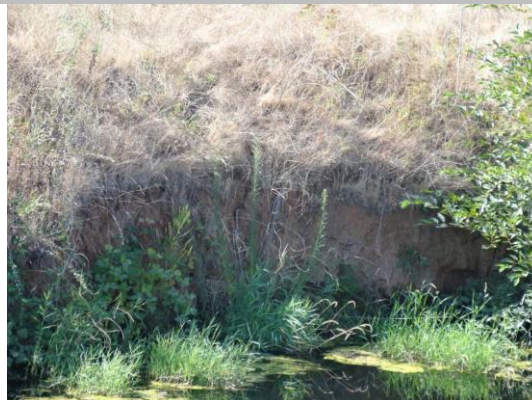
Photo 3 of 3 : SJR2016\_NA0017U16RM21.95\_3.jpg

Close view of the erosion.

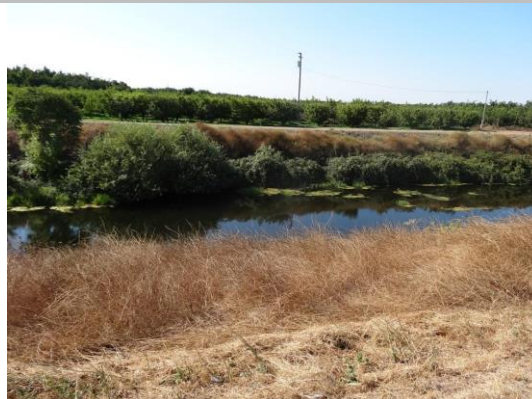
Photo 1 of 3 : SJR2016\_NA0017U16RM22.01\_1.jpg

Front view of the erosion site from the left river bank.

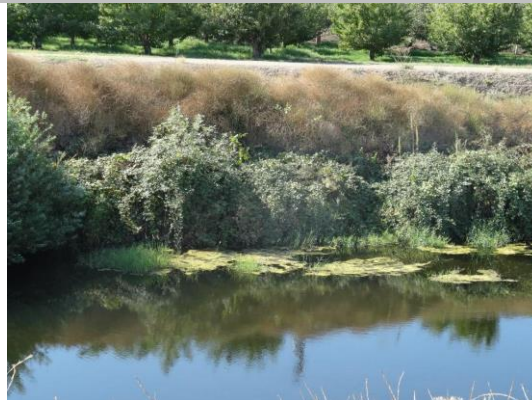
Photo 2 of 3 : SJR2016\_NA0017U16RM22.01\_2.jpg

Front view of the pocket erosion covered by dense vegetation.

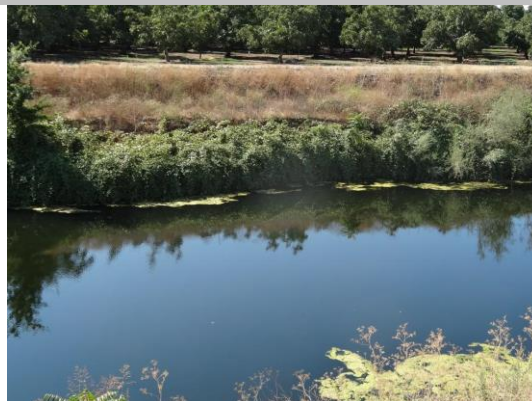
Photo 2 of 3 : SJR2016\_NA0017U16RM21.94\_2.jpg

Front view of the erosion.

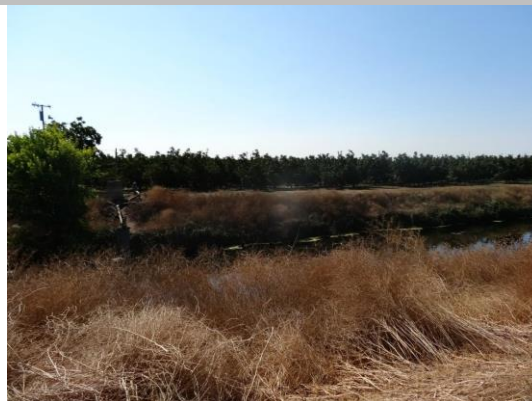
Photo 1 of 3 : SJR2016\_NA0017U16RM21.05\_1.jpg

Front view of the erosion

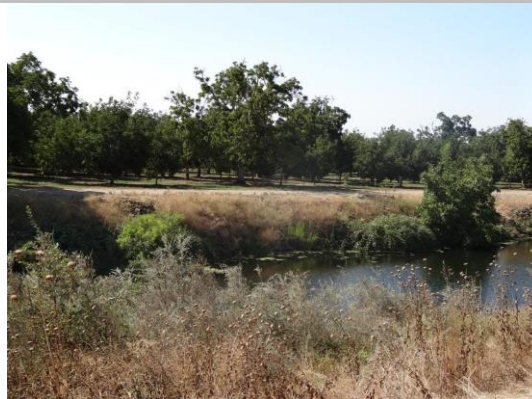
Photo 1 of 2 : SJR2016\_NA0017U16RM20.62\_1.jpg

Front view of the site.

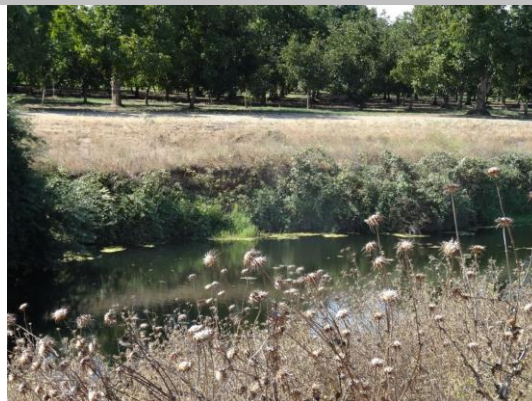
Photo 1 of 3 : SJR2016\_NA0017U16RM20.71\_1.jpg

Front view of the site.

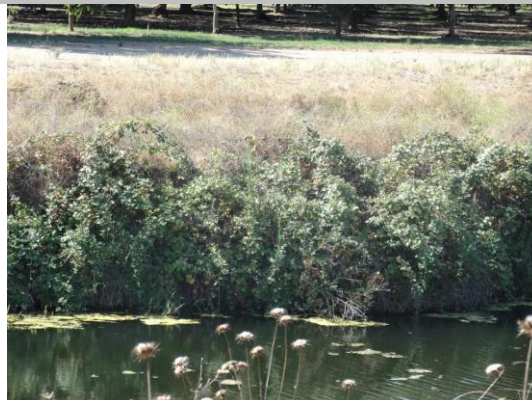
Photo 2 of 3 : SJR2016\_NA0017U16RM20.71\_3.jpg

Closer view of the erosion.

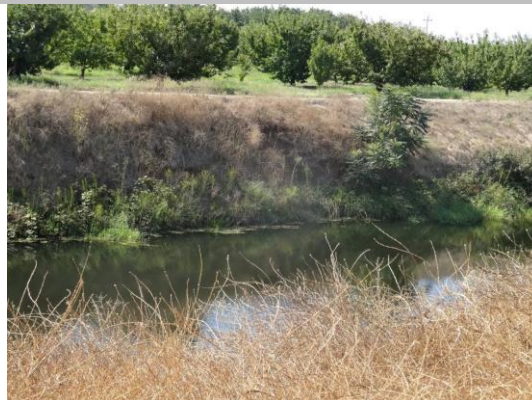
Photo 1 of 3 : SJR2016\_NA0017U16RM20\_1.jpg

LM Start	2.85	Rating **	U	Issue No.	80	
LM End	2.91	Issue Type +	Ma	Location *	WS	
Category	Supplemental			GPS Latitude/Longitude		
				Start	End	
Item	DWR Erosion Survey			38.026670 °	38.026670 °	
				-121.053031 °	-121.053031 °	
DWR ID						
Comment Code						
Inspector Comment						
08/16/2016: No significant change observed. 08/12/2015: No significant change observed. 08/20/2014: No significant change observed. 09/12/2013: No significant change observed. 08/22/2012: Site Comprised of series of pocket and scarp erosions. Some of erosions are covered by grass or shrubs. There is no levee structure on site. The levee crest width and levee height were not measured or estimated in the field. [2016 Site ID:NA0017U16RM20]

Front view of the erosion.

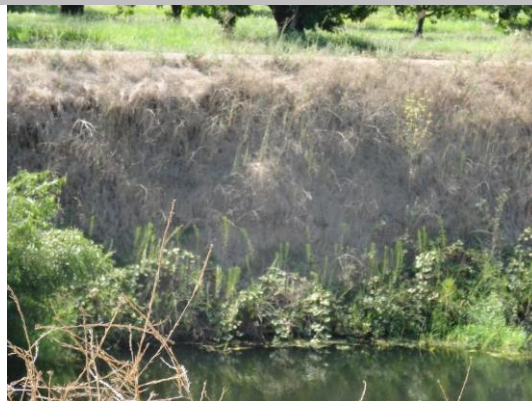
Photo 2 of 3 : SJR2016\_NA0017U16RM20\_3.jpg

Close view of the erosion.

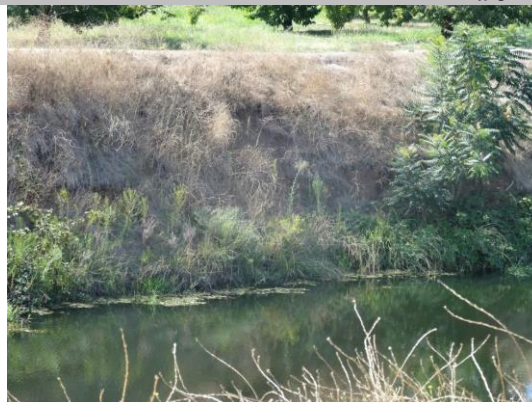
Photo 3 of 3 : SJR2016\_NA0017U16RM20\_4.jpg

Close view of the scarp erosion. Note the small tree at the erosion site.

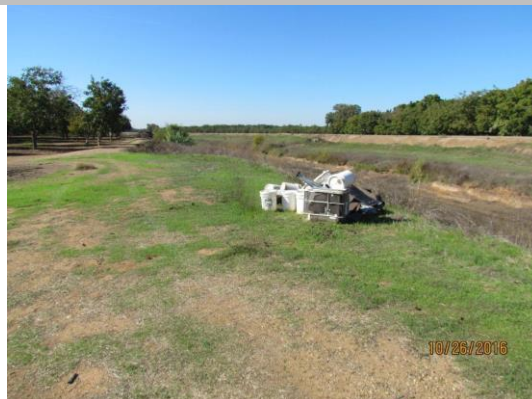
Photo 1 of 1 : FA\_2016\_NA0017\_160\_231\_20161028\_00374.jpg

LM Start	3.16	Rating **	M	Issue No.	231
LM End	3.16	Issue Type +	Ma	Location *	CR
Category	Earthen Levee			GPS Latitude/Longitude	
				Start	End
Item	Encroachments			38.024057°	38.024057°
				-121.056860°	-121.056860°
DWR ID	DWR_NA0017_16_f_2016_231				
Comment Code					
DE : Debris					
Inspector Comment

View of the debris on the crown of the levee. Fall 2016
