**Flood Control Project Maintenance  
Levee Inspections**

**Maintenance Issue Types Only, Levee Inspection Report By Mile - Fall 2016**

**San Joaquin County Flood Control and Water Conservation District**

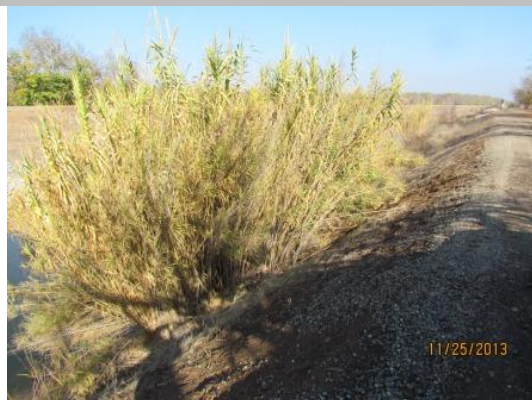
Photo 1 of 1 : FA\_2016\_NA0017\_160\_152\_20160823\_00115.jpg

LM Start	3.48	Rating **	A/W	Issue No.	152
LM End	3.48	Issue Type +	Ma	Location *	WS
Category	Earthen Levee			GPS Latitude/Longitude	
				Start	End
Item	Vegetation			38.020965 °	38.020965 °
				-121.061215 °	-121.061215 °
DWR ID	DWR_NA0017_16_f_2013_152				
Comment Code					
V2 : Remove the wild growth other than native grasses from the levee slopes.					
Inspector Comment					
Arundo was obstructing to inspect the channel from the patrol road.

Arundo was found on the waterside toe of the levee looking upstream.

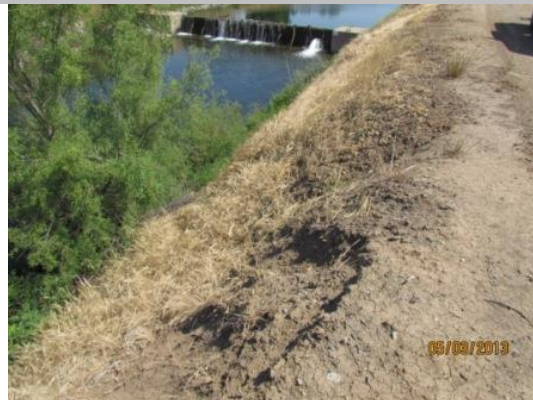
Photo 2 of 2 : FA\_2016\_NA0017\_160\_230\_20160823\_00139.jpg

LM Start	<b>3.53</b>	Rating **	A/W	Issue No.	<b>230 (cont)</b>
LM End	<b>3.53</b>	Issue Type +	Ma	Location *	WS

Erosion was found on the waterside slope of the levee looking upstream.

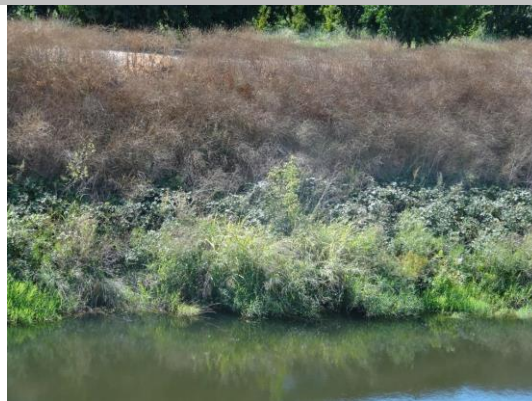
Photo 2 of 3 : SJR2016\_NA0017U16RM19.18\_3.jpg

08/16/2016: No significant change observed at the erosion. More vegetation observed at the site.  
 08/12/2015: No significant change observed.  
 08/20/2014: No significant change observed.  
 09/12/2013: No significant change observed.  
 08/22/2012: River-induced erosion occurred on the berm, while the runoff-induced erosion occurred on the levee slope. Site is covered with vegetation. There is no levee structure on site. The levee crest width and levee height were not measured or estimated in the field. [2016 Site ID:NA0017U16RM19.18]

Front view of the erosion at the berm.

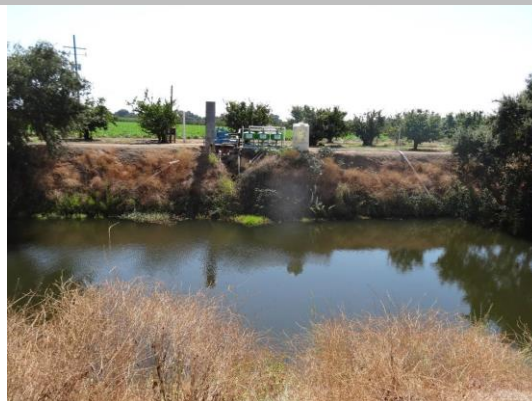
Photo 1 of 3 : SJR2016\_NA0017U16RM18.69\_1.jpg

08/16/2016: No significant change observed.  
 08/12/2015: No significant change observed.  
 08/20/2014: No significant change observed.  
 09/12/2013: No significant change observed.  
 08/22/2012: An irrigation pipe is present at the site, but probably did not cause the erosion. There is no levee structure on site. The levee crest width and levee height were not measured or estimated in the field.  
 [2016 Site ID:NA0017U16RM18.69]

View of the erosion site.

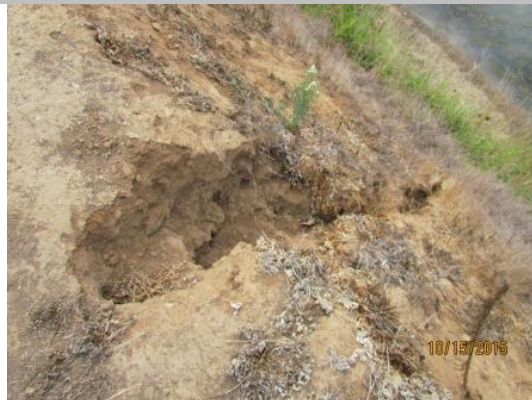
Photo 3 of 3 : FA\_2016\_NA0017\_160\_73\_20160823\_00067.jpg

LM Start	4.27	Rating **	M	Issue No.	73 (cont)	
LM End	4.27	Issue Type +	Ma	Location *	WS	
Category	Earthen Levee			GPS Latitude/Longitude		
				Start		End
Item	Erosion / Bank Caving			38.011288 °		38.011288 °
				-121.068579 °		-121.068579 °
DWR ID	DWR_NA0017_16_s_2013_73					
Comment Code						
E2 : Schedule repair of erosion site prior to the next inspection.						
Inspector Comment						
The erosion may cut into the access road if it is not repaired.

Erosion was found on the waterside shoulder of the levee looking upstream.

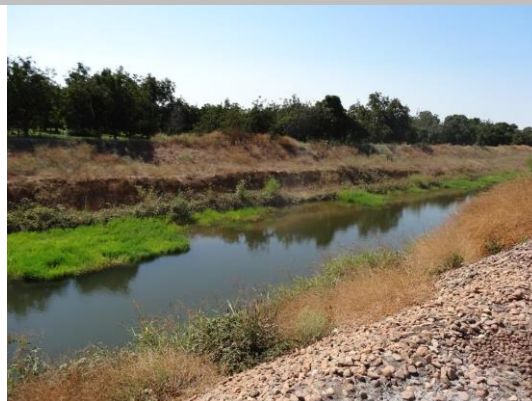
Photo 1 of 2 : SJR2016\_NA0017U16RM17.81\_1.jpg

08/16/2016: No significant change observed.  
 08/12/2015: No significant change observed.  
 08/20/2014: No significant change observed.  
 09/12/2013: No significant change observed.  
 08/22/2012: The site is located at the opposite river bank of E. Tobacco Road. There is no levee structure on site. The levee crest width and levee height were not measured or estimated in the field. [2016 Site ID:NA0017U16RM17.81]

Upstream view of the site from right river bank.

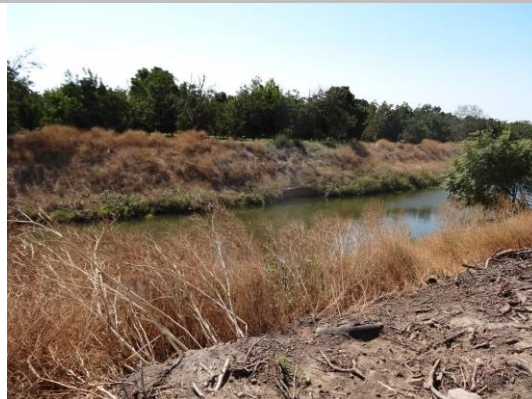
Photo 1 of 2 : SJR2016\_NA0017U16RM17.27\_1.jpg

08/16/2016: No significant change observed.  
08/12/2015: No significant change observed.  
08/20/2014: No significant change observed.  
09/12/2013: The erosion seems to be caused by high river flow. Dense vegetation is present at the site. Signs of animal activities are visible. There is no levee structure on site. The levee crest width and levee height were not measured or estimated in the field. [2016 Site ID:NA0017U16RM17.27]

View of the erosion from right river bank.

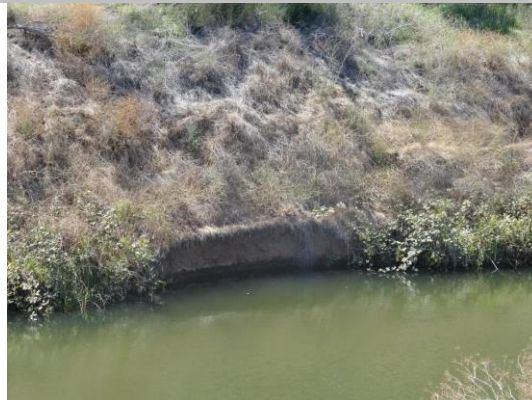
Photo 2 of 2 : SJR2016\_NA0017U16RM17.27\_3.jpg

Close view of the erosion.

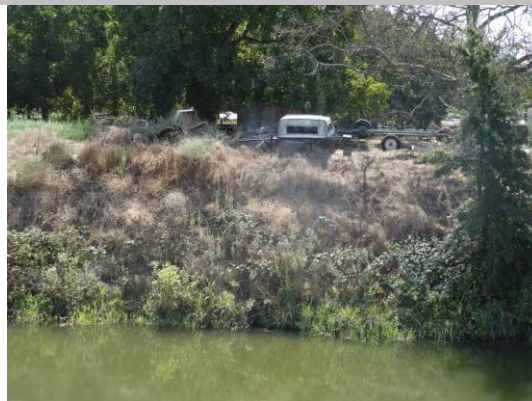
Photo 1 of 3 : SJR2016\_NA0017U16RM17.11\_1.jpg

LM Start	5.71	Rating **	M	Issue No.	41
LM End	5.72	Issue Type +	Ma	Location *	WS
Category	Supplemental			GPS Latitude/Longitude	
				Start	End
Item	DWR Erosion Survey			37.993525 °	37.993525 °
				-121.081679 °	-121.081679 °
DWR ID					
Comment Code					
Inspector Comment					
08/16/2016: No significant change observed.					
08/12/2015: No significant change observed.					
08/20/2014: The erosion is near a tree and probably has been made worse by the unstable bank slope. [2016 Site ID:NA0017U16RM17.11]

View of the site from right river bank.

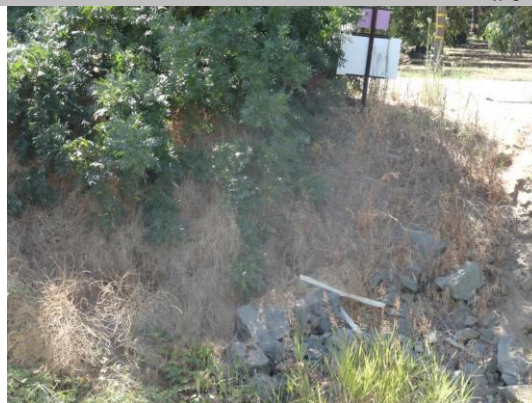
Photo 2 of 3 : SJR2016\_NA0017U16RM17.11\_3.jpg

Close view of the erosion.

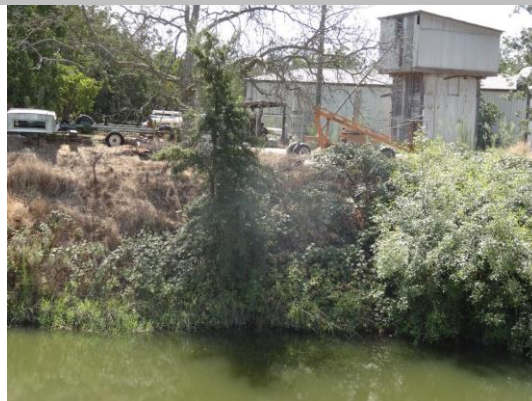
Photo 3 of 3 : SJR2016\_NA0017U16RM17.11\_4.jpg

Close view of the erosion.

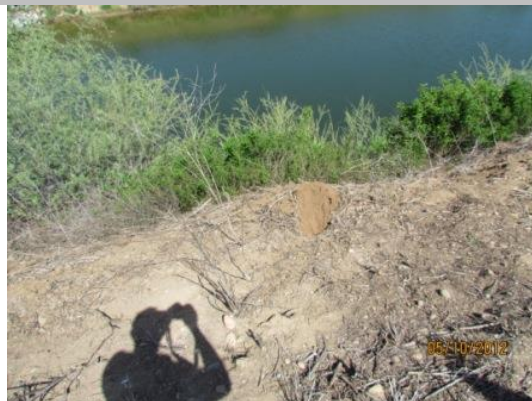
Photo 2 of 2 : FA\_2016\_NA0017\_160\_170\_20160823\_00123.jpg

LM Start	6.15	Rating **	A/W	Issue No.	170 (cont)	
LM End	6.15	Issue Type +	Ma	Location *	WS	
Category	Earthen Levee			GPS Latitude/Longitude		
				Start		End
Item	Animal Control			37.988385 °		37.988385 °
				-121.086292 °		-121.086292 °
DWR ID	DWR_NA0017_16_s_2012_170					
Comment Code						
A3 : No rodents visible, but rodent burrows visible; need to backfill and compact or grout burrows.						
Inspector Comment

An animal hole was found on the waterside of the levee looking upstream.

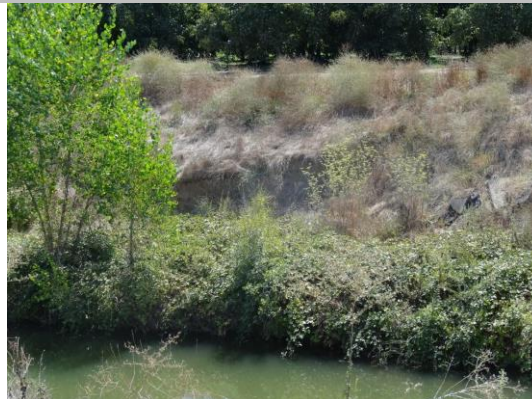
Photo 1 of 3 : SJR2016\_NA0017U16RM16.27\_1.jpg

LM Start	6.49	Rating **	U	Issue No.	40
LM End	6.68	Issue Type +	Ma	Location *	WS
Category	Supplemental			GPS Latitude/Longitude	
				Start	End
Item	DWR Erosion Survey			37.983279°	37.983279°
				-121.090843°	-121.090843°
DWR ID					
Comment Code					
Inspector Comment					
08/16/2016: No significant change observed.					
08/12/2015: No significant change observed.					
08/20/2014: No significant change observed.					
09/12/2013: Site has been surveyed and the erosion has worsened since last year.					
08/22/2012: Discontinuous scarp or pocket erosions occurred along a long stretch of the river, with an erosion height greater than 25 ft. at certain points. There is no levee structure on site. The levee crest width and levee height were not measured or estimated in the field. [2016 Site ID:NA0017U16RM16.27]

Upstream view of the site from right river bank.

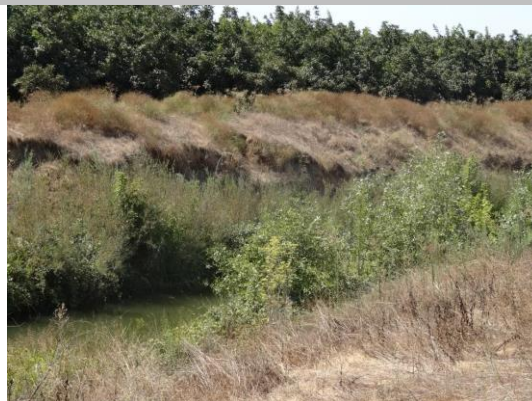
Photo 2 of 3 : SJR2016\_NA0017U16RM16.27\_3.jpg

08/16/2016: No significant change observed.  
 08/12/2015: No significant change observed.  
 08/20/2014: No significant change observed.  
 09/12/2013: Site has been surveyed and the erosion has worsened since last year.  
 08/22/2012: Discontinuous scarp or pocket erosions occurred along a long stretch of the river, with an erosion height greater than 25 ft. at certain points. There is no levee structure on site. The levee crest width and levee height were not measured or estimated in the field. [2016 Site ID:NA0017U16RM16.27]

Front view of the erosion.

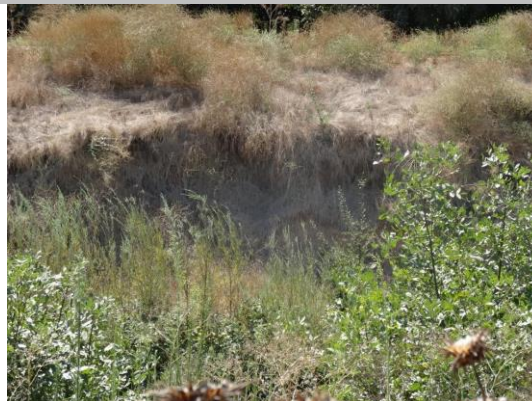
Photo 3 of 3 : SJR2016\_NA0017U16RM16.27\_4.jpg

Close view of the erosion.

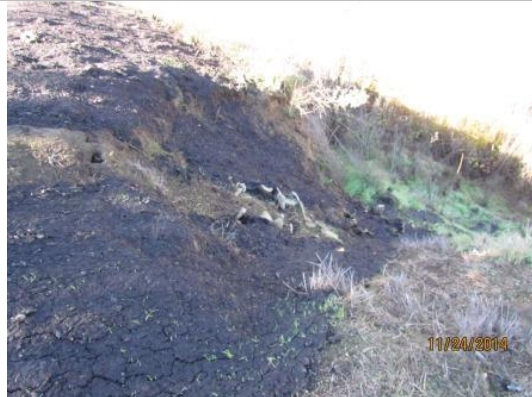
Photo 1 of 2 : FA\_2016\_NA0017\_160\_120\_20160823\_00097.jpg

LM Start	6.70	Rating **	A/W	Issue No.	120
LM End	6.70	Issue Type +	Ma	Location *	WS
Category	Earthen Levee			GPS Latitude/Longitude	
				Start	End
Item	Slope Stability			37.982299 °	37.982299 °
				-121.092665 °	-121.092665 °
DWR ID	DWR_NA0017_16_s_2014_120				
Comment Code					
S1 : Repair slope instability.					
Inspector Comment					
This portion of the levee is non-project. Therefore, an A/W rating was given.

Updated picture of the slope instability on the waterside of the levee looking downstream.

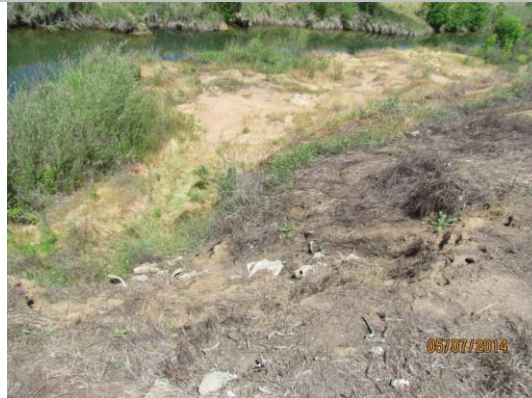
Photo 2 of 2 : FA\_2016\_NA0017\_160\_120\_20160823\_00098.jpg

Slope instability was found on the waterside of the levee looking upstream.

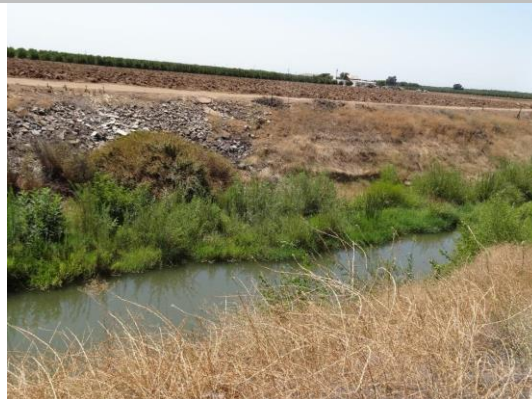
Photo 1 of 3 : SJR2016\_NA0017U16RM15.57\_1.jpg

08/16/2016: No significant change observed.  
 08/12/2015: No significant change observed.  
 08/20/2014: No significant change observed. Note the site ID changed from NA0017U16RM10.82 to NA0017U16RM15.57 to reflect the correct river mile.  
 09/12/2013: The site is located at immediately downstream of a levee segment protected by broken concrete. There is no levee structure on site. The levee crest width and levee height were not measured or estimated in the field. [2016 Site ID:NA0017U16RM15.57]

View of the site from right river bank.

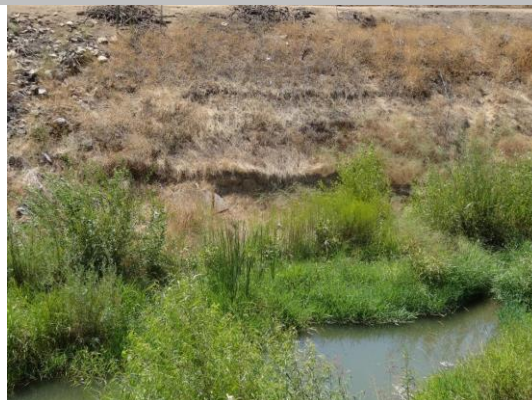
Photo 2 of 3 : SJR2016\_NA0017U16RM15.57\_3.jpg

Close view of the erosion.

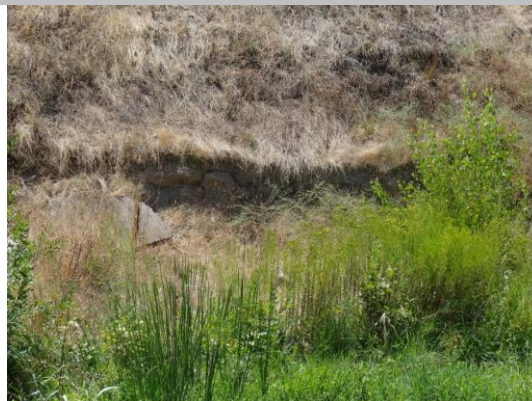
Photo 3 of 3 : SJR2016\_NA0017U16RM15.57\_4.jpg

LM Start	7.27	Rating **	U	Issue No.	39 (cont)
LM End	7.33	Issue Type +	Ma	Location *	WS
Category	Supplemental			GPS Latitude/Longitude	
				Start	End
Item	DWR Erosion Survey			37.978194 °	37.978194 °
				-121.101696 °	-121.101696 °
DWR ID					
Comment Code					
Inspector Comment					
08/16/2016: No significant change observed.					
08/12/2015: No significant change observed.					
08/20/2014: No significant change observed. Note the site ID changed from NA0017U16RM10.82 to NA0017U16RM15.57 to reflect the correct river mile.					
09/12/2013: The site is located at immediately downstream of a levee segment protected by broken concrete. There is no levee structure on site. The levee crest width and levee height were not measured or estimated in the field. [2016 Site ID:NA0017U16RM15.57]

Close view of the erosion.

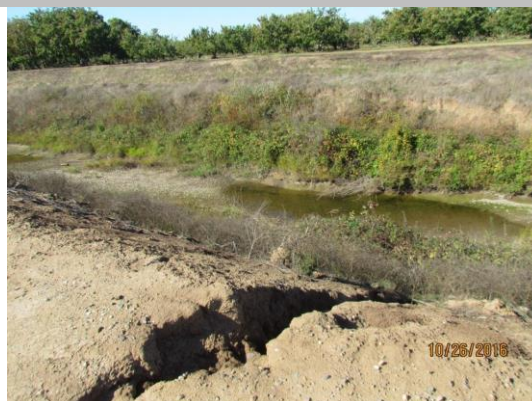
Photo 1 of 2 : FA\_2016\_NA0017\_160\_246\_20161031\_00377.jpg

LM Start	7.39	Rating **	M	Issue No.	246
LM End	7.39	Issue Type +	Ma	Location *	WS
Category	Earthen Levee			GPS Latitude/Longitude	
				Start	End
Item	Erosion / Bank Caving			37.977610 °	37.977610 °
				-121.103159 °	-121.103159 °
DWR ID	DWR_NA0017_16_s_2015_246				
Comment Code					
E2 : Schedule repair of erosion site prior to the next inspection.					
Inspector Comment					
Erosion may cut into the access road.

View of the erosion on the waterside shoulder of the levee. Fall 2016

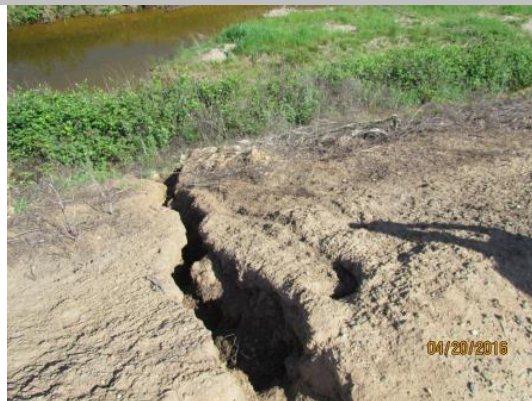
Photo 2 of 2 : FA\_2016\_NA0017\_160\_246\_20160823\_00145.jpg

LM Start	7.39	Rating **	M	Issue No.	246 (cont)	
LM End	7.39	Issue Type +	Ma	Location *	WS	
Category	Earthen Levee			GPS Latitude/Longitude		
				Start		End
Item	Erosion / Bank Caving			37.977610 °		37.977610 °
				-121.103159 °		-121.103159 °
DWR ID	DWR_NA0017_16_s_2015_246					
Comment Code						
E2 : Schedule repair of erosion site prior to the next inspection.						
Inspector Comment						
Erosion may cut into the access road.

Updated picture of the erosion on the waterside shoulder of the levee during spring 2016 inspection.

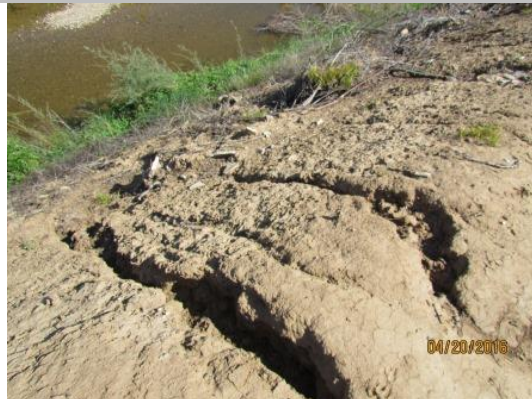
Photo 1 of 2 : FA\_2016\_NA0017\_160\_237\_20160823\_00141.jpg

LM Start	7.42	Rating **	M	Issue No.	237
LM End	7.42	Issue Type +	Ma	Location *	WS
Category	Earthen Levee			GPS Latitude/Longitude	
				Start	End
Item	Erosion / Bank Caving			37.977421°	37.977421°
				-121.103507°	-121.103507°
DWR ID	DWR_NA0017_16_f_2015_237				
Comment Code					
E2 : Schedule repair of erosion site prior to the next inspection.					
Inspector Comment					
Erosion may cut into the access road.

Updated picture of the erosion on the waterside shoulder of the levee during spring 2016 inspection.

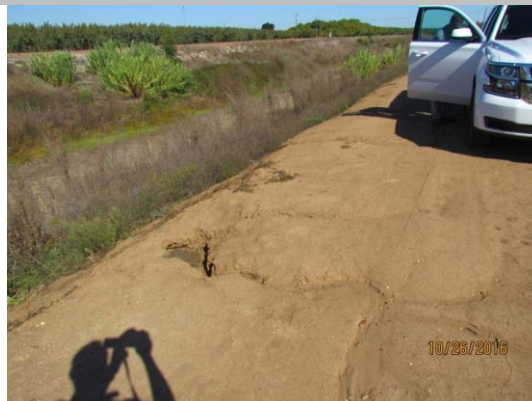
Photo 1 of 2 : FA\_2016\_NA0017\_160\_275\_20161031\_00378.jpg

LM Start	7.84	Rating **	M	Issue No.	275
LM End	7.84	Issue Type +	Ma	Location *	WS
Category	Earthen Levee			GPS Latitude/Longitude	
				Start	End
Item	Erosion / Bank Caving			37.973620°	37.973620°
				-121.109680°	-121.109680°
DWR ID	DWR_NA0017_16_s_2016_275				
Comment Code					
E2 : Schedule repair of erosion site prior to the next inspection.					
Inspector Comment					
Erosion may cut into the access road.

View of the erosion caused by rodent holes on the waterside shoulder of the levee looking upstream. Fall 2016

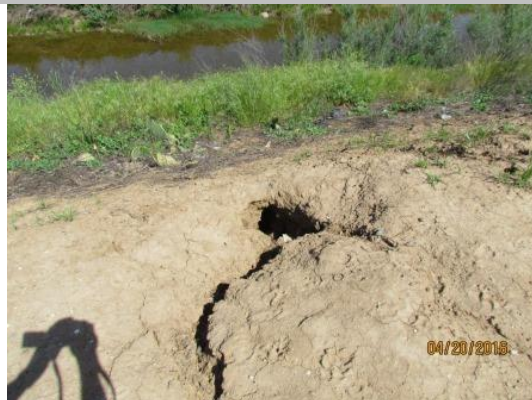
Photo 2 of 2 : FA\_2016\_NA0017\_160\_275\_20160823\_00154.jpg

View of a rodent hole on the waterside shoulder of the levee.

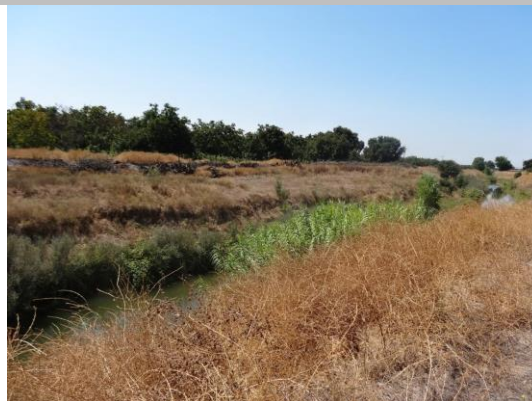
Photo 1 of 3 : SJR2016\_NA0017U16RM14.48\_1.jpg

08/16/2016: No significant change observed.  
 08/12/2015: No significant change observed.  
 08/20/2014: No significant change observed.  
 09/12/2013: No significant change observed.  
 08/22/2012: The erosion occurred on a berm of approximately 25 ft. wide. Site is covered with dense vegetation. There is no levee structure on site. The levee crest width and levee height were not measured or estimated in the field. [2016 Site ID:NA0017U16RM14.48]

View of the site from right river bank.

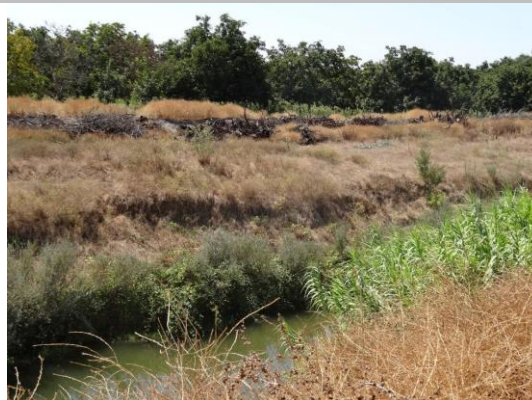
Photo 2 of 3 : SJR2016\_NA0017U16RM14.48\_2.jpg

Front view of the erosion.

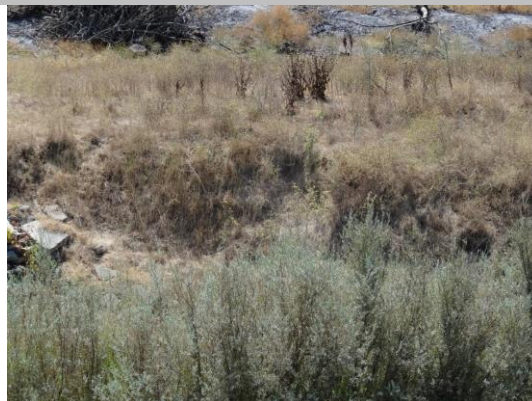
Photo 3 of 3 : SJR2016\_NA0017U16RM14.48\_3.jpg

LM Start	8.34	Rating **	M	Issue No.	38 (cont)		
LM End	8.38	Issue Type +	Ma	Location *	WS		
Category	Supplemental			GPS Latitude/Longitude			
				Start		End	
Item	DWR Erosion Survey			37.969213	°	37.969213	°
				-121.116574	°	-121.116574	°
DWR ID							
Comment Code							
Inspector Comment							
08/16/2016: No significant change observed. 08/12/2015: No significant change observed. 08/20/2014: No significant change observed. 09/12/2013: No significant change observed. 08/22/2012: The erosion occurred on a berm of approximately 25 ft. wide. Site is covered with dense vegetation. There is no levee structure on site. The levee crest width and levee height were not measured or estimated in the field. [2016 Site ID:NA0017U16RM14.48]

Close view of the erosion.

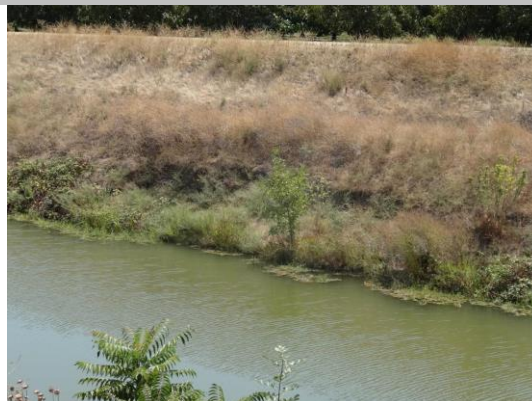
Photo 1 of 3 : SJR2016\_NA0017U16RM13.86\_1.jpg

08/16/2016: No significant change observed.  
08/12/2015: No significant change observed.  
08/20/2014: No significant change observed.  
09/12/2013: No significant change observed.  
08/22/2012: Pocket erosion at the levee toe and slope. The erosion is covered with dense vegetation. There is no levee structure on site. The levee crest width and levee height were not measured or estimated in the field. [2016 Site ID:NA0017U16RM13.86]

Front view of the erosion.

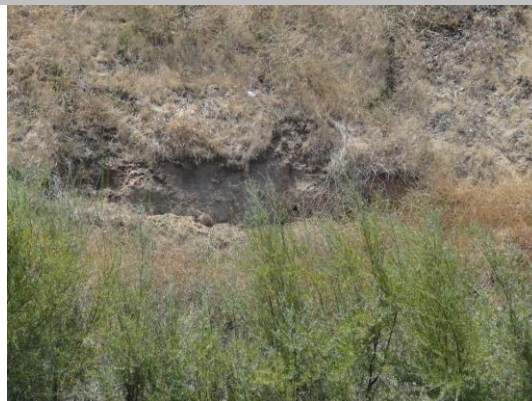
Photo 2 of 2 : SJR2016\_NA0017U16RM13.85\_4.jpg

LM Start	9.03	Rating **	U	Issue No.	36 (cont)	
LM End	9.03	Issue Type +	Ma	Location *	WS	
Category	Supplemental			GPS Latitude/Longitude		
				Start	End	
Item	DWR Erosion Survey			37.966661 °	37.966661 °	
				-121.127864 °	-121.127864 °	
DWR ID						
Comment Code						
Inspector Comment						
08/16/2016: No significant change observed.						
08/12/2015: No significant change observed.						
08/20/2014: No significant change observed.						
09/12/2013: The erosion might have been caused by river flow combined with runoff. Dense vegetation is presents at the site. There is no levee structure on site. The levee crest width and levee height were not measured or estimated in the field. [2016 Site ID:NA0017U16RM13.85]

Close view of the erosion.

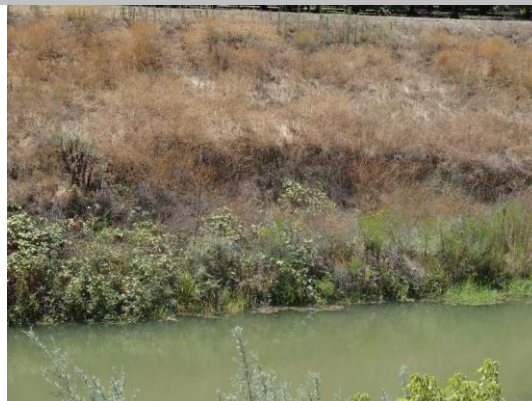
Photo 2 of 3 : SJR2016\_NA0017U16RM13.72\_3.jpg

08/16/2016: No significant change observed.  
 08/12/2015: No significant change observed.  
 08/20/2014: No significant change observed.  
 09/12/2013: No significant change observed.  
 08/22/2012: The erosion is covered with dense vegetation. There is no levee structure on site. The levee crest width and levee height were not measured or estimated in the field. [2016 Site ID:NA0017U16RM13.72]

Close view of the erosion.

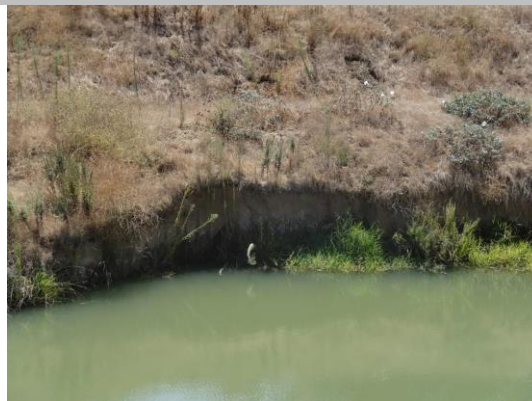
Photo 3 of 3 : SJR2016\_NA0017U16RM13.53\_4.jpg

LM Start	9.31	Rating **	M	Issue No.	14 (cont)	
LM End	9.33	Issue Type +	Ma	Location *	WS	
Category	Supplemental			GPS Latitude/Longitude		
				Start	End	
Item	DWR Erosion Survey			37.966772 °	37.966772 °	
				-121.133071 °	-121.133071 °	
DWR ID						
Comment Code						
Inspector Comment						
08/16/2016: No significant change observed. 08/12/2015: No significant change observed. 08/20/2014: No significant change observed. 09/12/2013: No significant change observed. 08/22/2012: The erosion is on berm. The berm width is estimated. There is no levee structure on site. The levee crest width and levee height were not measured or estimated in the field. [2016 Site ID:NA0017U16RM13.53]

Close view of the erosion.

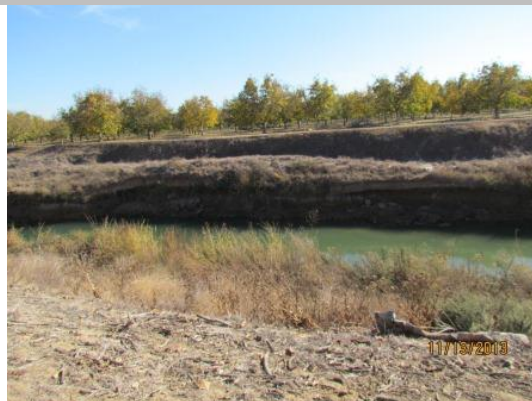
Photo 1 of 1 : FA\_2016\_NA0017\_160\_28\_20160823\_00018.jpg

LM Start	9.48	Rating **	A/W	Issue No.	28
LM End	9.48	Issue Type +	Ma	Location *	WS
Category	Earthen Levee			GPS Latitude/Longitude	
				Start	End
Item	Erosion / Bank Caving			37.966239 °	37.966239 °
				-121.136172 °	-121.136172 °
DWR ID	DWR_NA0017_16_f_2013_28				
Comment Code					
E2 : Schedule repair of erosion site prior to the next inspection.					
Inspector Comment					
Erosion was found on the waterside toe of the levee.

View of the erosion on the waterside toe of the levee looking from the opposite side of the levee.

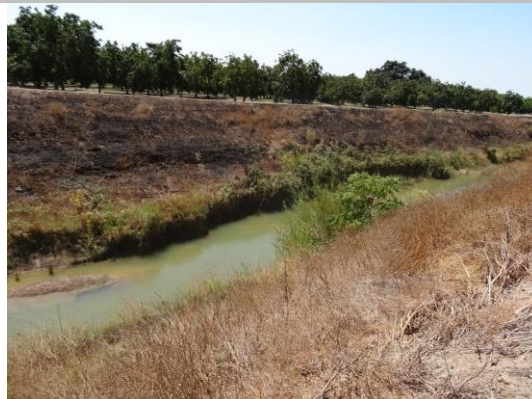
Photo 1 of 3 : SJR2016\_NA0017U16RM12.95\_1.jpg

LM Start	9.86	Rating **	M	Issue No.	10
LM End	9.88	Issue Type +	Ma	Location *	WS
Category	Supplemental			GPS Latitude/Longitude	
				Start	End
Item	DWR Erosion Survey			37.964735 °	37.964735 °
				-121.142503 °	-121.142503 °
DWR ID					
Comment Code					
Inspector Comment					
08/16/2016: No significant change observed.					
08/12/2015: No significant change observed.					
08/20/2014: No significant change observed.					
09/12/2013: No significant change observed.					
08/22/2012: Dense vegetation on site. There is no levee structure on site. The levee crest width and levee height were not measured or estimated in the field. [2016 Site ID:NA0017U16RM12.95]

Upstream view of the site from right river bank.

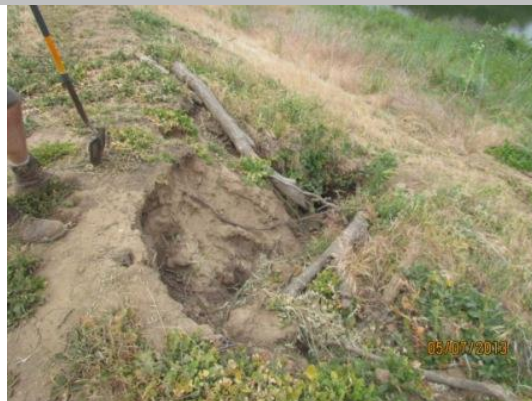
Photo 2 of 2 : FA\_2016\_NA0017\_160\_139\_20160823\_00110.jpg

LM Start	10.79	Rating **	M	Issue No.	139 (cont)
LM End	10.79	Issue Type +	Ma	Location *	WS
Category	Earthen Levee			GPS Latitude/Longitude	
				Start	End
Item	Erosion / Bank Caving			37.962182°	37.962182°
				-121.158684°	-121.158684°
DWR ID	DWR_NA0017_16_s_2013_139				
Comment Code					
E2 : Schedule repair of erosion site prior to the next inspection.					
Inspector Comment

Erosion was found on the waterside of the levee looking downstream.

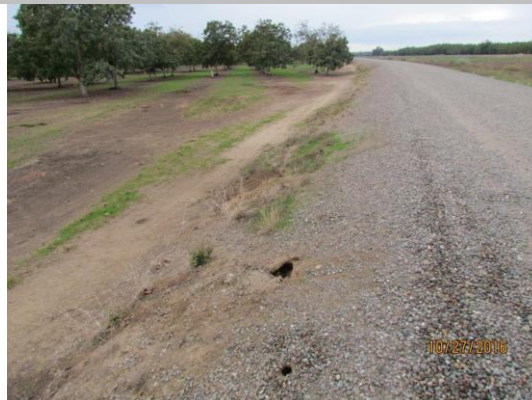
Photo 1 of 1 : FA\_2016\_NA0017\_160\_50\_20161031\_00379.jpg

LM Start	11.57	Rating **	M	Issue No.	50
LM End	11.57	Issue Type +	Ma	Location *	LS
Category	Earthen Levee			GPS Latitude/Longitude	
				Start	End
Item	Animal Control			37.960763 °	37.960763 °
				-121.172122 °	-121.172122 °
DWR ID	DWR_NA0017_16_f_2016_50				
Comment Code					
A3 : No rodents visible, but rodent burrows visible; need to backfill and compact or grout burrows.					
Inspector Comment

View of rodent holes on the landside of the levee. Fall 2016

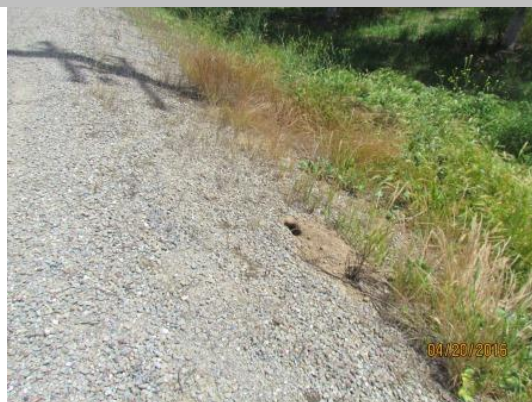
Photo 1 of 1 : FA\_2016\_NA0017\_160\_126\_20160823\_00102.jpg

LM Start	12.32	Rating **	M	Issue No.	126
LM End	12.32	Issue Type +	Ma	Location *	LS
Category	Earthen Levee			GPS Latitude/Longitude	
				Start	End
Item	Animal Control			37.960427 °	37.960427 °
				-121.185560 °	-121.185560 °
DWR ID	DWR_NA0017_16_s_2016_126				
Comment Code					
A3 : No rodents visible, but rodent burrows visible; need to backfill and compact or grout burrows.					
Inspector Comment

View of a rodent hole on the landside of the levee.

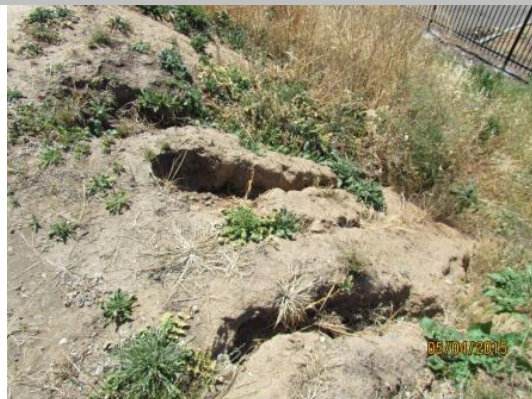
Photo 1 of 2 : FA\_2016\_NA0017\_160\_150\_20160823\_00113.jpg

LM Start	16.43	Rating **	M	Issue No.	150
LM End	16.43	Issue Type +	Ma	Location *	LS
Category	Earthen Levee			GPS Latitude/Longitude	
				Start	End
Item	Erosion / Bank Caving			37.982318 °	37.982318 °
				-121.252095 °	-121.252095 °
DWR ID	DWR_NA0017_16_s_2013_150				
Comment Code					
E2 : Schedule repair of erosion site prior to the next inspection.					
Inspector Comment					
Runoff

Updated picture of the erosion on the landside shoulder of the levee looking upstream during spring 2015 inspection.

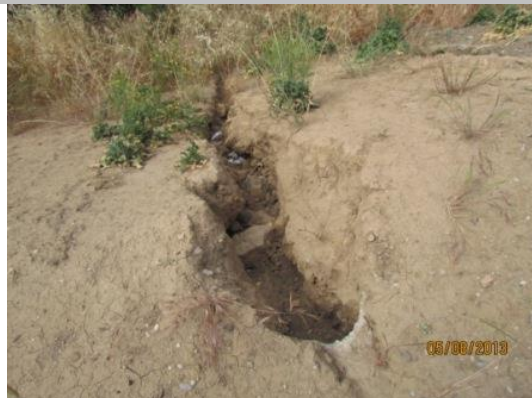
Photo 2 of 2 : FA\_2016\_NA0017\_160\_150\_20160823\_00114.jpg

Erosion was found on the landside of the levee looking downstream.

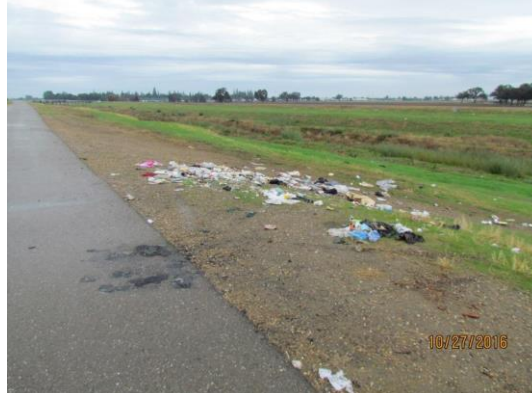
Photo 1 of 1 : FA\_2016\_NA0017\_160\_252\_20161031\_00381.jpg

LM Start	16.88	Rating **	M	Issue No.	252
LM End	16.88	Issue Type +	Ma	Location *	WS
Category	Earthen Levee			GPS Latitude/Longitude	
				Start	End
Item	Encroachments			37.985426 °	37.985426 °
				-121.259382 °	-121.259382 °
DWR ID	DWR_NA0017_16_f_2016_252				
Comment Code					
DE : Debris					
Inspector Comment

View of debris on the waterside of the levee. Fall 2016

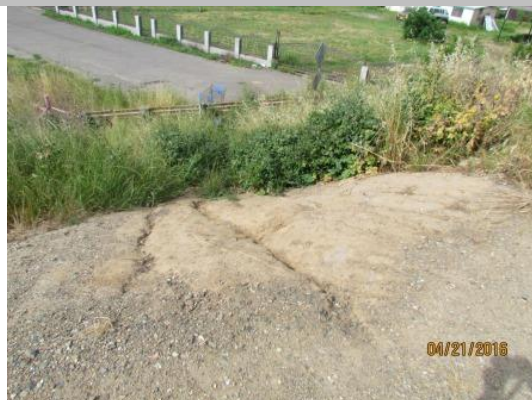
Photo 1 of 1 : FA\_2016\_NA0017\_160\_293\_20160823\_00162.jpg

LM Start	17.14	Rating **	M	Issue No.	293	
LM End	17.14	Issue Type +	Ma	Location *	LS	
Category	Earthen Levee			GPS Latitude/Longitude		
				Start		End
Item	Erosion / Bank Caving			37.987210 °		37.987210 °
				-121.263501 °		-121.263501 °
DWR ID	DWR_NA0017_16_s_2016_293					
Comment Code						
E2 : Schedule repair of erosion site prior to the next inspection.						
Inspector Comment						
Runoff

View of an erosion on the landside slope of the levee.

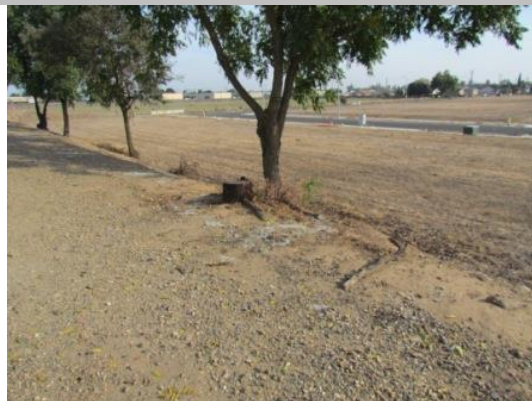
Photo 1 of 1 : FA\_2016\_NA0017\_160\_65\_20160823\_00058.jpg

LM Start	19.04	Rating **	N	Issue No.	65
LM End	19.04	Issue Type +	Ma	Location *	LS
Category	Earthen Levee			GPS Latitude/Longitude	
				Start	End
Item	Trim / Thin Trees			37.991617°	37.991617°
				-121.295628°	-121.295628°
DWR ID	DWR_NA0017_16_s_2012_65				
Comment Code					
T5 : Tree stumps.					
Inspector Comment

A tree stump was found on the landside of the levee looking upstream.

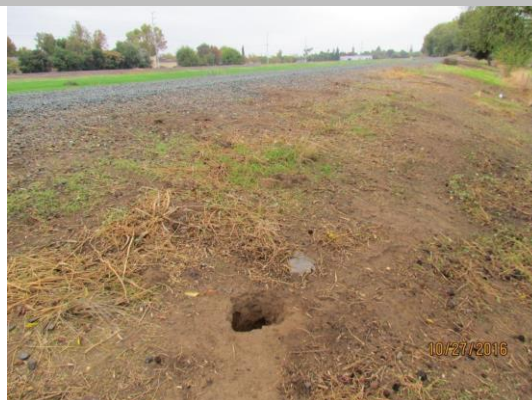
Photo 1 of 1 : FA\_2016\_NA0017\_160\_254\_20161031\_00382.jpg

LM Start	19.88	Rating **	M	Issue No.	254	
LM End	19.88	Issue Type +	Ma	Location *	LS	
Category	Earthen Levee			GPS Latitude/Longitude		
				Start		End
Item	Animal Control			37.986025 °		37.986025 °
				-121.307306 °		-121.307306 °
DWR ID	DWR_NA0017_16_f_2016_254					
Comment Code						
A3 : No rodents visible, but rodent burrows visible; need to backfill and compact or grout burrows.						
Inspector Comment

View of a rodent hole on the landside of the levee. Fall 2016

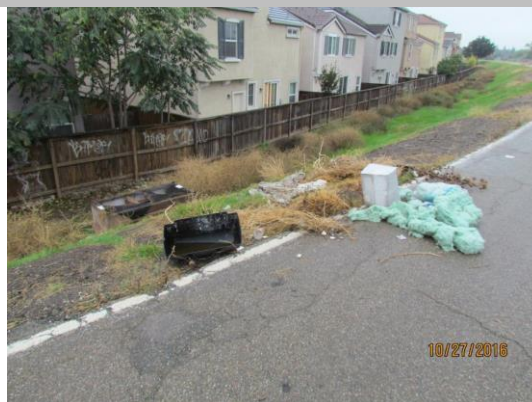
Photo 1 of 1 : FA\_2016\_NA0017\_160\_255\_20161031\_00384.jpg

LM Start	20.82	Rating **	M	Issue No.	255
LM End	20.82	Issue Type +	Ma	Location *	LS
Category	Earthen Levee			GPS Latitude/Longitude	
				Start	End
Item	Encroachments			37.980036 °	37.980036 °
				-121.320325 °	-121.320325 °
DWR ID	DWR_NA0017_16_f_2016_255				
Comment Code					
DE : Debris					
Inspector Comment

View of debris on the landside shoulder of the levee. Fall 2016

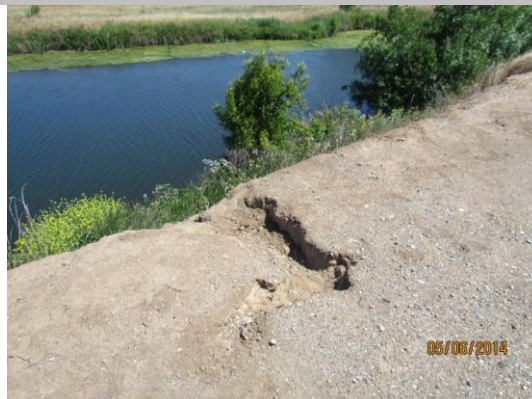
Photo 1 of 2 : FA\_2016\_NA0017\_160\_197\_20160823\_00130.jpg

LM Start	20.97	Rating **	M	Issue No.	197
LM End	20.97	Issue Type +	Ma	Location *	WS
Category	Earthen Levee			GPS Latitude/Longitude	
				Start	End
Item	Erosion / Bank Caving			37.980569 °	37.980569 °
				-121.322985 °	-121.322985 °
DWR ID	DWR_NA0017_16_s_2013_197				
Comment Code					
E2 : Schedule repair of erosion site prior to the next inspection.					
Inspector Comment

Updated picture of the erosion on the waterside of the levee looking upstream during spring 2014 inspection.

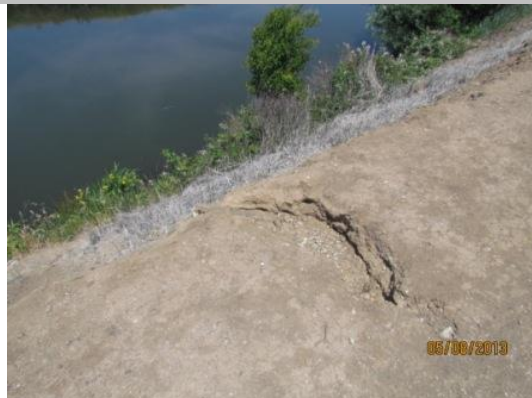
Photo 2 of 2 : FA\_2016\_NA0017\_160\_197\_20160823\_00131.jpg

Erosion was found on the waterside slope of the levee looking upstream.

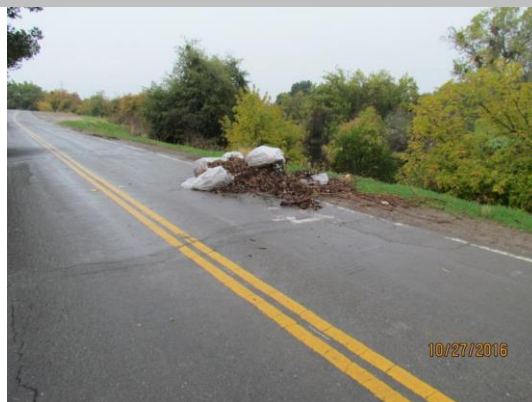
Photo 1 of 1 : FA\_2016\_NA0017\_160\_257\_20161031\_00386.jpg

LM Start	21.09	Rating **	M	Issue No.	257
LM End	21.09	Issue Type +	Ma	Location *	CR
Category	Earthen Levee			GPS Latitude/Longitude	
				Start	End
Item	Encroachments			37.980908 °	37.980908 °
				-121.325130 °	-121.325130 °
DWR ID	DWR_NA0017_16_f_2016_257				
Comment Code					
DE : Debris					
Inspector Comment

View of debris on the crown of the levee. Fall 2016

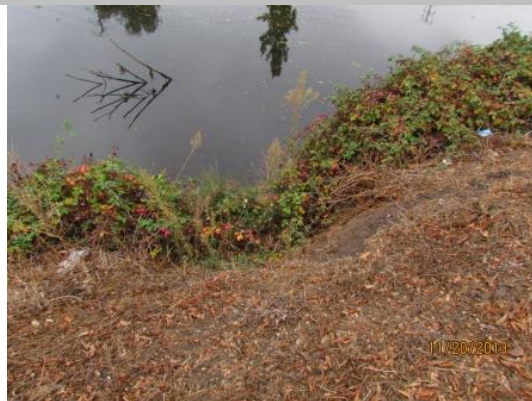
Photo 1 of 1 : FA\_2016\_NA0017\_160\_62\_20160823\_00053.jpg

LM Start	21.94	Rating **	M	Issue No.	62
LM End	21.94	Issue Type +	Ma	Location *	WS
Category	Earthen Levee			GPS Latitude/Longitude	
				Start	End
Item	Erosion / Bank Caving			37.979251°	37.979251°
				-121.340012°	-121.340012°
DWR ID	DWR_NA0017_16_f_2013_62				
Comment Code					
E2 : Schedule repair of erosion site prior to the next inspection.					
Inspector Comment

Erosion was found on the waterside slope of the levee looking upstream.

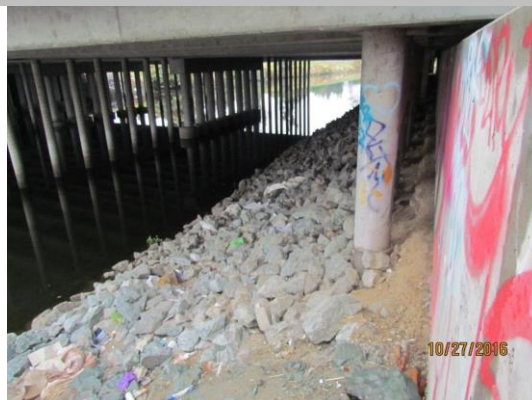
Photo 1 of 5 : FA\_2016\_NA0017\_160\_48\_20161031\_00387.jpg

LM Start	22.04	Rating **	A/W	Issue No.	48
LM End	22.04	Issue Type +	Ma	Location *	WS
Category	Earthen Levee			GPS Latitude/Longitude	
				Start	End
Item	Erosion / Bank Caving			37.978697 °	37.978697 °
				-121.341581 °	-121.341581 °
DWR ID	DWR_NA0017_16_s_2012_48				
Comment Code					
E2 : Schedule repair of erosion site prior to the next inspection.					
Inspector Comment					
Caltrans repaired the issue. (Permit # 18562) Another repair might be needed if it deteriorates.

View of the riprap on the waterside slope of the levee. Fall 2016

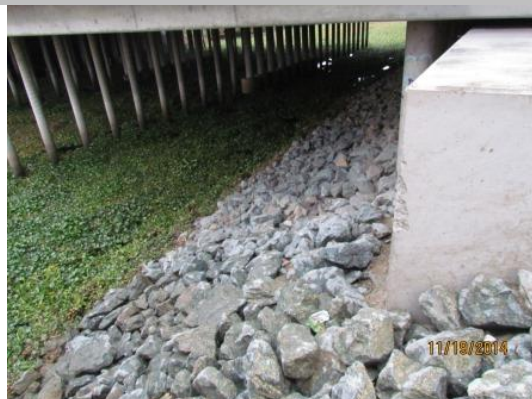
Photo 2 of 5 : FA\_2016\_NA0017\_160\_48\_20160823\_00038.jpg

LM Start	22.04	Rating **	A/W	Issue No.	48 (cont)	
LM End	22.04	Issue Type +	Ma	Location *	WS	
Category	Earthen Levee			GPS Latitude/Longitude		
				Start		End
Item	Erosion / Bank Caving			37.978697 °		37.978697 °
				-121.341581 °		-121.341581 °
DWR ID	DWR_NA0017_16_s_2012_48					
Comment Code						
E2 : Schedule repair of erosion site prior to the next inspection.						
Inspector Comment						
Caltrans repaired the issue. (Permit # 18562) Another repair might be needed if it deteriorates.

Caltrans repaired the erosion under the southbound (I-5) bridge. The picture was taken from the crown looking upstream during fall 2014 inspection.

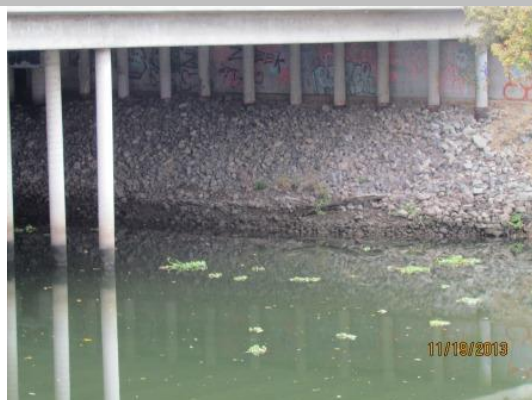
Photo 3 of 5 : FA\_2016\_NA0017\_160\_48\_20160823\_00039.jpg

Updated picture of erosion was found on the waterside toe of the levee looking from the opposite side of the levee. Fall 2013

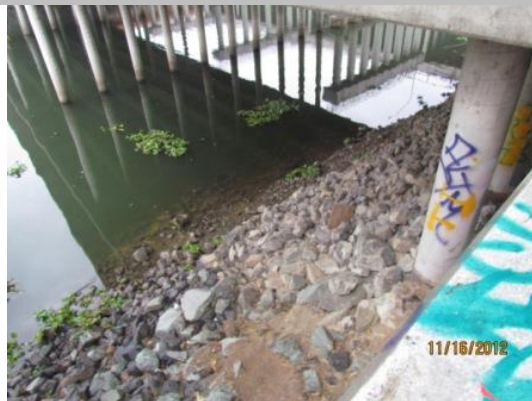
Photo 4 of 5 : FA\_2016\_NA0017\_160\_48\_20160823\_00040.jpg

LM Start	22.04	Rating **	A/W	Issue No.	48 (cont)
LM End	22.04	Issue Type +	Ma	Location *	WS
Category	Earthen Levee			GPS Latitude/Longitude	
				Start	End
Item	Erosion / Bank Caving			37.978697 °	37.978697 °
				-121.341581 °	-121.341581 °
DWR ID	DWR_NA0017_16_s_2012_48				
Comment Code					
E2 : Schedule repair of erosion site prior to the next inspection.					
Inspector Comment					
Caltrans repaired the issue. (Permit # 18562) Another repair might be needed if it deteriorates.

Updated view of the erosion site repaired by Caltrans on the waterside slope of the levee looking upstream. Fall 2012

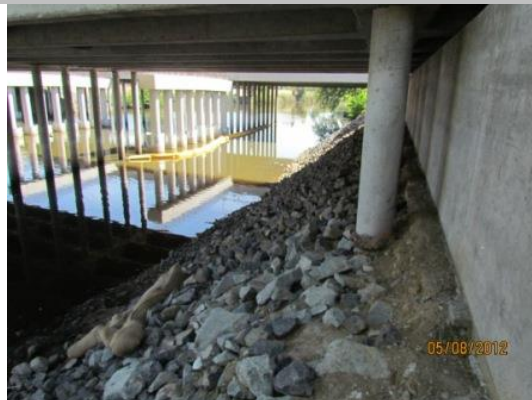
Photo 5 of 5 : FA\_2016\_NA0017\_160\_48\_20160823\_00041.jpg

View of the erosion site repaired by Caltrans under the I-5 freeway going southbound. This picture was taken from the toe of the levee looking upstream. Spring 2012

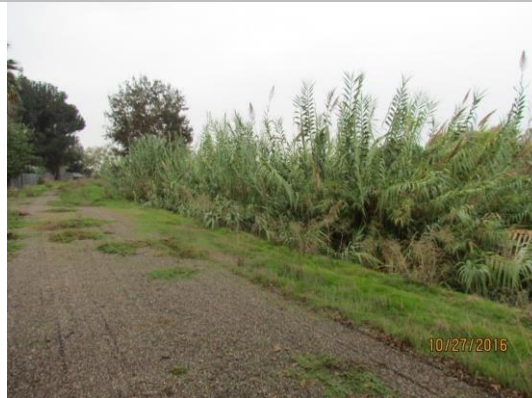
Photo 1 of 2 : FA\_2016\_NA0017\_160\_45\_20161031\_00388.jpg

LM Start	22.53	Rating **	U	Issue No.	45
LM End	22.53	Issue Type +	Ma	Location *	WS
Category	Earthen Levee			GPS Latitude/Longitude	
				Start	End
Item	Vegetation			37.973578 °	37.973578 °
				-121.347848 °	-121.347848 °
DWR ID	DWR_NA0017_16_f_2012_45				
Comment Code					
V2 : Remove the wild growth other than native grasses from the levee slopes.					
Inspector Comment					
Arundo on the waterside of the levee is completely blocking the visibility.

Updated picture of the arundo on the waterside slope of the levee. Fall 2016

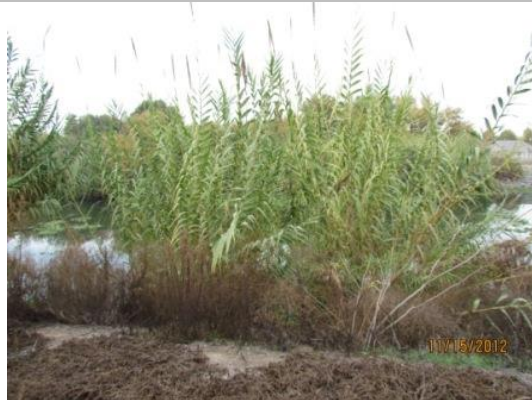
Photo 2 of 2 : FA\_2016\_NA0017\_160\_45\_20160823\_00034.jpg

Arundo was found on the waterside slope of the levee looking upstream.

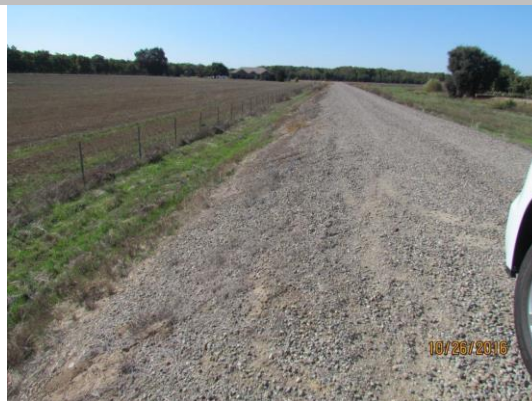
Photo 1 of 1 : FA\_2016\_NA0017\_162\_3\_20161031\_00005.jpg

LM Start	0.01	Rating **	A	Issue No.	3
LM End	0.01	Issue Type +	Ma	Location *	LS
Category	Earthen Levee			GPS Latitude/Longitude	
				Start	End
Item	Vegetation			37.957521 °	37.957521 °
				-121.148672 °	-121.148672 °
DWR ID	DWR_NA0017_18_f_2016_3				
Comment Code					
V1 : Control annual grass and weeds on the levee slopes and easements.					
Inspector Comment					
Acceptable vegetation.

View of the landside slope of the levee. Fall 2016

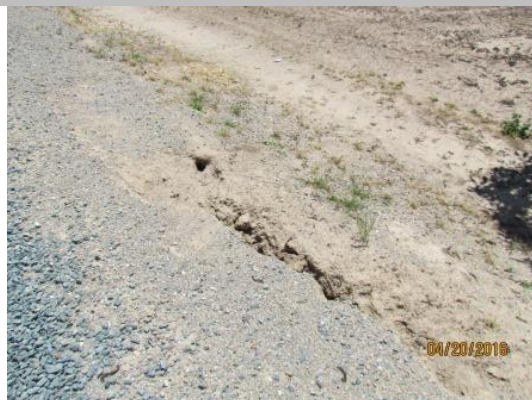
Photo 1 of 1 : FA\_2016\_NA0017\_162\_4\_20160823\_00002.jpg

LM Start	0.87	Rating **	M	Issue No.	4
LM End	0.87	Issue Type +	Ma	Location *	LS
Category	Earthen Levee			GPS Latitude/Longitude	
				Start	End
Item	Animal Control			37.960206 °	37.960206 °
				-121.163559 °	-121.163559 °
DWR ID	DWR_NA0017_18_f_2015_4				
Comment Code					
A3 : No rodents visible, but rodent burrows visible; need to backfill and compact or grout burrows.					
Inspector Comment

Rodent holes were found on the landside of the levee.

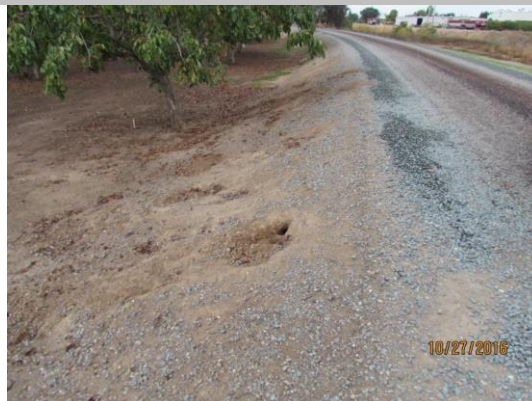
Photo 1 of 1 : FA\_2016\_NA0017\_162\_5\_20161031\_00006.jpg

LM Start	0.89	Rating **	M	Issue No.	5
LM End	0.89	Issue Type +	Ma	Location *	LS
Category	Earthen Levee			GPS Latitude/Longitude	
				Start	End
Item	Animal Control			37.960275 °	37.960275 °
				-121.163858 °	-121.163858 °
DWR ID	DWR_NA0017_18_f_2016_5				
Comment Code					
A3 : No rodents visible, but rodent burrows visible; need to backfill and compact or grout burrows.					
Inspector Comment

View of the rodent holes on the landside of the levee. Fall 2016
