Flood Control Project Maintenance
2008 Structure Summary Report
Overall Unit and Item Ratings

San Joaquin County Flood Control District

2008 Structure Inspection Results

**Flood Control Project Maintenance
Inspection Report - Structure 2008**

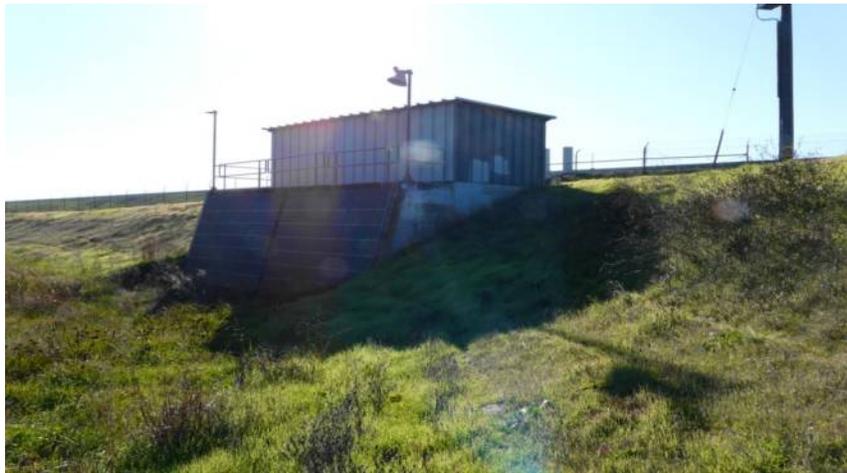
Report Line	3
Location	
Category	Pump Stations
Item	Plant Building
View of the station diagonally from the basin.

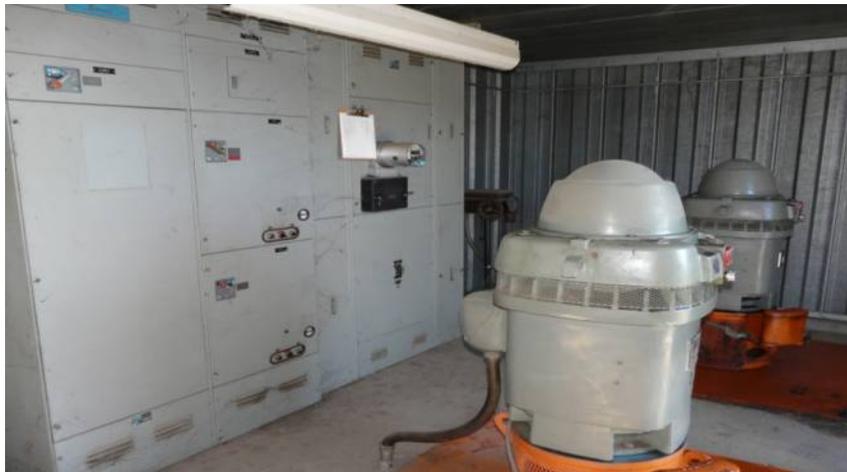
Report Line	7
Location	
Category	Pump Stations
Item	Pumps
View of the two pumps inside the station building. Station switching gear and stilling well can be seen in the background. The clipboard next to the electric meter is a log for electrical use at the station.

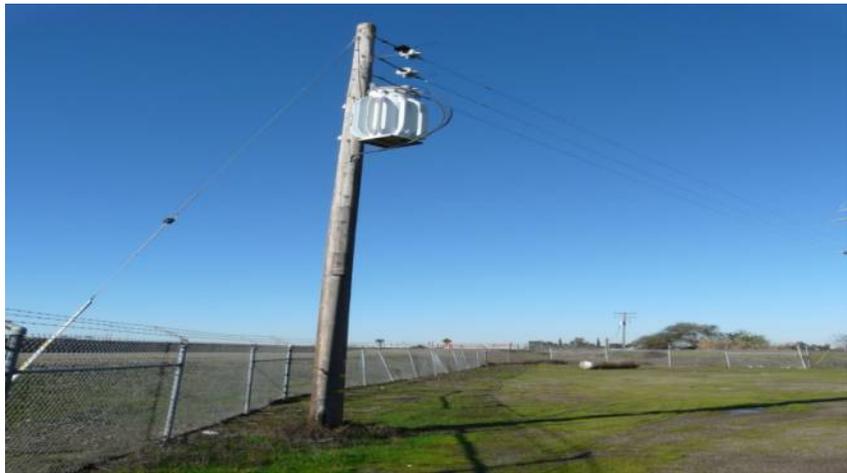
Report Line	8
Location	
Category	Pump Stations
Item	Power
View of power pole and transformer that supplies the plan with power.

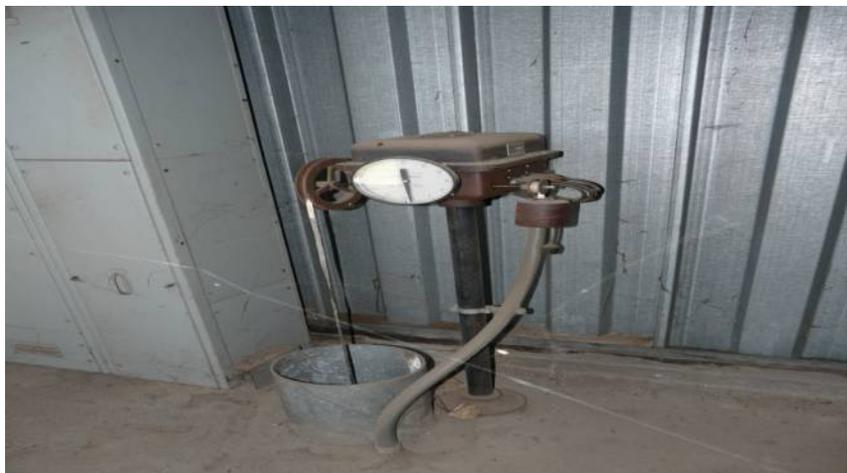
Report Line	10
Location	
Category	Pump Stations
Item	Pump Control Systems
View of stilling well used to control pump operations.

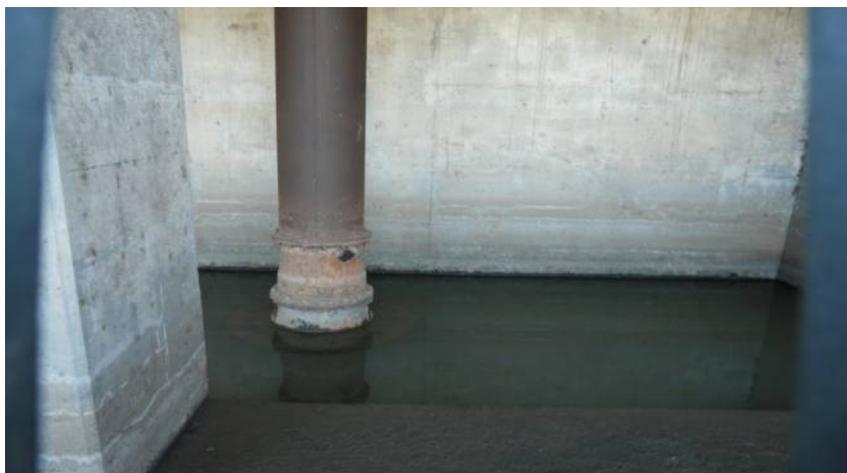
Report Line	11
Location	
Category	Pump Stations
Item	Sumps/Wet Well
View of right portion of sump.

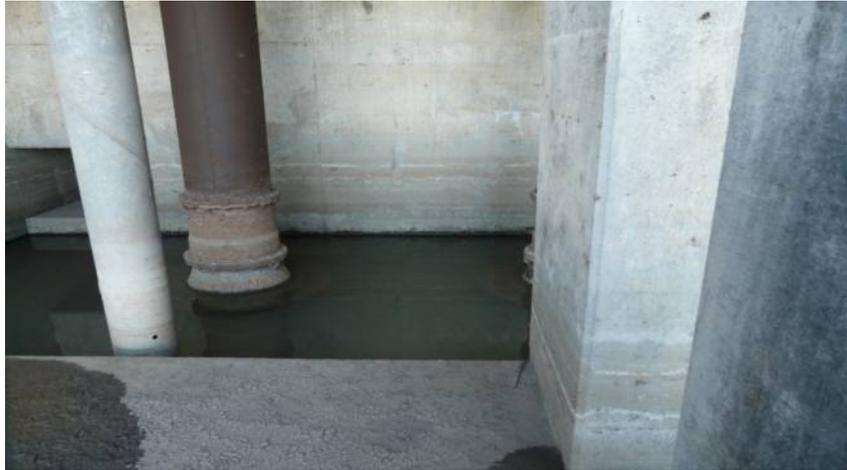
Report Line	11
Location	
Category	Pump Stations
Item	Sumps/Wet Well
View of left portion of sump. The opening on the left portion of the photo is the low flow/gravity channel.

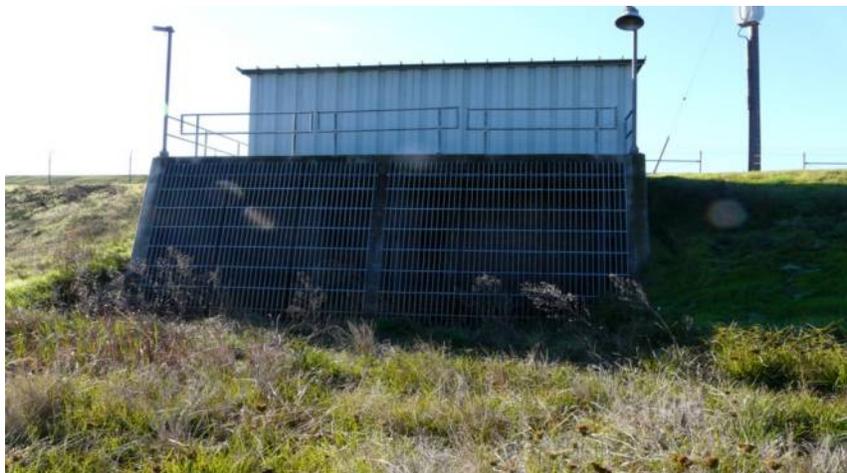
Report Line	12
Location	
Category	Pump Stations
Item	Trash Racks
View of pump station from basin side showing the trash rack.

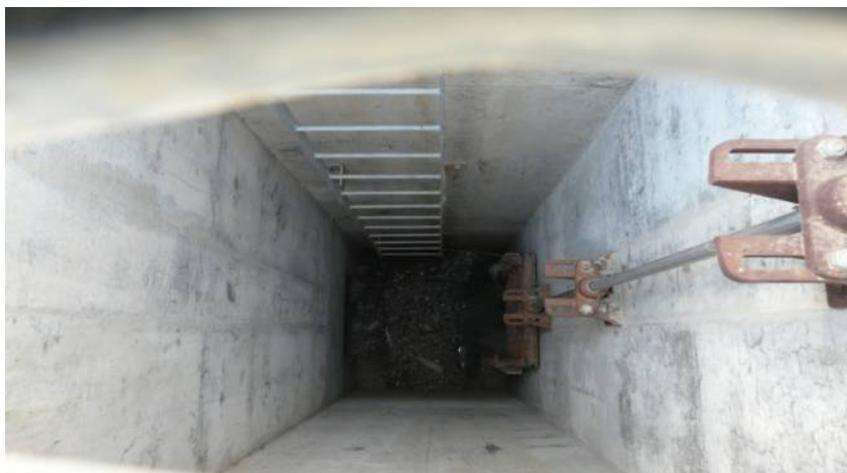
Report Line	14
Location	
Category	Pump Stations
Item	Sluice / Slide Gates
View looking at slide gate on water side of the levee.

14	Pump Stations	Sluice / Slide Gates		A	The slide gate was not closely inspected or opened or closed, but appears to be in acceptable condition.	°	Y	14
15	Pump Stations	Electric Gate Operators		N	There are no electronic gate operators at this station.	°		15
16	Pump Stations	Manual Gate Operators		A	The gate was not opened or closed during the inspection, but the screw and operator appear in acceptable condition.	°	Y	16

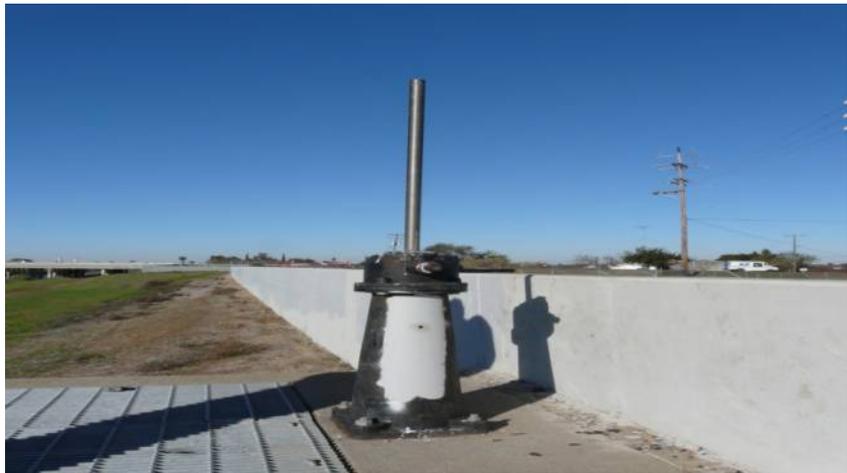
Report Line	16
Location	
Category	Pump Stations
Item	Manual Gate Operators

View of top of slide gate and manual operator.

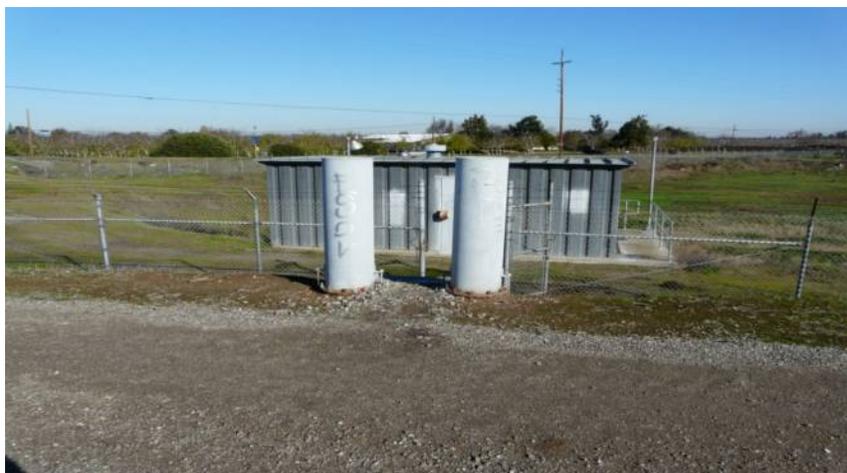
Report Line	19
Location	
Category	Pump Stations
Item	Closure Structures

View of risers around siphon breakers at the crown of the levee.

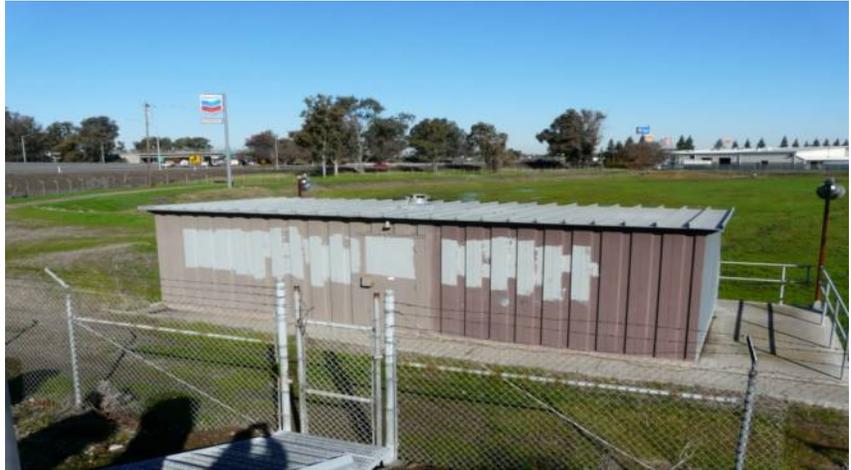
Report Line	3
Location	
Category	Pump Stations
Item	Plant Building

View of station building from the levee. Note the vent in the middle of the roof.

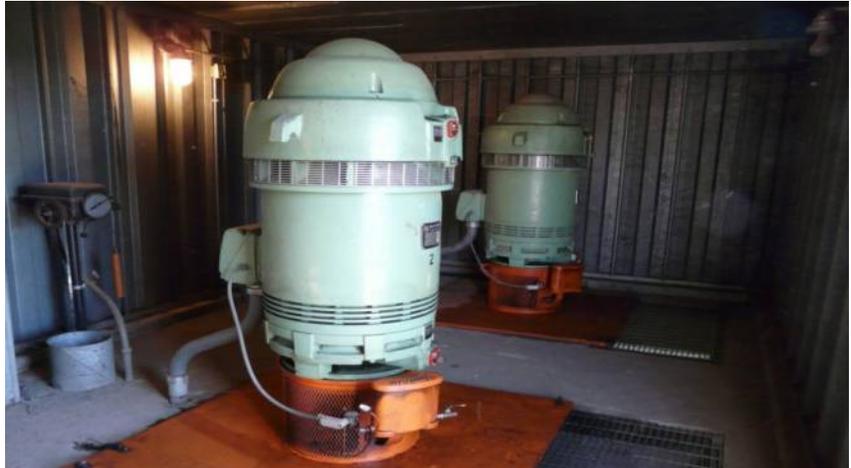
Report Line	7
Location	
Category	Pump Stations
Item	Pumps

View of the two pumps inside the pump station building.

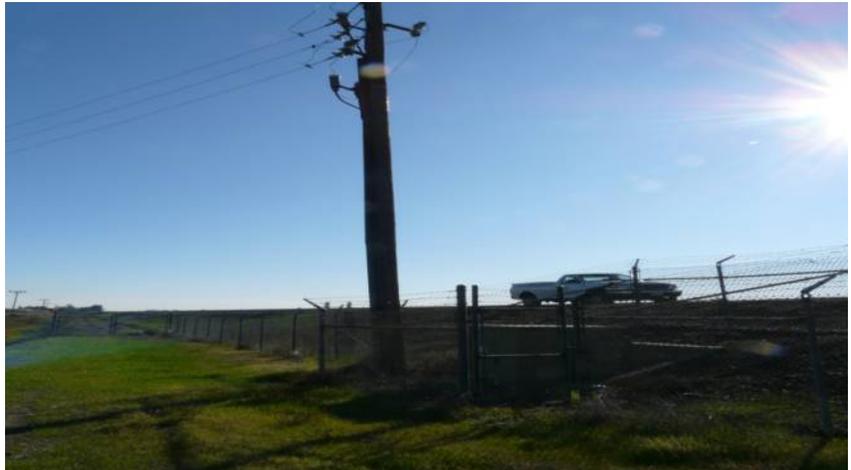
Report Line	8
Location	
Category	Pump Stations
Item	Power

View of power pole and transformer supplying power to the station.

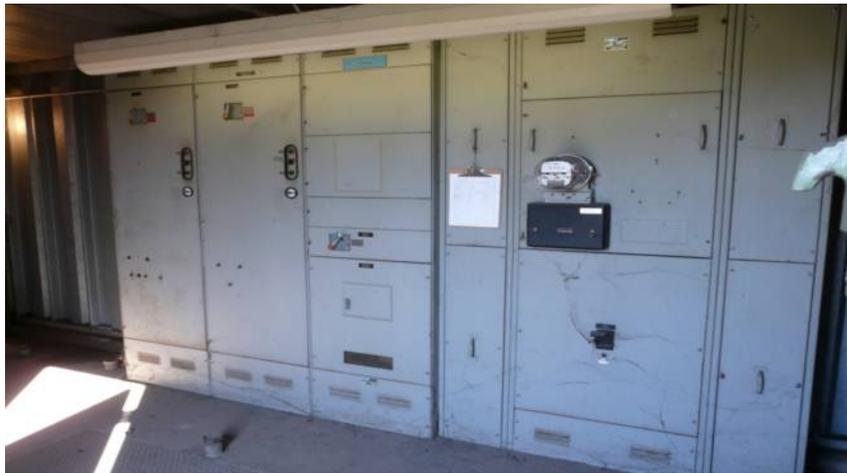
Report Line	10
Location	
Category	Pump Stations
Item	Pump Control Systems
View of electrical switching gear and pump controls. The clipboard on the panel is for logging electrical use.

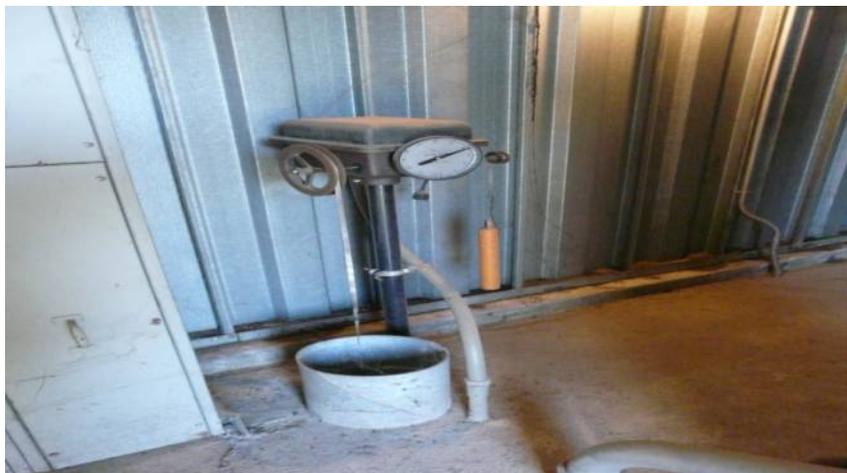
Report Line	10
Location	
Category	Pump Stations
Item	Pump Control Systems
View of stilling well used to control pump operations.

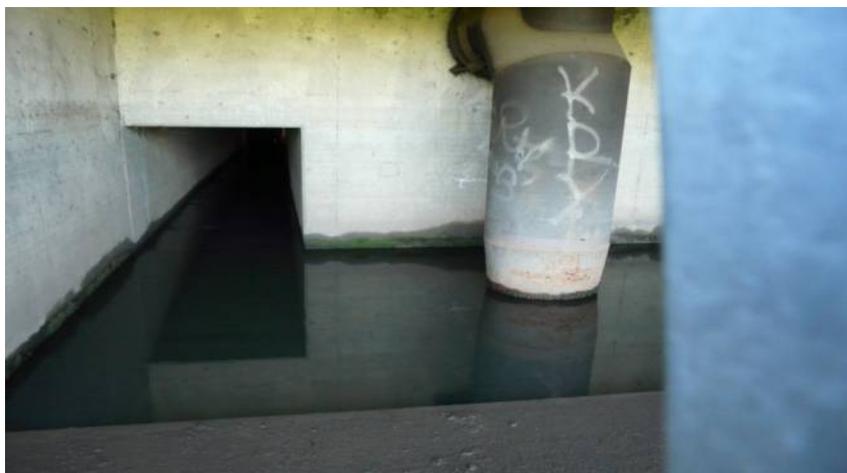
Report Line	11
Location	
Category	Pump Stations
Item	Sumps/Wet Well
View of left portion of sump. The opening on the left portion of the photo is the low flow/gravity channel.

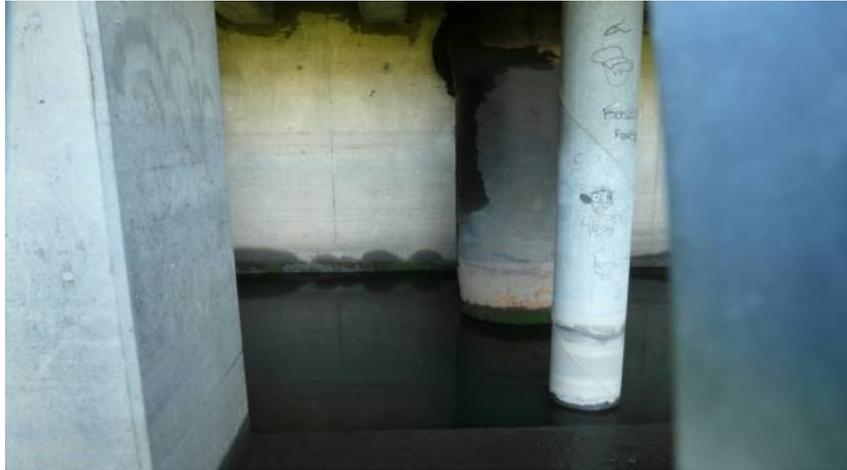
Report Line	11
Location	
Category	Pump Stations
Item	Sumps/Wet Well
View of right portion of sump. The pipe in the foreground is the stilling well.

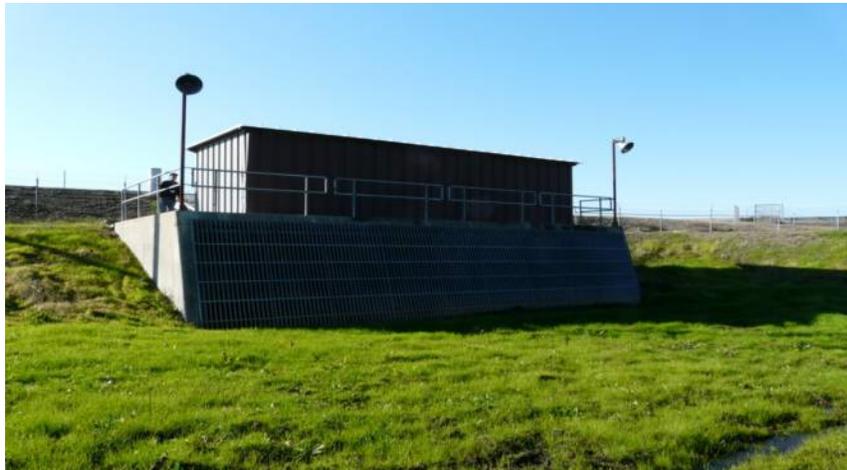
12	Pump Stations	Trash Racks		A	Trash rack at the station appears to be in good condition and clear of debris. There is trash at one of the inlet pipes to the basin that may impede flow into the basin but should not affect the pump station's operation.	°	Y	12
13	Pump Stations	Trash Rakes		N	There are no automatic trash rakes on this station. Trash racks are manually cleared by County workers.	°		13
14	Pump Stations	Sluice / Slide Gates		A	The slide gate was not closely inspected or opened or closed, but appears to be in acceptable condition.	°	Y	14
15	Pump Stations	Electric Gate Operators		N	There are no electronic gate operators at this station.	°		15

Report Line	12
Location	
Category	Pump Stations
Item	Trash Racks
View of station from basin. Note the trash racks along this side of the station.

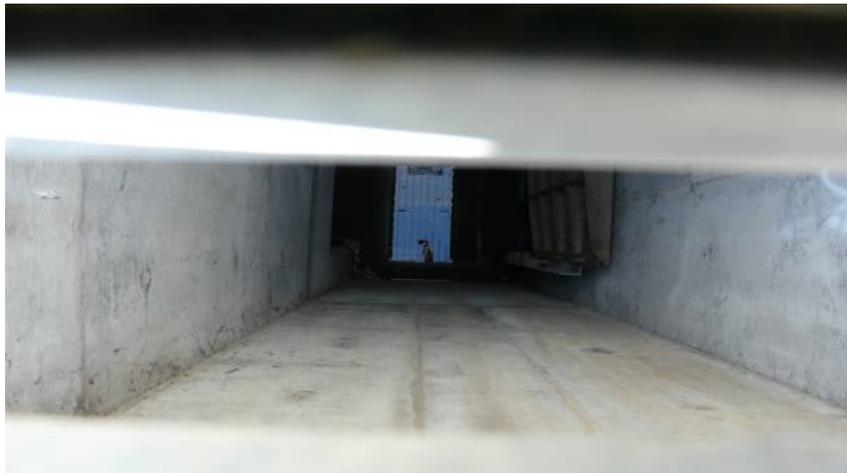
Report Line	14
Location	
Category	Pump Stations
Item	Sluice / Slide Gates

View looking at slide gate on water side of the levee.

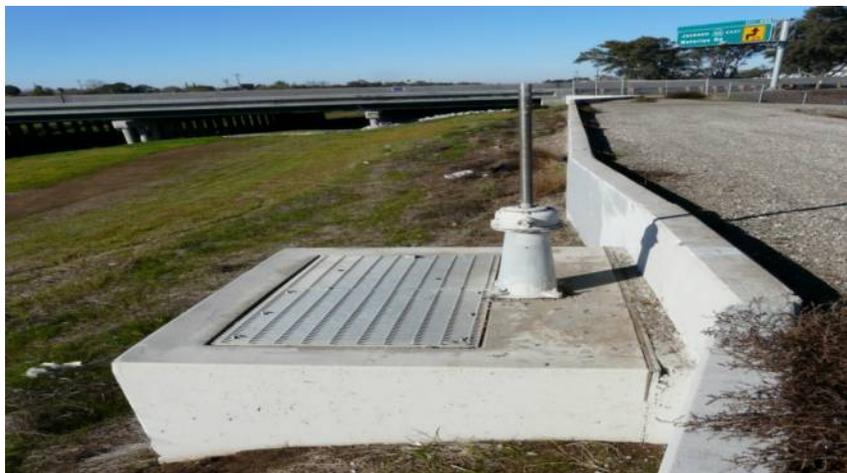
Report Line	16
Location	
Category	Pump Stations
Item	Manual Gate Operators

Roll Line	Category	Item	Location *	Rating **	Comment	GPS	Photo	Issue
16	Pump Stations	Manual Gate Operators		A	The gate was not opened or closed during the inspection, but the screw and operator appear in acceptable condition.		°	Y 16
17	Pump Stations	Other Metallic Items		A	Metal components of the station appear to be maintained acceptably. The joints on the handrails on the station have some corrosion. Does not appear to affect safety or operation of pump. New metal steps have been installed to the station.		°	17
18	Pump Stations	Flap Gates		A	The flap gates close completely and are free of debris. Some silt is located at the gates but should not affect operations of the gates.		°	Y 18
19	Pump Stations	Closure Structures		A	Siphon breakers are located at the crown of the levee and appear to be in adequate condition.		°	Y 19
20	Pump Stations	Security Fencing		A	Barbed wire above fence at entry gate is not intact. The fence around the remainder of the station and basin appears to be adequate.		°	Y 20

View of top of slide gate and manual operator.

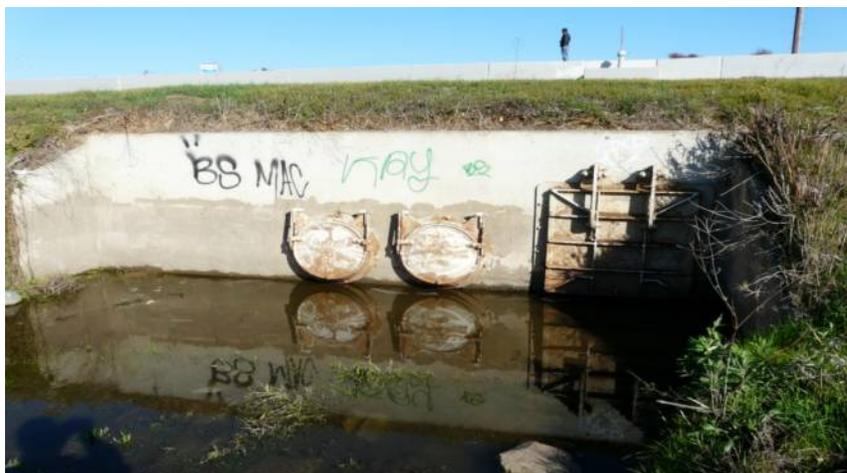
Report Line	18
Location	
Category	Pump Stations
Item	Flap Gates

View of flap gates for the pressure pipes (left) and gravity channel (right). Flap gates close completely and the silt does not affect their operation.

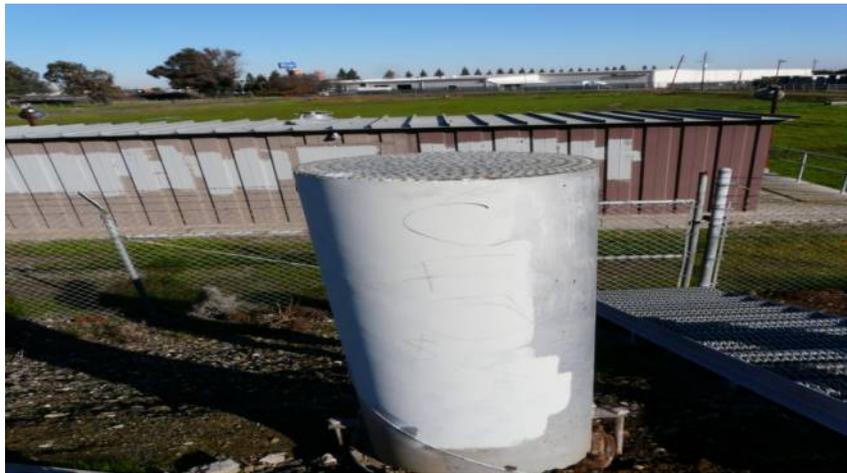
Report Line	19
Location	
Category	Pump Stations
Item	Closure Structures

View of one of the siphon breakers at the crown of the levee.

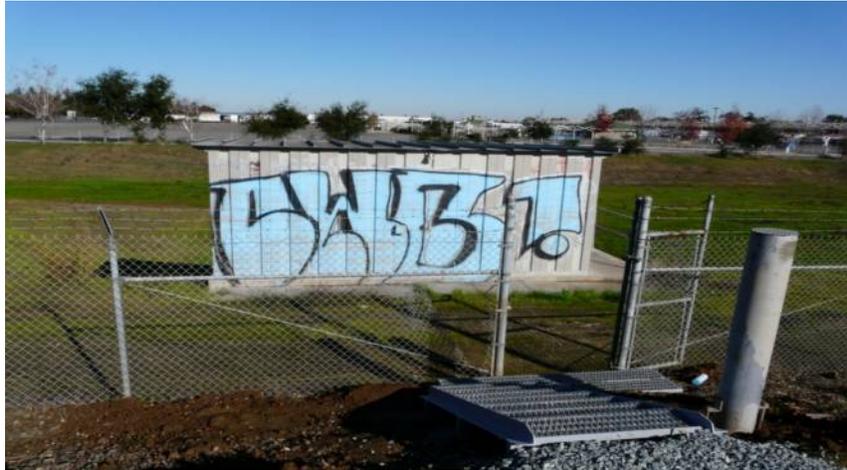
Report Line	3
Location	
Category	Pump Stations
Item	Plant Building

View of the station building from the levee.

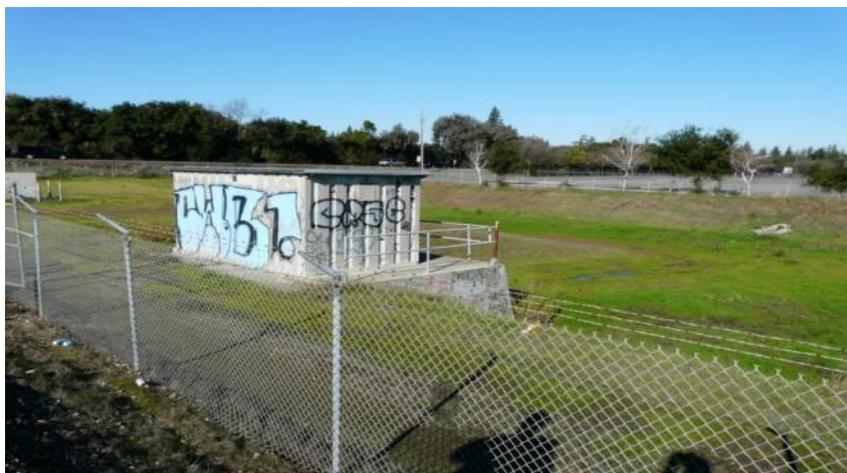
Report Line	3
Location	
Category	Pump Stations
Item	Plant Building

Additional view of station building from the levee side.

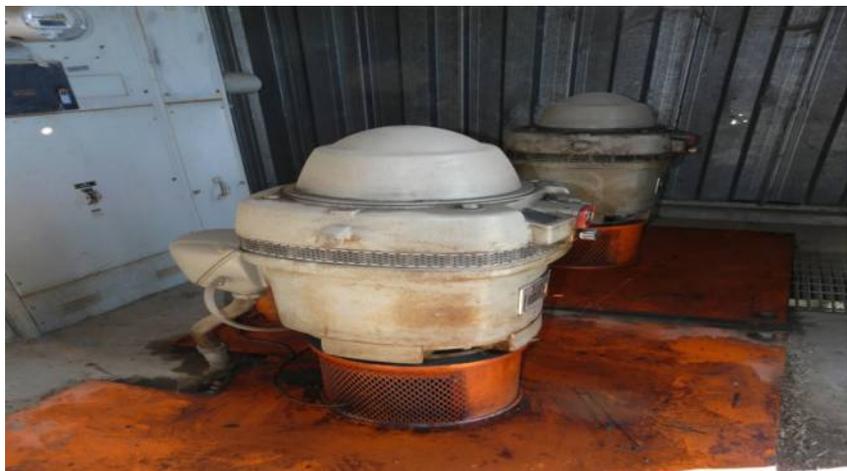
Report Line	7
Location	
Category	Pump Stations
Item	Pumps
View of the pumps inside the station building.

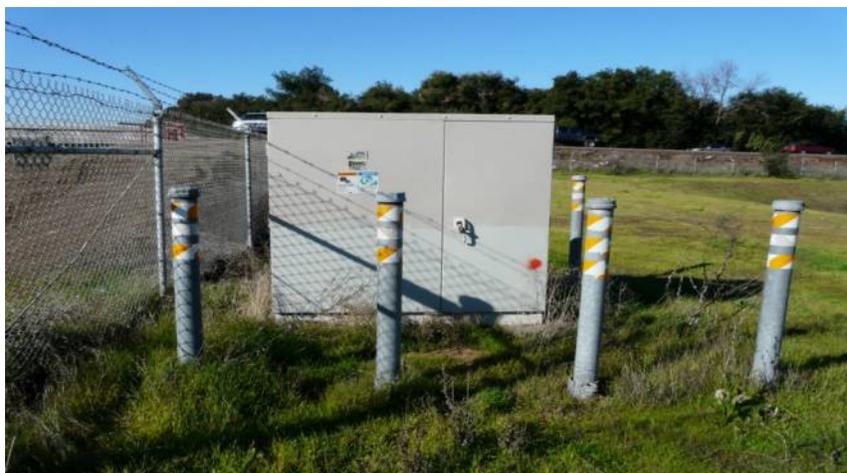
Report Line	8
Location	
Category	Pump Stations
Item	Power
View of electrical transformer located on-site that provides power to the pump station.

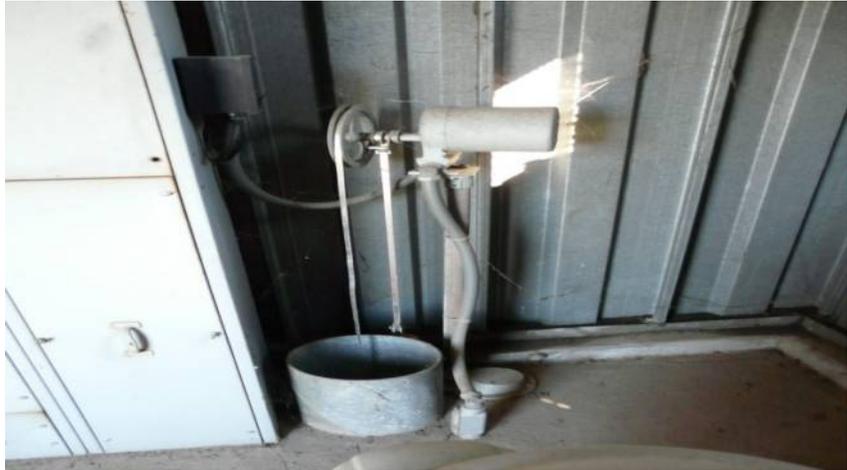
Report Line	10
Location	
Category	Pump Stations
Item	Pump Control Systems
View of stilling well used to control pump operations.

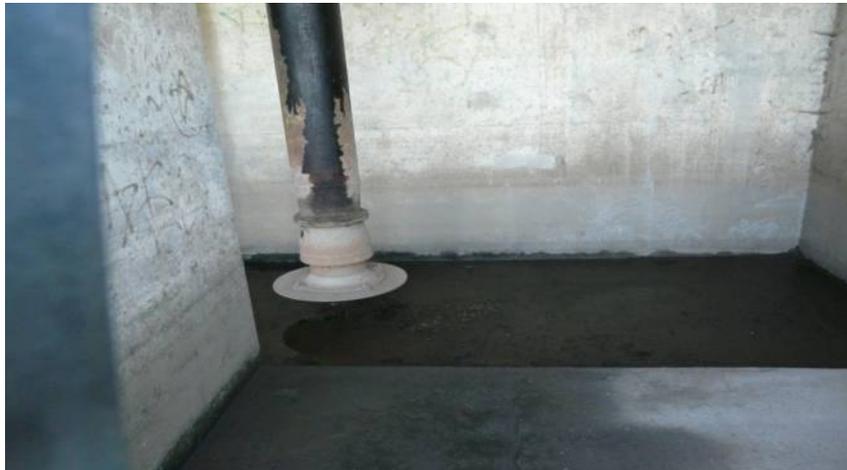
Report Line	11
Location	
Category	Pump Stations
Item	Sumps/Wet Well
View of right portion of sump.

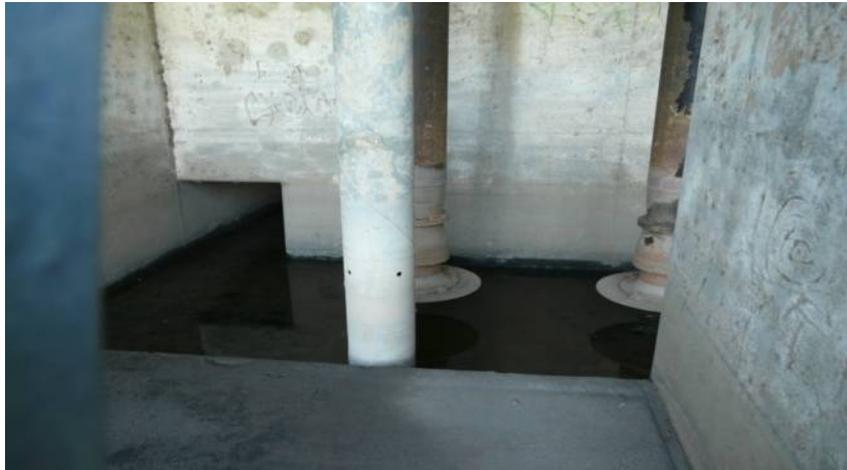
Report Line	11
Location	
Category	Pump Stations
Item	Sumps/Wet Well
View of left portion of sump. The opening on the left portion of the photo is the low flow/gravity channel.

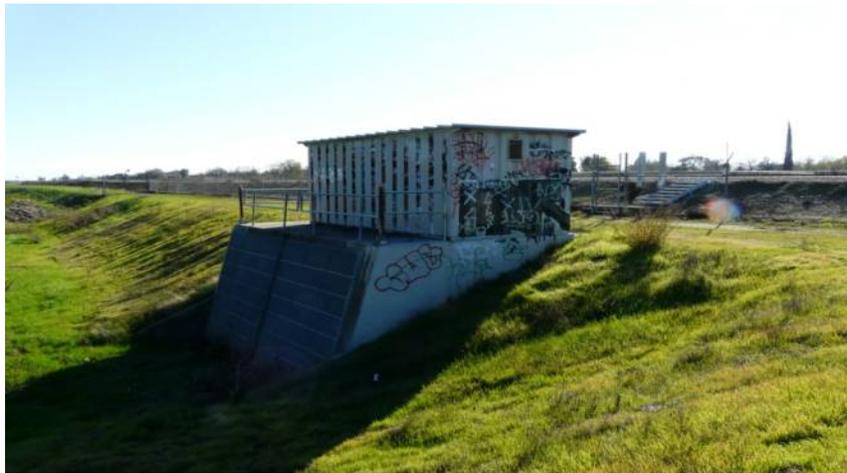
12	Pump Stations	Trash Racks		A	Trash racks appear in good condition and are clear of debris.	°	Y	12
13	Pump Stations	Trash Rakes		N	There are no automatic trash rakes on this plan. Trash racks are manually cleared by County workers.	°		13
14	Pump Stations	Sluice / Slide Gates		A	The slide gate was not closely inspected or opened or closed, but appears to be in acceptable condition.	°	Y	14
15	Pump Stations	Electric Gate Operators		N	There are no electronic gate operators at this station.	°		15

Report Line	12
Location	
Category	Pump Stations
Item	Trash Racks
Diagonal view of station from basin side. Note the trash racks on the station.

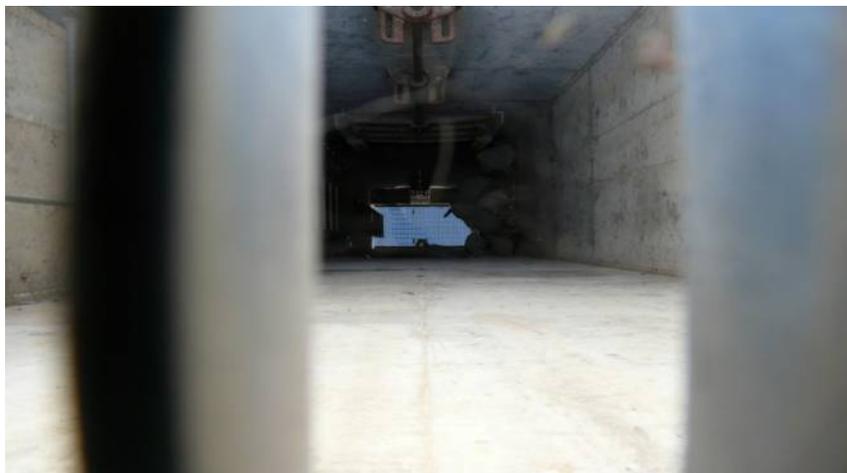
Report Line	14
Location	
Category	Pump Stations
Item	Sluice / Slide Gates
View looking at slide gate on water side of the levee.

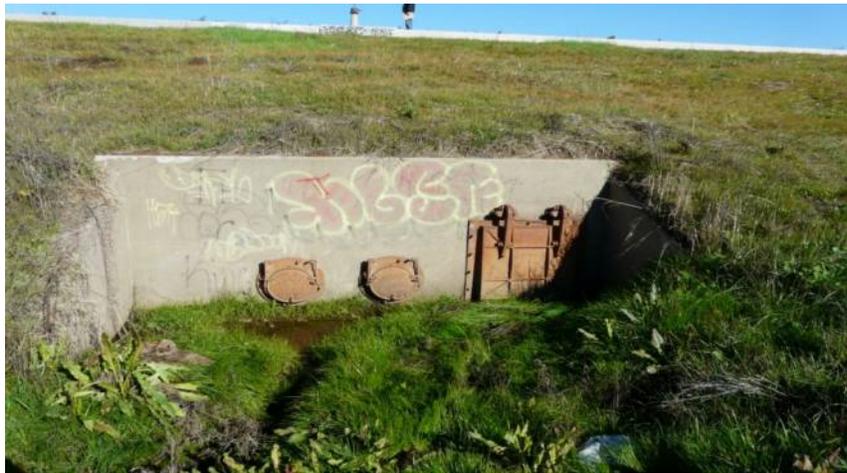
Report Line	18
Location	
Category	Pump Stations
Item	Flap Gates

View of flap gates for the pressure pipes (left) and gravity channel (right). Flap gates close completely and the silt does not affect their operation.

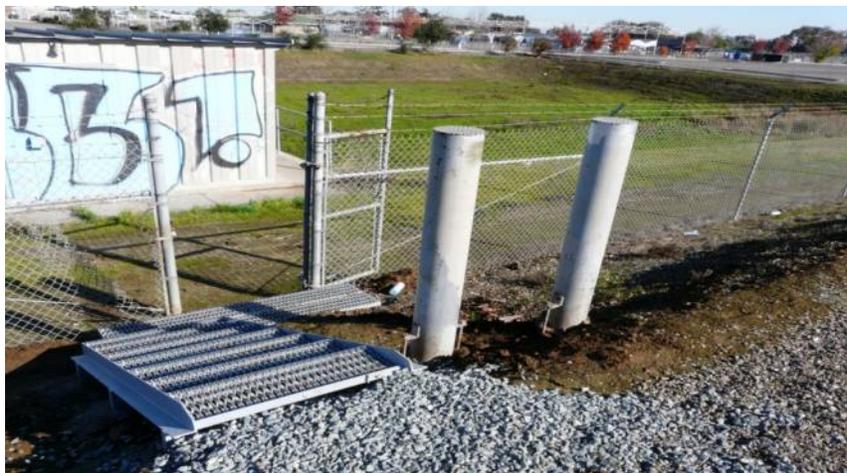
Report Line	19
Location	
Category	Pump Stations
Item	Closure Structures

View of risers around siphon breakers at the crown of the levee.
