**Flood Control Project Maintenance**  
**2016 Structure Summary Report**  
**Overall Unit and Item Ratings**

**San Joaquin County Flood Control and Water Conservation District**

**Duck Creek Diversion Weir And Control Structure**

**2016 Structure Inspection Results**

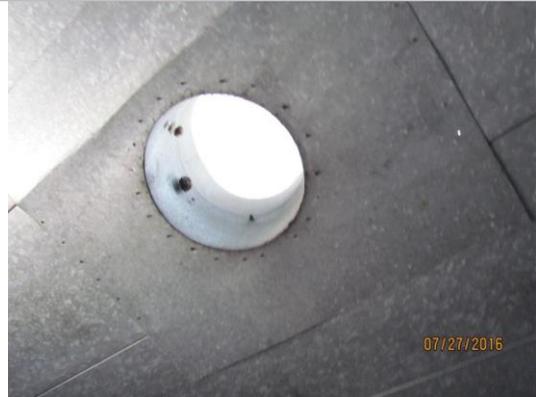
Photo 1 of 1 : ST\_2016\_NA0017\_18\_10\_20160805\_00019.jpg

LM Start	<b>0.00</b>	Rating **	A	Issue No.	<b>10</b>
LM End	<b>0.00</b>	Issue Type +	Ma	Location *	
Category	Pump Stations			GPS Latitude/Longitude	
				Start	End
Item	Motors, Engines, Fans & Gear Reducers			37.989633 °	37.989633 °
				-121.266933 °	-121.266933 °
DWR ID	DWR_NA0017_18_t_2012_10				
Action/Comments					
Inspector Comments: The vent fan was operational.

View of the ventilation inside the plant.

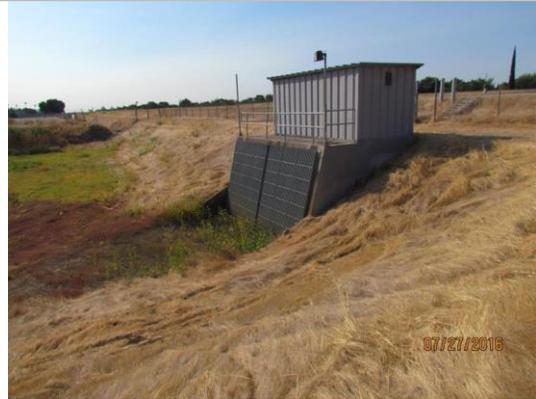
Photo 1 of 1 : ST\_2016\_NA0017\_18\_13\_20160805\_00022.jpg

LM Start	<b>0.00</b>	Rating **	A	Issue No.	<b>13</b>
LM End	<b>0.00</b>	Issue Type +	Ma	Location *	
Category	Pump Stations		GPS Latitude/Longitude		
			Start	End	
Item	Trash Racks		37.989633 °	37.989633 °	
			-121.266933 °	-121.266933 °	
DWR ID	DWR_NA0017_18_t_2012_13				
Action/Comments					
Inspector Comments: Trash racks were properly maintained and clear of debris.

View of the trash racks.

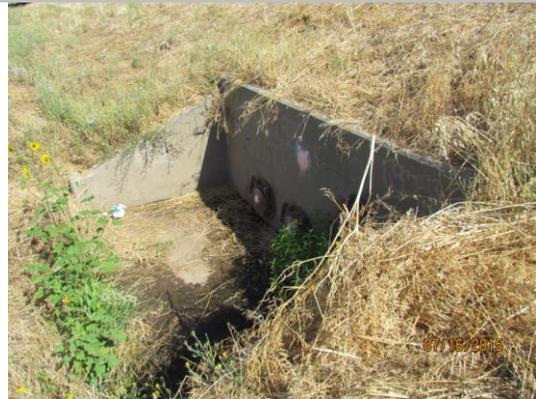
Photo 2 of 2 : ST\_2016\_NA0017\_18\_19\_20160613\_00011.jpg

LM Start	<b>0.00</b>	Rating **	A	Issue No.	<b>19</b>
LM End	<b>0.00</b>	Issue Type +	Ma	Location *	
Category	Pump Stations		GPS Latitude/Longitude		
			Start	End	
Item	Flap Gates		37.989633 °	37.989633 °	
			-121.266933 °	-121.266933 °	
DWR ID	DWR_NA0017_18_t_2012_19				
Action/Comments					
Inspector Comments: The flap gates appeared to be in good working condition.

View of the flap gates.

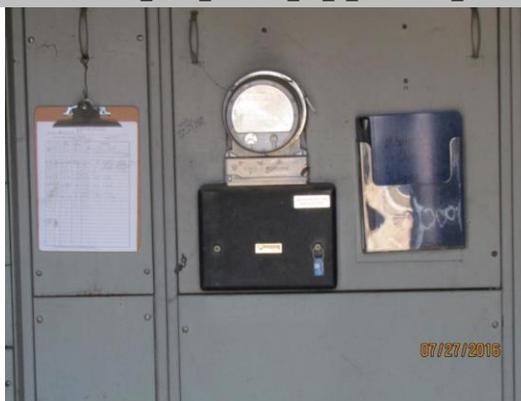
Photo 1 of 1 : ST\_2016\_NA0017\_19\_1\_20160808\_00028.jpg

LM Start	<b>0.00</b>	Rating **	A	Issue No.	<b>1</b>
LM End	<b>0.00</b>	Issue Type +	Ma	Location *	
Category	Pump Stations		GPS Latitude/Longitude		
			Start	End	
Item	Operating Log		37.982317 °	37.982317 °	
			-121.249433 °	-121.249433 °	
DWR ID	DWR_NA0017_19_t_2012_1				
Action/Comments					
Inspector Comments: Operational log was present at the pump station.

View of the operation log and O&M manual inside the pumping plant.

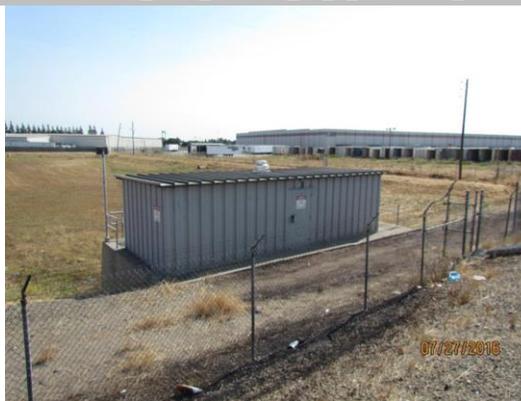
Photo 1 of 1 : ST\_2016\_NA0017\_19\_3\_20160808\_00029.jpg

LM Start	<b>0.00</b>	Rating **	A	Issue No.	<b>3</b>
LM End	<b>0.00</b>	Issue Type +	Ma	Location *	
Category	Pump Stations		GPS Latitude/Longitude		
			Start	End	
Item	Plant Building		37.982317 °	37.982317 °	
			-121.249433 °	-121.249433 °	
DWR ID	DWR_NA0017_19_t_2012_3				
Action/Comments					
Inspector Comments: The plant building was in good structural condition without any major deficiencies.

View of the pumping plant.

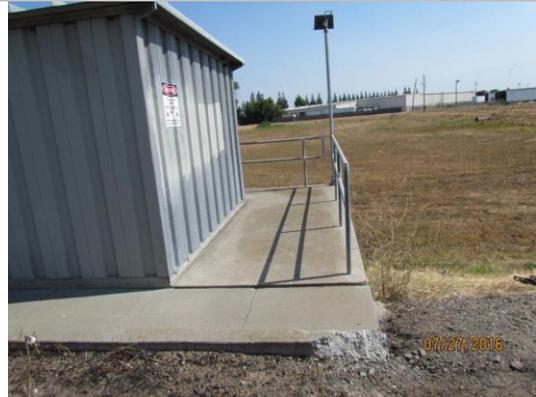
Photo 1 of 1 : ST\_2016\_NA0017\_19\_5\_20160808\_00030.jpg

LM Start	<b>0.00</b>	Rating **	A	Issue No.	<b>5</b>
LM End	<b>0.00</b>	Issue Type +	Ma	Location *	
Category	Pump Stations		GPS Latitude/Longitude		
			Start	End	
Item	Safety		37.982317 °	37.982317 °	
			-121.249433 °	-121.249433 °	
DWR ID	DWR_NA0017_19_t_2012_5				
Action/Comments					
Inspector Comments: No safety hazard was found around the structure. All hand rails were in working condition.

View of the hand rails around the pumping plant.

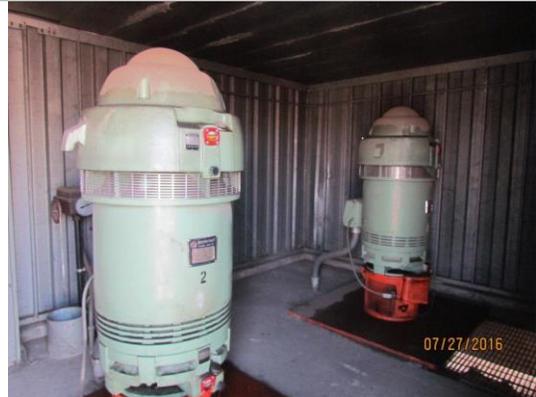
Photo 1 of 1 : ST\_2016\_NA0017\_19\_7\_20160808\_00032.jpg

LM Start	<b>0.00</b>	Rating **	A	Issue No.	<b>7</b>
LM End	<b>0.00</b>	Issue Type +	Ma	Location *	
Category	Pump Stations		GPS Latitude/Longitude		
			Start	End	
Item	Pumps		37.982317 °	37.982317 °	
			-121.249433 °	-121.249433 °	
DWR ID	DWR_NA0017_19_t_2012_7				
Action/Comments					
Inspector Comments: The pumps appeared to be well maintained and lubricated properly and the pumping system was tested periodically.

View of the pumps inside the plant.

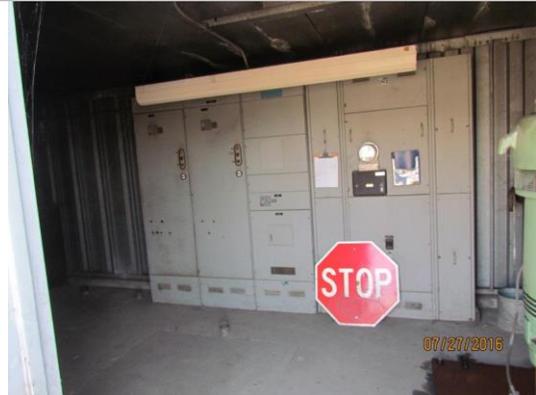
Photo 1 of 1 : ST\_2016\_NA0017\_19\_11\_20160808\_00034.jpg

LM Start	<b>0.00</b>	Rating **	A	Issue No.	<b>11</b>
LM End	<b>0.00</b>	Issue Type +	Ma	Location *	
Category	Pump Stations		GPS Latitude/Longitude		
			Start	End	
Item	Pump Control Systems		37.982317 °	37.982317 °	
			-121.249433 °	-121.249433 °	
DWR ID	DWR_NA0017_19_t_2012_11				
Action/Comments					
Inspector Comments: The pump control system was maintained to be free of corrosion or any damage.

View of the power control system.

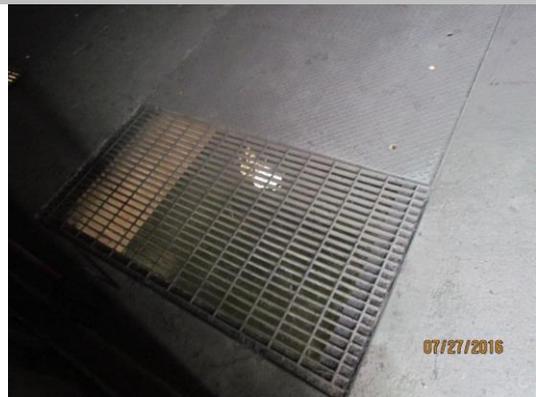
Photo 1 of 1 : ST\_2016\_NA0017\_19\_12\_20160808\_00035.jpg

LM Start	<b>0.00</b>	Rating **	A	Issue No.	<b>12</b>
LM End	<b>0.00</b>	Issue Type +	Ma	Location *	
Category	Pump Stations		GPS Latitude/Longitude		
			Start	End	
Item	Sumps/Wet Well		37.982317 °	37.982317 °	
			-121.249433 °	-121.249433 °	
DWR ID	DWR_NA0017_19_t_2012_12				
Action/Comments					
Inspector Comments: The wet well appeared to be clear of excessive debris or sediments.

View of the wet well.

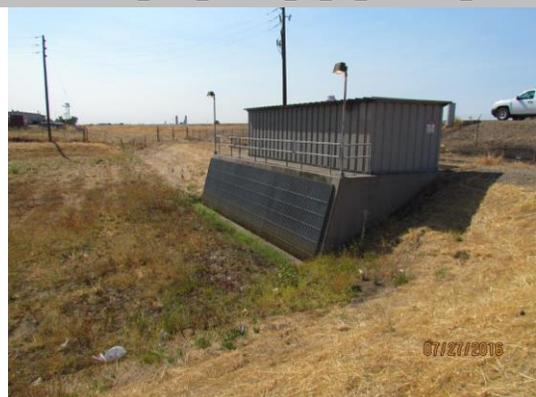
Photo 1 of 1 : ST\_2016\_NA0017\_19\_13\_20160808\_00036.jpg

LM Start	<b>0.00</b>	Rating **	A	Issue No.	<b>13</b>
LM End	<b>0.00</b>	Issue Type +	Ma	Location *	
Category	Pump Stations		GPS Latitude/Longitude		
			Start	End	
Item	Trash Racks		37.982317 °	37.982317 °	
			-121.249433 °	-121.249433 °	
DWR ID	DWR_NA0017_19_t_2012_13				
Action/Comments					
Inspector Comments: Trash racks were properly maintained and free of any debris.

View of the trash racks.

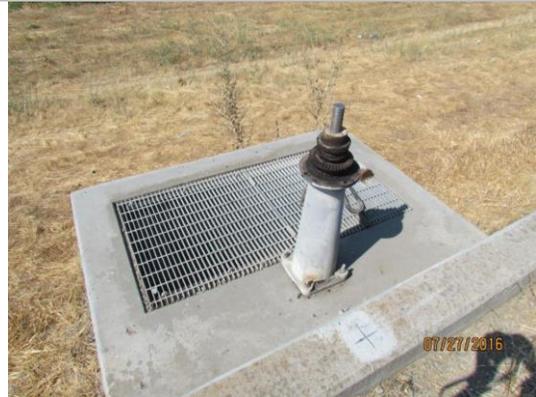
Photo 1 of 1 : ST\_2016\_NA0017\_19\_15\_20160808\_00037.jpg

LM Start	<b>0.00</b>	Rating **	A	Issue No.	<b>15</b>
LM End	<b>0.00</b>	Issue Type +	Ma	Location *	
Category	Pump Stations		GPS Latitude/Longitude		
			Start	End	
Item	Sluice / Slide Gates		37.982317 °	37.982317 °	
			-121.249433 °	-121.249433 °	
DWR ID	DWR_NA0017_19_t_2012_15				
Action/Comments					
Inspector Comments: The slide gate appeared to be operational.

View of the slide gate.

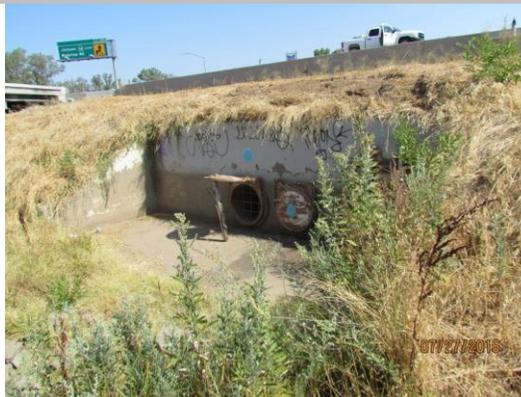
Photo 1 of 1 : ST\_2016\_NA0017\_19\_19\_20160808\_00038.jpg

LM Start	<b>0.00</b>	Rating **	A	Issue No.	<b>19</b>
LM End	<b>0.00</b>	Issue Type +	Ma	Location *	
Category	Pump Stations		GPS Latitude/Longitude		
			Start	End	
Item	Flap Gates		37.982317 °	37.982317 °	
			-121.249433 °	-121.249433 °	
DWR ID	DWR_NA0017_19_t_2012_19				
Action/Comments					
Inspector Comments: Flap gates were in good condition and showed no damage. There was a lot of vegetation growth around the outlet, but the gates operation was not affected. One of the gates was temporarily propped open and should be closed before flood season.

View of the flap gates for the pumping plant.

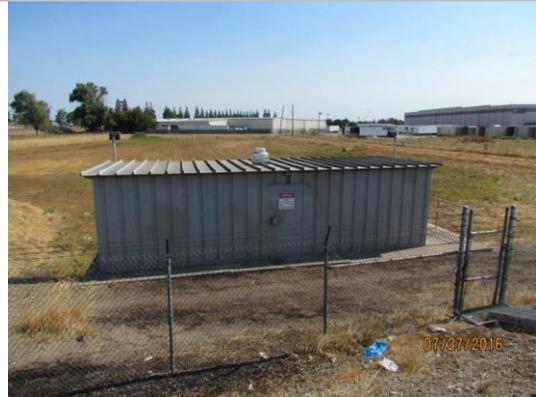
Photo 1 of 1 : ST\_2016\_NA0017\_19\_21\_20160808\_00039.jpg

LM Start	<b>0.00</b>	Rating **	A	Issue No.	<b>21</b>
LM End	<b>0.00</b>	Issue Type +	Ma	Location *	
Category	Pump Stations		GPS Latitude/Longitude		
			Start	End	
Item	Security Fencing		37.982317 °	37.982317 °	
			-121.249433 °	-121.249433 °	
DWR ID	DWR_NA0017_19_t_2012_21				
Action/Comments					
Inspector Comments: Security fencing was in good condition without any damage.

View of the security fencing.

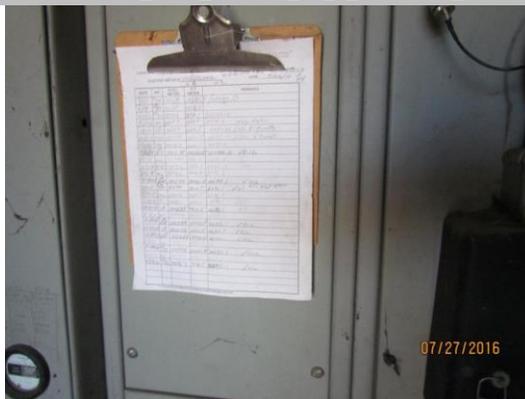
Photo 1 of 1 : ST\_2016\_NA0017\_20\_1\_20160808\_00019.jpg

LM Start	<b>0.00</b>	Rating **	A	Issue No.	<b>1</b>
LM End	<b>0.00</b>	Issue Type +	Ma	Location *	
Category	Pump Stations		GPS Latitude/Longitude		
			Start	End	
Item	Operating Log		37.973983 °	37.973983 °	
			-121.229967 °	-121.229967 °	
DWR ID	DWR_NA0017_20_t_2012_1				
Action/Comments					
Inspector Comments: Maintenance log was present at the pumping plant.

View of the operating log inside the plant.

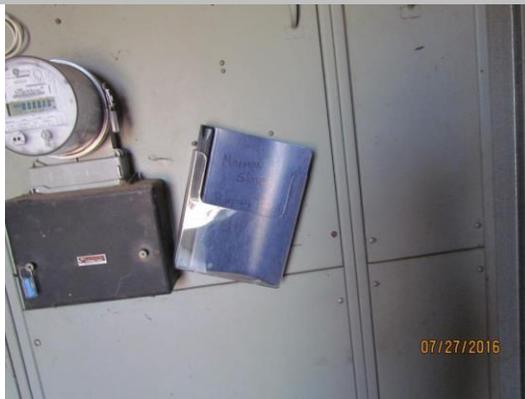
Photo 1 of 1 : ST\_2016\_NA0017\_20\_2\_20160808\_00020.jpg

LM Start	<b>0.00</b>	Rating **	A	Issue No.	<b>2</b>
LM End	<b>0.00</b>	Issue Type +	Ma	Location *	
Category	Pump Stations		GPS Latitude/Longitude		
			Start	End	
Item	Operation & Maintenance Manual		37.973983 °	37.973983 °	
			-121.229967 °	-121.229967 °	
DWR ID	DWR_NA0017_20_t_2012_2				
Action/Comments					
Inspector Comments: The O&M Manual was present at the pumping plant next to the operating log.

View of the O&M manual inside the pumping plant.

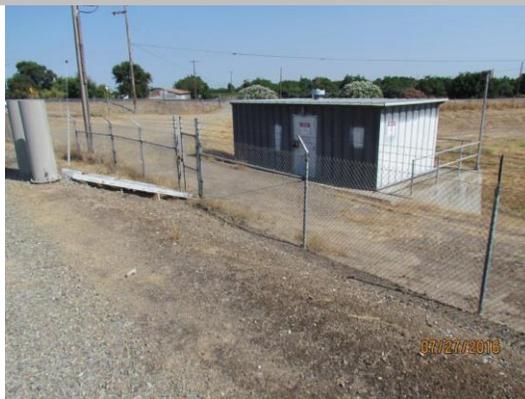
Photo 1 of 1 : ST\_2016\_NA0017\_20\_3\_20160808\_00021.jpg

LM Start	<b>0.00</b>	Rating **	A	Issue No.	<b>3</b>
LM End	<b>0.00</b>	Issue Type +	Ma	Location *	
Category	Pump Stations		GPS Latitude/Longitude		
			Start	End	
Item	Plant Building		37.973983 °	37.973983 °	
			-121.229967 °	-121.229967 °	
DWR ID	DWR_NA0017_20_t_2012_3				
Action/Comments					
Inspector Comments: The plant building appeared to be in good structural condition.

View of the pumping plant.

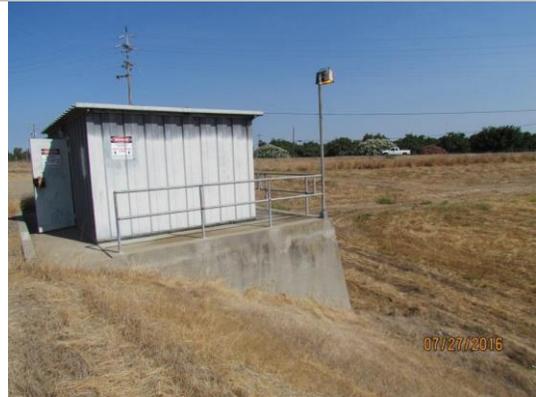
Photo 1 of 1 : ST\_2016\_NA0017\_20\_5\_20160808\_00022.jpg

LM Start	<b>0.00</b>	Rating **	A	Issue No.	<b>5</b>
LM End	<b>0.00</b>	Issue Type +	Ma	Location *	
Category	Pump Stations		GPS Latitude/Longitude		
			Start	End	
Item	Safety		37.973983 °	37.973983 °	
			-121.229967 °	-121.229967 °	
DWR ID	DWR_NA0017_20_t_2012_5				
Action/Comments					
Inspector Comments: No safety hazard was found around the pumping plant and guard rails around the plant were in a good condition.

View of the guard rails around the pumping plant.

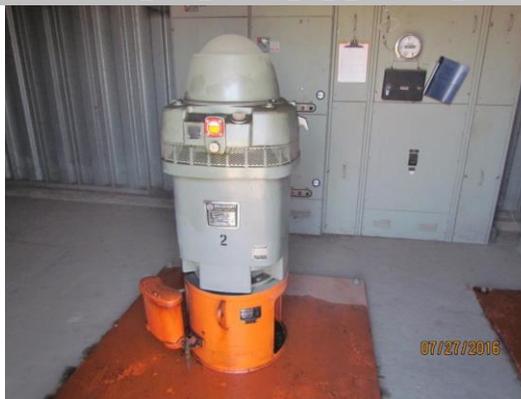
Photo 1 of 3 : ST\_2016\_NA0017\_20\_7\_20160808\_00023.jpg

LM Start	<b>0.00</b>	Rating **	A	Issue No.	<b>7</b>
LM End	<b>0.00</b>	Issue Type +	Ma	Location *	
Category	Pump Stations			GPS Latitude/Longitude	
				Start	End
Item	Pumps			37.973983 °	37.973983 °
				-121.229967 °	-121.229967 °
DWR ID	DWR_NA0017_20_t_2012_7				
Action/Comments					
Inspector Comments: All pumps appeared to be in good condition and maintained properly.

View of one of the pumps inside the pumping plants.

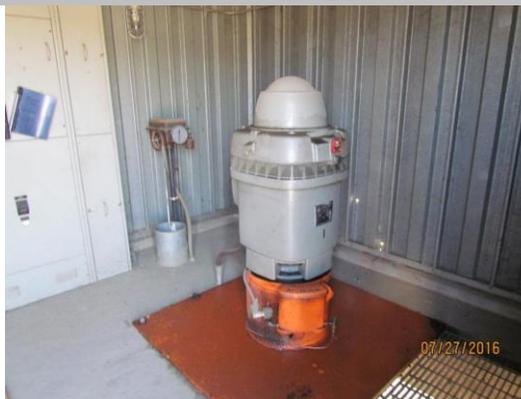
Photo 2 of 3 : ST\_2016\_NA0017\_20\_7\_20160808\_00024.jpg

View of another pump inside the plant.

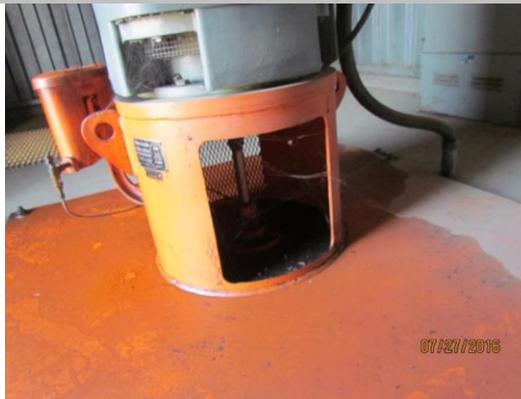
Photo 3 of 3 : ST\_2016\_NA0017\_20\_7\_20160808\_00025.jpg

View of bottom shaft of one of the pumps inside the plant.

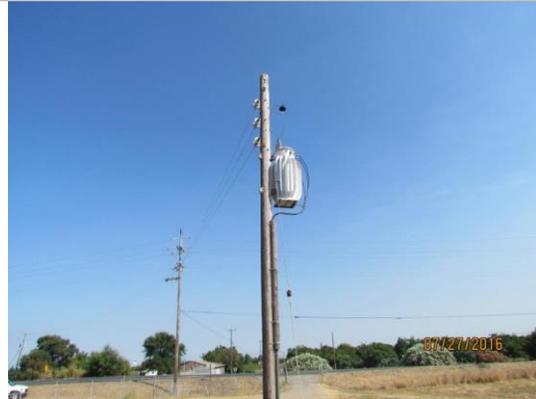
Photo 1 of 1 : ST\_2016\_NA0017\_20\_8\_20160808\_00026.jpg

LM Start	<b>0.00</b>	Rating **	A	Issue No.	<b>8</b>
LM End	<b>0.00</b>	Issue Type +	Ma	Location *	
Category	Pump Stations		GPS Latitude/Longitude		
			Start	End	
Item	Power		37.973983 °	37.973983 °	
			-121.229967 °	-121.229967 °	
DWR ID	DWR_NA0017_20_t_2012_8				
Action/Comments					
Inspector Comments: The power source appeared to be safe and reliable.

View of the power source for the pumping plant.

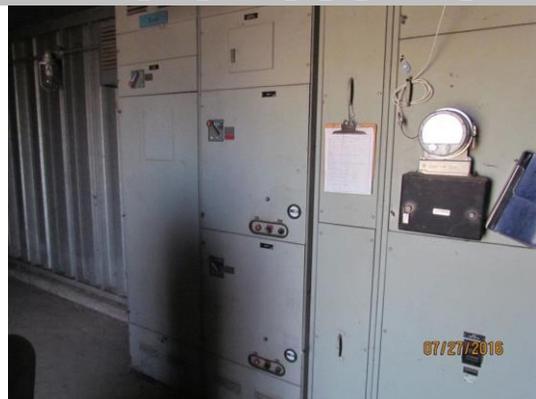
Photo 1 of 1 : ST\_2016\_NA0017\_20\_11\_20160808\_00027.jpg

LM Start	<b>0.00</b>	Rating **	A	Issue No.	<b>11</b>
LM End	<b>0.00</b>	Issue Type +	Ma	Location *	
Category	Pump Stations		GPS Latitude/Longitude		
			Start	End	
Item	Pump Control Systems		37.973983 °	37.973983 °	
			-121.229967 °	-121.229967 °	
DWR ID	DWR_NA0017_20_t_2012_11				
Action/Comments					
Inspector Comments: The pump control system appeared to be operational and free of damage.

View of the power control systems inside the plant.

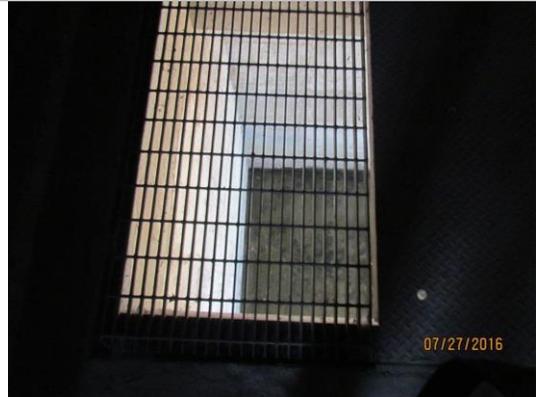
Photo 1 of 1 : ST\_2016\_NA0017\_20\_12\_20160808\_00028.jpg

LM Start	<b>0.00</b>	Rating **	A	Issue No.	<b>12</b>
LM End	<b>0.00</b>	Issue Type +	Ma	Location *	
Category	Pump Stations		GPS Latitude/Longitude		
			Start	End	
Item	Sumps/Wet Well		37.973983 °	37.973983 °	
			-121.229967 °	-121.229967 °	
DWR ID	DWR_NA0017_20_t_2012_12				
Action/Comments					
Inspector Comments: Wet well was clear of any excessive debris.

View of wet well.

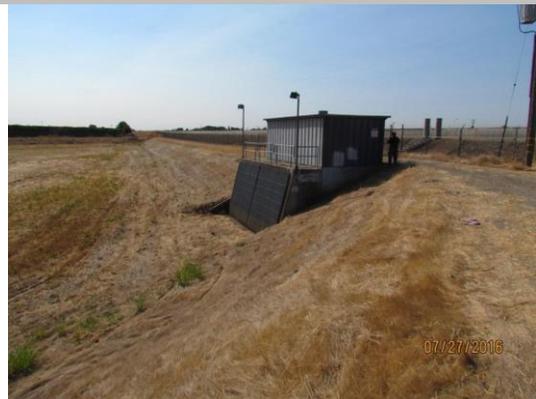
Photo 1 of 1 : ST\_2016\_NA0017\_20\_13\_20160808\_00029.jpg

LM Start	<b>0.00</b>	Rating **	A	Issue No.	<b>13</b>
LM End	<b>0.00</b>	Issue Type +	Ma	Location *	
Category	Pump Stations		GPS Latitude/Longitude		
			Start	End	
Item	Trash Racks		37.973983 °	37.973983 °	
			-121.229967 °	-121.229967 °	
DWR ID	DWR_NA0017_20_t_2012_13				
Action/Comments					
Inspector Comments: The trash racks were free of any debris.

View of the trash racks.

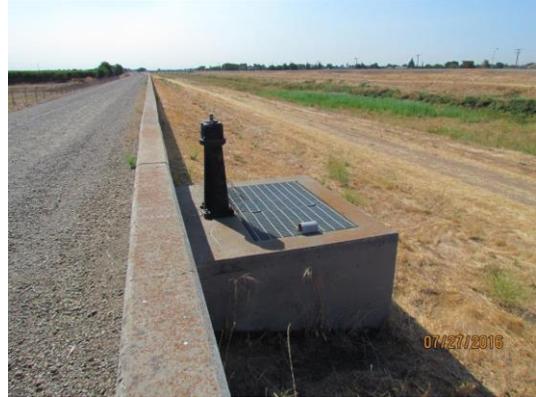
Photo 1 of 1 : ST\_2016\_NA0017\_20\_15\_20160808\_00030.jpg

LM Start	<b>0.00</b>	Rating **	A	Issue No.	<b>15</b>
LM End	<b>0.00</b>	Issue Type +	Ma	Location *	
Category	Pump Stations		GPS Latitude/Longitude		
			Start	End	
Item	Sluice / Slide Gates		37.973983 °	37.973983 °	
			-121.229967 °	-121.229967 °	
DWR ID	DWR_NA0017_20_t_2012_15				
Action/Comments					
Inspector Comments: Slide gates appeared to be free of sediment and obstructions.

View of the slide gate.

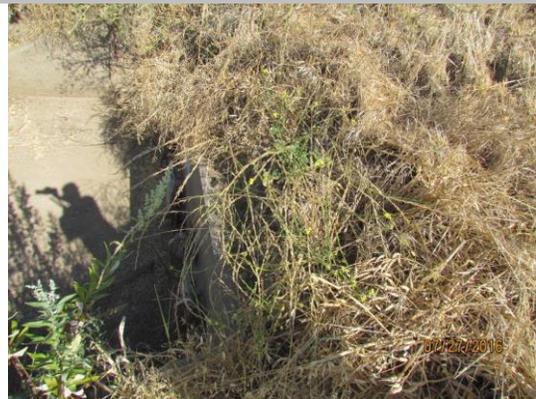
Photo 1 of 1 : ST\_2016\_NA0017\_20\_19\_20160808\_00031.jpg

LM Start	<b>0.00</b>	Rating **	A	Issue No.	<b>19</b>
LM End	<b>0.00</b>	Issue Type +	Ma	Location *	
Category	Pump Stations		GPS Latitude/Longitude		
			Start	End	
Item	Flap Gates		37.973983 °	37.973983 °	
			-121.229967 °	-121.229967 °	
DWR ID	DWR_NA0017_20_t_2012_19				
Action/Comments					
Inspector Comments: Flap gates appeared to be in good condition. There was a lot of vegetation around the headwall, but gate operation was not affected.

View of the flap gates.

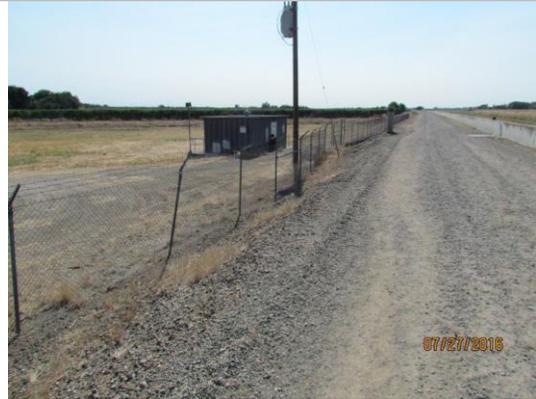
Photo 1 of 1 : ST\_2016\_NA0017\_20\_21\_20160808\_00032.jpg

LM Start	<b>0.00</b>	Rating **	A	Issue No.	<b>21</b>
LM End	<b>0.00</b>	Issue Type +	Ma	Location *	
Category	Pump Stations			GPS Latitude/Longitude	
				Start	End
Item	Security Fencing			37.973983 °	37.973983 °
				-121.229967 °	-121.229967 °
DWR ID	DWR_NA0017_20_t_2012_21				
Action/Comments					
Inspector Comments: Security fencing was undamaged and prevented unauthorized access.

View of the security fencing.
