**Flood Control Project Maintenance
Levee Inspections**

Fall 2015 Levee Maintenance Deficiency Summary Report

Tehama County Flood Control and Water Conservation District

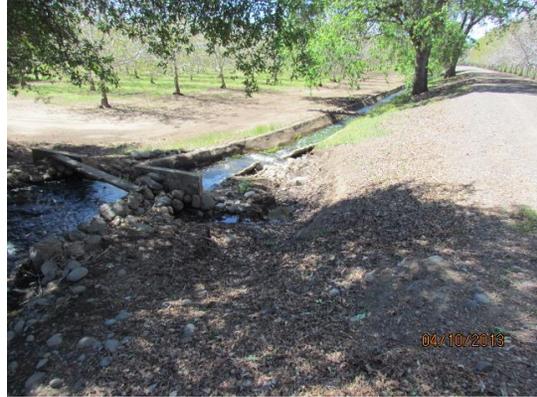
Photo 1 of 1 : FA_2015_NA0019_78_17_20150910_00009.jpg

LM Start	0.01	Rating **	M	Issue No.	17
LM End	0.01	Issue Type +	Ma	Location *	LS
Category	Earthen Levee			GPS Latitude/Longitude	
				Start	End
Item	Erosion / Bank Caving			39.973111 °	39.973111 °
				-121.980466 °	-121.980466 °
DWR ID	DWR_NA0019_01_s_2013_17				
Action/Comments					
Note and monitor erosion site.

View of the erosion along the landside slope.

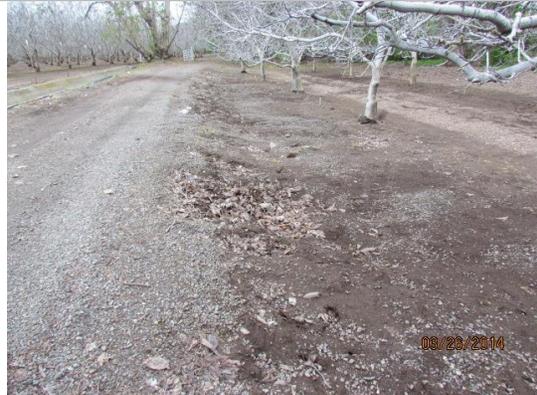
Photo 1 of 1 : FA_2015_NA0019_78_276_20150910_00017.jpg

LM Start	0.45	Rating **	M	Issue No.	276
LM End	0.45	Issue Type +	Ma	Location *	WS
Category	Earthen Levee			GPS Latitude/Longitude	
				Start	End
Item	Slope Stability			39.972377 °	39.972377 °
				-121.988559 °	-121.988559 °
DWR ID	DWR_NA0019_01_s_2014_276				
Action/Comments					
Repair slope instability.

View of the erosion along the waterside slope.

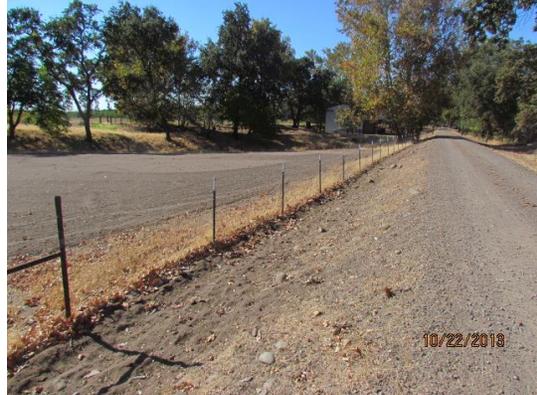
Photo 1 of 1 : FA_2015_NA0019_78_21_20150910_00013.jpg

LM Start	1.52	Rating **	M	Issue No.	21
LM End	1.52	Issue Type +	Ma	Location *	LS
Category	Earthen Levee		GPS Latitude/Longitude		
			Start	End	
Item	Animal Control		39.969419 °	39.969419 °	
			-122.007850 °	-122.007850 °	
DWR ID	DWR_NA0019_01_f_2013_21				
Action/Comments					
Repair the levee slope damaged by livestock and prevent large animal access.

View of the erosion caused by livestock on both slope of the levee.

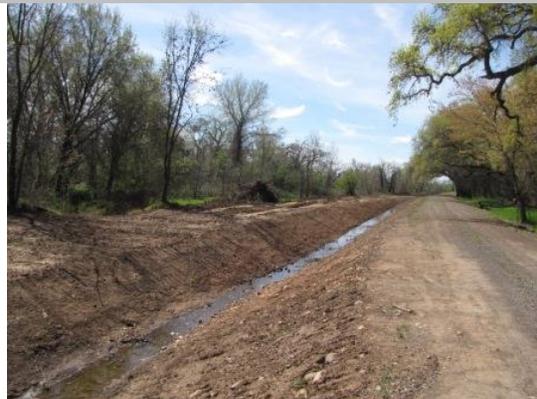
Photo 1 of 1 : FA_2015_NA0019_78_2_20150910_00001.jpg

LM Start	2.03	Rating **	M	Issue No.	2
LM End	2.21	Issue Type +	En	Location *	LS
Category	Earthen Levee			GPS Latitude/Longitude	
				Start	End
Item	Encroachments			39.968387 °	39.966968 °
				-122.016387 °	-122.019372 °
DWR ID	DWR_NA0019_01_s_2012_2				
Action/Comments					
Ditch

Remove agricultural ditch from toe of levee.

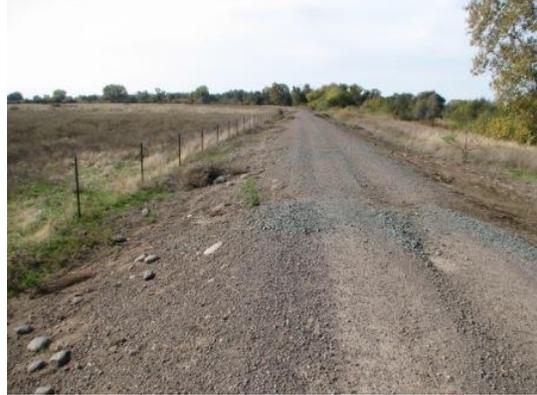
Photo 1 of 1 : FA_2015_NA0019_78_8_20150910_00003.jpg

LM Start	2.70	Rating **	M	Issue No.	8
LM End	2.73	Issue Type +	Ma	Location *	CR
Category	Earthen Levee		GPS Latitude/Longitude		
			Start	End	
Item	Slope Stability		39.965434 °	39.965180 °	
			-122.027776 °	-122.028331 °	
DWR ID	DWR_NA0019_01_s_2012_8				
Action/Comments					
Repair the levee slope damaged by foot traffic and prevent access where possible.

Erosion on crown and both slopes.

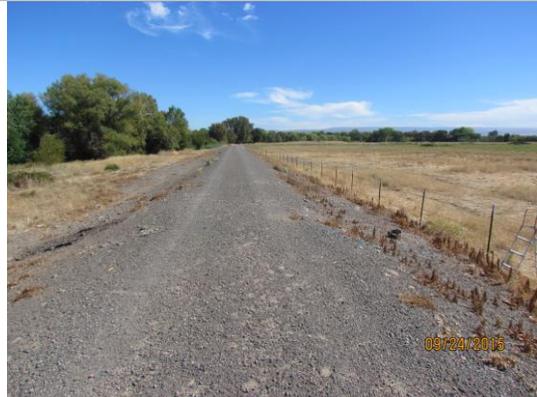
Photo 1 of 1 : FA_2015_NA0019_78_40_20151012_00029.jpg

LM Start	2.71	Rating **	A	Issue No.	40
LM End	2.71	Issue Type +	Ma	Location *	LS
Category	Earthen Levee		GPS Latitude/Longitude		
			Start	End	
Item	Vegetation		39.965367 °	39.965367 °	
			-122.027955 °	-122.027955 °	
DWR ID	DWR_NA0019_01_f_2015_40				
Action/Comments					
Control annual grass and weeds on the levee slopes and easements. Inspector Comments: Tehama Co. sprayed both slopes to remove all vegetation.

View of the no vegetation on both slopes.

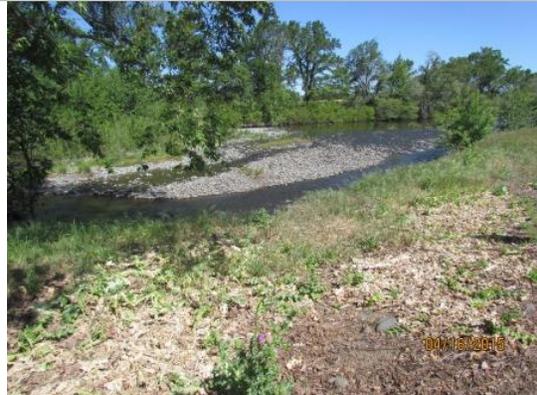
Photo 1 of 1 : FA_2015_NA0019_78_39_20150910_00015.jpg

LM Start	2.78	Rating **	M	Issue No.	39
LM End	2.78	Issue Type +	Ma	Location *	WS
Category	Earthen Levee		GPS Latitude/Longitude		
			Start	End	
Item	Erosion / Bank Caving		39.964772 °	39.964772 °	
			-122.029023 °	-122.029023 °	
DWR ID	DWR_NA0019_01_s_2015_39				
Action/Comments					
Note and monitor erosion site. Inspector Comments: Monitor the erosion during high water.

View of the erosion along the waterside toe.

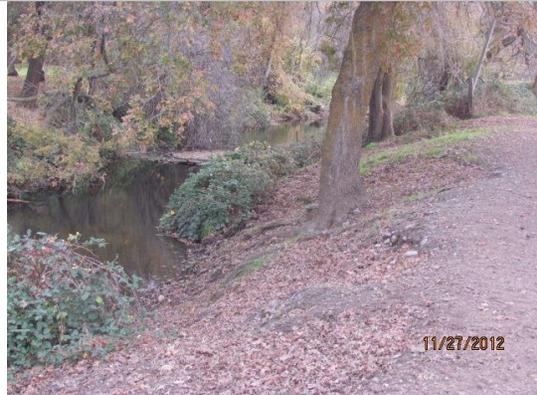
Photo 1 of 1 : FA_2015_NA0019_78_15_20150910_00007.jpg

LM Start	3.68	Rating **	M	Issue No.	15
LM End	3.68	Issue Type +	Ma	Location *	WS
Category	Earthen Levee			GPS Latitude/Longitude	
				Start	End
Item	Slope Stability			39.945045 °	39.945045 °
				-122.053469 °	-122.053469 °
DWR ID	DWR_NA0019_01_f_2012_15				
Action/Comments					
Repair slope instability.

View of the erosion caused by livestock along the landside slope.

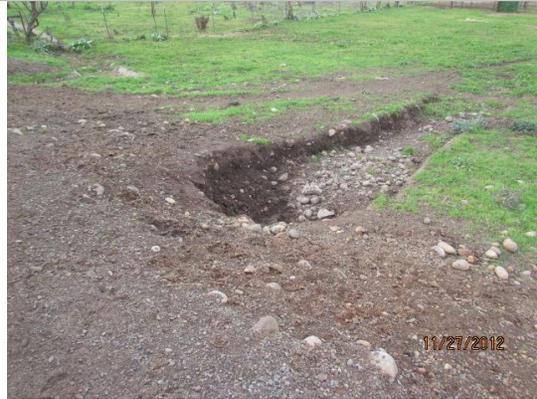
Photo 1 of 1 : FA_2015_NA0019_78_16_20150910_00008.jpg

LM Start	3.74	Rating **	M	Issue No.	16
LM End	3.74	Issue Type +	En	Location *	LS
Category	Earthen Levee			GPS Latitude/Longitude	
				Start	End
Item	Encroachments			39.944456 °	39.944456 °
				-122.053932 °	-122.053932 °
DWR ID	DWR_NA0019_01_f_2012_16				
Action/Comments					
Ditch

View of the ditch along the waterside toe.

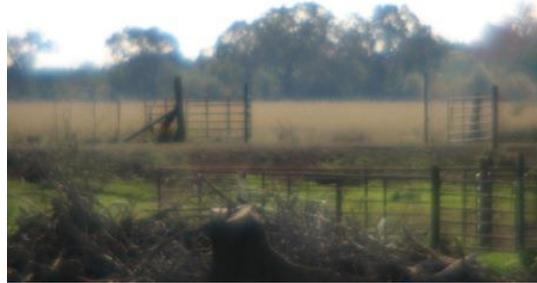
Photo 1 of 1 : FA_2015_NA0019_78_10_20150910_00005.jpg

LM Start	3.75	Rating **	M	Issue No.	10
LM End	3.75	Issue Type +	En	Location *	CR
Category	Earthen Levee			GPS Latitude/Longitude	
				Start	End
Item	Encroachments			39.944432 °	39.944432 °
				-122.054029 °	-122.054029 °
DWR ID	DWR_NA0019_01_s_2012_10				
Action/Comments					
Fence

View of the non-permitted gate on the crown roadway.

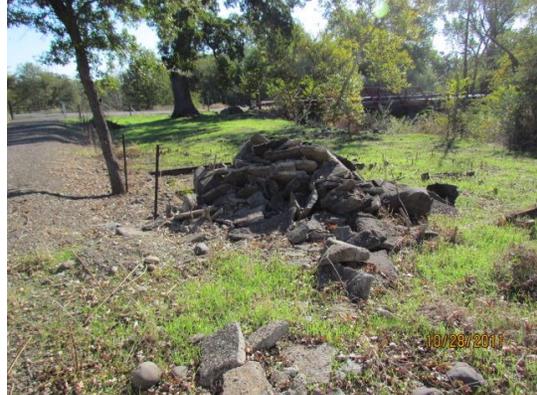
Photo 1 of 1 : FA_2015_NA0019_79_4_20150910_00003.jpg

LM Start	0.34	Rating **	M	Issue No.	4
LM End	0.34	Issue Type +	Ma	Location *	WS
Category	Earthen Levee		GPS Latitude/Longitude		
			Start	End	
Item	Encroachments		39.970210 °	39.970210 °	
			-122.015198 °	-122.015198 °	
DWR ID	DWR_NA0019_02_s_2012_4				
Action/Comments					
Debris

View of the concrete pile along the W/S toe.

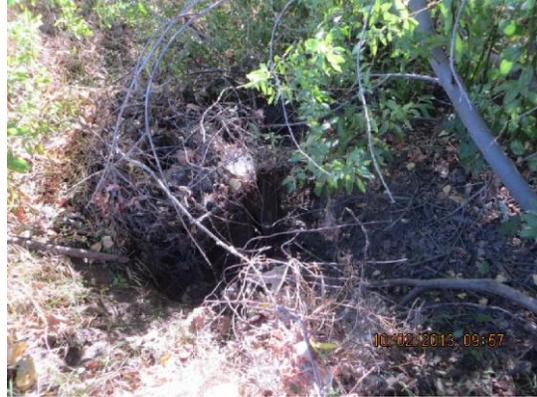
Photo 1 of 3 : UCIP_FA_2015_0731.jpg

LM Start	0.68	Rating **	U	Issue No.	14 (cont)
LM End	0.68	Issue Type +	En	Location *	LS

Outlet on WS toe.

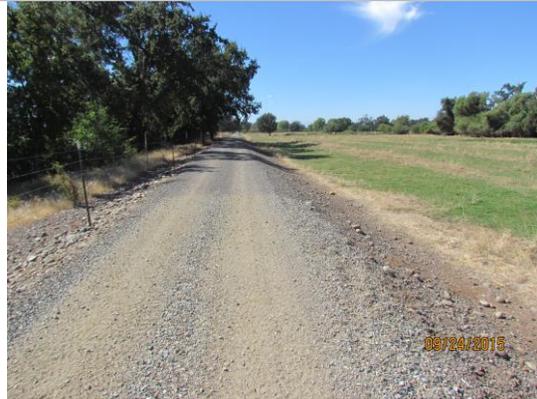
Photo 1 of 1 : FA_2015_NA0019_79_11_20151012_00007.jpg

LM Start	0.85	Rating **	A	Issue No.	11
LM End	0.85	Issue Type +	Ma	Location *	LS
Category	Earthen Levee			GPS Latitude/Longitude	
				Start	End
Item	Vegetation			39.968290 °	39.968290 °
				-122.023860 °	-122.023860 °
DWR ID	DWR_NA0019_02_f_2015_11				
Action/Comments					
Control annual grass and weeds on the levee slopes and easements. Inspector Comments: Tehama Co. sprayed both slopes to remove the vegetation.

View of no Vegetation on both slopes.

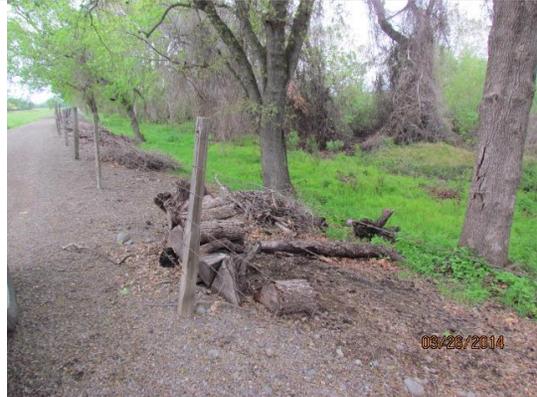
Photo 1 of 1 : FA_2015_NA0019_79_6_20150910_00004.jpg

LM Start	1.28	Rating **	M	Issue No.	6
LM End	1.28	Issue Type +	Ma	Location *	WS
Category	Earthen Levee		GPS Latitude/Longitude		
			Start	End	
Item	Encroachments		39.964883 °	39.964883 °	
			-122.030655 °	-122.030655 °	
DWR ID	DWR_NA0019_02_s_2012_6				
Action/Comments					
Firewood

Remove all firewood from the waterside slope.

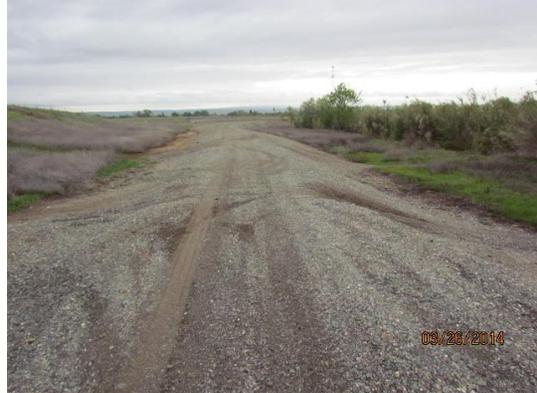
Photo 1 of 1 : FA_2015_NA0019_81_3_20150910_00003.jpg

LM Start	1.59	Rating **	M	Issue No.	3
LM End	1.69	Issue Type +	Ma	Location *	WS
Category	Earthen Levee		GPS Latitude/Longitude		
			Start	End	
Item	Slope Stability		40.052607 °	40.053558 °	
			-122.161418 °	-122.159903 °	
DWR ID	DWR_04_s_2012_3				
Action/Comments					
Repair the levee slope damaged by vehicle traffic and prevent access where possible. Inspector Comments: Tehama Co. repaired the slope that was damaged by vehicle traffic, but the damage has returned.

View of the levee slope damaged by vehicle traffic.

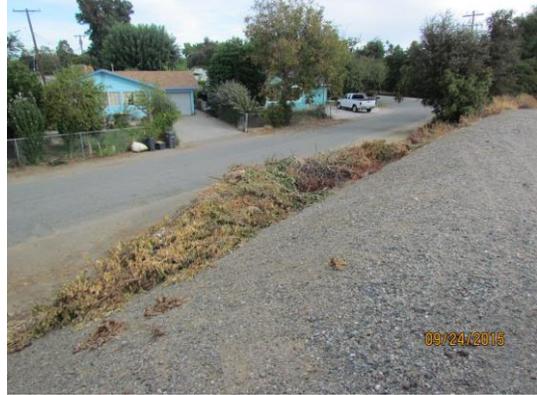
Photo 2 of 2 : FA_2015_NA0019_81_15_20151012_00021.jpg

LM Start	2.63	Rating **	M	Issue No.	15 (cont)
LM End	2.63	Issue Type +	En	Location *	LS
Category	Earthen Levee			GPS Latitude/Longitude	
				Start	End
Item	Encroachments			40.054337 °	40.054337 °
				-122.144235 °	-122.144235 °
DWR ID	DWR_NA0019_04_s_2015_15				
Action/Comments					
Prunings Inspector Comments: Remove the prunings from the landside toe.

View of the prunings along the landside toe.

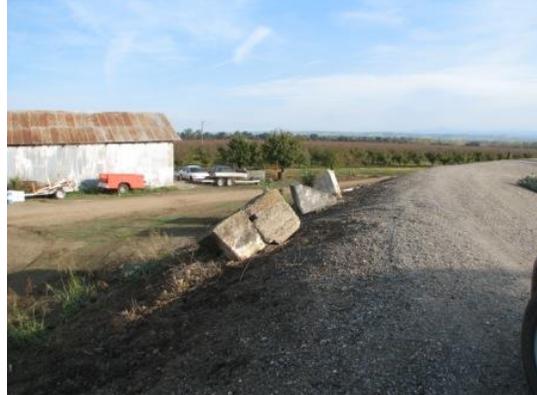
Photo 1 of 1 : FA_2015_NA0019_81_1_20150910_00001.jpg

LM Start	3.13	Rating **	M	Issue No.	1
LM End	3.13	Issue Type +	Ma	Location *	LS
Category	Earthen Levee		GPS Latitude/Longitude		
			Start	End	
Item	Encroachments		40.057285 °	40.057285 °	
			-122.137732 °	-122.137732 °	
DWR ID	DWR_NA0019_04_s_2012_1				
Action/Comments					
Stairway Inspector Comments: Remove the stairs from the landside slope.

View of the concrete stairways on the slope.

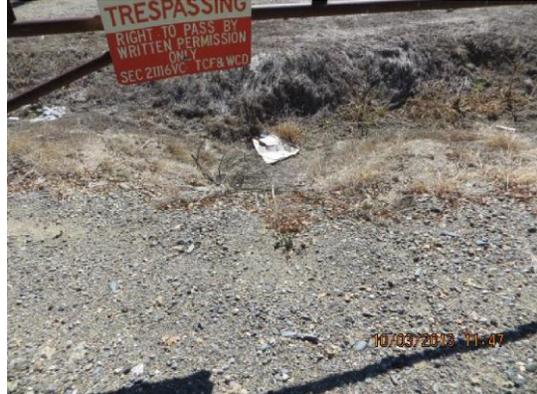
Photo 2 of 3 : UCIP_FA_2015_2426.jpg

LM Start	0.50	Rating **	M	Issue No.	17 (cont)
LM End	0.50	Issue Type +	En	Location *	LS

Inlet at LS toe.

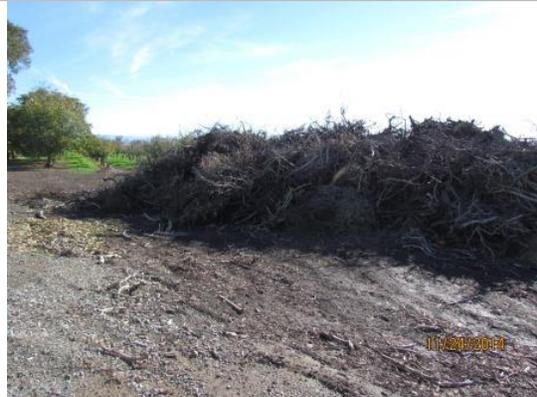
Photo 1 of 2 : FA_2015_NA0019_82_16_20150910_00005.jpg

LM Start	0.80	Rating **	M	Issue No.	16
LM End	0.80	Issue Type +	En	Location *	LS
Category	Earthen Levee			GPS Latitude/Longitude	
				Start	End
Item	Encroachments			40.050688 °	40.050688 °
				-122.177458 °	-122.177458 °
DWR ID	DWR_NA0019_05_f_2014_16				
Action/Comments					
Prunings Inspector Comments: Remove the chip prunings from the landside toe.

View of the prunings along the landside slope.

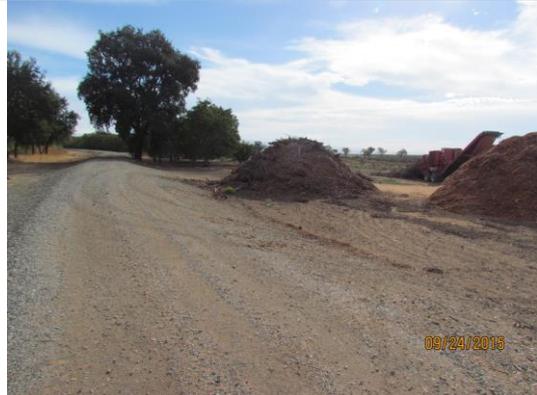
Photo 2 of 2 : FA_2015_NA0019_82_16_20151012_00009.jpg

LM Start	0.80	Rating **	M	Issue No.	16 (cont)
LM End	0.80	Issue Type +	En	Location *	LS

View of the Chip prunings along the landside toe.

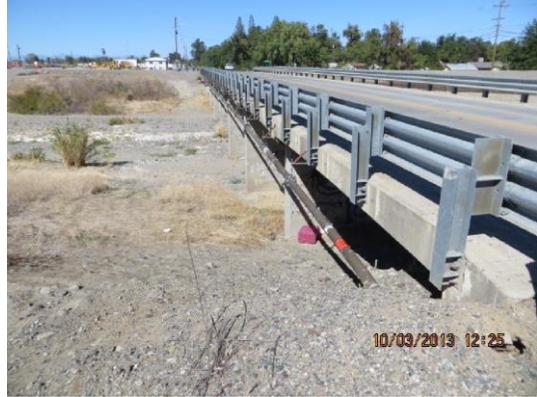
Photo 1 of 3 : UCIP_FA_2015_2058.jpg

LM Start	2.47	Rating **	M	Issue No.	19
LM End	2.47	Issue Type +	En	Location *	WS
Category	Supplemental			GPS Latitude/Longitude	
				Start	End
Item	DWR UCIP Field Study			40.051667 °	40.051667 °
				-122.149033 °	-122.149033 °
DWR ID					
Action/Comments					
Inspector Comments: FS_ID:23044 DS_ID:24693 EP_NO: N/A FS_HLM: 2.527 Repair Type: Non-Urgent Crossing Status: Found

Gasline on upstream side of bridge.

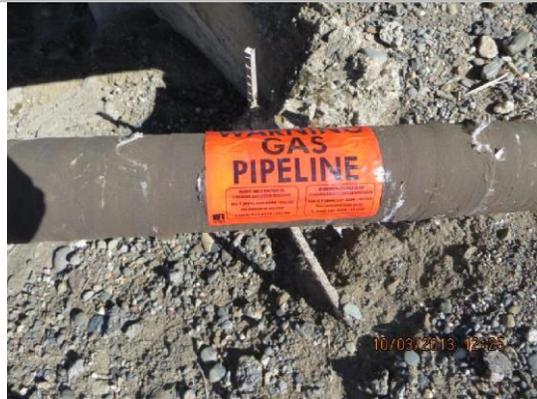
Photo 2 of 3 : UCIP_FA_2015_2059.jpg

Gasline on upstream side of bridge.

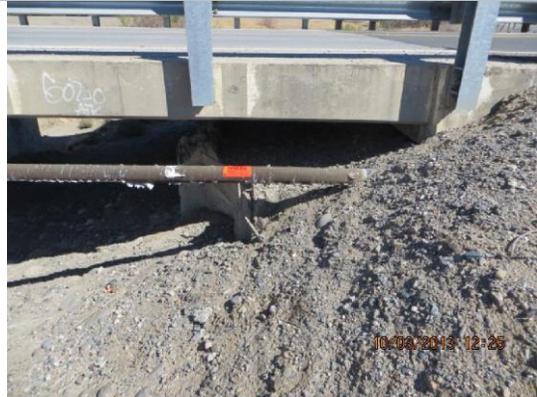
Photo 3 of 3 : UCIP_FA_2015_2060.jpg

Gasline on upstream side of bridge.

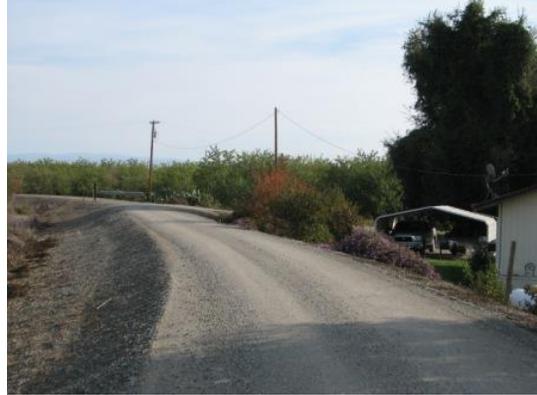
Photo 1 of 1 : FA_2015_NA0019_82_2_20150910_00001.jpg

LM Start	2.65	Rating **	M	Issue No.	2
LM End	2.70	Issue Type +	En	Location *	LS
Category	Earthen Levee			GPS Latitude/Longitude	
				Start	End
Item	Vegetation			40.051778 °	40.052243 °
				-122.145745 °	-122.144825 °
DWR ID	DWR_NA0019_05_s_2012_2				
Action/Comments					
Landscaping

View of the landscaping along the slope.
