**Flood Control Project Maintenance
Levee Inspections**

Fall 2011 Levee Maintenance Deficiency Summary Report

Yolo County Service Area 6

Waterway		Bank	Unit Miles
Unit No. 01 Right Bank of Sacramento River at Knights Landing		Right	5.97

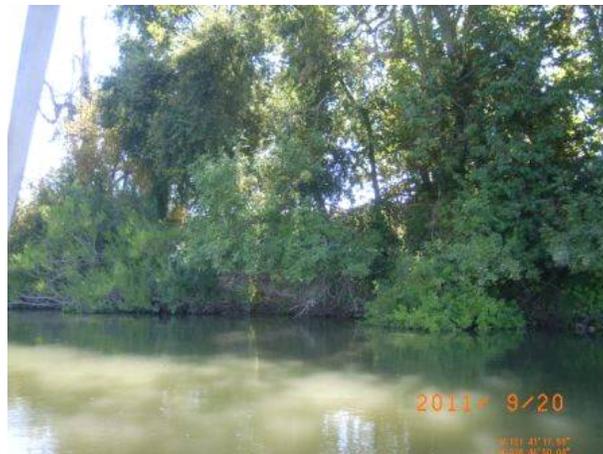
Levee Mile Report Line	31
Start Levee Mile	3.10
End Levee Mile	3.24
Location	Water Side
Category	Supplemental
Item	USACE Erosion Survey
USACE 2011 Photo #1	
USACE2011_SAC_86-9_R_1.jpg

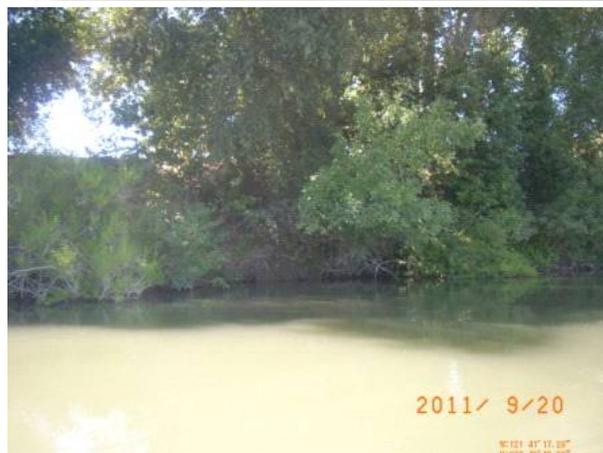
Levee Mile Report Line	31
Start Levee Mile	3.10
End Levee Mile	3.24
Location	Water Side
Category	Supplemental
Item	USACE Erosion Survey
USACE 2011 Photo #2	
USACE2011_SAC_86-9_R_2.jpg

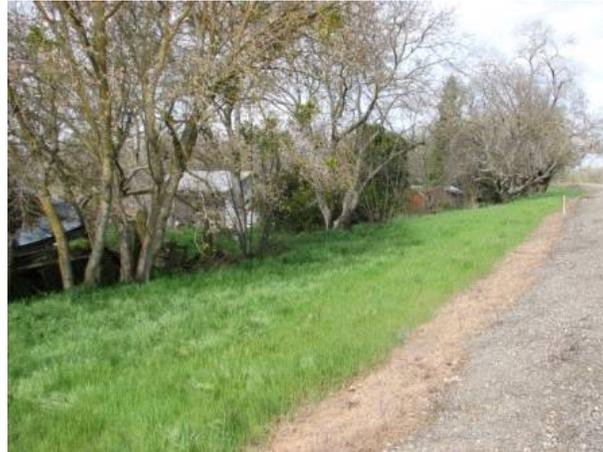
Levee Mile Report Line	32
Start Levee Mile	3.12
End Levee Mile	3.19
Location	Land Side
Category	Earthen Levee
Item	Encroachments
The buildings are encroaching into the levee slope.	
johngw_f_20110923_917.jpg

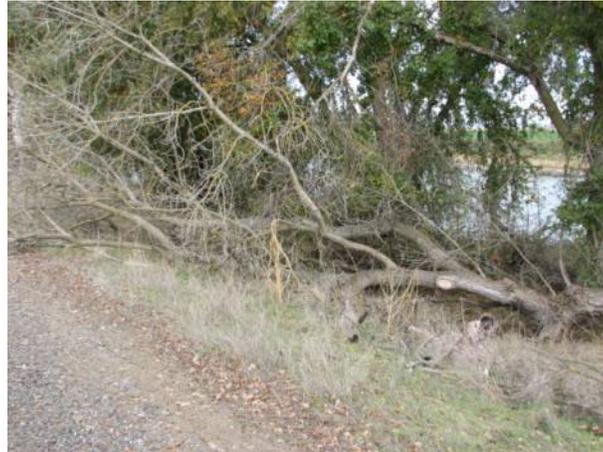
Levee Mile Report Line	35
Start Levee Mile	3.31
End Levee Mile	3.31
Location	Water Side
Category	Earthen Levee
Item	Trim / Thin Trees
A cottonwood tree has fallen over against the slope. Fall 2011	
johngw_f_20111118_574.jpg

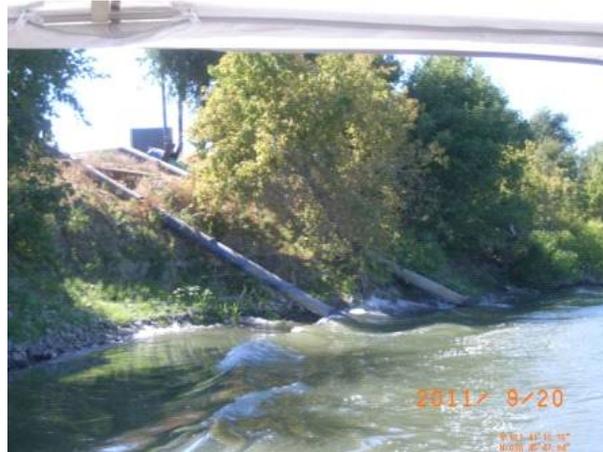
Levee Mile Report Line	37
Start Levee Mile	4.65
End Levee Mile	4.86
Location	Water Side
Category	Supplemental
Item	USACE Erosion Survey
USACE 2011 Photo #1	
USACE2011_SAC_85-4_R_1.jpg

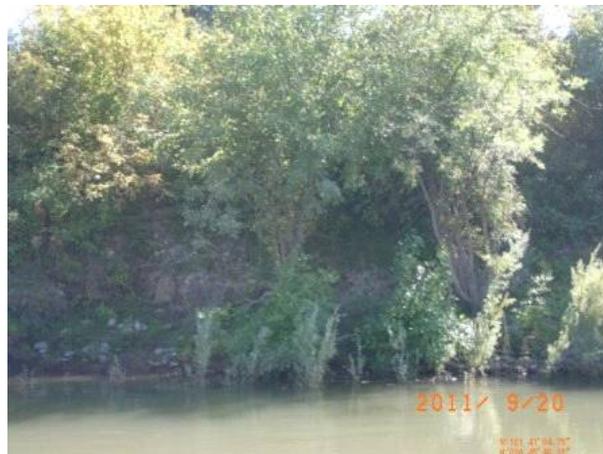
Levee Mile Report Line	37
Start Levee Mile	4.65
End Levee Mile	4.86
Location	Water Side
Category	Supplemental
Item	USACE Erosion Survey
USACE 2011 Photo #2	
USACE2011_SAC_85-4_R_2.jpg

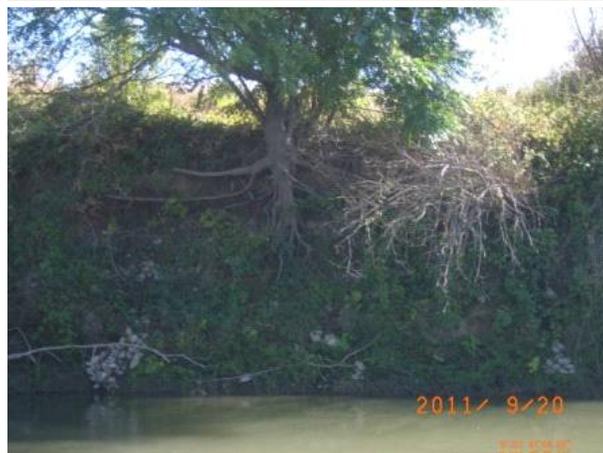
Levee Mile Report Line	37
Start Levee Mile	4.65
End Levee Mile	4.86
Location	Water Side
Category	Supplemental
Item	USACE Erosion Survey
USACE 2011 Photo #3	
USACE2011_SAC_85-4_R_3.jpg

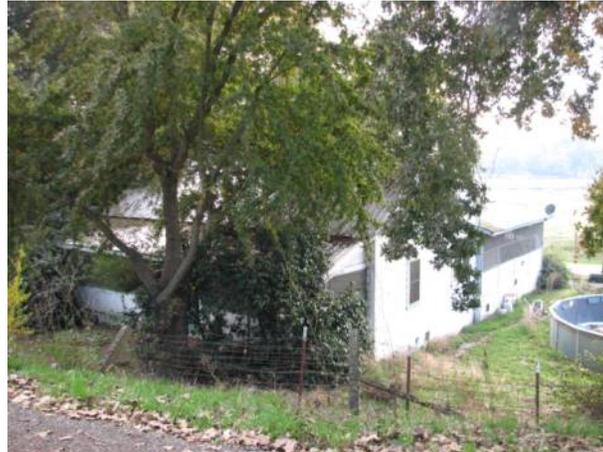
Levee Mile Report Line	39
Start Levee Mile	5.60
End Levee Mile	5.65
Location	Land Side
Category	Earthen Levee
Item	Encroachments
The house and landscape are in the easment of the levee. Fall 2011	
johngw_f_20111118_577.jpg

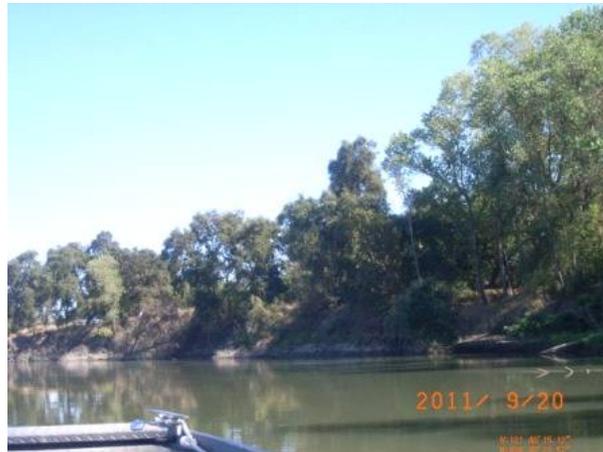
Levee Mile Report Line	40
Start Levee Mile	5.76
End Levee Mile	5.86
Location	Water Side
Category	Supplemental
Item	USACE Erosion Survey
USACE 2011 Photo #1	
USACE2011_SAC_83-9_R_1.jpg

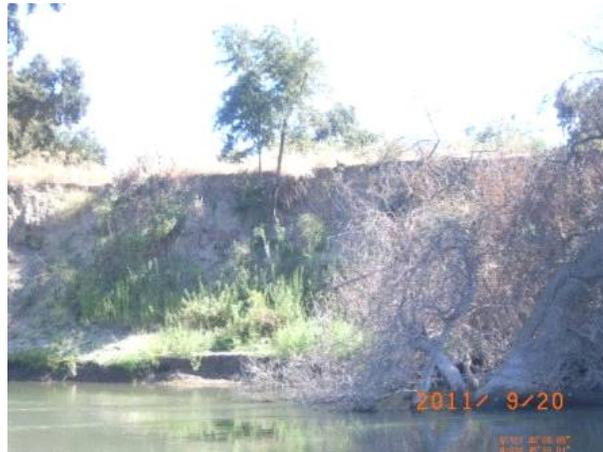
Levee Mile Report Line	40
Start Levee Mile	5.76
End Levee Mile	5.86
Location	Water Side
Category	Supplemental
Item	USACE Erosion Survey
USACE 2011 Photo #2	
USACE2011_SAC_83-9_R_2.jpg

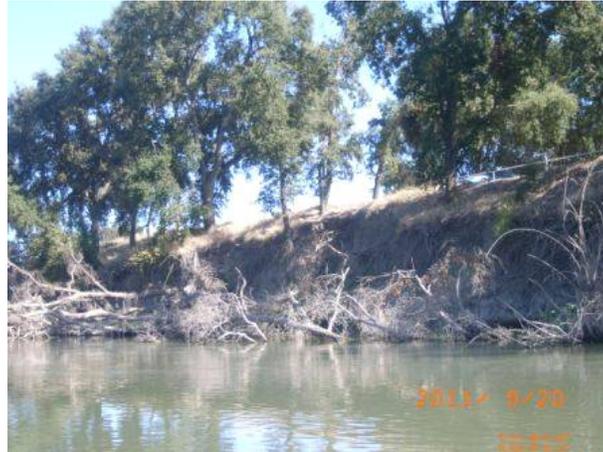
Levee Mile Report Line	40
Start Levee Mile	5.76
End Levee Mile	5.86
Location	Water Side
Category	Supplemental
Item	USACE Erosion Survey
USACE 2011 Photo #3	
USACE2011_SAC_83-9_R_3.jpg
