**Flood Control Project Maintenance
Levee Inspections**

Maintenance Issue Types Only, Levee Inspection Report By Mile - Spring 2016

Yolo County Service Area 6

Waterway	Bank	Unit Miles	Inspection Start/End	Inspector
Unit No. 01 Right Bank of Sacramento River at Knights Landing	Right	5.87	04/12/2016 04/12/2016	Jai Lor

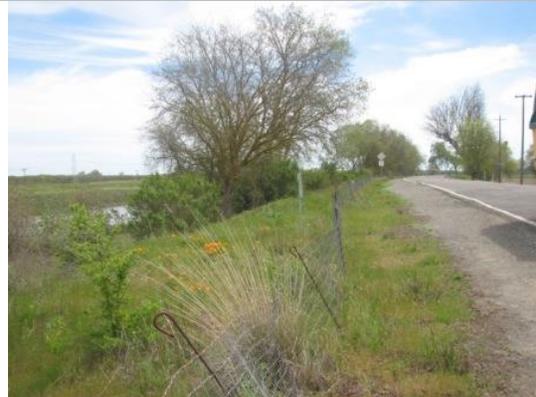
Photo 1 of 2 : SP_2016_NA0022_350_36_20160304_00032.jpg

LM Start	4.25	Rating **	A/W	Issue No.	36
LM End	4.49	Issue Type +	Ma	Location *	WS
Category	Earthen Levee			GPS Latitude/Longitude	
				Start	End
Item	Vegetation			38.767125 °	38.764582 °
				-121.693267 °	-121.690285 °
DWR ID	DWR_NA0022_01_s_2012_36				
Comment Code					
V8 : Environmental Requirements.					
Inspector Comment

Another view of the site.

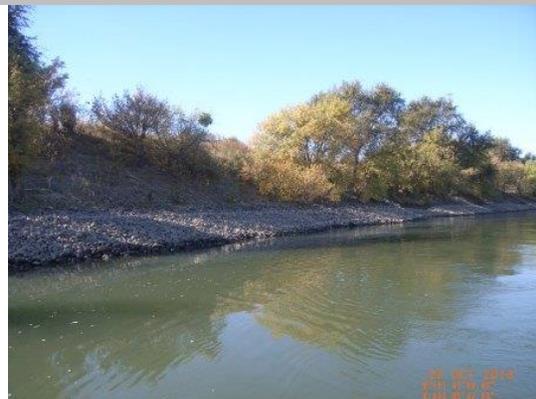
Photo 1 of 1 : SP_2016_NA0022_350_3_20160304_00002.jpg

LM Start	4.66	Rating **	M	Issue No.	3
LM End	4.86	Issue Type +	Ma	Location *	WS
Category	Supplemental		GPS Latitude/Longitude		
			Start	End	
Item	2015 USACE Erosion Survey, DRAFT		38.763486°	38.763313°	
			-121.687567°	-121.684038°	
DWR ID	DWR_NA0022_01_s_2016_3				
Comment Code					
Inspector Comment					
2009 - Erosion into the levee toe. Some cobbles have been dumped into the erosion pockets. 2010 - Old cobble site starting to unravel. 2012 - Slope continues to steepen and new animal holes. 2013 - Downstream cobble is unraveling. 2015: No observed changes. [2015 Site ID: SAC_85-4_R]

USACE 2013 Photo #1

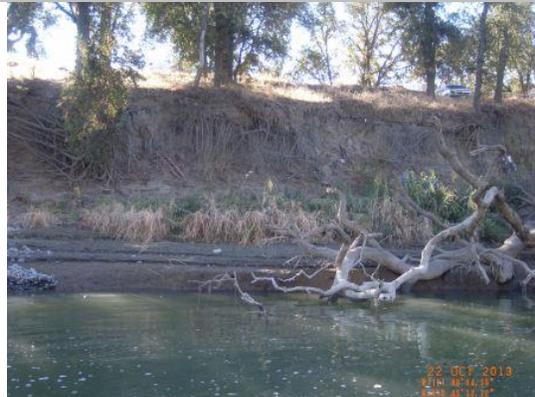
Photo 1 of 3 : SP_2016_NA0022_350_4_20160304_00003.jpg

LM Start	5.67	Rating **	M	Issue No.	4
LM End	5.85	Issue Type +	Ma	Location *	WS
Category	Supplemental			GPS Latitude/Longitude	
				Start	End
Item	2015 USACE Erosion Survey, DRAFT			38.759000 °	38.759390 °
				-121.670759 °	-121.667500 °
DWR ID	DWR_NA0022_01_s_2016_4				
Comment Code					
Inspector Comment					
2006 - Approximately 18 to 20 ft of bank near levee at the corner of the levee and the Freemont Weir. Vertical bank with undercutting/mass failure. 2007 - Staked at top of bank for monitoring. 2011 - Site has become significantly worse with more of the toe and lower bank eroded. Many trees have fallen since last year. 2012 - Site looks worse with more erosion around trees. 2013 - Additional erosion into the toe. 2015: Site extended upstream about 500 ft to account for eroding bank. [2015 Site ID: SAC_83-9_R]

USACE 2013 Photo #1

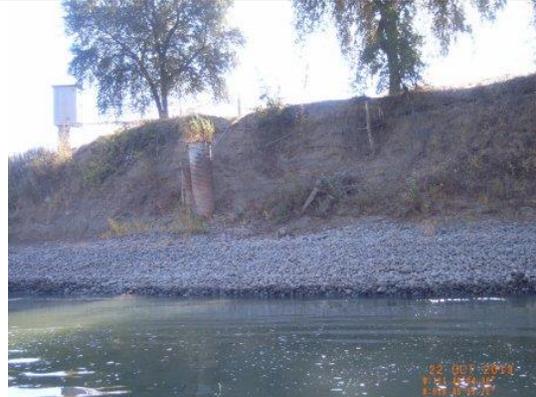
Photo 2 of 3 : SP_2016_NA0022_350_4_20160304_00004.jpg

LM Start	5.67	Rating **	M	Issue No.	4 (cont)
LM End	5.85	Issue Type +	Ma	Location *	WS
Category	Supplemental			GPS Latitude/Longitude	
				Start	End
Item	2015 USACE Erosion Survey, DRAFT			38.759000 °	38.759390 °
				-121.670759 °	-121.667500 °
DWR ID	DWR_NA0022_01_s_2016_4				
Comment Code					
Inspector Comment					
2006 - Approximately 18 to 20 ft of bank near levee at the corner of the levee and the Fremont Weir. Vertical bank with undercutting/mass failure. 2007 - Staked at top of bank for monitoring. 2011 - Site has become significantly worse with more of the toe and lower bank eroded. Many trees have fallen since last year. 2012 - Site looks worse with more erosion around trees. 2013 - Additional erosion into the toe. 2015: Site extended upstream about 500 ft to account for eroding bank. [2015 Site ID: SAC_83-9_R]

USACE 2013 Photo #2

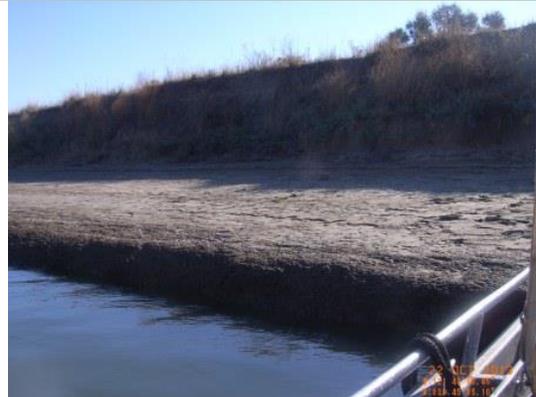
Photo 3 of 3 : SP_2016_NA0022_350_4_20160304_00005.jpg

USACE 2013 Photo #3
