**Flood Control Project Maintenance
Levee Inspections**
LMA District Cover Sheet
Spring 2014 Levee Inspection Results
Yolo County Service Area 6

**Flood Control Project Maintenance
Levee Inspections
Unit Cover Sheet
Spring 2014 Levee Inspection Results
Yolo County Service Area 6**

Waterway	Bank	Unit Miles
Unit No. 01 Right Bank of Sacramento River at Knights Landing	Right	5.97

Levee Inspection Report By Mile - Spring 2014

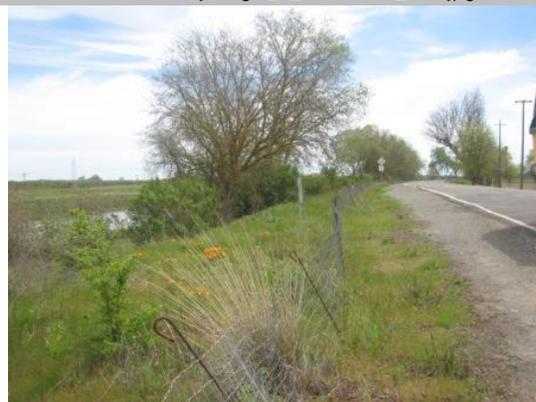
Photo 3 of 3 : johngw_s_20140414_157.jpg

LM Start	4.31	Rating **	A/W	Issue No.	36 (cont)
LM End	4.57	Issue Type +	Ma	Location *	WS

Another view of the site.

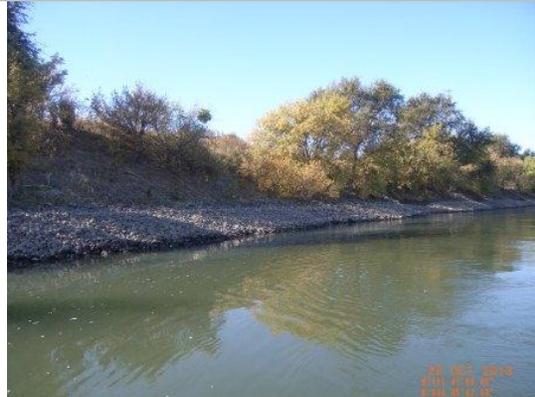
Photo 1 of 1 : USACE2013A_SAC_85-4_R_5.jpg

LM Start	4.44	Rating **	M	Issue No.	4
LM End	5.04	Issue Type +	Ma	Location *	WS
Category	Supplemental		GPS Latitude/Longitude		
			Start	End	
Item	USACE Erosion Survey		38.763486 °	38.763313 °	
			-121.687567 °	-121.684038 °	
DWR ID					
Action/Comments					
Inspector Comments: 2009 - Erosion into the levee toe. Some cobbles

USACE 2013 Photo #1
