**Flood Control Project Maintenance
Levee Inspections**

2010 Channel Summary Report

Fairfield Suisun Sewer District

2010 Channel Inspection Results

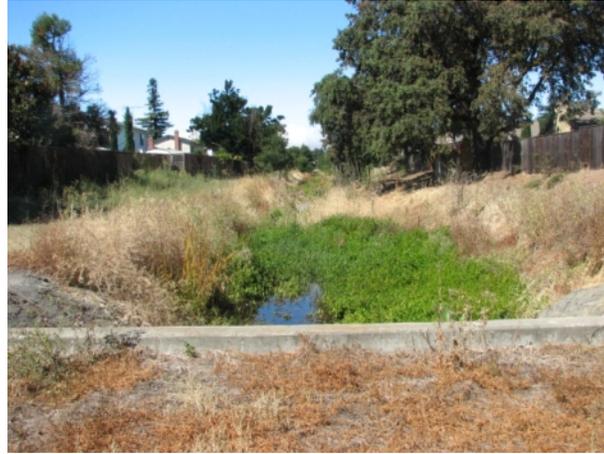
Levee Mile Report Line	1
Start Levee Mile	0.00
End Levee Mile	0.00
Location	
Category	Channels
Item	Vegetation & Obstructions
Outlet from detention basin to Ledgewood Creek in parking lot off Oliver Rd. Coordinates: 38.257797 -122.069687	
johngw_c_20100811_107.jpg

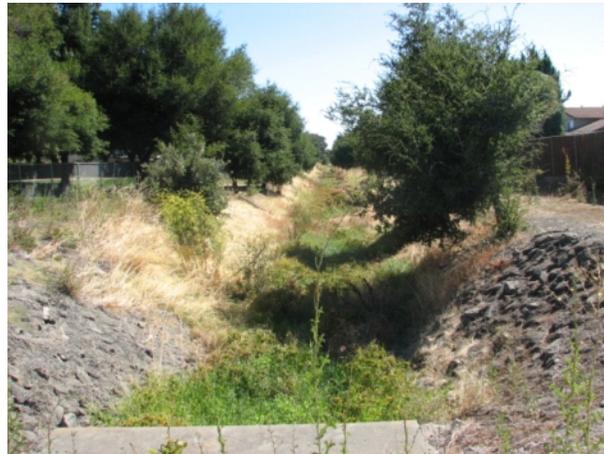
Levee Mile Report Line	1
Start Levee Mile	0.00
End Levee Mile	0.00
Location	
Category	Channels
Item	Vegetation & Obstructions
View is looking upstream at Astoria Dr.	
johngw_c_20100811_108.jpg

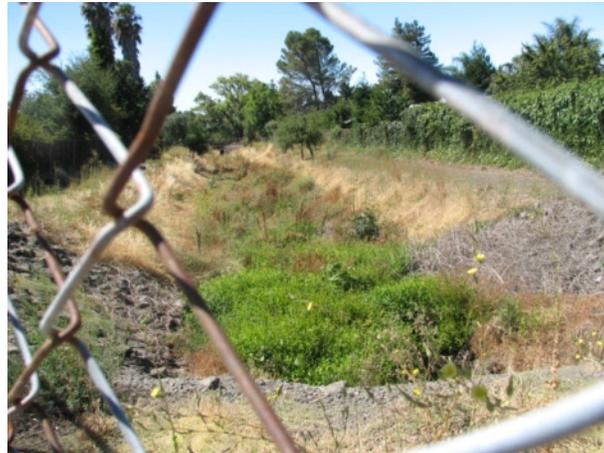
Levee Mile Report Line	6
Start Levee Mile	0.00
End Levee Mile	0.00
Location	
Category	Channels
Item	Vegetation & Obstructions
View is looking downstream at Astoria Dr.	
johngw_c_20100811_109.jpg

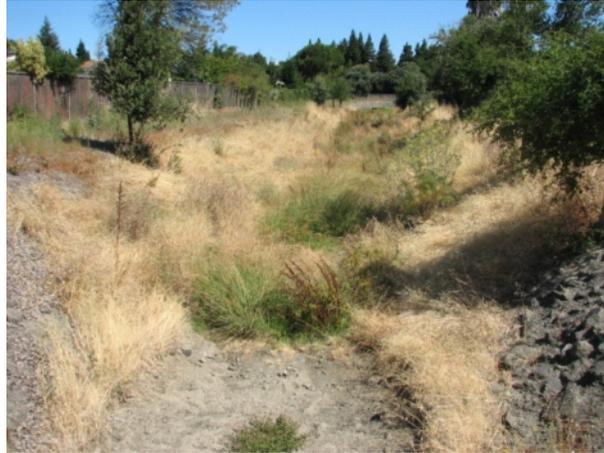
Levee Mile Report Line	11
Start Levee Mile	
End Levee Mile	
Location	
Category	Channels
Item	Vegetation & Obstructions
View is looking upstream at Springfield Dr.	
johngw_c_20100811_110.jpg

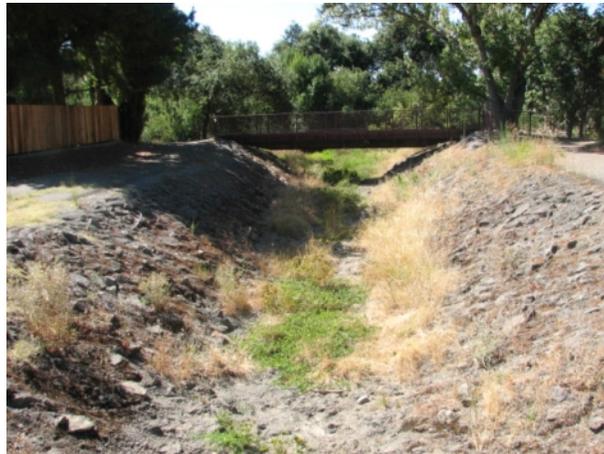
Levee Mile Report Line	16
Start Levee Mile	
End Levee Mile	
Location	
Category	Channels
Item	Vegetation & Obstructions
View is looking downstream at Springfield Dr.	
johngw_c_20100811_111.jpg

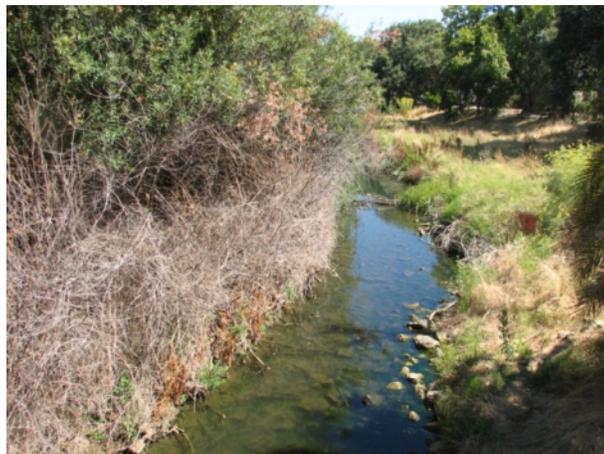
Levee Mile Report Line	21
Start Levee Mile	0.00
End Levee Mile	0.00
Location	
Category	Channels
Item	Vegetation & Obstructions
View is looking upstream at Rockville Rd.	
johngw_c_20100811_112.jpg

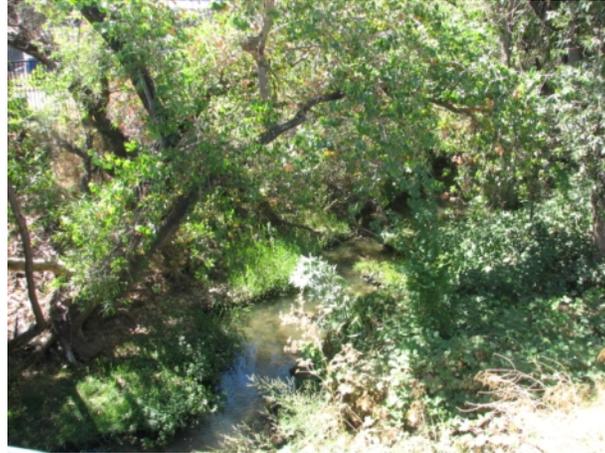
Levee Mile Report Line	26
Start Levee Mile	0.00
End Levee Mile	0.00
Location	
Category	Channels
Item	Vegetation & Obstructions
View is looking downstream at Rockville Rd.	
johngw_c_20100811_113.jpg

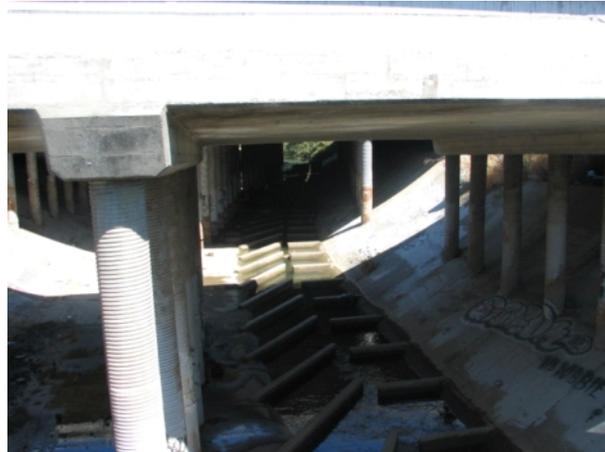
Levee Mile Report Line	31
Start Levee Mile	0.00
End Levee Mile	0.00
Location	
Category	Channels
Item	Vegetation & Obstructions
view is looking upstream at Auto Mall Parkway	
johngw_c_20100811_114.jpg

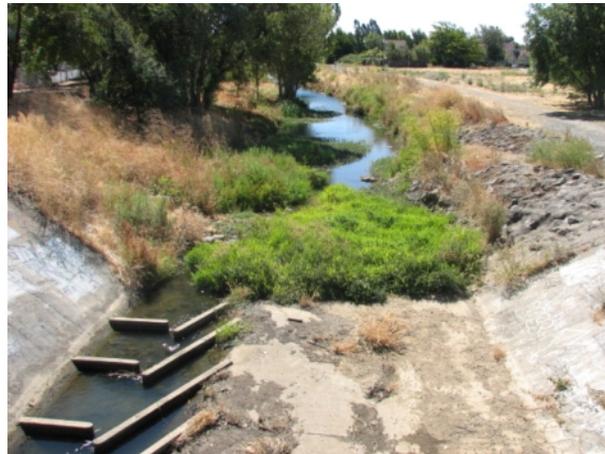
Levee Mile Report Line	37
Start Levee Mile	0.00
End Levee Mile	0.00
Location	
Category	Channels
Item	Vegetation & Obstructions
view is looking downstream at Auto Mall Parkway	
johngw_c_20100811_115.jpg

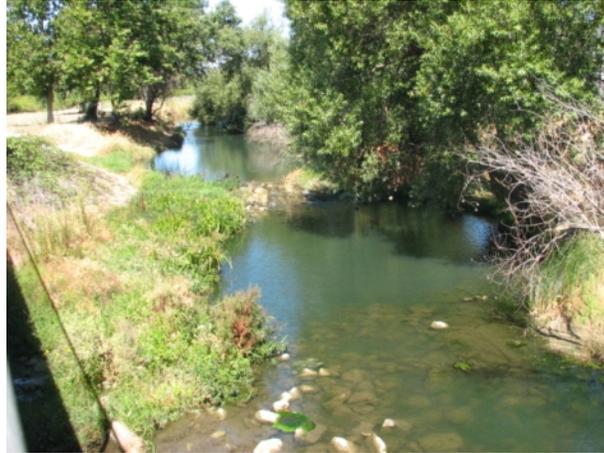
Levee Mile Report Line	42
Start Levee Mile	0.00
End Levee Mile	0.00
Location	
Category	Channels
Item	Vegetation & Obstructions
View is looking upstream at Woolner Ave	
johngw_c_20100811_116.jpg

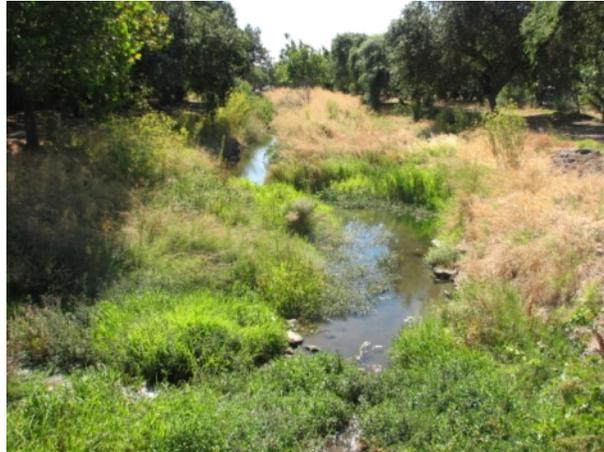
Levee Mile Report Line	47
Start Levee Mile	0.00
End Levee Mile	0.00
Location	
Category	Channels
Item	Vegetation & Obstructions
View is looking downstream at Woolner Ave.	
johngw_c_20100811_117.jpg

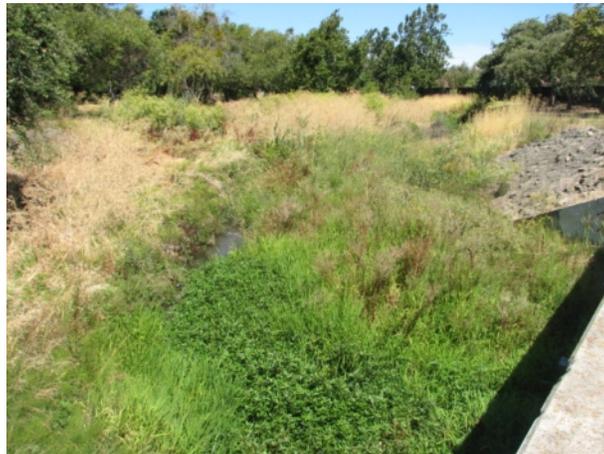
Levee Mile Report Line	52
Start Levee Mile	0.00
End Levee Mile	0.00
Location	
Category	Channels
Item	Vegetation & Obstructions
View is looking upstream at Beck Ave.	
johngw_c_20100811_118.jpg

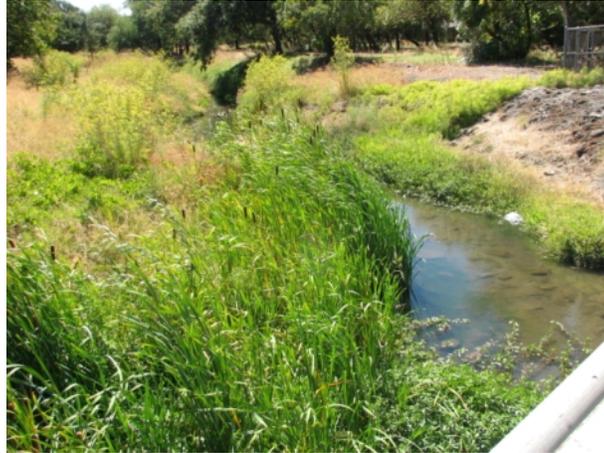
Levee Mile Report Line	57
Start Levee Mile	0.00
End Levee Mile	0.00
Location	
Category	Channels
Item	Vegetation & Obstructions
View is looking downstream at Beck Ave.	
johngw_c_20100811_119.jpg

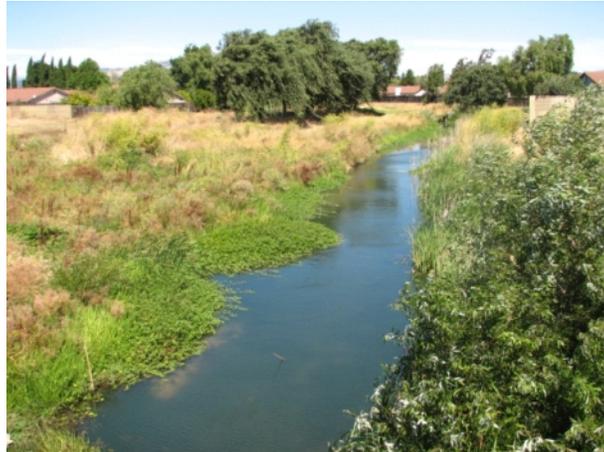
Levee Mile Report Line	62
Start Levee Mile	0.00
End Levee Mile	0.00
Location	
Category	Channels
Item	Vegetation & Obstructions
View is looking upstream at Hwy 12	
johngw_c_20100811_120.jpg

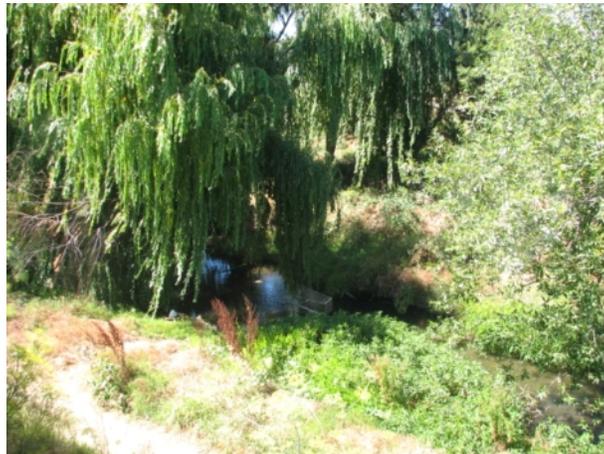
Levee Mile Report Line	67
Start Levee Mile	0.00
End Levee Mile	0.00
Location	
Category	Channels
Item	Vegetation & Obstructions
View is looking downstream at Hwy 12	
johngw_c_20100811_121.jpg

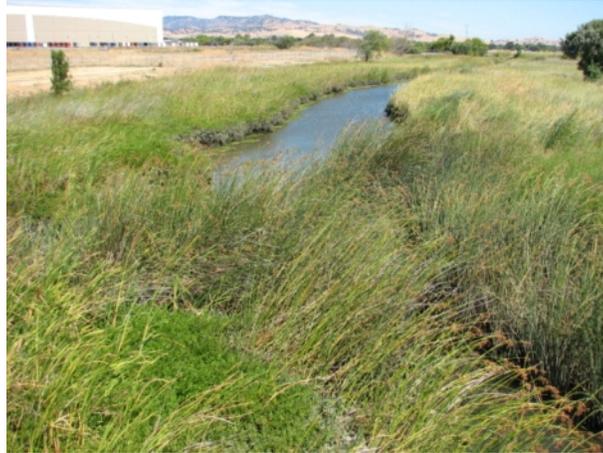
Levee Mile Report Line	72
Start Levee Mile	0.00
End Levee Mile	0.00
Location	
Category	Channels
Item	Vegetation & Obstructions
View is looking upstream at Cordelia Rd.	
johngw_c_20100811_122.jpg

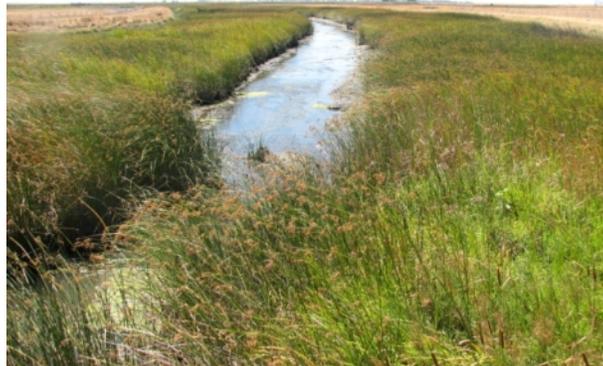
Levee Mile Report Line	77
Start Levee Mile	0.00
End Levee Mile	0.00
Location	
Category	Channels
Item	Vegetation & Obstructions
View is looking downstream towards Suisun Bay at Cordelia Rd.	
johngw_c_20100811_123.jpg

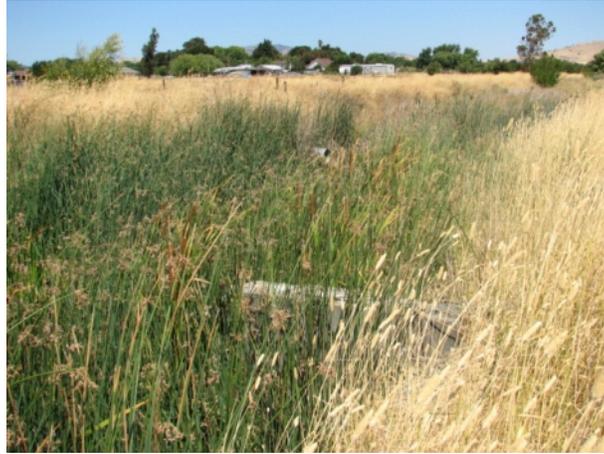
LMR No.	Check Point	View	Item	Location	Rating	Inspector Comment	GPS Latitude & Longitude	Photo	Issue No
1	Bella Vista Dr	Up	Vegetation & Obstructions		M	Inspector Comments: Cattails are in the channel and need to spray.	38.253280 ° -122.000670 °	Y	1
2		Up	Shoaling / Sedimentation		A		38.253280 ° -122.000670 °		2
3		Up	Erosion / Bank Caving		A		38.253280 ° -122.000670 °		3
4		Up	Revetments		M		38.253280 ° -122.000670 °		4
5		Up	Encroachments		A		38.253280 ° -122.000670 °		5
6		Down	Vegetation & Obstructions		M	Inspector Comments: Cattails are in the channel and need to spray.	38.253280 ° -122.000670 °	Y	6
7		Down	Shoaling / Sedimentation		A		38.253280 ° -122.000670 °		7
8		Down	Erosion / Bank Caving		A		38.253280 ° -122.000670 °		8
9		Down	Revetments		M		38.253280 ° -122.000670 °		9
10		Down	Encroachments		A		38.253280 ° -122.000670 °		10
11	Emperor Dr	Up	Vegetation & Obstructions		A		38.250738 ° -122.004355 °	Y	11

Levee Mile Report Line	1
Start Levee Mile	0.00
End Levee Mile	0.00
Location	
Category	Channels
Item	Vegetation & Obstructions
Upstream view at Bella Vista Dr.	
johngw_c_20100805_071.jpg

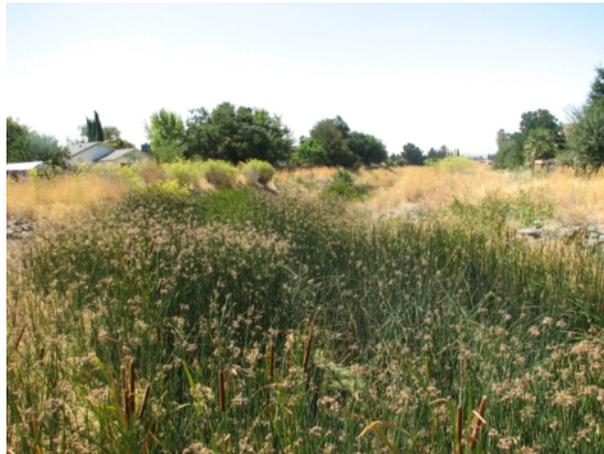
Levee Mile Report Line	6
Start Levee Mile	0.00
End Levee Mile	0.00
Location	
Category	Channels
Item	Vegetation & Obstructions
Downstream view at Bella Vista Dr.	
johngw_c_20100805_072.jpg

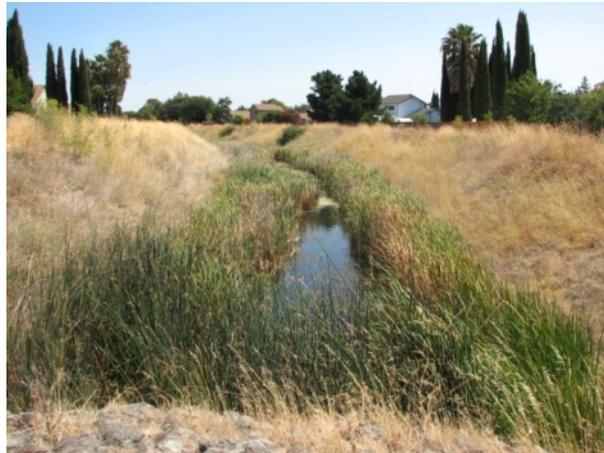
Levee Mile Report Line	11
Start Levee Mile	0.00
End Levee Mile	0.00
Location	
Category	Channels
Item	Vegetation & Obstructions
Upstream view at Emperor Dr.	
johngw_c_20100805_073.jpg

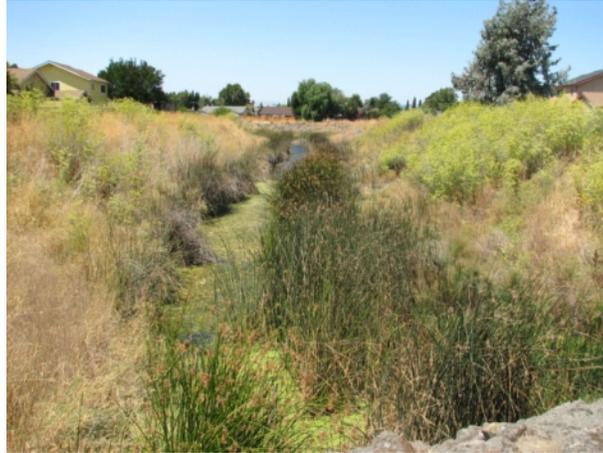
Levee Mile Report Line	16
Start Levee Mile	0.00
End Levee Mile	0.00
Location	
Category	Channels
Item	Vegetation & Obstructions
Downstream view at Emporer Dr.	
johngw_c_20100805_074.jpg

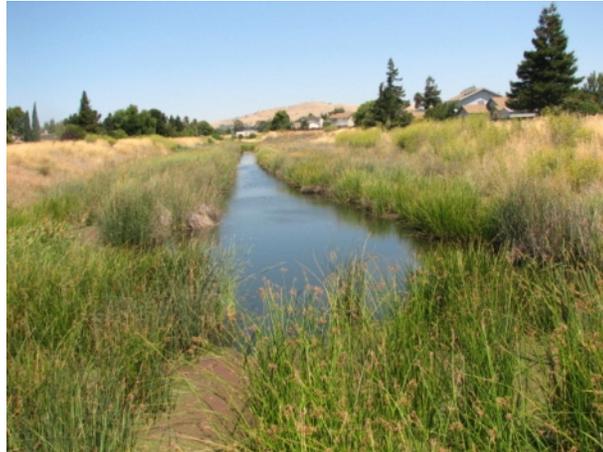
Levee Mile Report Line	21
Start Levee Mile	0.00
End Levee Mile	0.00
Location	
Category	Channels
Item	Vegetation & Obstructions
Upstream view at Pintail Dr.	
johngw_c_20100805_075.jpg

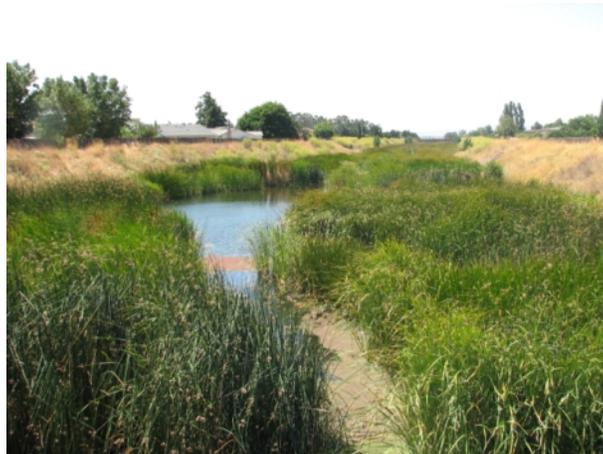
Levee Mile Report Line	26
Start Levee Mile	0.00
End Levee Mile	0.00
Location	
Category	Channels
Item	Vegetation & Obstructions
Downstream view at Pintail Dr.	
johngw_c_20100805_076.jpg

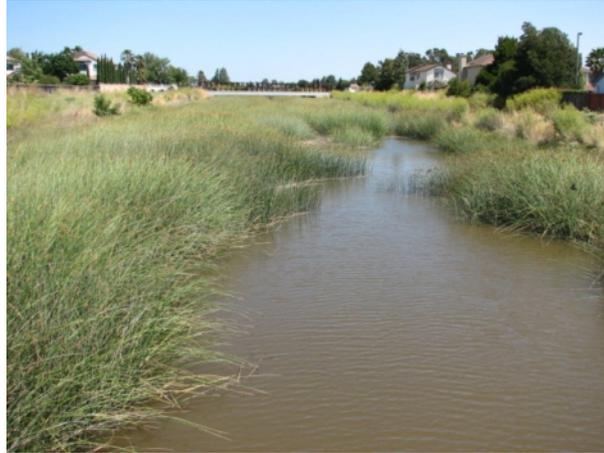
29		Down	Revetments		A		38.248542 ° -122.006378 °		29
30		Down	Encroachments		A		38.248542 ° -122.006378 °		30
31	Anderson Dr	Up	Vegetation & Obstructions		A	Inspector Comments: Cattails need to be cleared from bridge at least 50'.	38.241288 ° -122.012057 °	Y	31
32		Up	Shoaling / Sedimentation		A		38.241288 ° -122.012057 °		32
33		Up	Erosion / Bank Caving		A		38.241288 ° -122.012057 °		33

Levee Mile Report Line	31
Start Levee Mile	0.00
End Levee Mile	0.00
Location	
Category	Channels
Item	Vegetation & Obstructions
Upstream view at Anderson Dr. Highway12 in background	
johngw_c_20100805_077.jpg

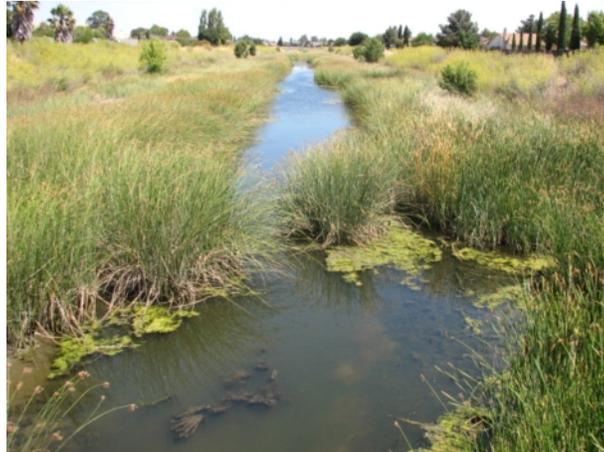
Levee Mile Report Line	31
Start Levee Mile	0.00
End Levee Mile	0.00
Location	
Category	Channels
Item	Vegetation & Obstructions
Upstream view at Highway 12	
johngw_c_20100805_078.jpg

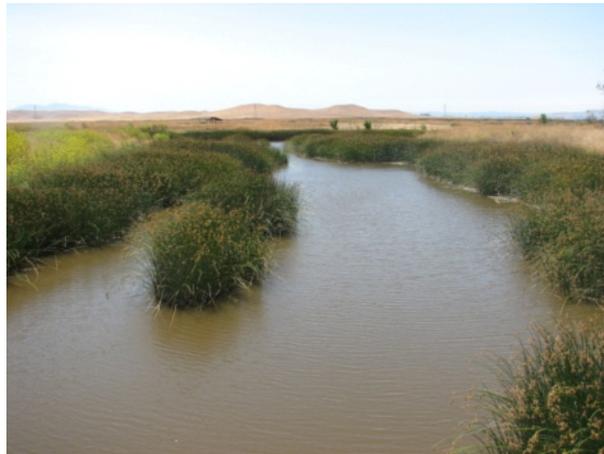
Levee Mile Report Line	36
Start Levee Mile	0.00
End Levee Mile	0.00
Location	
Category	Channels
Item	Vegetation & Obstructions
Downstream view at Anderson Dr.	
johngw_c_20100805_079.jpg

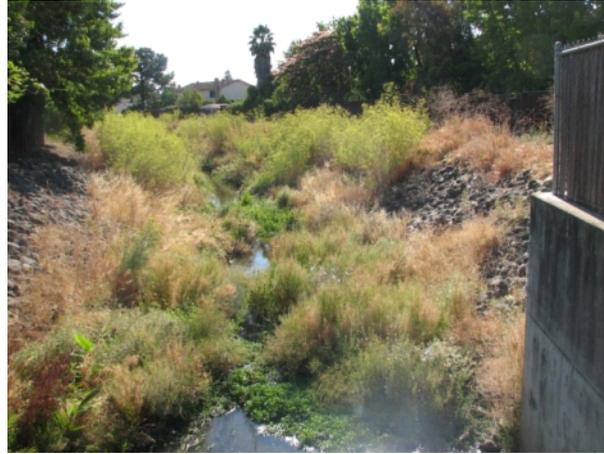
Levee Mile Report Line	6
Start Levee Mile	0.00
End Levee Mile	0.00
Location	
Category	Channels
Item	Vegetation & Obstructions
Downstream view at N. Texas Street.	
johngw_c_20100805_064.jpg

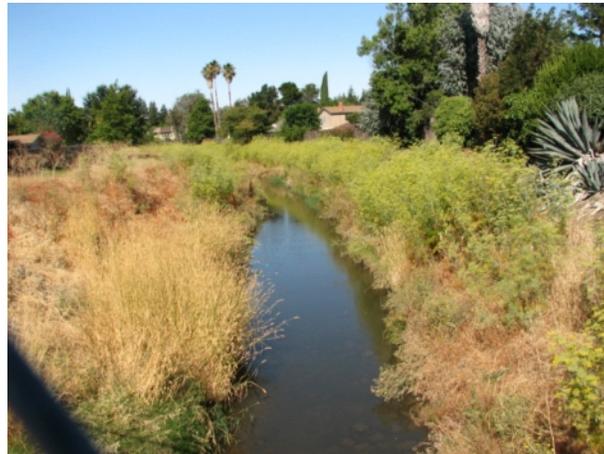
Levee Mile Report Line	11
Start Levee Mile	0.00
End Levee Mile	0.00
Location	
Category	Channels
Item	Vegetation & Obstructions
Upstream view at Camrose Ave.	
johngw_c_20100805_065.jpg

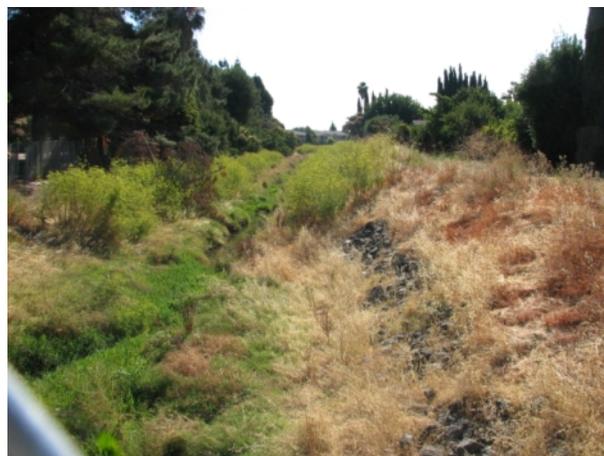
Levee Mile Report Line	16
Start Levee Mile	0.00
End Levee Mile	0.00
Location	
Category	Channels
Item	Vegetation & Obstructions
Downstream view at Camrose Ave.	
johngw_c_20100805_066.jpg

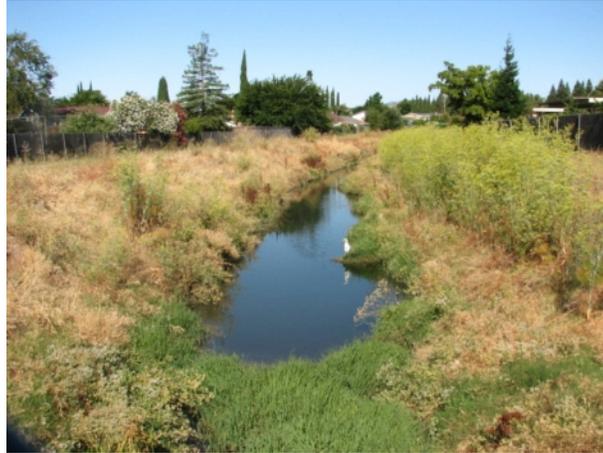
Levee Mile Report Line	21
Start Levee Mile	0.00
End Levee Mile	0.00
Location	
Category	Channels
Item	Vegetation & Obstructions
Upstream view at Dover Ave.	
johngw_c_20100805_067.jpg

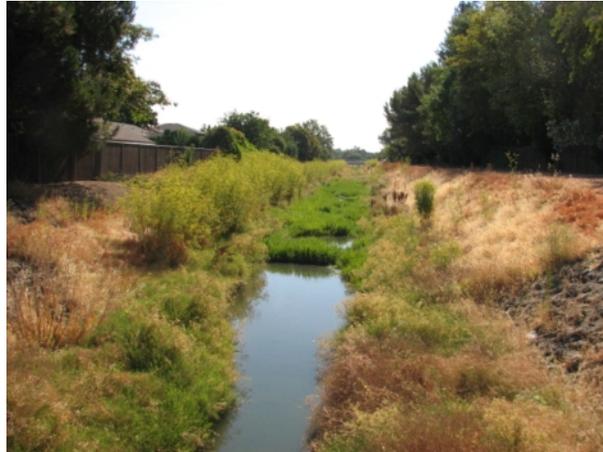
Levee Mile Report Line	26
Start Levee Mile	0.00
End Levee Mile	0.00
Location	
Category	Channels
Item	Vegetation & Obstructions
Downstream view at Dover Ave.	
johngw_c_20100805_068.jpg

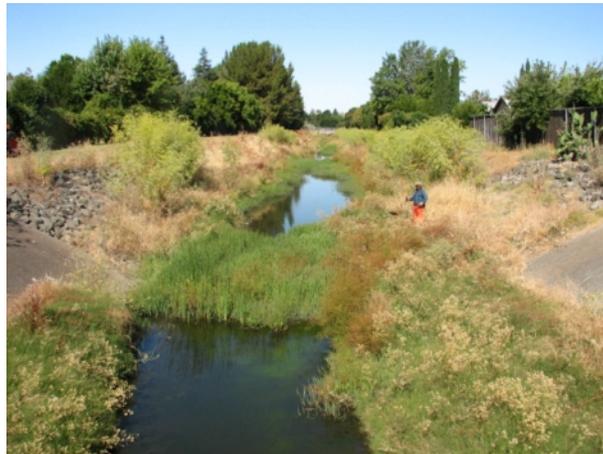
Levee Mile Report Line	31
Start Levee Mile	0.00
End Levee Mile	0.00
Location	
Category	Channels
Item	Vegetation & Obstructions
Upstream view at Gulf Dr.	
johngw_c_20100805_069.jpg

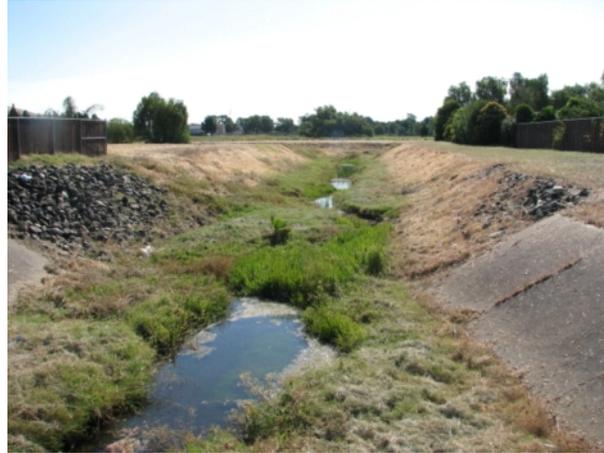
Levee Mile Report Line	36
Start Levee Mile	0.00
End Levee Mile	0.00
Location	
Category	Channels
Item	Vegetation & Obstructions
Downstream view at Gulf Dr.	
johngw_c_20100805_070.jpg
